# **ENGINEERING GEOLOGIC CHARACTERIZATION OF LEVEE FAILURES IN NEW ORLEANS DURING HURRICANE KATRINA**

**J. David Rogers, Ph.D., P.E., R.G.**

**Member, National Science Foundation Independent Levee Investigation Team and  
Karl F. Hasselmann Chair in Geological Engineering  
University of Missouri-Rolla**

**2006 Annual Meeting  
Association of Environmental and Engineering Geologists  
Boston, Massachusetts  
November 1, 2006**

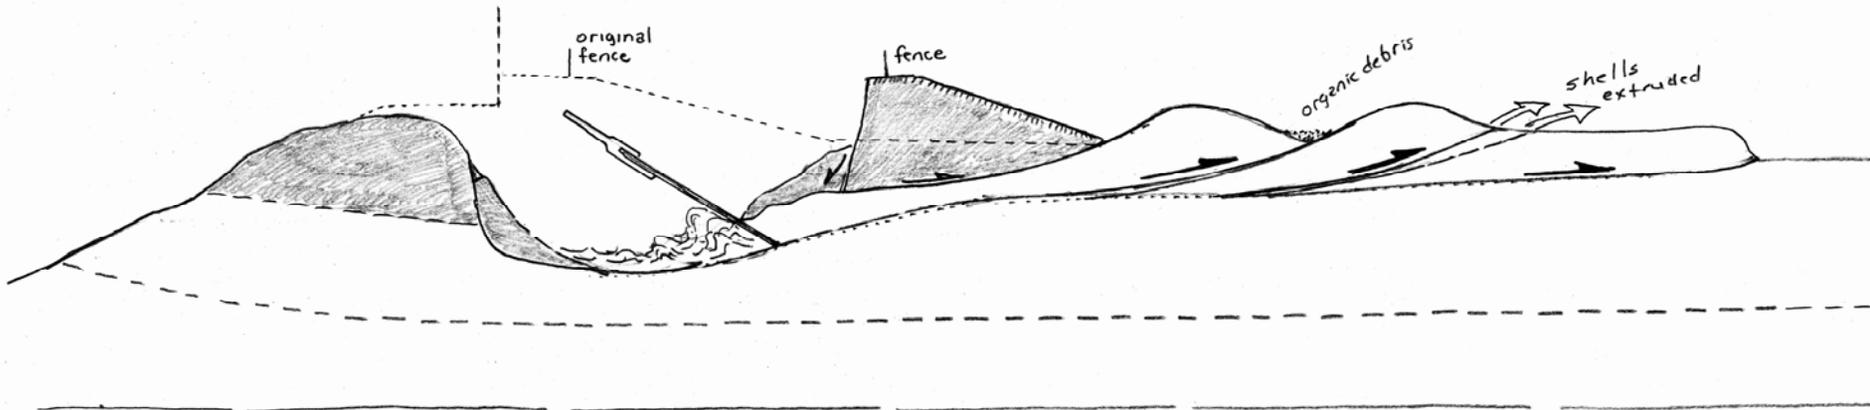
**Final stages of translational failure sequence. Lower section shows failed levee after 51 feet of displacement. The void was quickly backfilled with gravel as part of sealing the breach.**

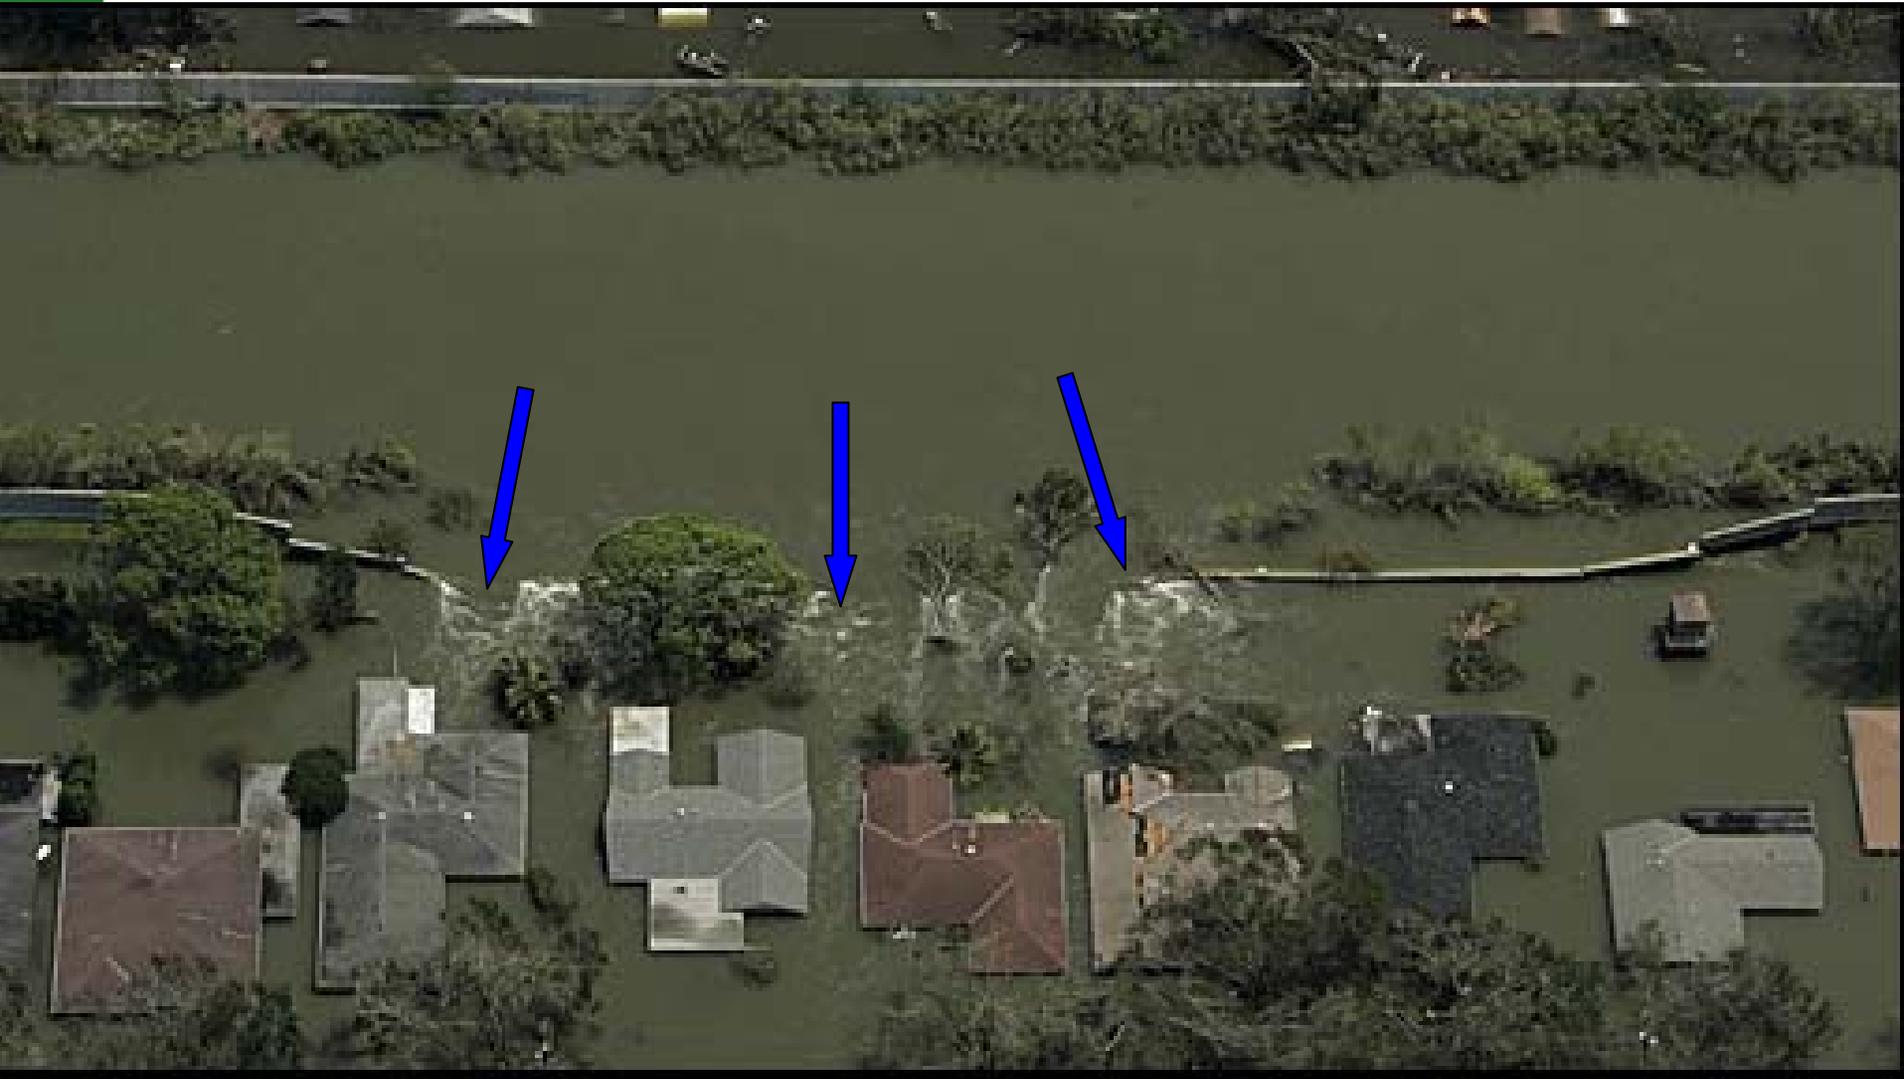
# London Avenue (North) breach

**Similar failure mechanism as 17<sup>th</sup> St Canal**

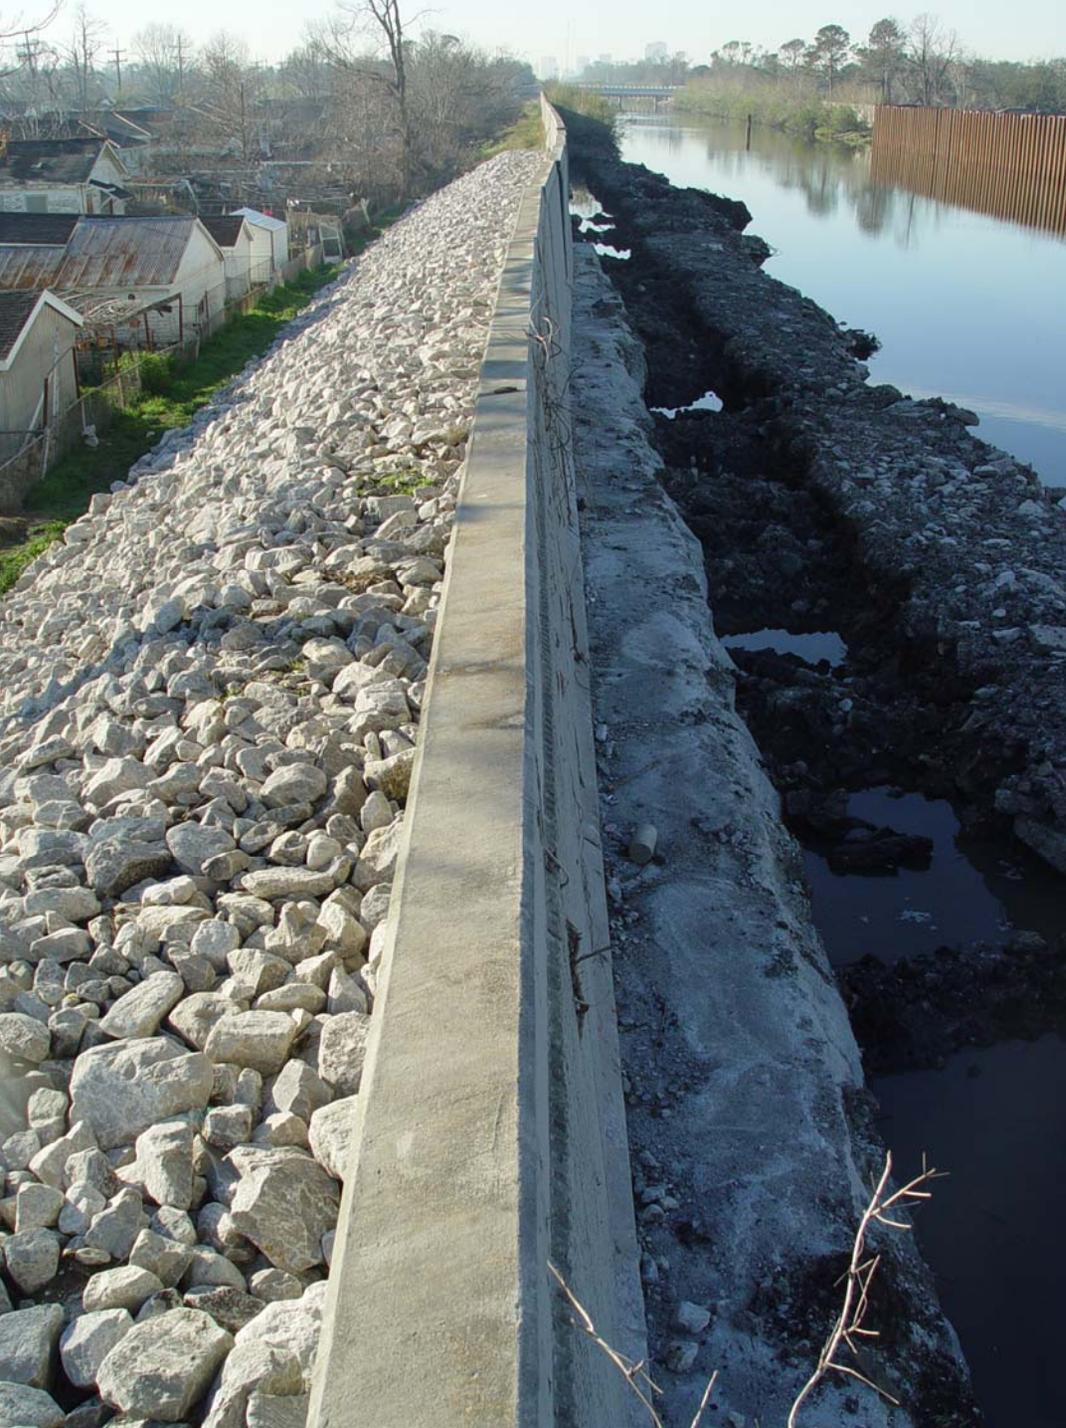
- **Tilted flood wall opposite the London Avenue North breach, at Robert E. Lee Blvd.**
- **Forensic scientists learn more from a partial failure than a complete one, because much of the critical evidence remains**

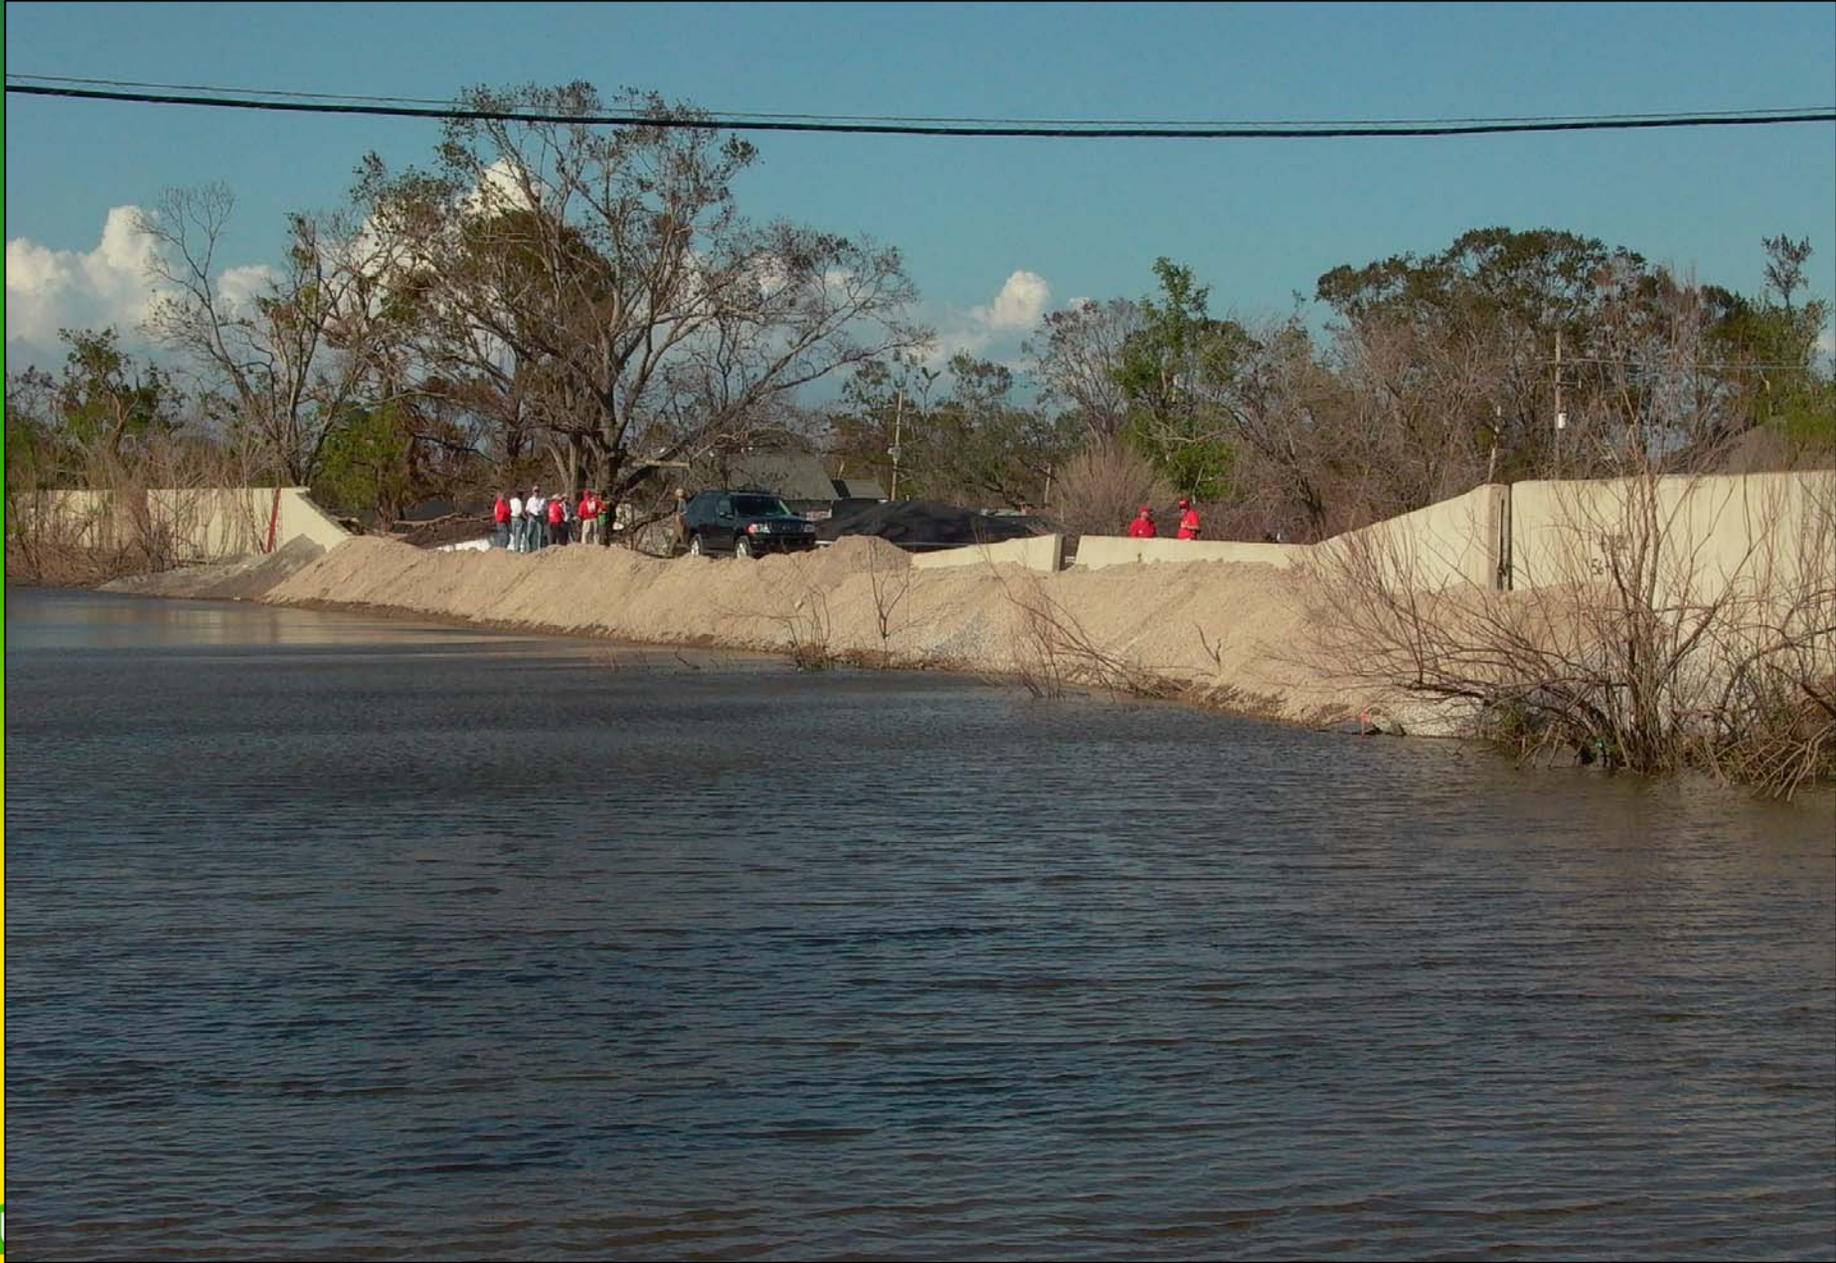
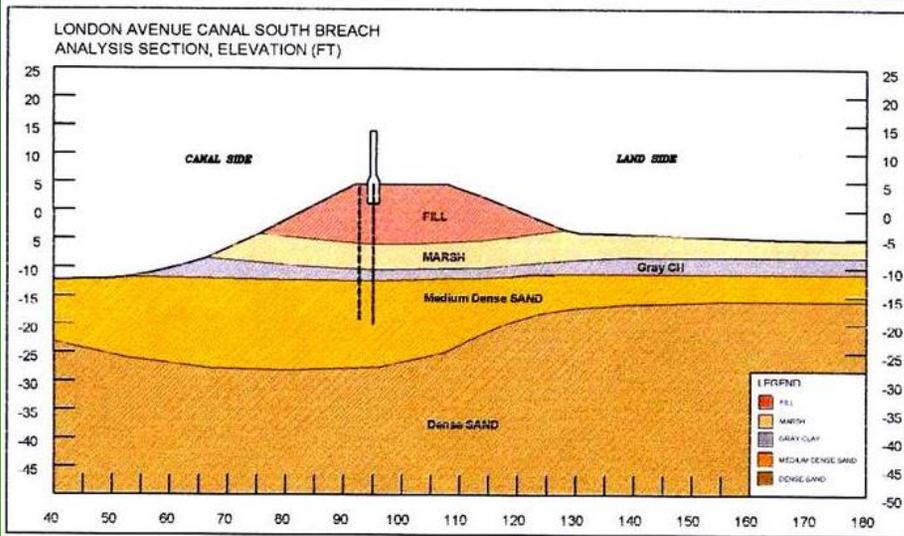
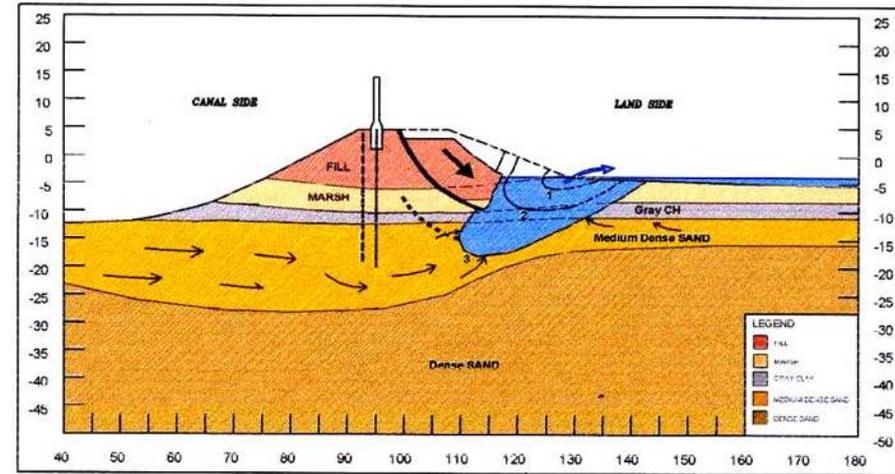
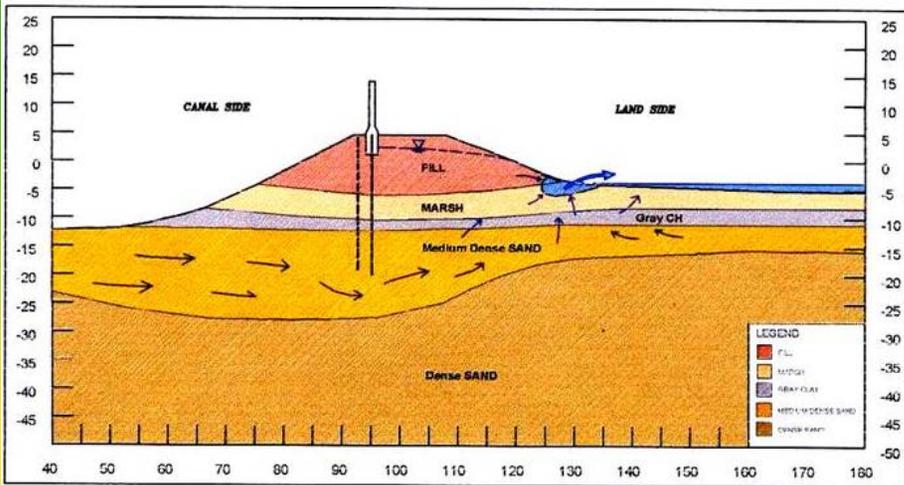
# London Avenue (South) breach

The South Breach of the London Avenue Canal was caused by **excess seepage pressures** developed in the sand underlying the canal, which had been dredged

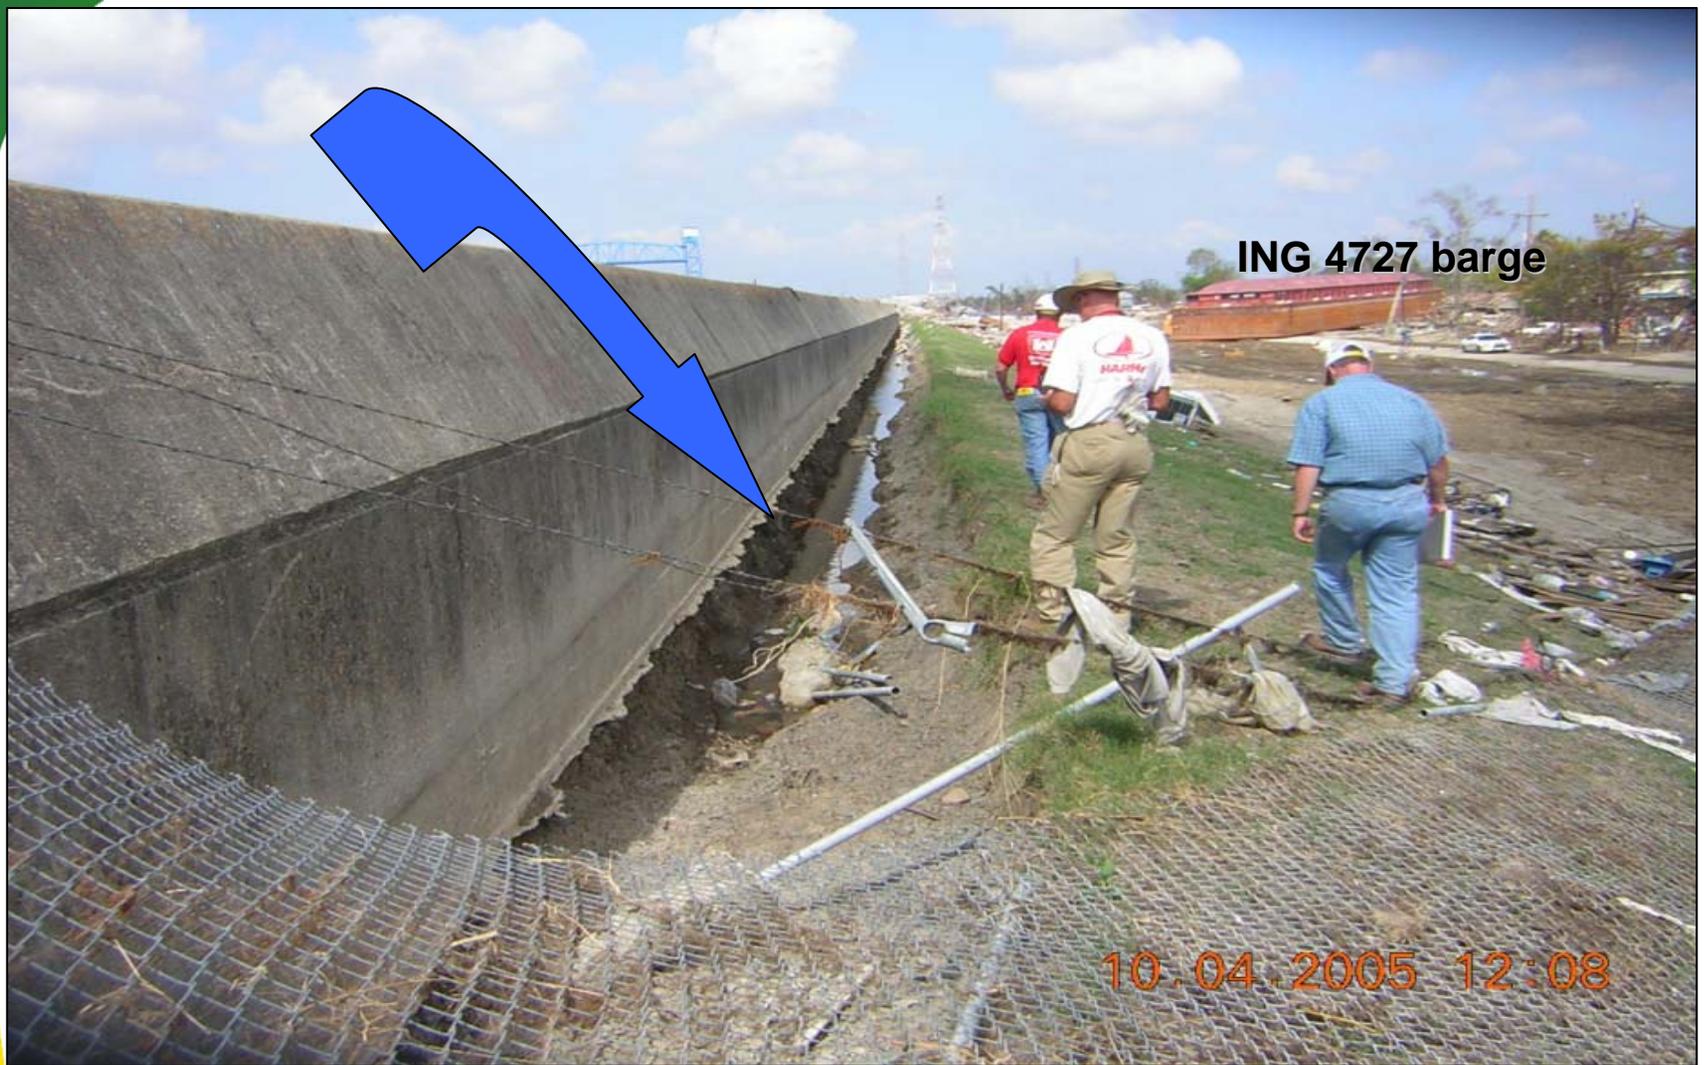
- **Some sections survived:** Evidence of sustained overtopping of concrete flood wall along the IHNC in the Lower Ninth Ward.

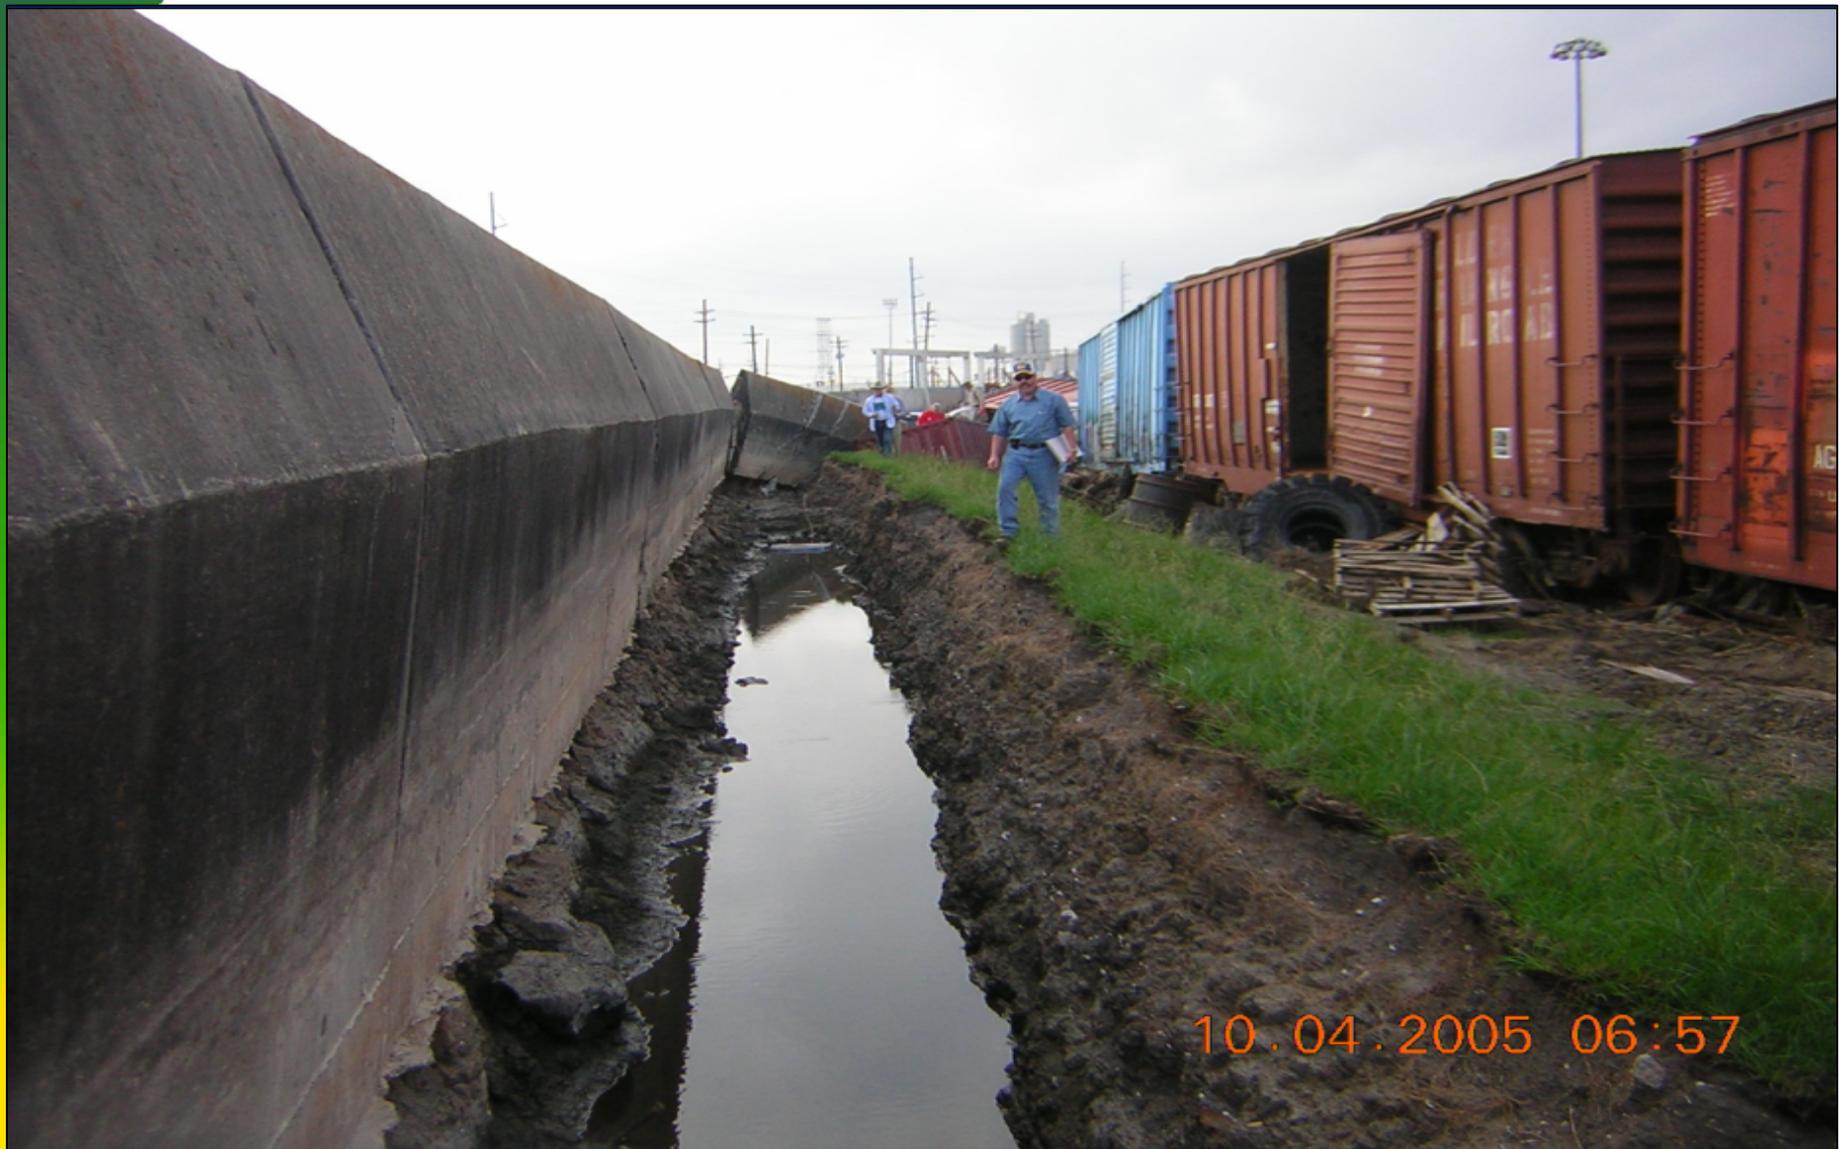
- **Overtopping scour holes along landside of flood wall on west side of the IHNC. Note broken wall in background. A splash pad on inboard side could have prevented this failure mode.**

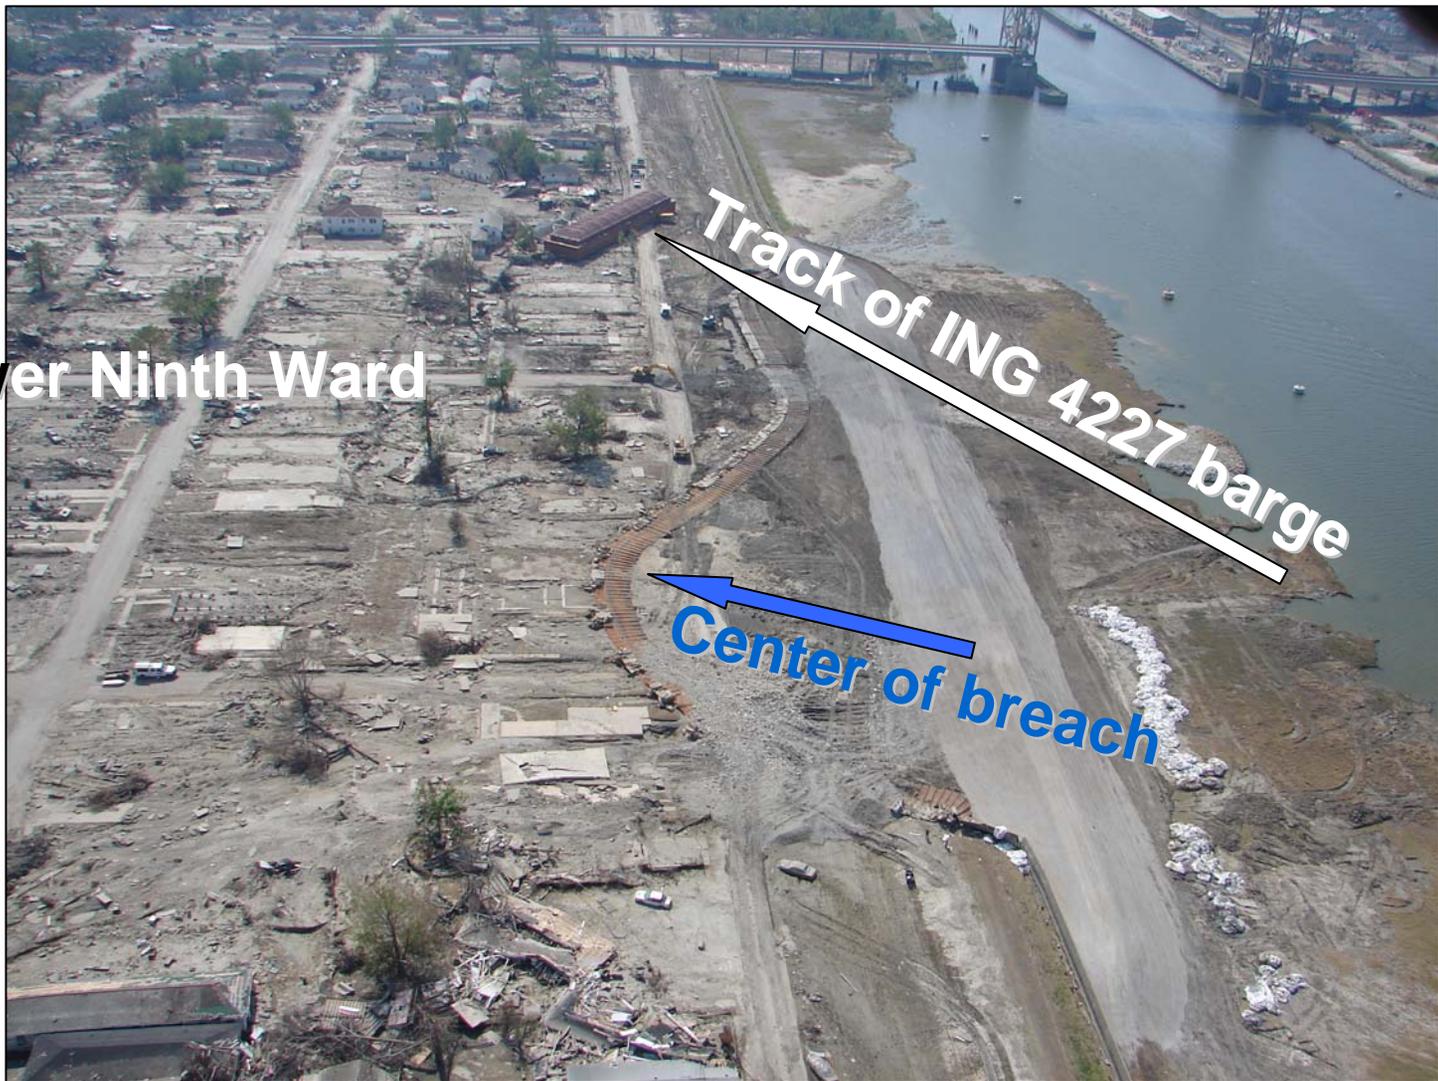
- **Aerial view of the south breach of the Inner Harbor Navigation Channel (IHNC) in the Lower Ninth Ward of New Orleans.**

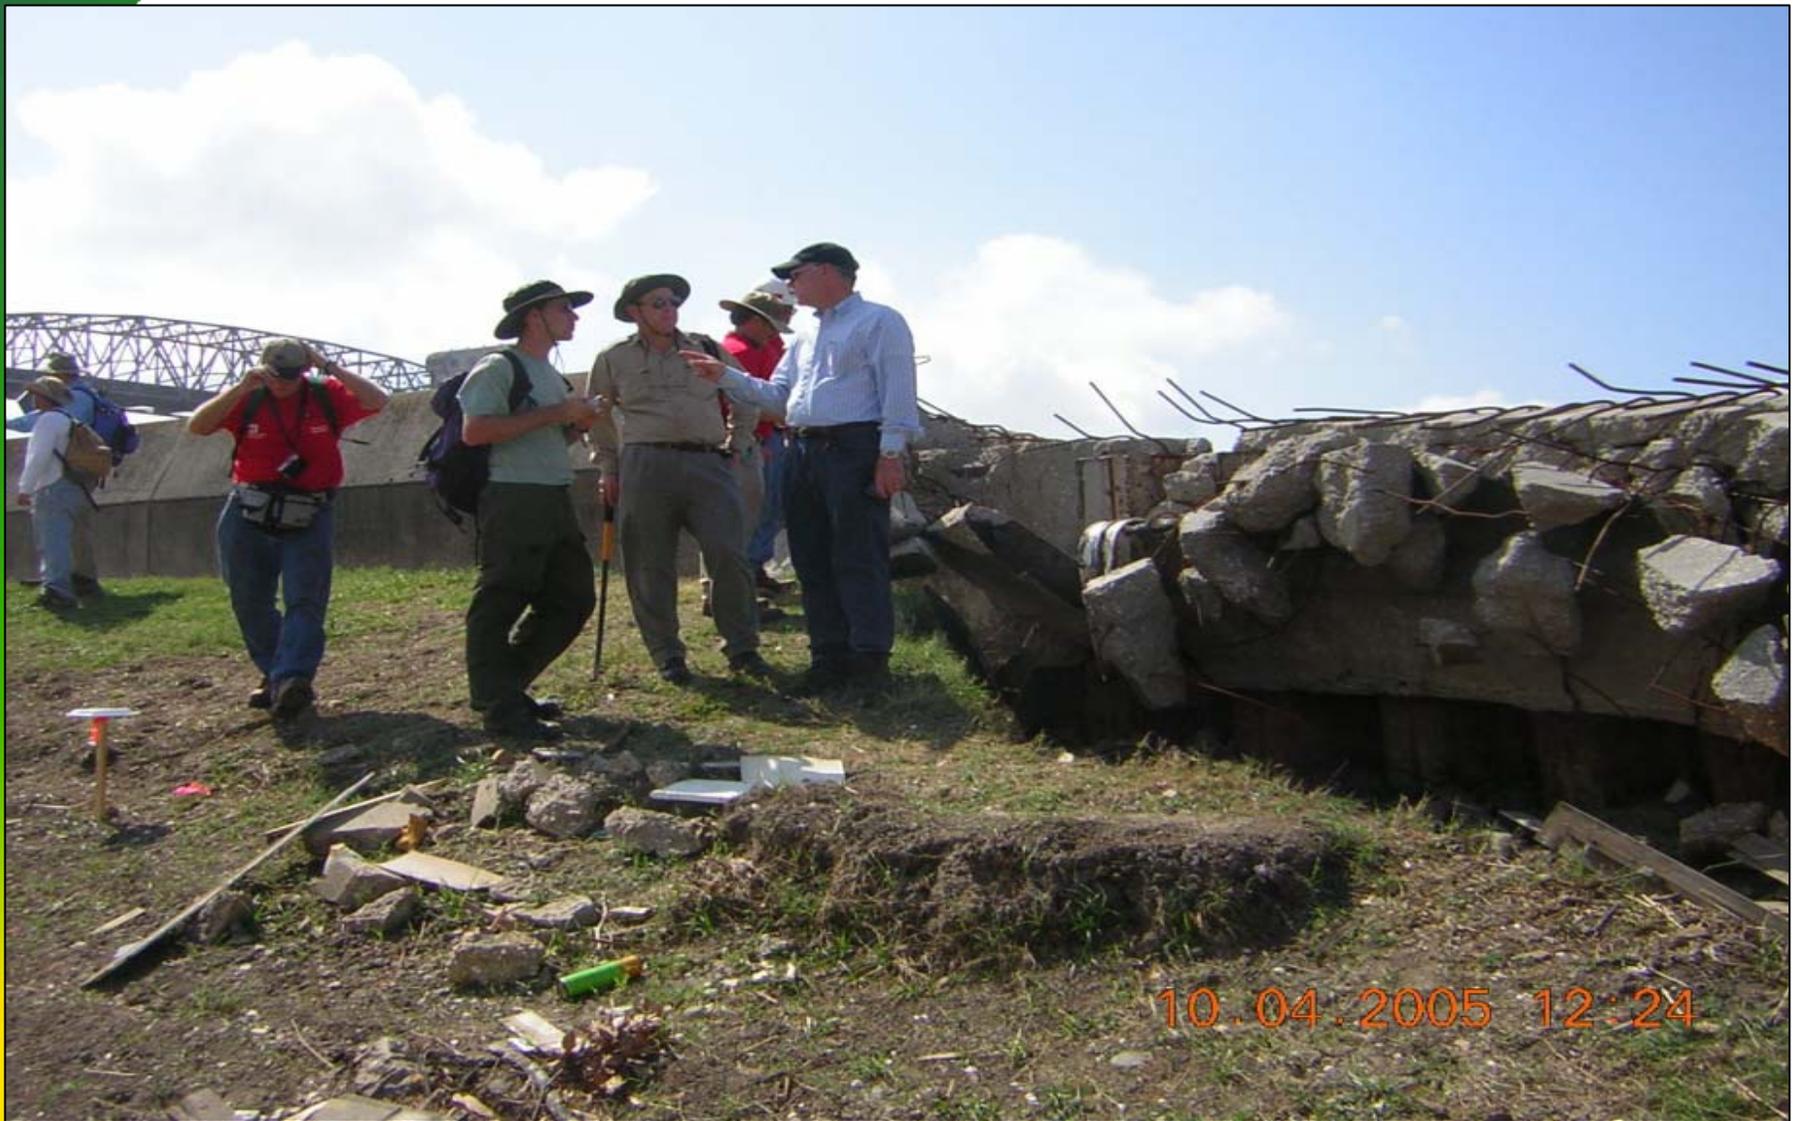
- **Damage to concrete flood wall where ING 4727 Barge collided with it, along the south side of the IHNC adjacent to the Lower Ninth Ward**

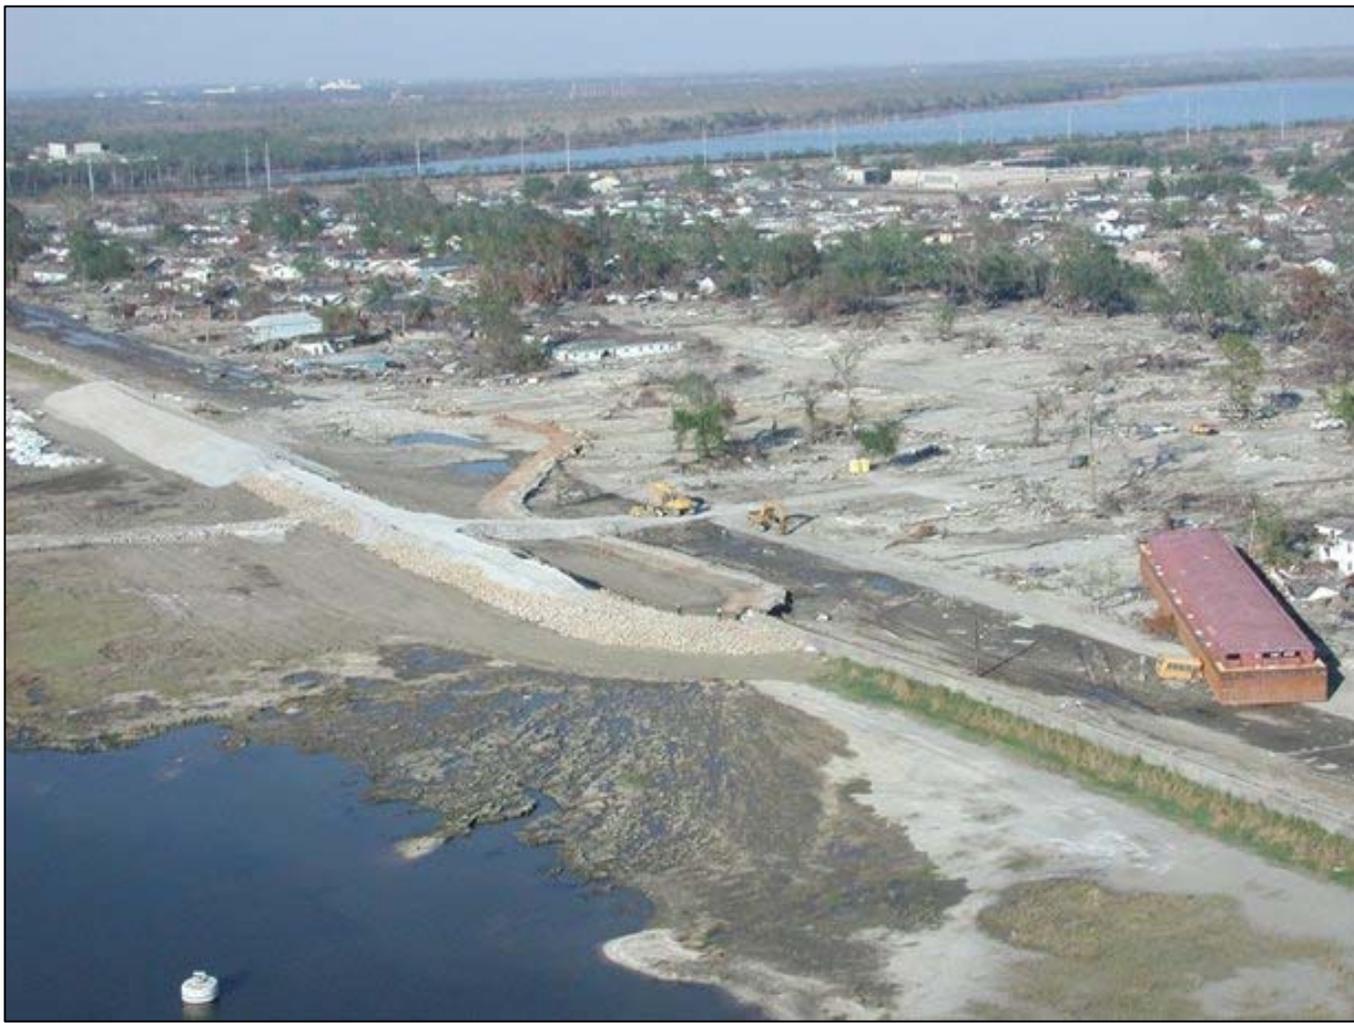
- **Seepage crevasse splay** exposed on the water side of the east levee of the IHNC breach after Hurricanes Katrina and Rita. **This same section of the IHNC levee failed in 1965 during Hurricane Betsy.**
- Note the **anomalous seepage** in lower foreground, which suggests much higher permeability in this particular portion of the dike, close to the south end of the failed section.

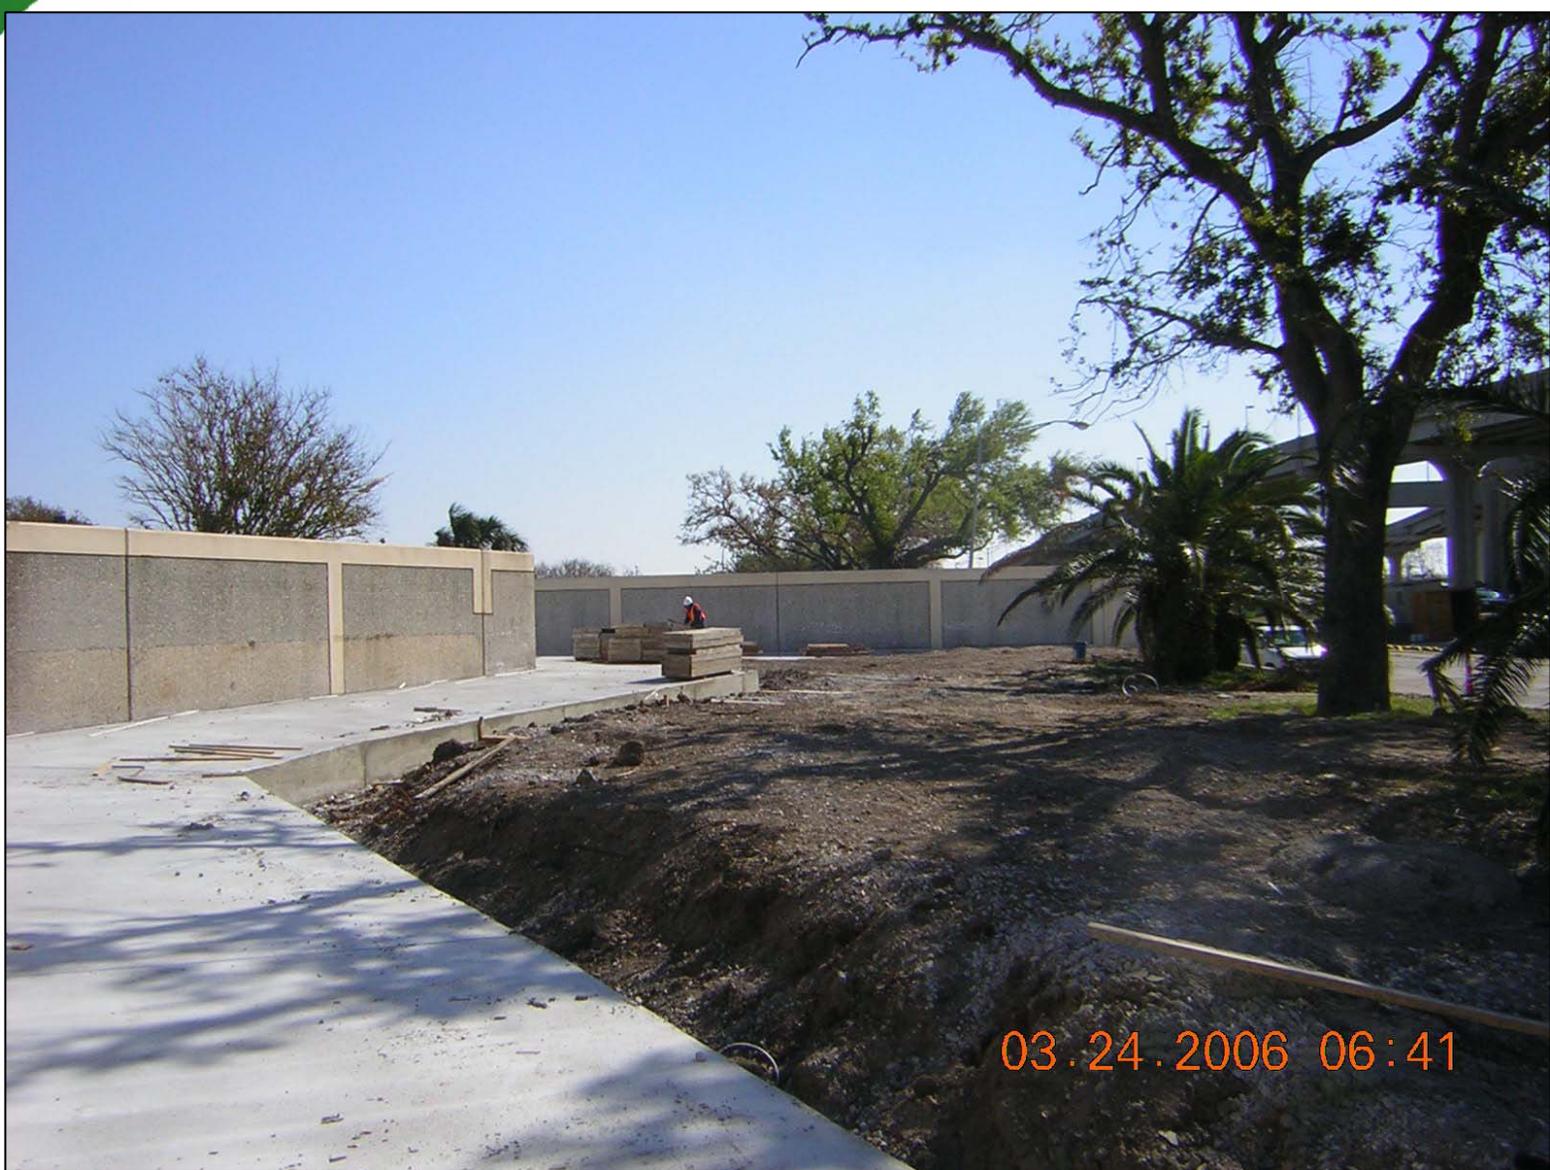
- It is impossible to accurately predict **actual flood surge heights**, because of a number of unknown factors
- Engineers have to select a flood height commensurate with **risk-consequence assessments** and **probabalistic analyses**.
- Consequences in a densely populated urban areas never a factor previously
- Flood control infrastructure, such as levees and flood walls, must be designed to withstand sustained overtopping.

Protective **concrete splash pads** would have protected the I-walls for about 0.5 % of the I-wall construction cost. They are being retrofitted to the flood walls. This is a cost-effective measure.
