REASSESSMENT OF THE ST. FRANCIS DAM FAILURE

J. David Rogers

CE and Engineering Geologist
Rogers/Pacific, Inc.
396 Civic Drive
Pleasant Hill, CA 94523

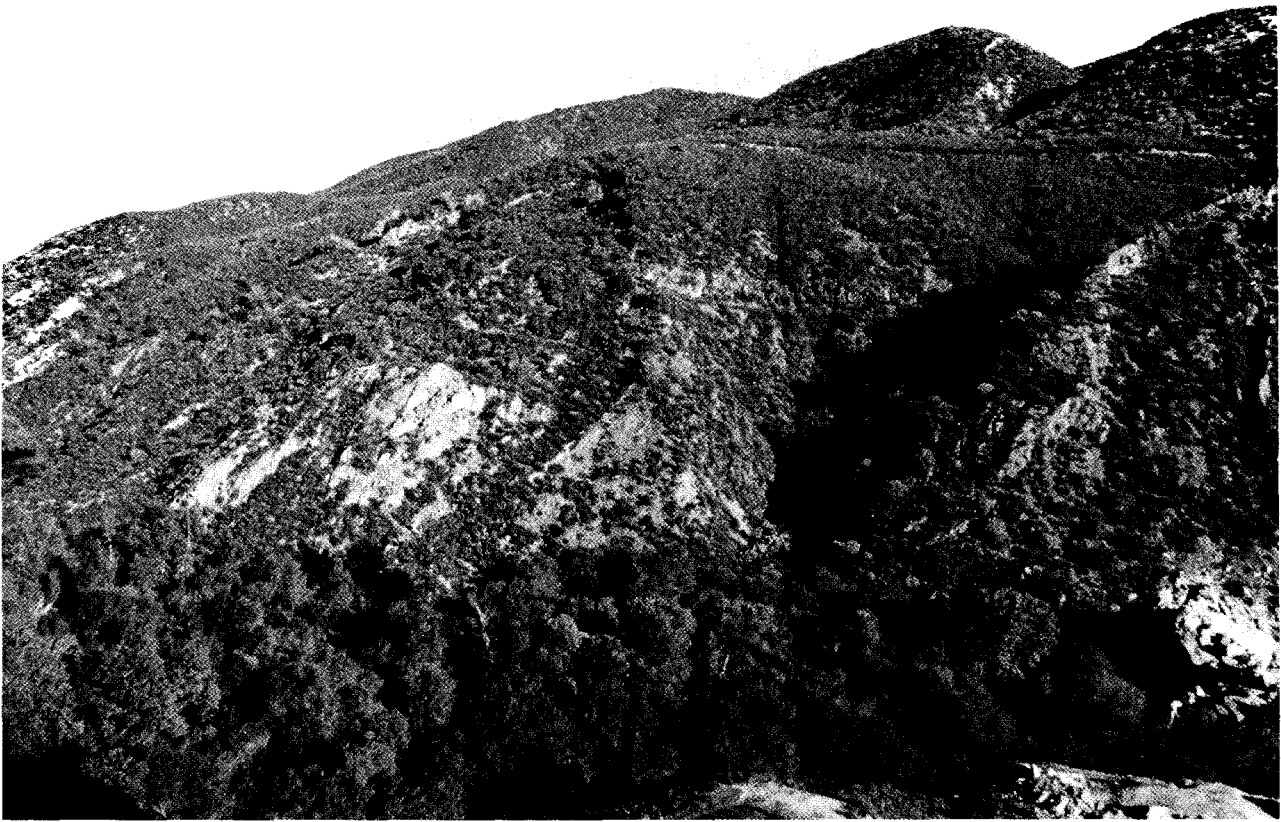
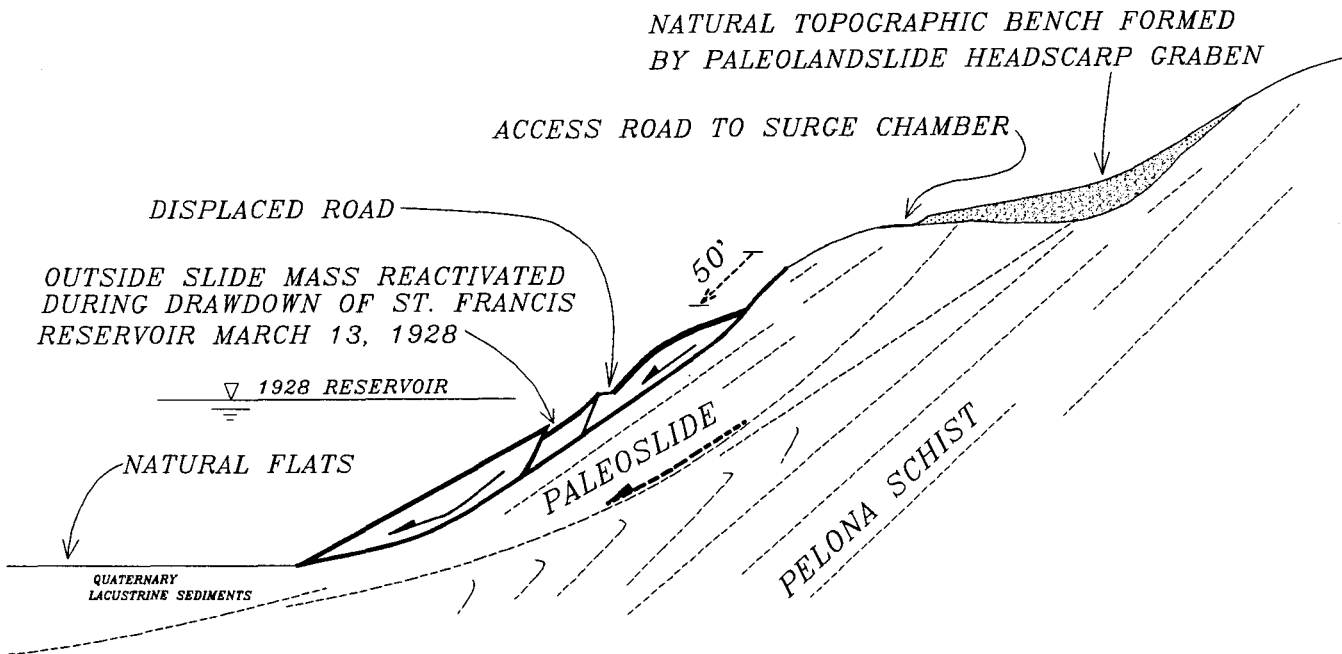
Figure 1. Present day view looking upstream at Pelona Schist escarpment along the southeastern side of San Francisquito Canyon. The remains of St. Francis Dam lie in the right foreground, while a drawdown-induced landslide, which slid approximately 50 feet into the reservoir, is at left center. The bench at the top of the slope appears to be the headscarp graben of an extensive paleomegaslide complex developed within the Pelona Schist, likely during the Pleistocene Epoch. The Los Angeles Aqueduct was built upon this surface in 1908-13. A schematic cross section through the 1928 slide and the surrounding slope is presented below.

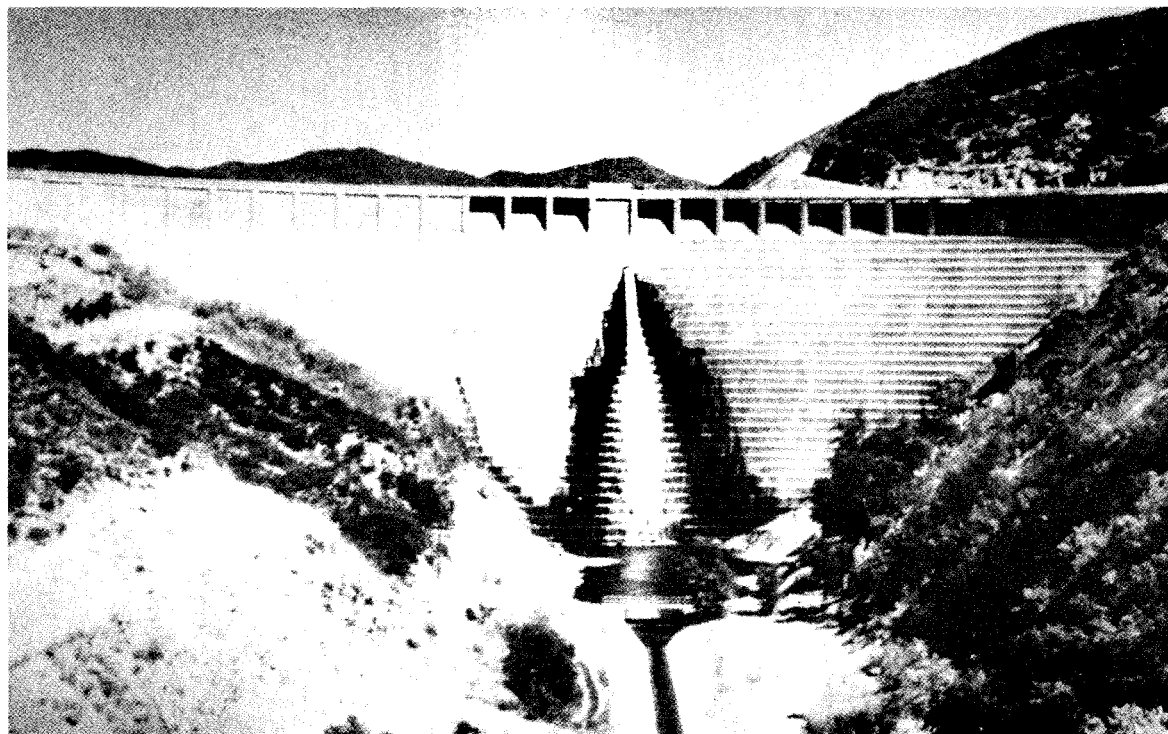
Figure 2. St. Francis Dam as it appeared just after its completion in May 1926. It was a curved concrete gravity section, standing approximately 200 feet high and was comprised of 130,000 cubic yards of concrete without benefit of any contraction joints, drainage galleries, cut-off walls, or grout curtain. The Pelona Schist made up the east abutment, on the right side of the photo, while the Sespe formation red beds comprised the upper two-thirds of the west abutment (shown at left).

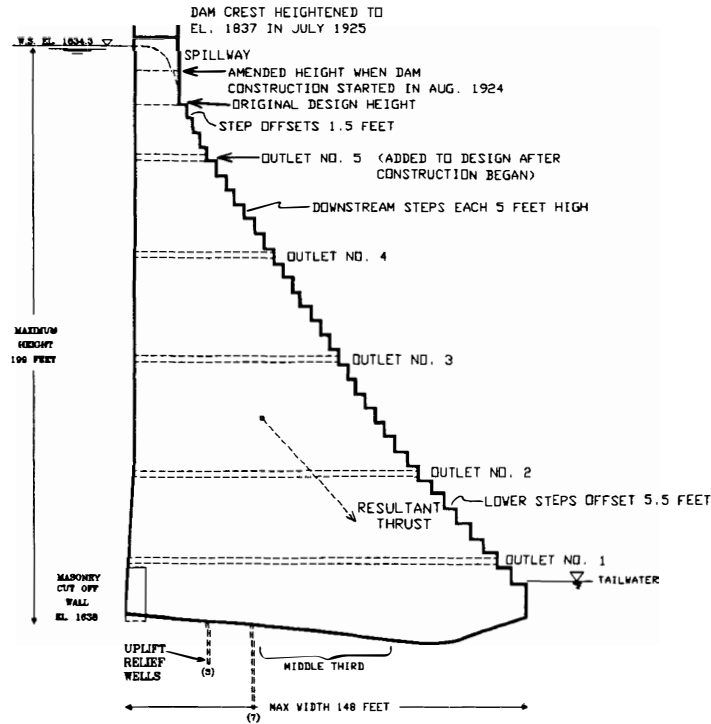
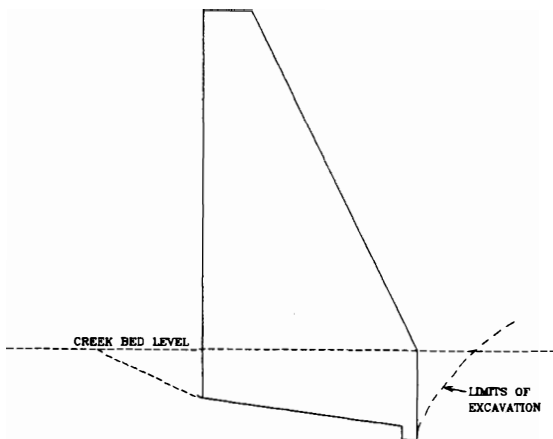
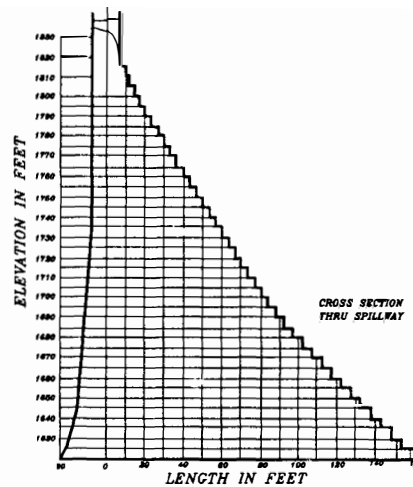
ELEVATION VIEW OF ST. FRANCIS DAM
TAKEN THROUGH SURVIVING BLOCK 1

DESIGN SECTION THRU STA 1 + 25.00 FROM LA DWP FILES. LIKELY THE ORIGINAL DESIGN, THE SECTIONS ARE CONSISTENT IN SHOWING THE DOWNSTREAM TOE CHOPPED OFF VERTICALLY, BELOW THE LEVEL OF THE STREAM BED.

CROSS SECTION PROVIDED BY THE LOS ANGELES BUREAU OF WATER WORKS AND SUPPLY TO GOVERNOR'S INQUIRY BOARD. SHOWING A FLARED DOWNSTREAM TOE. MULHOLLAND TOLD THE CORONER'S INQUEST THAT THE DAM WAS 170 FEET THICK AT THE BASE (WHICH, IF TRUE, APPEARS TO HAVE BEEN ADDED LATER)

Figure 3. Three cross sections of St. Francis Dam, through the outlet works contained in Block 1, the only section of the dam to survive the failure. The upper section represents a reconstruction by the author. That at the lower right is taken from LADWP files, and likely represents the original dam design. Note how the downstream toe was clipped, a feature Outland (1963) had discovered when examining construction photos. The section at lower right was the one provided to the various boards of inquiry into the failure. A few uplift relief wells had been provided for the central core of the dam, within the stream channel. No such protection was afforded the sloping abutments.

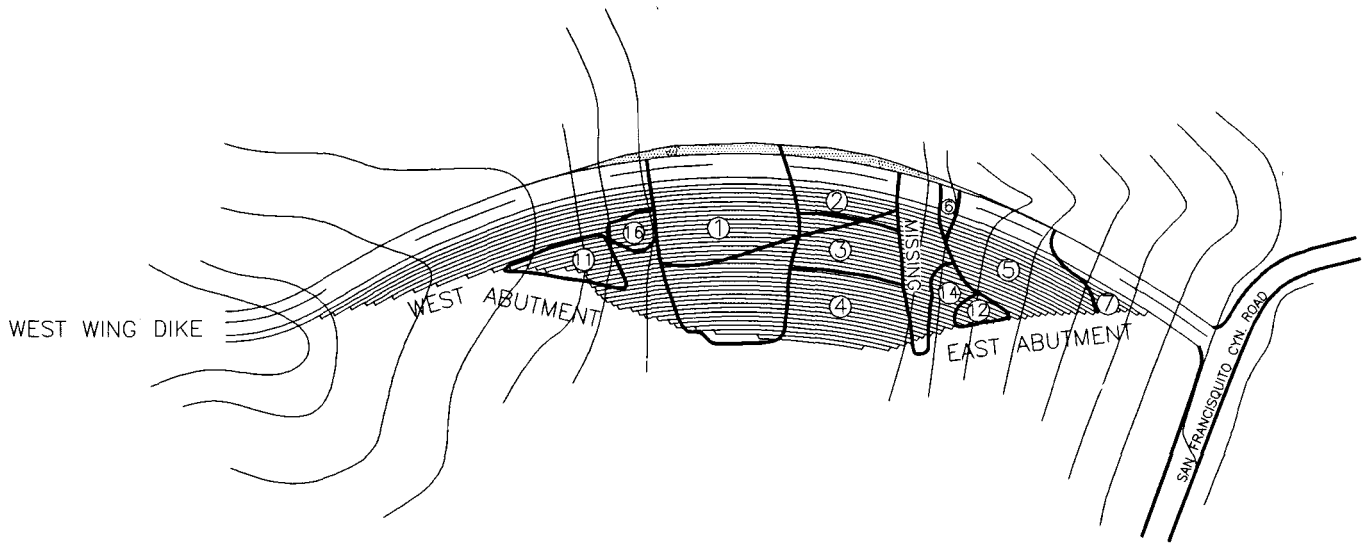
PLAN VIEW OF ST FRANCIS DAM AS DESIGNED

Figure 4. Plan view of the main section of St. Francis Dam as originally designed, from the files of the Los Angeles Department of Water and Power. Diagonal lines and numbers delineate the blocks identified in the post-failure analysis by the State (shown in Figure 8). The portion of the dam between Blocks 2/3/4 and the East Abutment (Blocks 5/6/7) was never found, this portion of the dam becoming the so-called "missing section". The dam's horizontal steps were each five feet high; and varied in width, from 5.5 feet in the lower part of the structure, to as little as 1.5 feet in the uppermost part of the dam. The unique spacing of the steps enables forensic assessment of where the blocks displaced downstream came from within the structure.

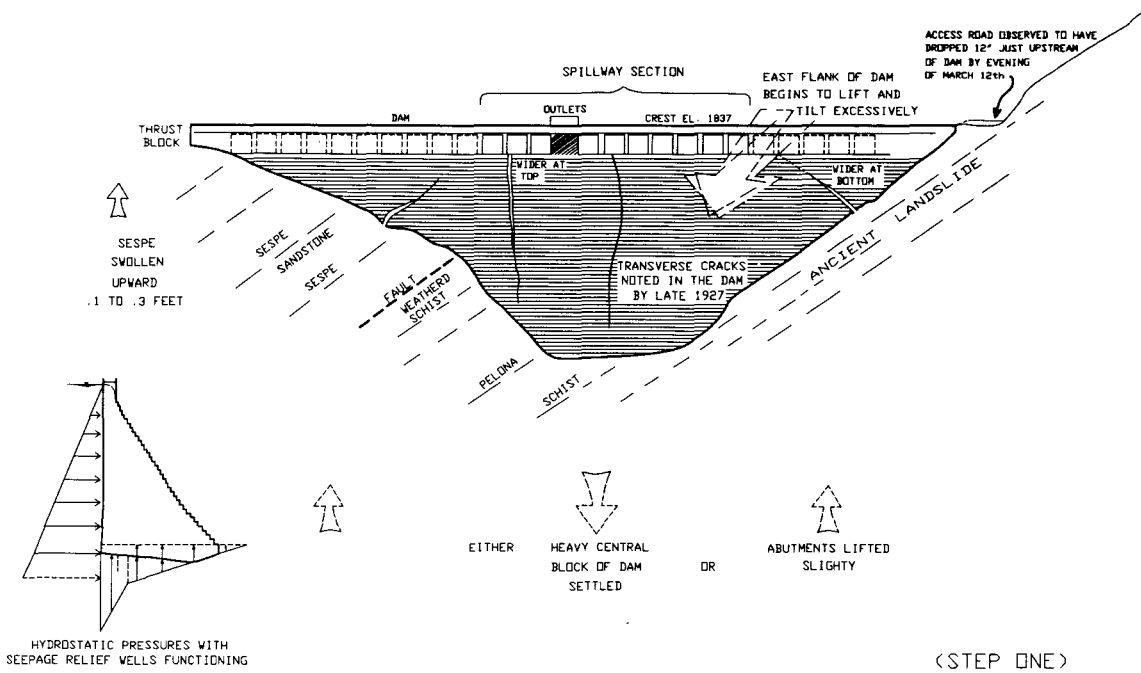
During the initial filling of 1926-27, several cracks appeared, transverse to the dam's axis, in the downstream face of the main structure. These cracks appeared to Mulholland to be "transverse contraction cracks", presumably caused by the thermal stresses associated with the curing of the mass concrete (the main structure was comprised of 130,500 cubic yards of concrete, placed in just 16 months). Two sets of cracks appear to have formed, those on the steeply rising flanks of the structure, and two within the maximum section. The approximate locations of these fractures, deduced from verbal descriptions and photographs, are depicted schematically in Figure 5. The flank cracks were observed to be wider at their juncture with the abutments, narrowing upwards; while the two longer, main section cracks, appeared widest at the top, near the parapet wall. The transverse

Figure 5. Schematic elevation view of transverse cracks which appeared on the downstream face of the dam prior to its failure. The four cracks most often described are portrayed, their having been formed by late 1927. Both abutment cracks were angled obliquely, and widest at their junctures with the foundation rock, suggesting either abutment uplift or main section settlement. The two longest cracks, in the dam's central section, were later found to be those bordering Block 1.

cracks within the main dam block were wedged with oakum on the downstream face and backfilled with cement grout.

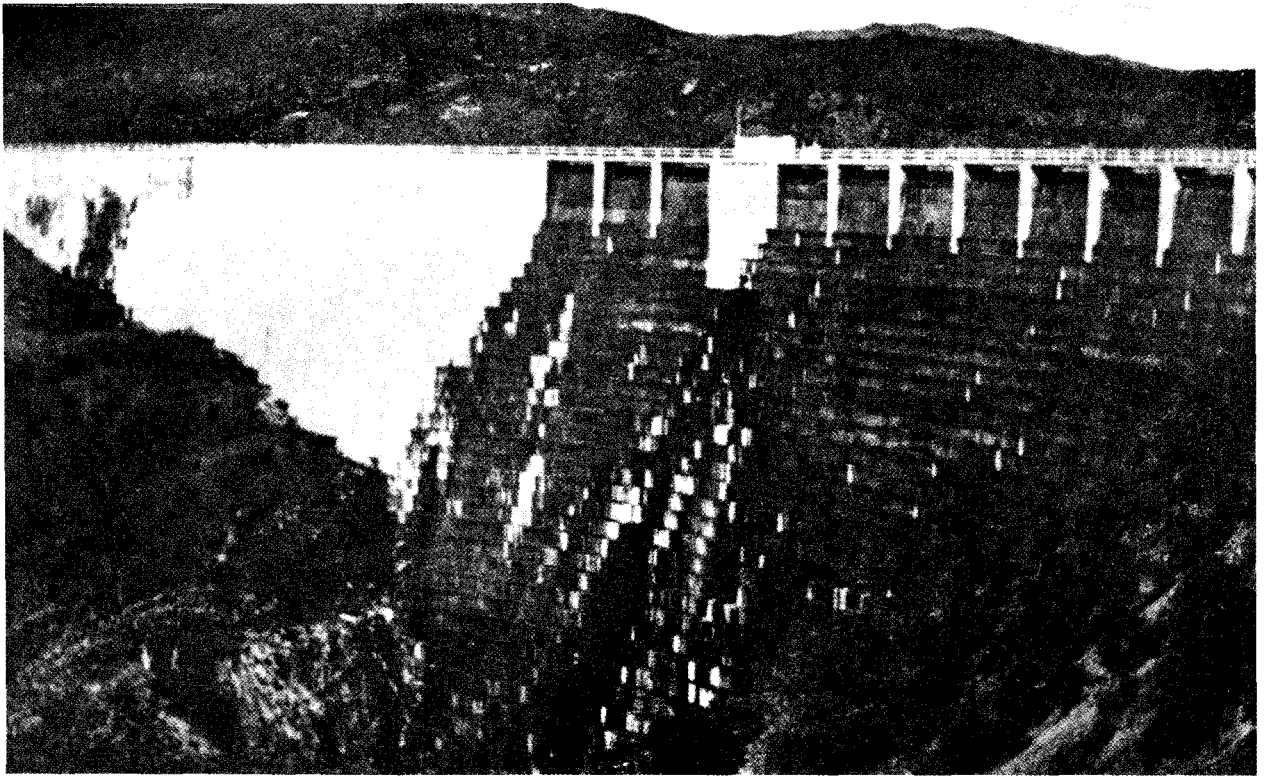
Figure 6. View of downstream face of St. Francis Dam, taken around noon on Monday March 12, 1928, the day of the failure. Note the windswept spillage coming over the spillways, thereby complicating the task of discerning last minute leakage from spillage. At this time approximately 2 cfs of water was running down the west abutment contact, shown at left center

Wave-whipped water was issuing over the spillways, even though the lake had dropped to 1834.3 over the past two days (Figure 6). Their inspection revealed that about 2 cfs outflow was now emanating from the the western abutment, but the water was decidedly clear, which would preclude the possibility of piping (but not that of uplift). The volume of water issuing from the abutment was observed to be somewhat inconsistent, with a surging style of flow. Further investigation showed that the water had only become muddy where it washed over uncompacted sidecast fill, on the west abutment access road (which had a 18% uphill grade). Though not appreciating its significance at the time, the pair also noticed "a small stream of clear water" cascading down the exposed (downstream) juncture of the dam's east abutment, against the schist. Mulholland and Van Norman left the dam around 12:30 PM, assuring Harnischfeger of its apparent soundness. Within 12 hours, Harnischfeger and his six year old son would be the first victim's of the dam's collapse, their bodies never being found.

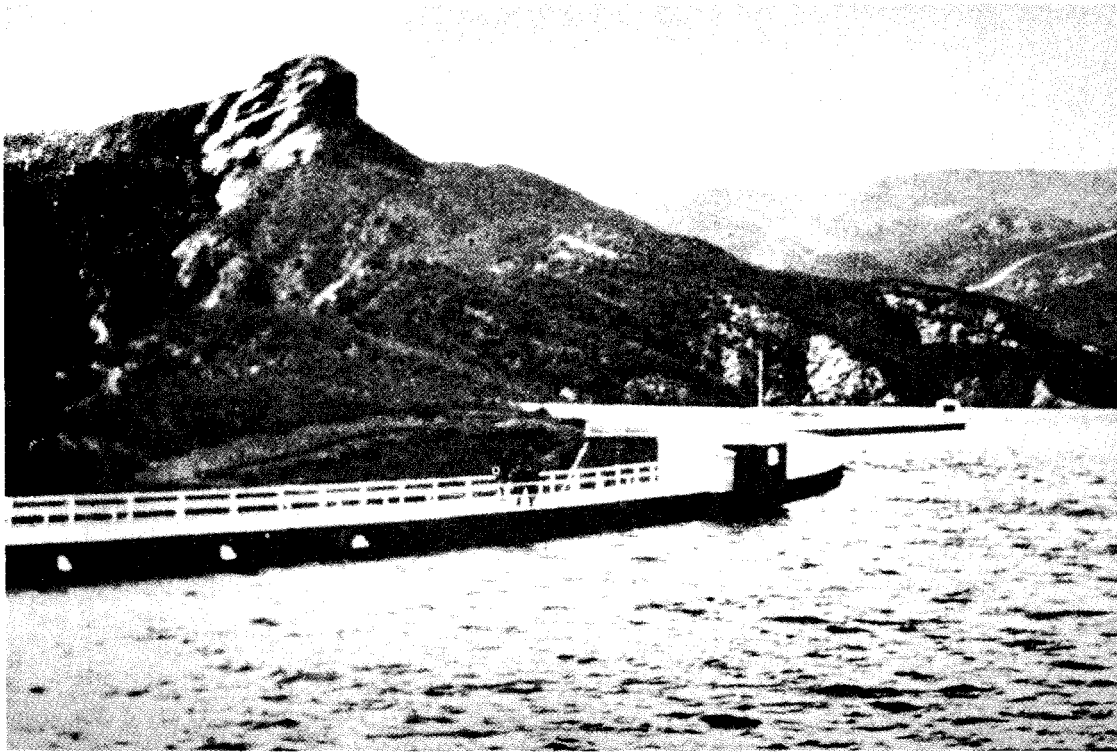
Figure 7. (upper) Bill Mulholland, Harvey Van Norman and damkeeper Tony Harnischfeger walking across the crest of the swollen dam, around noon on March 12, 1928, approximately 12 hours before the failure. The west dike, running across the top of a natural ridge in the Sespe formation red beds, lies at right center

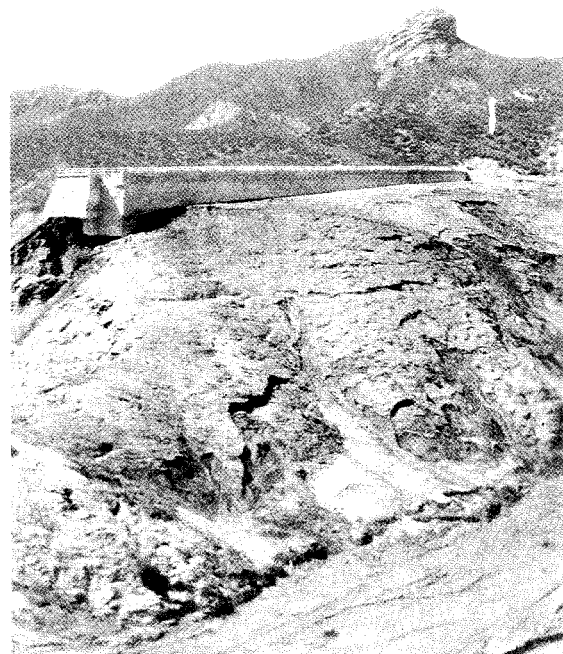
Figure 7. (lower) Approximately the same view, as seen the following day, after the dam failed, leaving the west dike in place. Water had been leaking from beneath this dike the previous day. Note the widespread occurrence of shallow earthflows on the Sespe slope, likely due to rapid drawdown-induced pore pressure differential as the reservoir emptied in about an hour (photo from Ventura County Museum of History and Art).

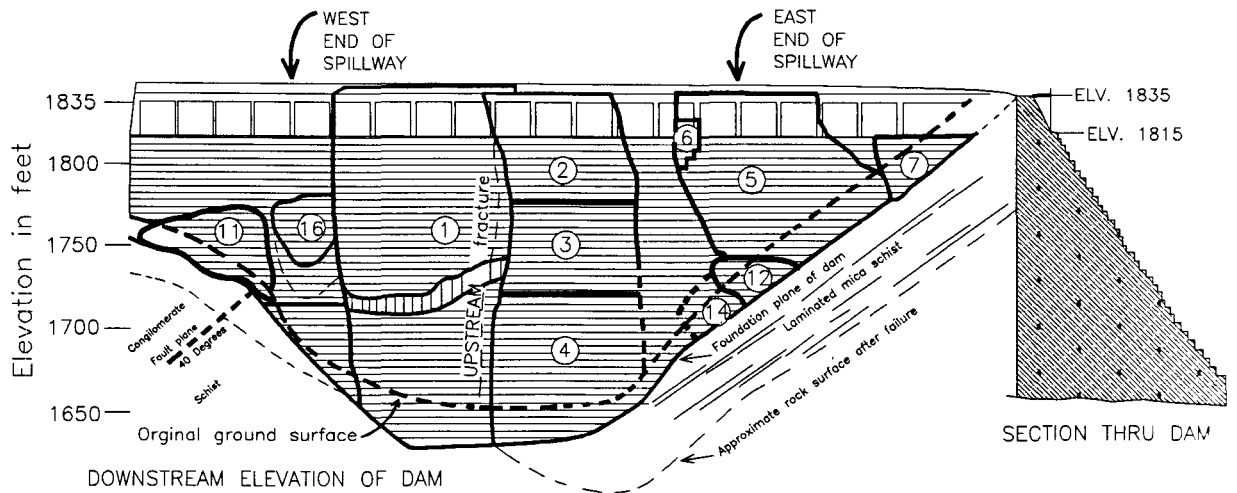
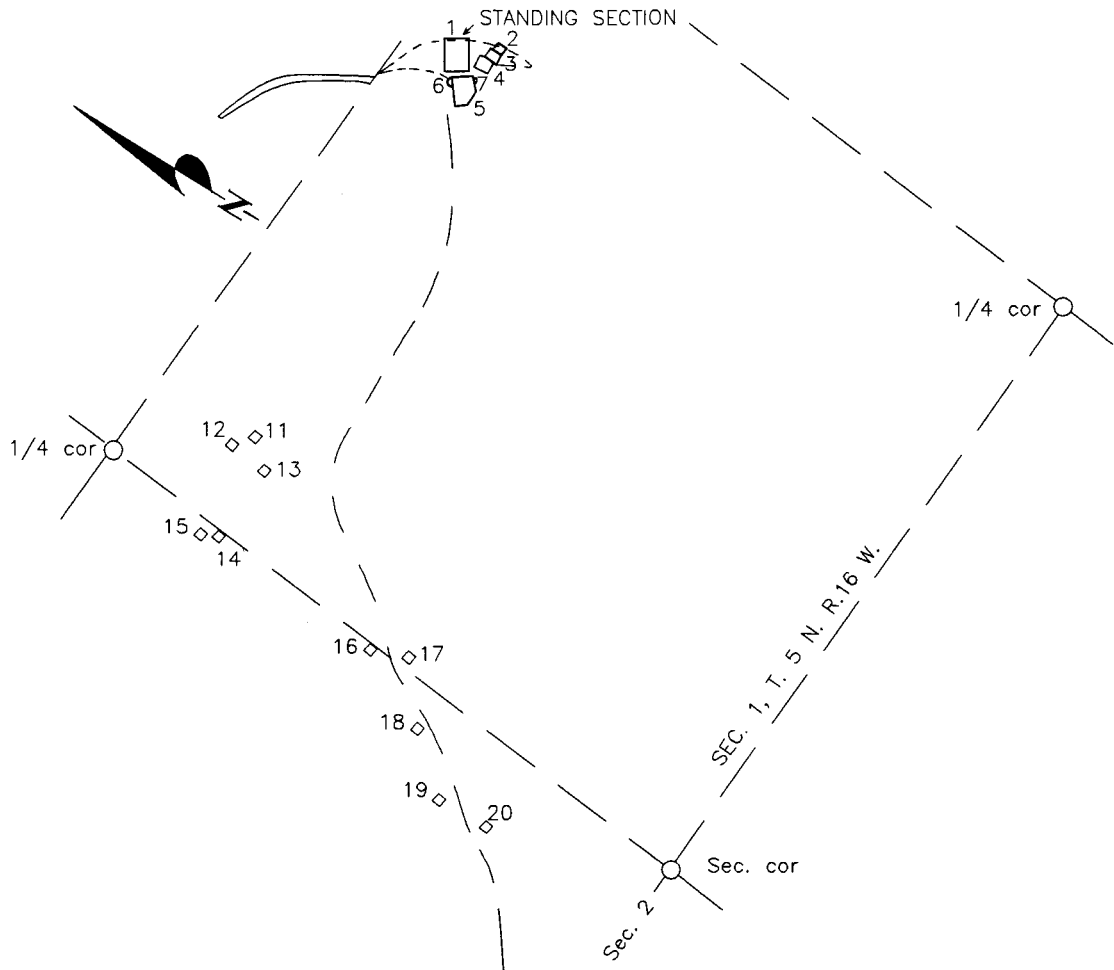
DIAGRAM SHOWING SECTION EROSION
AND
ORIGINAL POSITION OF IDENTIFIED FRAGMENTS

Figure 8. Distribution of fragments from the St. Francis Dam, as delineated in the State report of the disaster, issued 11 days after the failure. Some fragments from the west abutment were found as much as half a mile downstream, thereby influencing the Board's conclusion that the failure initiated on that side of the dam.

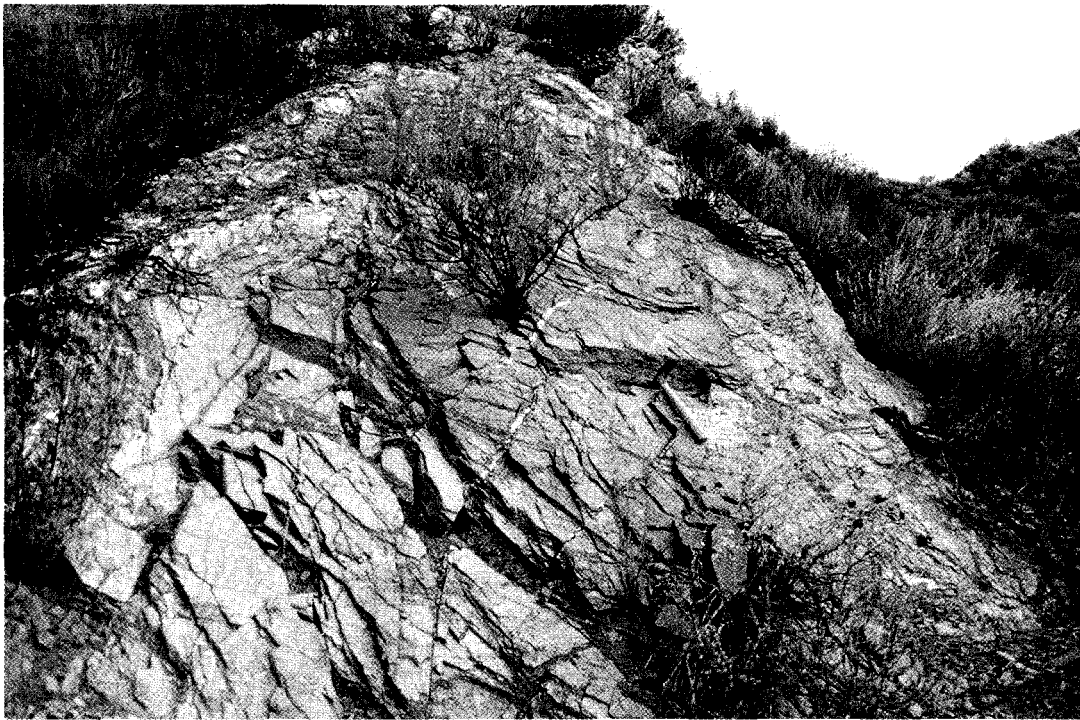
Figure 9. One of the better exposures of the Pelona Schist, seen today in the scar of the 1928 east abutment slide (shown in plan in Figure 15). Planes of foliation form the planar face, with numerous joints cutting the ground mass. A set of parallel shears cuts into the slope, while another, older set of joints is infilled with milky quartz. Discontinuity data from this and another, adjacent series of outcrops, was incorporated into the keyblock analysis of the east abutment (photo by author).

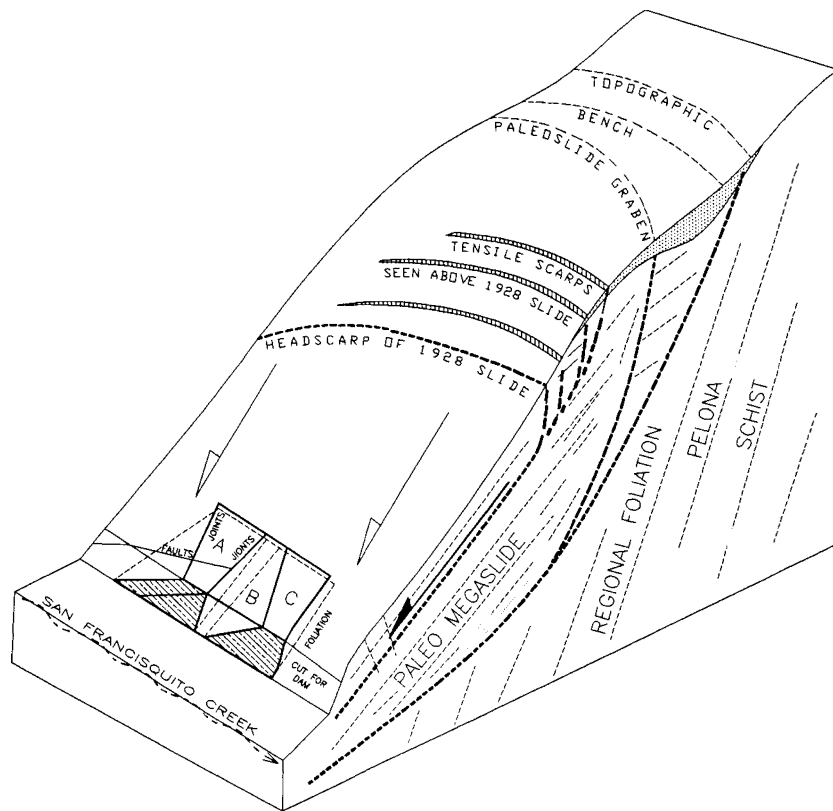
Figure 10. Schematic block diagram view of the St. Francis Dam east abutment, showing rock wedges A, B and C, identified in the keyblock analysis. The blocks are identified by their geometry, the sizes portrayed here are only for purposes of illustration. Block B would present particularly unfavorable geometry with respect to uplift. The approximate positions of the paleomegashide and the smaller, 1928 east abutment slide are shown.

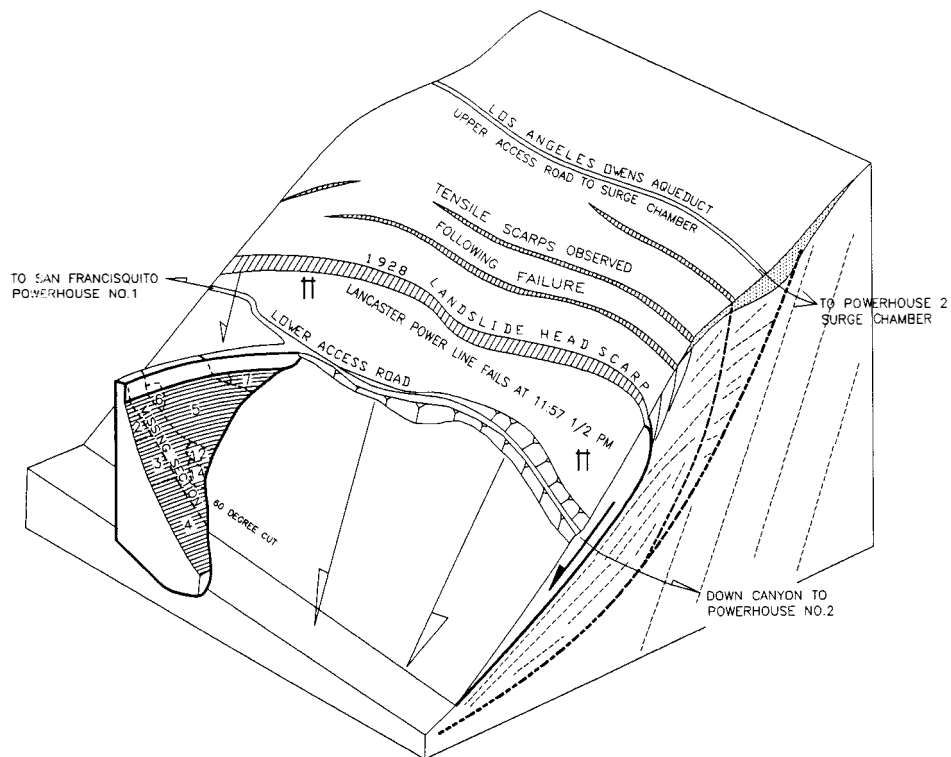
The original position of the dam’s east side was then superposed over the identified keyblock wedges, as presented in Figure 11. Figure 12 graphically depicts an apparent imbalance of uplift forces and the dam’s effective weight, absent any grouted seepage cutoff (in the style of analysis made

Figure 11. Schematic block diagram of the conditions on the east abutment of St. Francis Dam, just prior to its failure in March 1928. The "missing section" of the east abutment lies upon keyblocks A, B and C, shown in the previous figure, which coincide with the steepest excavation made for the dam. The approximate aerial limits of the east abutment slide are shown, as well as that of the Edison Company power lines that went down at 11:57:30 PM on the evening of the disaster. These lines were situated 90 feet above the dam crest.

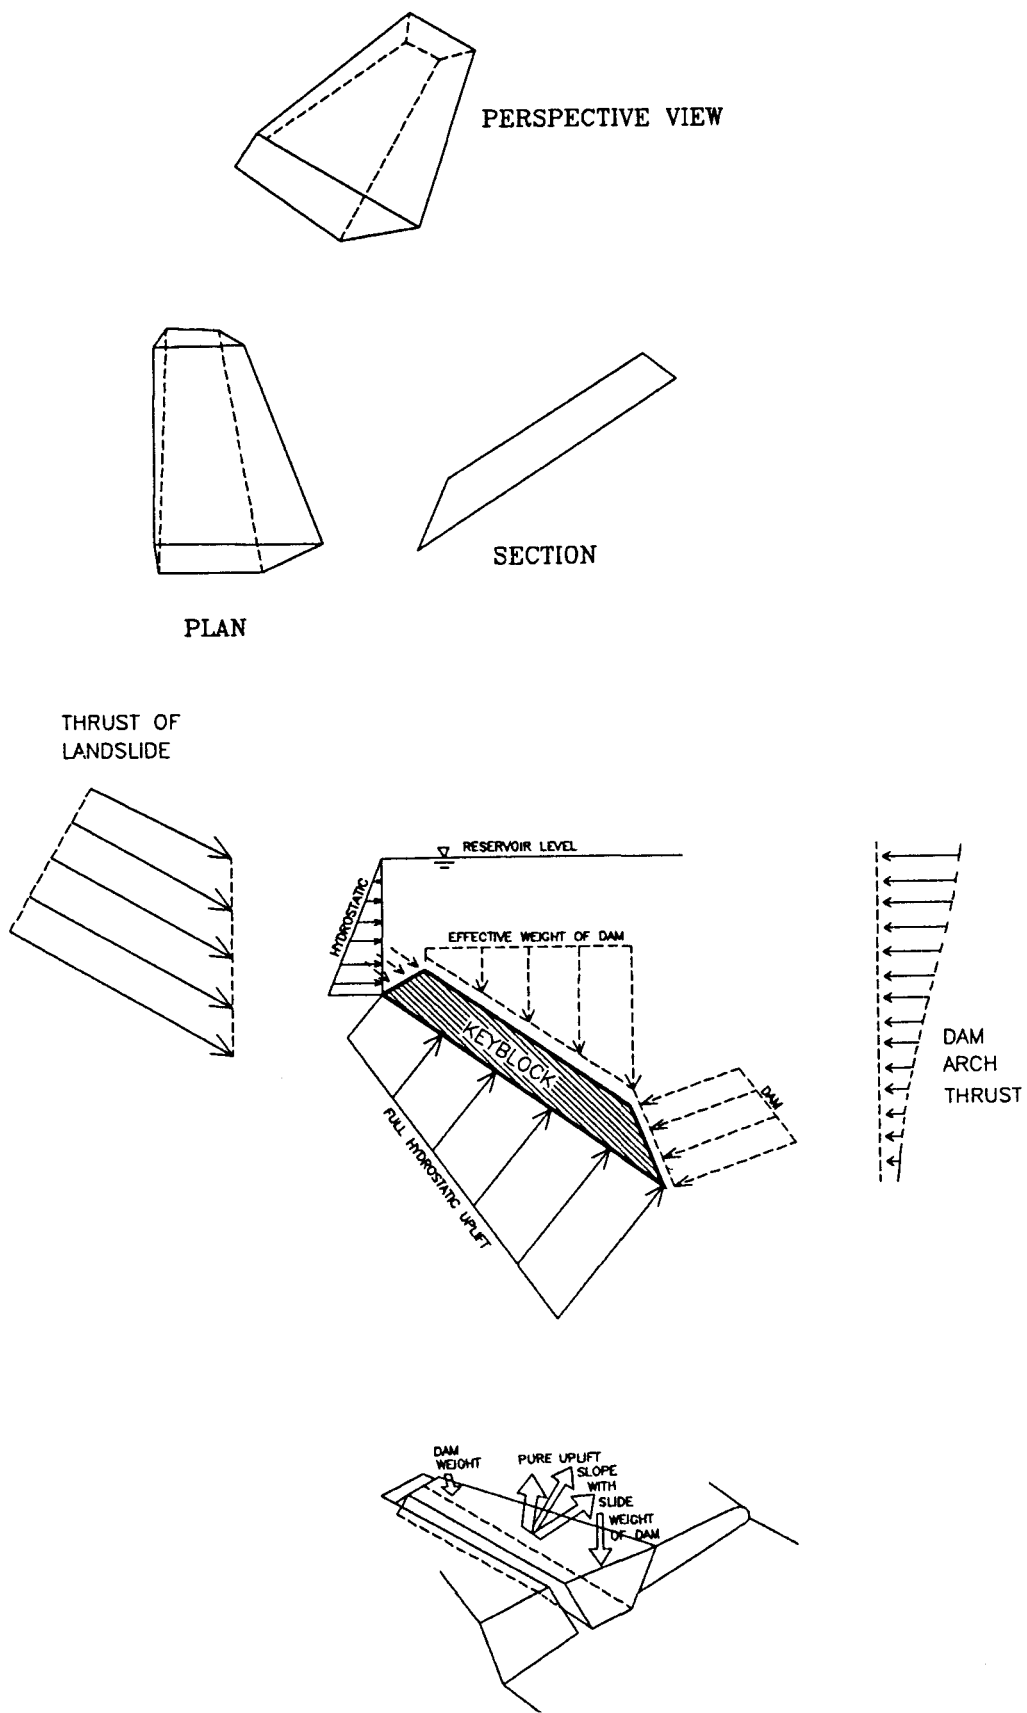
Figure 12. Plan, section and perspective views of keyblock "B", shown schematically in Figure 10. The section view parallels the schist foliation, the lower face that of the abutment excavation. The lower view shows an approximation of the loads that were likely acting on this and adjacent wedges, beneath the east abutment after the maximum reservoir pool was attained, five days preceding the failure. A simple stability analysis suggests that two-thirds of the lake's full reservoir head would have been sufficient to have lifted this block, with the dam upon it, the same manner of failure by which Malpasset Dam later failed in 1959.

by Pacher, 1964; and Londe, 1968). If two-thirds of the full reservoir hydraulic pressure were developed beneath any of the three wedge configurations ("B" being the worst of the three), it can be theoretically demonstrated that the dam abutment would have been lifted (as shown in the lower part of Figure 12), throwing parts of the sloping abutment into tension. Even with only 50% uplift, the normal effective weight of the dam, between Blocks 2/3/4 and 5/6, would appear prone to imminent failure (utilizing the Governor's Board of Inquiry block nomenclature, shown in Figure 8). Though slightly more complex (due to the sheer number of discontinuity suites present), the east abutment failure would appear similar to that experienced (due to a tetrahedrally-shaped wedge) at Malpasset Dam, a concrete arch structure in France, which collapsed catastrophically during initial filling in 1959 (Londe et al., 1968, 1969, 1970; Pacher, 1964; Terzaghi, 1962).

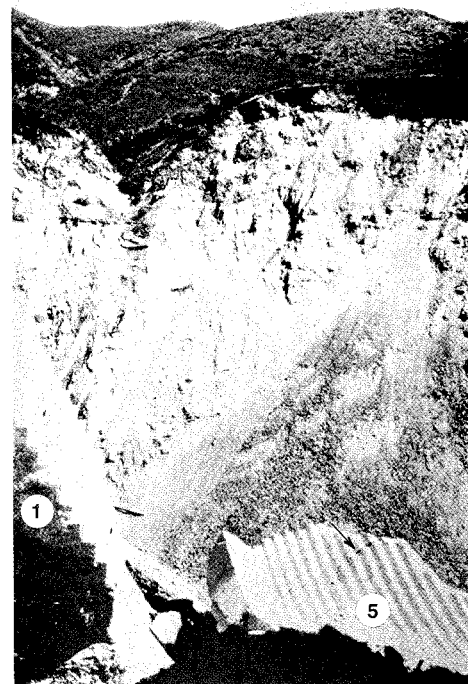
Figure 13 (upper) View looking southeast, at east abutment slide scar, from across canyon, atop the west abutment thrust block. The enormity of the slide can be vividly appreciated, the affected mass involving well over 500,000 cubic yards. The oakum patching of the diagonal crack in Block 5 can be clearly seen (arrow). Blocks 1 and 5 are indicated by their respective numbers

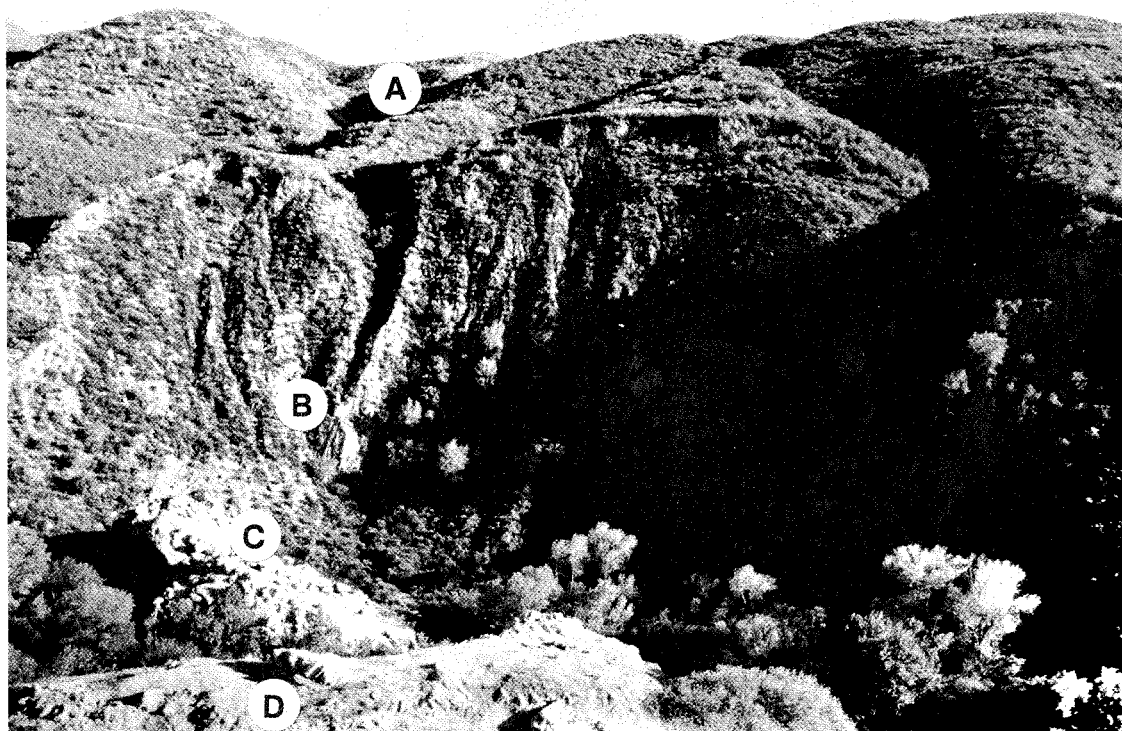
Figure 13. (lower) The same view as seen at the damsite today. "A" indicates the position of the old upper road along the LA Aqueduct (and within the paleoslide headscarp graben); "B" is the outcrop shown in Figure 9; "C" are the remains of dam Blocks 2 and 3; "D" is the remains of Block 1, demolished in 1929.

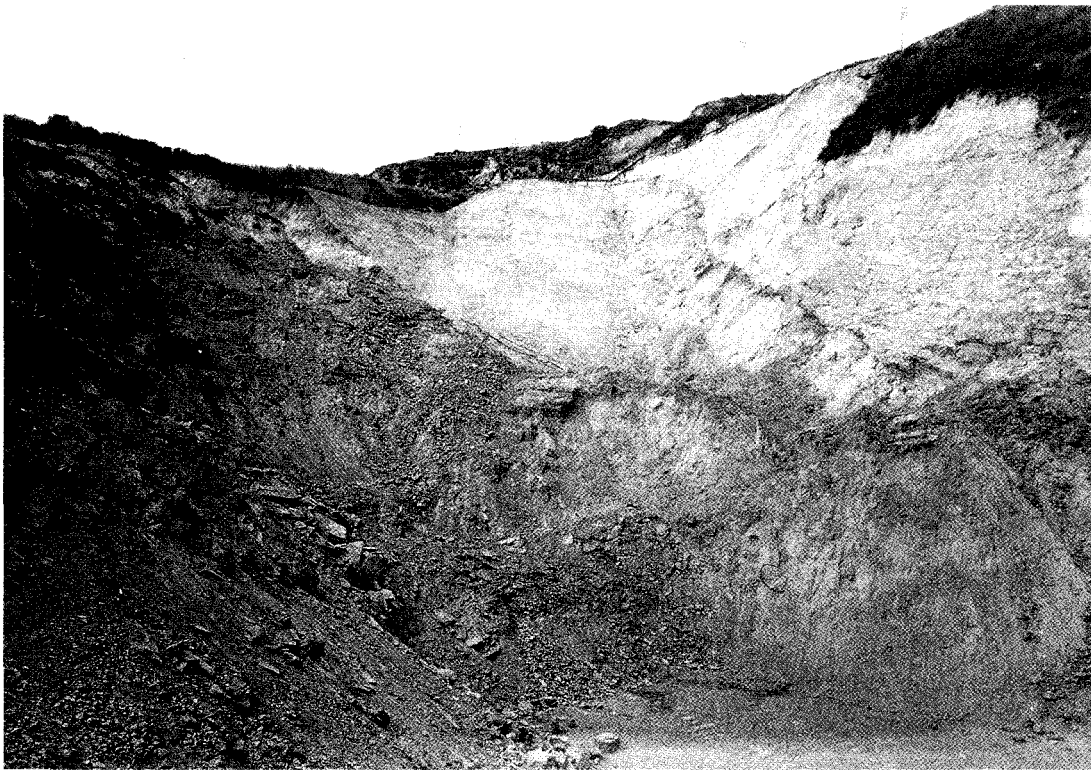
Figure 14. (upper) View looking uphill, into the evacuation scar of the 1928 east abutment slide, as seen from the floor of the canyon, just downstream of the dam's former position. This photo shows the guardrail of San Francisquito Canyon Road, parallel to the slide's west headscarp (thereby fixing its relative vertical position, shown in Figure 15). Photo reproduced by permission of Ventura County Museum of History and Art.

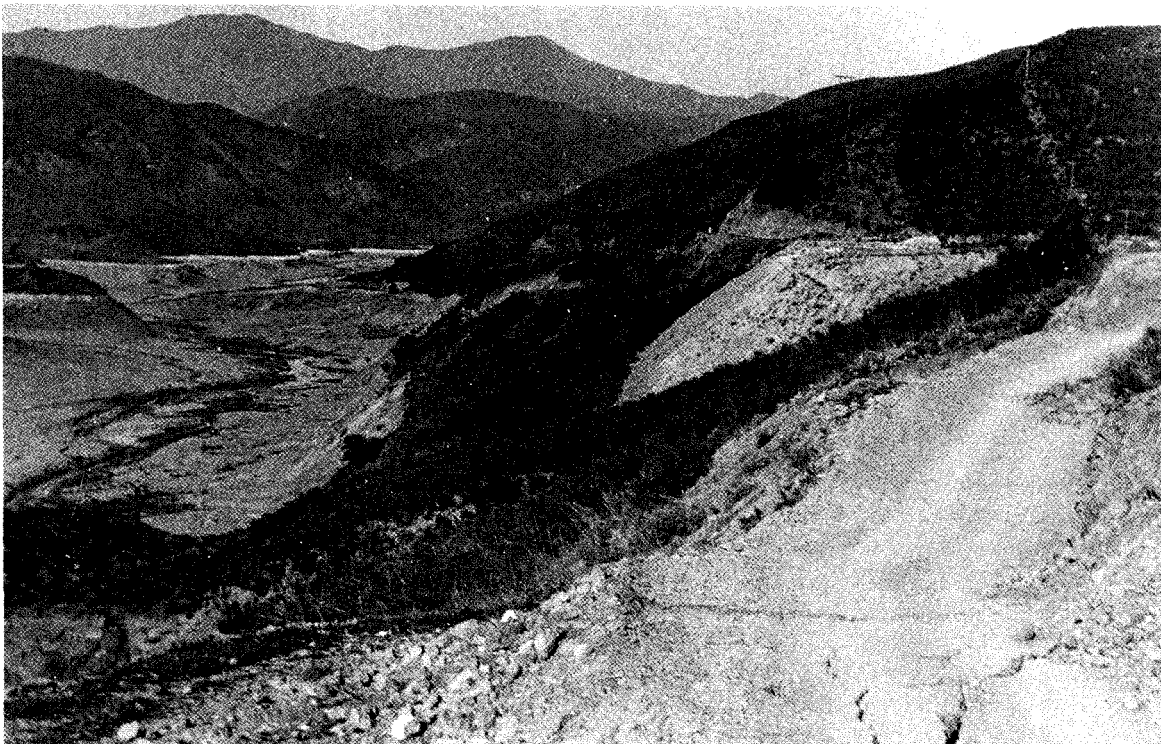
Figure 14. (lower) Post-failure view looking up-canyon from the higher, surge chamber road, above the east abutment slide headscarp (position "A" in lower portion Figure 13), a few days after the failure. Retrogressive tension scarps reached 200 feet uphill of the slide, encroaching on the high road as shown, dropping it by about 10 feet. The Edison Power line that went down at 11:57 PM is shown as "A" and the slide depicted in Figure 1 is delineated as "B".

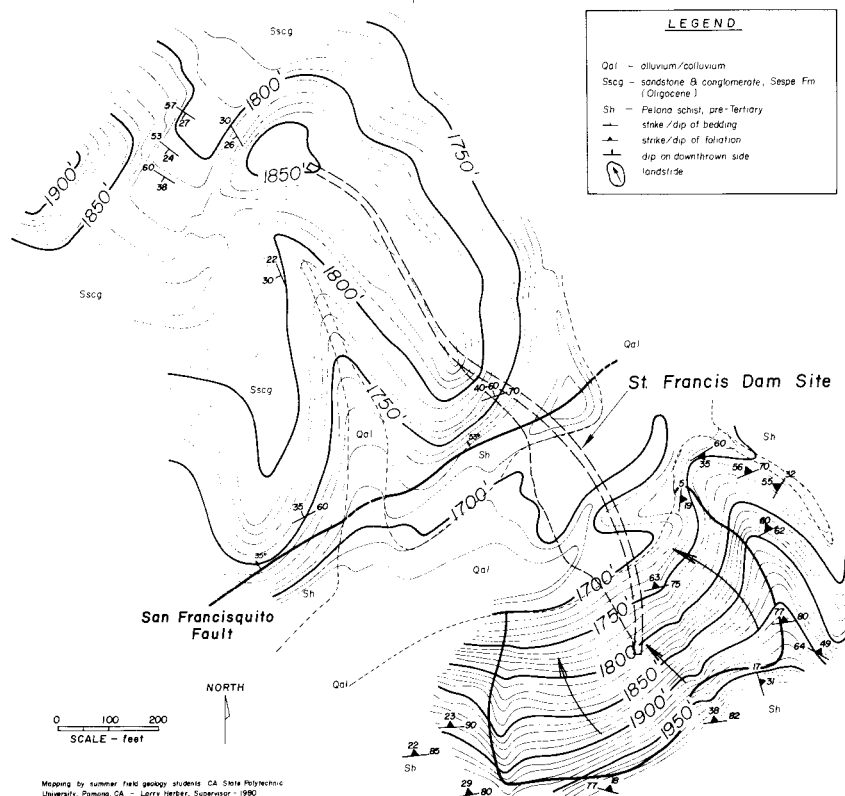
As the outermost piece of the paleomegaslide continued to creep downslope, it would have loaded the dam obliquely (Figure 15). Such lateral loading, much higher than that imposed by reservoir water, would have brought the upstream face of the dam into tension, induced by the downstream bending of the narrow abutment section (Blocks 5/6/7). The sudden creation of tensile stresses in the heel or upstream face of a brittle concrete dam is a requiem for disaster, as full reservoir hydraulic pressures would enter into such cracks and negate the dam's stabilizing dead load through buoyancy (upper half, Figure 27). A simple calculation can demonstrate that, were full reservoir pressures allowed to leak into a transverse crack (or series of cracks within the "missing section", between Blocks 2/3/4 and 5/6/7), the dam's resultant thrust would be deflected far downstream, theoretically causing overturning failure.

Figure 15. Surface geologic and topographic map of the St. Francis Dam site as it appears today, prepared under the direction of Professor Larry Herber at Cal Poly Pomona in 1980. The positions of the San Francisquito fault and the east abutment slide relative to the main section of the dam are easily discerned. Reversal of foliation attitudes in the Pelona schist are likely ascribable to buckling in the toe areas of the paleomegaslide.

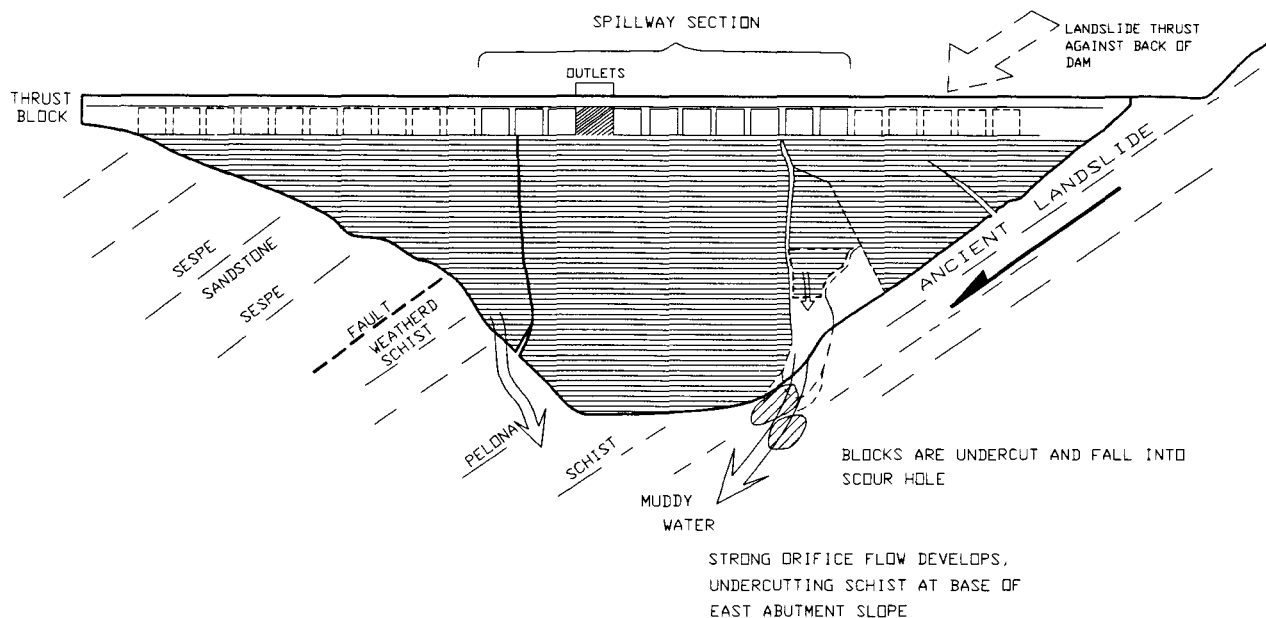
11:56 RESERVOIR WATER SURFACE BEGINS TO DROP AS
DRIFICE FLOWS GENERATE FROM LEAKS

Figure 16. (upper) Schematic elevation view depicting the onset of under cutting beneath the "missing section" of the east abutment slide (see Figures 8 and 11), between Blocks 2/3/4 and 5/6/7. This sequence likely began around 11:50 to 11:55 PM, and would have been hidden from the view of people passing along the road leading to the east abutment crest.

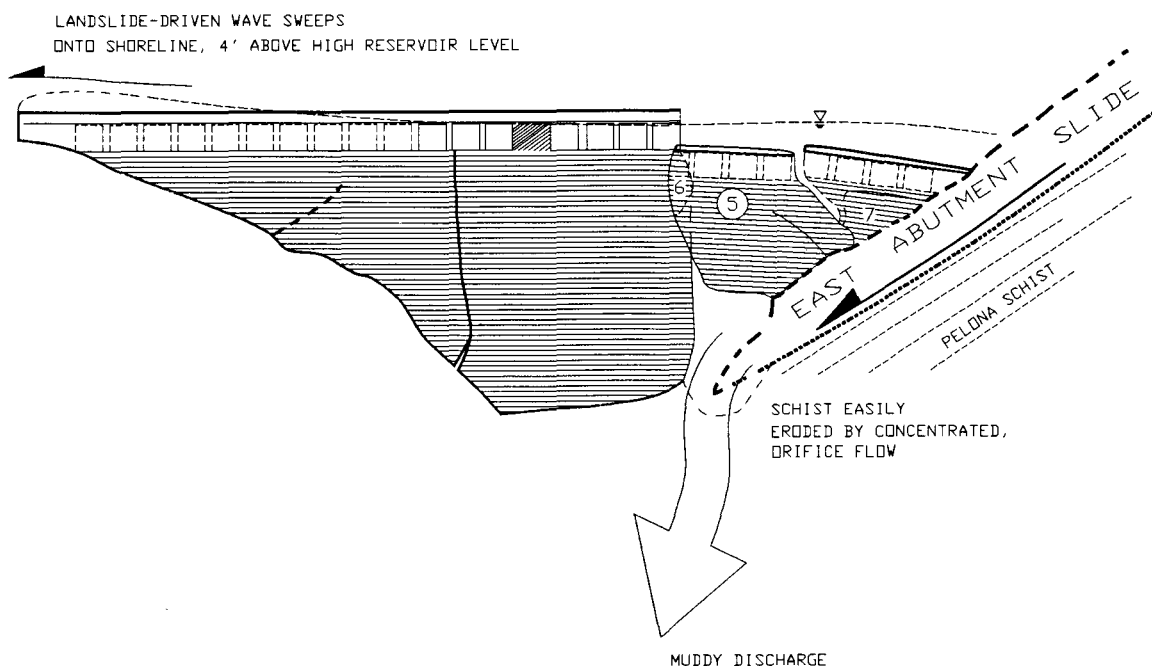
AT 11:57 1/2 PM EAST ABUTMENT SLIDES
INTO RESERVOIR, CUTTING EDISON POWER LINES

Figure 16. (lower) Schematic portrayal of the initial mobilization of the east abutment slide, around 11:57:30 PM. A sudden mass movement is suggested by several facts, including, but not limited to, the dropping of the Edison power lines some 90 feet above the dam crest at this instant (arguing against a toe-headward, progressive style of failure); the creation of wave floatsom 4 feet above the maximum reservoir level; and the apparent movement of Blocks 5/6/7 completely across the downstream face of the dam.

Regardless of just how large a hole developed, a massive chain reaction failure must have ensued shortly after a substantive portion of the "missing section" (between Blocks 2/3/4 and 5/6/7) was removed (Figure 16 lower). The apparent outpouring of water thru the "missing section" (Figures 8 and 11) must have undercut the incipient slide mass; thereby setting about its apparent catastrophic failure (Figure 16). Blocks 12 and 14 were later found a half mile downstream (Figures 8 and 16 lower), about 20 feet above the channel level, and offset 50 yards to the outside of the first bend in the San Francisquito channel (Figure 8).
