REASSESSMENT OF THE ST. FRANCIS DAM FAILURE

J. David Rogers

CE and Engineering Geologist
Rogers/Pacific, Inc.
396 Civic Drive
Pleasant Hill, CA 94523

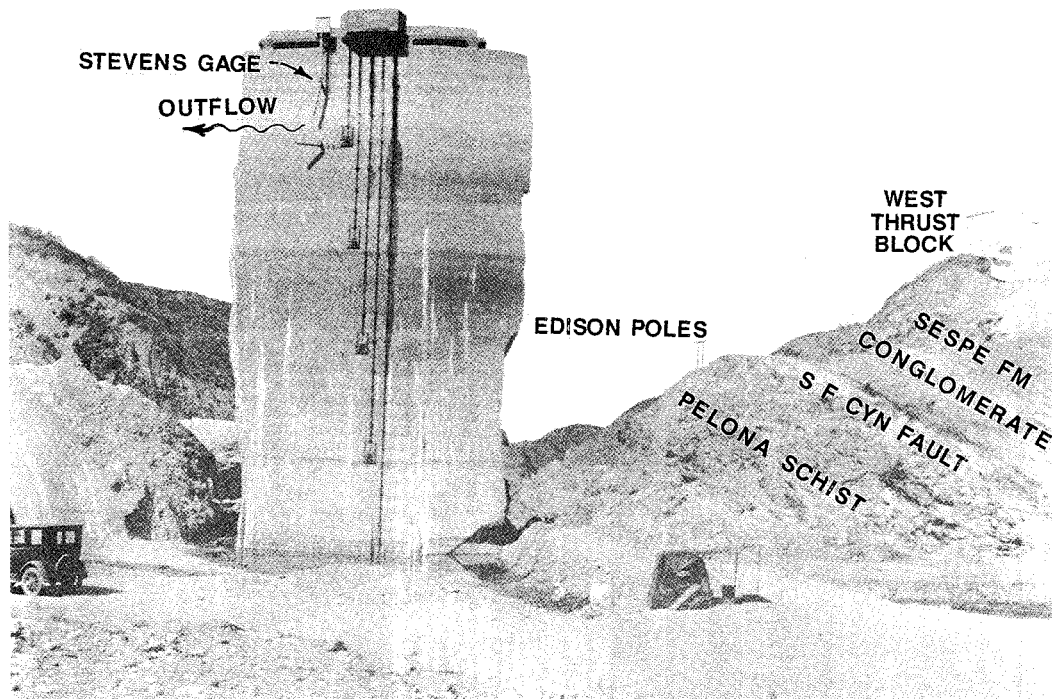
The Stevens Gage consisted of a 12-inch diameter pipe affixed to the upstream face of the dam (Figure 17). Water fed into this so-called “stilling well” through a 1-inch diameter hole at its lower extremity, with the purported intent of filtering out the oscillatory effects of waves on the back of the dam. In the failure’s aftermath, just about everyone attempted to correlate the apparent drop in lake level recorded by the gage with the theoretical outflow that could have lowered the lake by 3.6 inches. Predictably, this turned out to be a considerable quantity of water, beginning with around 1,000 cfs, and building up to over 15,000 cfs, just before the failure; an enormous amount of water in tiny San Francisco Canyon not to be noticed by the 11:30 PM shift change at Powerhouse 2 or by any of the three aforementioned parties that drove along the creek, leading up to the dam just before the failure. The road connecting the dam to Powerhouse 2 paralleled the creek to a point about 2600 feet downstream of the dam, then climbed the east wall of the canyon, joining the east abutment crest at Elevation 1837. We can catch a glimpse of this road in Figure 26.

Figure 17. Post-failure view looking downstream, at the upstream face of Block 1, the only remaining section of the dam. The thin black lines running vertically down the back of the dam are the gate controls for the dam's five outlet conduits (shown in Figure 3). The snapped portion of the 12-inch diameter housing for the Stevens Water Stage Gage is clearly seen to the left of the uppermost outlet gate, pointing towards the east abutment, between elevation 1800 and 1815 (arrow). The lake had been at elevation 1834.4 just prior to the failure. Photo used by permission of the Ventura County Museum of History and Art.

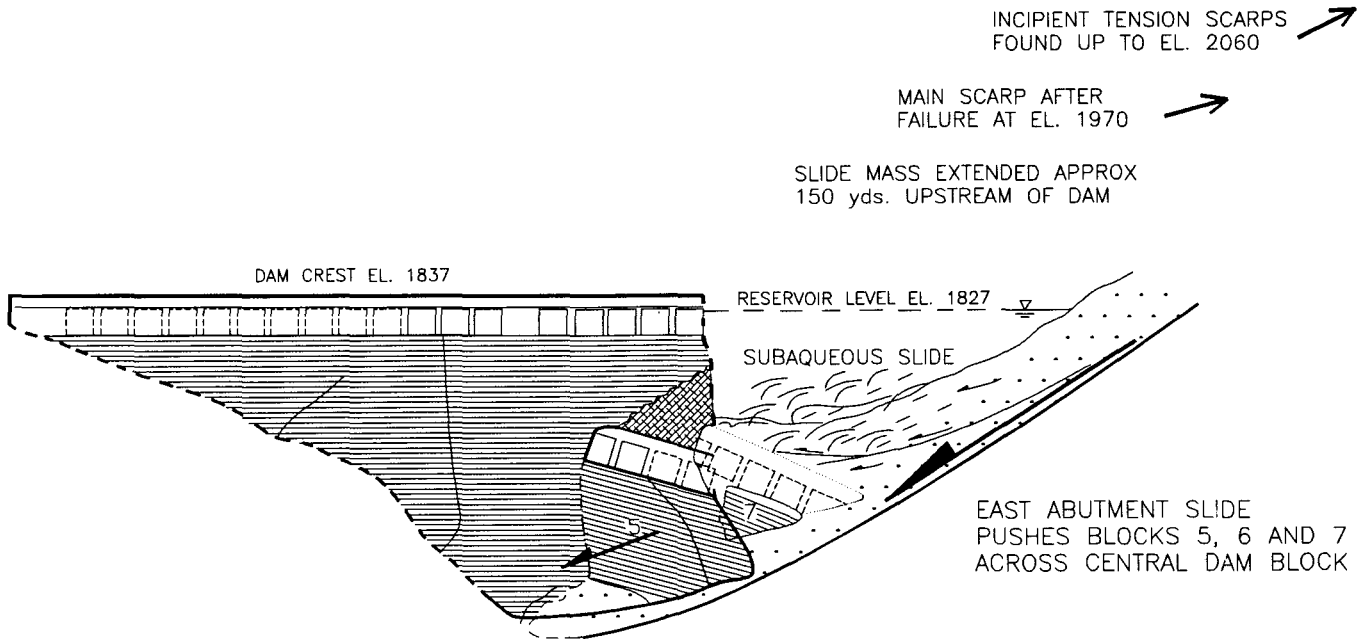
AT 11:58, BLOCK 5/6/7 IS CARRIED ACROSS MAIN SECTION OF DAM, CUTTING OFF DOWNSTREAM FACE; VIBRATION FROM SLIDE MOTION IS SO GREAT, IT IS FELT AS AN EARTHQUAKE BY SURGE CHAMBER ATTENDANT 1 MILE AWAY.

Figure 18. (upper) Schematic portrayal of the east abutment slide carrying Block 5/6/7 across the downstream face of the dam's central section (Blocks 1/2/3/4) early in the failure sequence. At this time, the lake level had likely only dropped 3 to 7 feet, to around elevation 1827. The outer 20 feet of the dam's face was abraded by the movement of Blocks 5/6/7.

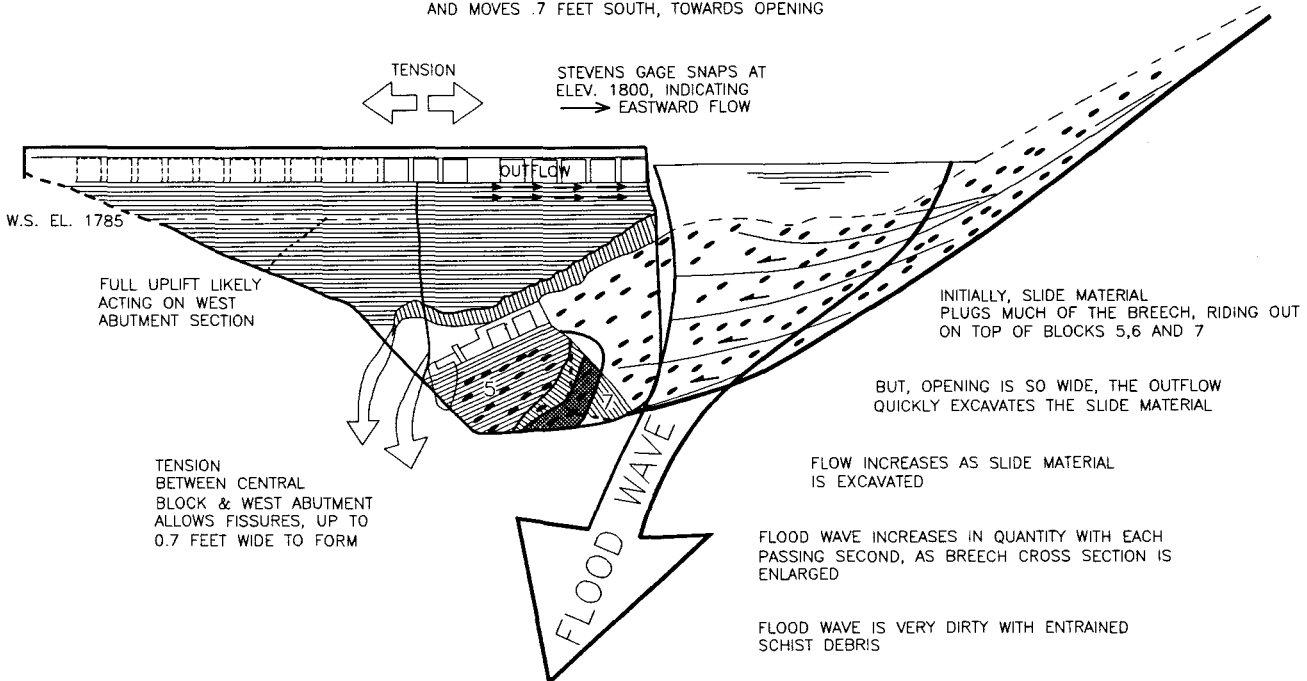
(STEP 8)

AS DOWNSTREAM TOE OF CENTRAL BLOCK IS SEVERED BY BLOCKS 5,6,& 7; BLOCK TILTS 0.1 DEGREES DOWNSTREAM, ENTRAPING GAGE LADDER; AND MOVES .7 FEET SOUTH, TOWARDS OPENING

Figure 18. (lower) Schematic portrayal of the landslide dam, temporarily formed across the east abutment breach. Debris from this translational slide probably overthrust upon itself, building up a short-lived impedence to outflow. The formation of a temporary dam with increasing discharge accounts for the 30 to 90 seconds of precursory outflow related by survivors at Powerhouse 2 before the maximum discharge arrived, killing 120.

The upper and lower halves of Figure 18 present what likely occurred, given the verifiable parts of the puzzle (both physical evidence and eyewitness accounts). After having its toe rapidly undercut and eroded by strong orifice flow (which would produce a misty "fog"), the toe of the east abutment slide was severely undercut (Figure 16). Such undercutting should have been sufficient to trigger the east abutment landslide, which was already in a stage of incipient failure if the road had indeed dropped 12 inches by the evening of March 12th. The east abutment slide was a simple translational failure, along slippery planes of foliation in the mica schist. We can infer that the slide must have begun its descent around 11:57:30, dropping the Edison Company Lancaster power lines. Depending on the speed at which the slide dropped, the moving mountain of schist should have infilled the tremendous void, at least temporarily (lower half, Figure 18). An alternative hypothesis could have the toe of the east abutment slide gradually being eaten away by the outpouring water, but such a scenario would then be unable to account for the very long trip taken by Block 5; which was shifted all the way over to the opposing abutment. We are left to conclude that the translation of Blocks 5/6/7 to the opposing side of the channel, below Block 1, argues for a rapid, dramatic

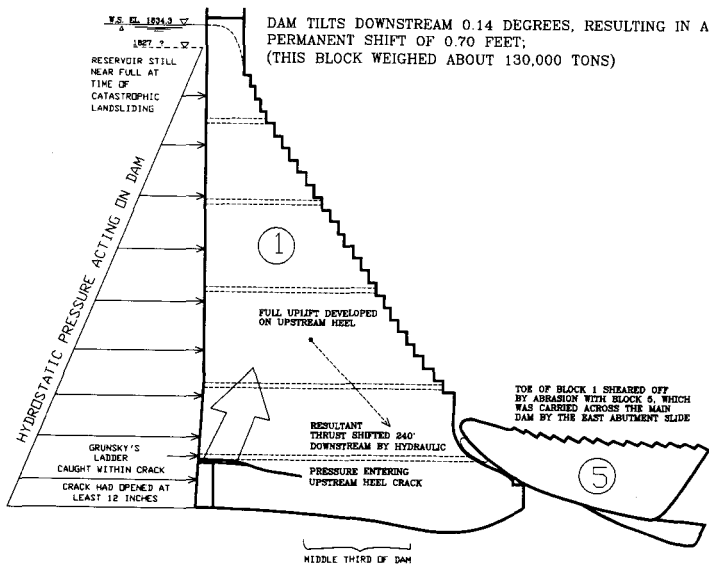
Figure 19. Loading conditions likely exerted upon Block 1, based on physical evidence observed immediately following the failure. The snapping of the Stevens Gage stilling well pipe, affixed to the upstream face of Block 1 (on the west side of the dam's central core), was found to have been buckled between elevation 1800 and 1815, towards the east abutment (Figure 17); indicating that a massive outpouring was occurring to the east side of the central dam block when the lake was still high.

1. meaning that a sizable wave had been generated while the lake was still at a relatively high level;
2. The Stevens Gage stilling well pipe, affixed to the upstream face of Block 1 (on the west side of the dam's central core), was found to have been buckled between elevation 1800 and 1815, towards the east abutment (Figure 17); indicating that a massive outpouring was occurring to the east side of the central dam block when the lake was still high.

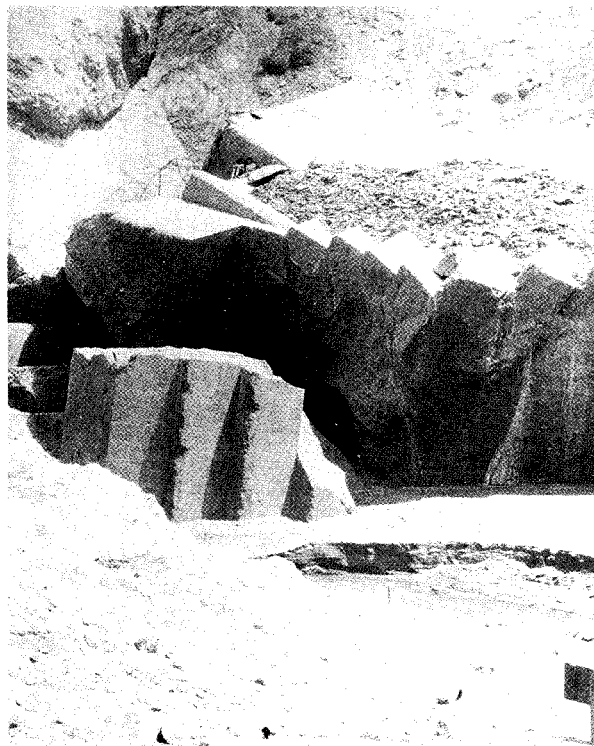
As Block 5 was carried upon the translating landslide, it sheared off the downstream face of Blocks 2/3/4 and Block 1, as depicted in Figures 19 and 20. By removing the downstream toe of the dam’s central block, the resultant thrust would have been projected even further downstream, thereby leaving the upstream heel in tension (as the dam tried to overturn). Post-failure assessment by Grunsky (1928) showed that Block 1 had separated at its upstream heel, between the masonry cut-off wall and the dam proper (Figure 19). Such tilting would have progressively worsened, due to the development of full hydrostatic uplift pressures, within the crack. This must have occurred, as the gage ladder was found swallowed into the crack at the base of the remaining section, suggesting that the dam MUST have tilted at least 12 inches to allow complete access into this crack (Figures 17 and 22).

Figure 20. The remains of Blocks 5 and 6, as seen immediately after the failure. The two lowermost steps of Block 1 appear to have been left in tact at the west end. Note the accumulation of schist detritus upon Block 5, about 20 to 30 feet above the creek bed.

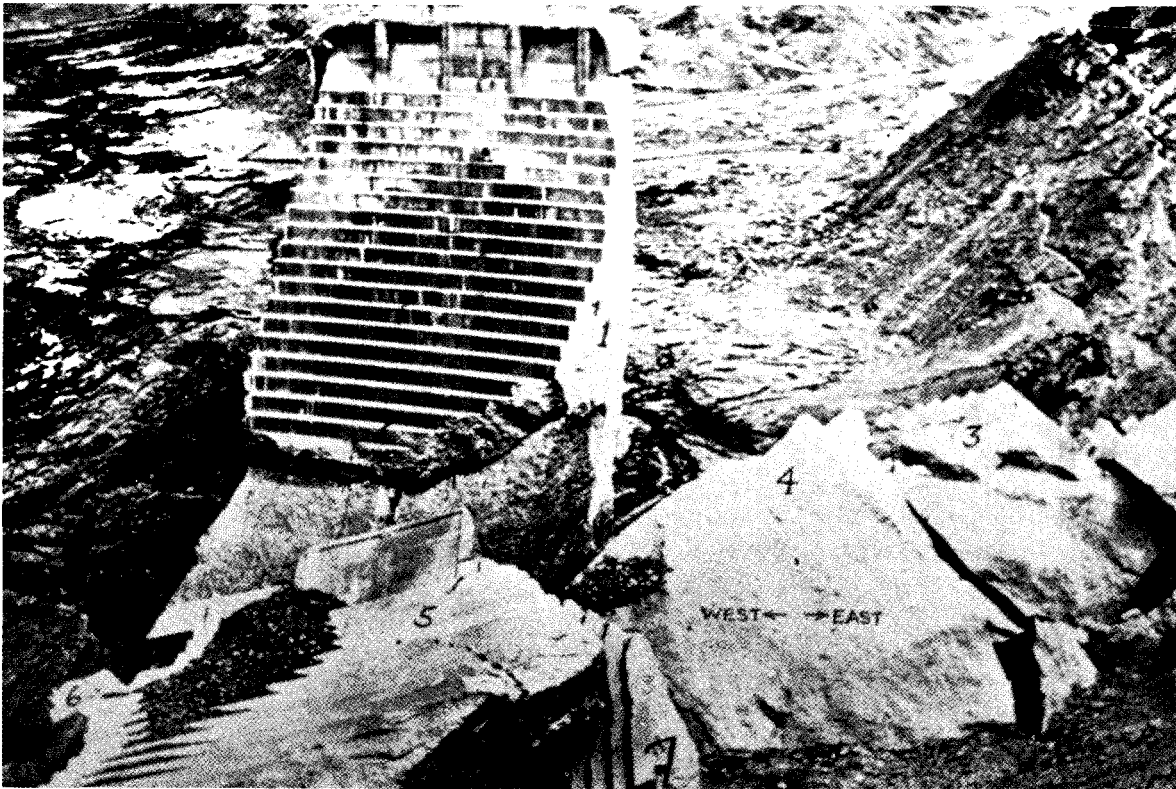
Figure 21. Photo looking upstream, showing the final resting positions of the east abutment and main section blocks. Note the schist detritus left upon Blocks 4 and 5. The oakum patch in Block 5 is also very apparent. Blocks 2/3/4 separated very late in the failure sequence, when much less water was available to dislodge them (they toppled upstream).

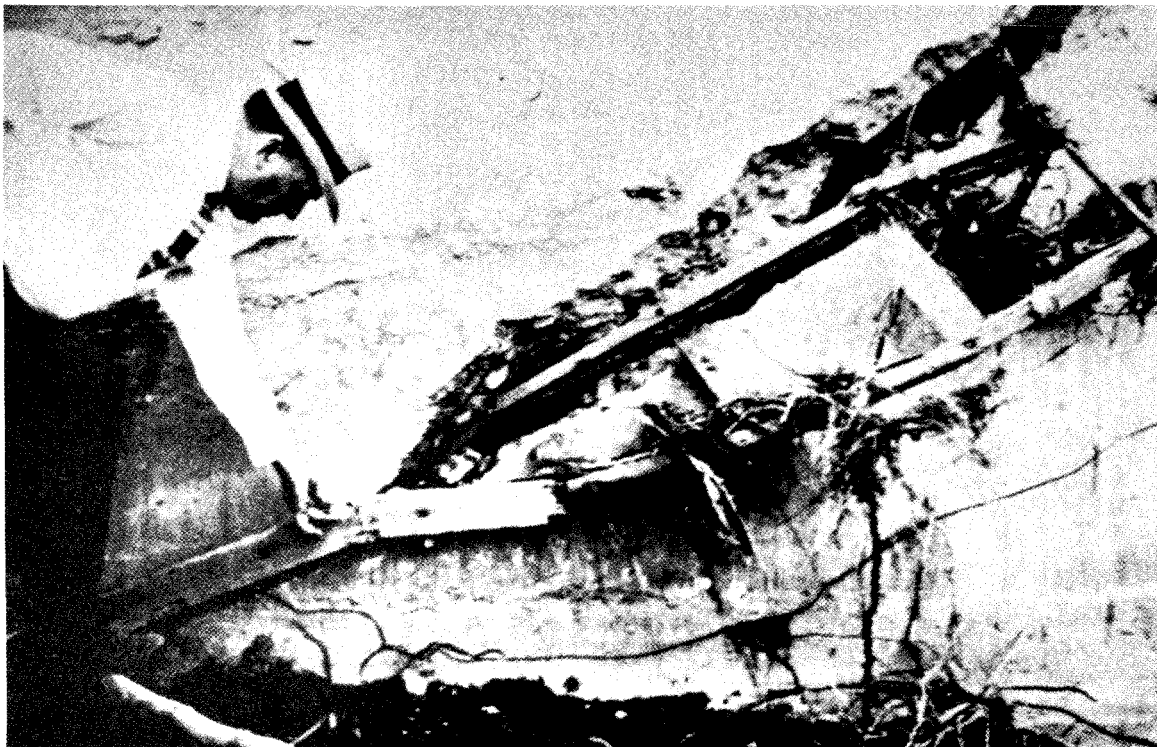
Figure 22. Grunsky's (1928) photo showing the upstream gage attendant's ladder wedged into a large crack at the west upstream heel of Block 1. Block 1 would have to have tilted at least 12 inches to swallow up the ladder, which was 18 inches wide. There is little doubt, therefore, that the upstream heel of the dam's central section was in tension and that, at some point, either before or during the failure sequence, full hydrostatic pressures must have acted upon the block's interior, significantly negating its effective dead load.

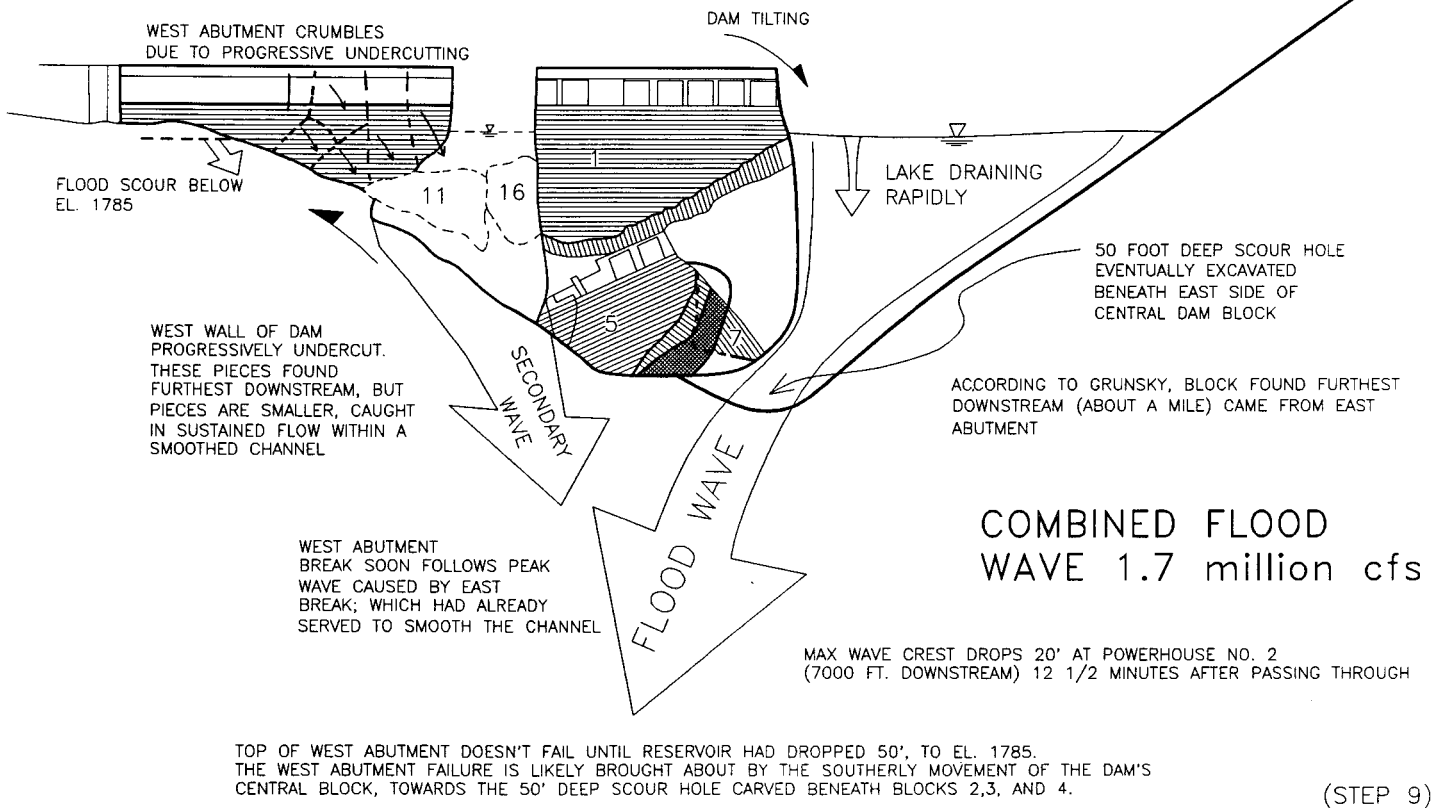
Figure 23. (upper) Schematic portrayal of east and west breaches combining to form the maximum discharge of 1.7 million cfs, sometime shortly after midnight on March 12/13, 1928. This wave crested at Powerhouse 2, 7000 feet downstream, sometime between 12:02:30 and 12:08; receding 20 feet by 12:15 AM. The maximum outflow was likely caused by the rapid erosion of the debris plug created by the east abutment slide at 11:57:30 PM.

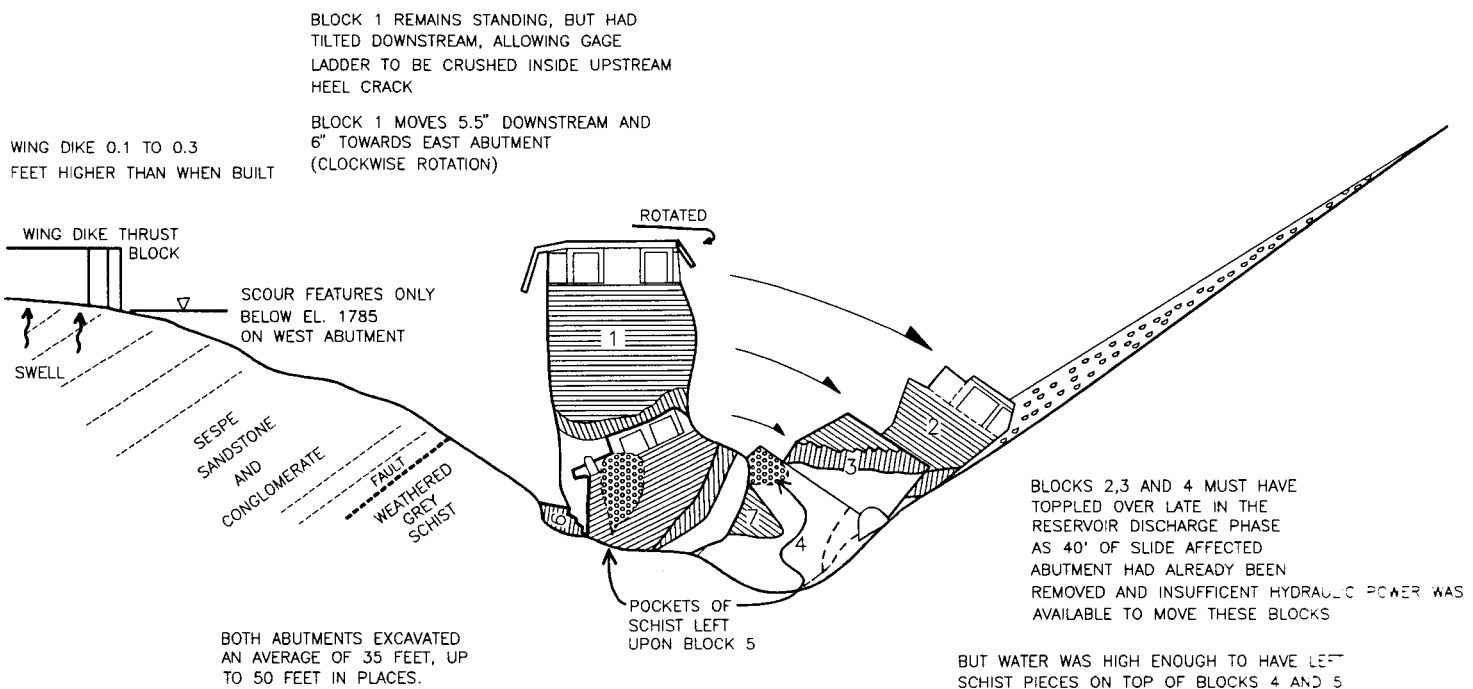
Figure 23. (lower) Schematic portrayal of the final stages of the St. Francis failure. The west abutment was scoured away very quickly once the initial piercement occurred, just west of Block 1 (see Figure 24). Block 2/3/4 was undercut by the outpouring through the east breach, eventually toppling over into a hole 50 feet deep, falling backward. The cutting of such a deep hole on the east side of the main structure also argues for more discharge emanating from this side of the structure. This is how the scene looked the following day (Figure 25).

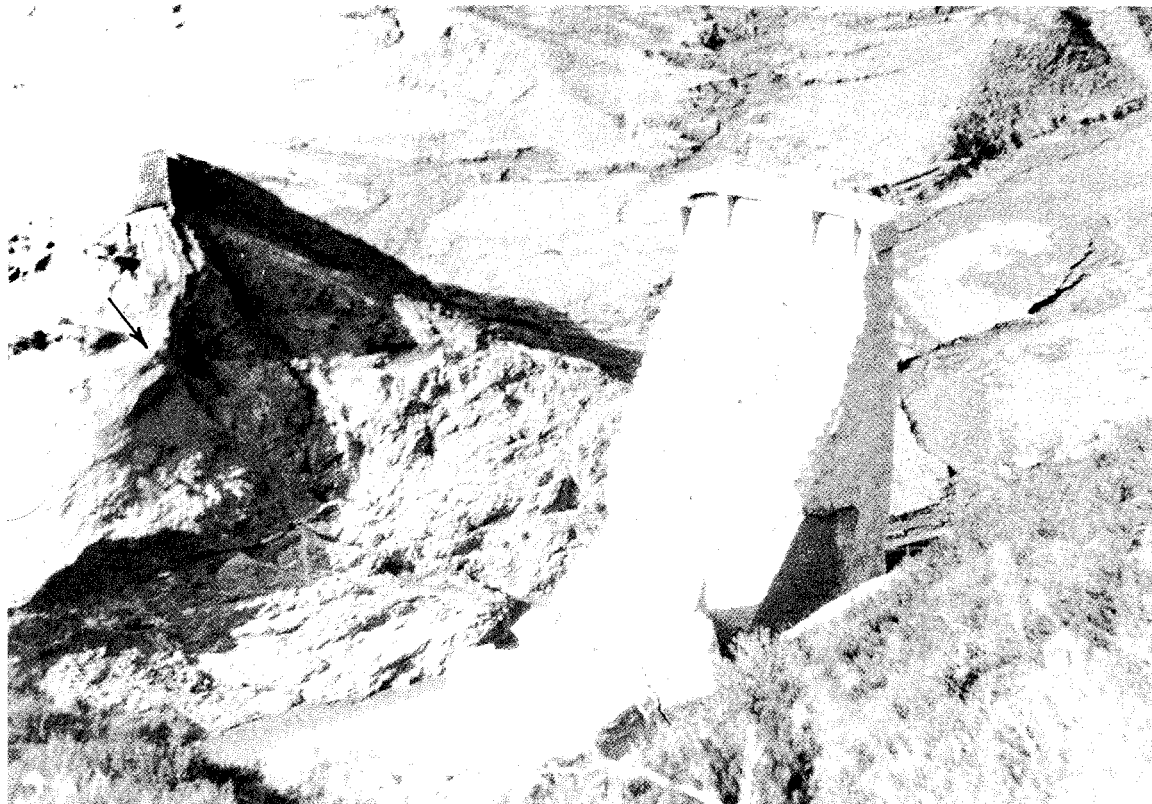
Figure 24. (upper) View looking down on the dam site from the upper surge chamber road (Figure 14 lower) the morning after the failure. Note how the original construction road, leading up to the wing dike, is not damaged above elevation 1785 (arrow). This suggests that, at a minimum, the upper portion of the west abutment did not fail until the reservoir had drained at least 30 to 50 feet (photo courtesy of Ventura County Museum of History and Art).

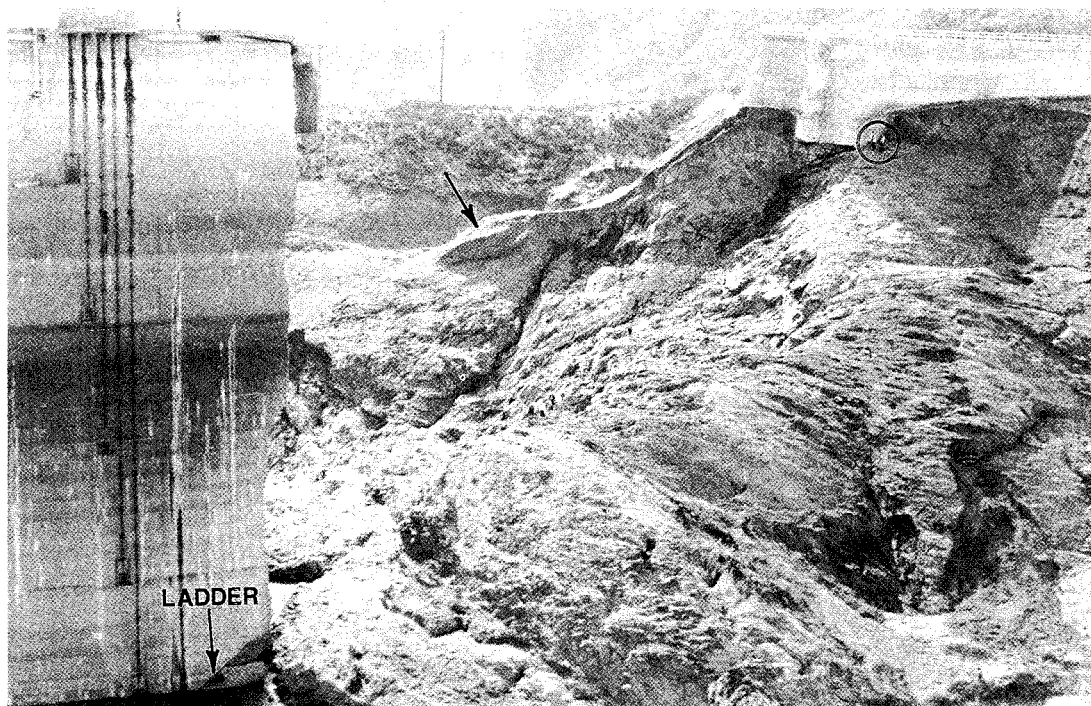
Figure 24. (lower) Detail of failed west abutment, looking downstream, with people circled for scale. Only a portion of the west dike access road side-cast fill was excavated by the outpouring water (arrow), with scrub brush left upon the cut slope, down to elevation 1785, 50 feet below the reservoir level. Grunsky's ladder, caught in the upstream heel crack as Block 1 tilted downstream, is annotated (photo courtesy of Ventura County Museum of History and Art).

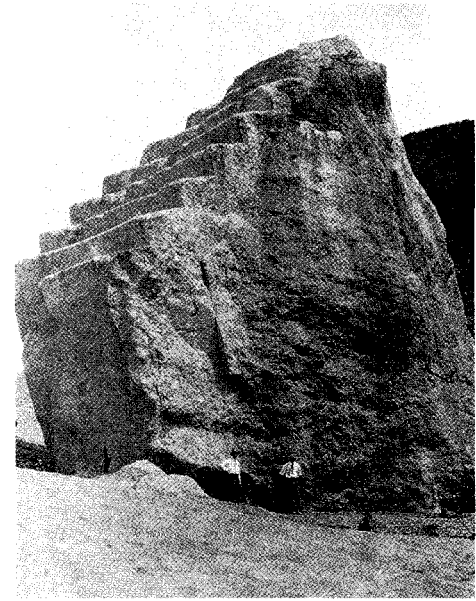
Figure 25. - Close up view of dam Block 16, which at 10,000 tons, was the largest piece of the dam moved any appreciable distance downstream (as shown in Figure 8). This block came from the lower part of the west abutment, adjacent to Block 1, which remained standing. The small holes visible on the upper cold joint (arrow) were for the rakers supporting the stepped forms for the dam's downstream face. Blocks of this size can be most easily transported in a dirty fluid or slurry, which greatly diminishes their effective weight, as suggested in Figure 27. Photo courtesy of Ventura County Museum of History and Art.

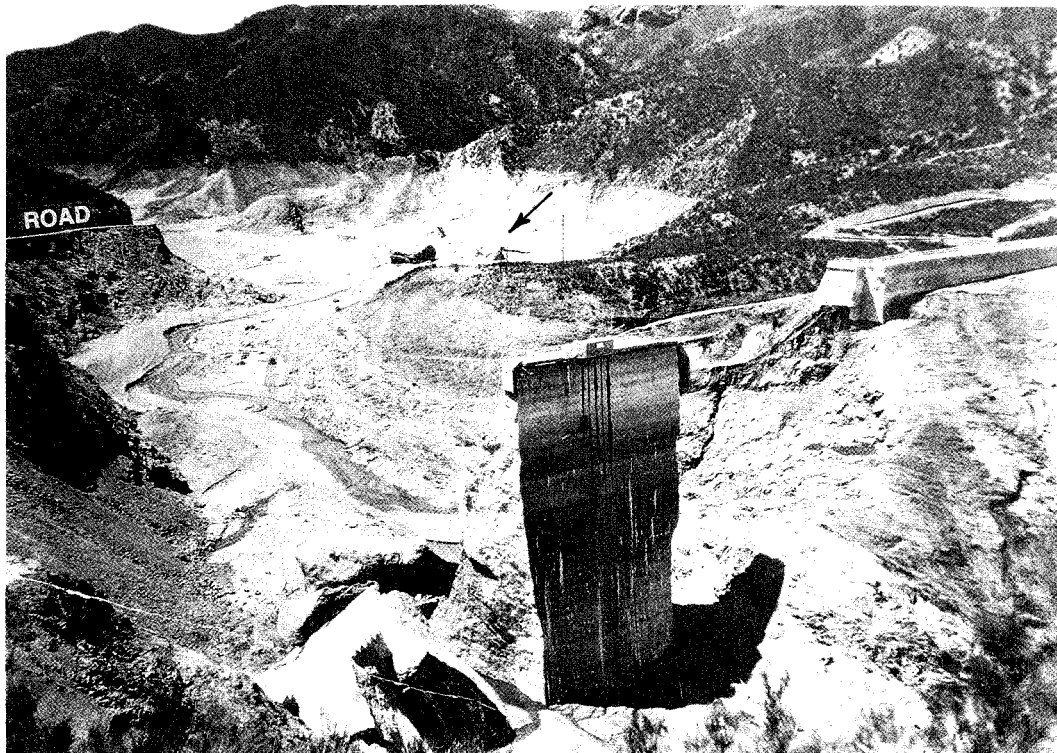
Figure 26. Overview of the flood's aftermath, immediately downstream of the dam. The flood wave scoured the canyon's slopes to a maximum depth of 120 feet above the stream level. The Edison power line crossed the channel, but was situated above the maximum scour line (arrow). San Francisquito Canyon road began climbing east wall of the canyon, at upper left. Photo courtesy of Ventura County Museum of History and Art.

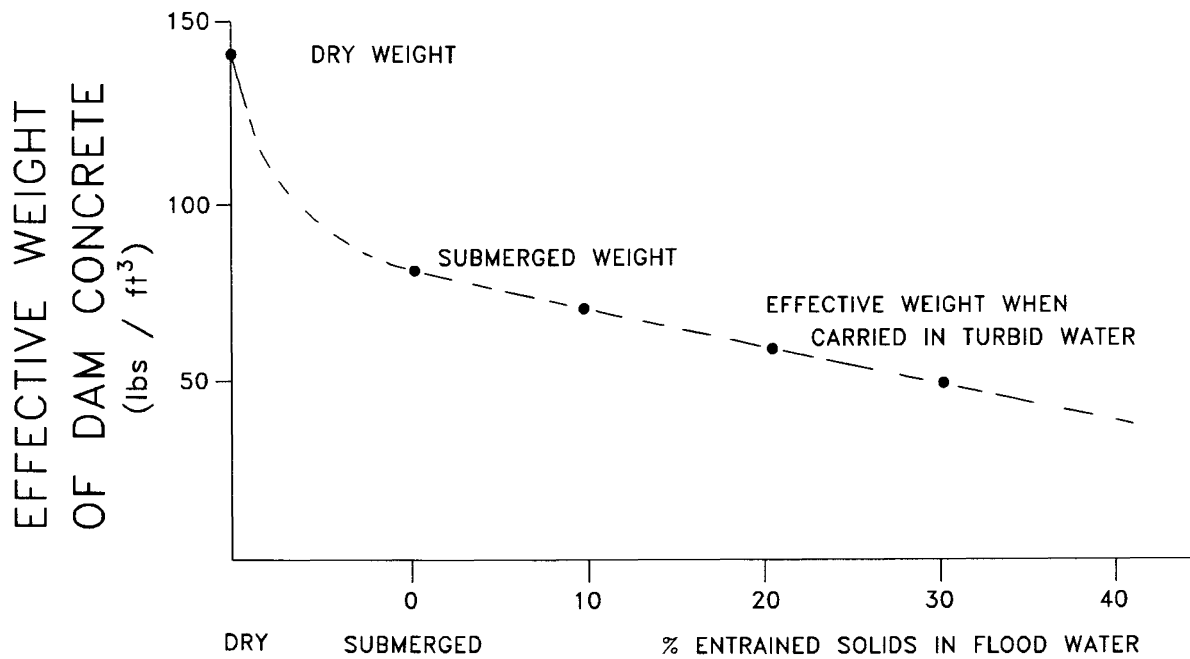
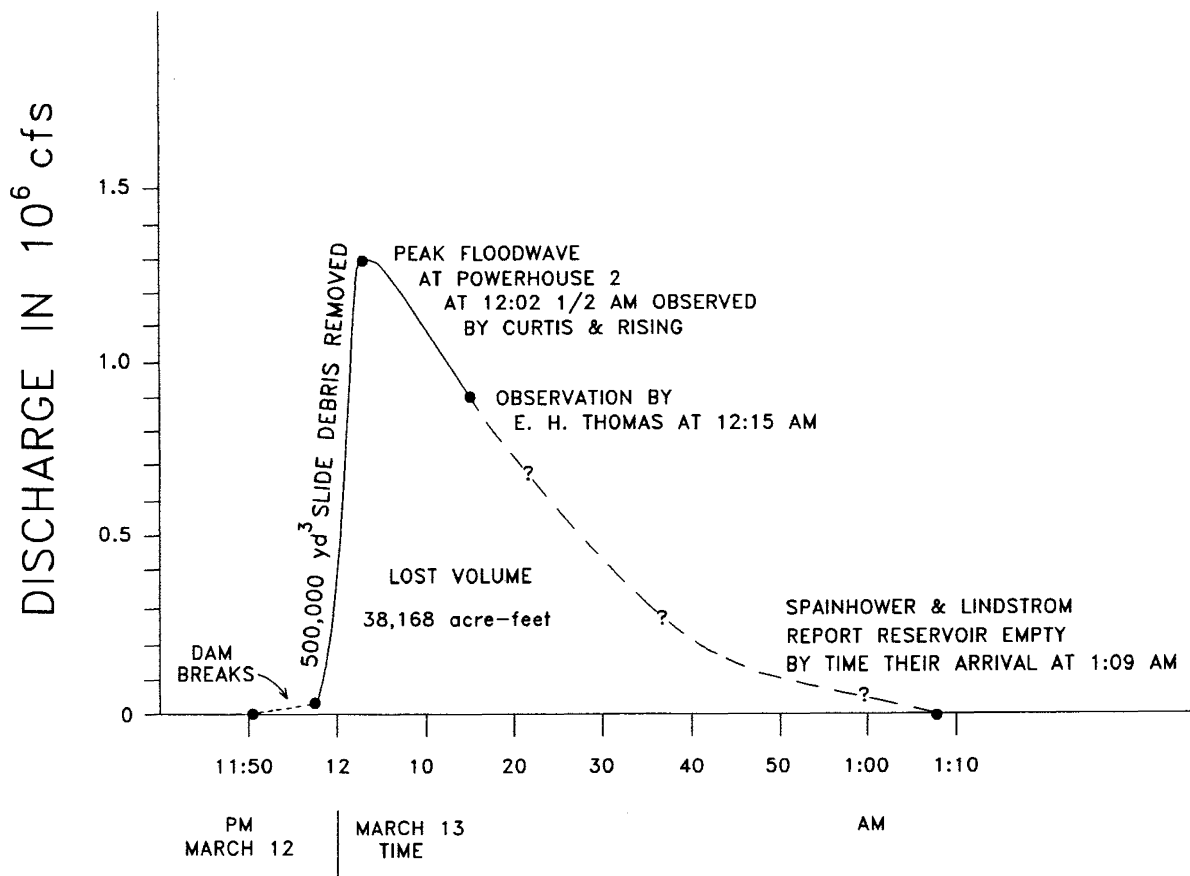
BOUYANCY EFFECT ON SUBAQUEOUS TRANSPORT OF DAM'S CONCRETE BLOCKS

Figure 27. Preliminary evaluation of flood wave turbidity effects on bouyancy of the dam's concrete blocks. Although heavy when dry, tests of the dam's concrete show it to have a void ratio of around 13%. Post- failure photos also suggest that the blocks were saturated, as they continued to weep moisture out of their cold joints for days following the failure. If saturated, and immersed in turbid flood waters, the effective weight of the blocks was reduced by as much as 67 percent
