Identification of Landslides Along Crowley's Ridge in the Upper Mississippi Embayment Using Topographic Algorithms

Briget C. Doyle and J. David Rogers
Department of Geological Engineering

Department of Geological Engineering
University of Missouri-Rolla

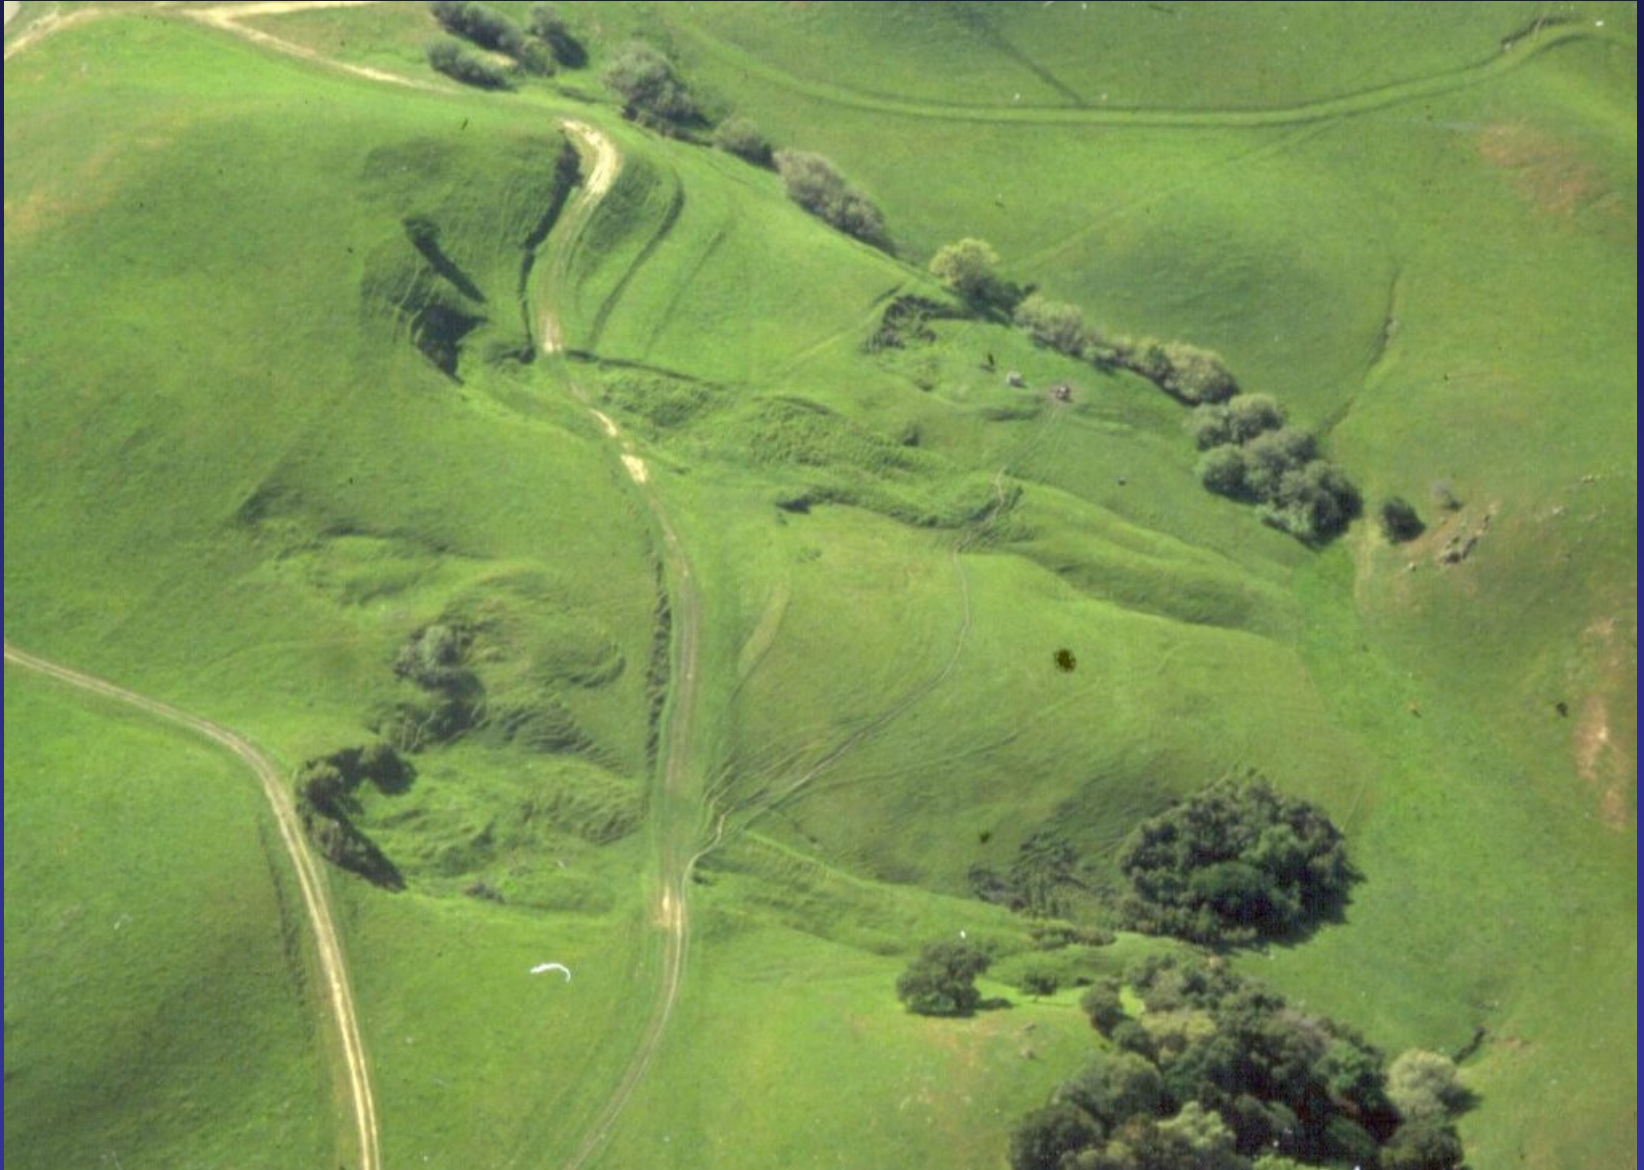
Topographic Expression of Earthflows

- Opposing contours
- Headscarp evacuation areas
- Necking down at transition between deflation/inflation zones

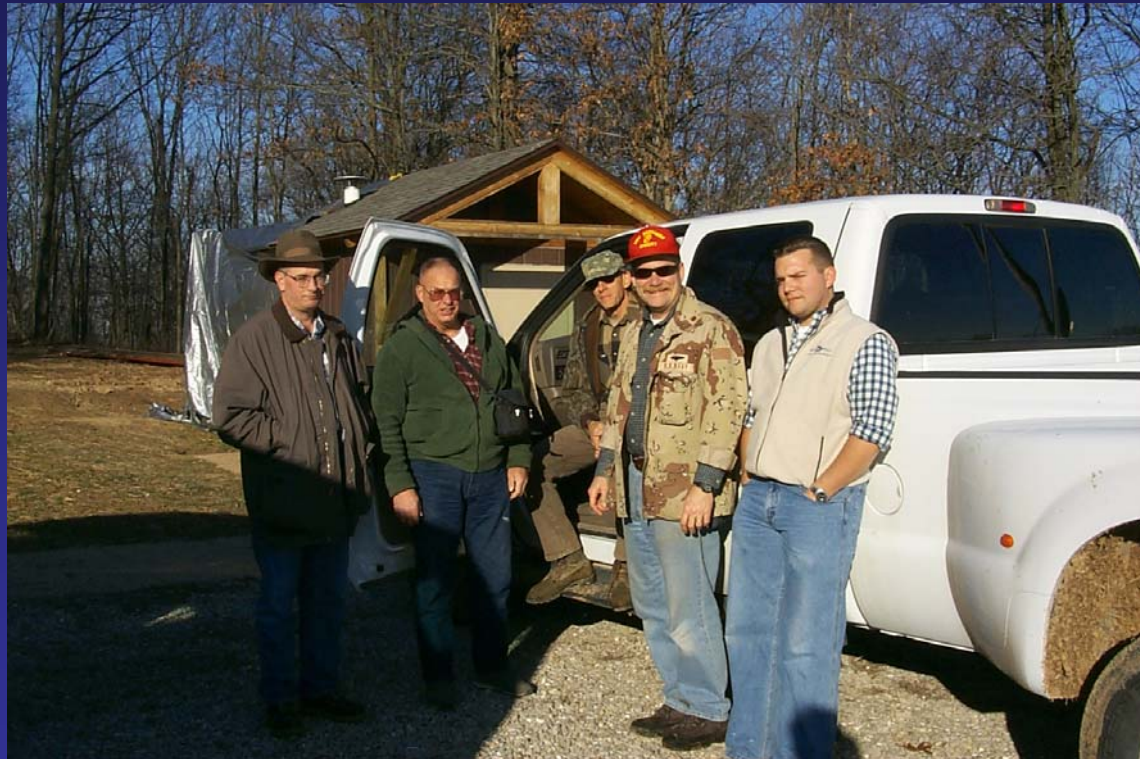
Field Work to Confirm Landslides

- Field reconnaissance
 - Hummocky topography
 - Head scarps
 - Deranged drainage
 - Graben structures
- Geophysics
 - Electrical Resistivity
 - Induced Polarization

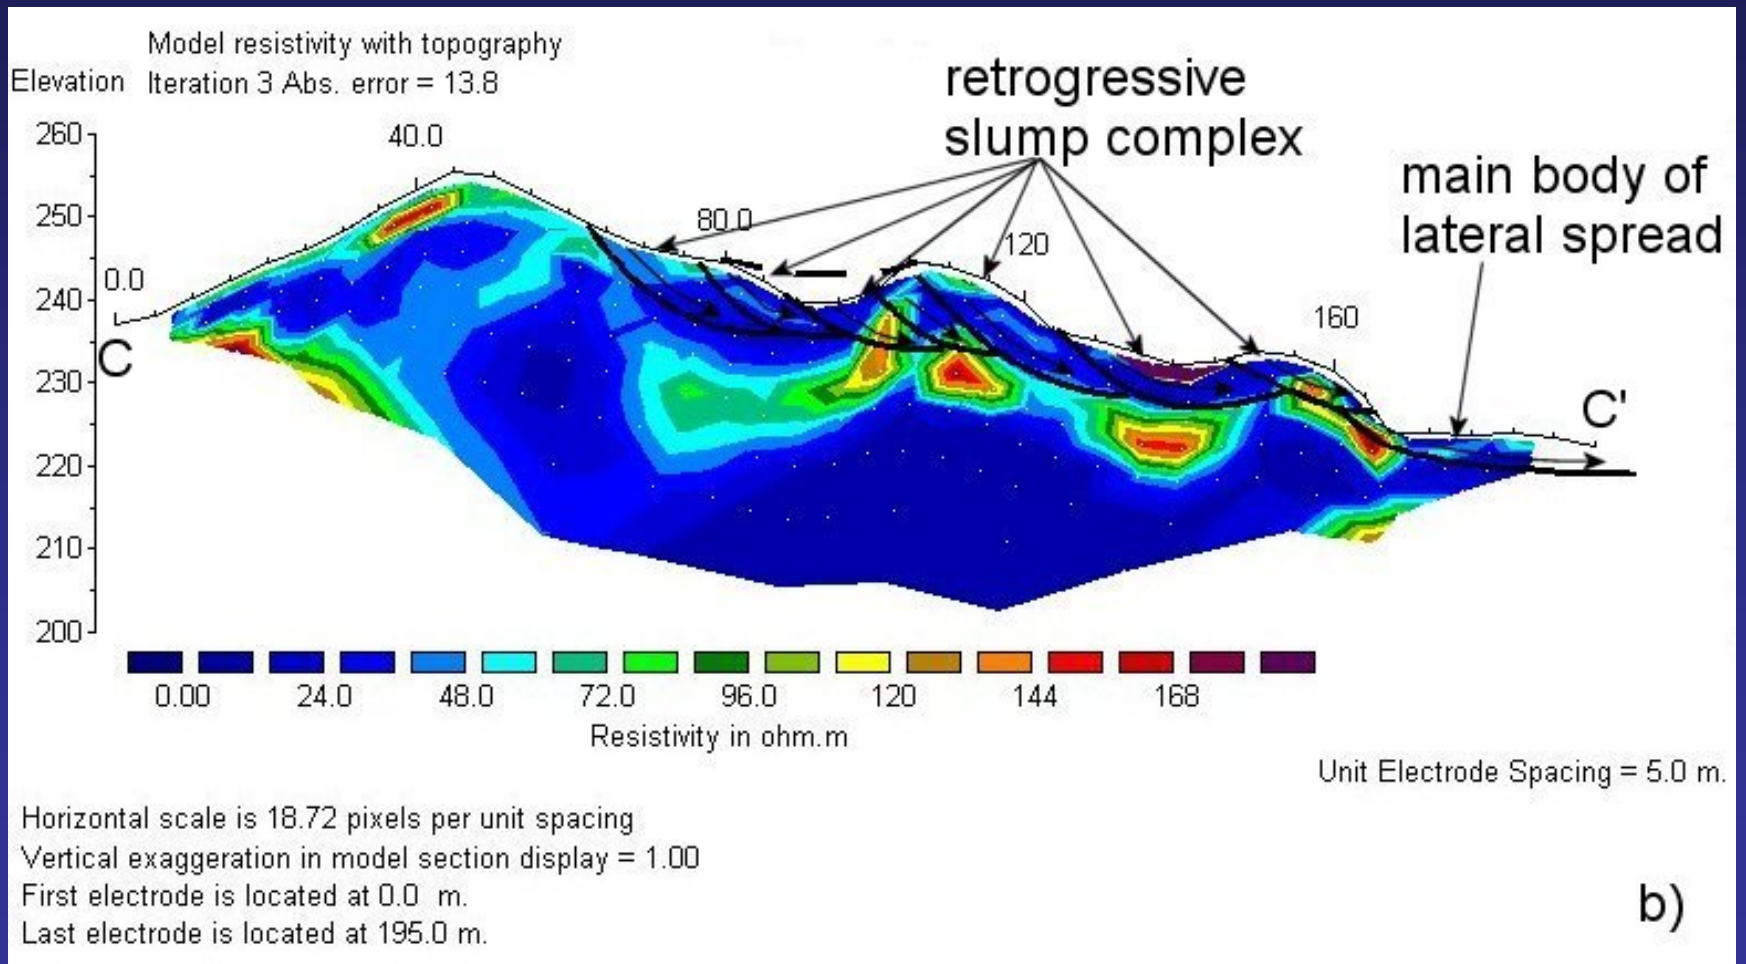
Geophysical investigations electrical resistivity
