Hoover Dam: Operational Milestones, Lessons Learned, and Strategic Import

J. David Rogers¹, Ph.D., P.E., P.G., F. ASCE

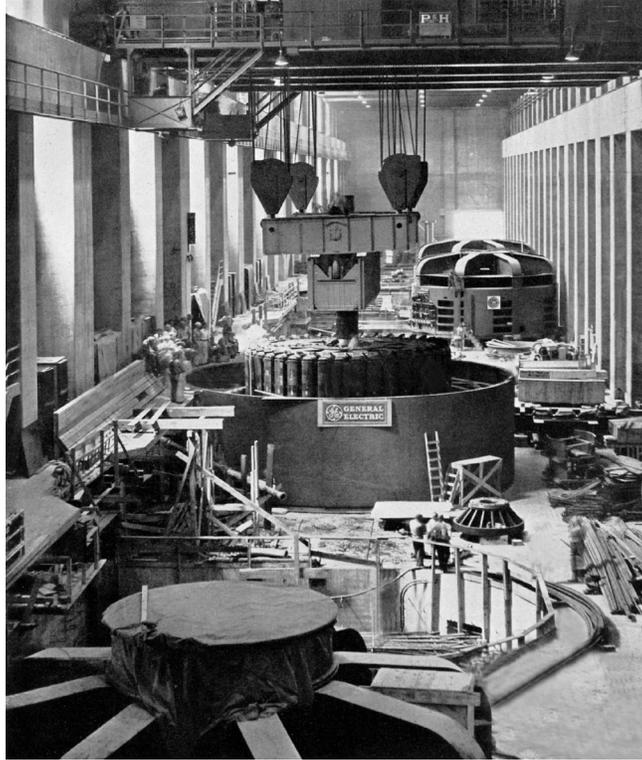
FIG. 3. Gantry crane in the Nevada Powerhouse lowering a 500-ton rotor of Generator N-2, one of the General Electric 82,500 kilovolt-ampere generating turbines, and the first to brought online at Hoover Dam, on October 26, 1936 (USBR).

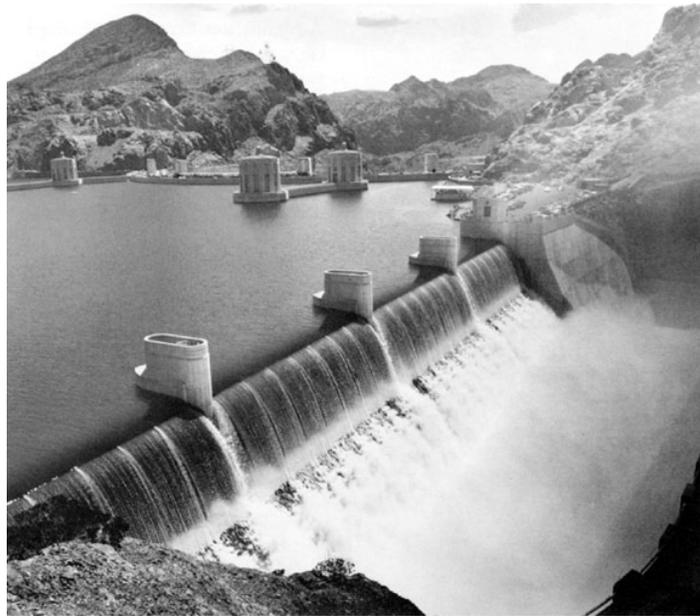
FIG. 5. Water from Lake Mead discharging over the four drum gates of the Nevada spillway during spillway tests in August and October 1941 (USBR).

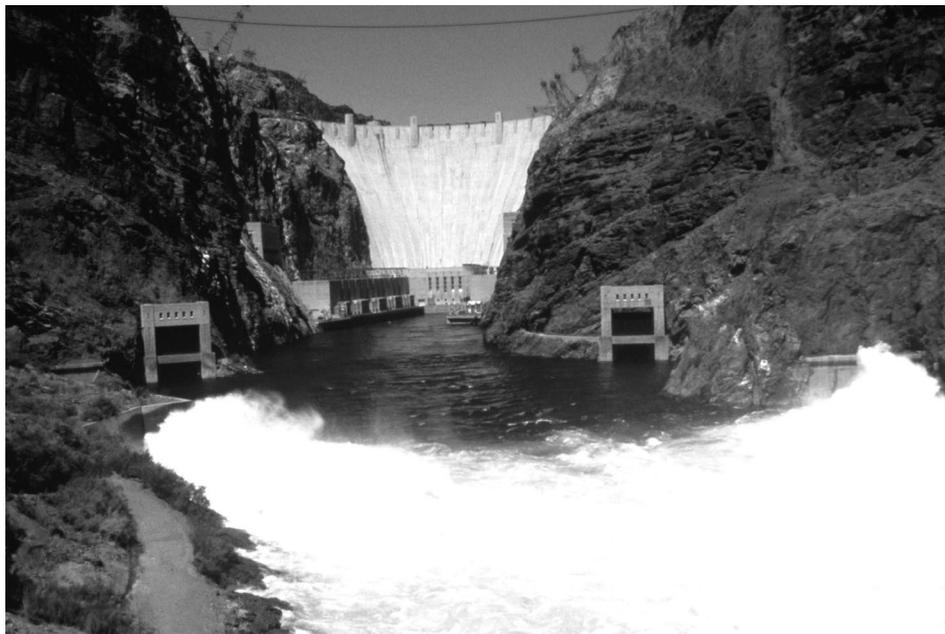
FIG. 8. In July and August 1983 the Nevada and Arizona side channel spillways discharged excess storage for the second time in the dam's history (USBR-LCR).

The roughness assumption was finally proven false to everyone's satisfaction during spillage at Glen Canyon and Hoover Dams in the summer of 1983 (Figure 8). That year the Upper Colorado River Basin experienced an abnormally late mountain snow accumulation, followed by an accelerated snowpack ablation, which triggered early seasonal flooding. Many Reclamation reservoirs found themselves without sufficient flood storage to handle the unanticipated inflows (Vandivere and Vorster, 1984).

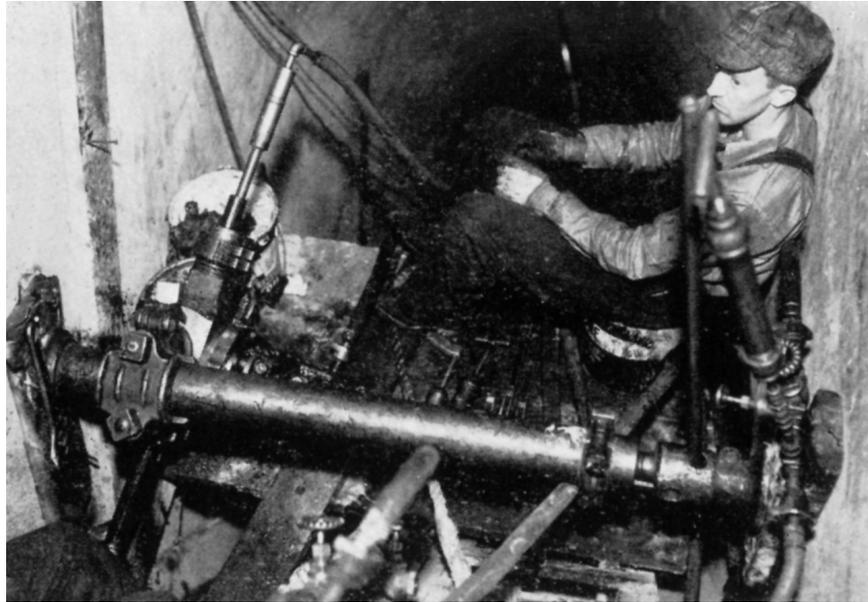
FIG. 15. Cramped working spaces typified the 9- year program of extending the grout curtain, between 1938 and 1947 (USBR).

The dam's grout curtain was extended deepened extensively between 1938 and 1947 (Figure 15). The grout holes were extended to depths of 300 feet beneath the dam's foundation, then pumped under pressure of full reservoir head. These were drilled from the dam's system of internal inspection galleries, shown in Figure 16. A schematic view of the deepened grout curtain, as it appeared in 1947 is shown in Figure 17.

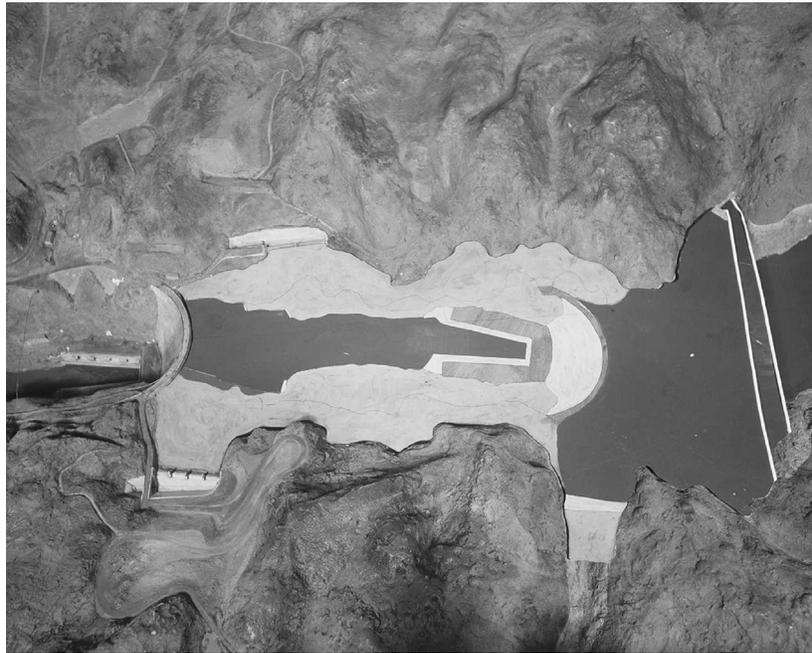
FIG. 22. Painted plaster model of a camouflage scheme believed to have been designed by Allen True, the Colorado artist who had previously designed the western and Native American themes depicted in Hoover Dam’s terrazzo floors. His design included a ‘dummy dam’ and false torpedo nets about a quarter mile upstream of the actual dam, both which would be lit at night. This model was informally preserved as a curiosity at the dam for many years thereafter (USBR).

In an April 1943 letter to the Chief of Engineers, Colonel W.J. Matteson provided a review of the plan to camouflage Hoover Dam by Colorado artist Allen True, as well as outlining additional or alternative measures that might be employed to protect Hoover, Parker, Grand Coulee, and Shasta Dams (Matteson, 1943). True's scheme was classified 'secret' and involved the erection of a cable-supported dummy dam upstream of the actual dam, as shown in Figure 22. The ruse would have employed a network of highly reflective features attached to welded wire mesh draped over heavy supporting cables, attached to the steep walls of Black Canyon. This scheme was designed to look like concrete and rock. Similar techniques were employed by the

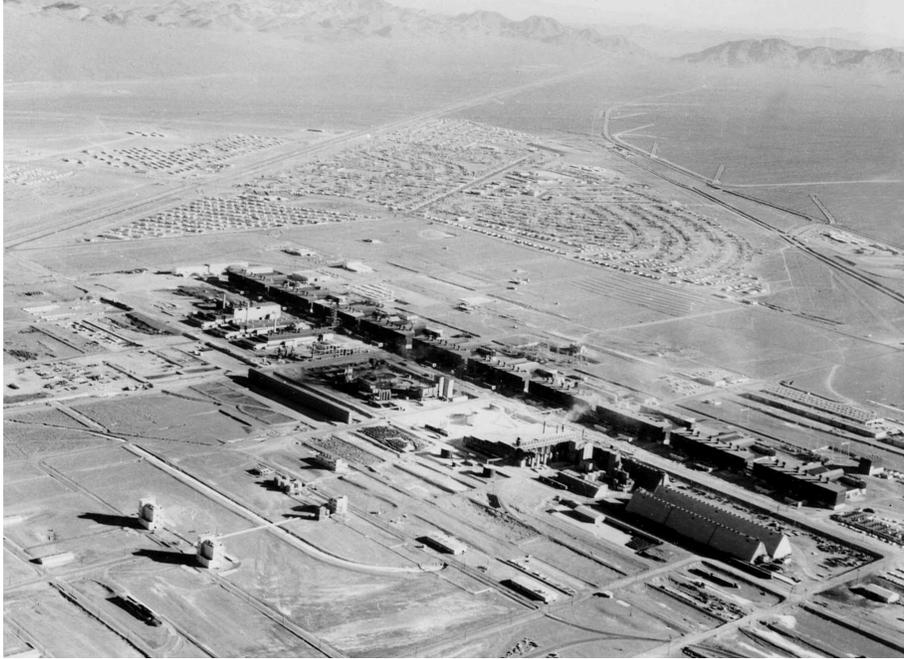
FIG. 23. The sprawling Basic Magnesium Industries Plant and the community of Henderson were built during the war to supply this strategic metal for the aircraft industry in southern California (Nevada Historical Society).

BMI met their manpower shortfall by importing African American workers from Mississippi, who were undaunted by southern Nevada's dry heat. This was during the era of segregation, so the Defense Housing Corporation scrambled to build a separate 324-unit Victory Village which they christened "Carver Village" (for George Washington Carver) on the western side of Las Vegas, which was pretty desolate (Moehring, 1986). By mid-1943 this sprawling complex would include ten separate plants employing 5,000 workers (Figure 23). By war's end BMI would employ almost 10,000 workers.
