# Geologic Setting of the Sacramento-San Joaquin Delta

Berkeley NSF RESIN Project Meeting

January 26, 2011

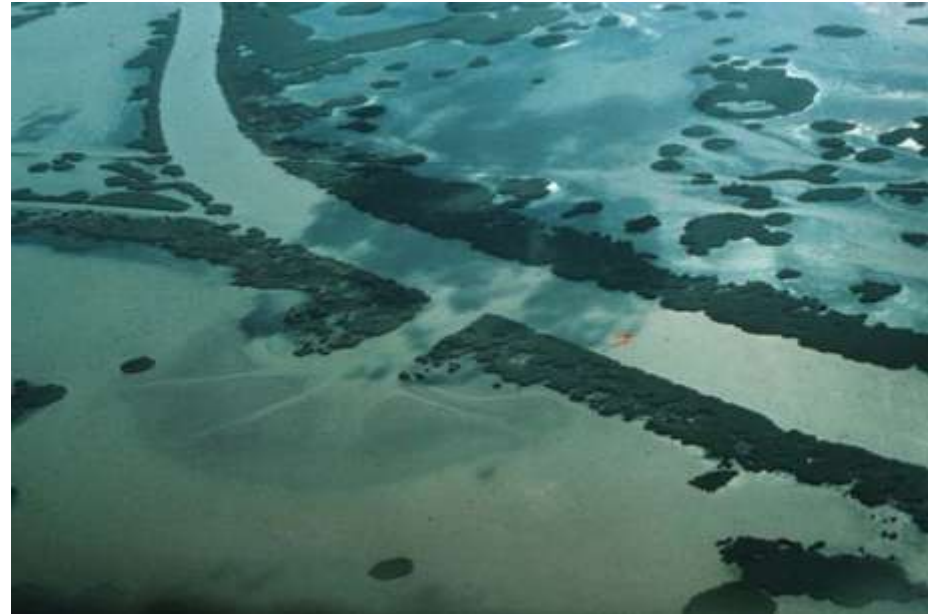
**Meandering low-gradient channels tend to breach their own natural bank levees at crevasse splays, often along an outboard turn of the channel. These become prime locations for future seepage problems and repeated bank failures because of the pervious sands that are deposited in the outbreak troughs, as seen above.**

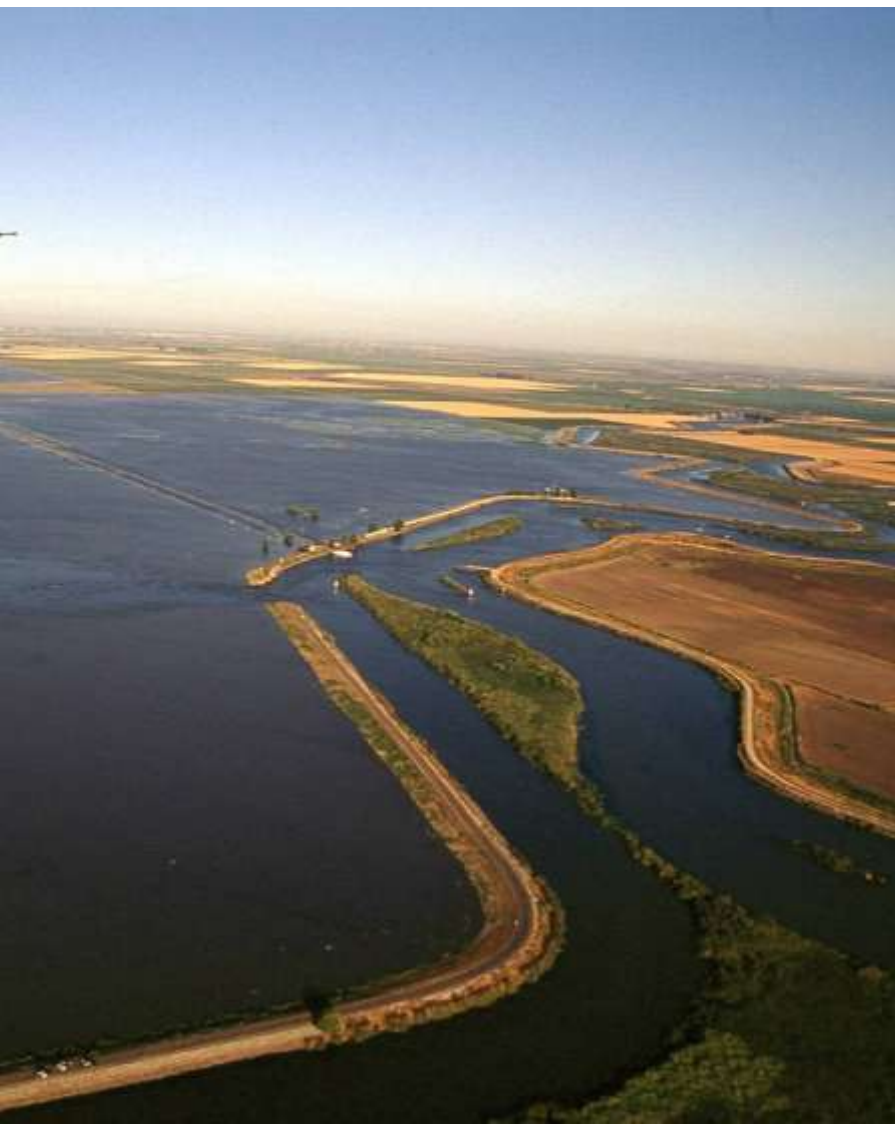
The dredged channel at left lies *outboard* of the natural channel, so the levee lies upon compressible peats rather than upon the natural levee bordering the river channel.

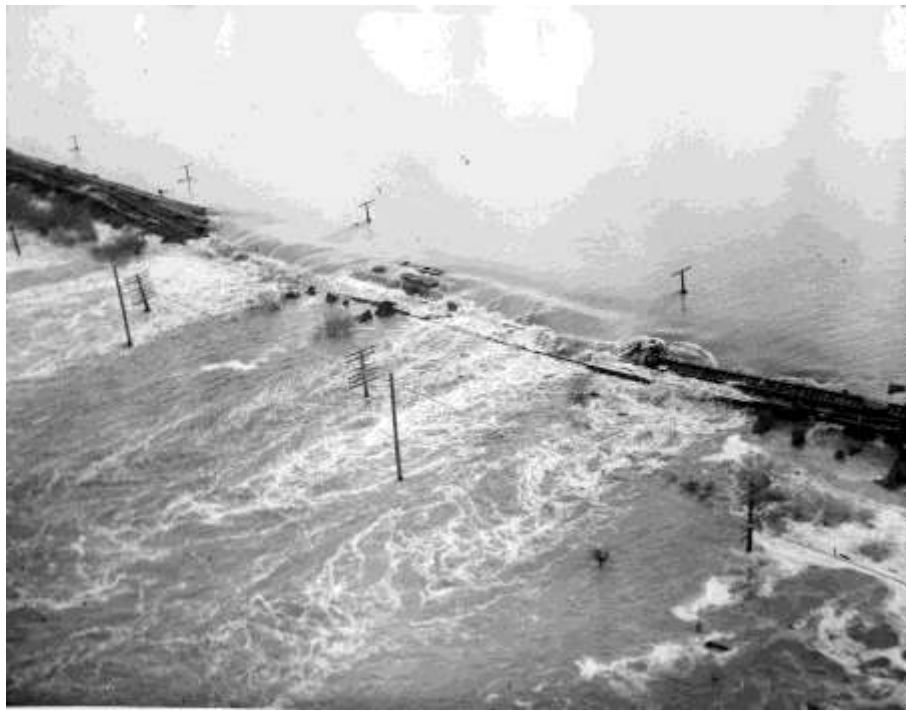
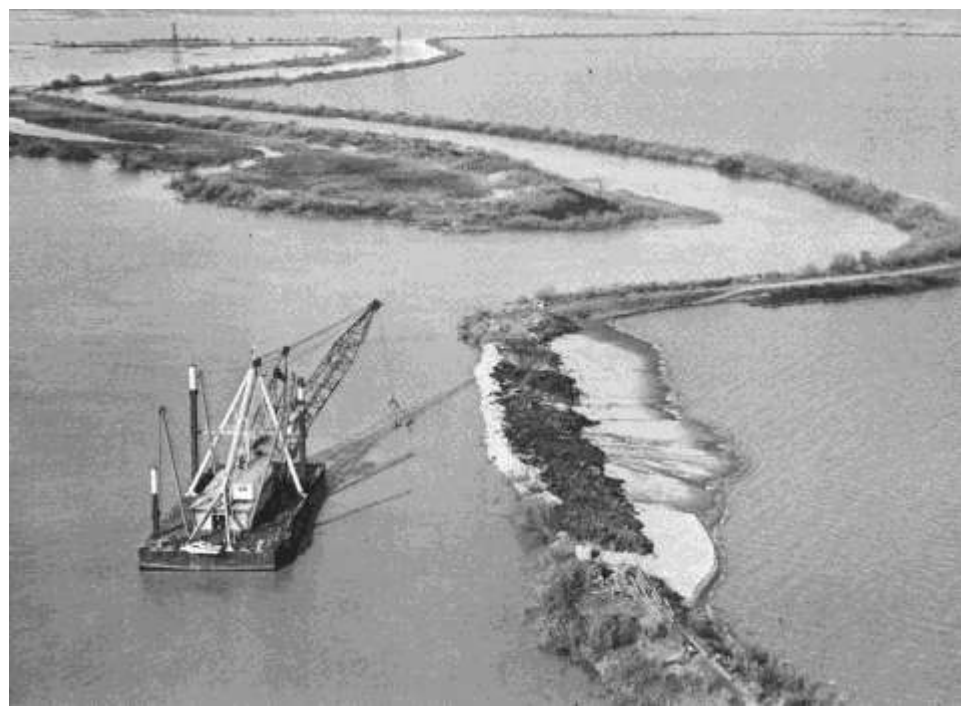
**Levee failures can be triggered by any number, or combination of factors. The most common is overtopping, followed by underseepage and piping. Aging effects and the variability of channel geometry, foundation materials, and penetrations through embankment materials combine to make reliable stability analyses difficult.**

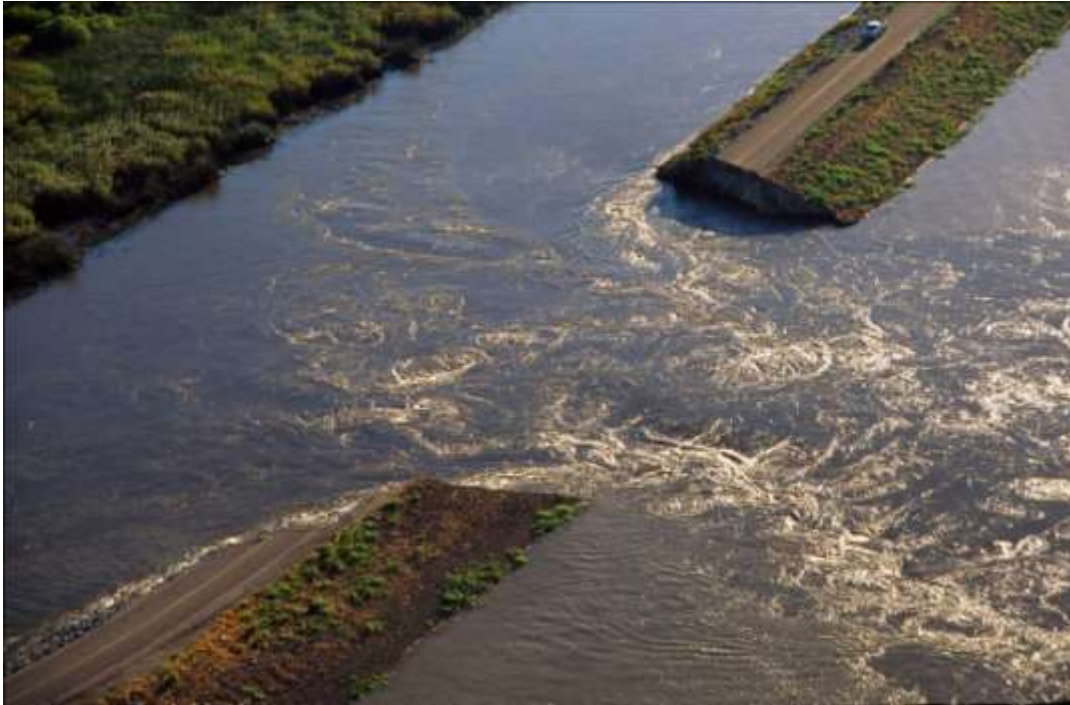
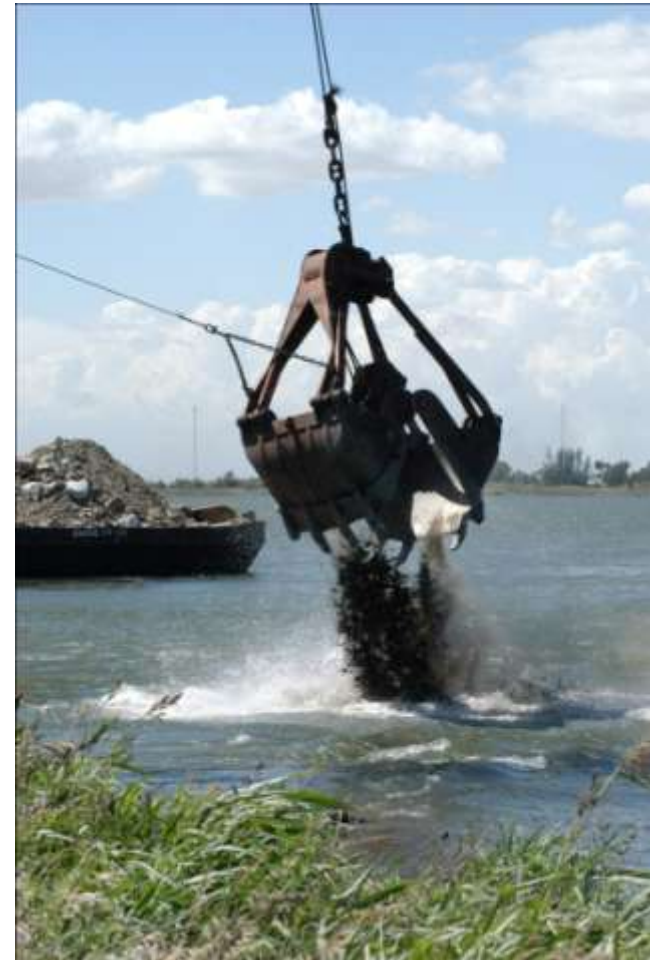
Delivering the minus 36-inch rock mixture via “air-mailing” (shown at right) allows the fines to be swept away by the intrushing current (shown at left). This can result in an overly very pervious dike closure. This is what appears to have occurred at the north end of the 2004 closure, which leaked.
