Geologic Conditions Beneath the New Orleans Area

J. David Rogers, Ph.D., P.E., P.G.

University of Missouri-Rolla

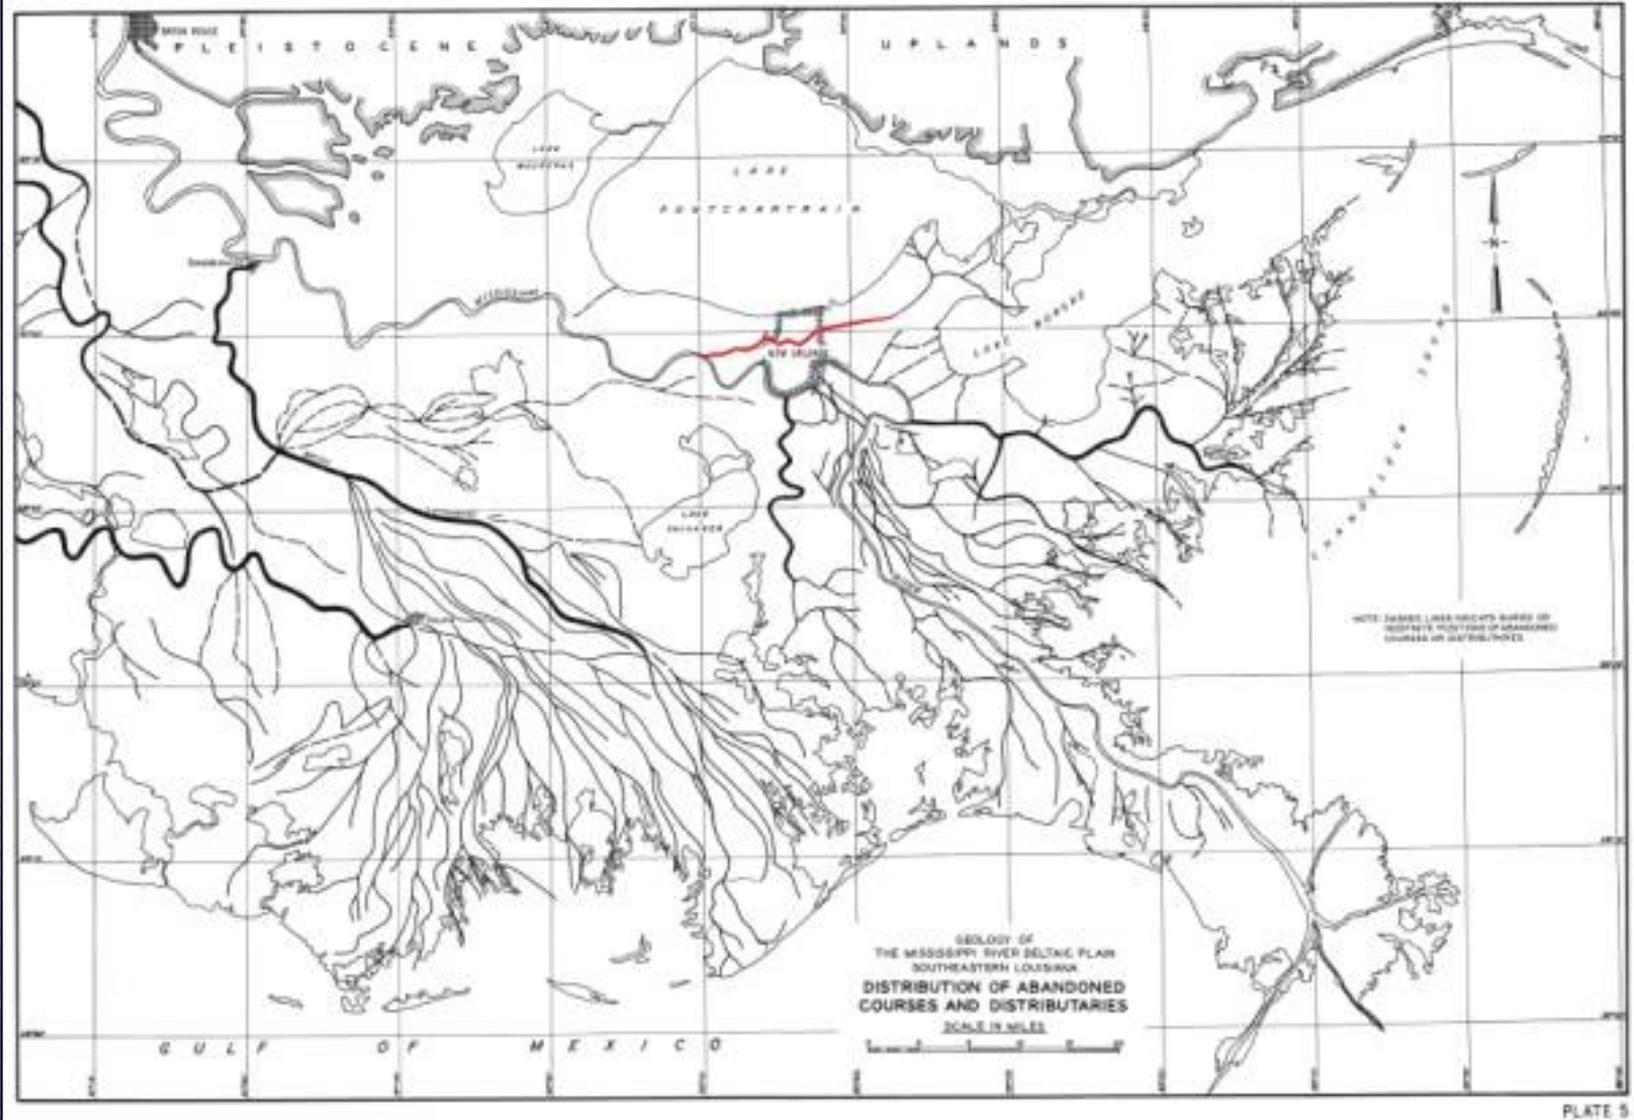
- Areal distribution of abandoned channels and distributaries of the Mississippi River. The **Metairie Ridge distributary channel** (highlighted in red) lies between two different depositional provinces in the center of New Orleans.

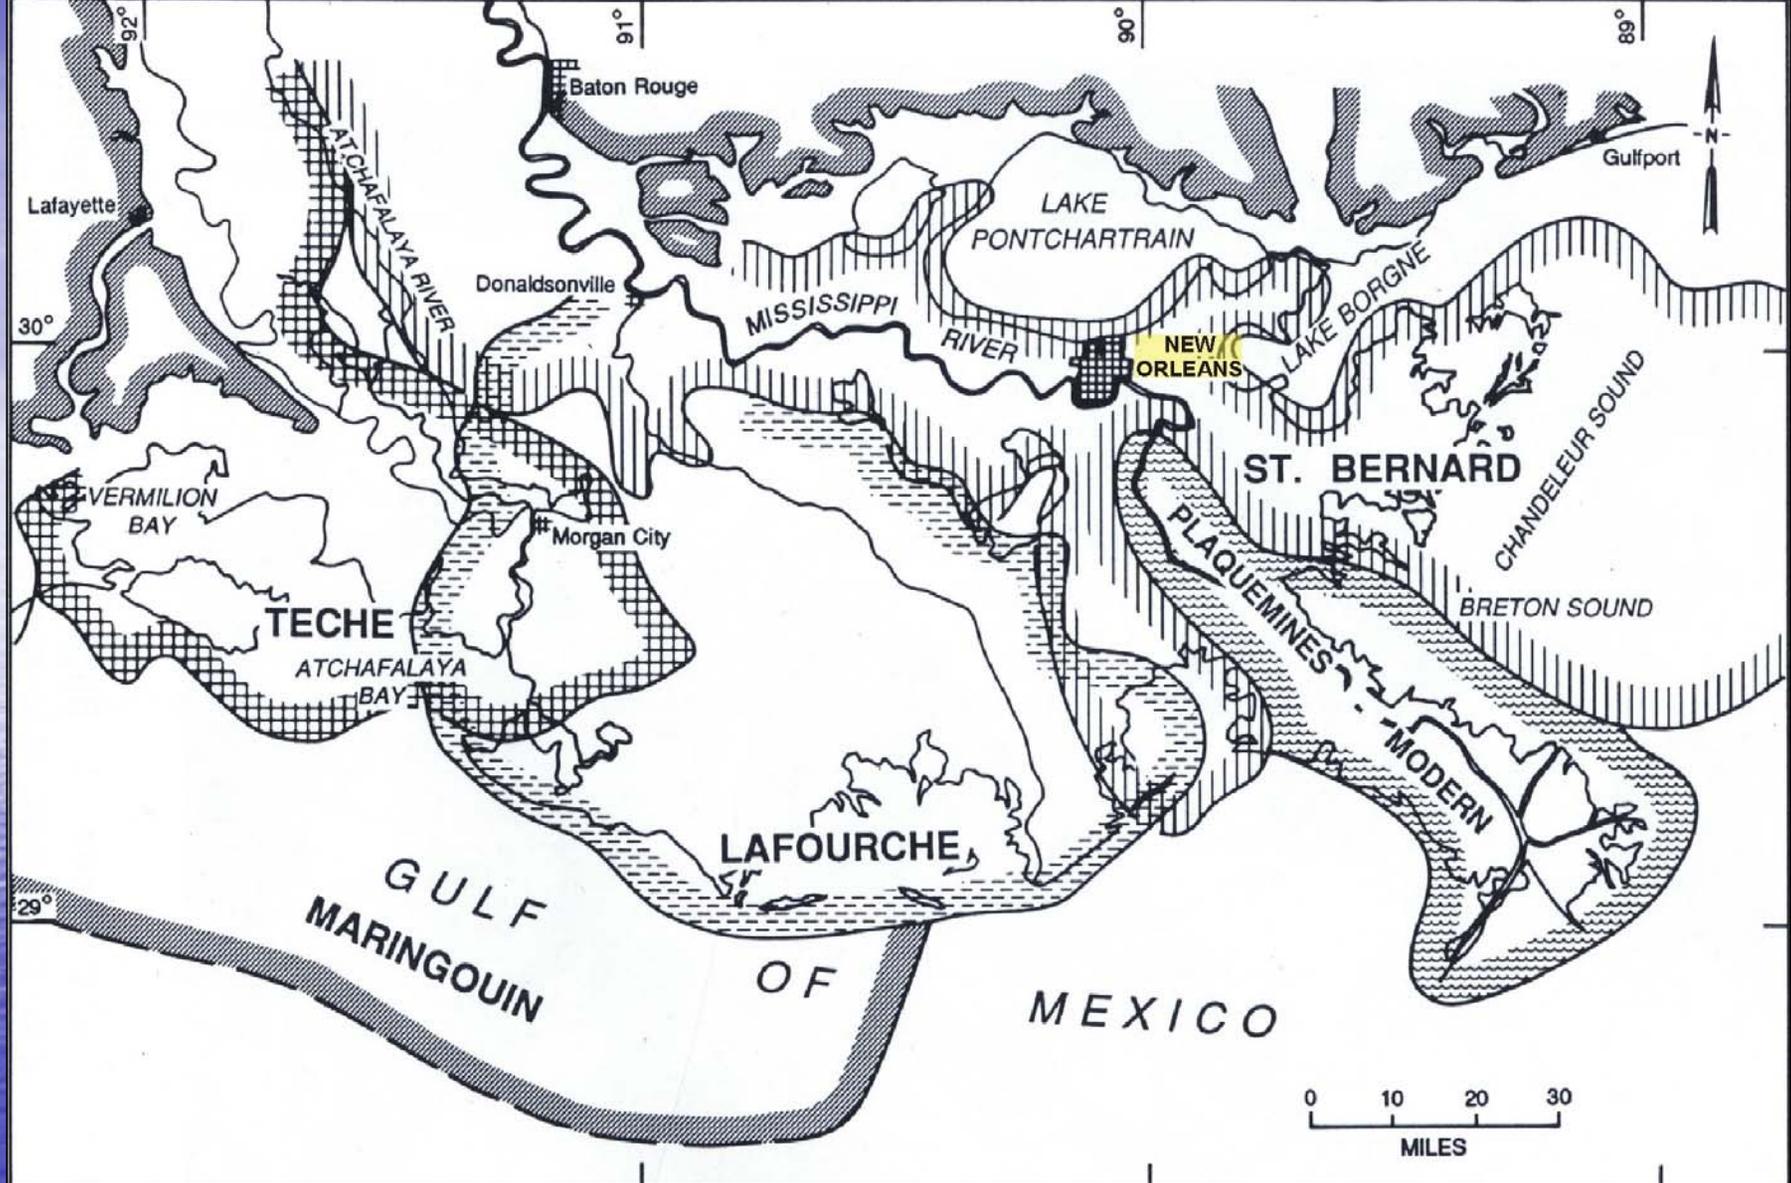
- Major depositional lobes identified in lower Mississippi Delta around New Orleans.

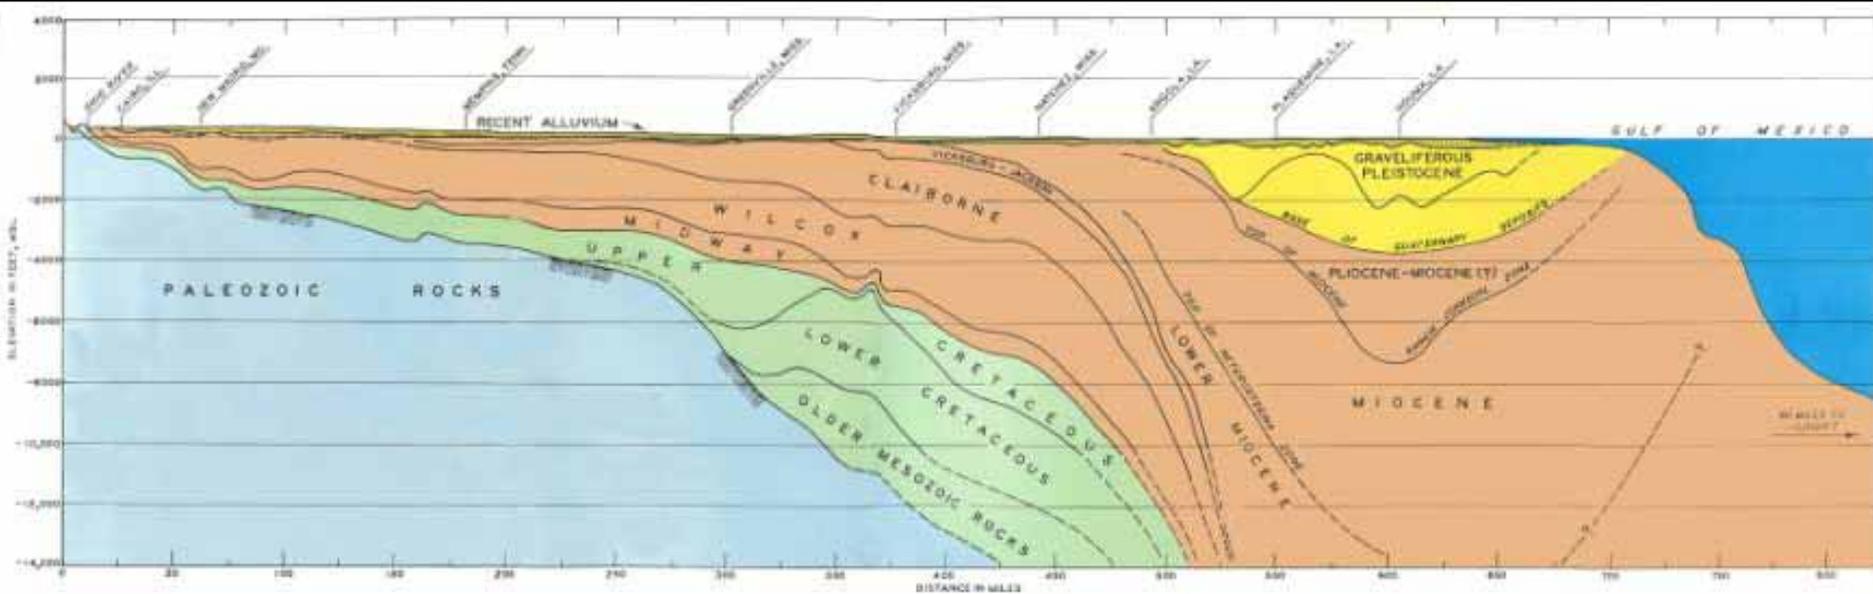
- North-south **geologic cross section** through the central Gulf of Mexico Coastal Plain, along the Mississippi River Embayment.
- Note the axis of the **Gulf Coast Geosyncline** beneath Houma, LA, southwest of New Orleans. In this area the Quaternary age deposits reach a thickness of 3600 ft.

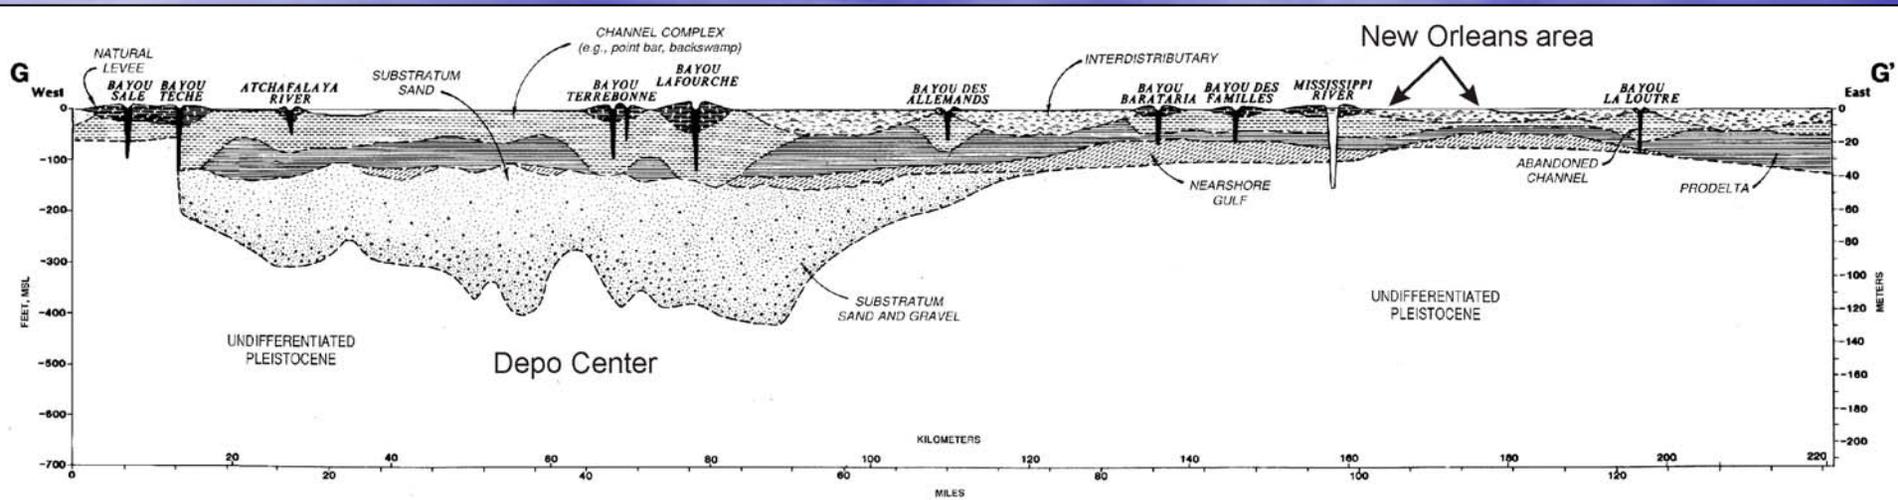
- Transverse cross section in a west to east line, across the **Mississippi River Delta** a few miles south of New Orleans, cutting across the southern shore of Lake Borgne.
- **New Orleans** is located on a relatively thin deltaic plain towards the eastern side of the delta's depositional center, which underlies the Atchafalaya Basin, west of New Orleans.

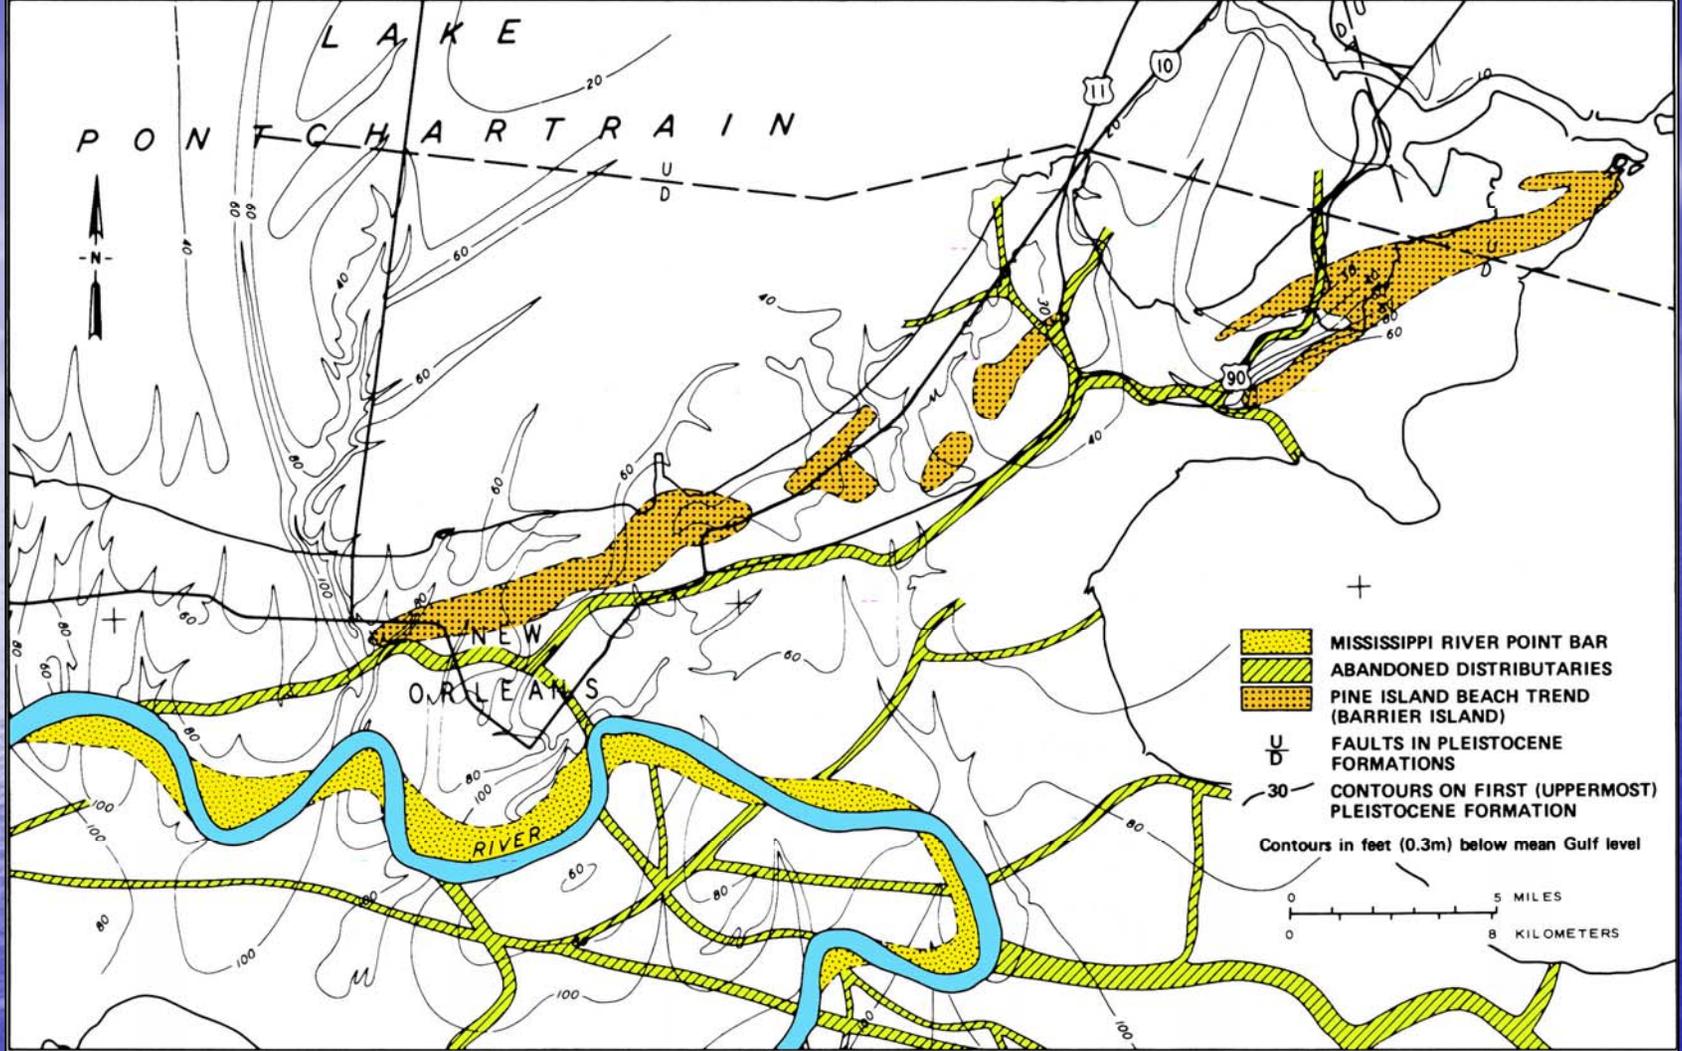
- Pleistocene geologic map of the New Orleans area. The yellow stippled bands are the principal distributary channels of the lower Mississippi during the late Pleistocene, while the present channel is shown in light blue. The Pine Island Beach Trend is shown in the ochre dotted pattern. Depth contours on the upper Pleistocene age horizons are also shown.

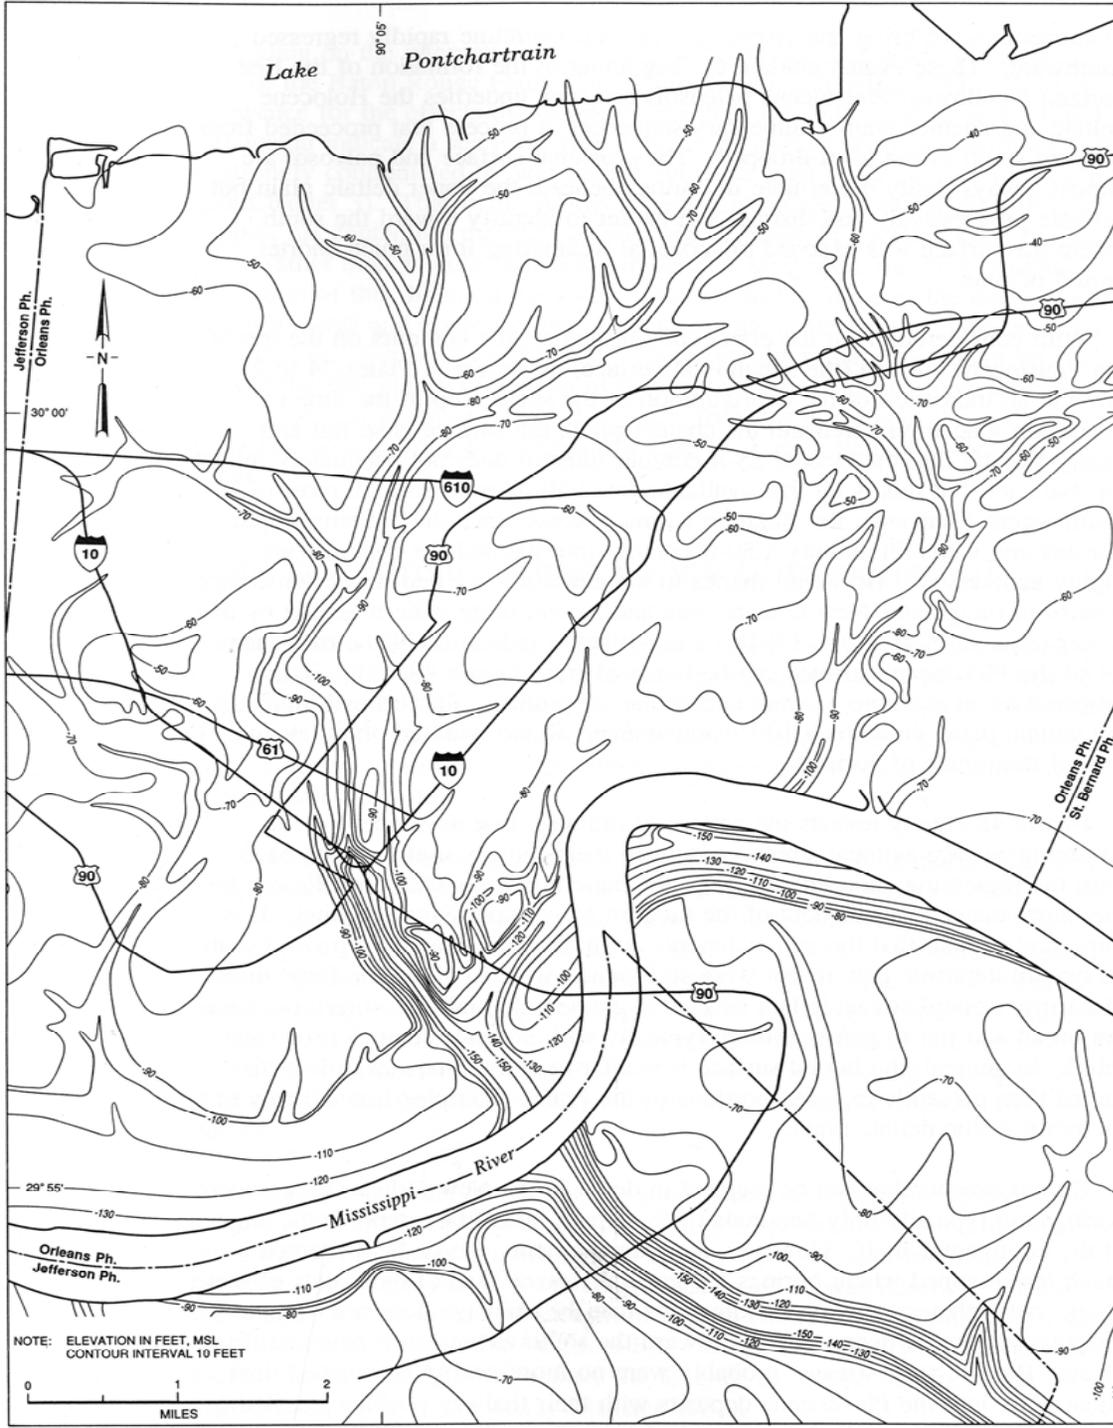
- Contours of the entrenched surface of the Wisconsin glacial age deposits underlying New Orleans.
- Note the well developed channel leading southward, towards what used to be the oceanic shoreline. This channel reaches a maximum depth of 150 feet below sea level.

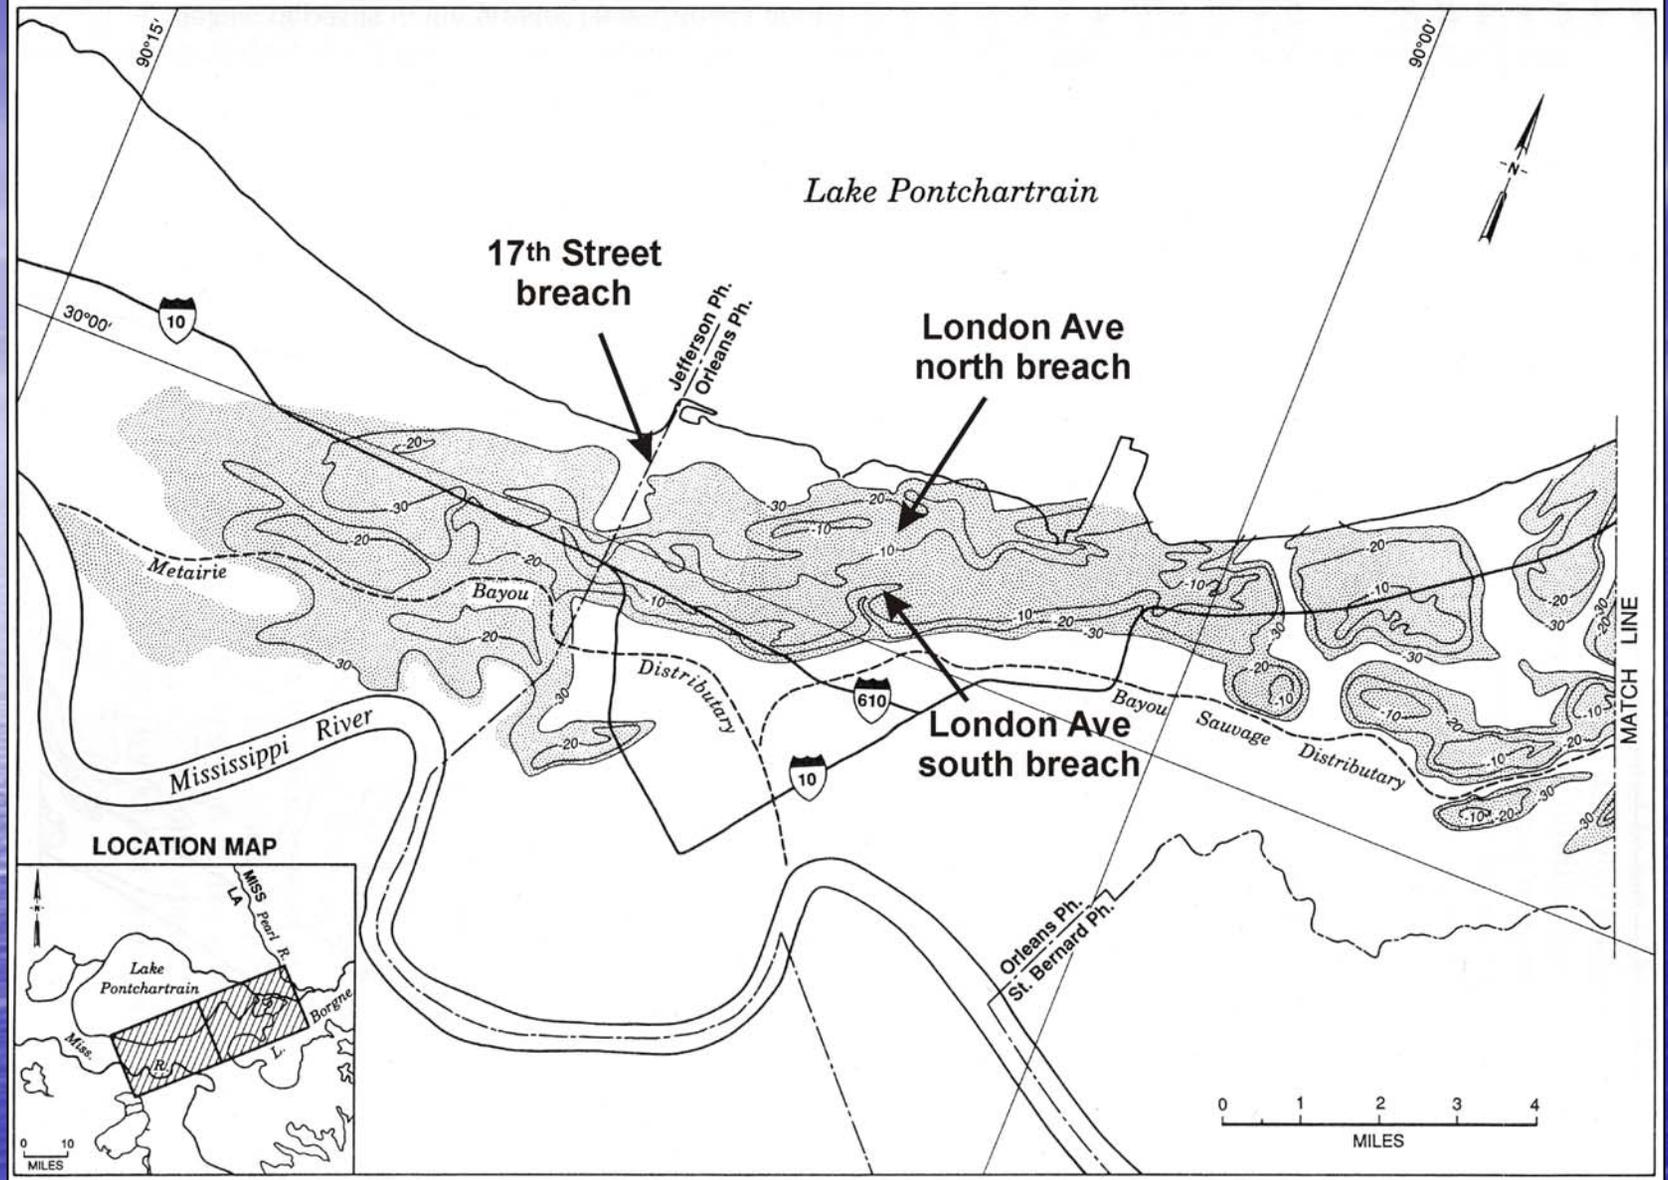
- Areal distribution and depth to top of formation isopleths for the **Pine Island Beach Trend** beneath lower New Orleans.

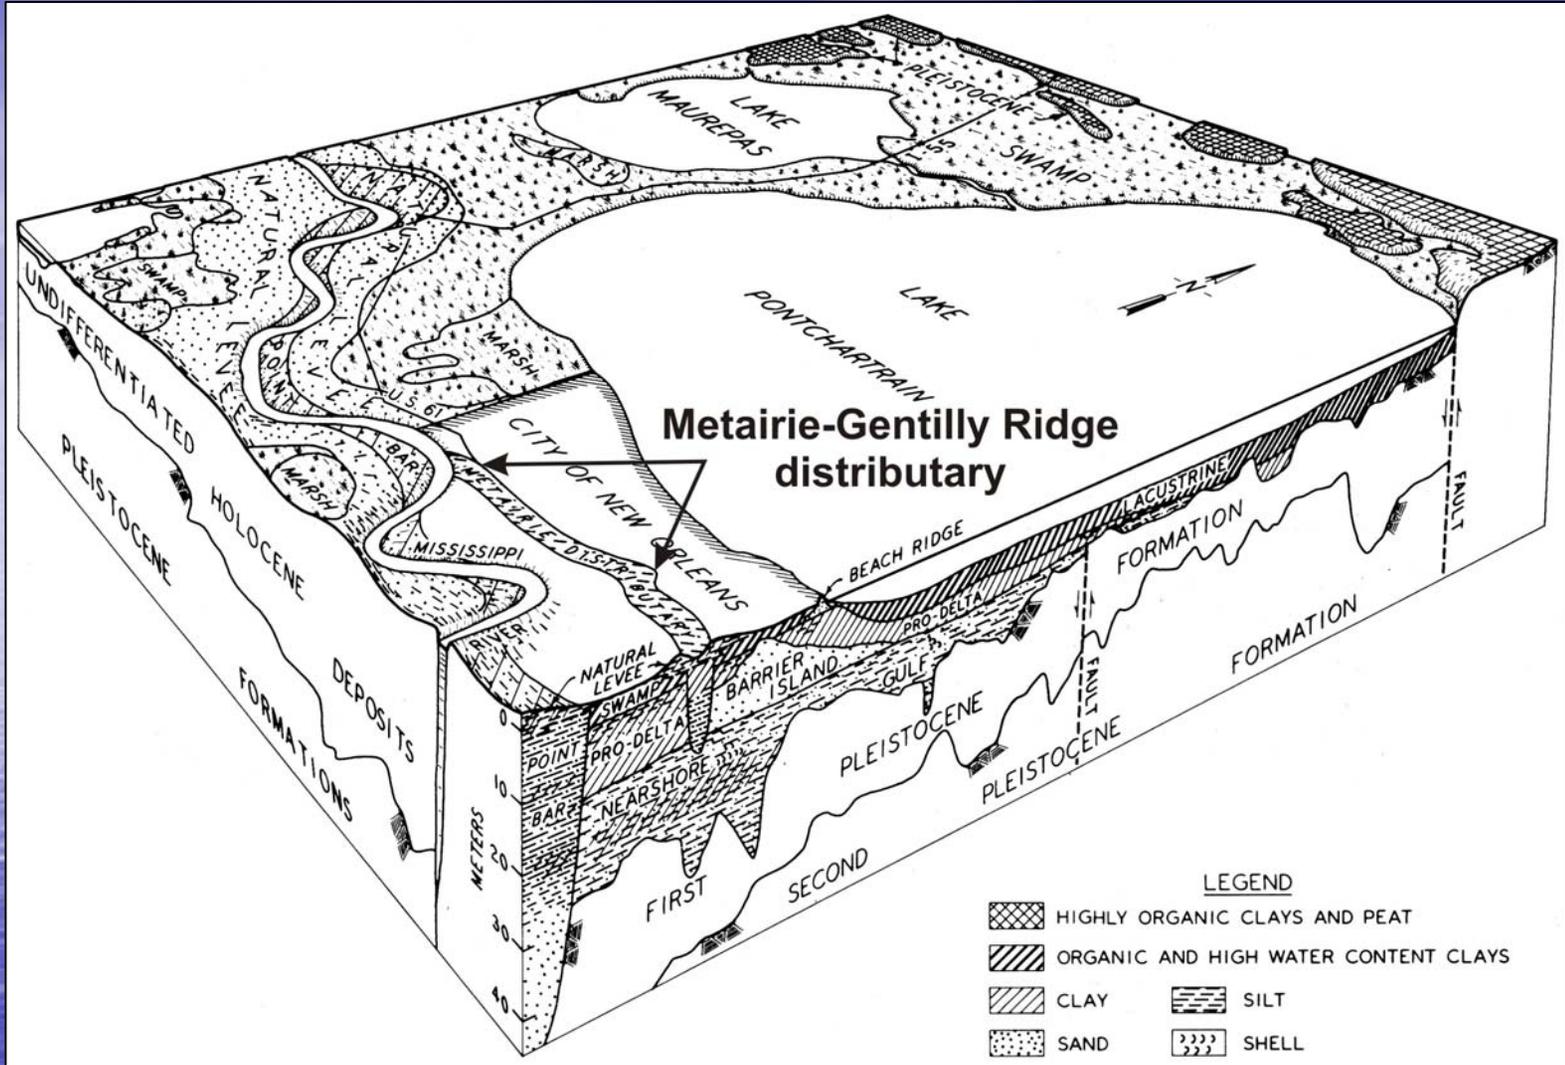
- Block diagram of the geology underlying New Orleans. The principal feature dividing New Orleans is the **Metairie distributary channel**, shown here, which extends to a depth of 50 feet below MGL and separates geologic regimes on either side. Note the underlying faults, beneath Lake Pontchartrain.

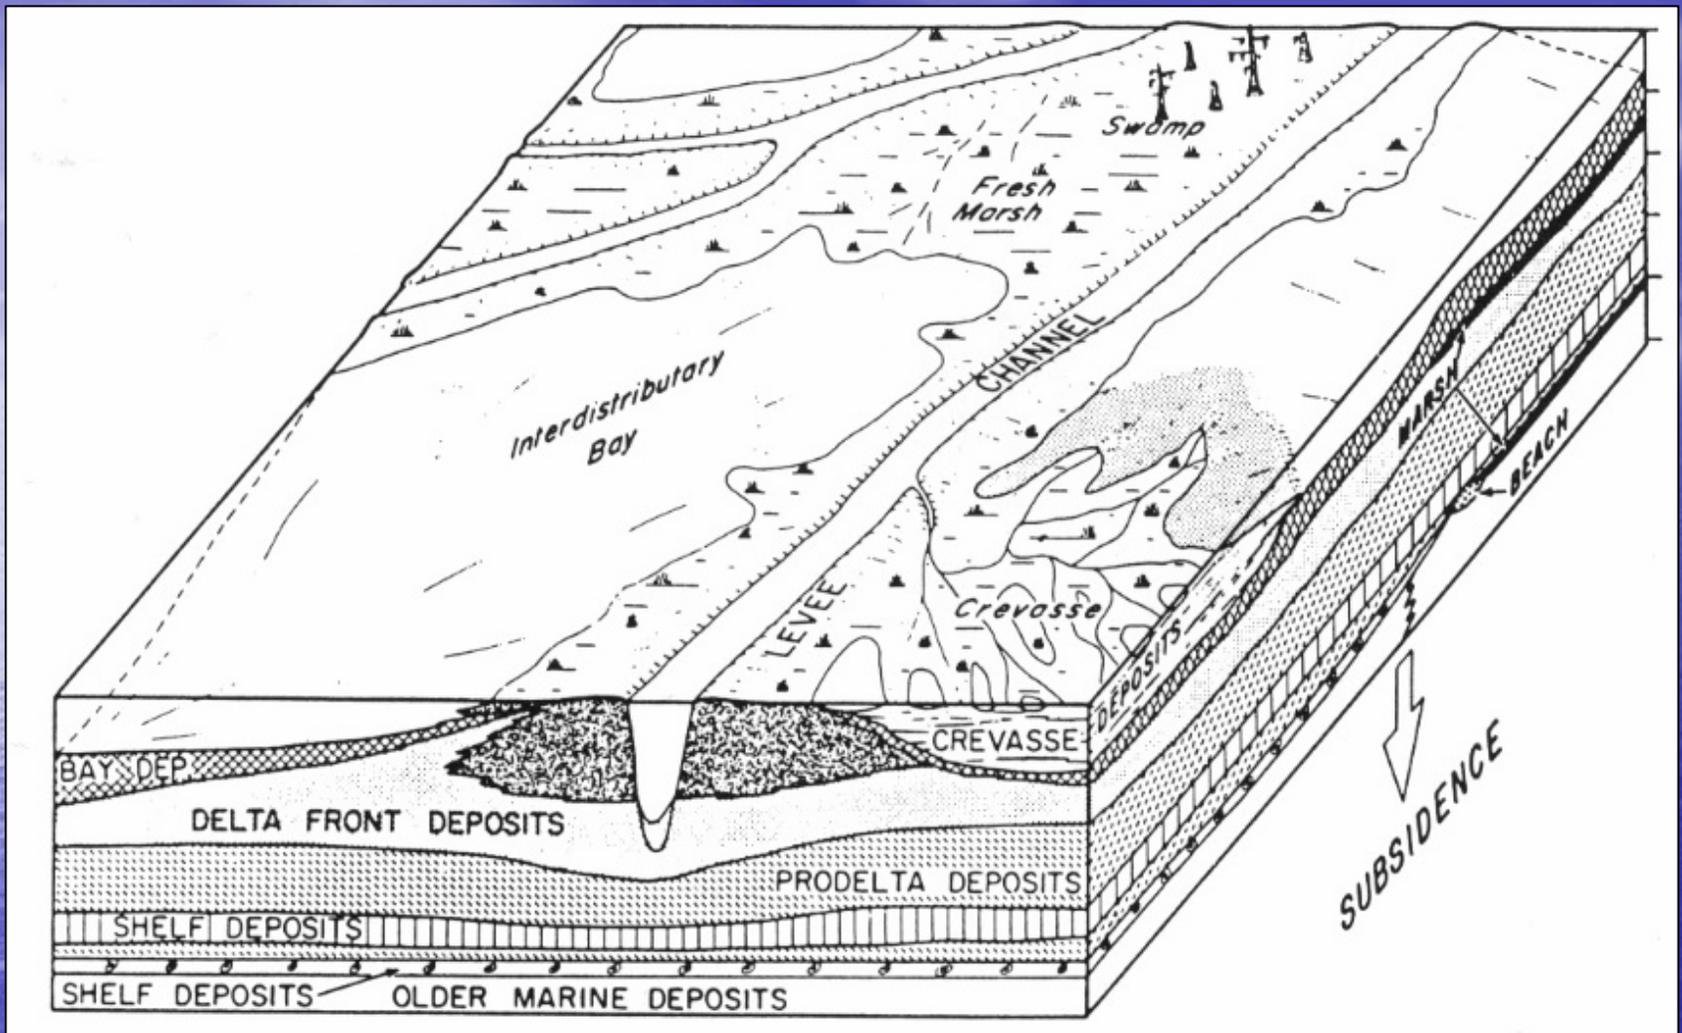
- Block diagram illustrating relationships between **subaerial and subaqueous deltaic environments** in relation to a single distributary lobe. The Lakeview and Gentilly neighborhoods of New Orleans are underlain by interdistributary sediments, overlain by peaty soils laid down by fresh marshes and cypress swamps.

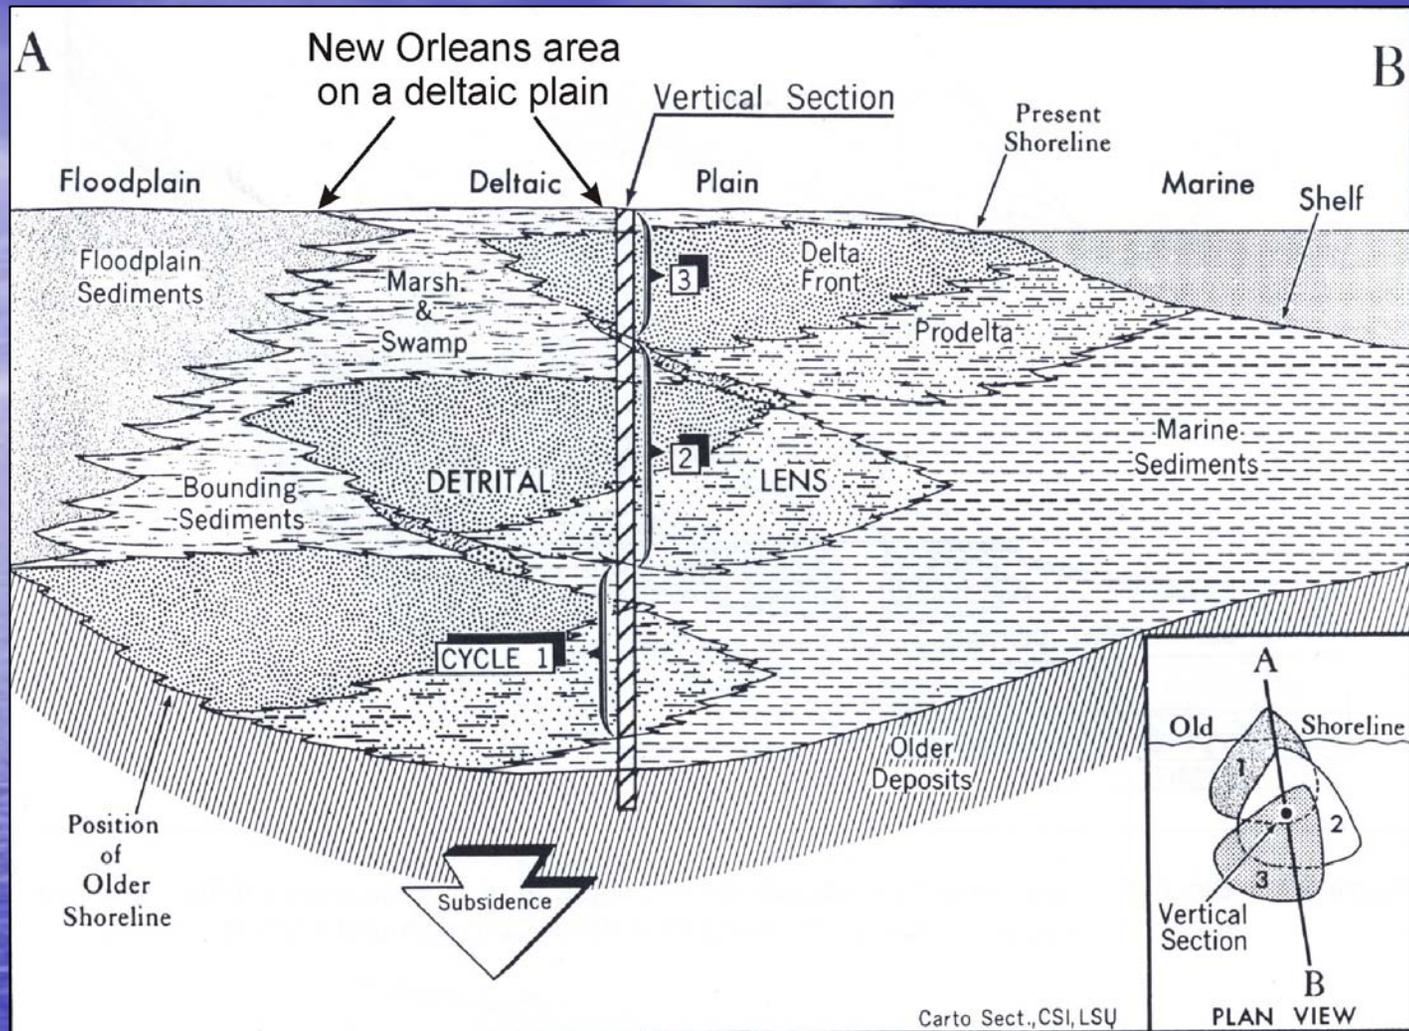
- **Sedimentary sequence** caused by overlapping cycles of deltaic deposition, along a trend normal to that portrayed in the previous figure. As long as the distributary channel receives sediment the river mouth progrades seaward.
- The Lakeview and Gentilly neighborhoods lie on a **deltaic plain** with marsh and swamp deposits delta front deposits closer to Metairie-Gentilly Ridge, the nearest distributary channel.

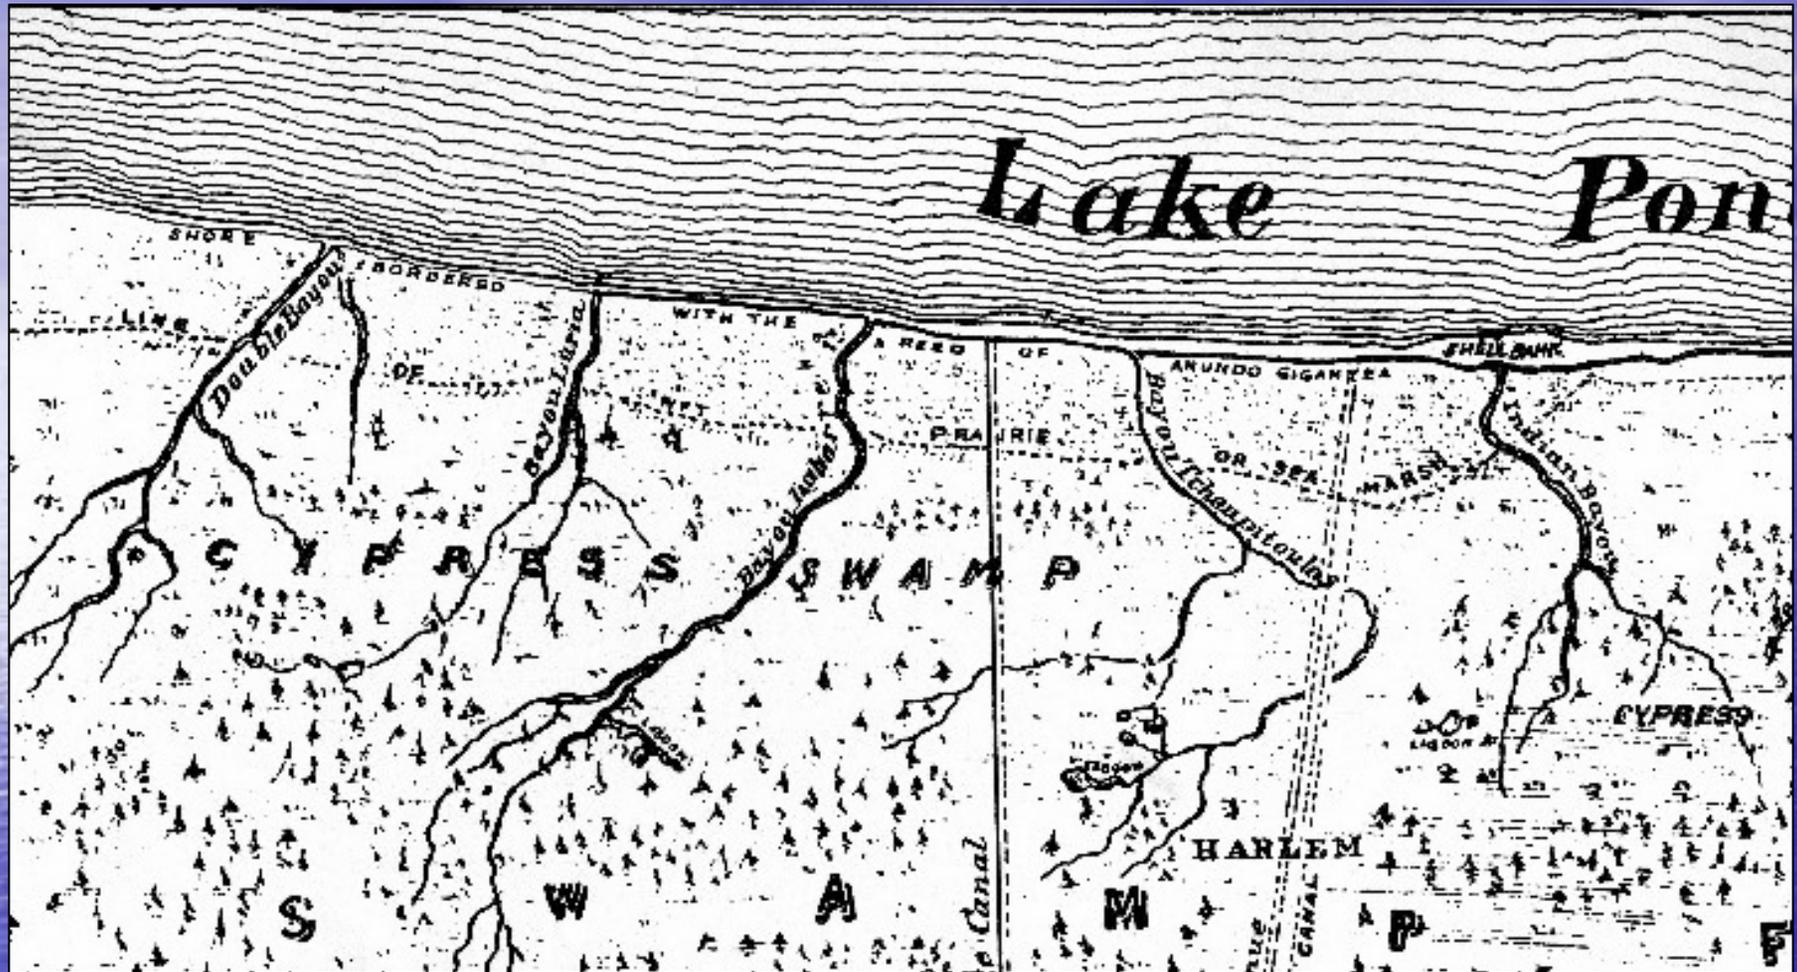
- Portion of the 1849 flood map showing the mapped demarcation between **brackish and fresh water marshes** along Lake Pontchartrain. This delineation is shown on many of the historic maps, dating back to 1749.

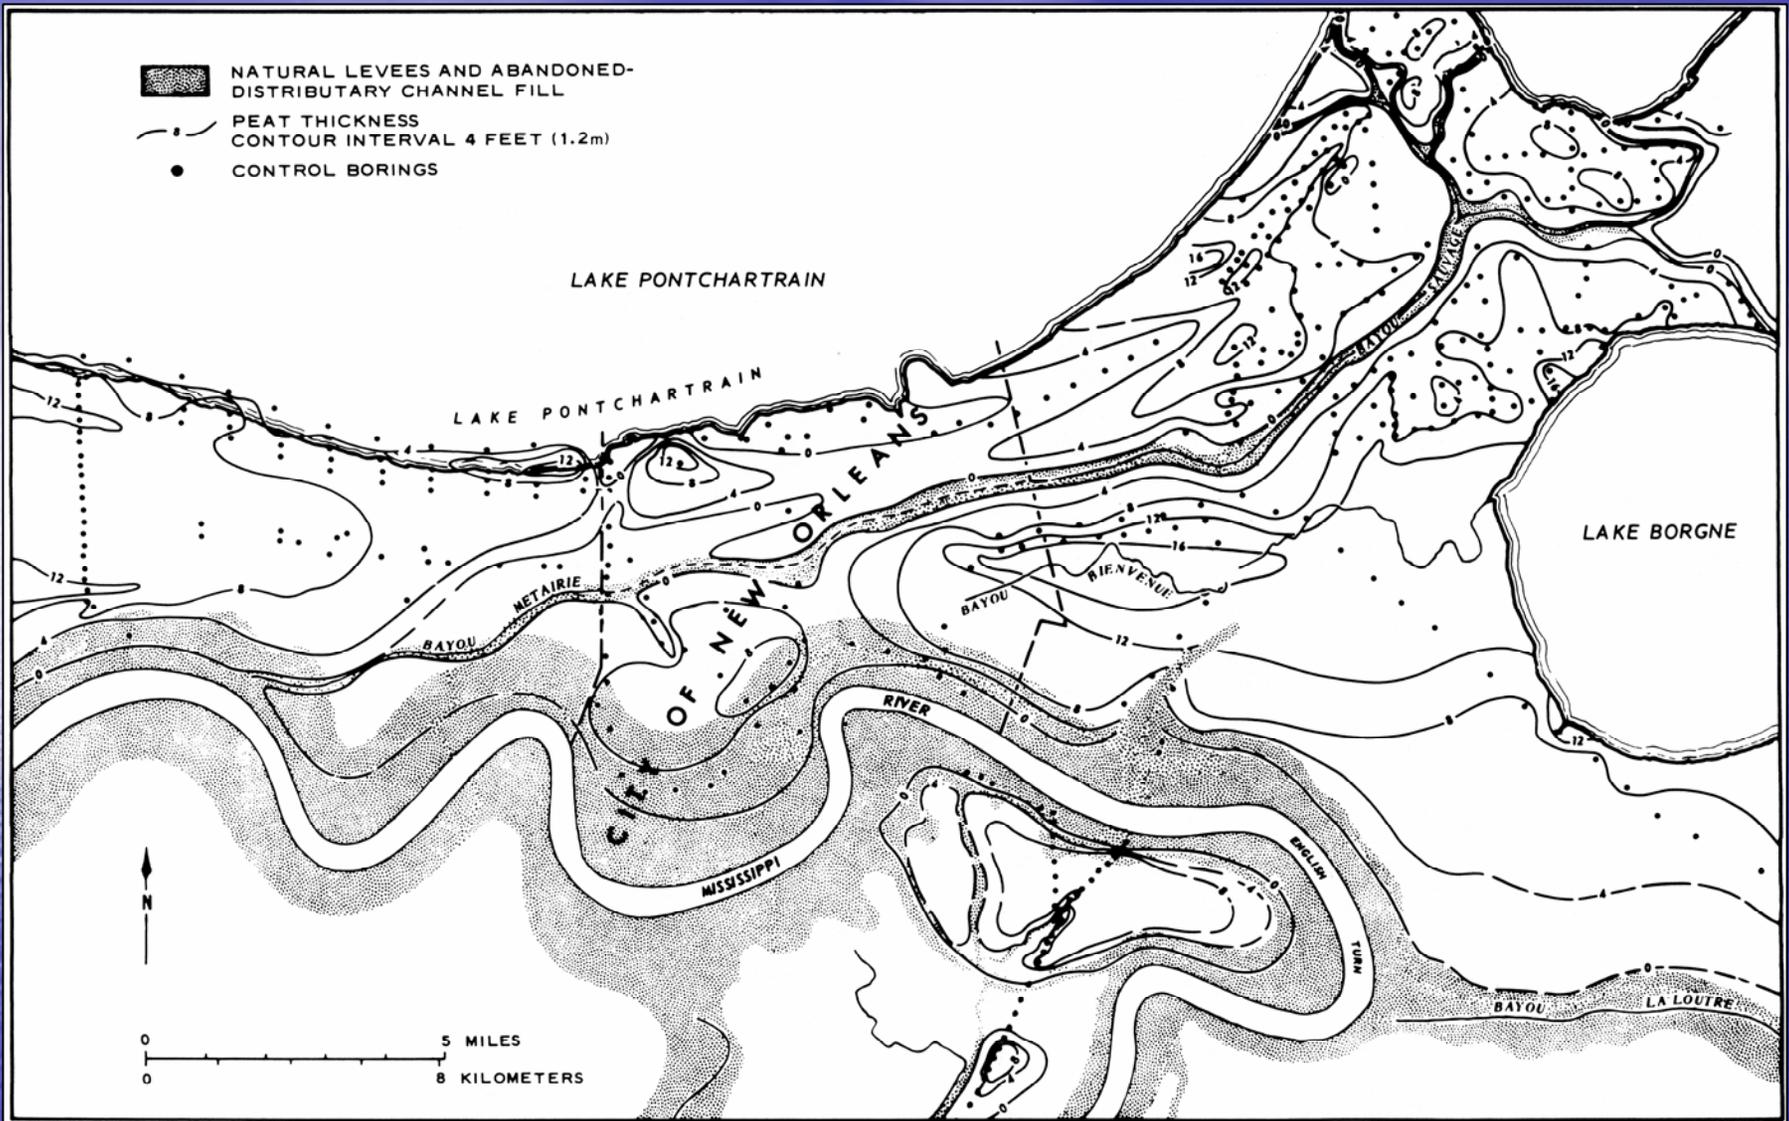
- Distribution and apparent thickness of surficial peat deposits in vicinity of New Orleans.

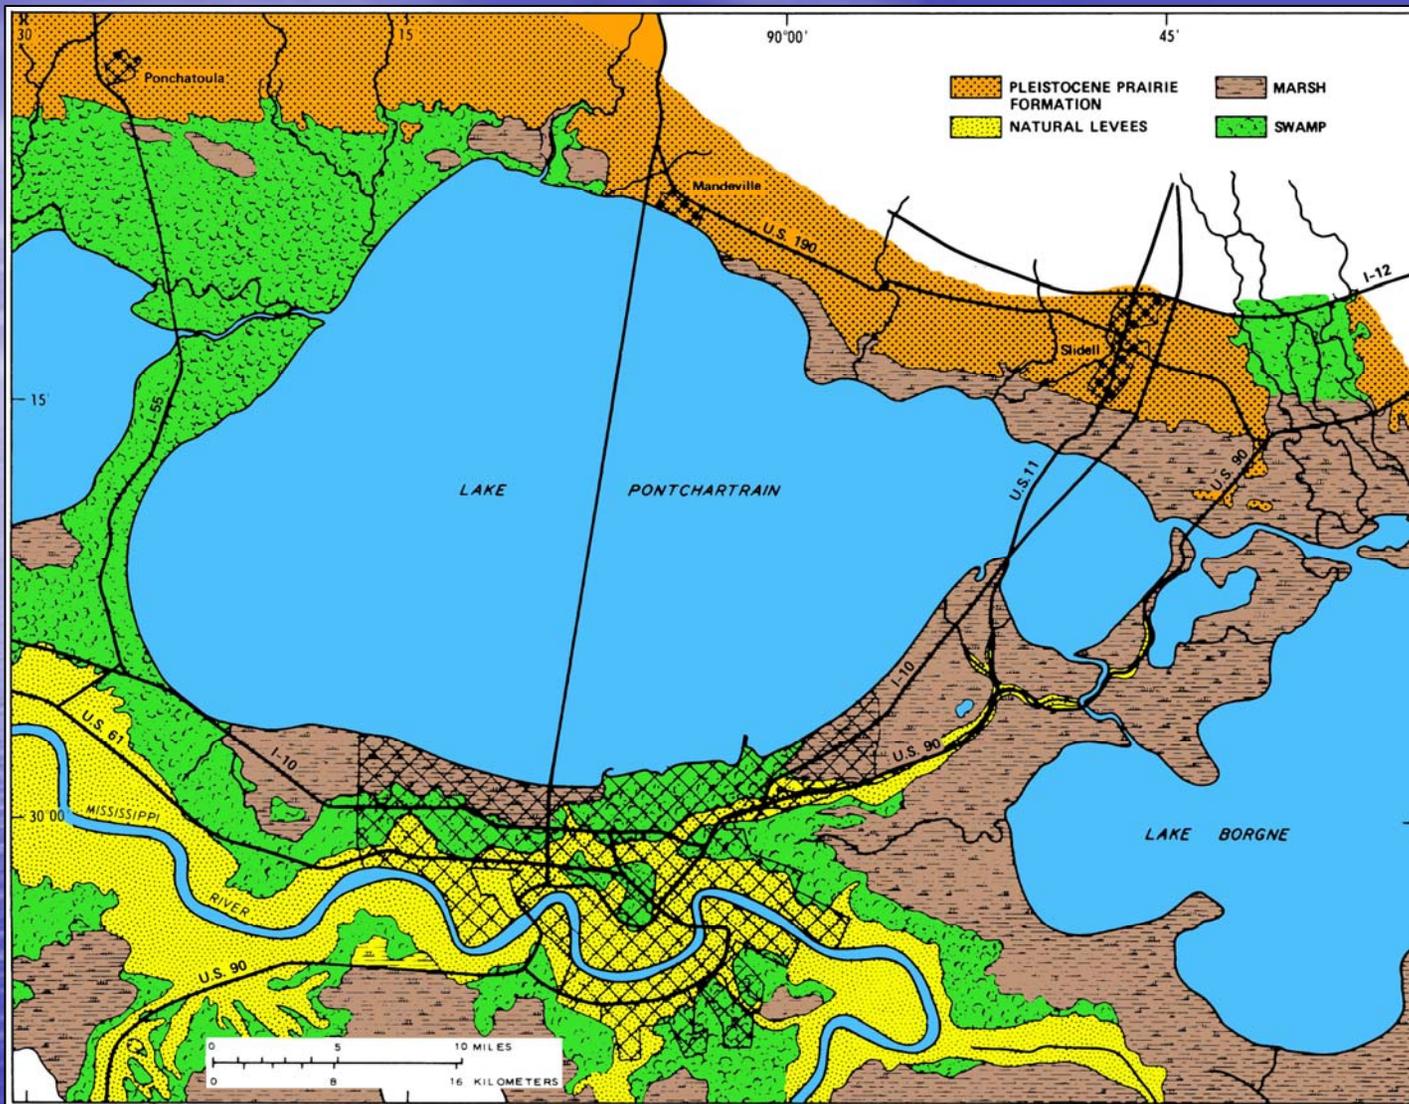
- Geologic map of the greater New Orleans area. The sandy materials shown in yellow are natural levees, green areas denote old cypress swamps and brown areas are historic marshlands. The stippled zone indicates the urbanized portions of New Orleans.
