Geologic Conditions Beneath the New Orleans Area

J. David Rogers, Ph.D., P.E., P.G.

University of Missouri-Rolla

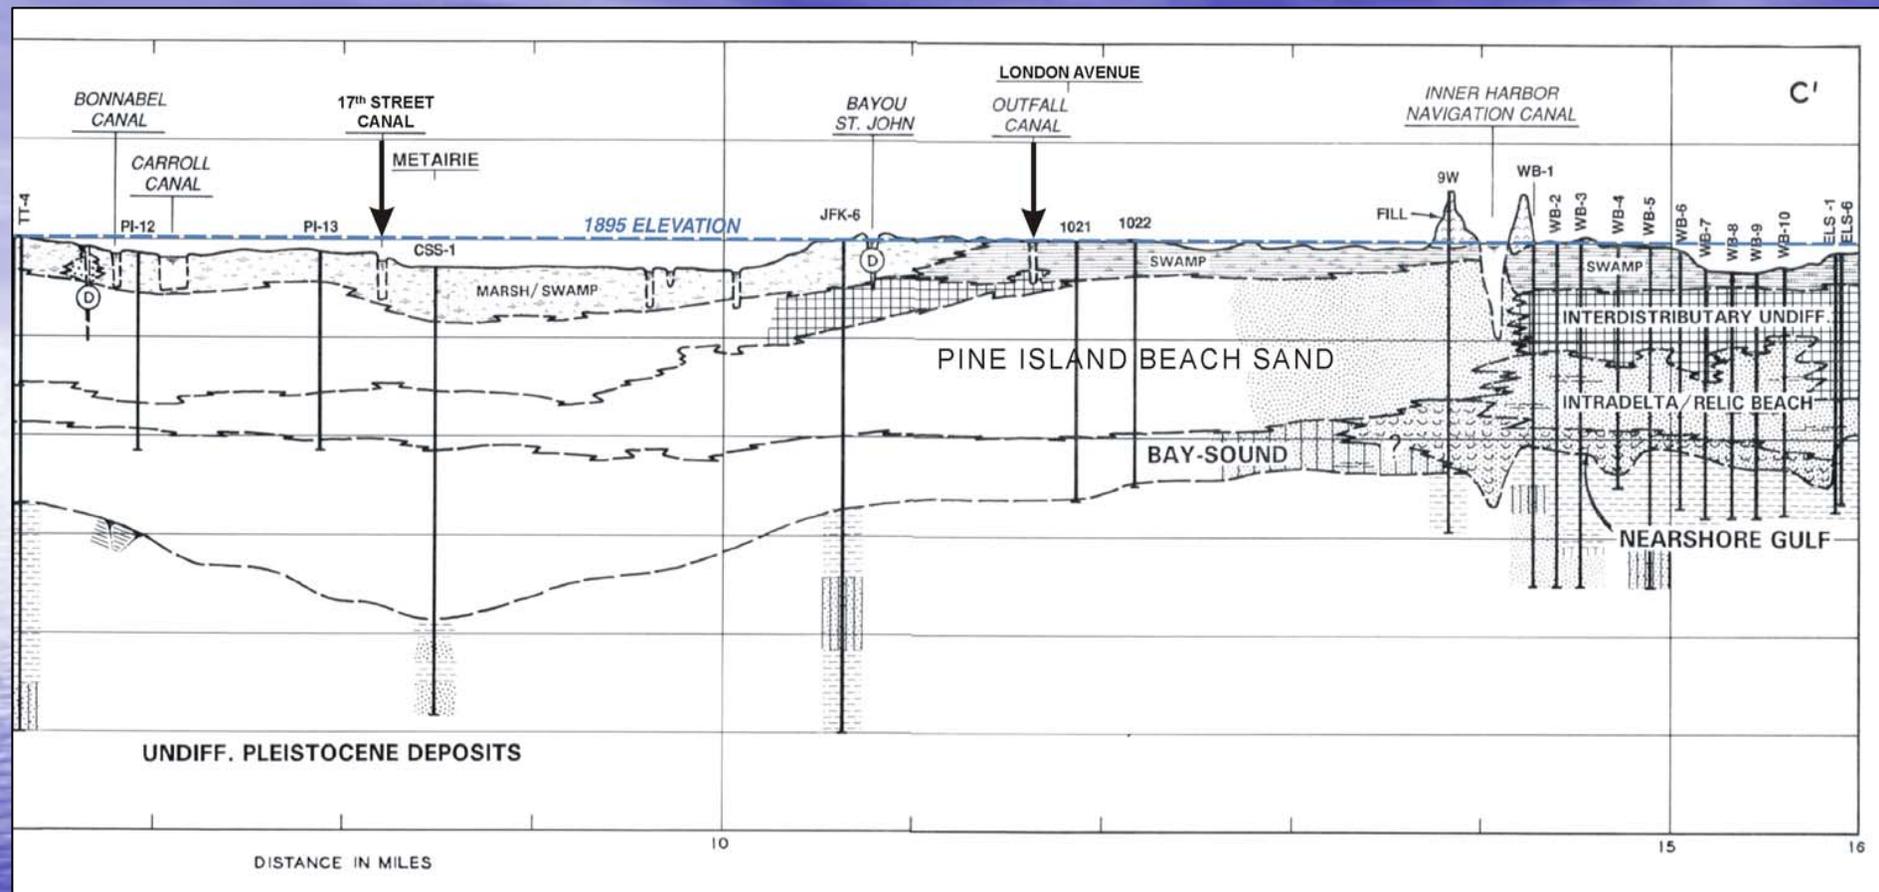
- Geologic cross section along south shore of Lake Pontchartrain in the Lakeside, Gentilly, and Ninth Ward neighborhoods, where the 17th Street, London Avenue, and IHNC levees failed during Hurricane Katrina on Aug 29, 2005. Notice the apparent settlement that has occurred since the city survey of 1895 (blue line), and the correlation between settlement and non-beach sediment thickness.

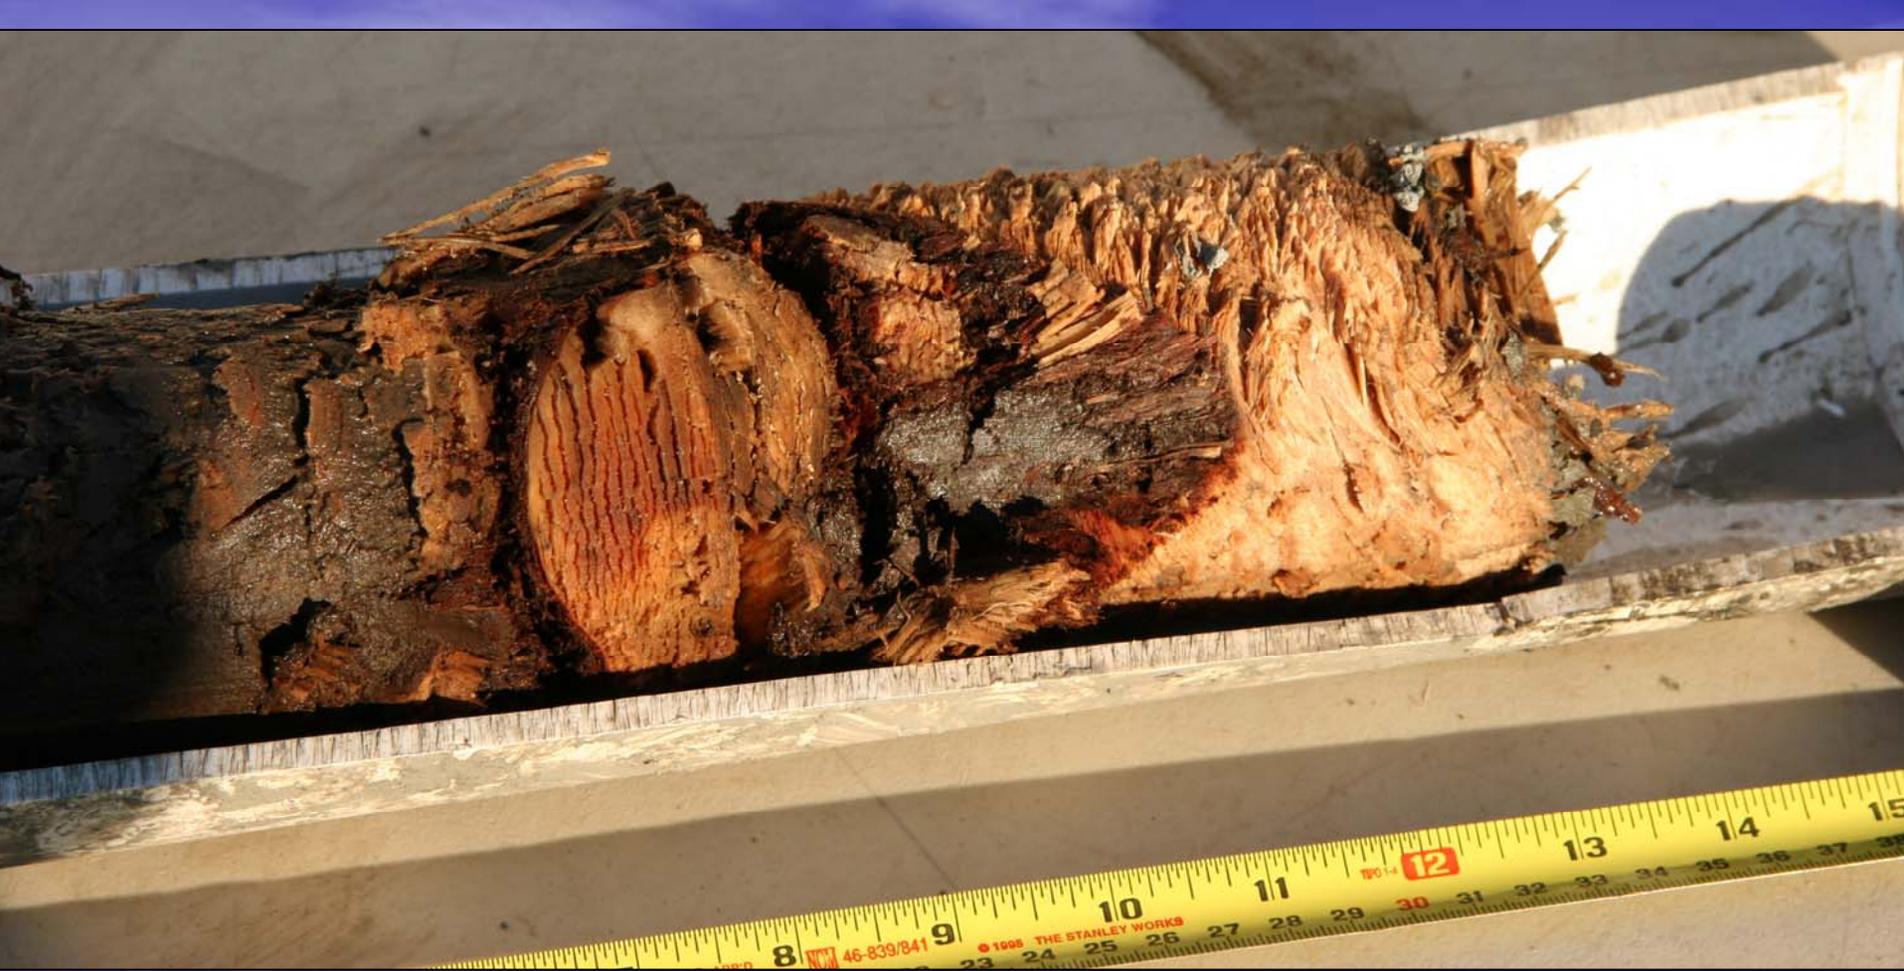
- Wood and other organic debris was commonly sampled in exploratory borings carried out after Hurricane Katrina throughout the city.
- This core contains wood from the old cypress marsh that was recovered near the 17th Street Canal breach. Organic materials are decaying throughout the city wherever the water table has been lowered, causing the land surface to subside.

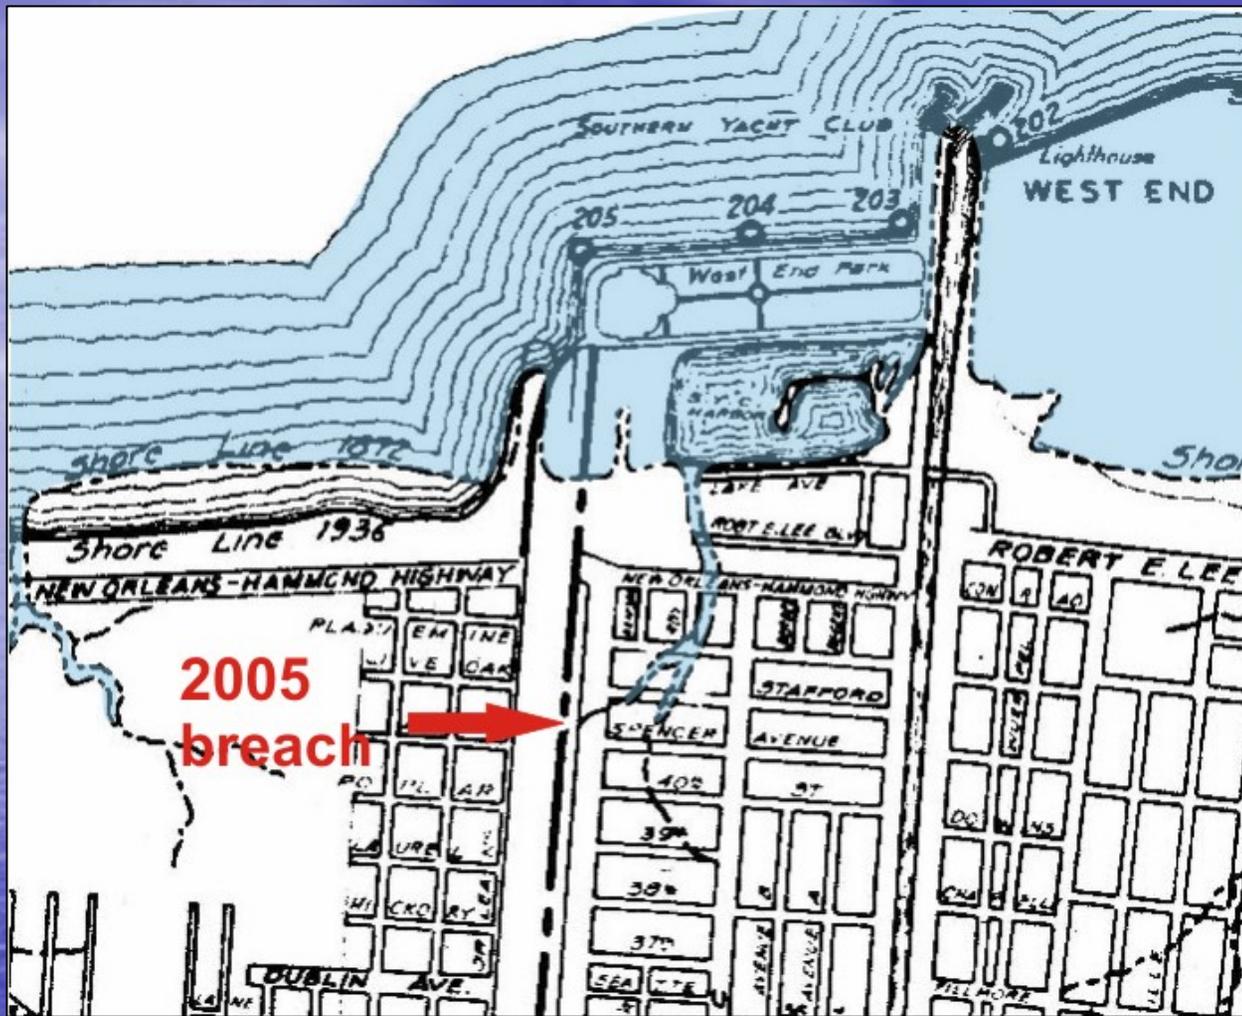
- Overlay of 1872 map by Valery Sulakowski on the WPA-LA (1937) map, showing the 1872 shoreline and sloughs (in blue) along Lake Pontchartrain. Although subdivided, only a limited number of structures had been built in this area prior to 1946. The position of the 2005 breach along the east side of the 17th Street Canal is indicated by the red arrow.

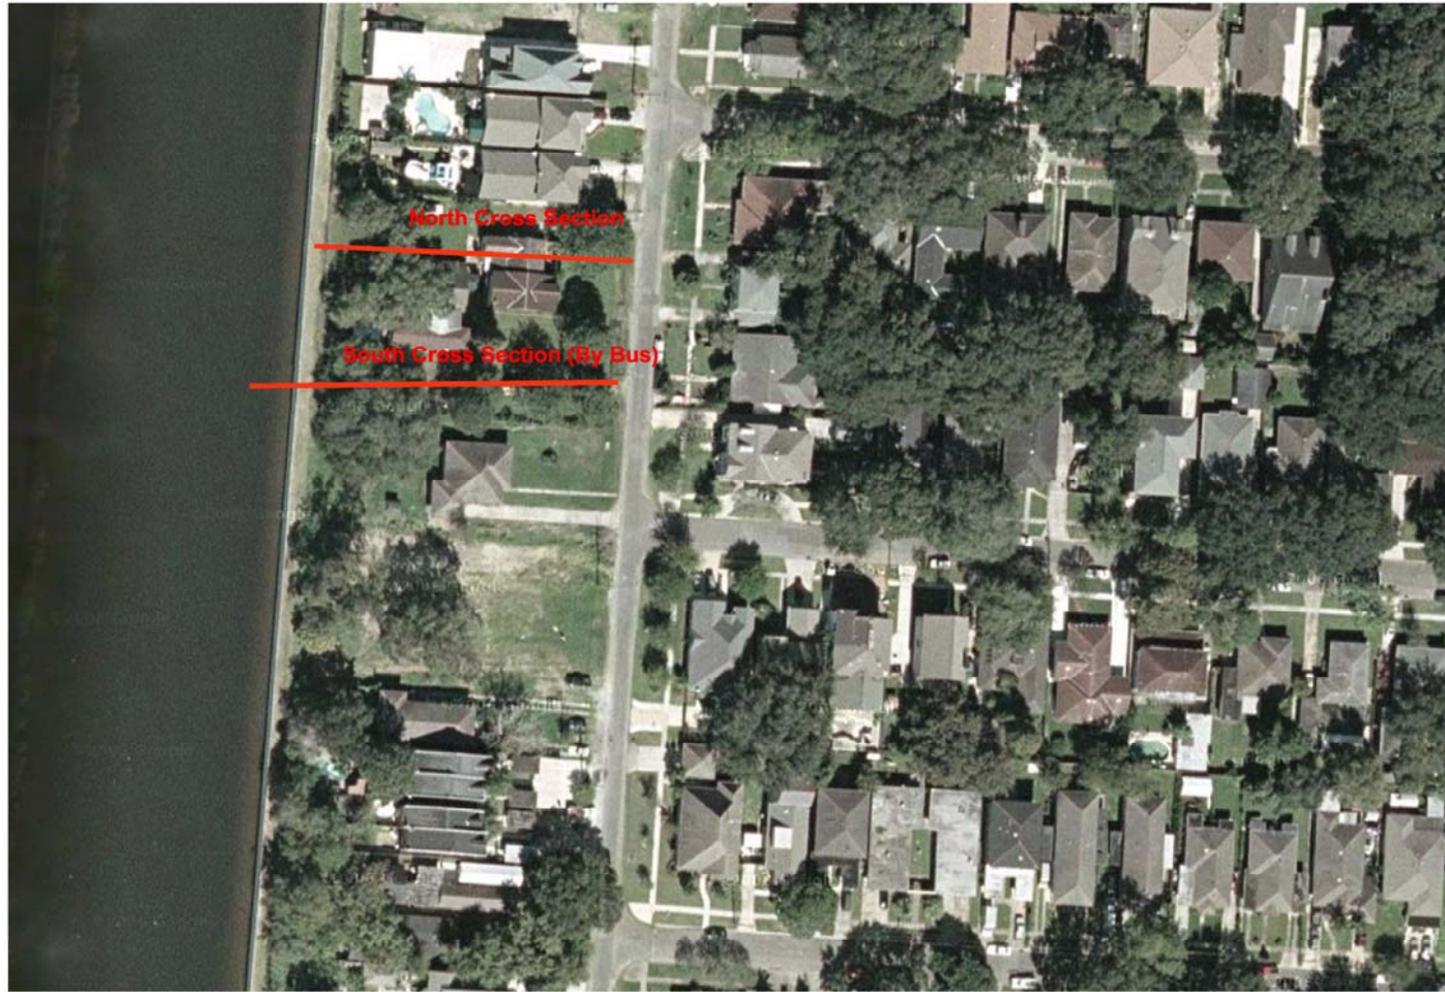
17th St. OUTFALL CANAL LEVEE BREAK CROSS SECTION LOCATIONS

- Aerial photo of the 17th Street Canal breach site before the failure of August 29, 2005. The red lines indicate the positions of the geologic sections.

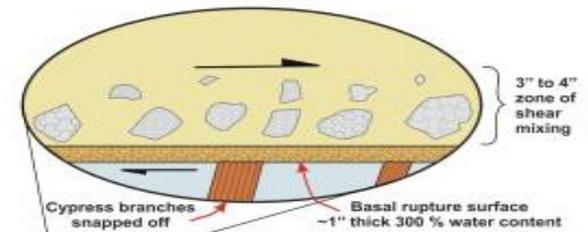
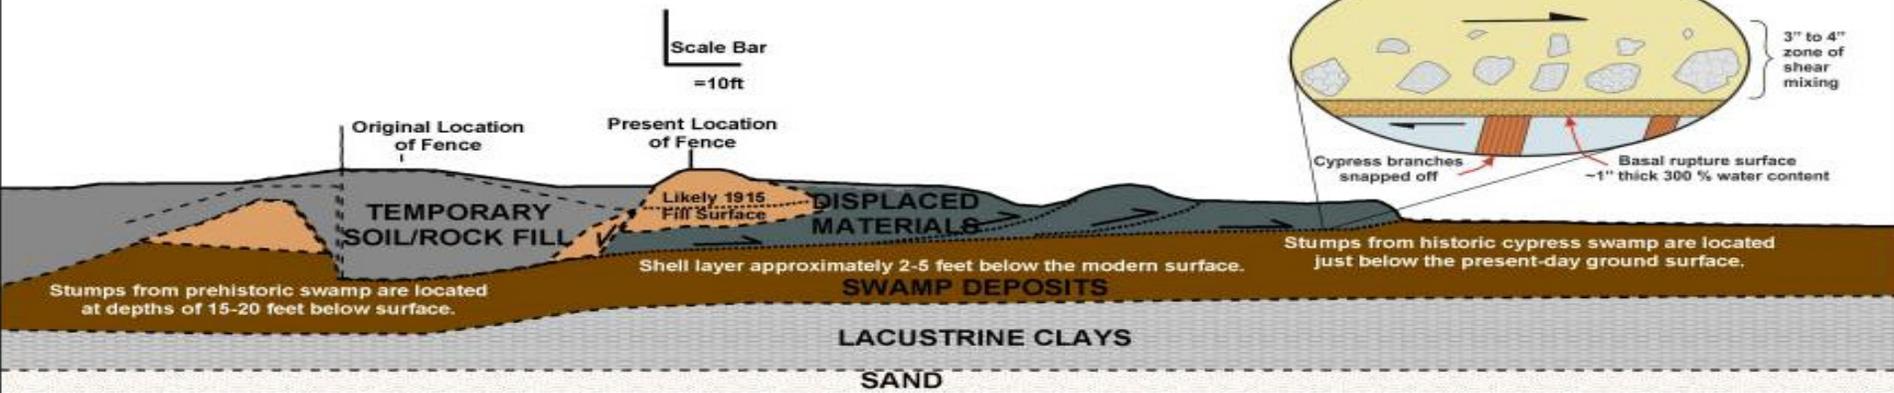
**17th St. Canal Levee Break Cross Section, South
After Construction of USACOE Temporary Embankment Fille and Sheet Pile Wall
-From Intact Levee Block To Yard With School Bus**

- West-to-east geologic cross section through the **17th Street Canal failure** approximately 60 feet north of the northern curb of Spencer Avenue, close to the yellow school bus. A detailed sketch of the basal rupture surface is sketched above right.
- The slip surface was about one inch thick with a high moisture content (watery ooze). A zone of brecciation 3 to 4 inches thick was above this. Numerous pieces of cypress wood, up to 2 inches diameter, were sheared off along the basal rupture surface.

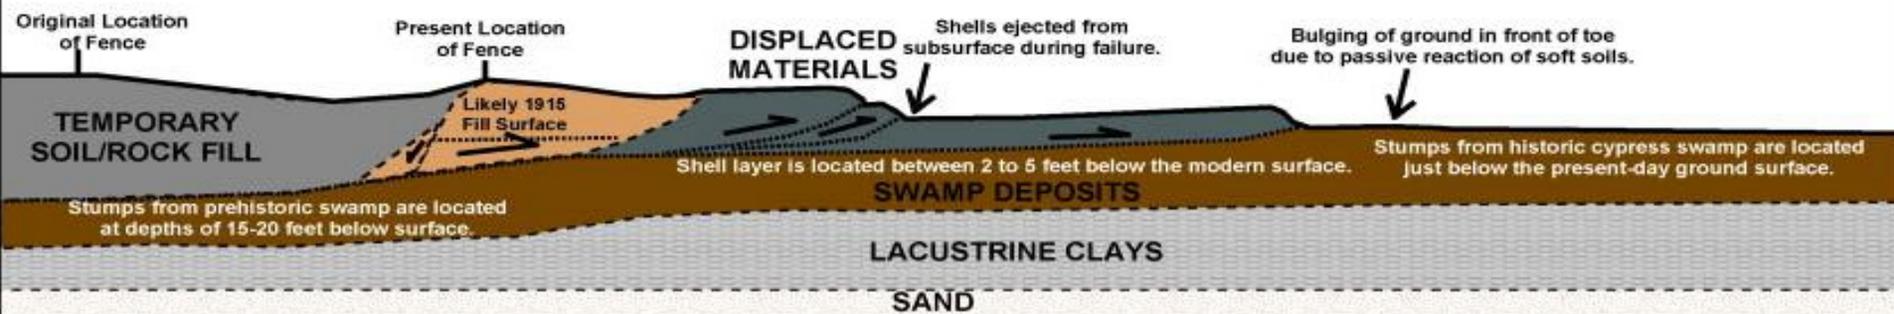
17th St. Canal Levee Break Cross Section, North
-From Intact Levee Block Between Two Houses Affected By Failure

- West-to-east geologic cross section through the 17th Street Canal failure approximately 140 feet north of the northern curb of Spencer Avenue.
- Large quantities of bivalve shells were extruded by high water pressure along the advancing toe thrusts. Note the slight back rotation of the distal thrust sheet.

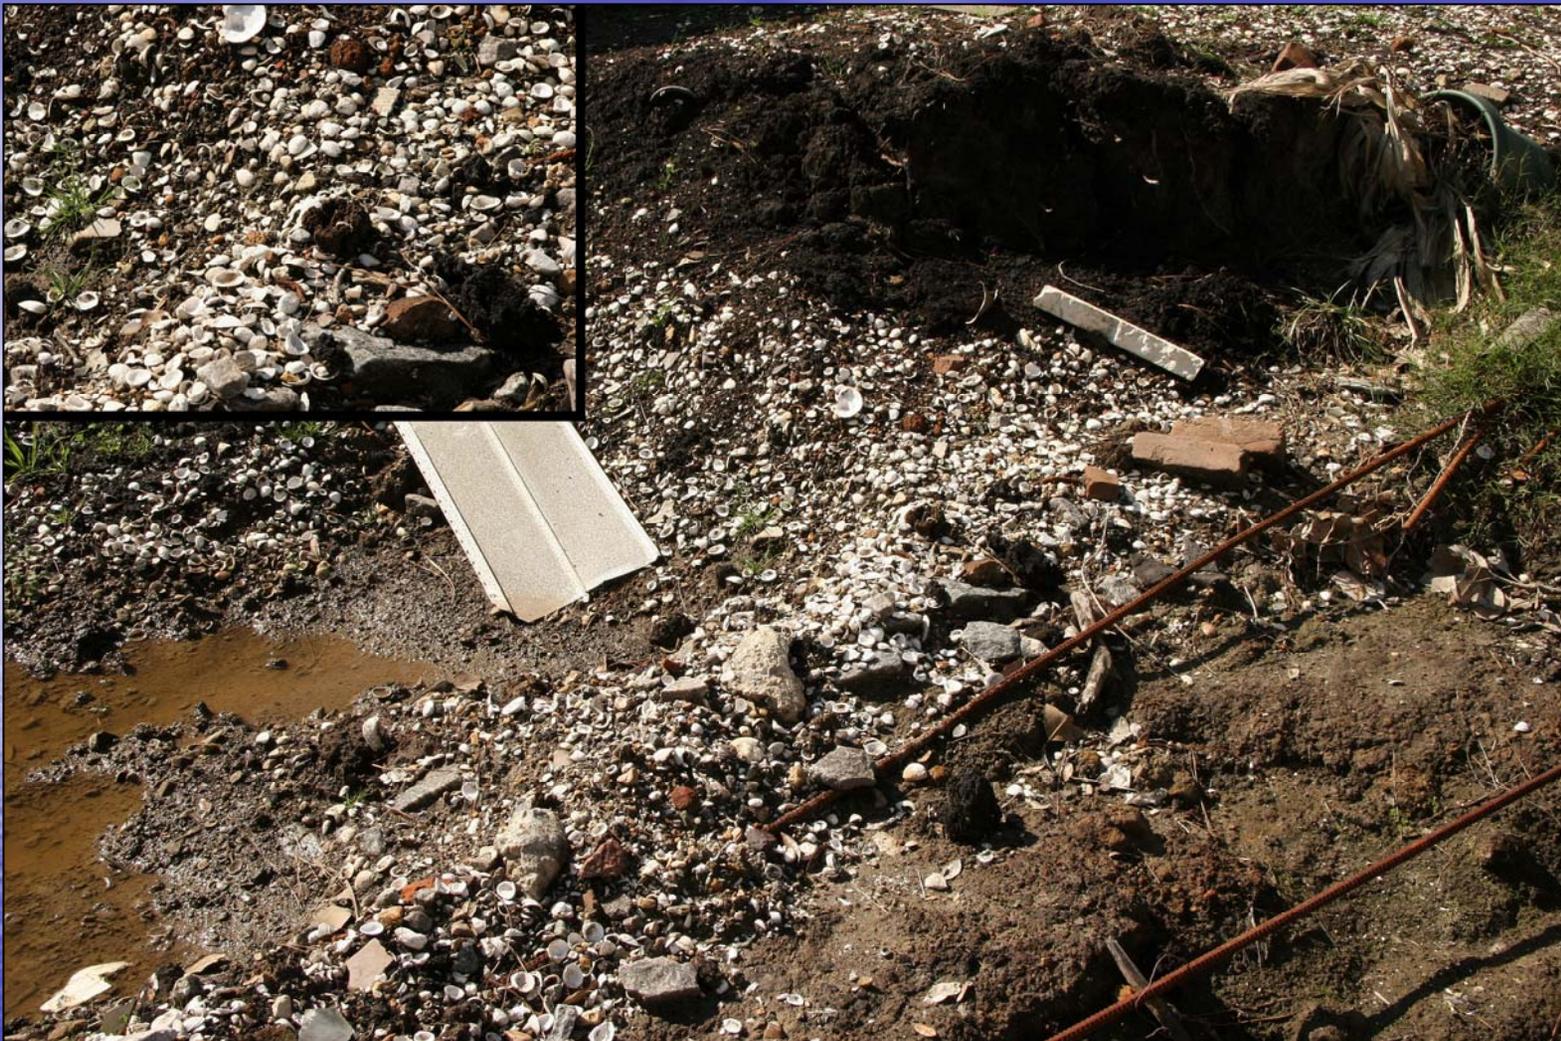
- Bivalve shells ejected by high pore pressures emanating from toe thrusts on landside of failed levee at the 17 Street Canal (detail view at upper left). These came from a distinctive horizon at a depth of 2 to 5 feet below the pre-failure grade.

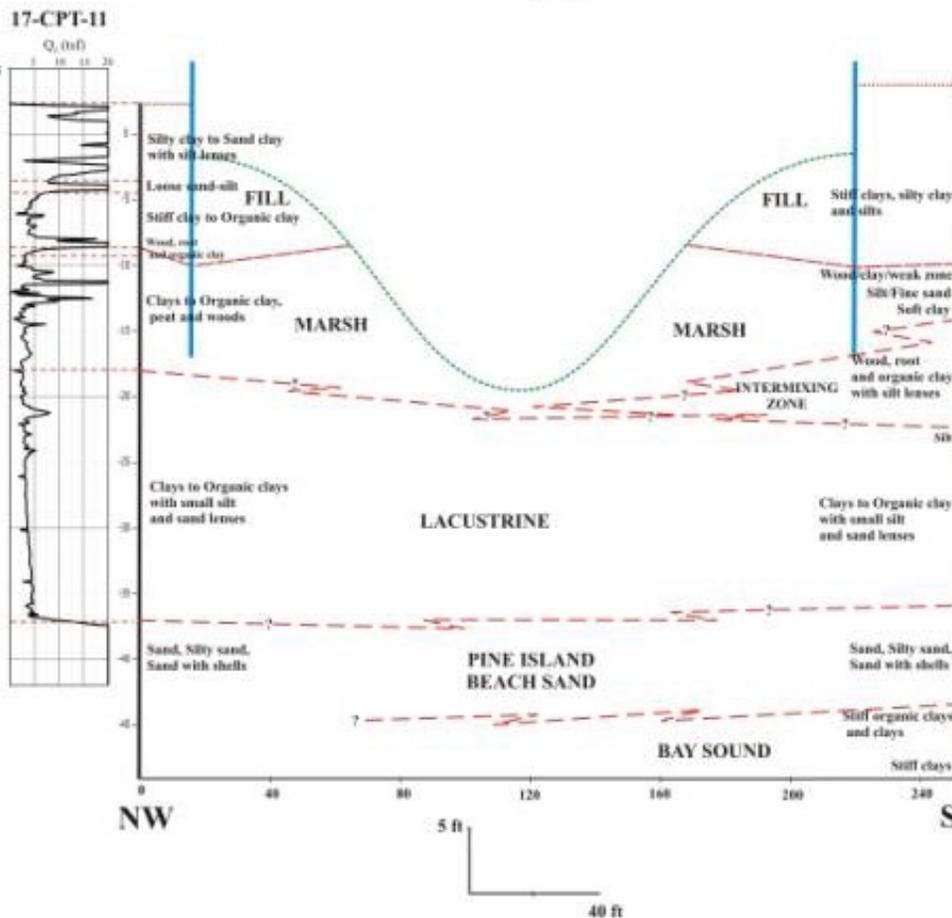
17th Street Canal Cross-section
B-B'

- Stratigraphic interpretations and cross-canal correlations in vicinity of the 17th Street Canal breach on August 29, 2005. The swamp much appeared to be thinning northerly, as does the underlying Pine Island Beach Trend. The lacustrine clays appear to thicken southward, as shown.
- The approximate positions of the flood walls (light blue) and canal bottom (dashed green) are indicated, based on information provided by the Corps of Engineers (IPET, 2006).

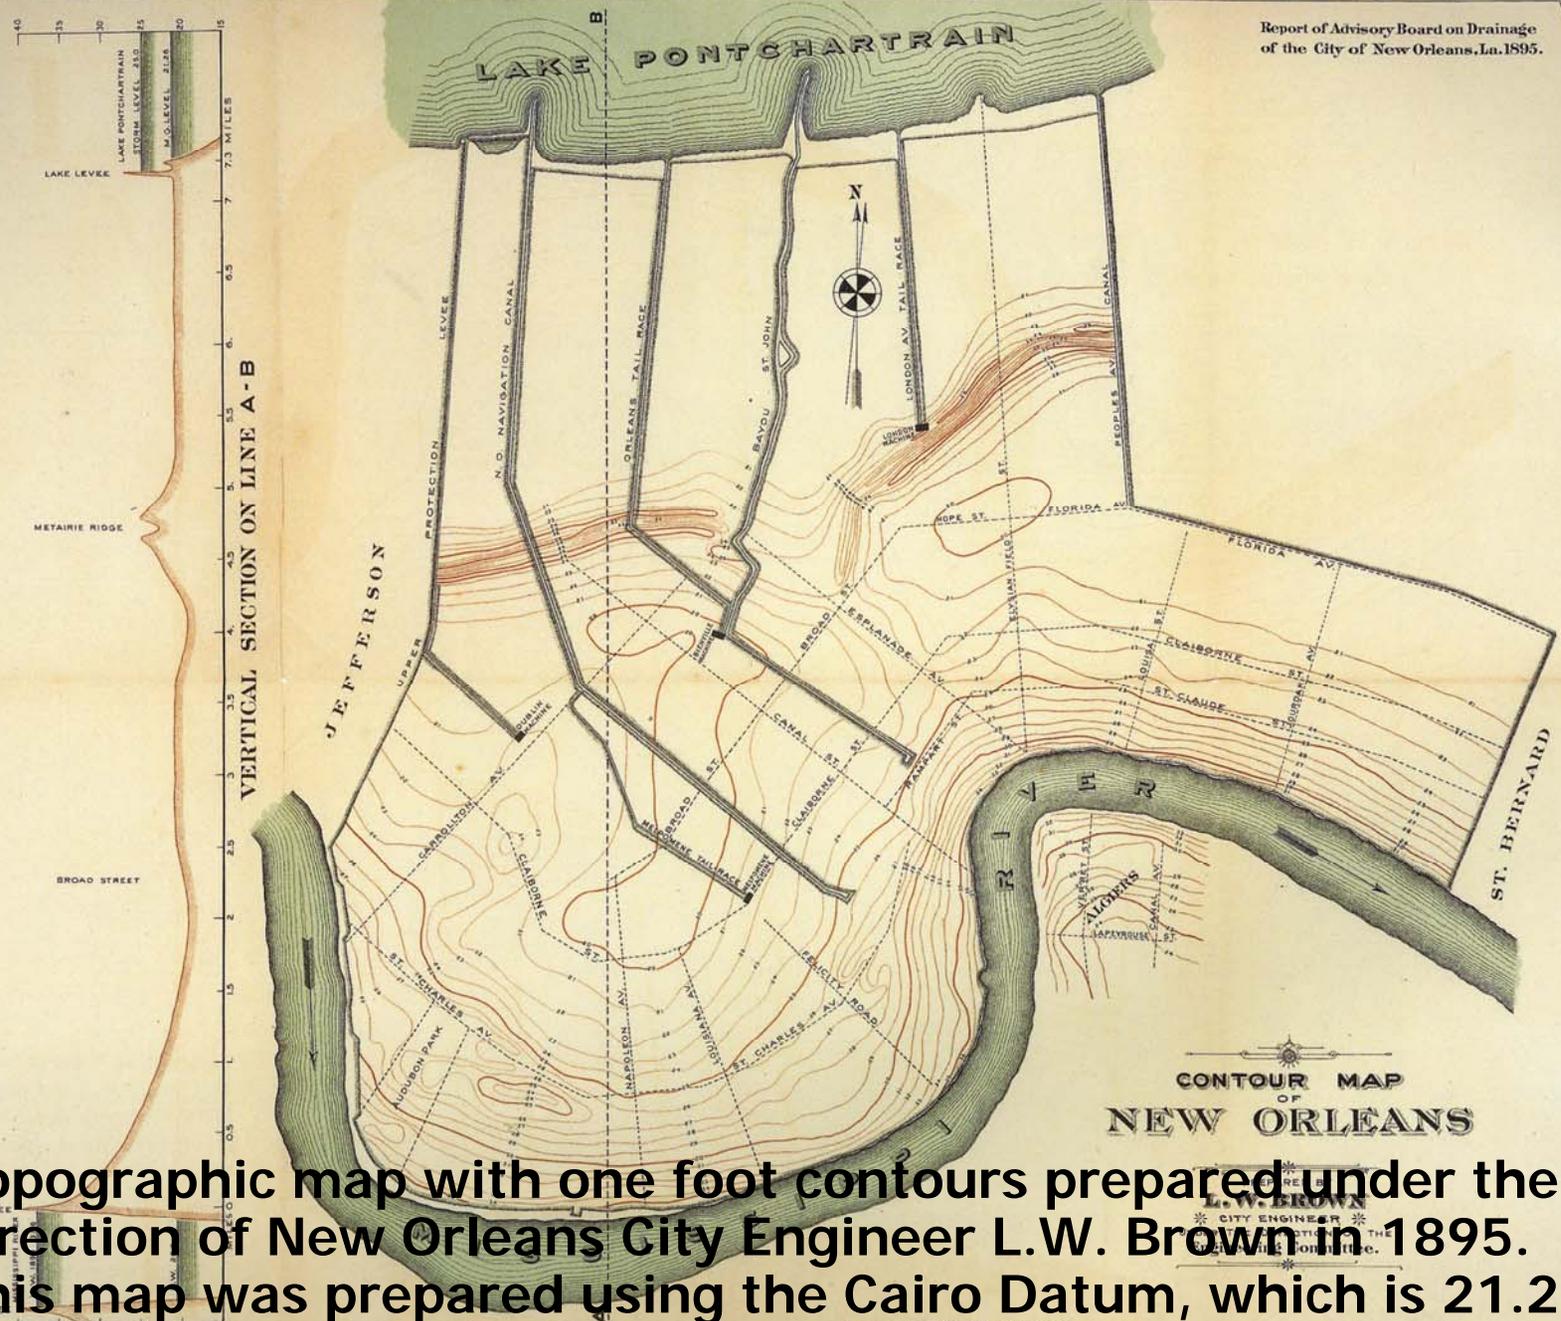
Topographic map with one foot contours prepared under the direction of New Orleans City Engineer L.W. Brown in 1895. This map was prepared using the Cairo Datum, which is 21.26 feet above Mean Gulf Level

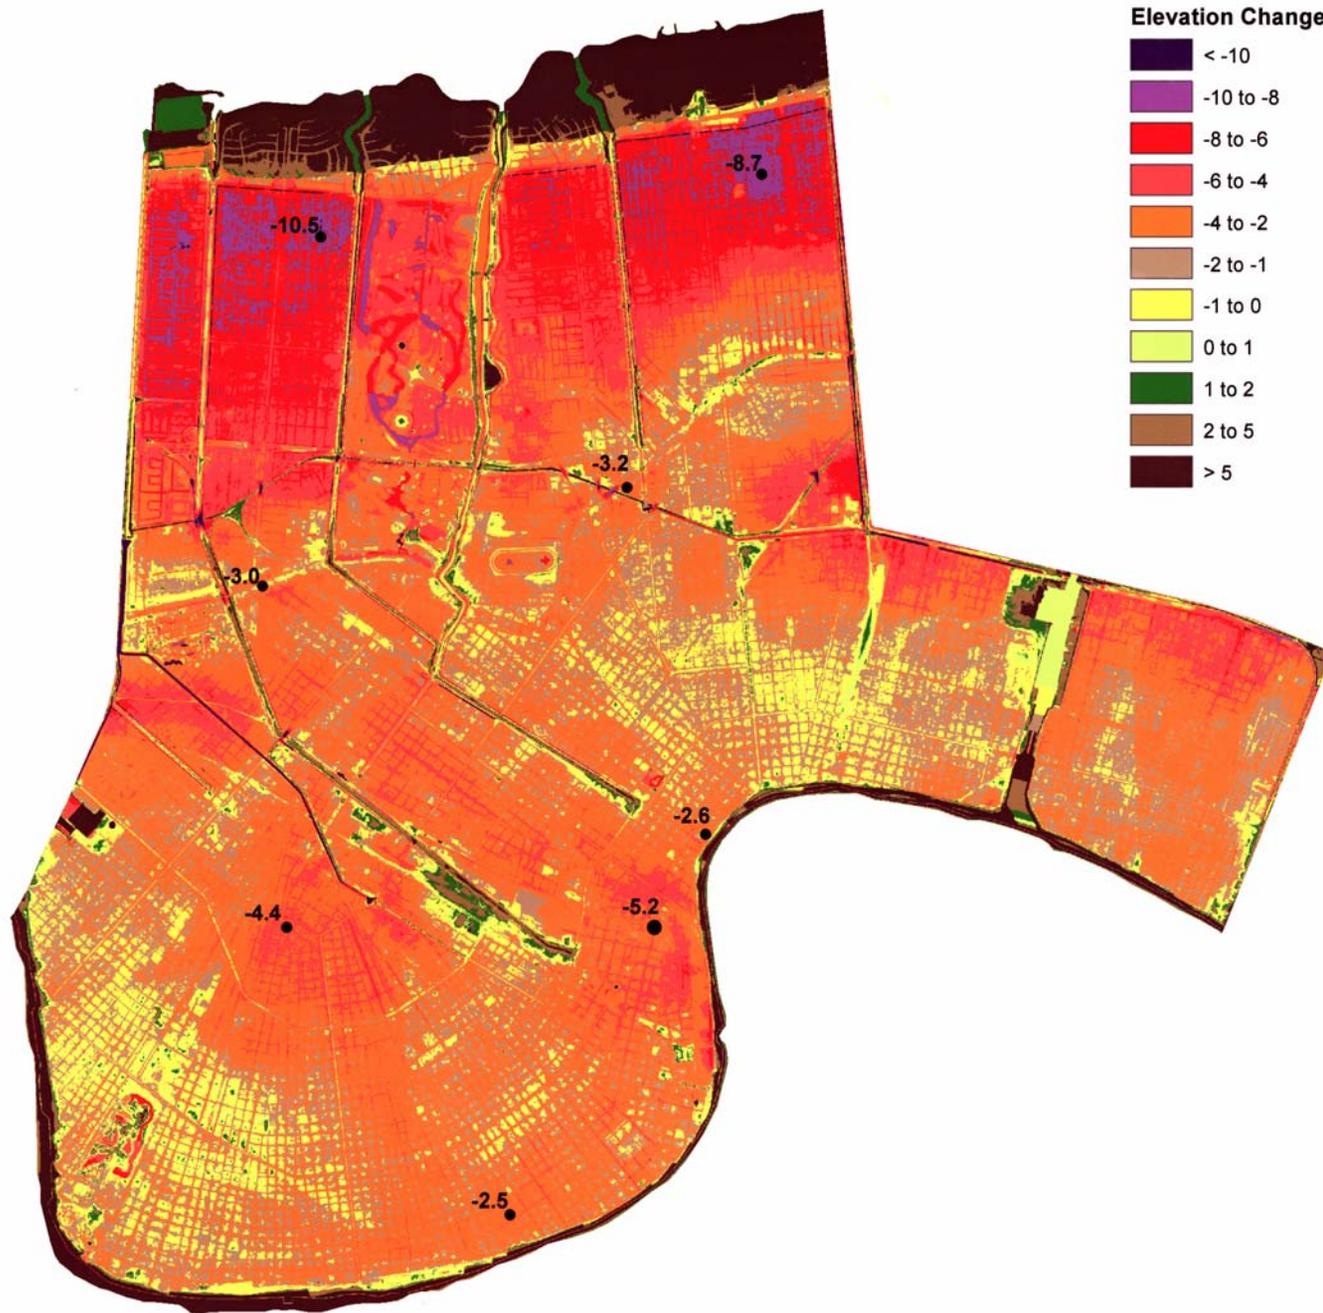
- Map showing relative elevation change between 1895 and 1999/2002, taken from URS (2006).
- The net subsidence was between 2 and 10+ feet, depending on location.

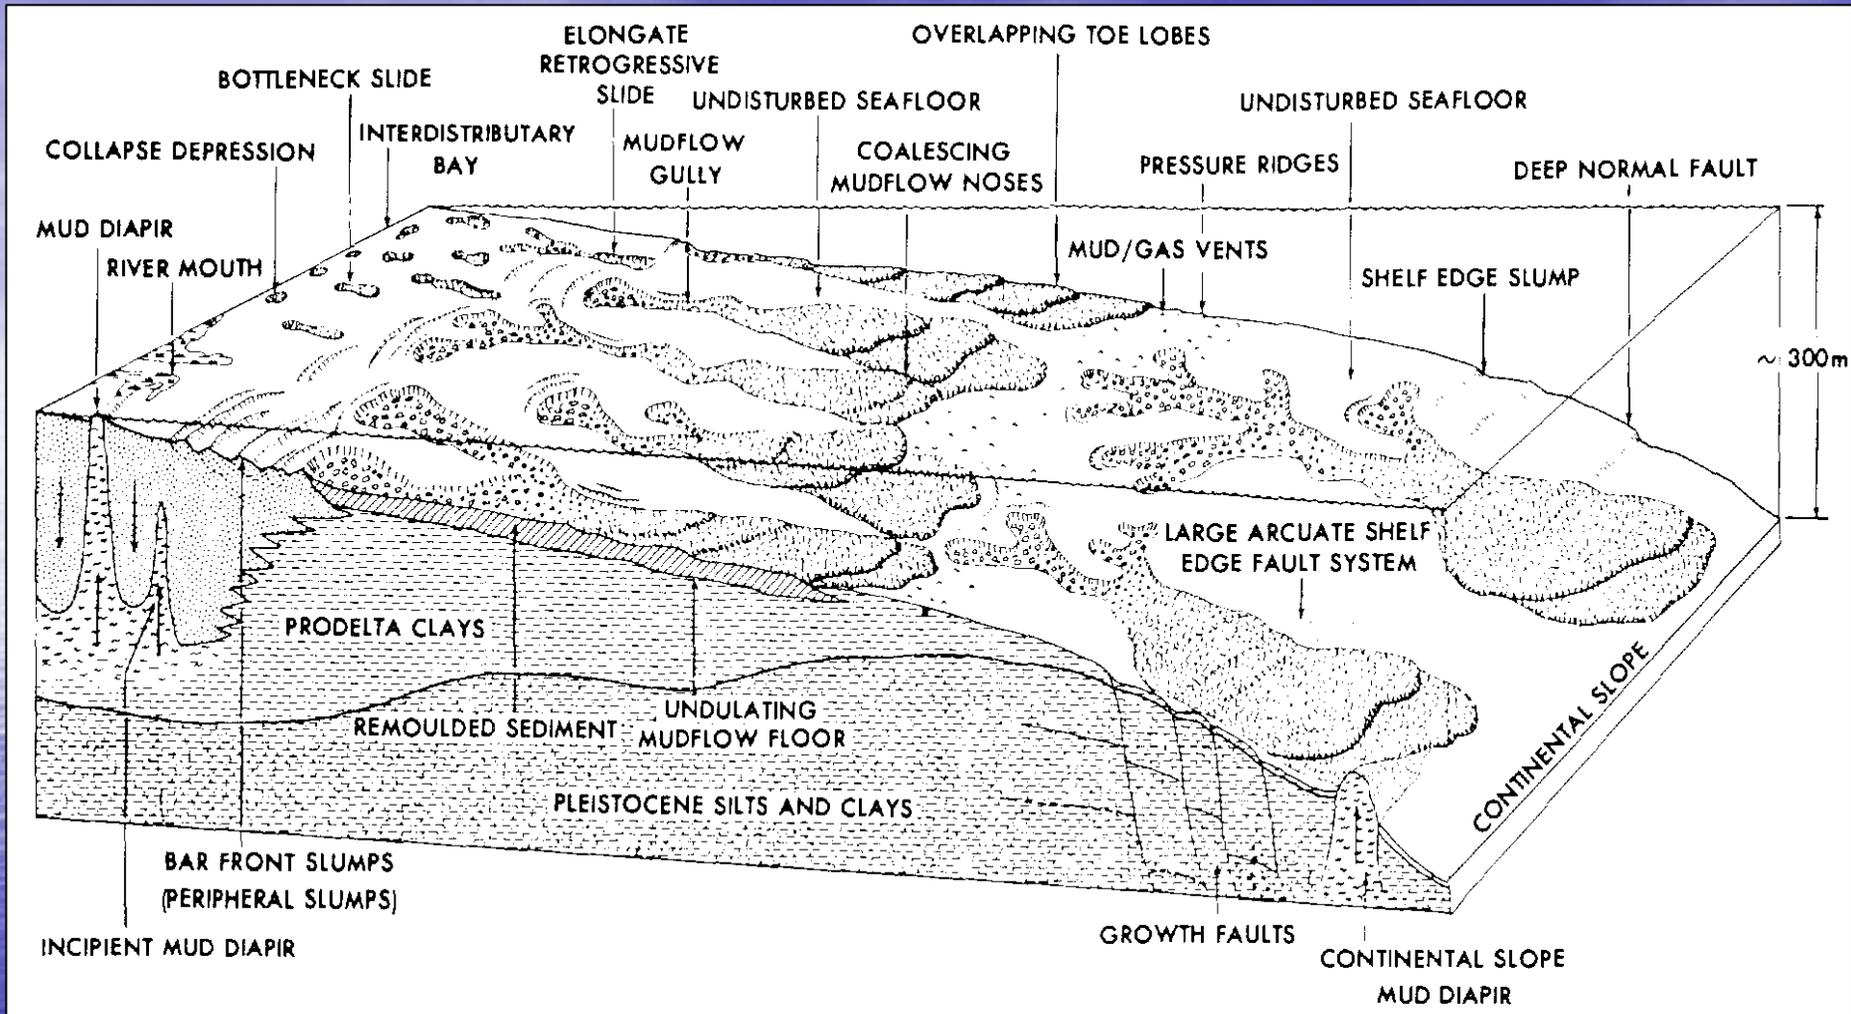
- Block diagram illustrating various types of **subaqueous sediment instabilities in the Mississippi River Delta**, taken from Coleman (1988).

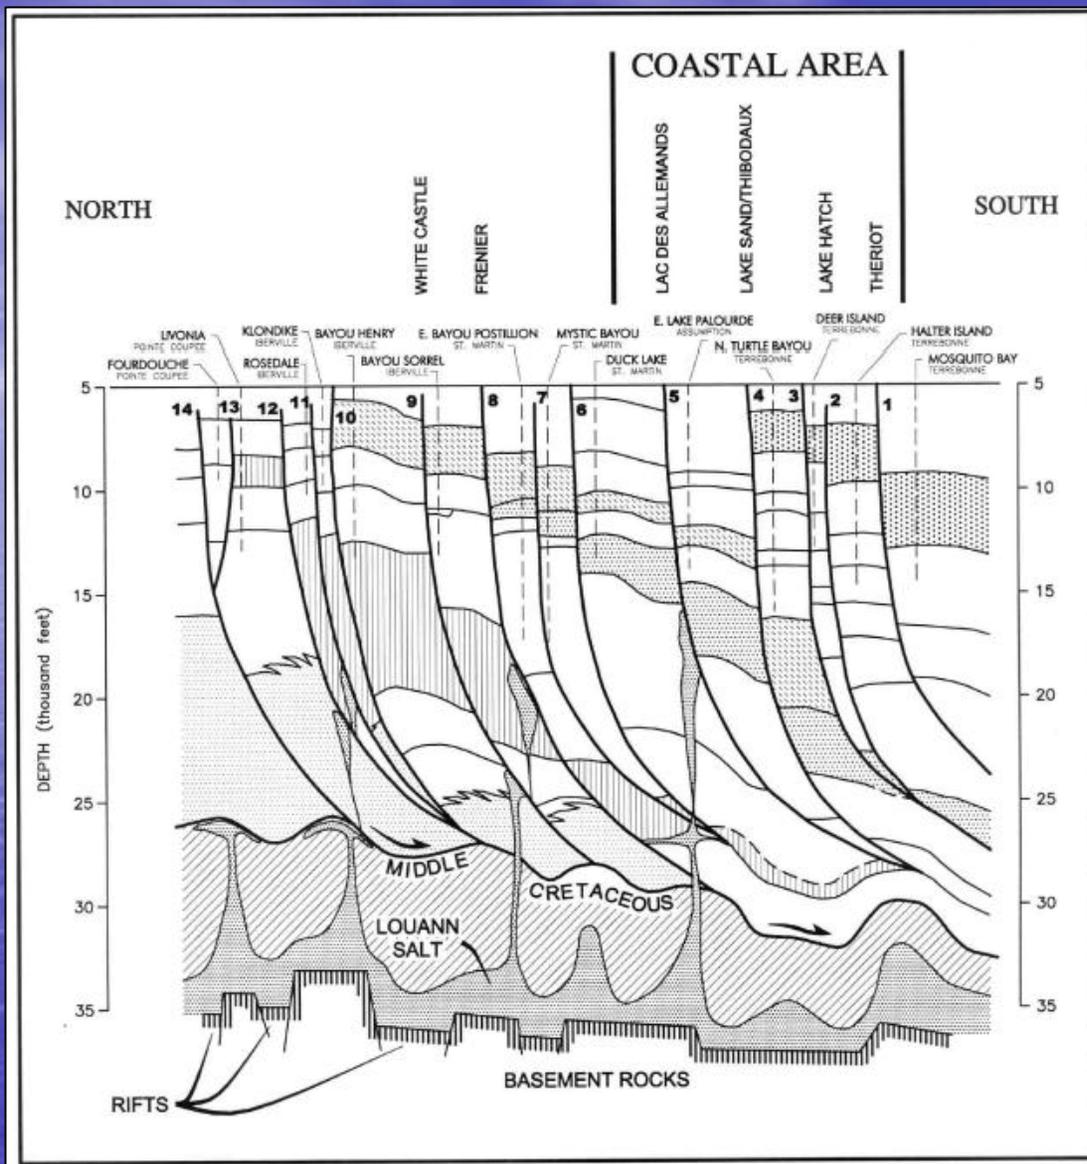
- Geologic cross section through the Gulf Coast Salt Dome Basin, taken from Adams (1997). This shows the retrogressive character of young lystric normal faults cutting coastal Louisiana, from north to south. The faults foot in a basement-salt-decollement surface of middle Cretaceous age (> 100 Ma).

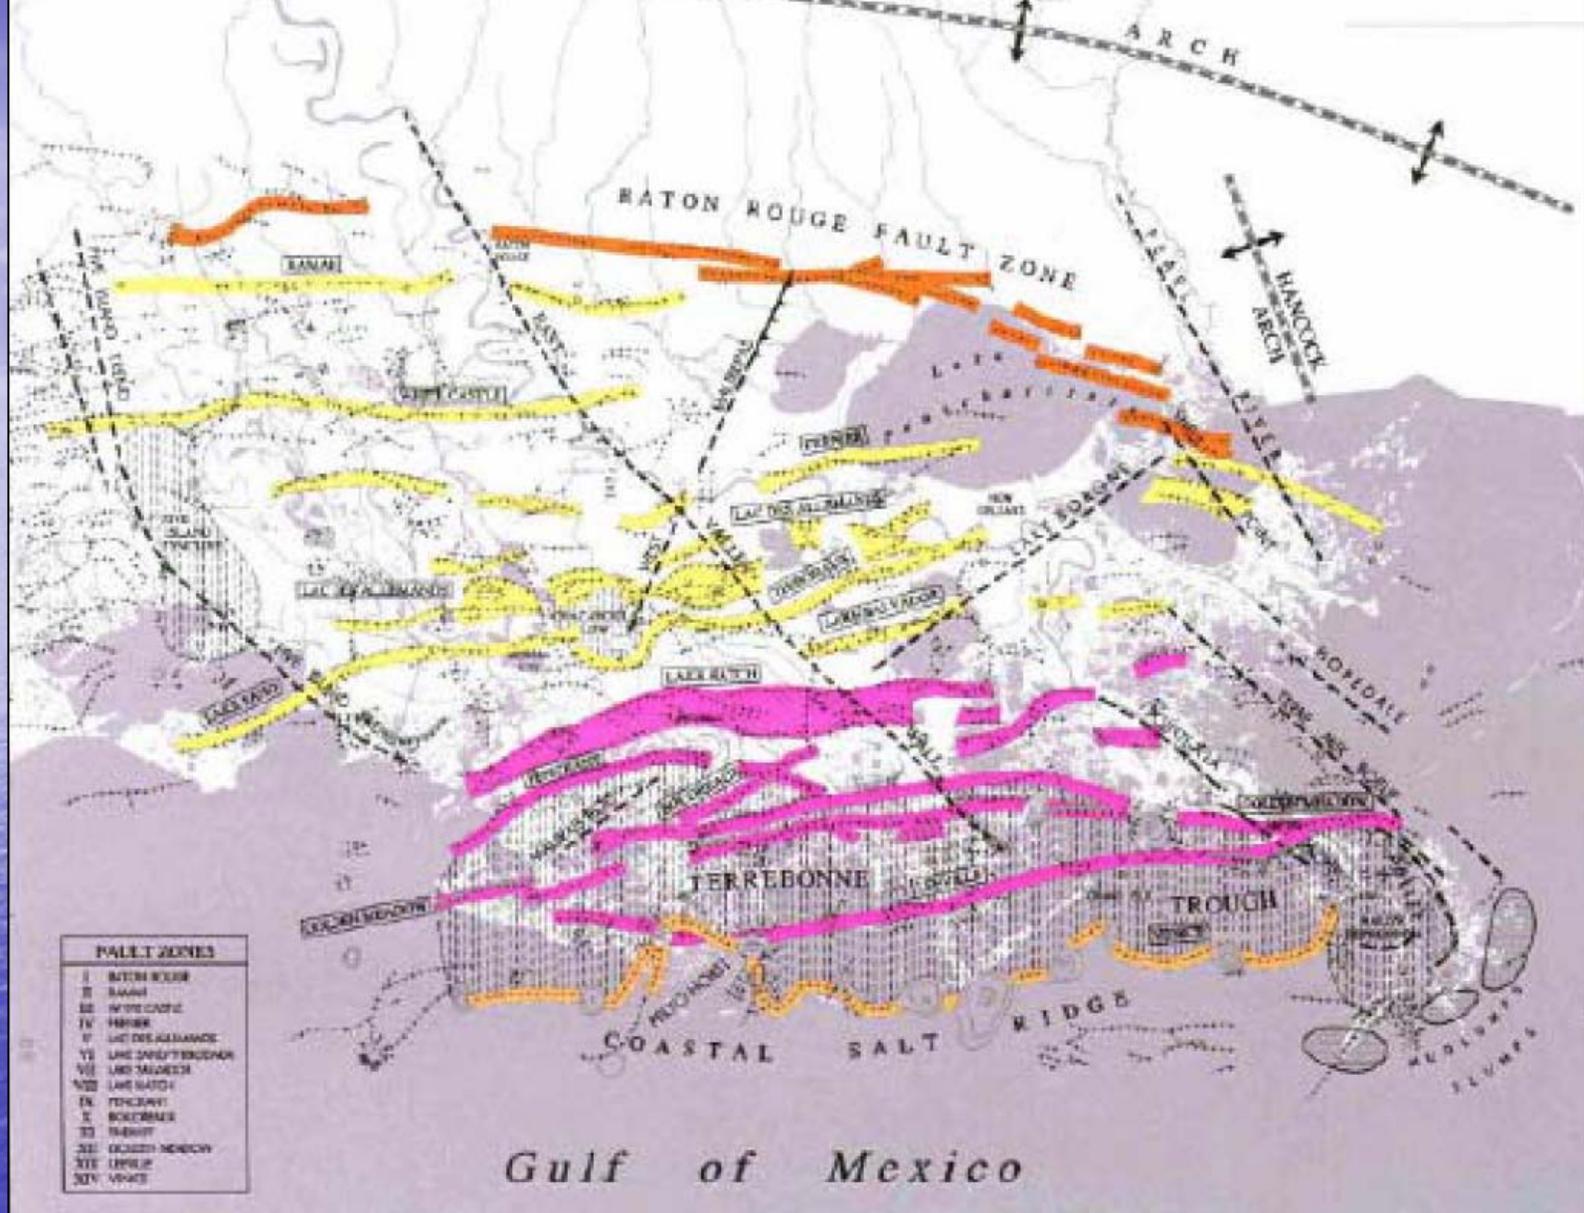
• This plot illustrates the en-echelon belts of **growth faults** forming more or less parallel to the depressed coastline. The Baton Rouge Fault Zone (shown in orange) has emerged over the past 50 years, north and west of Lake Pontchartrain.

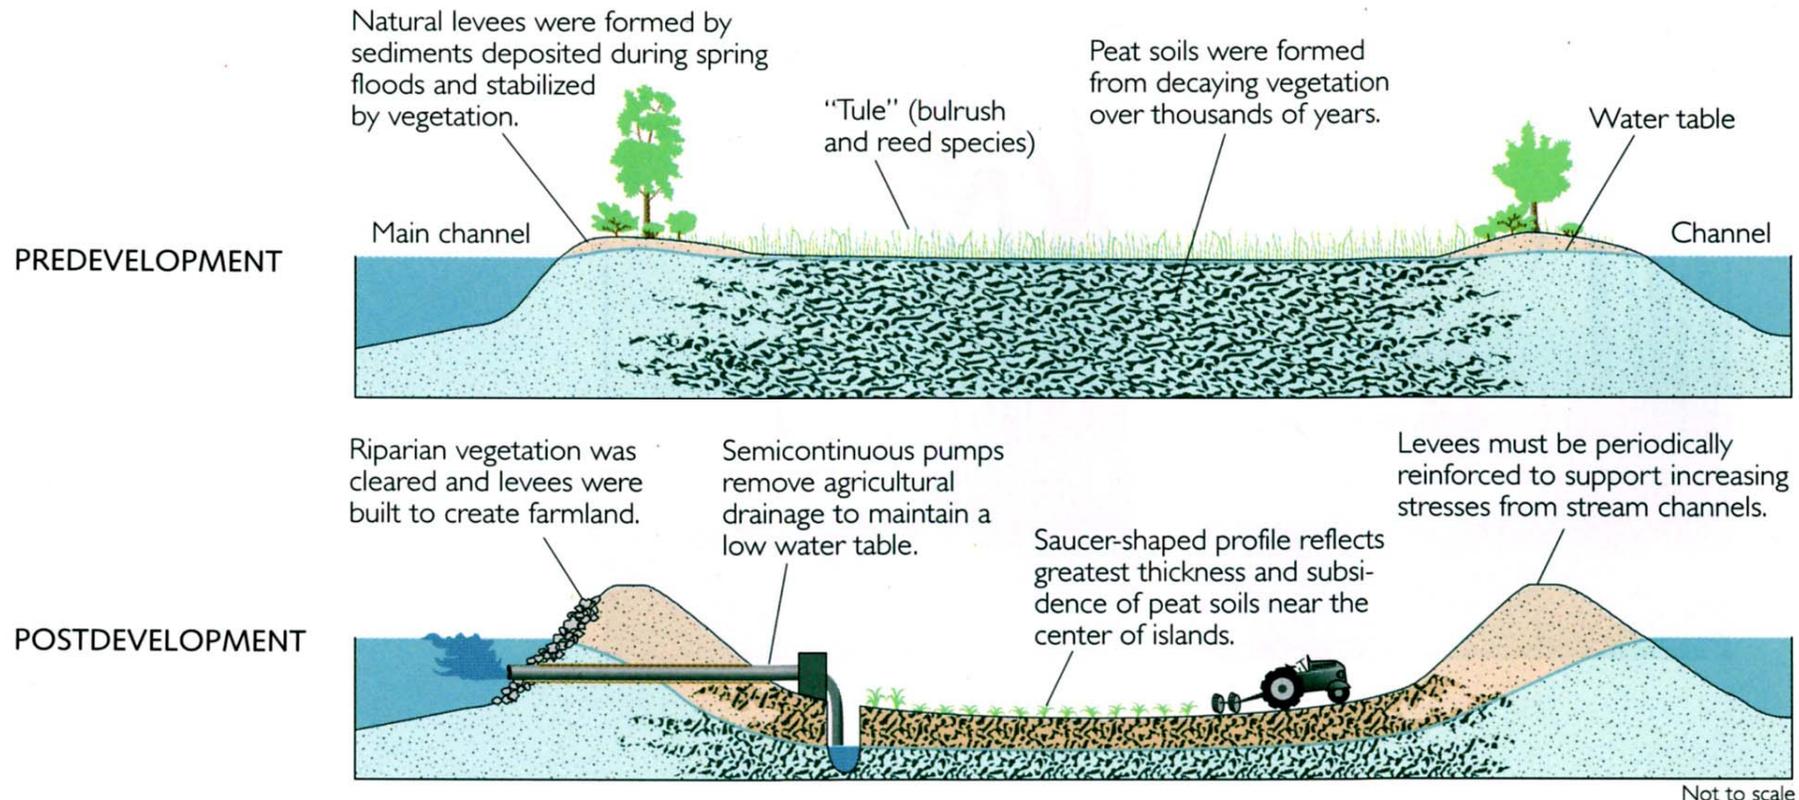
- Lowering the water table increases the effective stress on underlying sediments and hastens rapid biochemical oxidation of organic materials, causing settlement of these surficial soils.

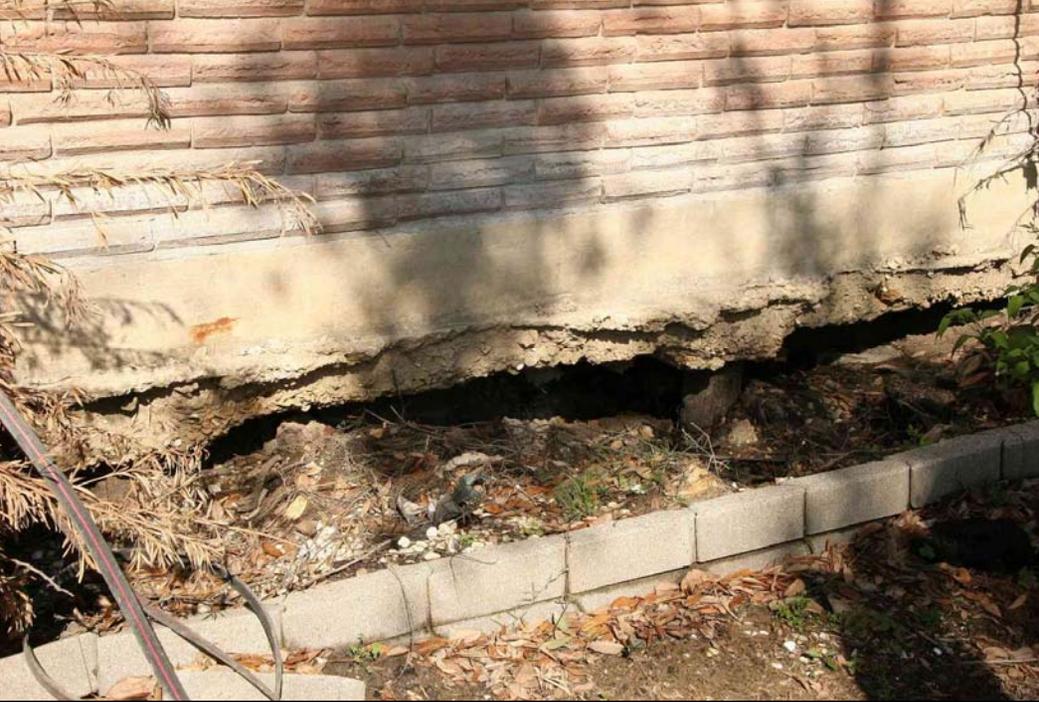
- The upper photo shows gross near-surface settlement of homes in the Lakeview neighborhood, close to the 17th Street Canal breach. Most of the homes were constructed from 1956-75 and are founded on wood piles about 30 feet deep.

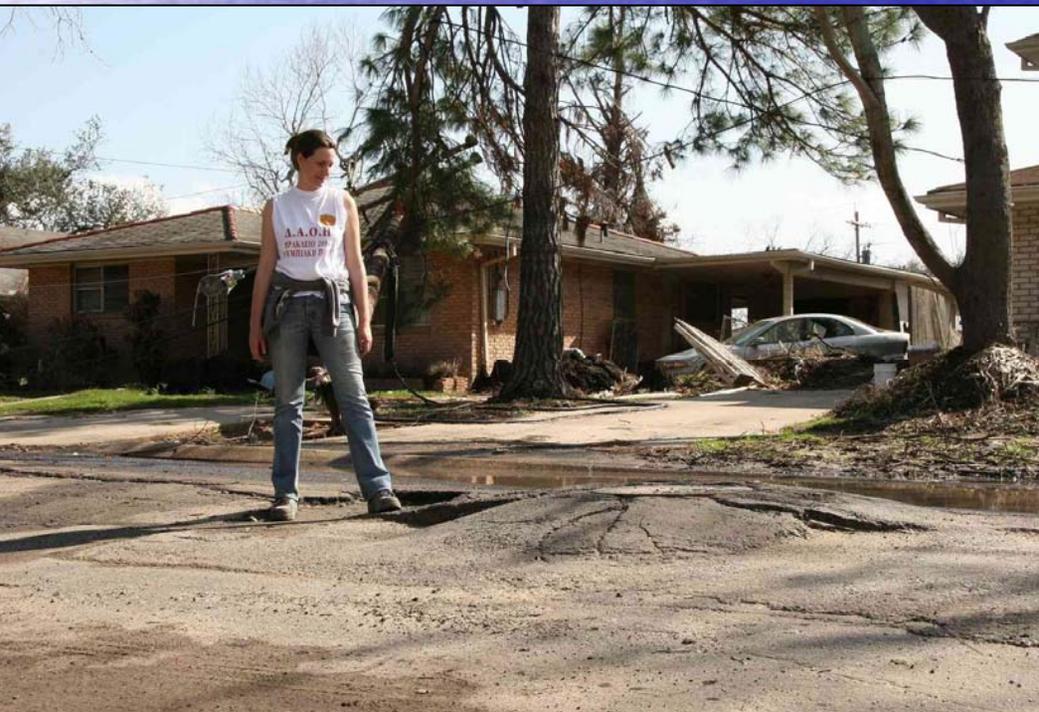
- The lower photo shows protrusion of a brick-lined manhole on Spencer Avenue, suggestive of at least 12 inches of near surface settlement during the same interim.
