Geologic Conditions Beneath the New Orleans Area

J. David Rogers, Ph.D., P.E., P.G.

University of Missouri-Rolla

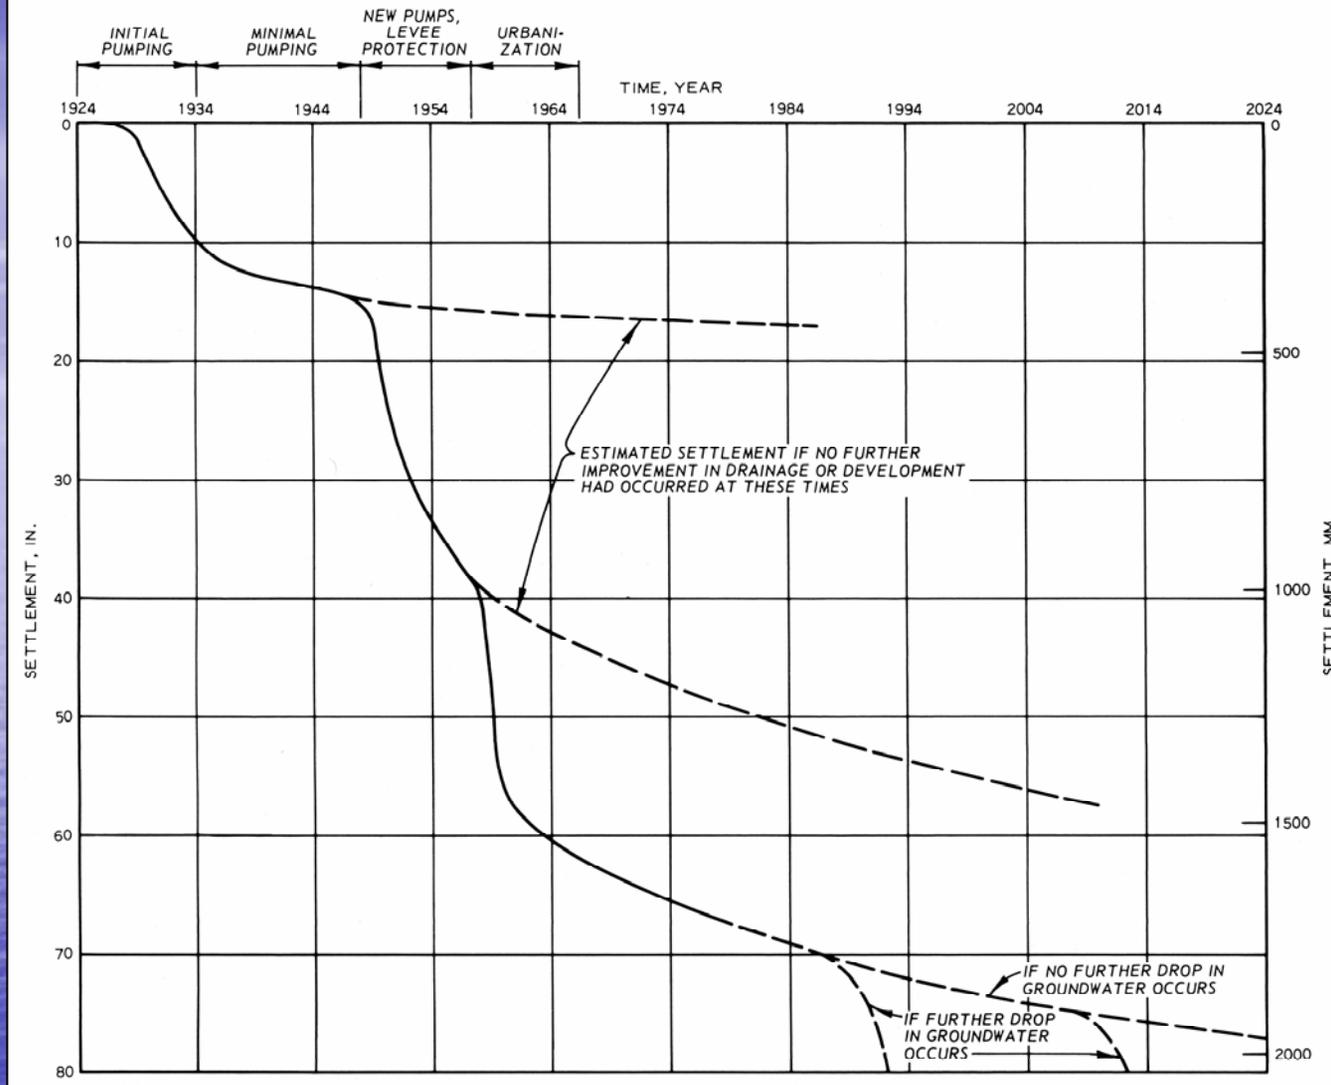
- Record of **historic settlement** in the town of Kenner, which is characterized by 6.5 to 8 feet of surficial peaty soils.
- The steps in these curves were triggered by **groundwater withdrawal** for industrial use and urban development. This area was covered by dense cypress swamps prior to development.

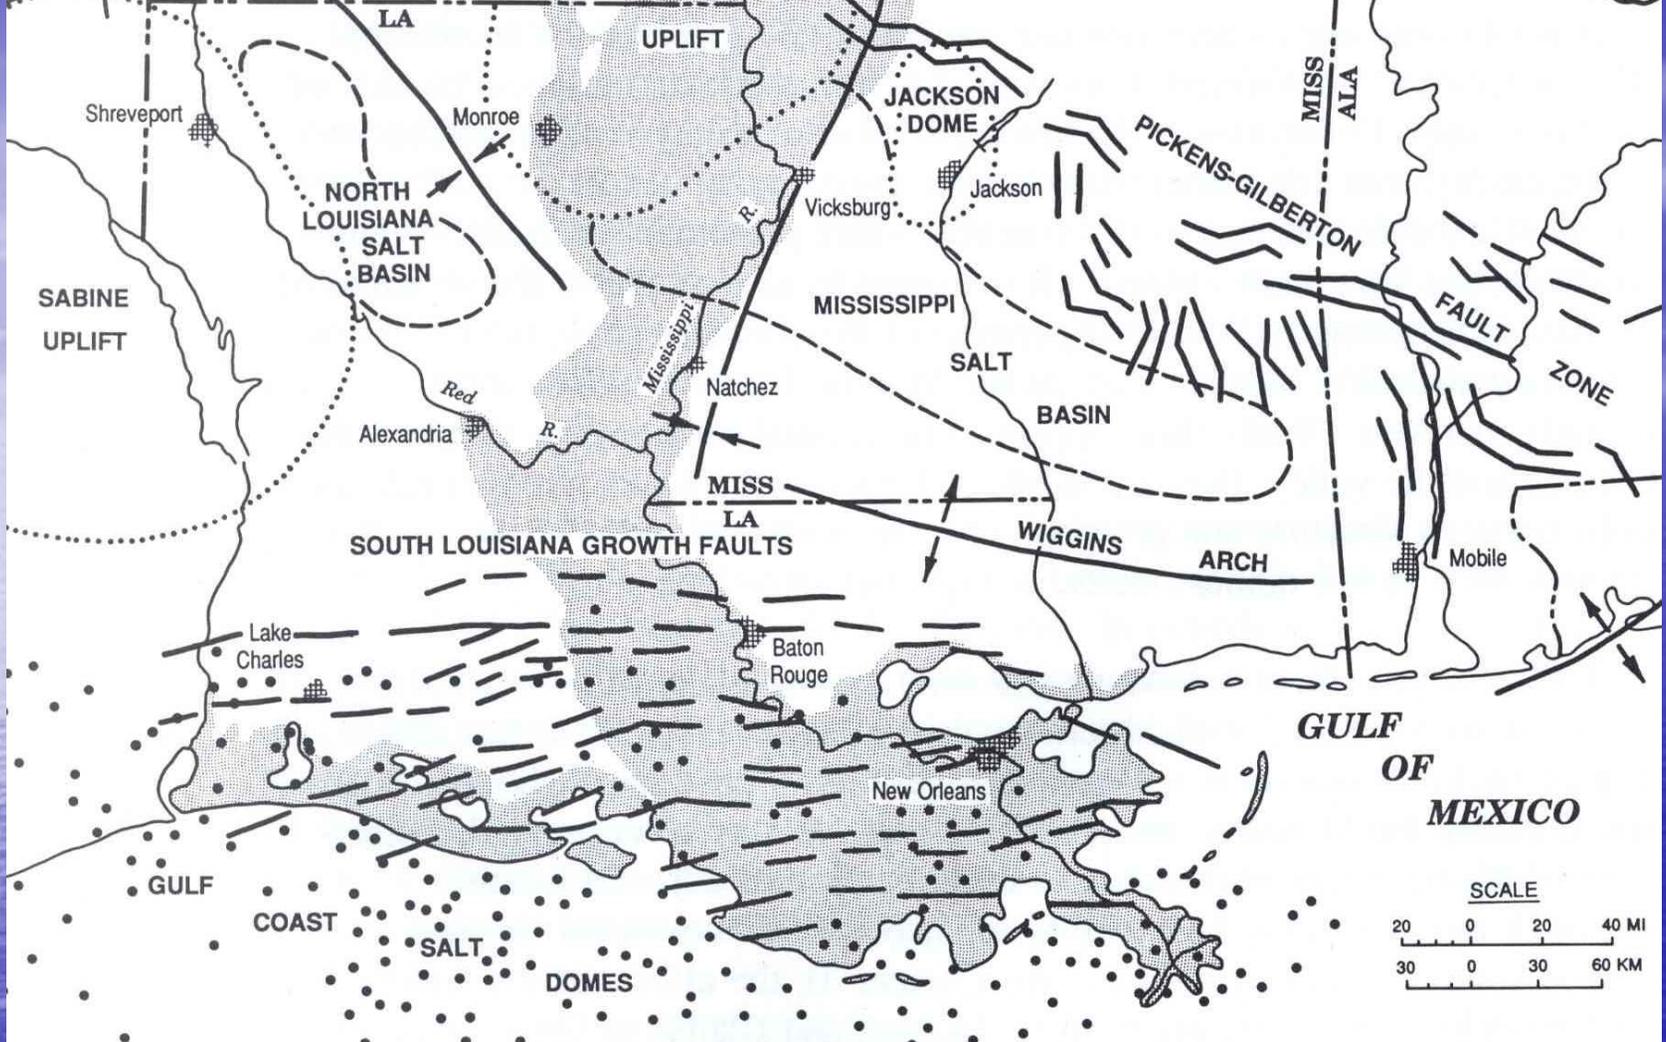
- Structural geologic framework of the lower Mississippi River Delta.** Growth faults (solid black lines) perturb the coastal deltaic plain, as do salt domes (shown as dots). This study did not uncover evidence of growth faults materially affecting any of the levee failures from Hurricane Katrina, although such possibility exists.

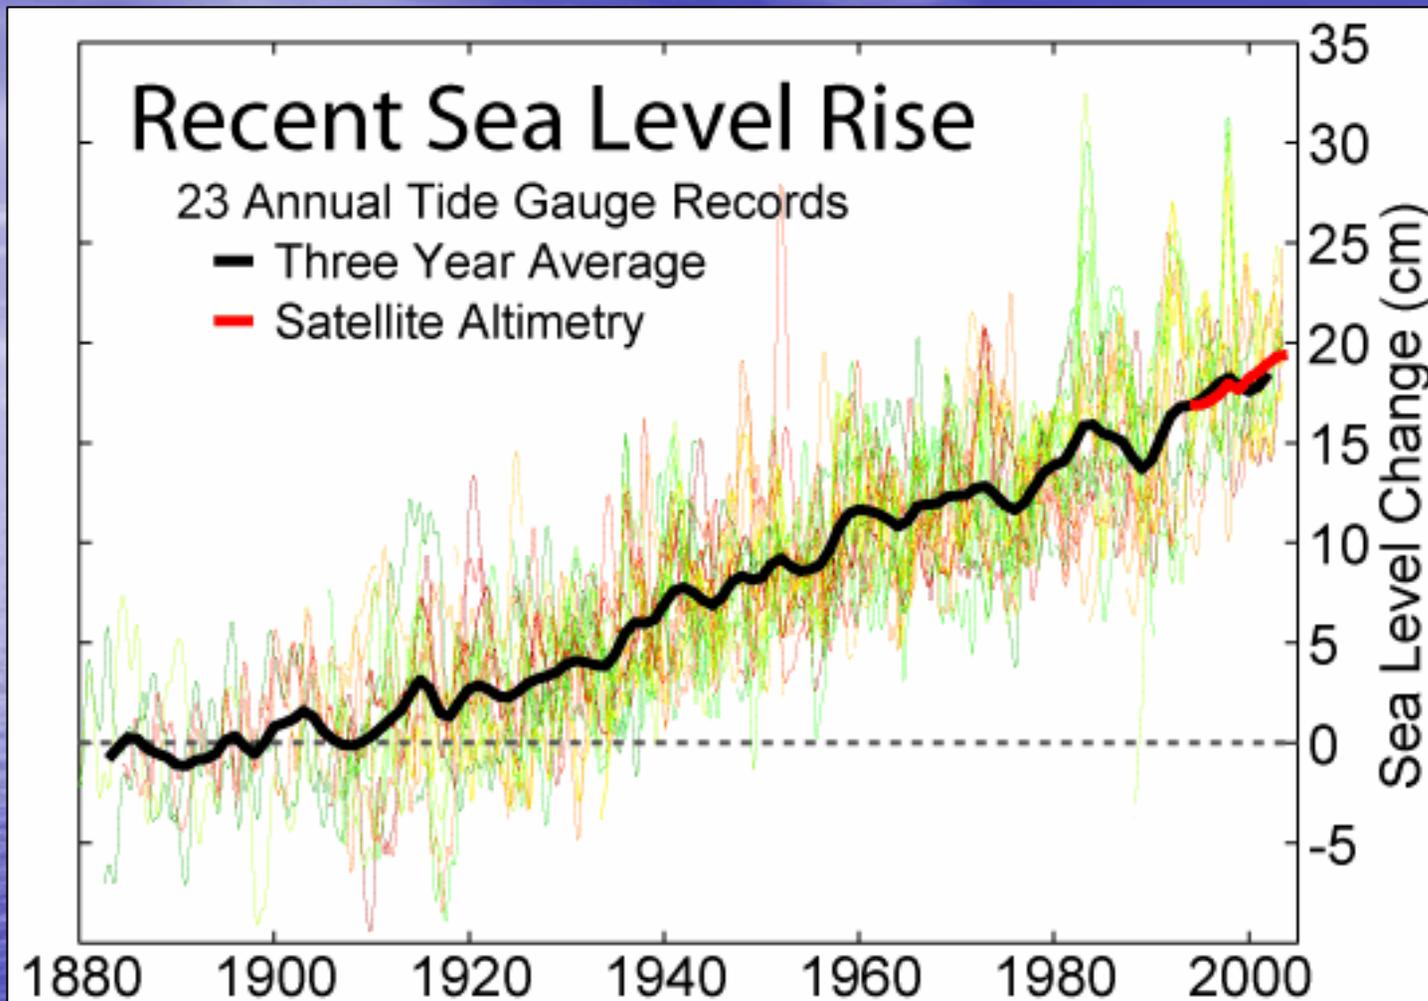
Coastal land loss in Louisiana is also exacerbated by **sea level rise**, which is currently averaging about 12 inches per century.
