# New Orleans and Hurricane Katrina. III: The 17th Street Drainage Canal

**Abstract:** The failure of the levee and floodwall section on the east bank of the 17th Street drainage canal was one of the most catastrophic breaches that occurred during Hurricane Katrina. It produced a breach that rapidly scoured a flow pathway below sea level, so that after the storm surge had largely subsided, floodwaters still continued to stream in through this breach for the next two and a half days. This particular failure contributed massively to the overall flooding of the Metropolitan Orleans East Bank protected basin. Slightly more than half of the loss of life, and a similar fraction of the overall damages, occurred in this heavily populated basin. There are a number of important geotechnical and geoforensic lessons associated with this failure. Accordingly, this paper is dedicated solely to investigating this single failure. Geological and geotechnical details, such as a thin layer of sensitive clay that was laid down by a previous hurricane, proper strength characterization of soils at and beyond the toe of the levee, and recognition of a water-filled gap on the inboard side of the sheet pi

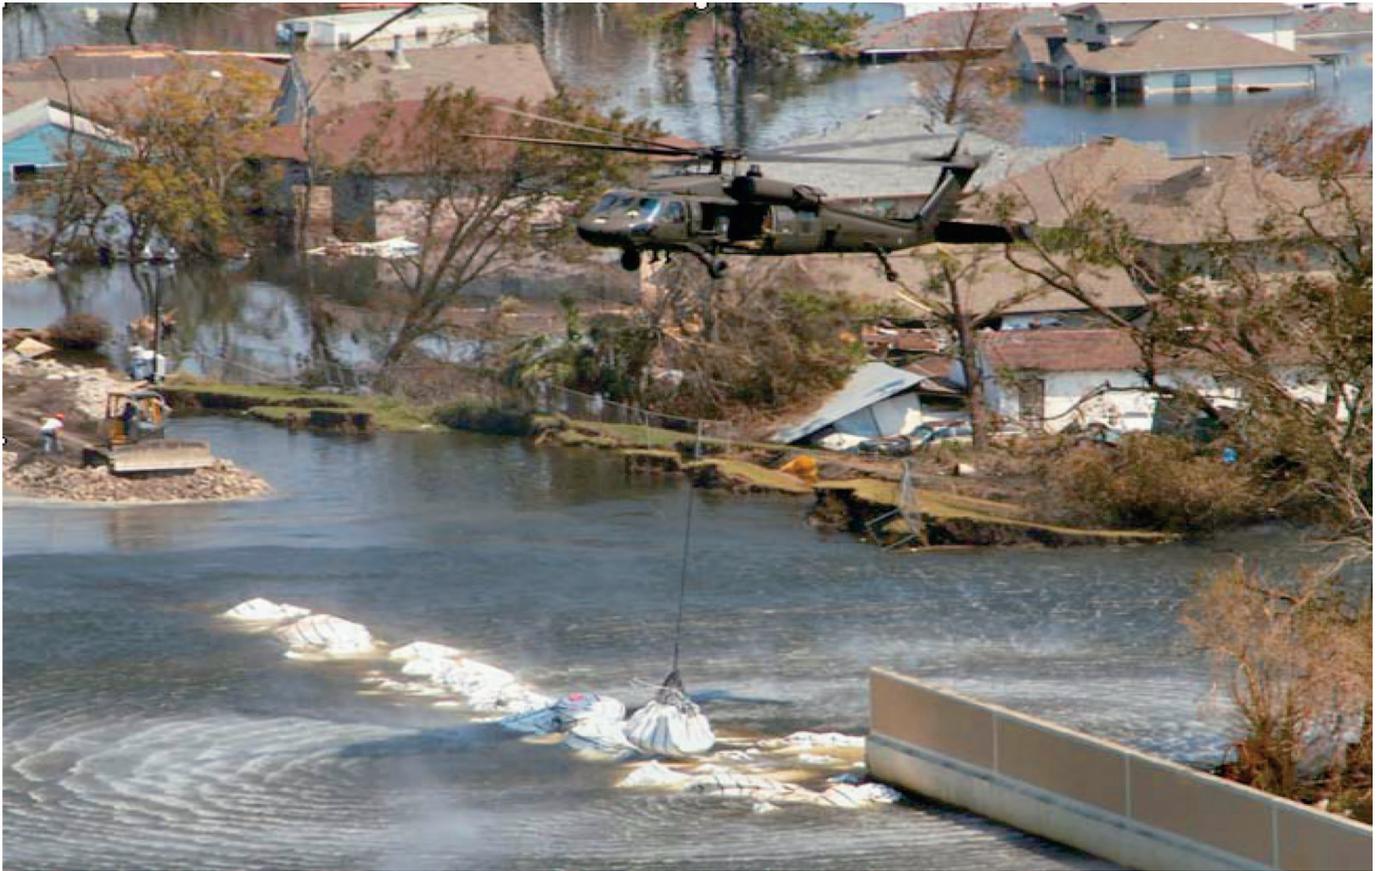
**Fig. 2.** (Color) Breach at the East Bank of the 17th Street Drainage Canal (USACE 1990)

Fig. 2 shows an oblique aerial view of the large breach that occurred on the east bank of the 17th Street canal, with a military helicopter lowering an oversized gravel-filled bag into the breach as a part of the initial closure and emergency repairs. In the photograph in Fig. 2, which was taken on September 2, 2005, it can be noted that the floodwaters have equilibrated, and the surrounding inboard-side neighborhood is fully flooded. Also shown in the middle of the photograph in Fig. 2 is the large, relatively intact section of the original embankment that has slid laterally away from the canal over a travel distance of approximately 49 ft (with its crest fence still nearly vertical) and a small shed and a home that have been damaged near the inboard-side toe of this laterally displaced embankment section.

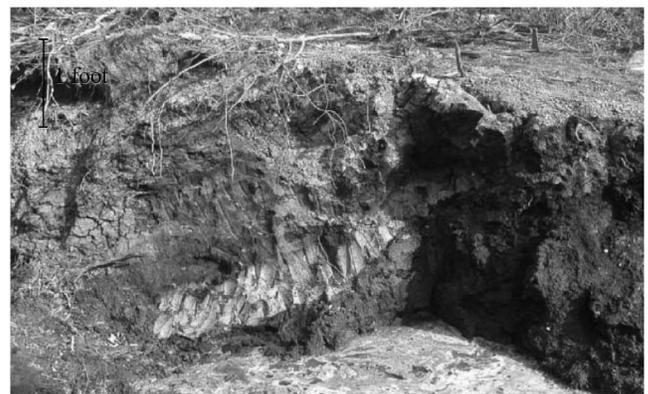
Fig. 5 shows an excavated trench through the first toe scarp at the inboard side toe of the laterally displaced levee section [Toe Scarp 1 from Fig. 4(b)]. This feature had been jointly noted and partially excavated manually by the combined ASCE and National Science Foundation (NSF)-sponsored ILIT field investigation teams on September 27 and 29, 2005, and was subsequently further excavated by the U.S. Army Corps of Engineers (USACE) as part of their initial IPET field investigations (IPET 2007). Fig. 6 shows the two additional toe scarps [Scarp Nos. 2 and 3 from Fig. 4(b)] that occurred further inboard (farther to the landside) from the scarp shown in Fig. 5. This breach was extensively investigated by both the IPET and ILIT investigation teams, and there are numerous additional borings and piezocone logs available at adjacent sections to the north and south of this central cross section of Fig. 4 (ILIT 2006; IPET 2007). An illustration of the sequence of evolution and progression of this failure (taken along a transect slightly north of that shown in Fig. 4), is presented in a series of six successive stages or increments in the companion paper by Rogers et al. (2008).

Fig. 5. View of the exit of the upper failure surface (Toe Scarp No.1), at the inboard toe of the laterally translated embankment (IPET 2006)

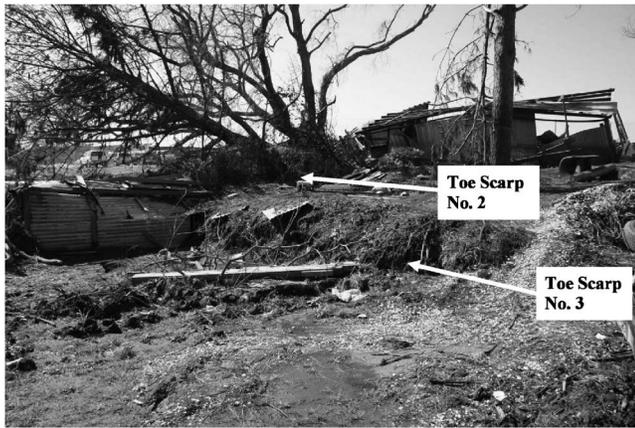
**Fig. 6.** View of Toe Scarp Nos. 2 and 3 at the inboard edge of the lateral translational failure at the 17th Street drainage canal

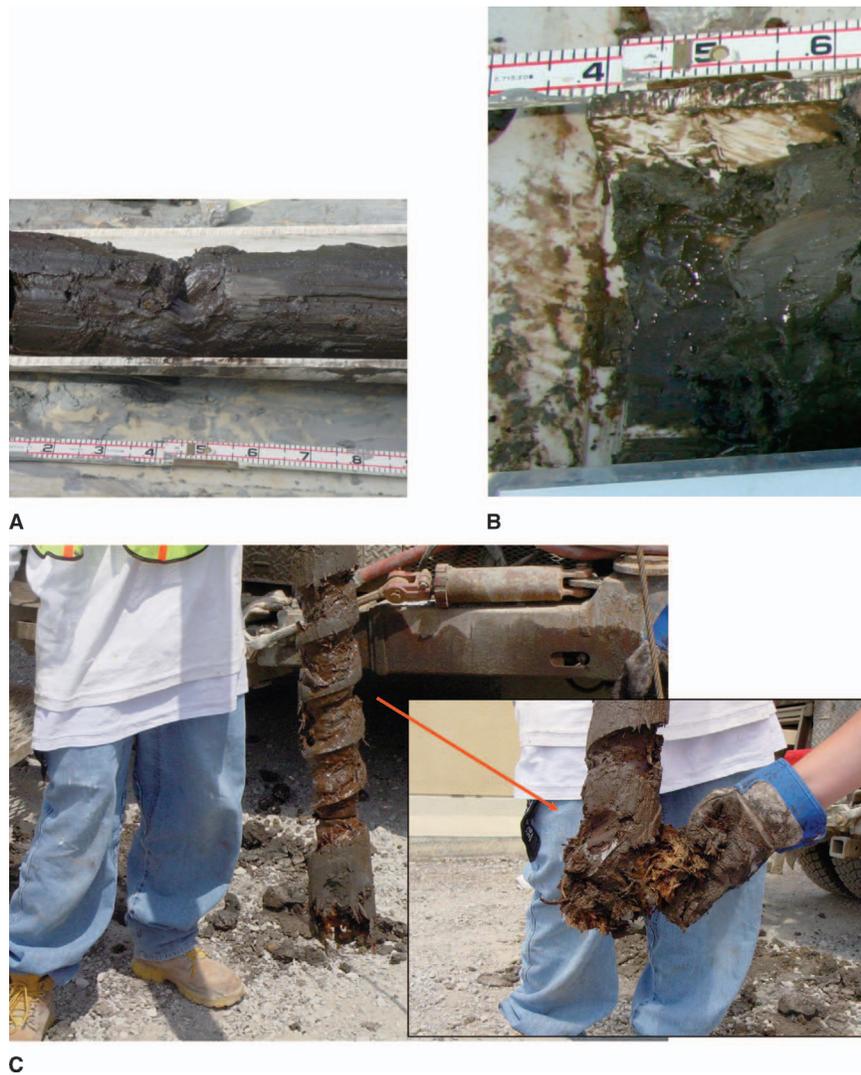
Fig. 14(a) shows a photograph of the sensitive layer, believed to have served as the basal rupture surface beneath the translated blocks shown previously in Fig. 3 and depicted in Fig. 4. The sample shown in Fig. 14(a) was obtained from within the shear failure zone, and has been remoulded to a residual condition. The layer exhibited physical evidence of having been unidirectionally sheared and remoulded in situ, and in the direction of the observed

translational failure, as demonstrated by the unidirectional pulling and tearing of organic fibers (up to 5 cm thick), and it exhibited an unusually low (nearly zero) residual strength (ILIT 2006). This is the stratum along which the main translational shear failure is hypothesized to have occurred at this site. Fig. 14(b) shows another sample of the sensitive layer; this time recovered from an area well outside of the August 2005 failure zone, and so representing a more nearly undisturbed specimen. These relatively undisturbed samples exhibited distinctive contrasts from those in the failure zone insofar that they appeared much less disturbed and without snapped branches, dragged organics, or water-filled large voids. The sensitive layer also contained discernible sequences of organic, peaty materials, and soft clays. The nearby soft clays do not exhibit a glossy character, and at in situ water contents they appear flat and dull. The layer of sensitive organic silty clay is starkly different. As shown in Fig. 14(b), this material is highly glossy, and is also somewhat translucent. This material is softer than the nearby soft clays and marsh deposits, and it is exhibited greater sensitivity during shear testing.

**Fig. 14.** (Color) (a) Sheared sample of the sensitive organic silty clay layer from within the slide area; (b) unsheared sample of the same material from near to the slide area, but not within it; and (c) shiny dark brown to black sensitive organic clay on auger stem and (inset) closeup view of layers of leaves and twigs—17th Street Canal breach site
