# **SITE CHARACTERIZATION AND LEVEE FAILURE MODES: With special reference to the Paterno Flood Case**

**J. David Rogers, Ph.D., P.E., P.G., C.E.G., C.HG.**

**Richard L. Meehan, P.E., G.E.**

**ASCE-AEG Joint Meeting  
Berkeley, California  
November 13, 2008**

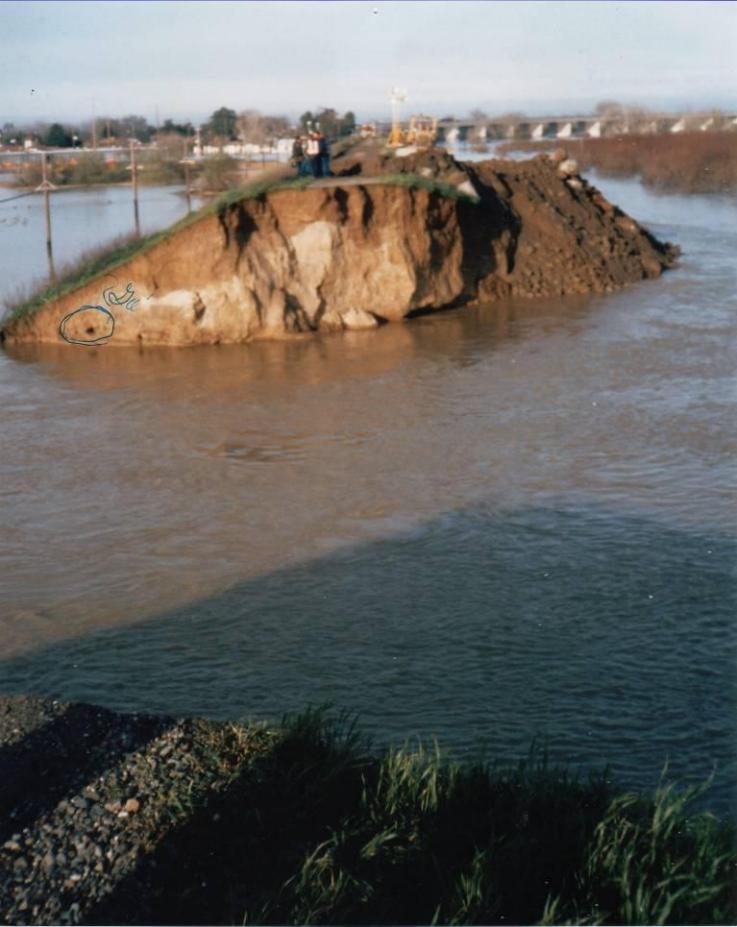
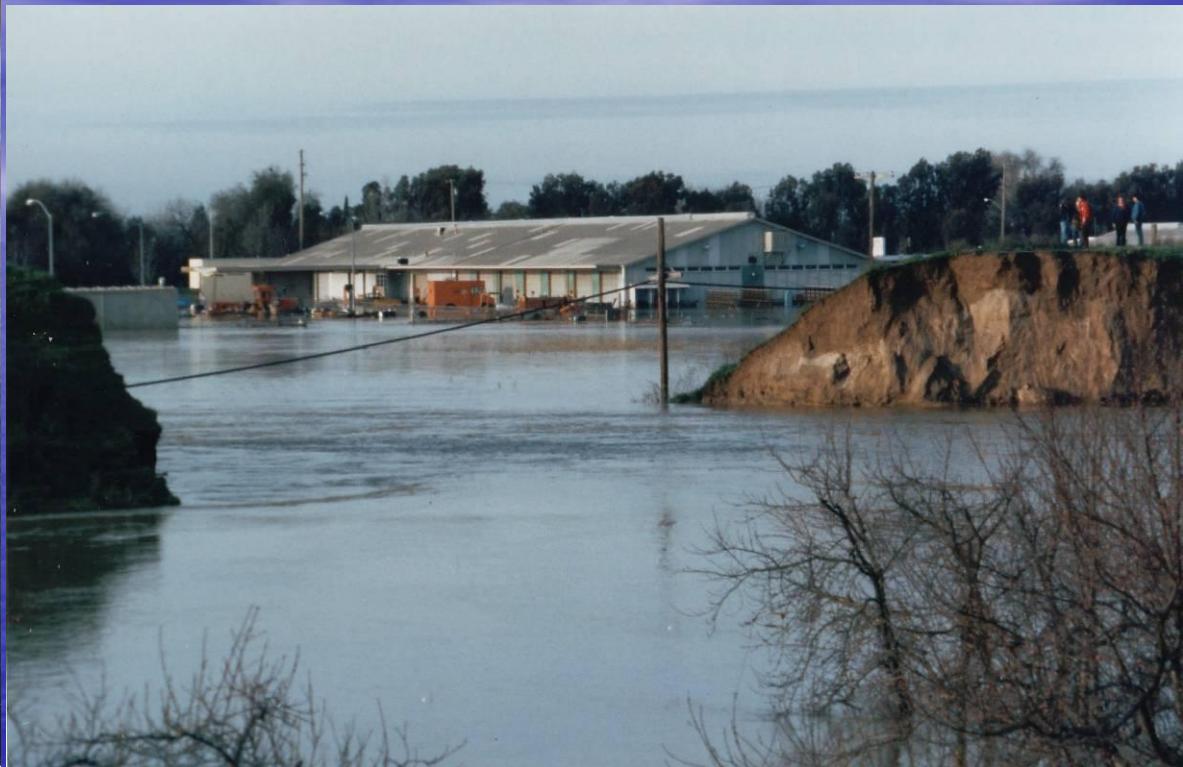
# The Linda breach

- The breach of the Linda Levee along the south side of the Yuba River near its mouth was *only 170 feet wide*, even after flood waters had poured through the opening for five days.

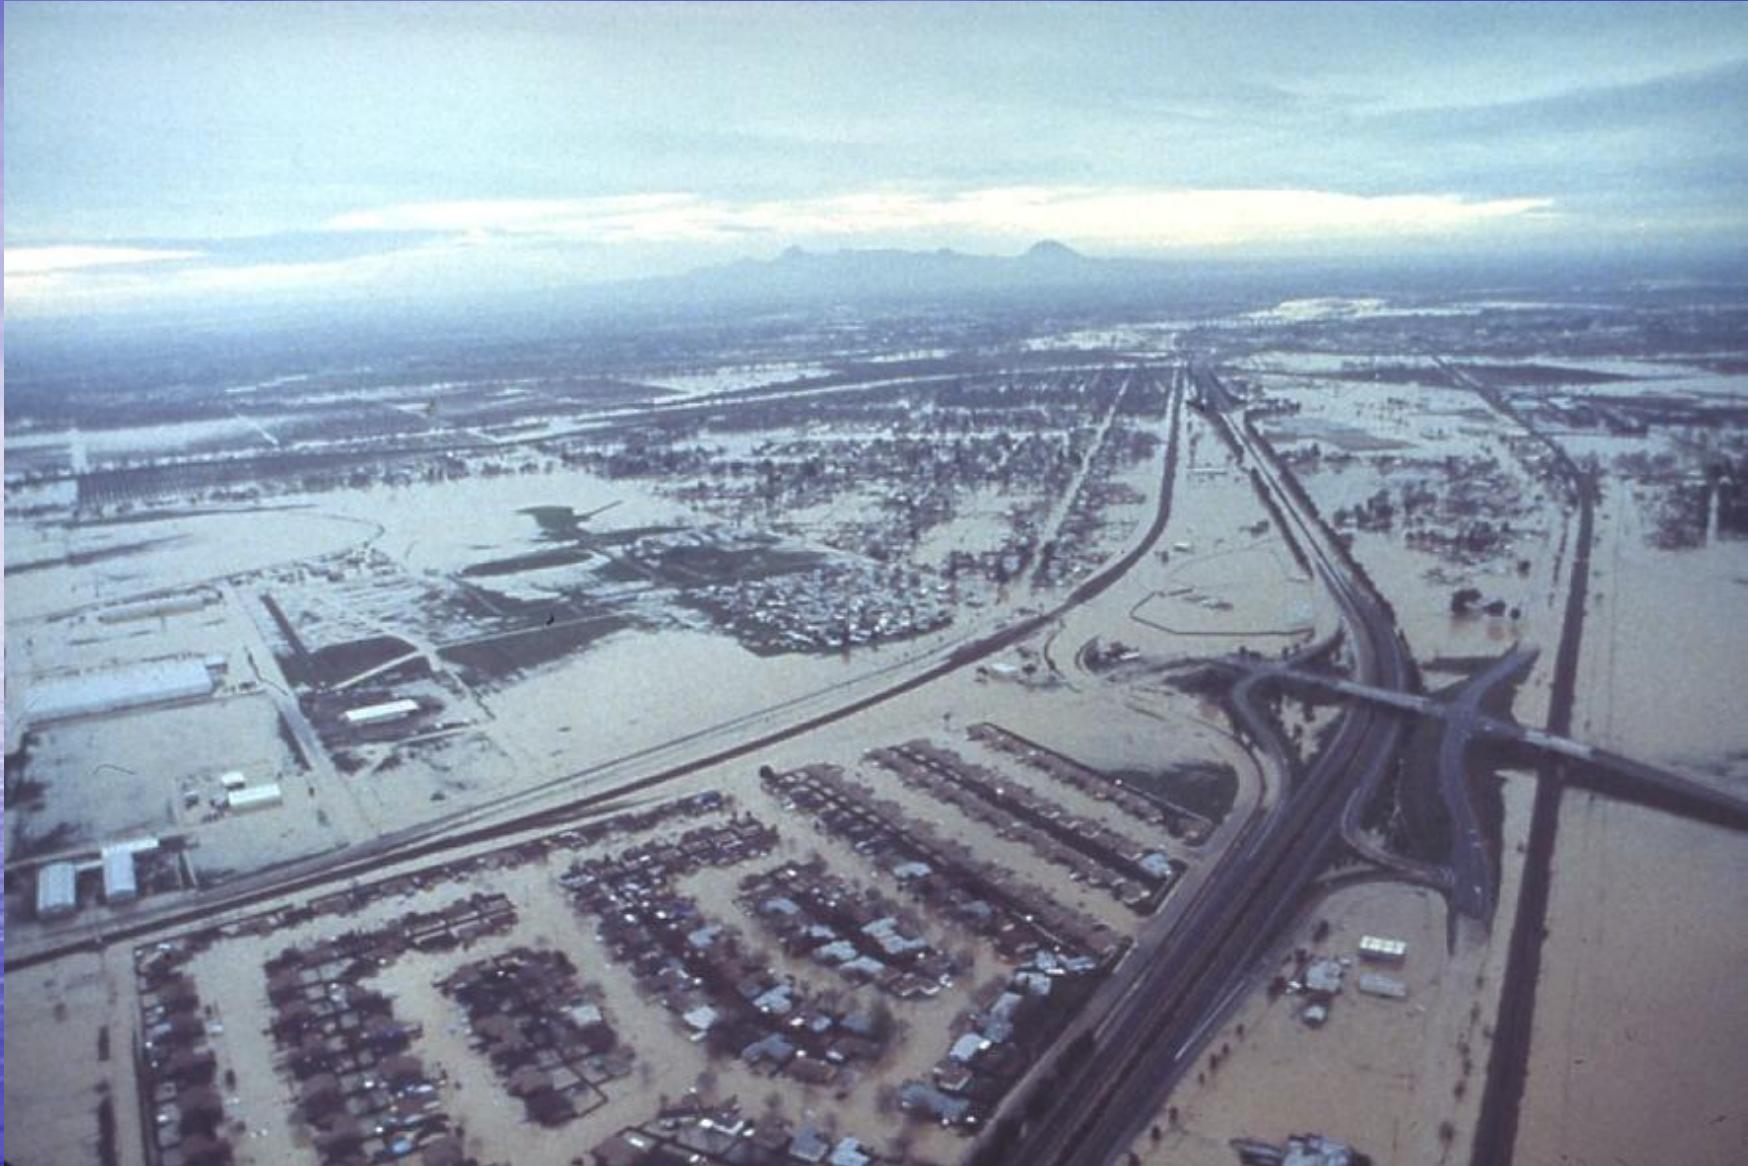
- Around 6 PM on February 20, 1986 the Linda Levee suddenly broke, on the south side of the Yuba River about half a mile above its junction with the Feather River.

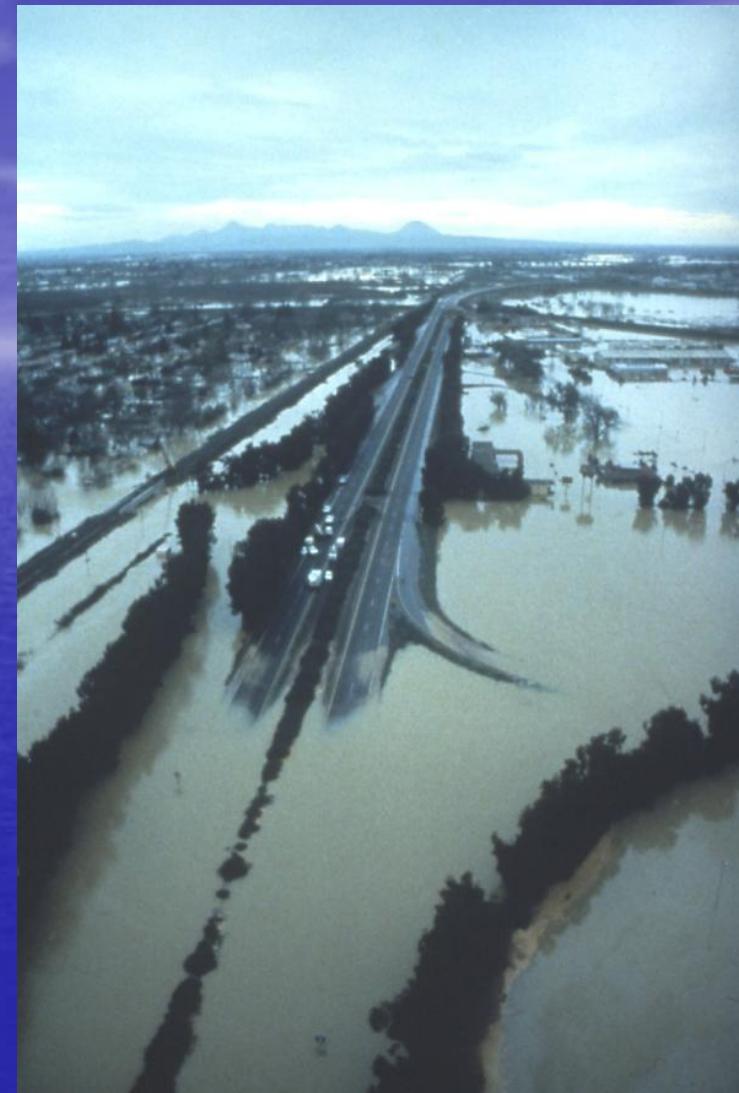
- **Entire neighborhoods were flooded, and relief efforts were complicated by the inundation of Highway 70, shown at right, the main access route serving the area.**

**Inundation of CA Route 70 in Olivehurst, looking northerly, towards Sutter Buttes.**

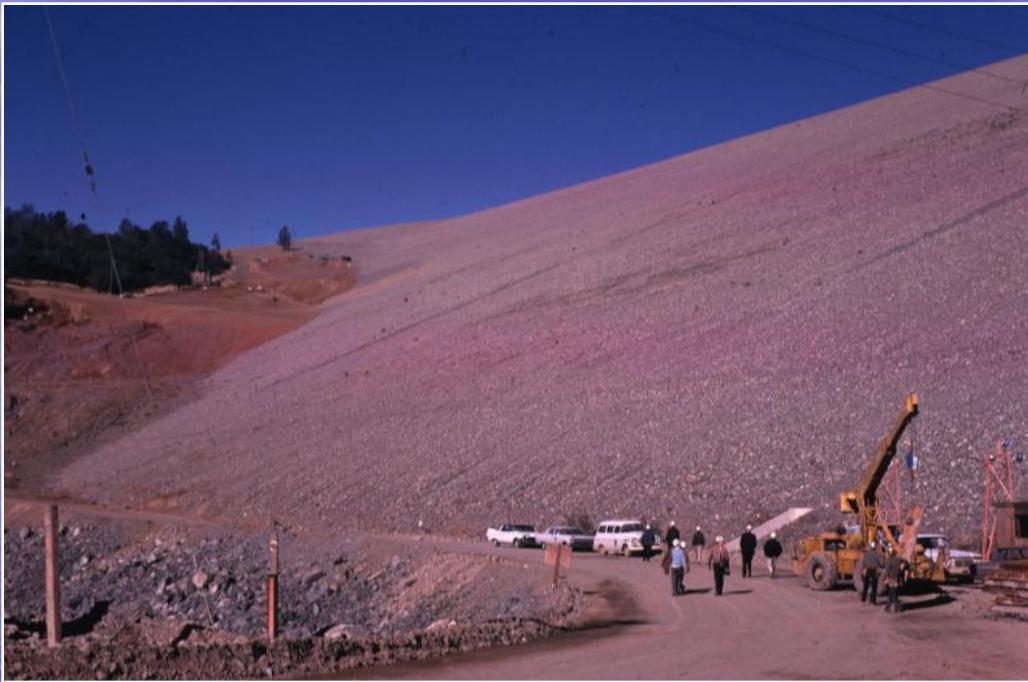
# HIGHEST DAM IN THE WORLD (1967)

- At 770 feet high and 5,600 feet long, **Oroville Dam** was the highest dam in the world when it was completed on the Feather River in 1967. It was designed by the CA DWR , with embankment volume of 80 million yds<sup>3</sup>.
- Oroville Dam is the kingpin structure of the massive **California Water Project**, which diverts water from the Feather River to southern California.

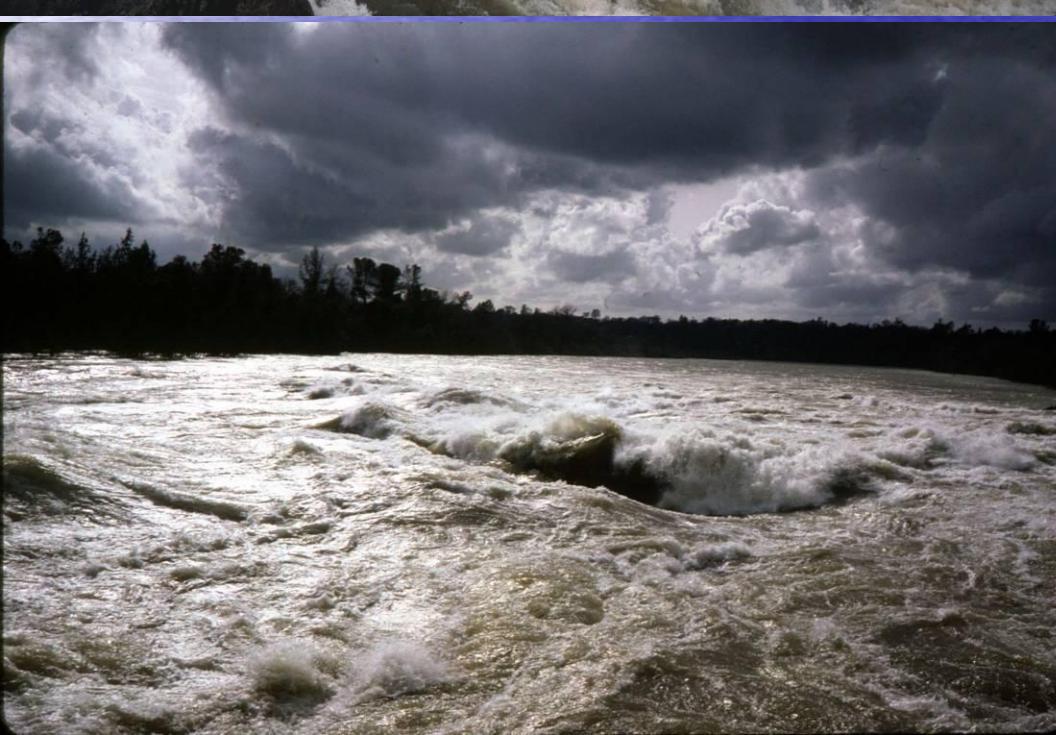
# February 1986 floods

- Views showing the high flows disgorging through the Yuba Narrows in Feb 1986
- On February 11th a series of warm tropical storms struck Northern California, lasting 10 days.
- This included the *heaviest 24-hr event ever recorded in the Central Valley, 17.60 inches*, on Feb. 17th at Four Trees, in the Feather River Basin.

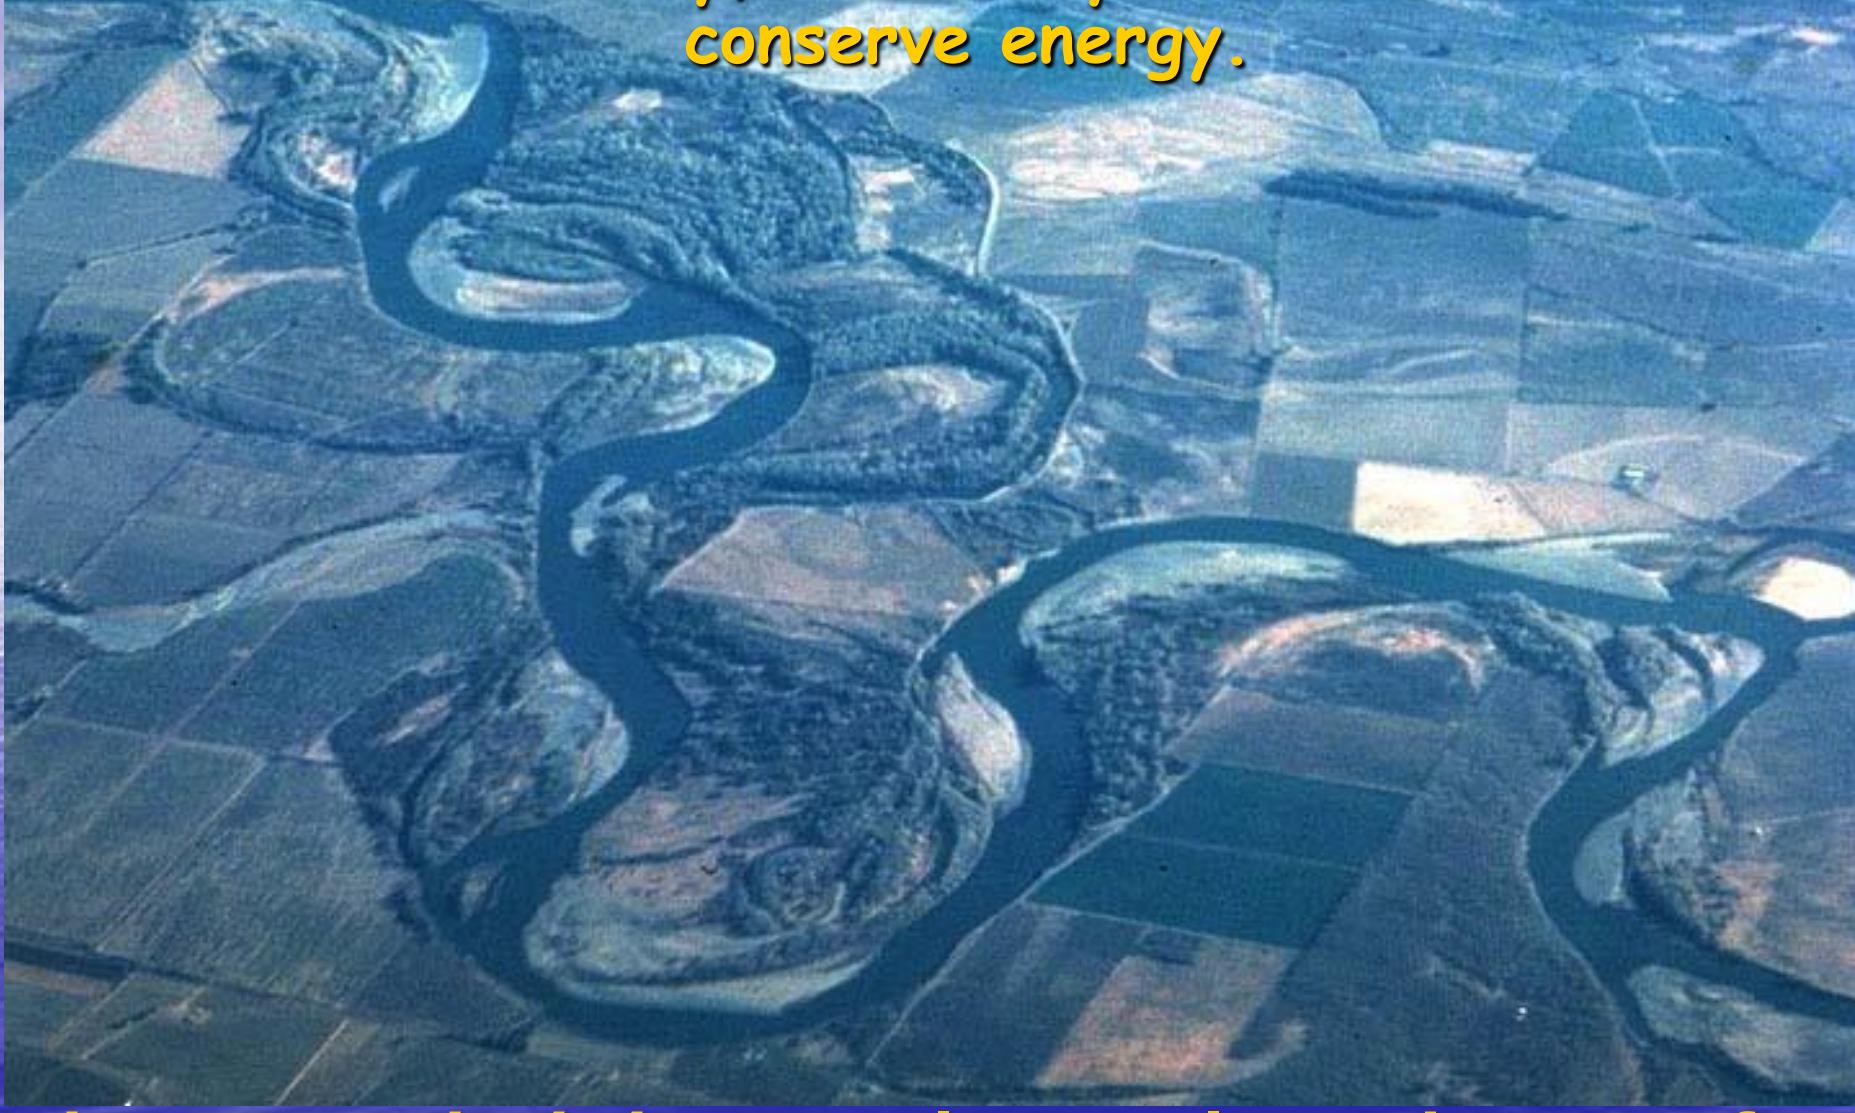
- Serpentine character of modern channels in the Sacramento Valley, caused by the river's desire to conserve energy.

These *meander belts* conceal a complex understory of pinched and truncated channels of varying permeability

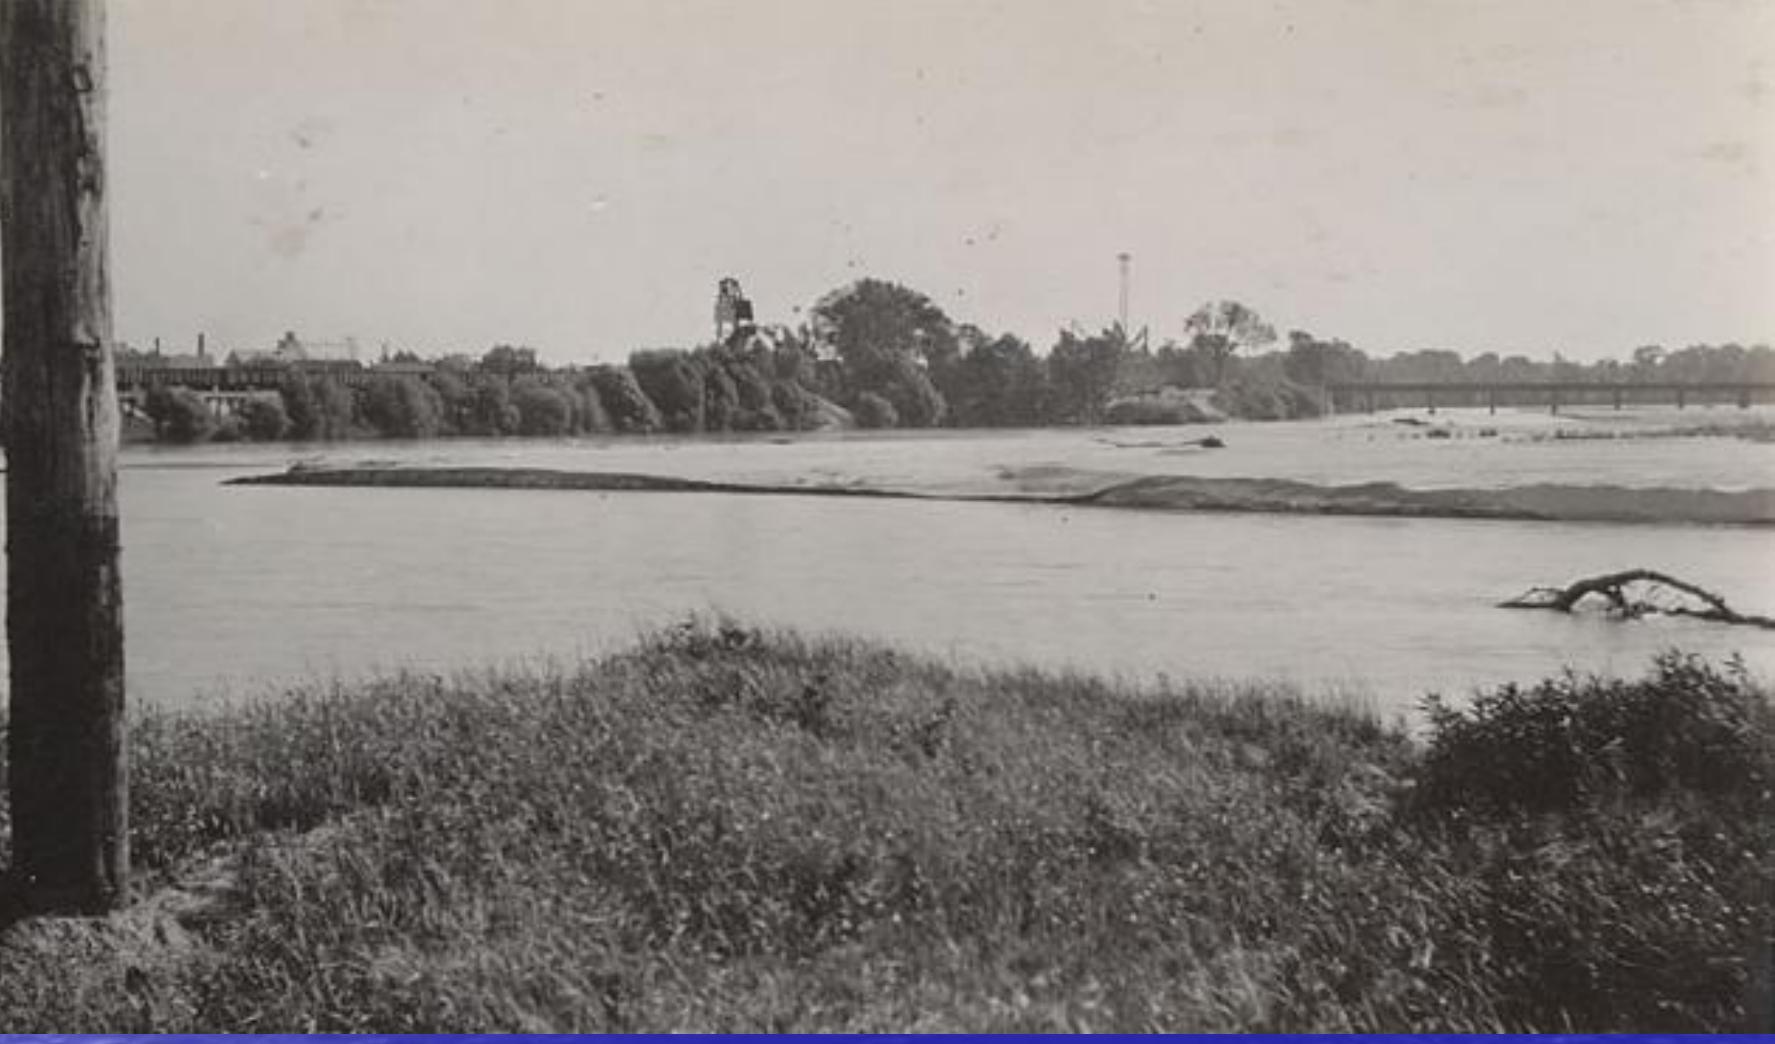
- **The deposition of 20 to 30 feet of mine slickens at the mouth of the Yuba River, and about 18 feet in the Feather River, increased the flood threat posed to Marysville. Photo taken in 1913, looking up the lower Yuba River and the old D Street Bridge (from UC Water Resources Center Archives, Berkeley).**

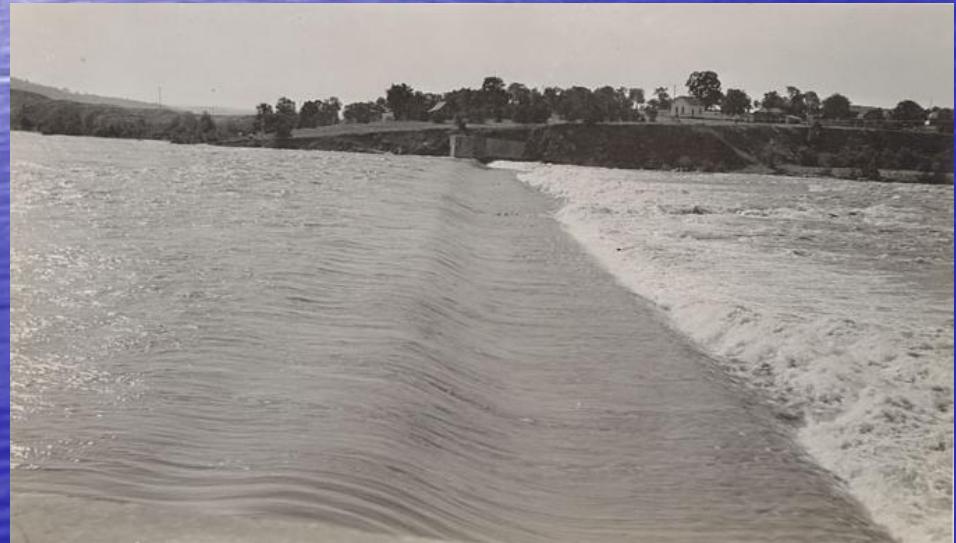
Flood flow over Daguerre Pt Weir in 1913

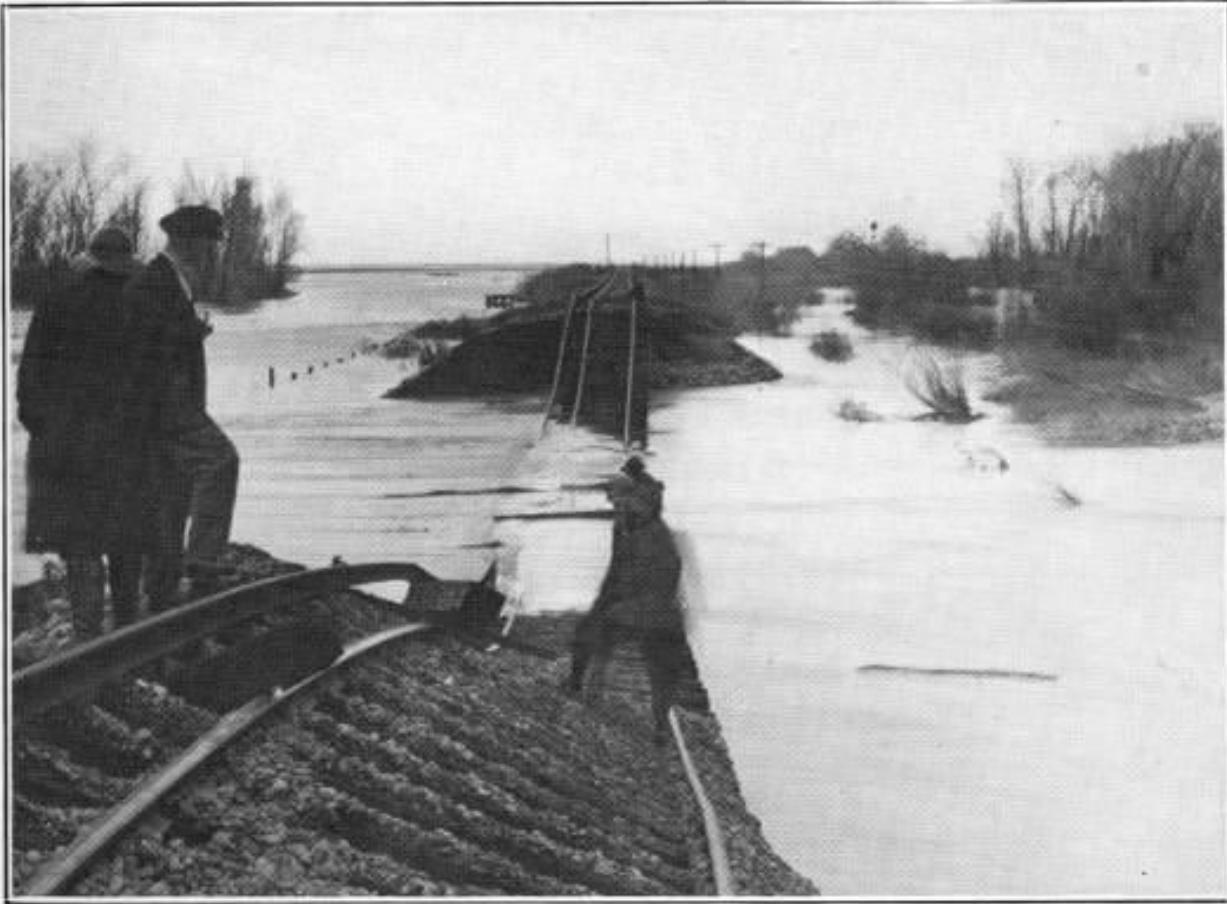
Break in east levee of the Feather River just south of Marysville during flood of January, 1914.

- The Yuba and Feather Rivers experienced severe flooding in **1907, 1909, 1914** (shown here), and **1940**. The **1940 flood** was the last one that inundated the Linda-Olivehurst area prior to **1986**.

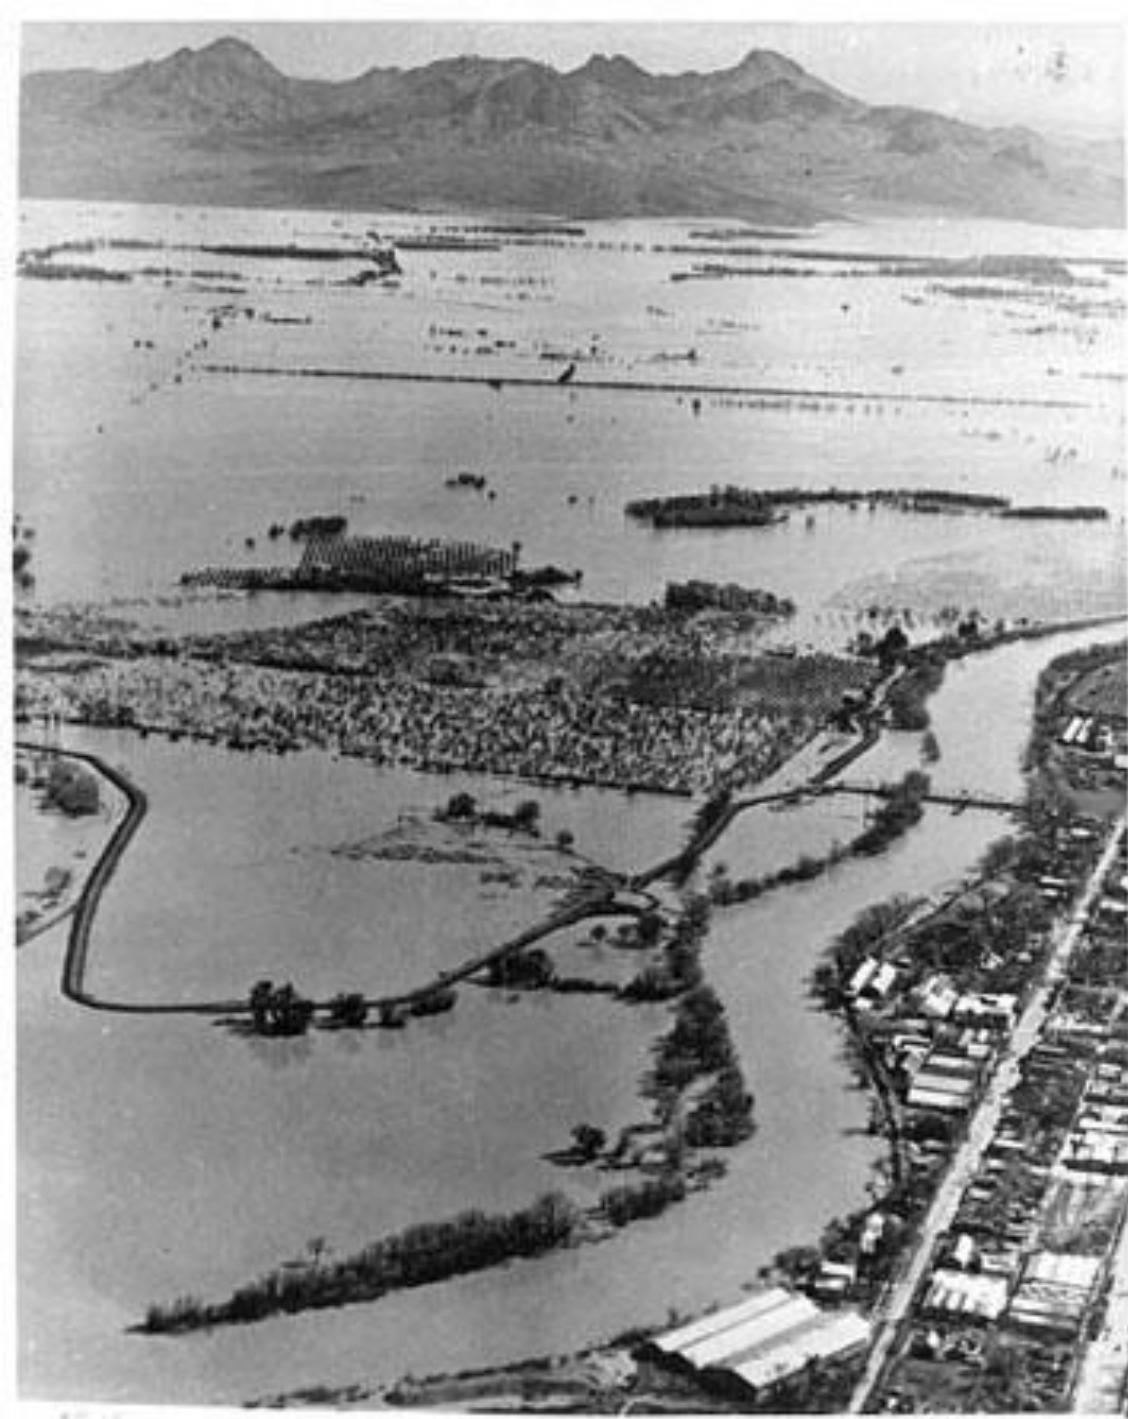
# Levee Heightening

- The Linda Levee was heightened by the local reclamation district in 1936
- In 1940 this new levee was overtapped, and other parts of the Sutter Basin were also flooded, as shown here
- The Army Corps of Engineers raised the levee again in 1940

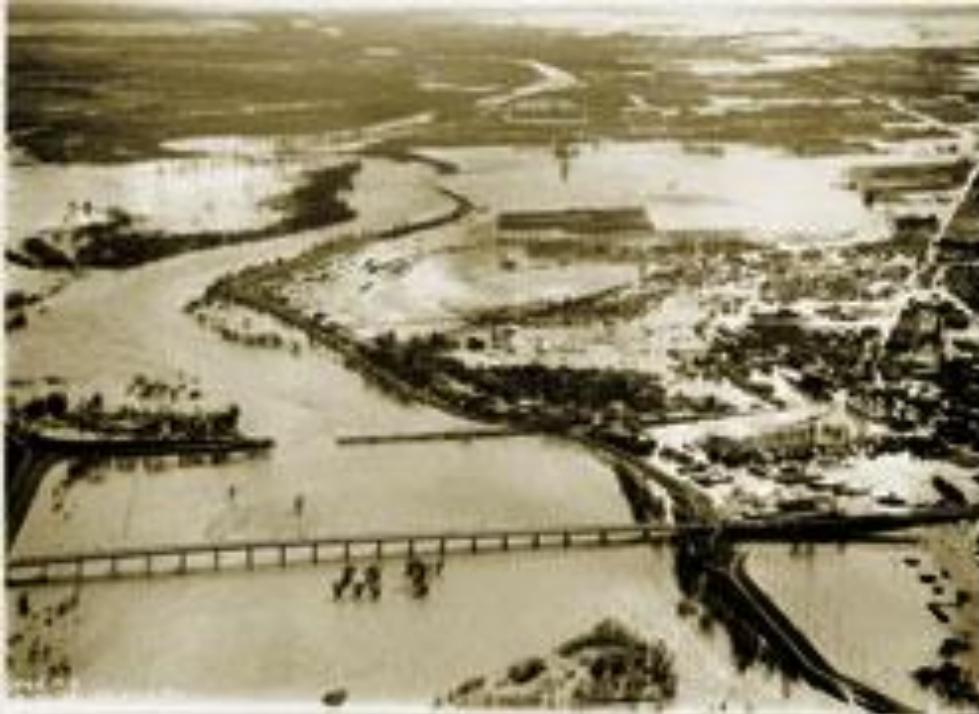
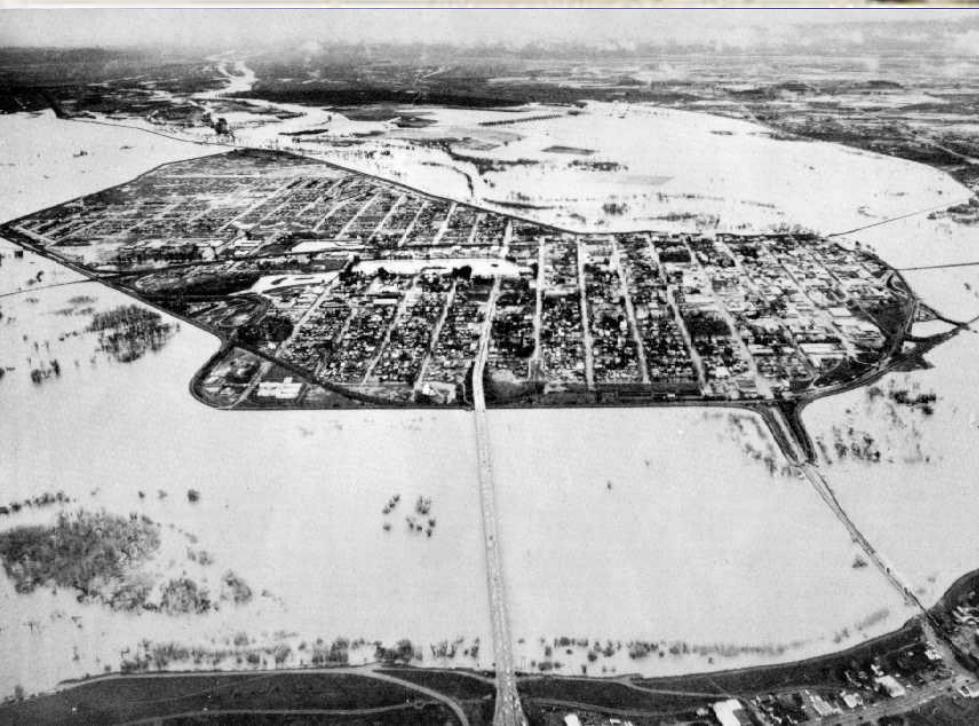
# December 1955 floods

- The most disastrous flooding impacting the Marysville-Yuba City-Linda area was the Christmas Eve storm of December 1955, which killed 38 people in Yuba City (upper image)
- The ring dike surrounding Marysville held (lower image)

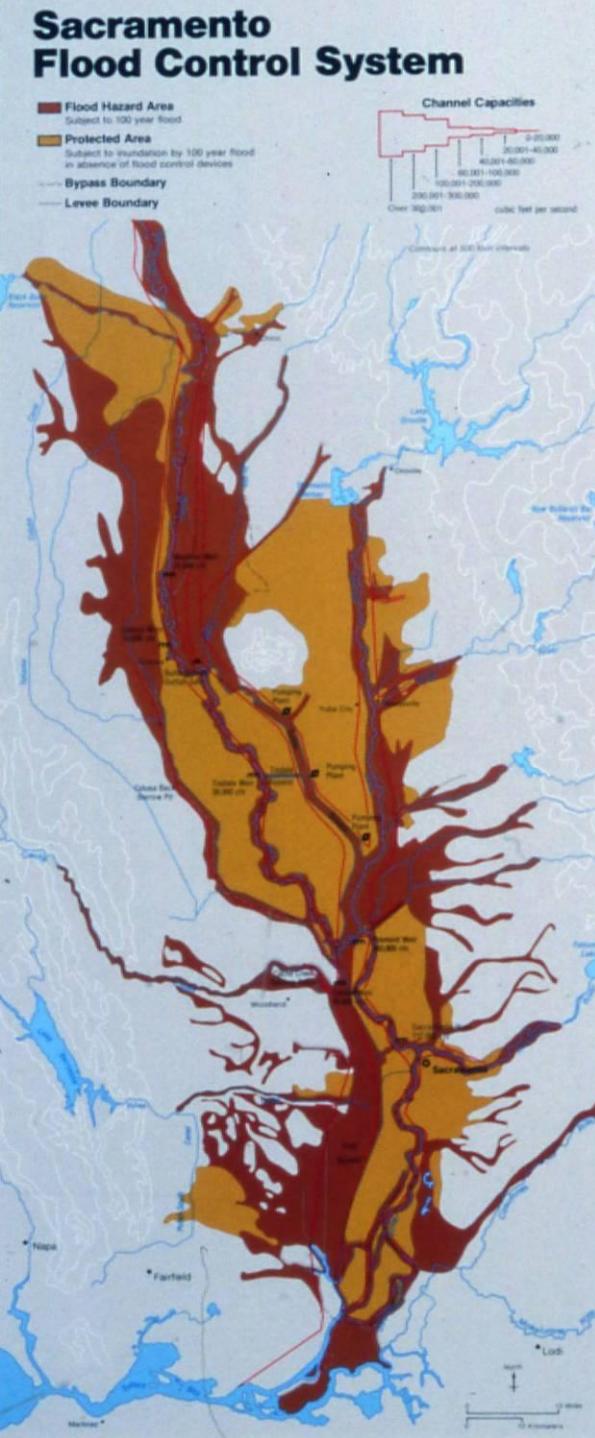
## **Sacramento Flood Control System**

- Developed by Carl E. Grunsky and approved by the California Debris Commission/Corps of Engineers in 1913; Constructed between 1914-60
  - It employs earthen levees to protect populated areas
  - It conveys excess flood waters through a system of **bypass weirs** that spill into large basins (shown in dark brown), limited to agricultural usage

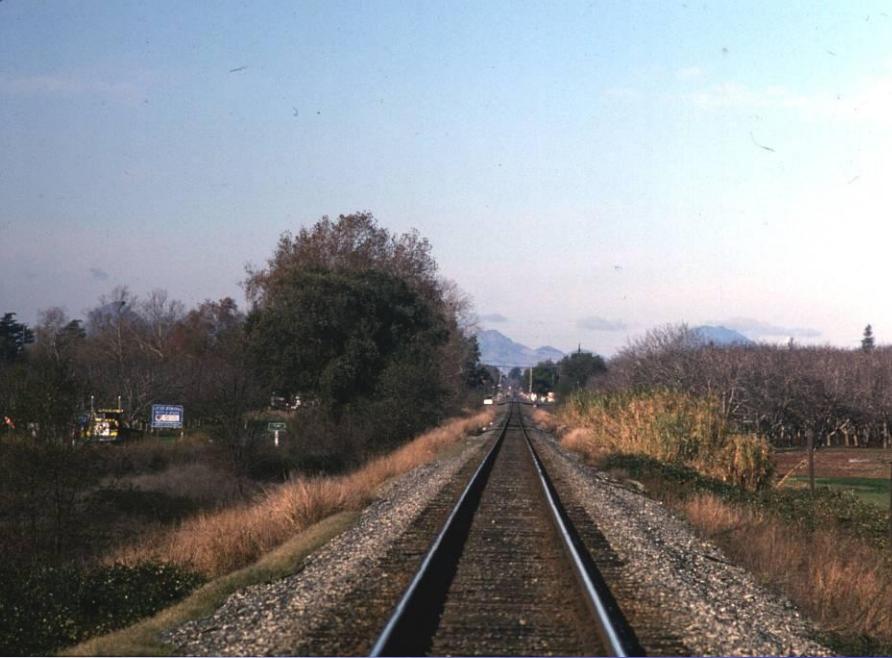
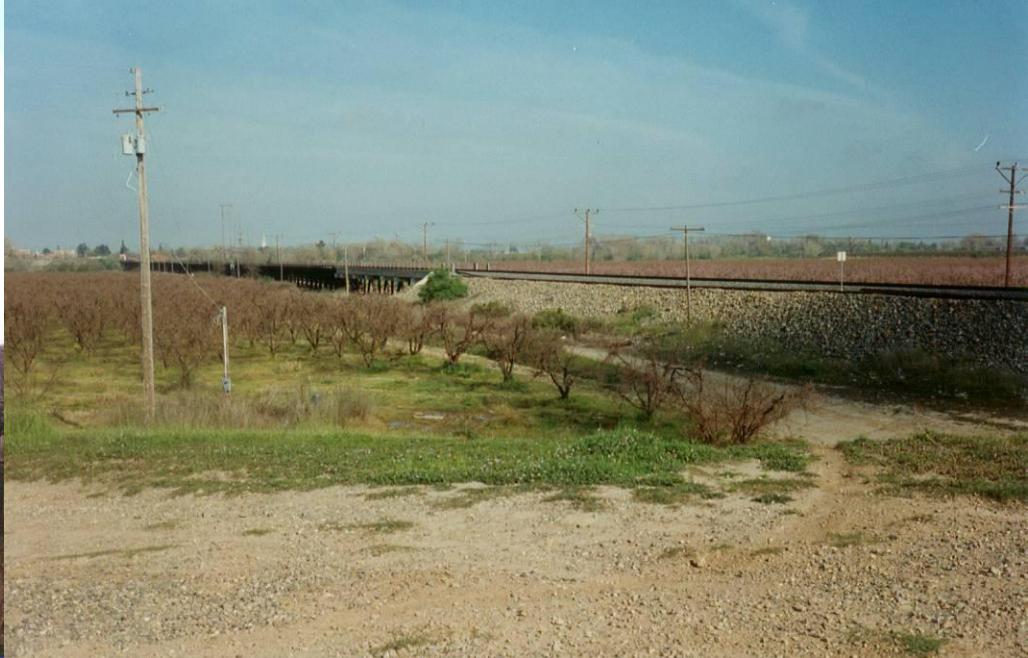
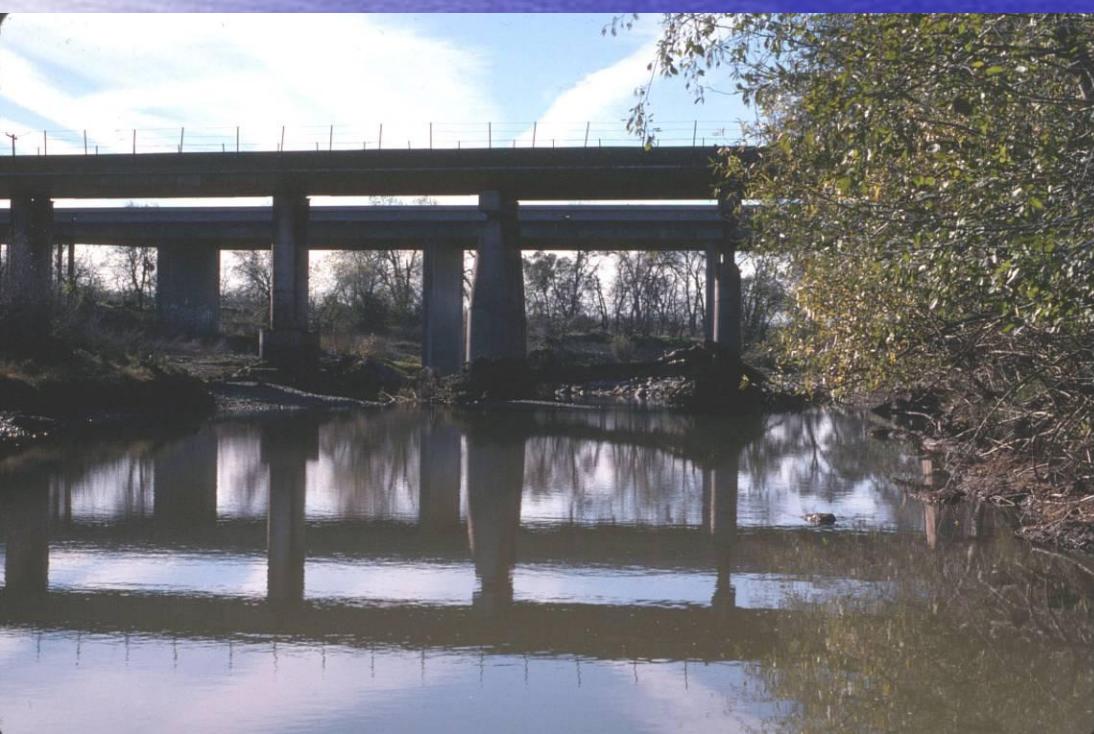
**The Southern Pacific Railroad constructed their line across the Yuba River in 1872, followed by the Western Pacific in 1909, and Sacramento Northern in 1914.**

**As the channel excavated its bed downward, the bridge supports had to be retrofitted to accommodate to increased height of the bents.**

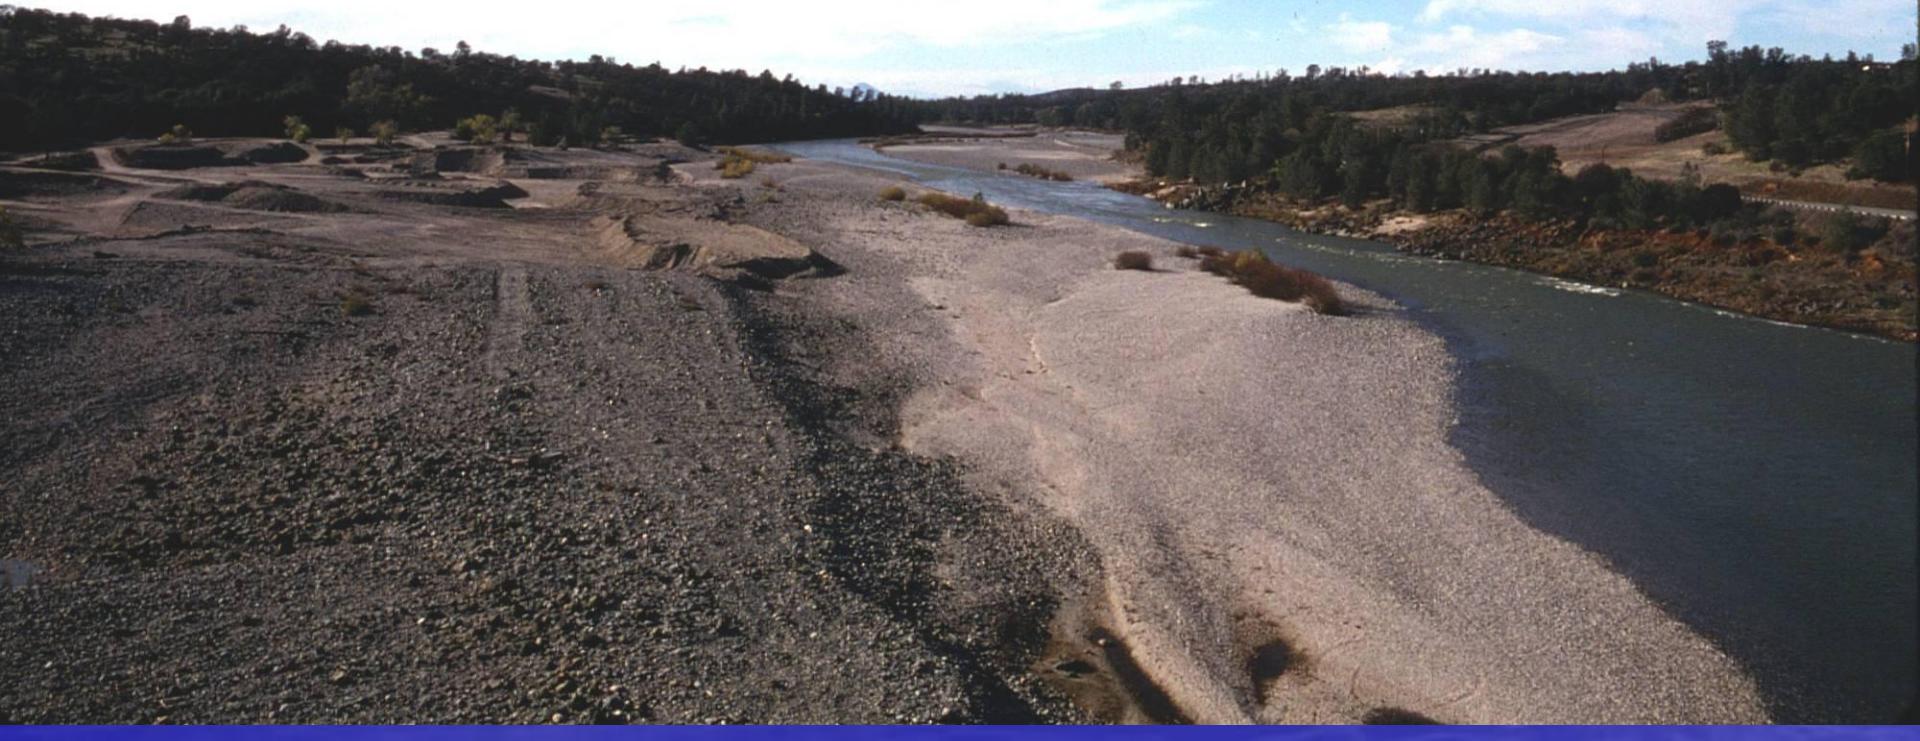
**Speckert gravel  
pit established  
in the Yuba  
River channel in  
1973**

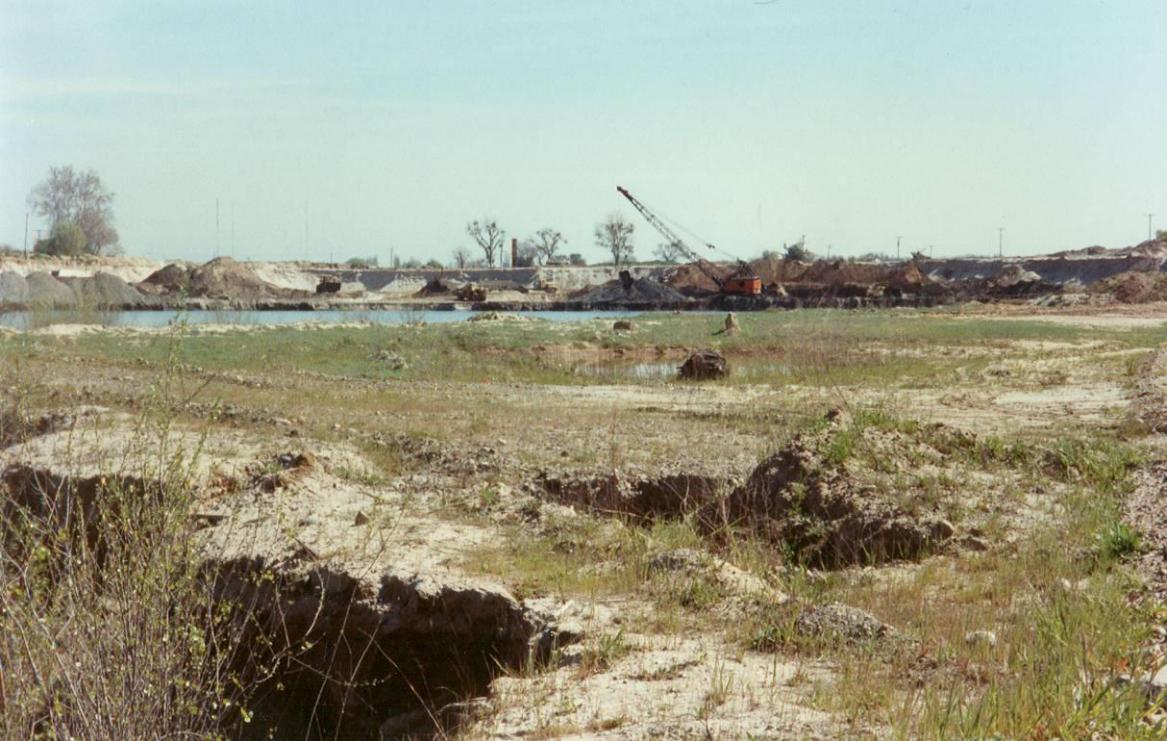
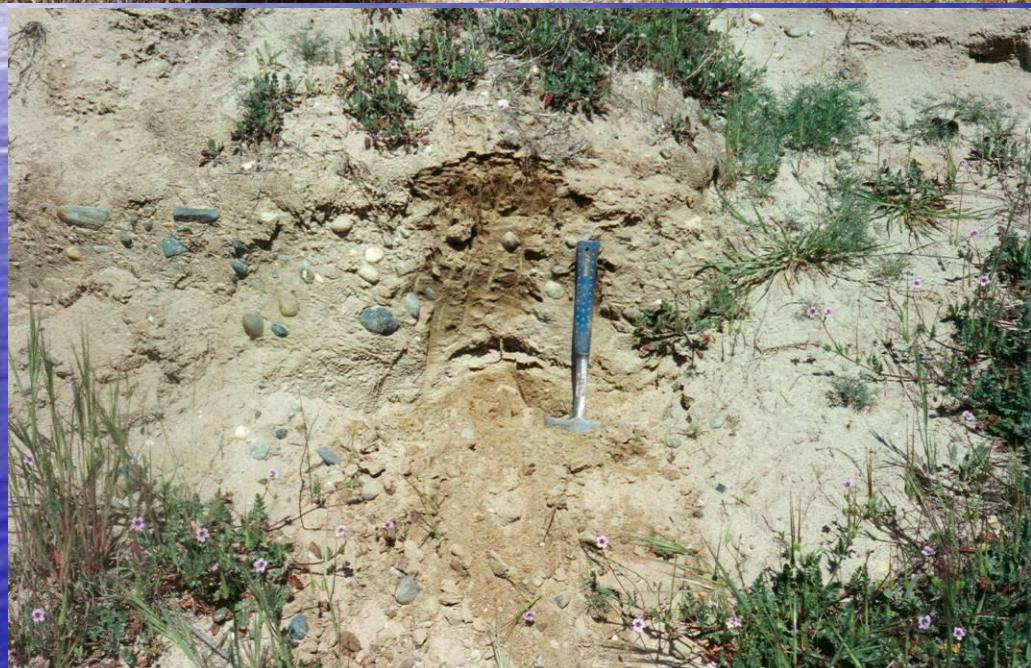
# Speckert Pit

In-stream mining can pose a threat to adjacent levees if they pierce ***conductive materials*** (gravels) and are subject to inundation during floods

The Speckert Pit pierced a veneer of gravelly Holocene sands and mined the late Pleistocene cobble gravels, to depths of 37 feet.

Pore pressures emanating from the cobble gravels extend into the low permeability paleosol cap. As soon as flood waters filled the Speckert gravel pit, that pressure head would have acted on the leaky aquifer, engendering considerable uplift

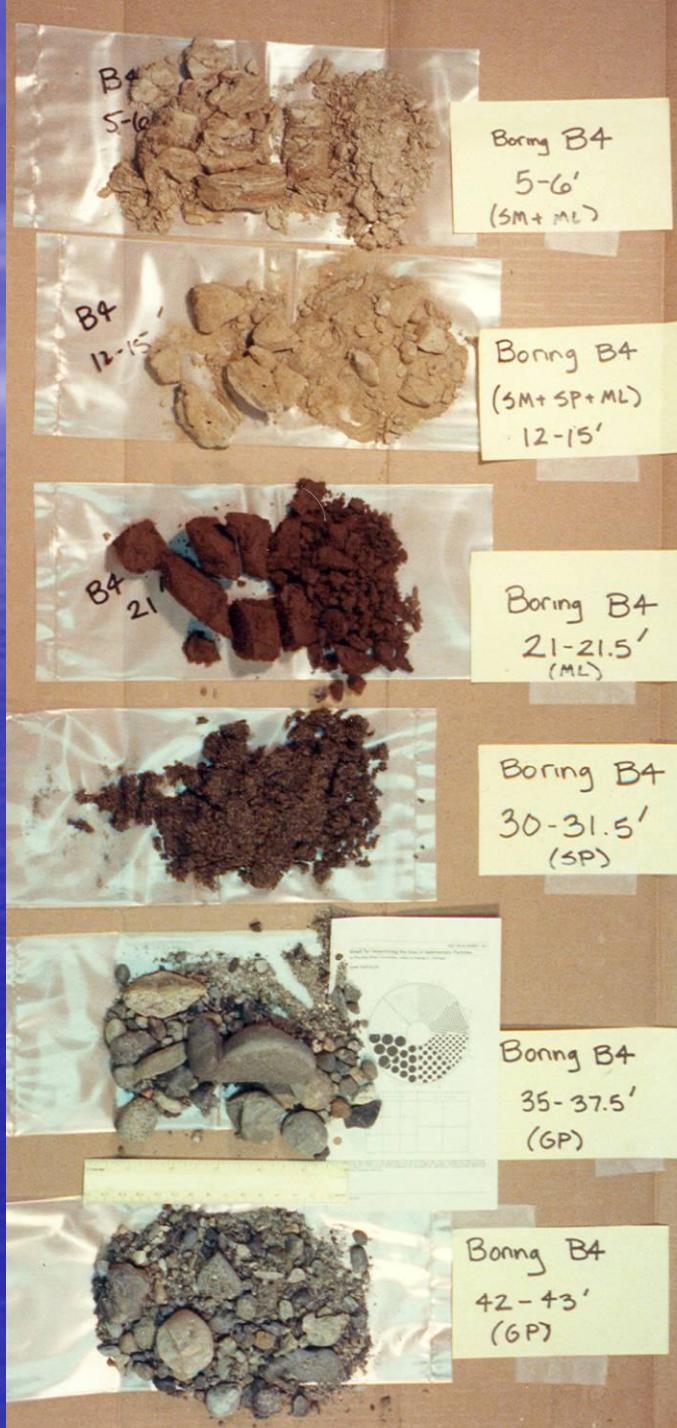
- The borings encountered mine slickens over a vibrant paleosol marker, over channel sands, over coarse granitic gravel and cobbles
