# **SITE CHARACTERIZATION AND LEVEE FAILURE MODES: With special reference to the Paterno Flood Case**

**J. David Rogers, Ph.D., P.E., P.G., C.E.G., C.HG.**

**Richard L. Meehan, P.E., G.E.**

**ASCE-AEG Joint Meeting  
Berkeley, California  
November 13, 2008**

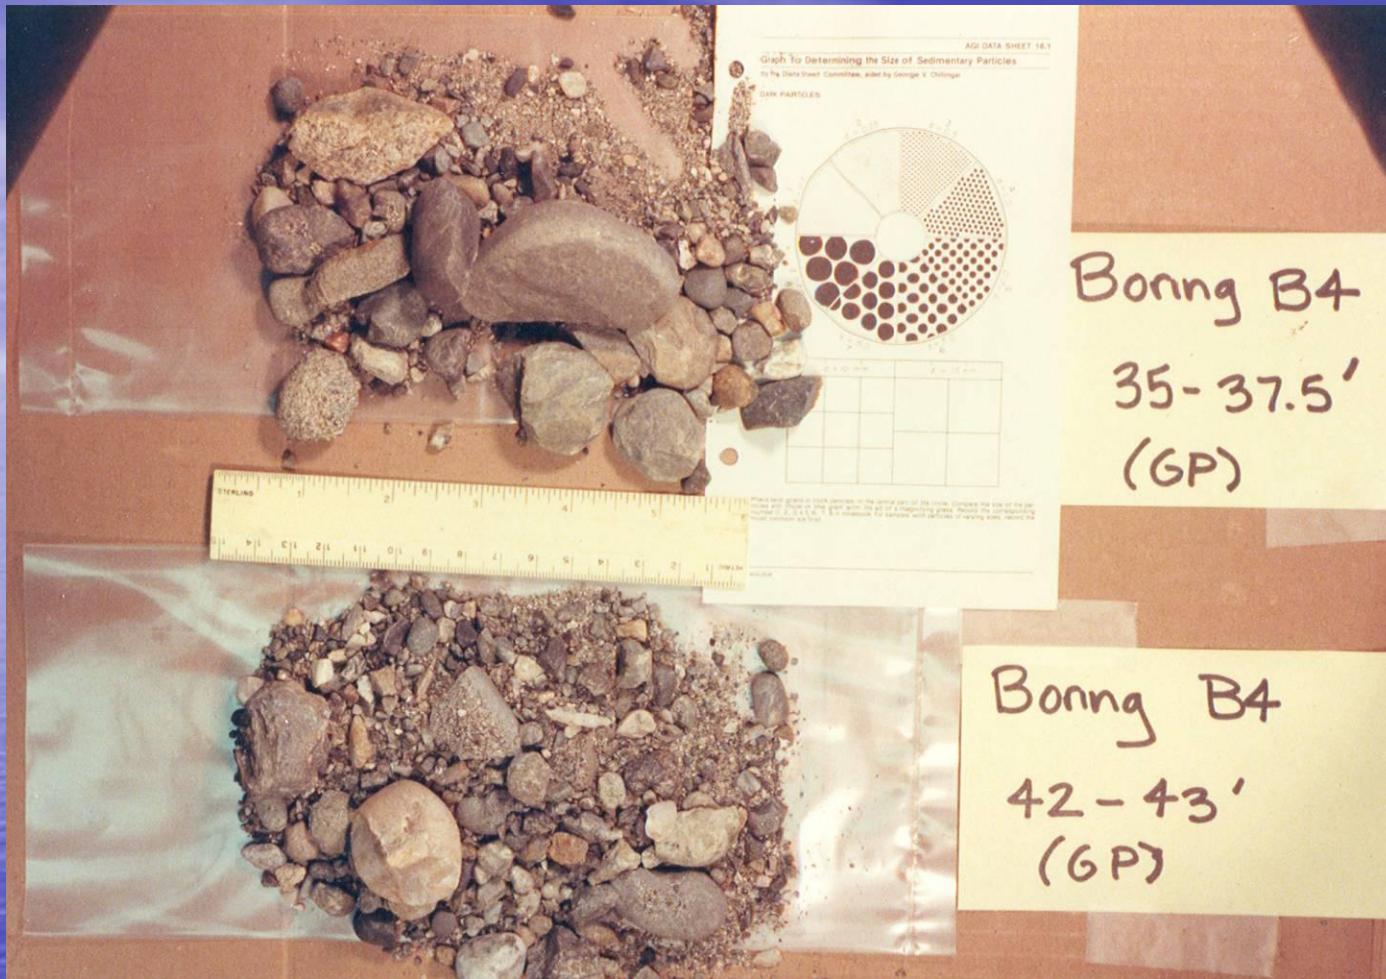
**So, how important was  
it to model the  
underlying cobble  
gravel ?**

- The coarse channel gravels had not been detected in any of the previous geotechnical investigations, not even those FOLLOWING the 1986 levee failure! Ouch!!

- In the 1991 trial, Rogers and Meehan opined that they would expect hydraulic conductivities of **0.1 to 1.0 cm/sec** in the coarse channel gravels lying beneath the failed levee section
