MAPPING THE ST. FRANCIS DAM OUTBURST FLOOD WITH GEOGRAPHIC INFORMATION SYSTEMS

J. David Rogers

Department of Geological Engineering

University of Missouri-Rolla

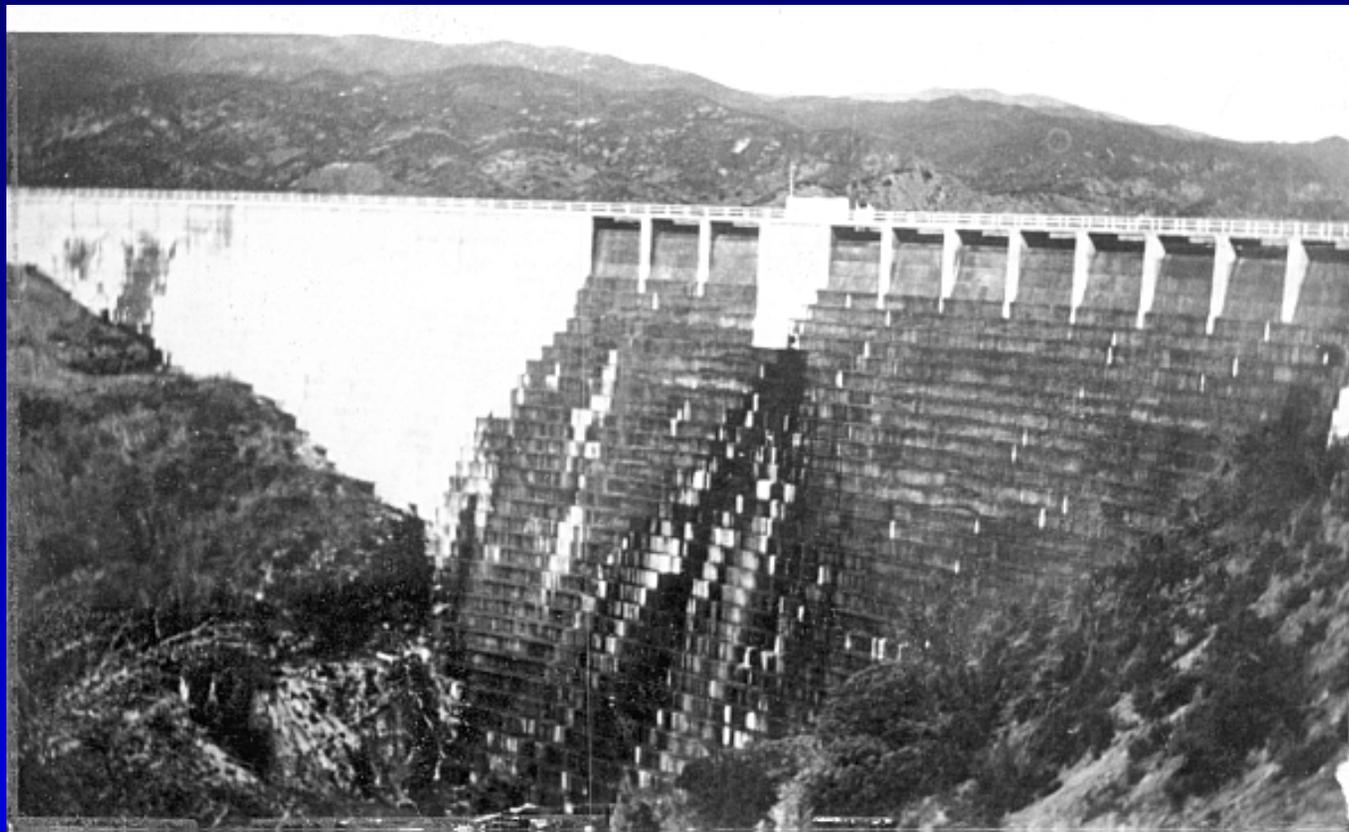
- The reservoir was brought up to within 4 inches of spillway crest for the first time on Wed., March 7, 1928.
- The damkeeper called City engineers on the morning of the failure to report discharge of about 2 cfs from the right abutment area. This view shows wind-whipped waves splashing over the spillway panels about 12 hours before the failure.

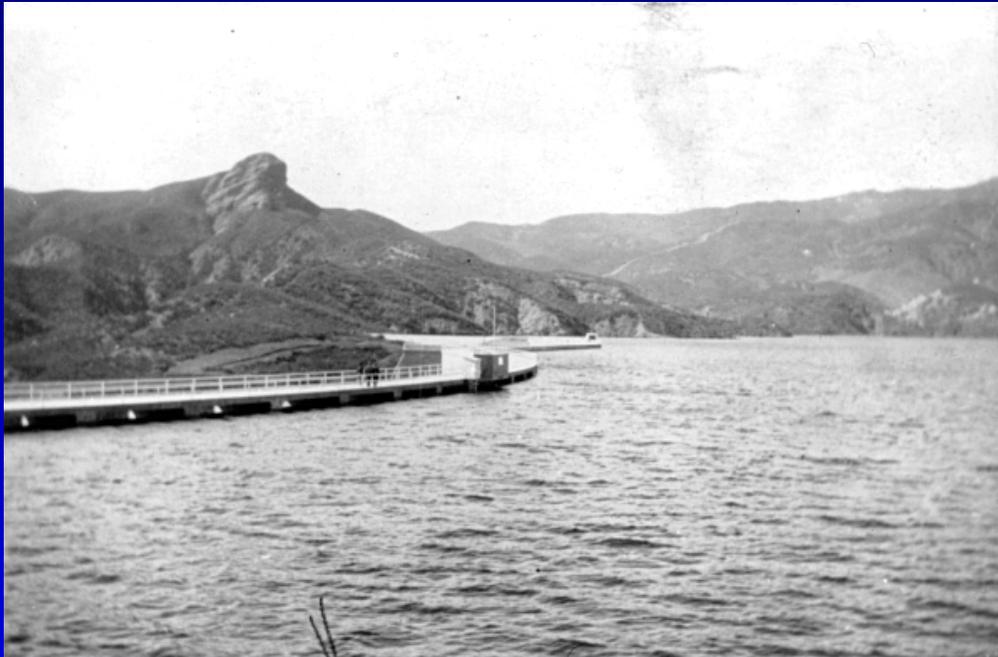
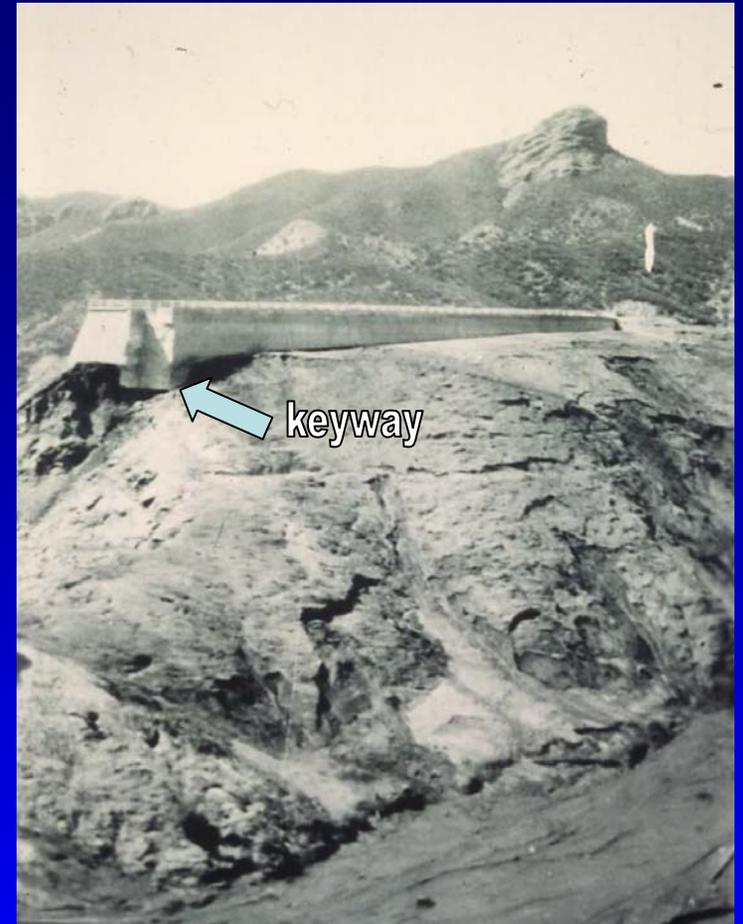
Before and After

- Comparative views taken of the dam's upstream face looking at the right abutment, 12 hours before the failure (at left) and the day after (right)
- Note exposed keyway beneath right abutment dike

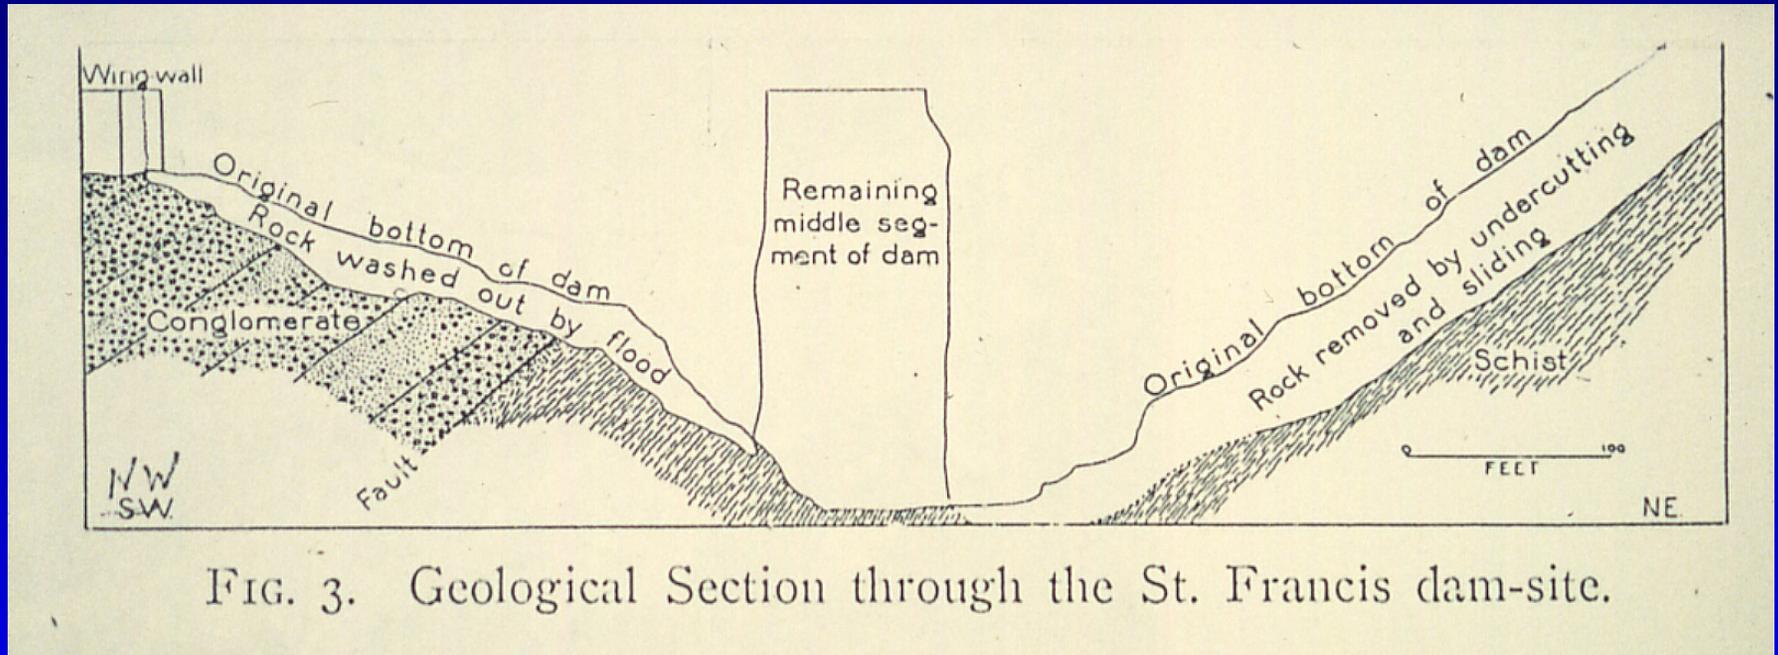
FIG. 3. Geological Section through the St. Francis dam-site.

- The dam site could not be used for a back-analysis of the outbreak flood hydrograph (quantity of flow versus time) because the cross-sectional area was varying with each passing minute of the failure, beginning with a small area and ending with the maximum area.

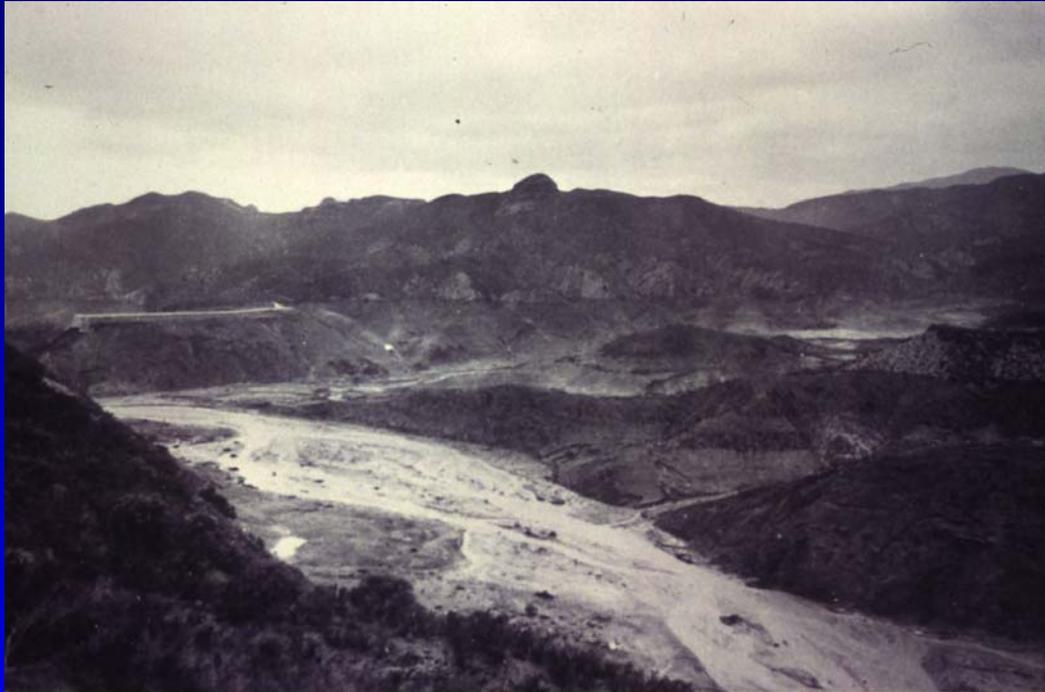
- According to eye witness accounts, the **reservoir was essentially empty by 1:09 AM**, as shown above
- The Lancaster 70 Kv power line went down at 11:57-1/2 PM in vicinity of the dam site
- Powerhouse 2, located 7300 feet downstream, went offline at 12:02-1/2 AM

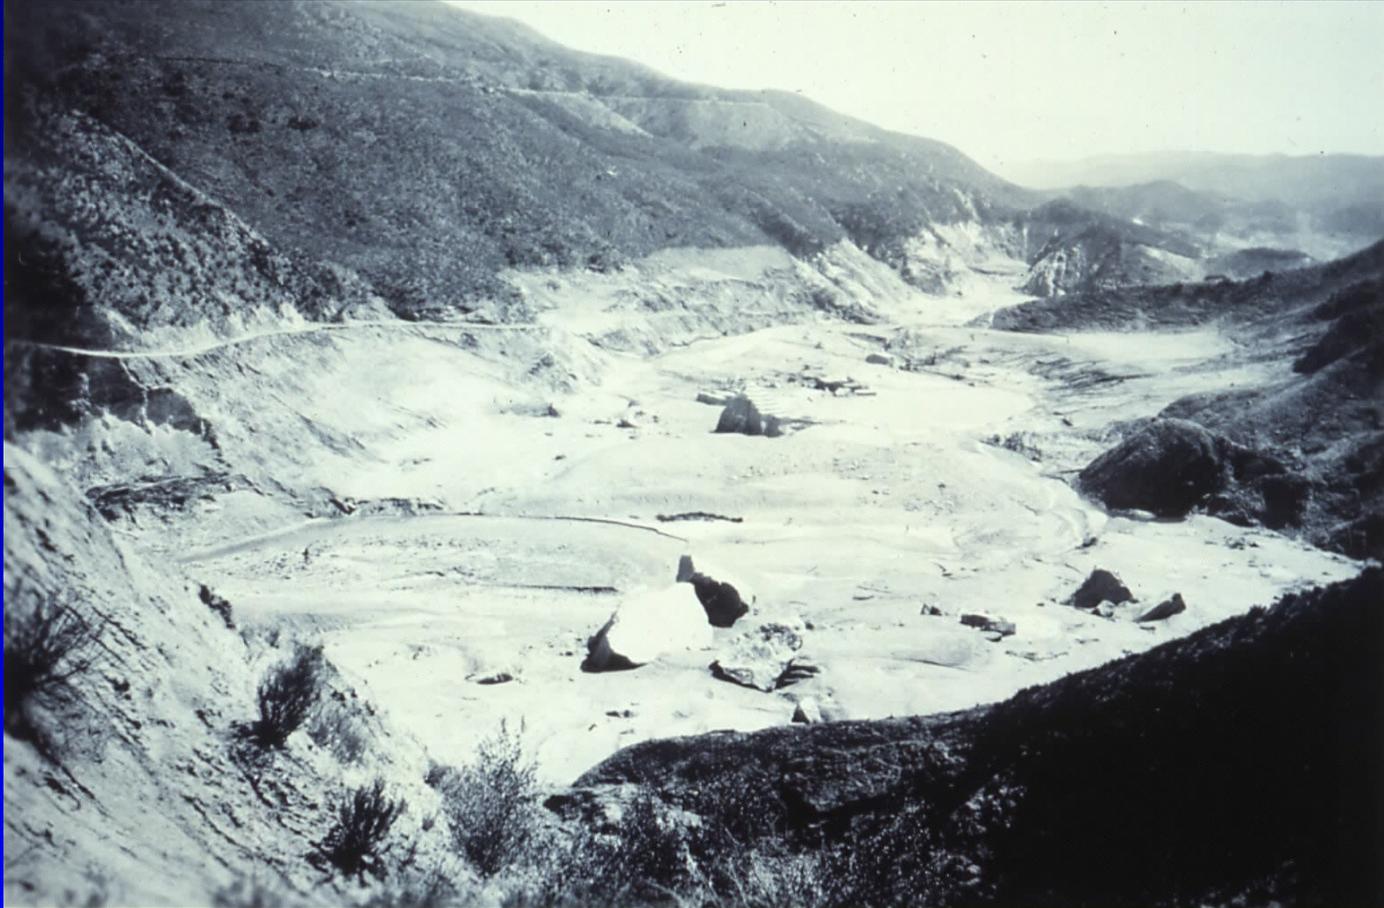
- The maximum depth of the outbreak flood was known from measurements made at the time and we used terrestrial photogrammetry to fill in the gaps
- The depth of flood water was about 140 feet just downstream of the dam and about 110 feet at Powerhouse 2, 1.4 miles downstream

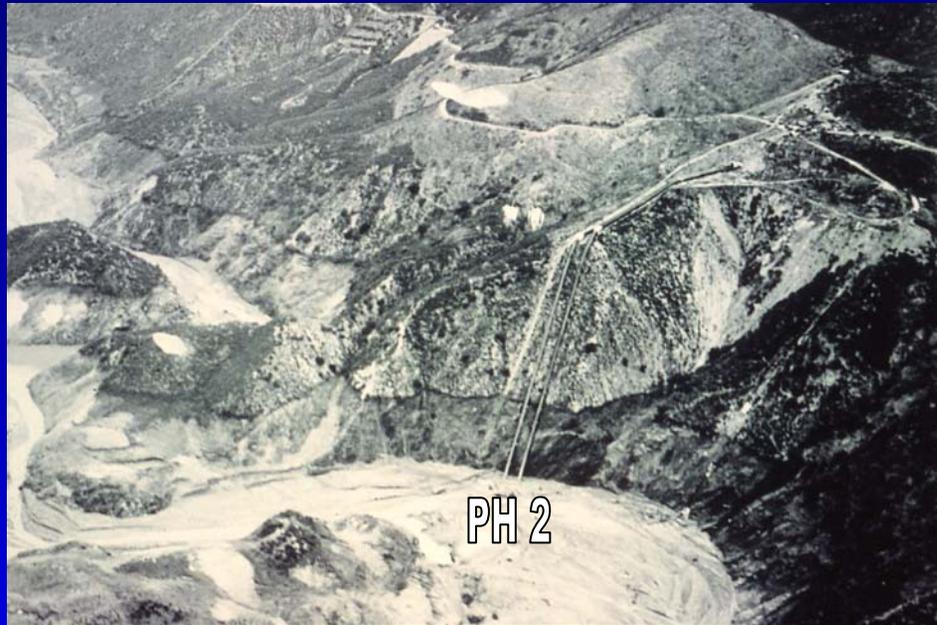
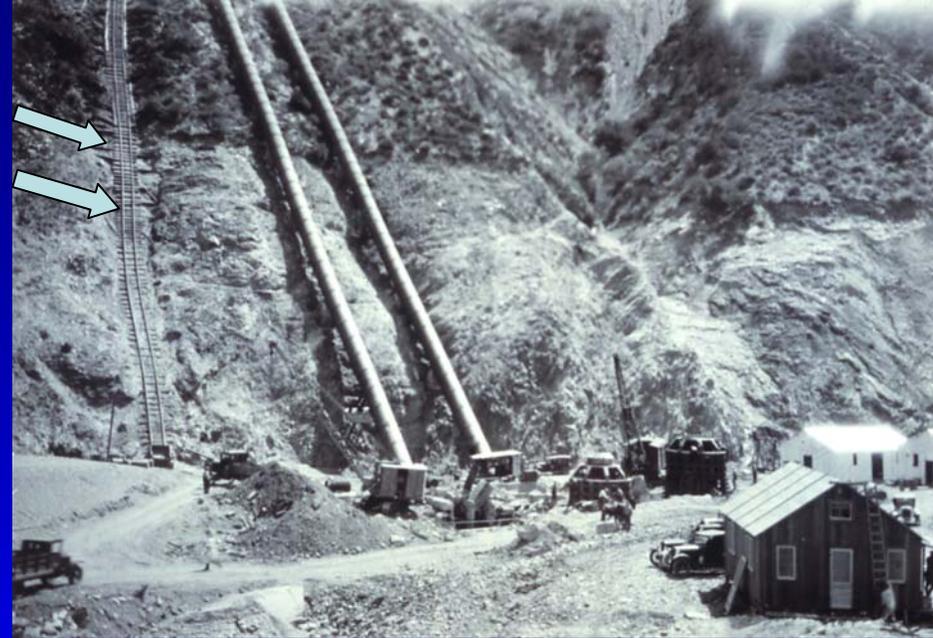
- At Powerhouse 2, the surge chamber attendant climbed down the tramway tracks during the flood, shown at left side of the photo at right (arrows)
- He reached the high water line at 12:15 AM, and noted that the level had already dropped 20 feet

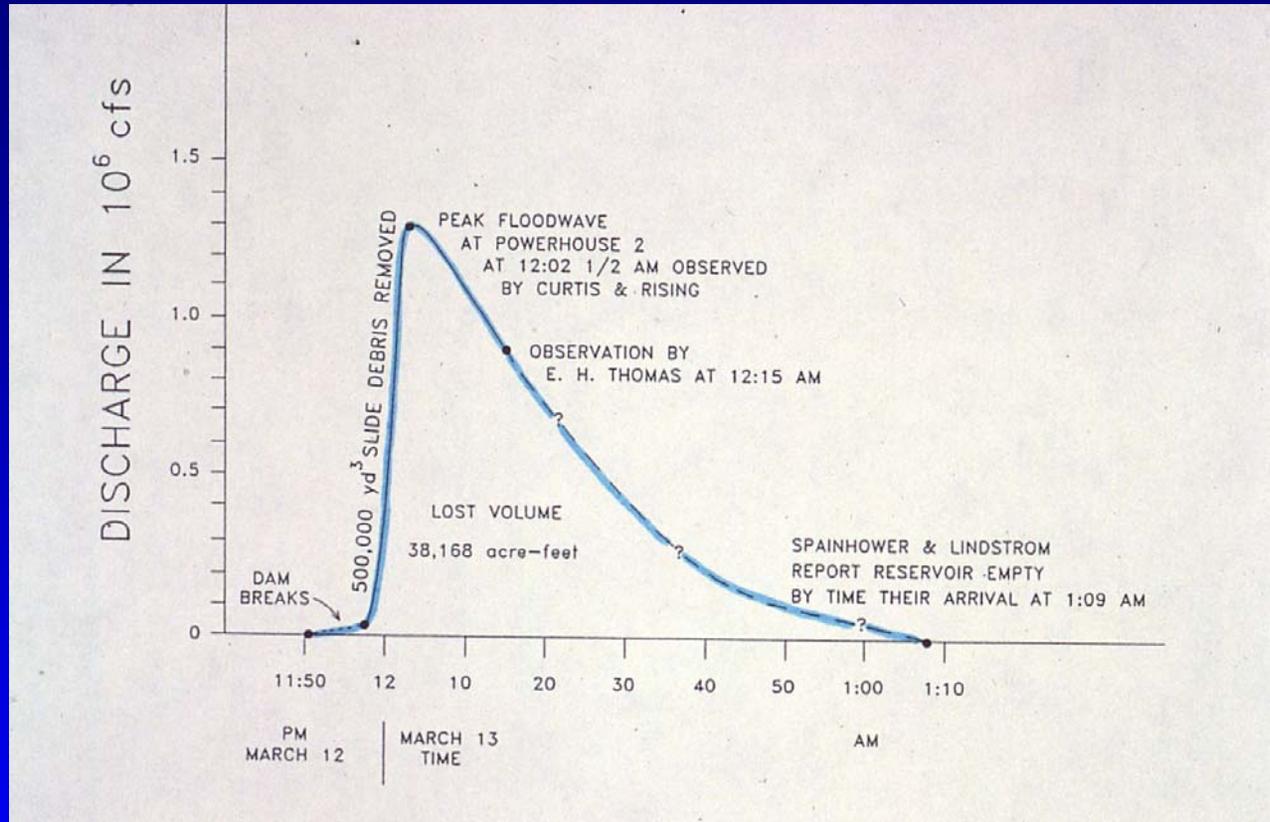
Flood hydrograph at Powerhouse 2

- A peak flow of **1.3 million cfs** was calculated for Powerhouse 2, 1.4 miles downstream of the dam
- The peak flow at the damsite was likely close to **1.7 million cfs**

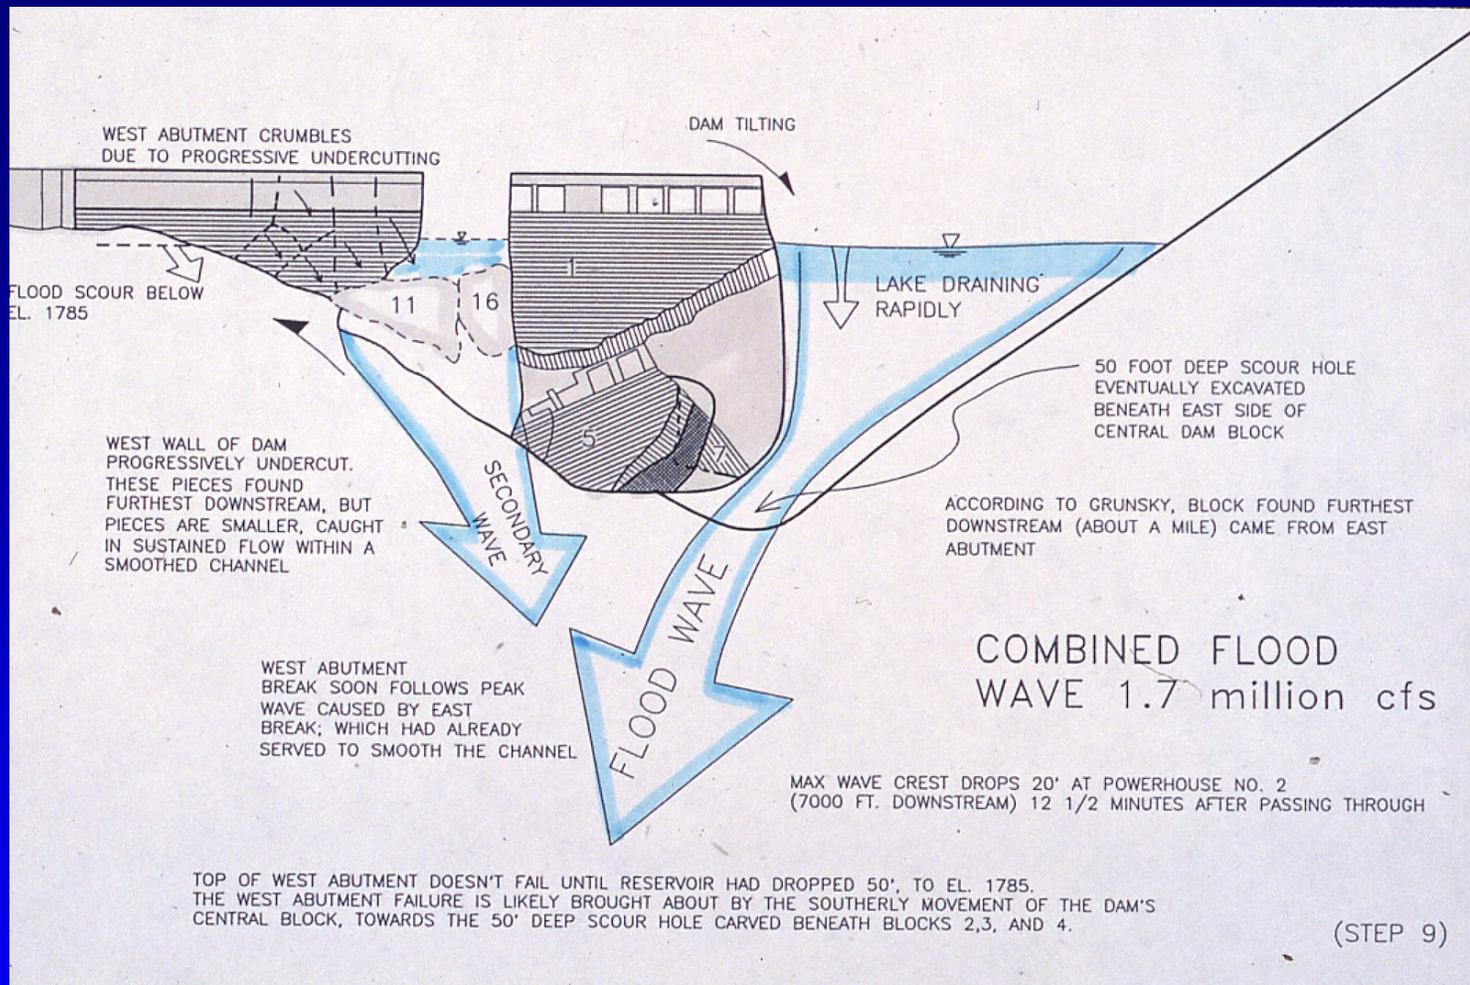
- As the left side of the main dam was undercut, it moved into the enlarging void, triggering a chain-reaction failure of the right abutment area after the reservoir had dropped about 75 to 85 feet.
- **The peak outflow at the dam site was likely something close to 1.7 million cfs.** The maximum outflow estimate in 1928 was only 400,000 cfs.

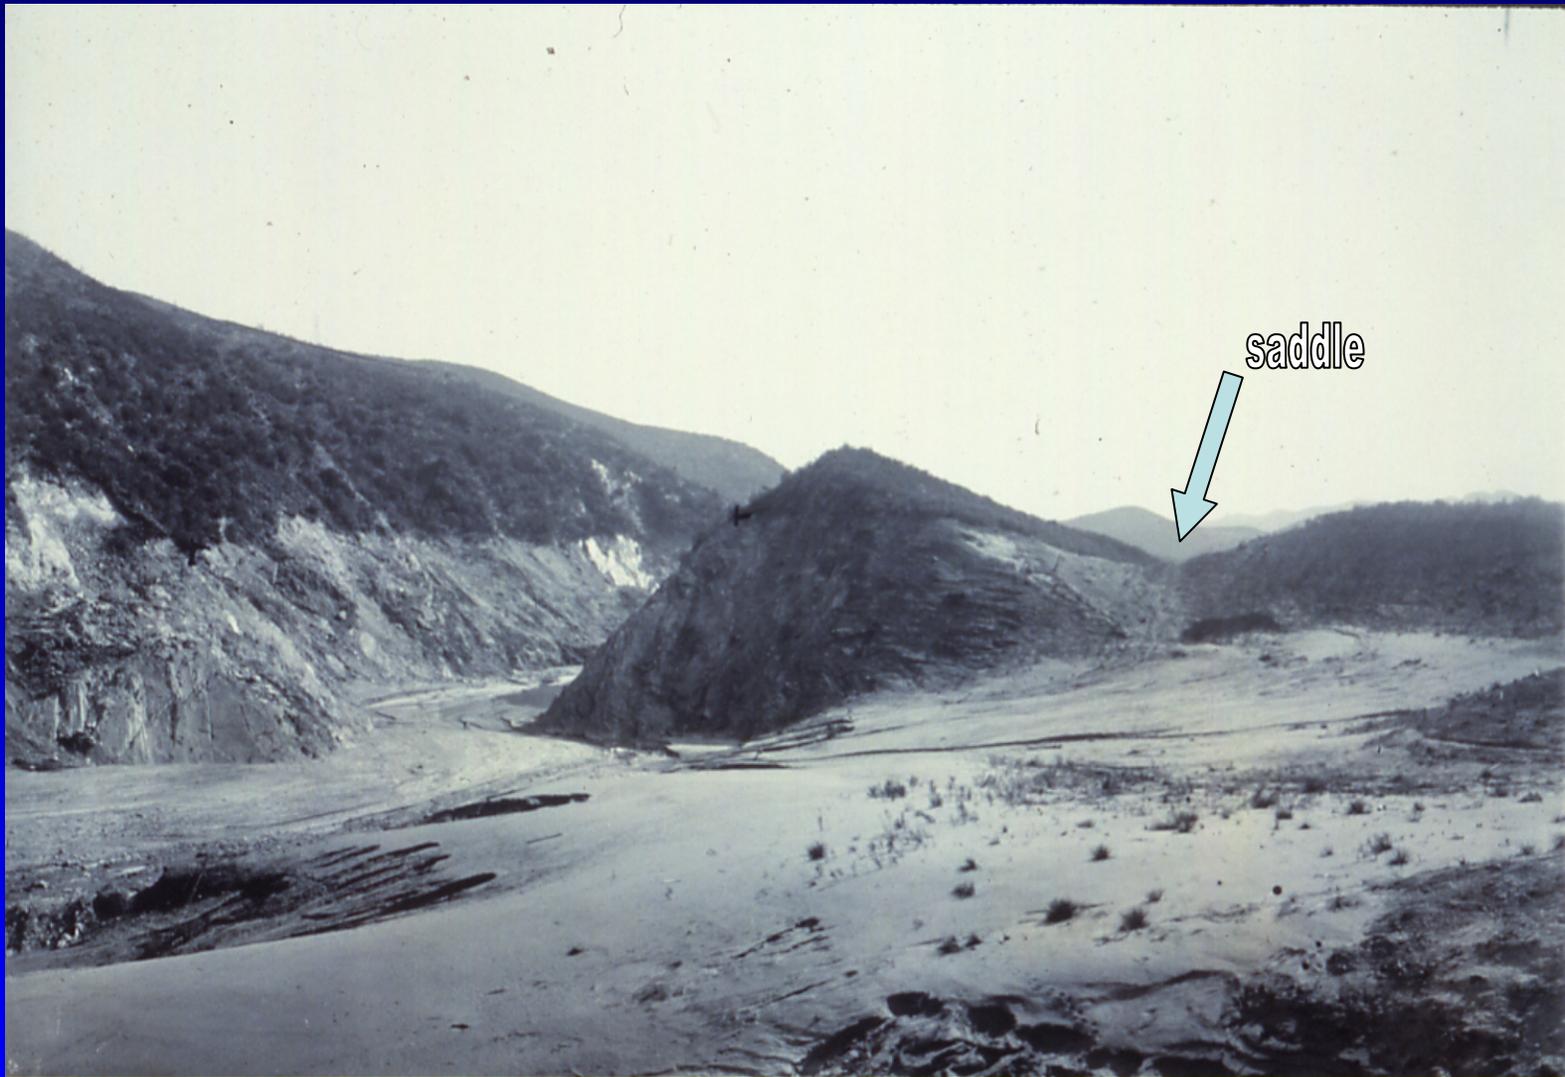
- As the flood moved downstream, the depth of flow diminished. This view shows a saddle 120 feet above the creek bed about $\frac{3}{4}$ mile downstream, which was overtopped by the outpouring waters.

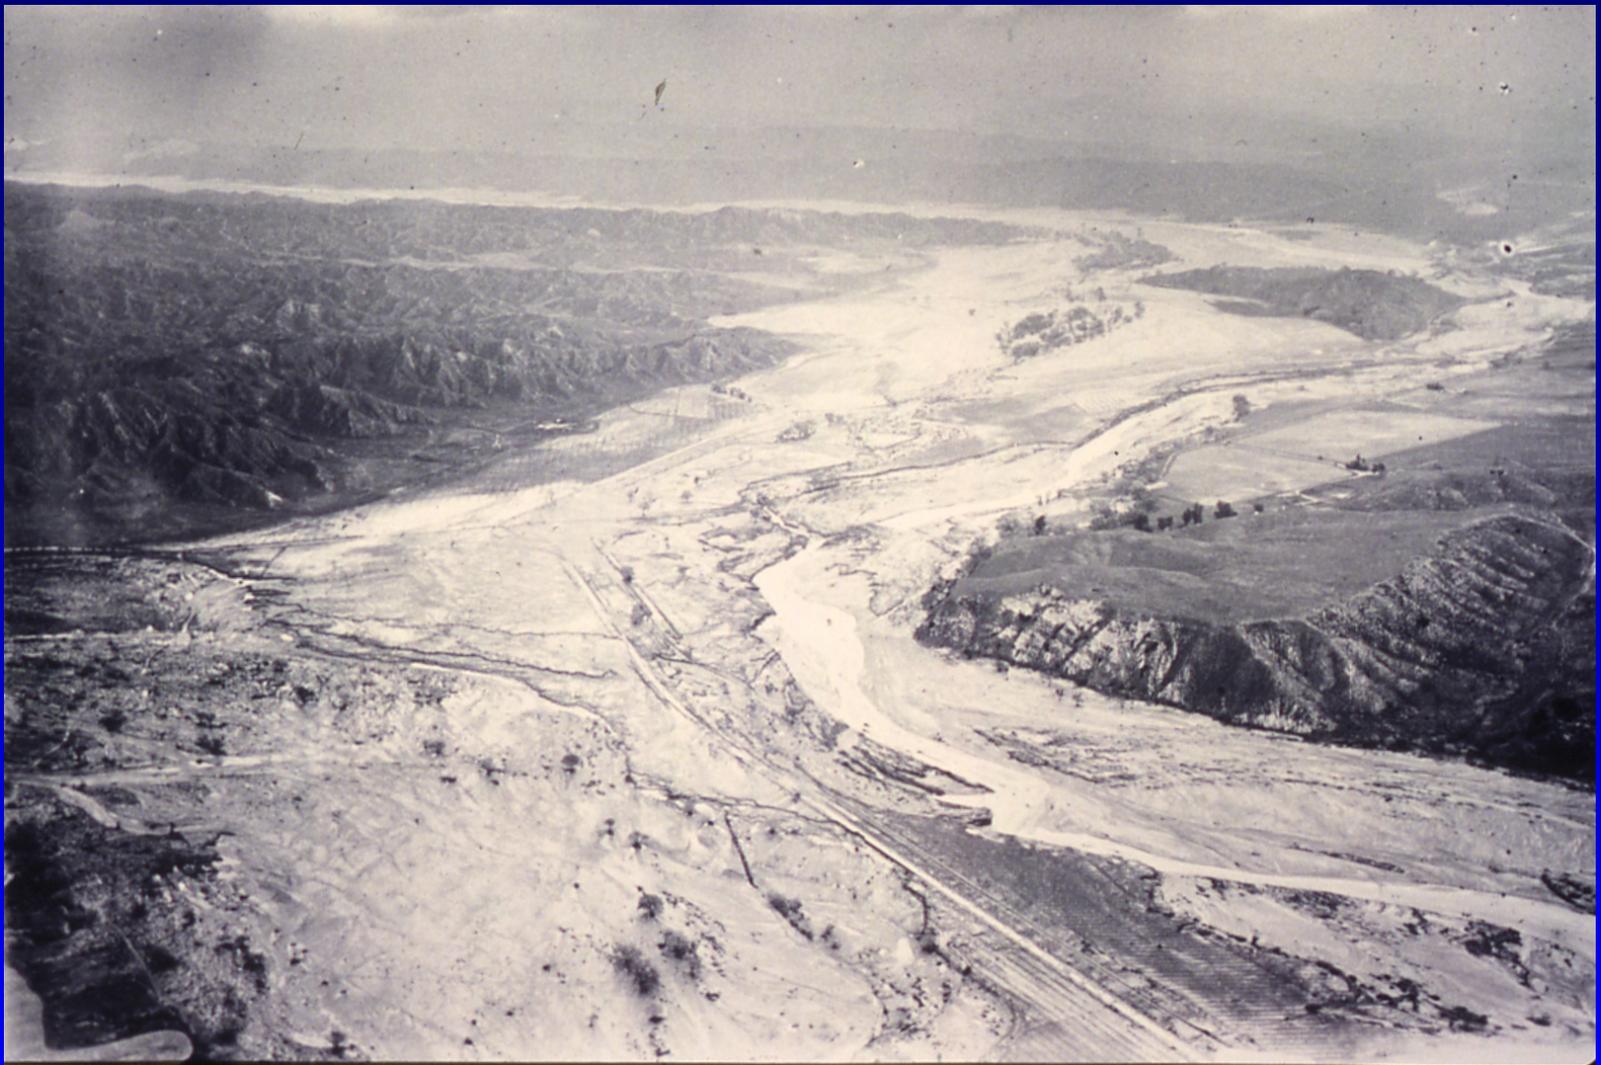
- The flood swept 6 miles down San Francisquito Canyon to its junction with the much larger Santa Clara River, where it made a right-hand reverse turn through Castaic Junction.

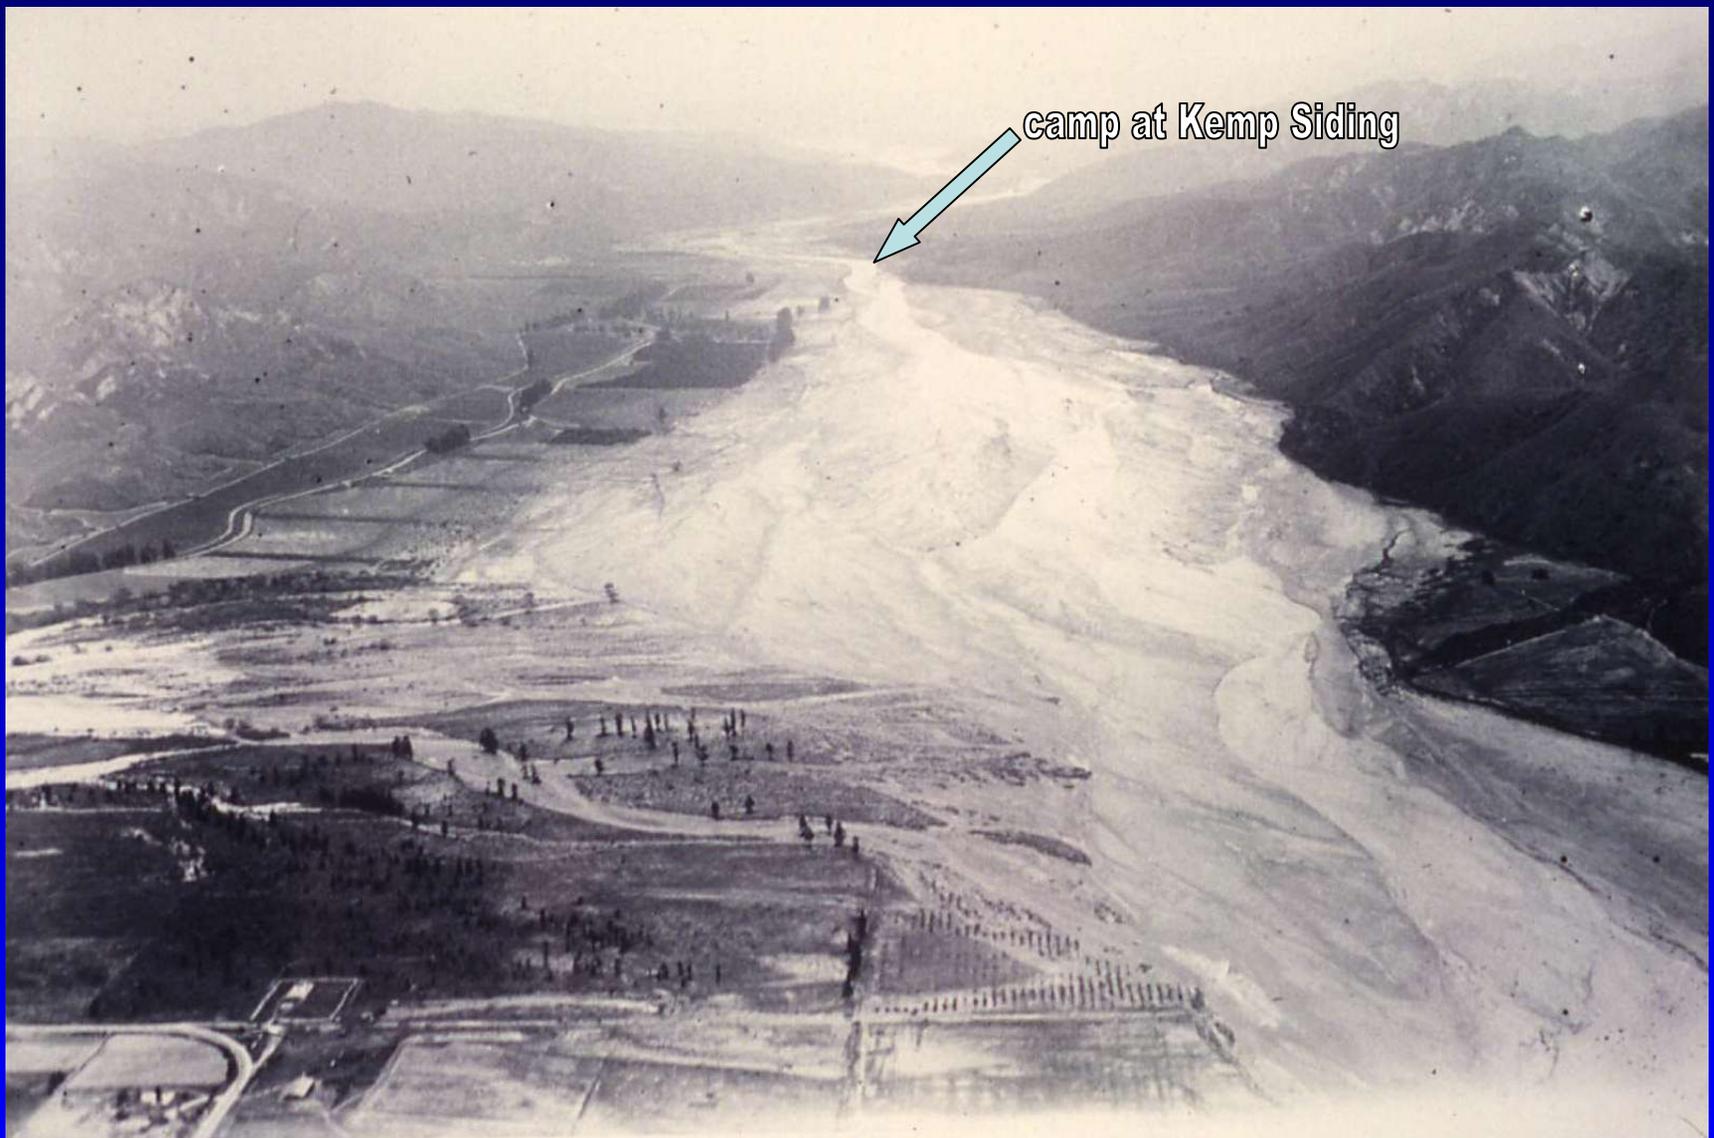
camp at Kemp Siding

- At Castaic Junction, the flood turned west and swept down the Santa Clara River valley, through the Southern California Edison construction camp at Kemp Siding, **drowning 84 of the 140 workers** sleeping there.

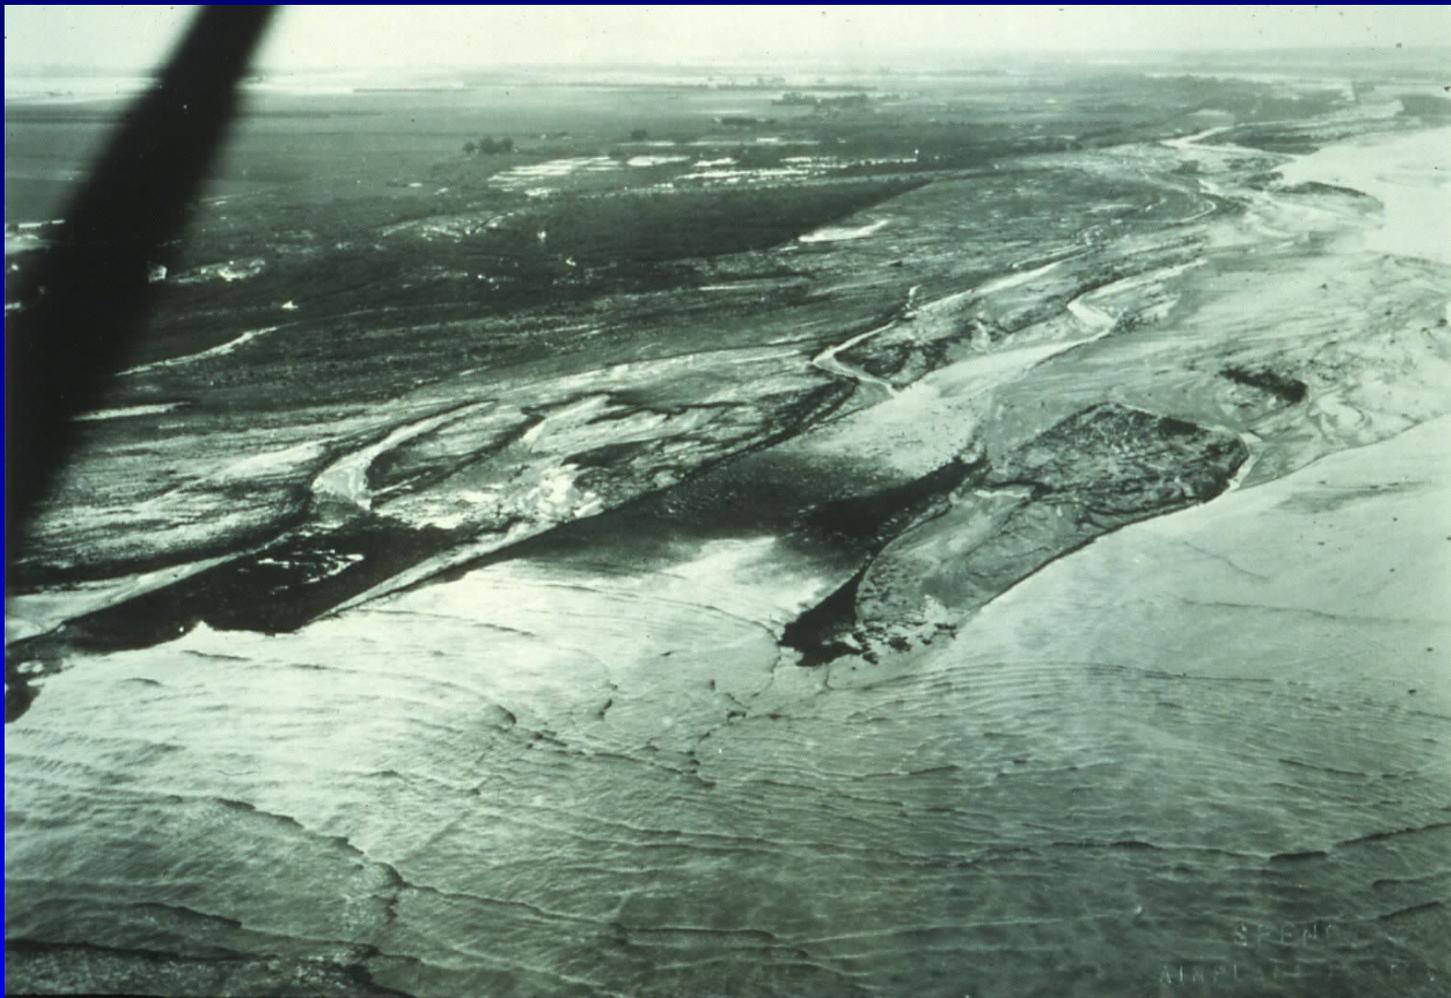
- The flood reached the Pacific Ocean at Montalvo around 5:30 AM. By this time the velocity had dropped to about 5 miles per hour and the flood was two miles wide. Both the railroad and highway bridges were washed out. Some bodies were recovered from the ocean as far south as San Diego.

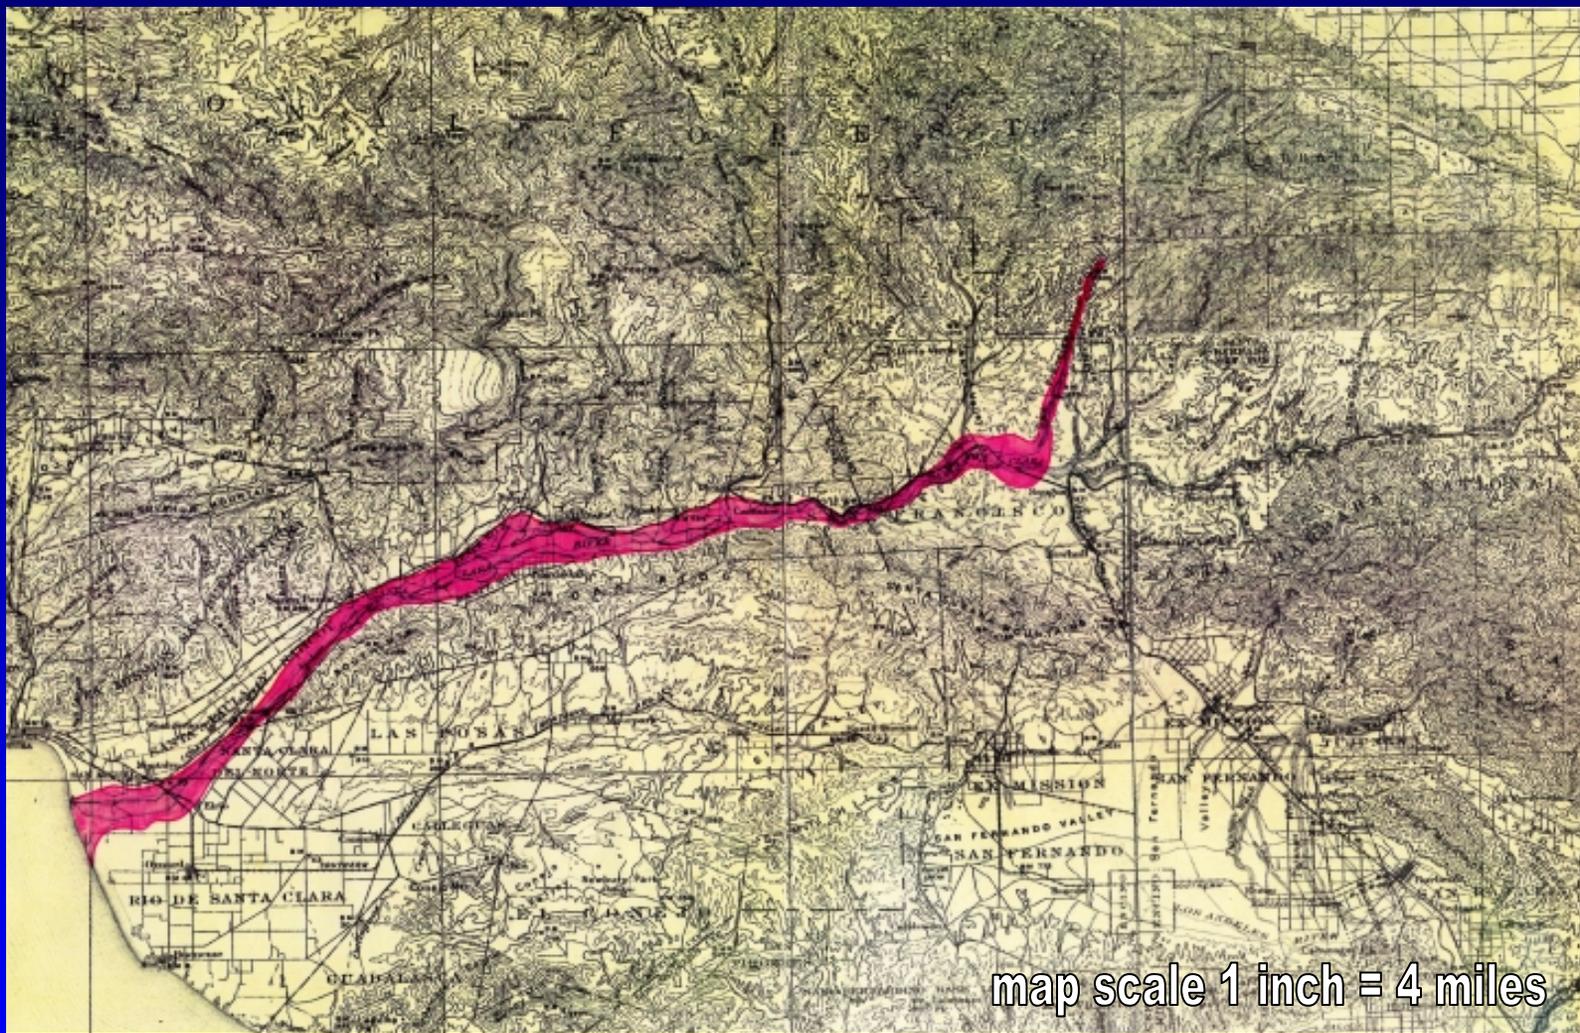
- Charles Lee's map of the flooded area, extending 54 miles from the St. Francis Dam site, through Castaic, Camulos, Filmore, Santa Paula, Saticoy and Montalvo. The smoothed flow distance was 52 miles.

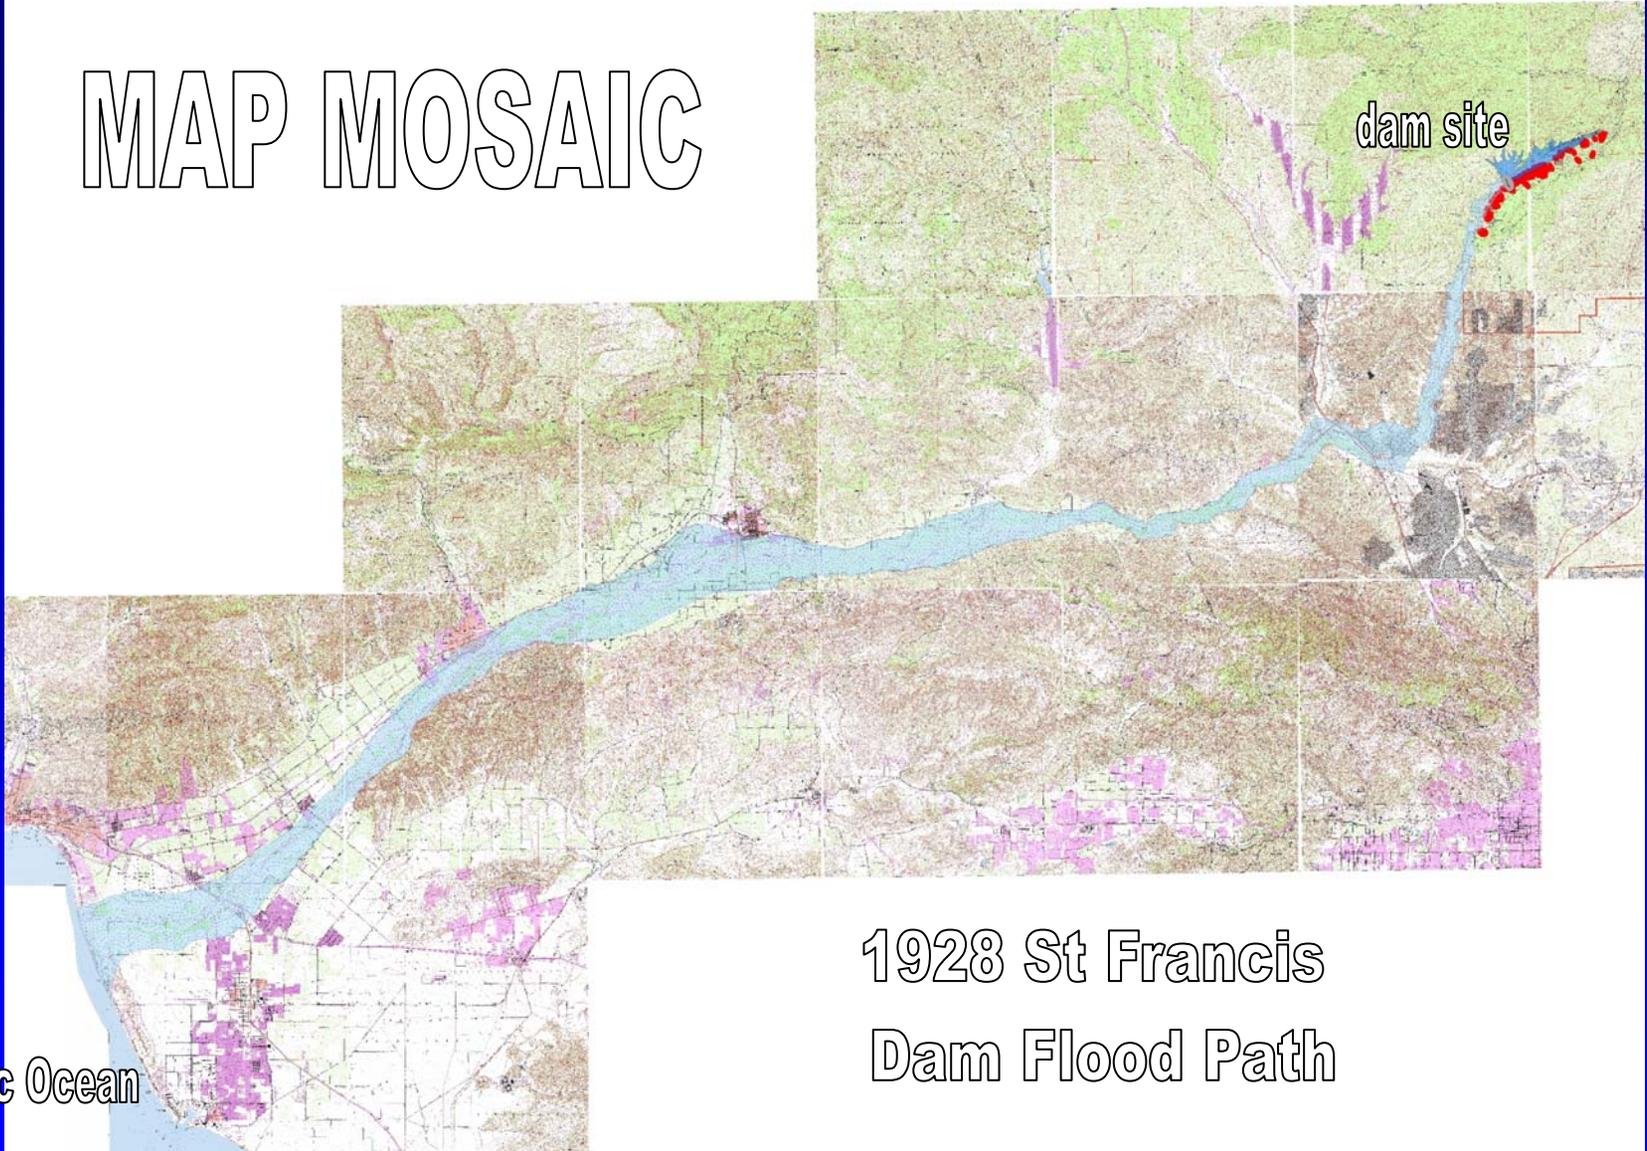
MAP MOSAIC

- 19 USGS 1:24,000 scale Digital Raster Graphic (DRGs) quadrangles were stitched to create a flood base map.

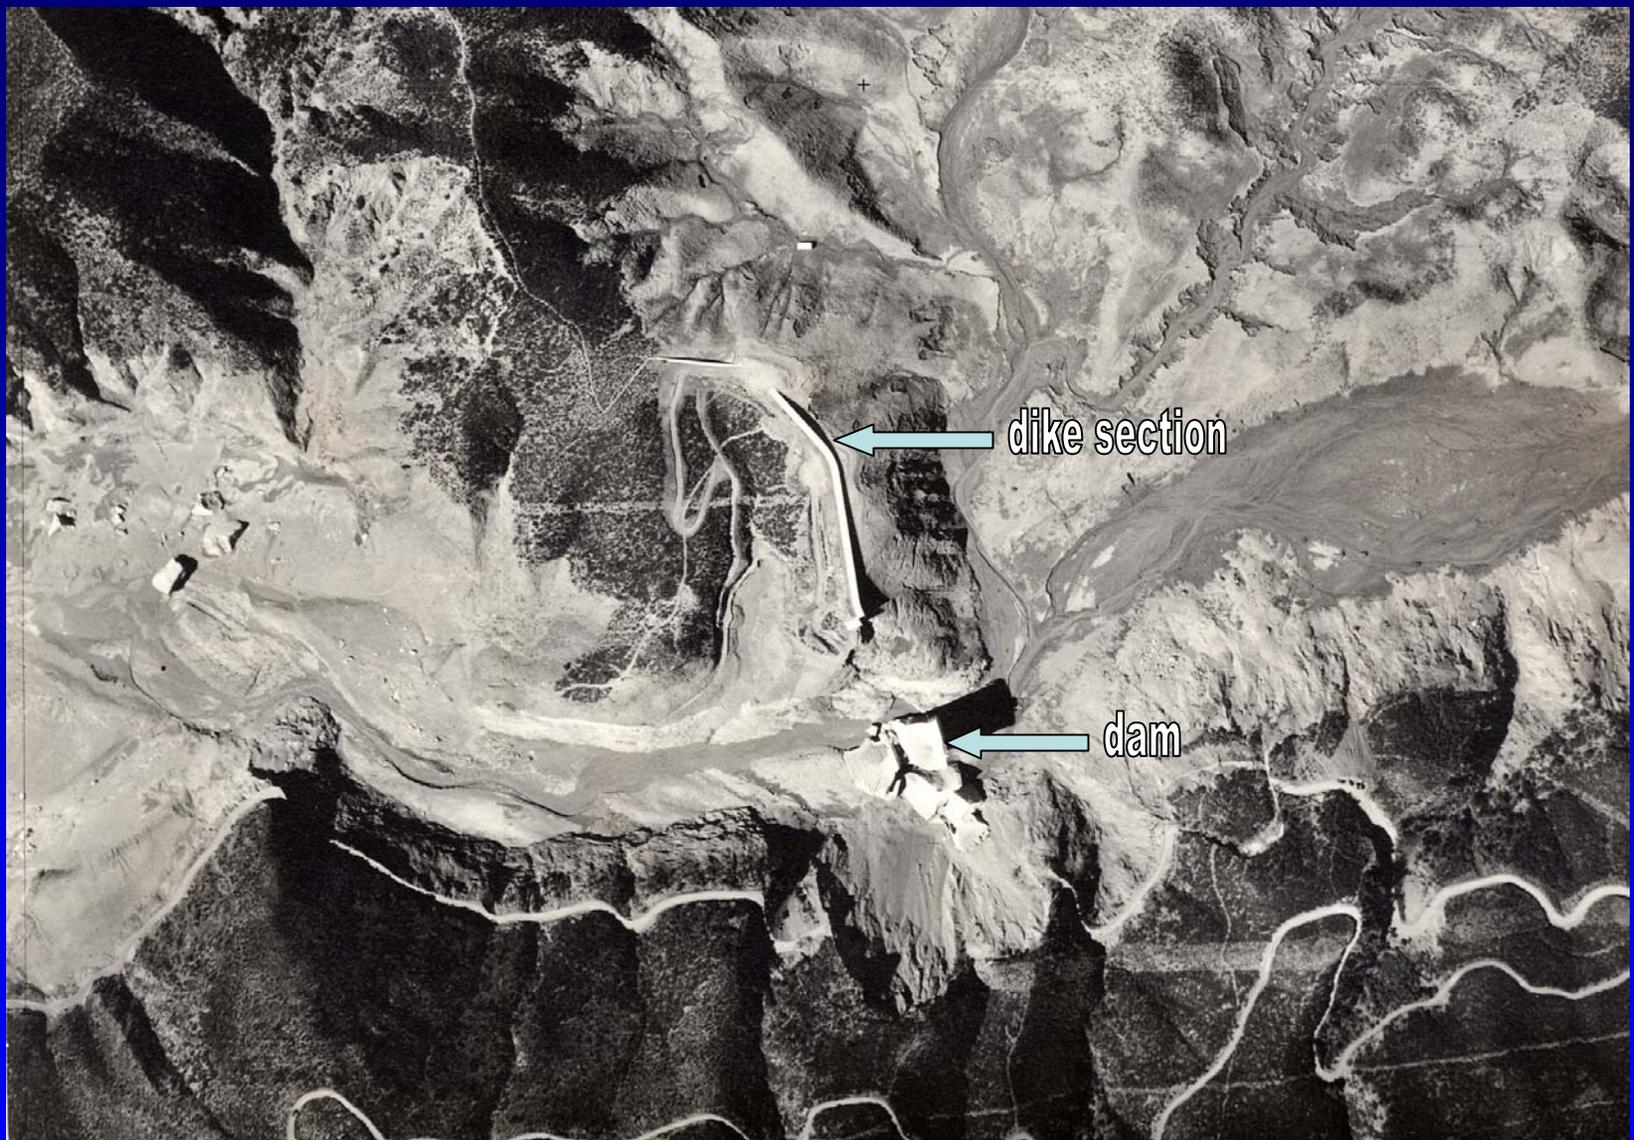
- Stereopair aerial photos were orthorectified on present-day DRGs to obtain areal limits of flood waters. This view shows the dam site and immediately downstream.
