MAPPING THE ST. FRANCIS DAM OUTBURST FLOOD WITH GEOGRAPHIC INFORMATION SYSTEMS

J. David Rogers

Department of Geological Engineering

University of Missouri-Rolla

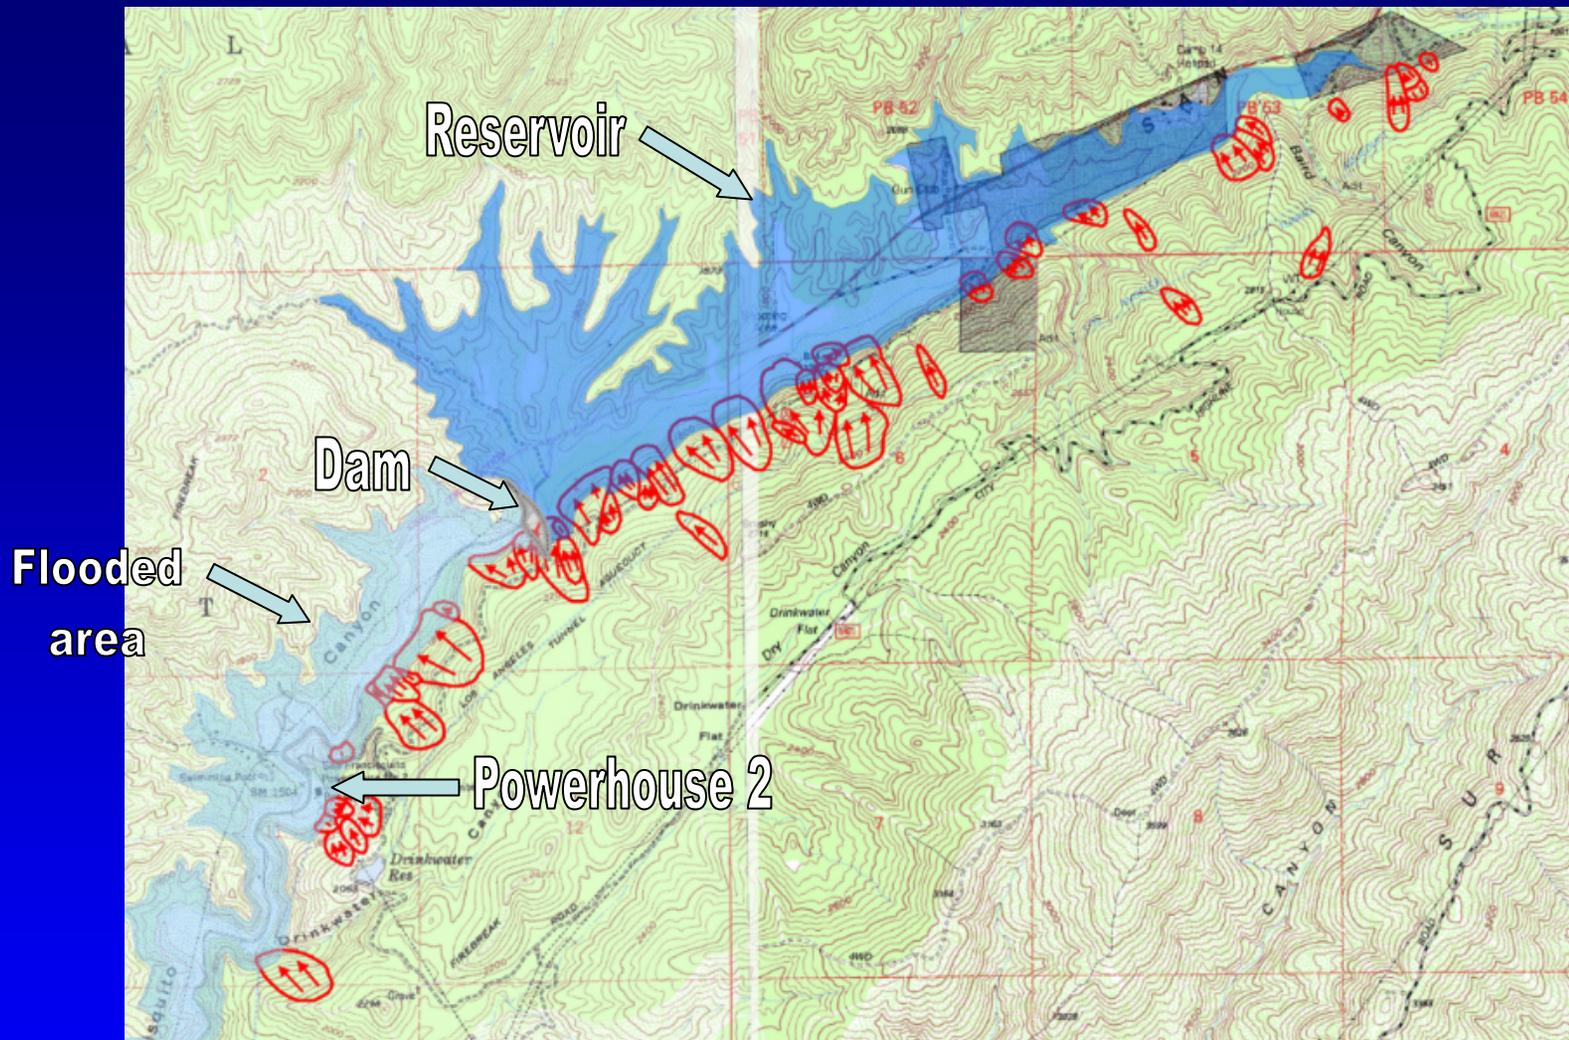
- This flood map was created in ArcGIS on USGS 7.5-minute DRGs. It shows the 1928 reservoir in dark blue and the flood limits in light blue. Landslides are shown in red.

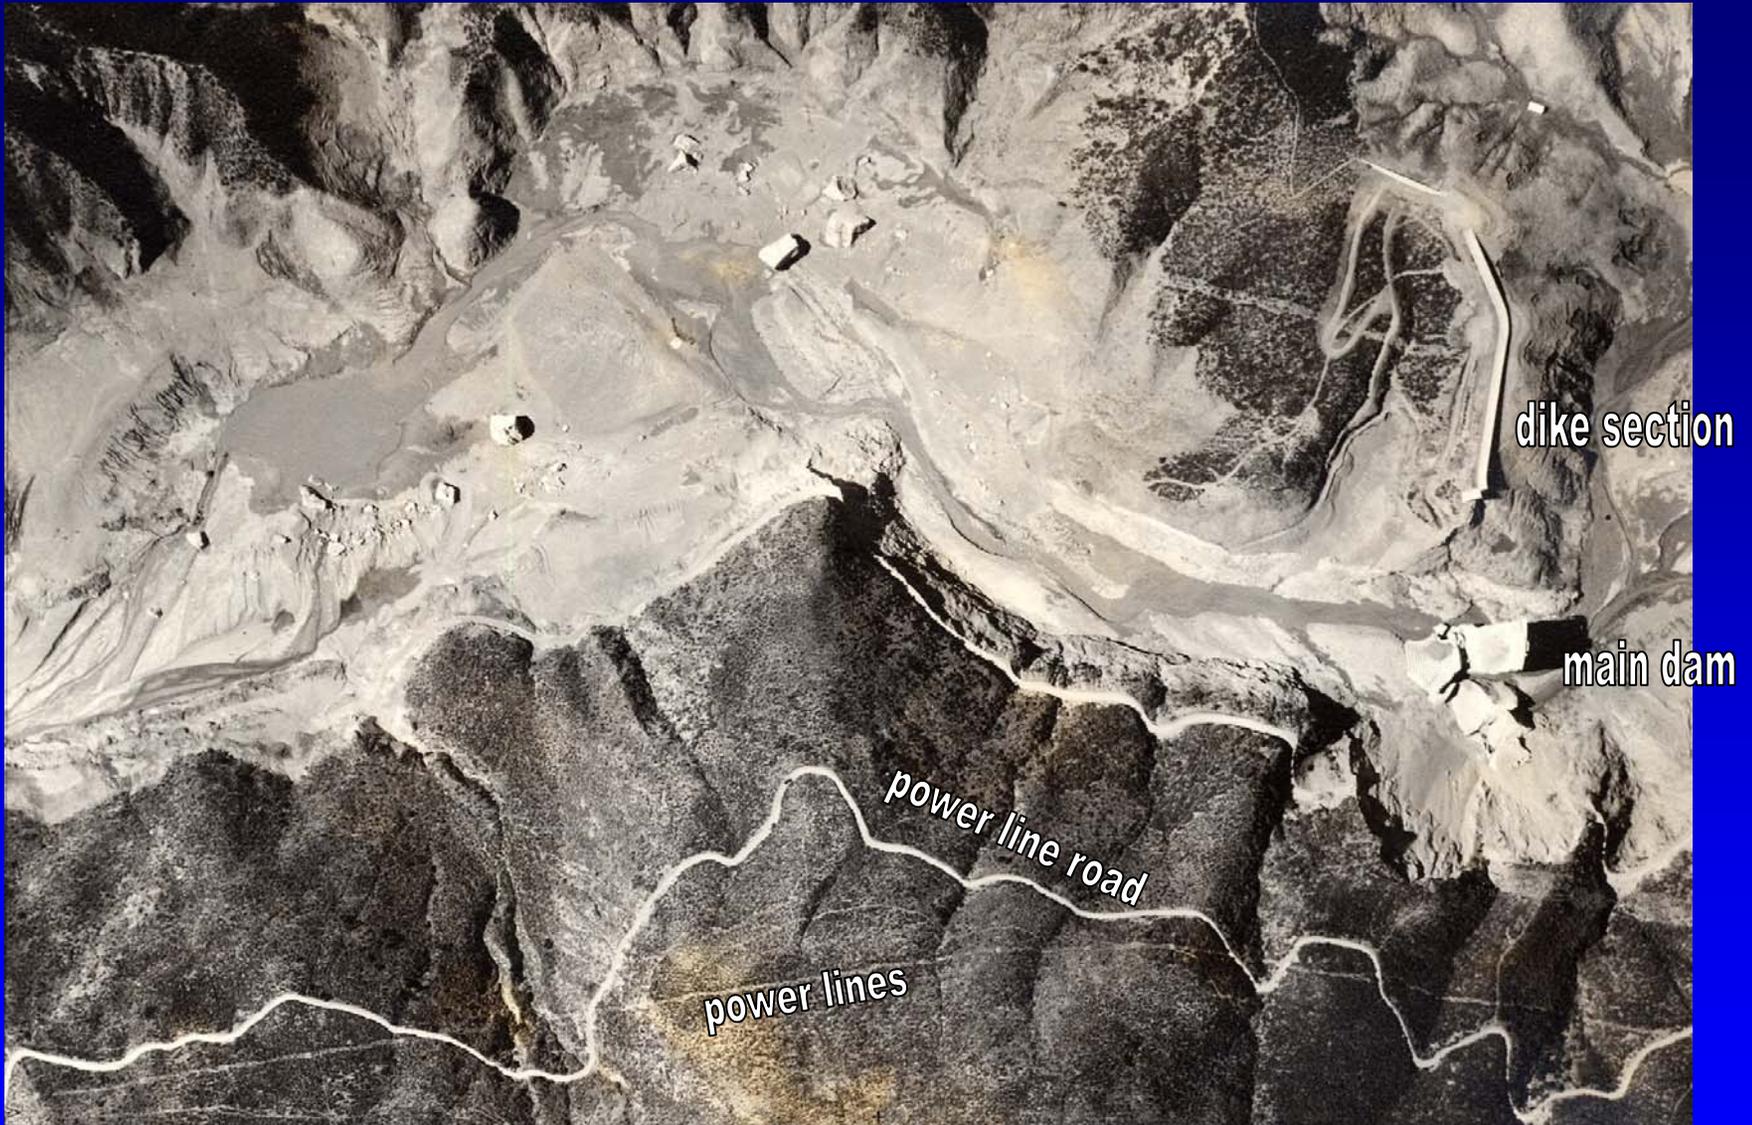
- Orthorectified flood images are overlain on present day DRGs using **control points** visible on both the photos and present day maps. In this case the power line road across the lower portion of the photo was useful.

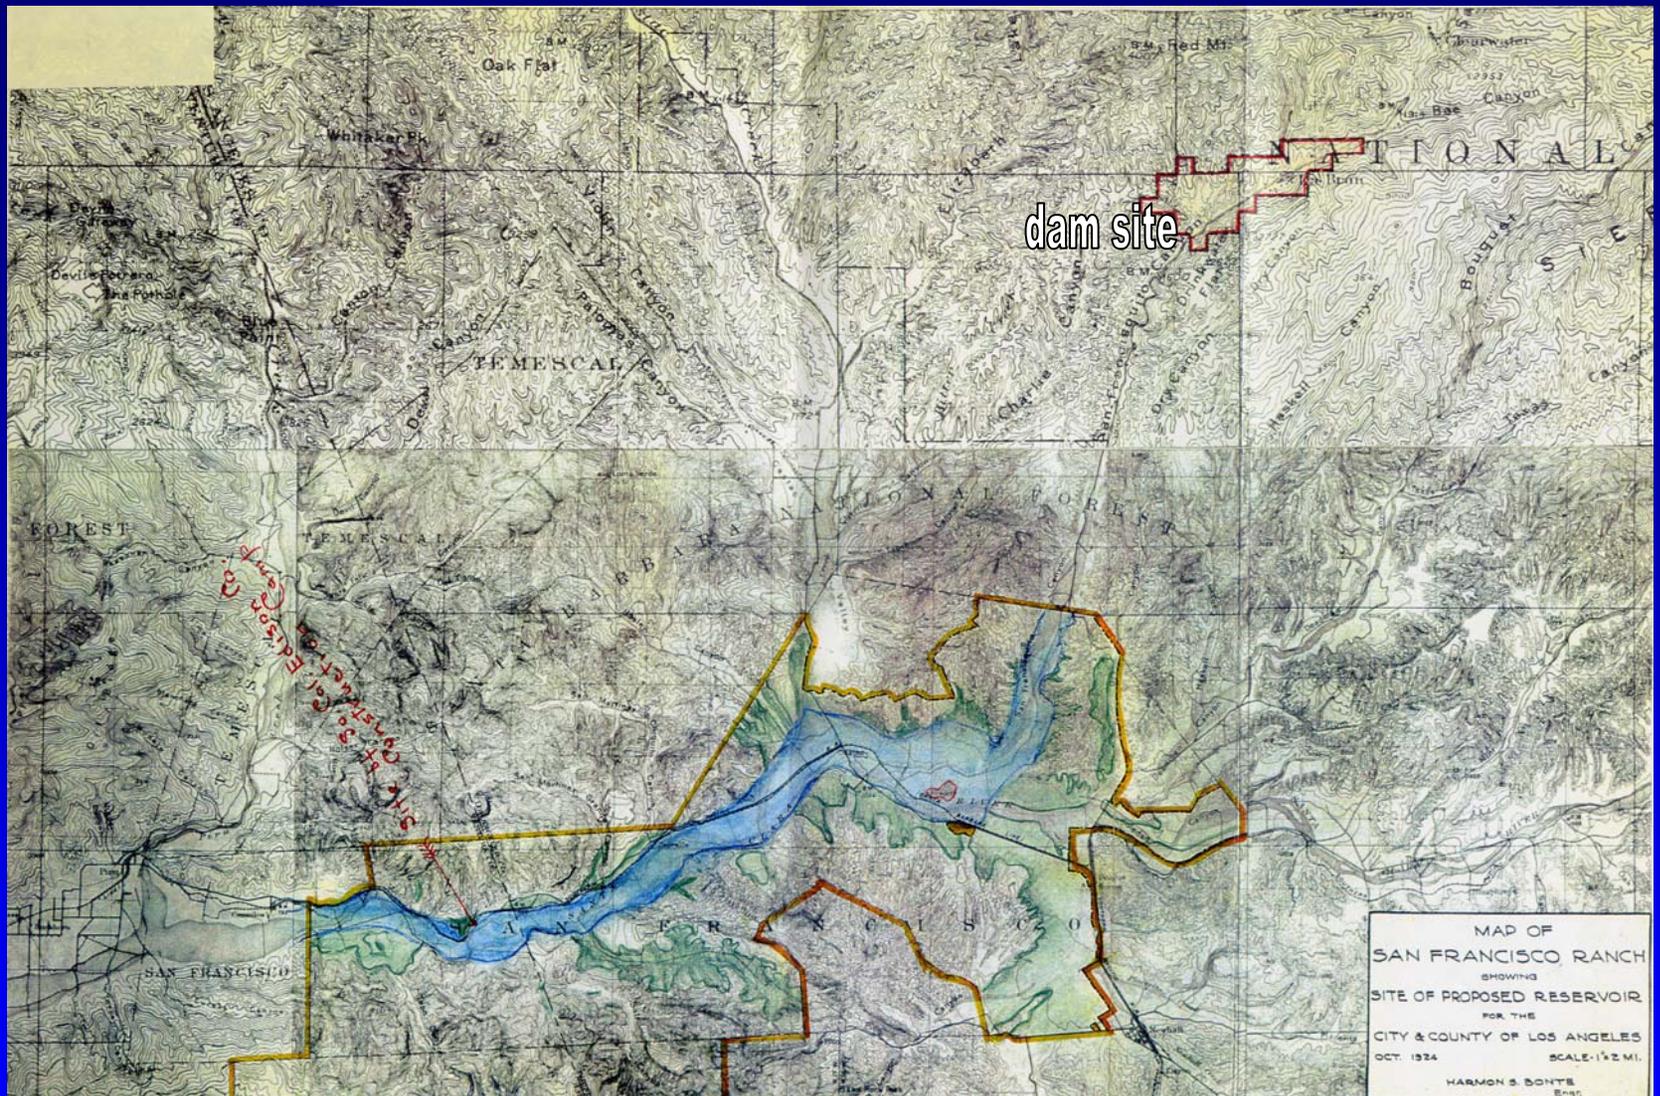
- Isolated flood damage maps were constructed by engineers for several of the larger ranches to document property damage. This map was made for the Newhall Land Company at a scale of 1" = 880 ft

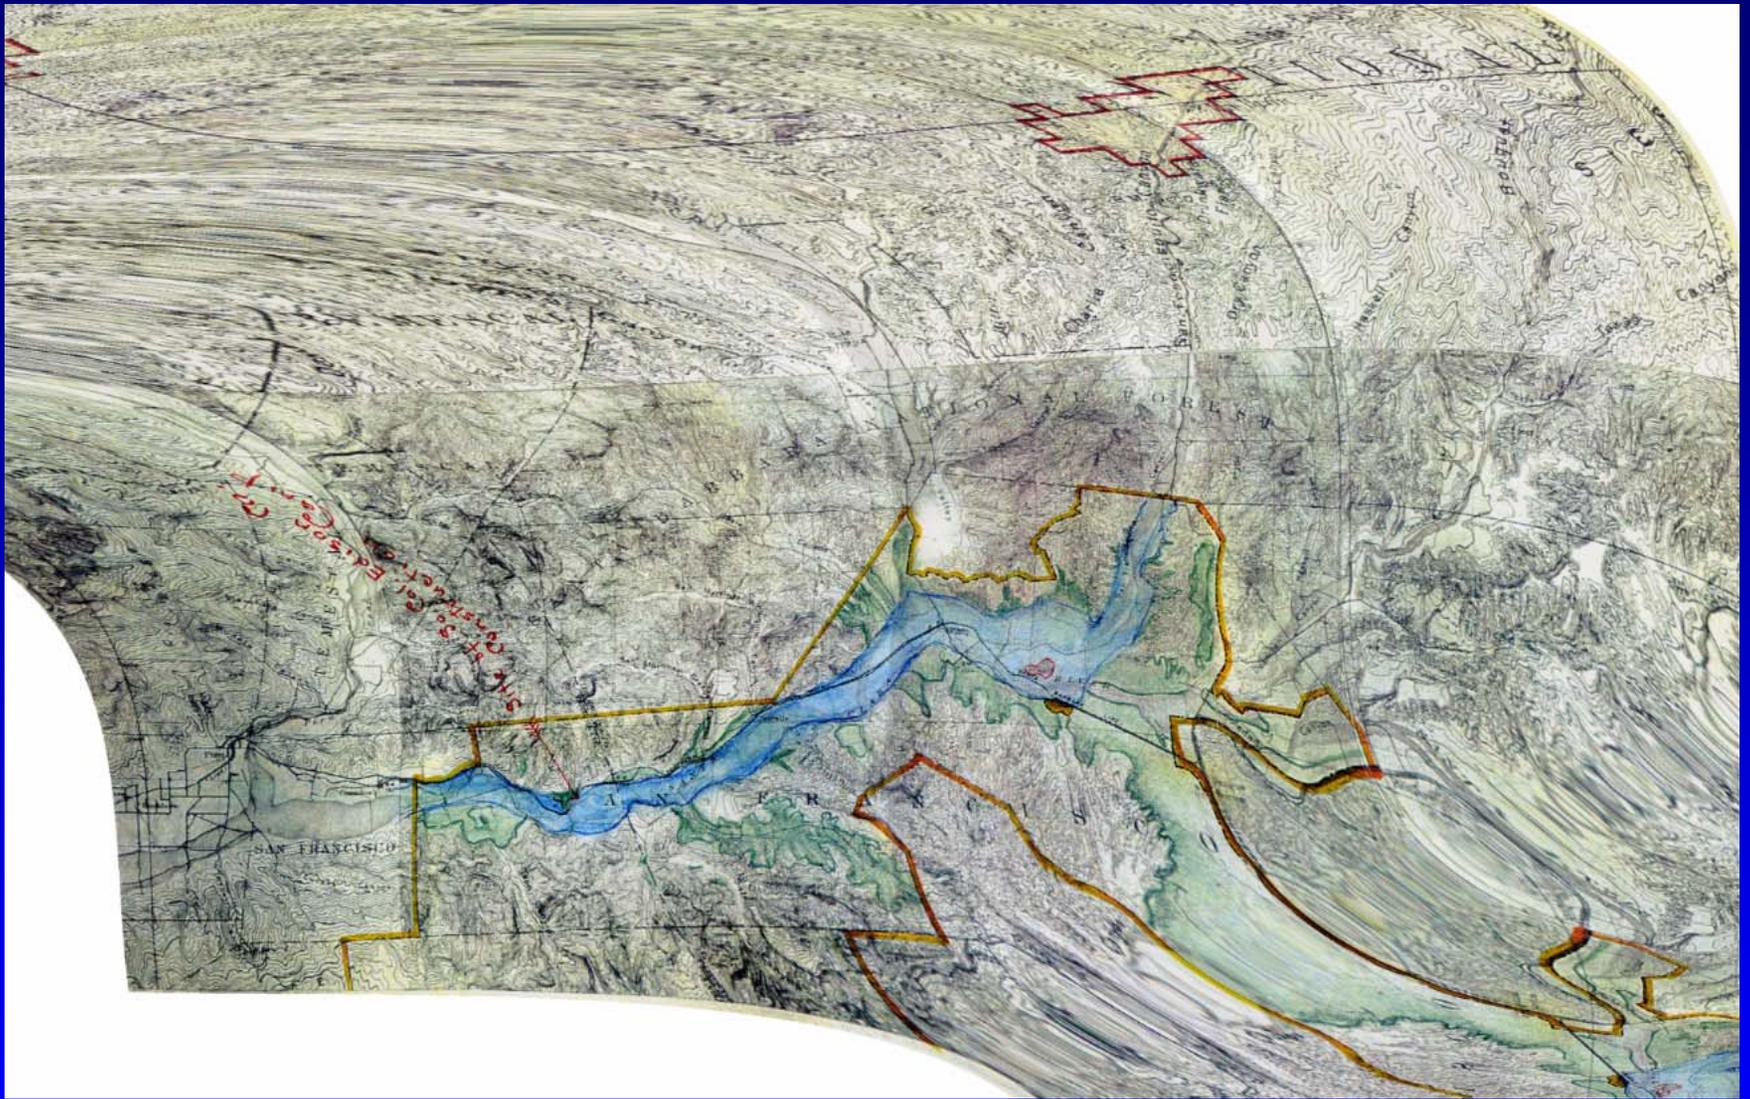
- These more detailed inundation maps were orthorectified using cadastral features, such as section lines, latitude, longitude lines and county boundaries.

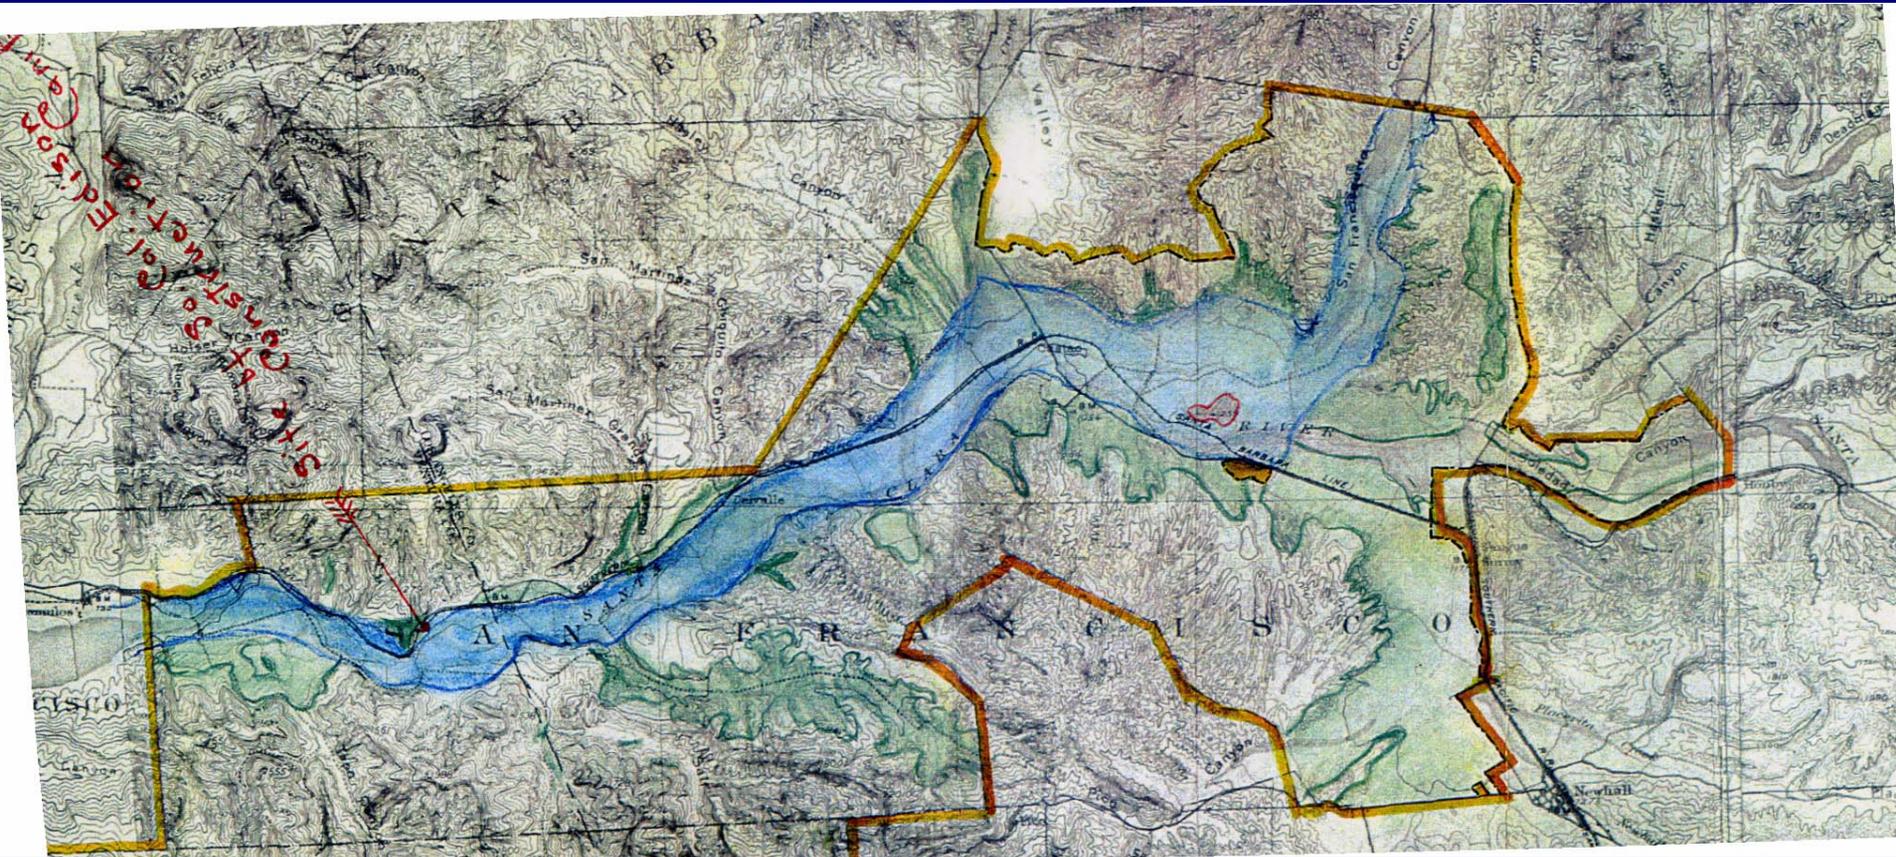
- **Orthorectified local flood map.** By applying Universal Transverse Mercator (UTM) Grid North American Datum (NAD) 1983 (83) geospatial controls, the 1928 planar map is skewed slightly when orthorectified to present-day map projection standards that account for the Earth's actual curvature.

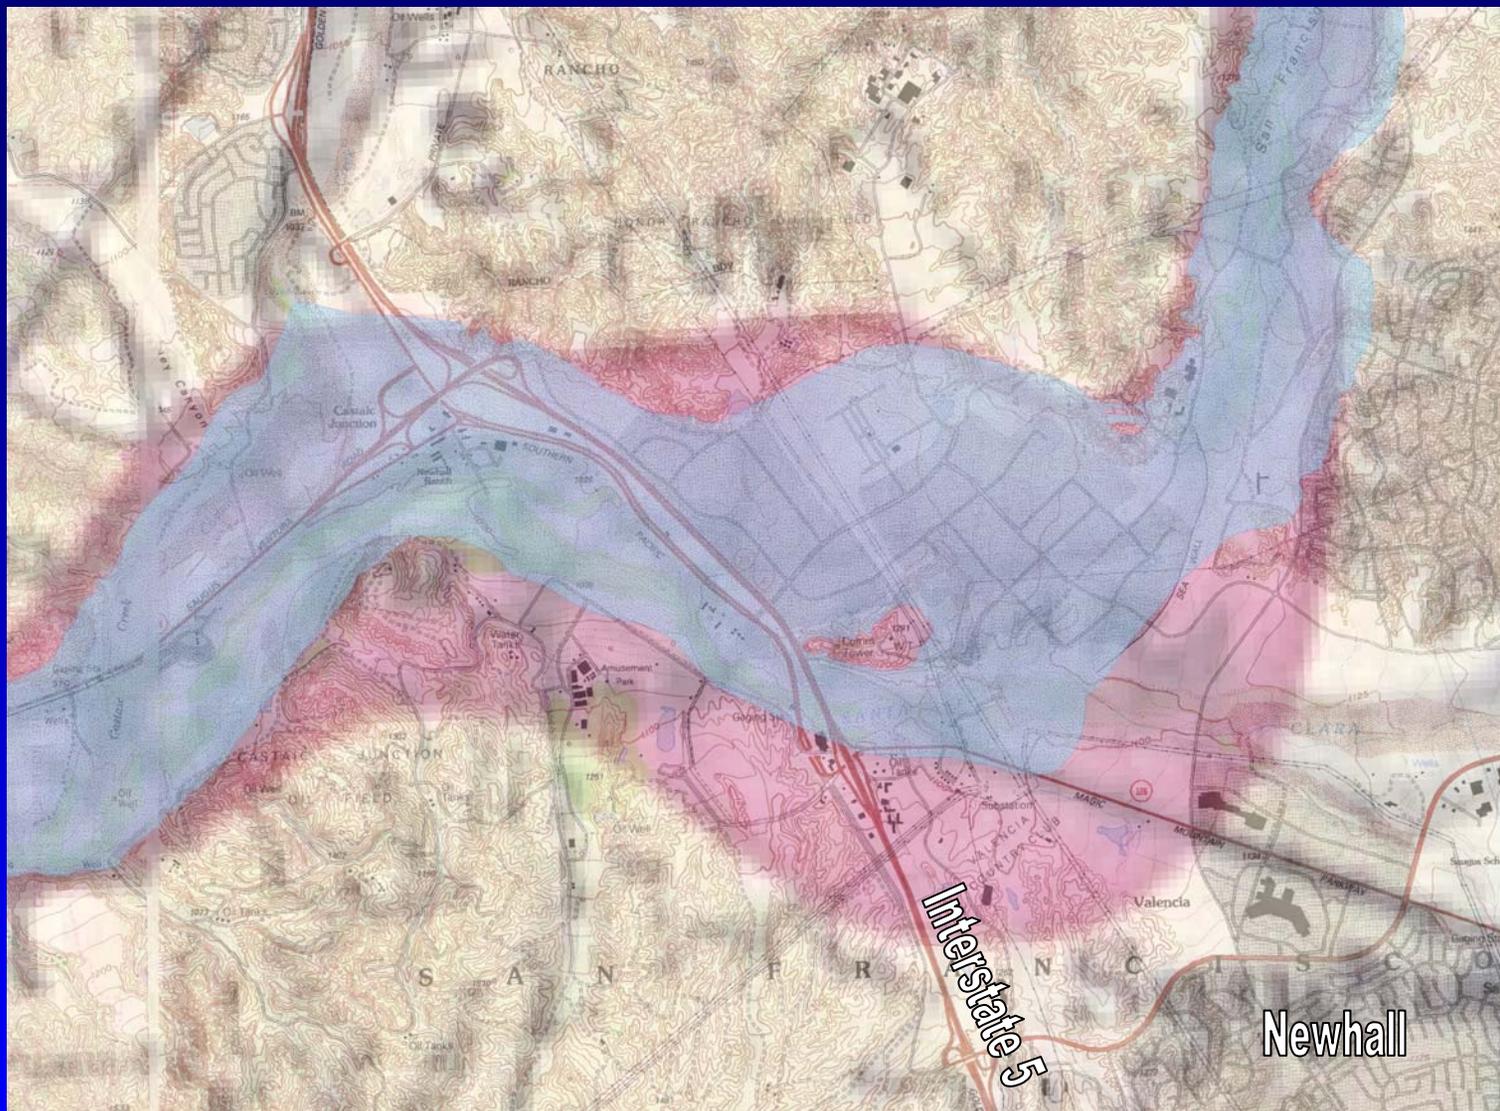
- When our GIS map (blue) was overlain on Charles Lee's flood map (red); it appeared that he greatly overestimated the spatial limits of flooding in the Castaic Junction area.

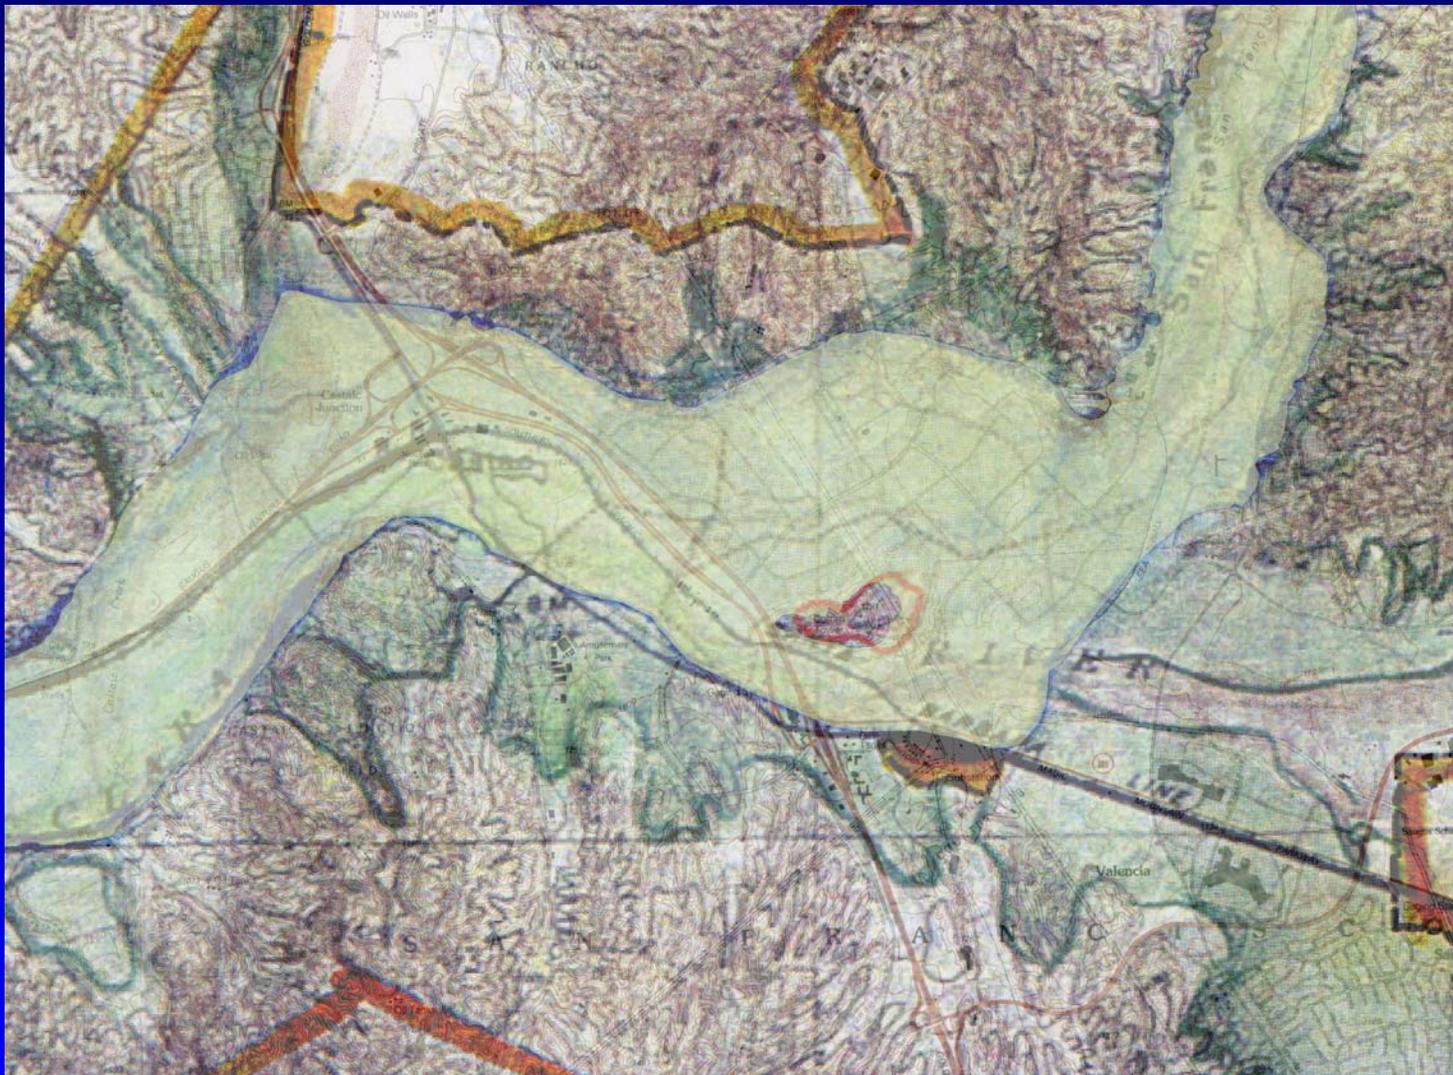
- The flood limits shown on our new map are very similar to those shown on the damage map prepared for the Newhall Land Company in the Castaic Junction area.

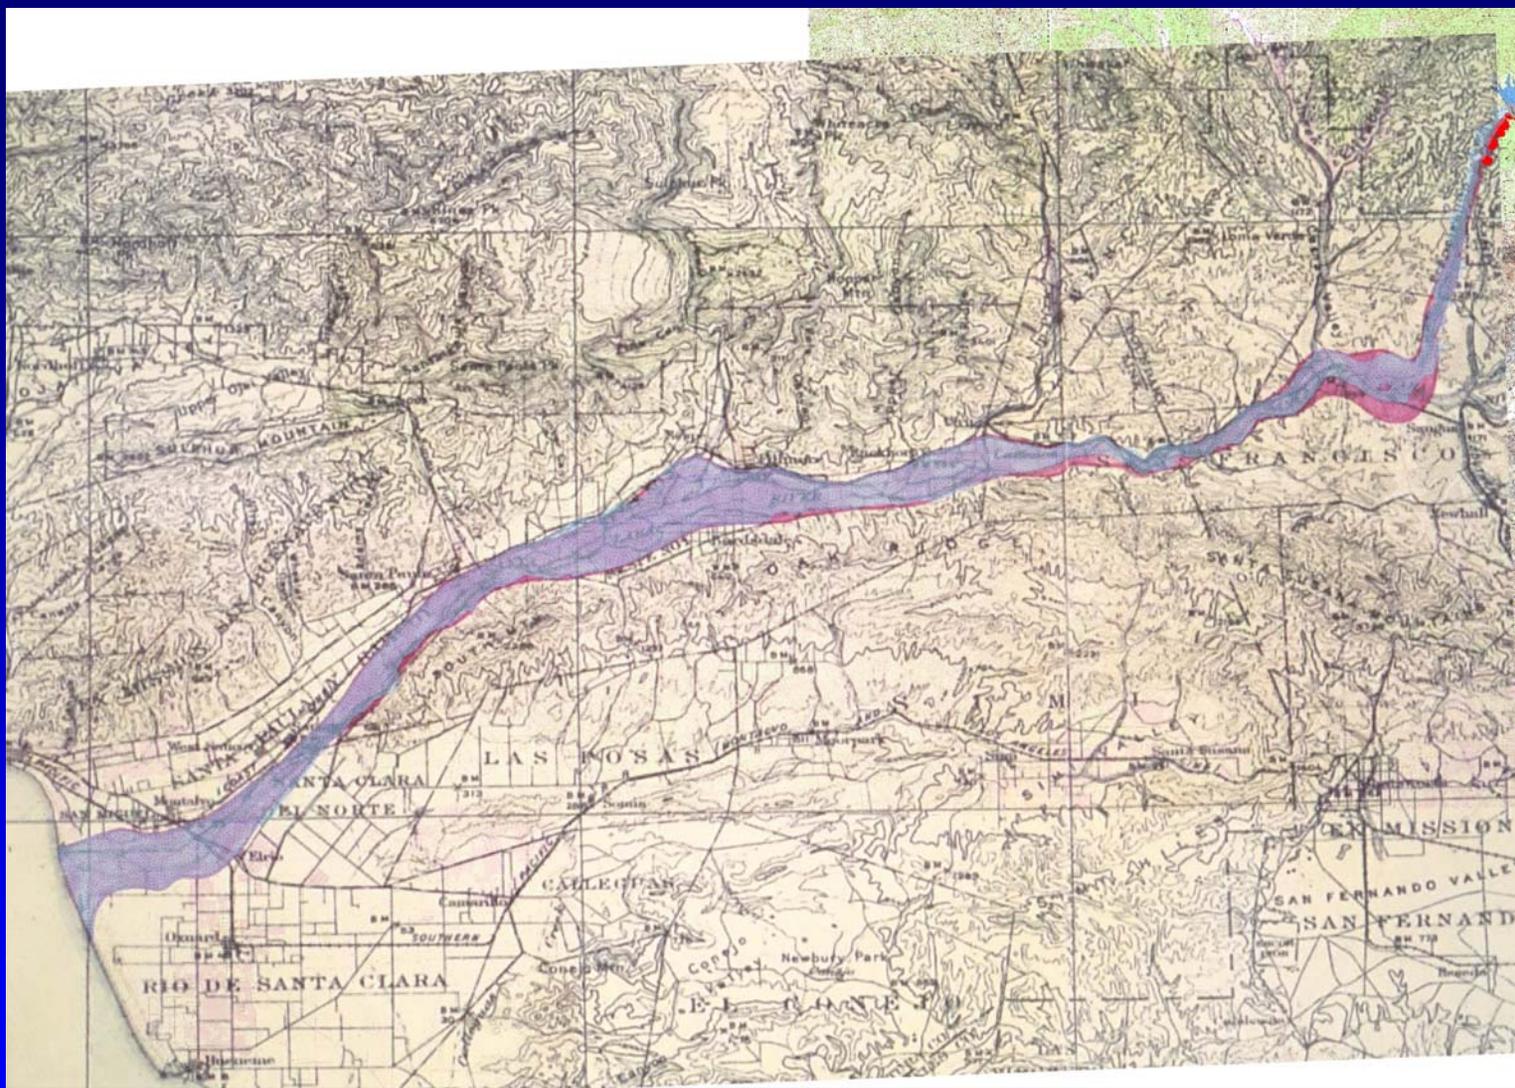
- Comparison between orthorectified version of Lee's flood map (red) and our new flood map (blue). Lee's map was prepared on a 1:250,000 scale base map (1 inch = 4 miles).

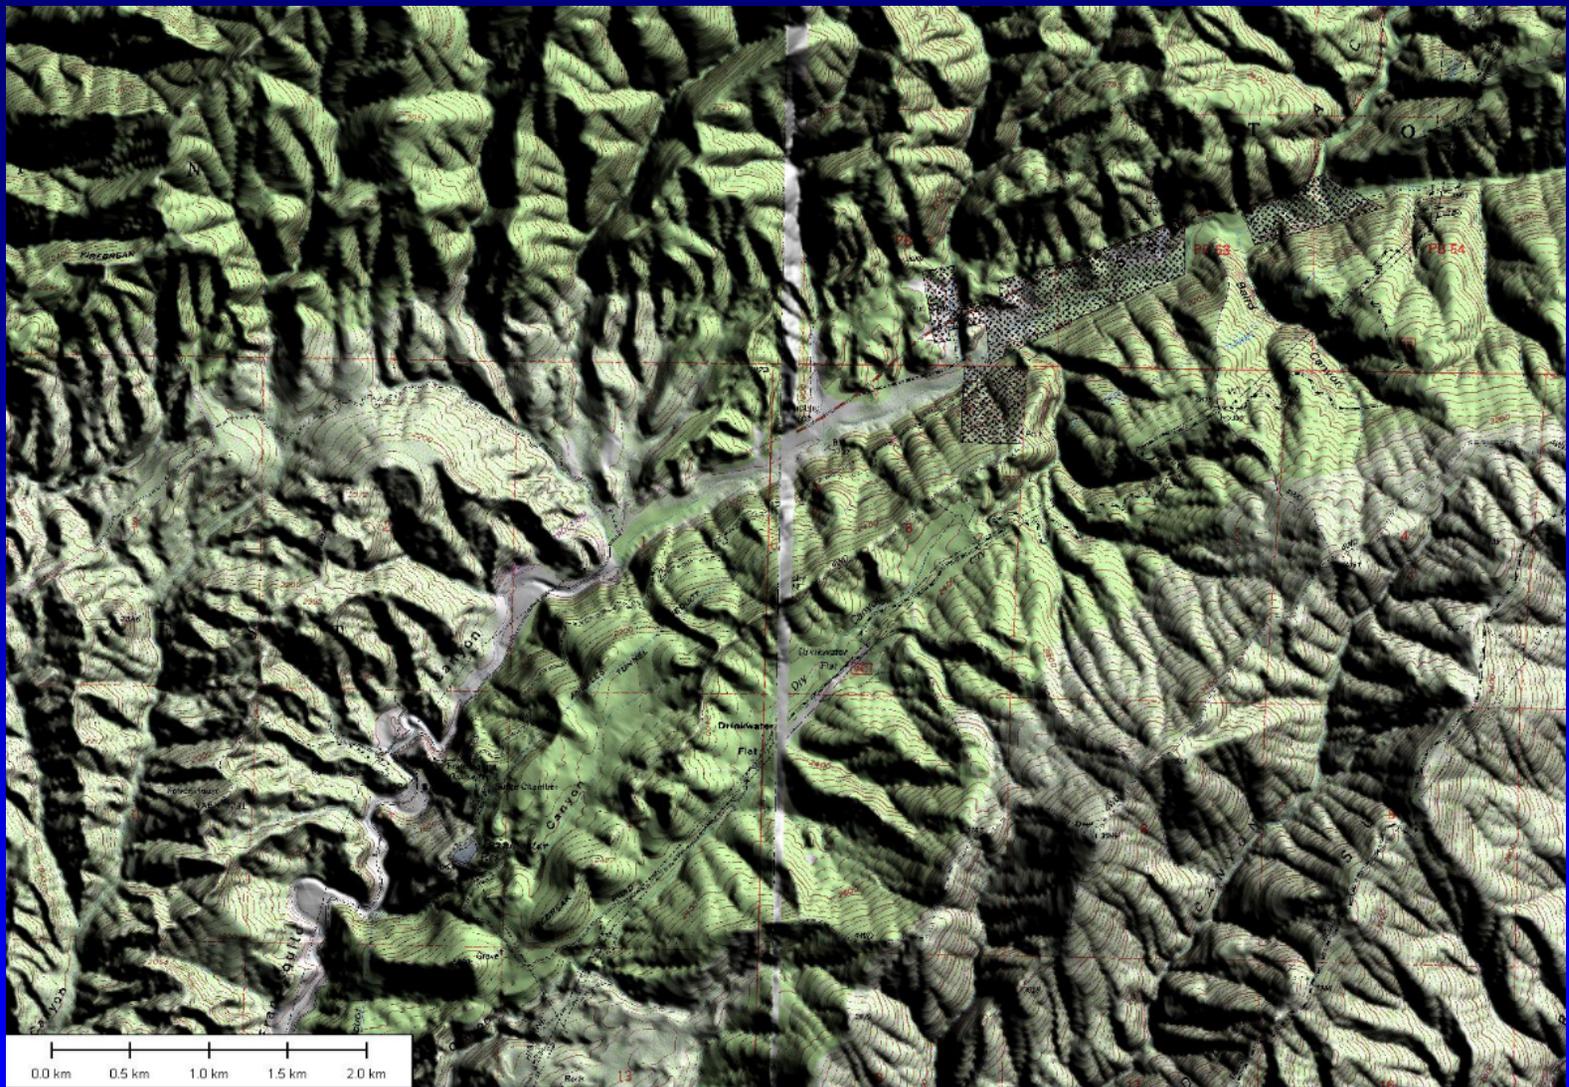
- Shaded 10 meter DEMs of the St. Francis Dam site overlain on USGS DRGs, created using Global Mapper. This combination can be useful for flood modeling.
