Corps of Engineers Exhumation of the Battleship Maine, 1912

CPT David A. Pounds

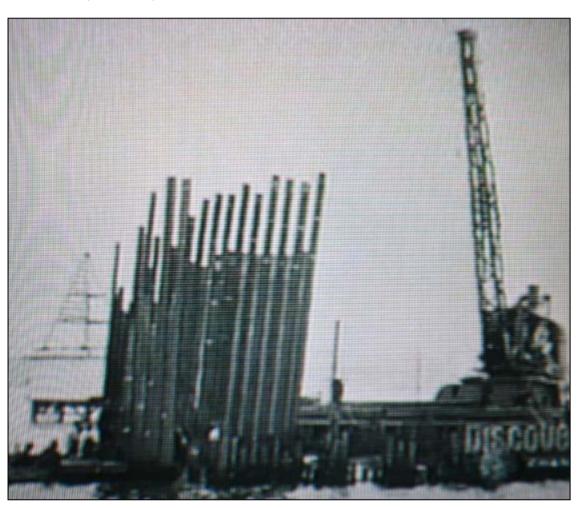
- 29 AUG 10 Maine Board Meeting
- 13 OCT 10 Project Approved
- DEC 10 Cofferdam Construction Started
