**SALVAGE OF THE
BATTLESHIP
USS *OKLAHOMA*
FOLLOWING THE ATTACK
ON PEARL HARBOR
1942-46**

Situation when salvage began-1942

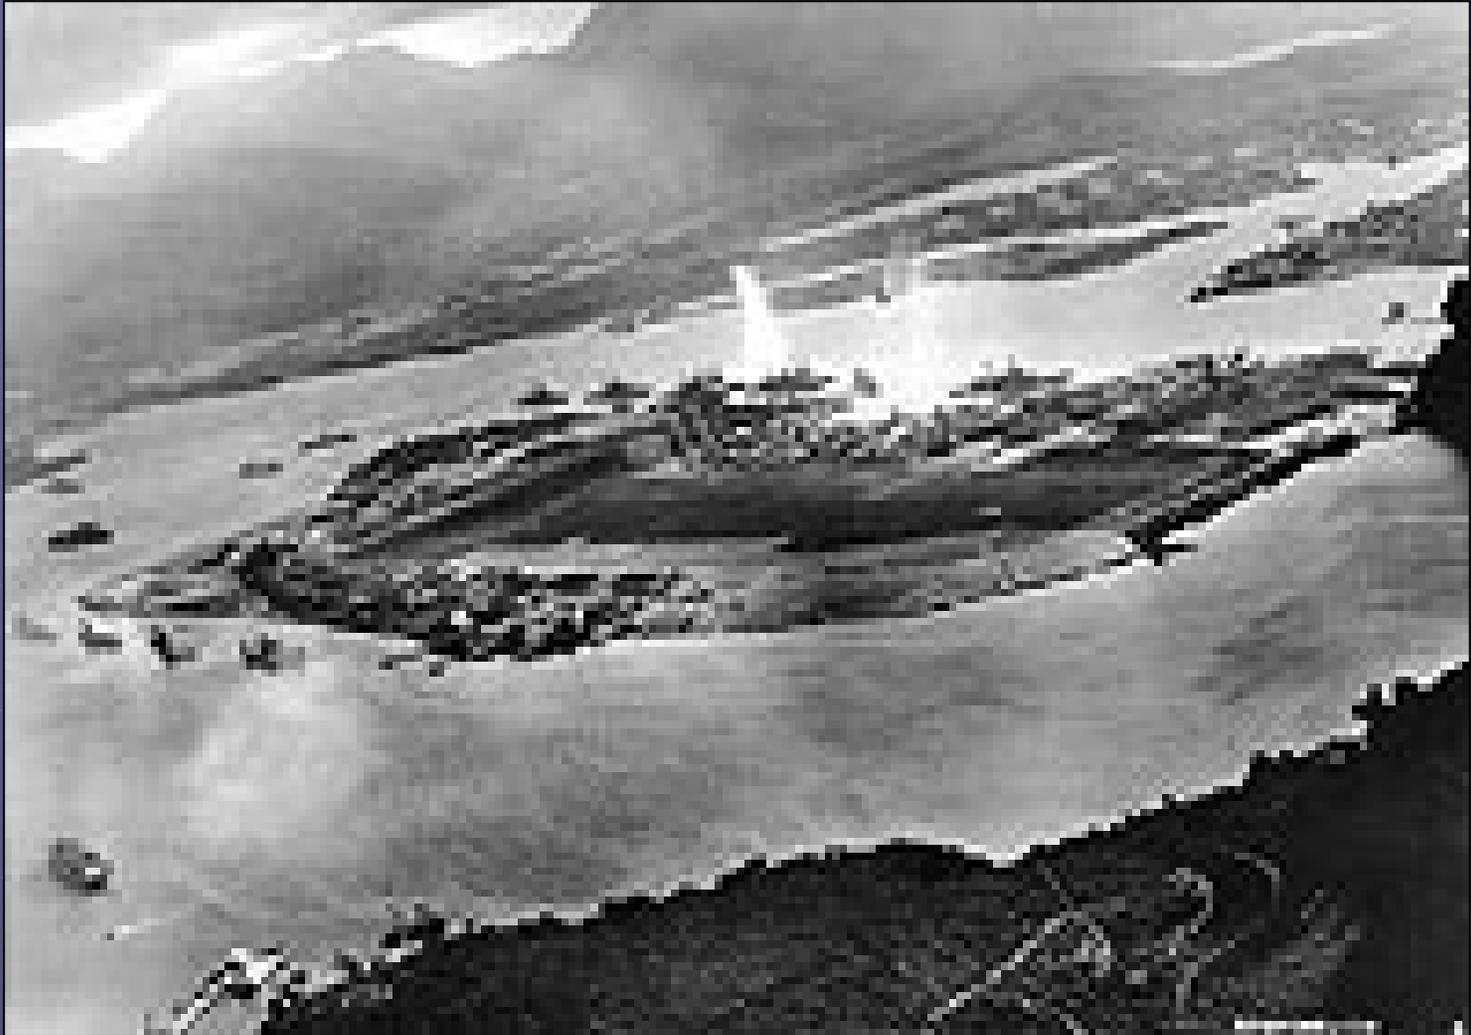
Japanese torpedo exploding against hull of the Oklahoma

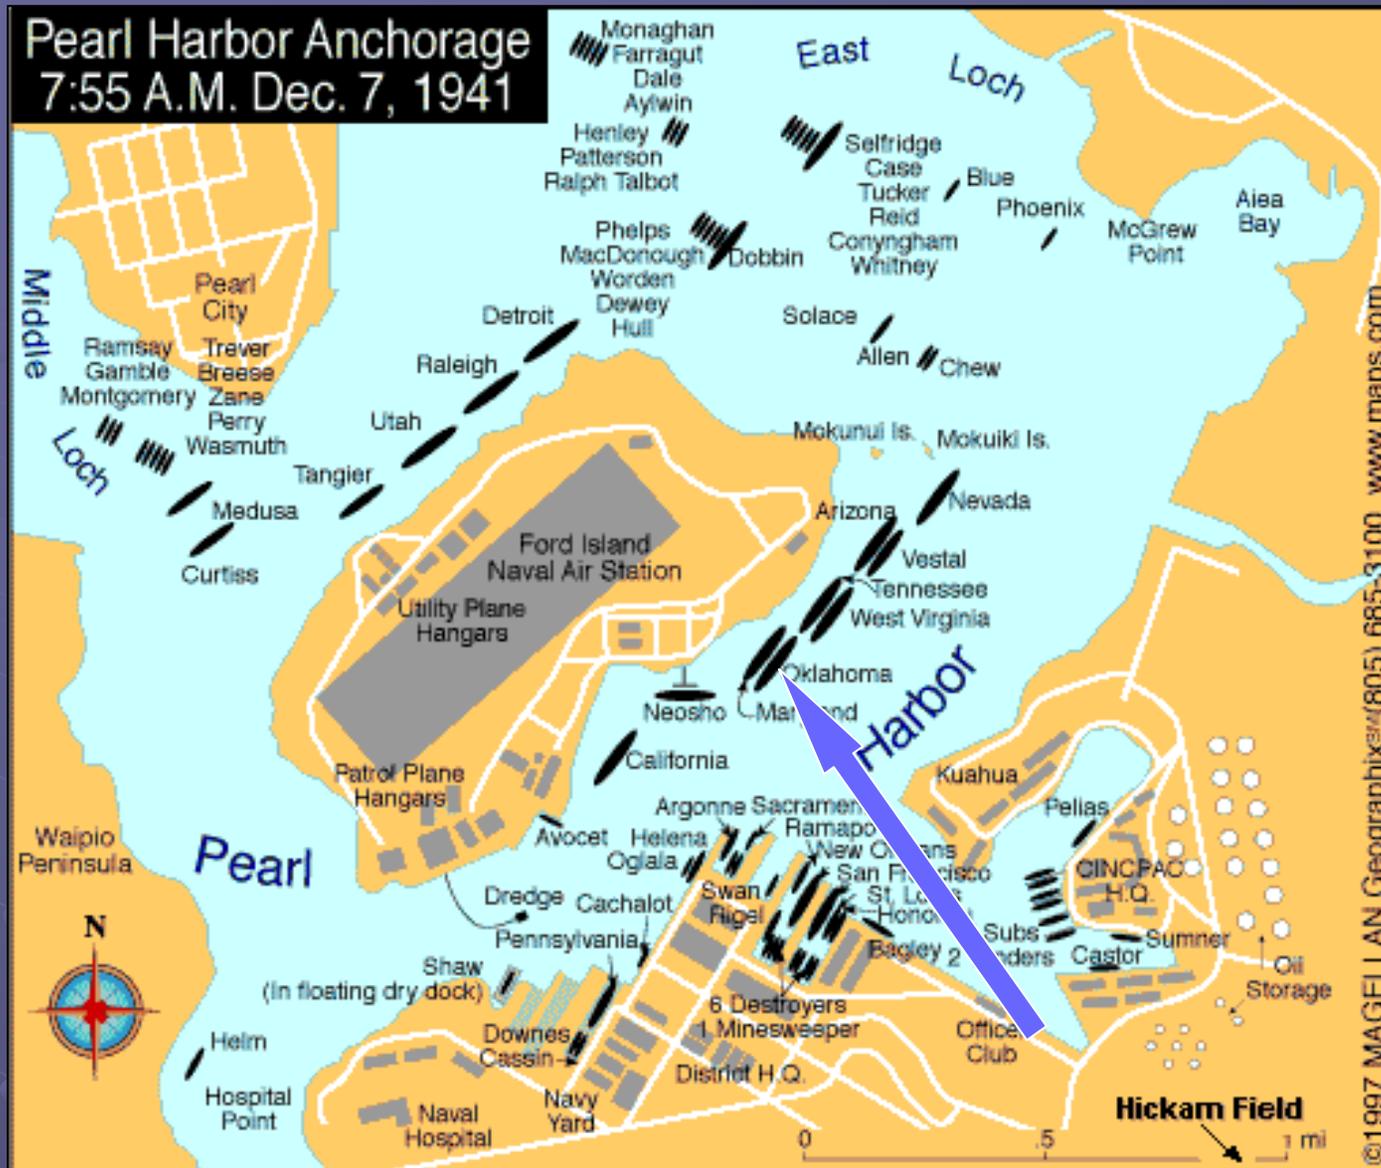
Pearl Harbor Anchorage 7:55 A.M. Dec. 7, 1941

The Oklahoma's berth provided the clearest approach path for Japanese torpedo bombers along battleship row

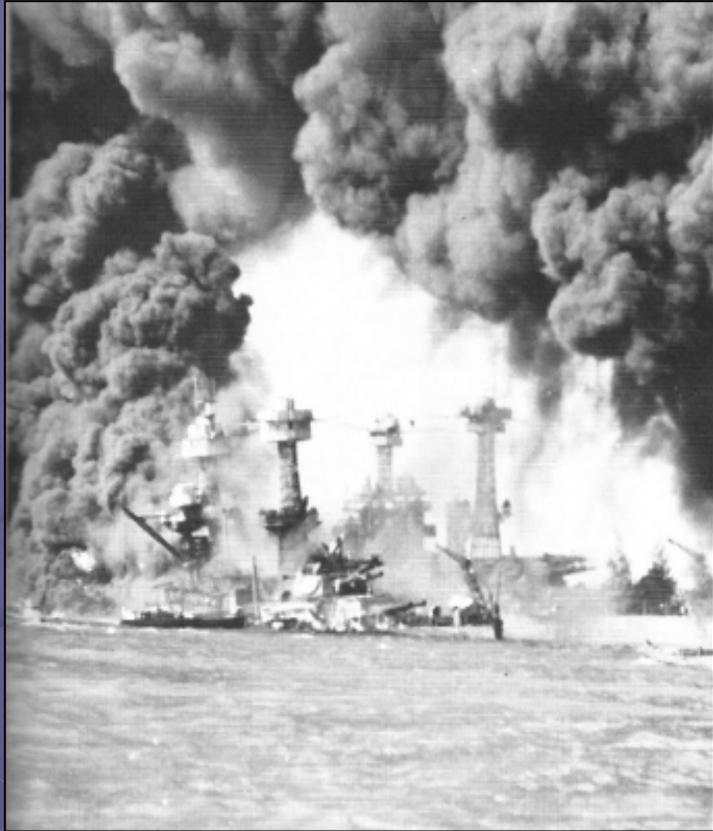
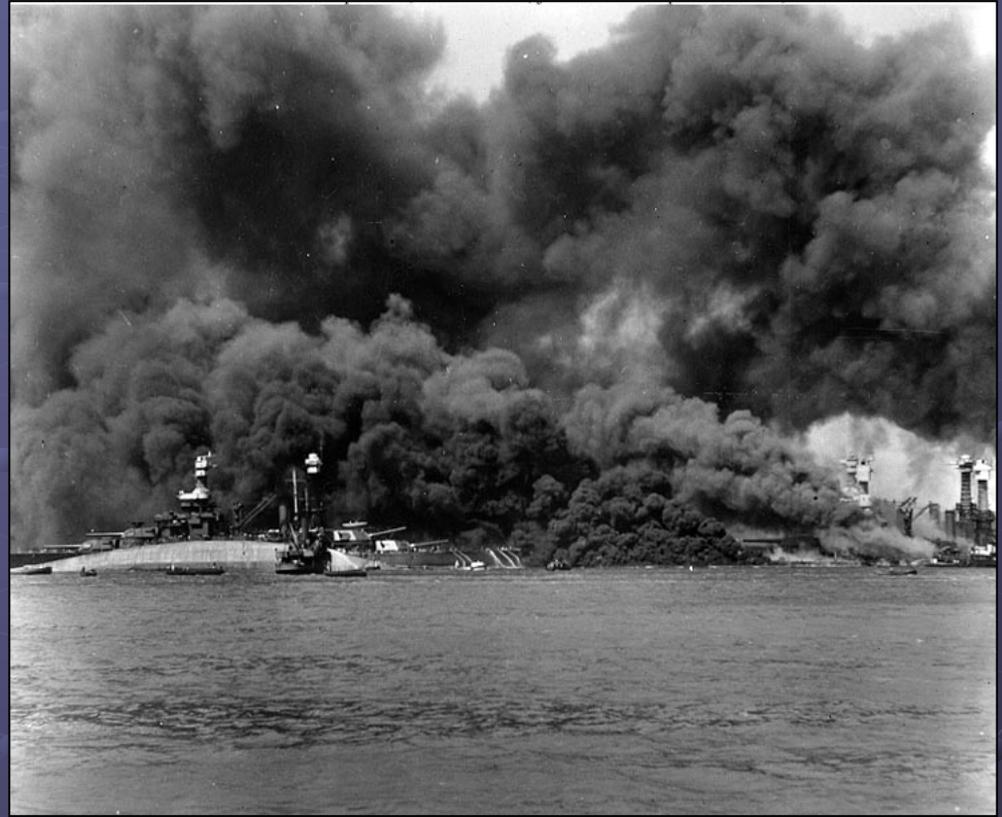
ATTACK ON BATTLESHIP ROW

- The *Oklahoma* was hit by 9 torpedoes because of her position opposite the inner harbor, which allowed Japanese bombers a clear approach path

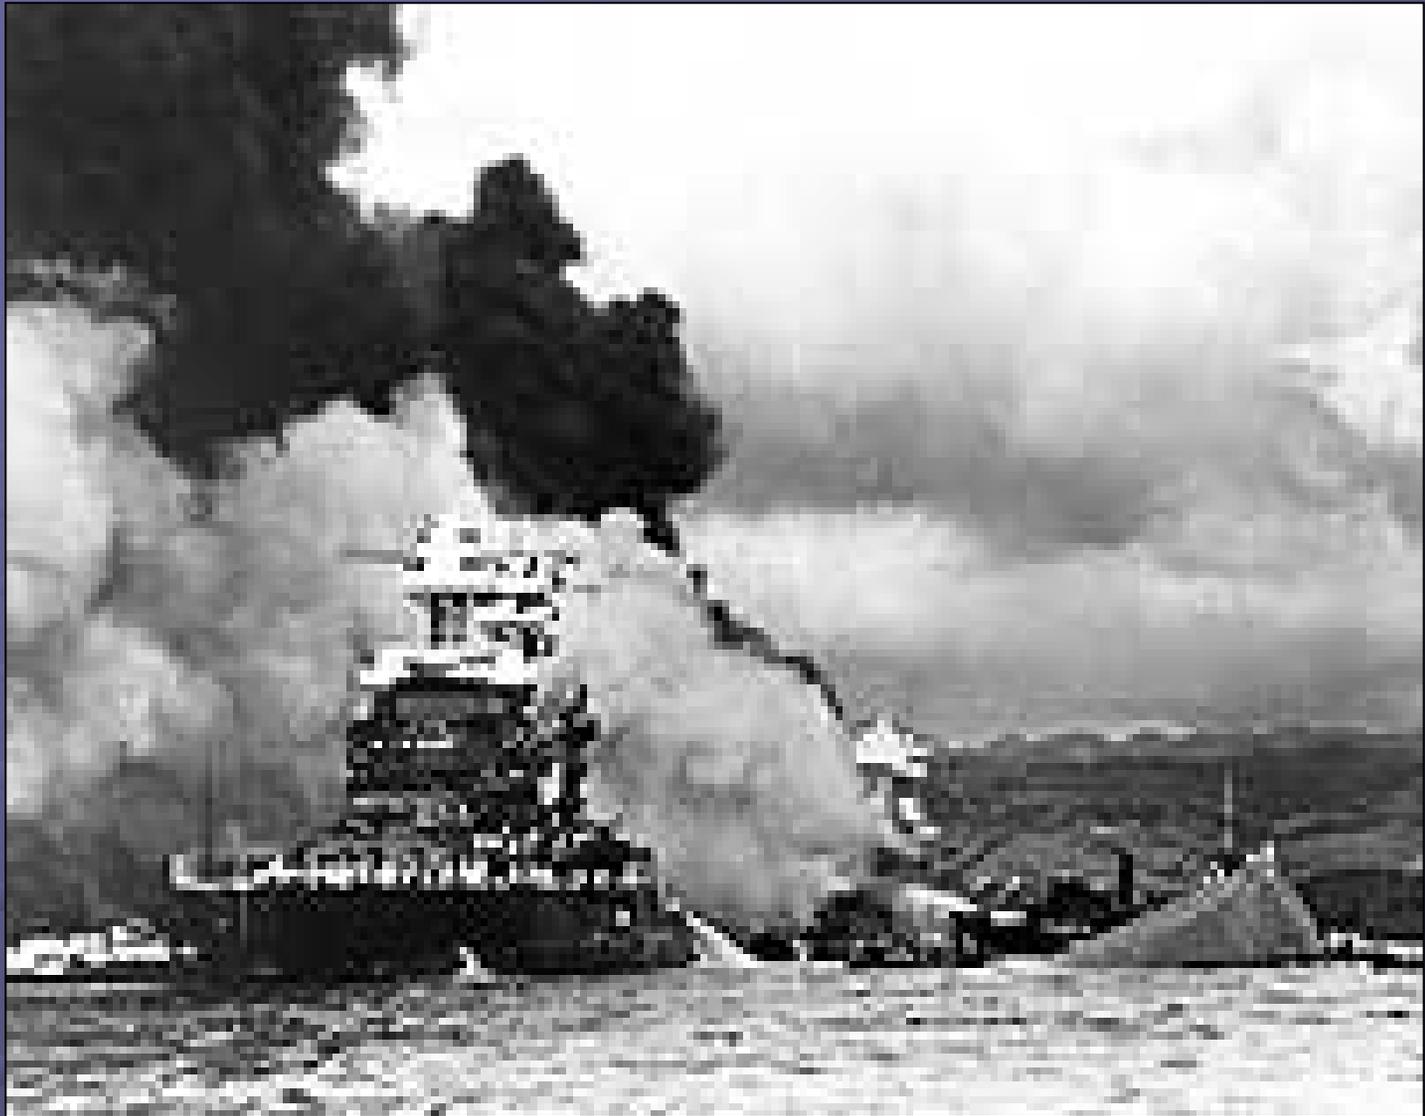
Each torpedo struck the Oklahoma's port side at higher levels because the ship began listing soon after the first torpedo detonated. This plot was assembled by John F. DeVirgilio (1991).

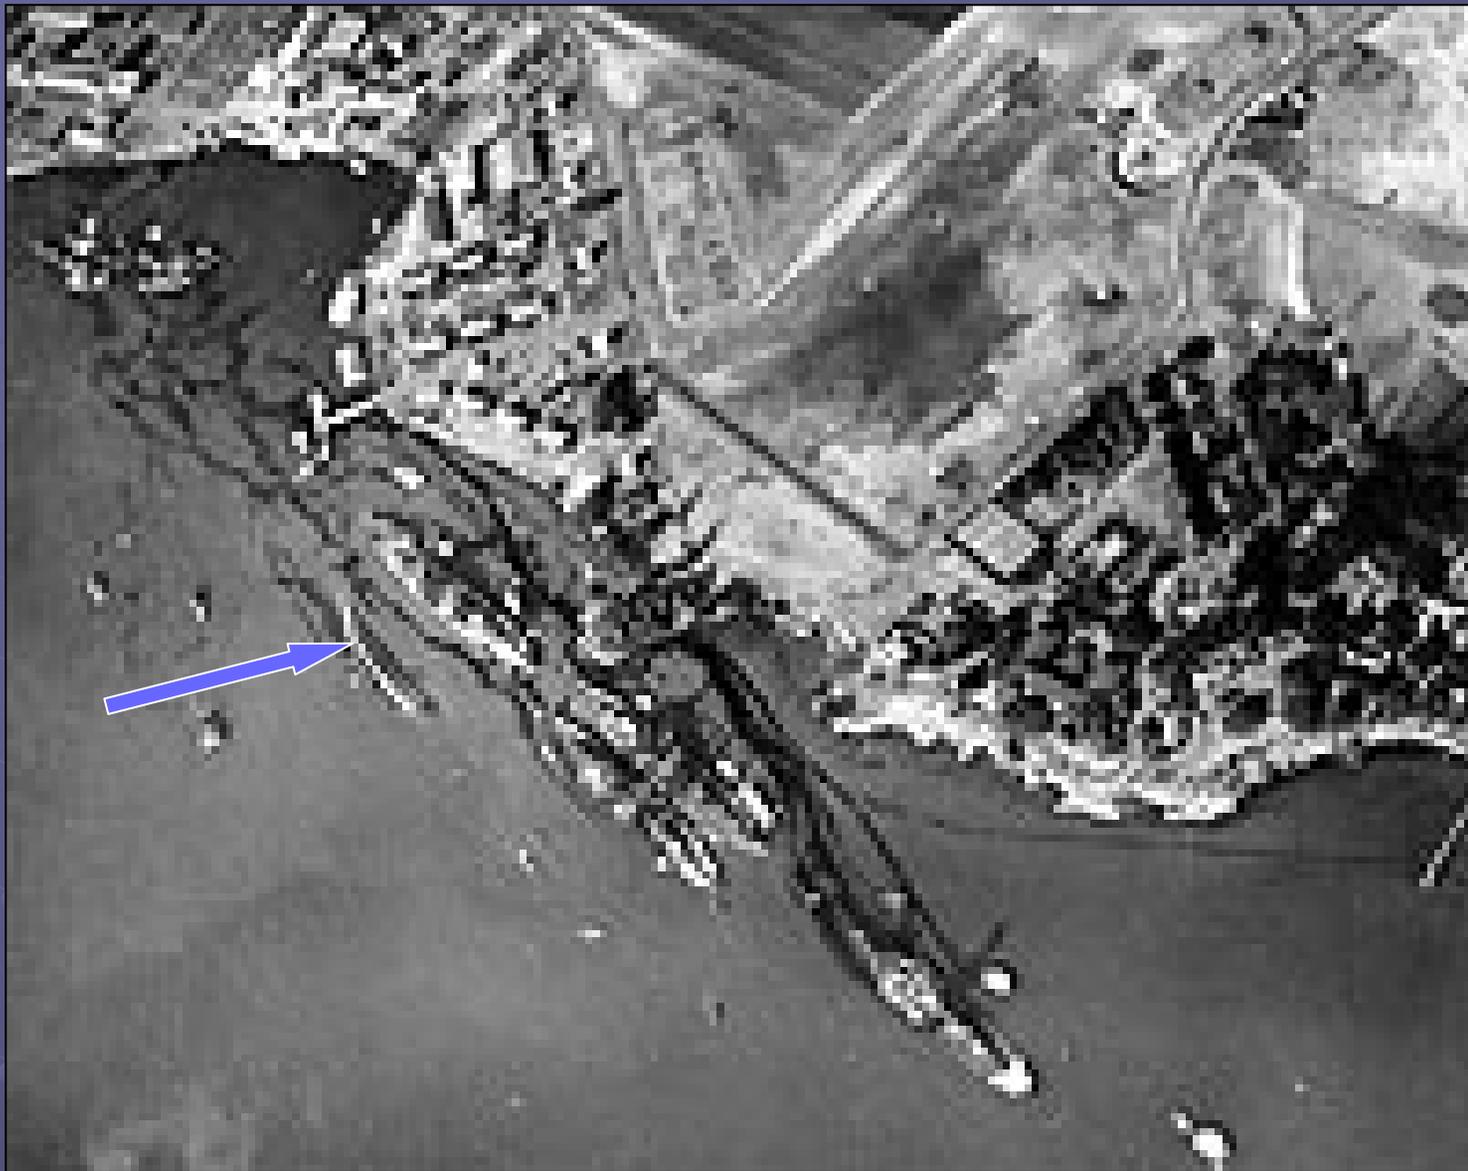
Damage Assessment: Aerial view of battleship row, showing capsized hull of Oklahoma (arrow)

The Oklahoma had her bilge inspection covers removed for a scheduled inspection the following day (Dec 8th). This precluded counter flooding to prevent her from capsizing . Although 32 sailors wee saved after 3 days, 415 of her crewmen perished

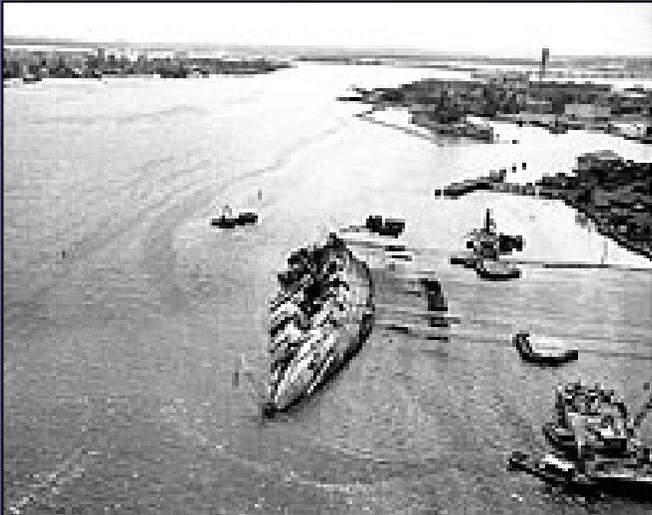
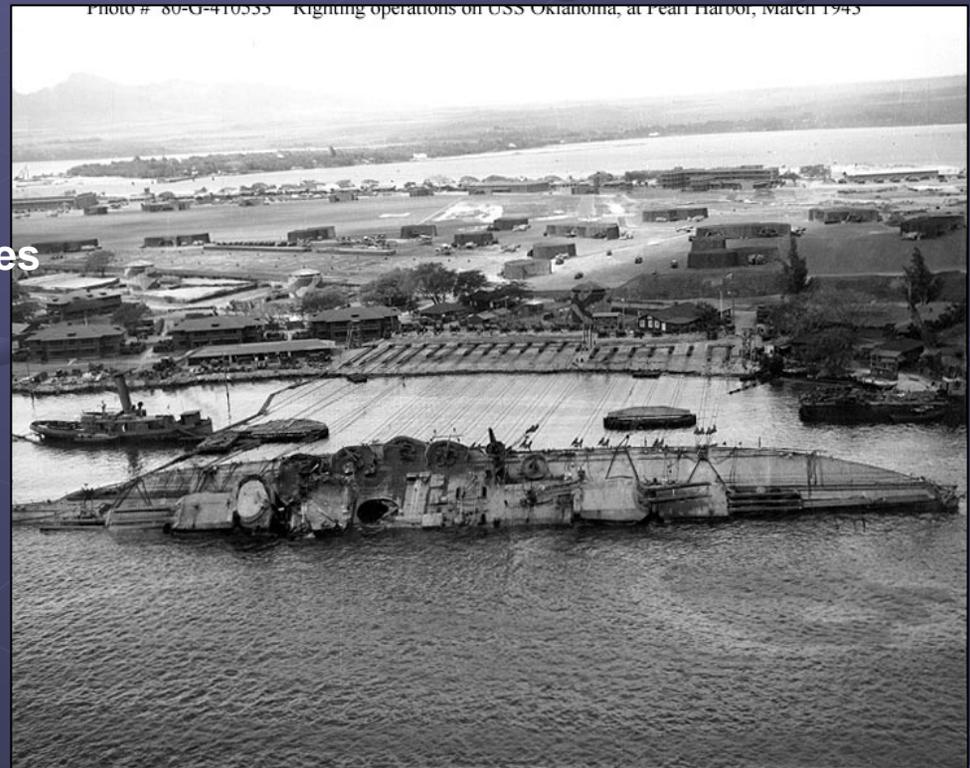
Successful Righting of the Oklahoma

First Pull configuration began 8 March 1943
Final Pull configuration from 20 May 1943
74 days used to turn ship over

A-frames dropped out around 70 degrees

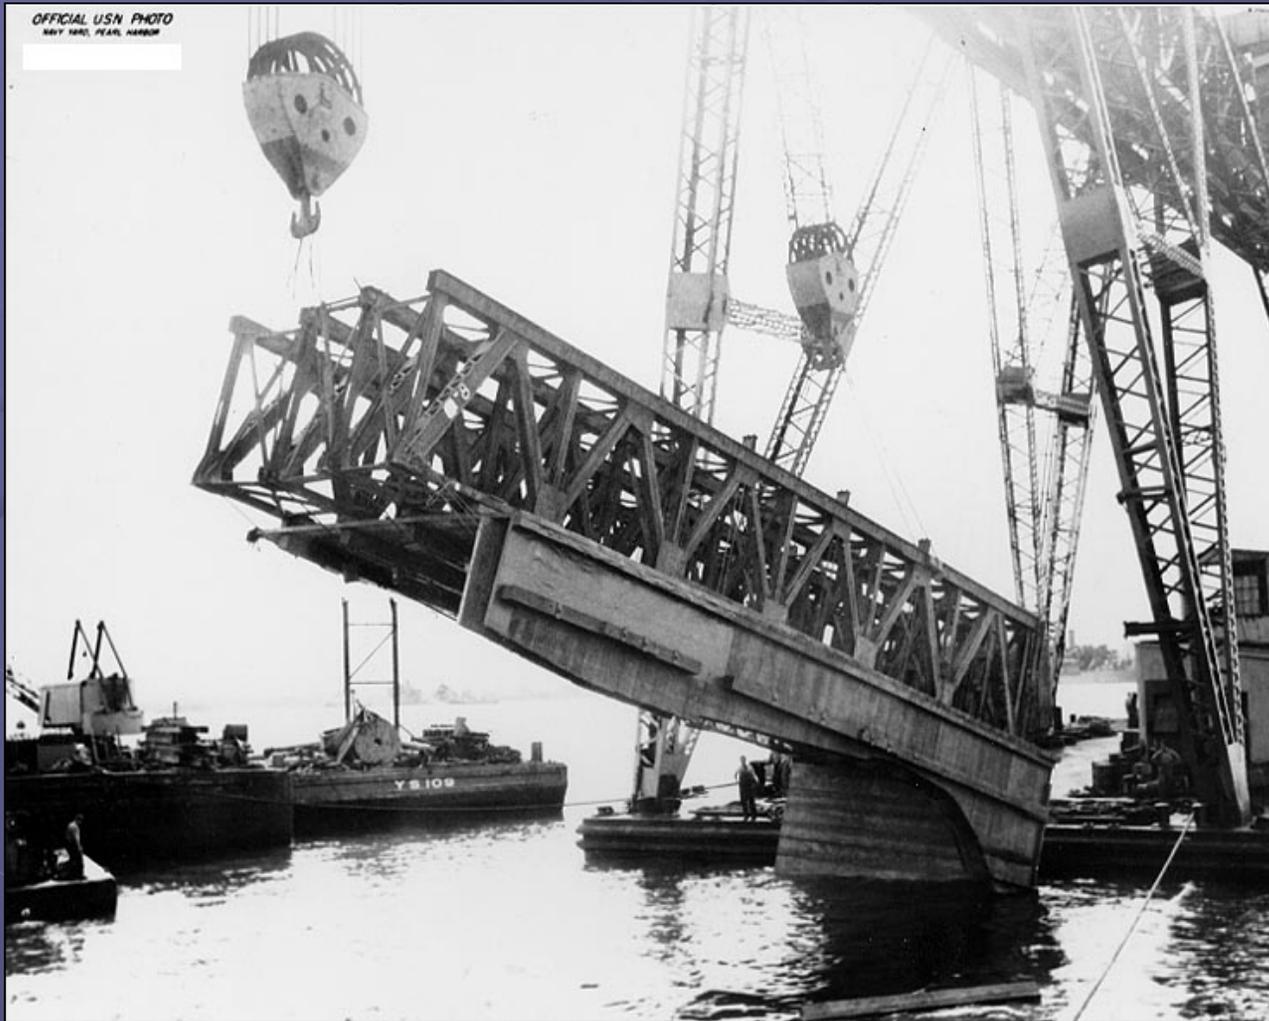
Preparing the hull for refloating

Placing the first cofferdam patch over torpedo damaged hull's port side. Each patch was custom made to fit a certain portion of the deformed hull

The ship was about 10 feet below water level after righting operations were completed

- Refloating of the sunken hull required all hull leaks to be patched
- Gaping torpedo holes were covered with enormous timber cofferdams
- Concrete patches used beneath the cofferdams
- Biggest challenge was gaps between hull plates because frame was distorted by capsizing and salvage roll over
- Divers stuffed kapok into gaps between hull plates as water was pumped from hull. This eventually worked

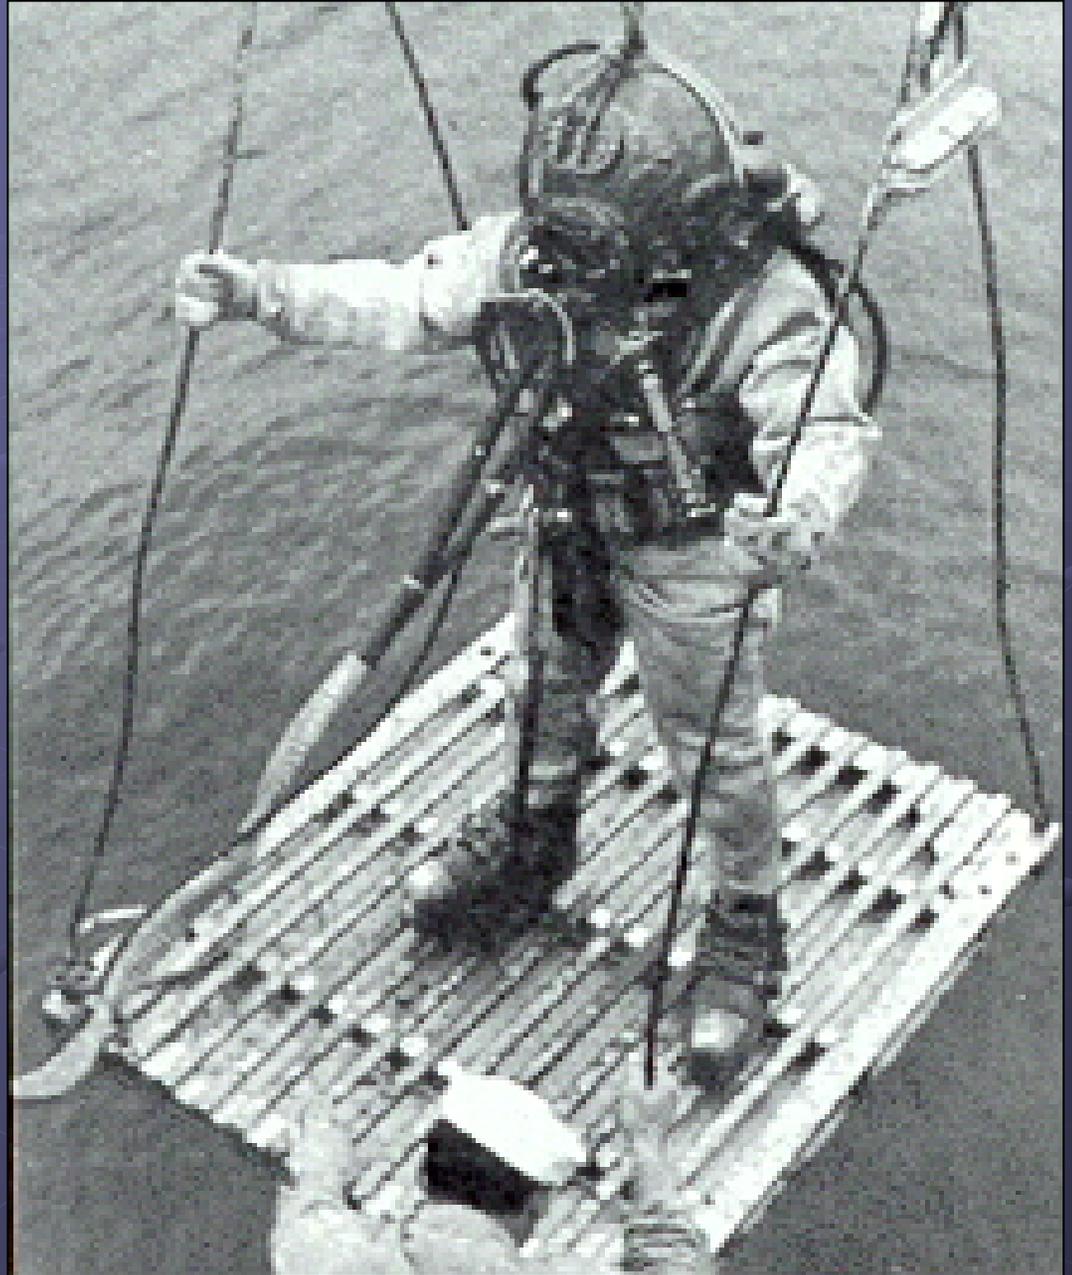
Mk V Deep Sea Diver rig was used in much of the underwater salvage work. Many of the salvage techniques used today were developed by these divers during World War II, who spent 2 to 3 years at Pearl Harbor; such things as arc welding underwater with 440 amps and using hydraulic jets to excavate tunnels beneath sunken hulls.

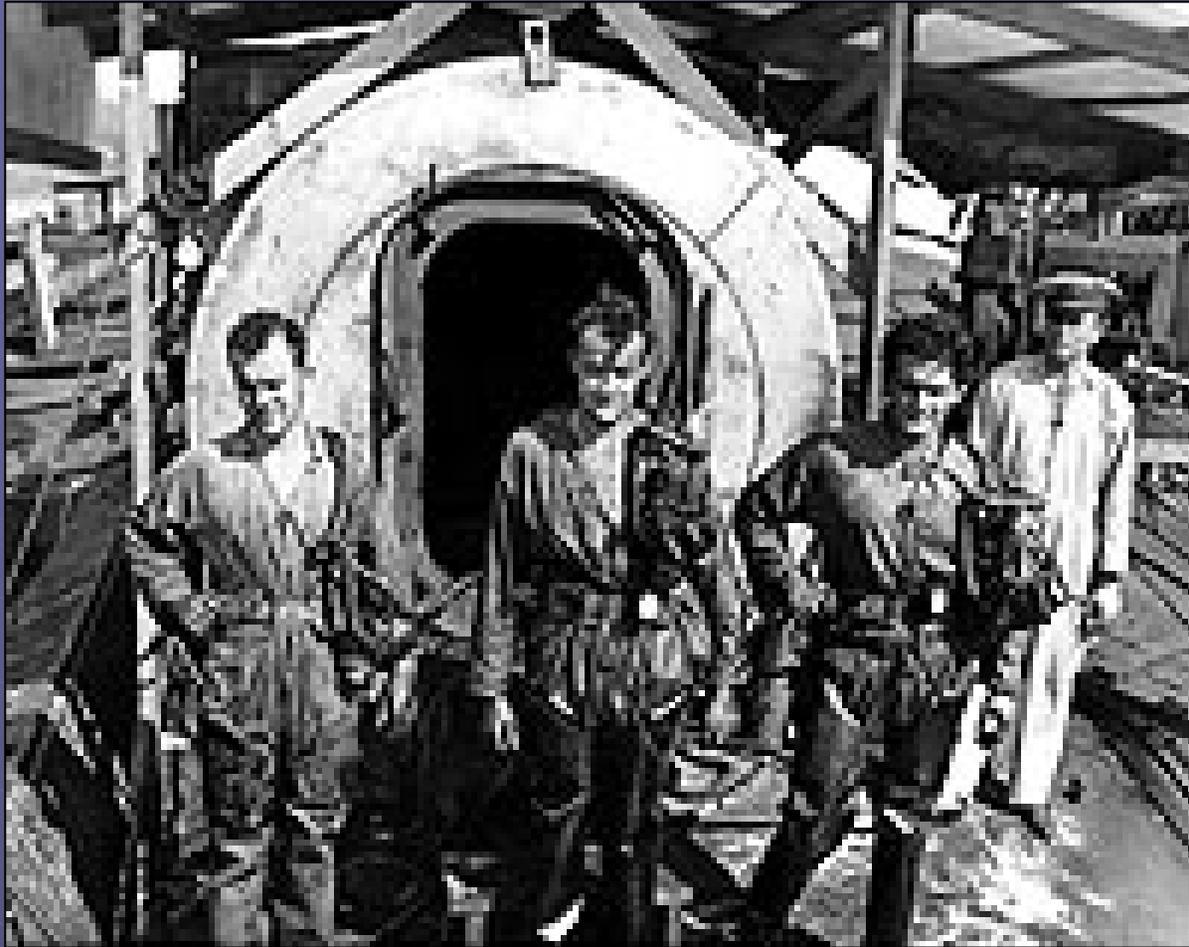
- In the salvage of the *Oklahoma* alone divers made 1,848 dives involving 10,279 man hours under pressure. There were only five diving supervisors.

All the diving and decompression on the Oklahoma never killed a military diver, but a civilian diver from the Pacific Bridge Company was killed when his air hoses became severed. The Navy divers had a better safety record.

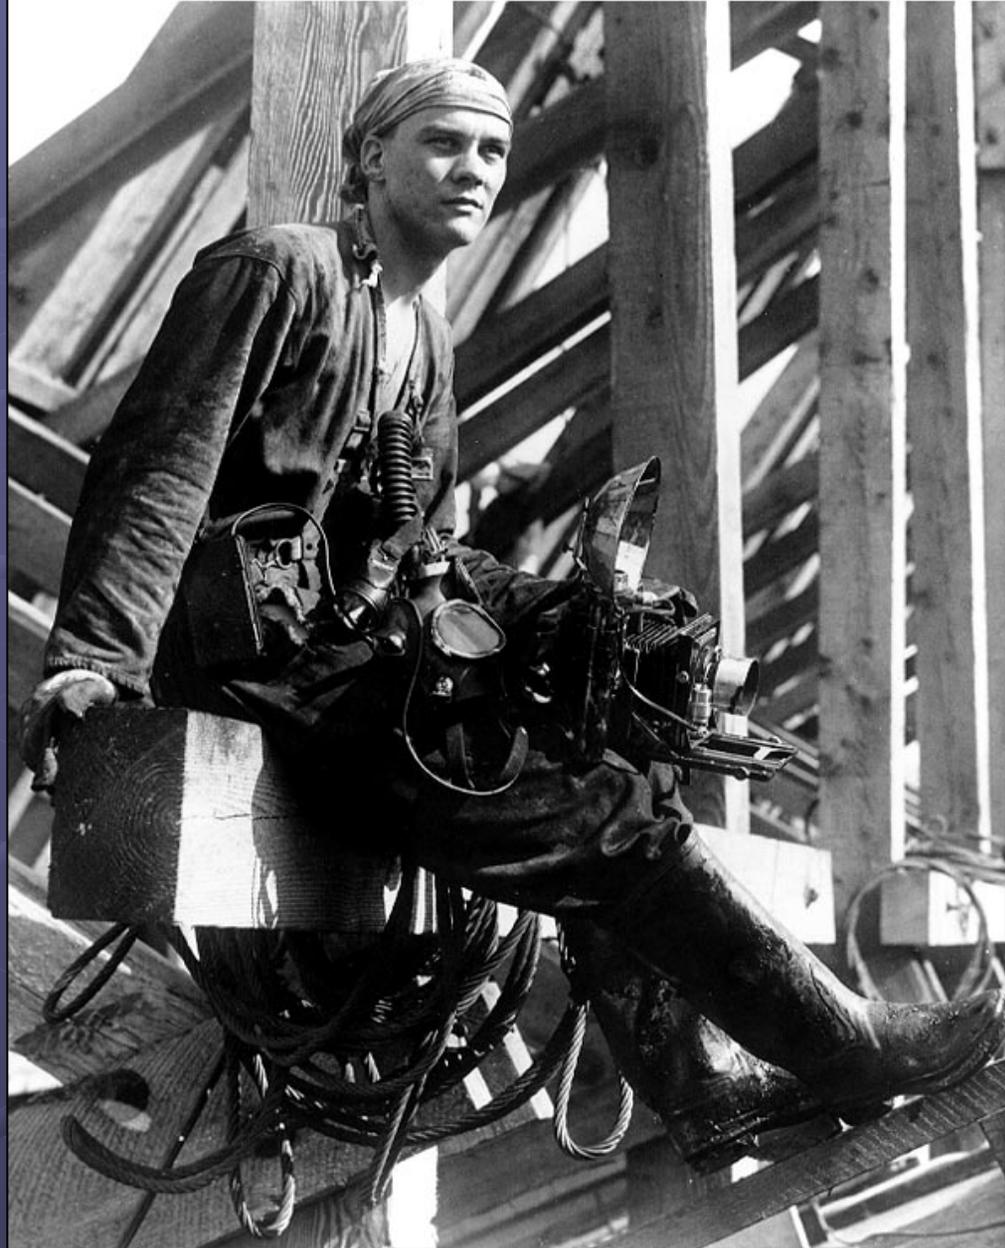
Photo # 80-G-276601 Photographer works on wreck of USS Oklahoma, Jan. 1943

Salvage workers entered the ship through airlocks into the pressurized hull
Note the mask, tank suit, gloves, boots, and camera. He is sitting on one of the timber frames.

The safety wear is because of the decomposition of bodies, fuel and supplies.

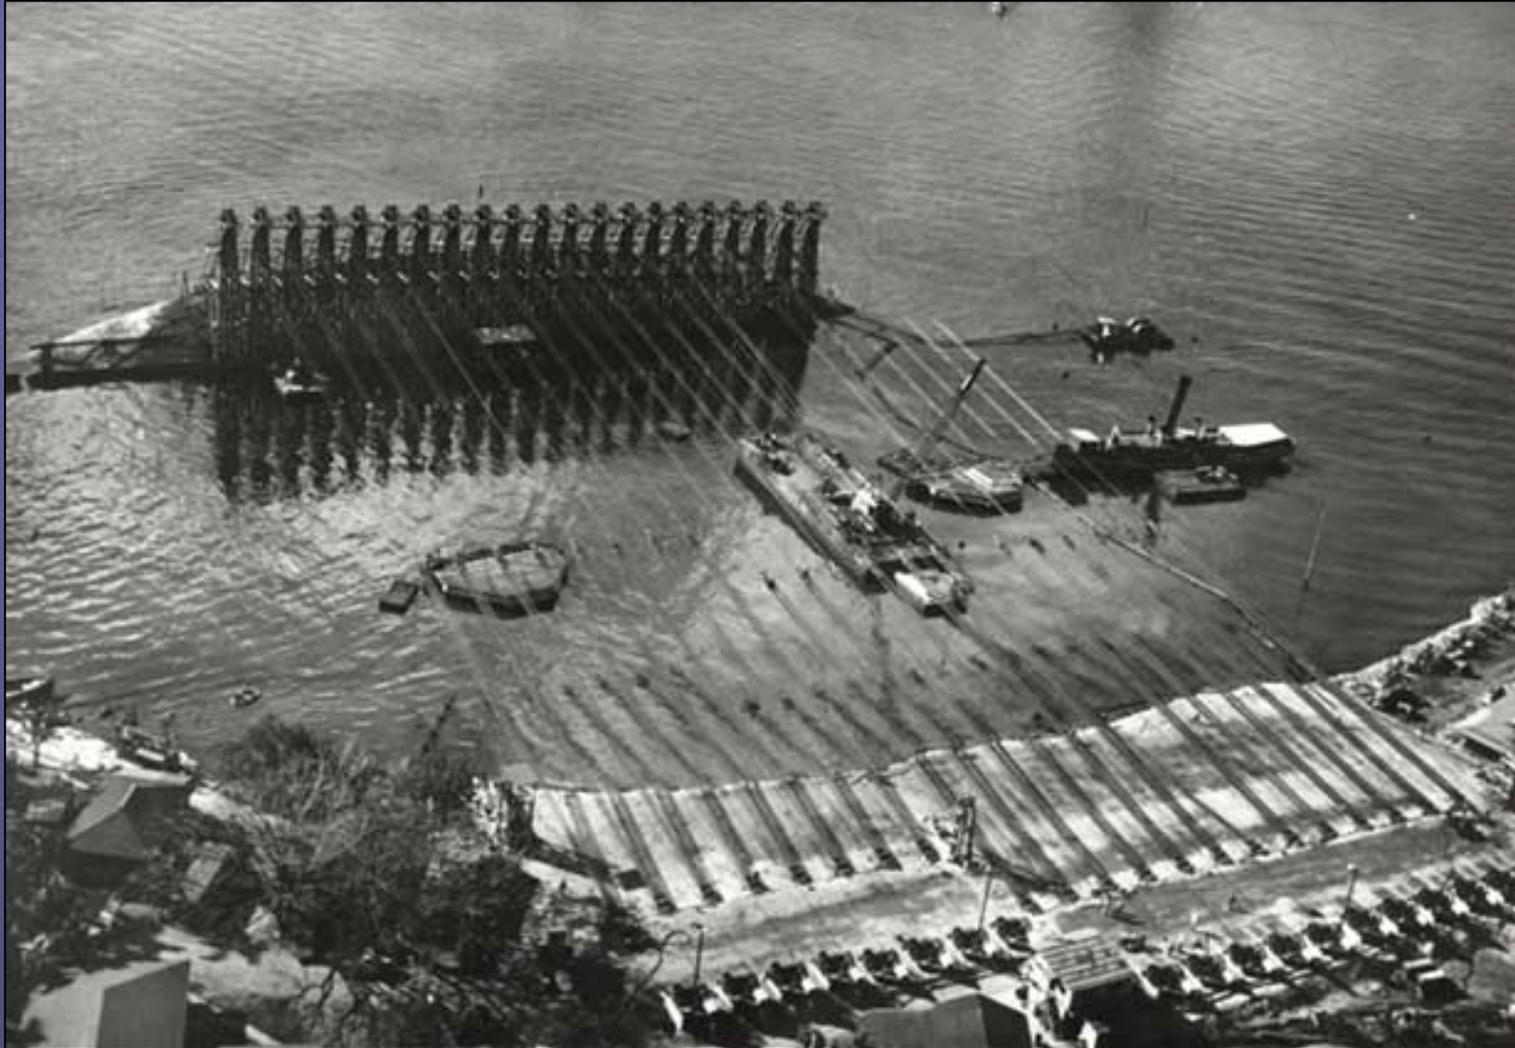
Righting of the Oklahoma begins

Cables pulling the Oklahoma's sunken hull out of Pearl Harbor on March 8, 1943

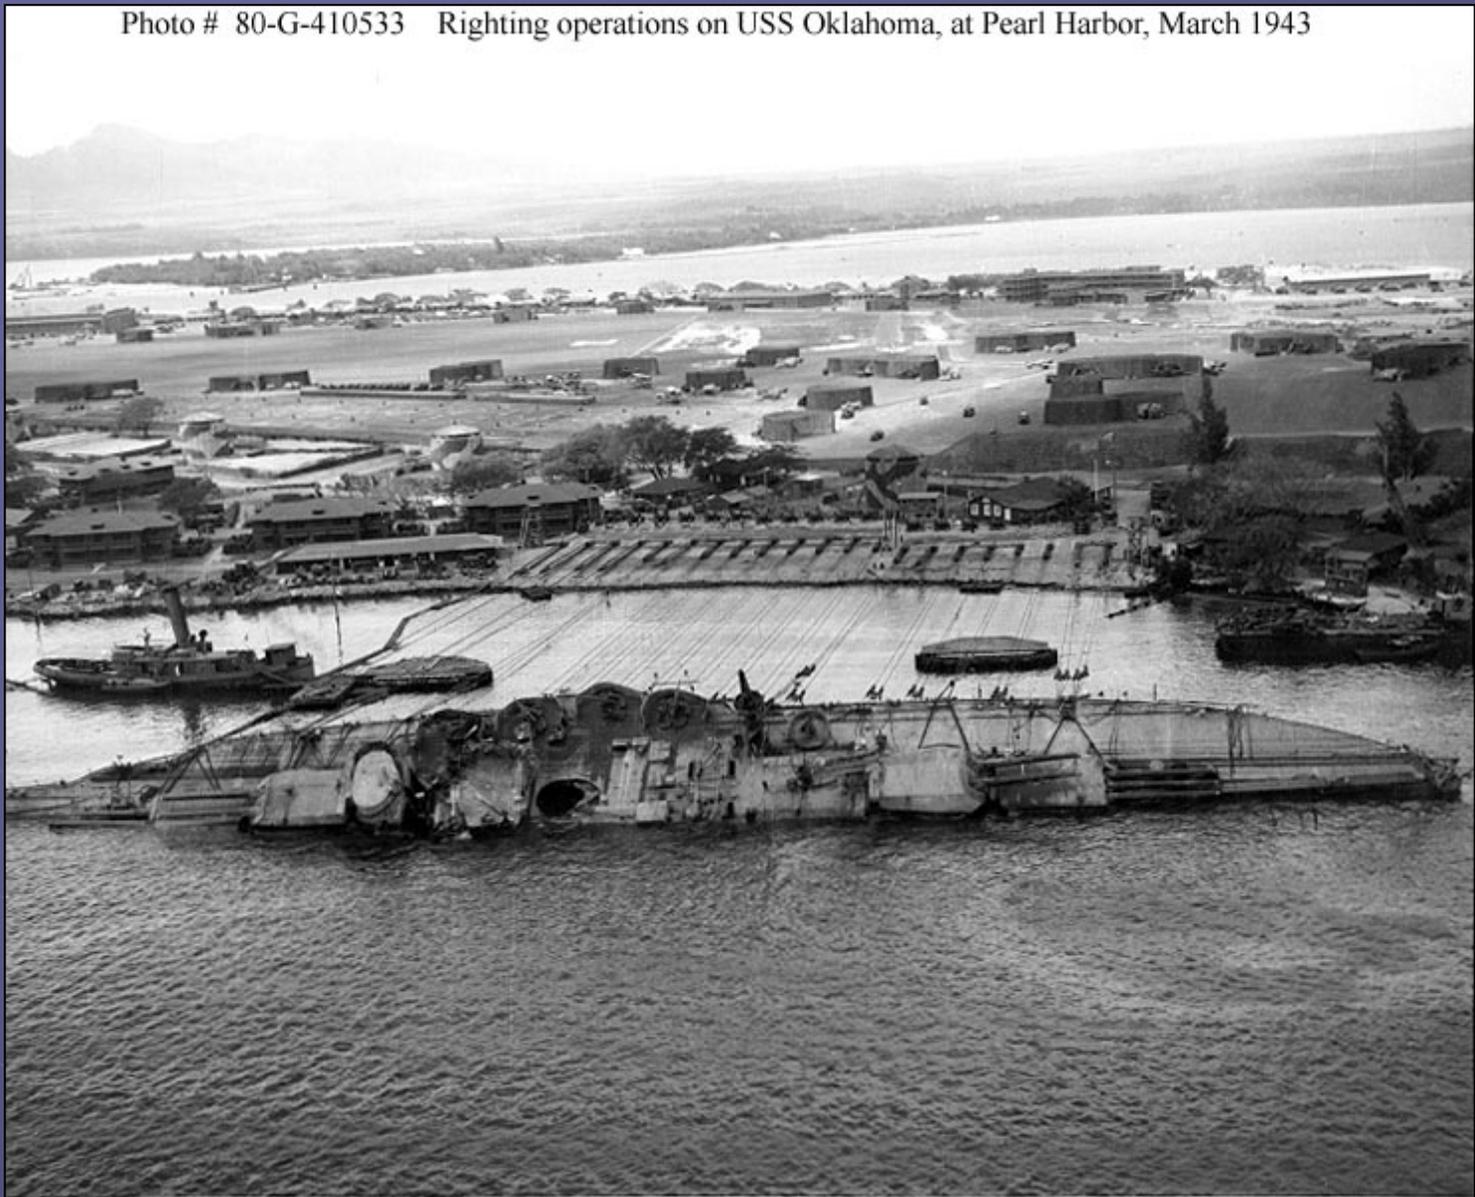
Photo # 80-G-410533 Righting operations on USS Oklahoma, at Pearl Harbor, March 1943

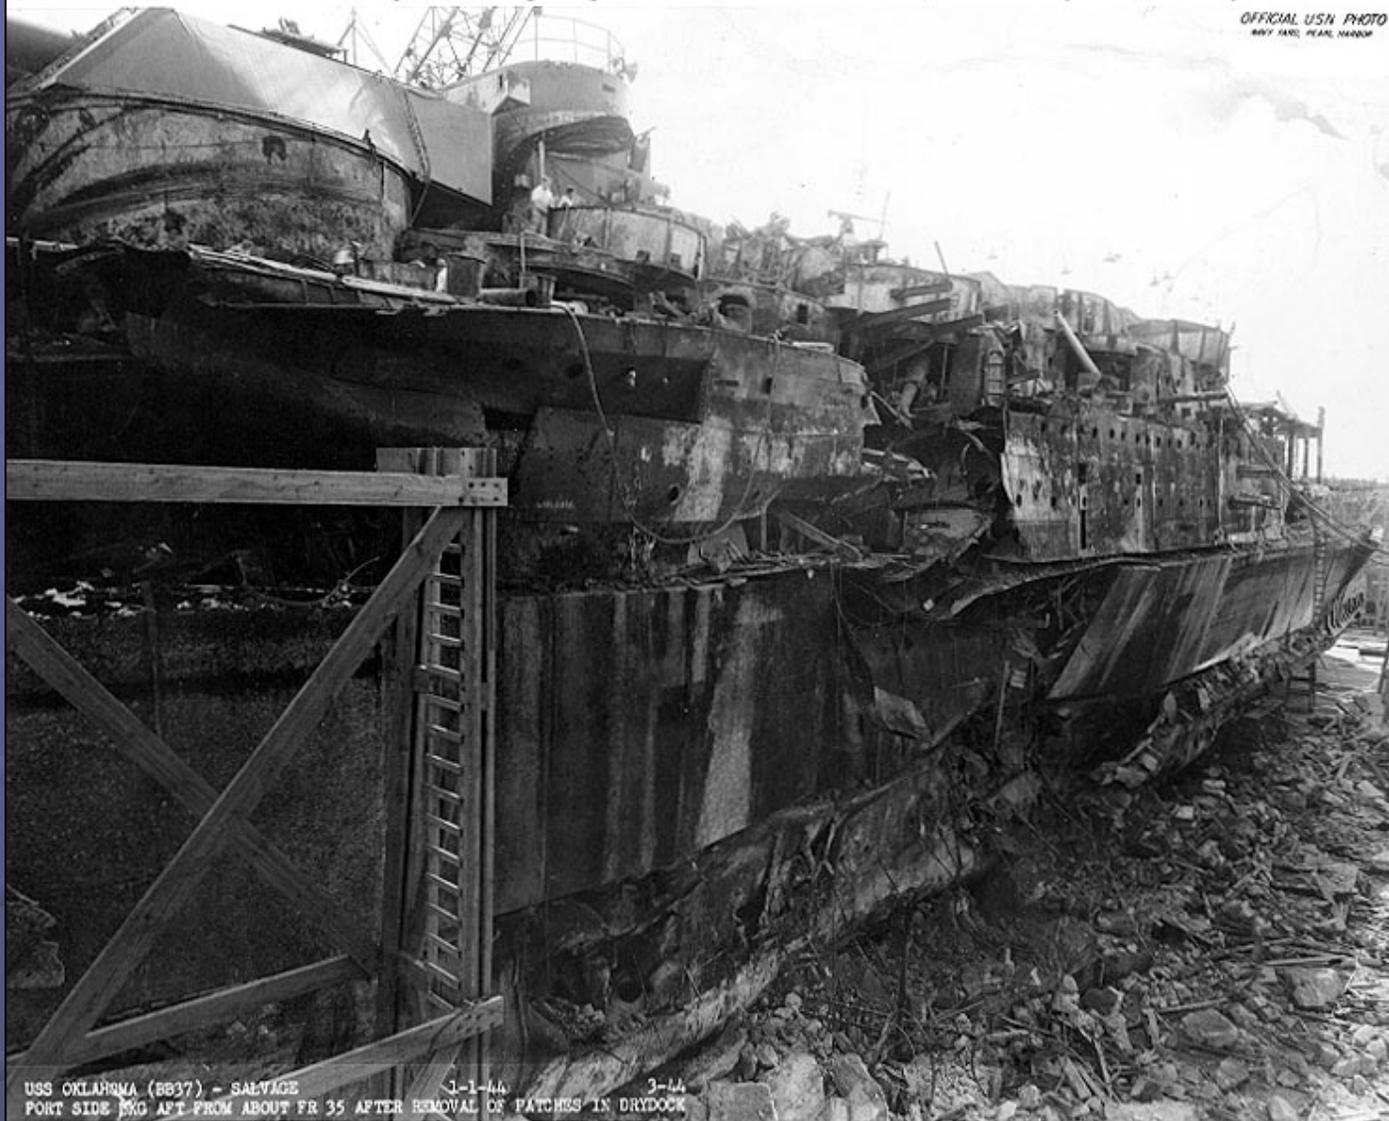
ASBF (VJI) #23029 - 6 Nov., 1943.
U.S.S. OKLAHOMA - Salvage
Aerial view from port side after refloating.

The Oklahoma was eventually floated using twenty 10,000 gallon per minute pumps during an 11 hour period on November 3, 1943

Photo # NH 63917 Torpedo damage to port side of USS Oklahoma, taken in drydock, January 1944

USS OKLAHOMA (BB37) - SALVAGE
PORT SIDE 8MG AFT PROM ABOUT FR 35 AFTER REMOVAL OF PATCHES IN DRYDOCK
1-1-44 3-44

Caved in hull of Oklahoma as revealed after chipping away temporary concrete patches. The torpedoes ripped holes as wide as 40 feet. Taken in January 1944
