# FAILED PINION

# ONE OF NINE DRIVE PINIONS

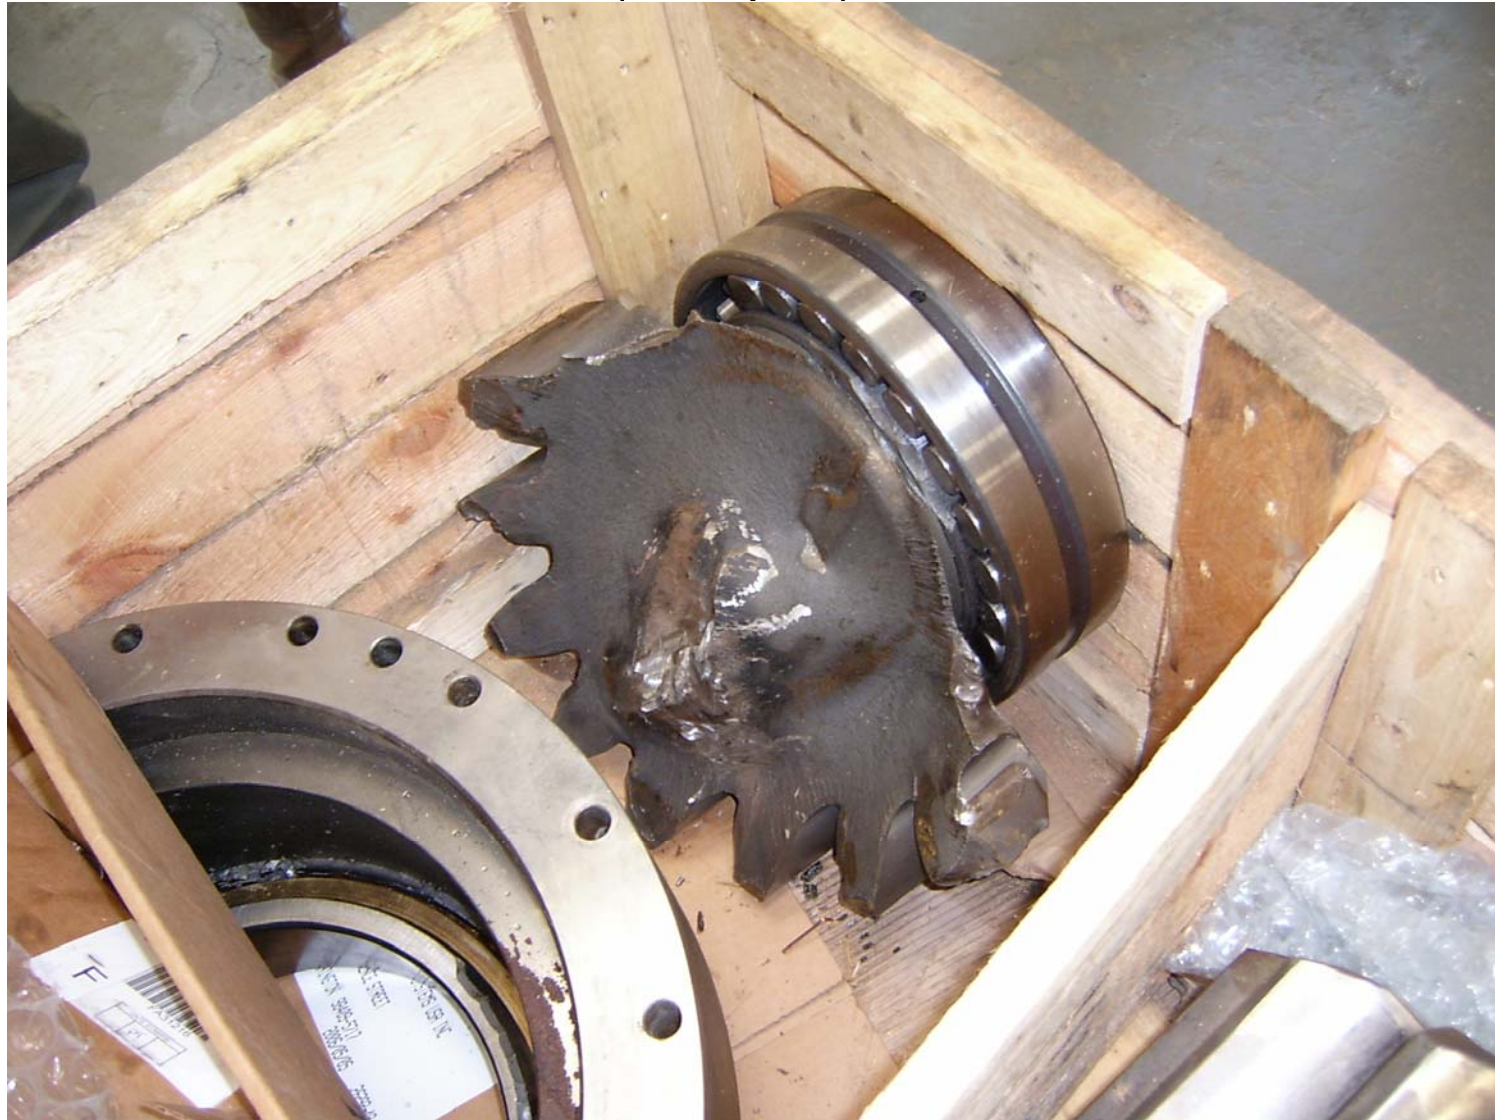
*(front part)*

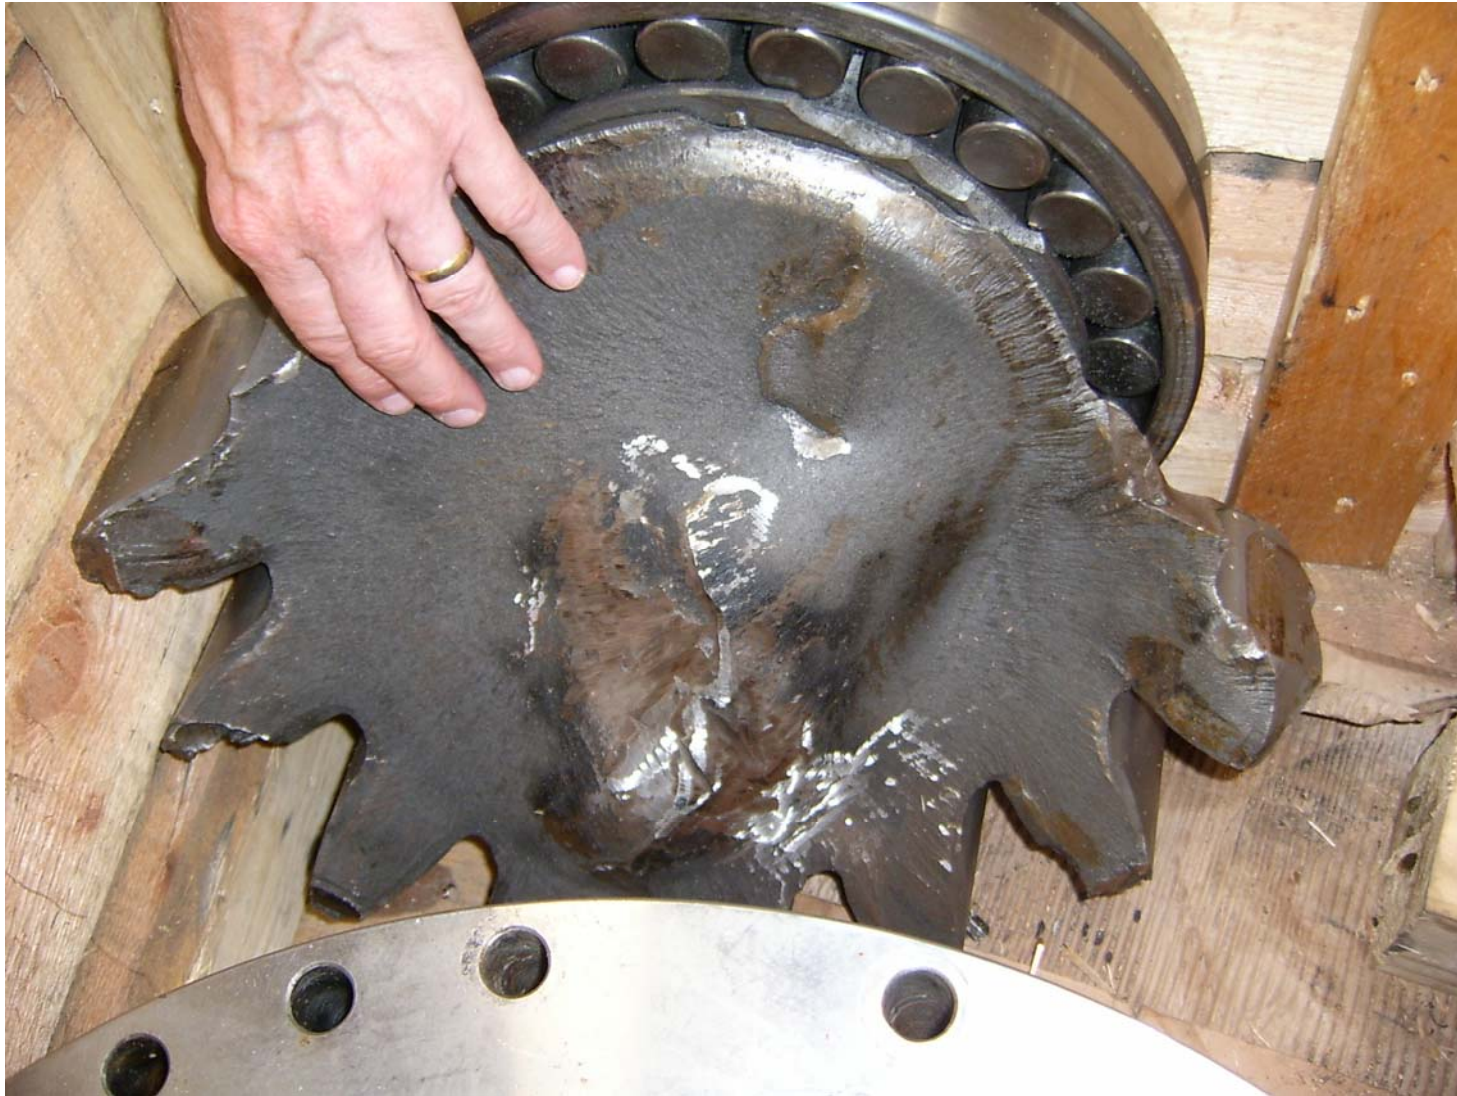
# FAILED PINION

*(Front Part)*

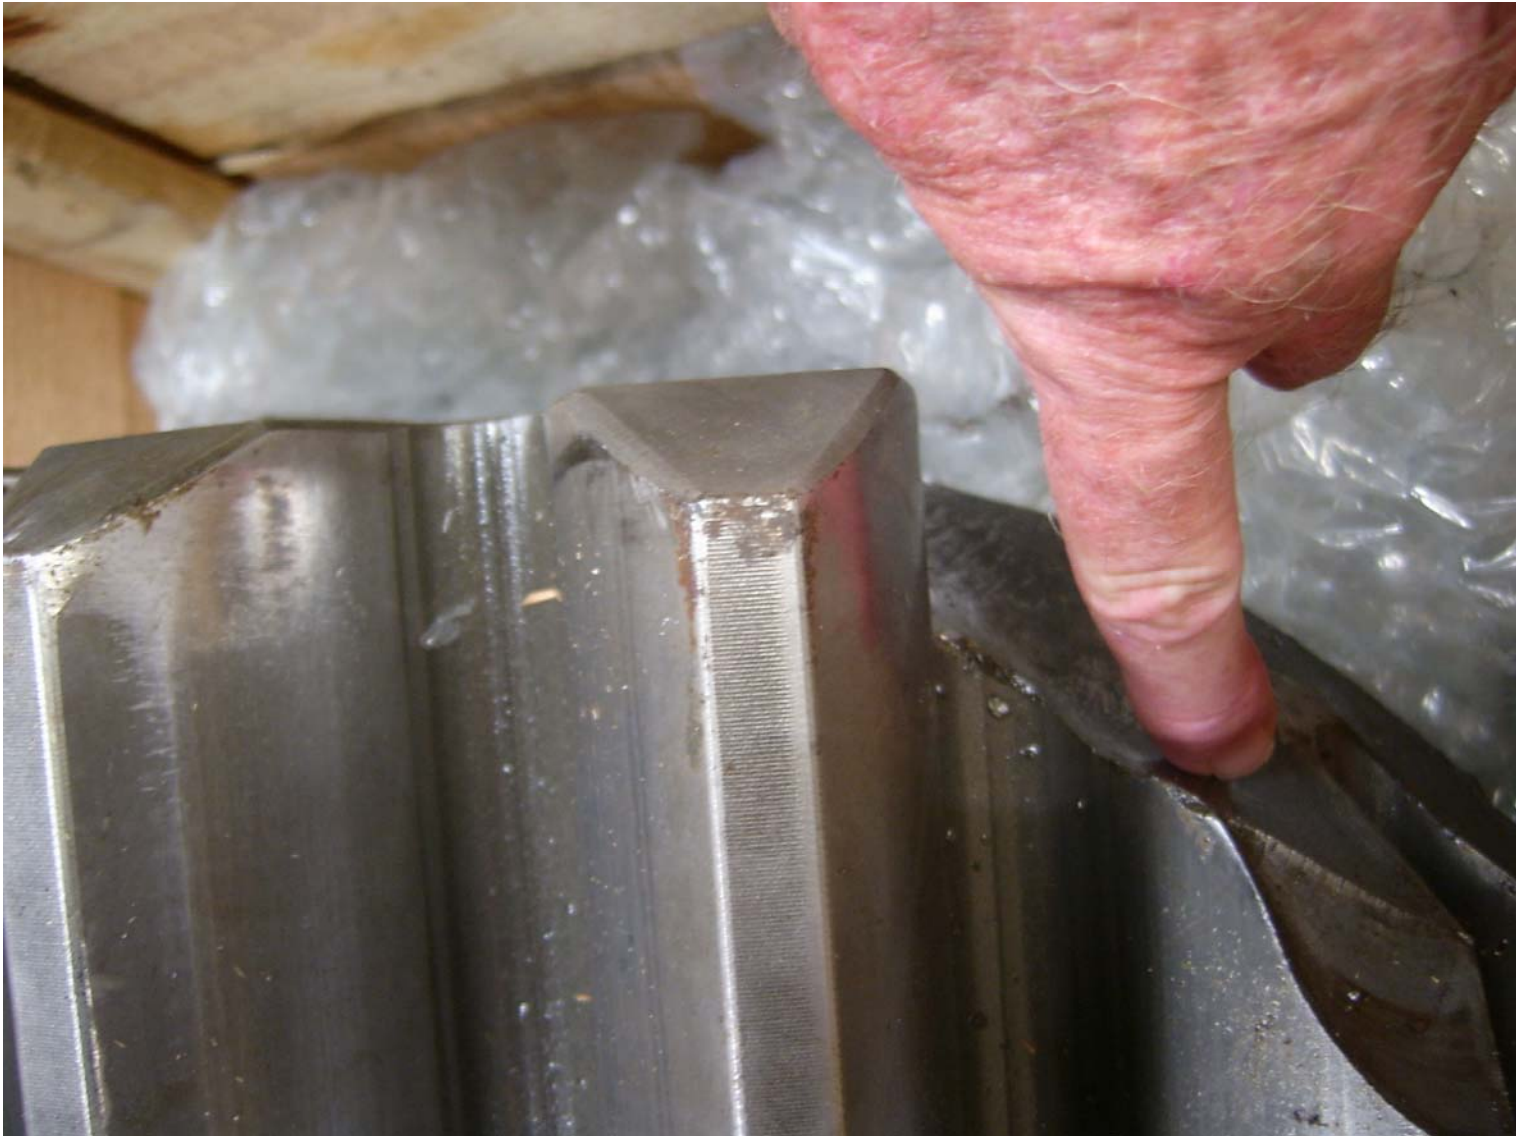
# FAILED PINION

*(Rear Part)*

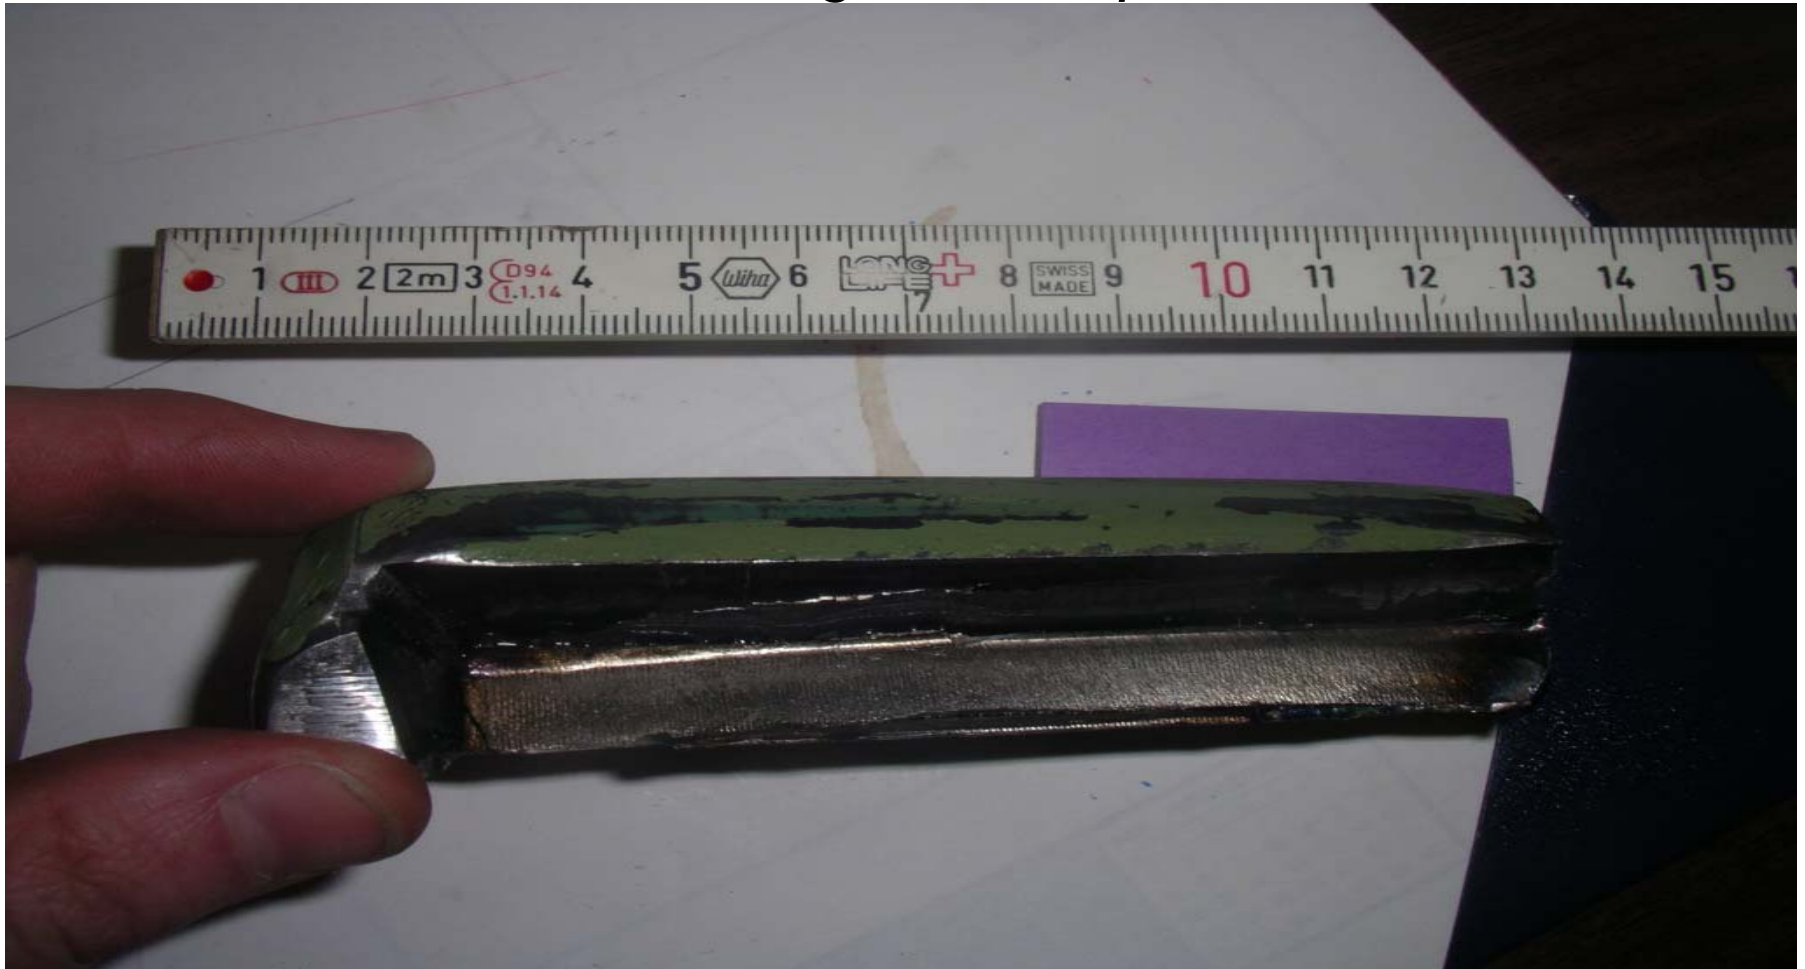
# BROKEN MAIN GEAR TOOTH

*Found during initial inspection*

Crushed and indentation caused by broken pinion running out of mesh with main gear

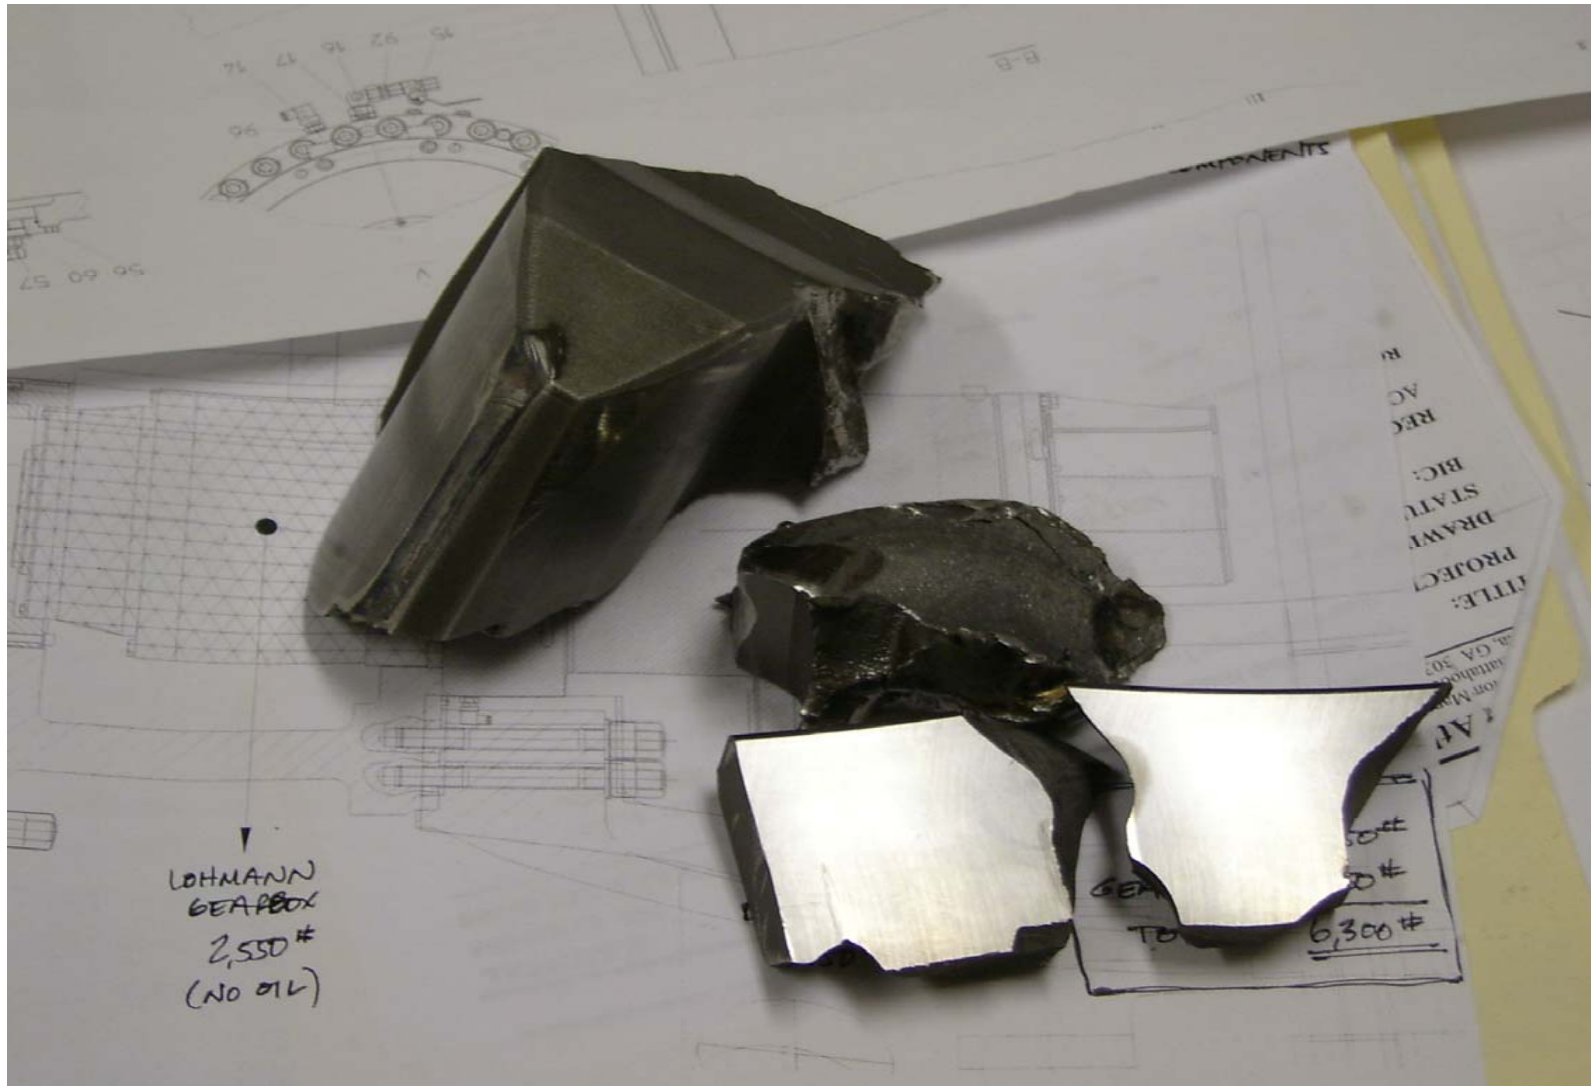
# BROKEN PINION GEAR TOOTH

Chunk of gear tooth and broken support bearing outer race

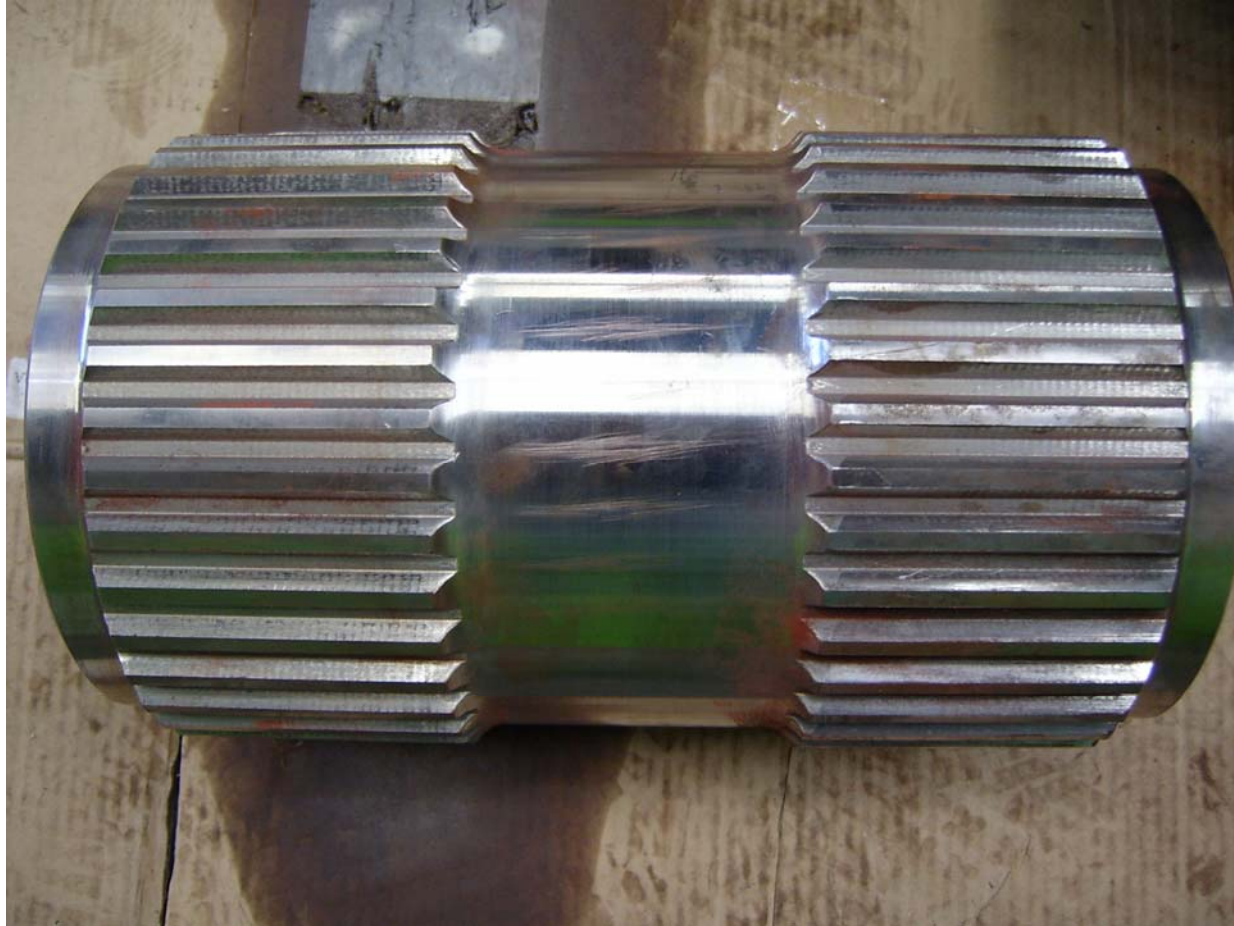
# SPLINED DRIVE SHAFT

One end connects to gear box and other end connects to the splined pocket of the drive pinion

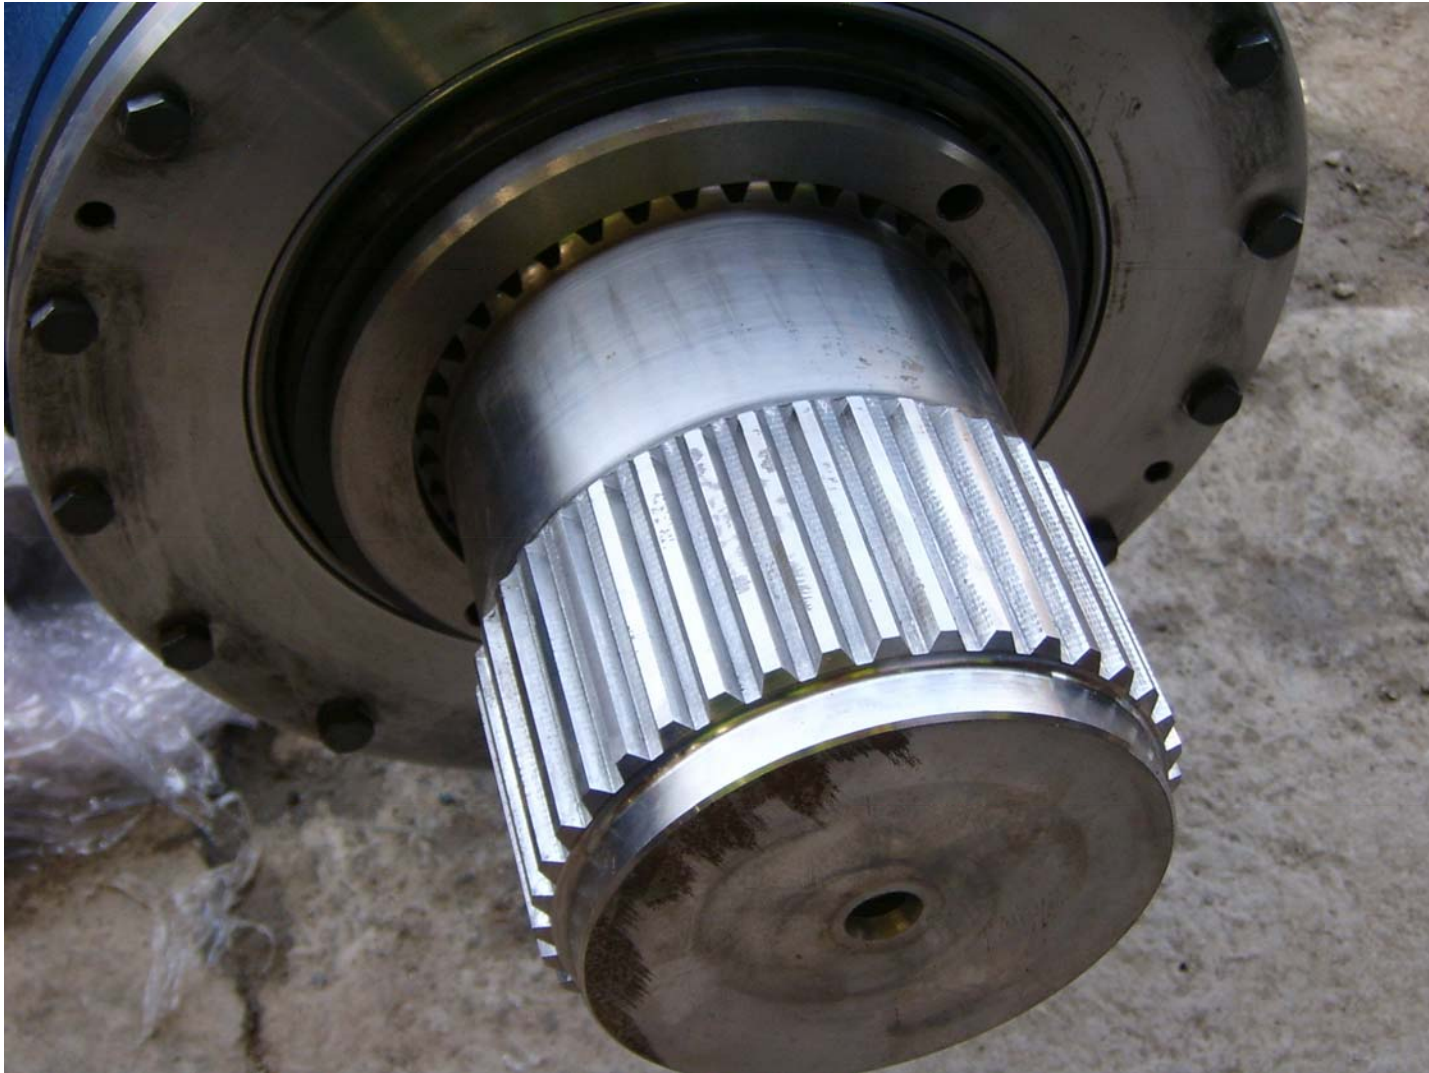
# SPLINED SHAFT

Mounted in gear box output

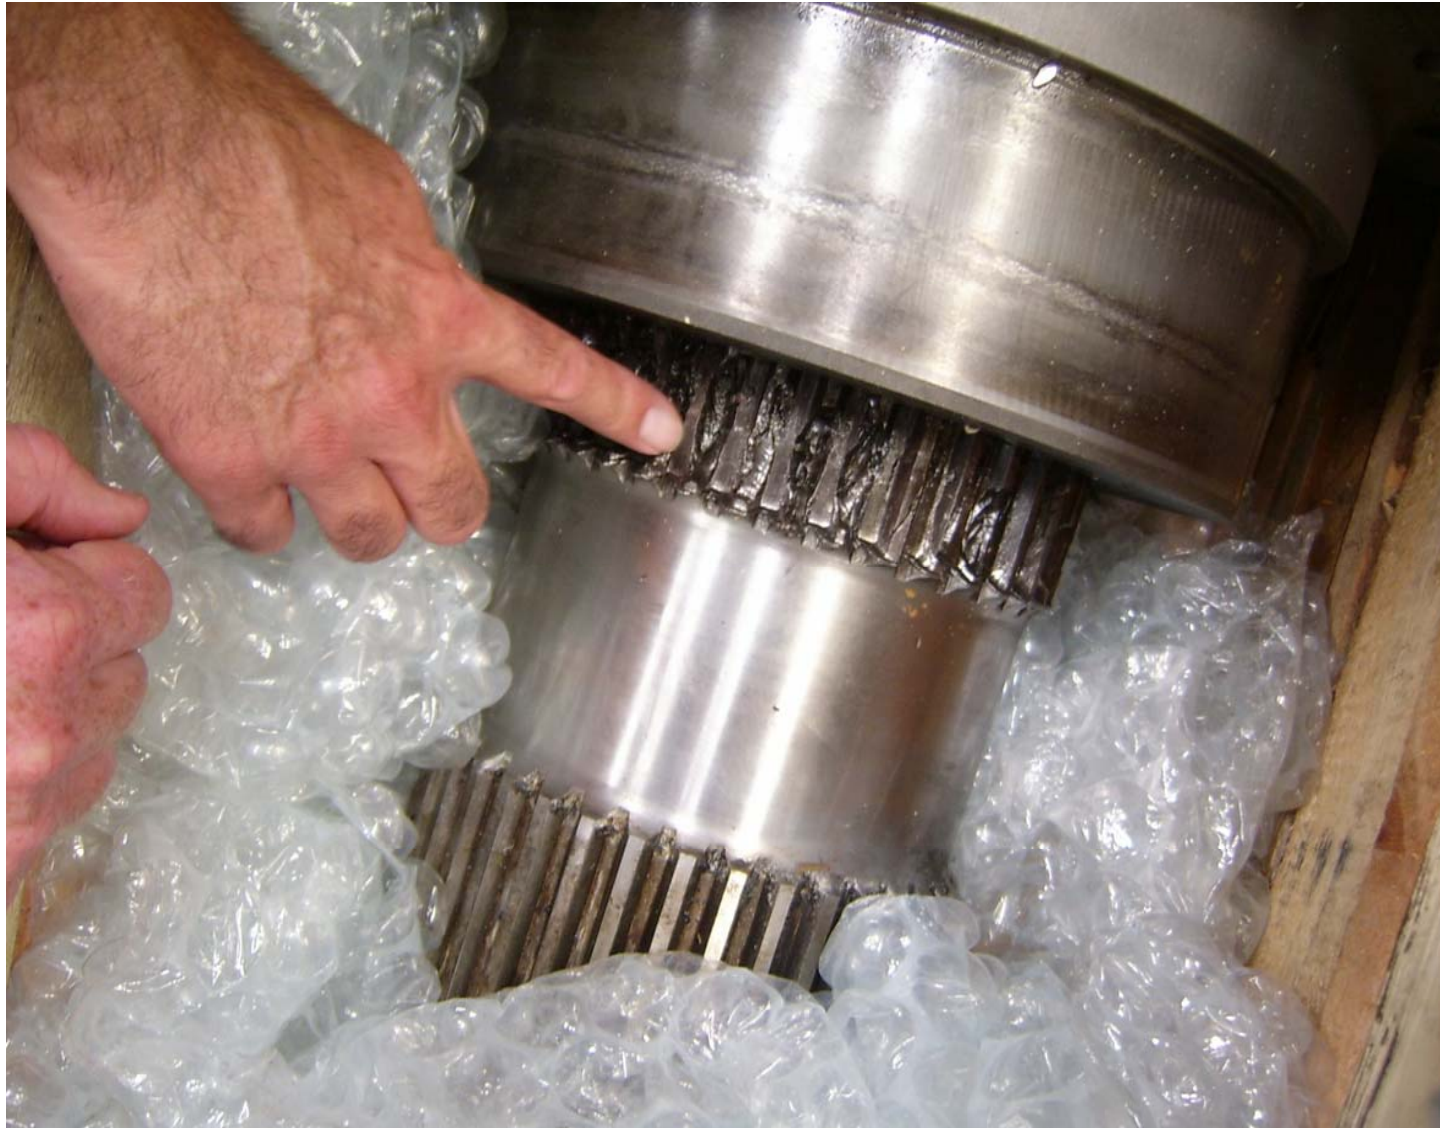
# SPLINED DRIVE SHAFT OF BROKEN PINION

Destroyed when pinion failed

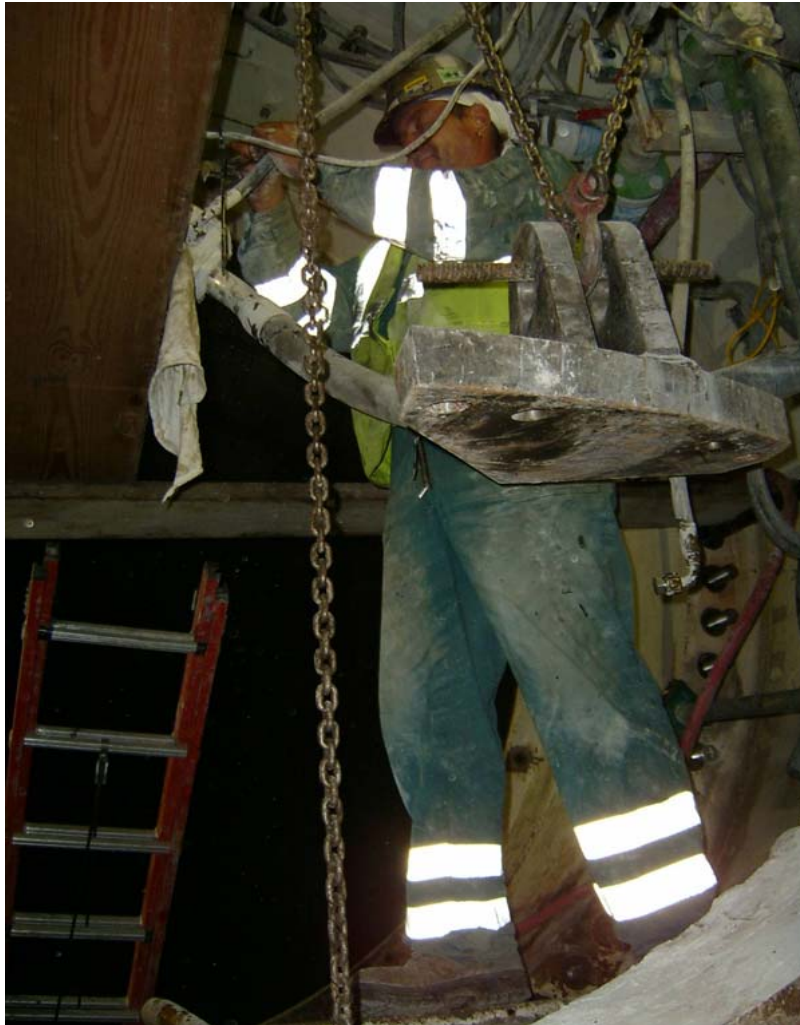
# INSIDE MAIN BEAM

*Looking out front of TBM*

Cutterhead has been removed and bolted to the tunnel face.

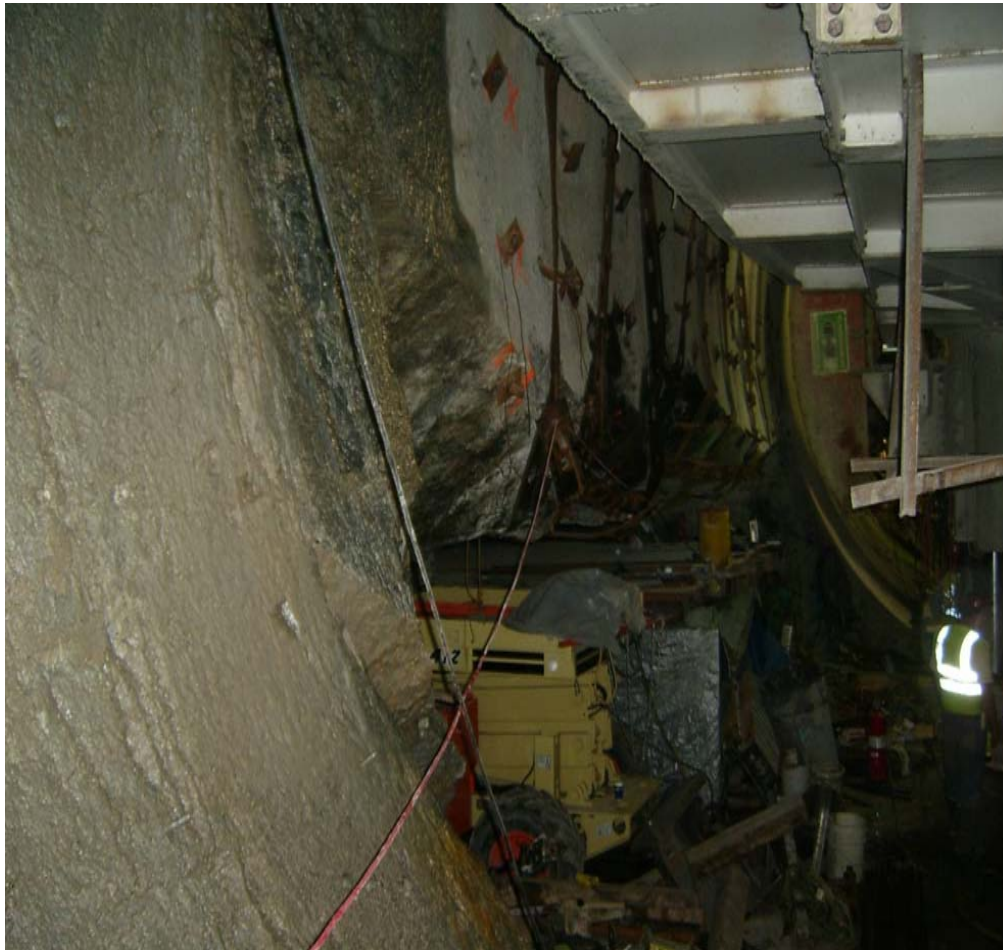
# Bearing Bypass Cavern

*In tunnel side wall*

Blasted 300 ft.  
from tunnel face  
behind TBM  
trailing gear

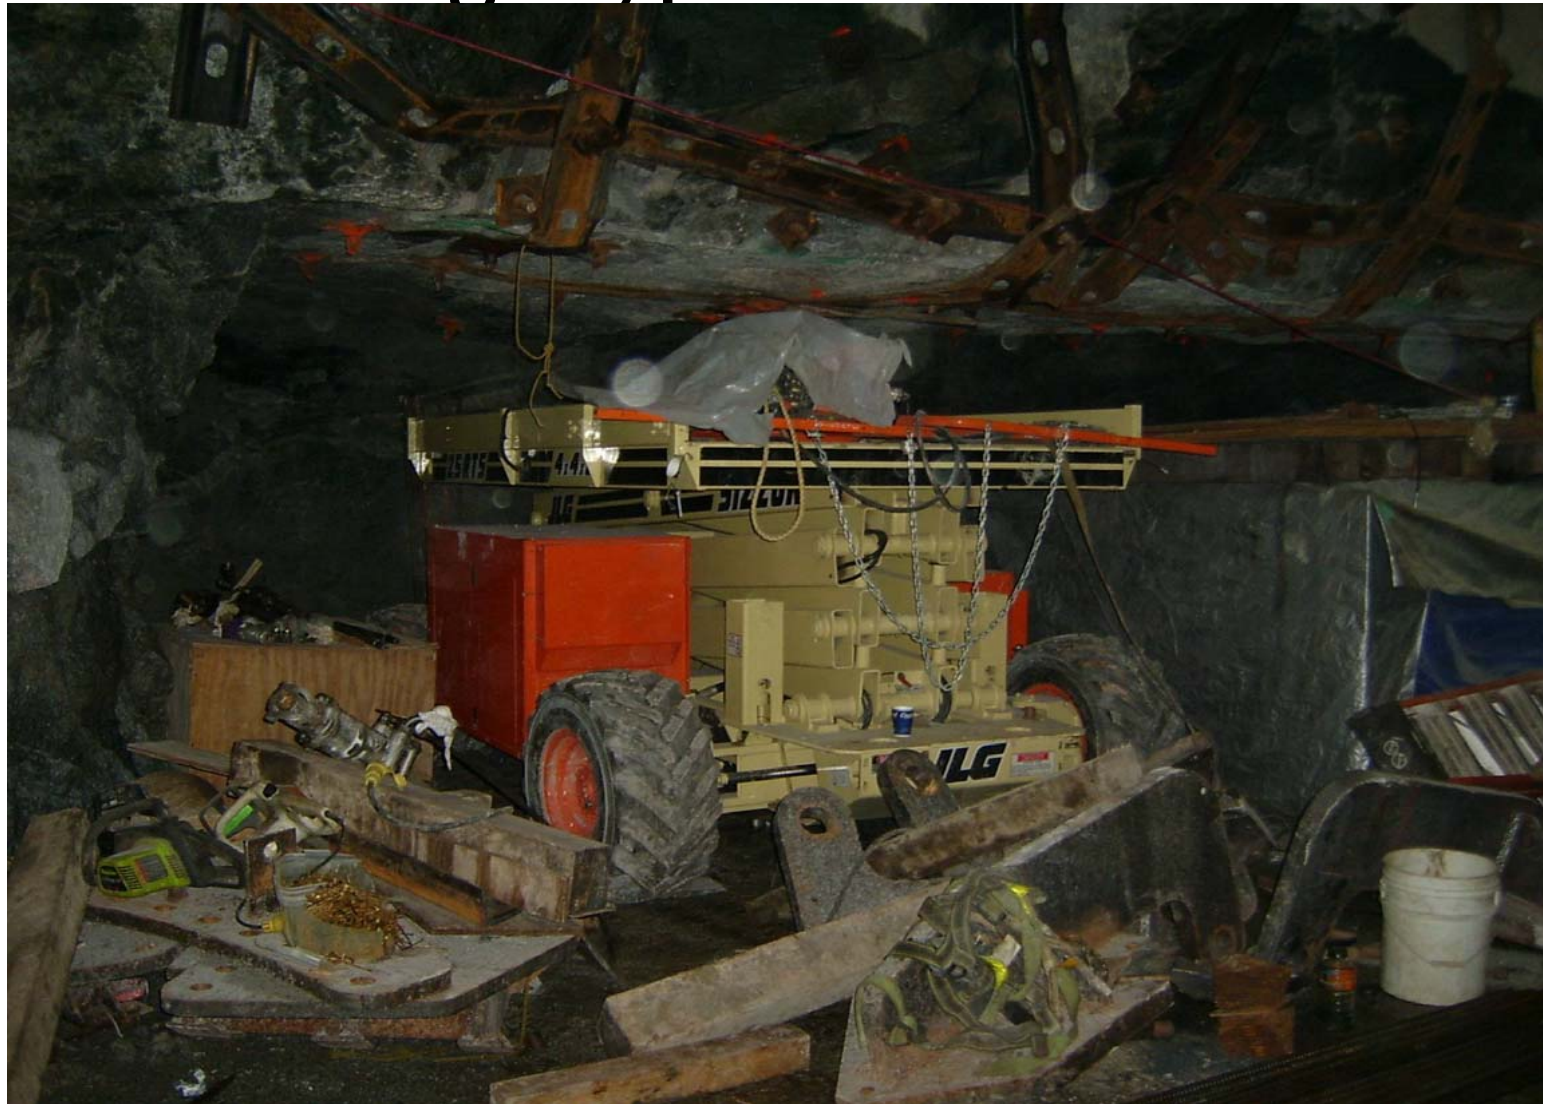
# Bearing Bypass Chamber

Housing new main bearing and man-lift

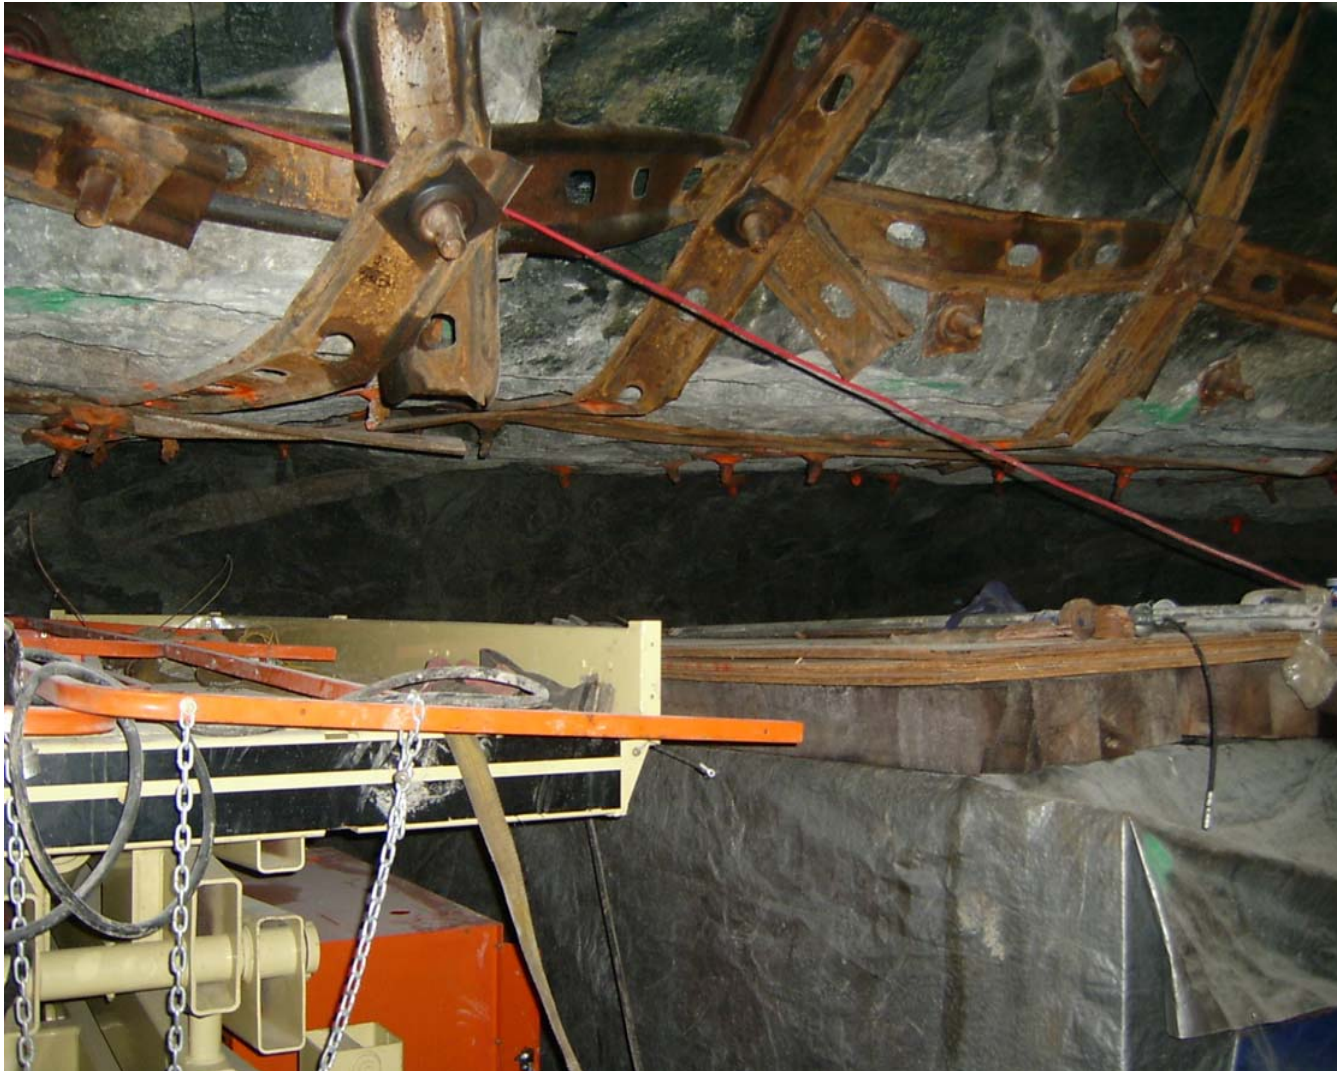
# ROCK BOLTS & STRAPS

Supporting roof bypass cavern

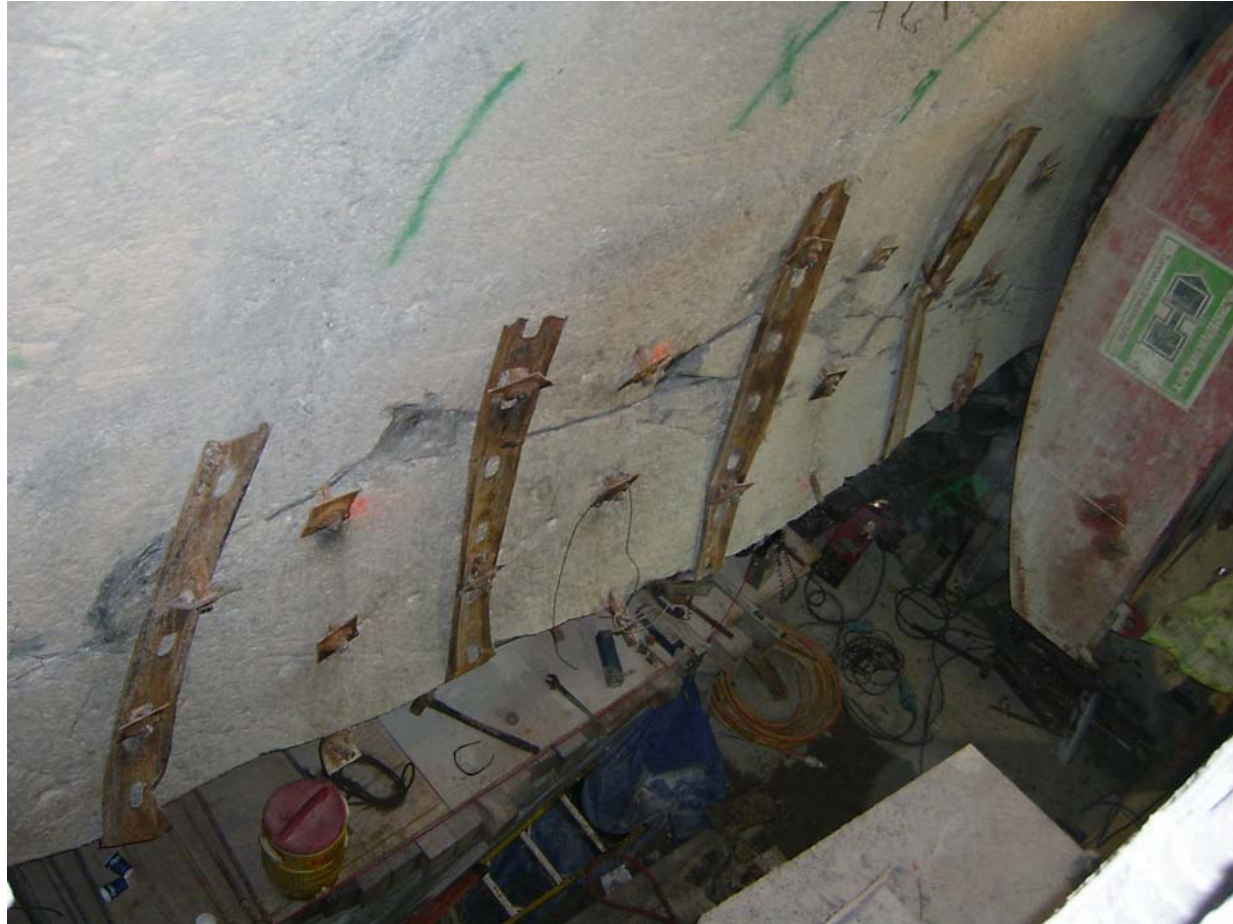
# FRACTURED ROCK

- Fractured rock above Bypass cavern prevent TBM gripper from being used to walk past cavern.
- A “walking shoe” was fabricated and bolted to the tunnel floor.

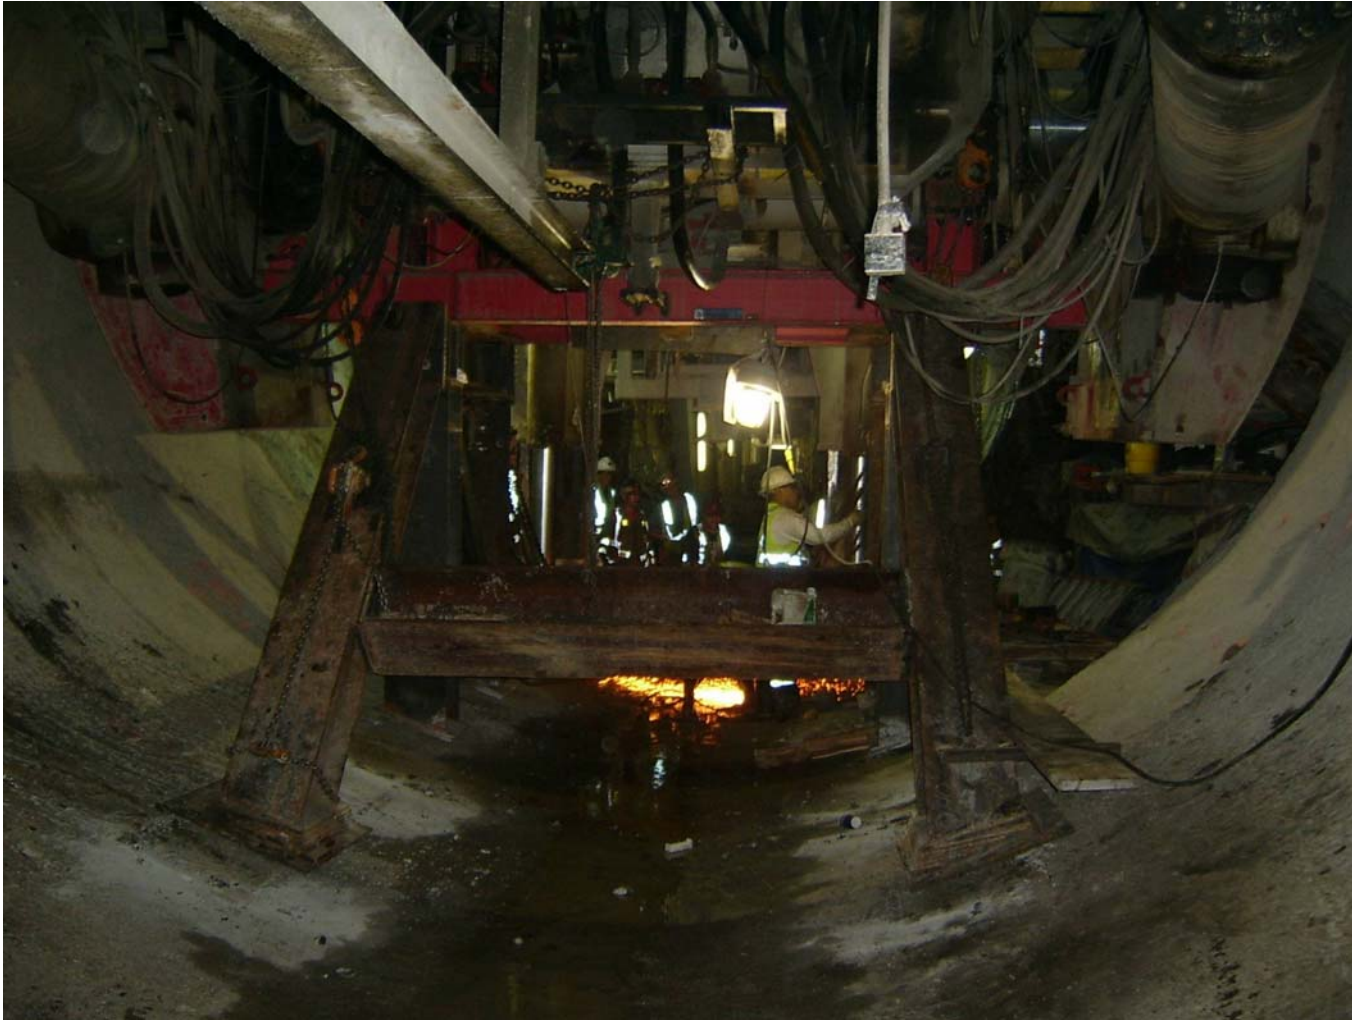
# WALKING SHOE

Walking shoe attached to tunnel floor allows moving TBM without using the gripper as it moves past bearing bypass cavern

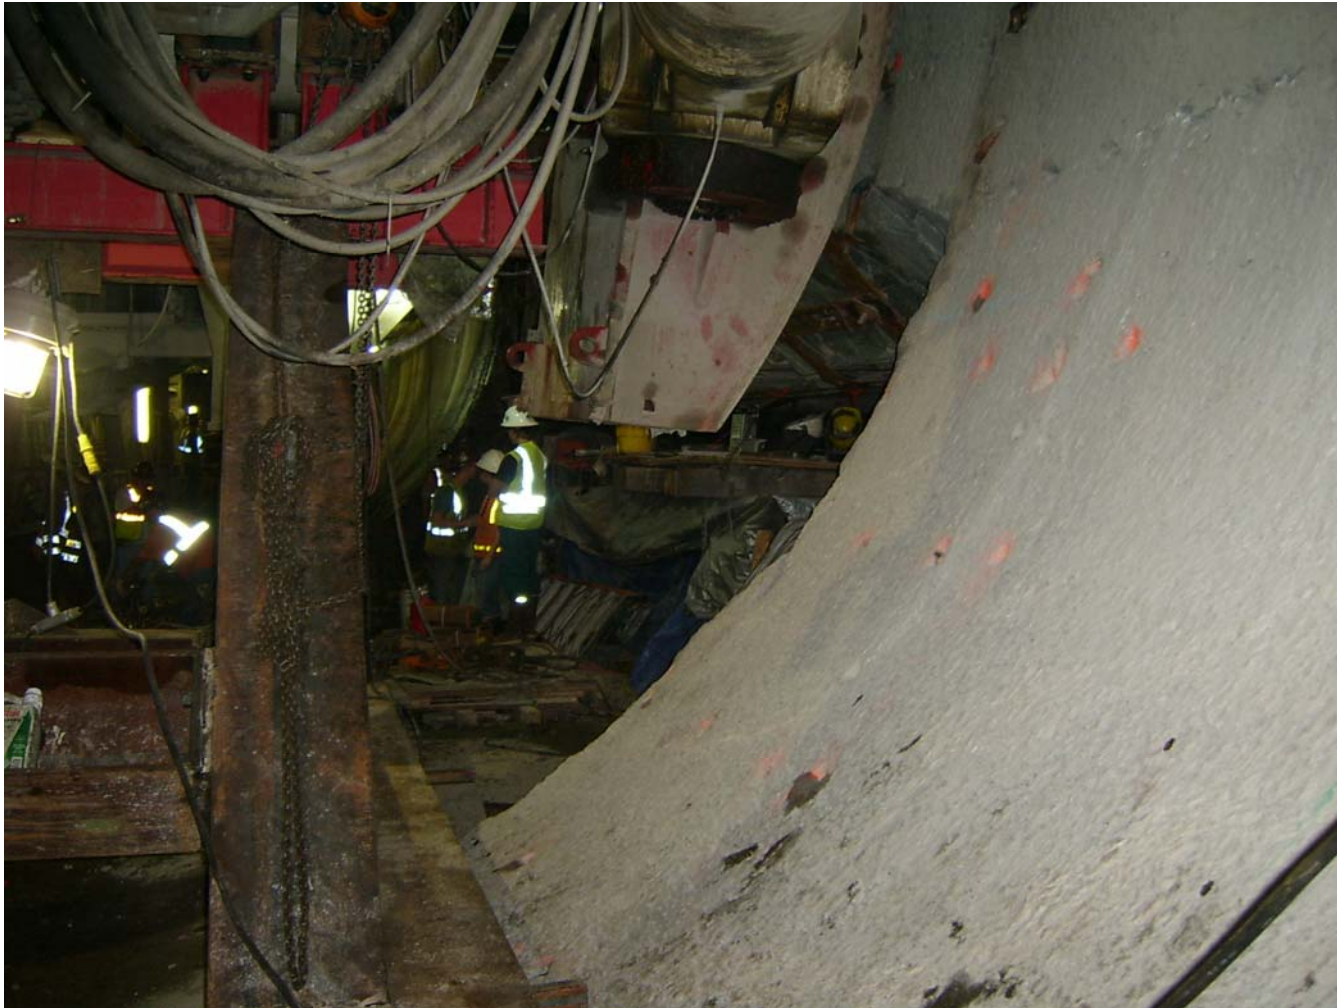
# Bypass Cavern

*Looking back from face*

Note: gripper shoe is off the wall
