# FAILED PINION

# ONE OF NINE DRIVE PINIONS

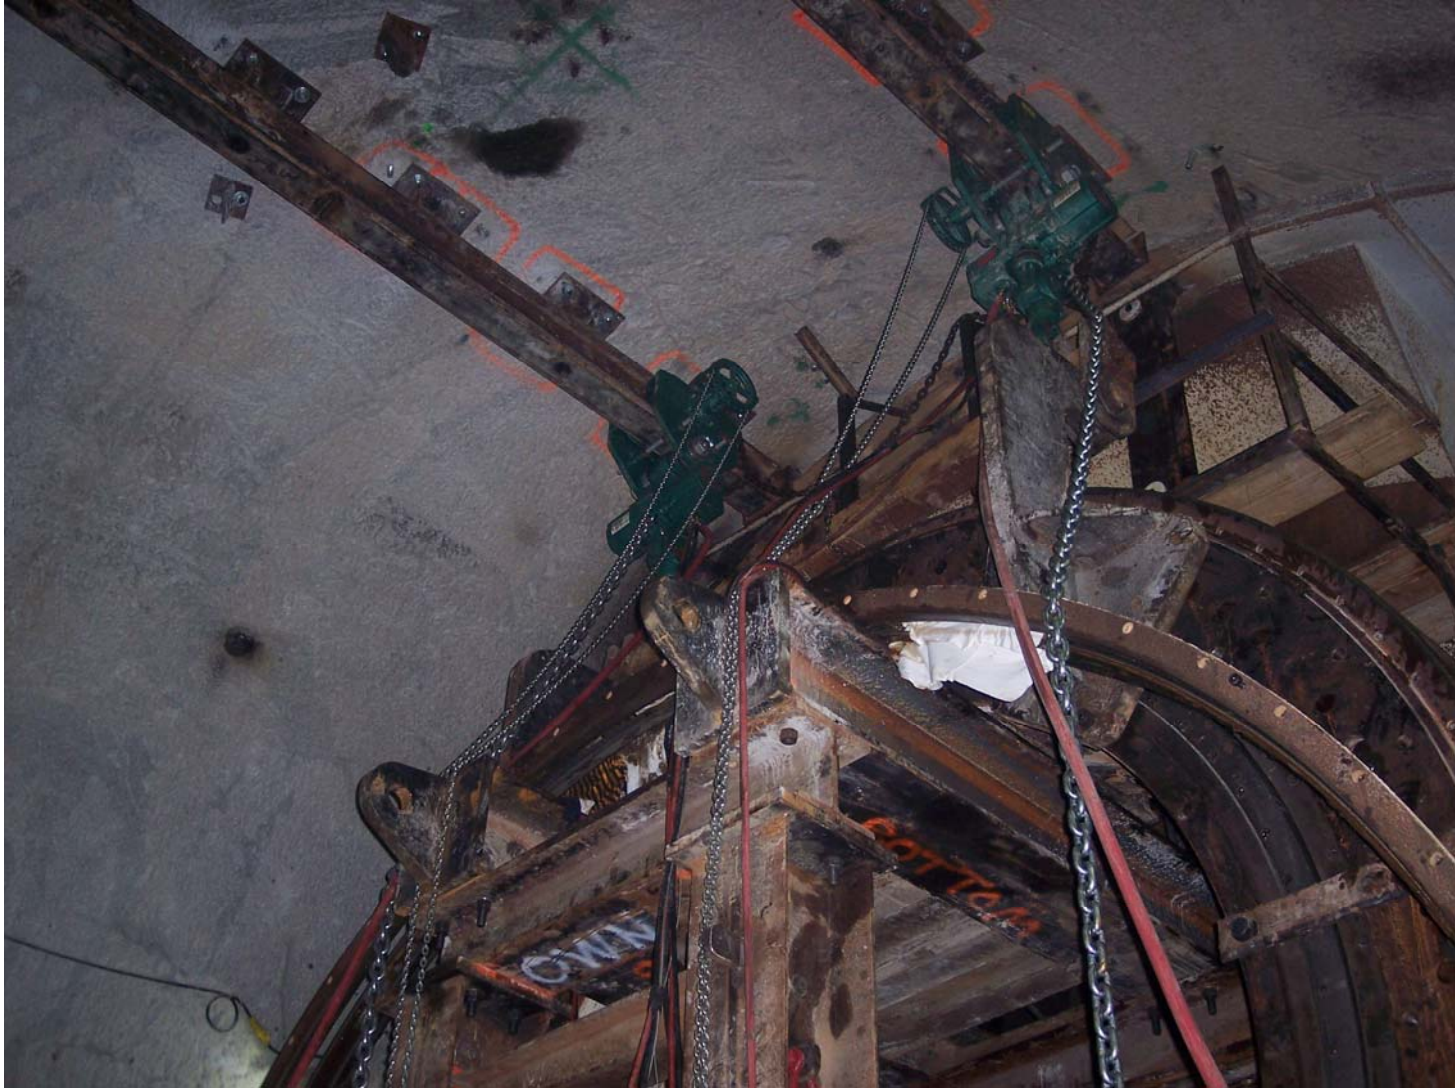
# OVERHEAD MONORAIL SYSTEM

50 ton monorail system to lift and move main bearing

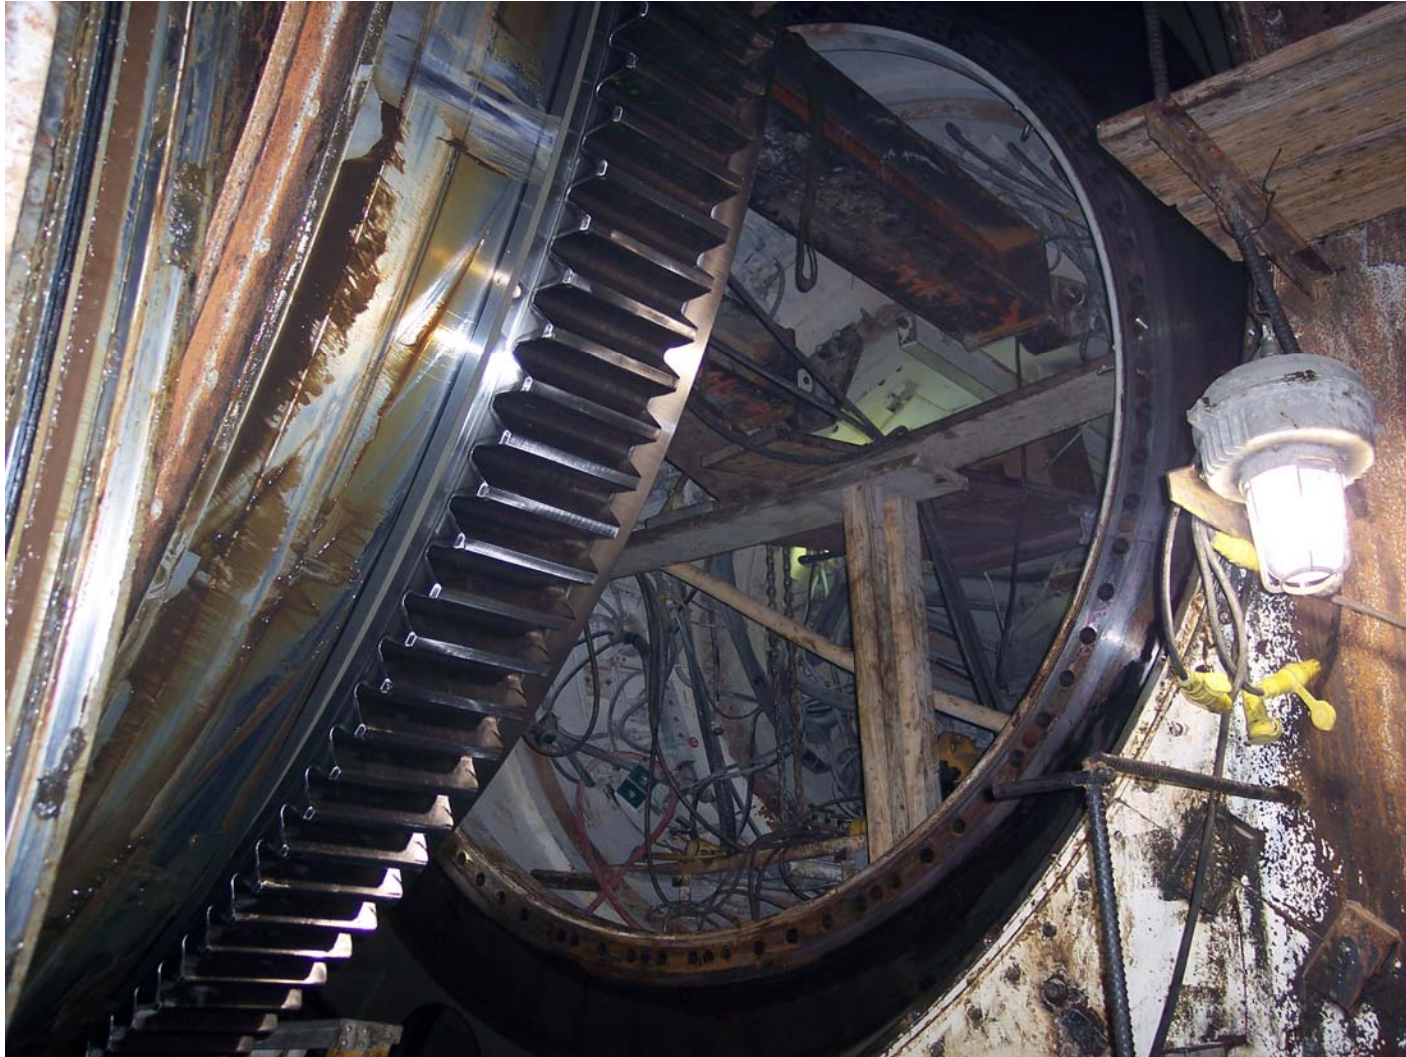
# MAIN BEARING

Damaged main bearing removed from TBM on 8/16/06
