# **West Lost Trail Creek Sturzstrom: A Composite Landslide**

**J. David Rogers**

**Nicholas H. Beckmann**

# West Lost Trail Creek Landslide

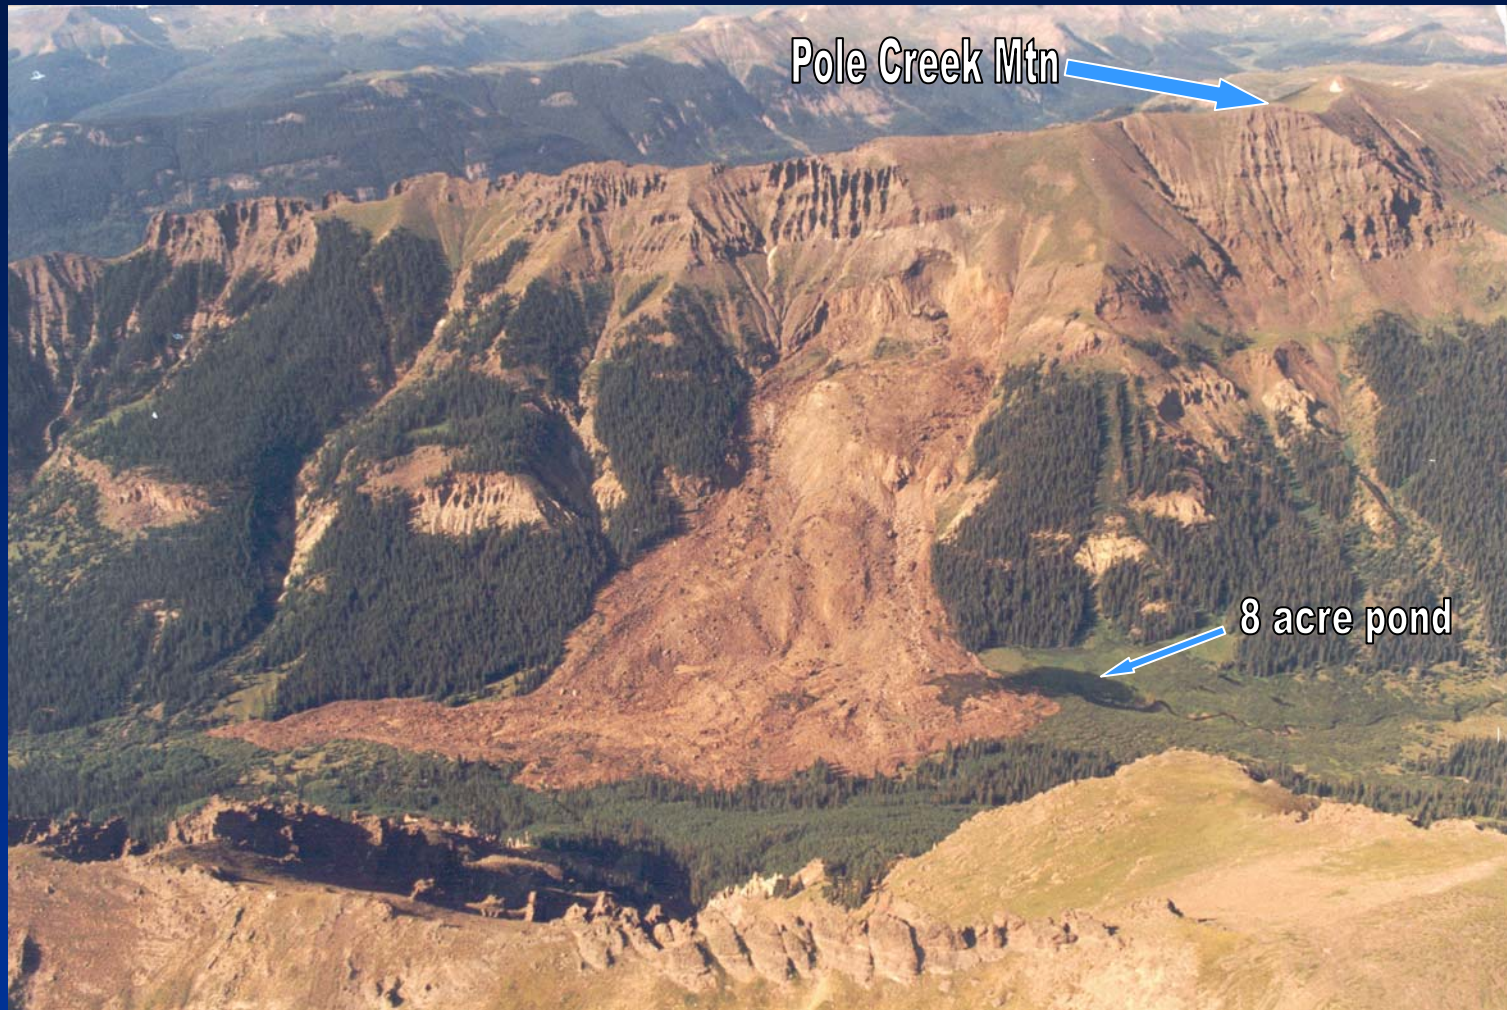
- 8 million cubic meters of rock debris slid down slope in about 25 to 30 seconds, between elevations of 12,400 and 11,000 feet. Pole Creek Mtn lies at el. 13,716 ft. Photo by Dave Noe

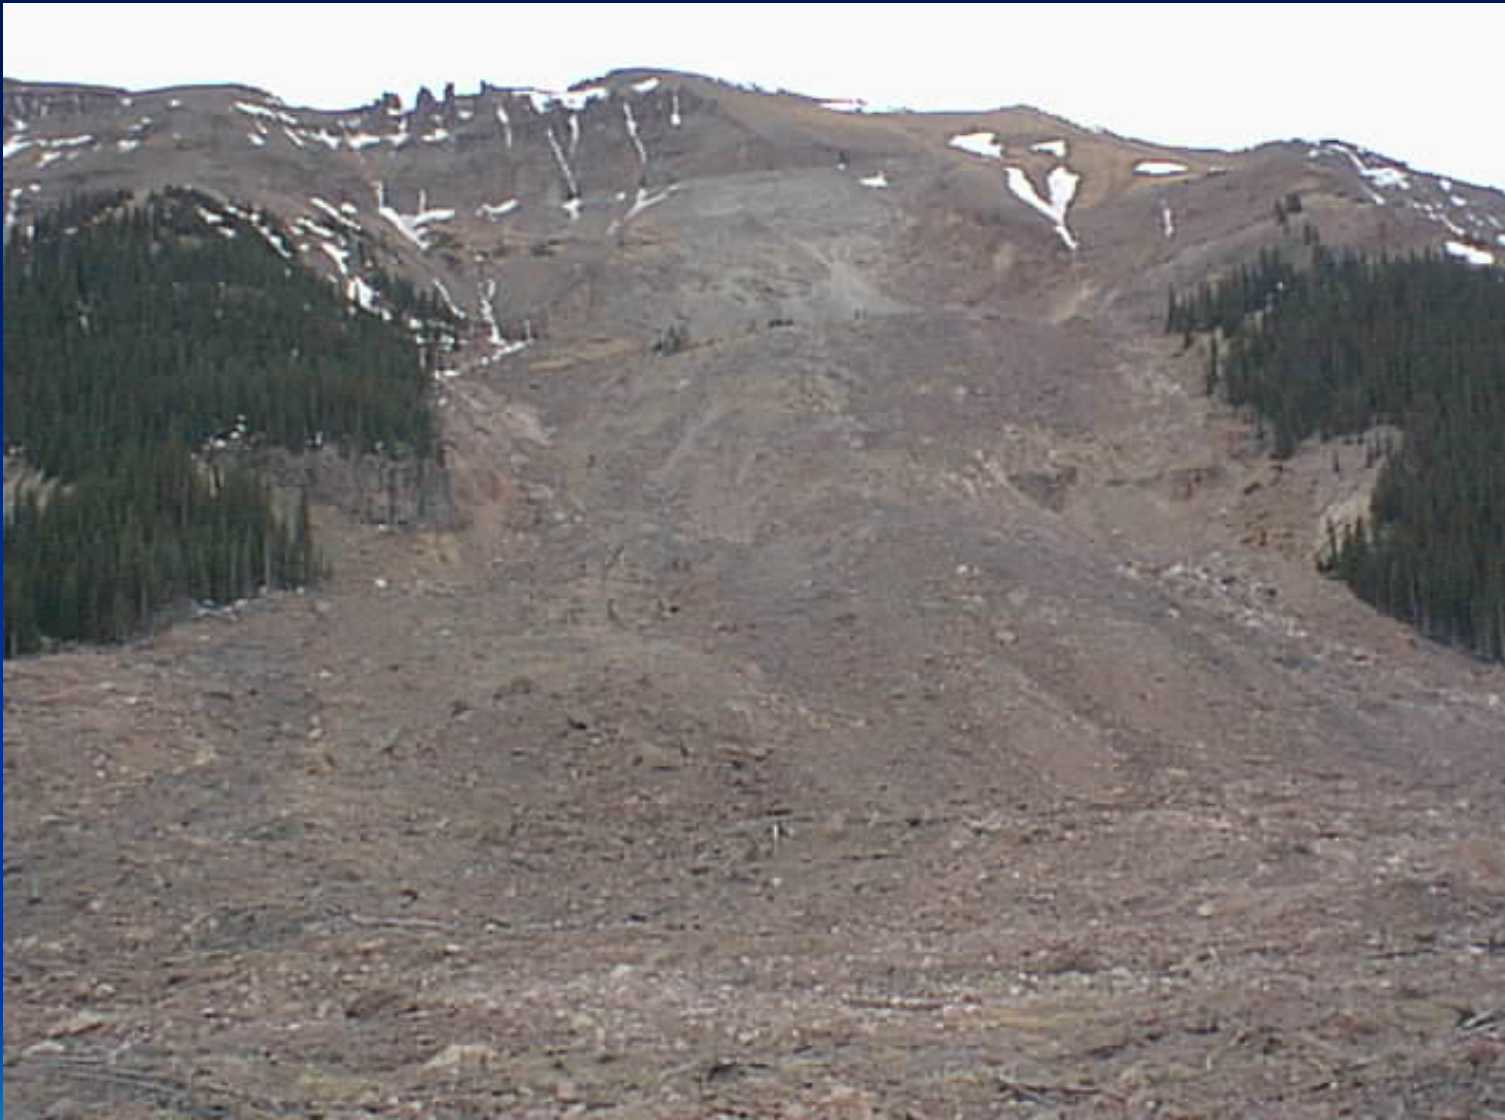
- View looking up at the debris field from the distal toe

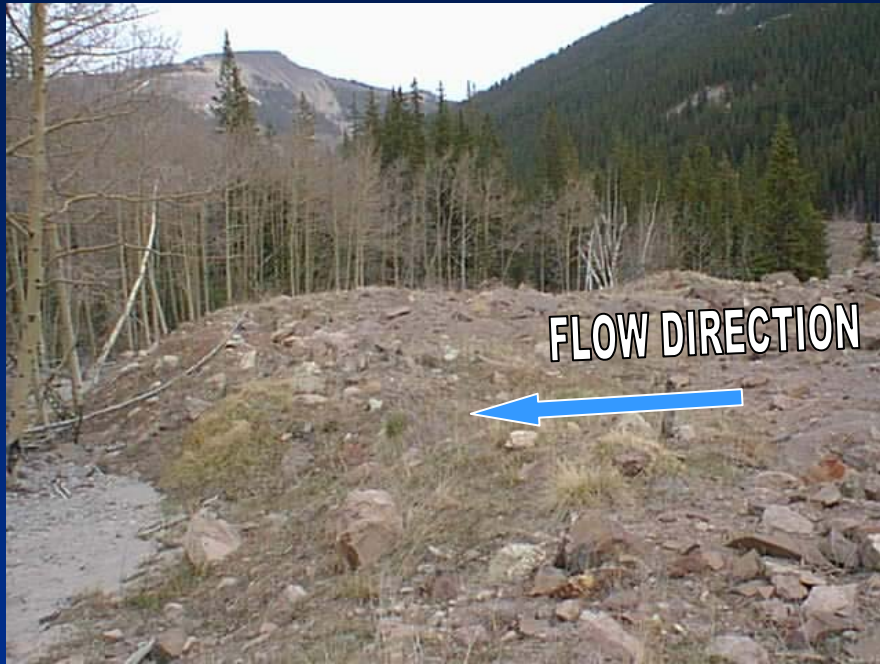
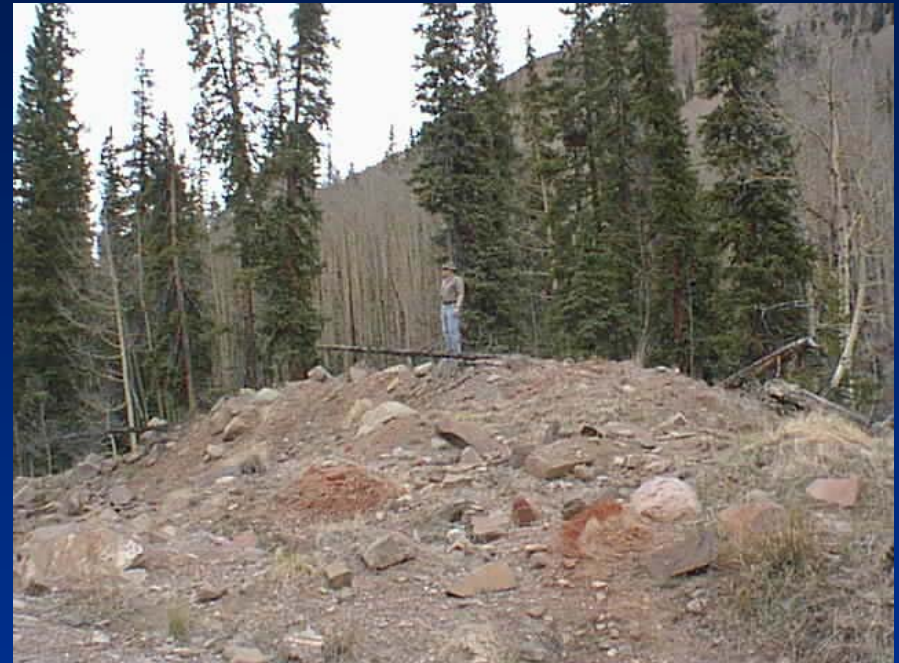
# DISTAL RIM OF STURZSTROM TOE

- The slide gouged up portions of the indurated valley bottom like a giant dozer blade. The slide appears to have stopped rather suddenly, leaving a steeply inclined toe 3 to 5 m high.

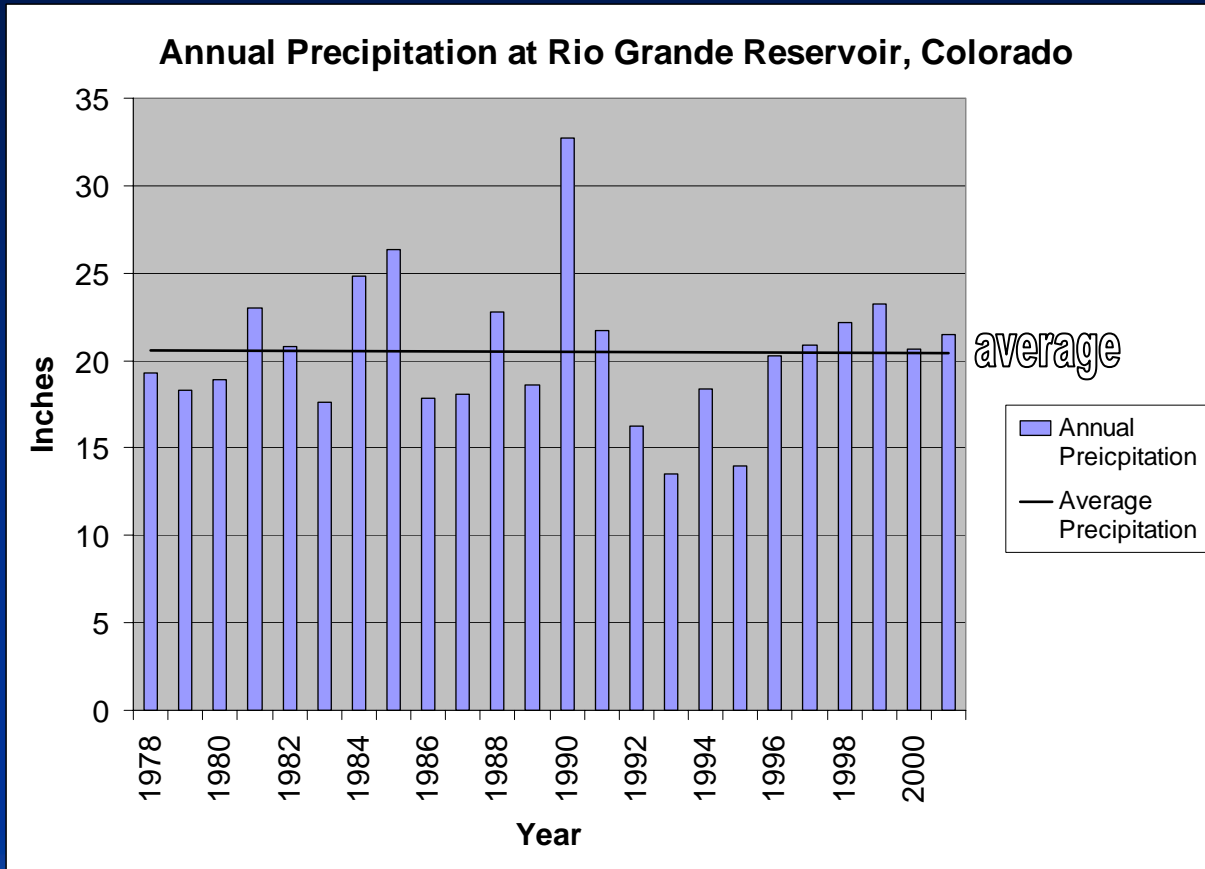
# 1990-91 was an exceptional year

- The seasonal precipitation was 165% of normal during the water year preceding the landslide

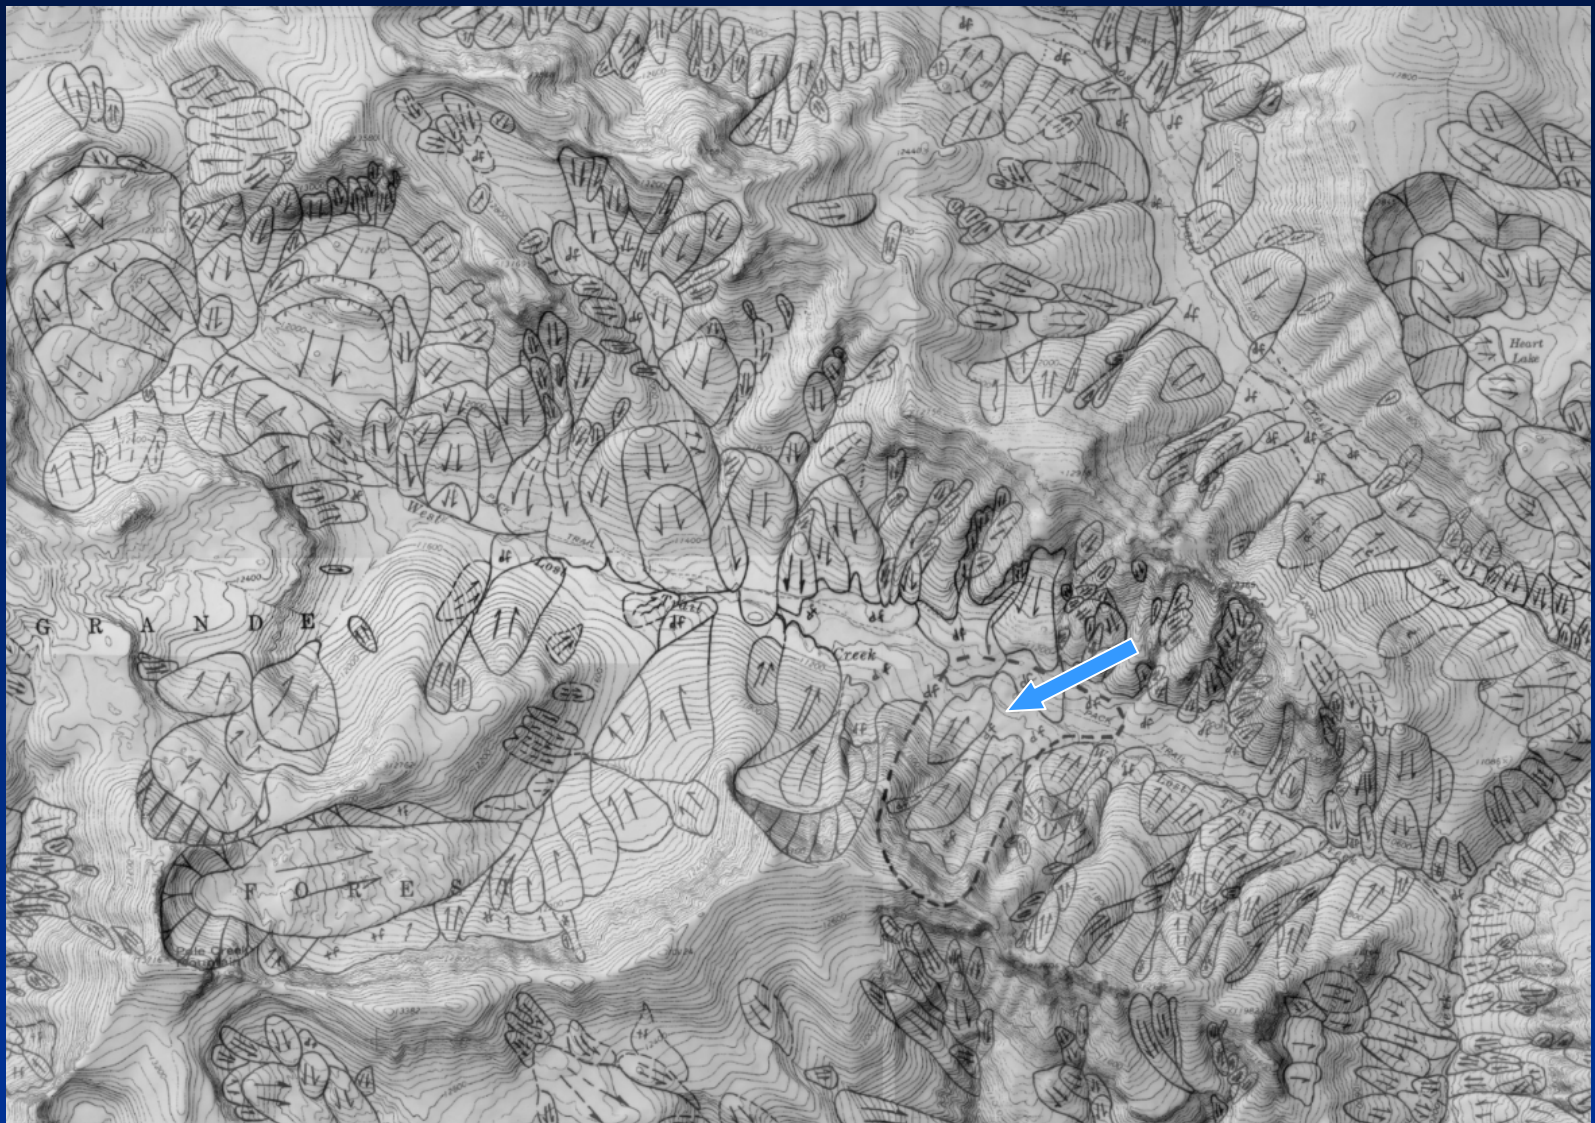
- Landslide inventory map created on a shaded relief DEM covering 65 km<sup>2</sup> area surrounding the subject landslide (arrow)

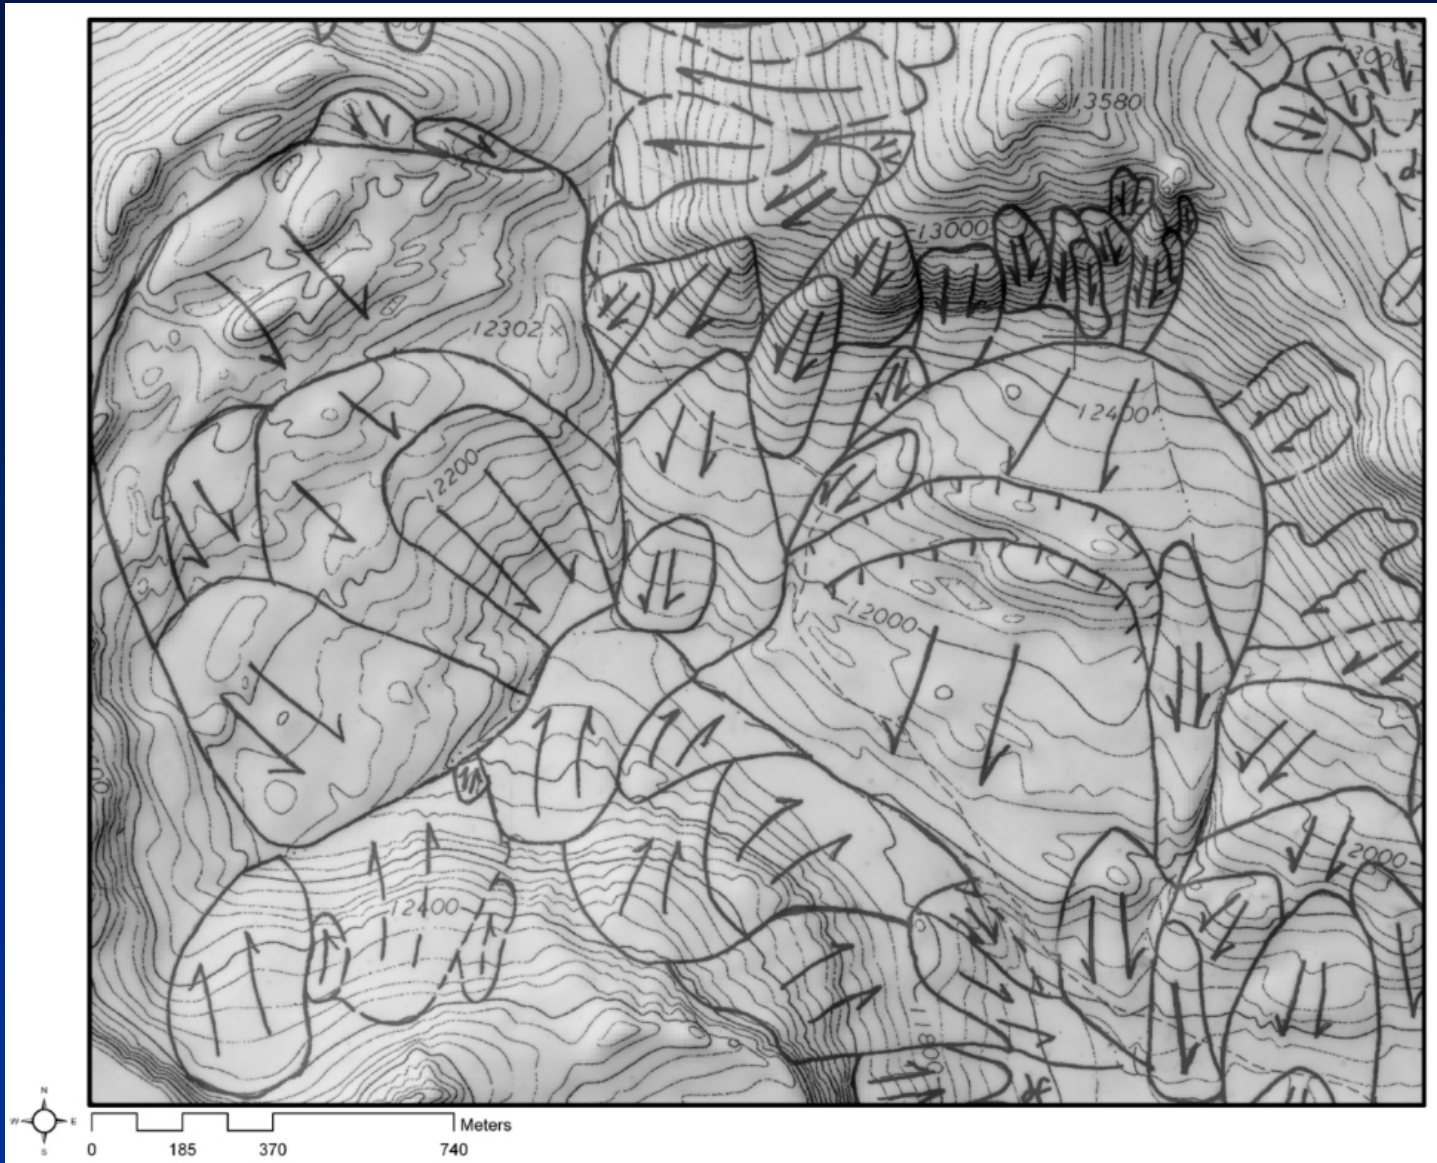
- Landslide inventory map of upper West Lost Trail Creek watershed

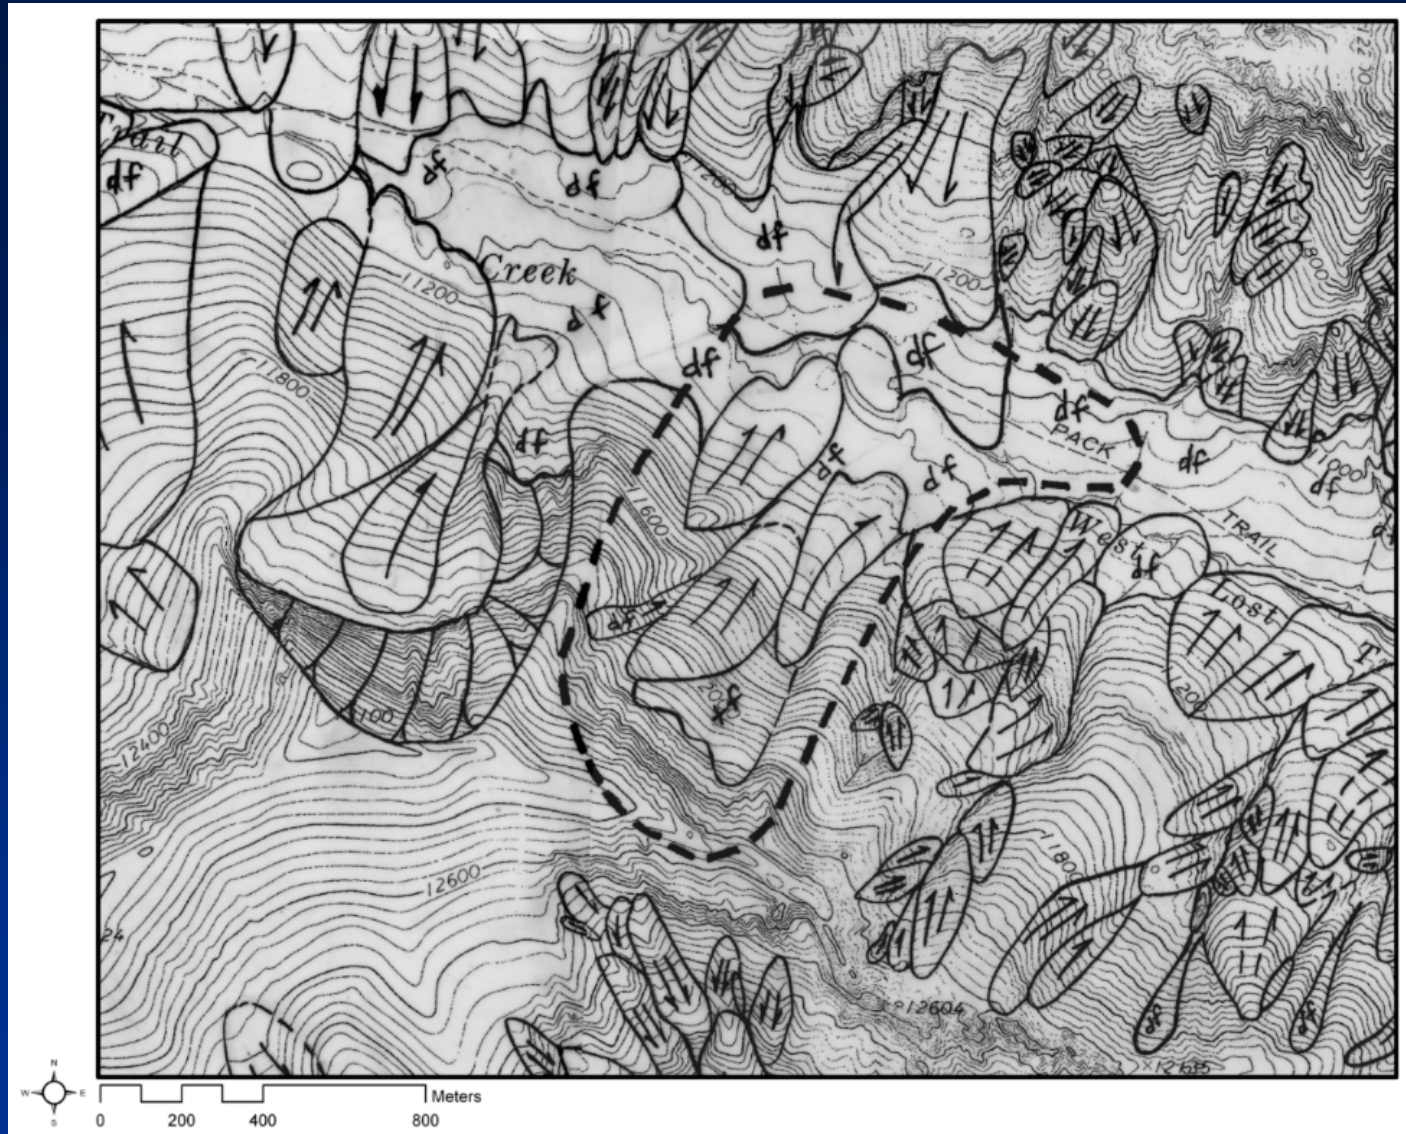
- Landslide inventory map of the West Lost Trail Creek area on **pre-slide topography**. Dashed line surrounds the 1991 slide area. Note pre-existing slumps and flows.

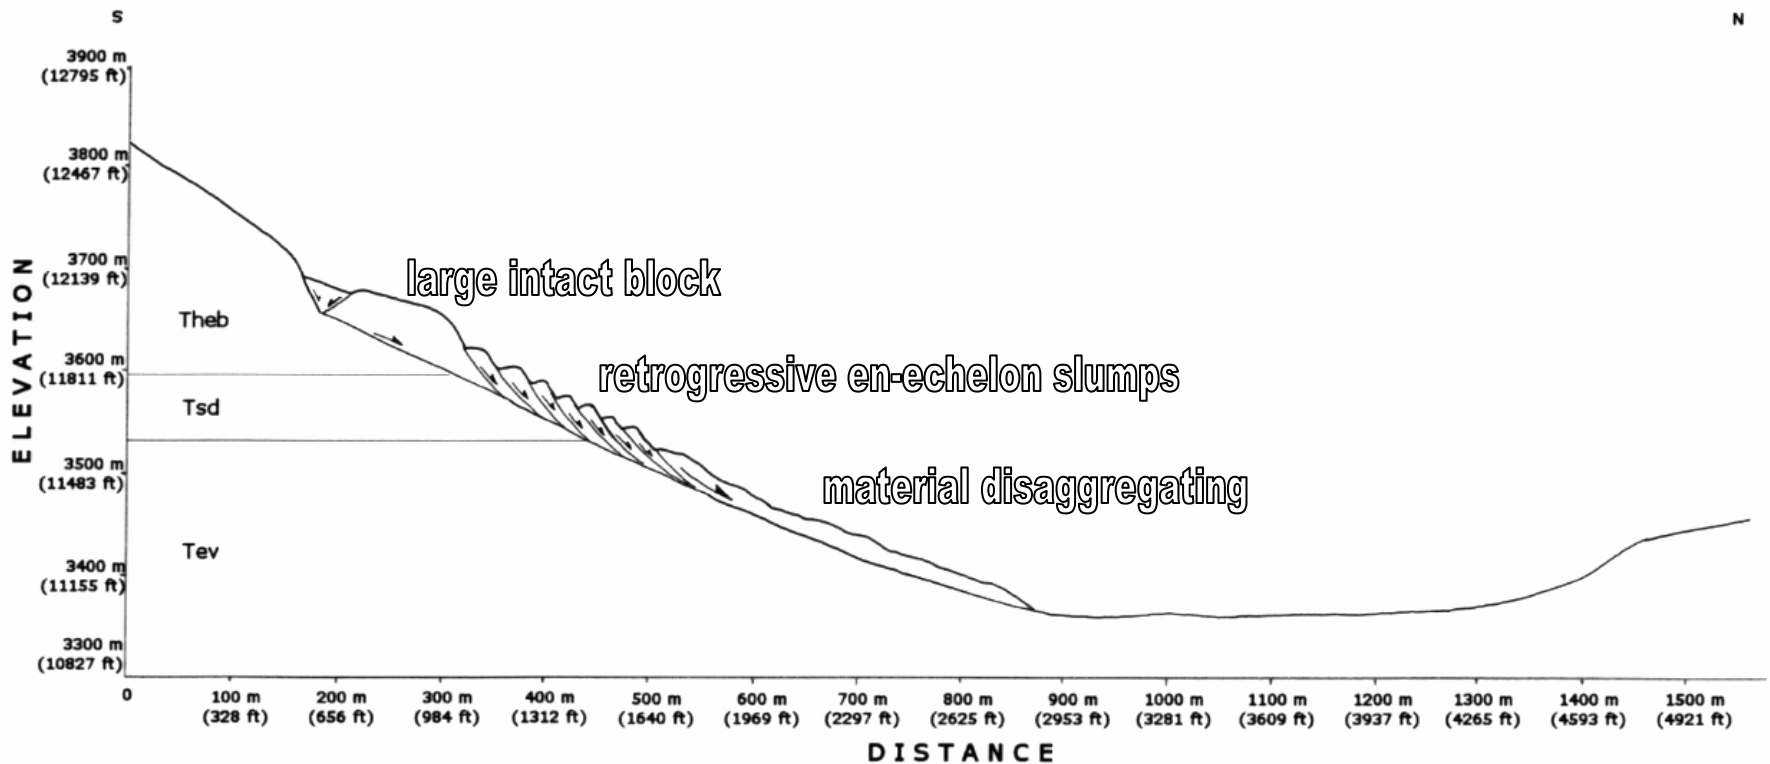
## CROSS-SECTION OF WEST LOST TRAIL CREEK COMPOSITE LANDSLIDE

- The 1991 event appears to have initiated as a series of retrogressive rotational slumps, progressing upslope over a period of 10 to 15 minutes

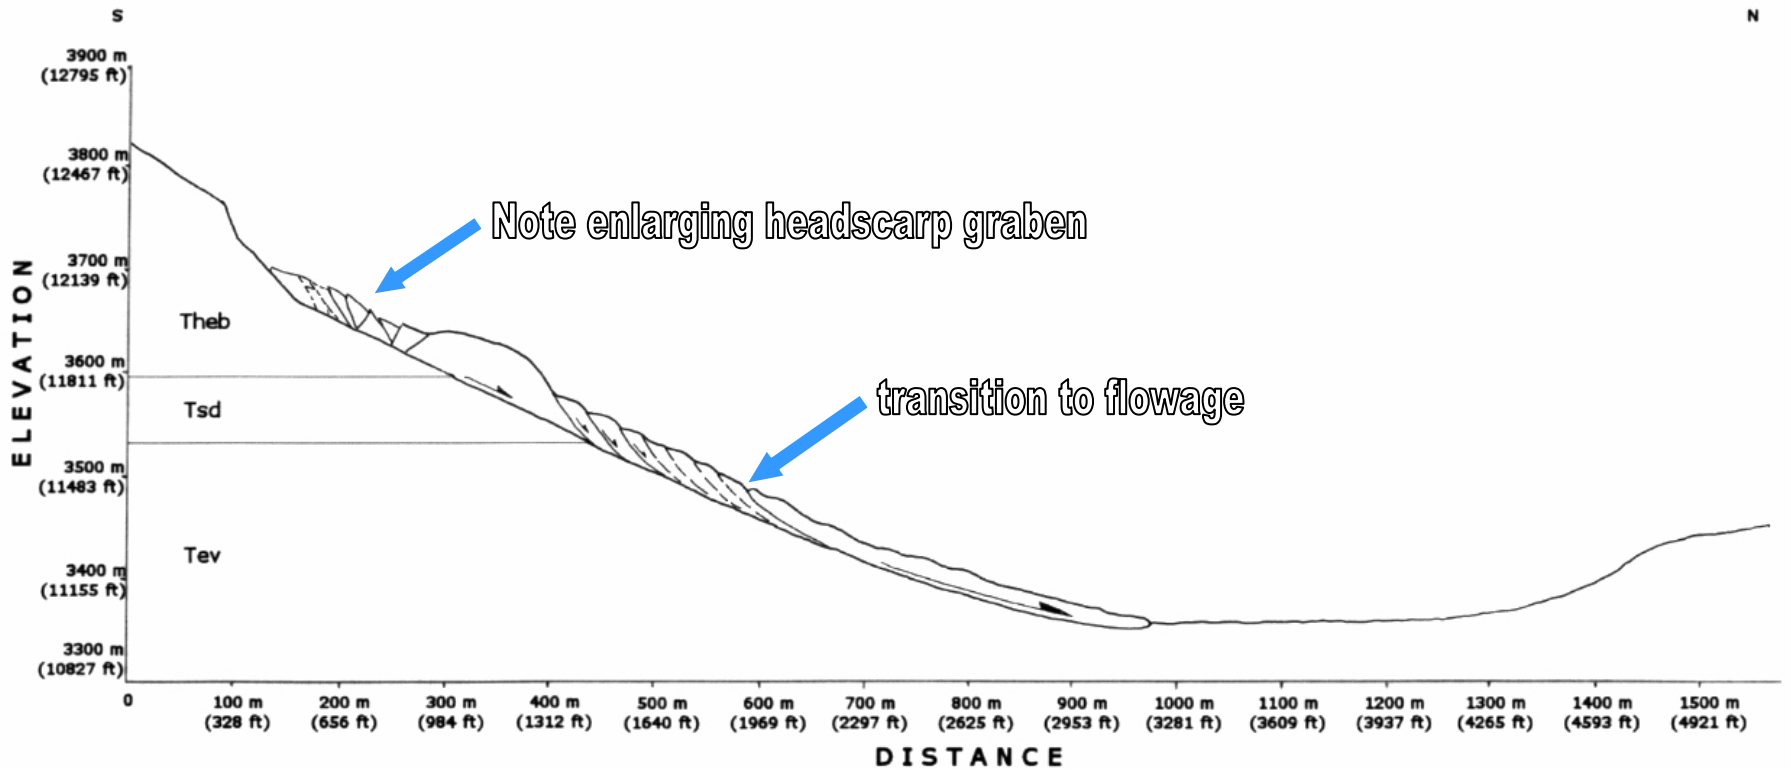
## CROSS-SECTION OF WEST LOST TRAIL CREEK COMPOSITE LANDSLIDE

- As the entire mass mobilized and began moving down slope, the lower portion detached and fluidized.

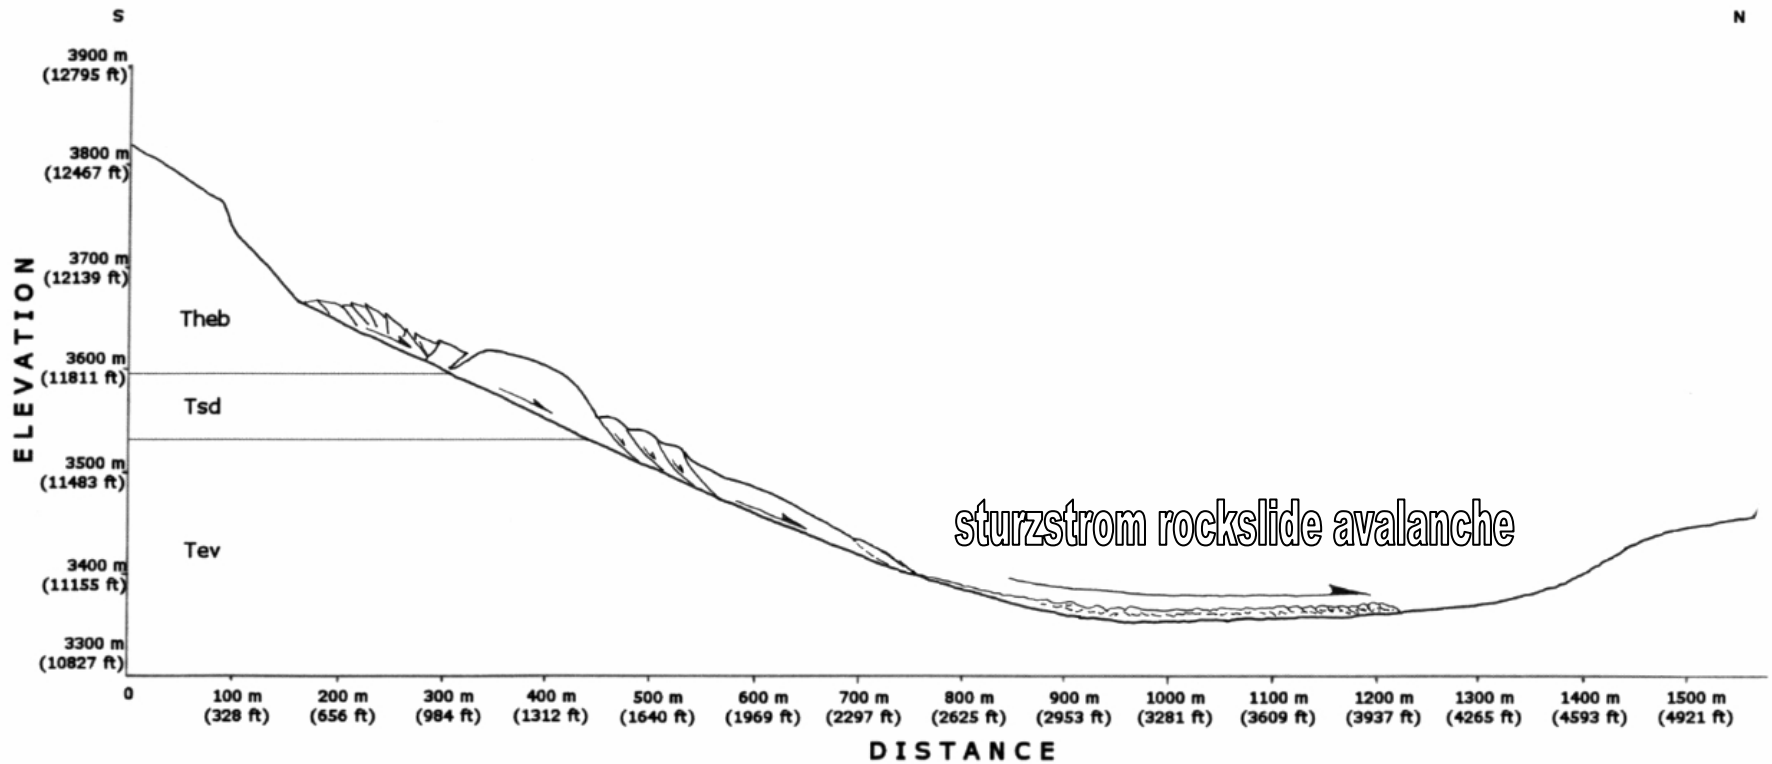
## CROSS-SECTION OF WEST LOST TRAIL CREEK COMPOSITE LANDSLIDE

- The disaggregated material detaches and flows as a sturzstrom rockslide avalanche

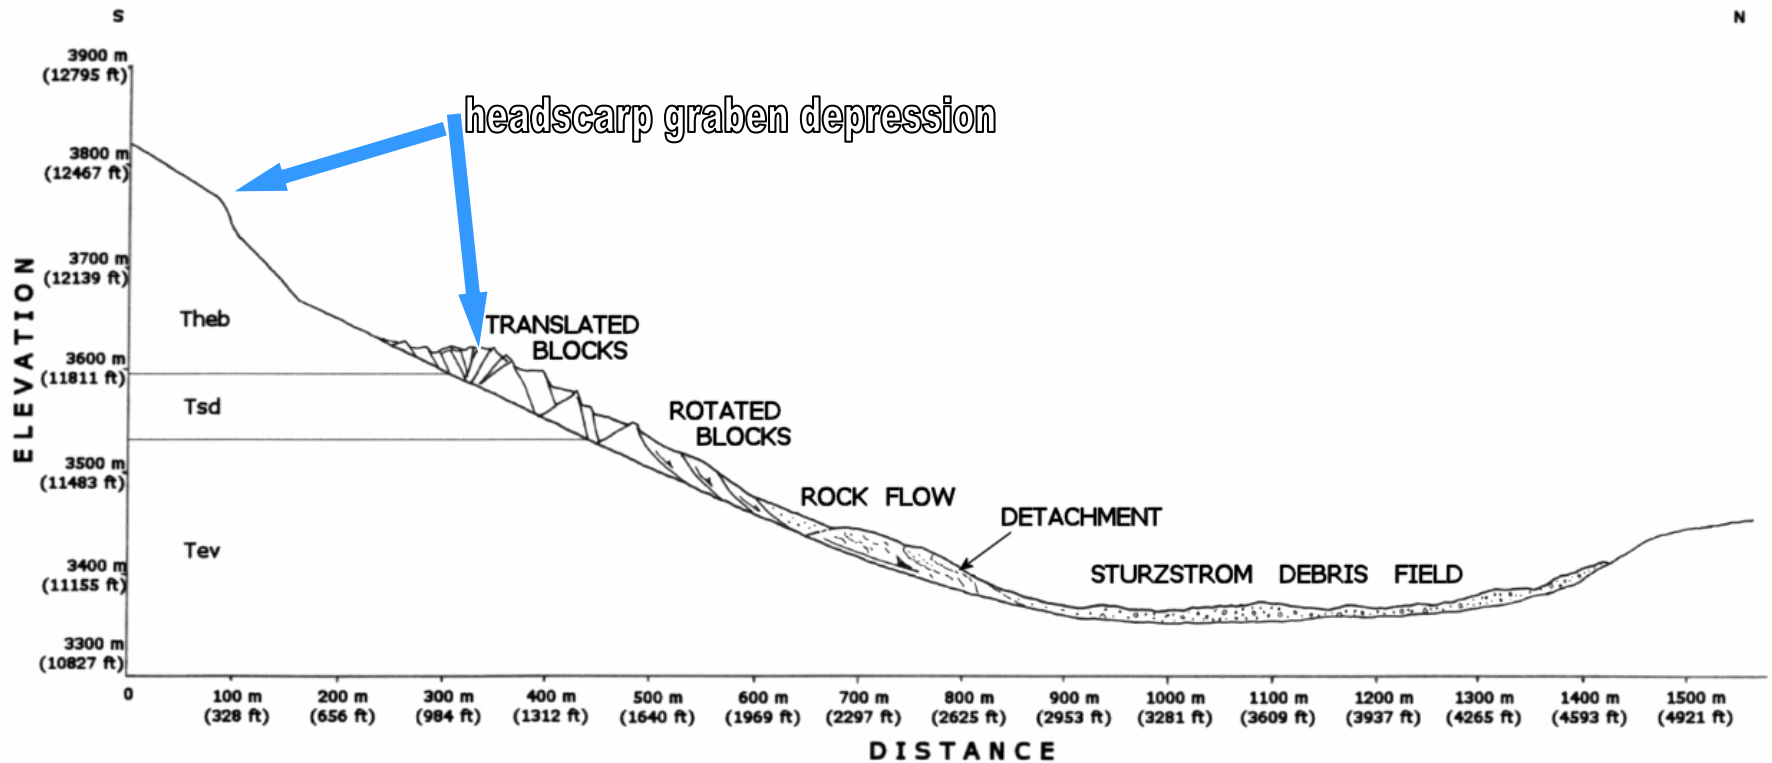
## CROSS-SECTION OF WEST LOST TRAIL CREEK COMPOSITE LANDSLIDE

- Cross section through 1991 sturzstrom after movement ceased, showing the various components of the slide mass

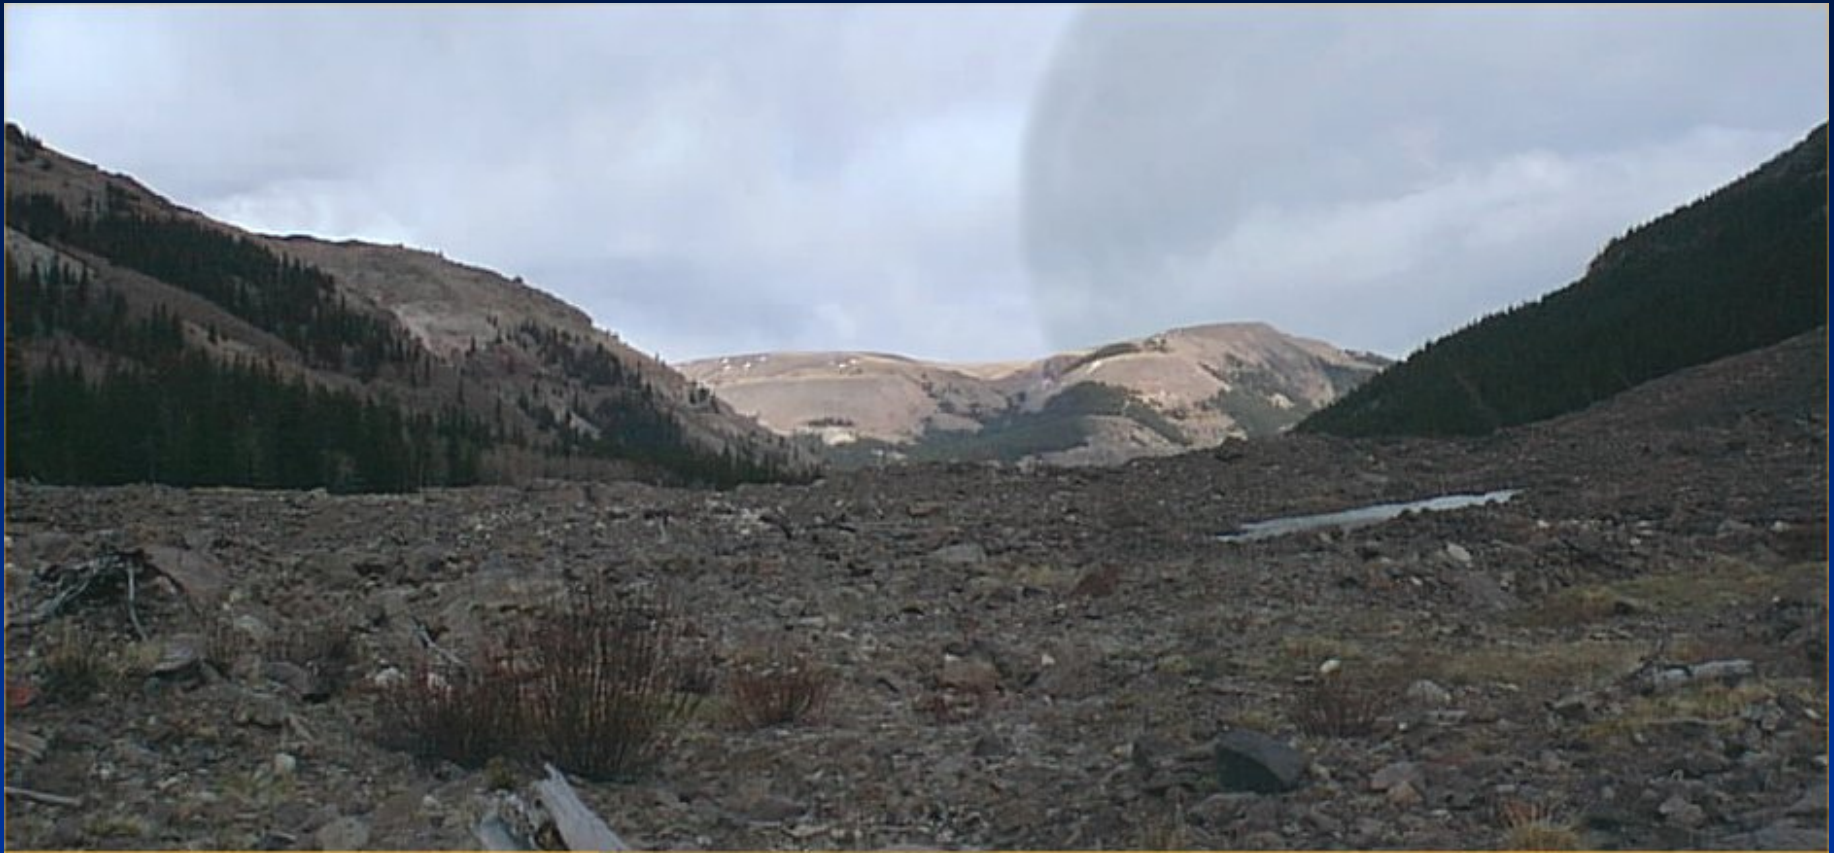
- Surface of the debris field filling the valley bottom, looking downstream.

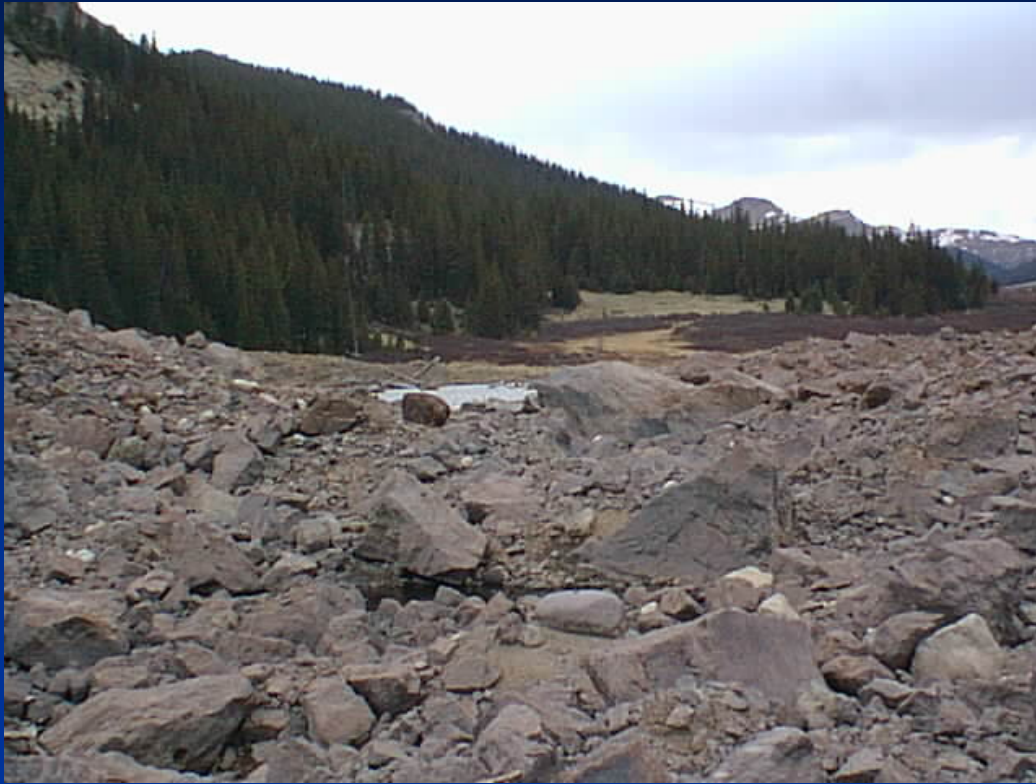
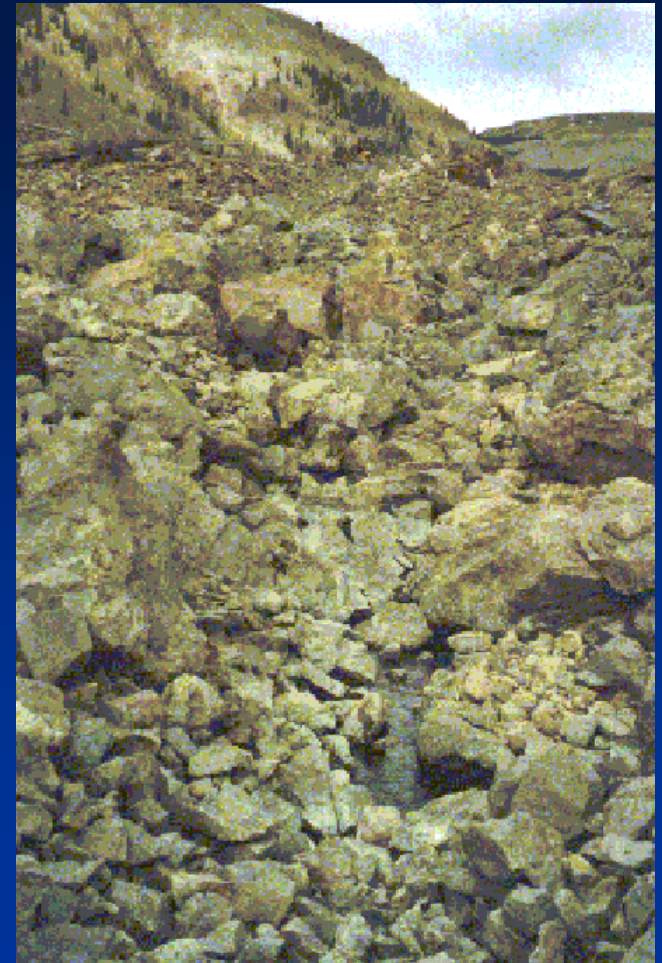
# Varying Particle Sizes

- Particle size ranges between about 6 inches and almost 50 feet. Water percolates through with ease

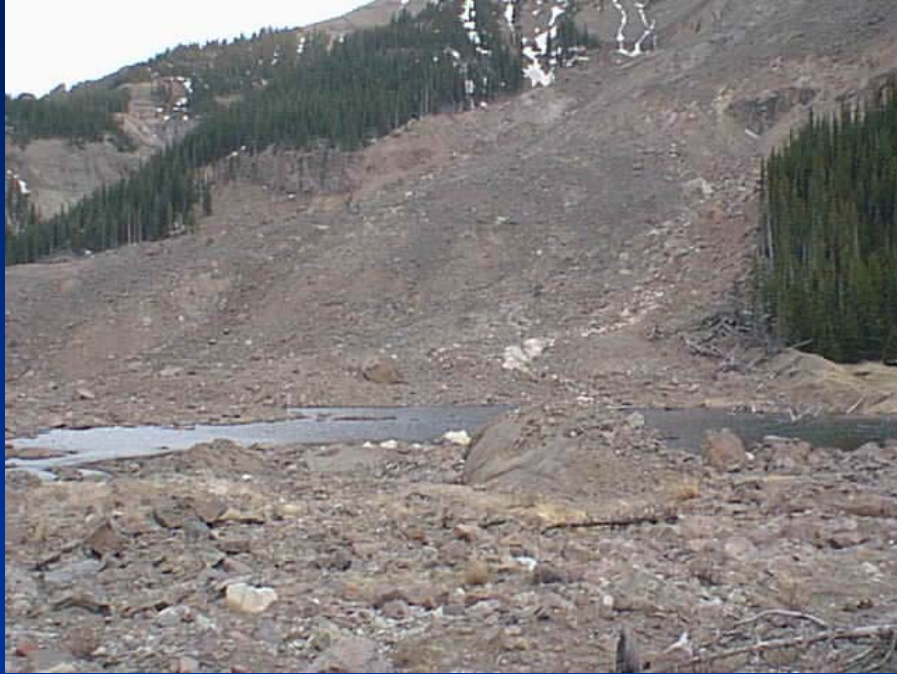
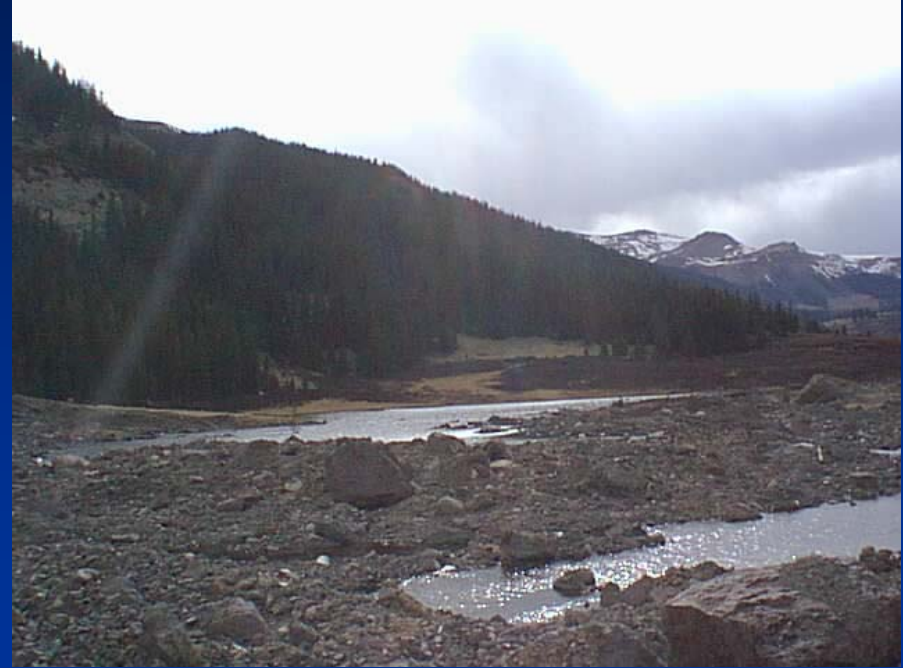
# Impoundment of West Lost Trail Creek

- An 8 acre lake has backed up behind the debris dam
- Water is percolating through the debris field

- Erosion may not play a significant role here because water is freely percolating through the debris (very few fines at this location)
- Ratio of lake volume (36 ac-ft) to the slide volume (10.46 million yds<sup>3</sup>) and watershed area (11.5 mi<sup>2</sup>) is much smaller than most large landslide dams
- By comparison, the 1925 Gros Ventre Landslide impounded a lake volume of 164,000 ac-ft with a slide volume of 50,000,000 yds<sup>3</sup> and tributary watershed of 596 mi<sup>2</sup>

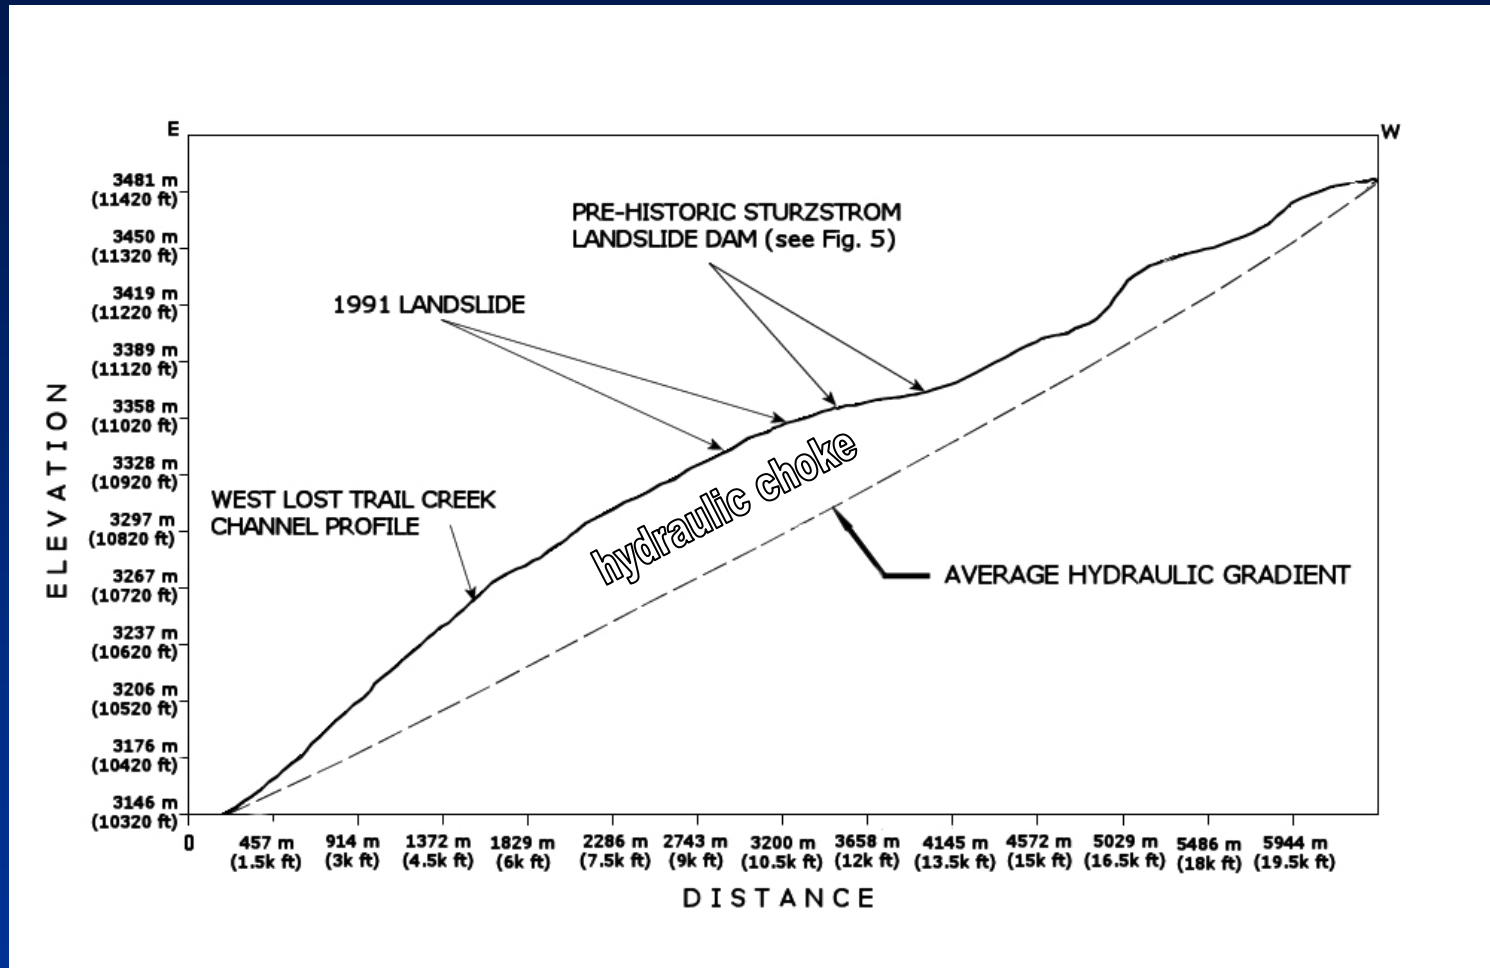
- Channel profile along West Lost Trail Creek. The convex-upward profile is diagnostic of a channel containing more debris than it has hydraulic capacity to remove (Hack, 1973).
