# **NEW FINDINGS RELATED TO COMPOSITE BEDROCK MEGALANDSLIDES IN THE GRAND CANYON**

**Conor Watkins and  
J. David Rogers**

**Department of Geological Sciences & Engineering  
University of Missouri – Rolla  
AEG 2005, Las Vegas, NV**

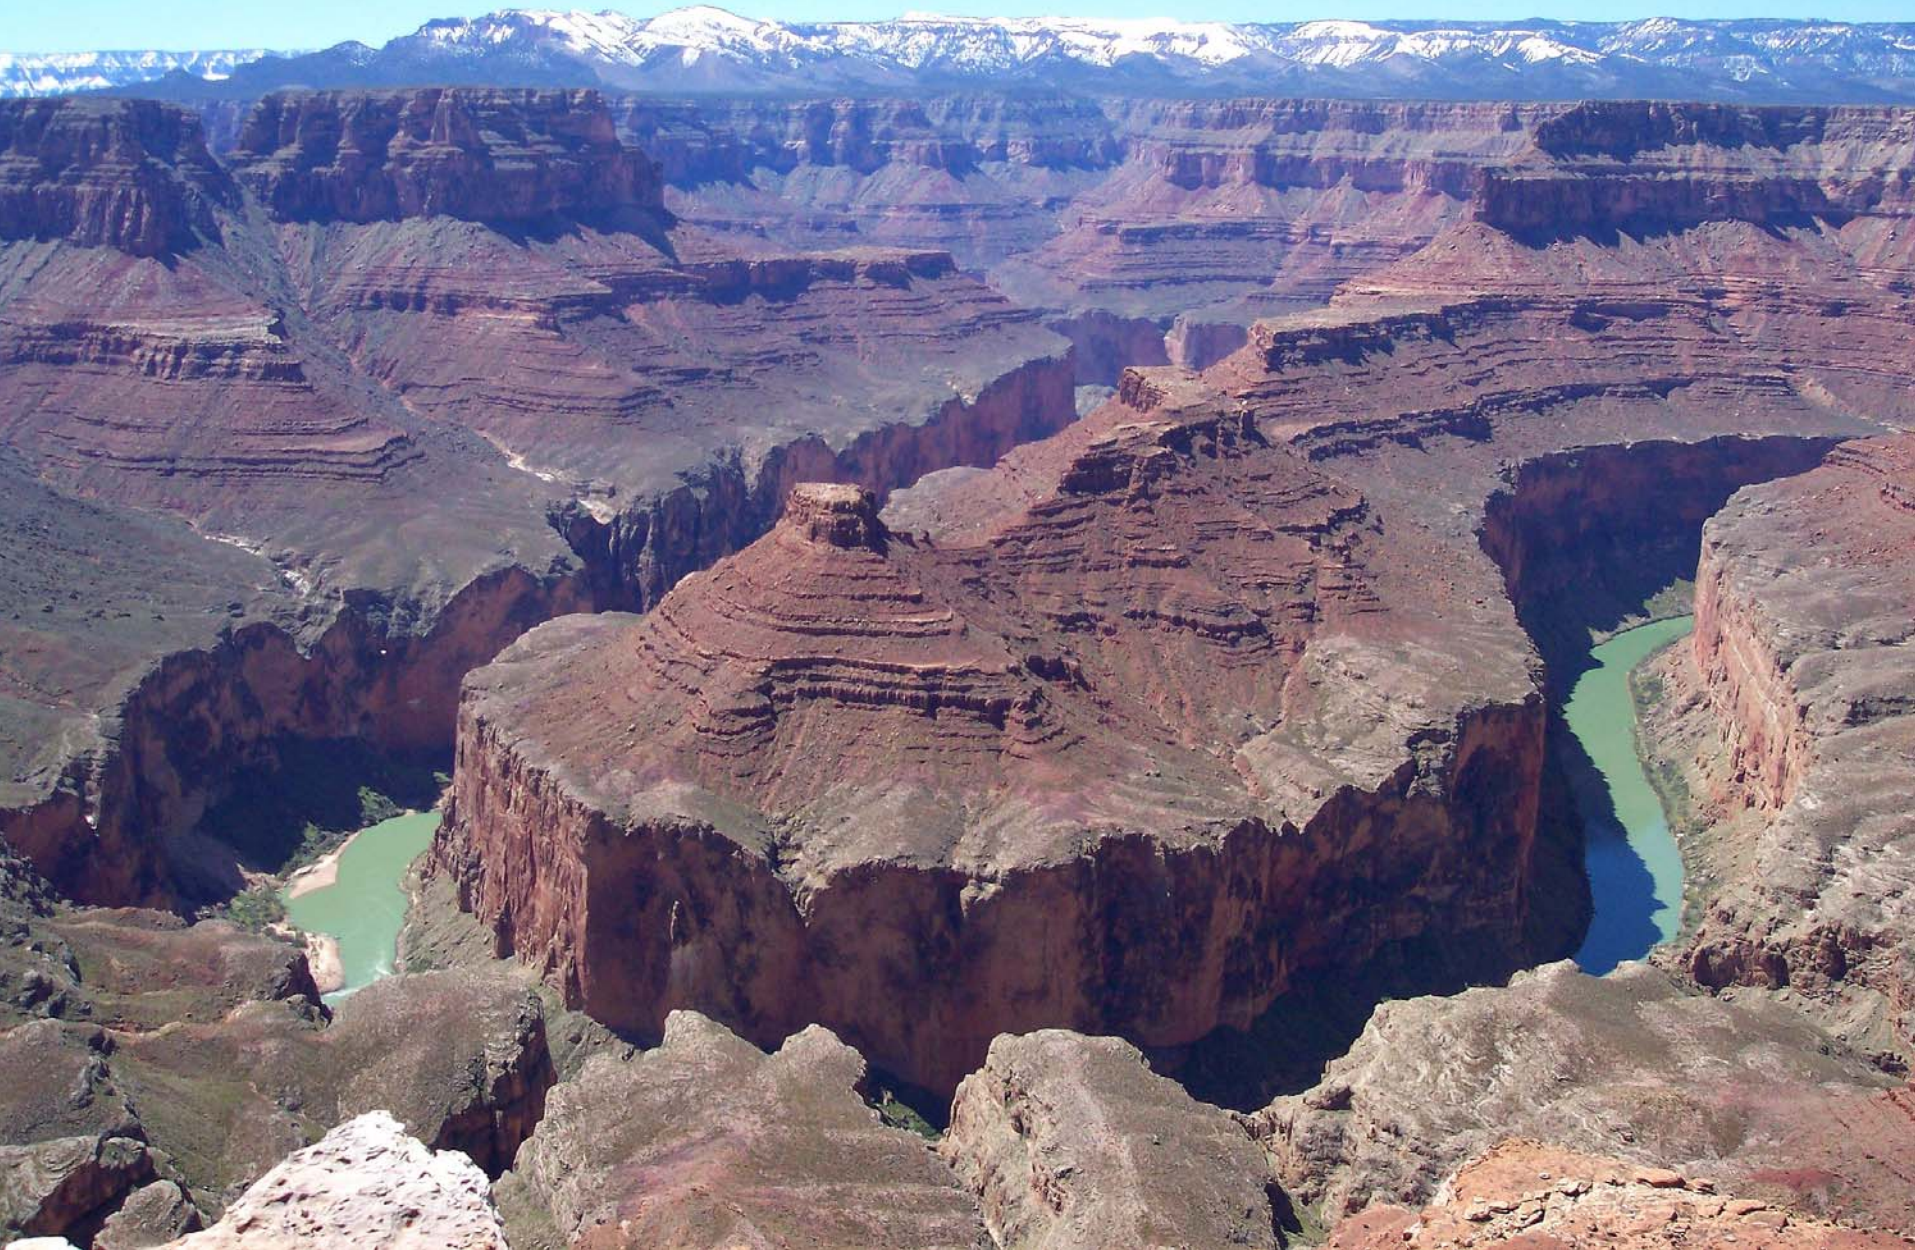
**Displaced strata, part of a large slumped mass, is present along the  
Eminence Break Route.**

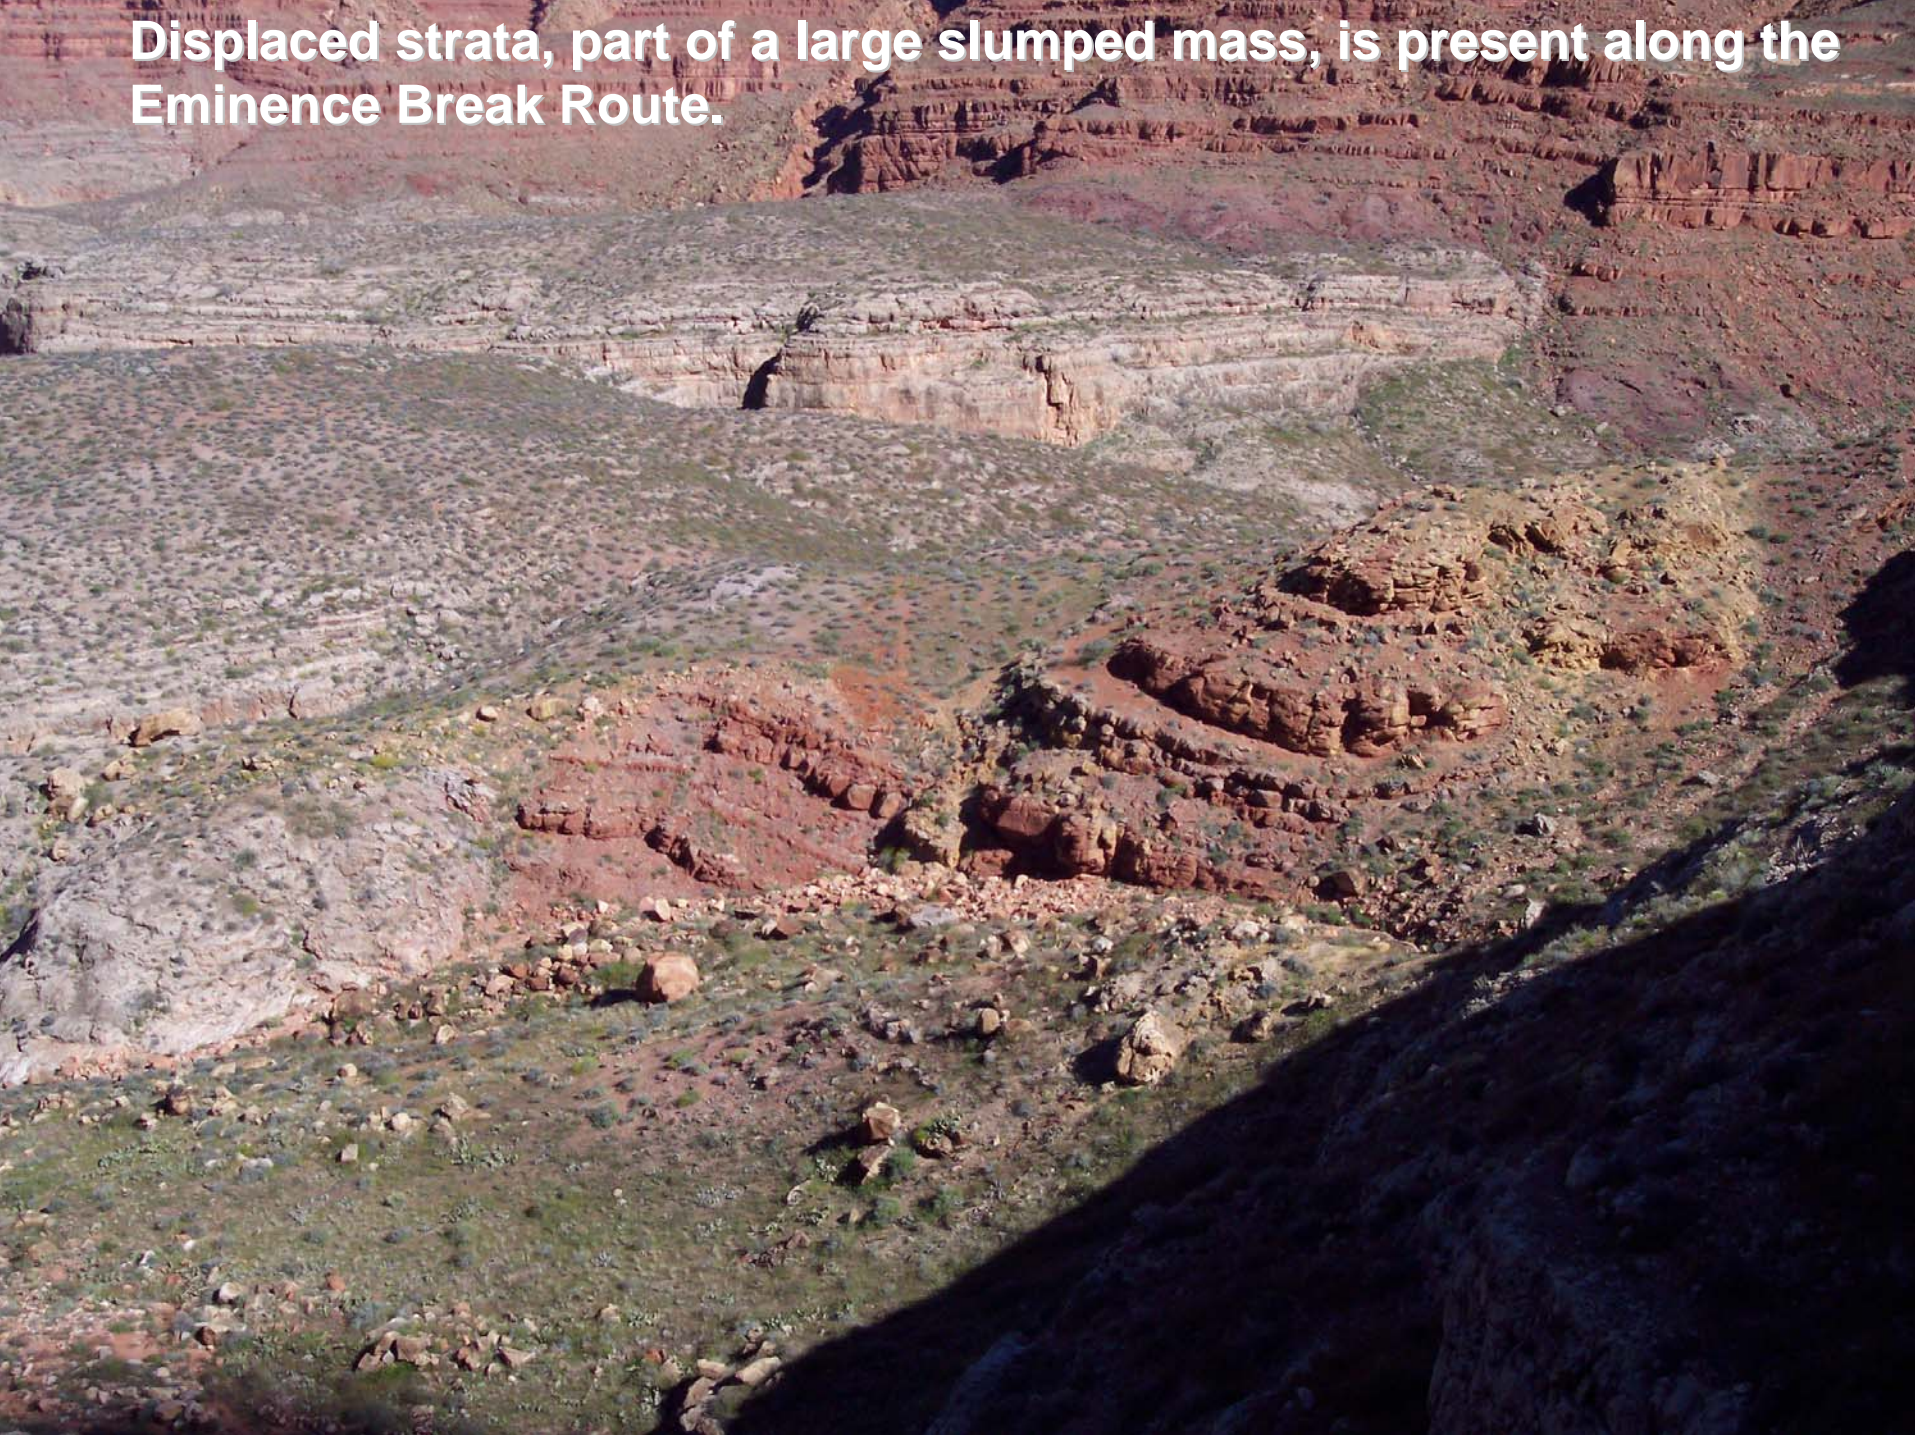
**The Eminence Break Fault Landslide appears to have a scarp largely controlled by the fault.**

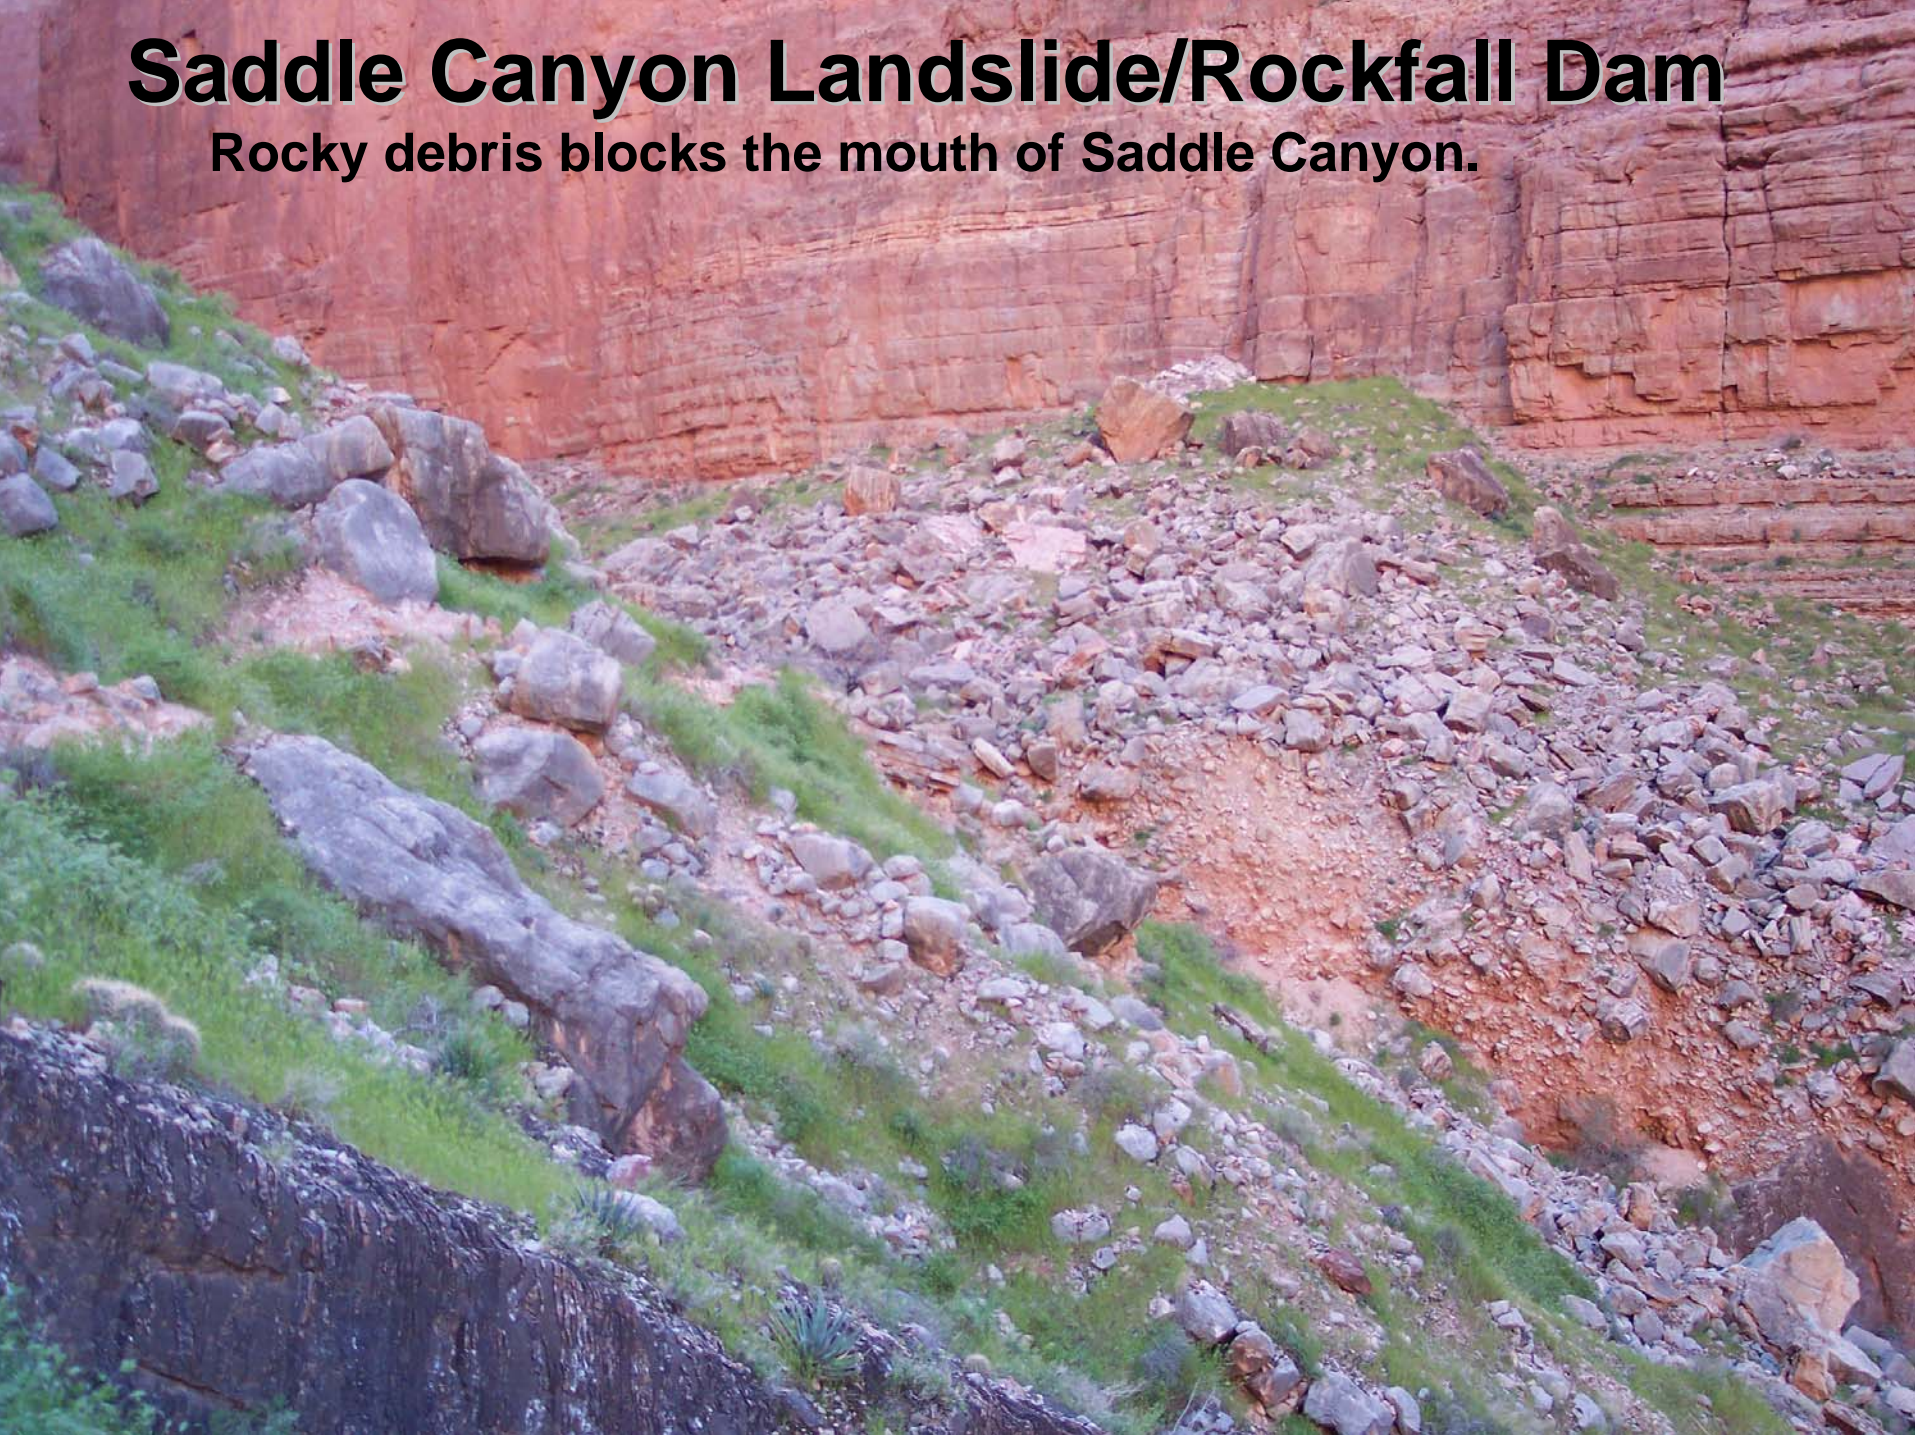
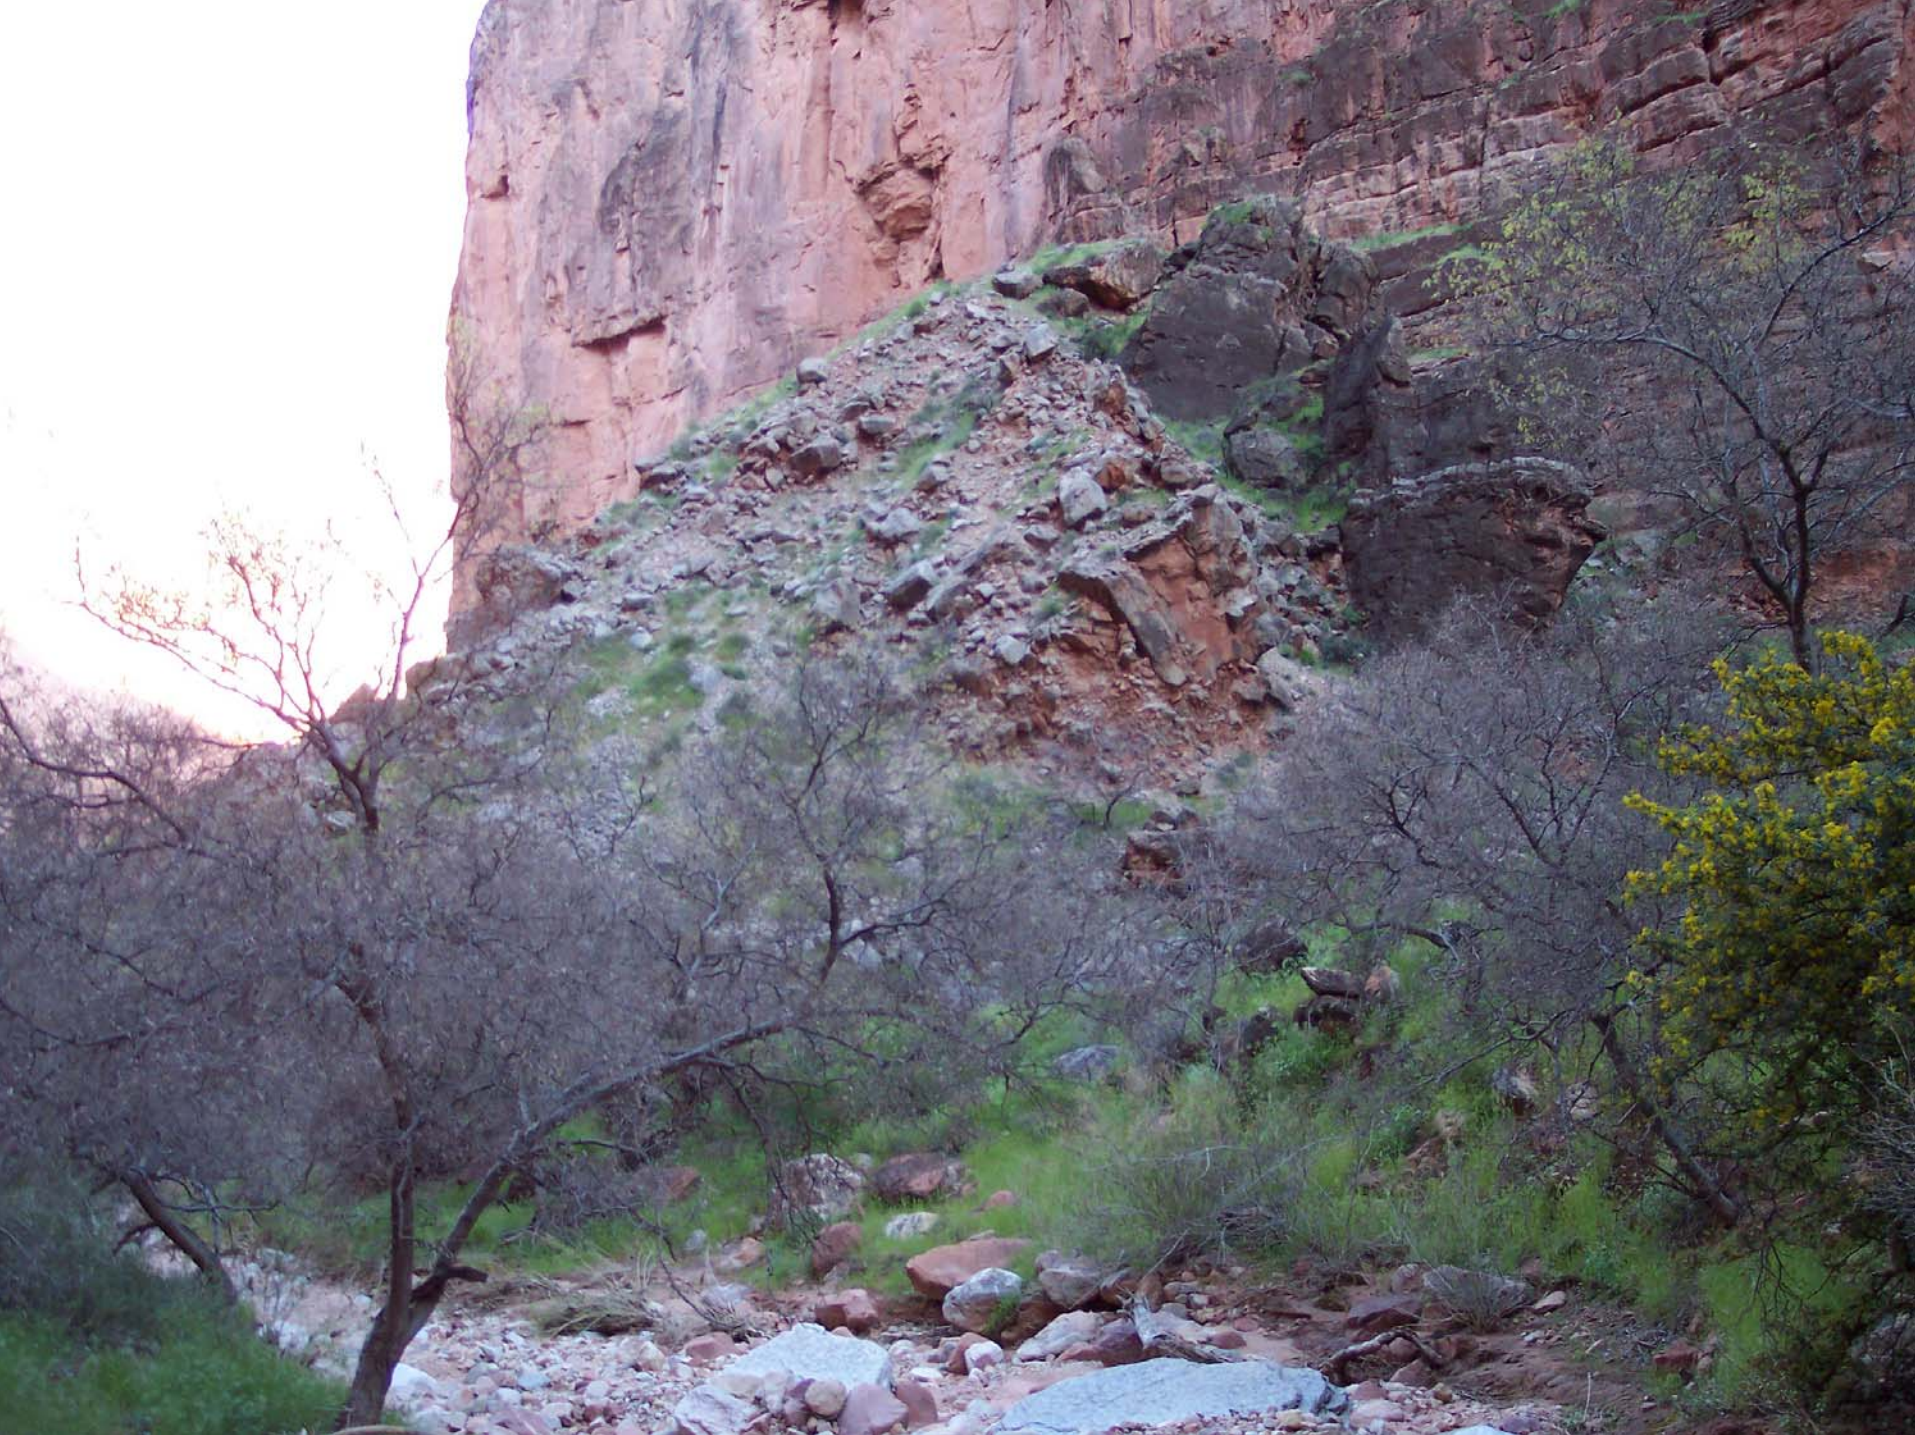
Rocky debris blocks the mouth of Saddle Canyon.

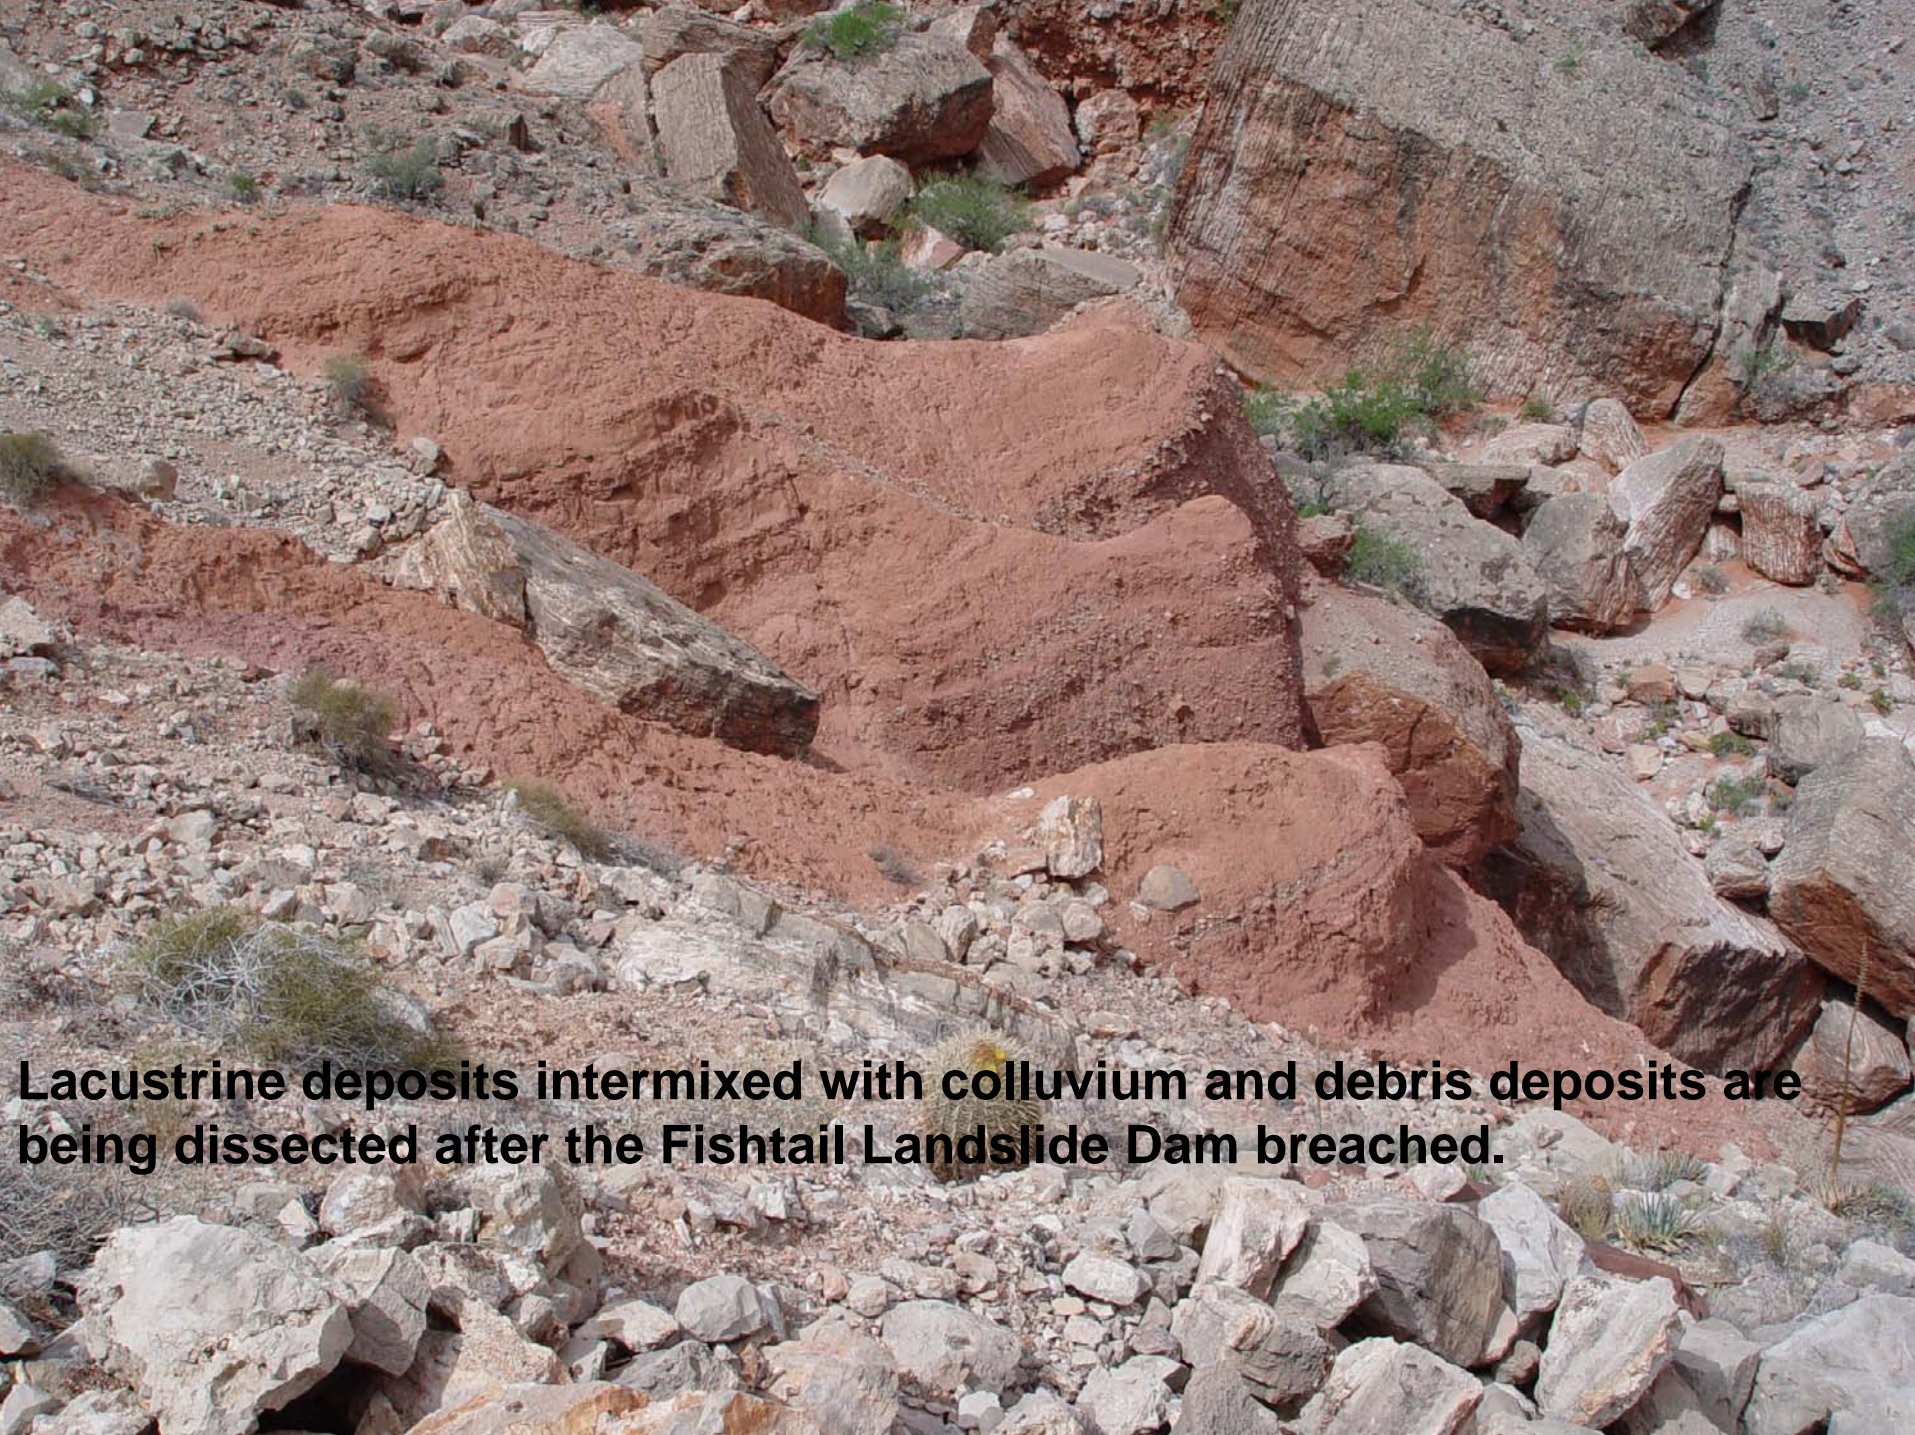
**Lacustrine deposits intermixed with colluvium and debris deposits are being dissected after the Fishtail Landslide Dam breached.**

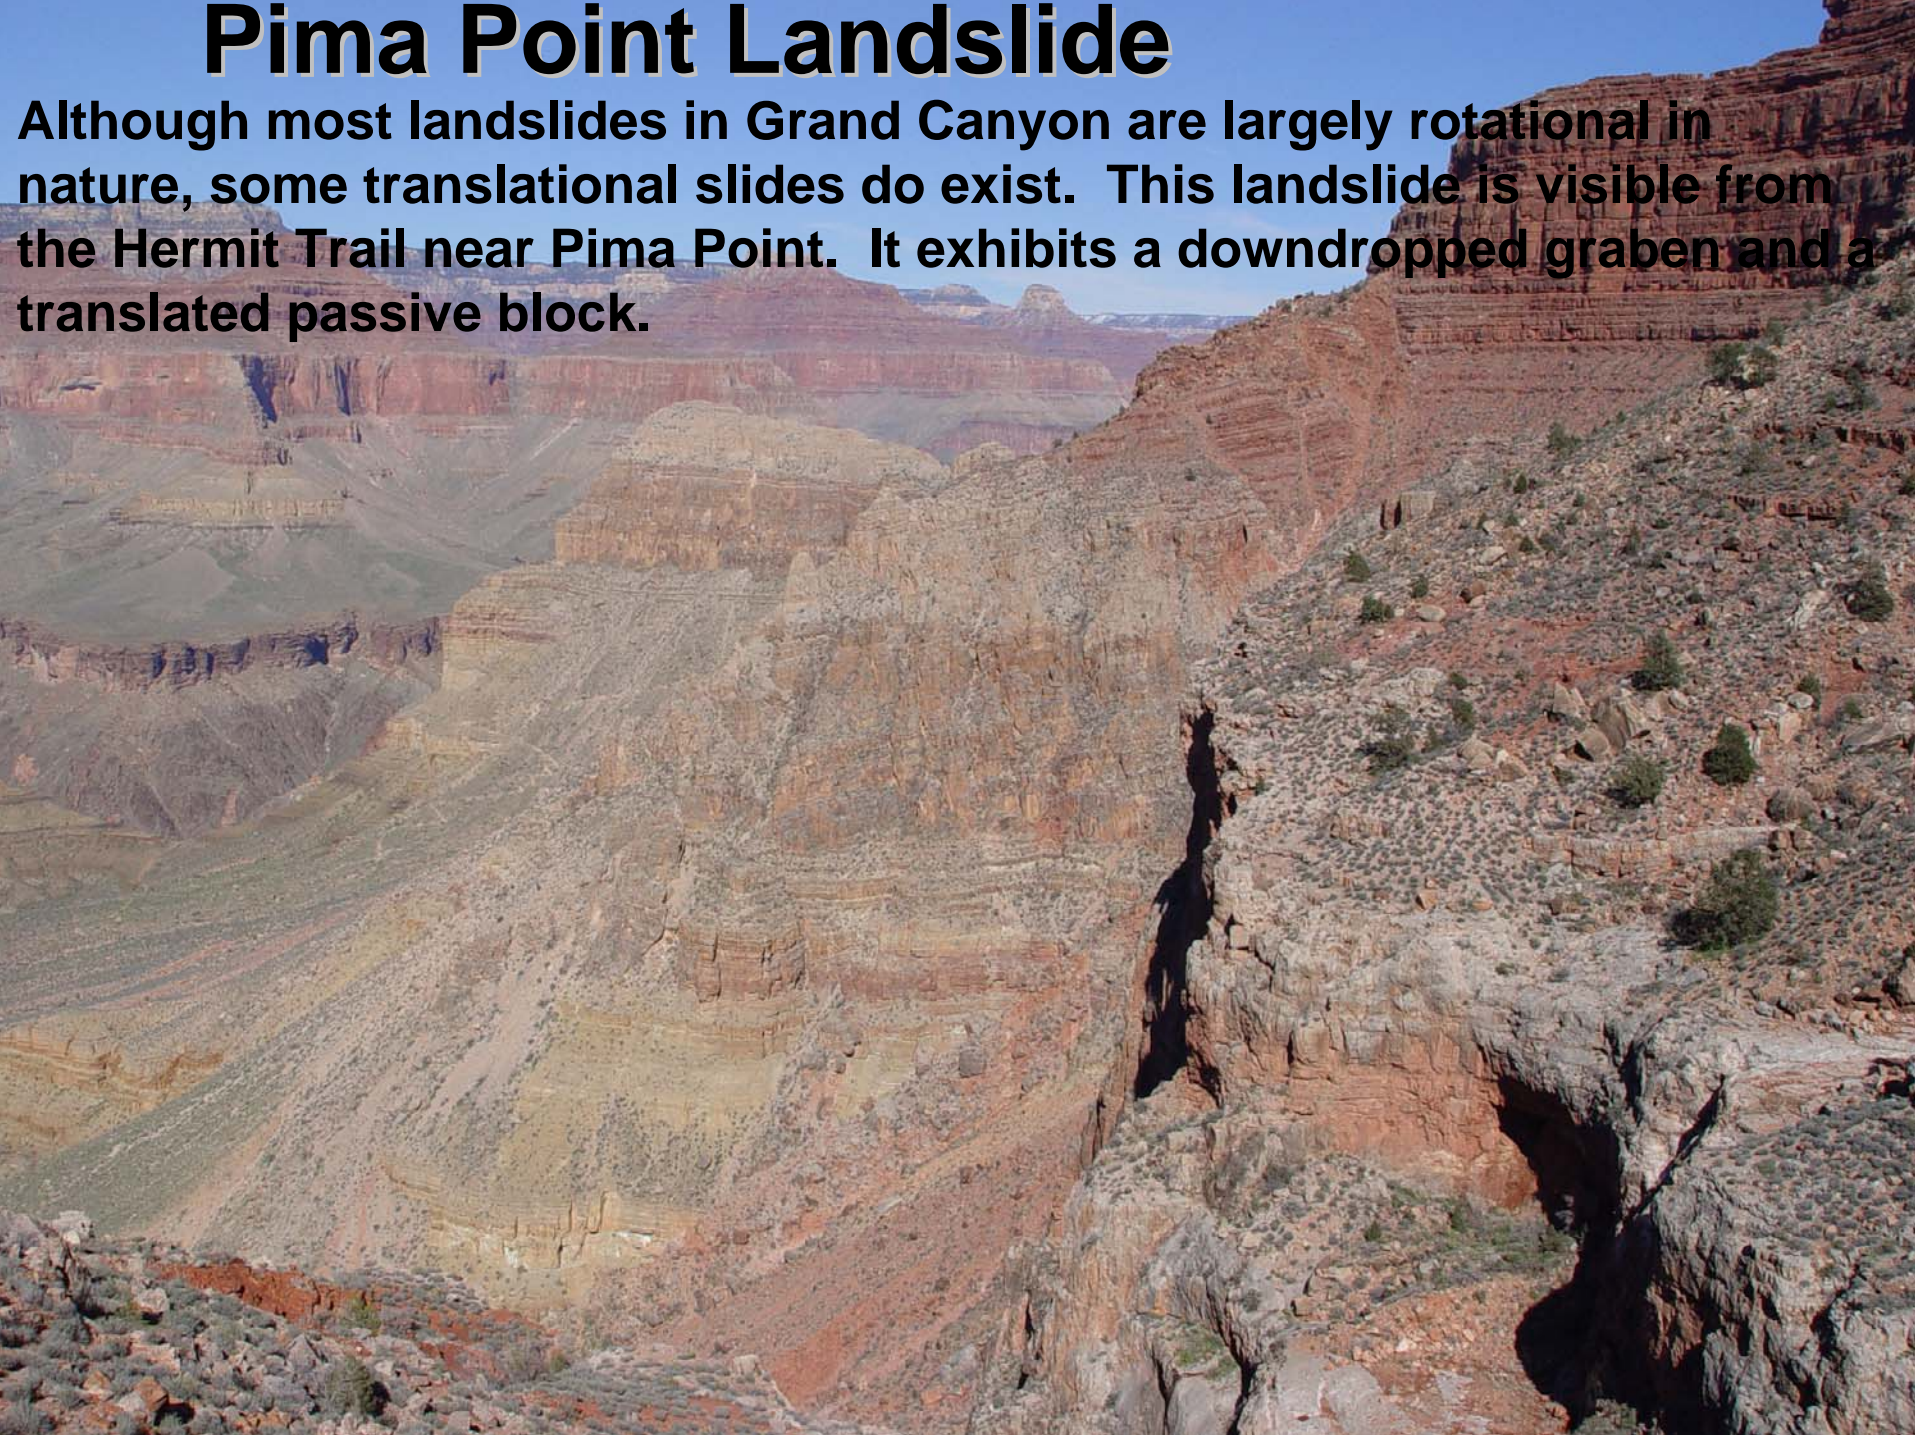
Although most landslides in Grand Canyon are largely rotational in nature, some translational slides do exist. This landslide is visible from the Hermit Trail near Pima Point. It exhibits a downdropped graben and a translated passive block.

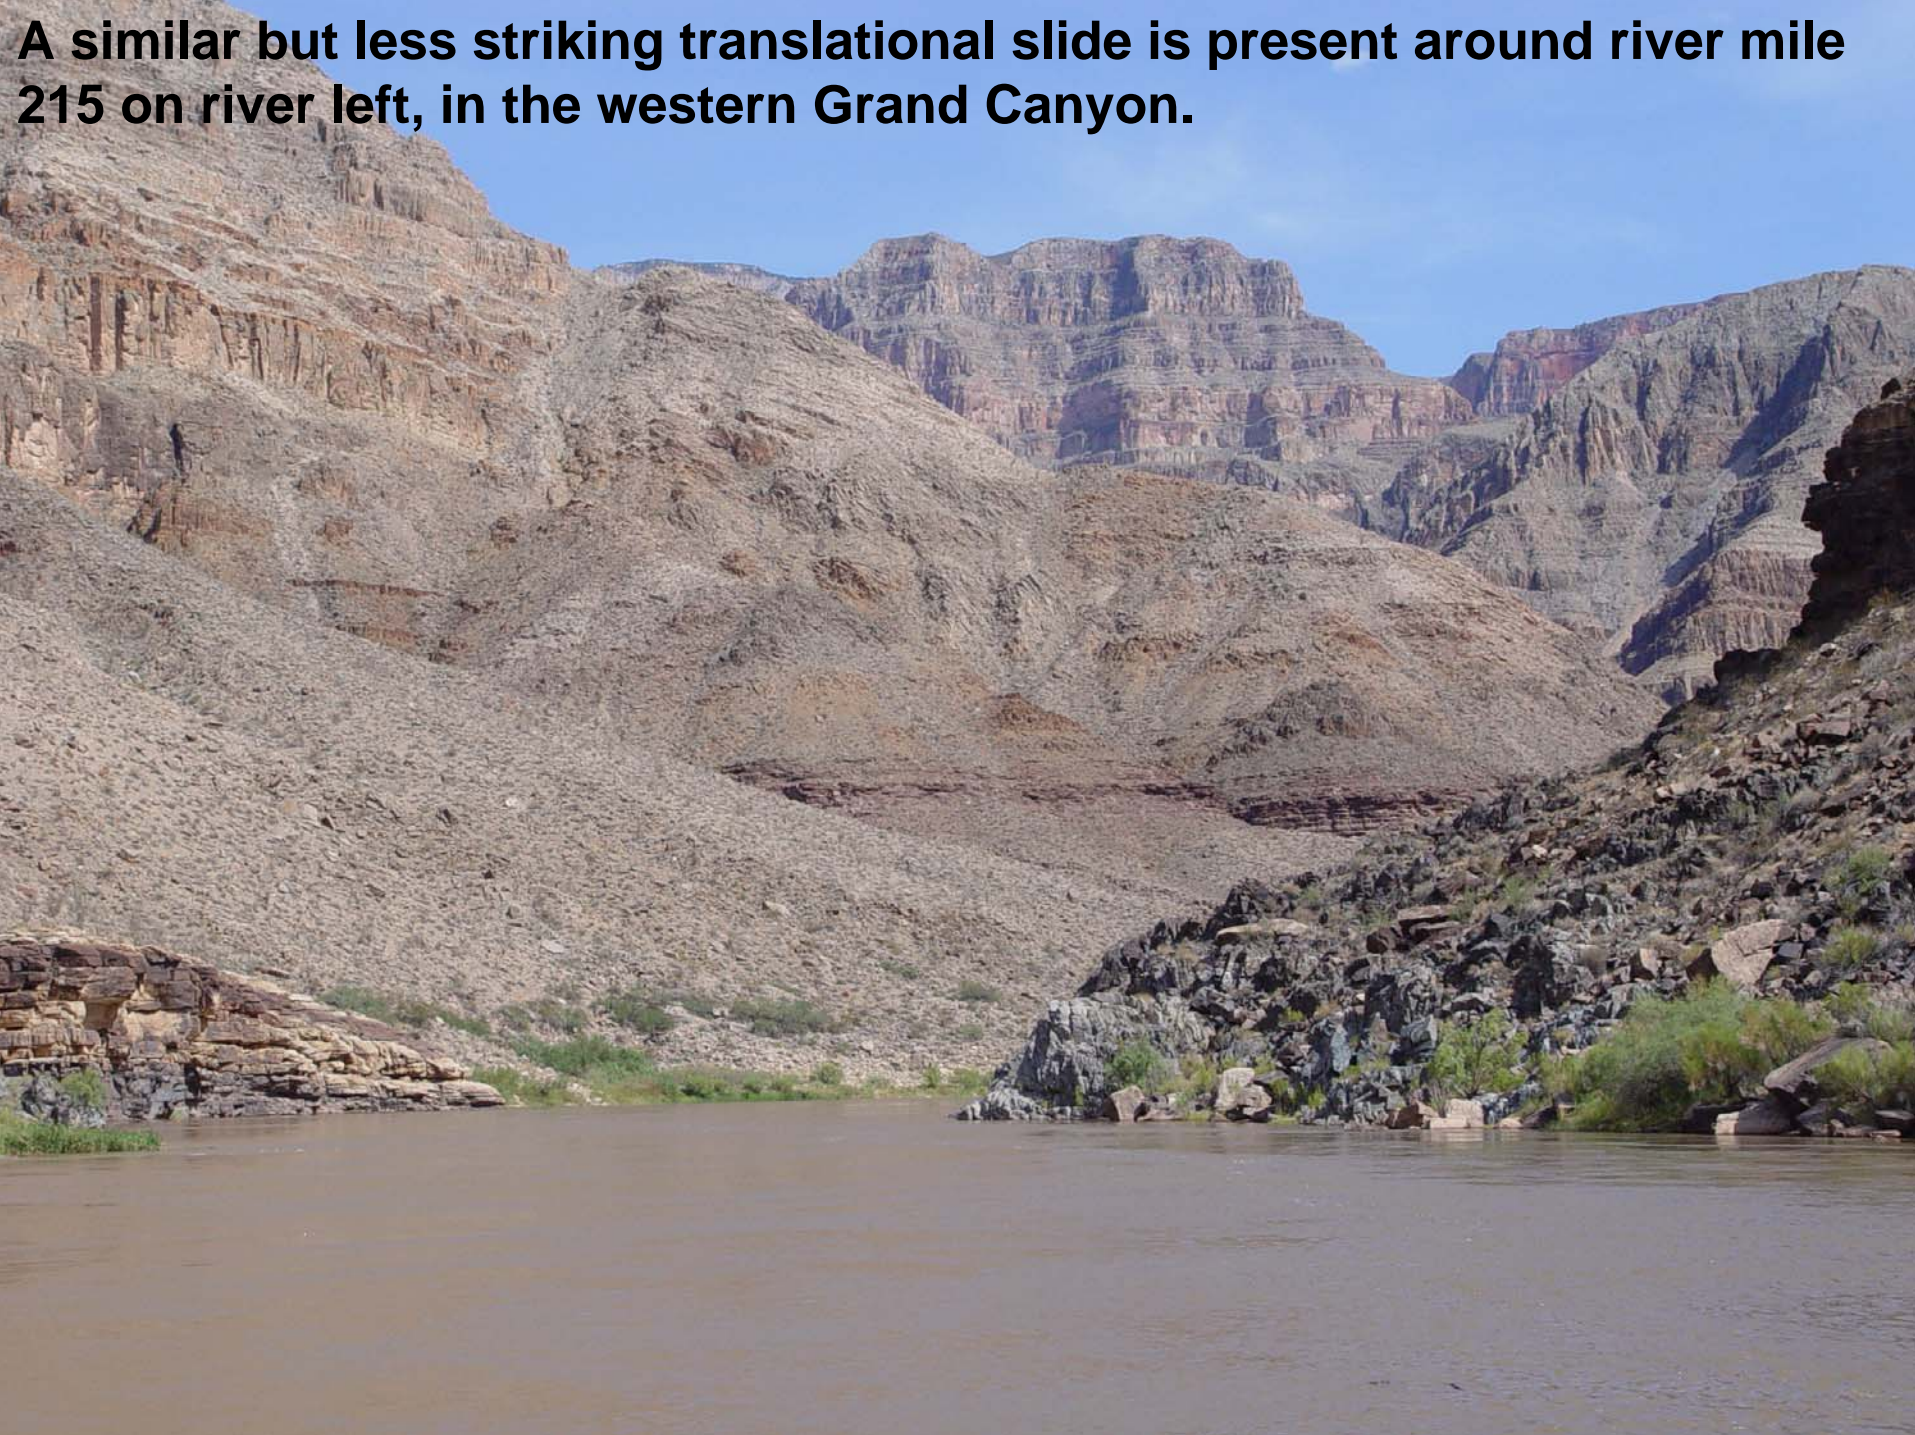
**A similar but less striking translational slide is present around river mile 215 on river left, in the western Grand Canyon.**
