# **NEW FINDINGS RELATED TO COMPOSITE BEDROCK MEGALANDSLIDES IN THE GRAND CANYON**

**Conor Watkins and  
J. David Rogers**

**Department of Geological Sciences & Engineering  
University of Missouri – Rolla  
AEG 2005, Las Vegas, NV**

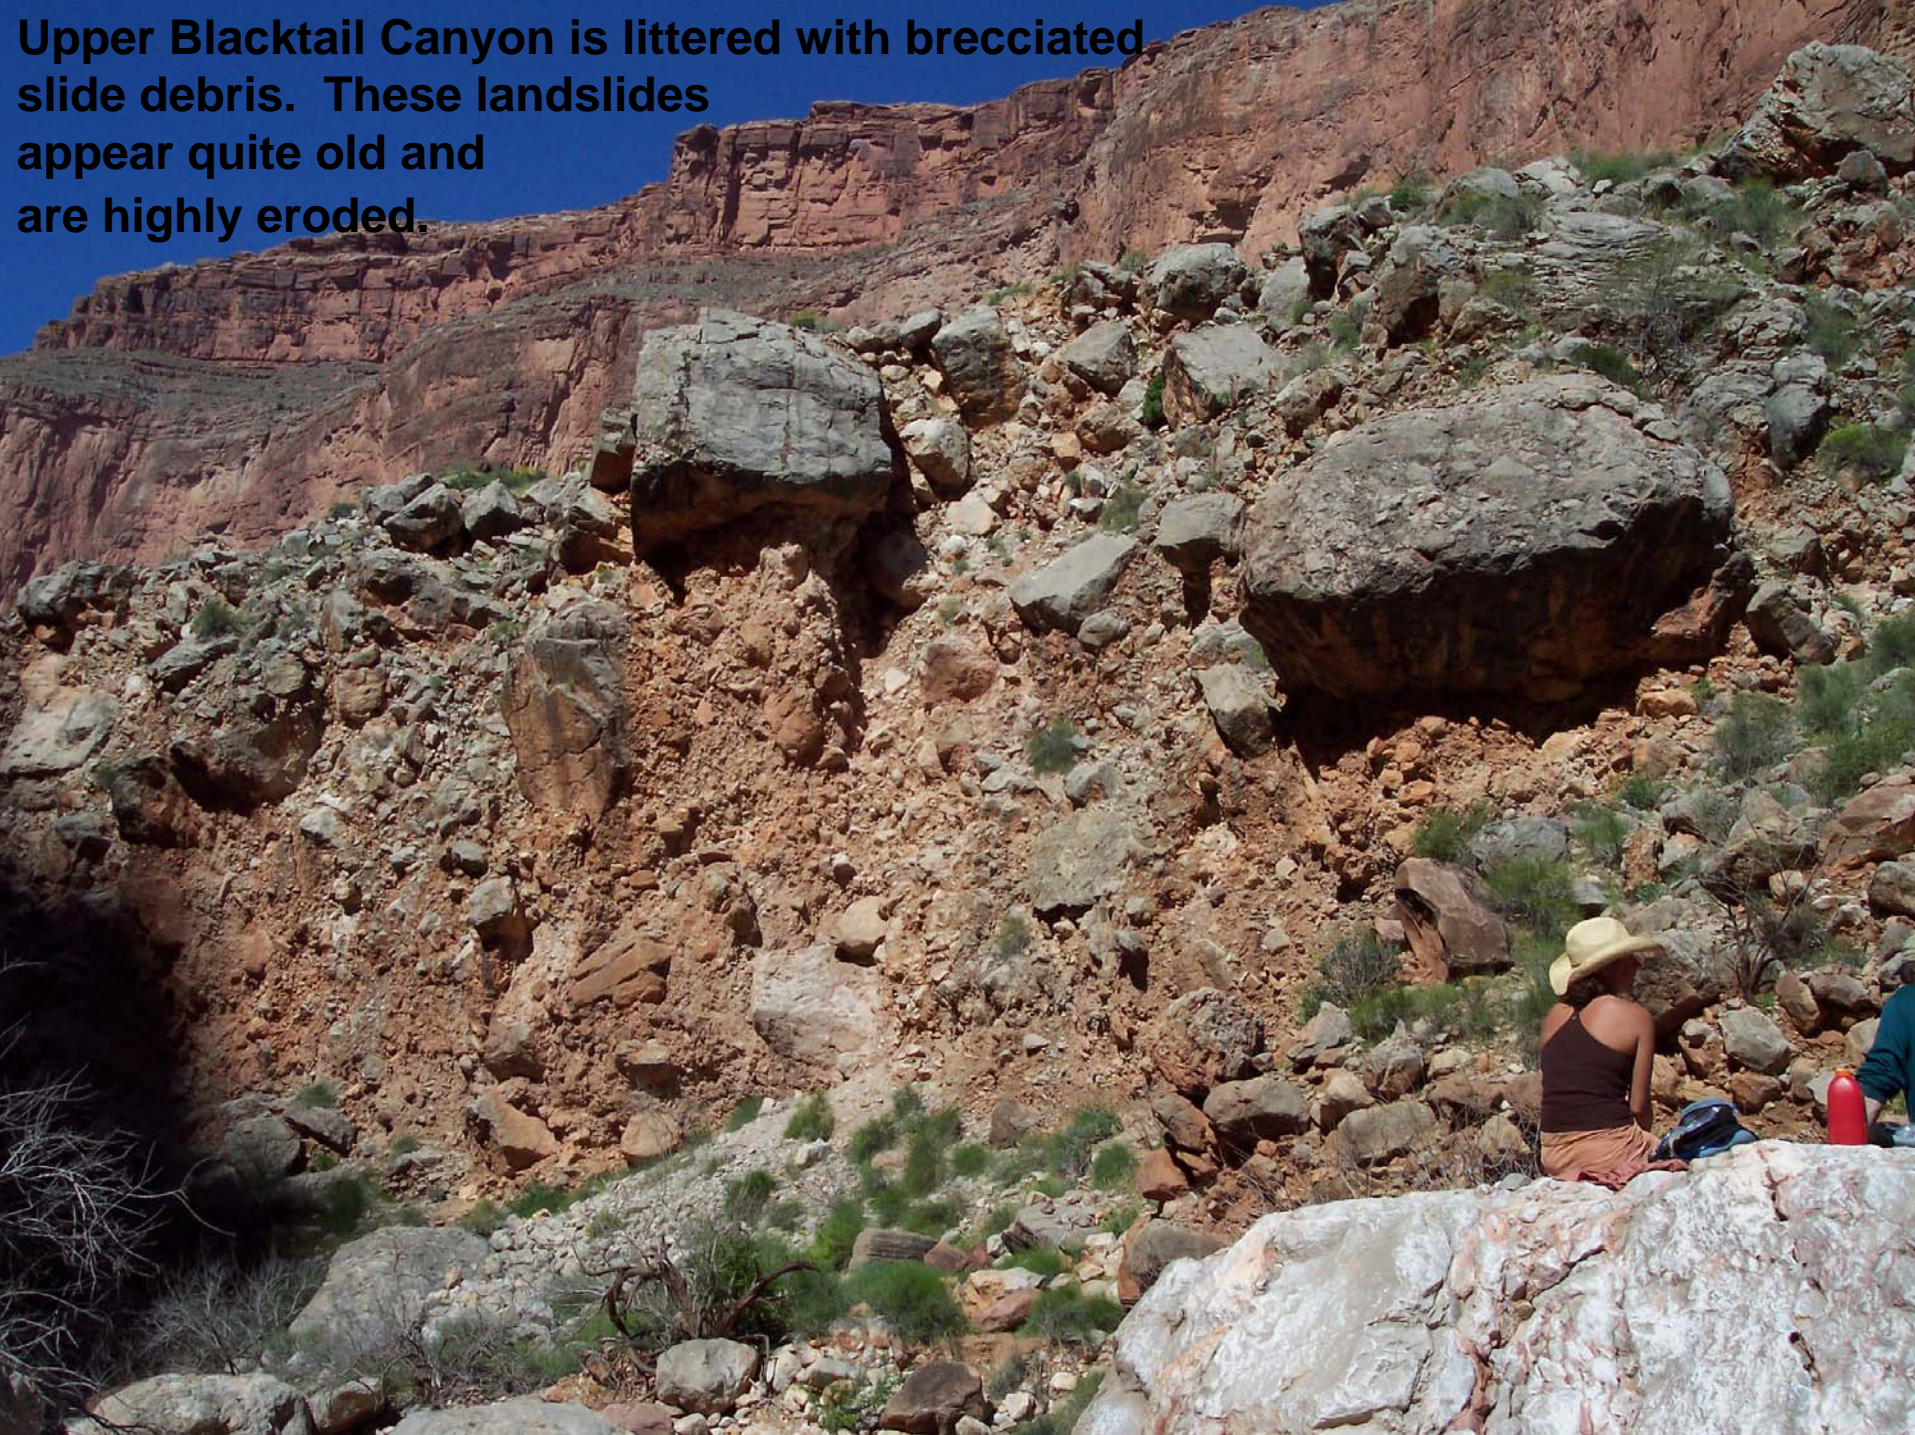
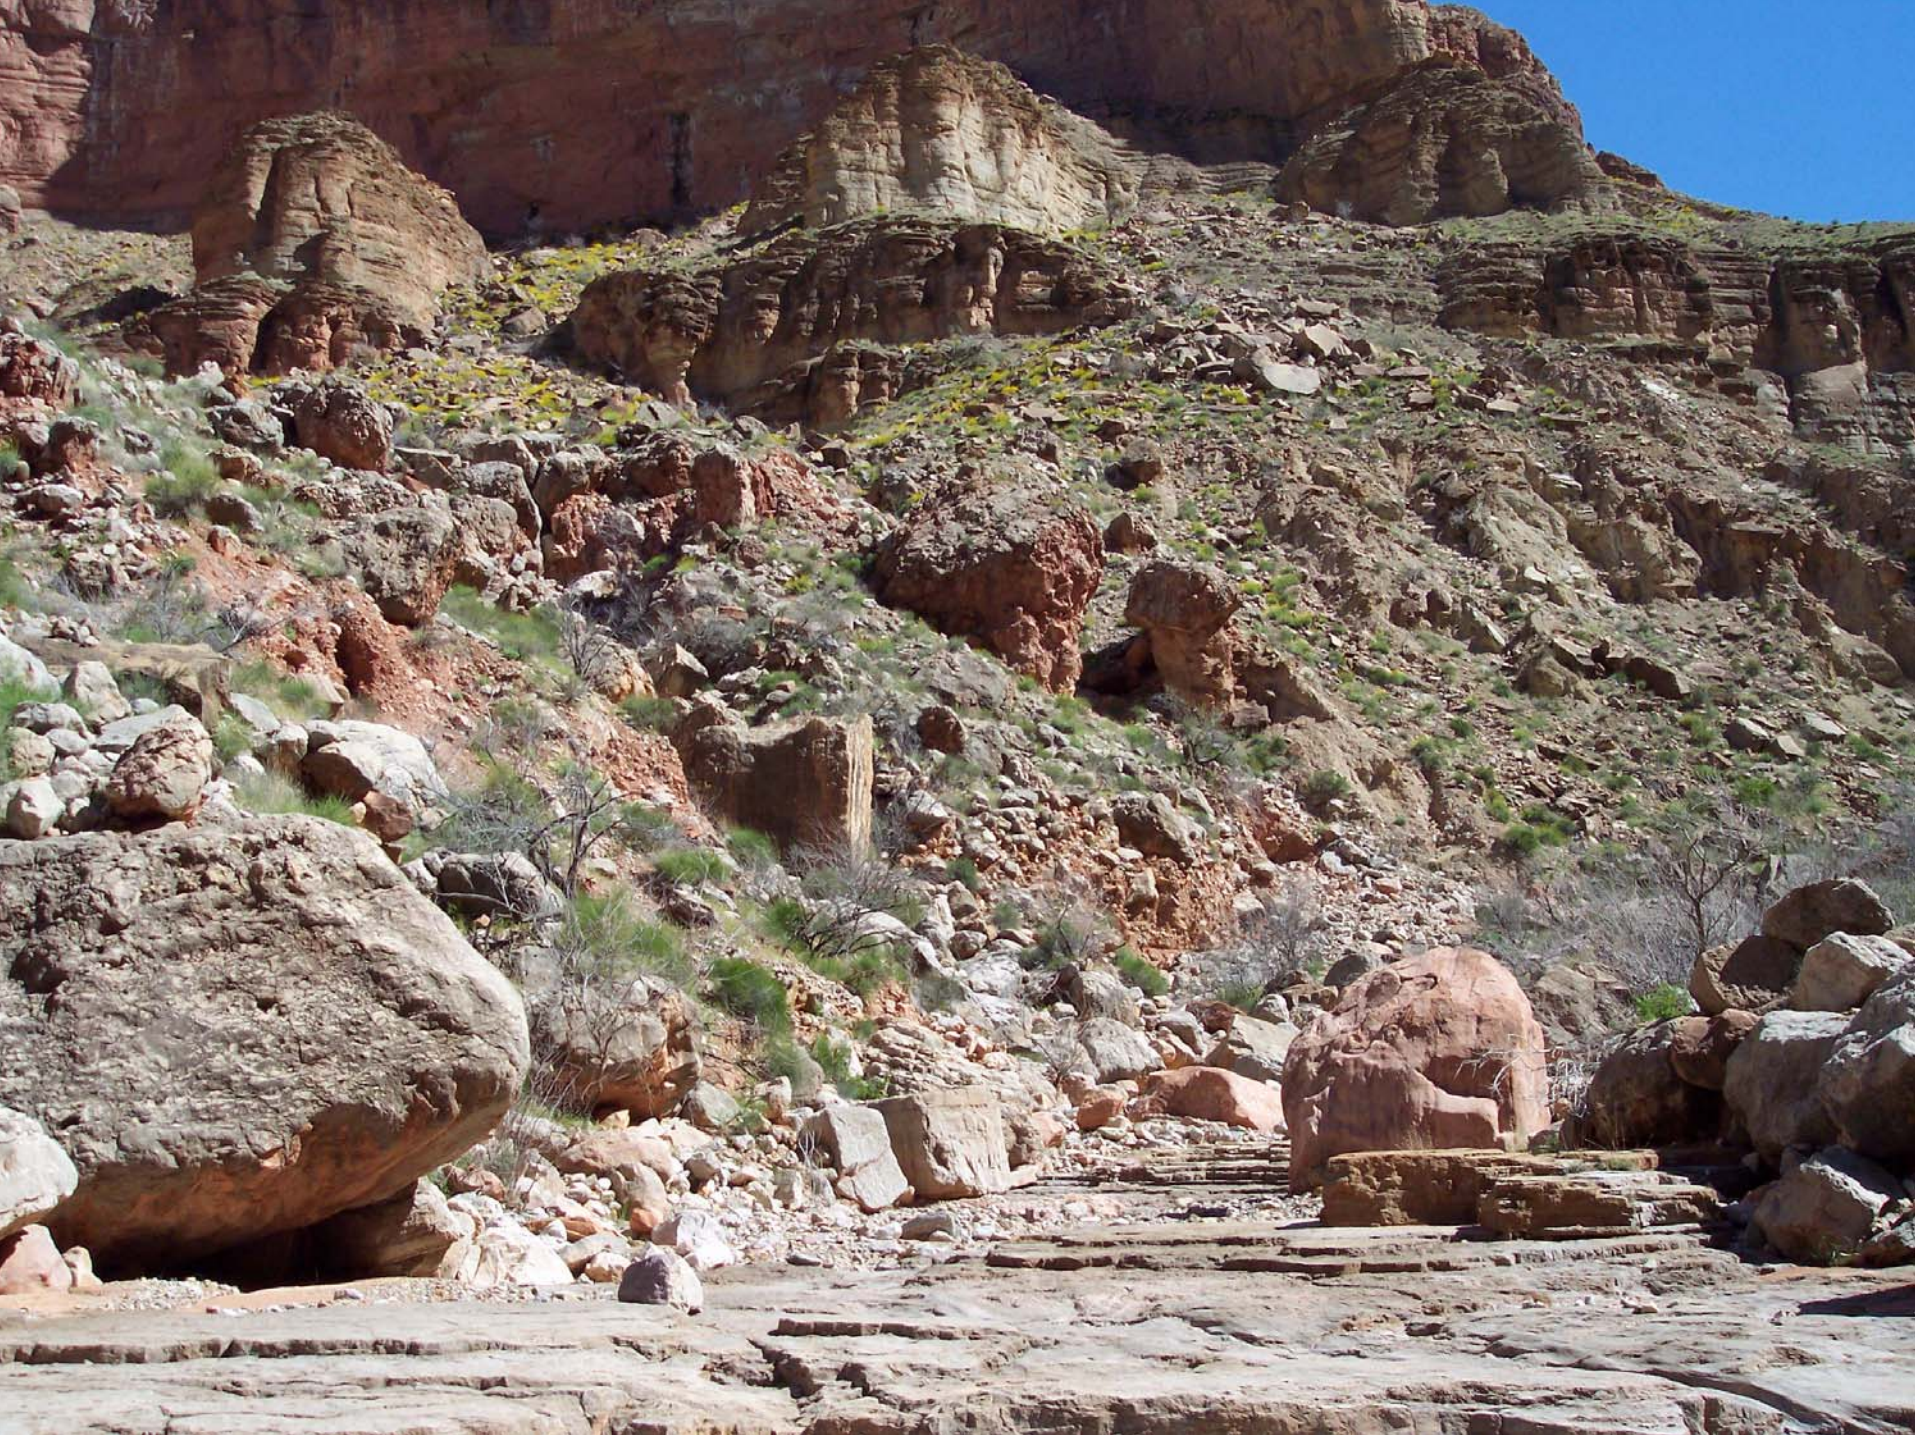
**Upper Blacktail Canyon is littered with brecciated slide debris. These landslides appear quite old and are highly eroded.**

**The above picture shows a recent rockfall that has dammed Blacktail Canyon as viewed from downstream (note circled person for scale). For now, the course debris is allowing the intermittent flow of Blacktail Canyon to run through the blockage and the dam has not breached**

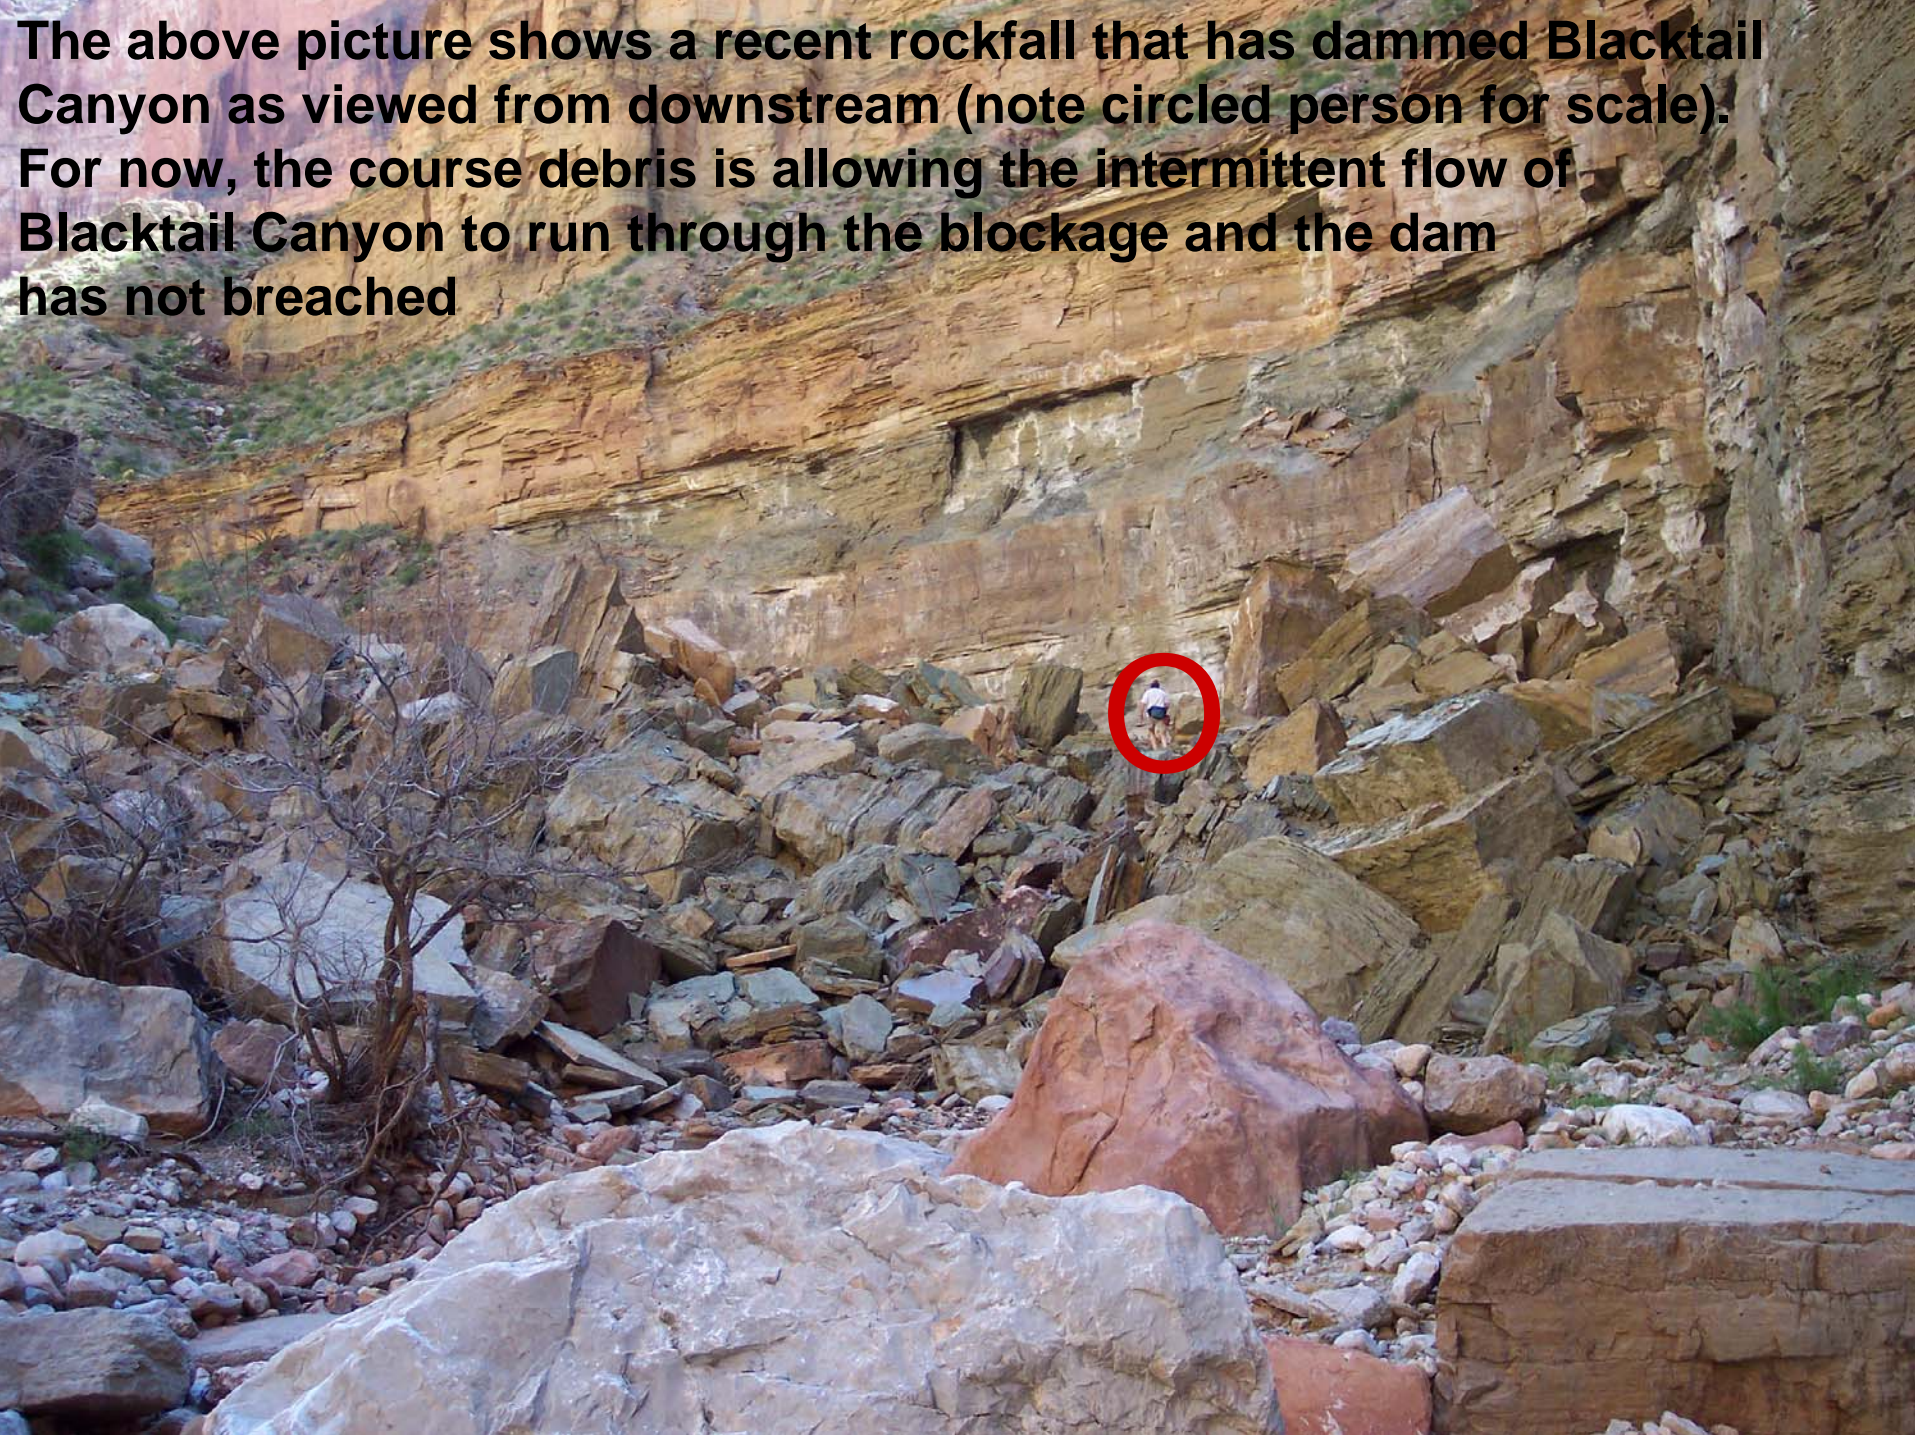
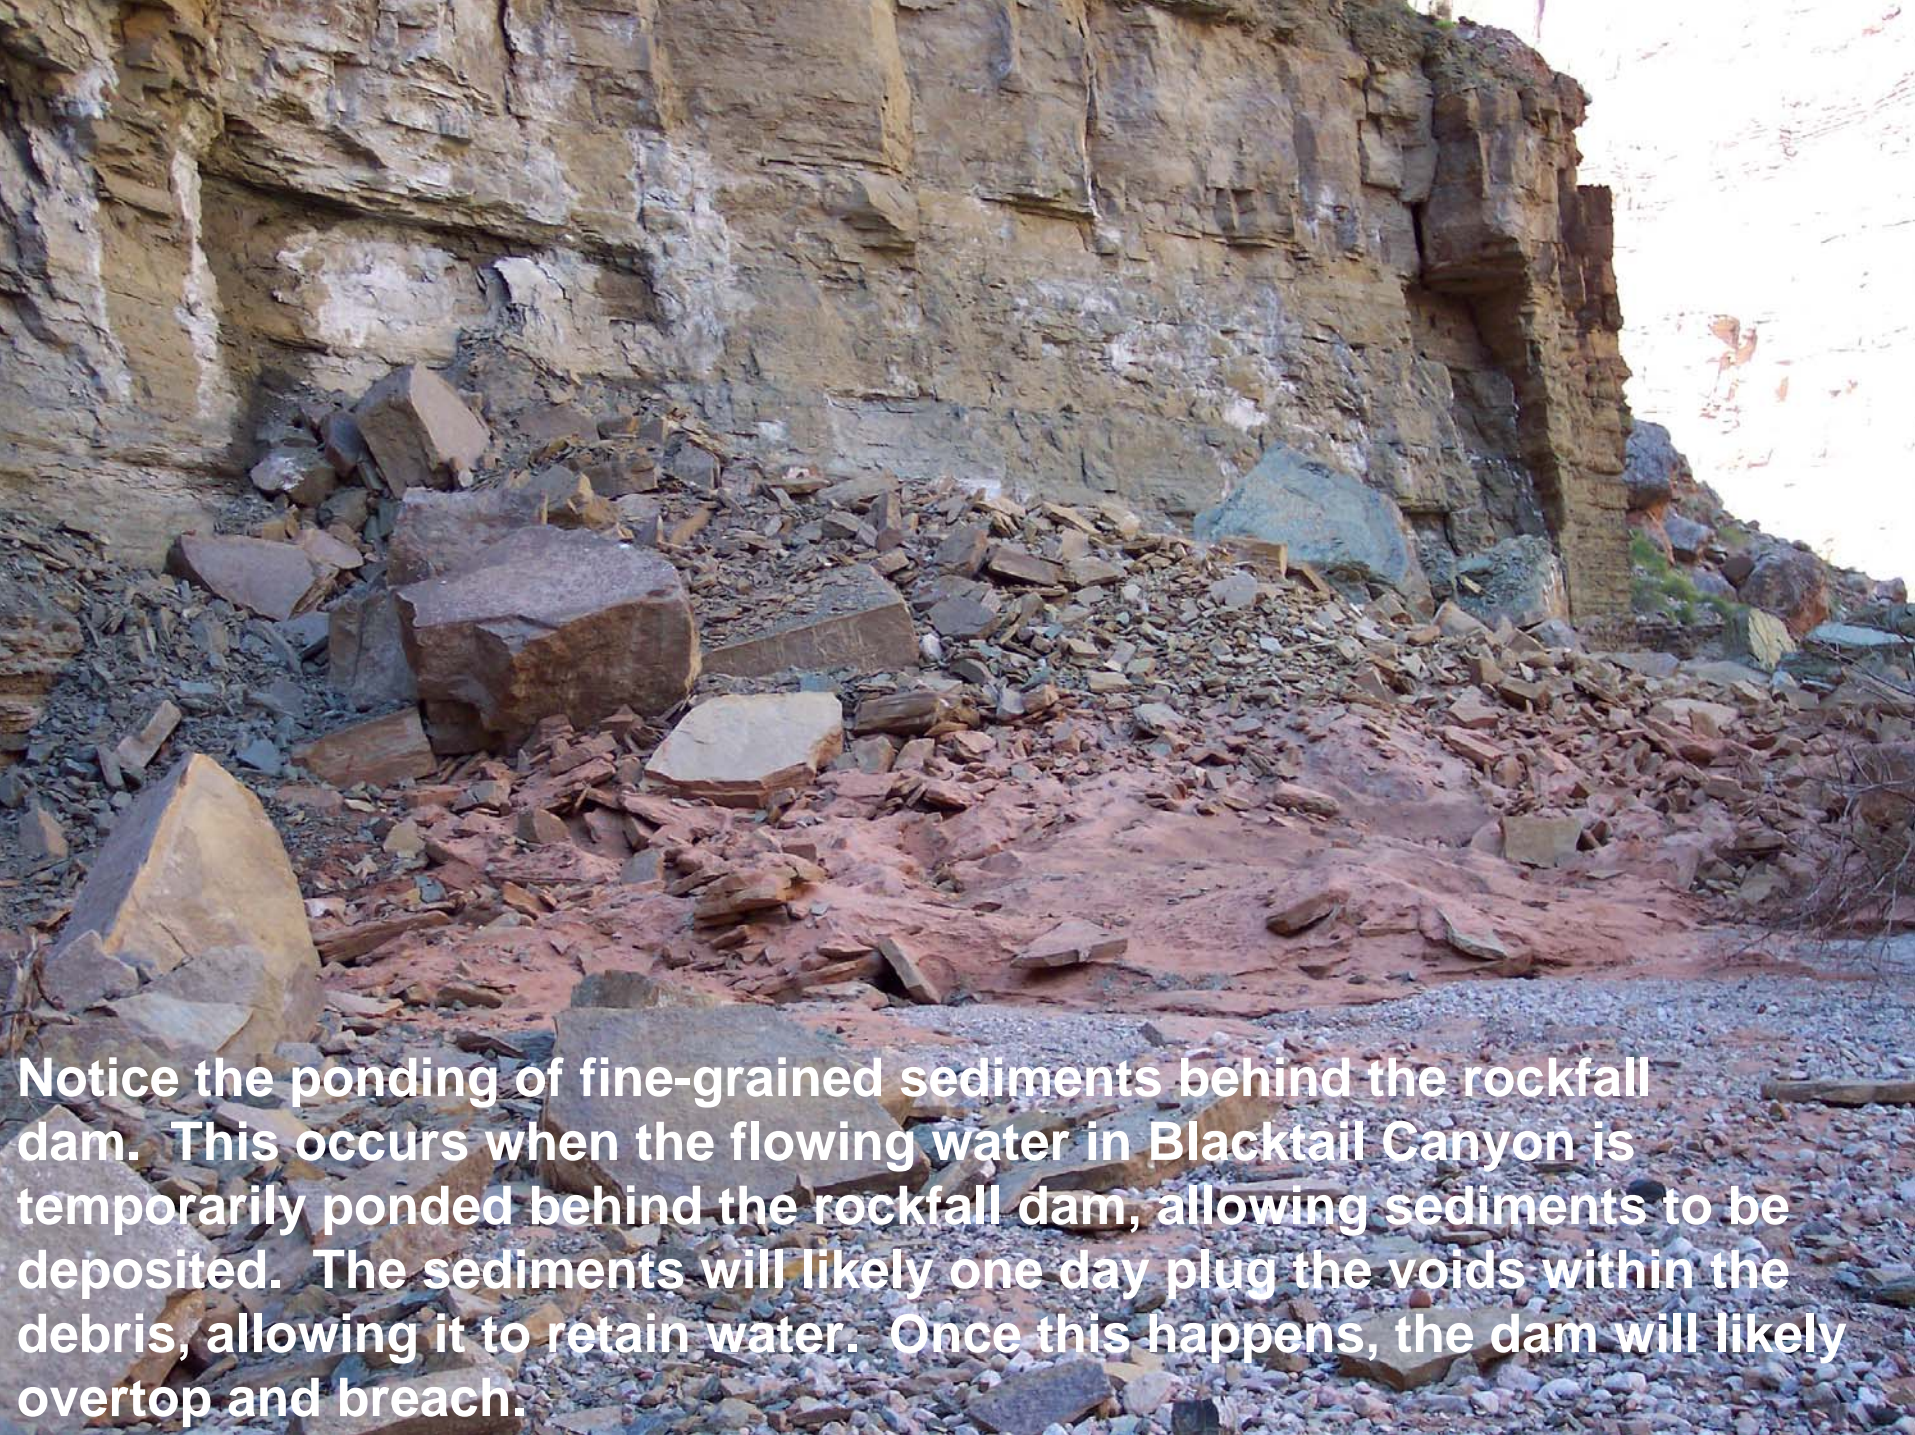
**Notice the ponding of fine-grained sediments behind the rockfall dam. This occurs when the flowing water in Blacktail Canyon is temporarily ponded behind the rockfall dam, allowing sediments to be deposited. The sediments will likely one day plug the voids within the debris, allowing it to retain water. Once this happens, the dam will likely overtop and breach.**

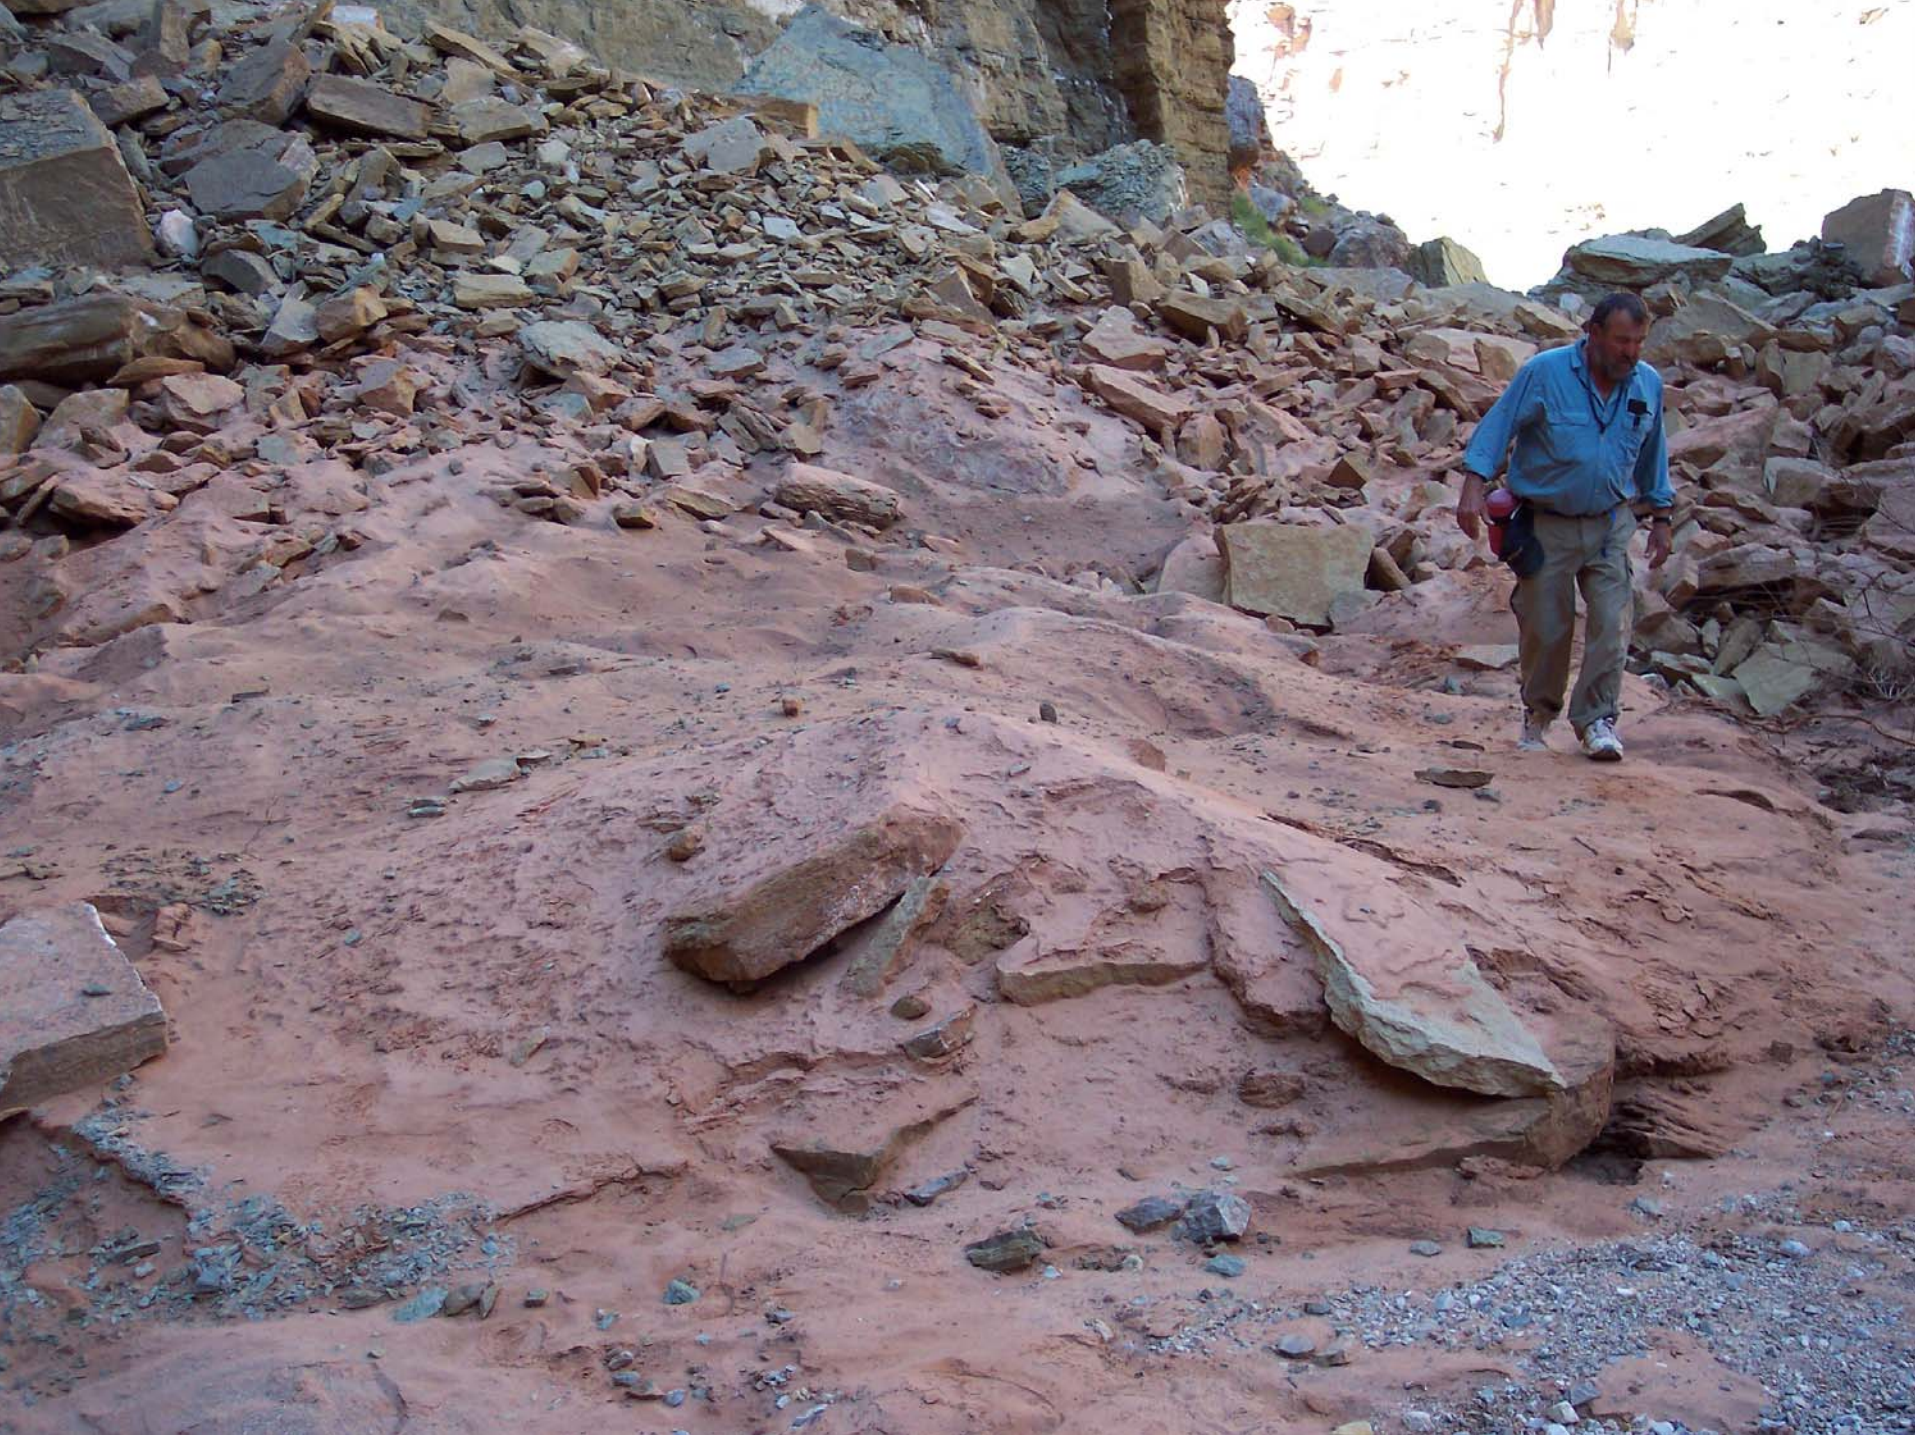
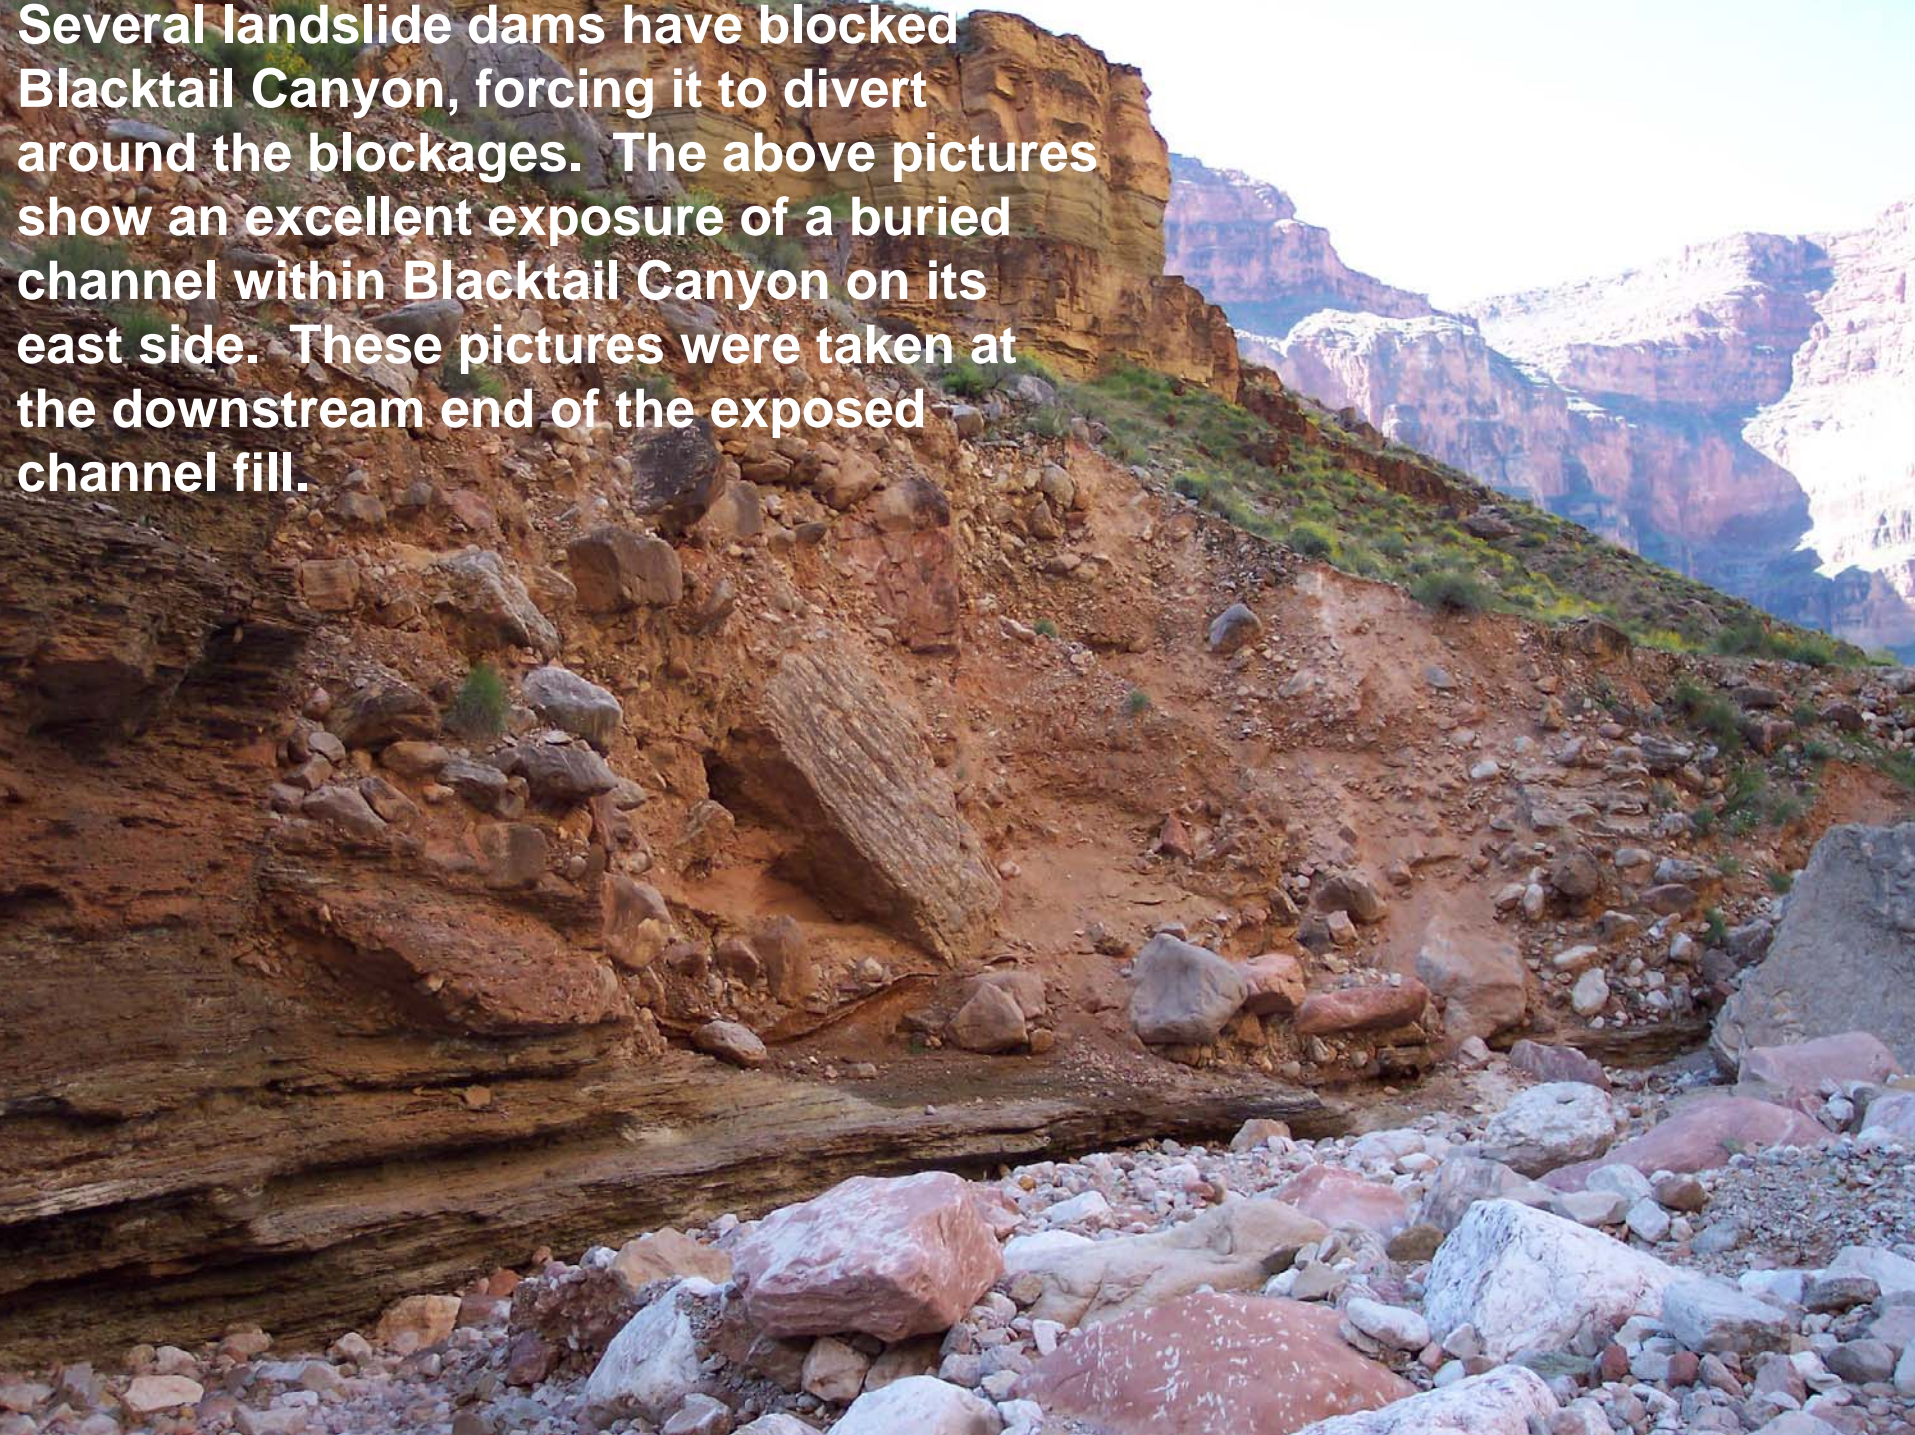
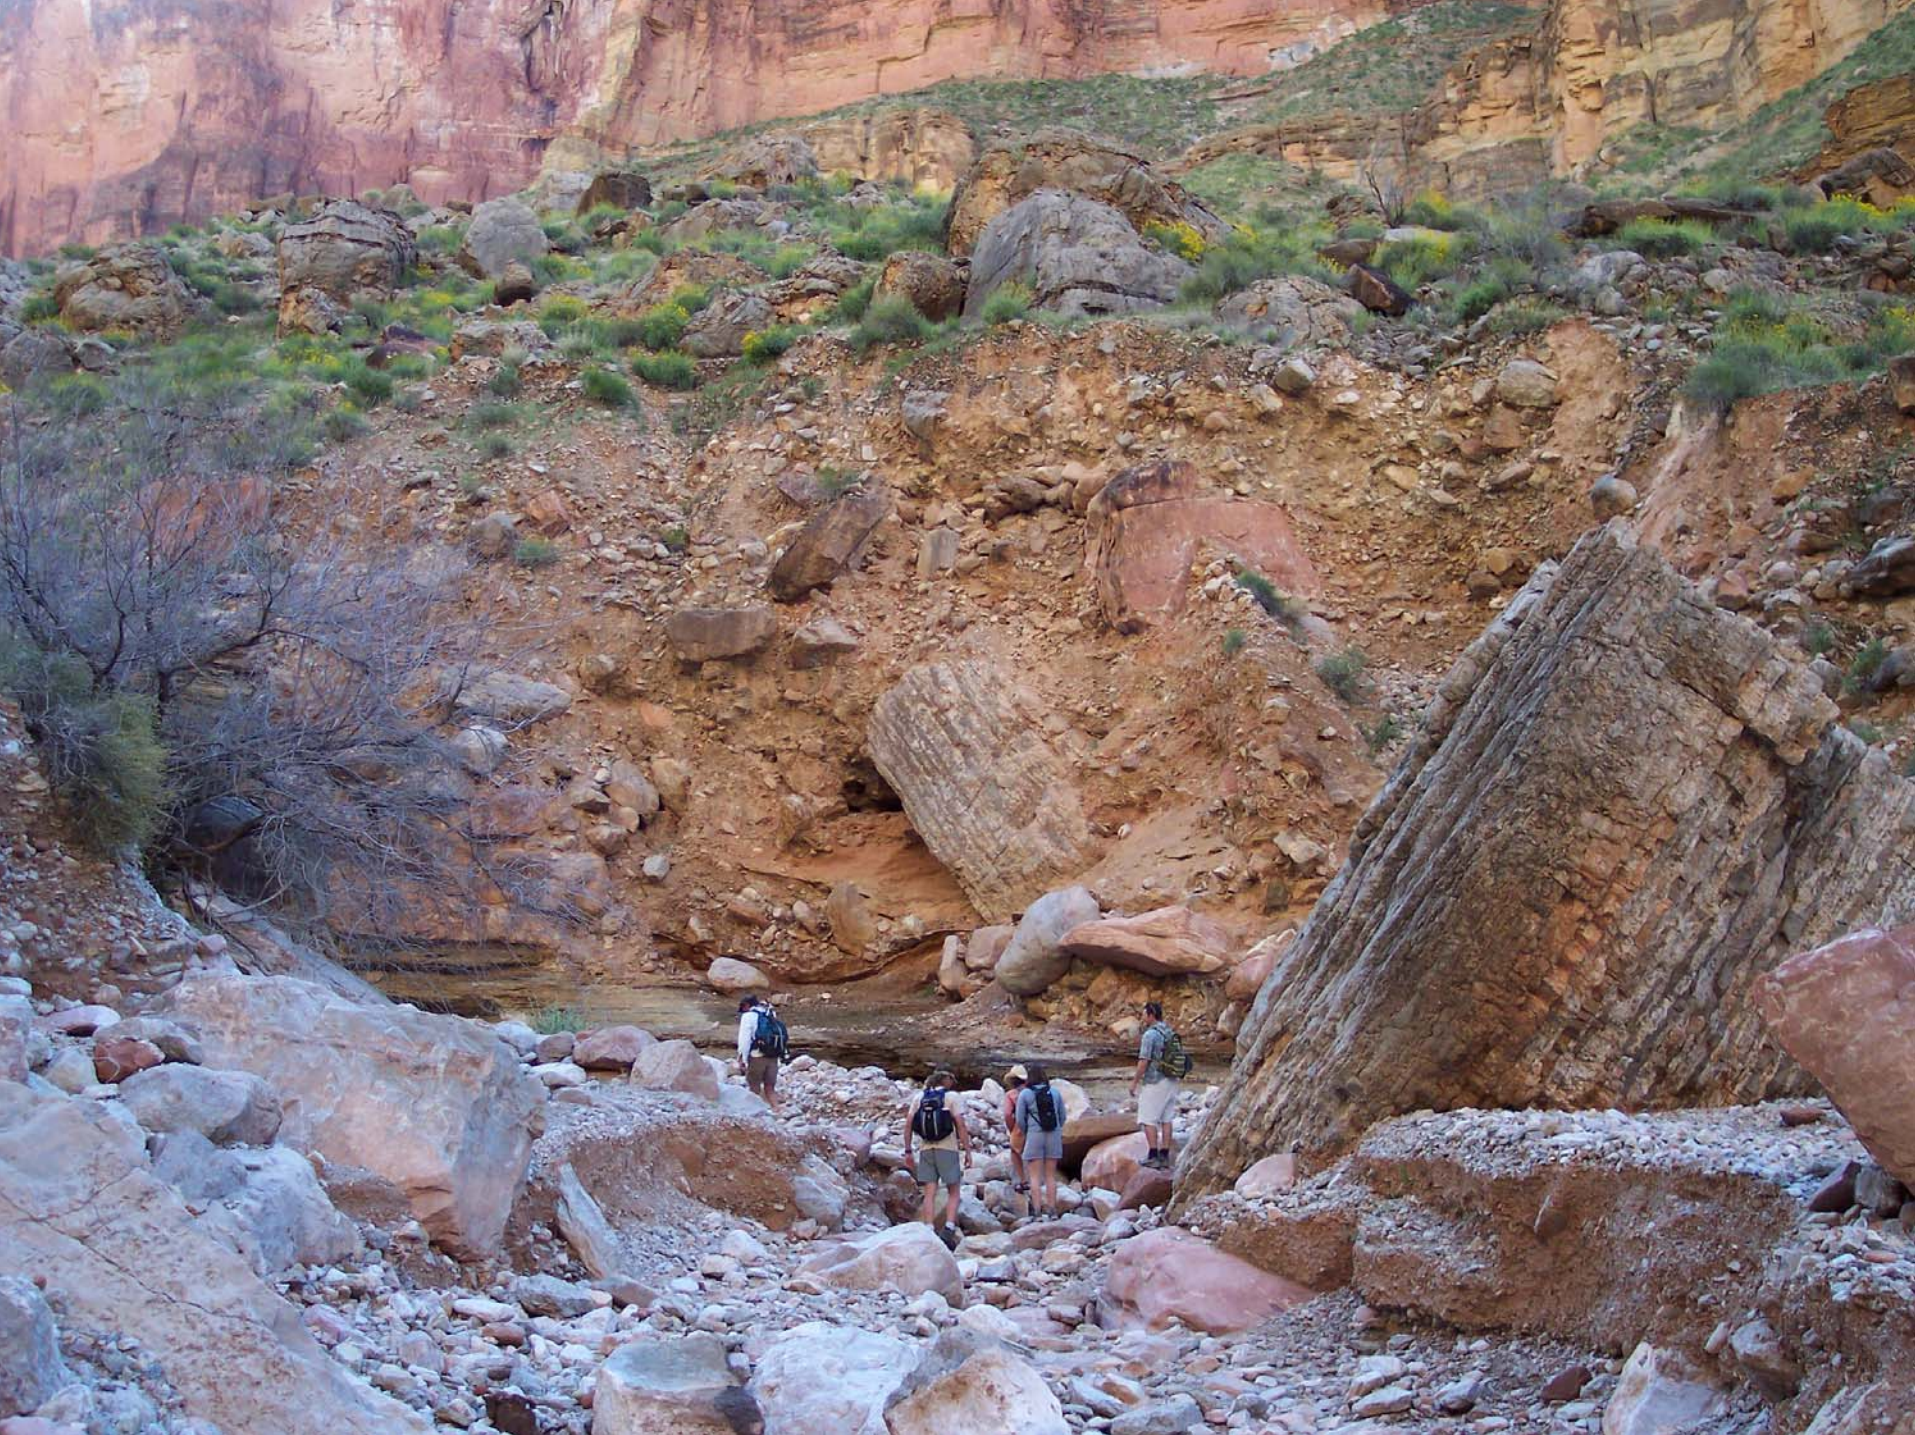
Several landslide dams have blocked Blacktail Canyon, forcing it to divert around the blockages. The above pictures show an excellent exposure of a buried channel within Blacktail Canyon on its east side. These pictures were taken at the downstream end of the exposed channel fill.

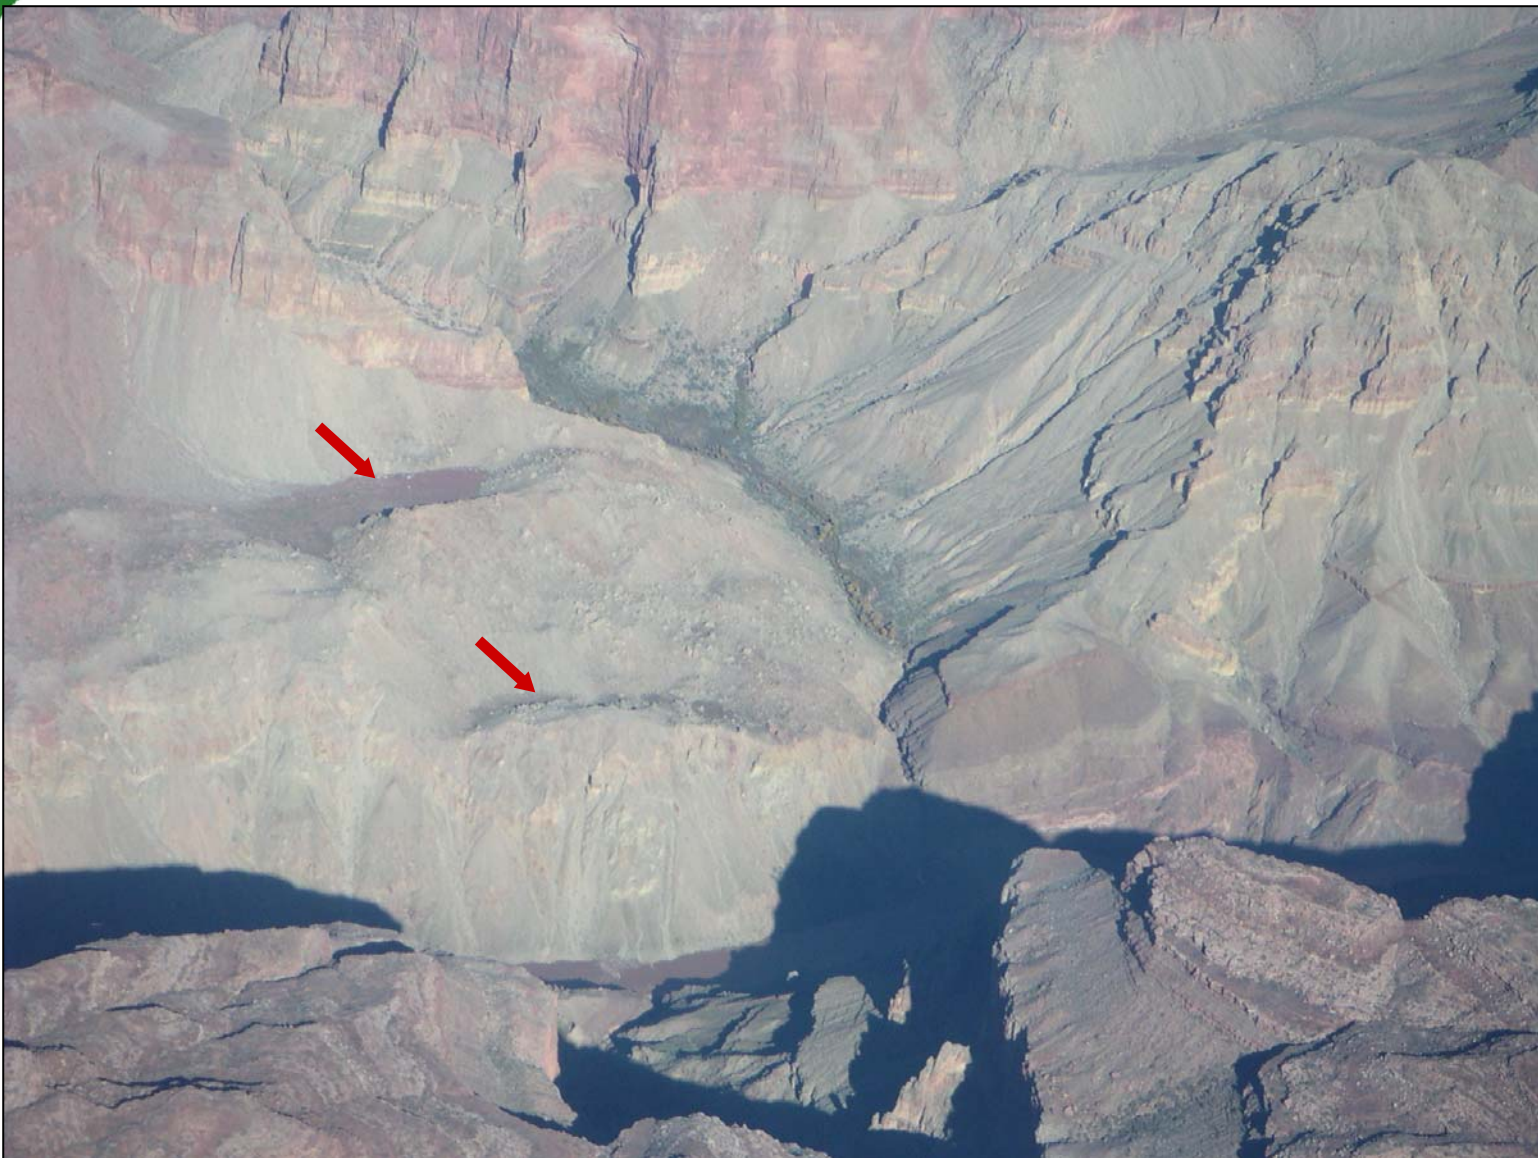
- **The Deer Creek Landslide as viewed from overhead at its eastern end. It extends along the north bank of the Colorado River for 3.7 km. Enclosed depressions are indicated by arrows.**
