# **NEW FINDINGS RELATED TO COMPOSITE BEDROCK MEGALANDSLIDES IN THE GRAND CANYON**

**Conor Watkins and  
J. David Rogers**

**Department of Geological Sciences & Engineering  
University of Missouri – Rolla  
AEG 2005, Las Vegas, NV**

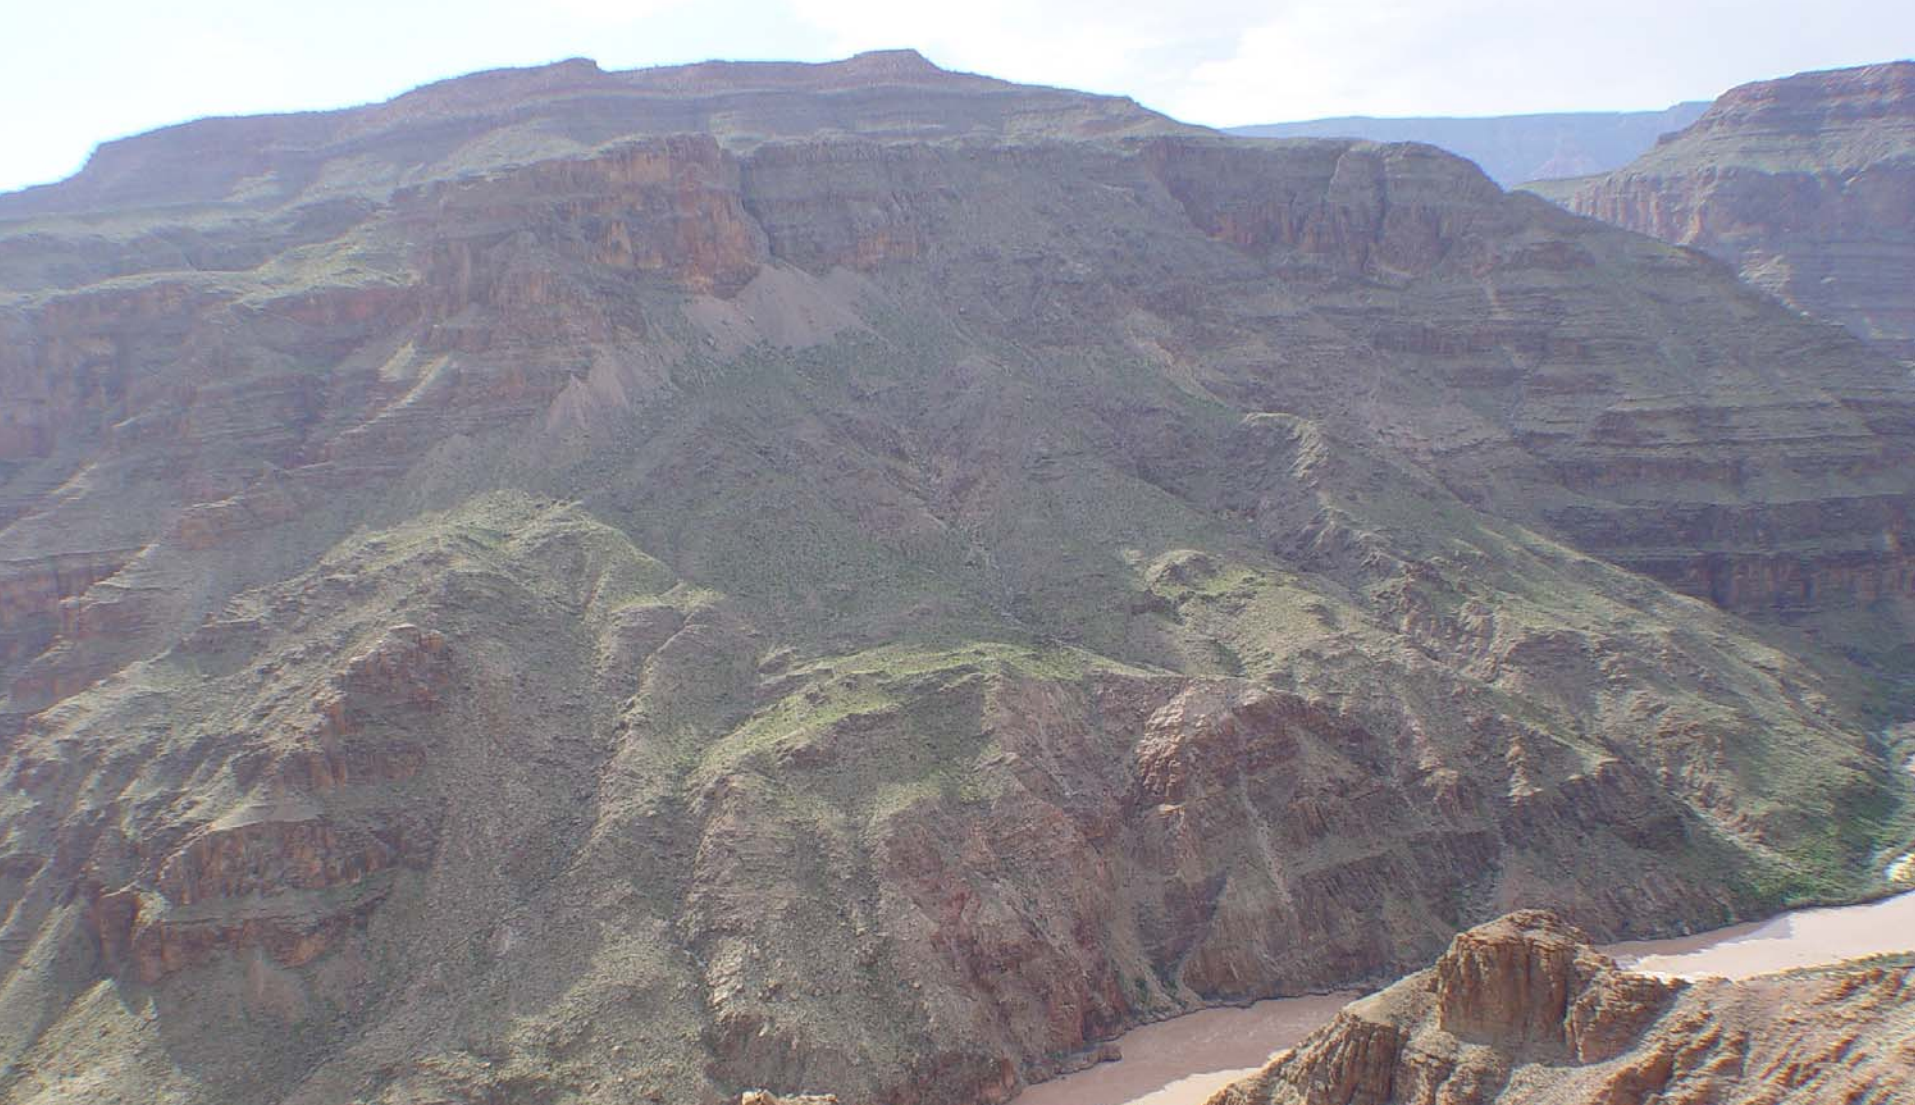
- **The Colorado River curves around the toe of the 205-Mile River Right Landslide and appears to have been dammed/diverted by this event.**

**View of the 205-Mile River Right Slide taken from the opposite side of the canyon atop the 205-Mile River Left Landslide. Secondary retrogressive slumps line the right bank of the channel, where the toe of the main slide mass is being undercut by the Colorado River. Talus cones along the headscarp are fresh, indicating the scarp is still raveling.**

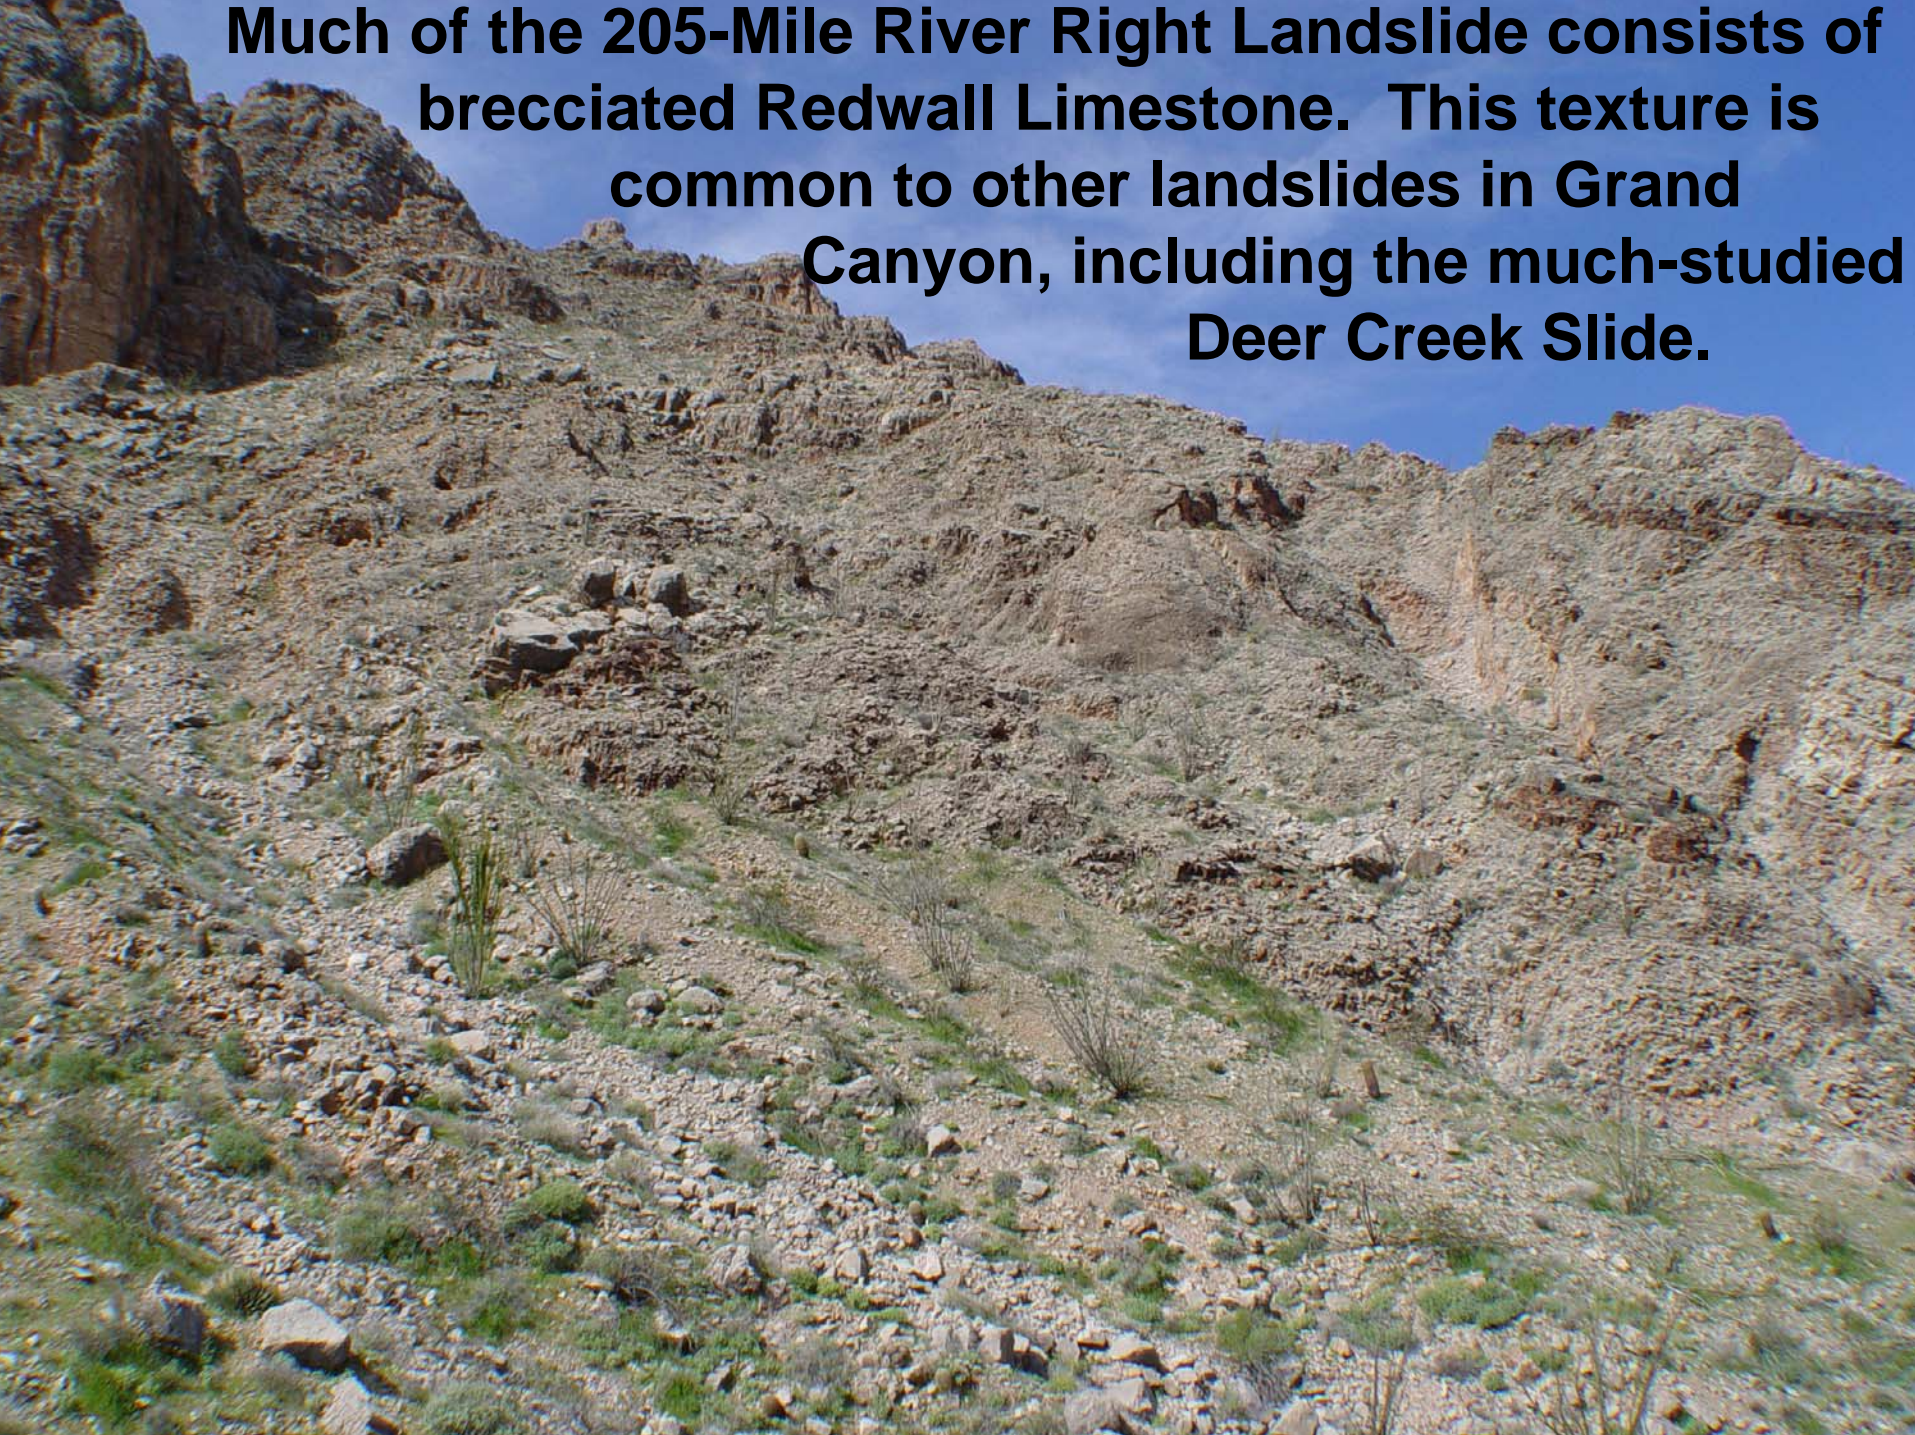
**Much of the 205-Mile River Right Landslide consists of brecciated Redwall Limestone. This texture is common to other landslides in Grand Canyon, including the much-studied Deer Creek Slide.**

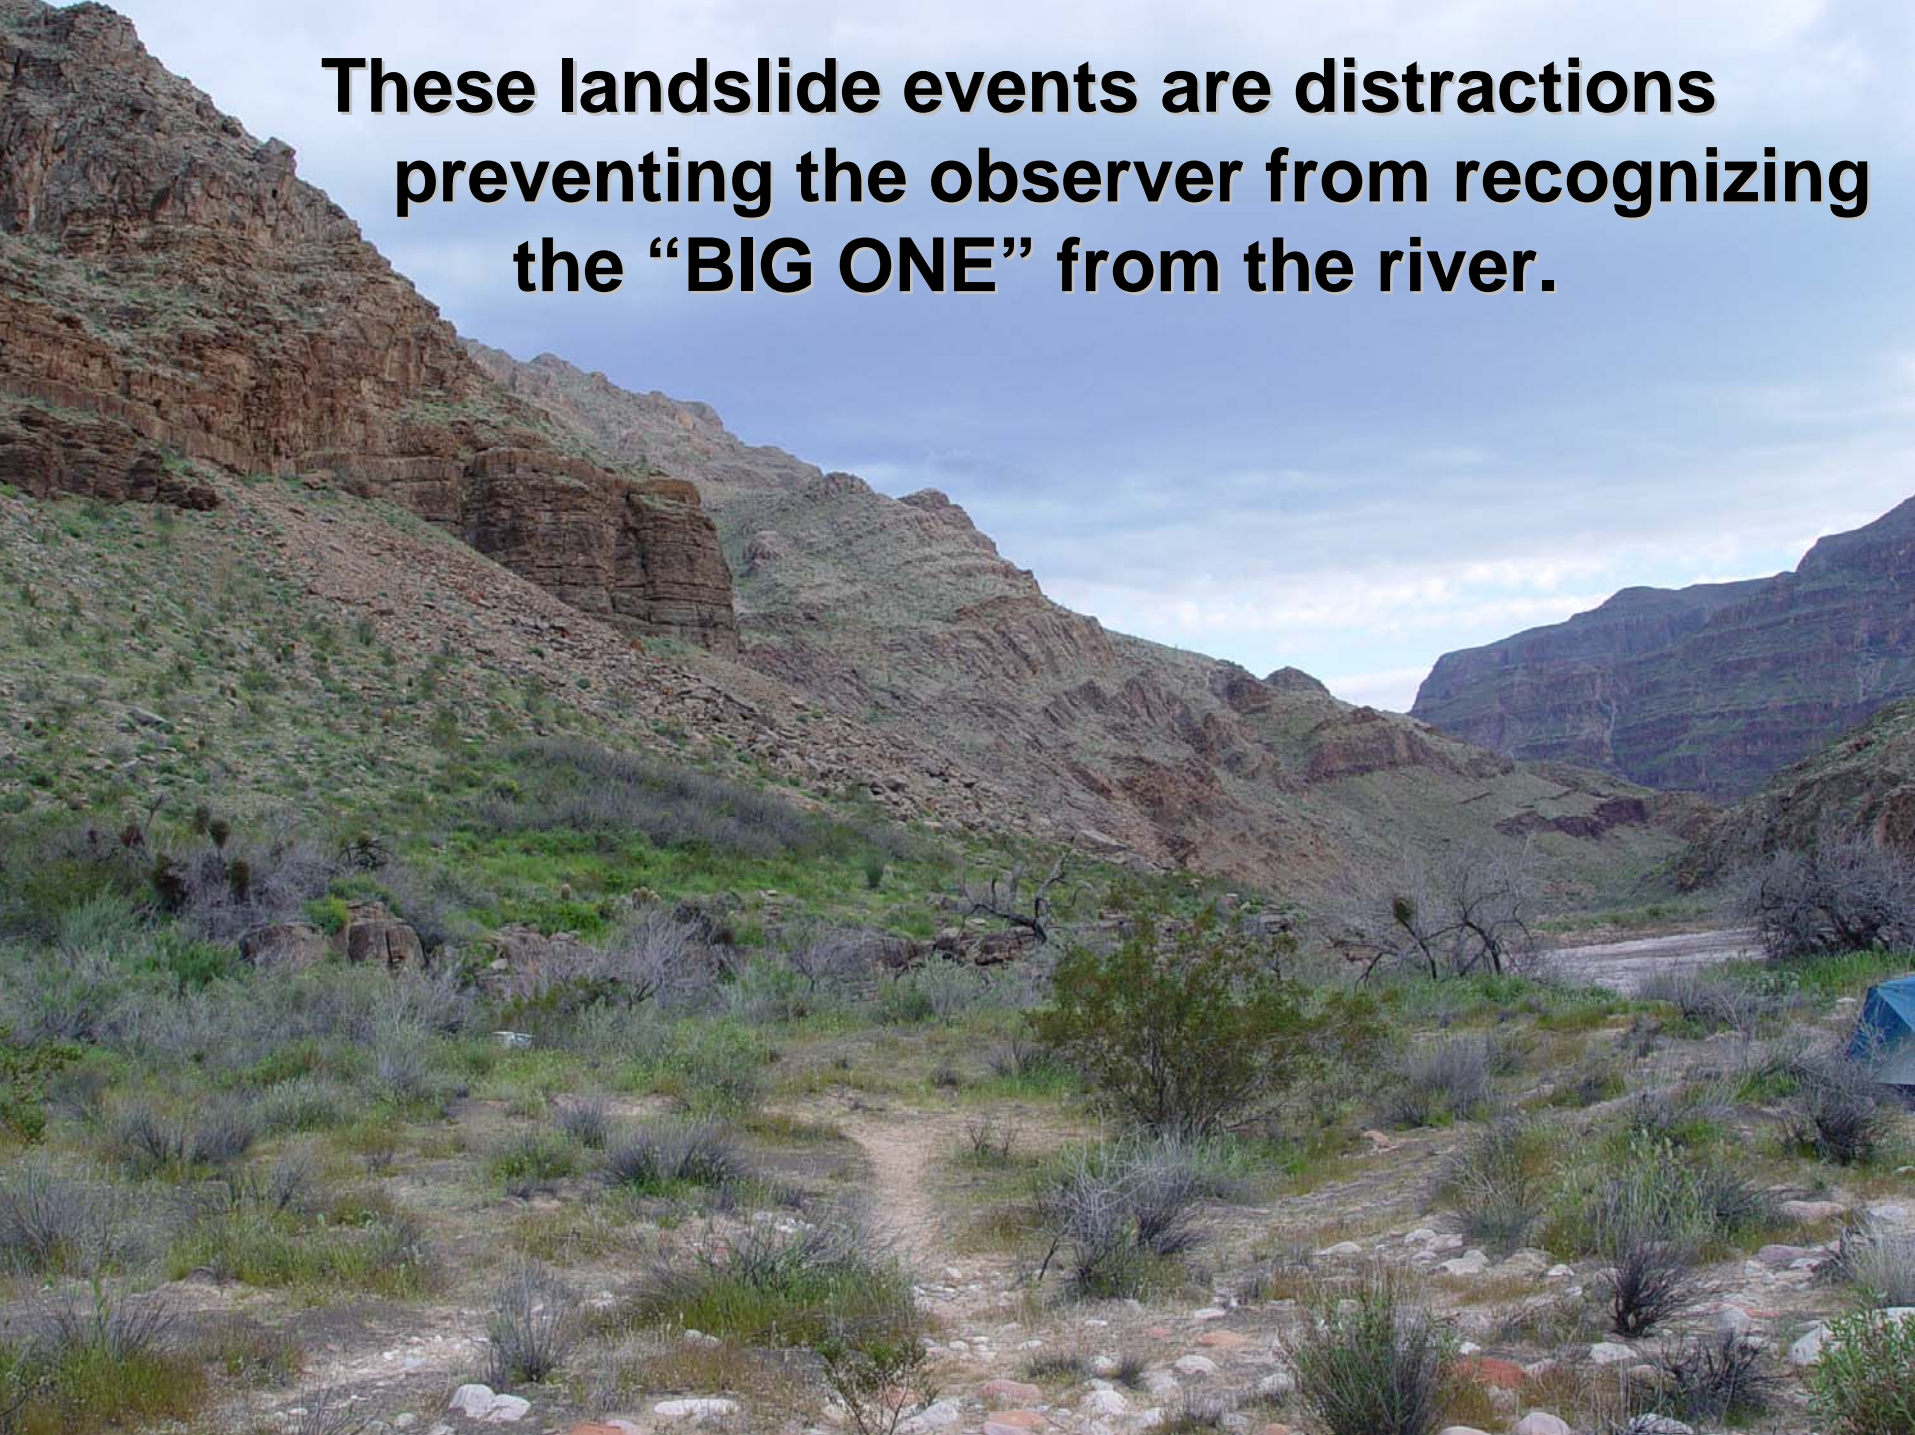
**These landslide events are distractions preventing the observer from recognizing the “BIG ONE” from the river.**

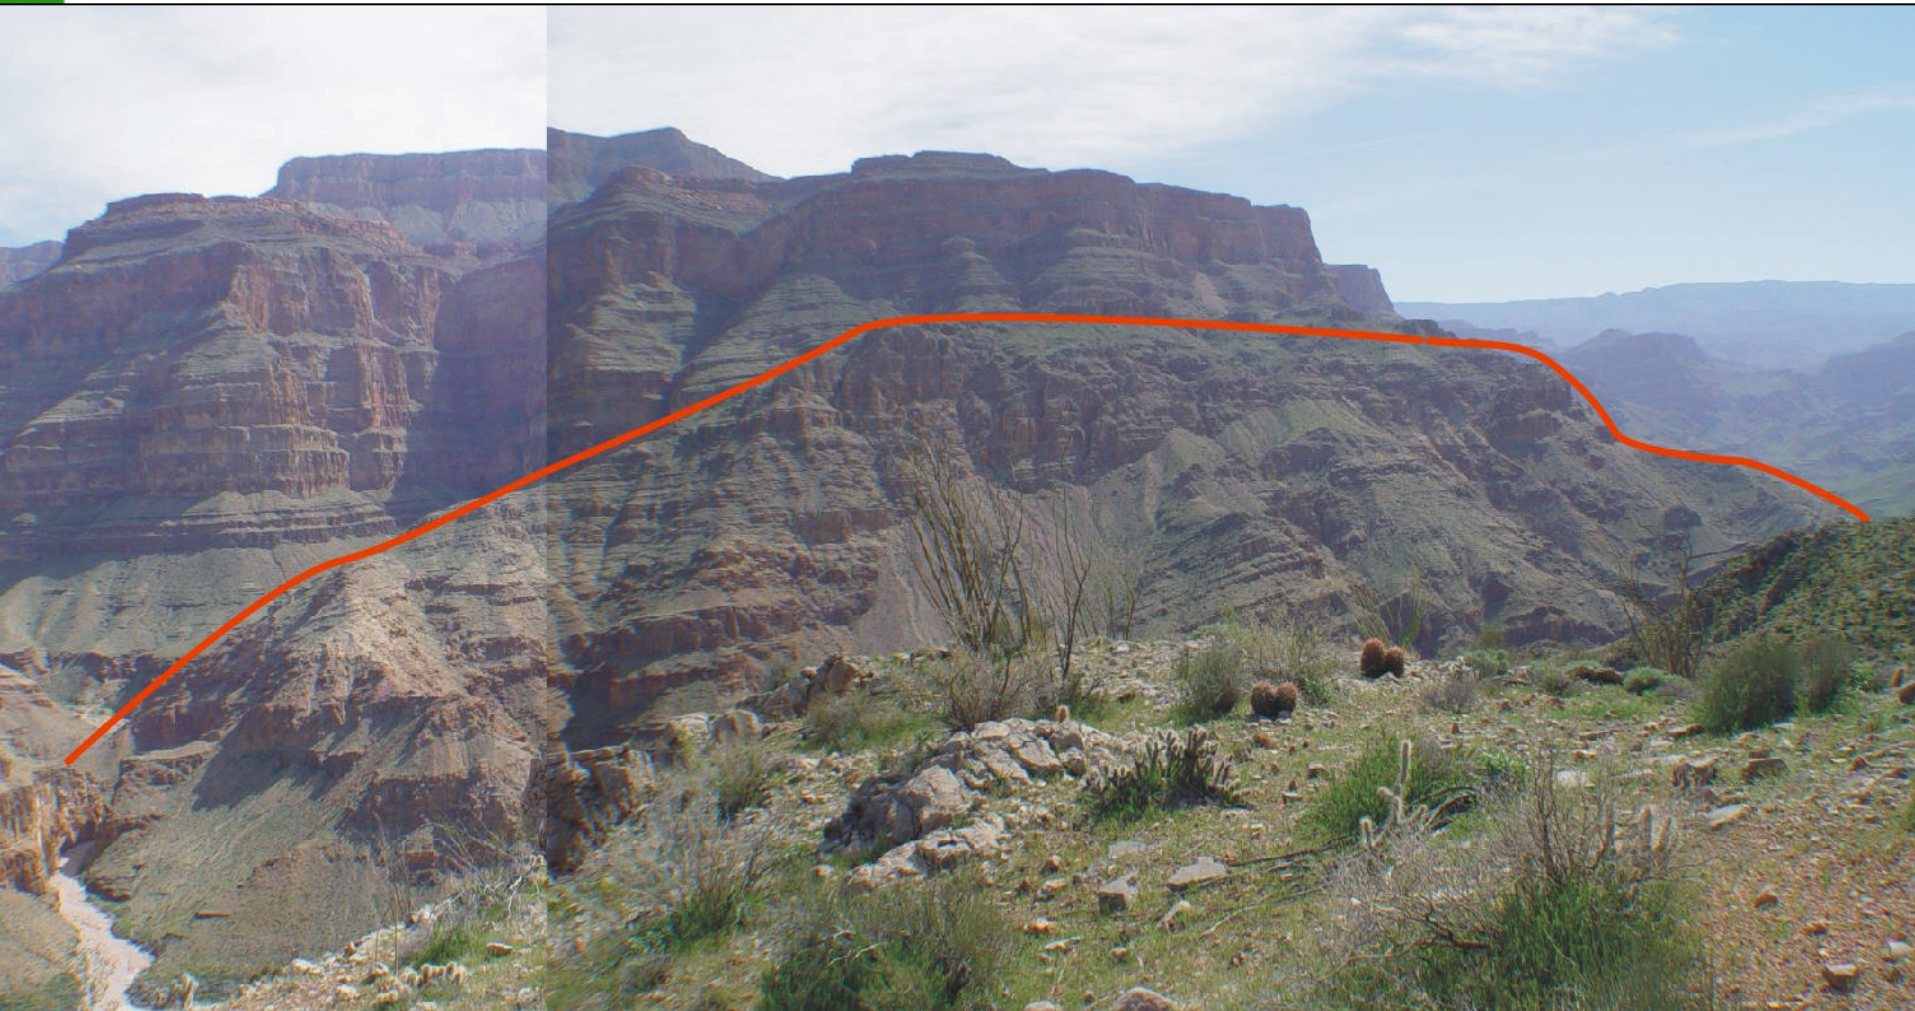
**This view of the 205-Mile River Left Landslide was taken from atop the 205-Mile River Right Landslide. This enormous landslide block spans more than two miles and is outlined here in red.**

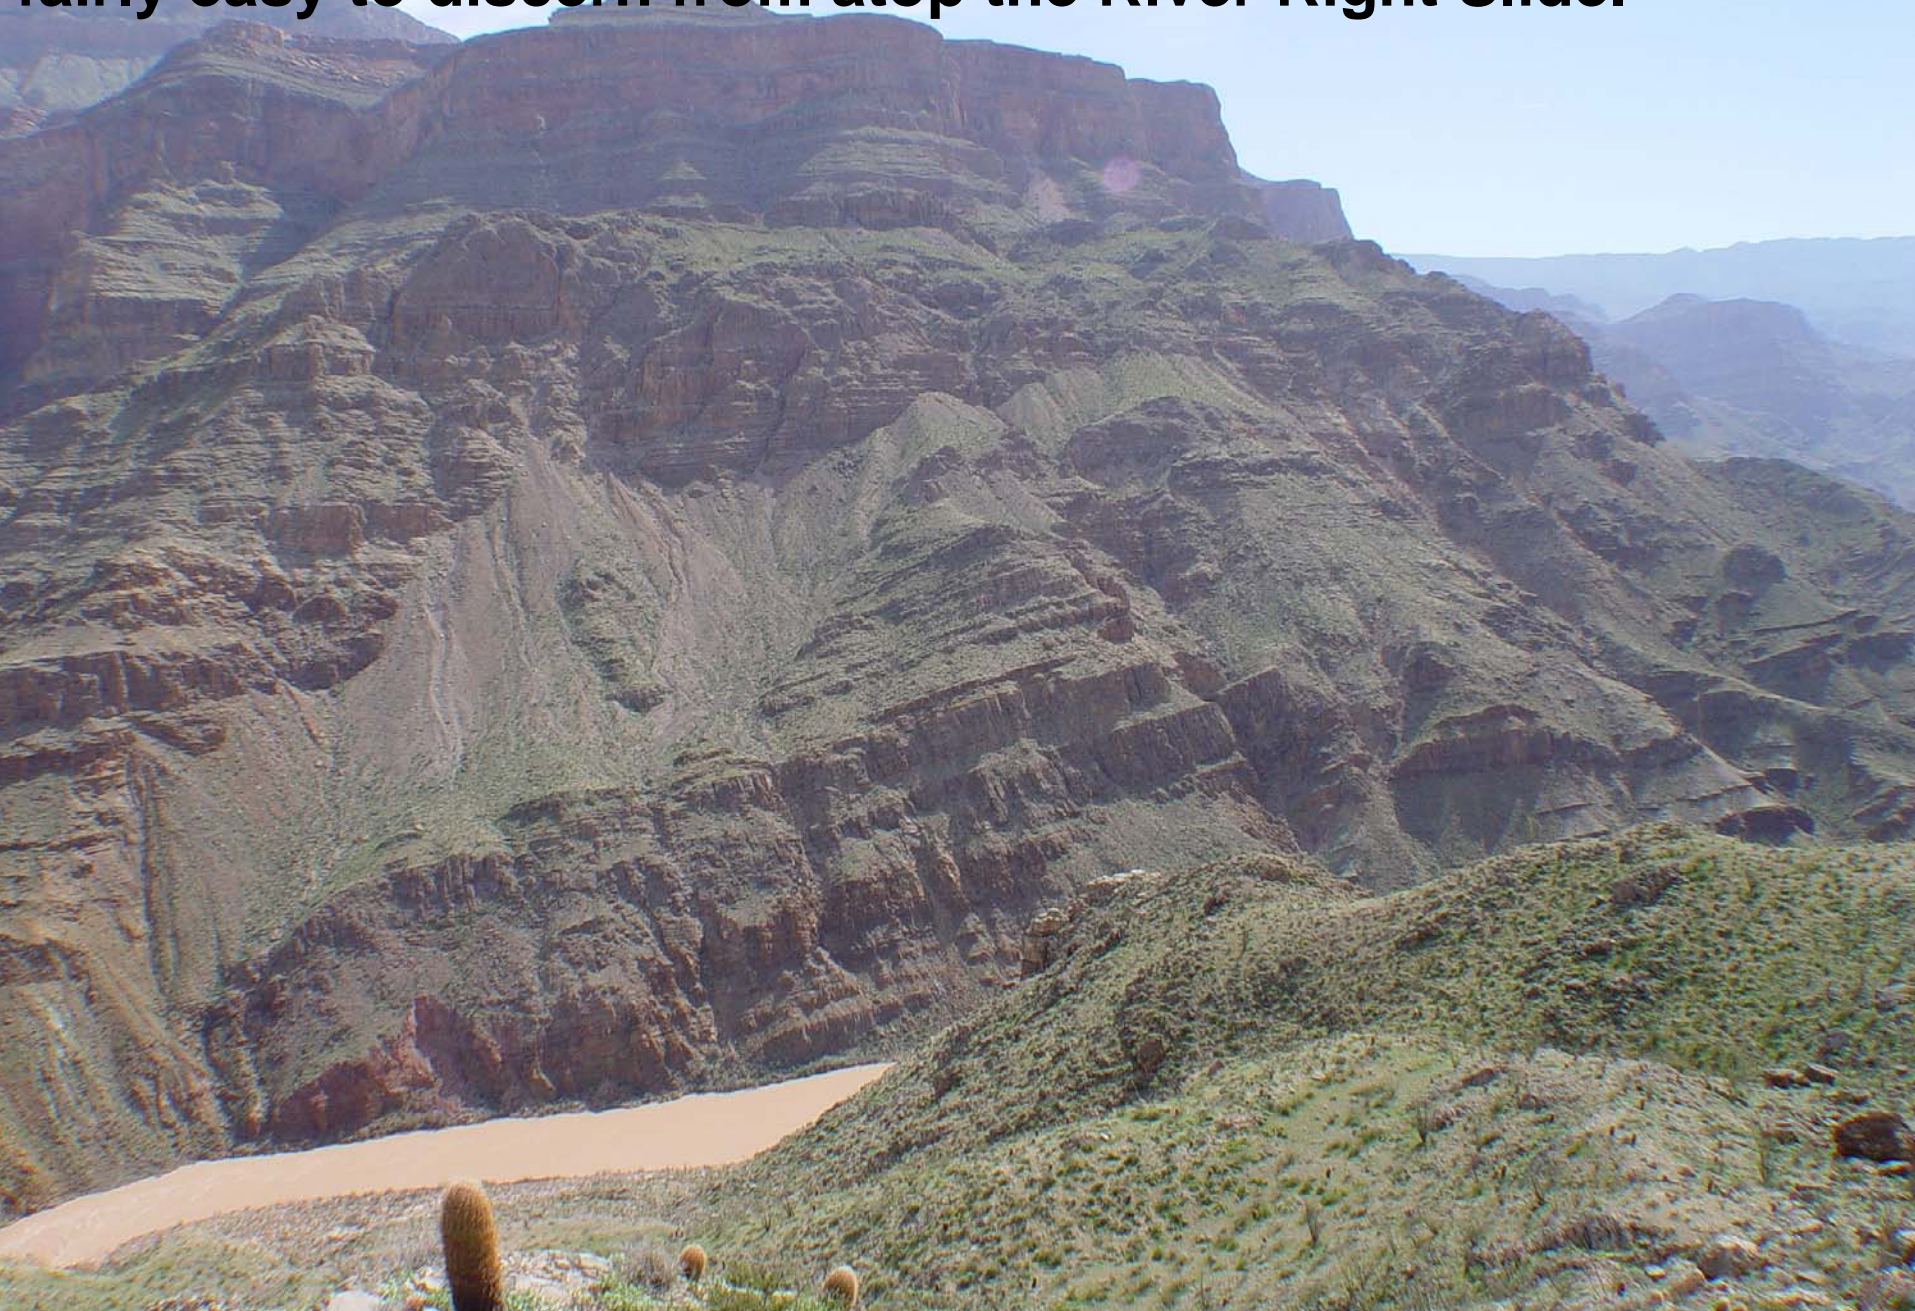
**The large secondary slump off the 205-Mile River Left Slide is fairly easy to discern from atop the River Right Slide.**

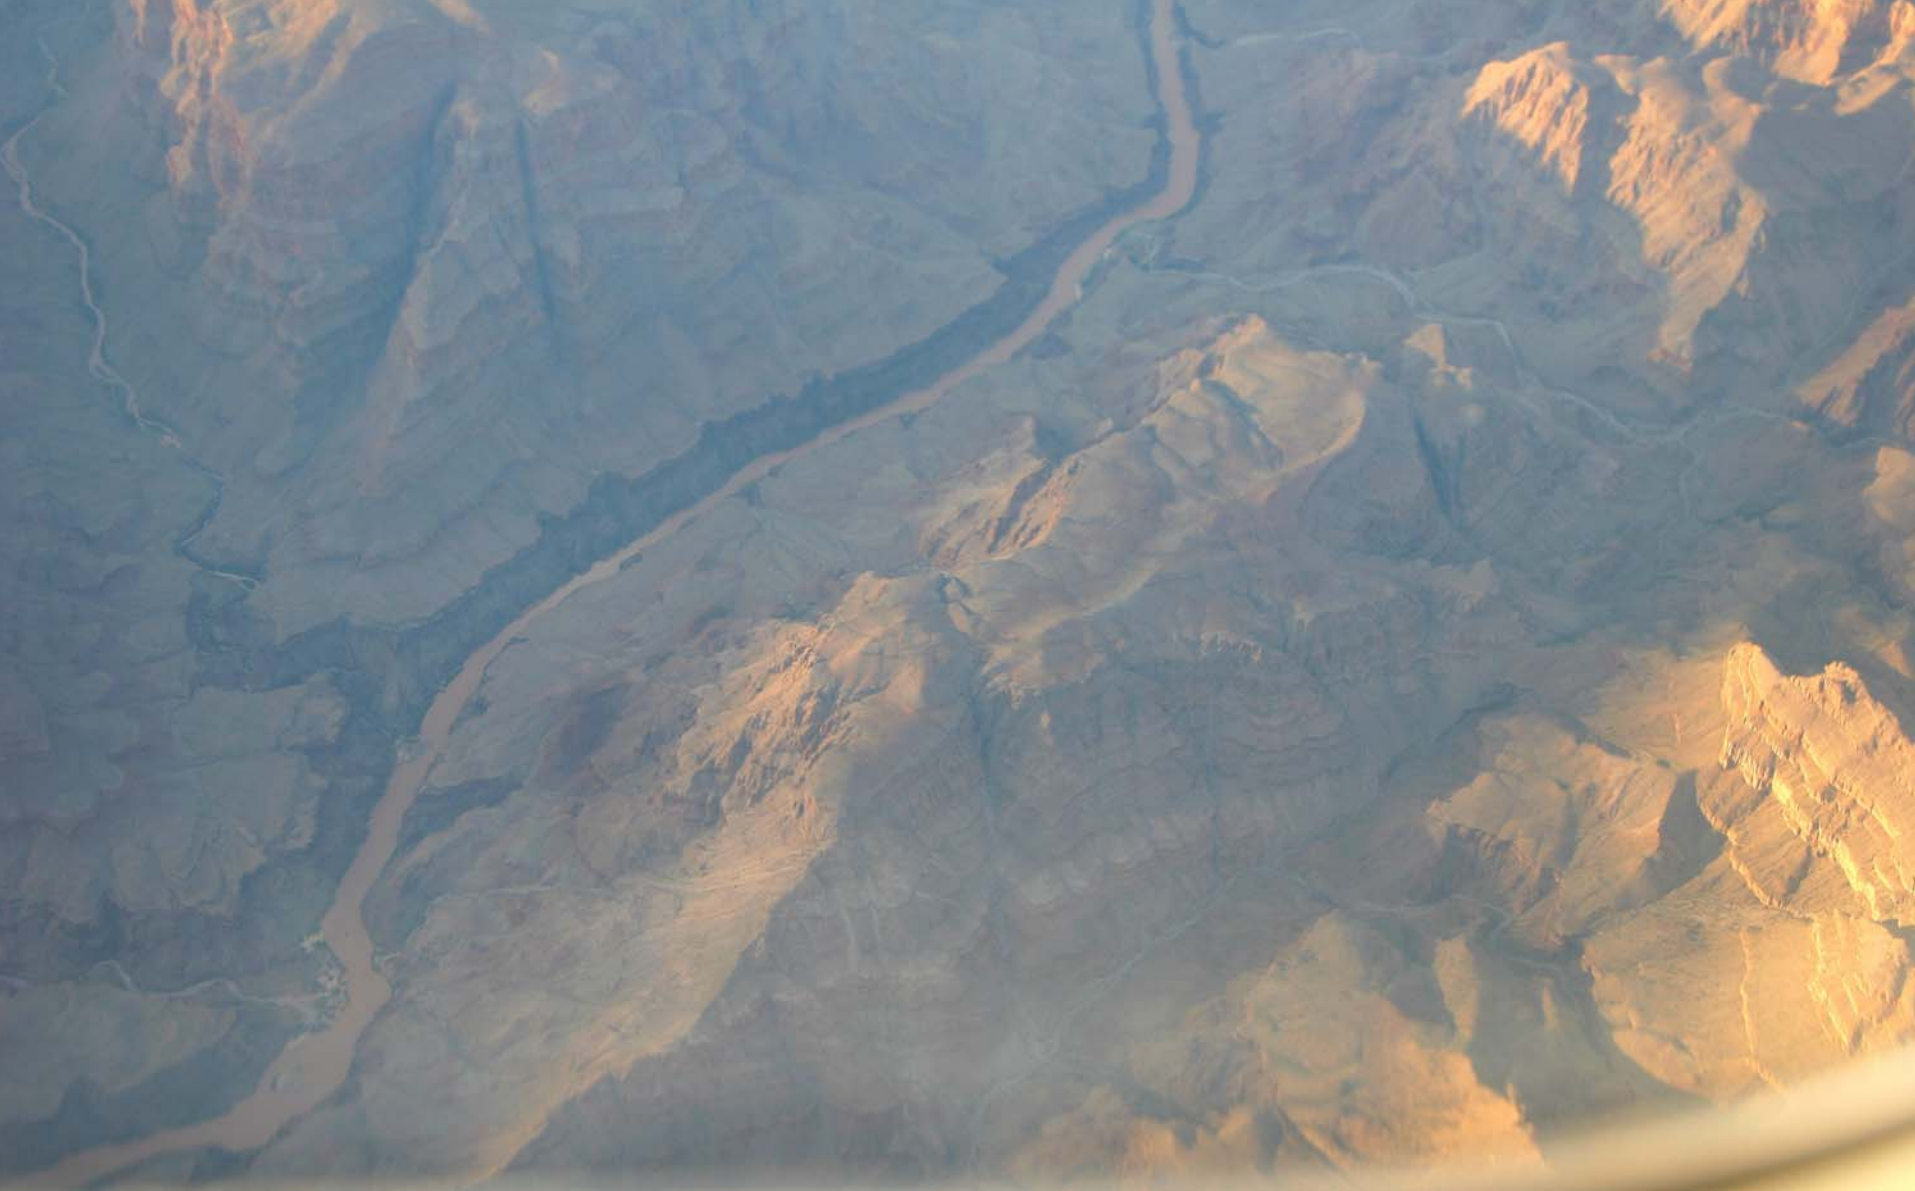
**The River Mile 205 Left Landslide as viewed from the air on Southwest Flt 2272 en-route to Las Vegas on 9-19-2005 at approx 6:45 p.m. looking NNE.**

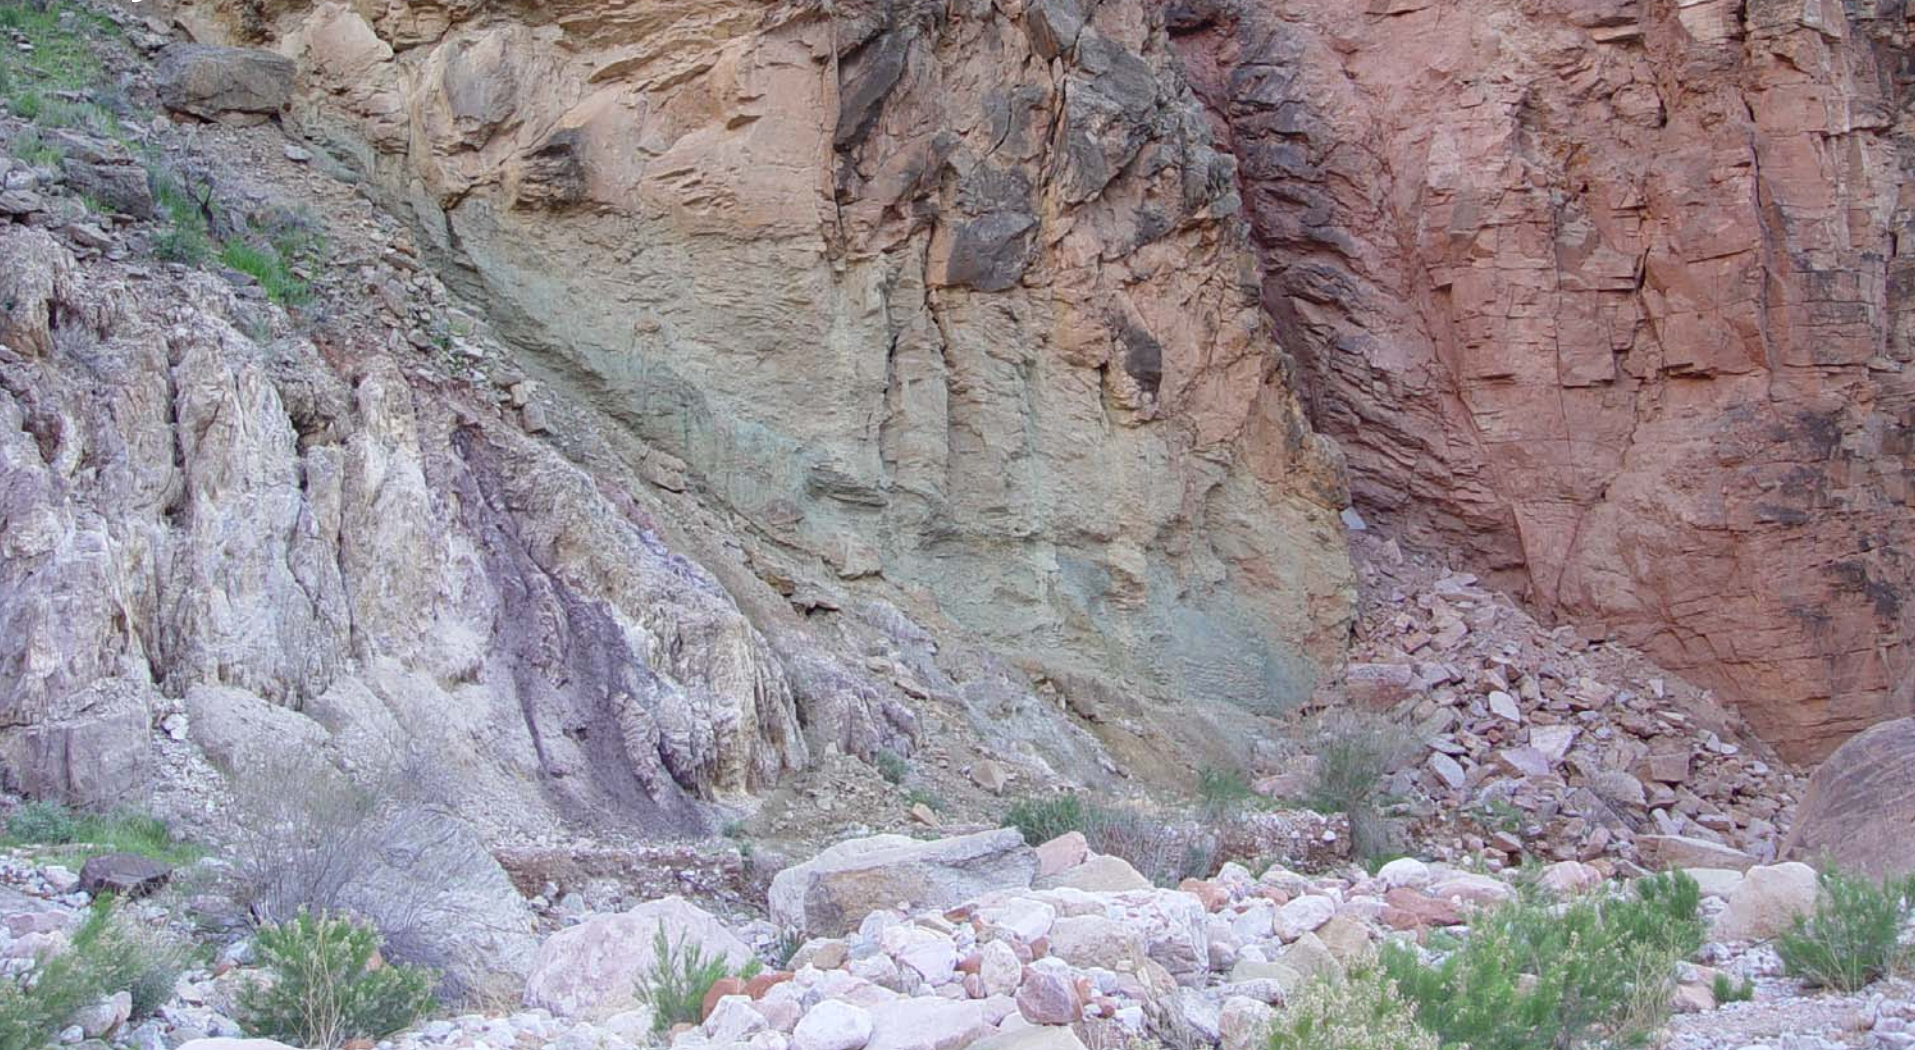
The Granite Park Fault and a zone of clayey gouge is clearly exposed in 205-Mile Canyon. Faults usually create low permeability zones with low shear strength, promoting secondary displacements that occur in response to surface processes and loading. Visually, this gouge resembles the Bright Angel Shale, but further analysis will be required to verify this observation.

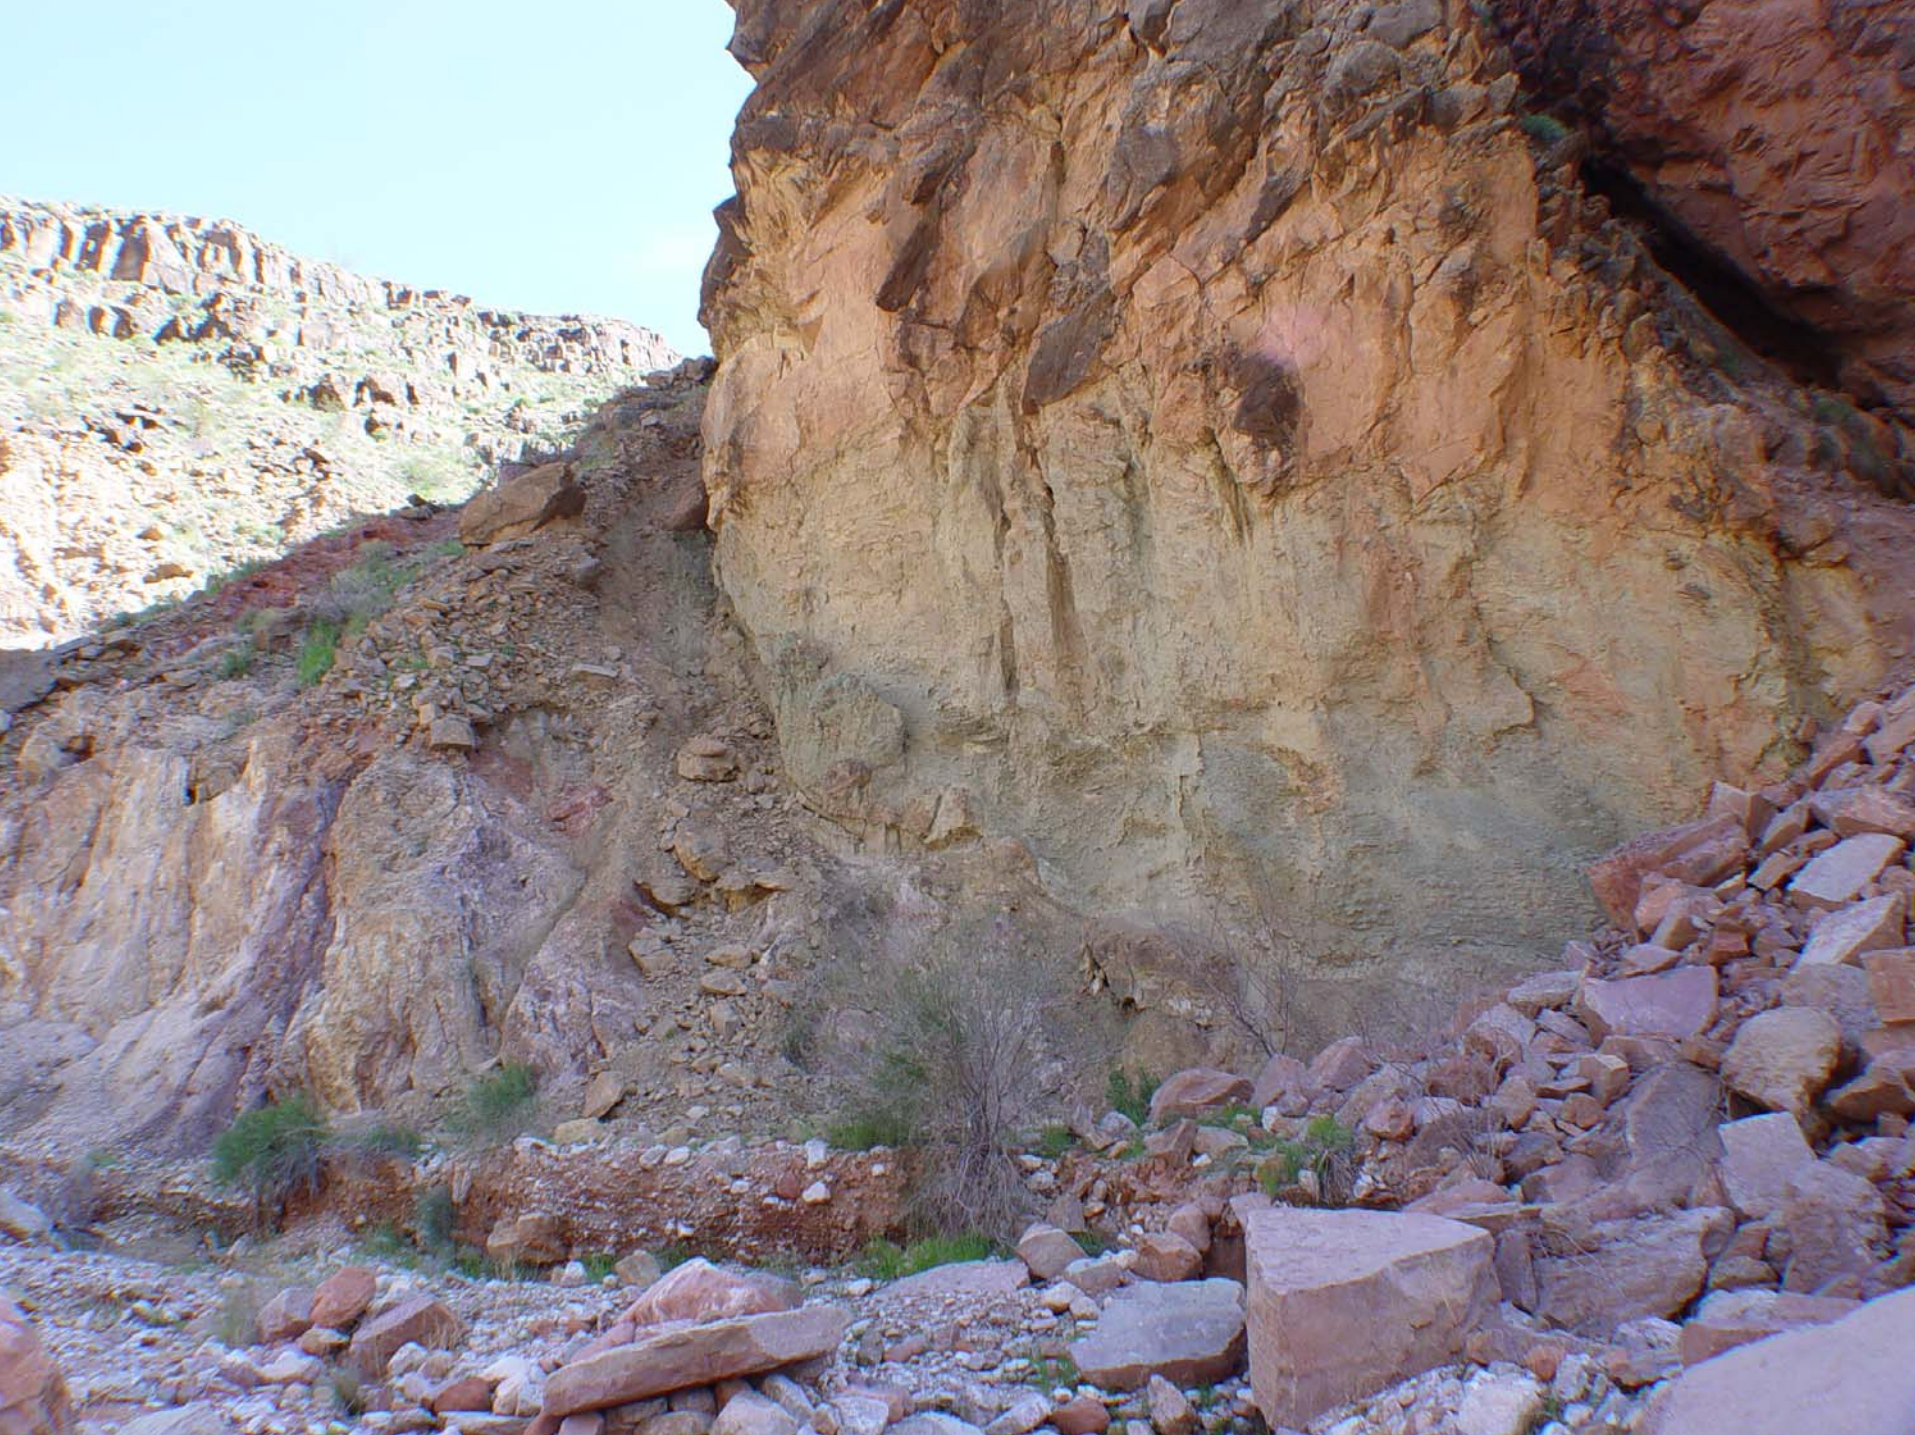
**A small thrust has been preserved in a large Muav boulder in the narrows of 205-Mile Canyon, just downstream (west) of the Granite Park Fault.**

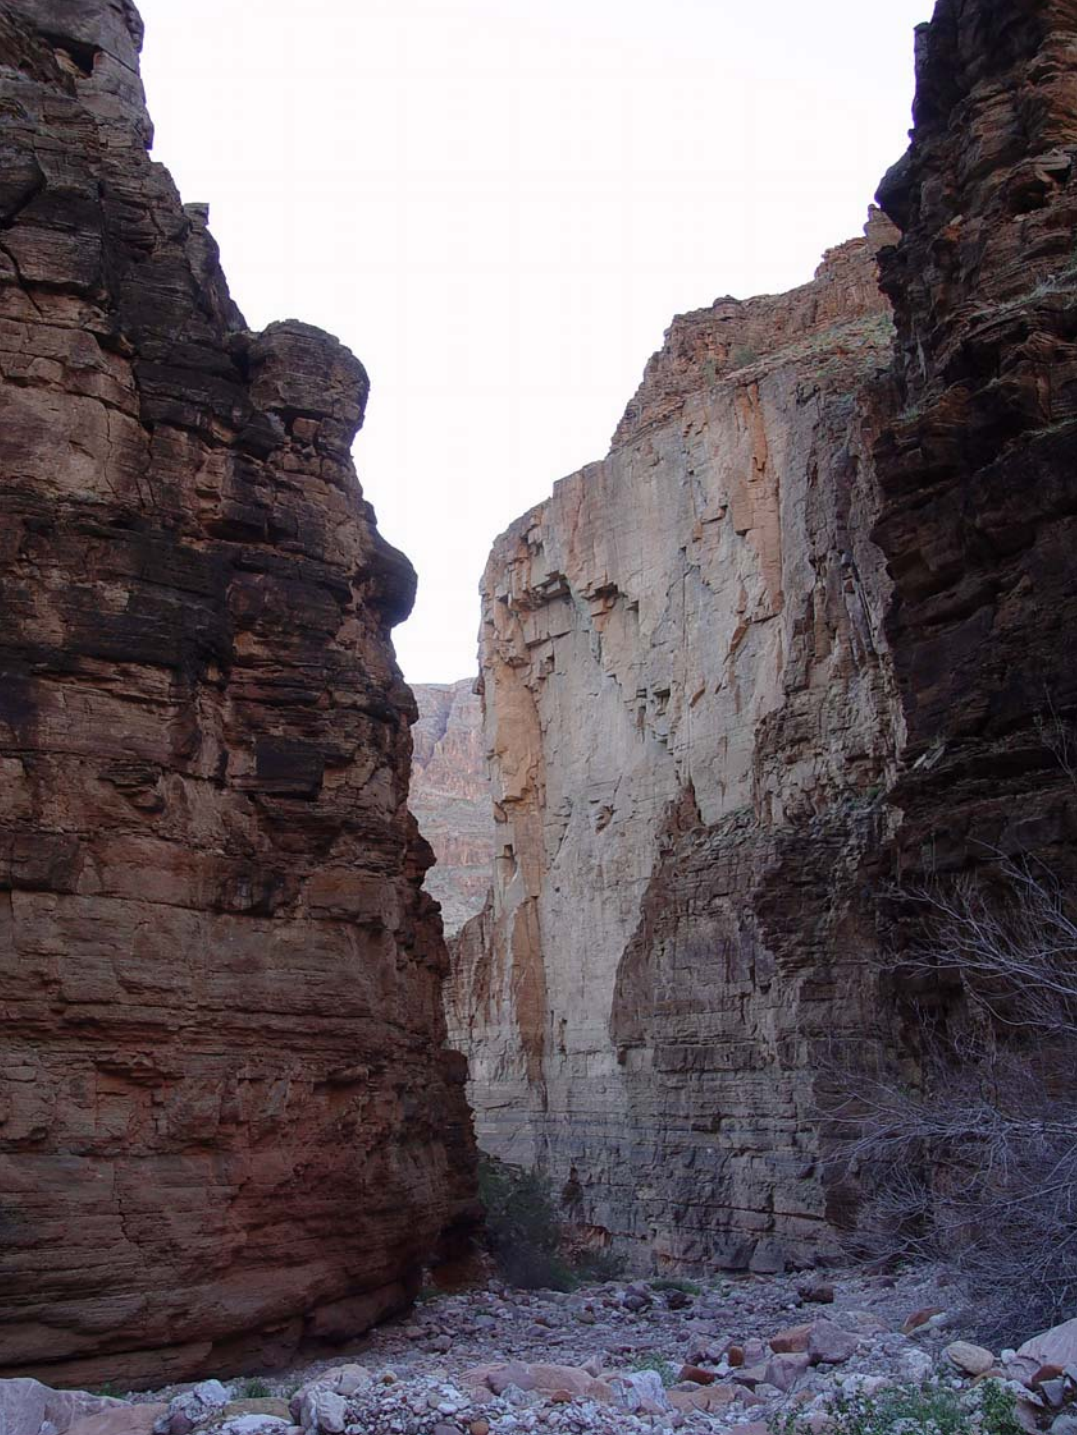
**The Granite Park Fault and/or the 205-Mile River Left Landslide appears to have altered the course of 205-Mile Canyon. The canyon has carved a striking narrows through the Muav Limestone on the downdropped (west) side of the fault, but is much wider on the uplifted (east) side developed in the more resistant Tapeats Sandstone. This suggests the Muav Narrows are a geologically young feature. This side canyon also follows the Granite Park Fault until the narrows, where it turns abruptly to the west. Some reddish sediments are preserved upstream of the narrows. Most of these appear to be debris flow related, but some fine lenses may represent lacustrine deposition that were collected behind a landslide dam.**
