# **NEW FINDINGS RELATED TO COMPOSITE BEDROCK MEGALANDSLIDES IN THE GRAND CANYON**

**Conor Watkins and  
J. David Rogers**

**Department of Geological Sciences & Engineering  
University of Missouri – Rolla  
AEG 2005, Las Vegas, NV**

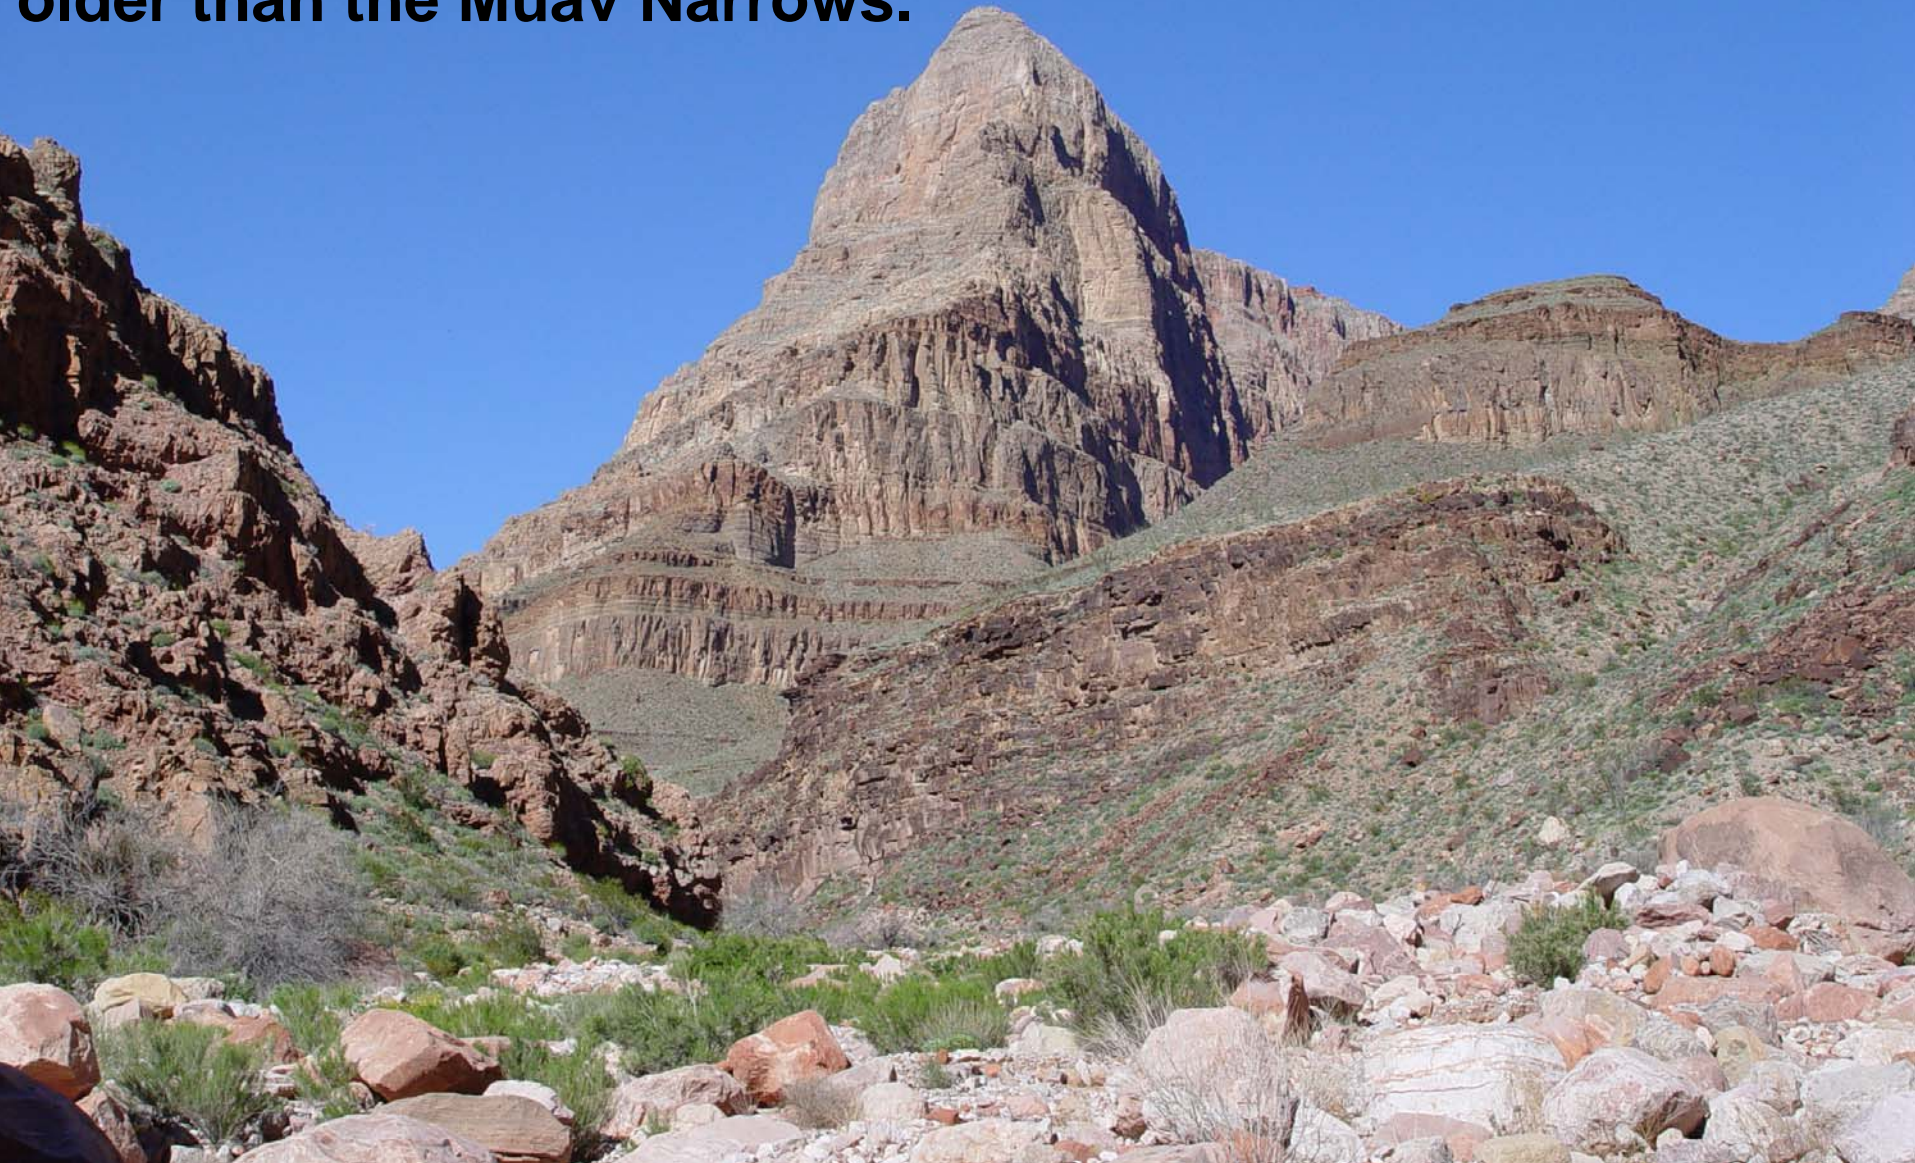
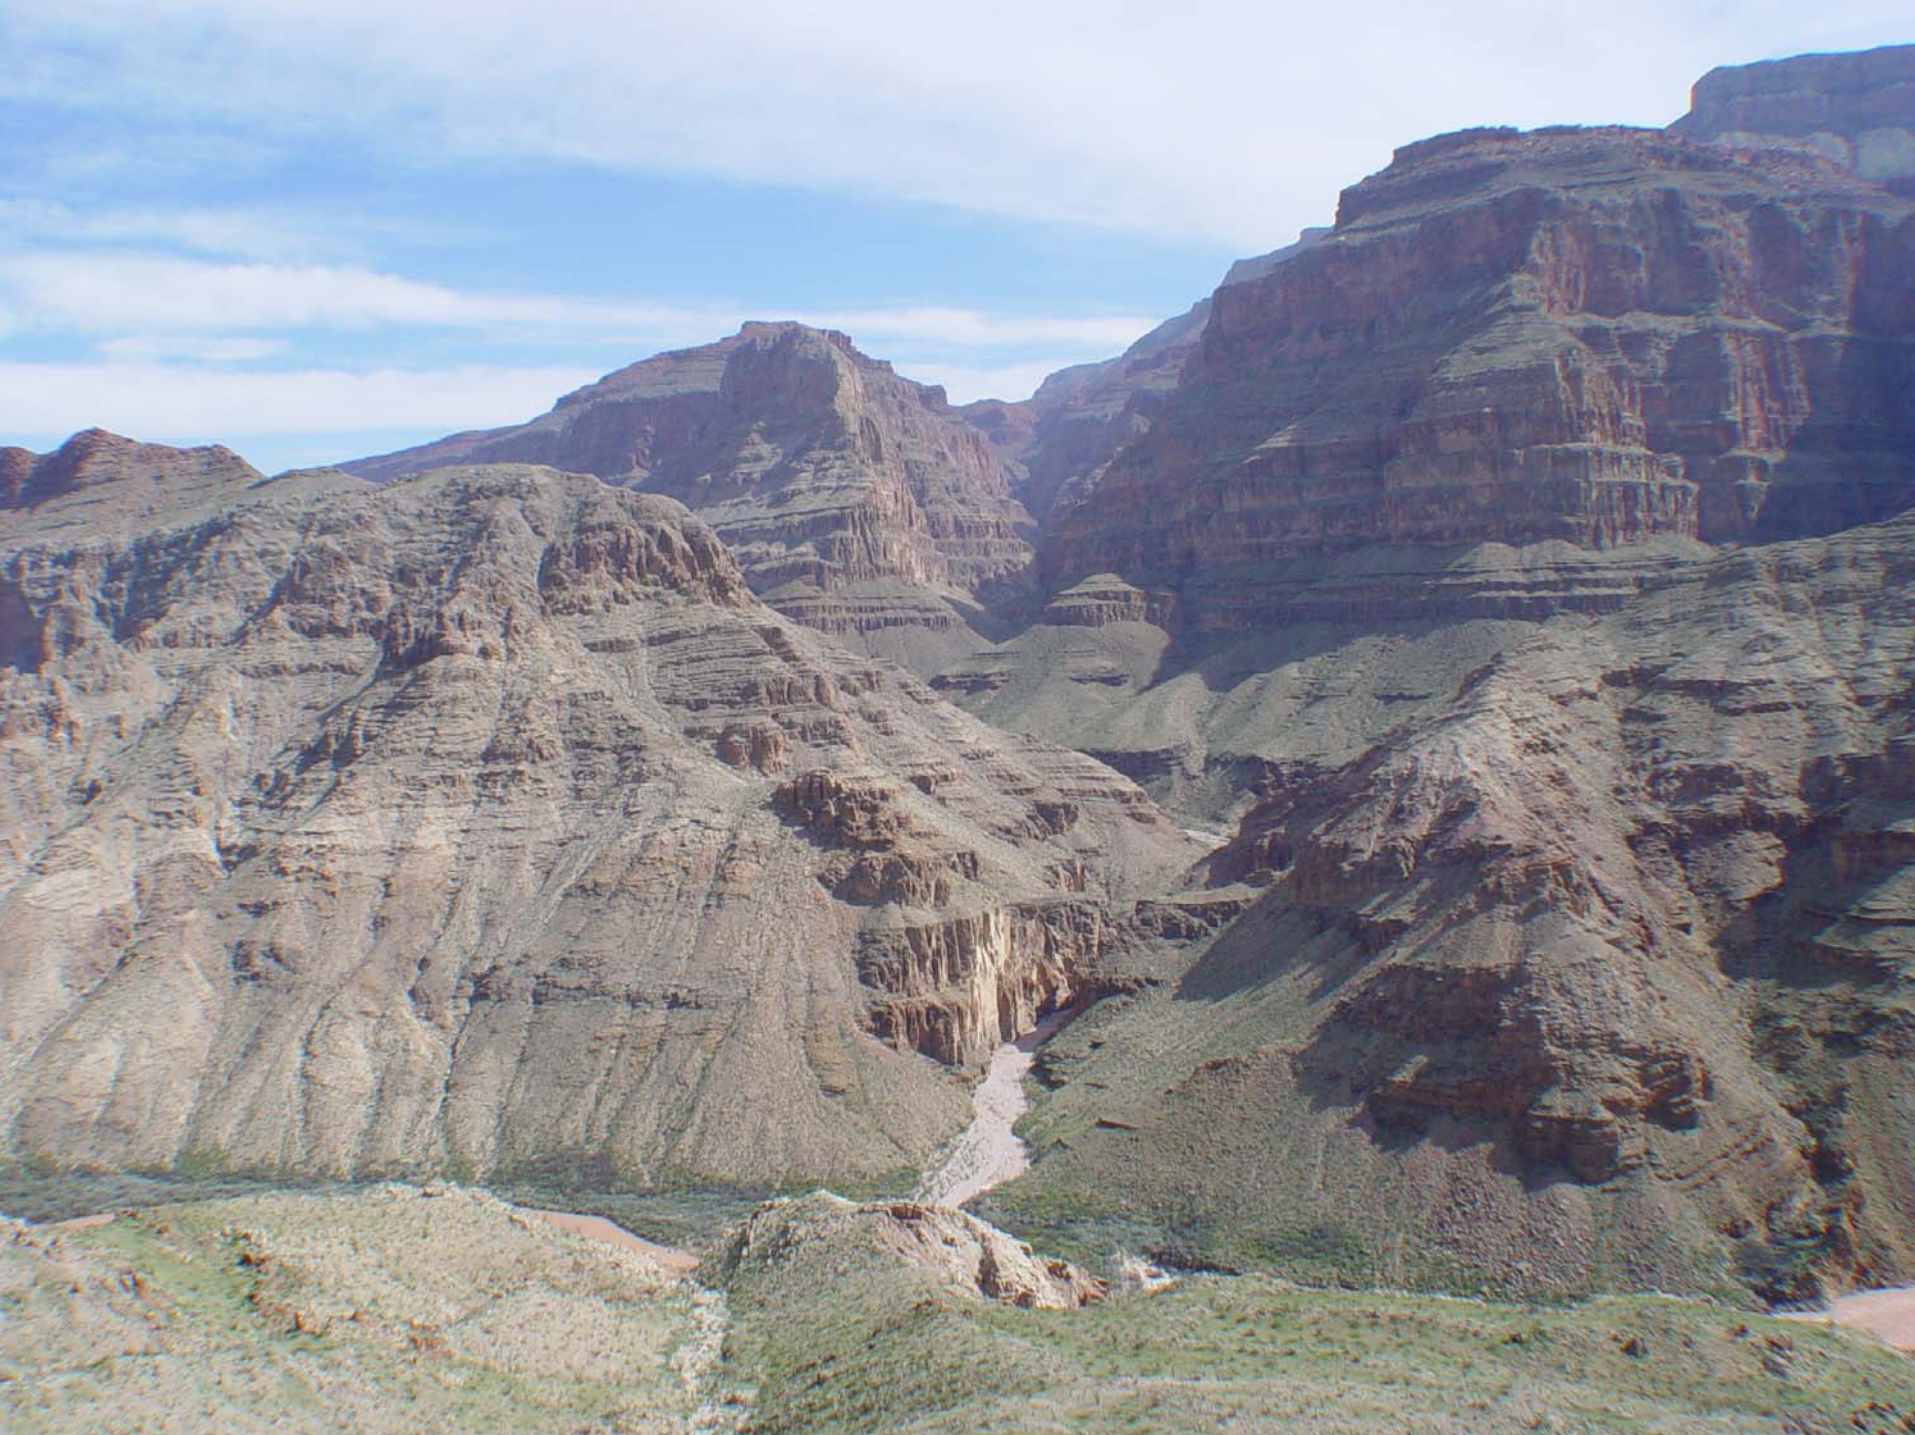
**205-Mile Canyon opens up and becomes much wider east of the Granite Park Fault. This part of the canyon is developed in more resistant Tapeats Sandstone, so it is likely much older than the Muav Narrows.**

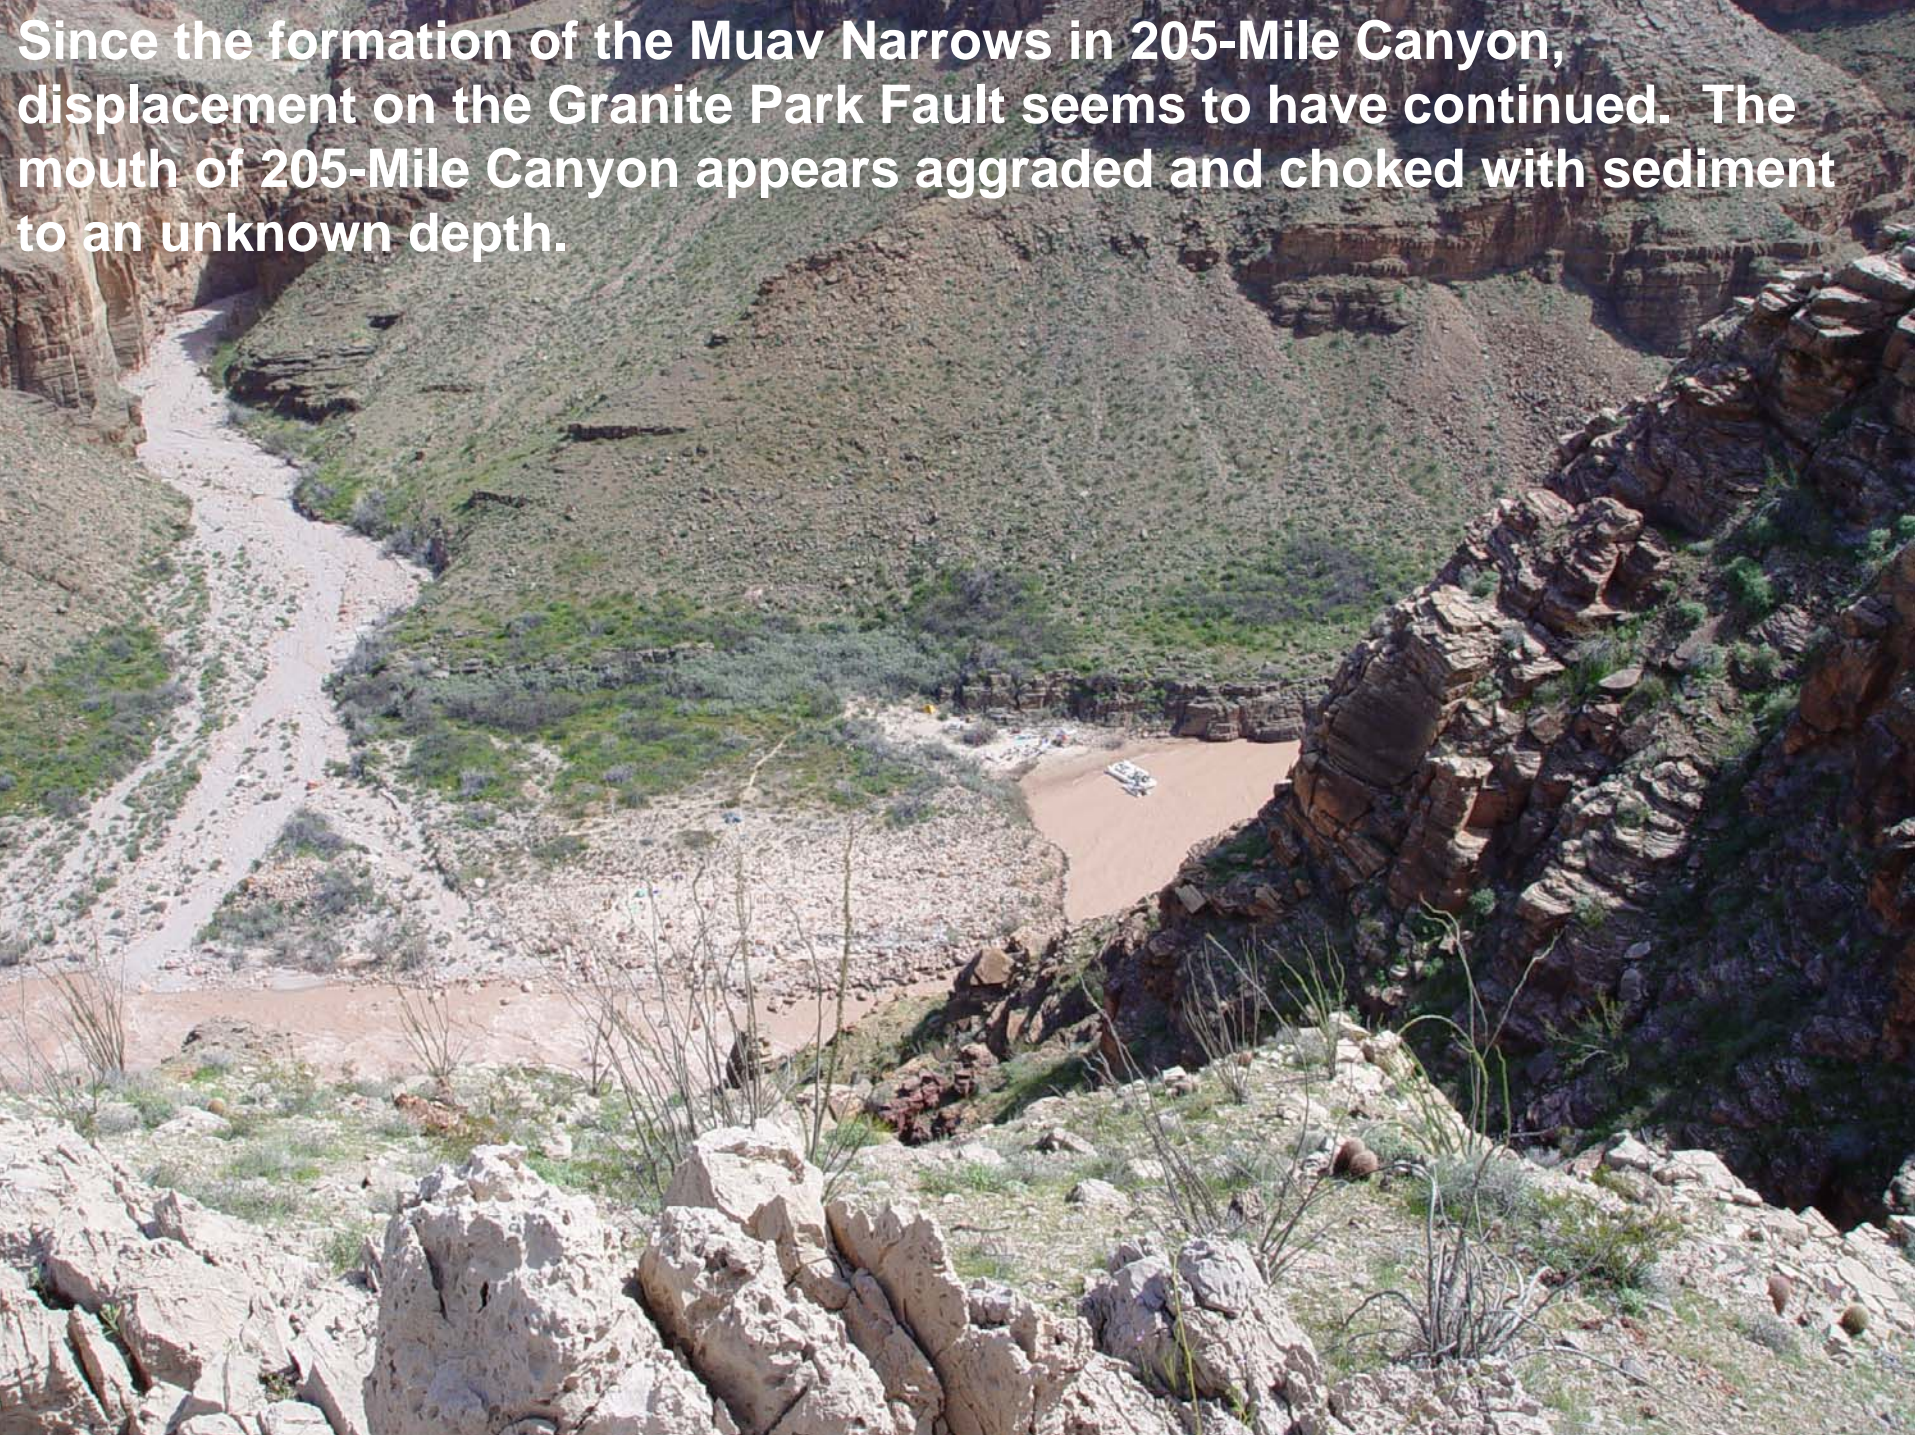
Since the formation of the Muav Narrows in 205-Mile Canyon, displacement on the Granite Park Fault seems to have continued. The mouth of 205-Mile Canyon appears aggraded and choked with sediment to an unknown depth.

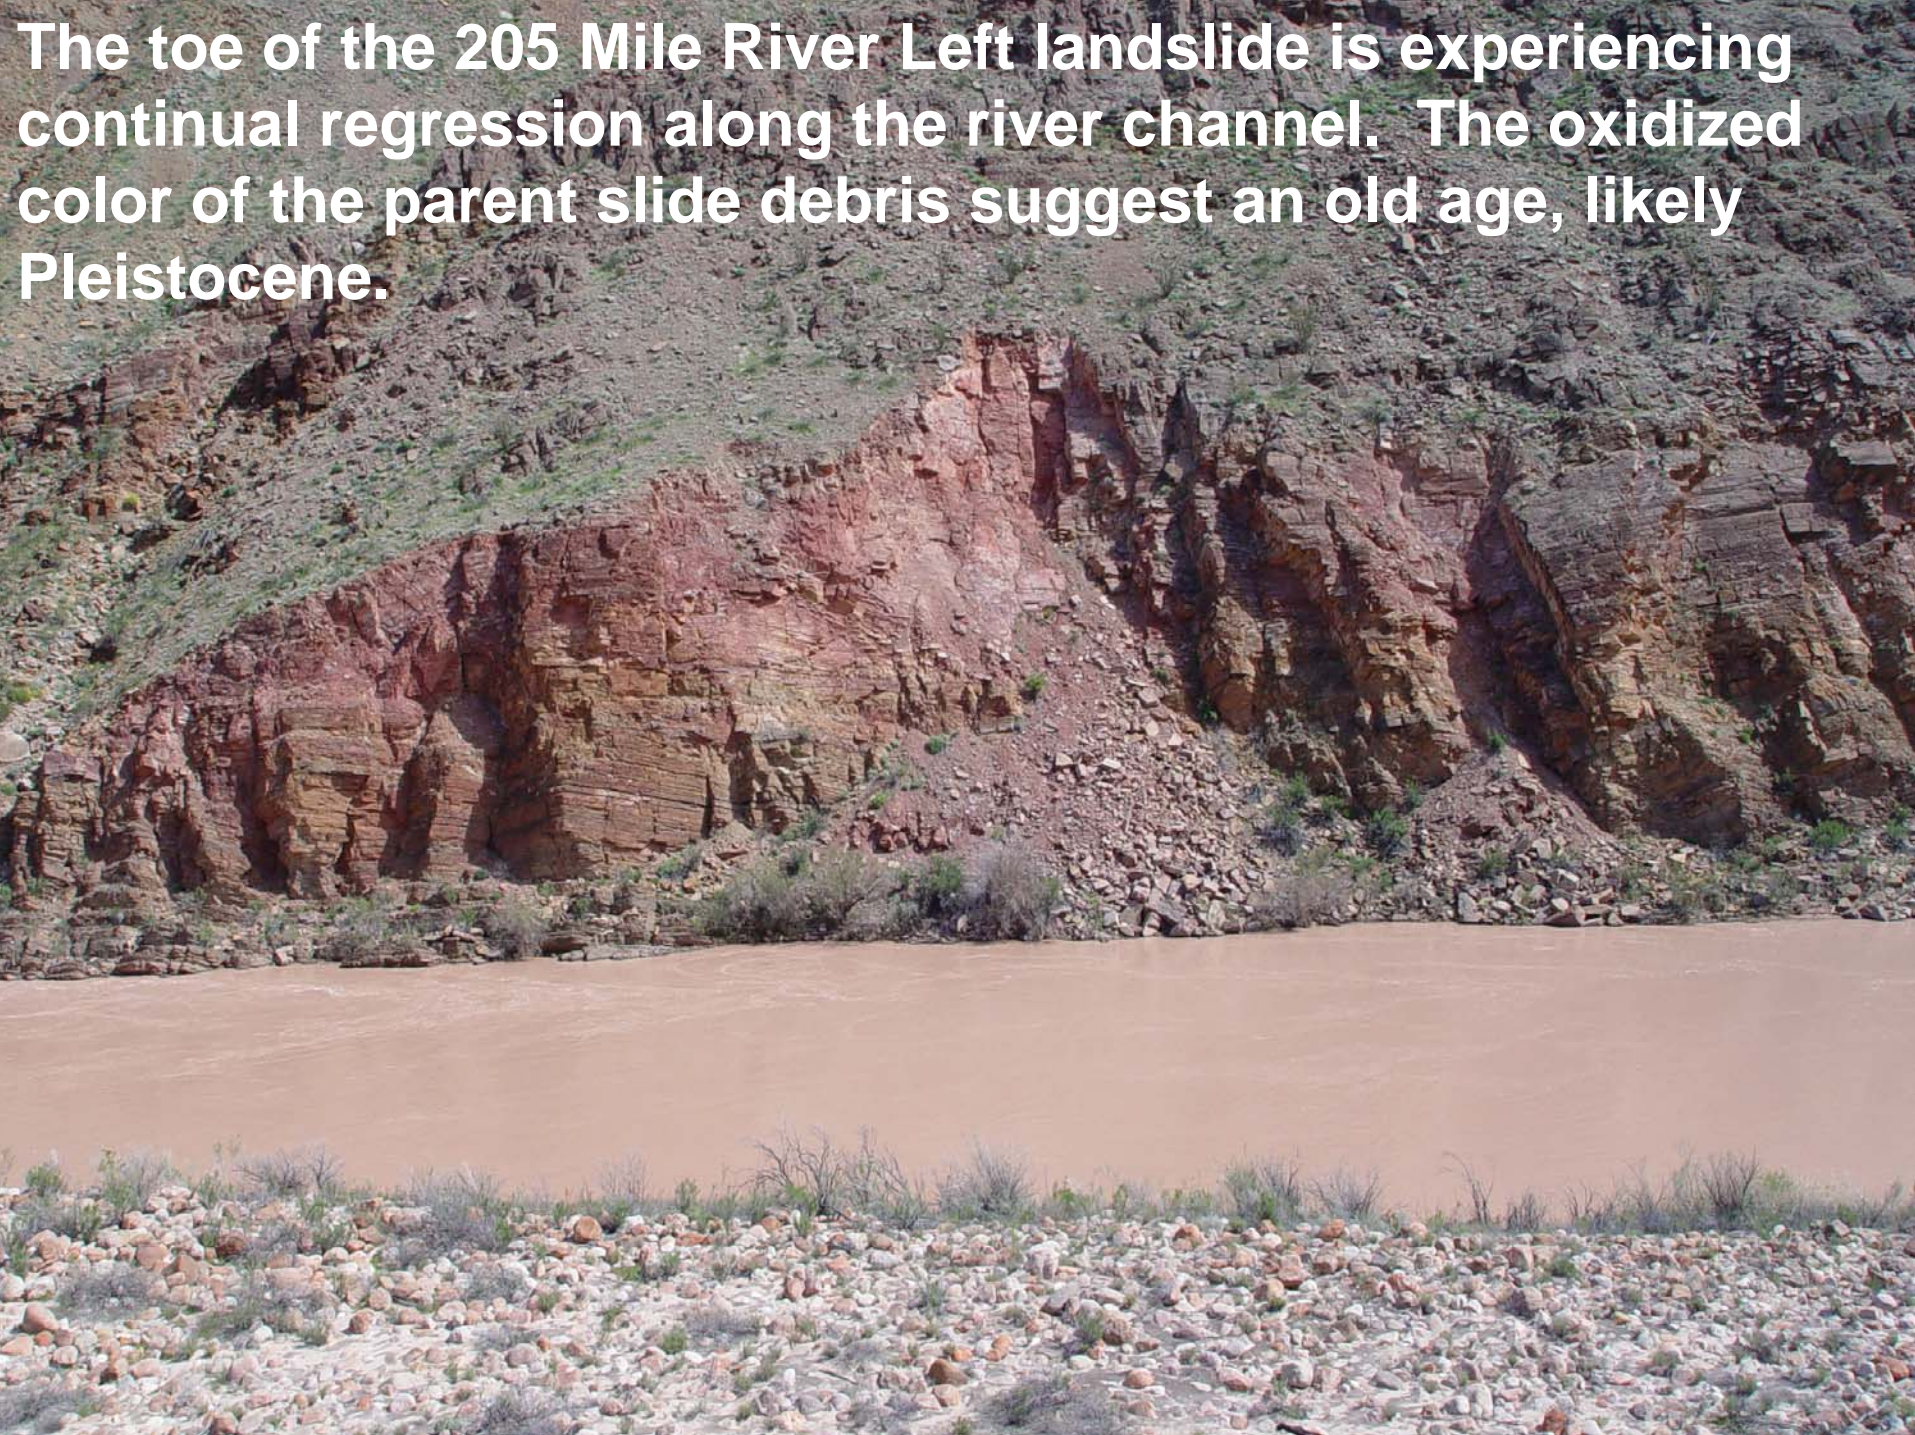
The toe of the 205 Mile River Left landslide is experiencing continual regression along the river channel. The oxidized color of the parent slide debris suggest an old age, likely Pleistocene.

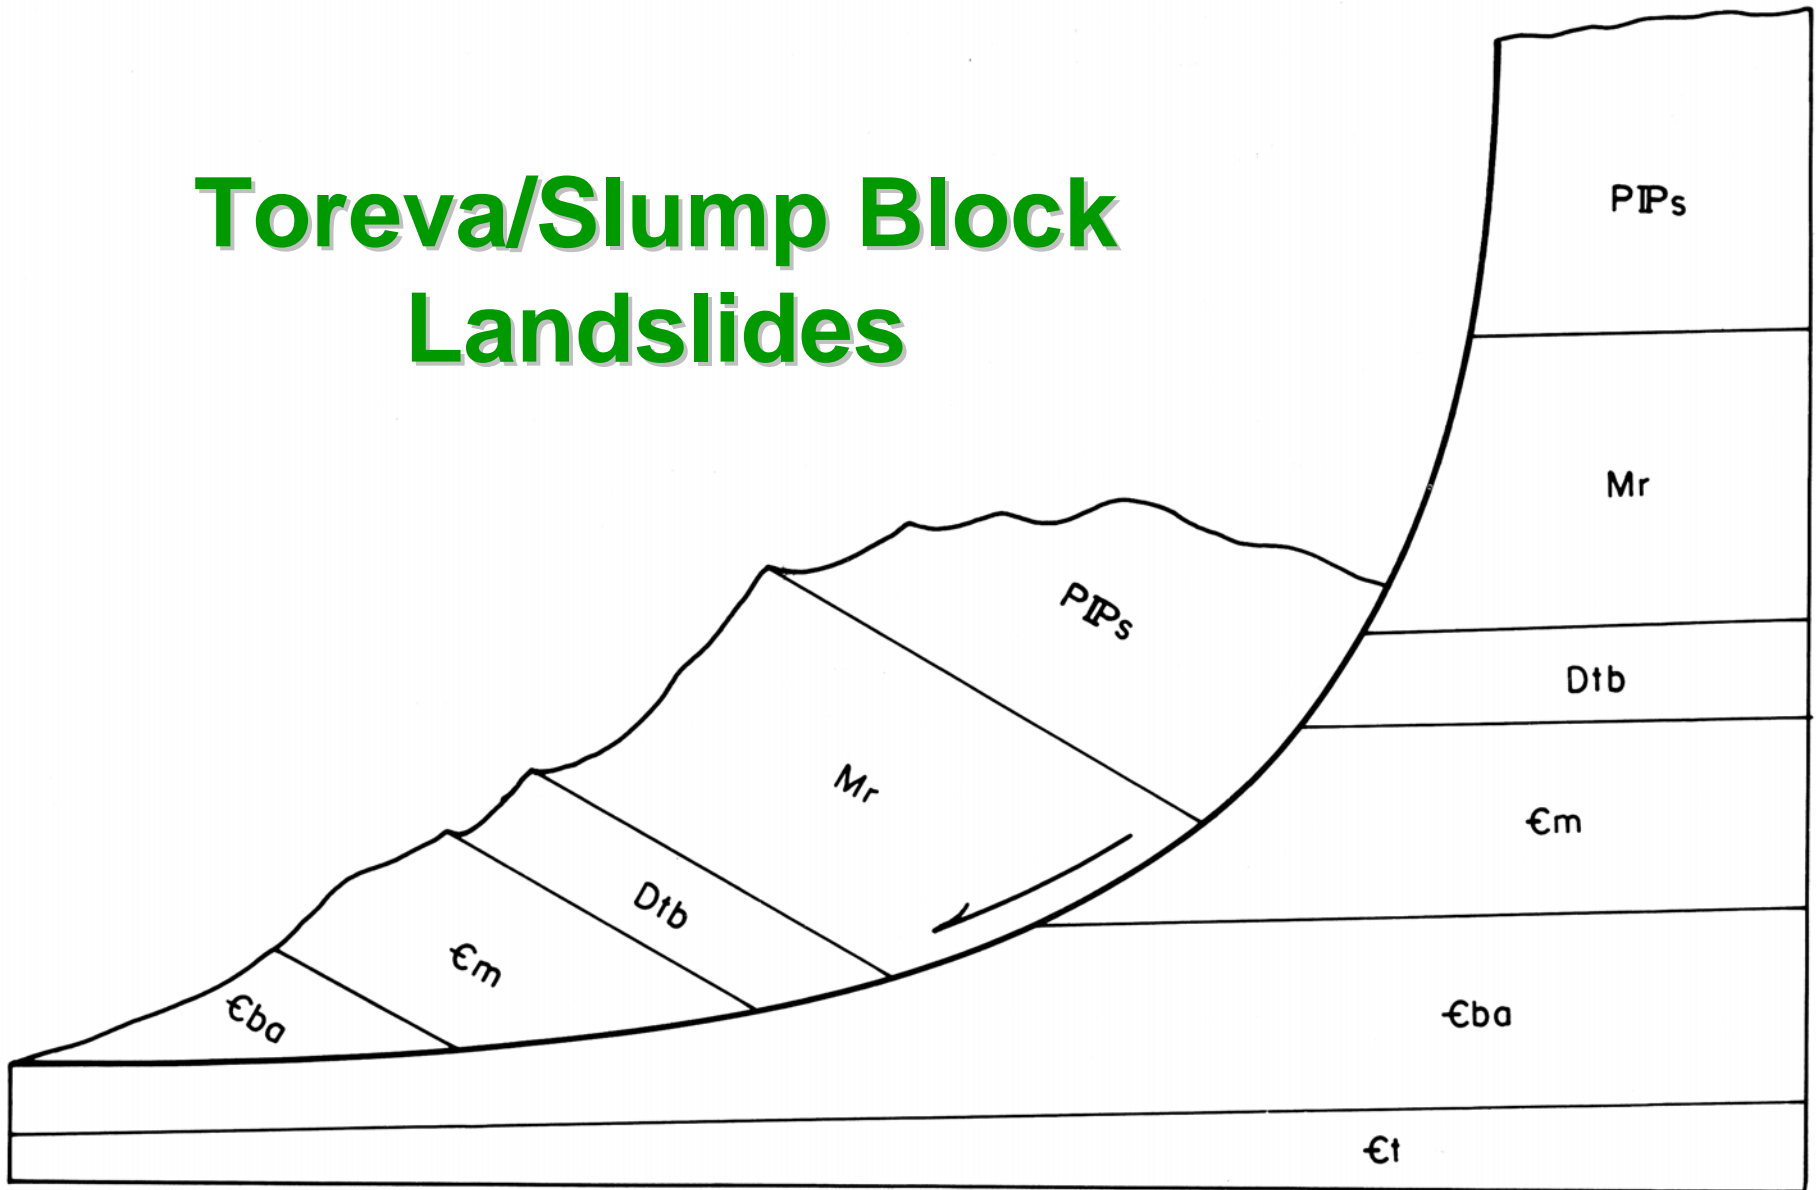
**Schematic of a simple Toreva or slump block typical of Surprise Valley in Grand Canyon (from Huntoon, 1978). This type of landslide exhibits rotational motion during movement.**

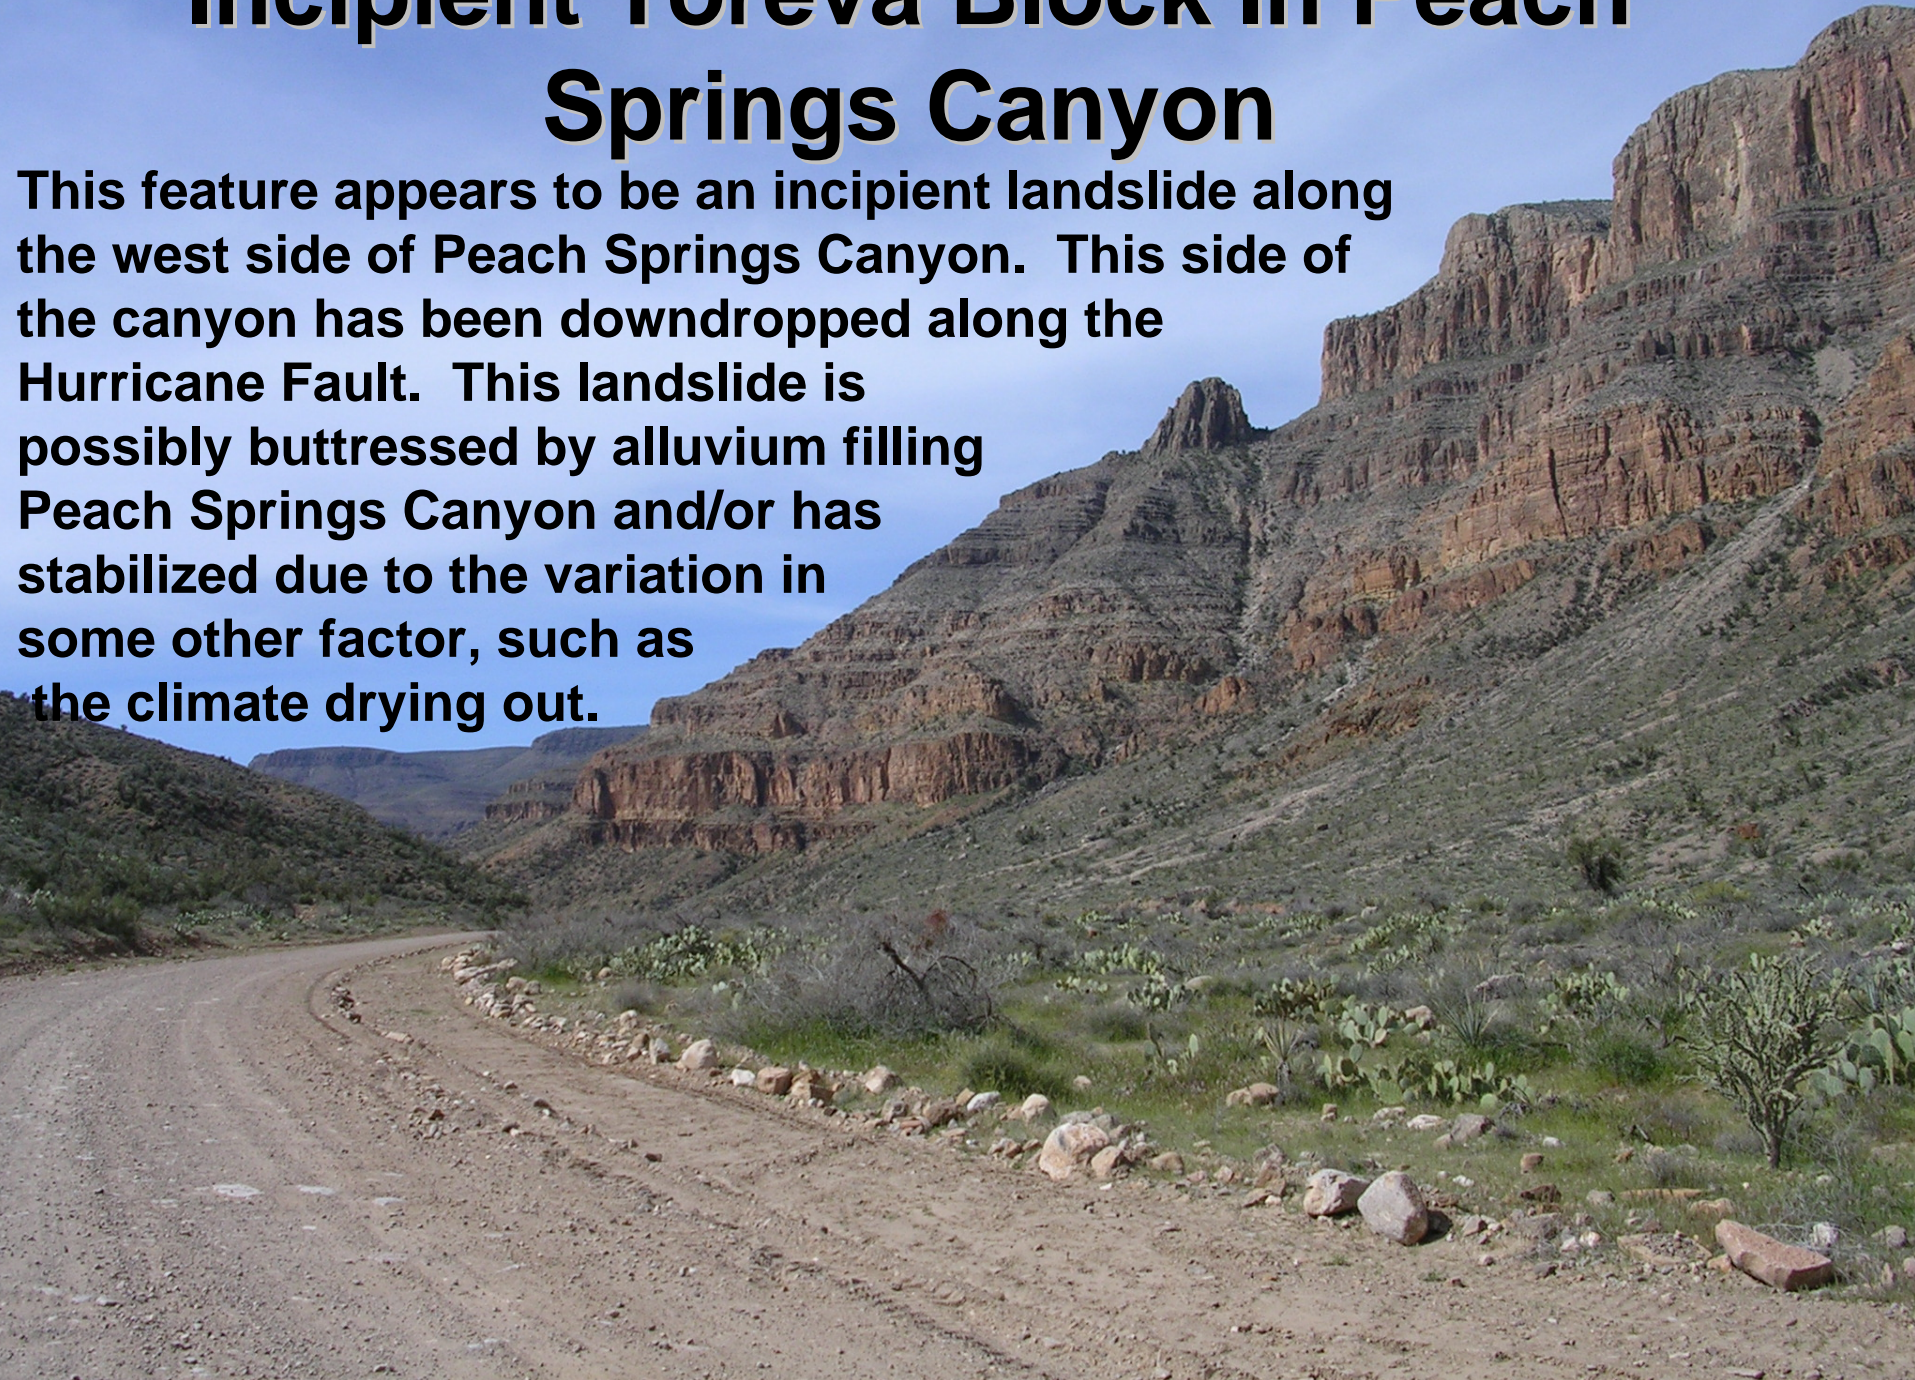
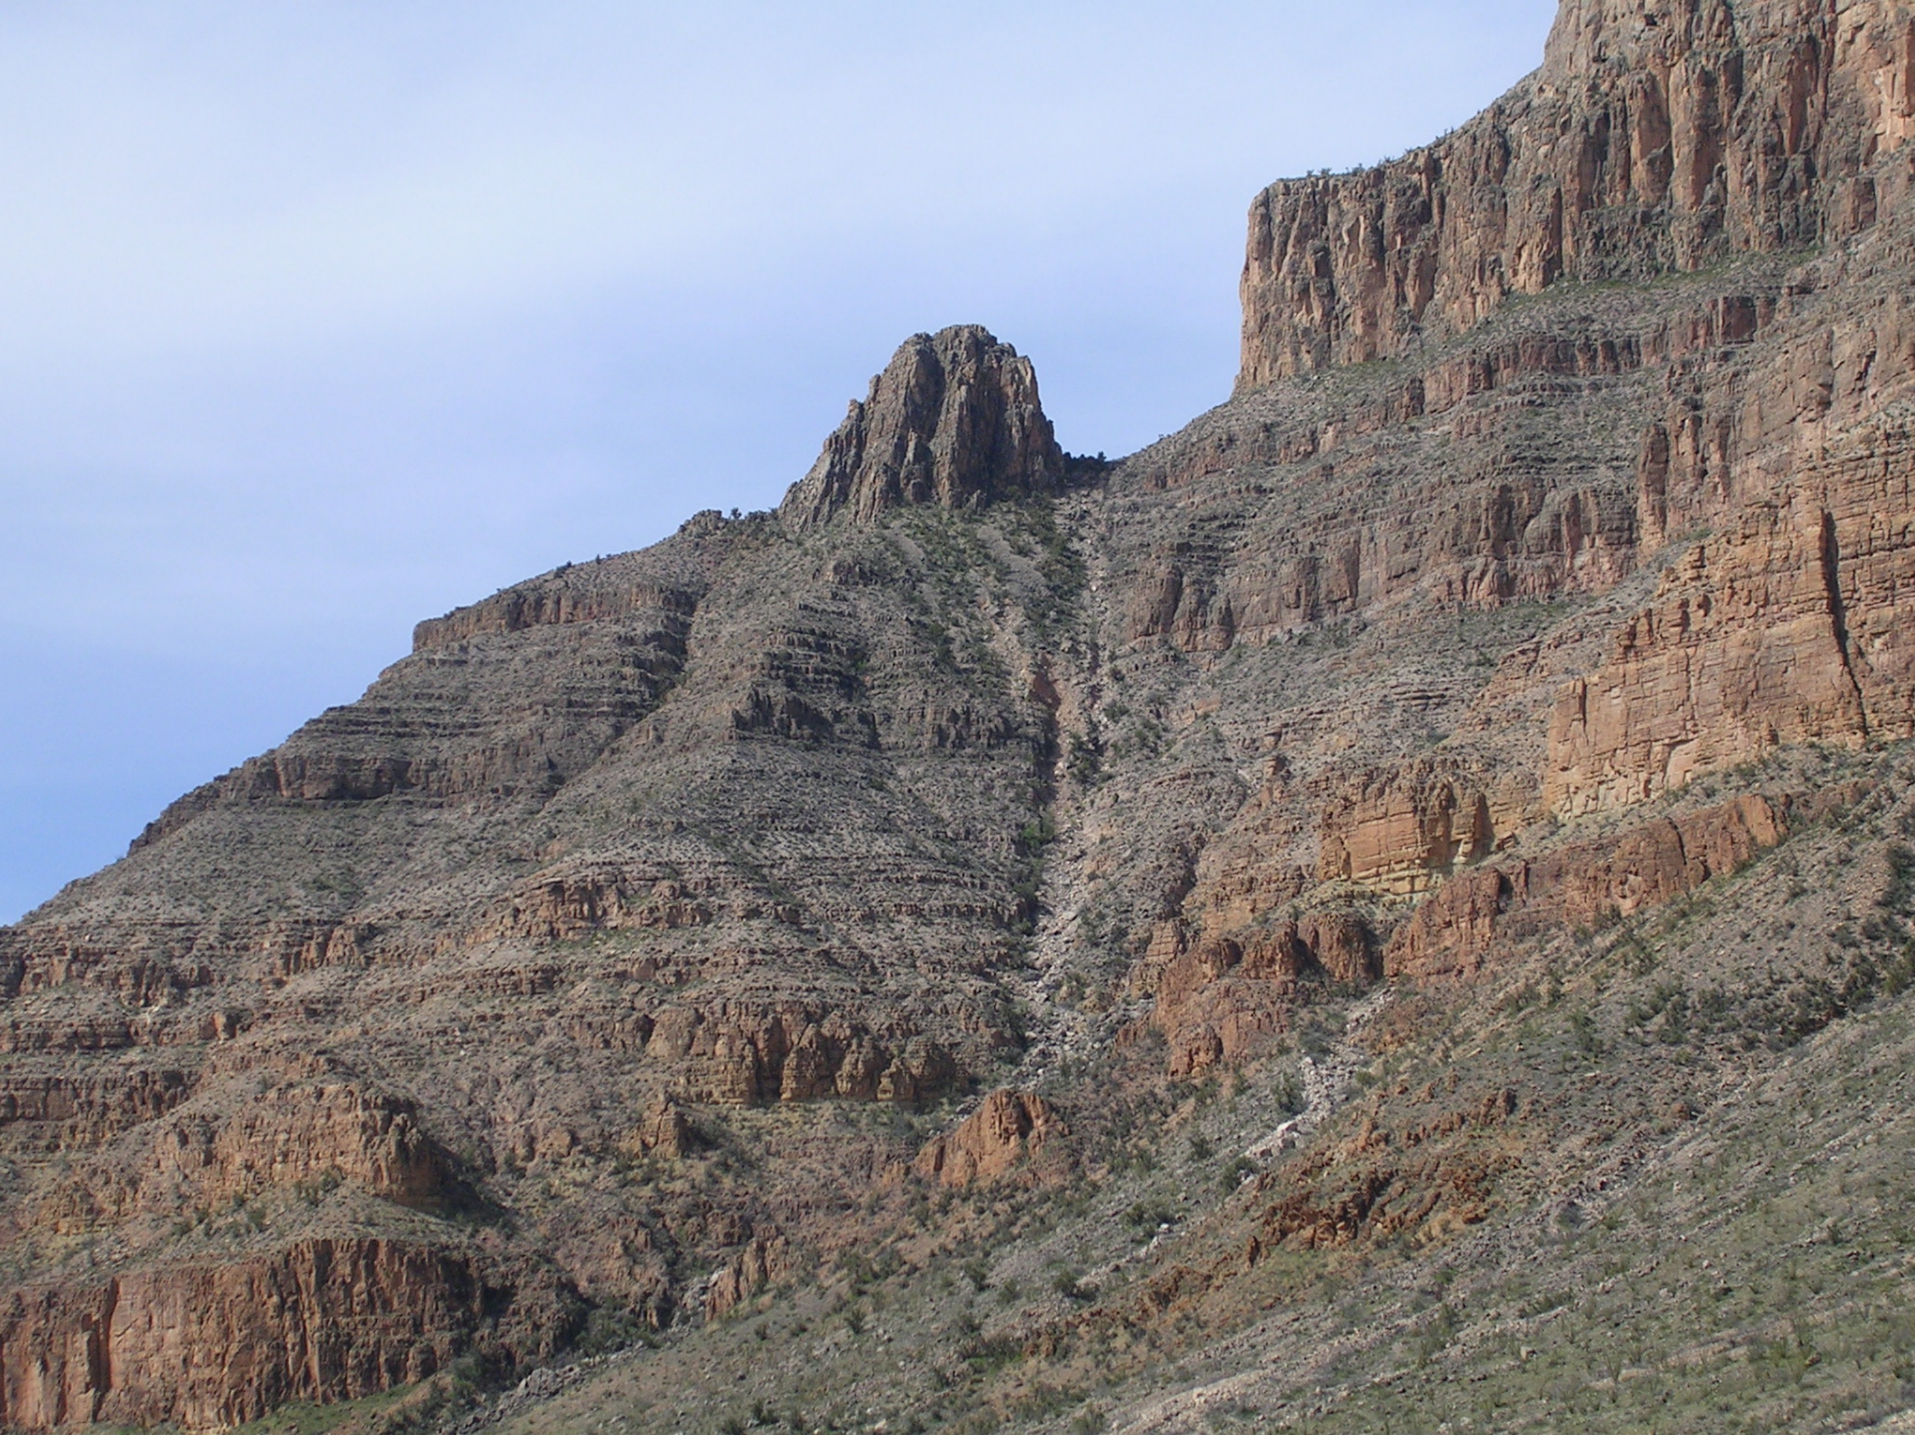
**This feature appears to be an incipient landslide along the west side of Peach Springs Canyon. This side of the canyon has been downdropped along the Hurricane Fault. This landslide is possibly buttressed by alluvium filling Peach Springs Canyon and/or has stabilized due to the variation in some other factor, such as the climate drying out.**

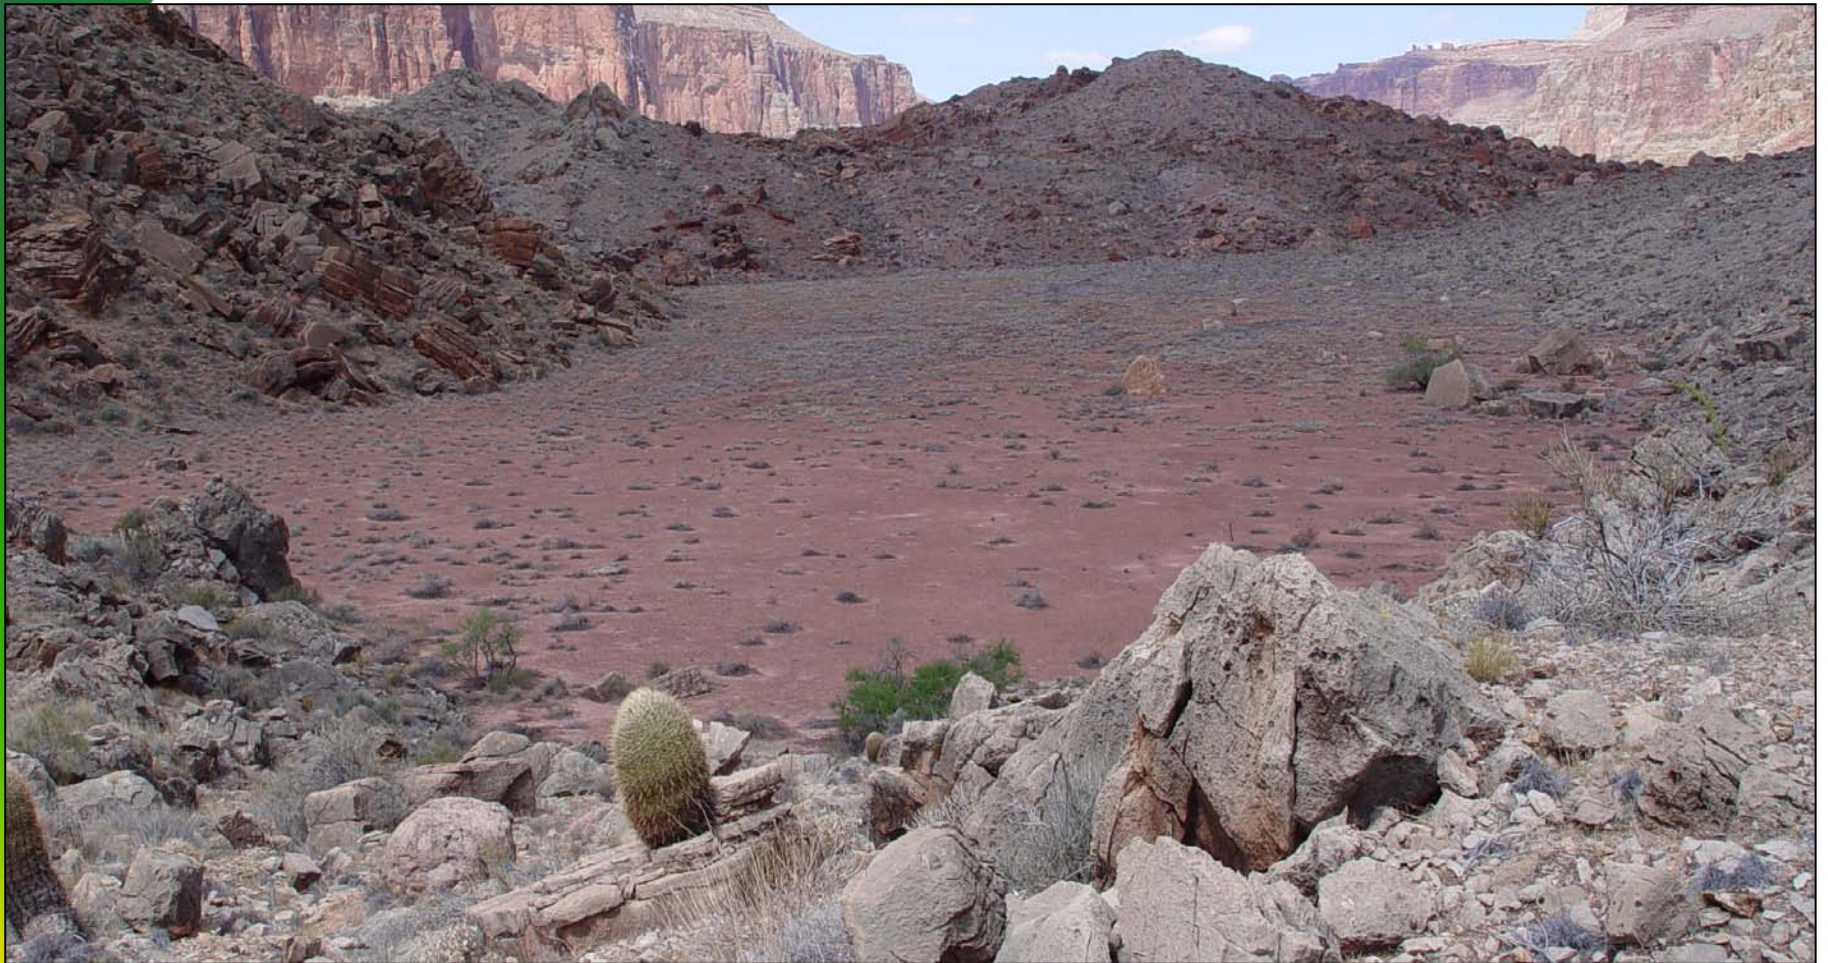
**The main headscarp graben of the Deer Creek Landslide formed a closed basin that has been accumulating lacustrine sediments and talus since its formation. The deposits may be 100 + meters thick. In order to date the landslide one would need to obtain samples from the lower horizons of this deposit.**

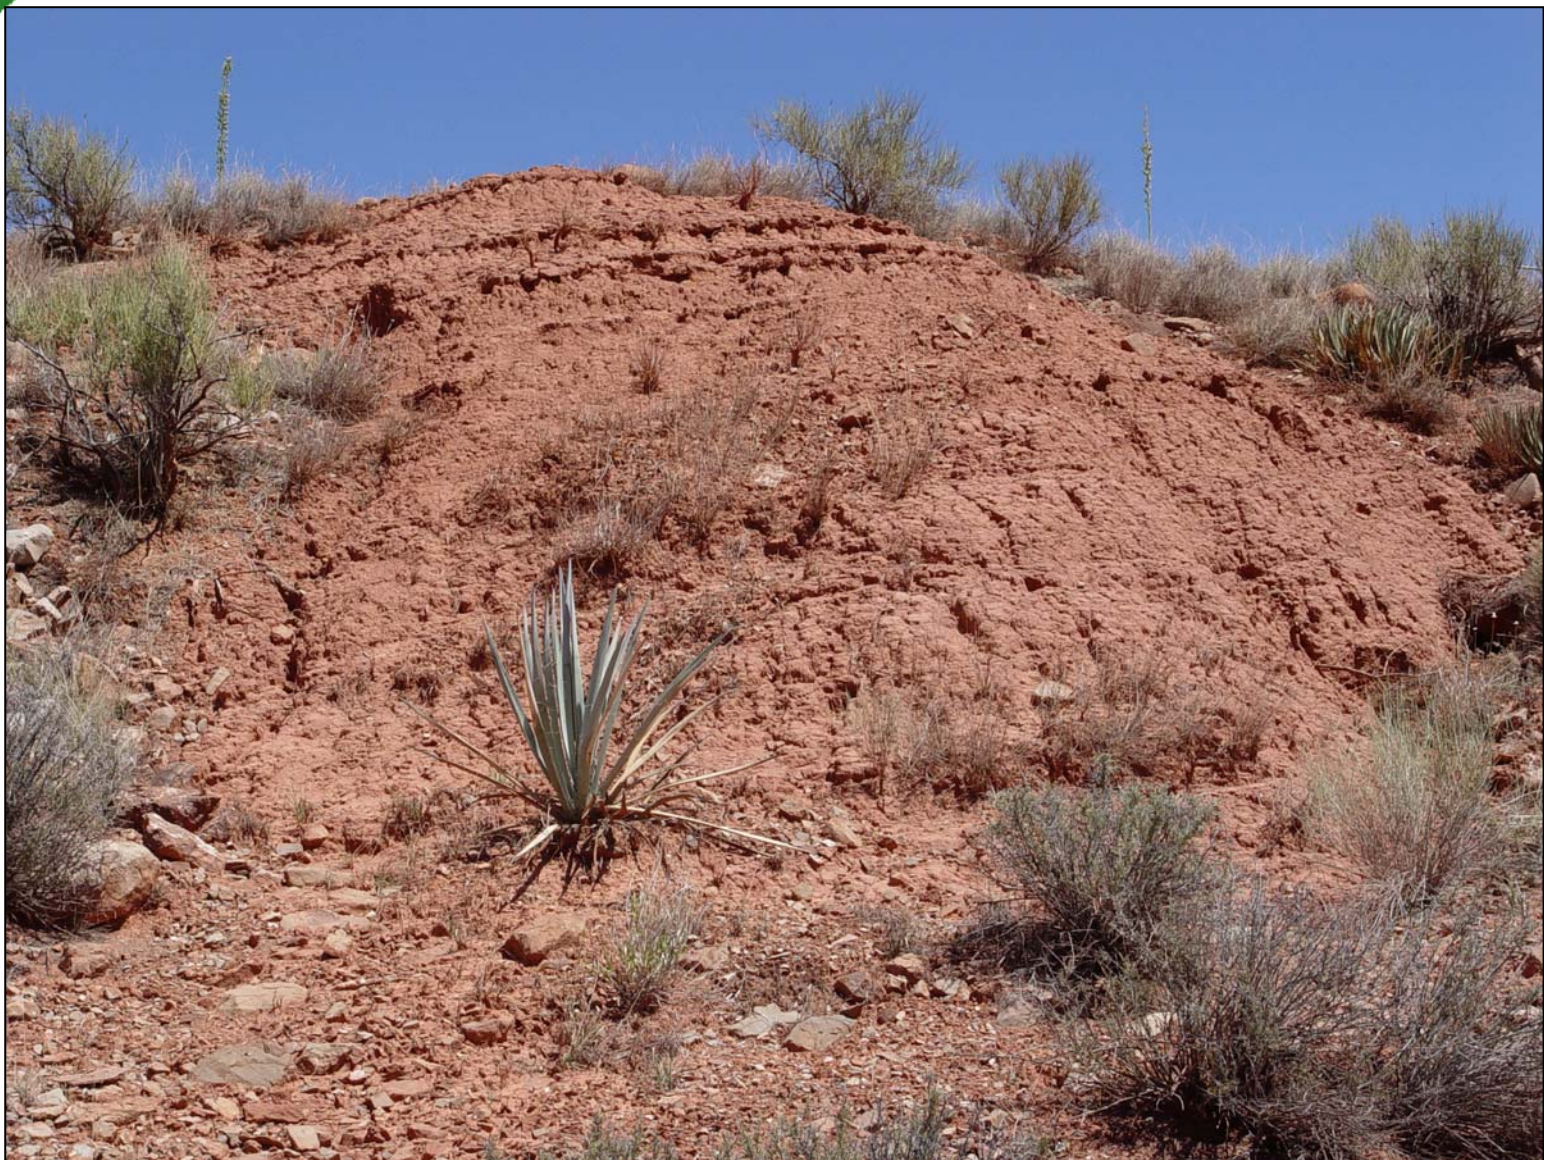
**Fine-grained lacustrine deposits in Surprise Valley have yielded 18 types of spores, fungal hyphae, and pollen, including that of freshwater algae. Although these deposits appear red and oxidized, their parent materials (mainly Hermit and Supai Formations) are red in color.**
