APPLICATIONS OF GEOGRAPHICAL INFORMATION SYSTEMS TO TERRAIN ANALYSIS

J. David Rogers
Karl F. Hasselmann Chair in Geological Engineering

University of Missouri-Rolla

Mapping Mass Movements: Past, Present and Future

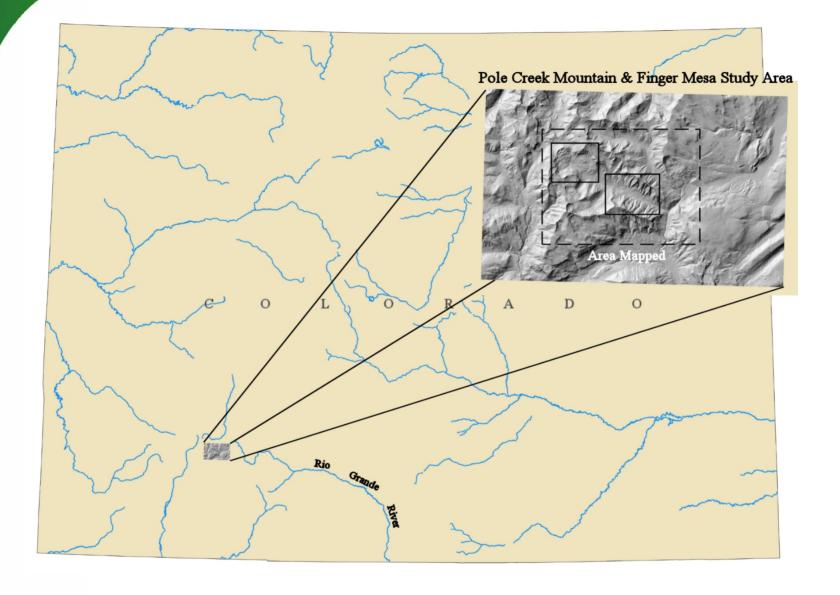
The 1991 West Lost Trail Creek Landslide occurred on the boundary of the Pole Creek Mountain and Finger Mesa 7.5-min quadrangles in the upper Rio Grande watershed.

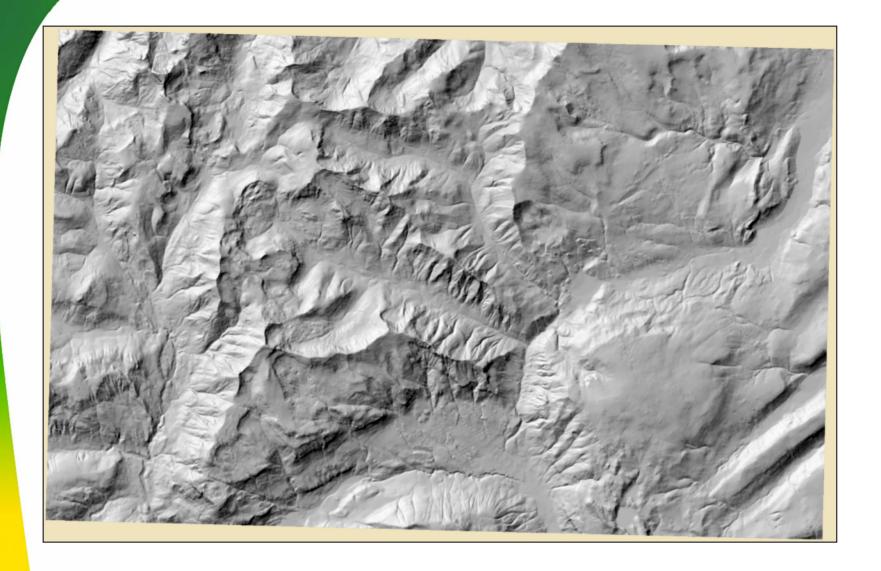
10 m Digital Elevation Models for the Pole Creek Mountain and Finger Mesa quadrangles, based on September 1998 photos

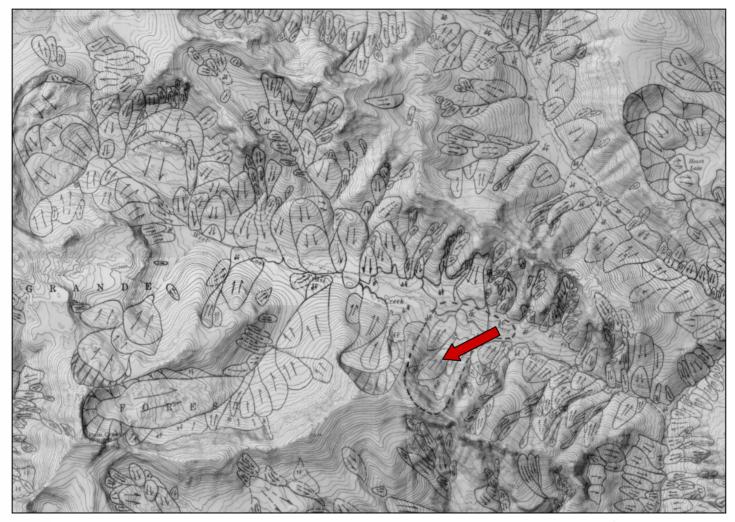
Landslide inventory map created on a shaded relief DEM covering 65 km² area surrounding the subject landslide (arrow)

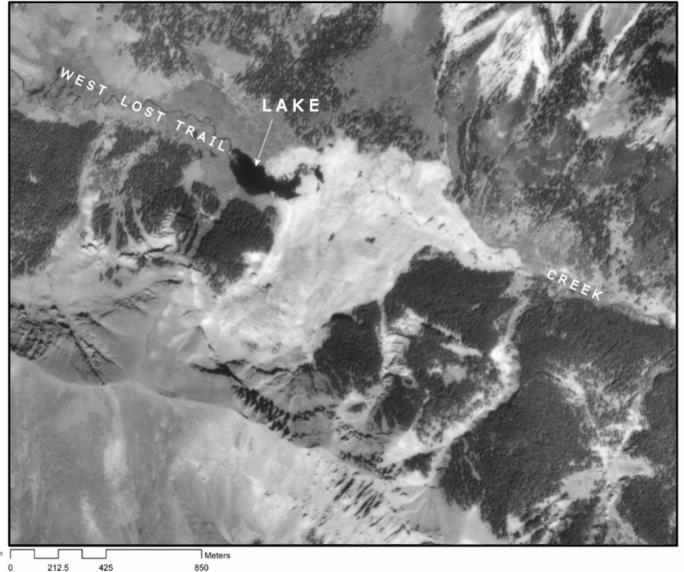
Aerial photo imaged in September 1998 showing the lake formed along West Lost Trail Creek and the isolated ponds throughout the debris field

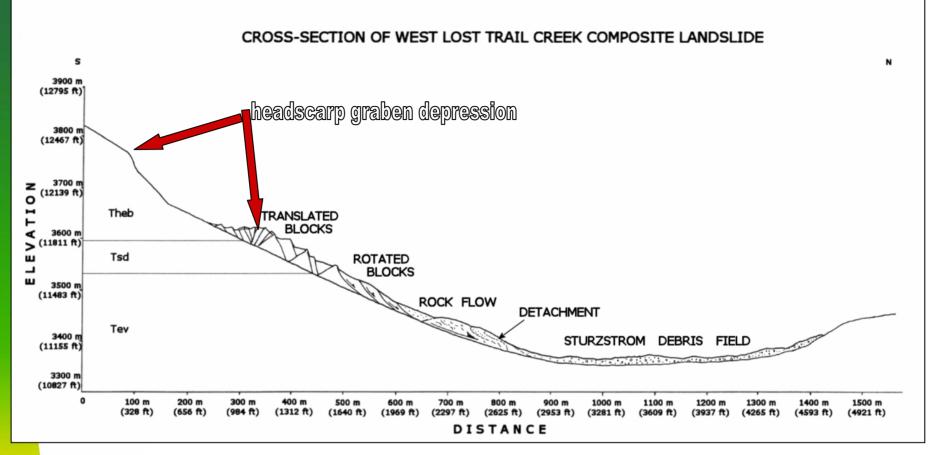
CROSS-SECTION OF WEST LOST TRAIL CREEK COMPOSITE LANDSLIDE

Cross section through 1991 sturzstrom after movement ceased, showing the various components of the slide mass

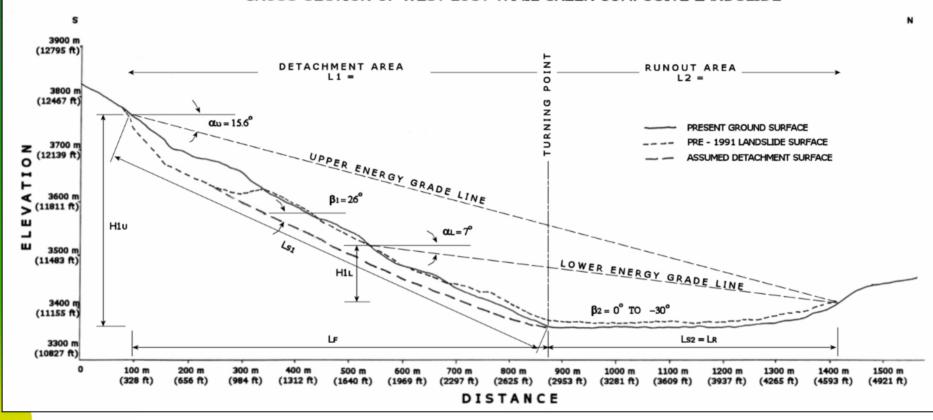
Energy Line Models used for evaluating sturzstroms. Complete detachment only occurred below el. 11,480'

The lower ELM predicted runout (1926 ft) within 10% of that observed (1739 ft) and should have taken 32 seconds to decelerate (25 to 30 estimated by observer)

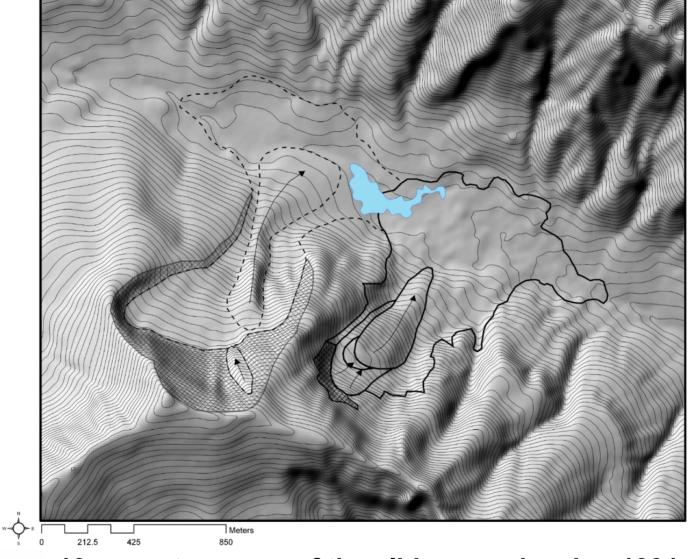
10 m contour map of the slide area showing 1991 slide and larger prehistoric event immediately upstream

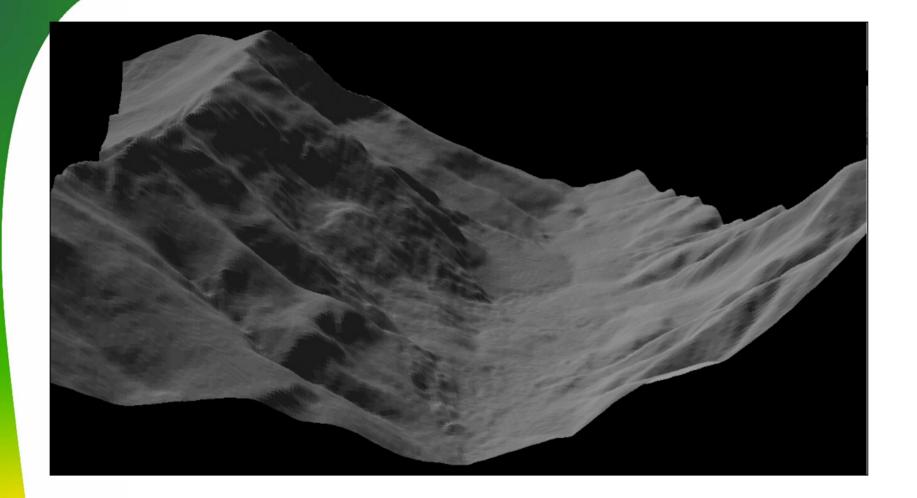
Oblique view of the 1991 West Lost Trail Creek landslide on the10 m DEM prepared from 1998 photos using MicroDEM/Terrabase II

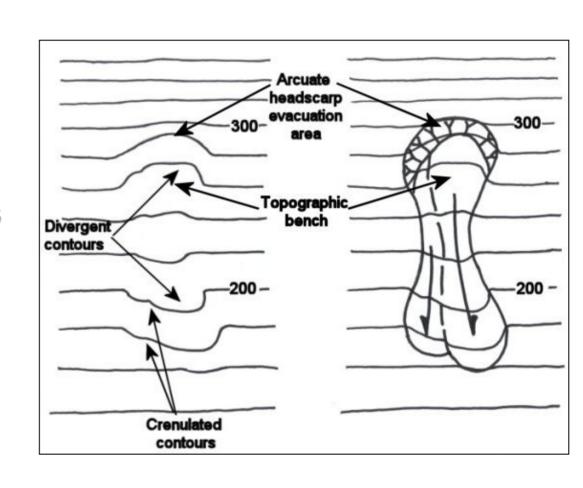
Diagnostic Topographic Patterns

Use drainage and topographic keys to recognize anomalous site characteristics typical of landslides

- Divergent contours
- Crenulated contours
- Arcuate headscarp evacuation areas
- Isolated topographic benches

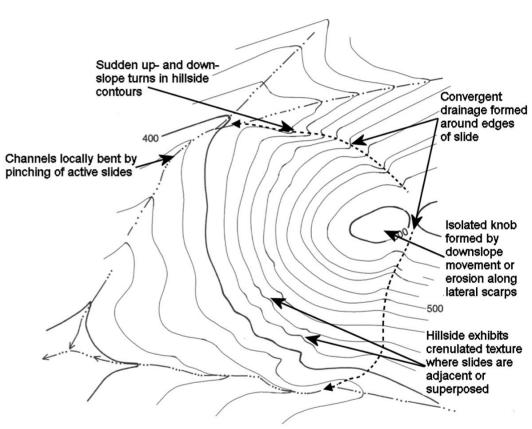
Topographic Patterns on Composite Landslides

Use drainage and topographic keys to recognize anomalous site characteristics typical of landslides

- Extended ridges or isolated knobs
- Sudden turns in hillside contours
- Convergent drainage

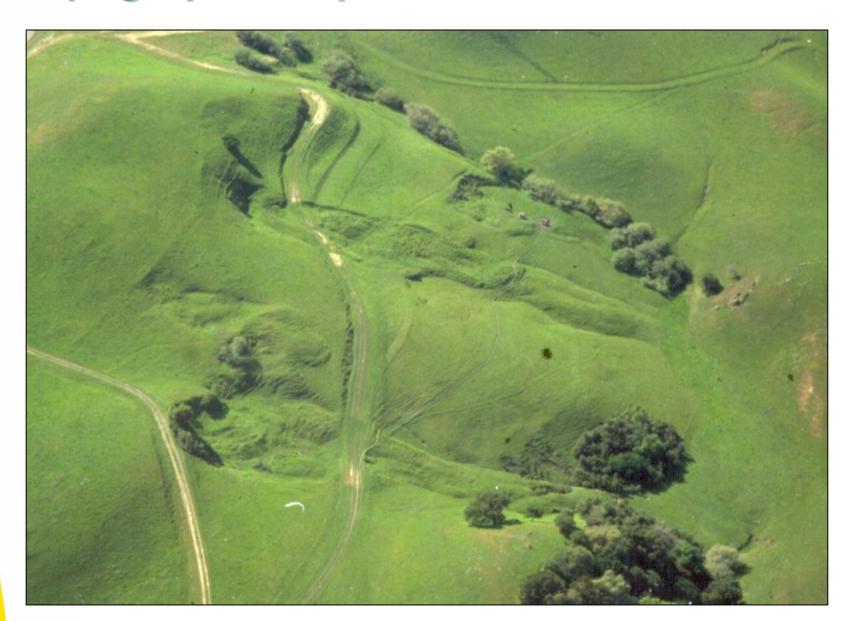
Topographic Expression of Earthflows

Topographic Keys to Identify Earthflows

- Opposing contours
- Headscarp evacuation areas
- Necking down at transition between deflation/ inflation zones

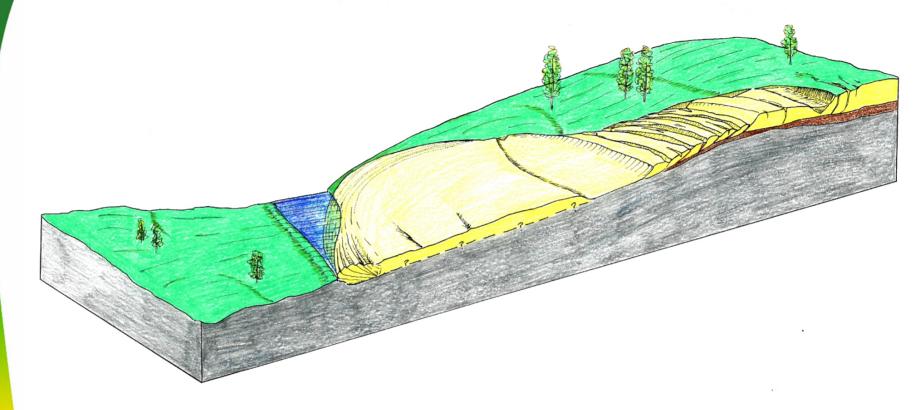
Lateral spreads are caused by liquefaction of discrete buried horizons, which allow overlying materials to "raft" towards an adjacent topographic depression

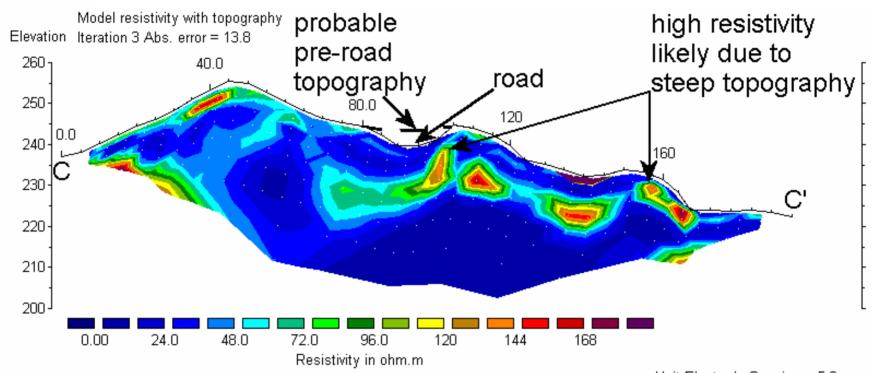
Soil Resistivity Profiling

Unit Electrode Spacing = 5.0 m.

Horizontal scale is 18.72 pixels per unit spacing Vertical exaggeration in model section display = 1.00 First electrode is located at 0.0 m. Last electrode is located at 195.0 m.

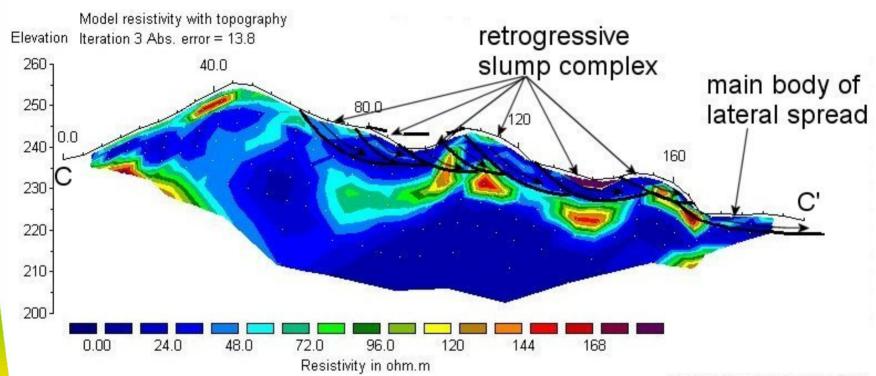
Geologic Interpretation

Unit Electrode Spacing = 5.0 m.

Horizontal scale is 18.72 pixels per unit spacing Vertical exaggeration in model section display = 1.00 First electrode is located at 0.0 m. Last electrode is located at 195.0 m.

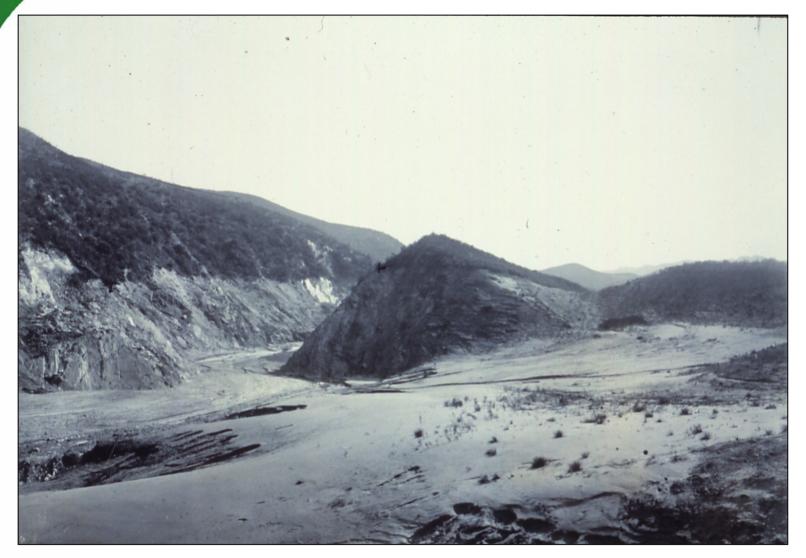
As the flood moved downstream, the depth of flow diminished. This view shows a saddle 120 feet above the creek bed about ¾ mile downstream, which was overtopped by the outpouring waters.

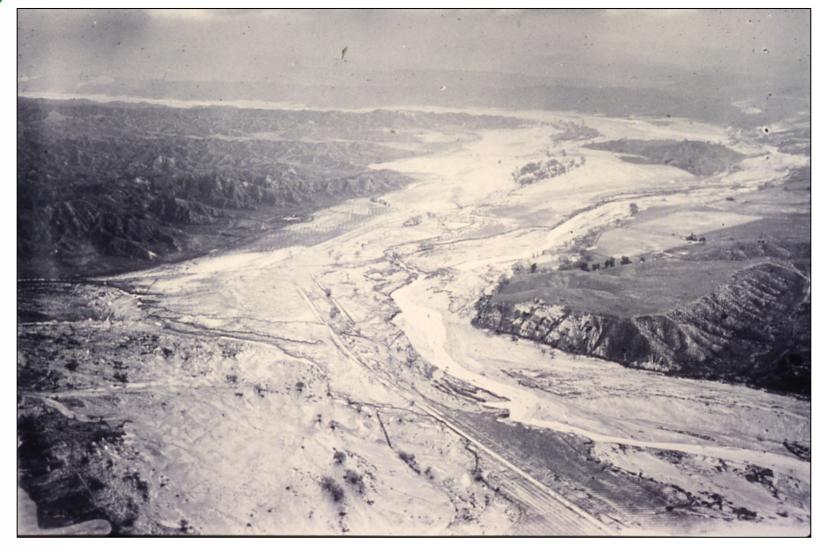
The flood swept 6 miles down San Francisquito Canyon to it's junction with the much larger Santa Clara River, where it made a right-hand reverse turn through Castaic Junction.

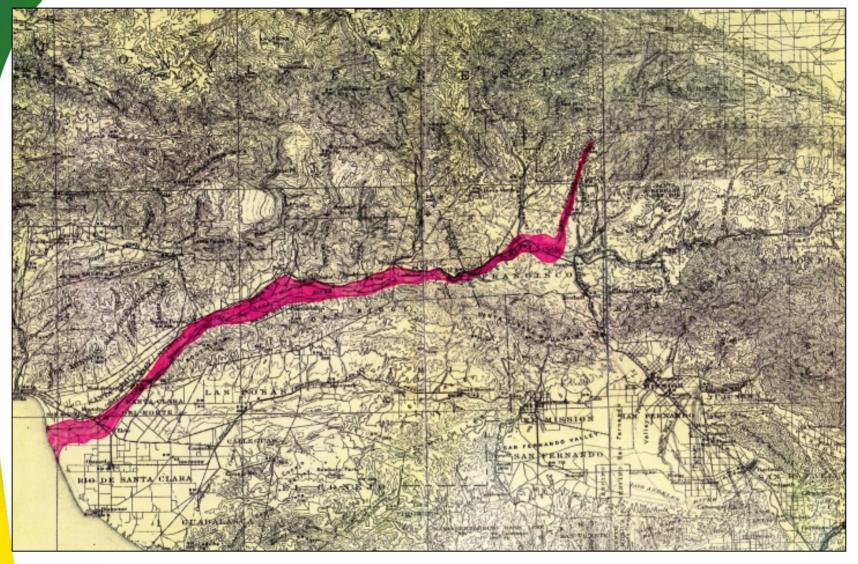
Charles Lee's map of the flooded area, extending 54 miles from the St. Francis Dam site, through Castaic, Camulos, Filmore, Santa Paula, Saticoy and Montalvo. The smoothed flow distance was 52 miles.

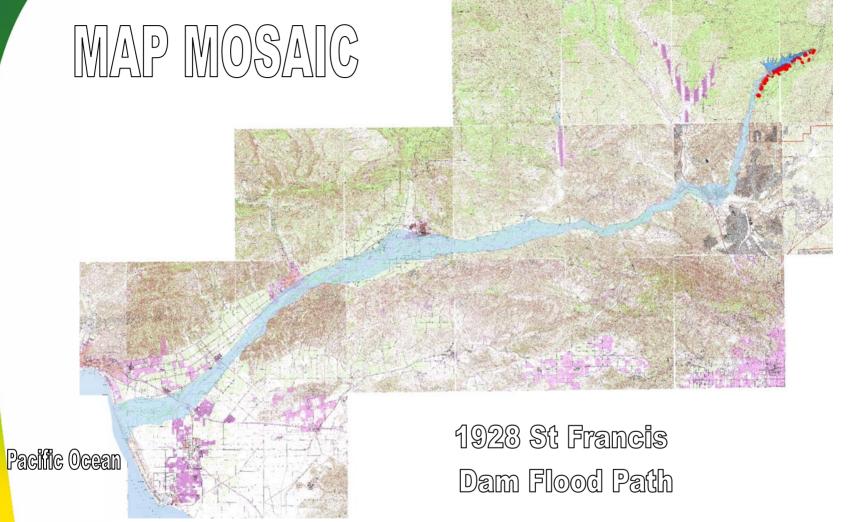
19 USGS 1:24,000 scale Digital Raster Graphic (DRGs) quadrangles were stitched to create a flood base map.

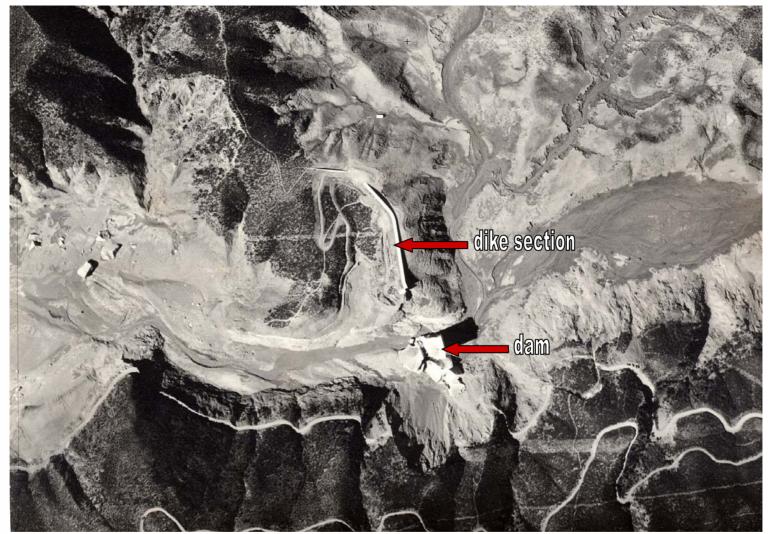
Stereopair aerial photos were orthorectified on present-day DRGs to obtain aerial limits of flood waters. This view shows the dam site and immediately downstream.

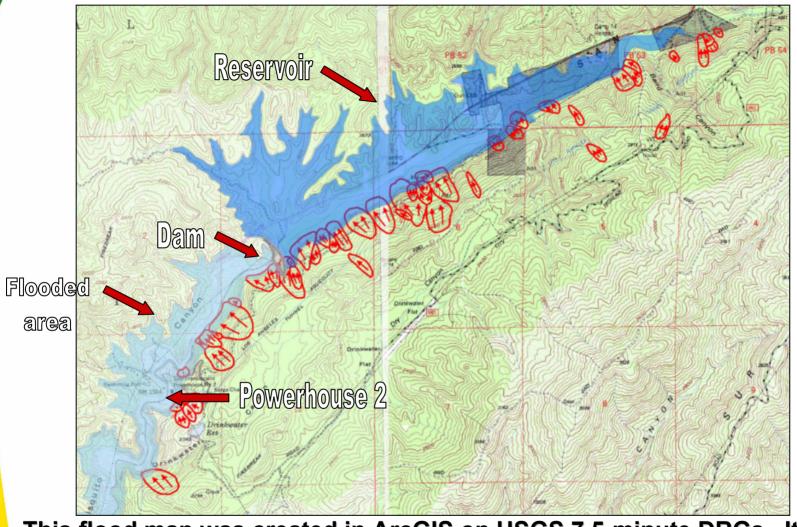
This flood map was created in ArcGIS on USGS 7.5-minute DRGs. It shows the 1928 reservoir in dark blue and the flood limits in light blue. Landslides are shown in red.

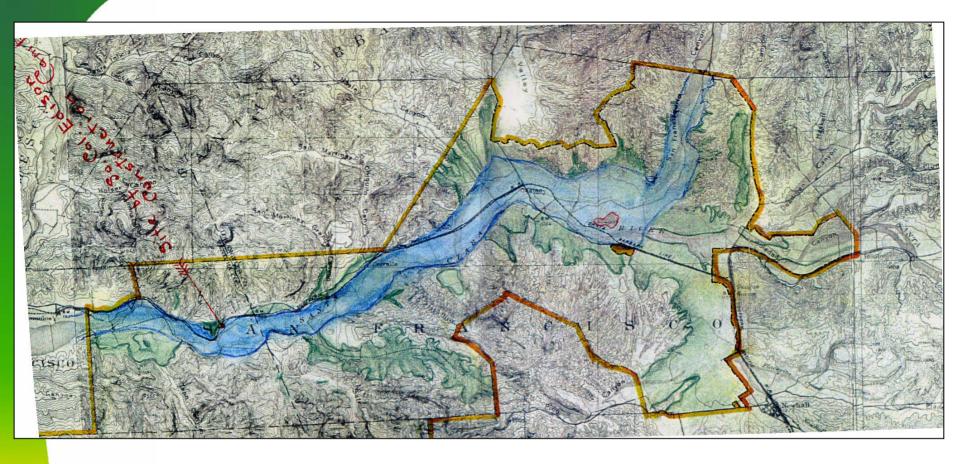
Orthorectifed local flood map. By applying Universal Transverse Mercator (UTM) Grid North American Datum (NAD) 1983 (83) geospatial controls, the 1928 planar map is skewed slightly when orthorectified to present-day map projection standards that account for the Earth's actual curvature.

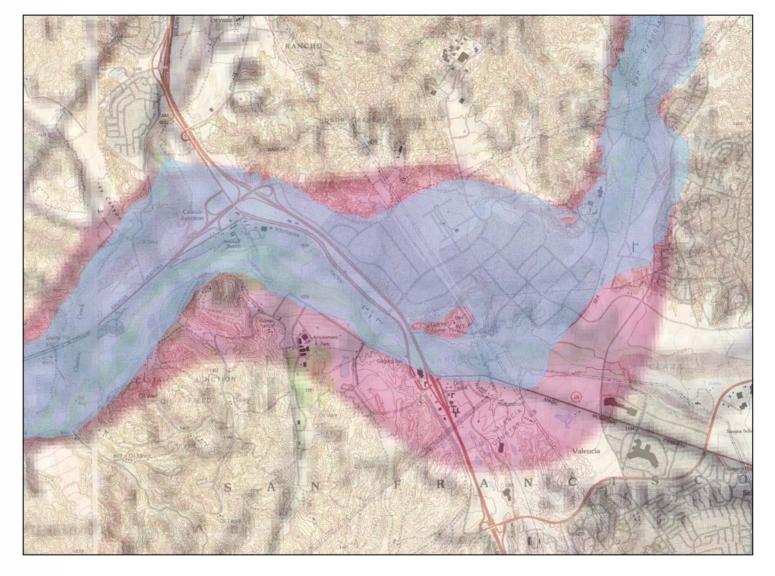
When our GIS map (blue) was overlain on Charles Lee's flood map (red); it appeared that he greatly overestimated the spatial limits of flooding in the Castaic Junction area.

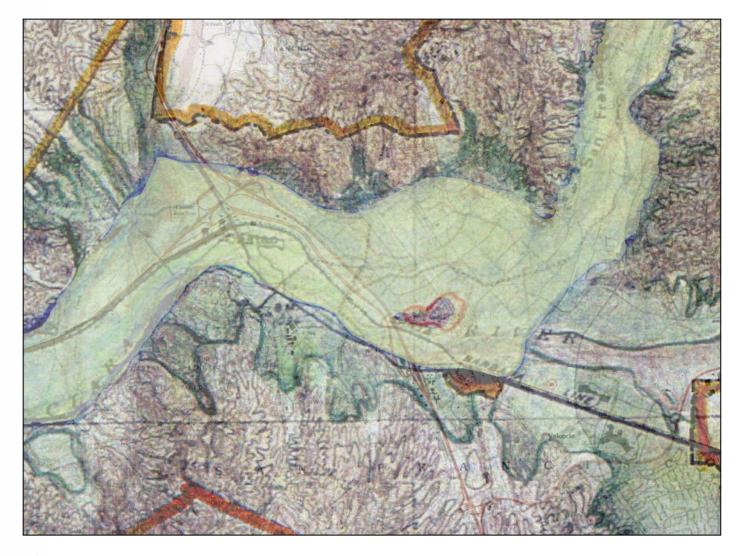
The flood limits shown on our new map are very similar to those shown on the damage map prepared for the Newhall Land Company in the Castaic Junction area.

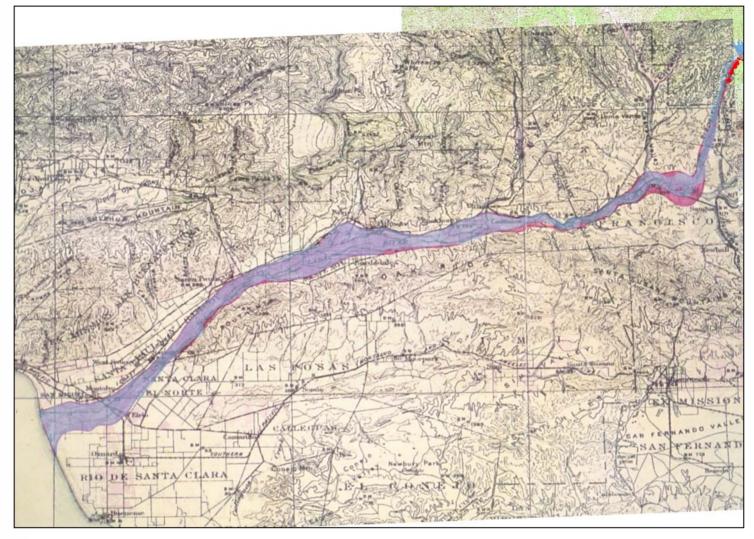
Comparison between orthorectifeid version of Lee's flood map (red) and our new flood map (blue). Lee's map was prepared on a 1:250,000 scale base map (1 inch = 4 miles).

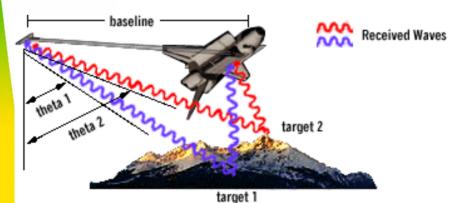
Figure 4: Differential Distance Gives Topography

Radar signals being transmitted and recieved in the SRTM mission (image not to scale).

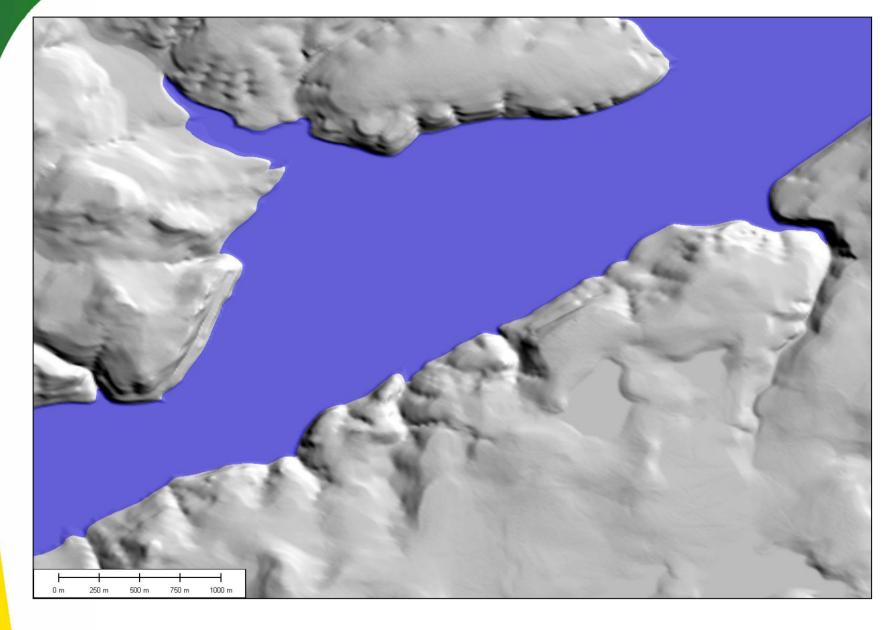
USGS 10m DEM - 9X resolution of 30 m DEM

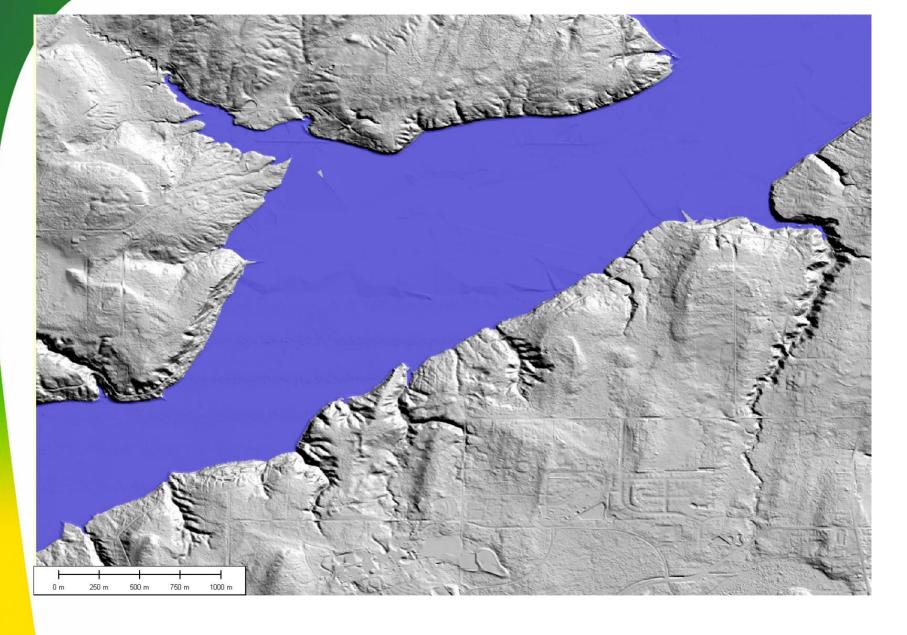
LiDAR 2m DEM – 25X resolution of 10 m DEM

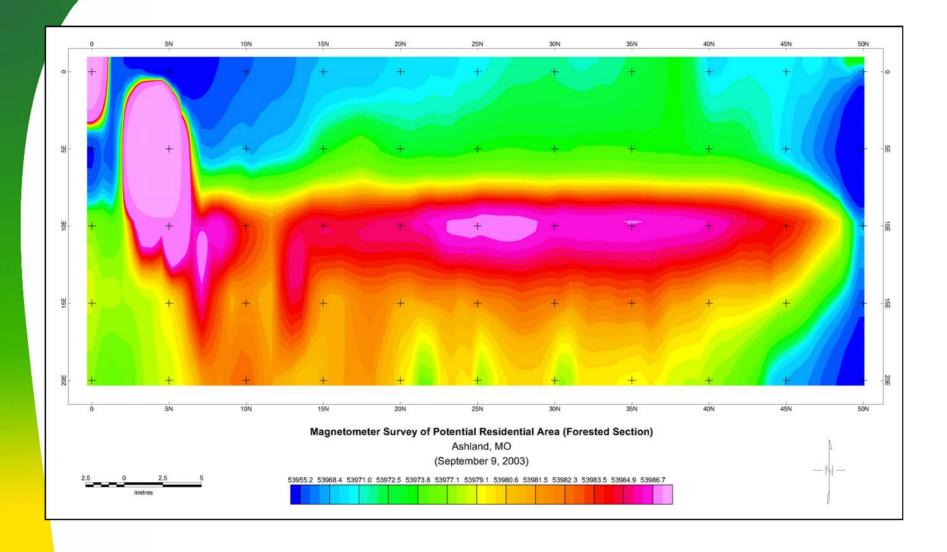
Building Site near Ashland, MO (South of Columbia, MO)

Magnetic Surveying gives the ability to see the metallic resonance in the subsurface.

Identifiable Features:

- Karst
- Buried Drums
- Deposit of Shallow Ores
- Utilities Identification
