# **GEOLOGIC ASSESSMENTS OF THE LAKE MEAD AREA FOR THE BOULDER CANYON PROJECT 1921-31**

**J. David Rogers, Ph.D., P.E., P.G.**

**Recent Advances in Engineering Geology**

**Annual Meeting  
Geological Society of America**

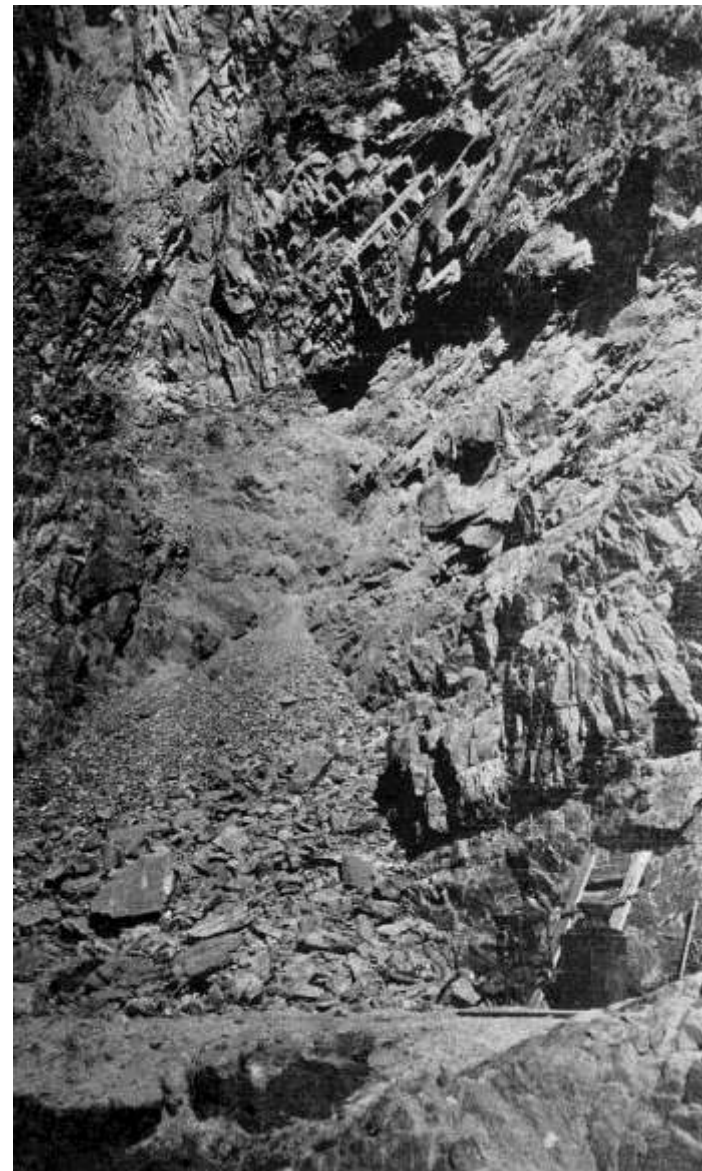
- Channel cross section through Boulder Canyon site (lower left), compared with earlier Reclamation projects. Right image shows fractured nature of the granite

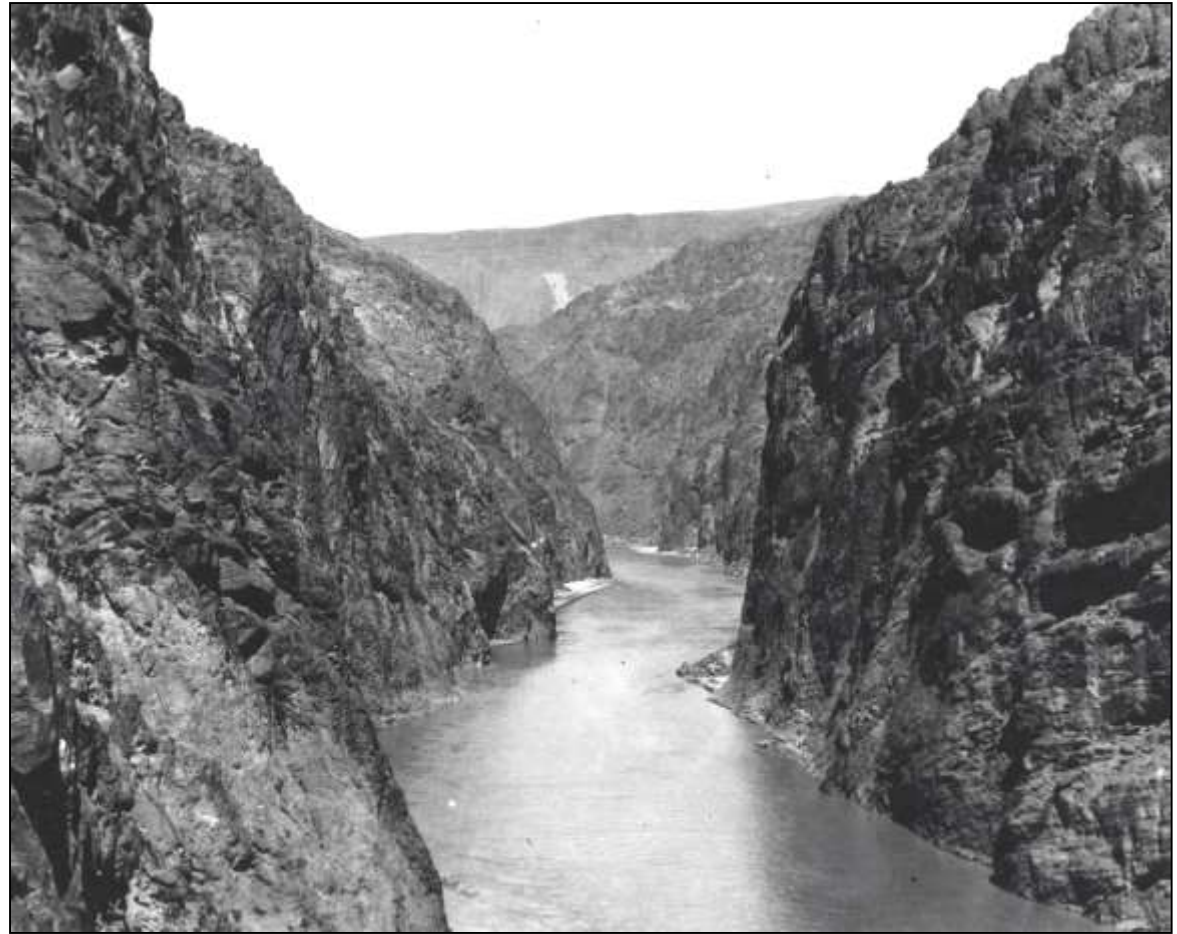
Hamlin's survey mark on what later became Hoover Dam centerline

**Engineer-geologist Homer Hamlin** made the first survey of upper Black Canyon dam sites in the spring of 1920; marking the axis of the site that was eventually chosen, 8-1/2 years later

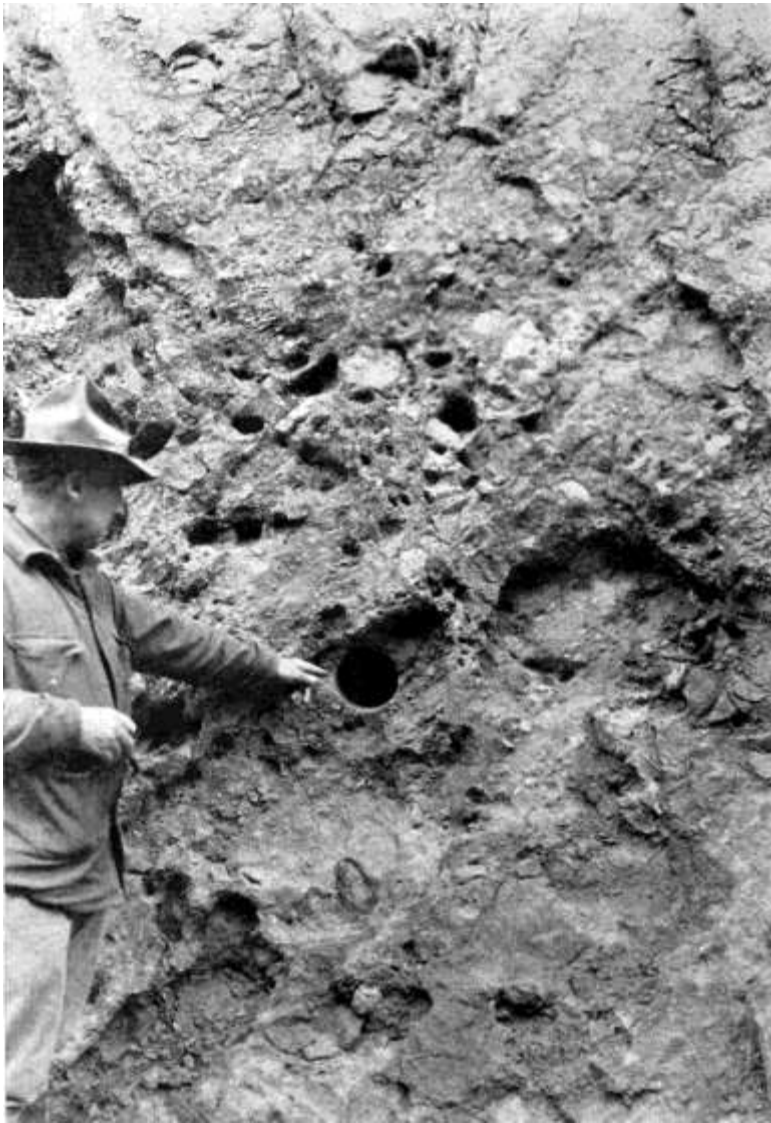
**6-inch cores were extracted from the abutments for unconfined compression tests**

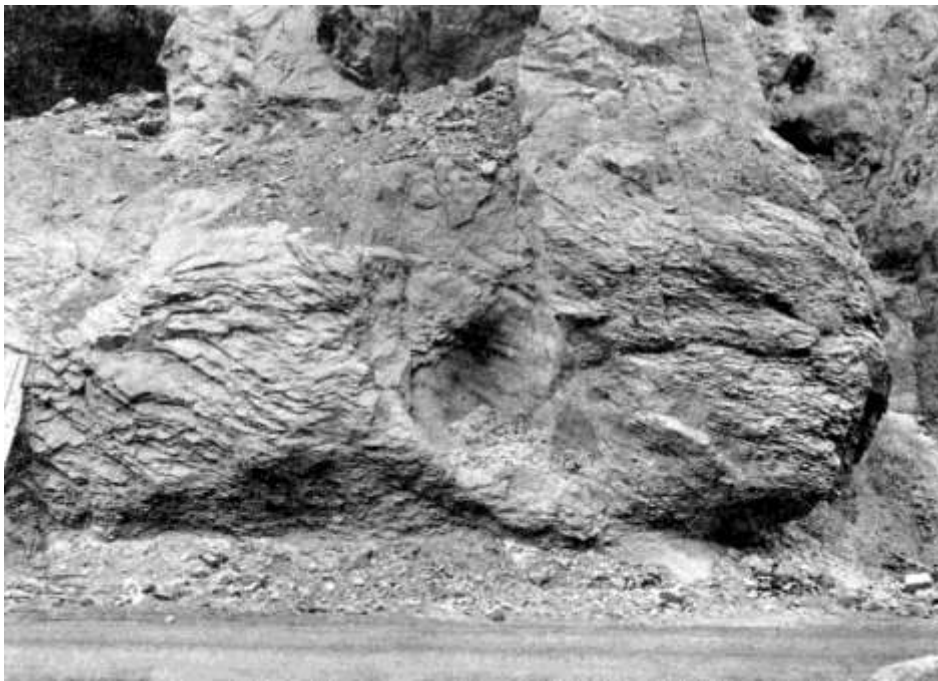
The latite breccia was characterized by locally intense fractures, especially along faults and shear zones. These inclined faults also crisscrossed one another.

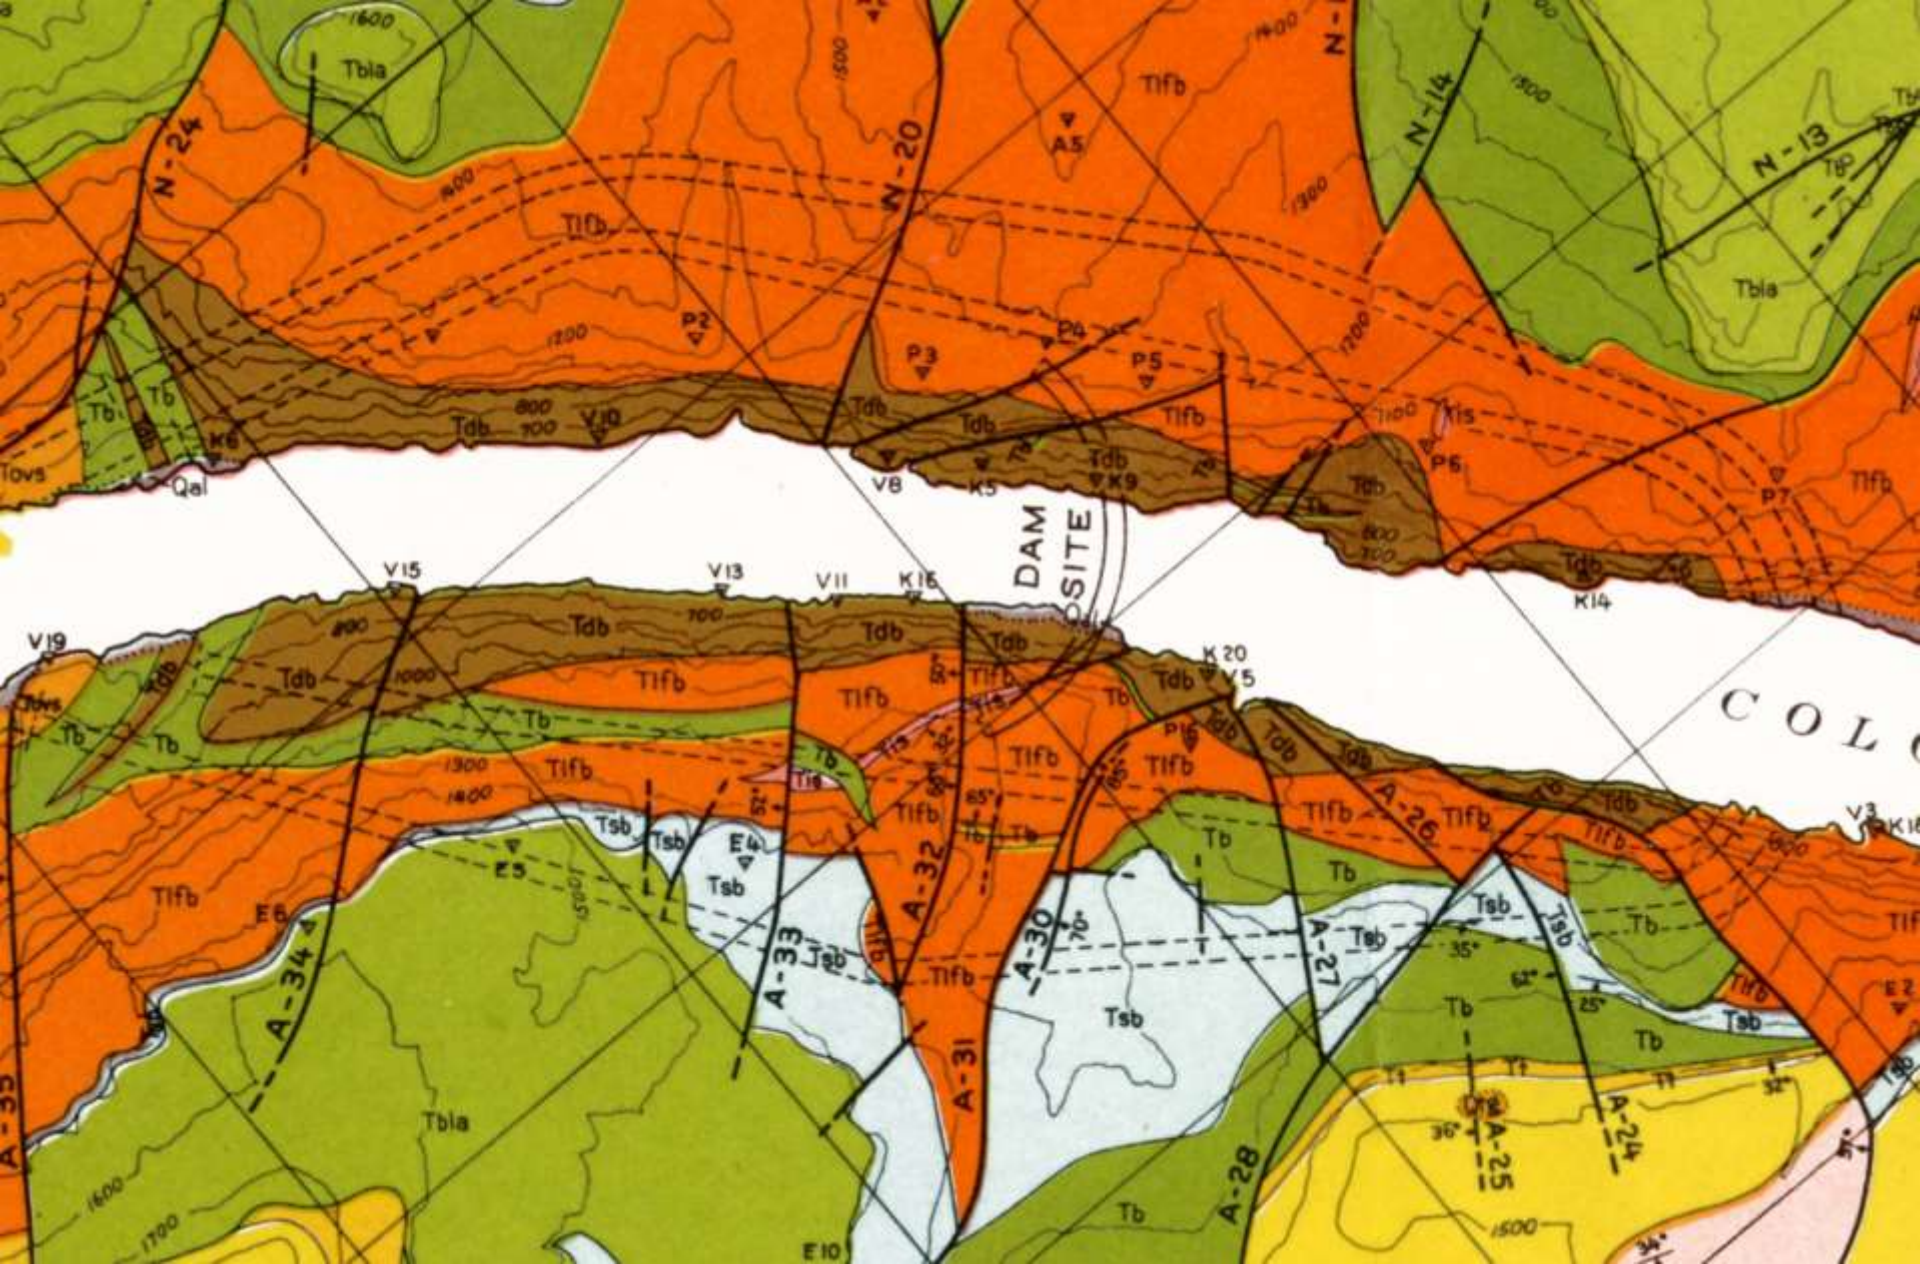
**Ransome's geologic map controlled the position of the dam's axis, to wedge the dam in between the two prominent faults mapped on the right abutment**

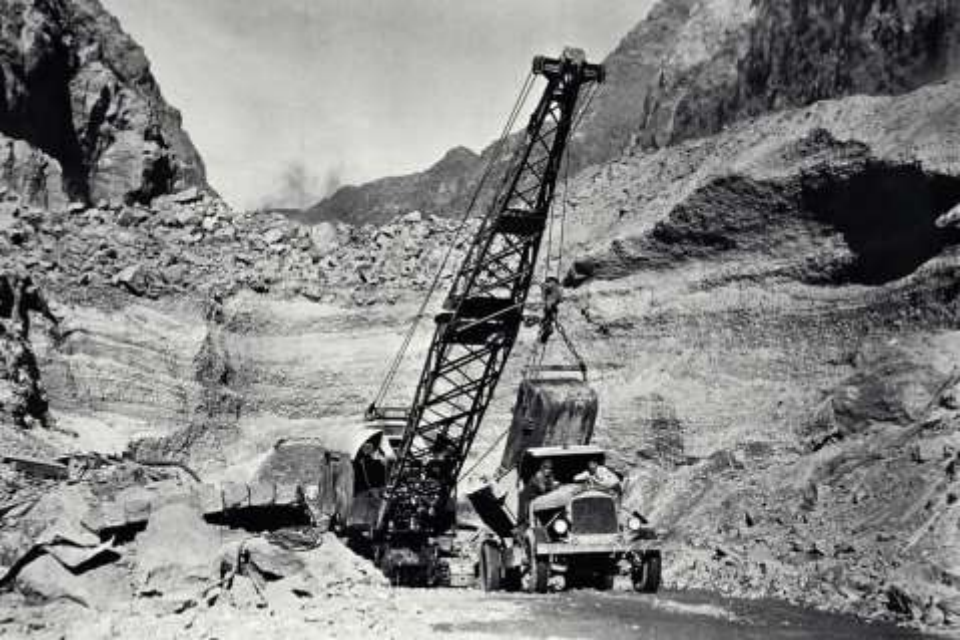
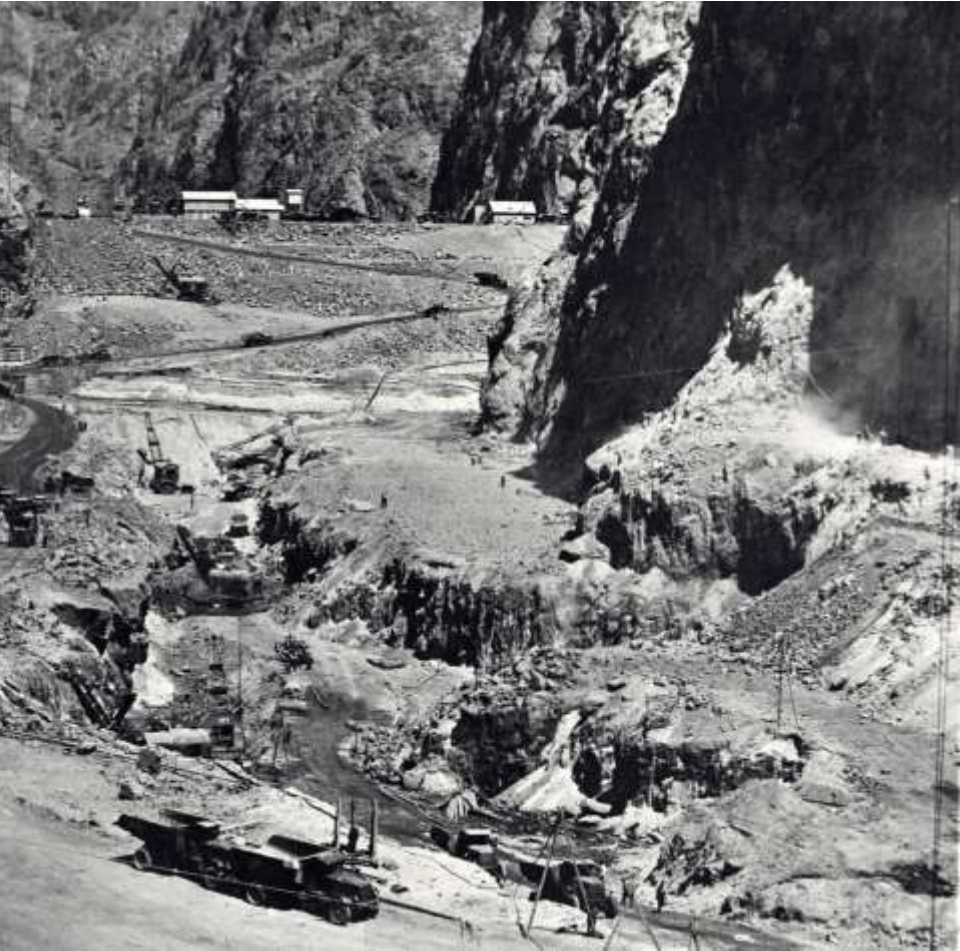
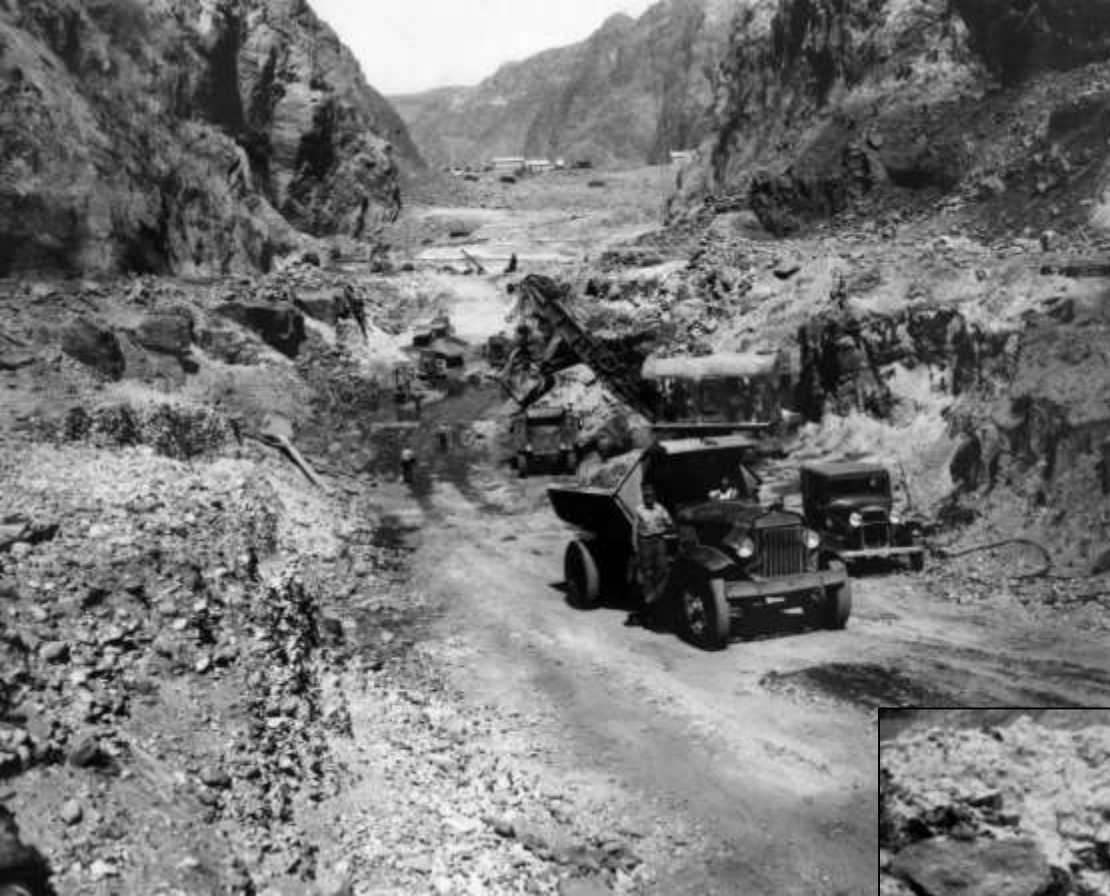
# Excavation of Inner Gorge in Colorado River channel beneath the dam.

**A total of 6 million yards of bedrock and alluvial material was excavated at the dam site.**

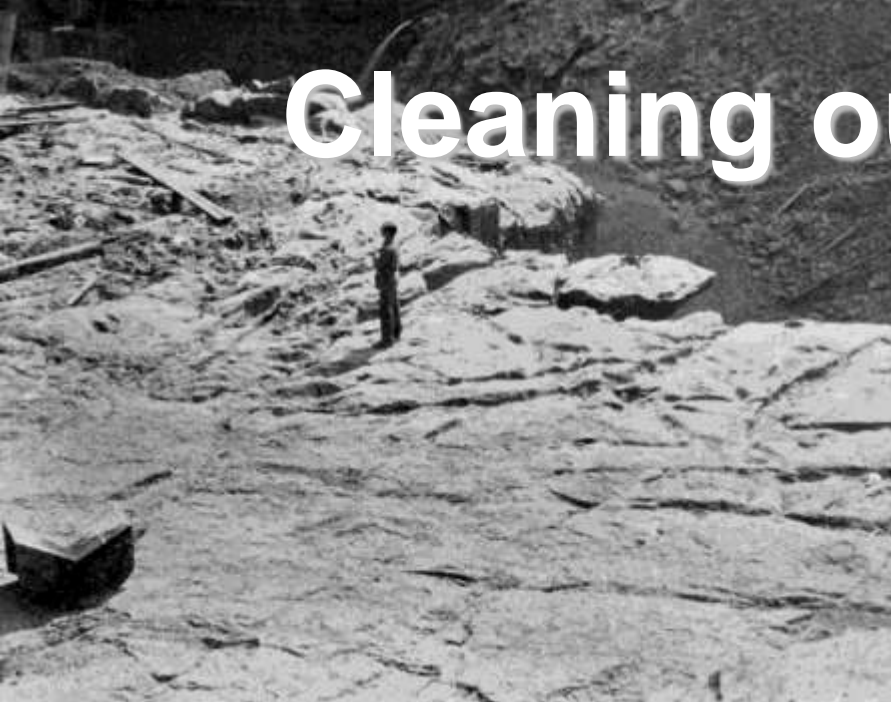
Uneven flute structures, note man for scale (lower left)

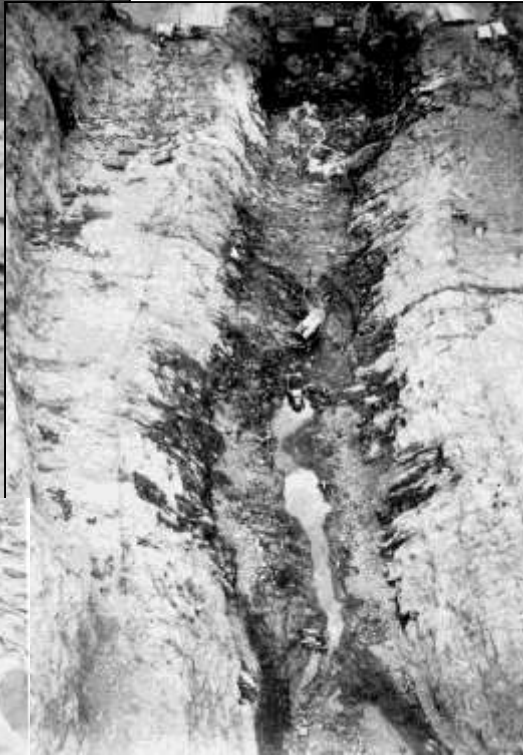
About 2 million cubic yards of material was excavated out of the river channel beneath the dam, revealing an incised inner gorge with fluting and boulders up to 12 feet across.

Note overhanging pothole structures

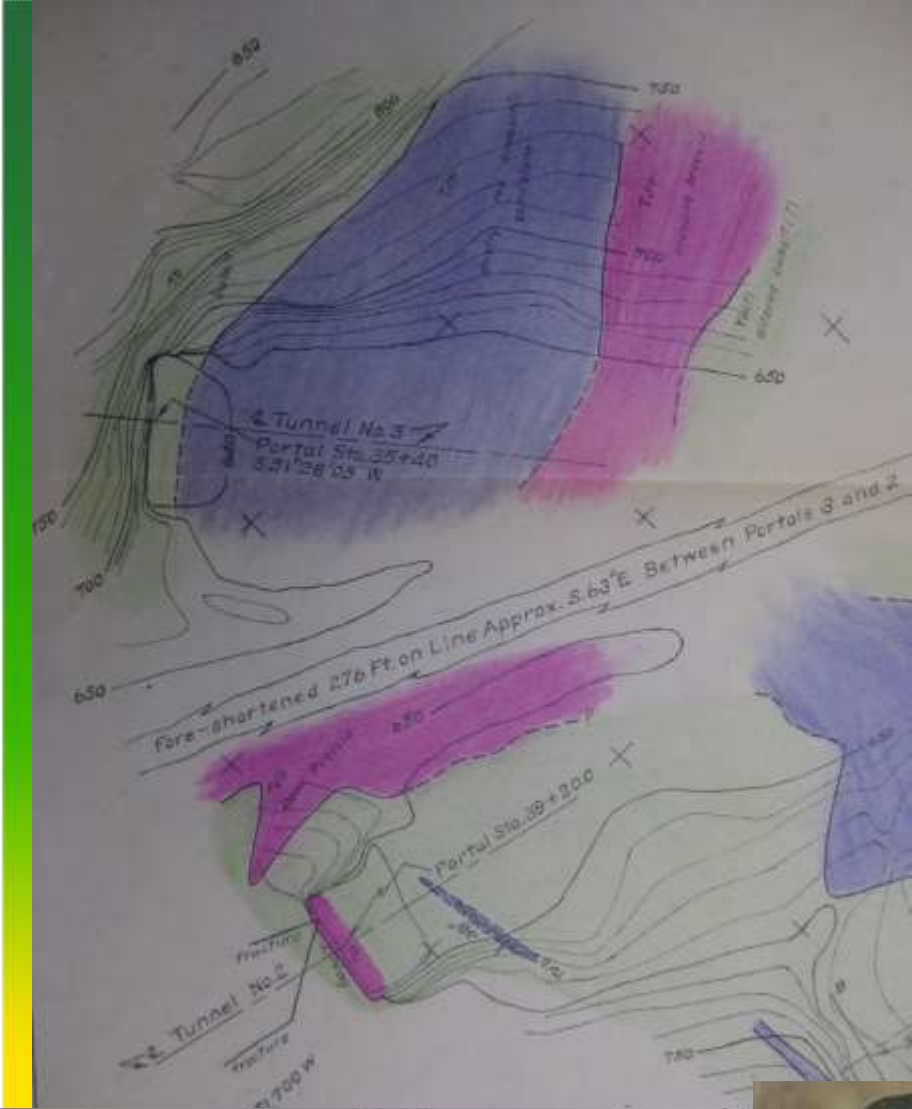
SCALE: 50' = 1"

OUTLET PORTALS OF DIVERSION  
TUNNELS - HOOVER DAM  
TOPOGRAPHY CORRECT TO DEC. 1, 1931  
GEOLOGY BY F.A. NICKELL - NOV. 1931

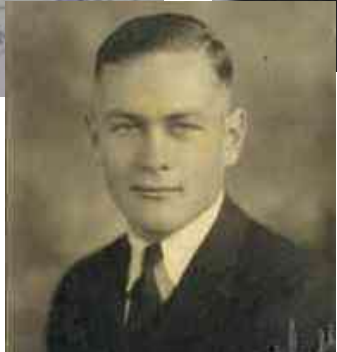
- Frank Nickell mapped the geology exposed in the numerous excavations as they were being advanced throughout 1931-32

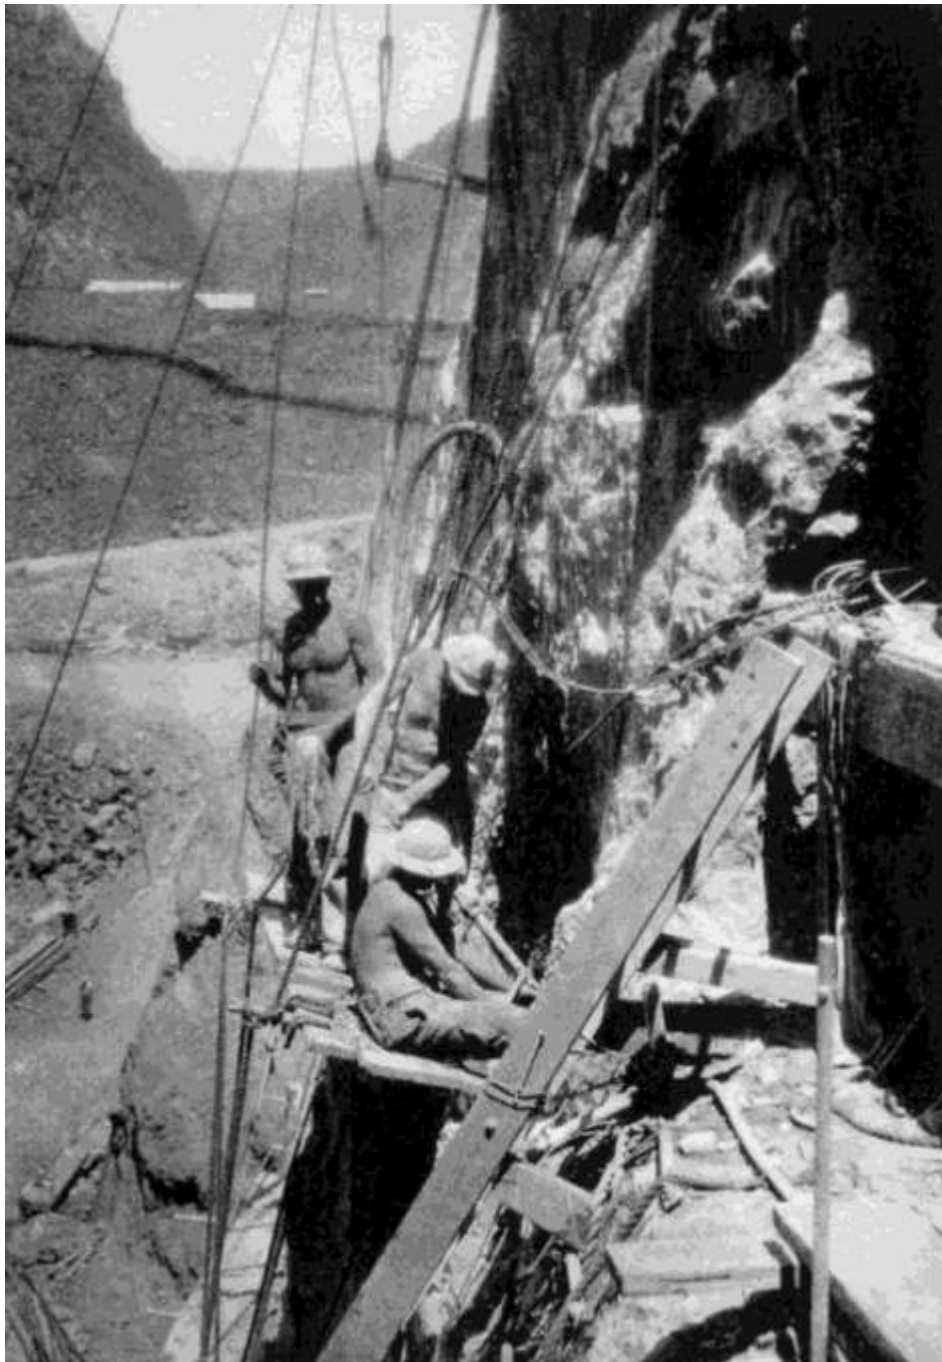
- Foundation grouting was carried out during construction along a *single line* of grout holes
- This shows grouting of fault A-31 in the Arizona abutment, which required 1300 bags of neat cement grout

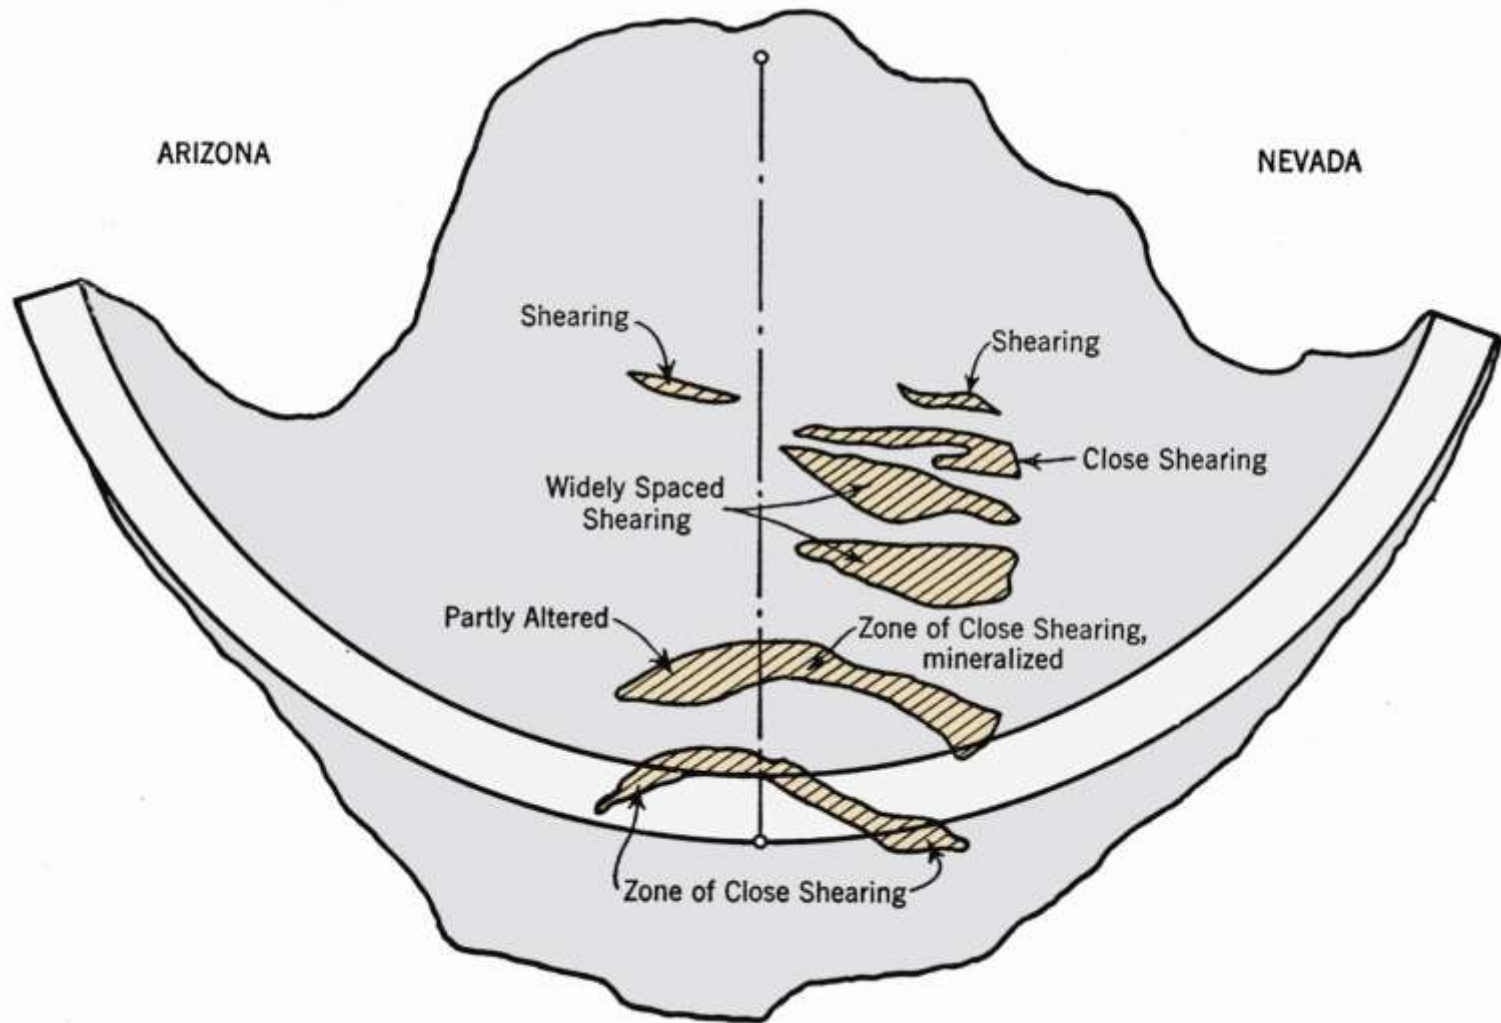
**Manganese-rich gouge zones** discovered in the dam foundation, along faults and shear zones.

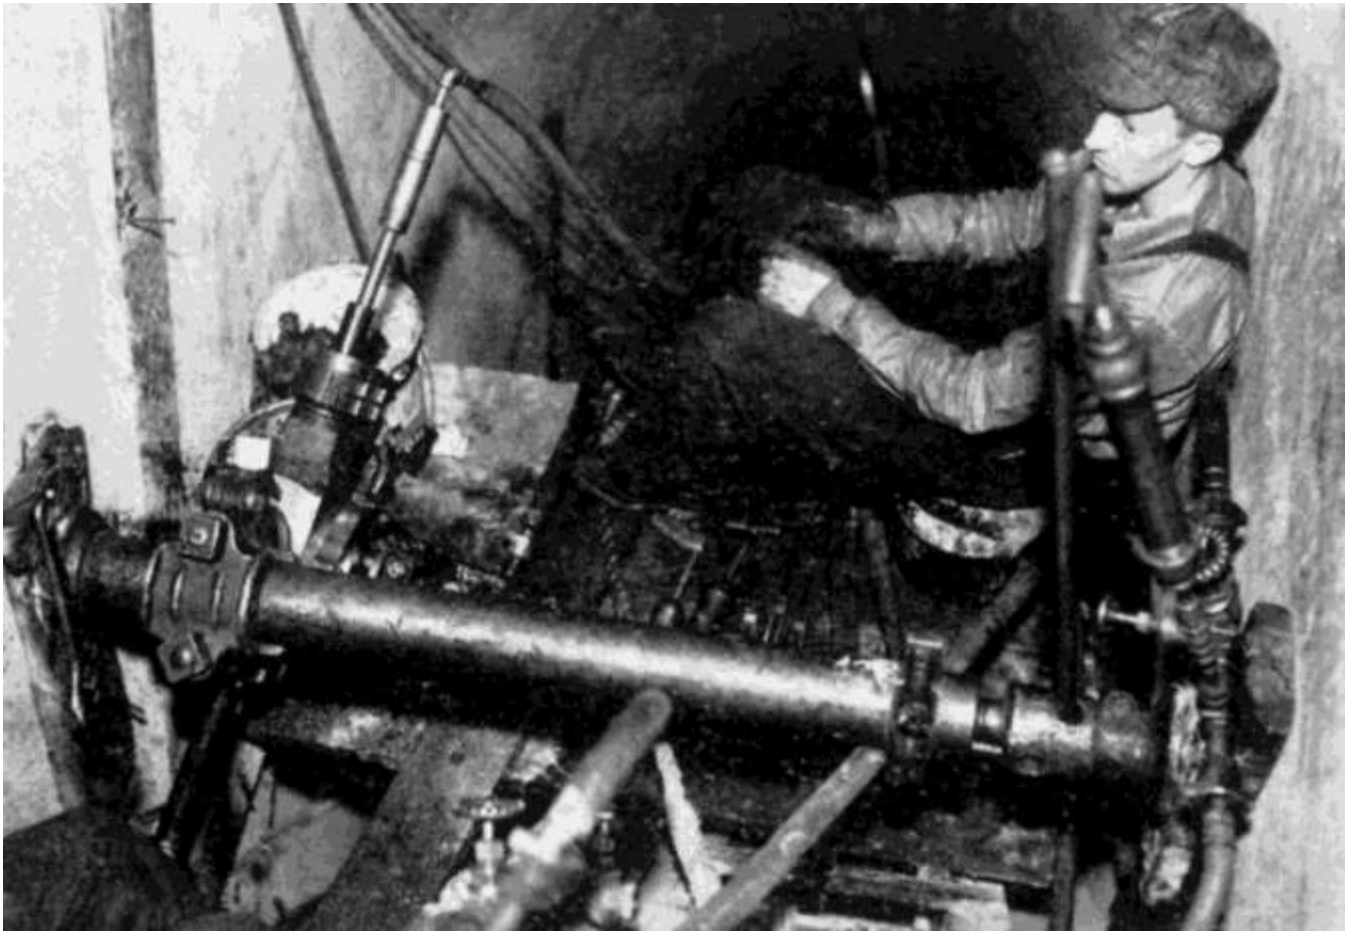
- **Tight working spaces typified the 9 year program of extending the grout curtain, between 1938-47.**
- **During the supplemental drilling program 410,000 linear feet of grout and drainage holes were drilled, and 422,000 cubic feet of grout were injected under pressure. This cost an additional \$3.86 million, about 7% of the dam's cost.**

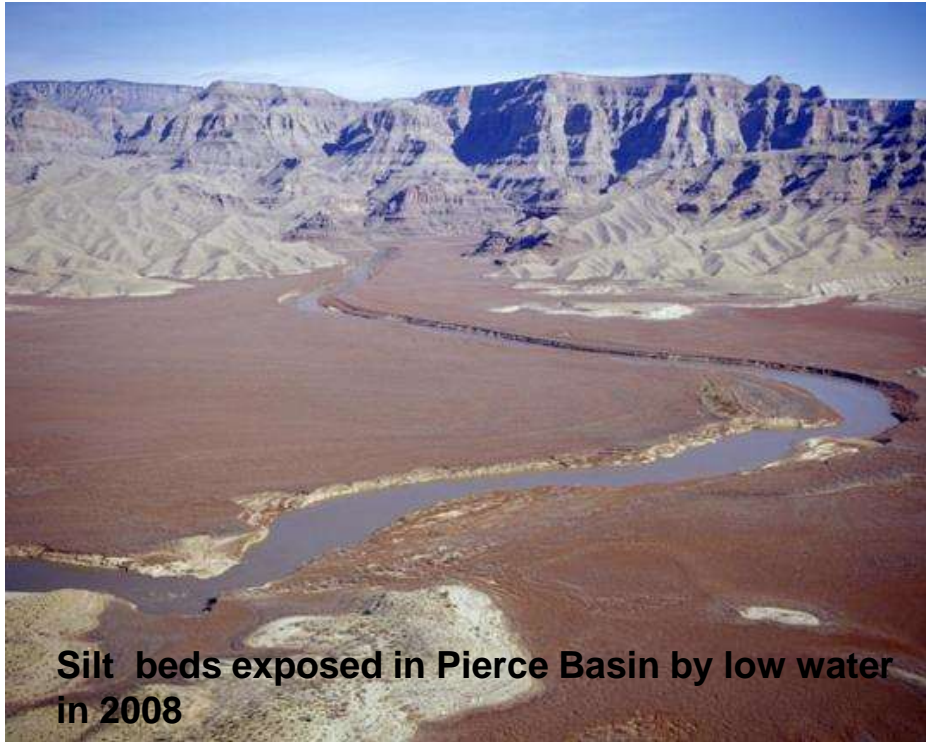
Silt beds exposed in Pierce Basin by low water in 2008
