## **Hoover Dam: Construction Milestones in Concrete Delivery and Placement, Steel Fabrication, and Job Site Safety**

J. David Rogers<sup>1</sup>, Ph.D., P.E., P.G., F. ASCE

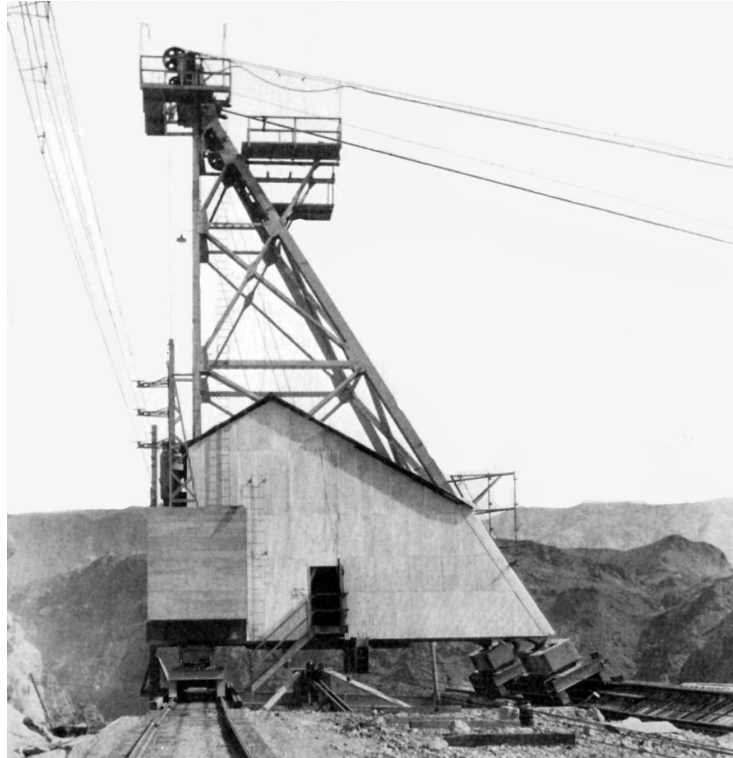
**FIG. 2. One of the 20-ton cableway towers mounted on rails, which allowed it and another similarly configured unit on the opposite canyon wall, to be moved 500 ft up or down the canyon, to facilitate precise placement of the 8-cubic-yard concrete buckets (USBR).**

The system had innumerable advantages insofar that it avoided cumbersome transport across rough or uneven ground and avoided all manner of obstructions, provided the various cableways were aerially separated. Figures 1 through 5 show some of the essential components of the aerial cableway systems employed by Six Companies during construction of Hoover Dam. All but the 150-ton Government Cableway were dismantled after the powerhouse was completed in 1936.

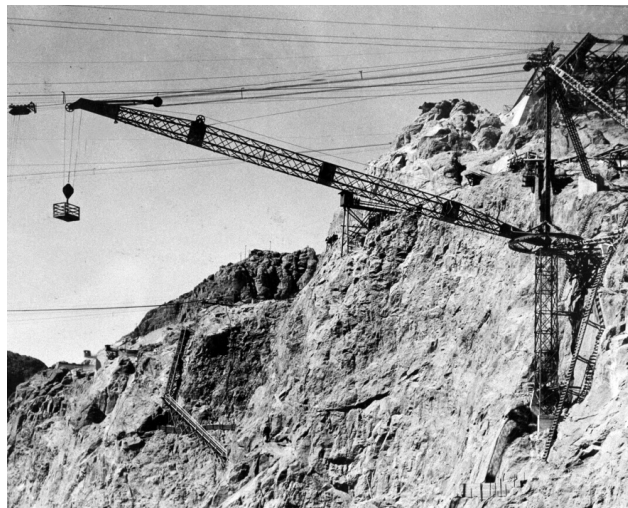
**FIG. 5. Another 20-ton capacity stiff-leg derrick in its precarious perch on the dam's right abutment to continue handling of concrete buckets coming from the Low-Level Mixing Plant after the dam rose 150 ft above the river bed. (USBR)**

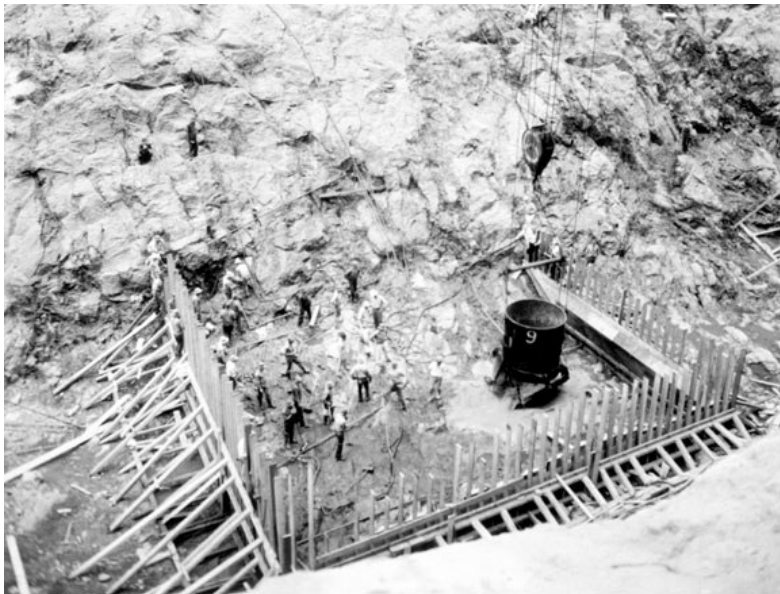
**FIG. 6. Placing the first 8-cubic-yard bucket of concrete on the scrubbed bedrock surface of the inner channel on June 6, 1933. Note batter boards supporting forms. (USBR)**

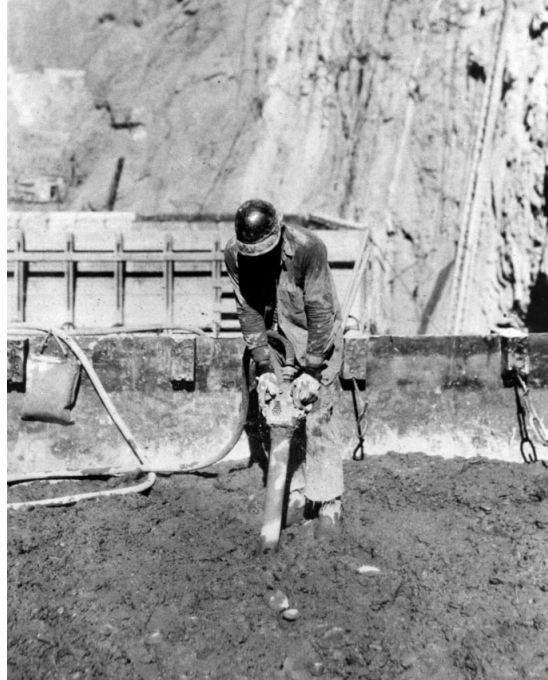
**FIG. 9. Workman using pneumatically powered concrete vibrator to remove some of the entrained air from wet concrete in one of the dam's blocks (USBR).**

Some of the essential elements of the concrete placement for the main dam structure are profiled in Figures 7 through 12, below. The most important aspects were the coordination that had to be maintained between adjacent blocks of the dam, and the working space that became increasingly congested as the dam rose and narrowed. The C-2 and C-5 cableways covered most of the two spillways, the intake towers, and the upstream portion of the dam, while the C-6 to C-7 cableways covered the abutments, which curled downstream. The pivoting C-8 cableway handled demands in the power plants, where a much lower volume of concrete was required for the reinforced concrete framework.

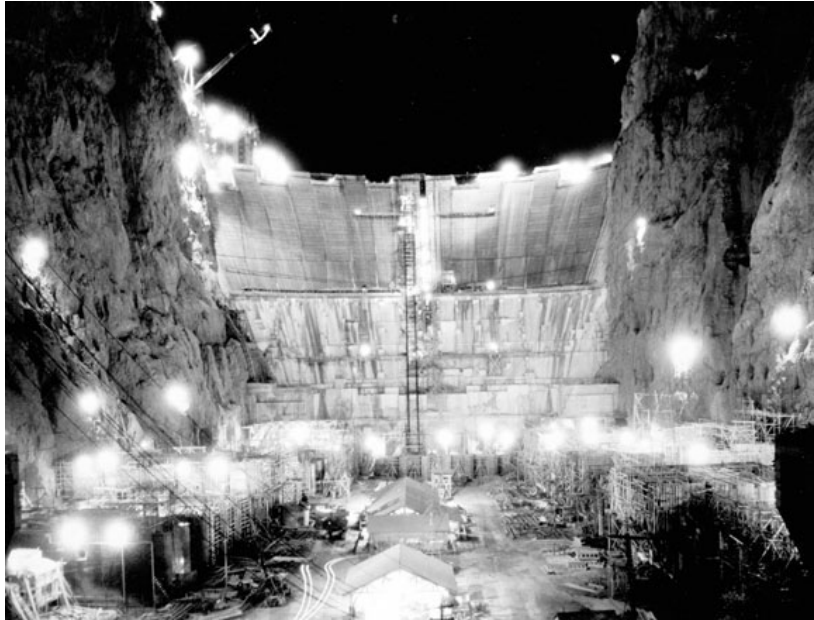
**FIG. 11. Concrete placement was carried out around-the-clock, and the night shifts were a welcome respite during the summer. This time exposure shows the formwork for the powerhouses in the foreground with the dam in the background (USBR).**

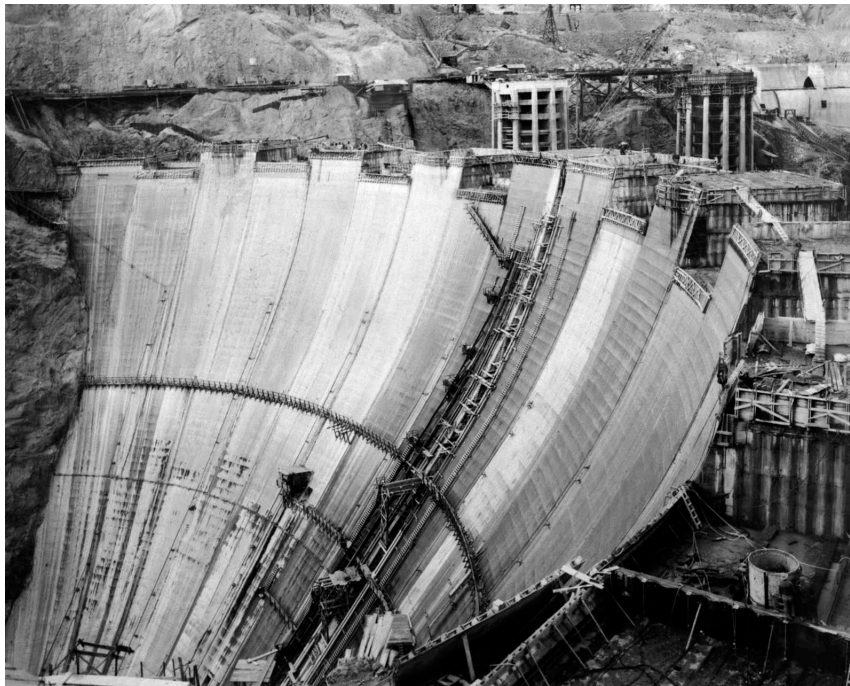
**FIG. 12. Hoover Dam nearing completion, as seen along the downstream face, around New Years 1935. Note the vertical slot at midstream, which was not filled until after cooling water circulation was completed in mid-March 1935 (USBR).**

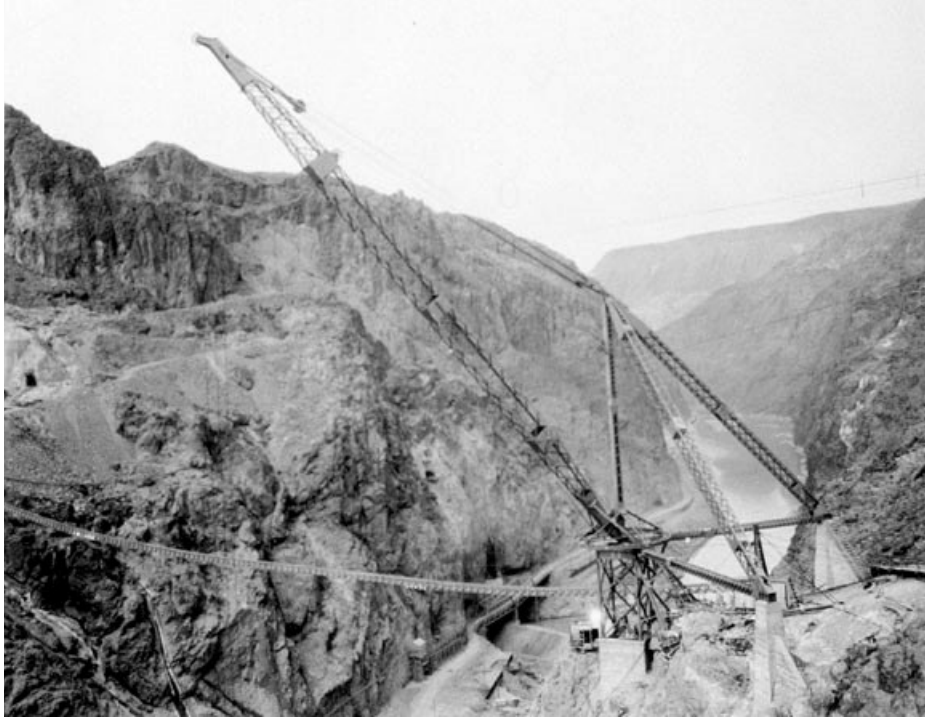
**FIG. 17. Stiff-leg derricks were also erected on the Arizona abutment to place concrete to the Arizona intake towers. Taken on December 27, 1933 (USBR).**

Their positions upstream of the main dam created some access problems that had to be overcome, as shown in Figures 16 and 17. The towers were constructed of high-strength reinforced concrete, using a 5-sack mix, traveling steel forms, and considerable timber falsework (Figure 18), because the towers taper upward.

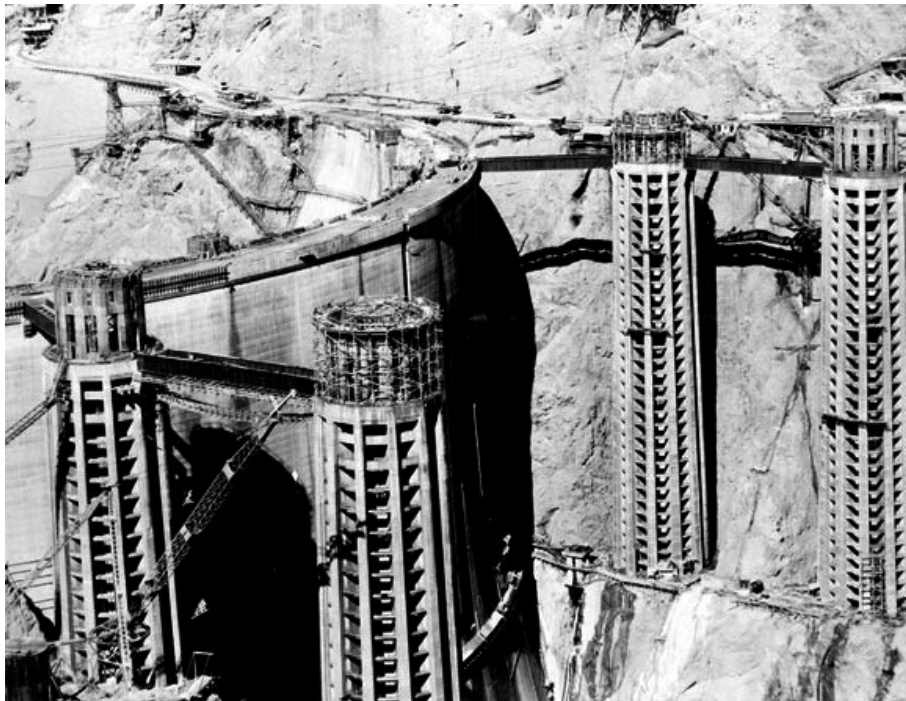
**FIG. 18. Overview of the four intake towers approaching completion, as seen on March 26, 1935. The towers rise above the dam crest and are just under 400 ft high (USBR).**

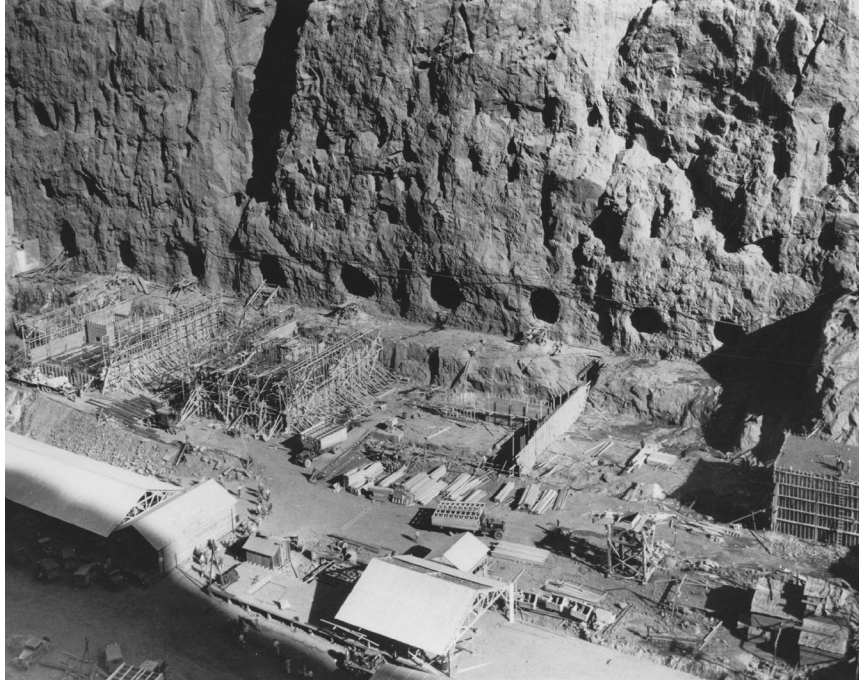
**FIG. 22. Oblique view of the eight 21-foot finished diameter penstock feeder tunnels connecting to the Arizona power house, under construction. The steel penstocks are 11 feet in diameter (USBR).**

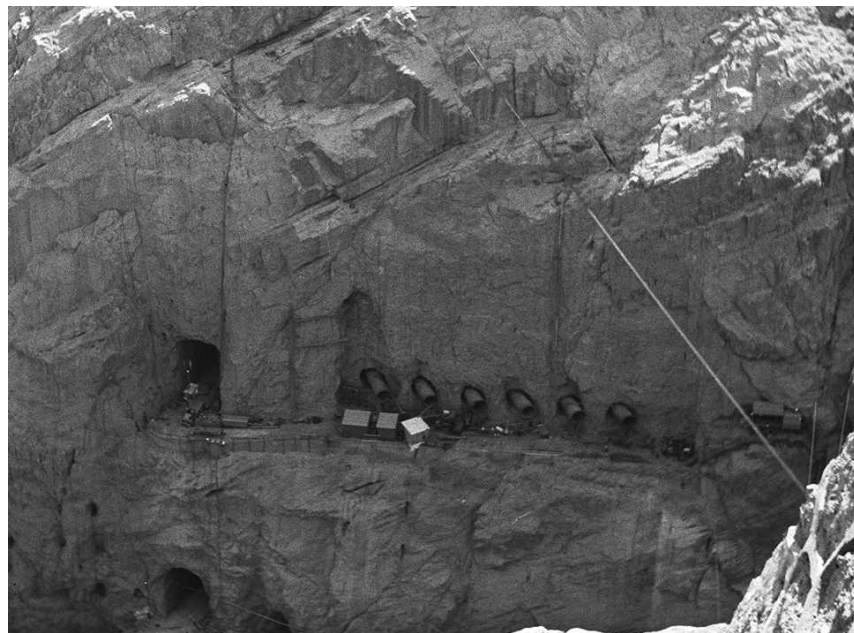
**FIG. 23. Oblique view of the canyon wall valve house outlet works tunnels. The conduits were 7 ft in diameter and the tunnels 11 ft in diameter with a horseshoe shape. These tunnels were lined after the 102-inch-diameter outlet pipes were placed (Preston Collection-Boulder City Library).**

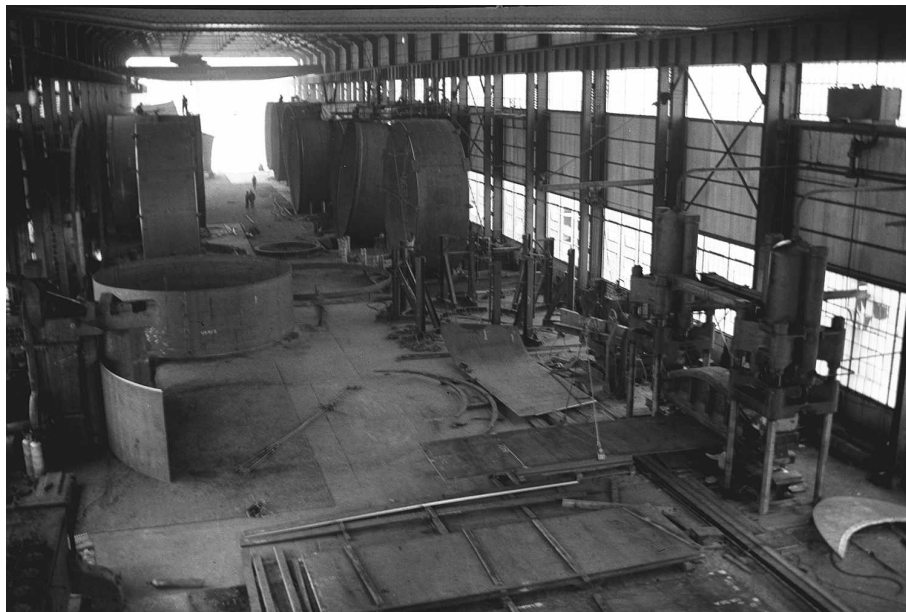
**FIG. 26. 11-foot-long sections of the 37-foot-diameter penstocks being bent and conjoined by arc-welding inside the Babcock & Wilcox Steel Fabrication Plant (Preston Collection-Boulder City Library).**

because the components were too large to transport by truck or by rail (Figures 25 and 26). The plant fabricated the required shapes from steel plate that varied between 5/8 inch and 2-3/4 inches in thickness. Penstock sections were fabricated in 11-foot-long sections, and adjoining sections were then attached to create 22-foot-long assemblies that could be transported the 1.6 miles to the dam site, as shown in Figure 27. 16,000 lineal feet of steel penstocks were fabricated at this plant, more than had ever been fabricated for any other dam up to that time (USBR, 1938).

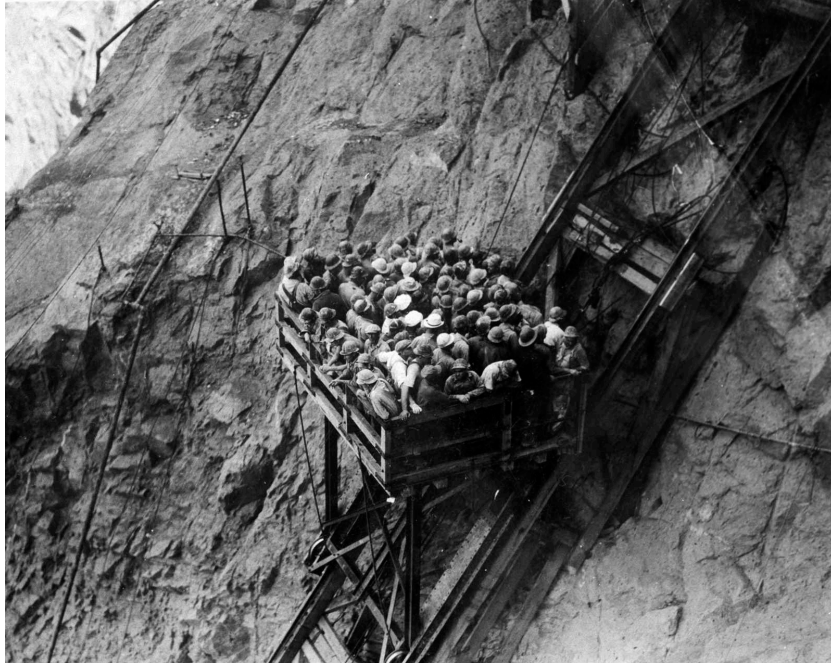
**FIG. 29. 80 men being taken down the 10 by 12 ft skiff on the Nevada Abutment, heading to work on the 4 PM to Midnight swing shift. The skiff made the 565 ft trip in just over a minute (USBR).**

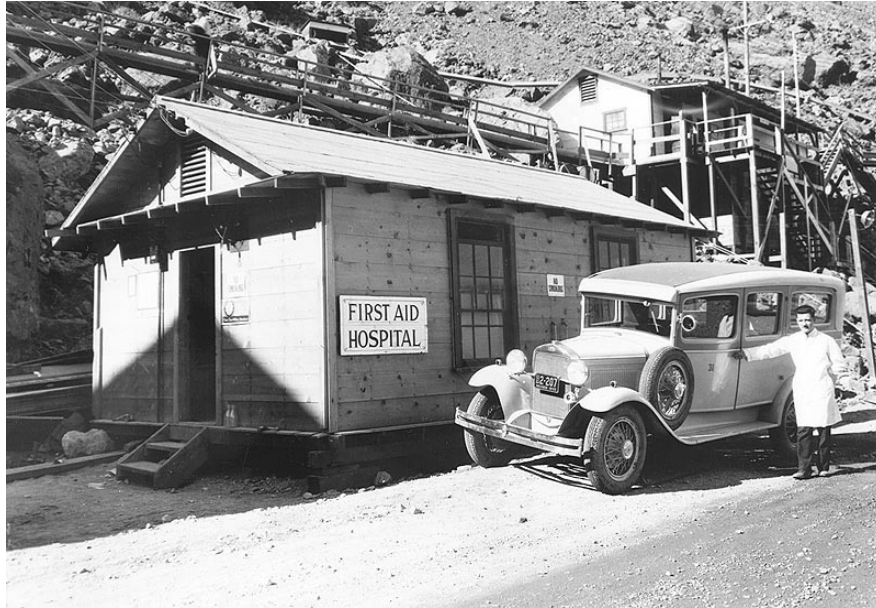
**FIG. 31. One of the medical dispensaries positioned on the job site after the deaths of more than a dozen men working in the diversion tunnels without forced-air ventilation. These were equipped with a doctor, nurse, ambulance, and driver (USBR).**

In total, 21,000 men worked on the dam over a four year period, with the workforce averaging 3,500 employees. At its zenith 5,218 men were on Six Companies payroll during June 1934. The labor troubles always stemmed from a job site safety problem of one kind or another, and Six Companies General Superintendent Frank Crowe was obliged to make whatever adjustments he could to keep the job moving and thereby appear concerned about the worker's safety (Hiltzik, 2010). These concessions included provision of potable water for the worker's dormitories, the hiring orderlies to carry ice water to workers on the job (Figure 28), transporting and feeding the workers using three shifts per day (Figures 29 and 30), establishing first aid stations with doctors and nurses closer on the job site instead of nine miles away at the Boulder City dispensary (Figure 31), and encouraging job site safety and security (Figure 32).

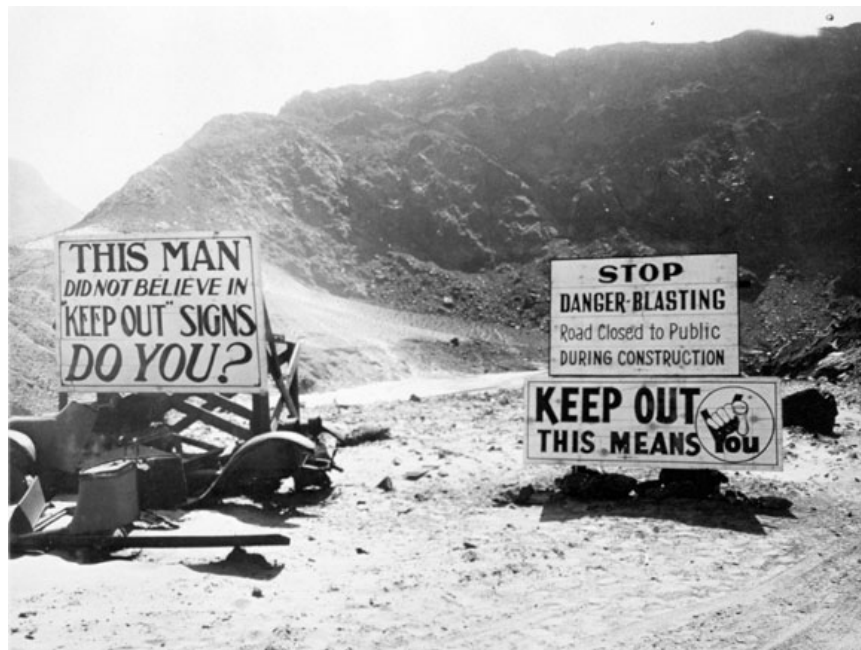
**FIG. 32. As the job progressed, increasing attention was paid to safety and security after accidents or carelessness had taken the lives of workers. These signs appeared after an accident involving a driver who failed to yield to one of the between-shift blasts in 1933 (USBR).**

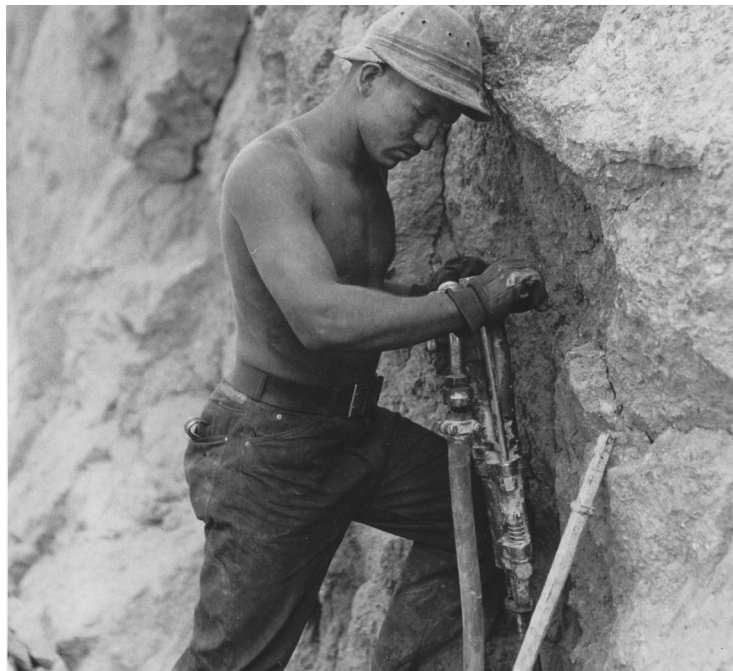
**FIG. 33. One of the high scalers at Hoover Dam wearing a home-made ‘hard-boiled hat’ fashioned by overlapping two baseball caps and dipping them in tar and chilling or brushing leather hats with shellac (USBR).**

In the fall of 1931 some of the high scalers working on the cliffs began fashioning “hard boiled” work hats by overlapping two baseball caps with bills front and back, then dipping it to form a thin layer of tar and quenching it with cold water, to create a hard shell (Figure 33). Others used shellac applied to leather hats. Six Companies liked this idea so much, they eventually contracted for thousands of these so-called ‘hard hats,’ from a number of different suppliers, including the E.D. Bullard Company in Sausalito, California.

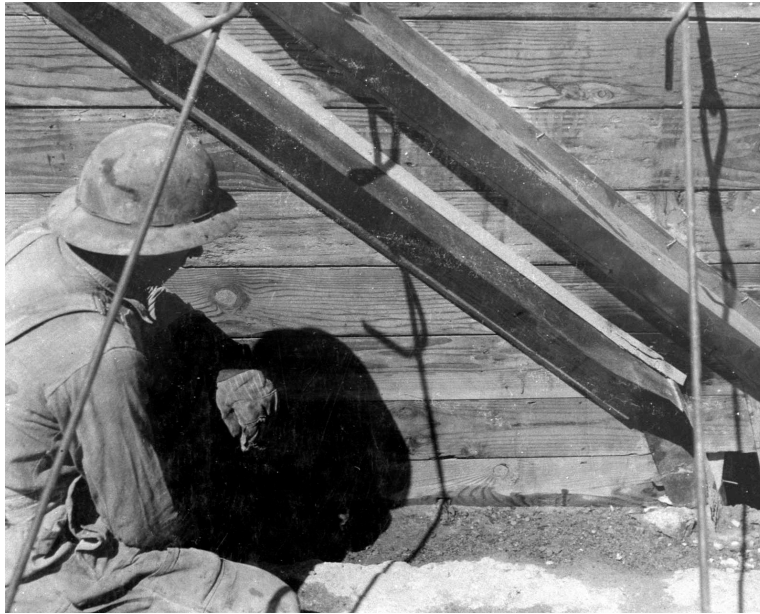
**FIG. 34. Six Companies worker wearing one of the mass-produced hard hats they issued free-of-charge to their workers, encouraging them to wear them wherever loose materials might fall upon them. They purchased five different kinds of hard hats, from different suppliers/manufacturers (USBR).**

Six Companies stopped short of requiring the hats be worn, because of the oppressive heat, but issued them to each worker and suggested strongly that men wear them when working in exposed areas, where loose materials could fall on them (Pettitt, 1935). A large proportion of the men working in exposed areas began wearing the hard hats, as shown in Figure 34. Sadly, the most deadly of these falling projectiles were not loose rocks, but tools dropped by other workmen! Hand tools were so crucial to the work at hand that at one point on the job Frank Crowe actually ordered 144,000 crescent wrenches (Stevens, 1988).
