PART 2

THE MISSISSIPPI RIVER AND TRIBUTARIES PROJECT 1928-1973

The Corps' Mississippi River and Tributaries Project - 1928

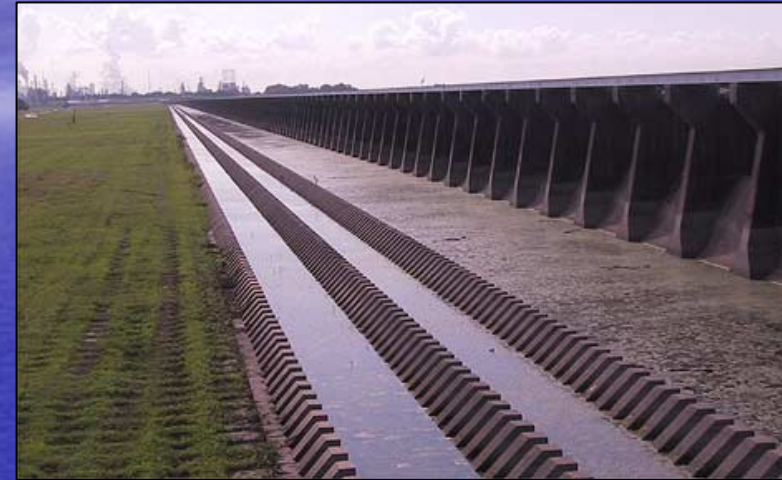
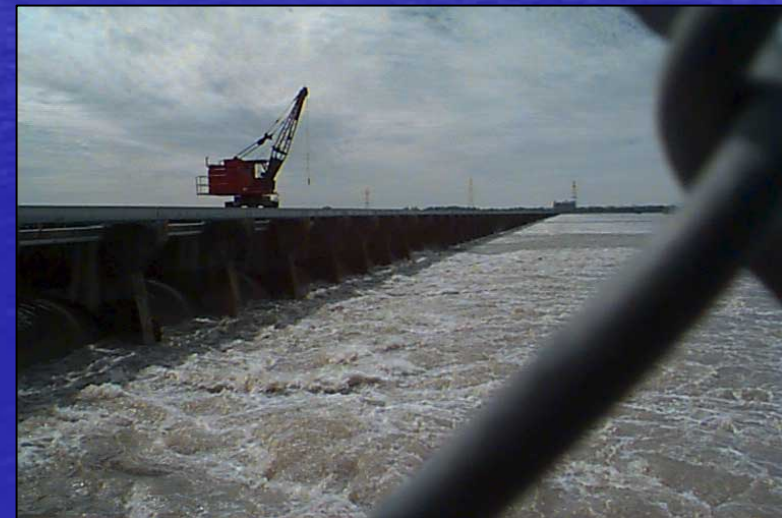
Bonnet Carre Spillway Bypass

Intended to protect New Orleans from a Mississippi River flood

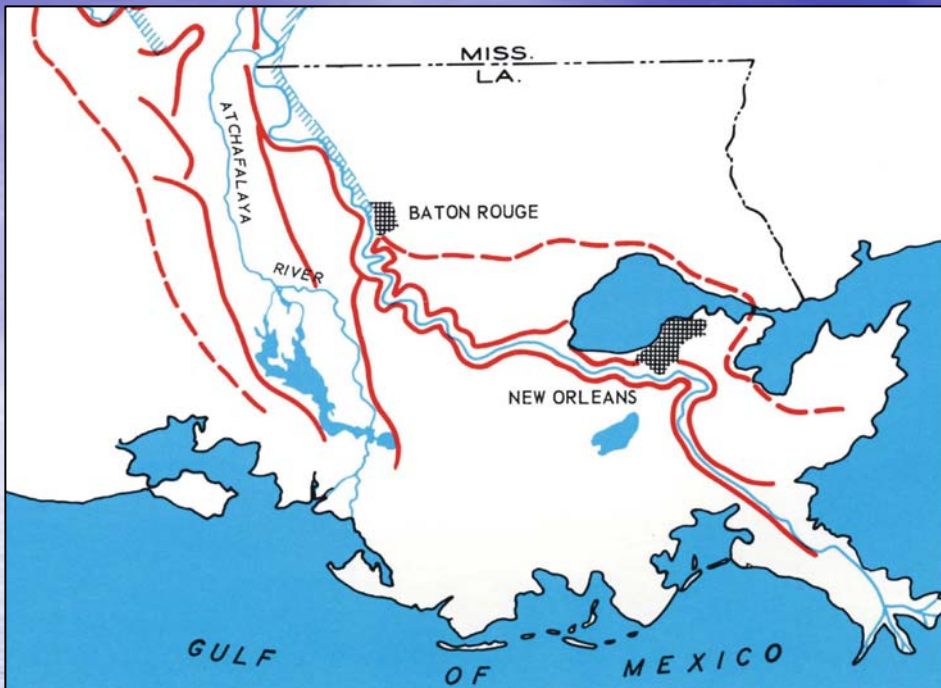
The Atchafalaya River is both steeper than the Mississippi (3:1 ratio in bed slope) and shorter (225 kilometers to the Gulf of Mexico from the

Red River entrance versus 480 kilometers for the Mississippi).

- Under natural conditions, the Mississippi River would probably have switched its course to the Gulf of Mexico via the Atchafalaya distributary between 1965 and 1975, if not for the levees.
- The Atchafalaya now drains about 30% of the combined flows of the Mississippi and Red rivers to the Gulf of Mexico.

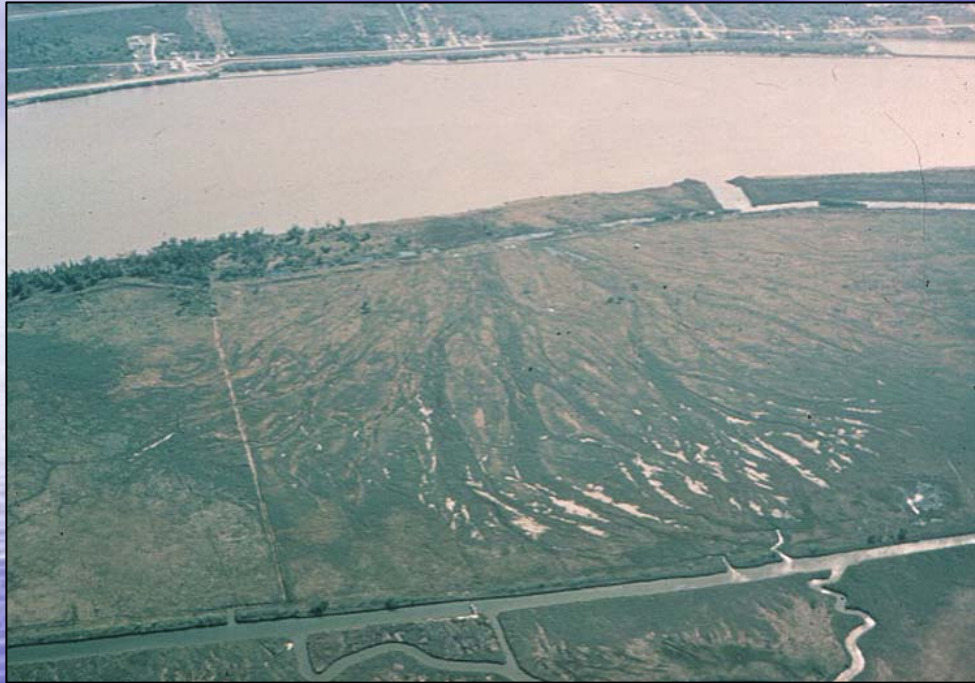
Natural crevasses beneath levees

Crevasses are sand filled distributary channels that form at high flow, and lie beneath earthen levees like ticking time bombs, waiting to explode.

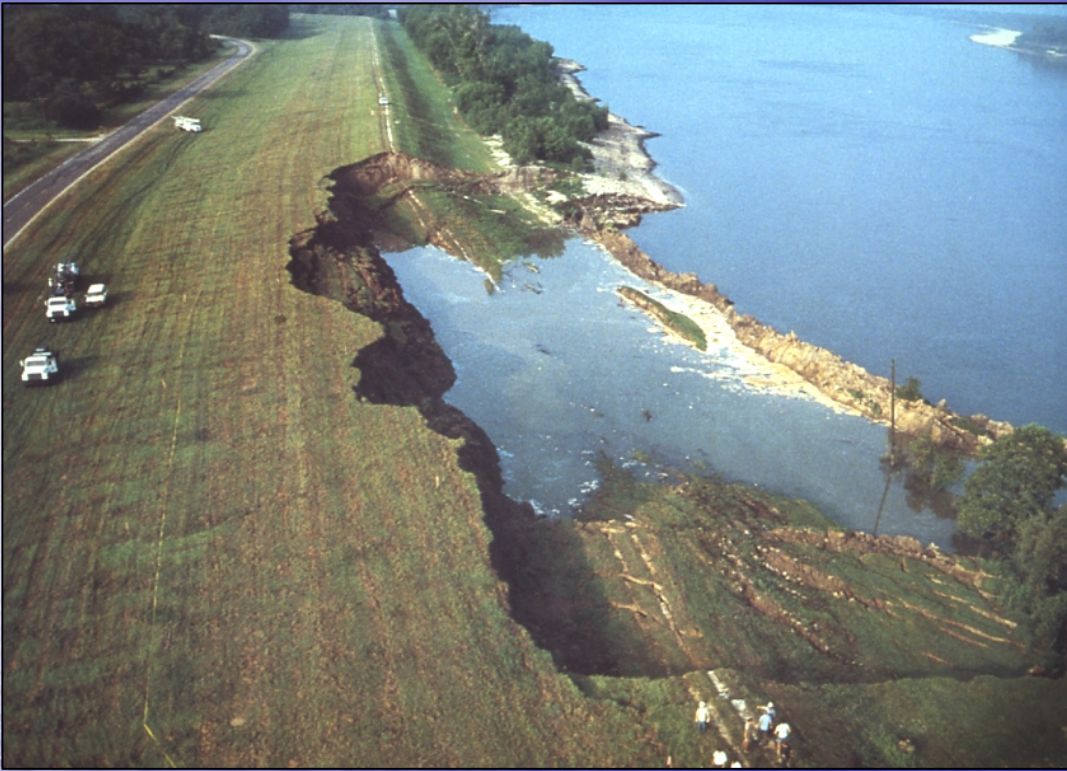
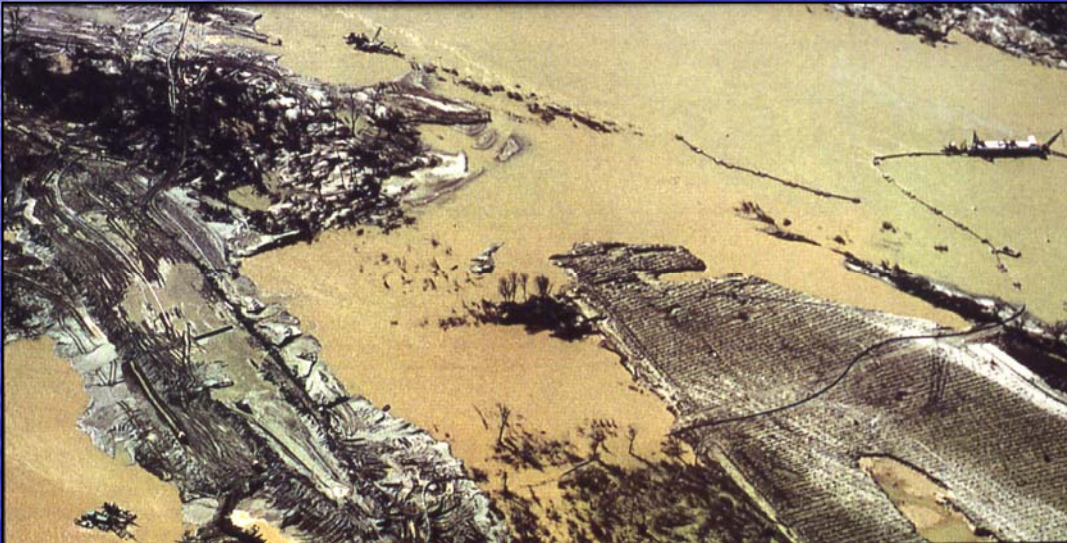
Levee Failures

- Levees tend to fail during sustained high flow events because of underseepage problems, toe scour, and overtopping

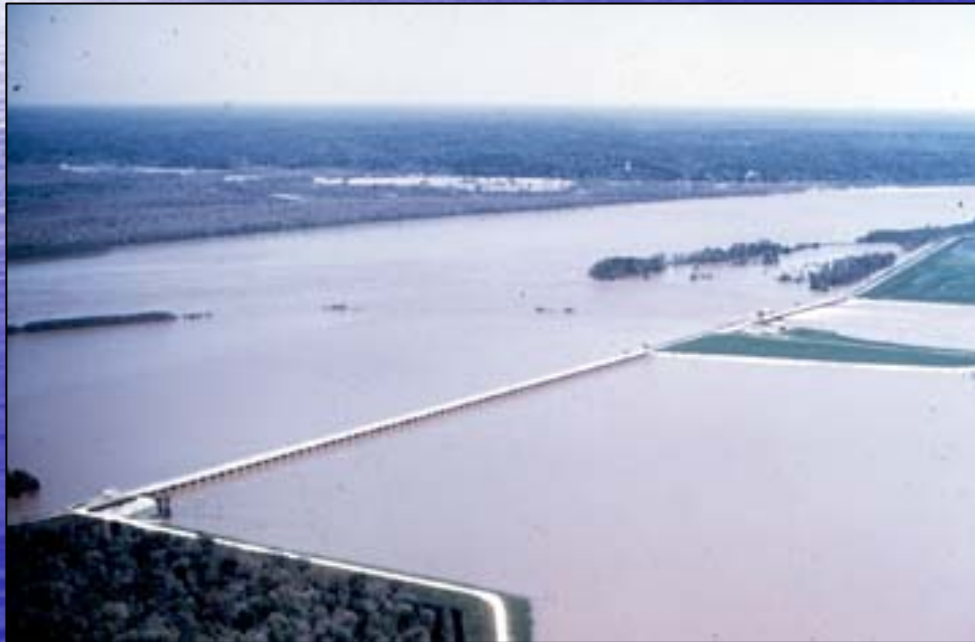
- The Corps of Engineers came perilously close to losing the Old River Diversion structure connecting to the Atchafalaya Bypass during the 1973 flood. Its capacity was doubled afterward.

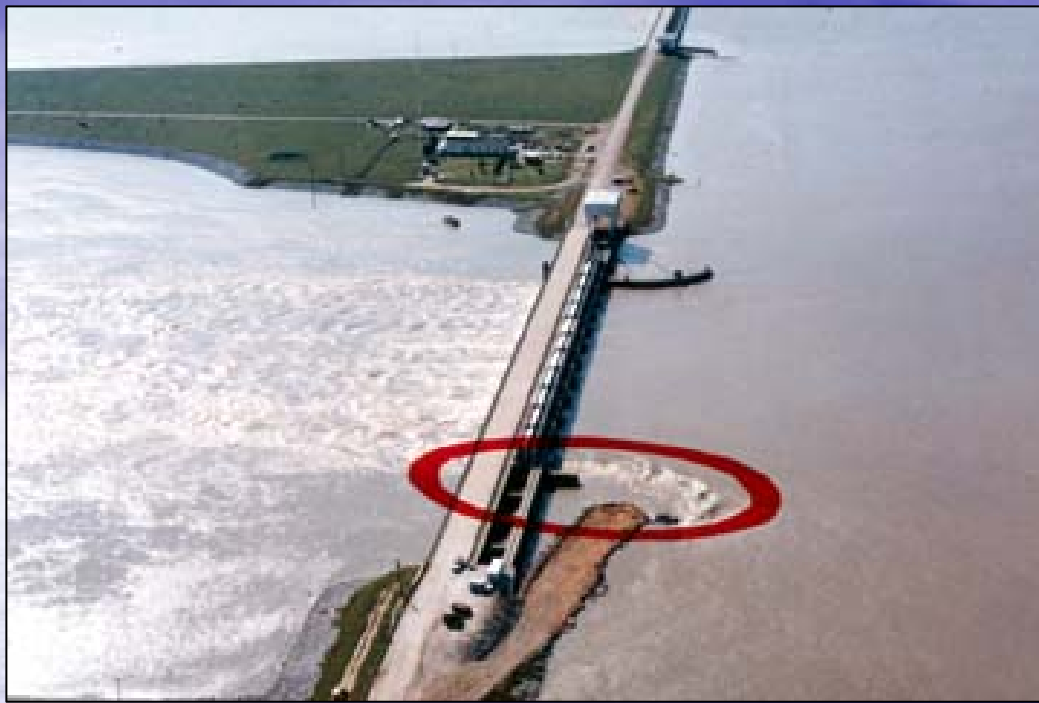
Collapsed Wing Wall on Old River Diversion Structure

- Scour cavities developed on both sides of the Low Sill Diversion Structure during the Flood of 1973.
- If these scour holes had conjoined, the structure would have failed, and a new Mississippi River channel would have been carved down the Atchafalaya River to the Gulf of Mexico.

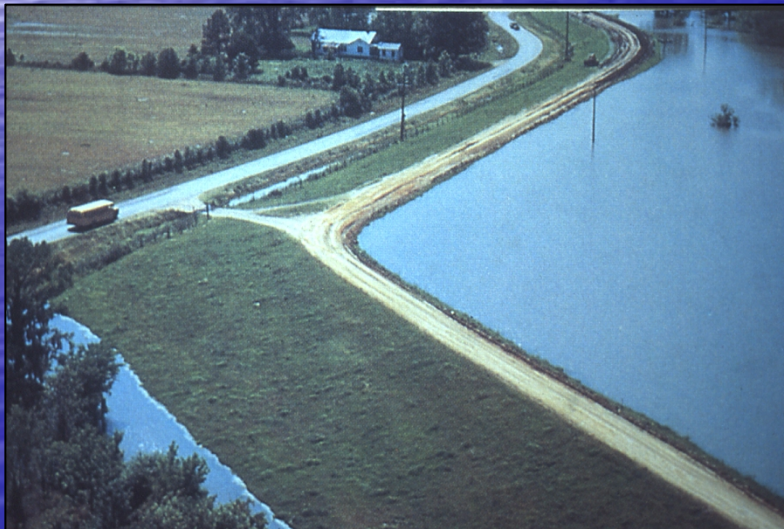
Levees still needed to be raised

- Typical levee cross section in New Orleans area
- Louisiana levee topped out during the record 1973 flood

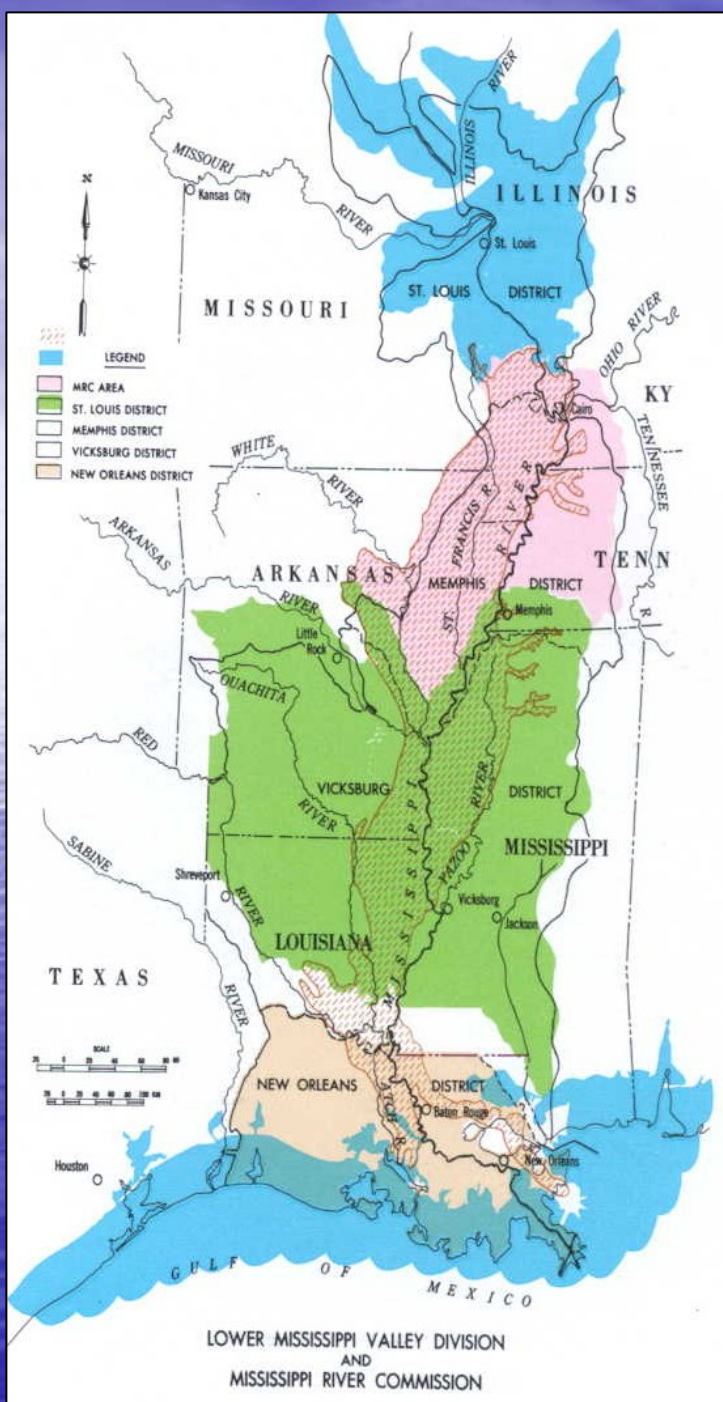
- O & M is handled by the respective Corps of Engineers Districts located along the Mississippi River Valley, shown here.
- The district's O&M budgets have been slashed to nothing in recent years, due to shifting Federal budget shortfalls
