Historical Background on the New Orleans Levee System

J. David Rogers, Ph.D., P.E., P.G.

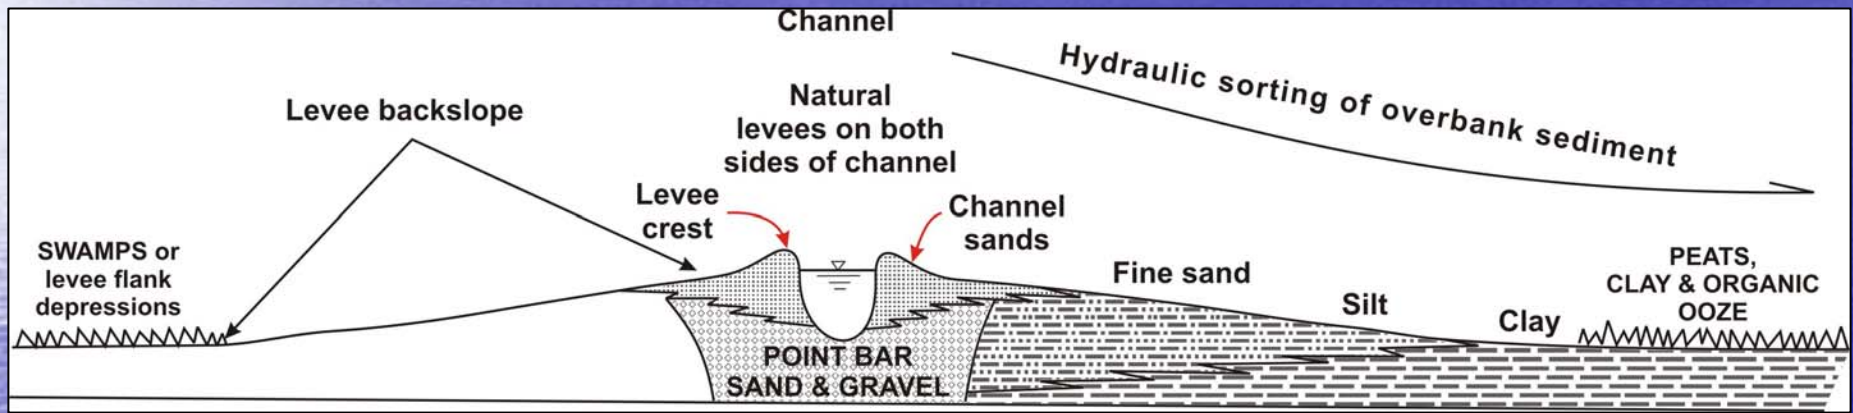
- Typical cross section through the sandy bank levees of the Mississippi River, illustrating how the river's **main channel lies above the surrounding flood plain**, which were poorly drained swamp lands prior to reclamation.
- There is significant **hydraulic sorting** of materials deposited on either side of these levees, as sketched below.

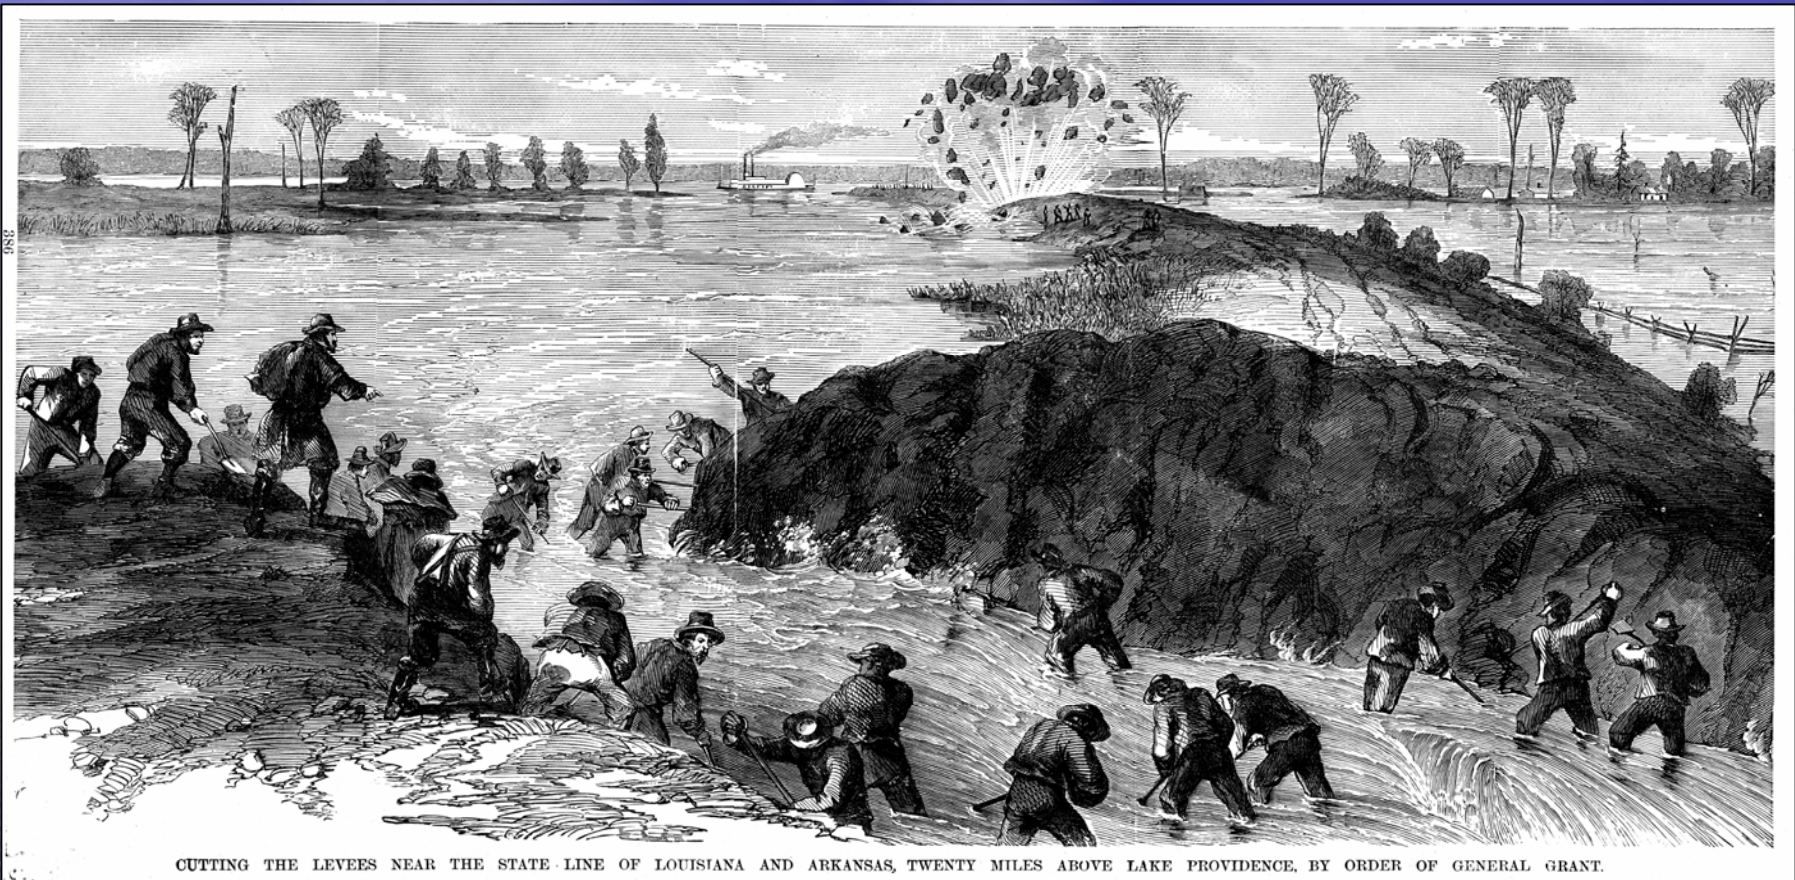
- Union forces cutting the levee near the state line of Louisiana and Arkansas, 20 miles above Lake Providence during the Civil War.
- Levees constructed of **cohesive clay** were found to be the most resilient, but those constructed of other materials, such as overbank silt, peat, or organic ooze were easily eroded.

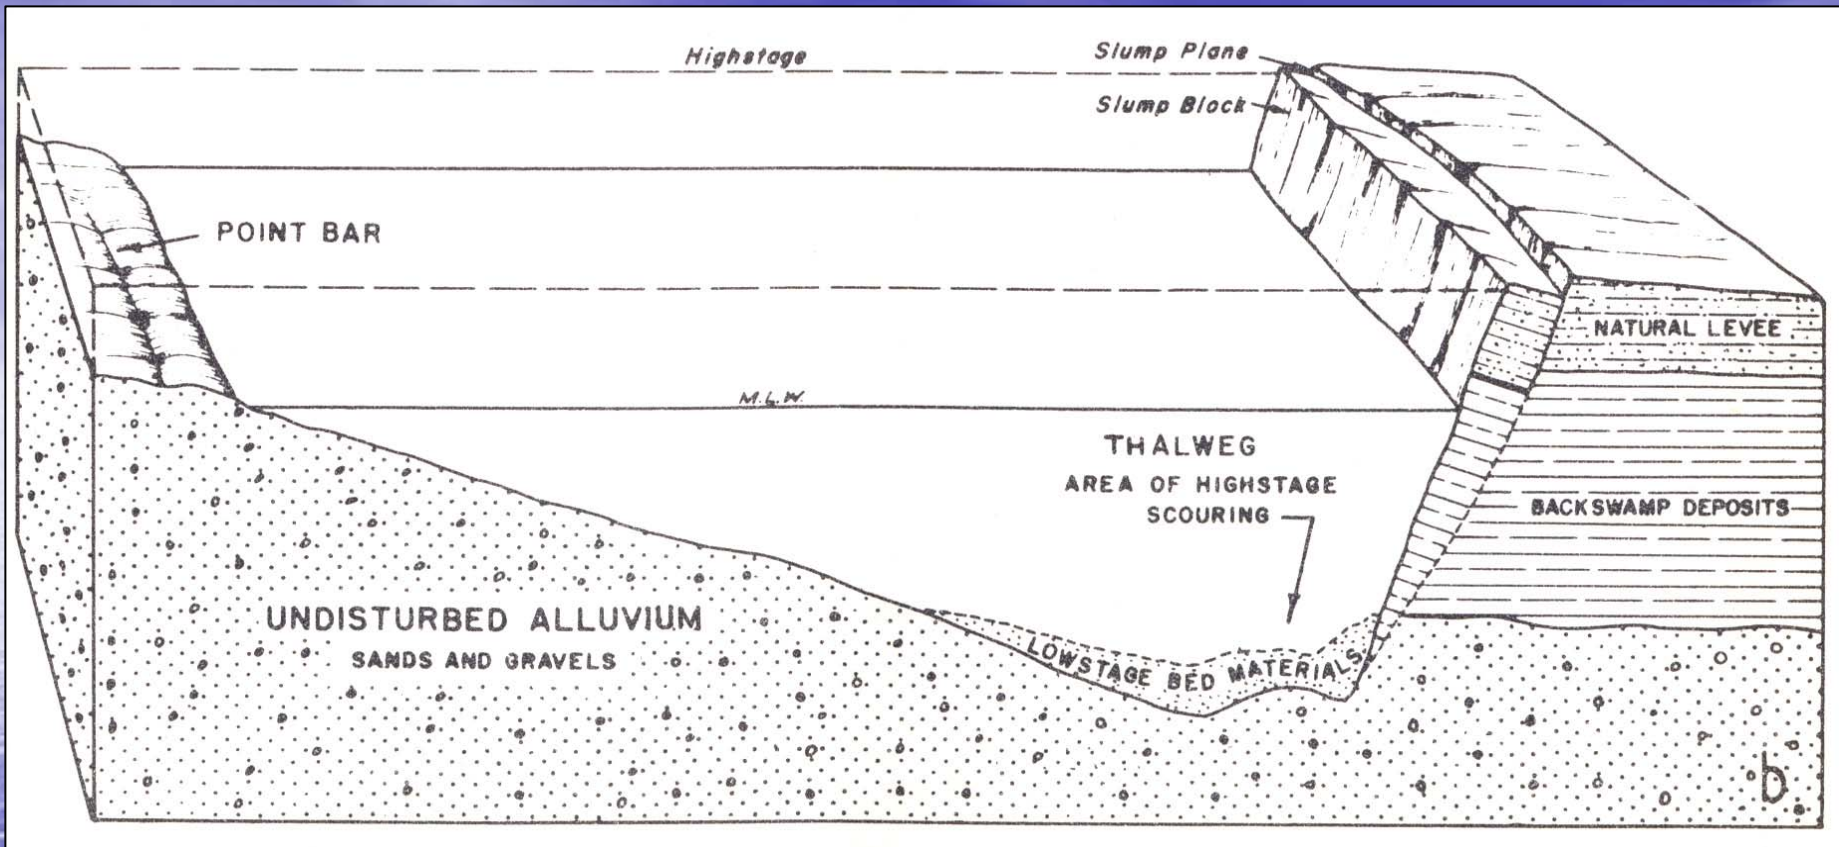
- **Asymmetric channel cross section** typical of the Mississippi River, showing slumping of the oversteepened banks on the outside of its turns and the relative position of the river's thalweg, the line connecting the lowest points along the bed of the river. River mileage is measured along the thalweg, not along the river centerline, because this line more accurately describes the actual flow path (from Fisk, 1952).

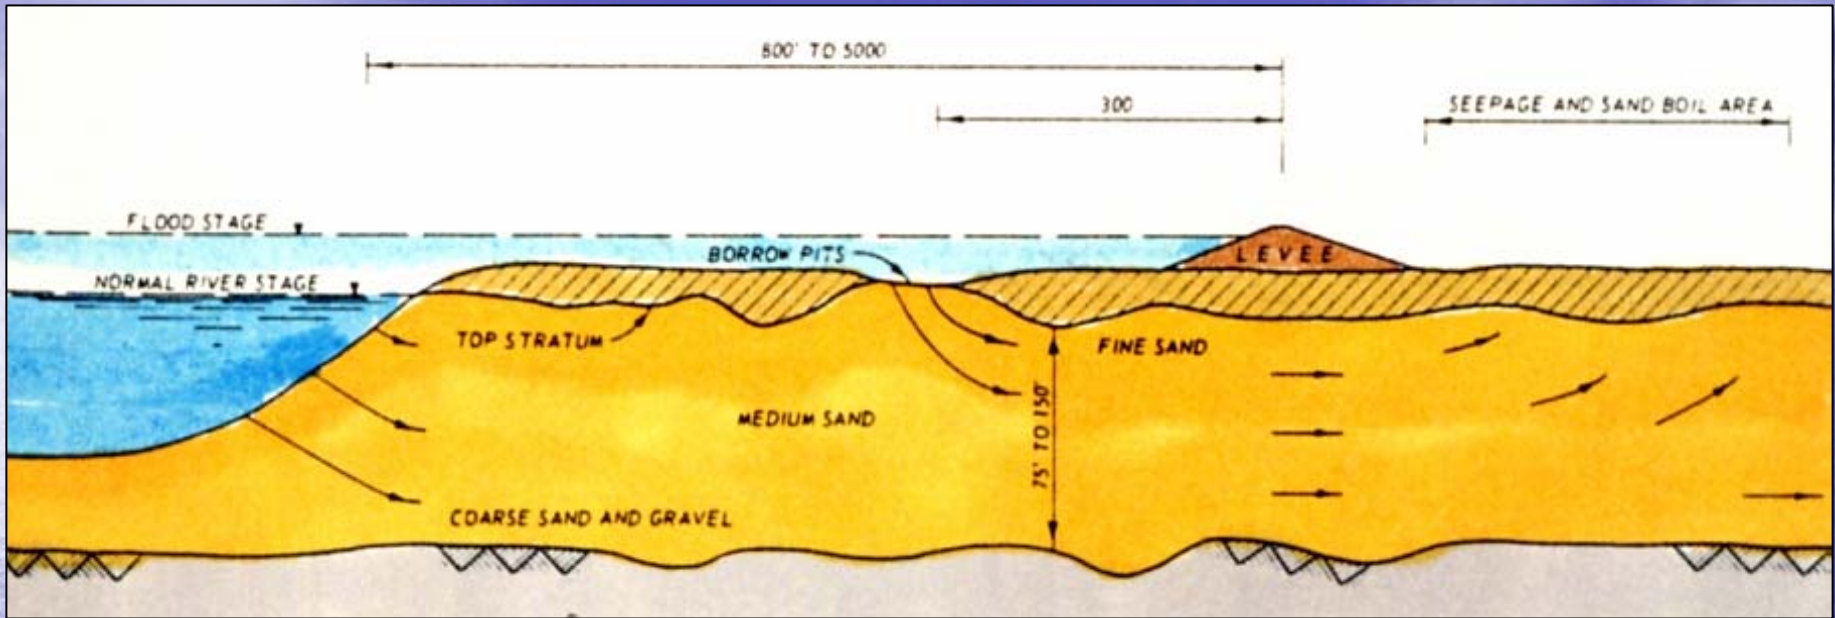
- Cross section through a **typical Corps of Engineers levee in an alluvial valley** (from Mansur and Kaufman, 1956).
- Analyses of levee stability depend in large measure on various **assumptions made about seepage conditions** beneath and adjacent to such structures.
- For instance, the coarse sand and gravel shown here may be 1000x more permeable than the overlying medium sand.

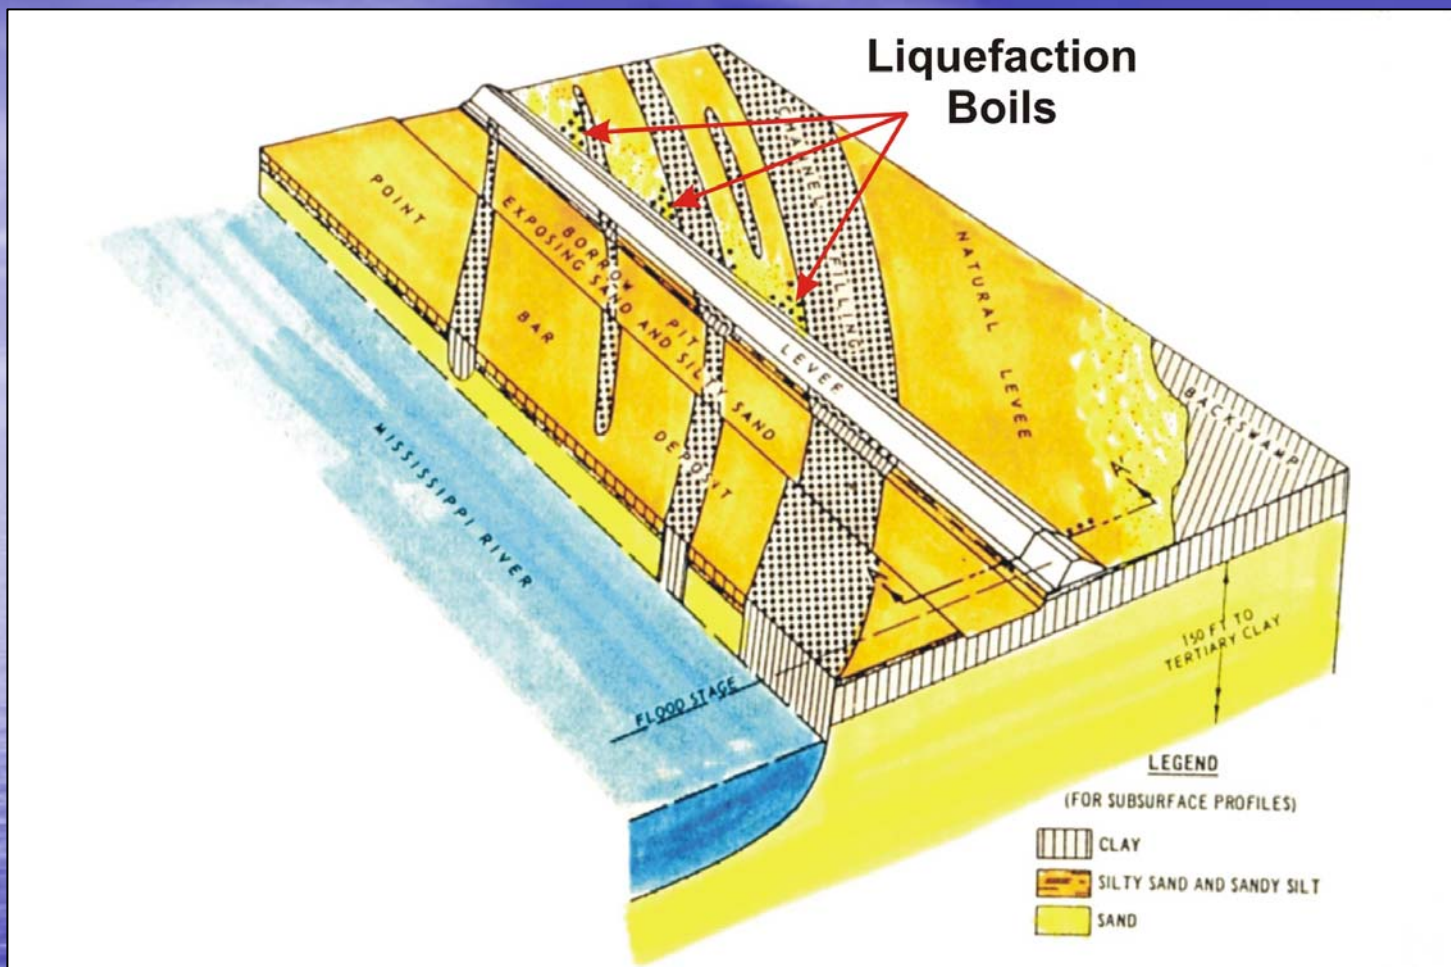
- A major problem with man-made levees constructed during the MR&T Project is that they are necessarily **constructed upon highly heterogeneous foundations**, as portrayed here (taken from Kolb, 1976).
- The **sharp contrast** between highly organic channel fills (stippled zones) and natural levee sands and gravelly point bars promotes dangerous concentrations of seepage and differential settlement.

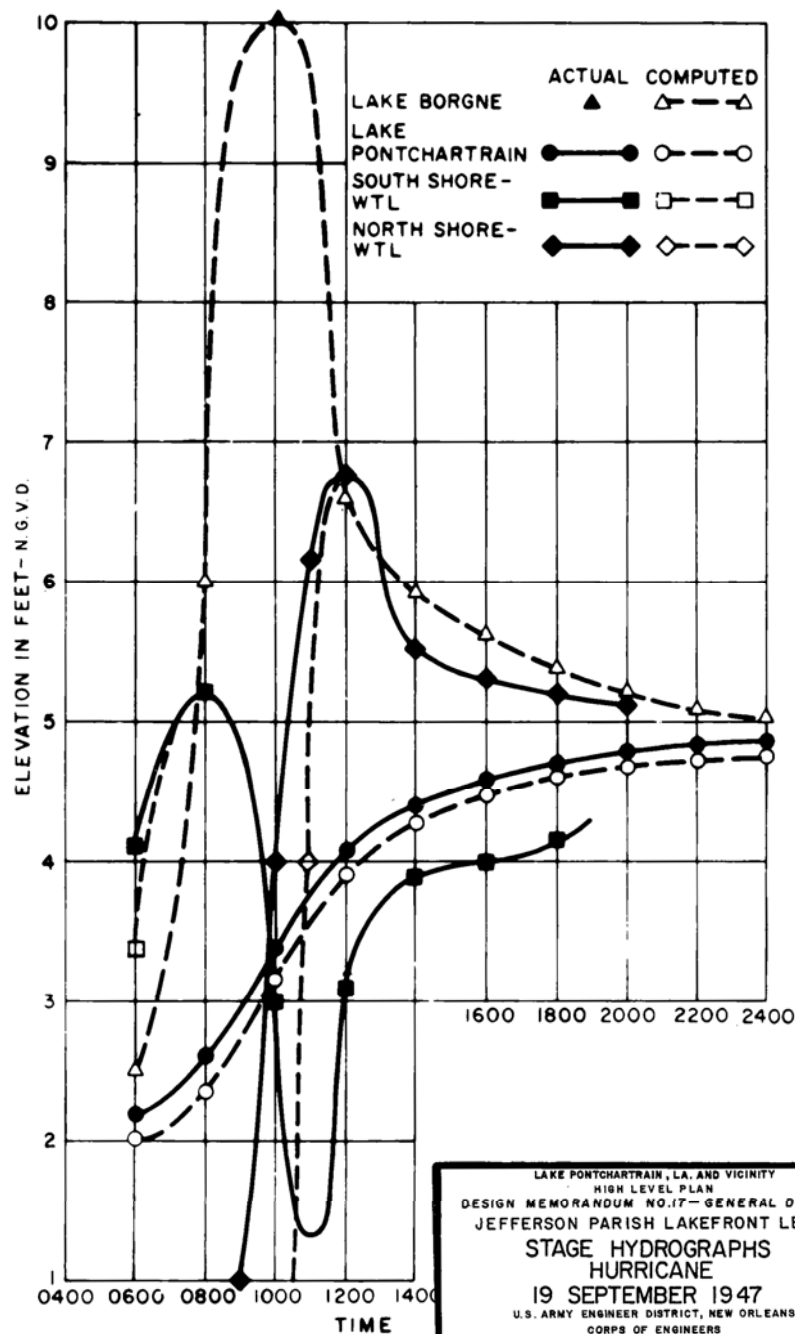
LAKE PONTCHARTRAIN, LA. AND VICINITY
 HIGH LEVEL PLAN
 DESIGN MEMORANDUM NO. 17 - GENERAL DESIGN
 JEFFERSON PARISH LAKEFRONT LEVEE
 STAGE HYDROGRAPHS
 HURRICANE
 19 SEPTEMBER 1947
 U.S. ARMY ENGINEER DISTRICT, NEW ORLEANS
 CORPS OF ENGINEERS

- Stage hydrographs on Lakes Borgne and Pontchartrain from the **September 1947 hurricane**.
- The **10 foot surge** on **Lake Borgne** was the highest recorded value up to that time, though short-lived.
- A **13 foot surge** was reported along **Lake Pontchartrain** during the 1915 Grand Isle Hurricane (before storm surge recorders were emplaced).

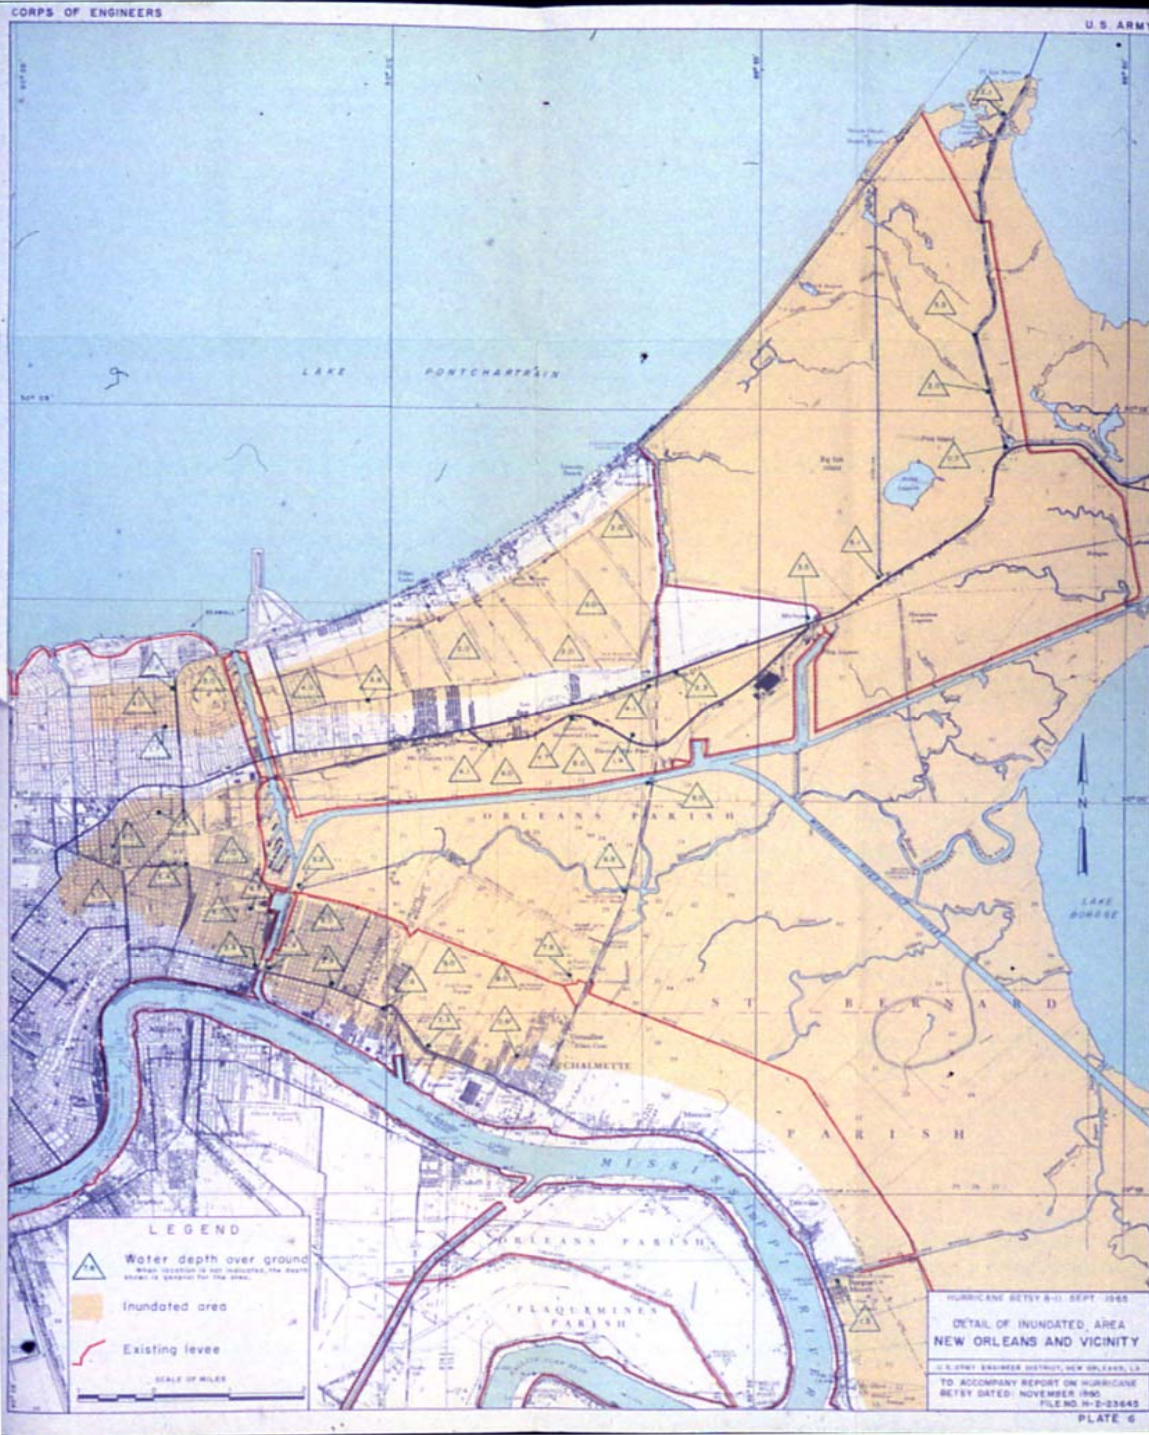
- Portion of the flood inundation map from **Hurricane Betsy in 1965**, showing the areas on either side of the Inner Harbor Navigation Channel which were affected by overtopping, from storm surges on Lakes Borgne and Pontchartrain.

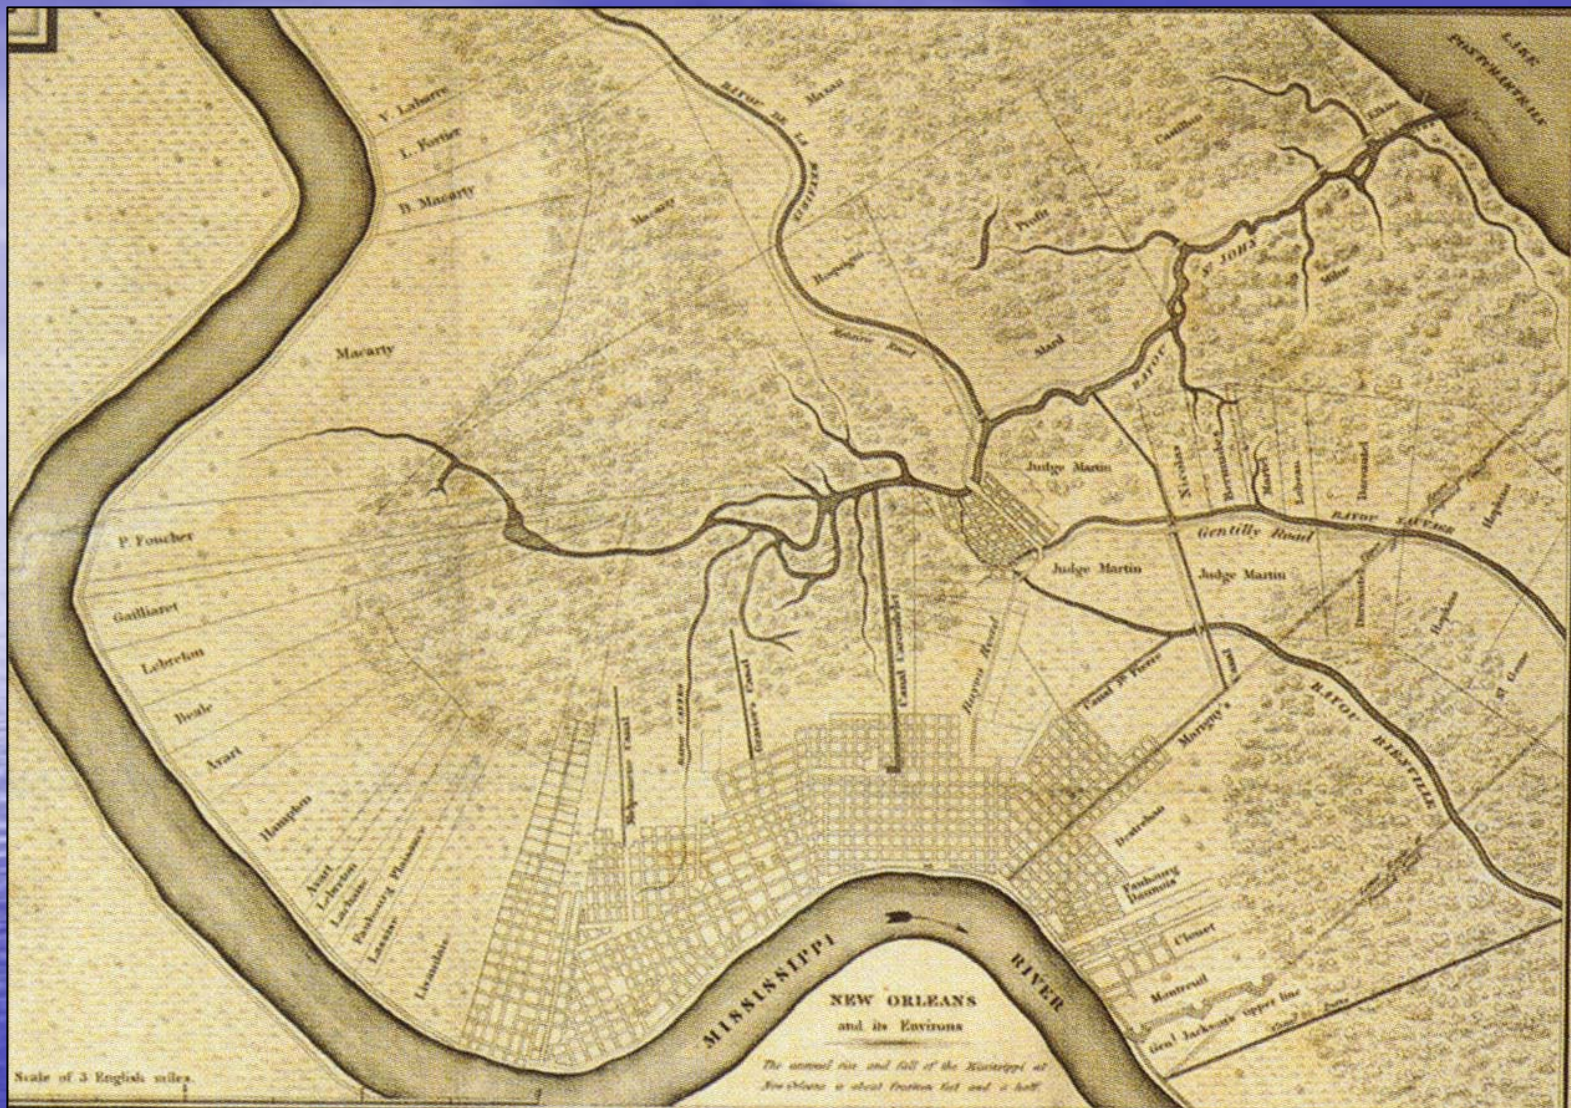
- Plan of the City of New Orleans prepared by Francis Ogden in 1829. Note the linear drainage canals feeding into Bayou St. John, thence into Lake Pontchartrain.

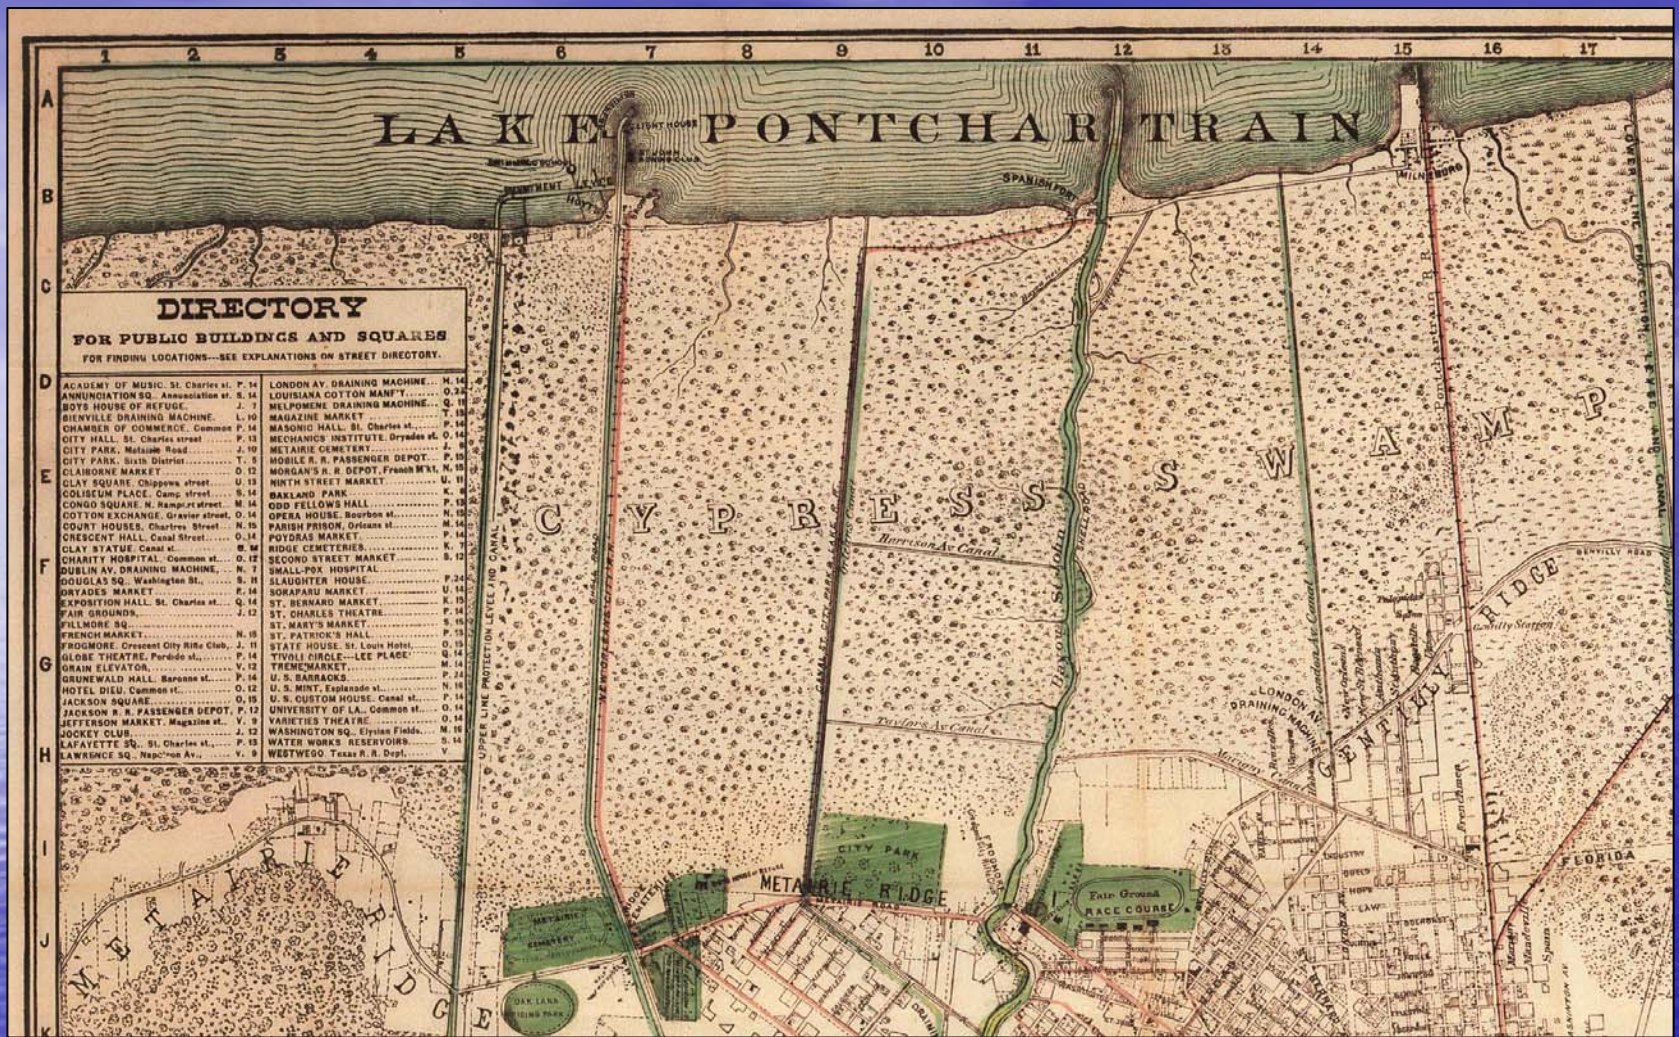
- All 36 miles of drainage canals in the Lakeview and Gentilly areas are shown in this portion the **1878 Hardee Map**. The canals are, from left: **17th Street**, **New Basin (infilled)**, **Orleans**, **Bayou St. John**, and **London Avenue**, and the **Lower Line Protection Levee**.

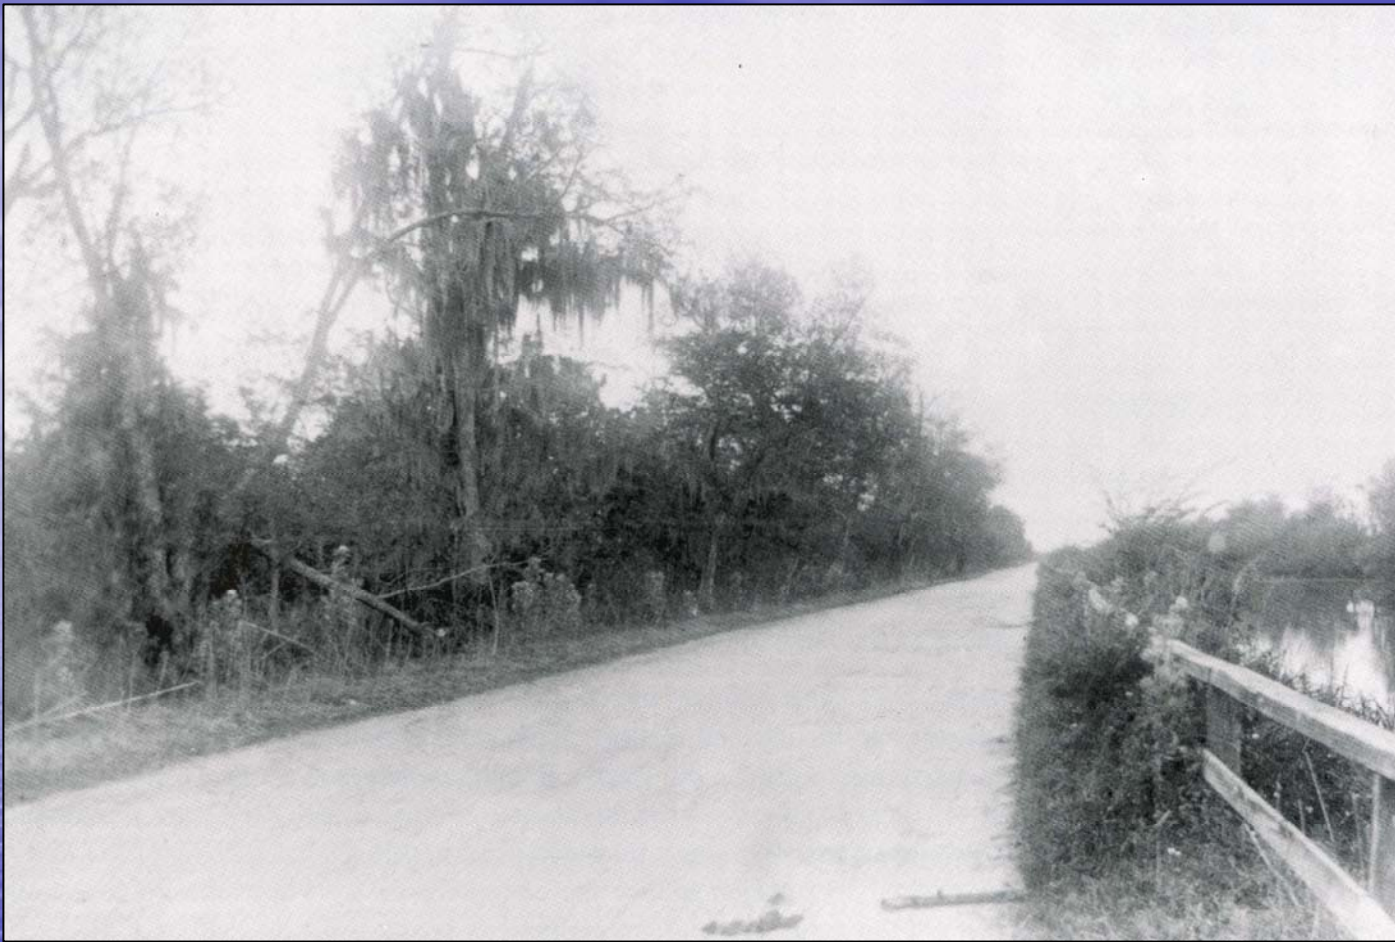
- Photo taken in 1890 looking north along the “shell road” than ran along the west side of the **New Basin Canal**, seen at extreme right.
- Note the modest height of the embankment, no more than 5 feet above the adjacent cypress swamp. The canal embankments were heightened after hurricane-induced overtopping in **1915** and **1947**.

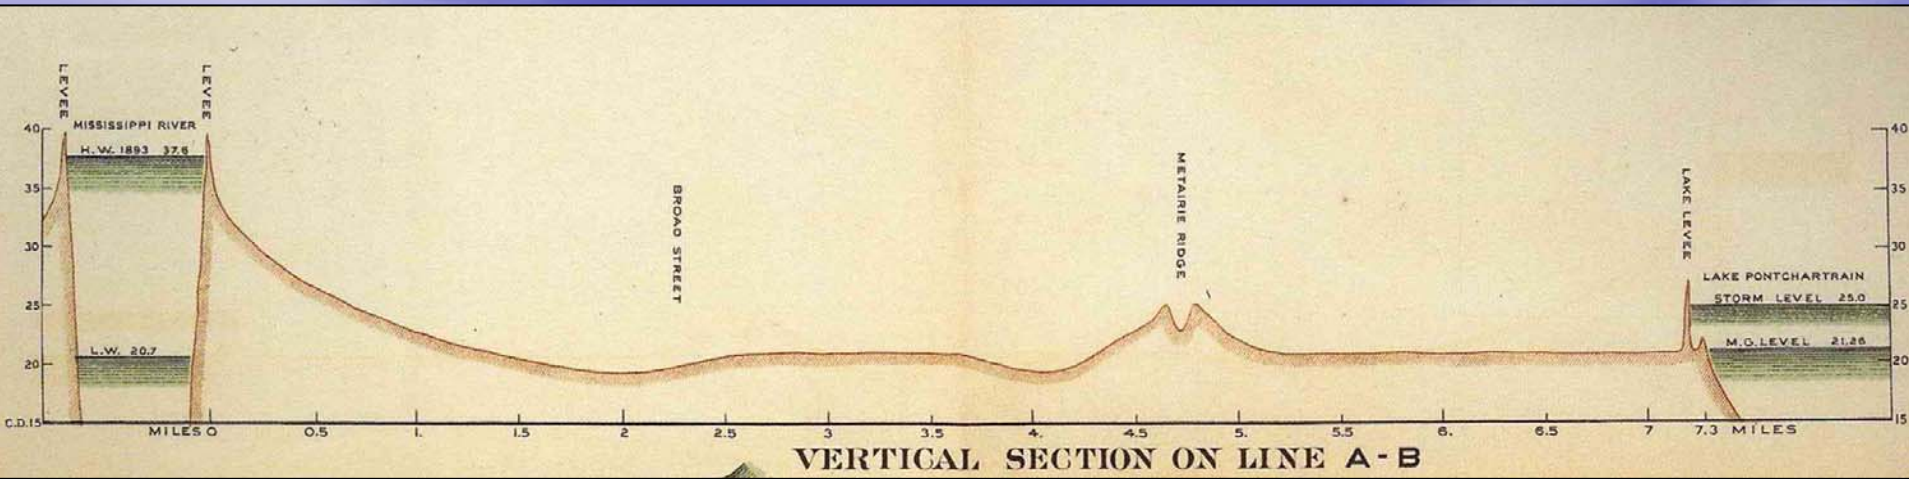
- **Cross section through New Orleans** prepared by City Engineer L. W. Brown in **1895** (from the Historic New Orleans Collection).
- This shows the elevated position of the Mississippi River and the **Metairie-Gentilly Ridge** distributary channel, which lies 3 to 6 feet above the surrounding area.
- The green lines denote high and low levels in the river and Lake Pontchartrain. Elevations are in the old Cairo Datum (21.26 ft above MGL).

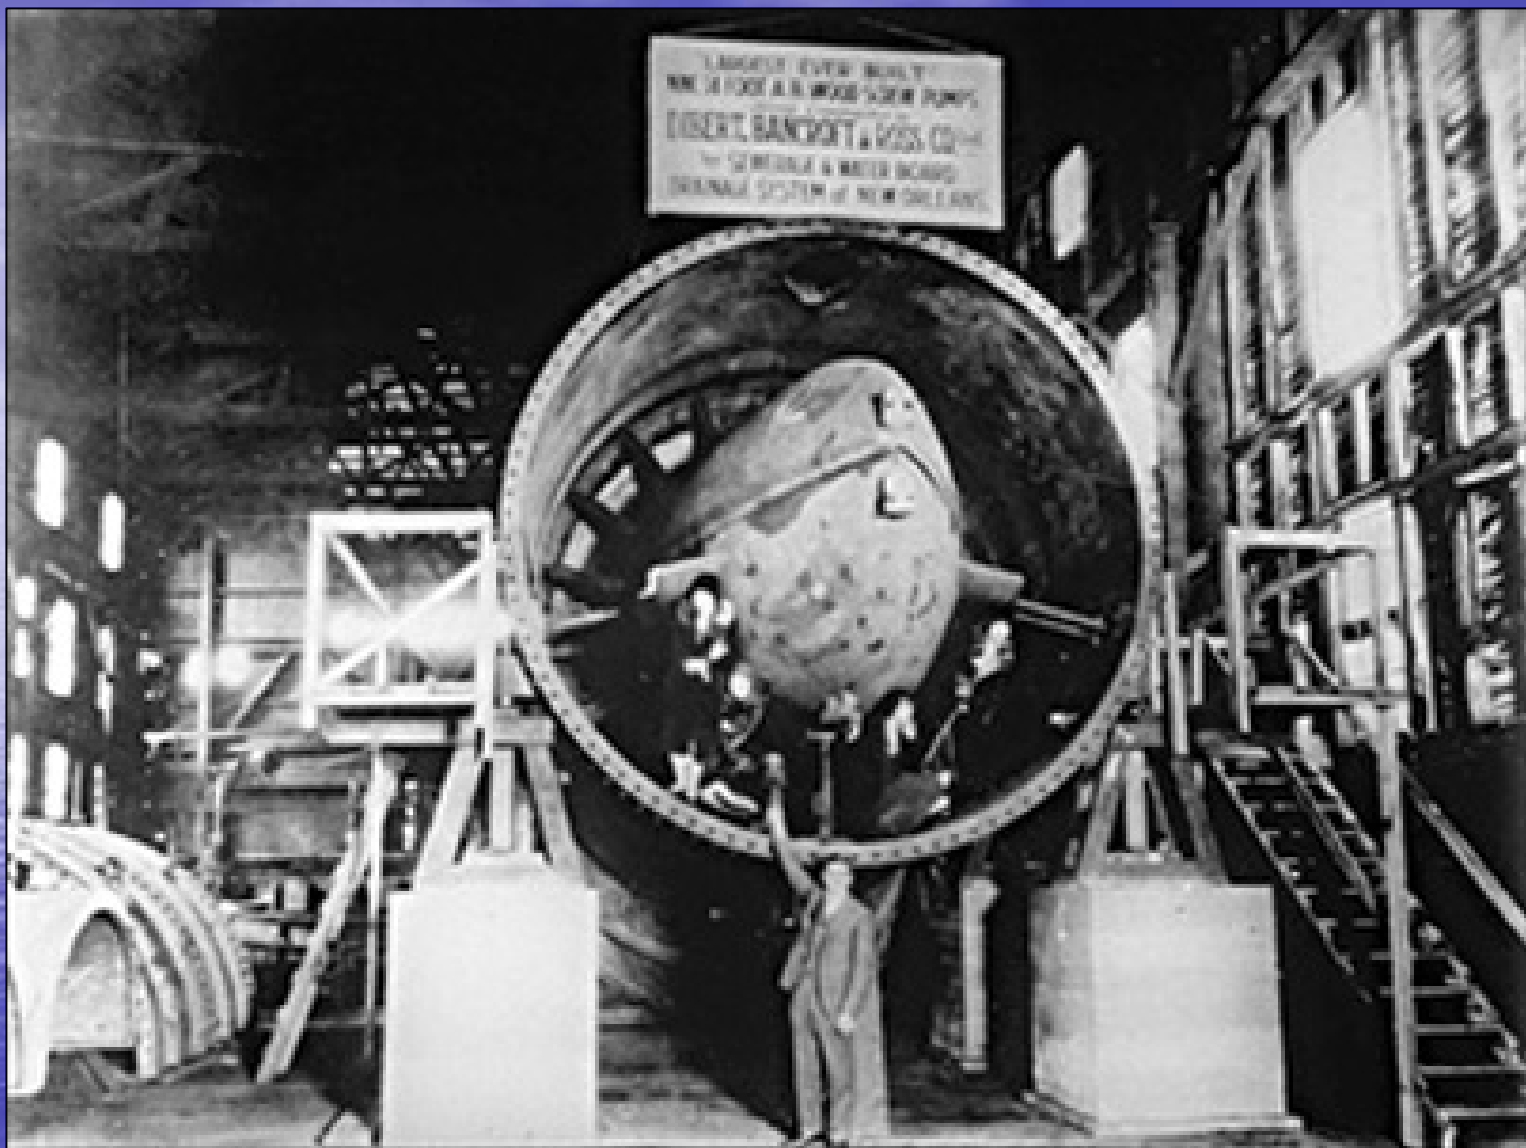
- S&WB engineer **A. Baldwin Wood** standing next to one of his 14-foot diameter screw pumps in 1929 with several of the board's secretaries sitting inside the housing for scale (courtesy of the Sewerage & Water Board of New Orleans).

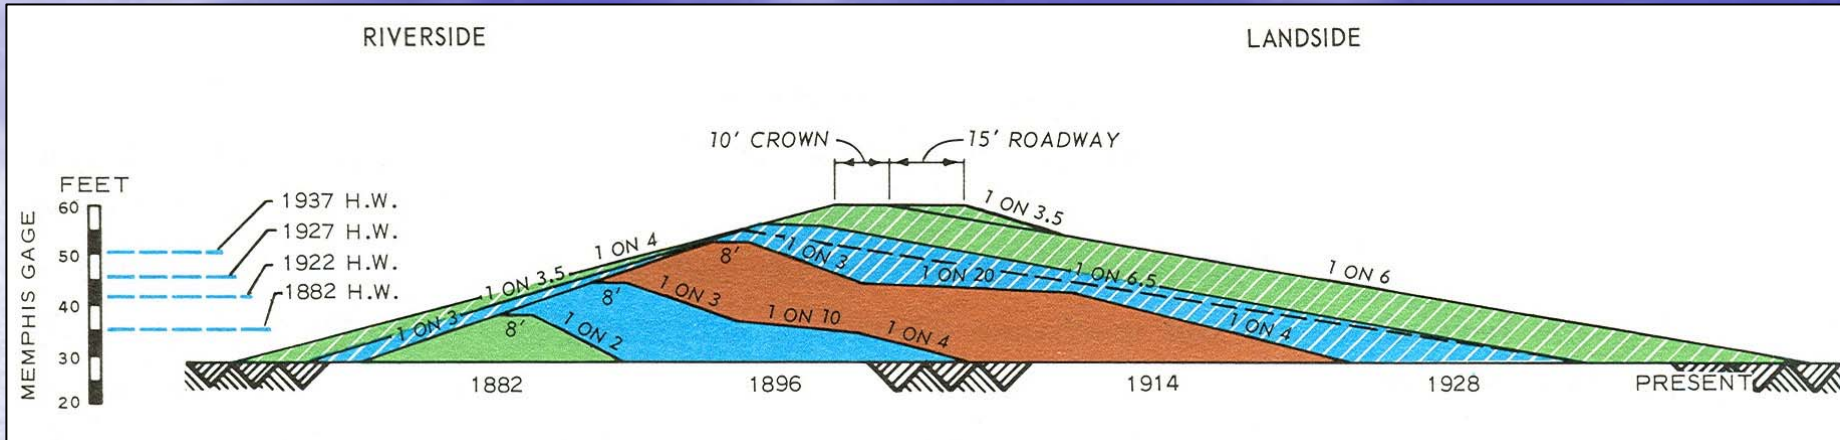
- Evolution of the Corps of Engineers' **standard levee section**, 1882 to 1972 (from Moore, 1972).
- Earth embankments levees are generally **heightened** sequentially by compacting additional soil on the **land side of the embankments** (each sequence of heightening shown as different colors).
- Levees adjacent to drainage canals or perennial channels are not raised on the river side of the embankment because excess moisture would prevent meaningful compaction of the fill.
- **Existing homes abutted the land side of the drainage canal levees in New Orleans by the time the Corps of Engineers began analyzing them in the 1960s.**

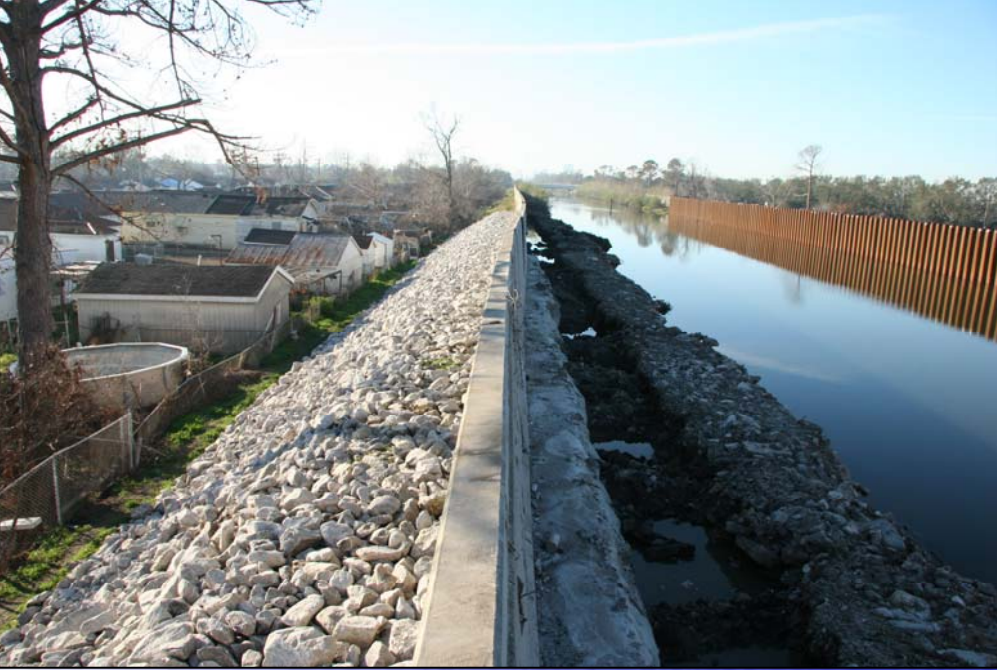
- View looking up the east side of the London Avenue Canal near Robert E. Le Boulevard crossing showing the **encroachment of homes against the slope of the levee**. This situation was common across New Orleans

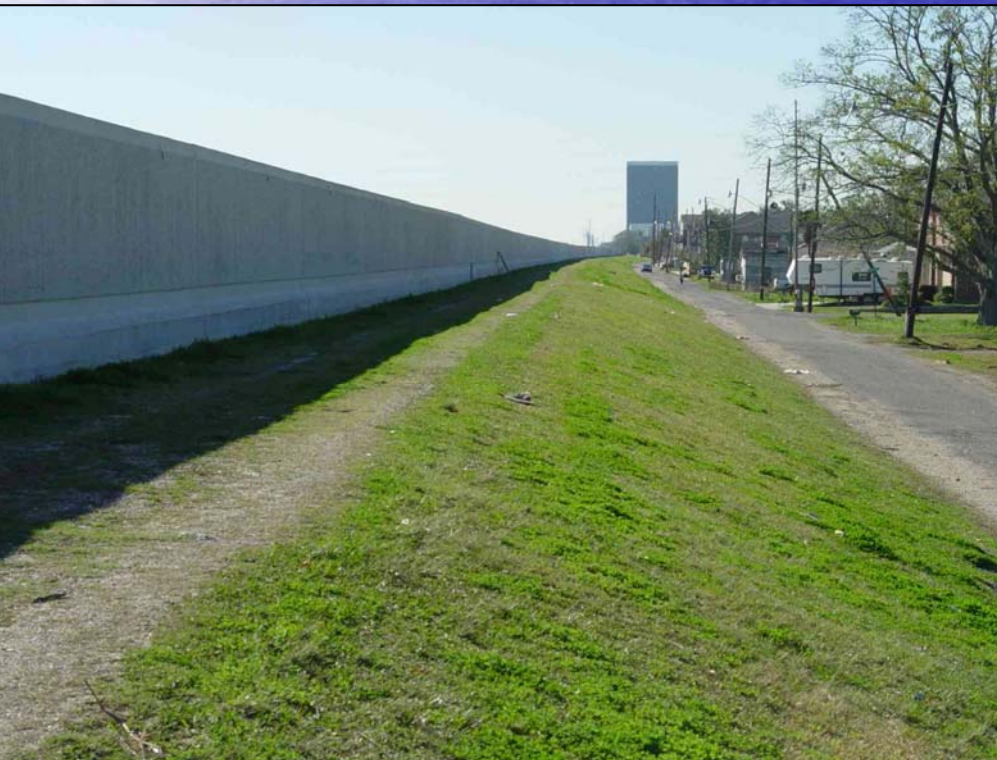
- **Concrete flood wall** along the west side of the 17th Street Canal in Jefferson Parish, where a street runs along the toe of the embankment. This scene is typical of the concrete I-walls constructed on steel sheetpiles driven into the crest of the drainage canal embankments in New Orleans in the 1990s to provide additional flood freeboard from hurricane-induced storm surges

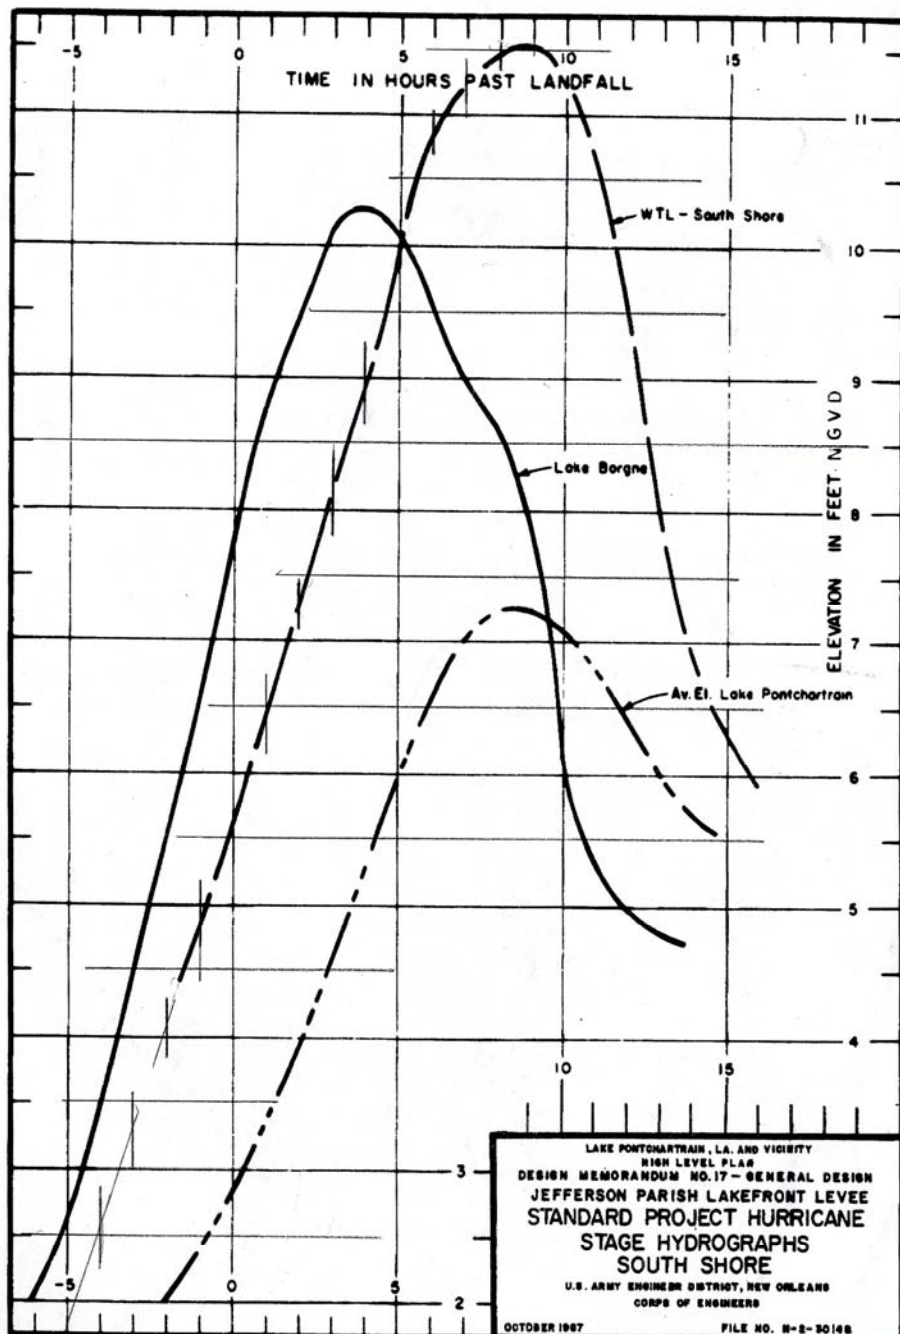
PLATE A-13

- Assumed Category 3 storm surge curves for the Gulf of Mexico shoreline, Lake Borgne, and Lake Pontchartrain used by the Army Corps of Engineers for planning and design purposes prior to Hurricane Katrina in 2005.
- Note the **short duration of extreme surges**, about 12 hours duration above 5 ft MGL for Lake Pontchartrain.

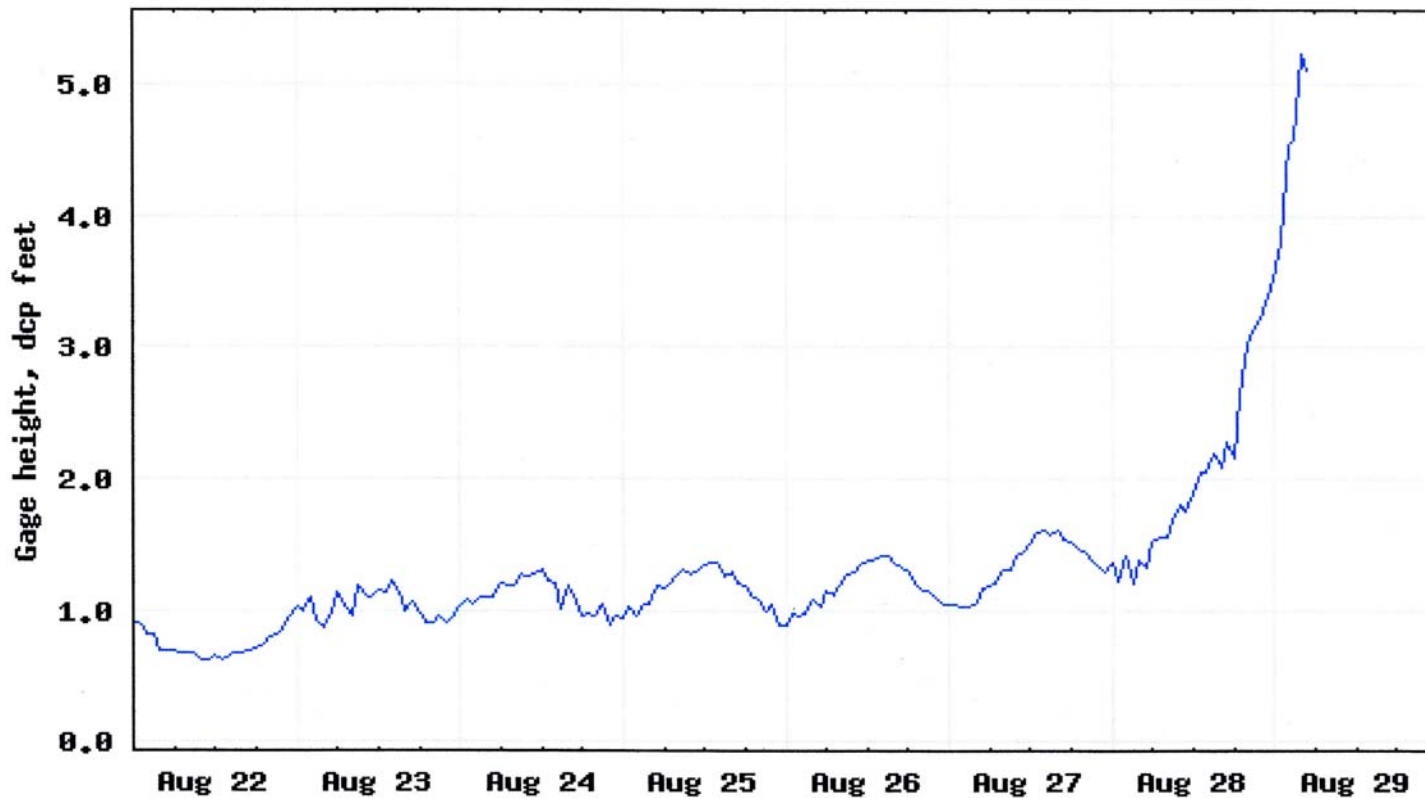
USGS 073802331 (COE) Lake Pontchartrain at West End, LA

- Incomplete record of the **Lake Pontchartrain tidal stage** gage at West End, near the mouth of the 17th Street Canal during the early stages of **Hurricane Katrina** (from U.S. Geological Survey).
- This record shows several steps in the storm surge, known as "ramping," beginning on August 28th, with the sharpest increase on the morning of August 29th, when the hurricane made landfall. The gage failed when the lake level reached 5.3 ft, before the peak surge was recorded.
