Historical Background on the New Orleans Levee System

J. David Rogers, Ph.D., P.E., P.G.

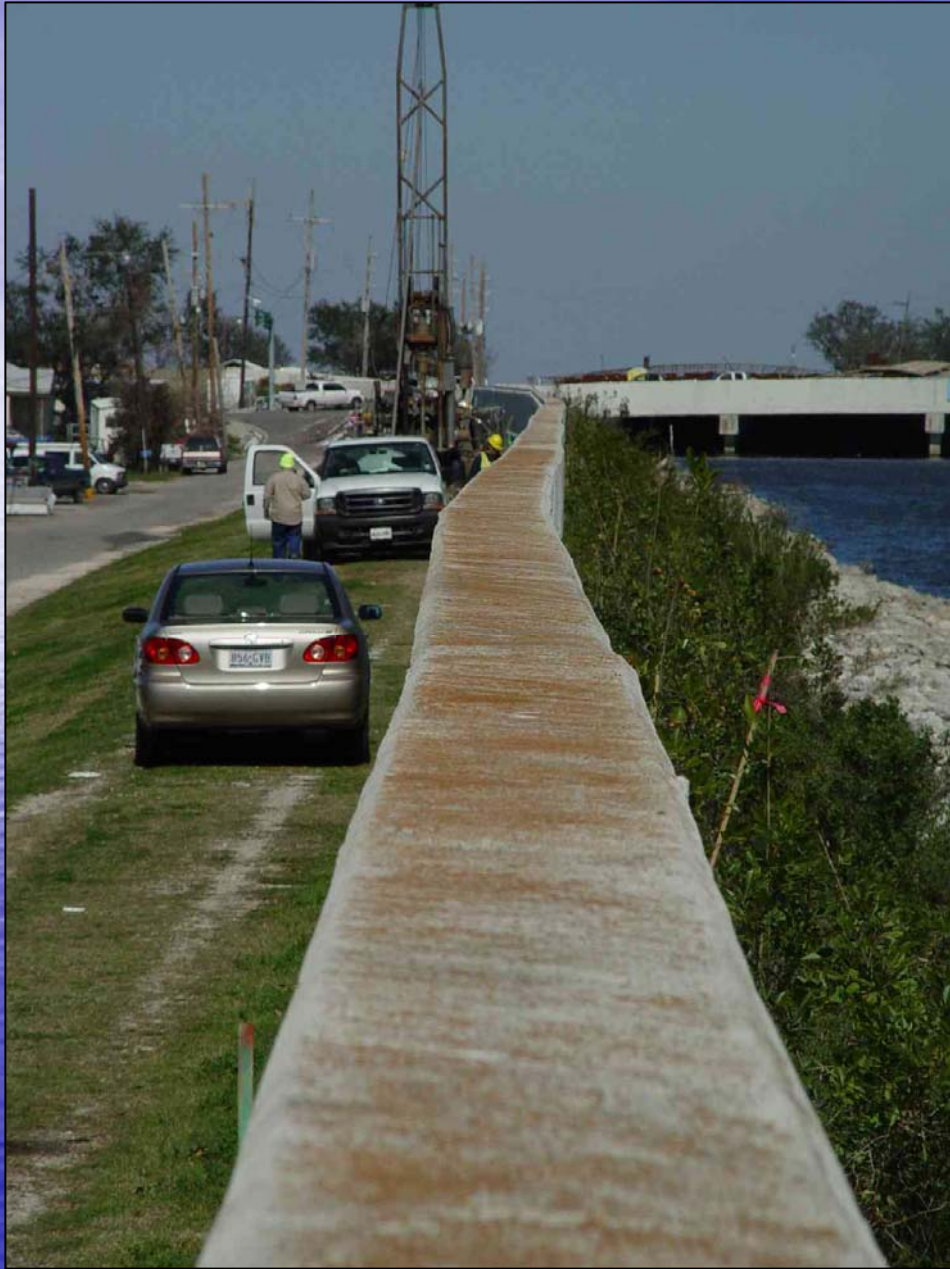
- Localized deflection of the west flood wall on the **Jefferson Parish side of the 17th Street Drainage Canal**, opposite the breach that occurred on the eastern side on August 29, 2005.
- The **gap formed at the construction joint** was wider at the base than the crest, suggesting deep-seated strain beneath the embankment (photo looking north).

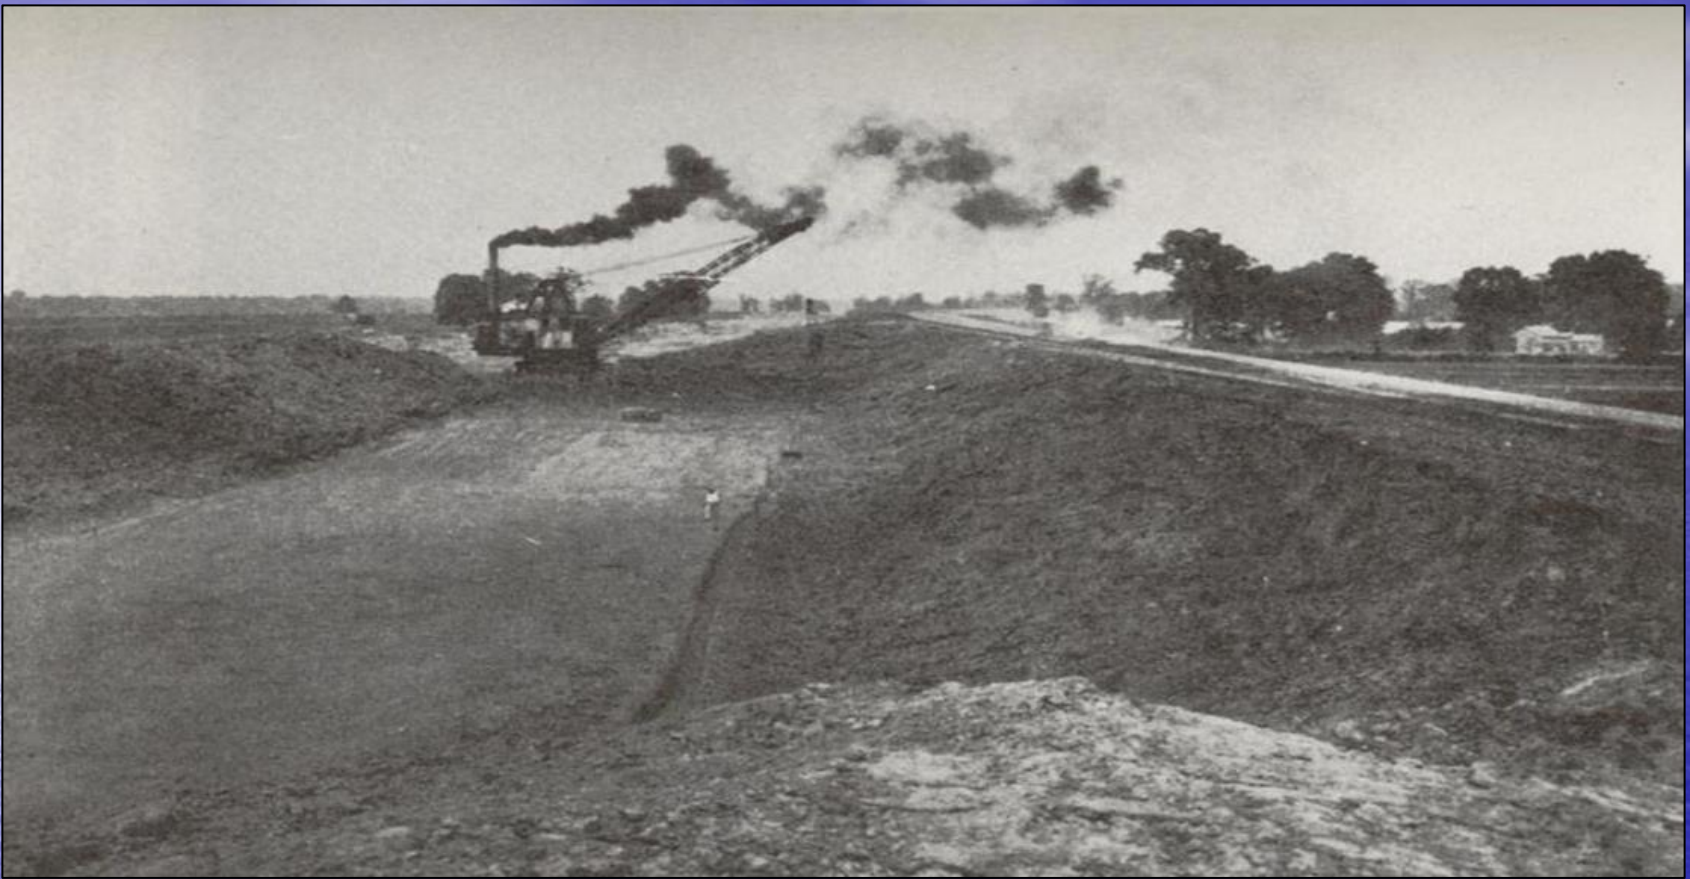
- Most of the IHNC was constructed using mobile dragline excavators like the one pictured here building the Morrison-Picayuneville Levee about 25 miles south of New Orleans in June 1931.
- Tower draglines could excavate materials up to a quarter mile away, dragging it back up onto the new levee.

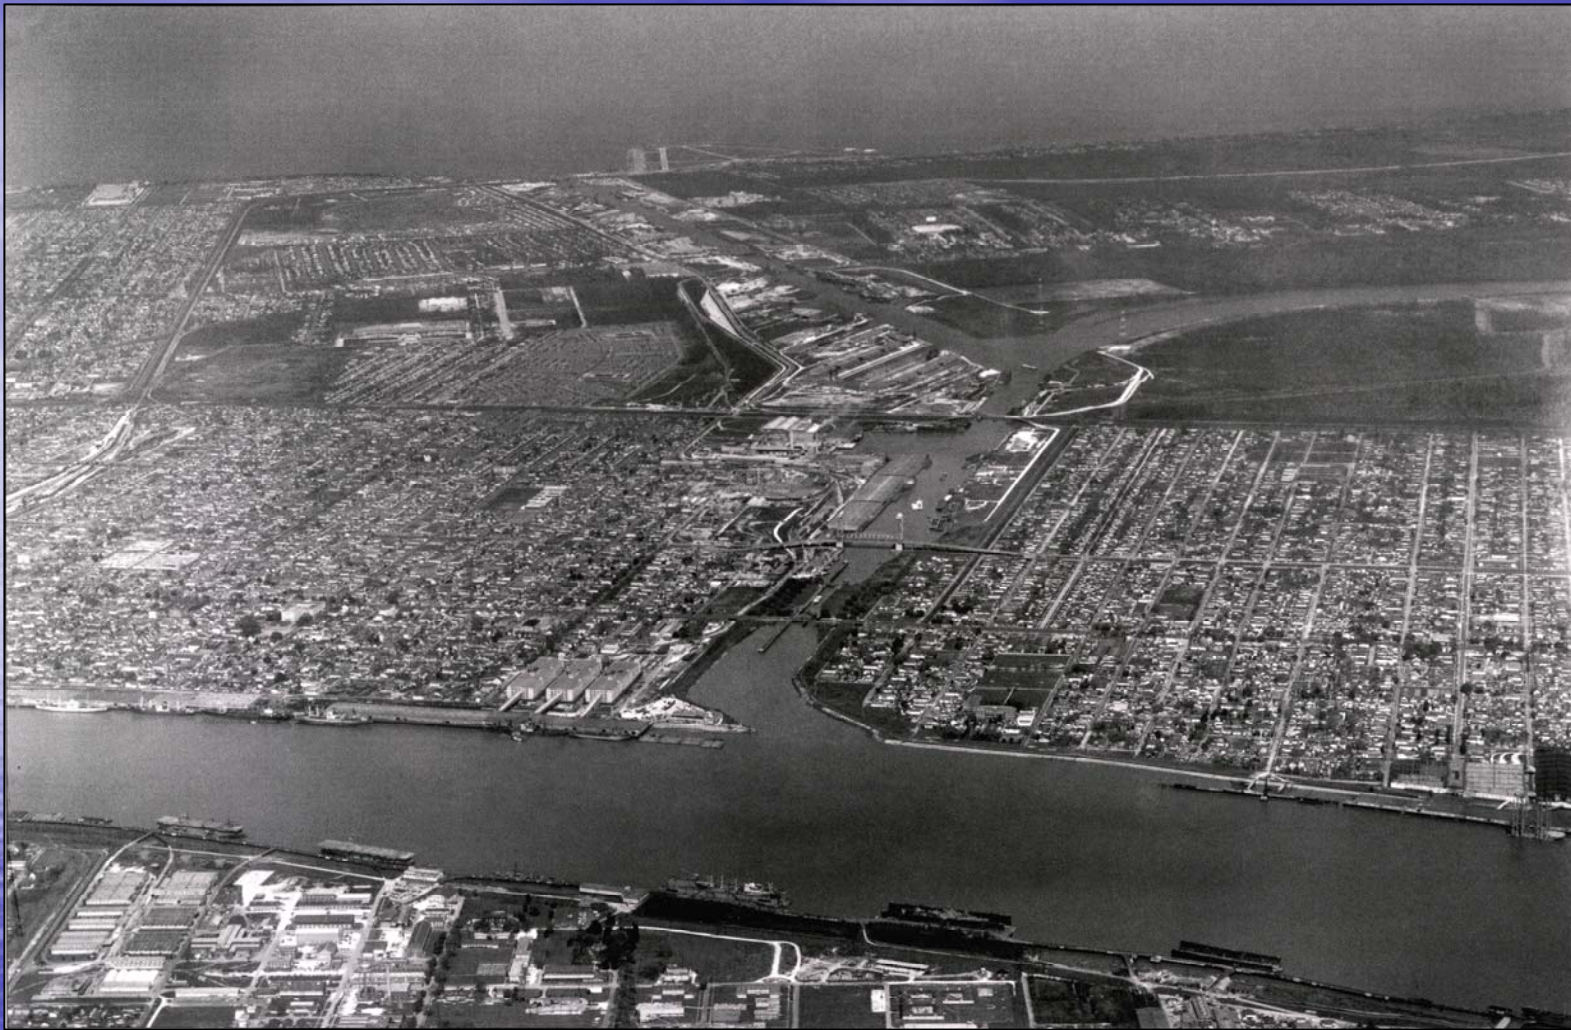
- Aerial oblique view of the **Inner Harbor Navigation Canal** between 1960-64, after the entry to the Mississippi River-Gulf Outlet Channel had been enlarged (upper right), connecting to the inner harbor area.

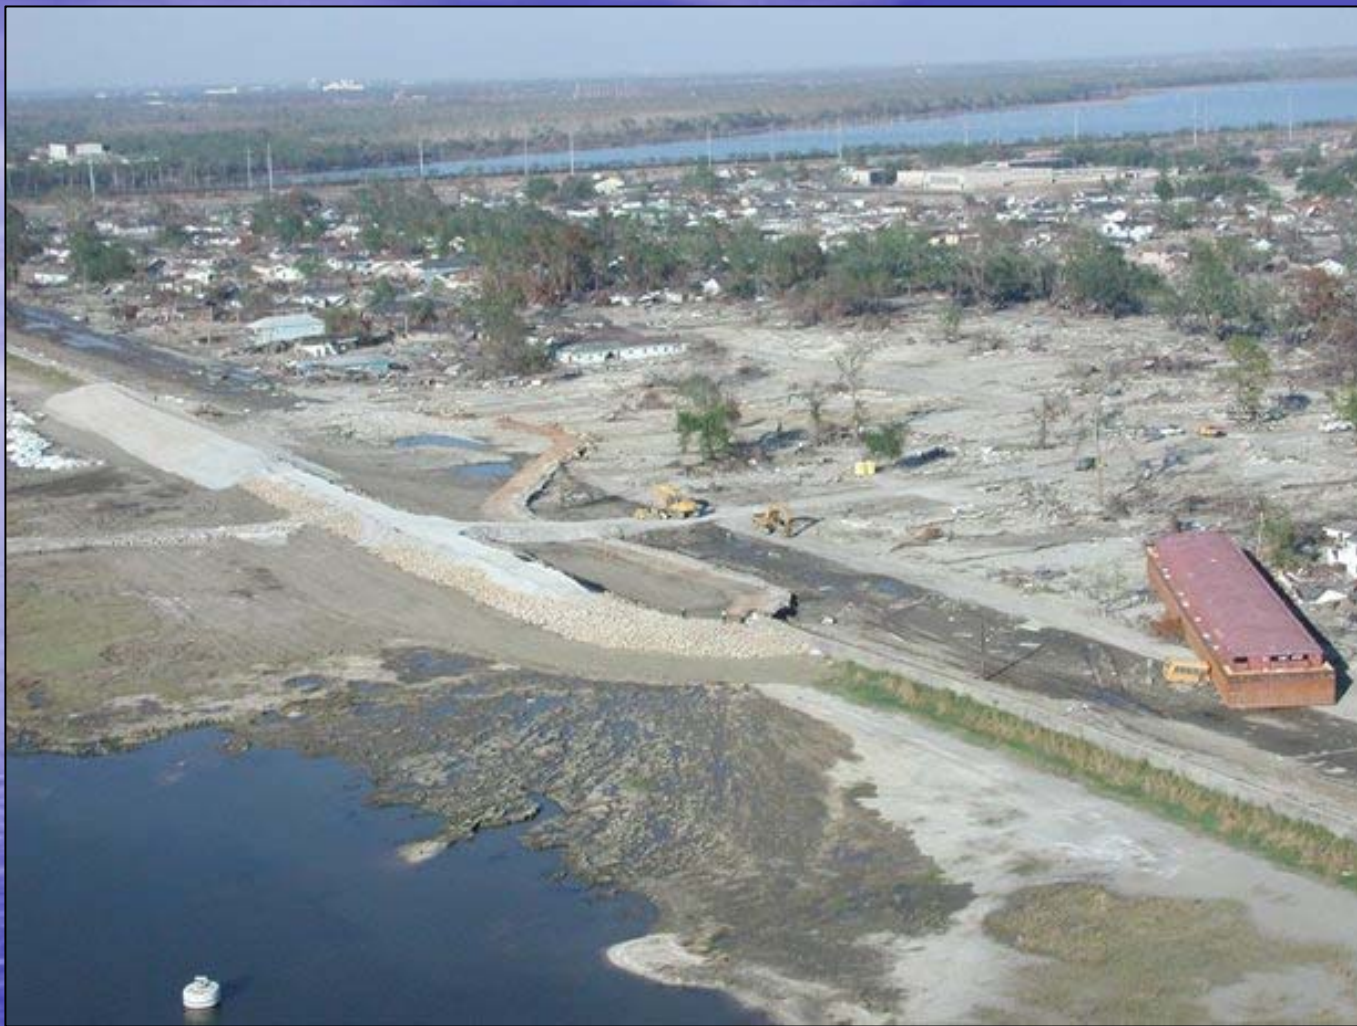
- **Seepage crevasse splay** exposed on the water side of the east levee of the IHNC breach after Hurricanes Katrina and Rita. **This same section of the IHNC levee failed in 1965 during Hurricane Betsy.**
- Levees tend to fail during sustained high flow events because of underseepage problems, toe scour, and overtopping. Note the **anomalous seepage** in lower foreground, which suggests much higher permeability in this particular portion of the dike, close to the south end of the failed section.
