# POST-FLOOD RECONNAISSANCE OF THE UPPER MISSISSIPPI RIVER VALLEY IN 2008

**J. David Rogers, Ph.D., P.E., R.G.**  
Natural Hazards Mitigation Institute  
Missouri University of Science & Technology

for the symposium on  
**Geologic Studies for Dams and Levees**  
**Association of Environmental & Engineering Geologists**  
**Lake Tahoe, California**  
**September 25, 2009**

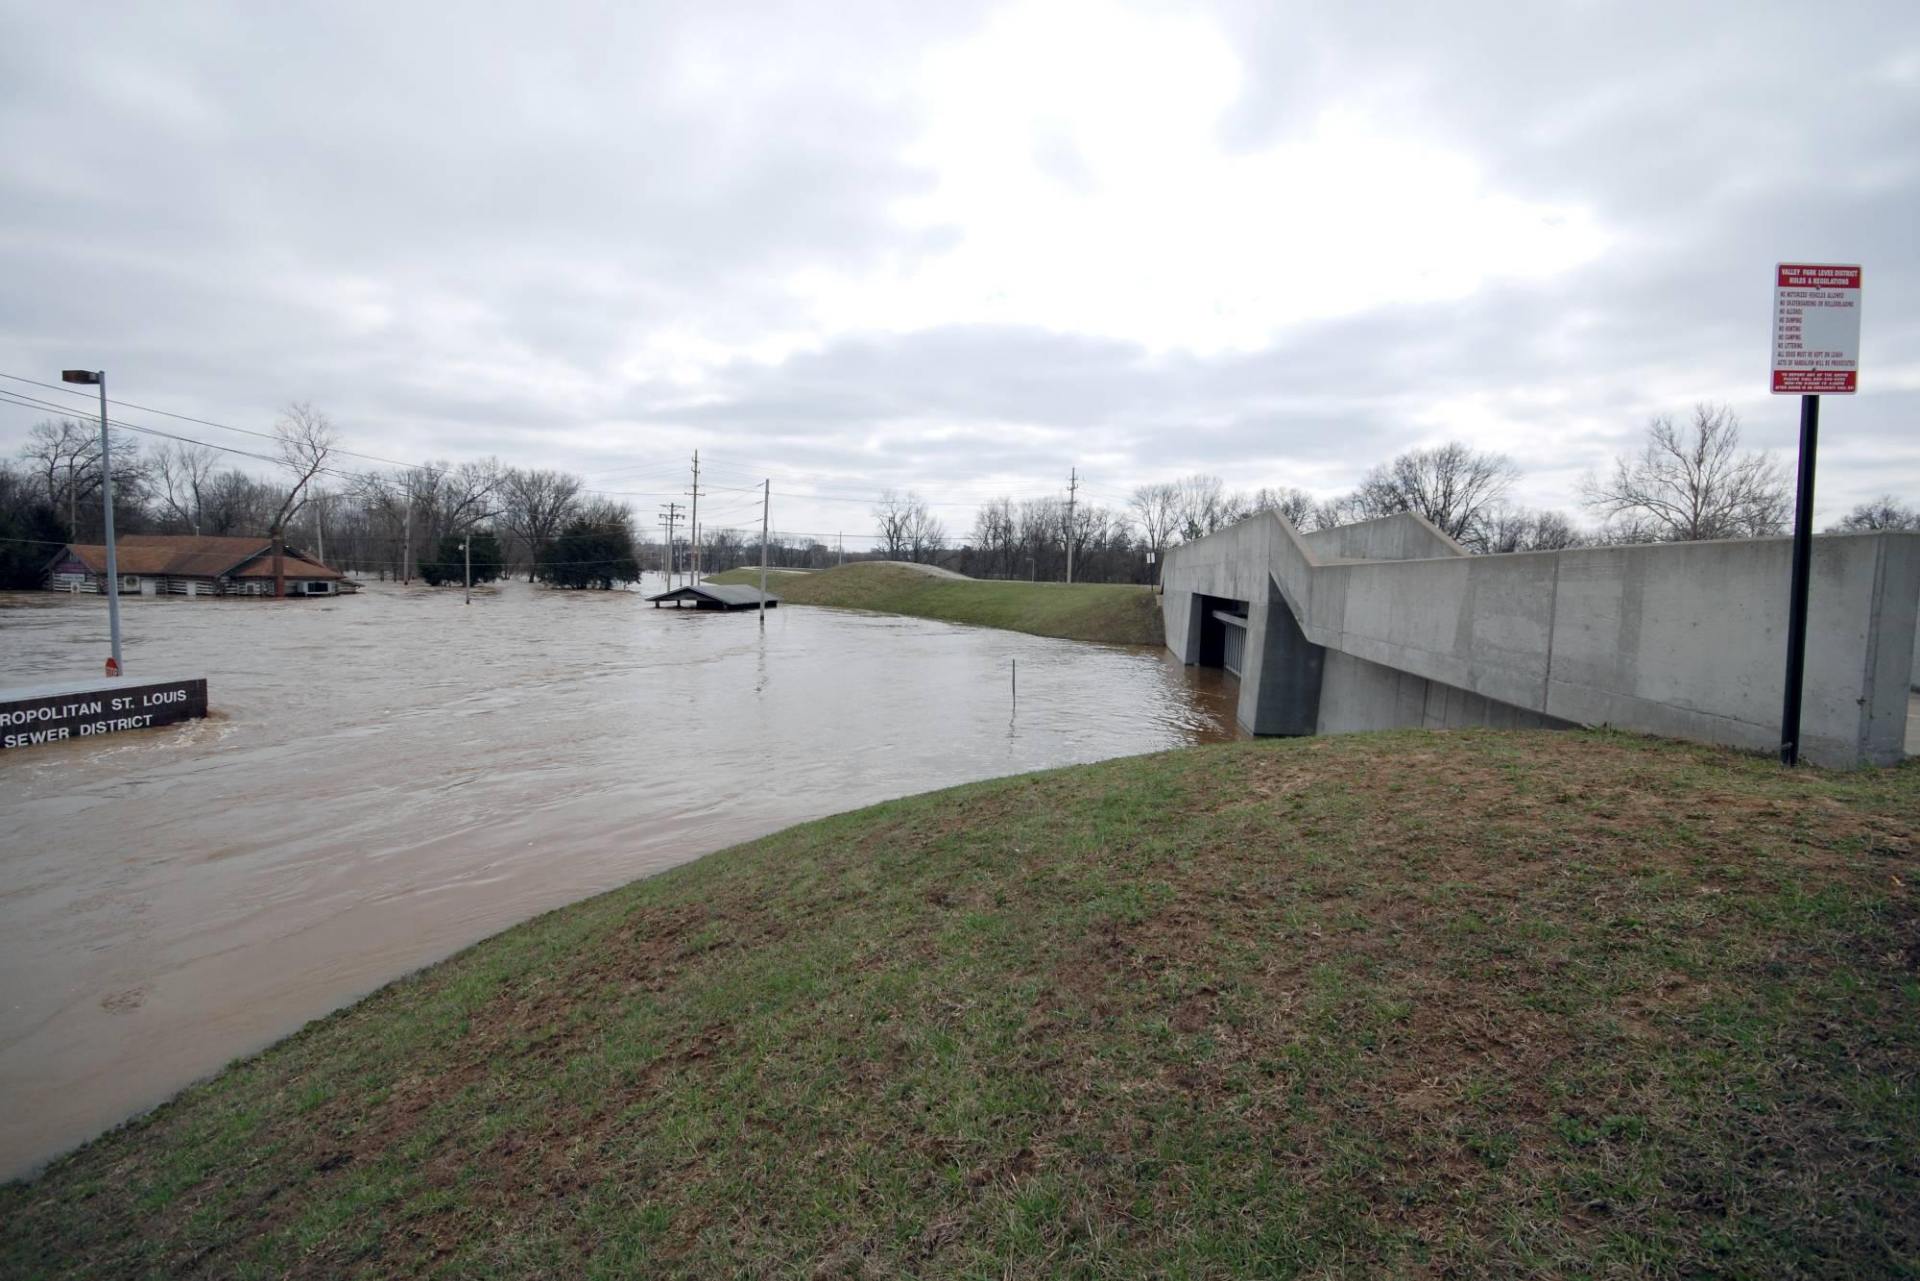
**Concrete flood walls often used to protect high-value business districts**

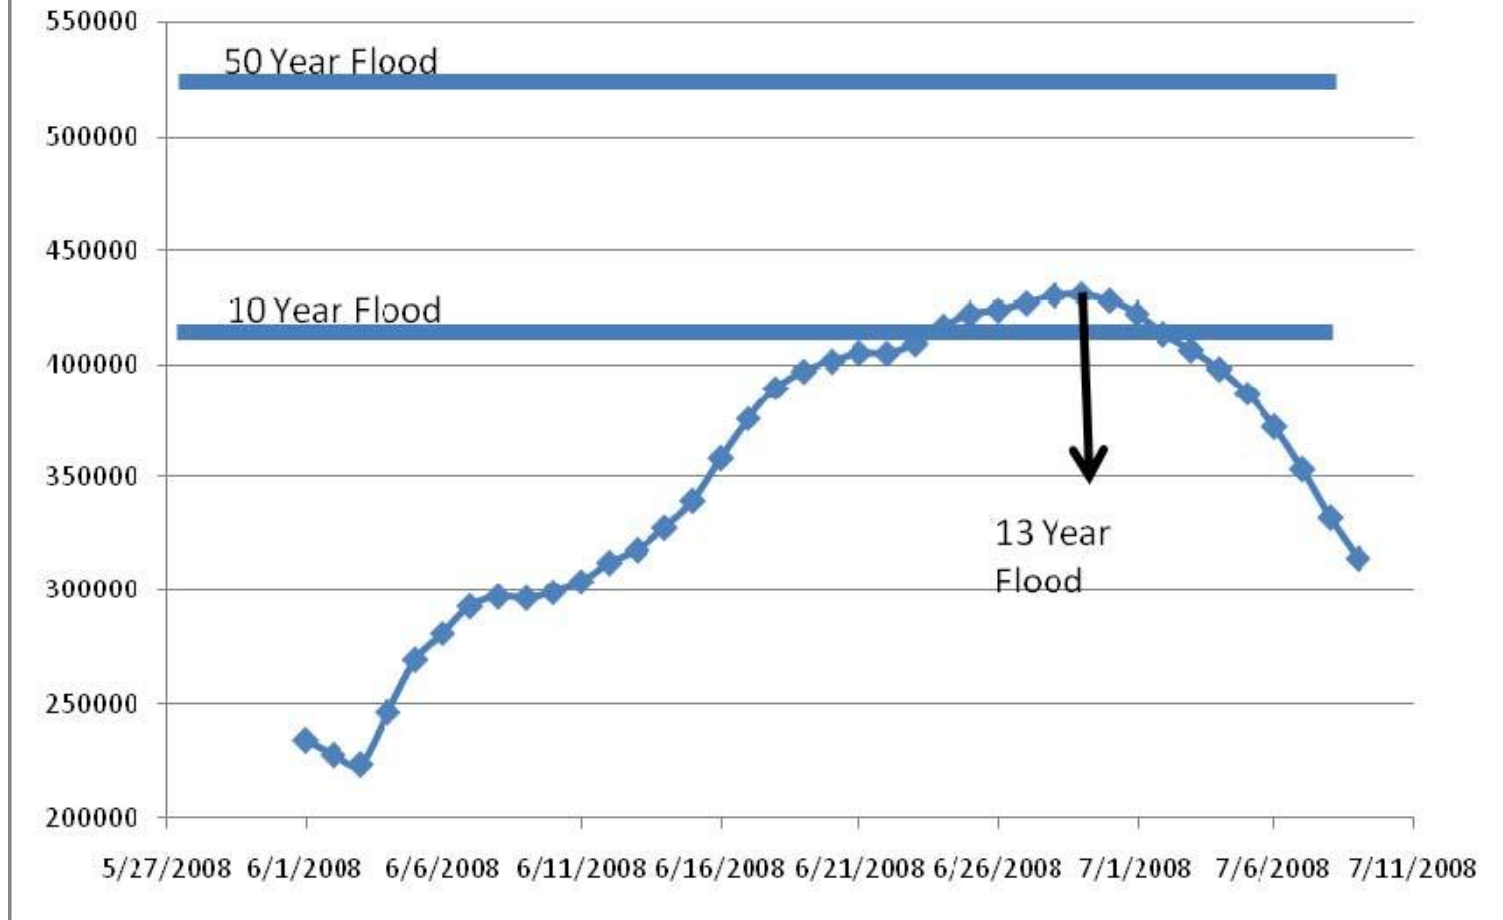
## Daily Hydrograph - USGS Gage 05587450

- **Mississippi River at Nauvoo, Illinois during June-July 2008**

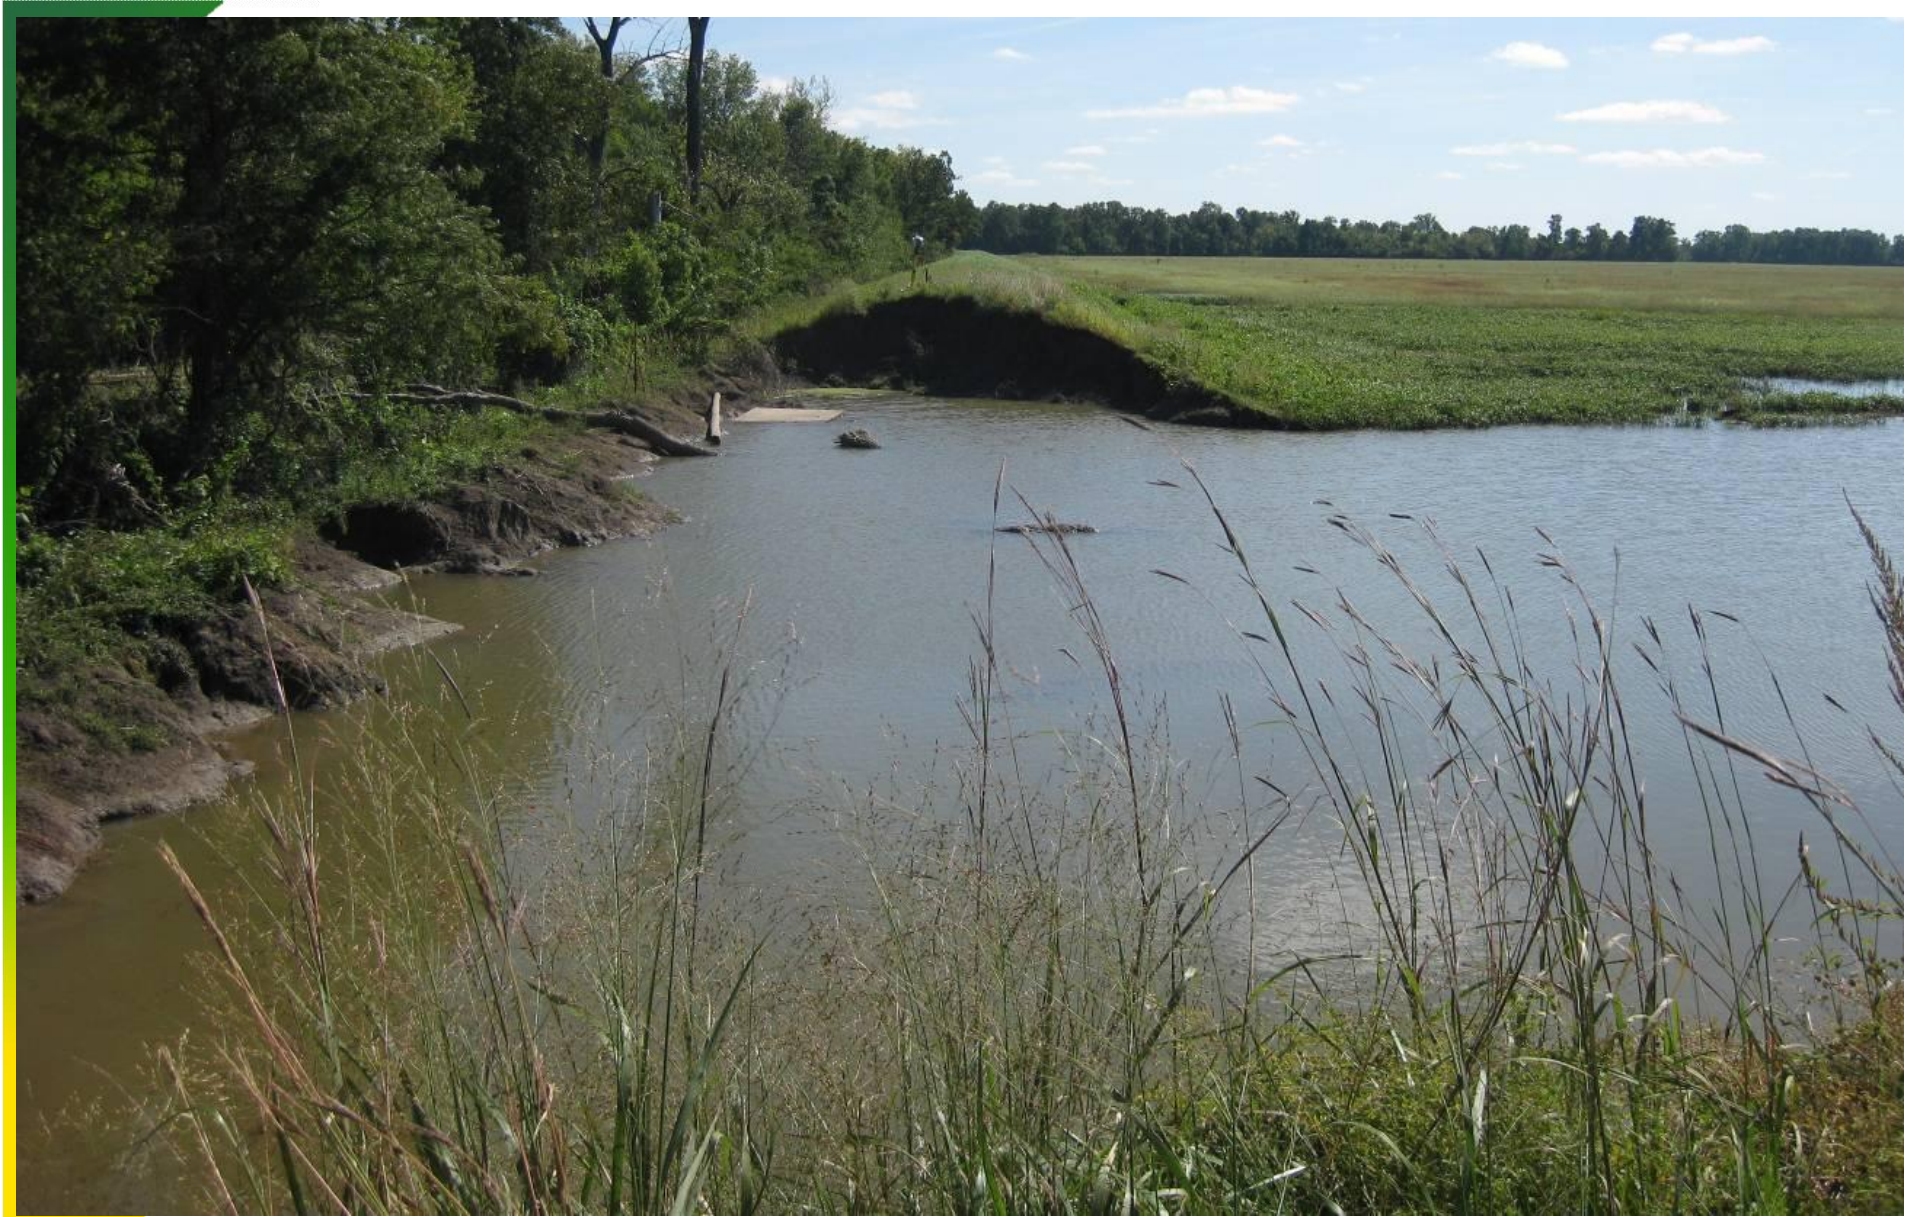
# • Norton Woods Breach

- **Norton Woods Breach and scour pool**

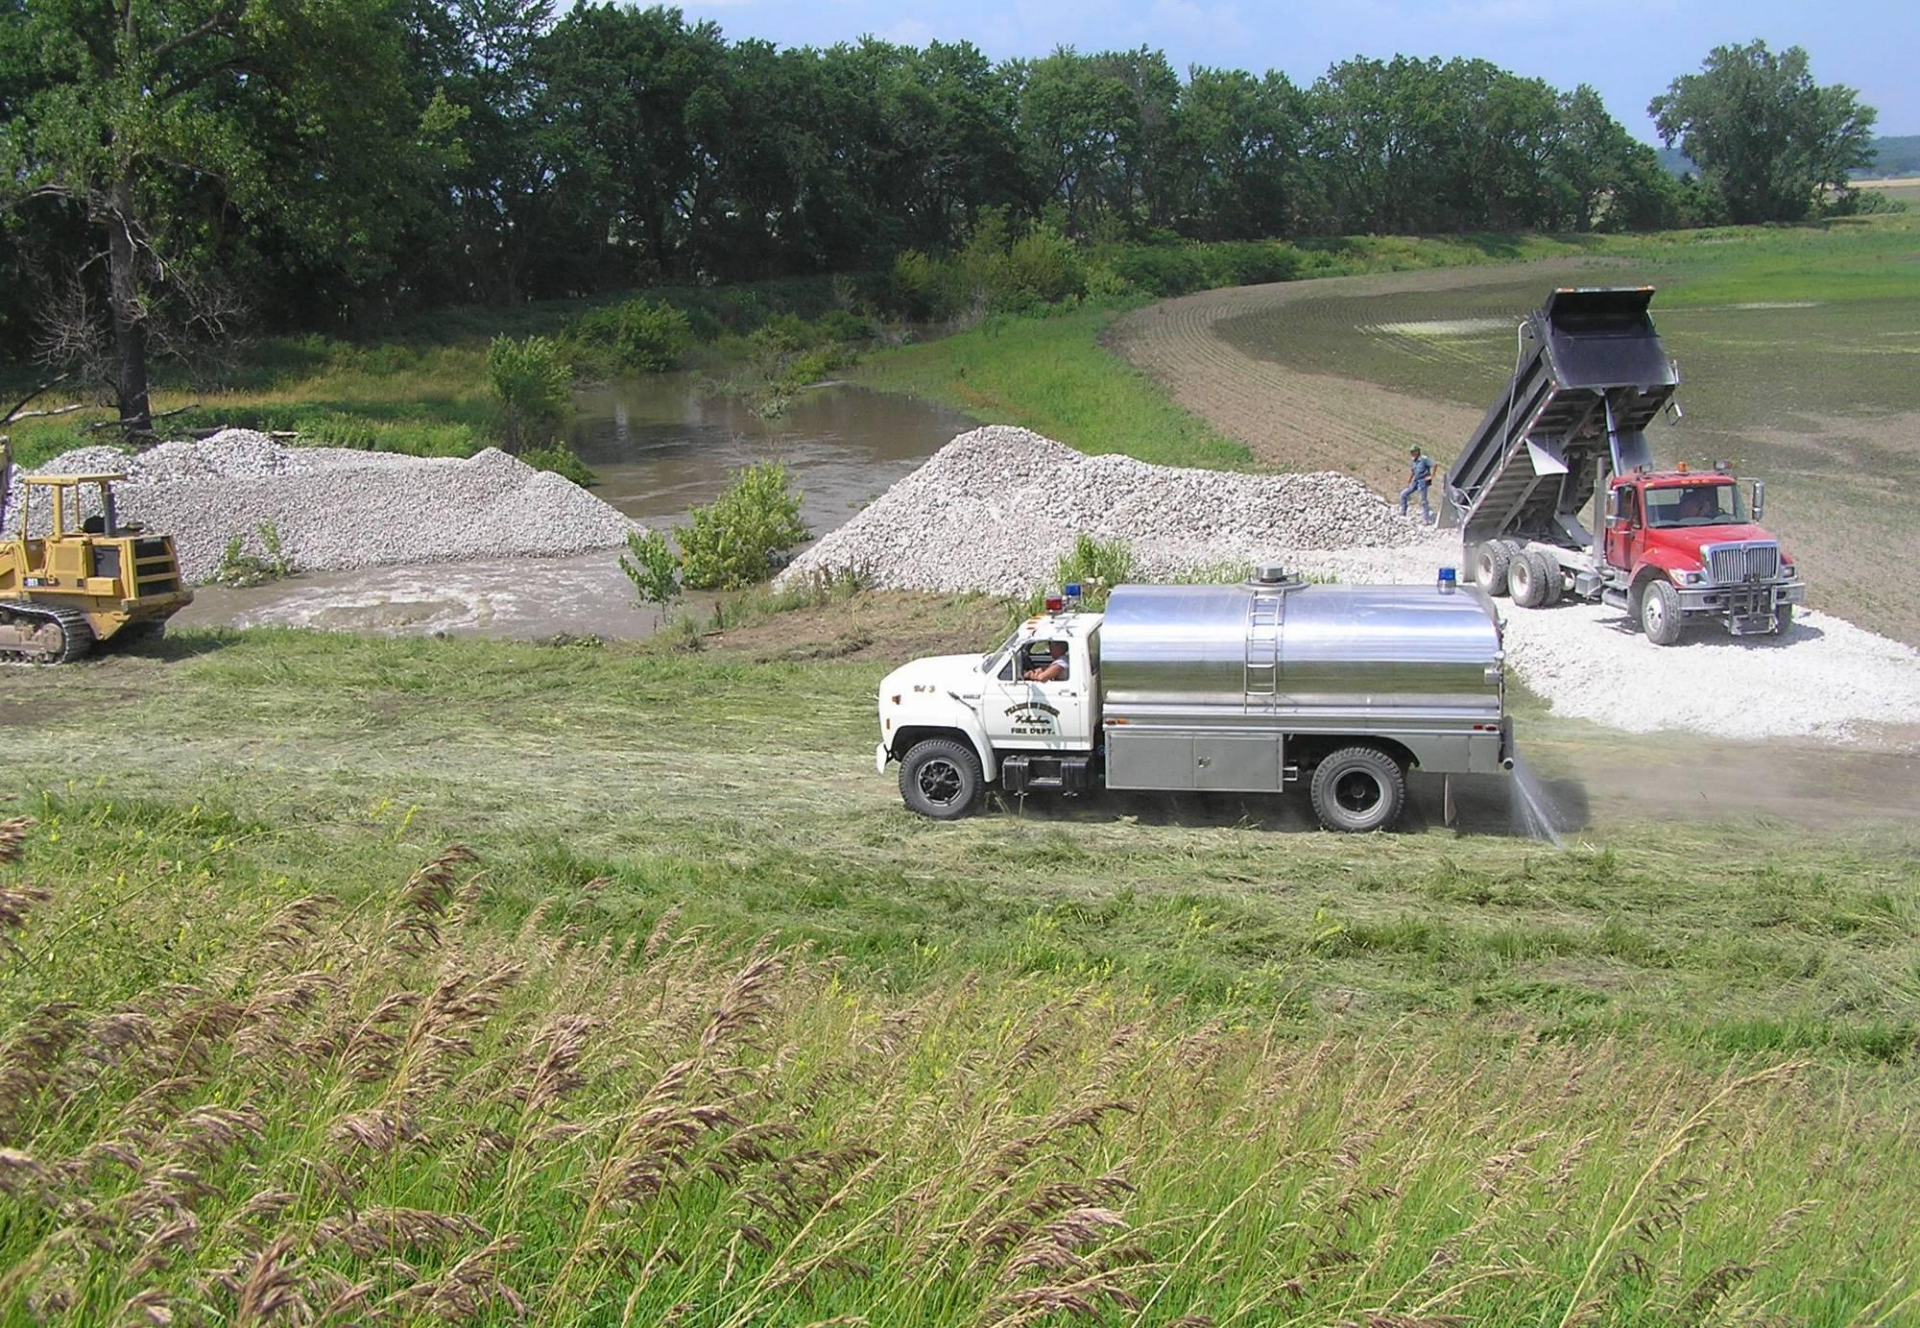
# Massive boil

**When hydraulic gradients  $> 1.0$ , piping of fine grained soils ensues.**

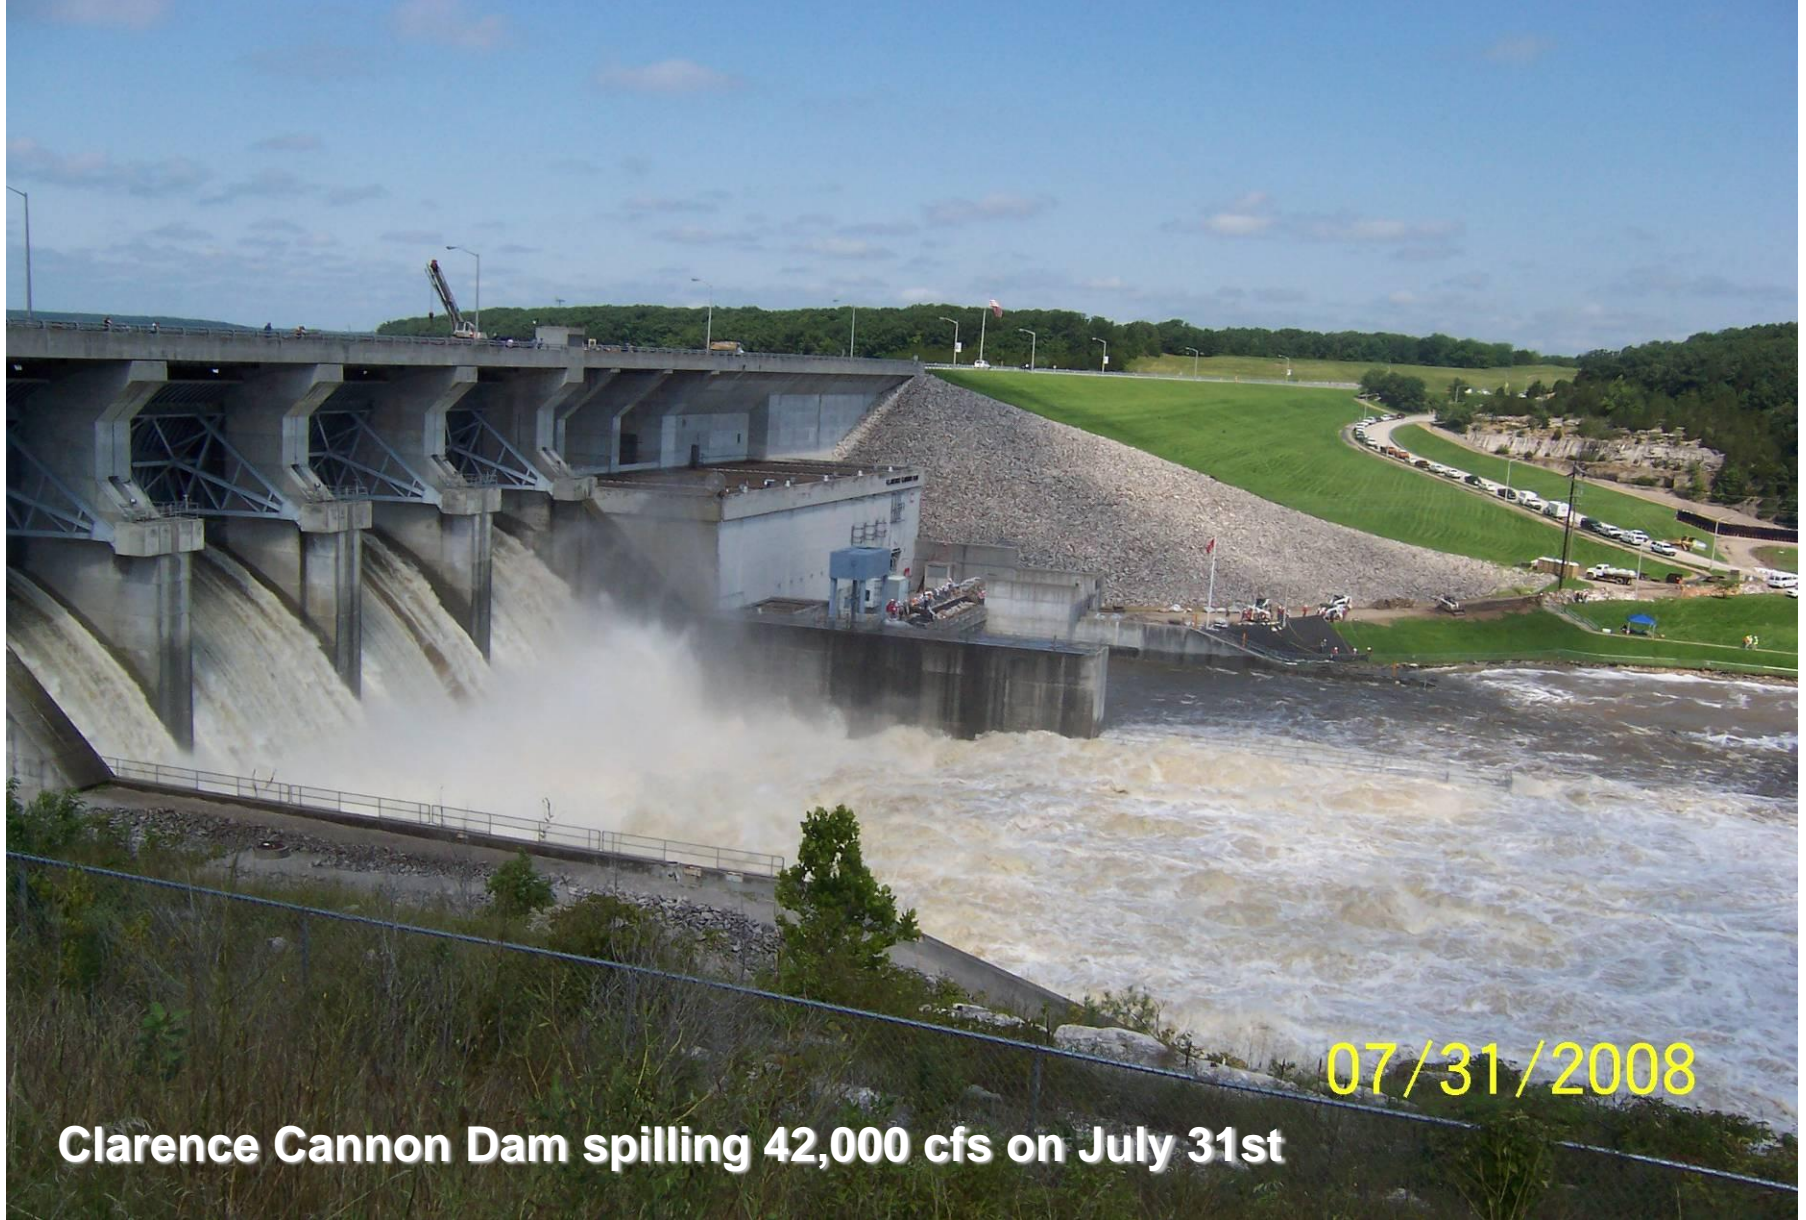
Mark Twain Lake's crest for the 2008 flood event was at 628 ft, utilizing about 60 percent of the reservoir's flood storage capacity. Mark Twain Lake held back inflows of over 21,000 cubic feet per second (cfs) several times in June

**Clarence Cannon Dam spilling 42,000 cfs on July 31st**

During the height of June's flooding, Mark Twain Lake, in conjunction with Truman Dam and Reservoir (Warsaw, Mo.), contributed to reducing the Mississippi River's stage at St. Louis and points south to Cape Girardeau approximately 3.5 ft.

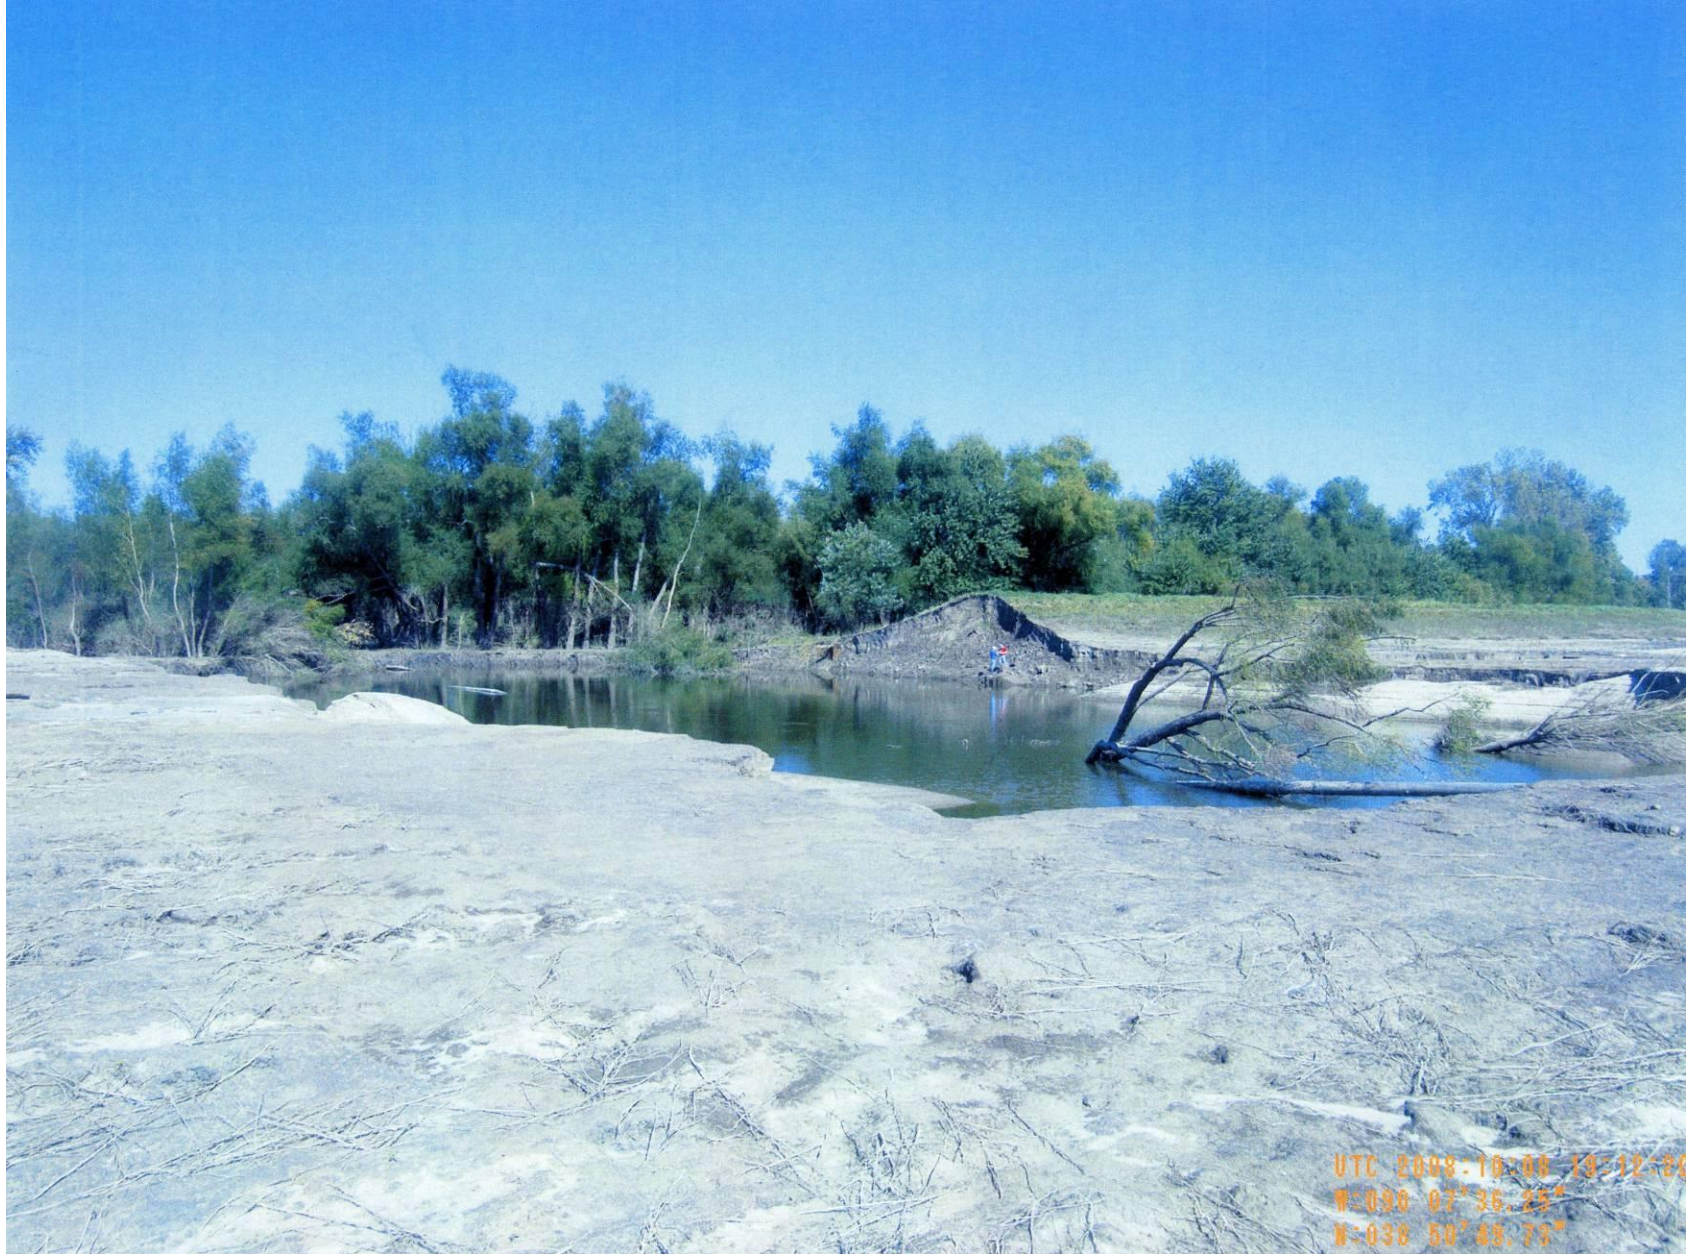
- Breach near Confluence Point likely influenced by seepage along pipeline trenches. Failures here in 1993 and 2008.

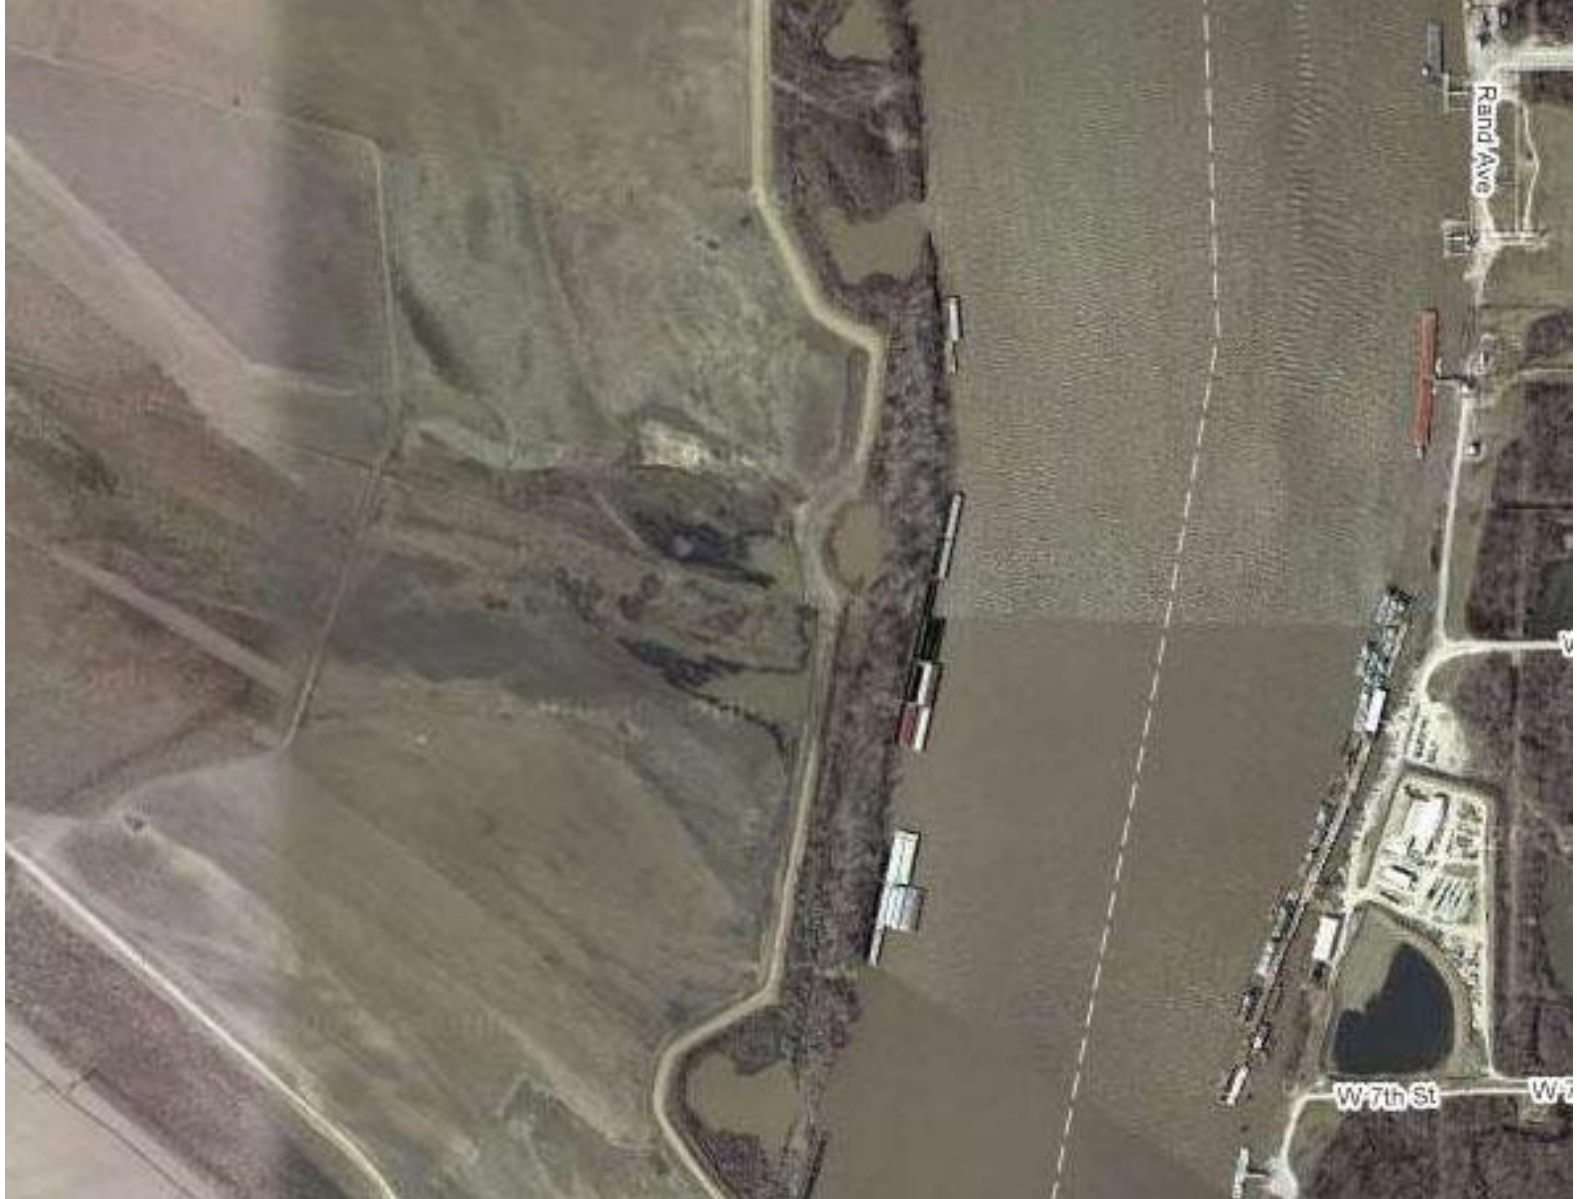
- Pipeline breaks in Kuhs Levee District. Note previous repairs, where dike turns in and out

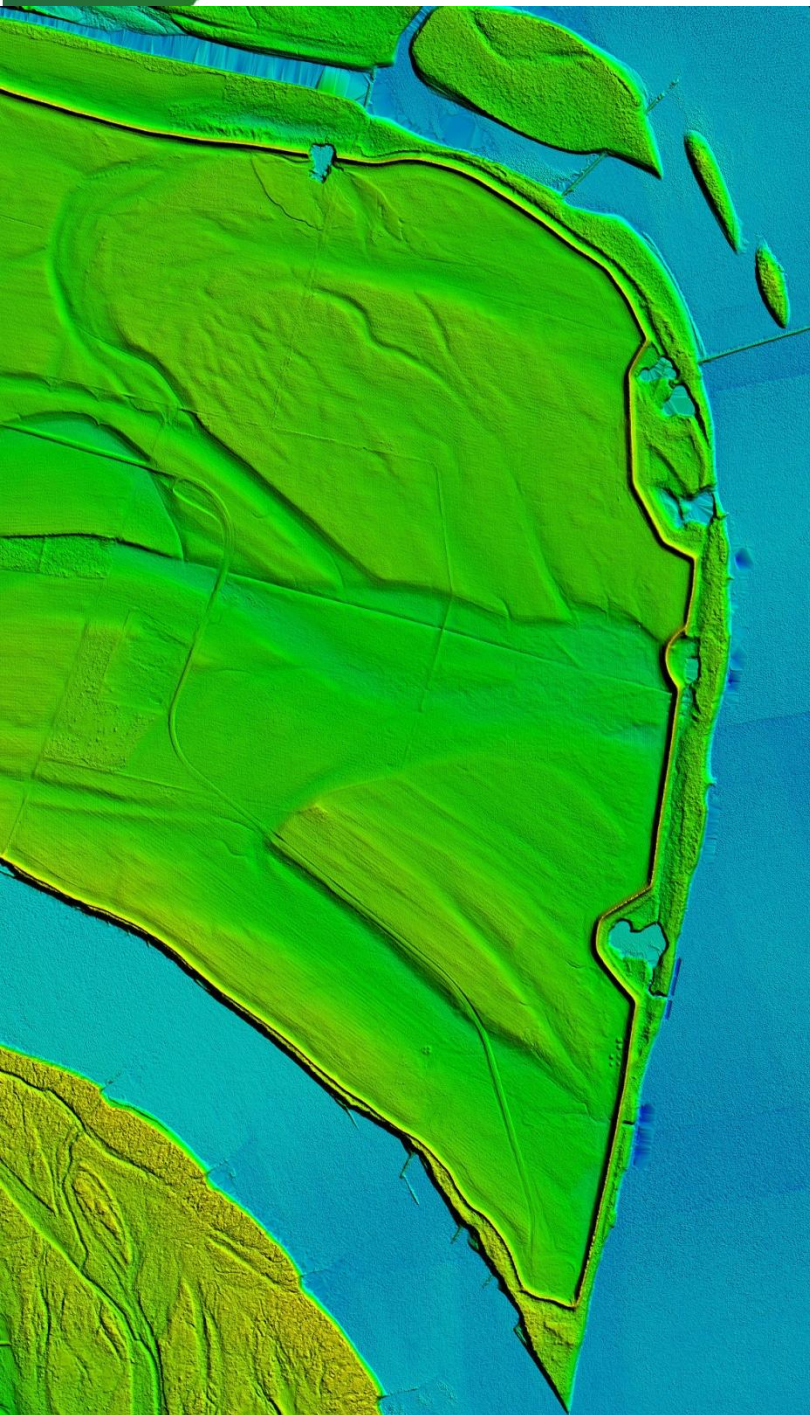
# LiDAR images at Kuhs District

- **LiDAR offers an incredible view of the flood plain topography**

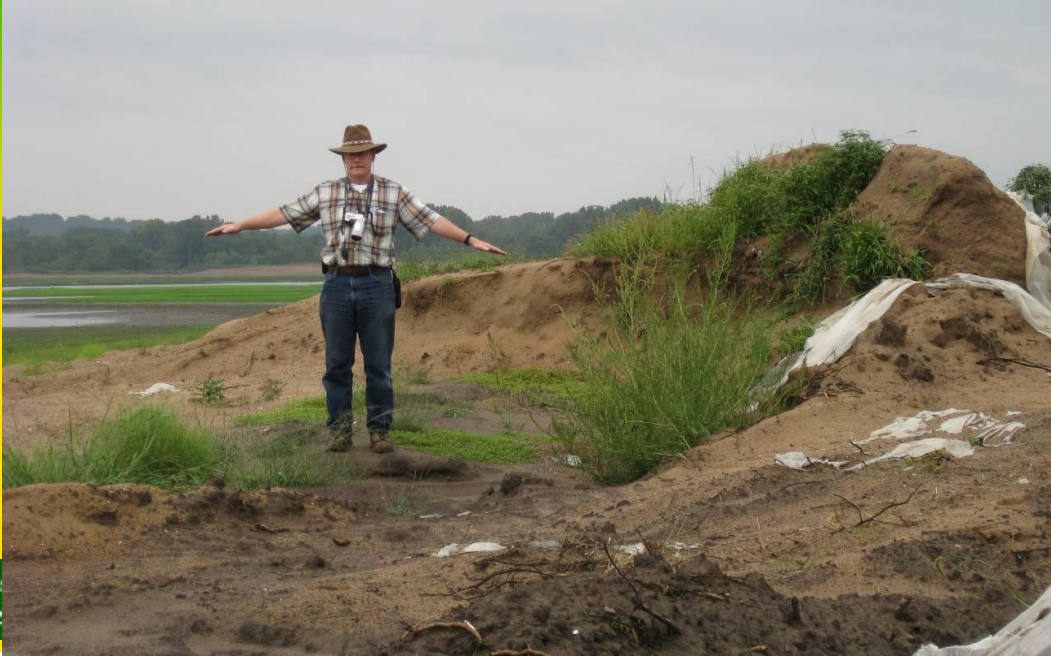
# Sand Shell Levees

- Sand shells provided an additional 5 ft
- Push-ups added another 5 ft

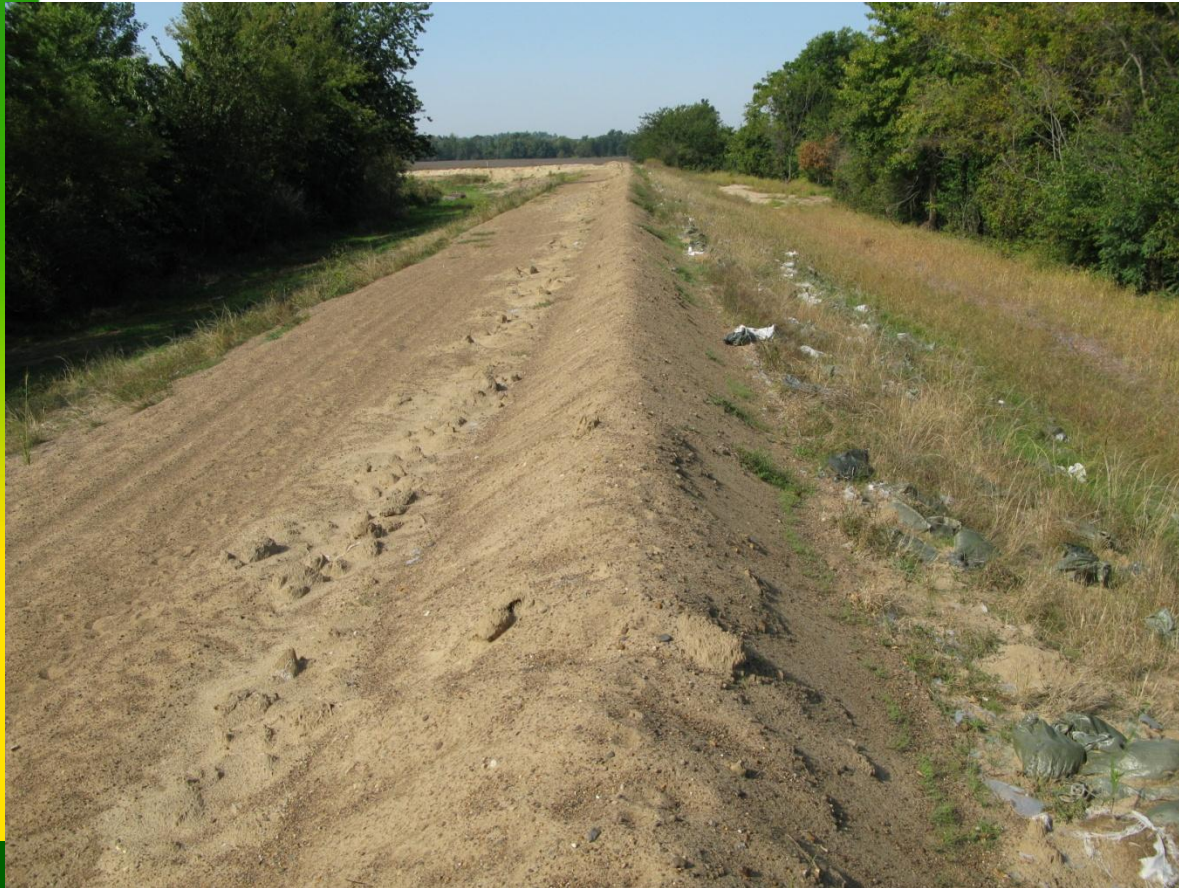
## Increased Flood Storage Using “Push-Ups”

- **After the 1993 floods the Rock Island District began using dozed sand “push-ups” instead of flash boards**

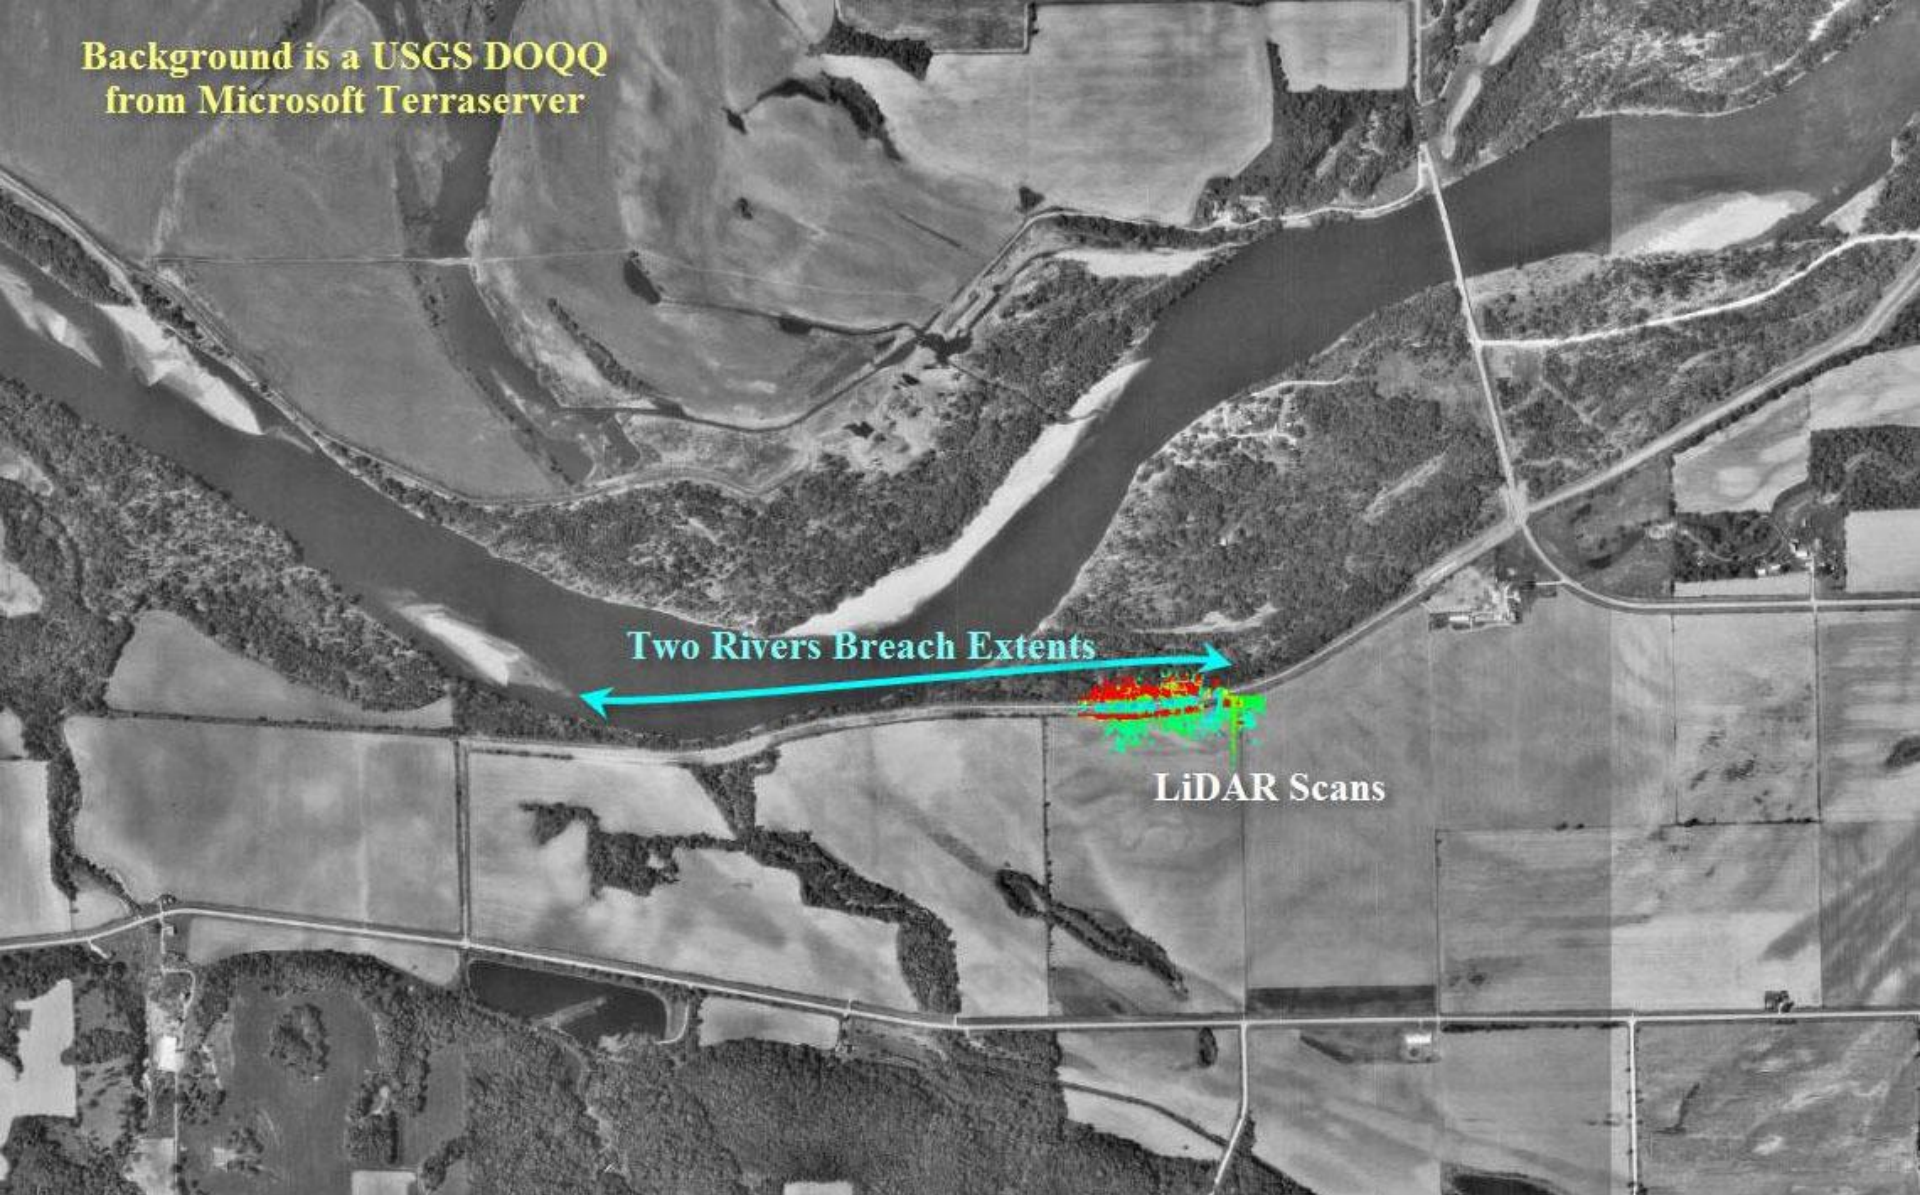
Two Rivers Breach Extents

- The breach along the southern bank of the lower Iowa River in the Two Rivers area southeast of Wapello, IA was one mile long. This break was a result of another break about 10 miles upstream, where US Hwy 61 crosses the river, which bifurcated the maximum flow, which re-joined at this location.

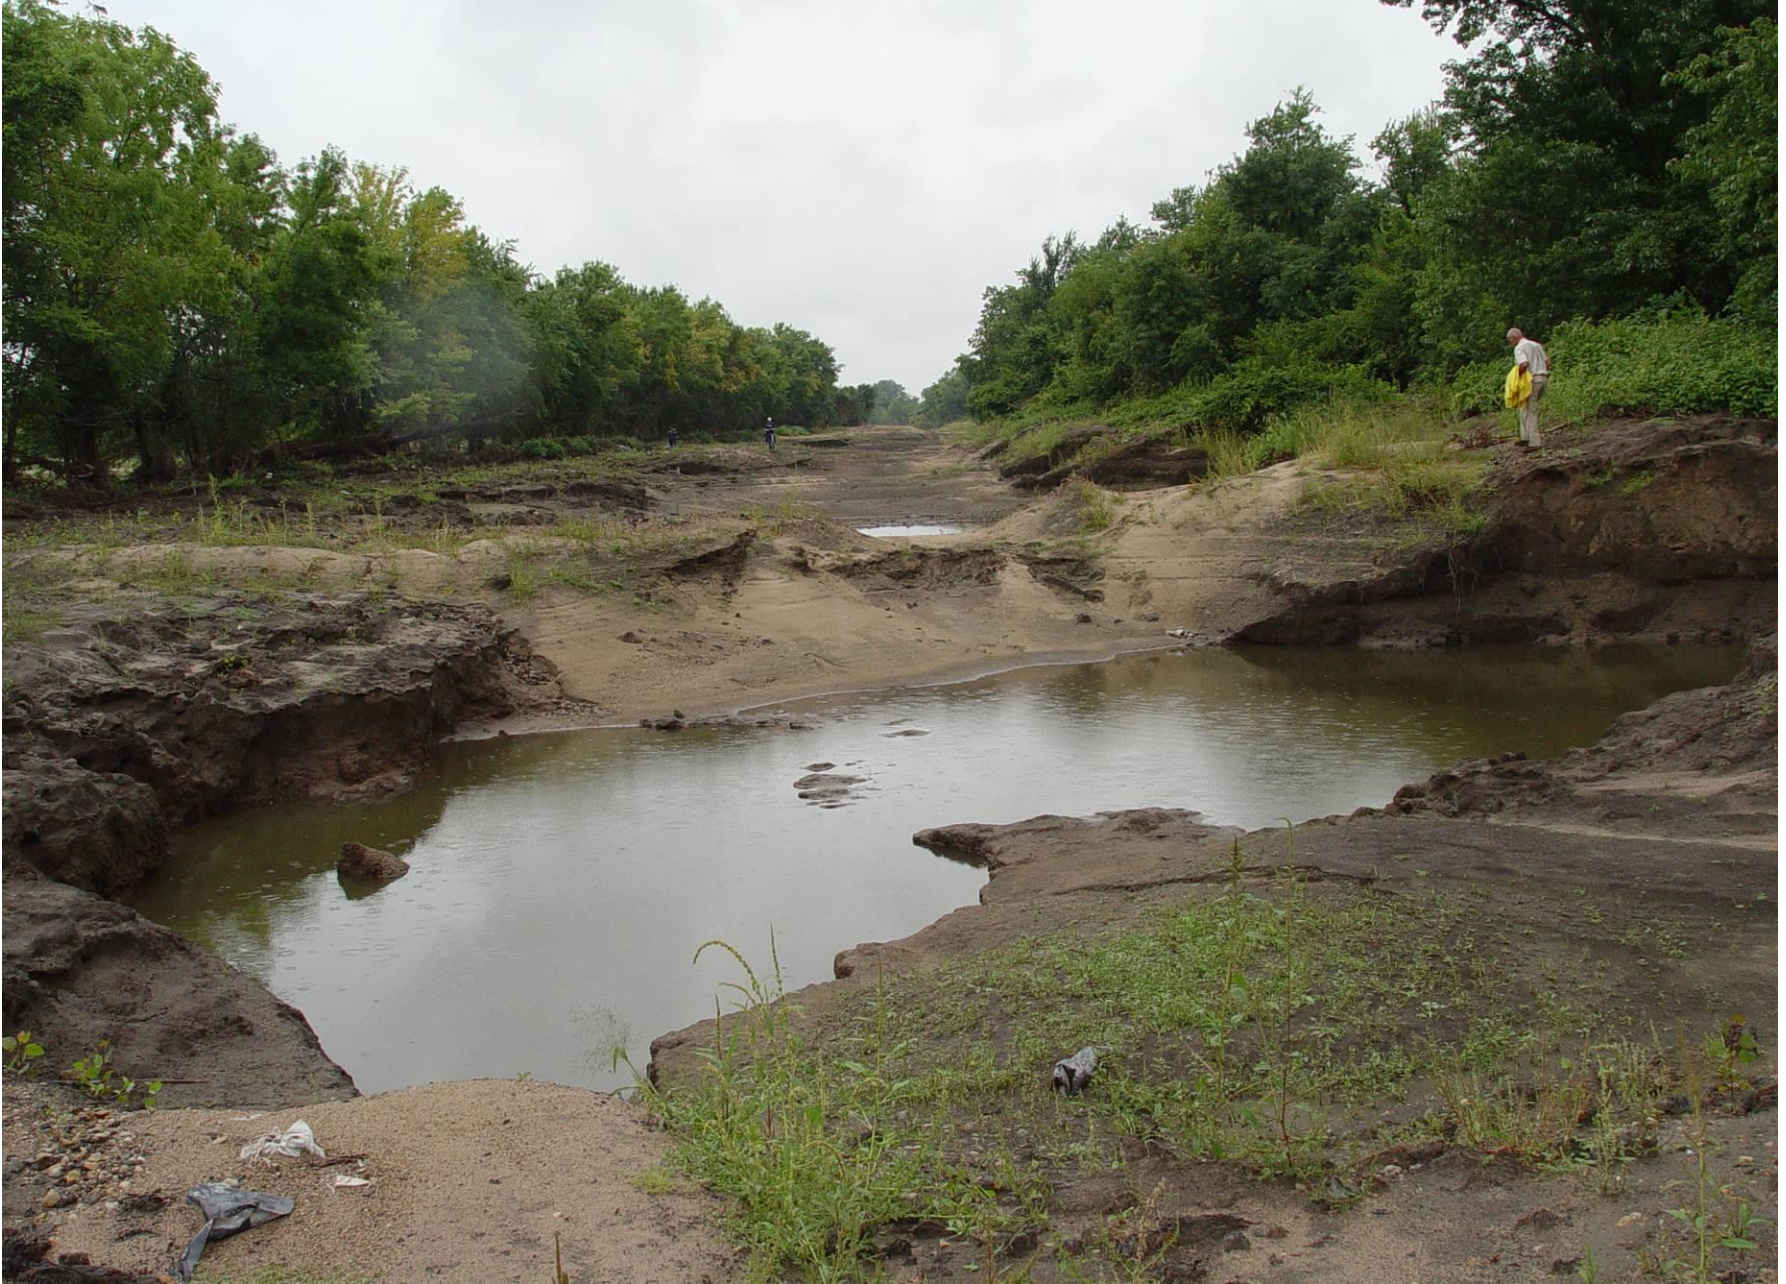
**Scour holes in a shale foundation testified to a large volume of water sweeping through, leaving almost no trace of the levee behind**
