# POST-FLOOD RECONNAISSANCE OF THE UPPER MISSISSIPPI RIVER VALLEY IN 2008

**J. David Rogers, Ph.D., P.E., R.G.**  
Natural Hazards Mitigation Institute  
Missouri University of Science & Technology

for the symposium on  
**Geologic Studies for Dams and Levees**  
**Association of Environmental & Engineering Geologists**  
**Lake Tahoe, California**  
**September 25, 2009**

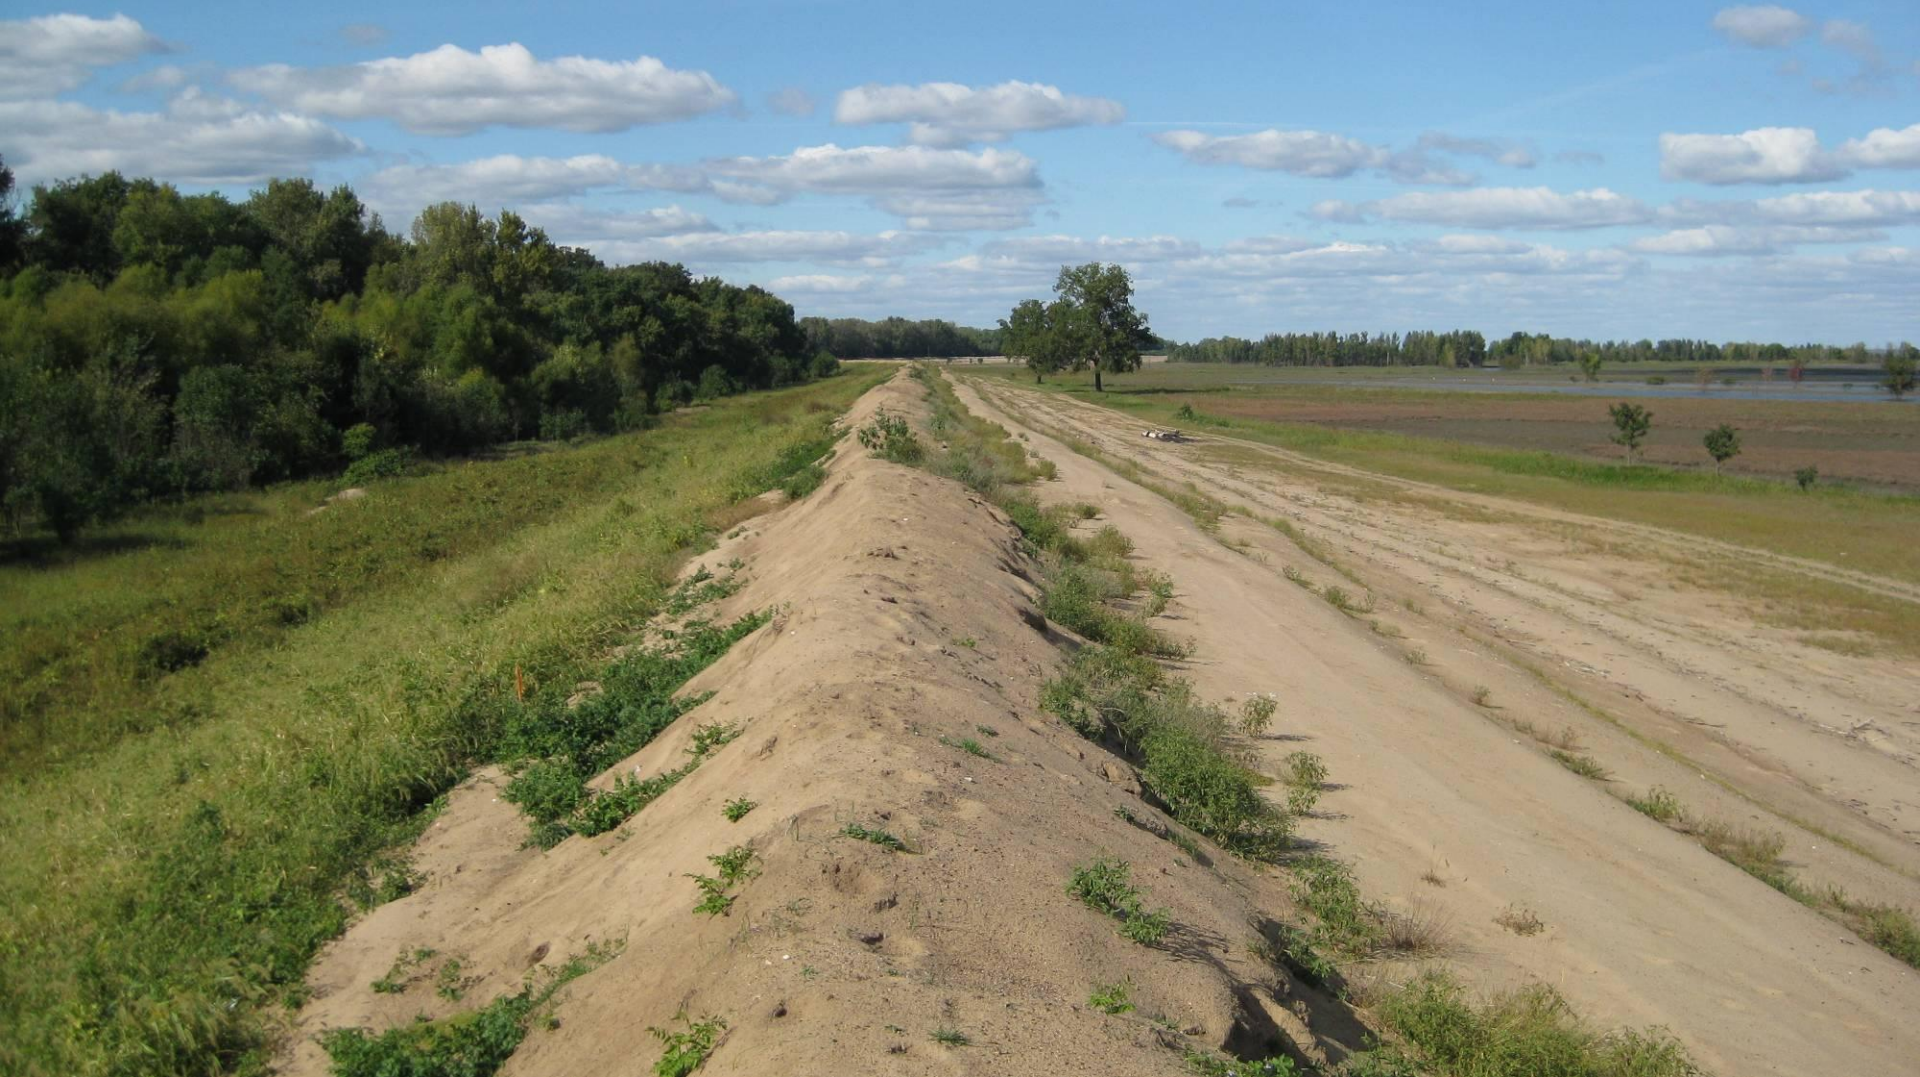
- **FEMA pays for the sand push-ups, but does not pay to have them removed after flooding subsides. This cost is born by local levee districts**

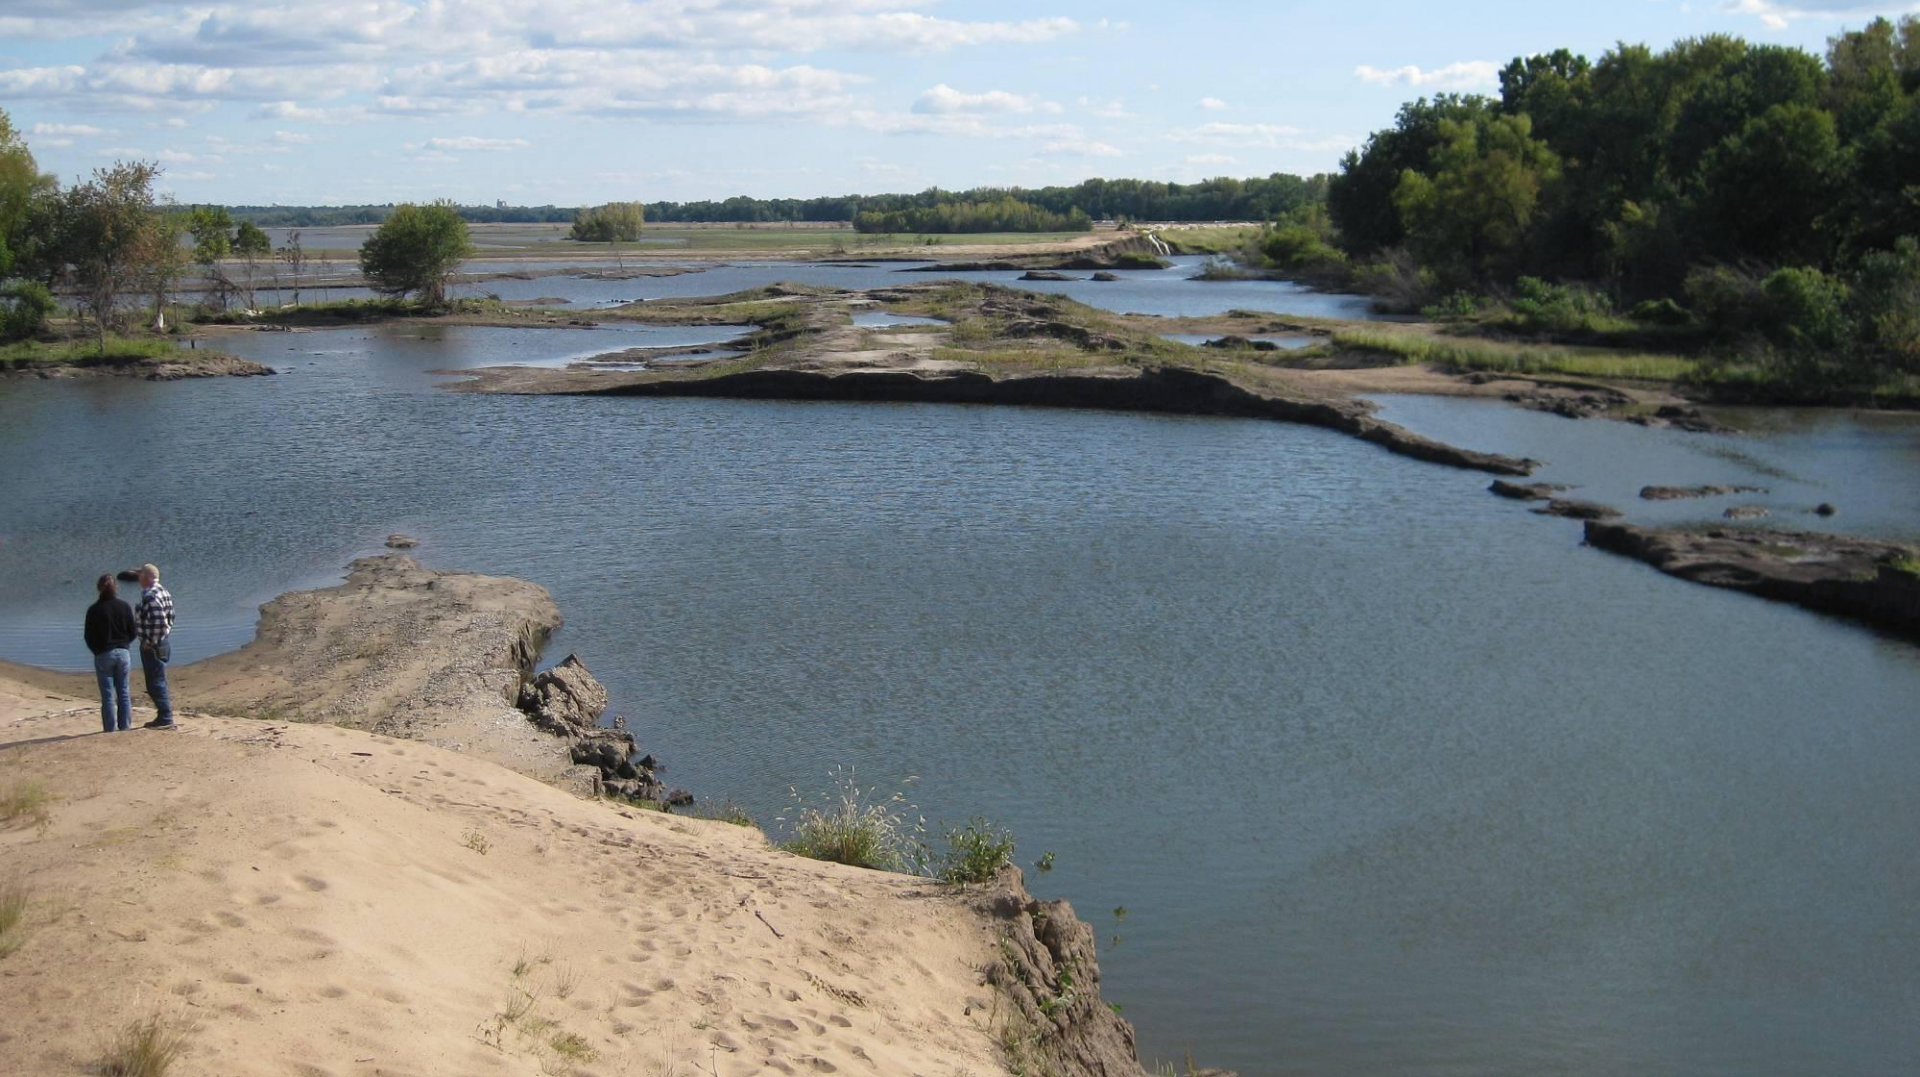
- **1300 ft wide breach at Indian Grave, near Quincy, IL. Failures have occurred here in 1947, 1965, 1993, and 2008. Four floods in 61 years is once every ~15 yrs. These agricultural levees are rated by the Corps of Engineers as 14-yr flood protection structures.**

**Setback protective levees needed, beyond the prominent channel networks. Training levees, fitted with control structures, can remain closer to the main channel. Consider returning about 25% of the river's floodplain back to flood storage**

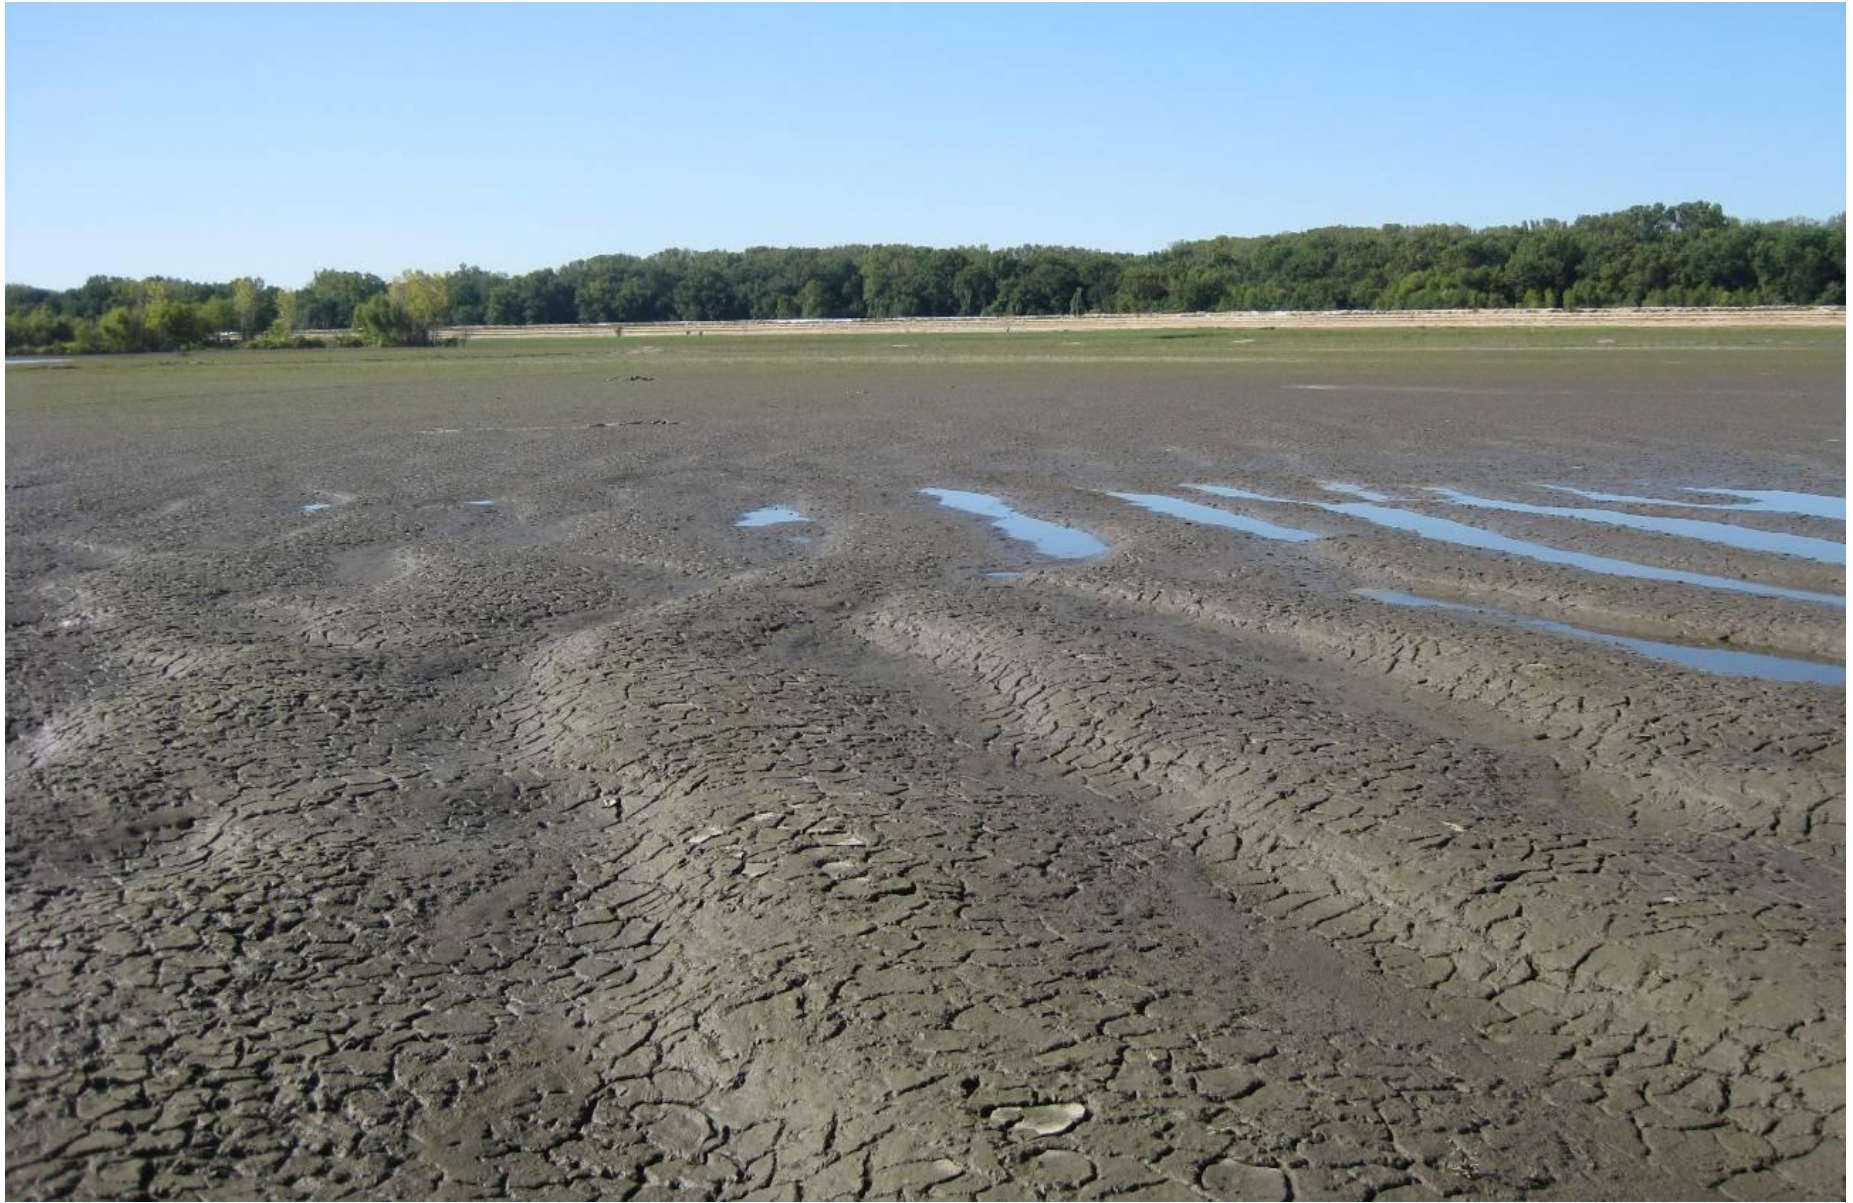
- **Ripple marks in aggraded sands at Indian Graves. Sand blanket up to 6 ft thick**
