# Construction of the Alcan Highway in 1942

**“One of the Top 10 Construction  
Achievements of the 20th Century”**

**J. David Rogers, Ph.D., P.E., P.G.**

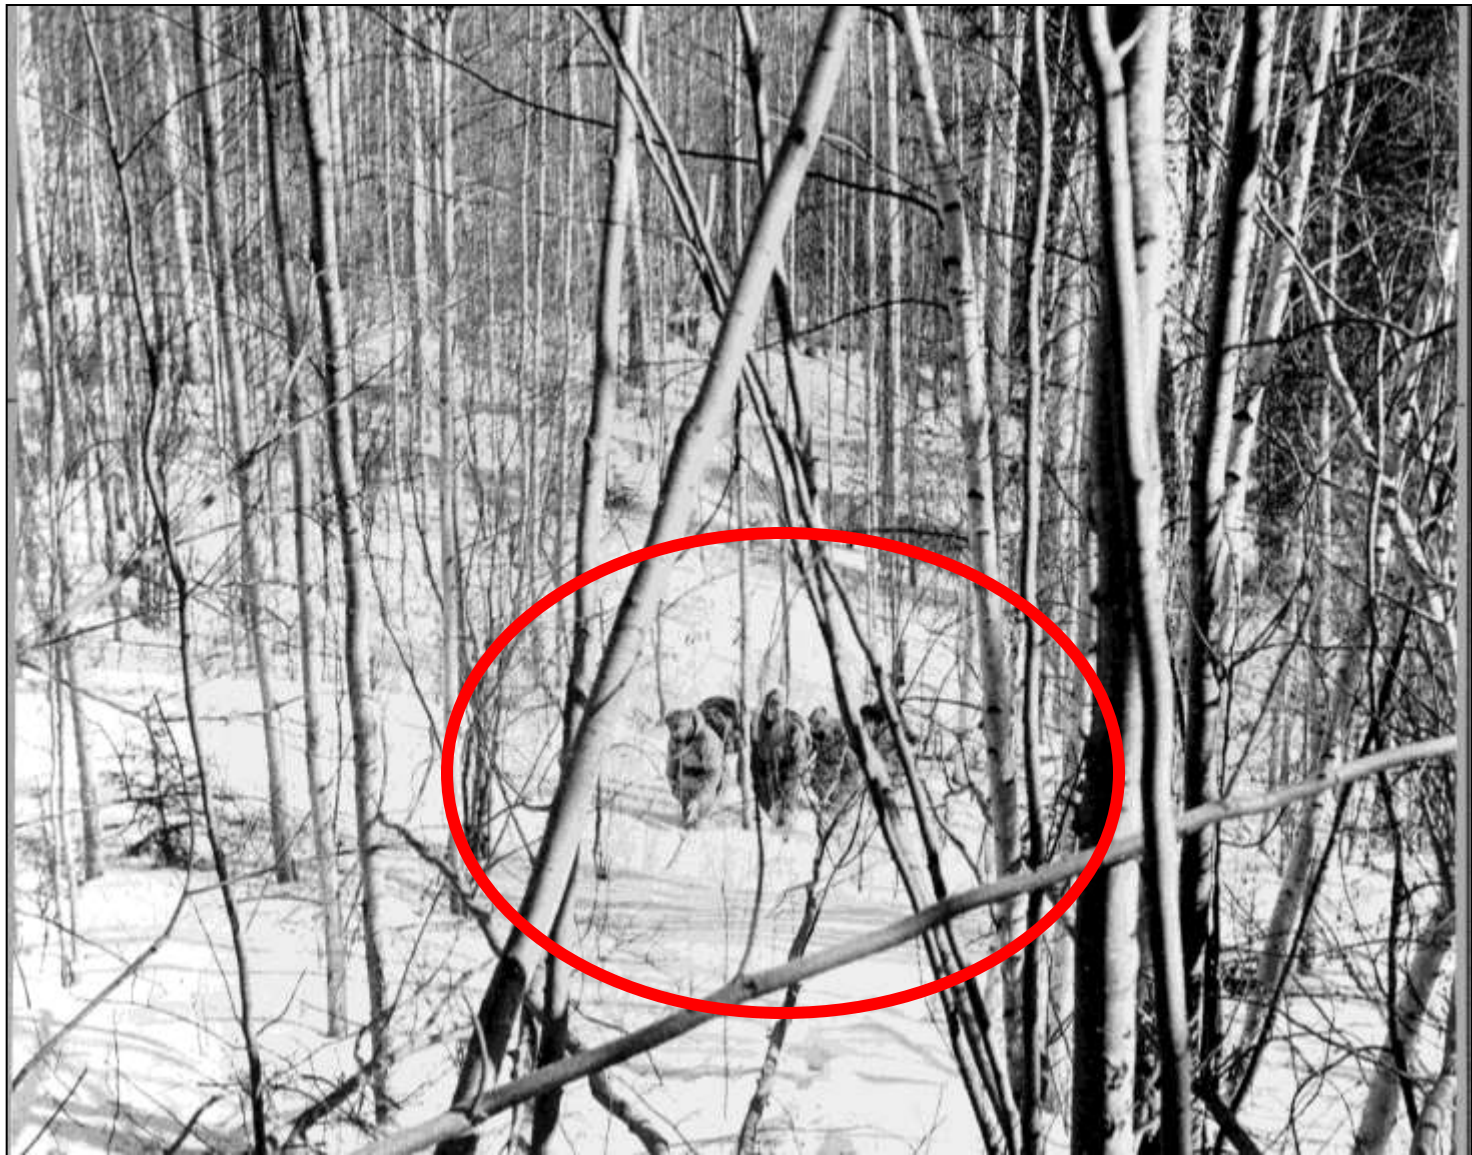
**Route surveying was made difficult by the adverse weather and heavy vegetation, which limited sighting distance**

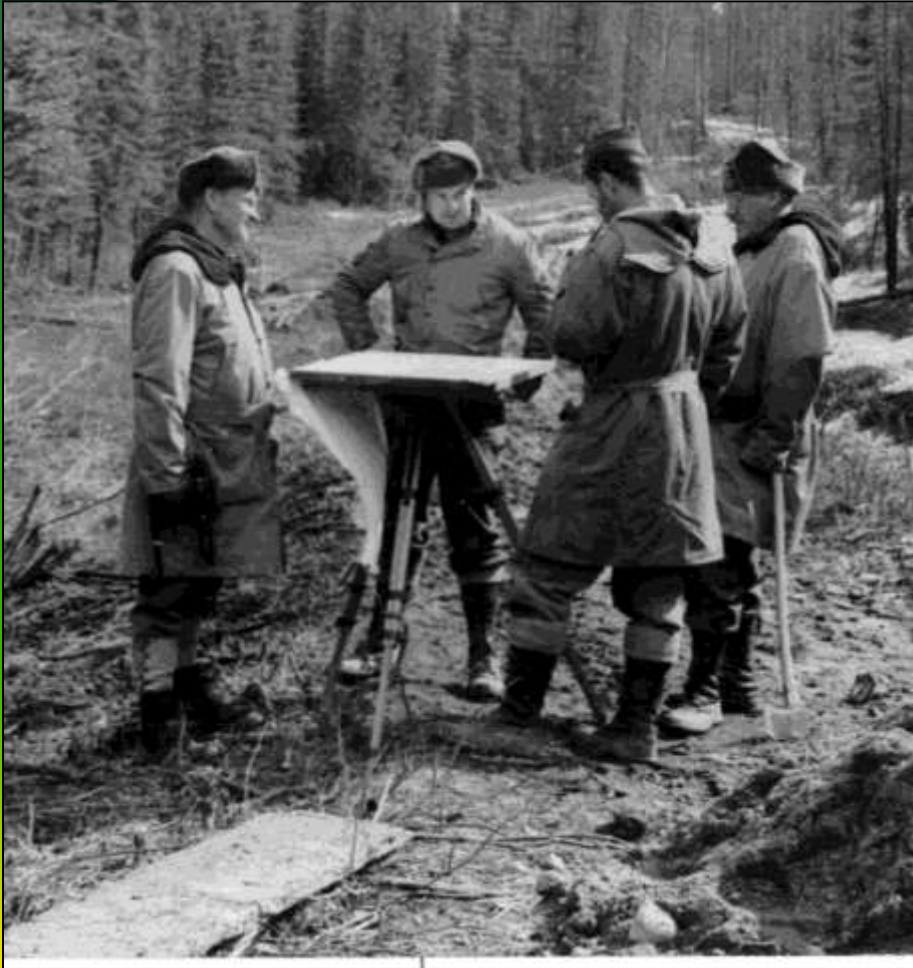
**A traverse team and recorders do final calculations to verify that the intended road meets specifications.**

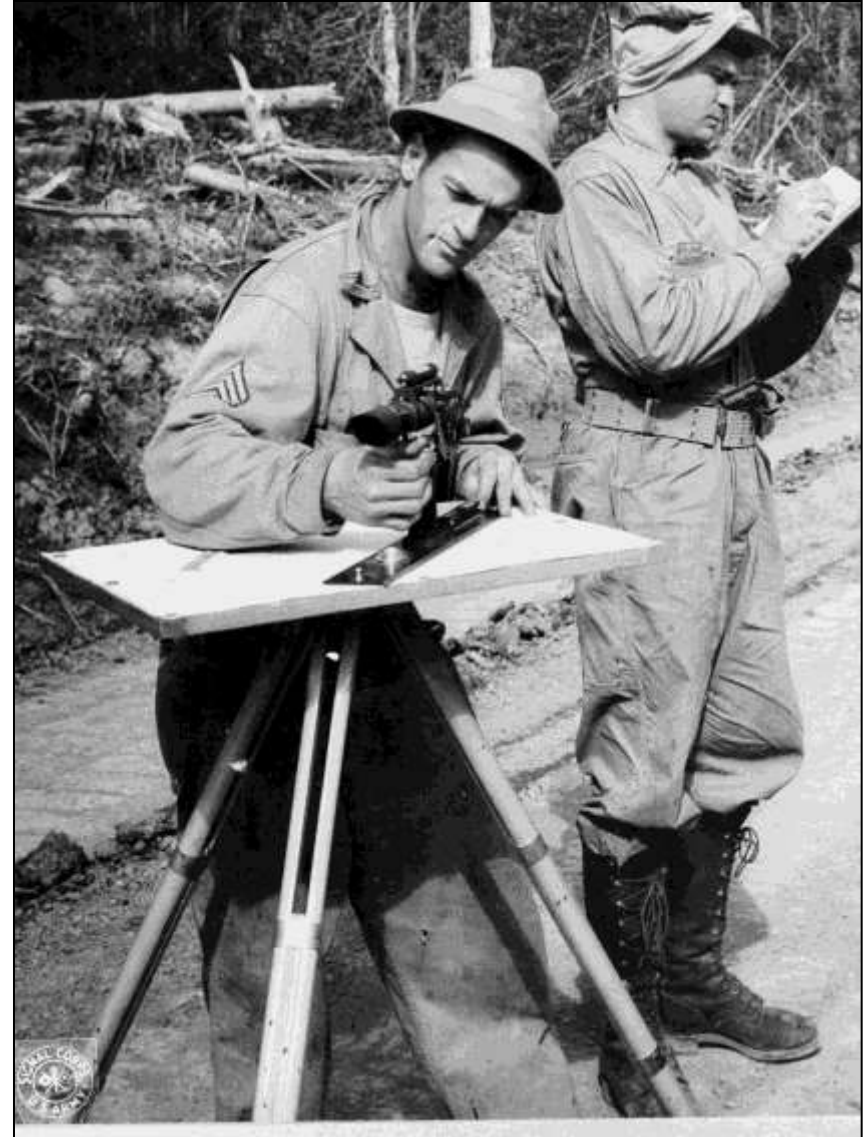
**These shots show two of the plane table survey teams, who fixed vertical elevations along the path**

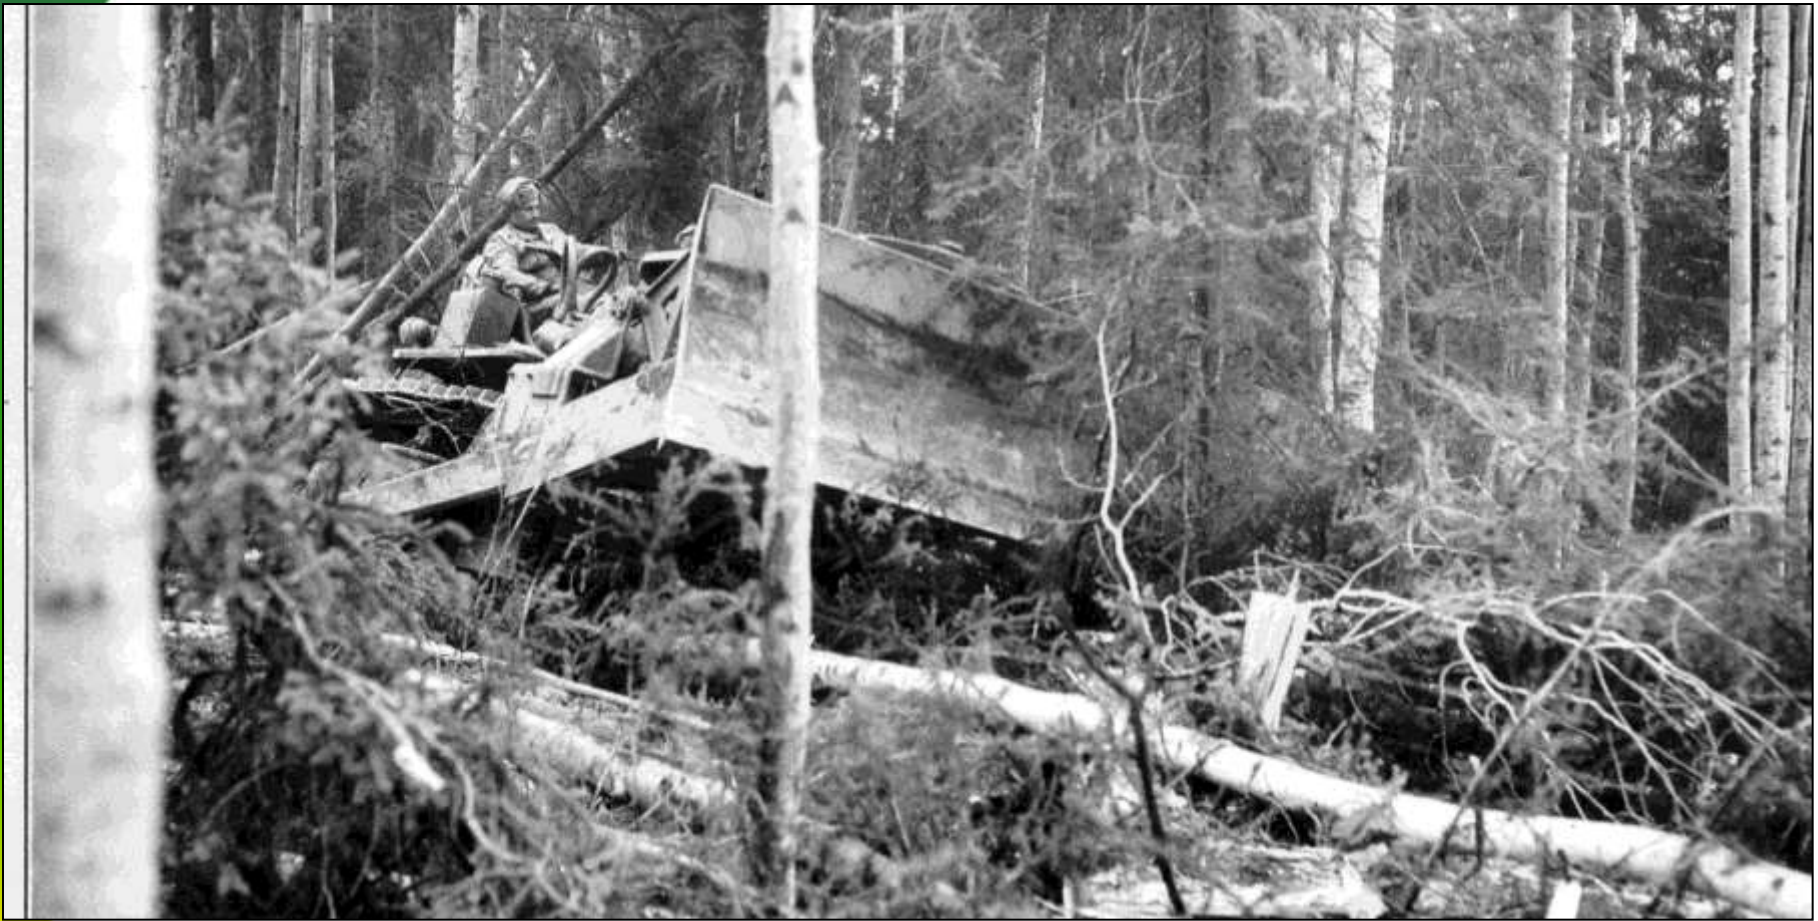
**Once the heavier equipment arrived, clearing a path became easy. Here a D-8 bulldozer clears a path.**

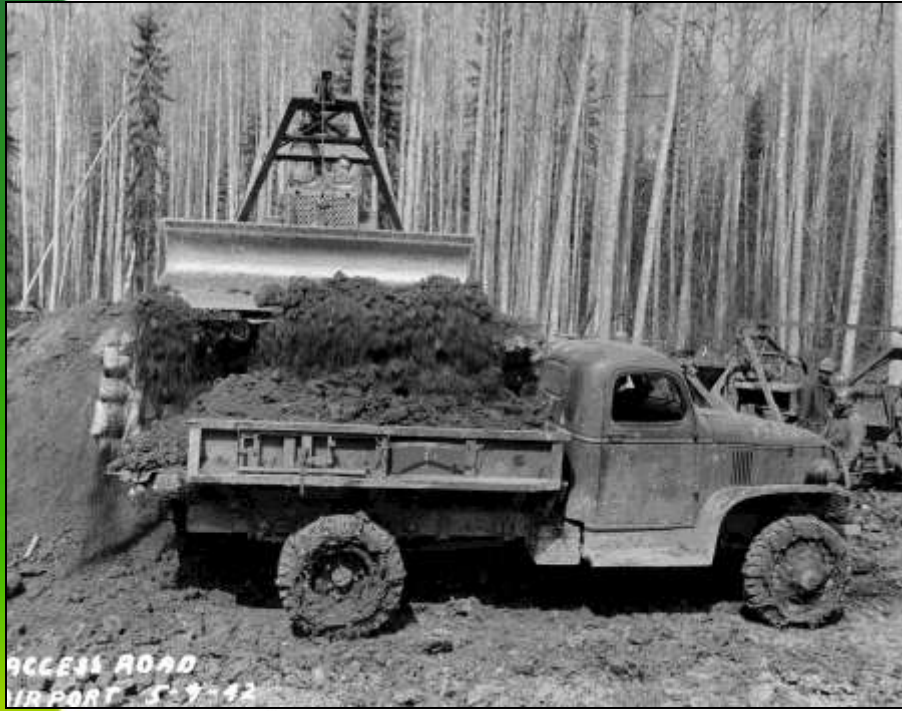
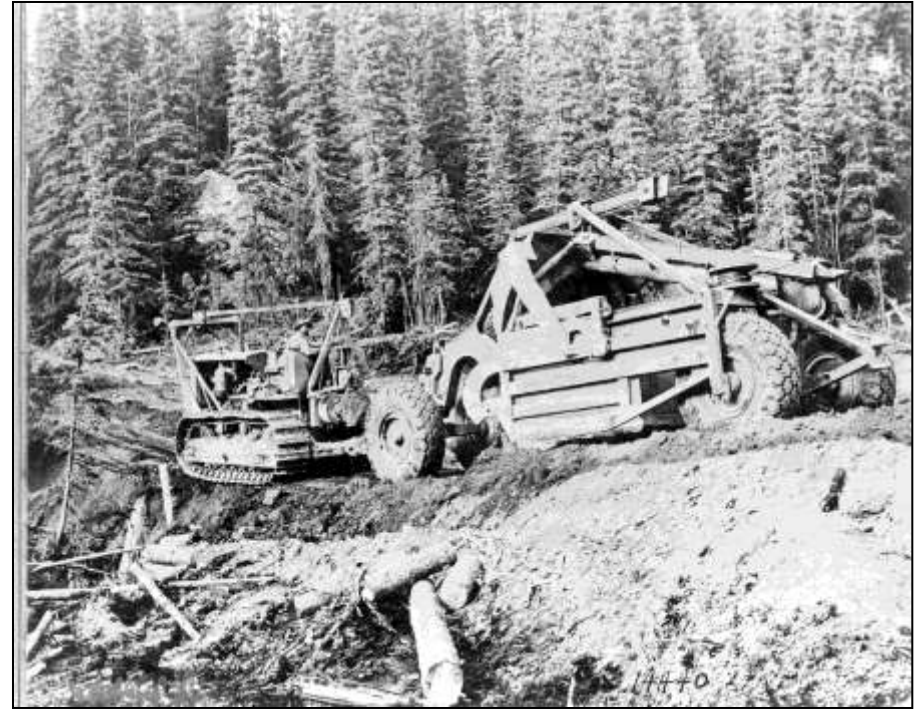
**Army Engineers used the best equipment available at the time, including Dodge and GMC dump trucks, various crawler tractors, like the D-4 shown here, and Letourneau Carryall scrappers. A decade earlier very little of this earthmoving equipment existed.**

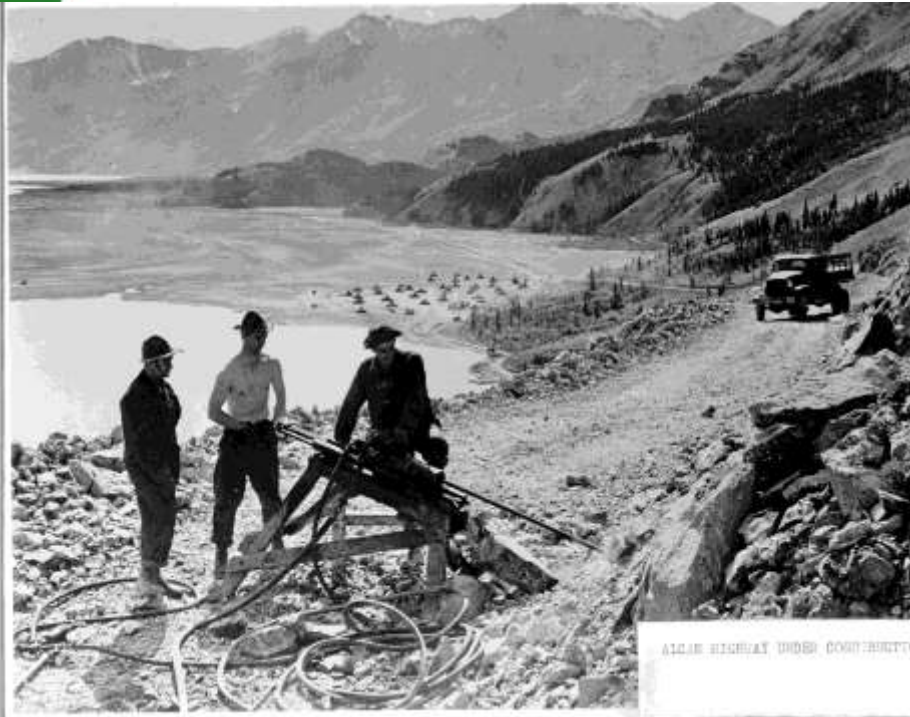
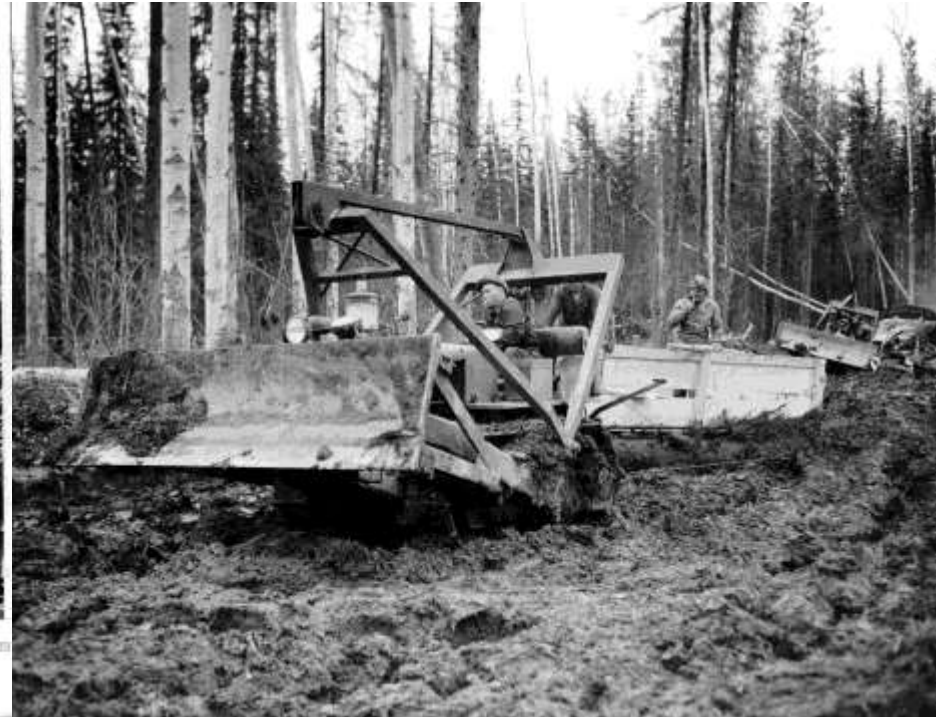
Left – Soldiers using an Ingersoll-Rand pneumatic drilling rig to excavate blast holes for a rock cut

Right – Small dozer pulling a **log dump sled**, which were fashioned by the men on site to better spread loads on the mushy, muddy ground

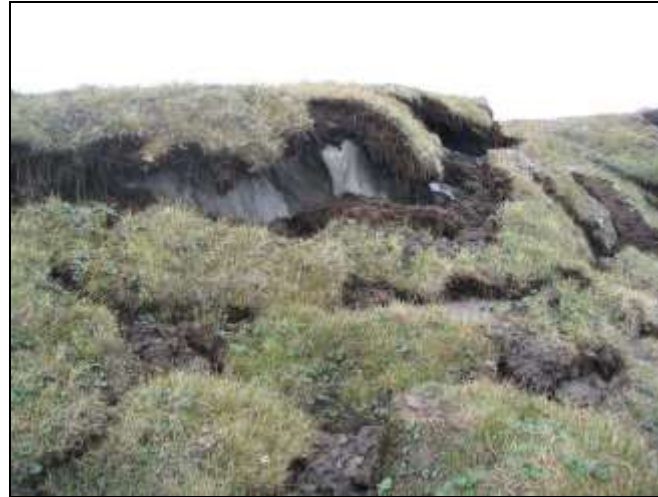
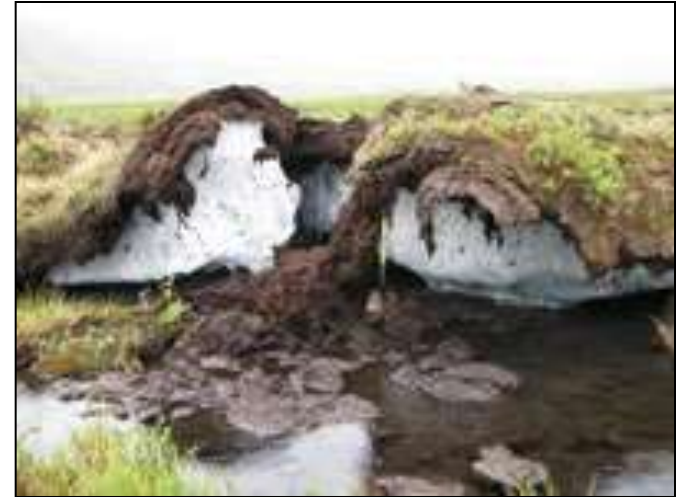
Inclusions of **glacial ice** are commonly found in **permafrost**. These were impediments to grading, like large boulders.

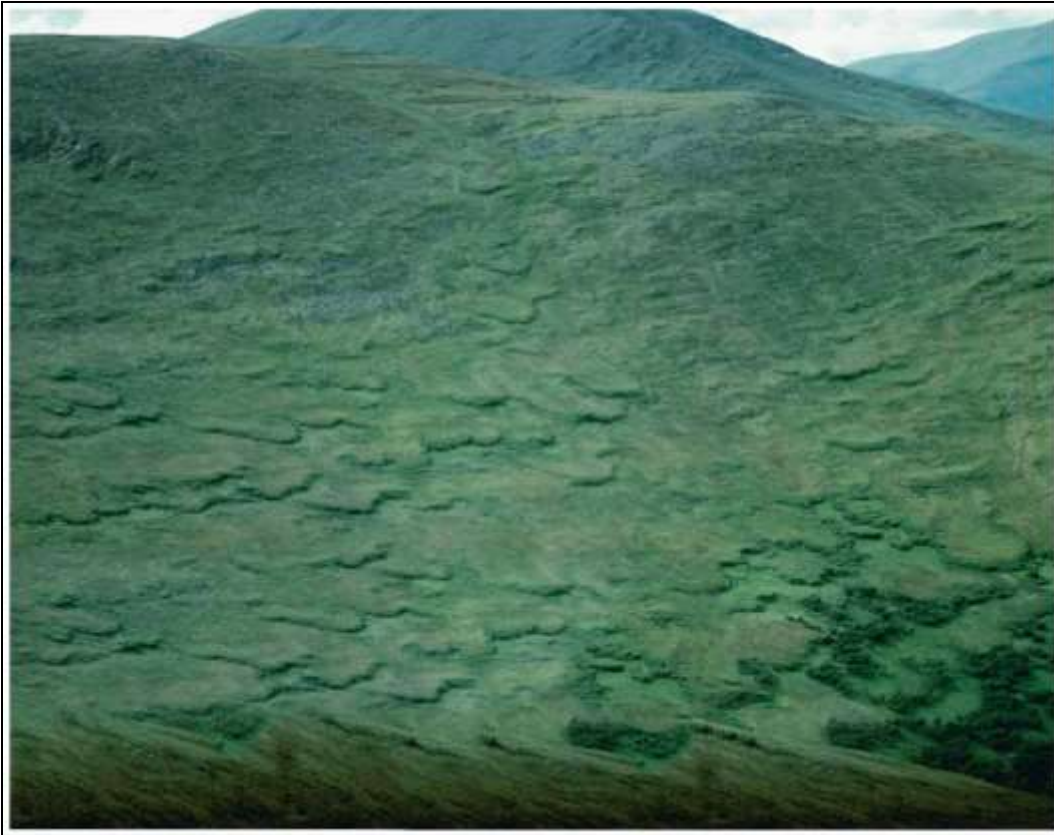
- Soils in the thawed active layer overlying the permafrost tend to creep downslope during the warm season through a process known as **“solifluction.”** This process is exacerbated by the inability of percolating rainfall to penetrate the permafrost, leading to the active layer becoming super saturated.

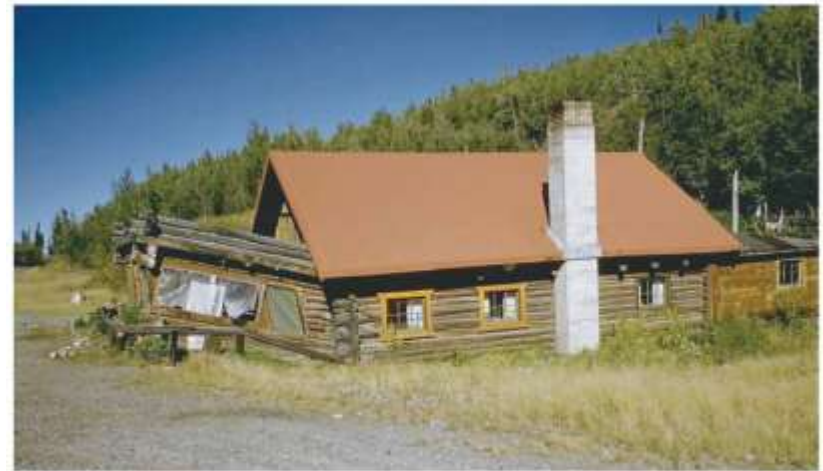
**Heat radiated by structures or their supporting elements can trigger differential settlement by thawing portions of the underlying permafrost**

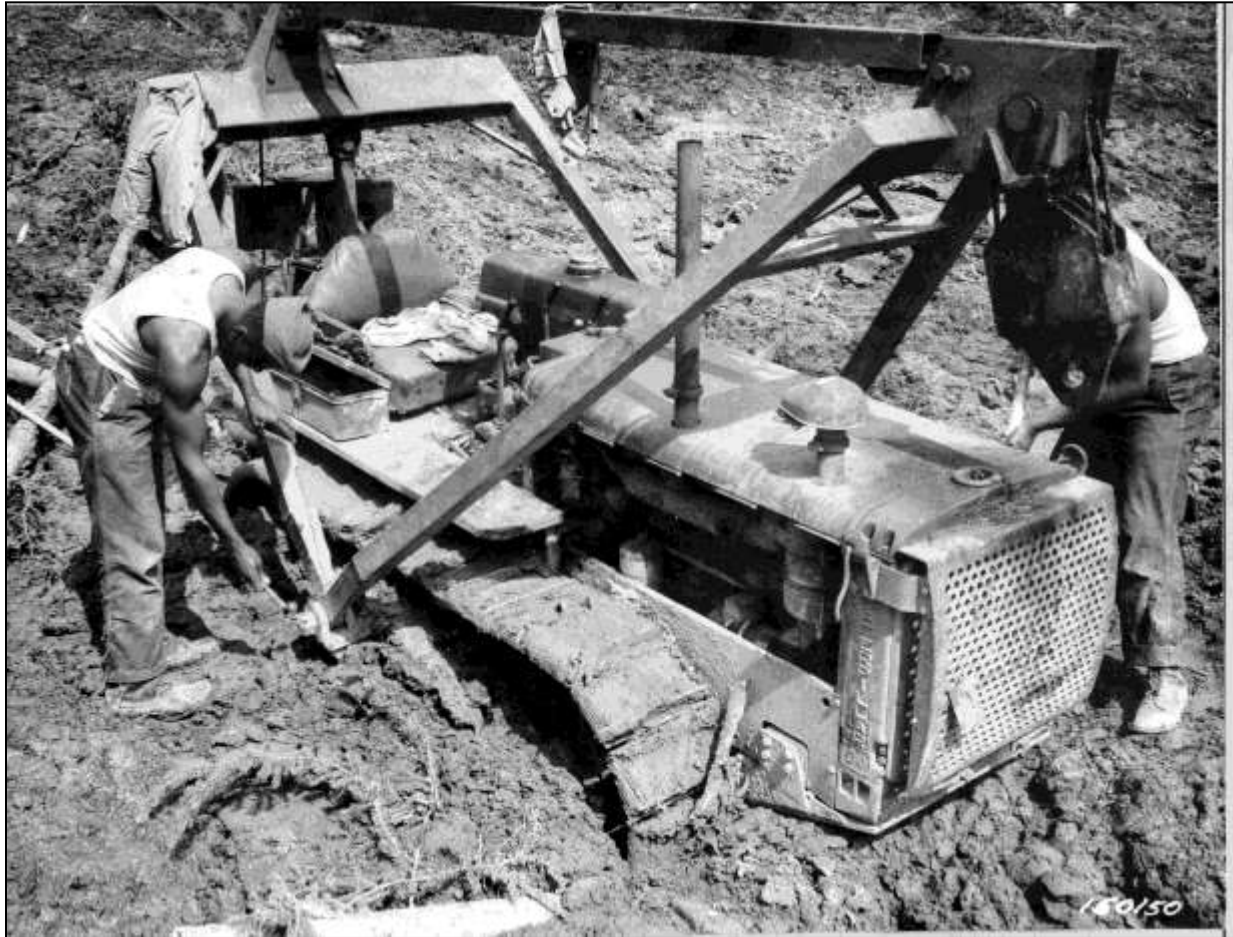
**MUSKEGS** are like a muddy version of quicksand. A vehicle would pass through a muskeg once, but within a short time, the area would turn into liquid mud, losing shear strength. Once caught, a vehicle had to be pulled out.

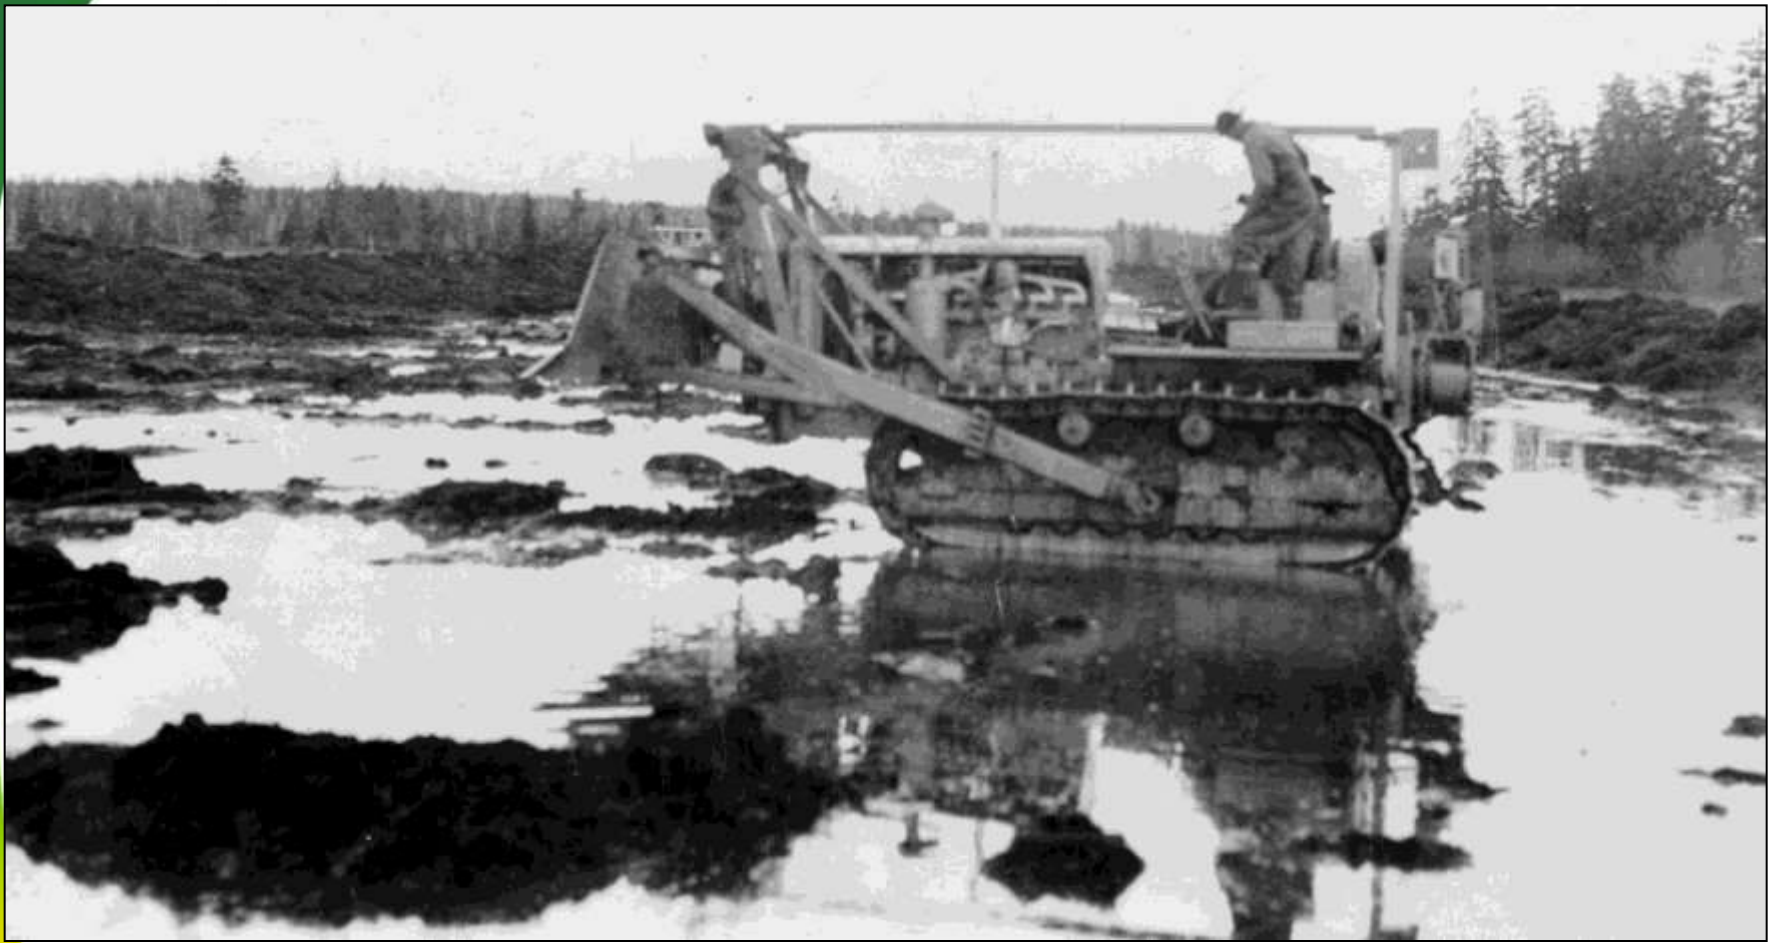
**A road in a muskeg without corduroy surfacing.  
The dozer is fine ridding on the permafrost until  
it encounters a unfrozen muskeg.**

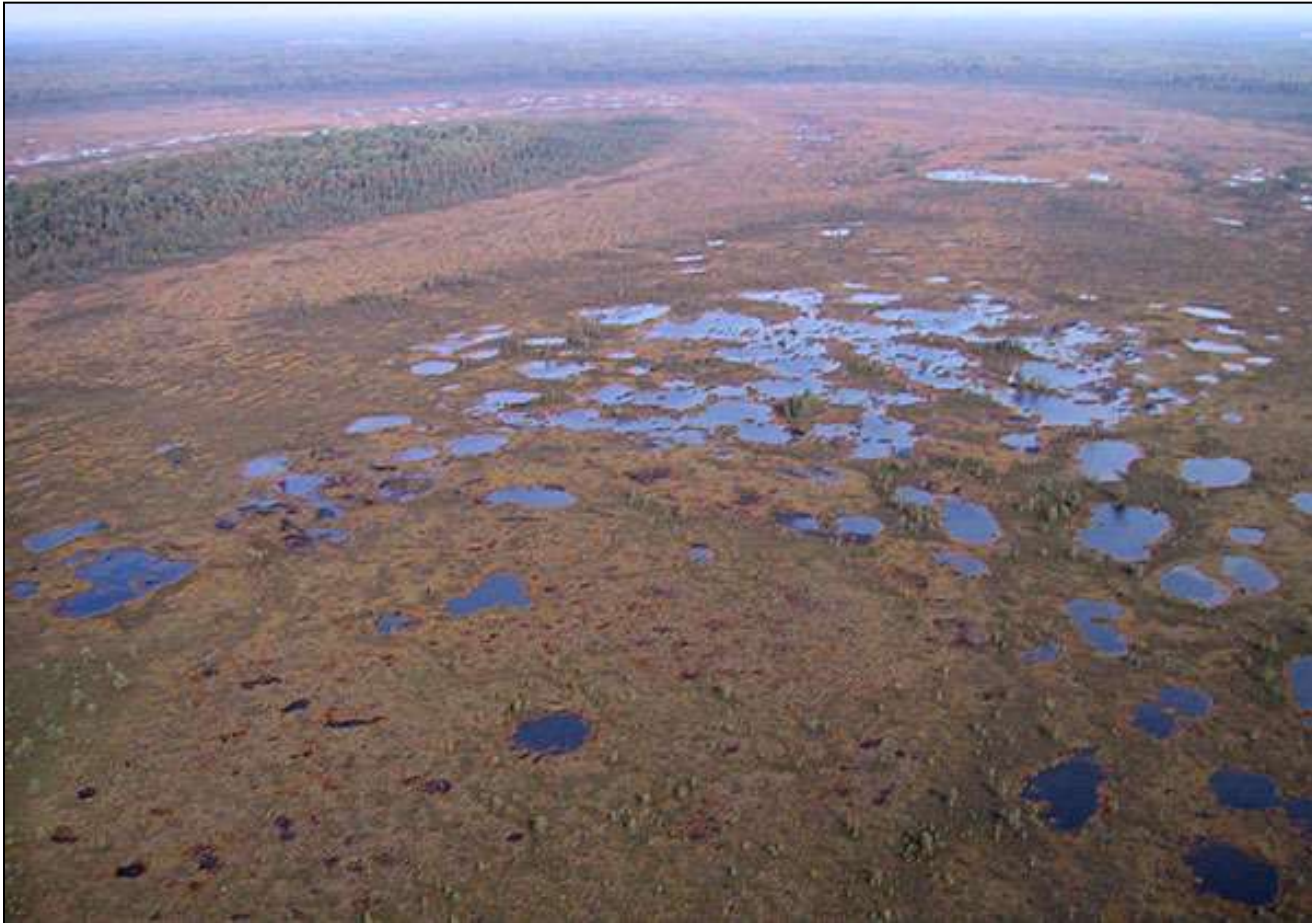
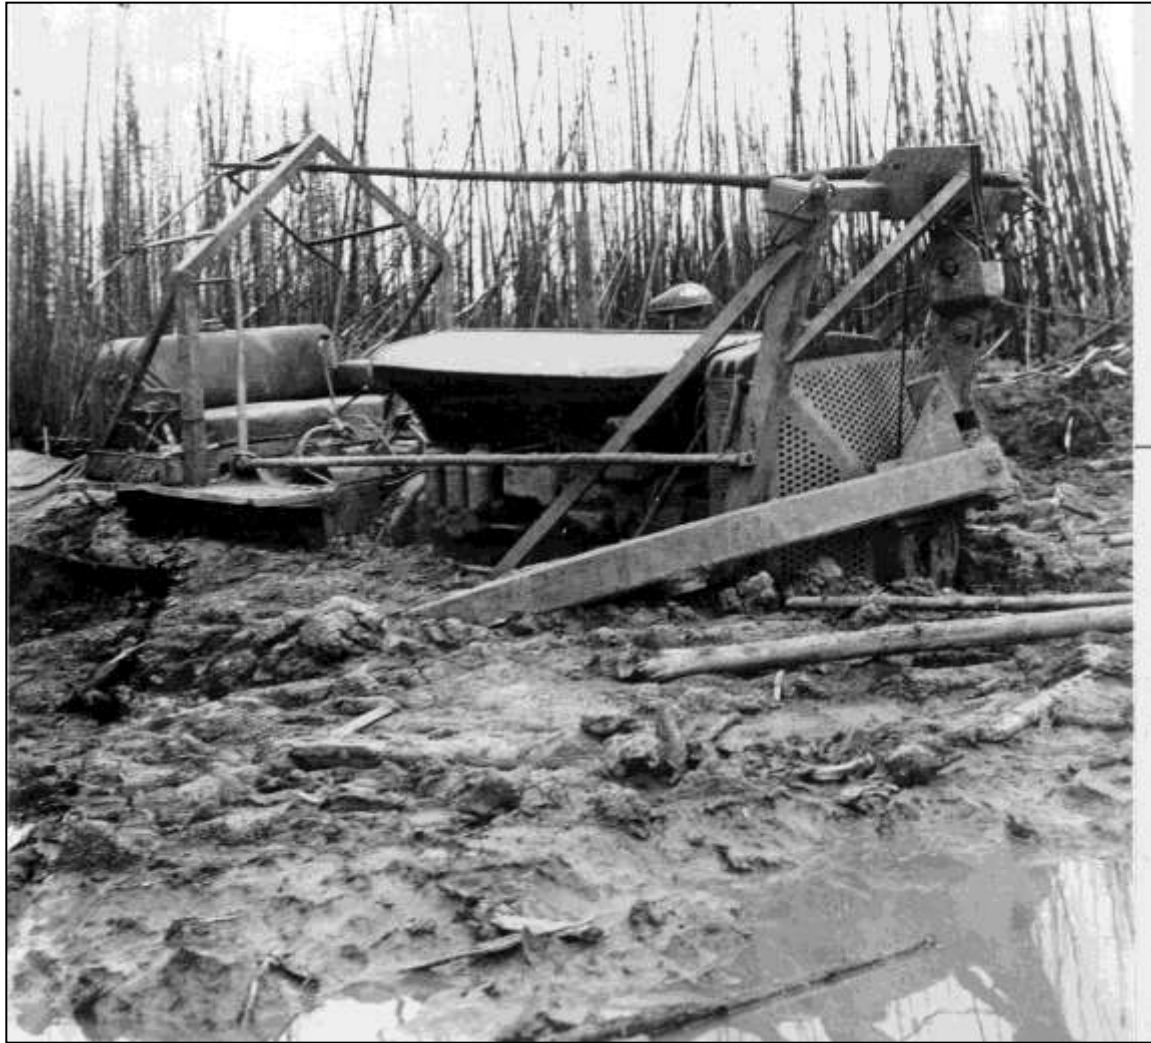
- Muskegs are deep bogs of **sphagnum peat**, frequently covered by grassy tussocks, which grow in wet, poor drained boreal regions, usually areas with permafrost. They are sometimes referred to simply as “peat bogs.” These pools are insulated if > 6 or 8 feet deep.

- Muskegs sometimes appeared to “swallow” the heavier equipment, then exhibiting *thixotropy*, by “setting up.”

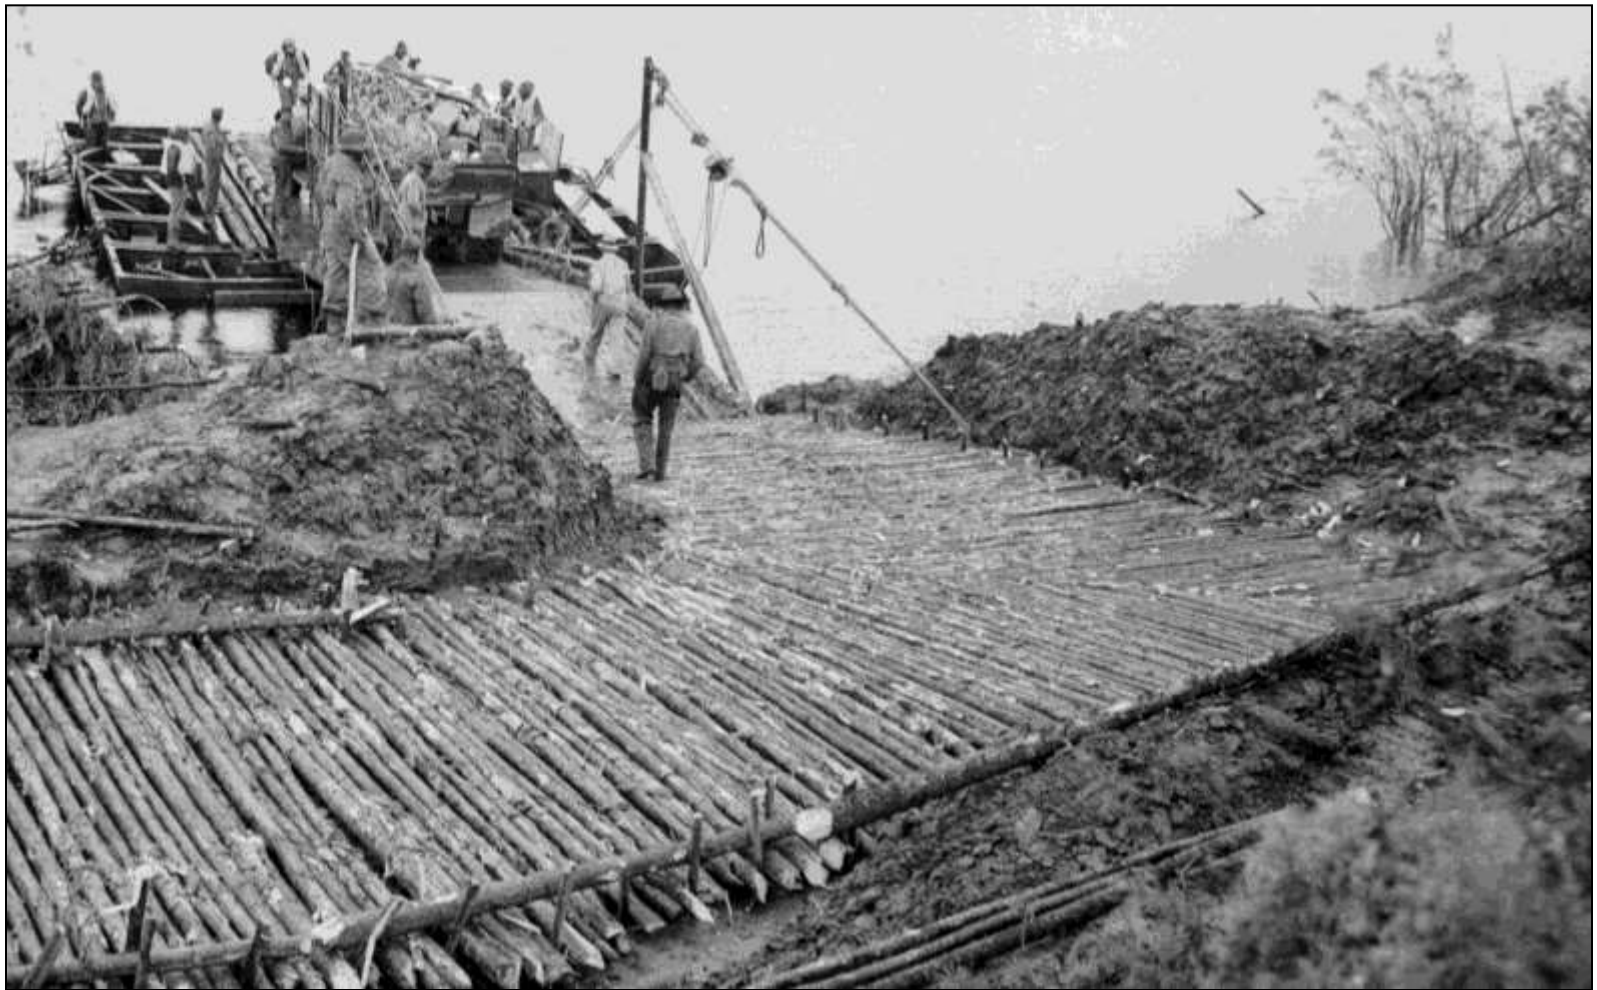
- To overcome the liquid mud created by disturbed Muskegs, the Engineers laid **corduroy**, just like the Romans.
- Corduroy road surface is constructed by first laying piles of brush, then logs, then more brush, and more logs, and finally a layer of gravel.
- In one stretch, two miles of corduroy was laid. Overall, over 100 miles of muskeg was corduroyed in this manner.

**Corduroy road surface under construction.** Some 100 miles (160 km) of route between Burwash Landing and Koidern, Yukon, became nearly impassable in May and June 1943, as the permafrost thawed, no longer protected by a layer of delicate vegetation. A corduroy road was built to restore the route, and corduroy still underlays old sections of highway in the area.

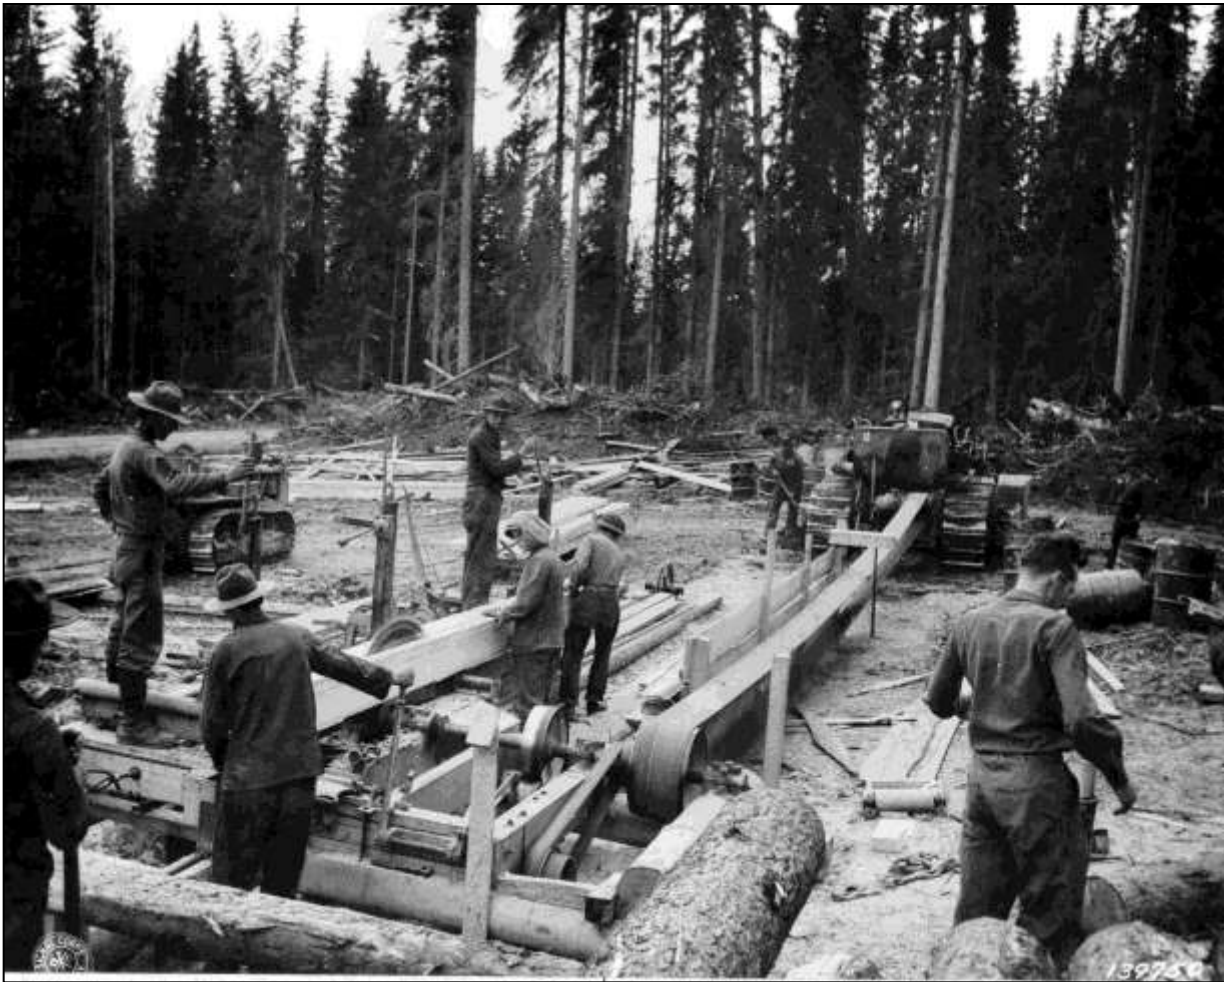
- **Portable sawmill operations set up by one of the regiment's sawmill companies. Prior to the Army's January 1943 reorganization, Combat Engineer Regiments included quarry, sawmill, construction, and camouflage companies.**

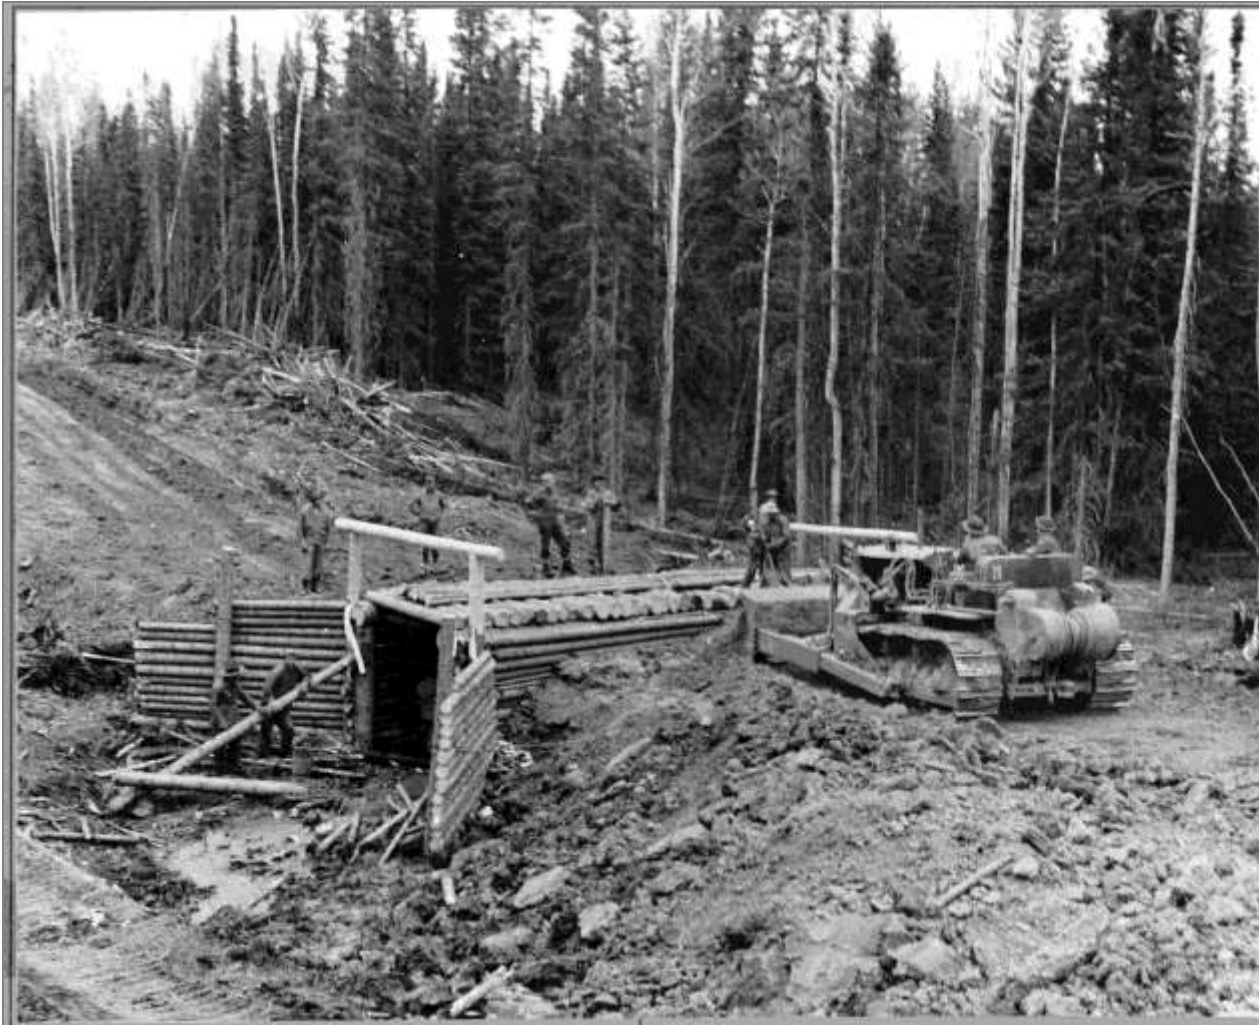
- **Log box culverts** were used everywhere along the highway to speed up construction because timber was the only material that was readily available.

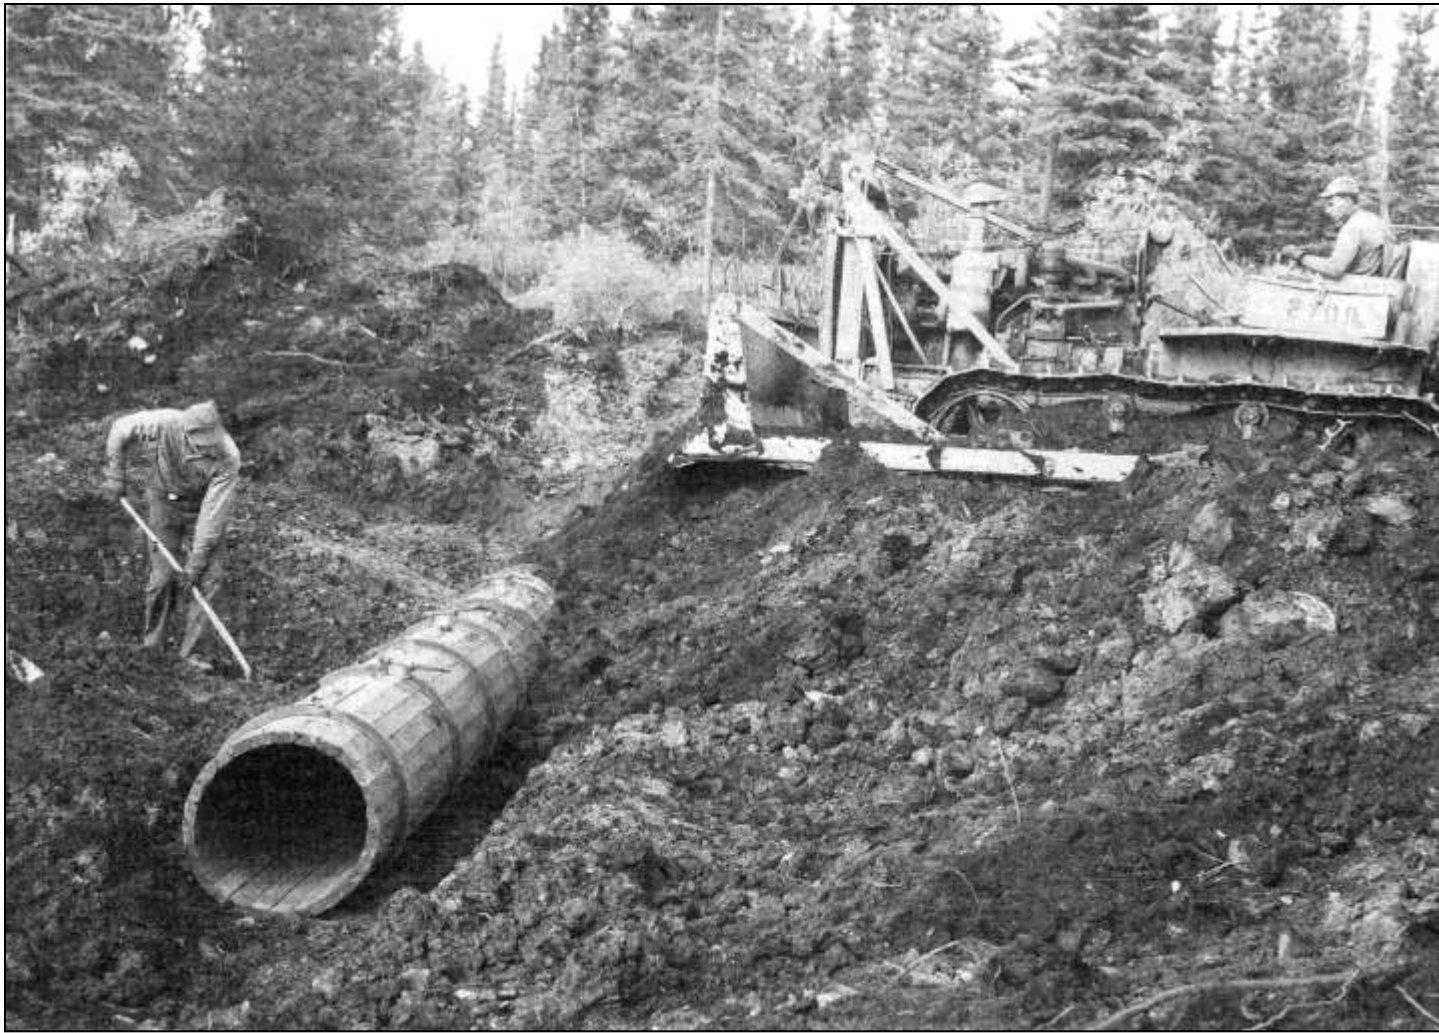
- **“Compaction dams”** could also trigger wholesale landslippage along even the smallest culverts, as sketched here.

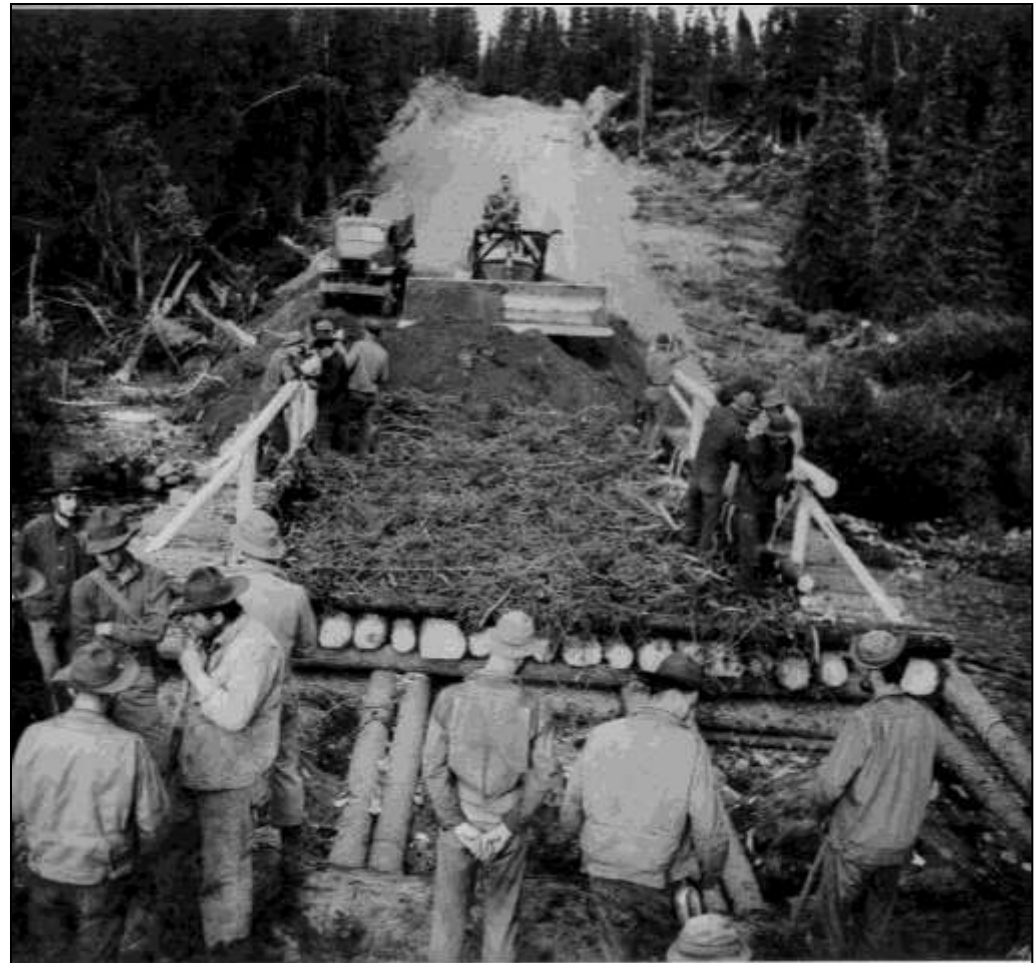
Dozer drifting roadway fill over a **protective evergreen brush layer** that served as an **effective filter and aerator**, protecting the logs from dry rot and preventing the fill from spilling through the slits between the logs.

- The larger culverts were generally constructed from the surrounding wood.
- They were intended to be temporary until the contractors came through to improve the road.
- Here you see construction of one of these temporary culverts. After the wood frame was erected, a brush layer was placed to protect the supporting logs and prevent the base course from sifting through. A bulldozer would then fill and level the basecourse over the top of the timber culvert.
