# Construction of the Alcan Highway in 1942

**“One of the Top 10 Construction  
Achievements of the 20th Century”**

**J. David Rogers, Ph.D., P.E., P.G.**

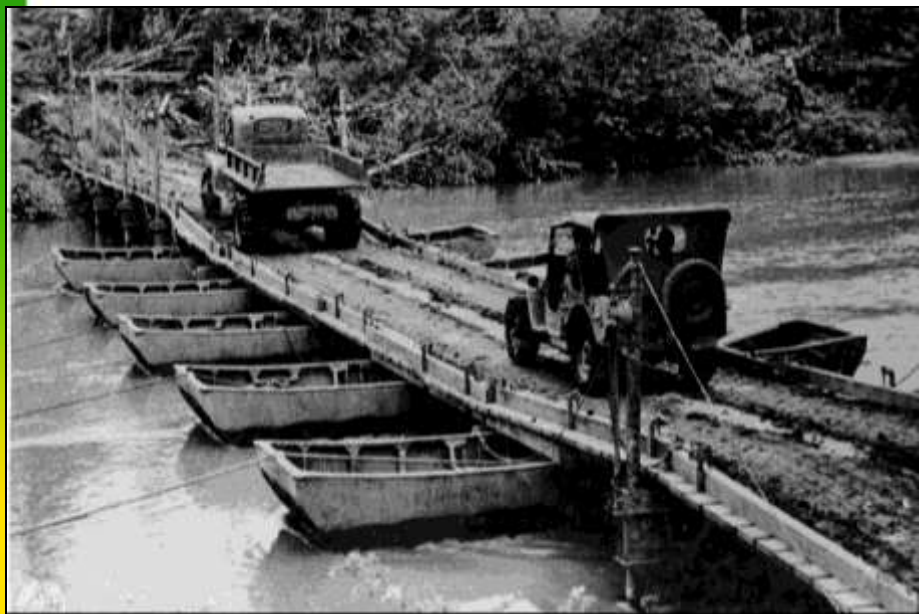
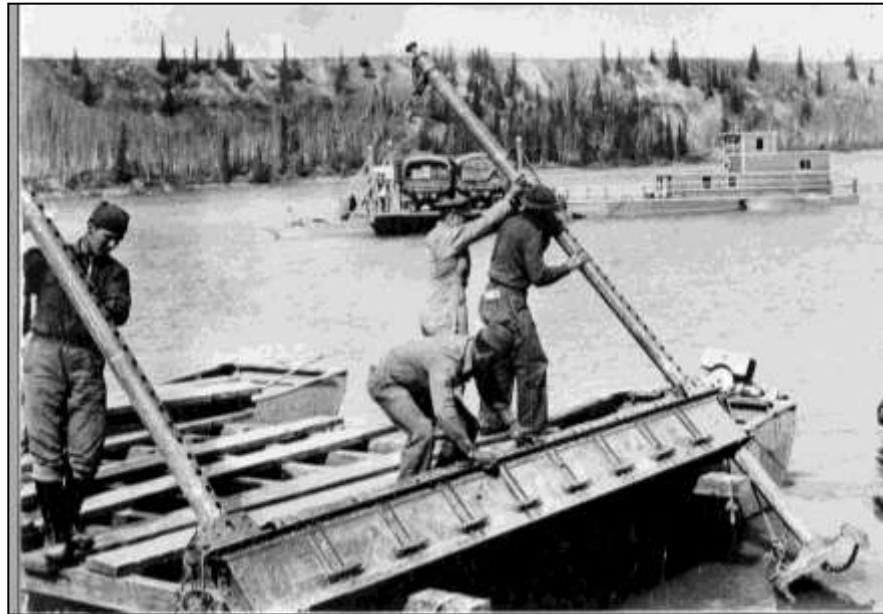
These views show combat engineers erecting the old prewar pontoons, only capable of supporting 15 ton/axle loads.

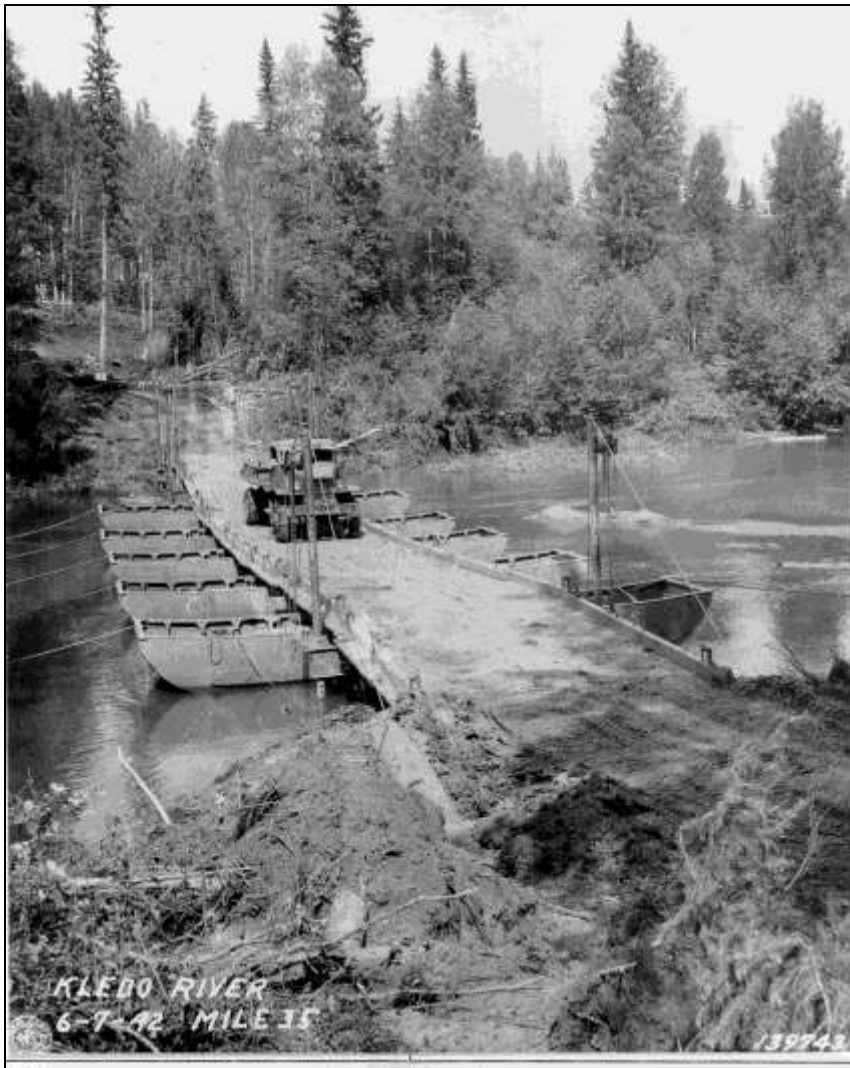
**Pontoon bridges** were of the prewar type, which were not suitable for heavy loads or sustained operations by bridging companies. Civilian contractors were brought in to construct timber trestle crossings of most rivers and streams.

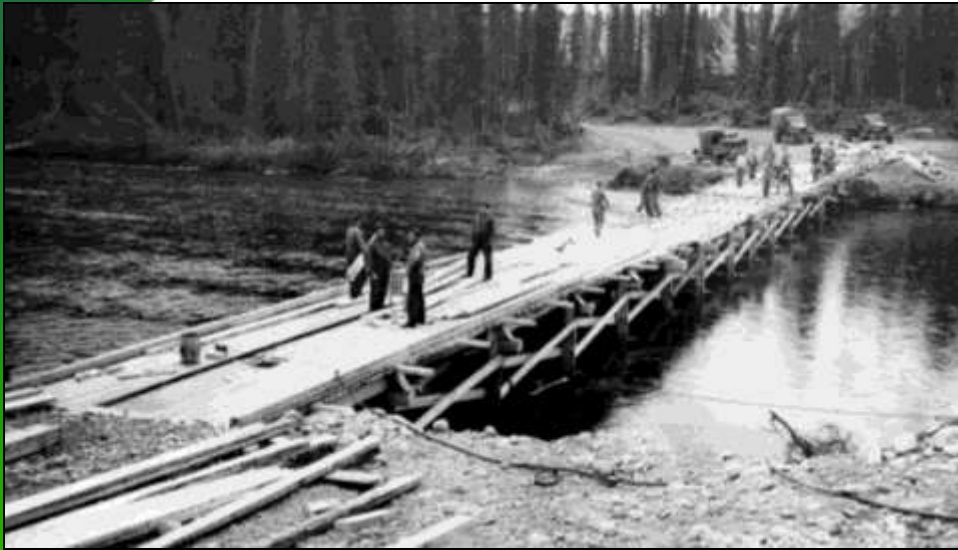
- The pontoon bridges and ferries were only temporary solutions until permanent bridges could be built.
- Using three sawmills, construction crews and members of the Public Roads Administration constructed bridges along the entire alignment, even during winter.

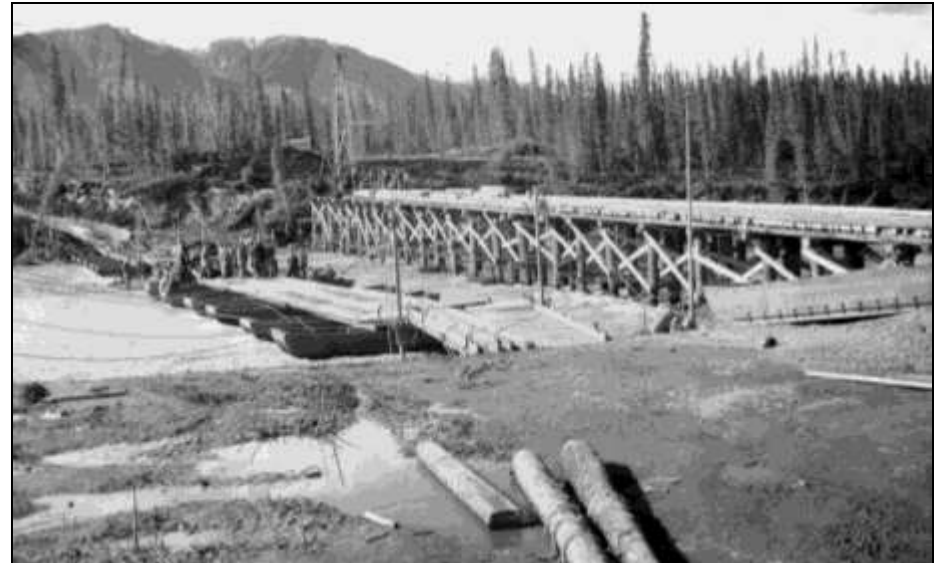
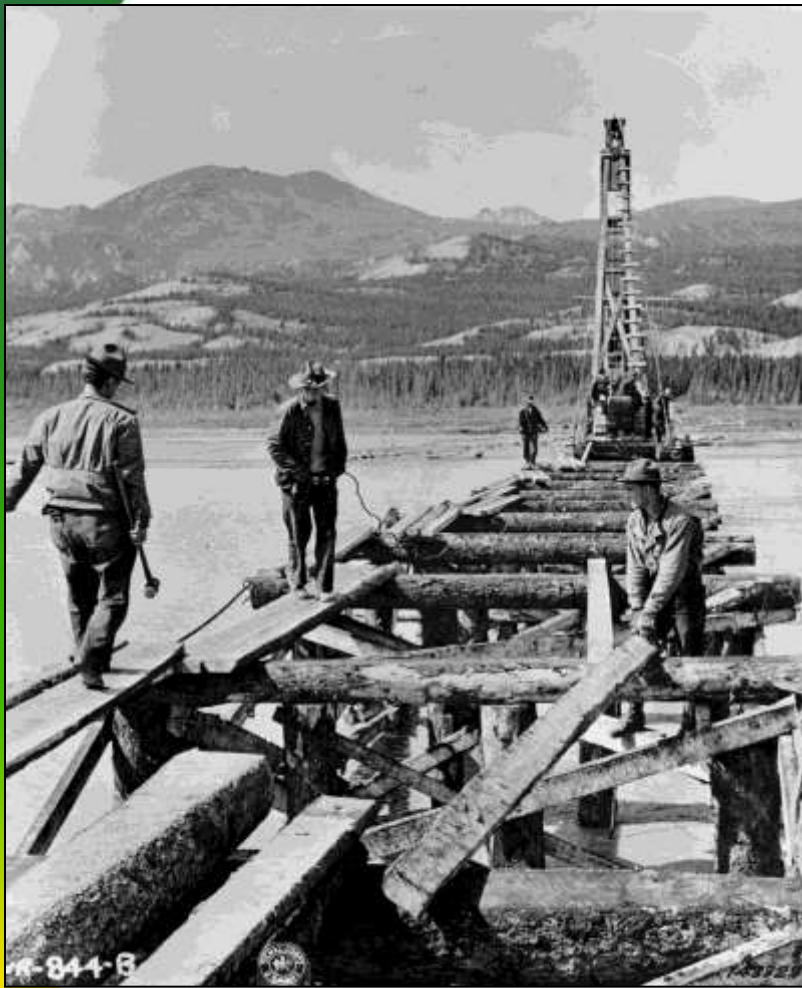
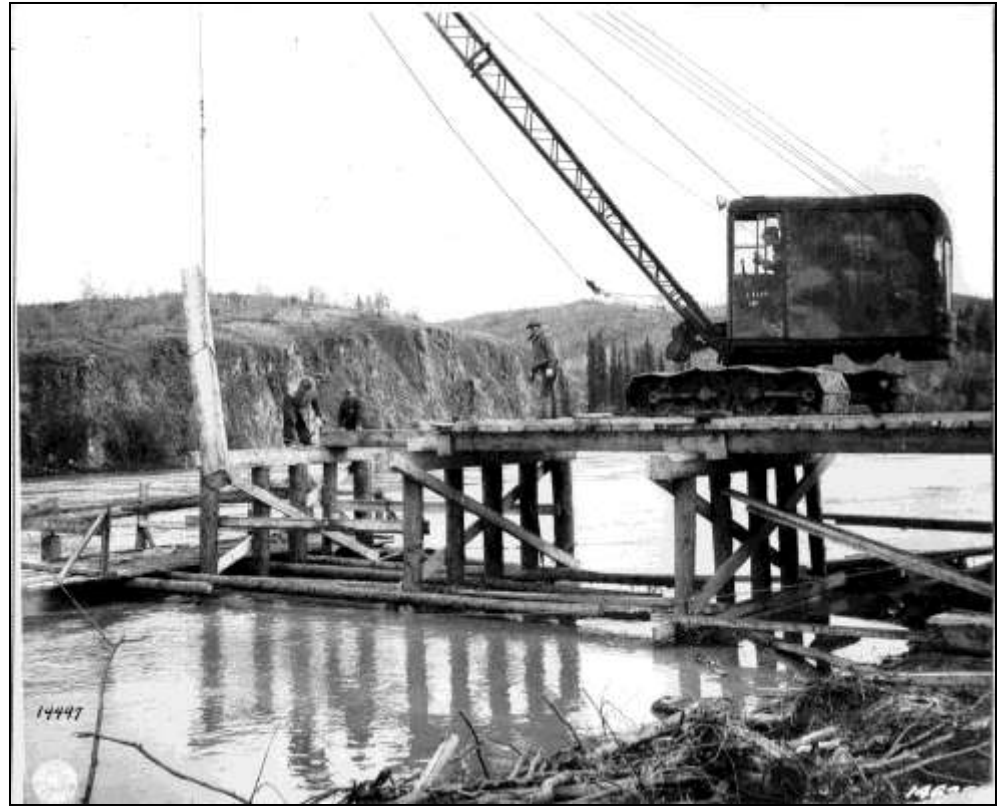
**PRA crews and civilian contracting firms built most of the timber trestle type bridges, which were expedient but temporary. The timber was harvested onsite. All of these were eventually replaced with more permanent timber, concrete, or steel bridges. Some the timber bridges lasted into the 1980s.**

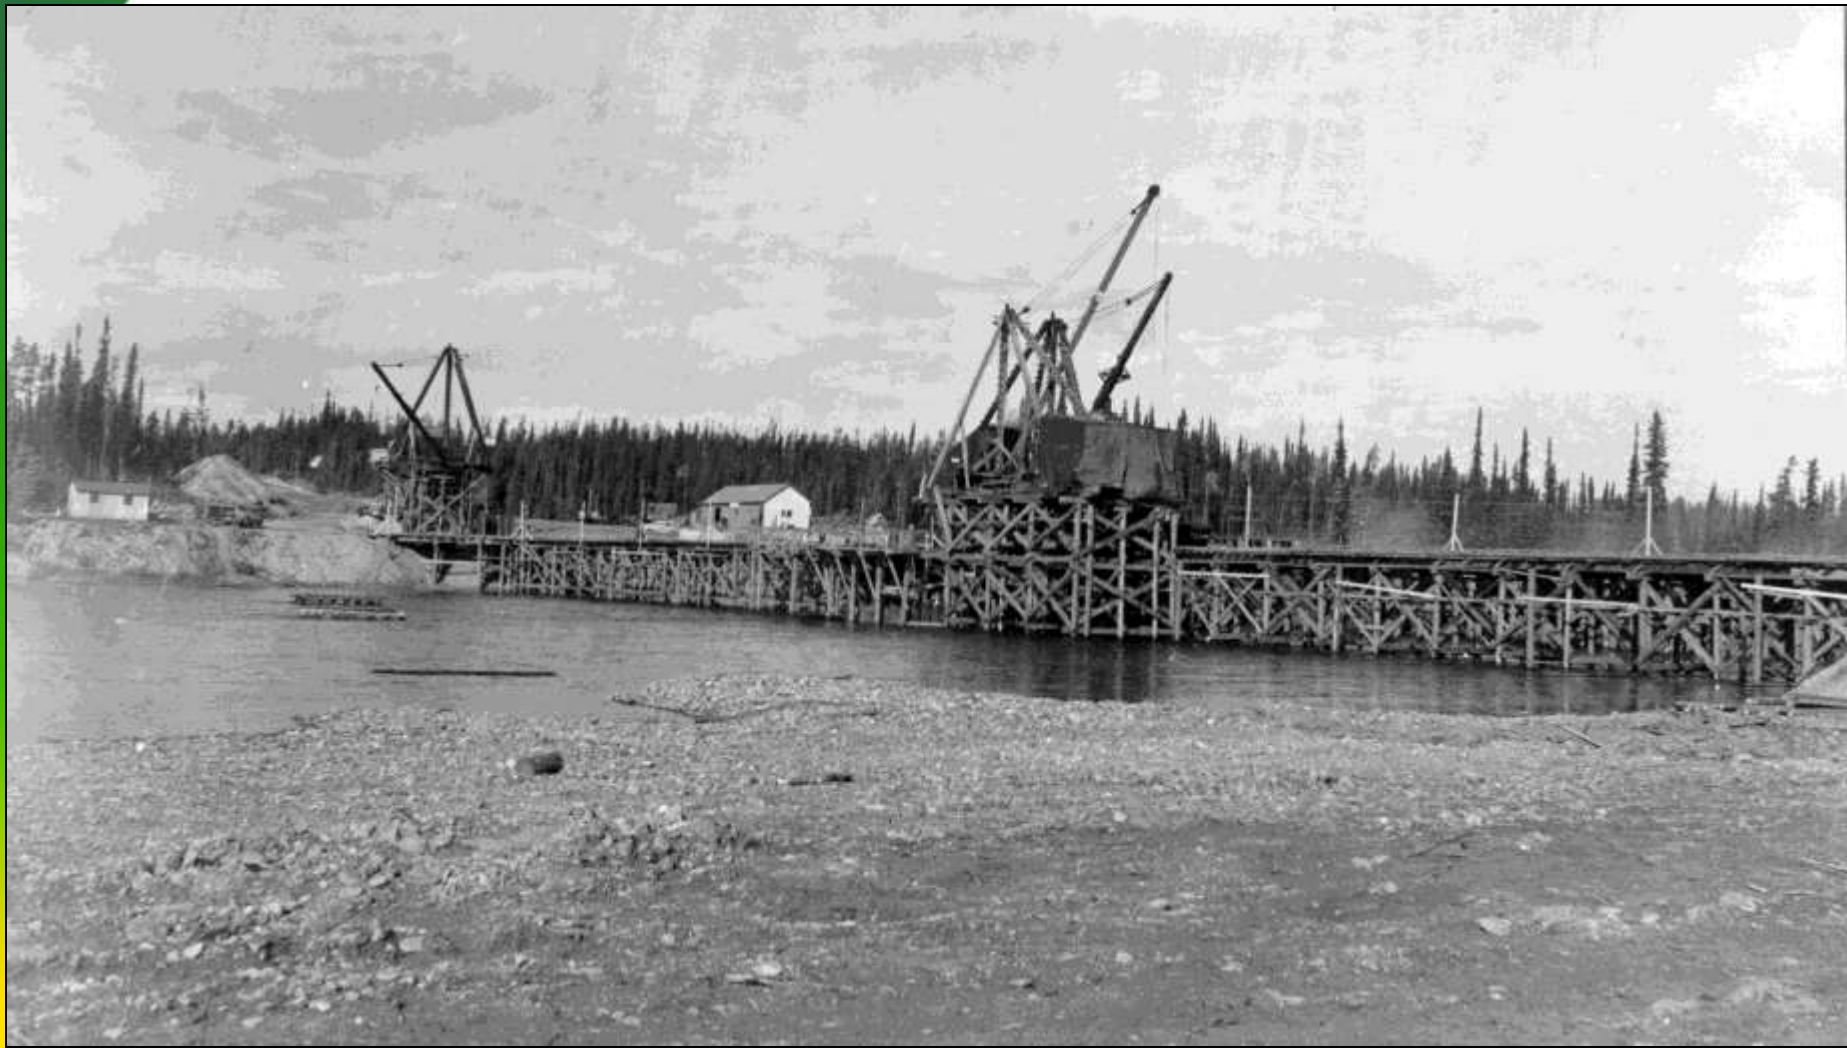
- **Timber trestle bridges like this were unable to handle summer freshets, which brought innumerable driftwood and fallen trees into the pilings.**

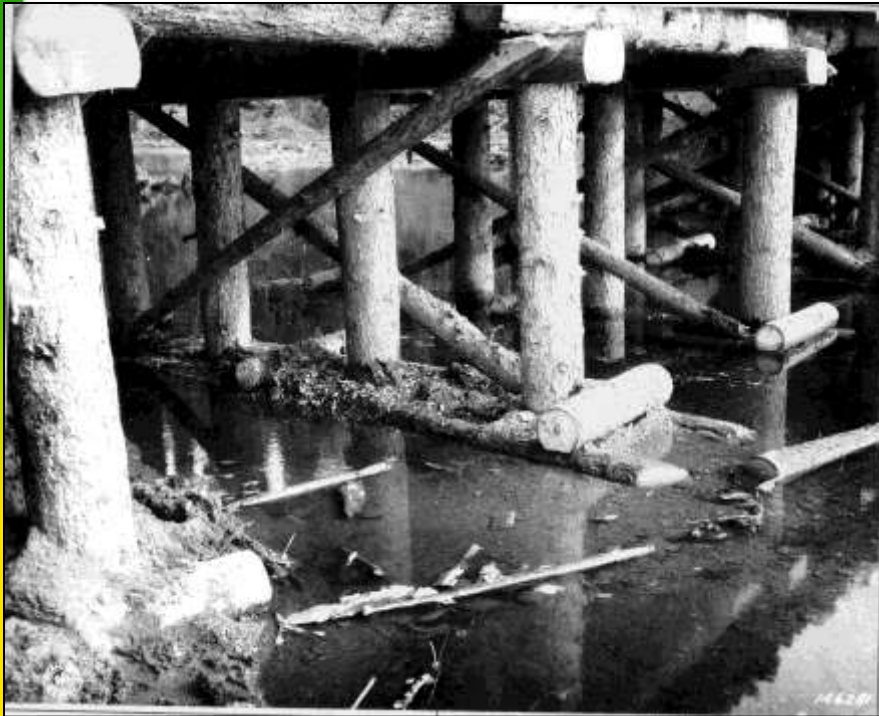
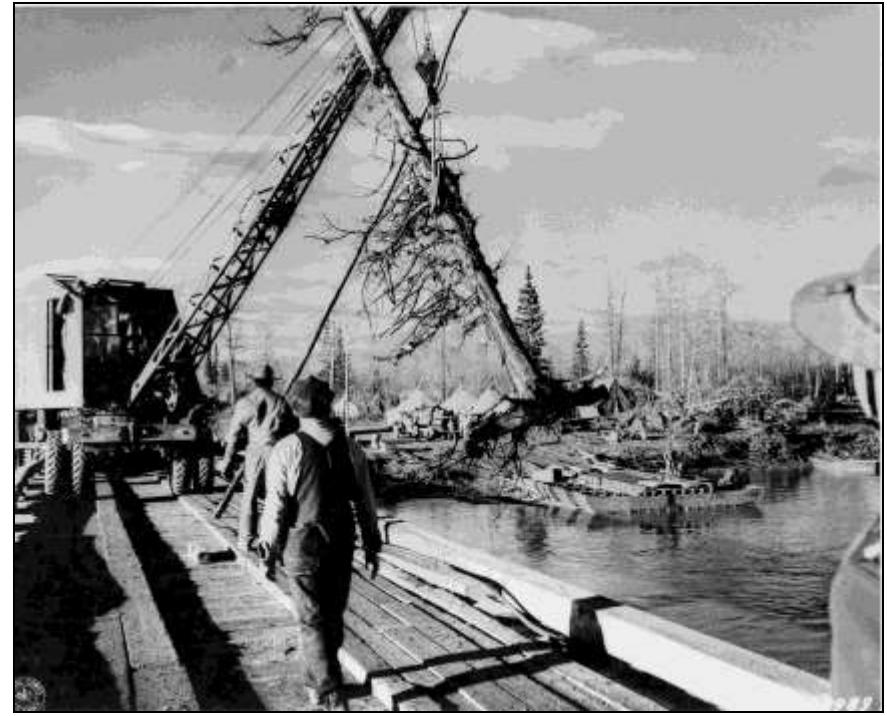
- **Maintaining the bridges posed the biggest problem. During construction, a guard was posted to make sure that large trees brought downstream did get snagged by the bridge pilings, which could easily damage or destroy the bridge.**

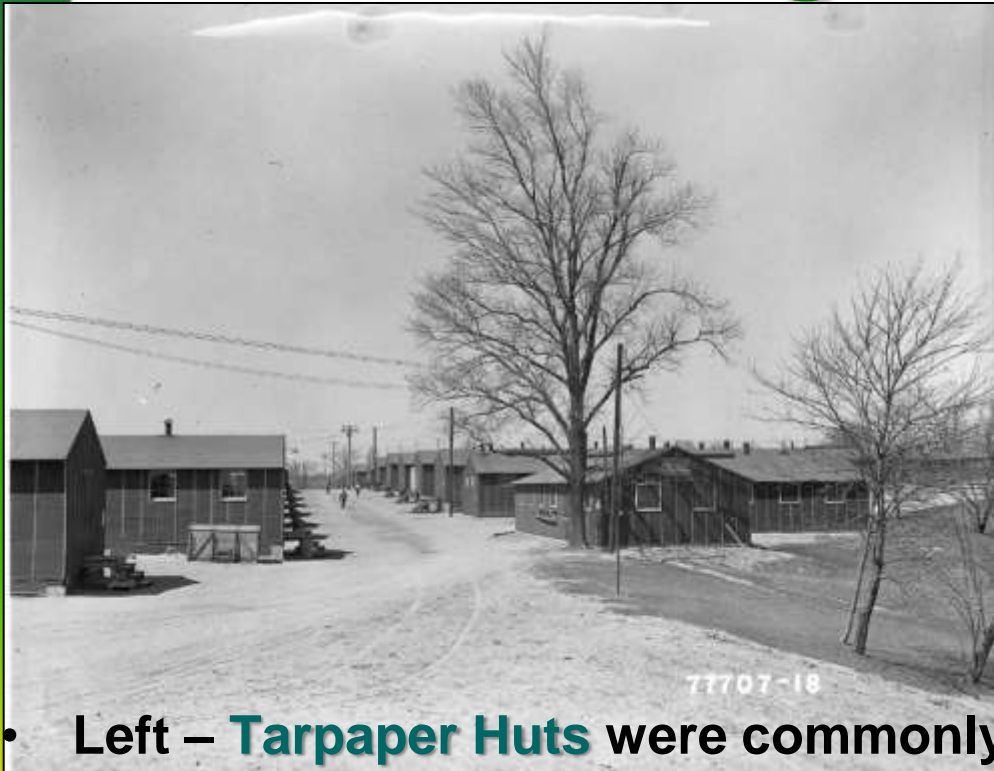
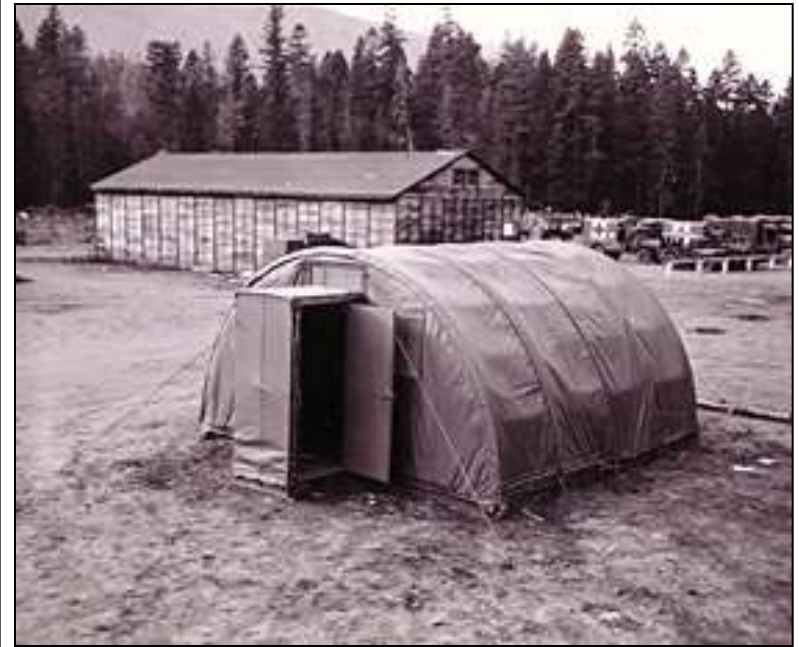
- Left – **Tarpaper Huts** were commonly employed for billeting troops at training facilities all over the world
- Right - **Jamesway Huts** were fashioned from multiples of 4' x 16' hemispheres, produced by the James Manufacturing Co of Fort Atkinson, Wisconsin. These used wooded ribs and insulated fabric covering, the only metal parts being nails, fasteners, and connecting bars.

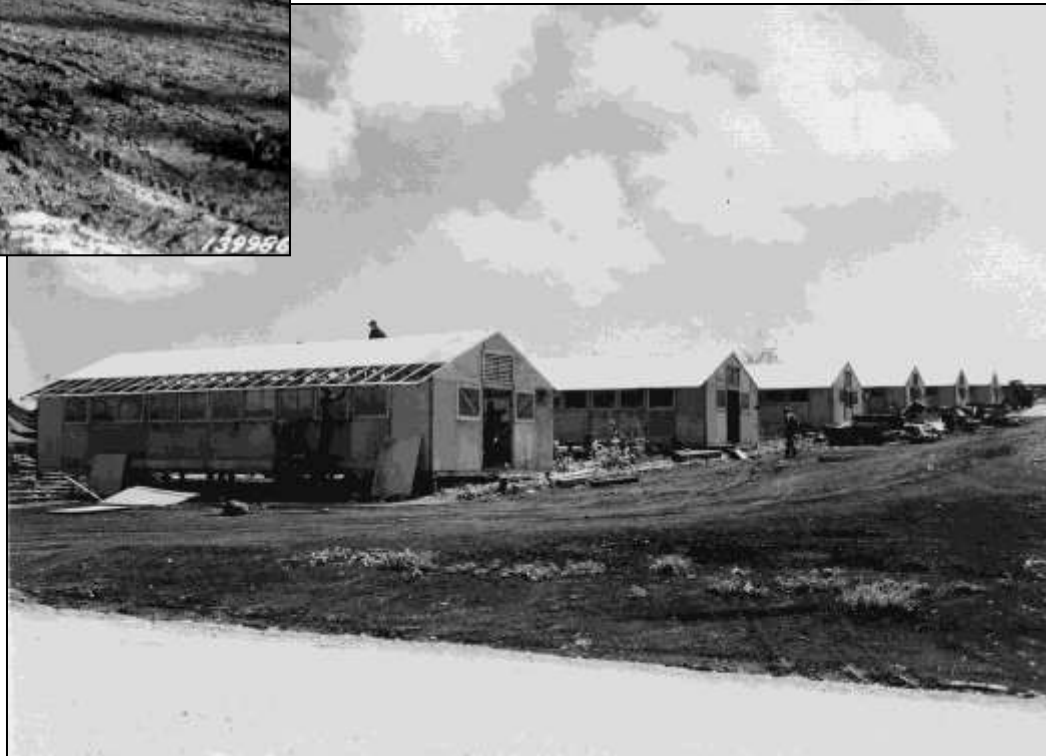
- This shows the erection of 20' x 48' prefabricated wood huts for billeting base personnel. These were made of plywood and shipped all over the world, especially for Army Air Corps facilities.

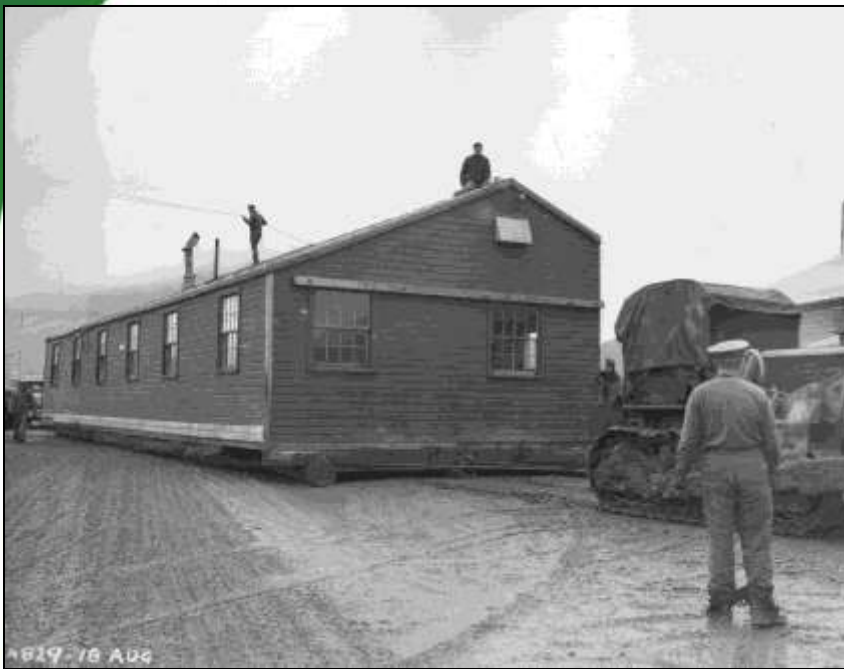
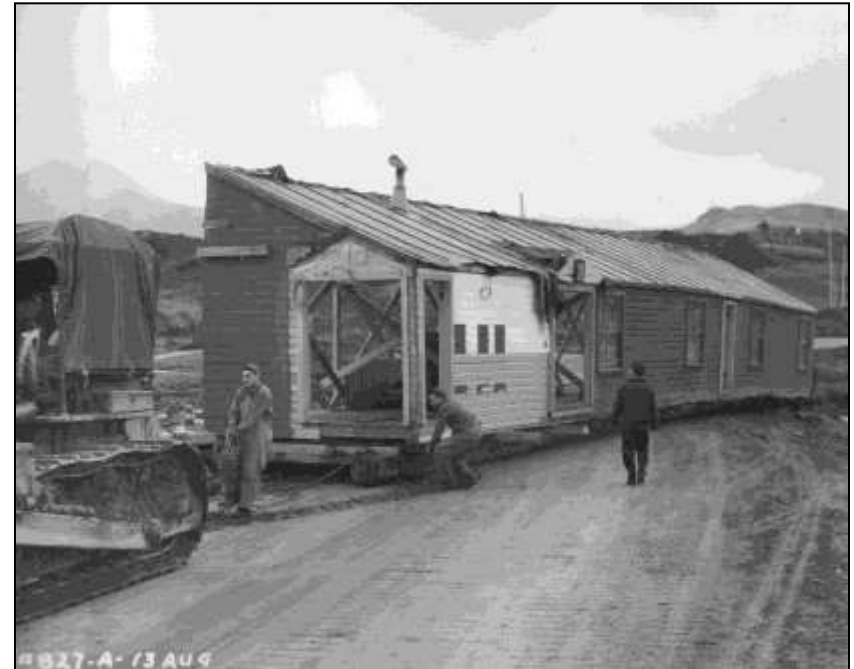
- **Wood frame structures** were normally constructed for military bases, as seen in these images from Attu. These views show a motor pool structure at lower left, and a dispensary being disassembled and moved using dozers and skids.
