DRAINAGE REQUIREMENTS AND MAINTENANCE OF HOMESITES

9-1 INTRODUCTION

EXCAVATION AND GRADING CODE ADMINISTRATION, INSPECTION, AND ENFORCEMENT

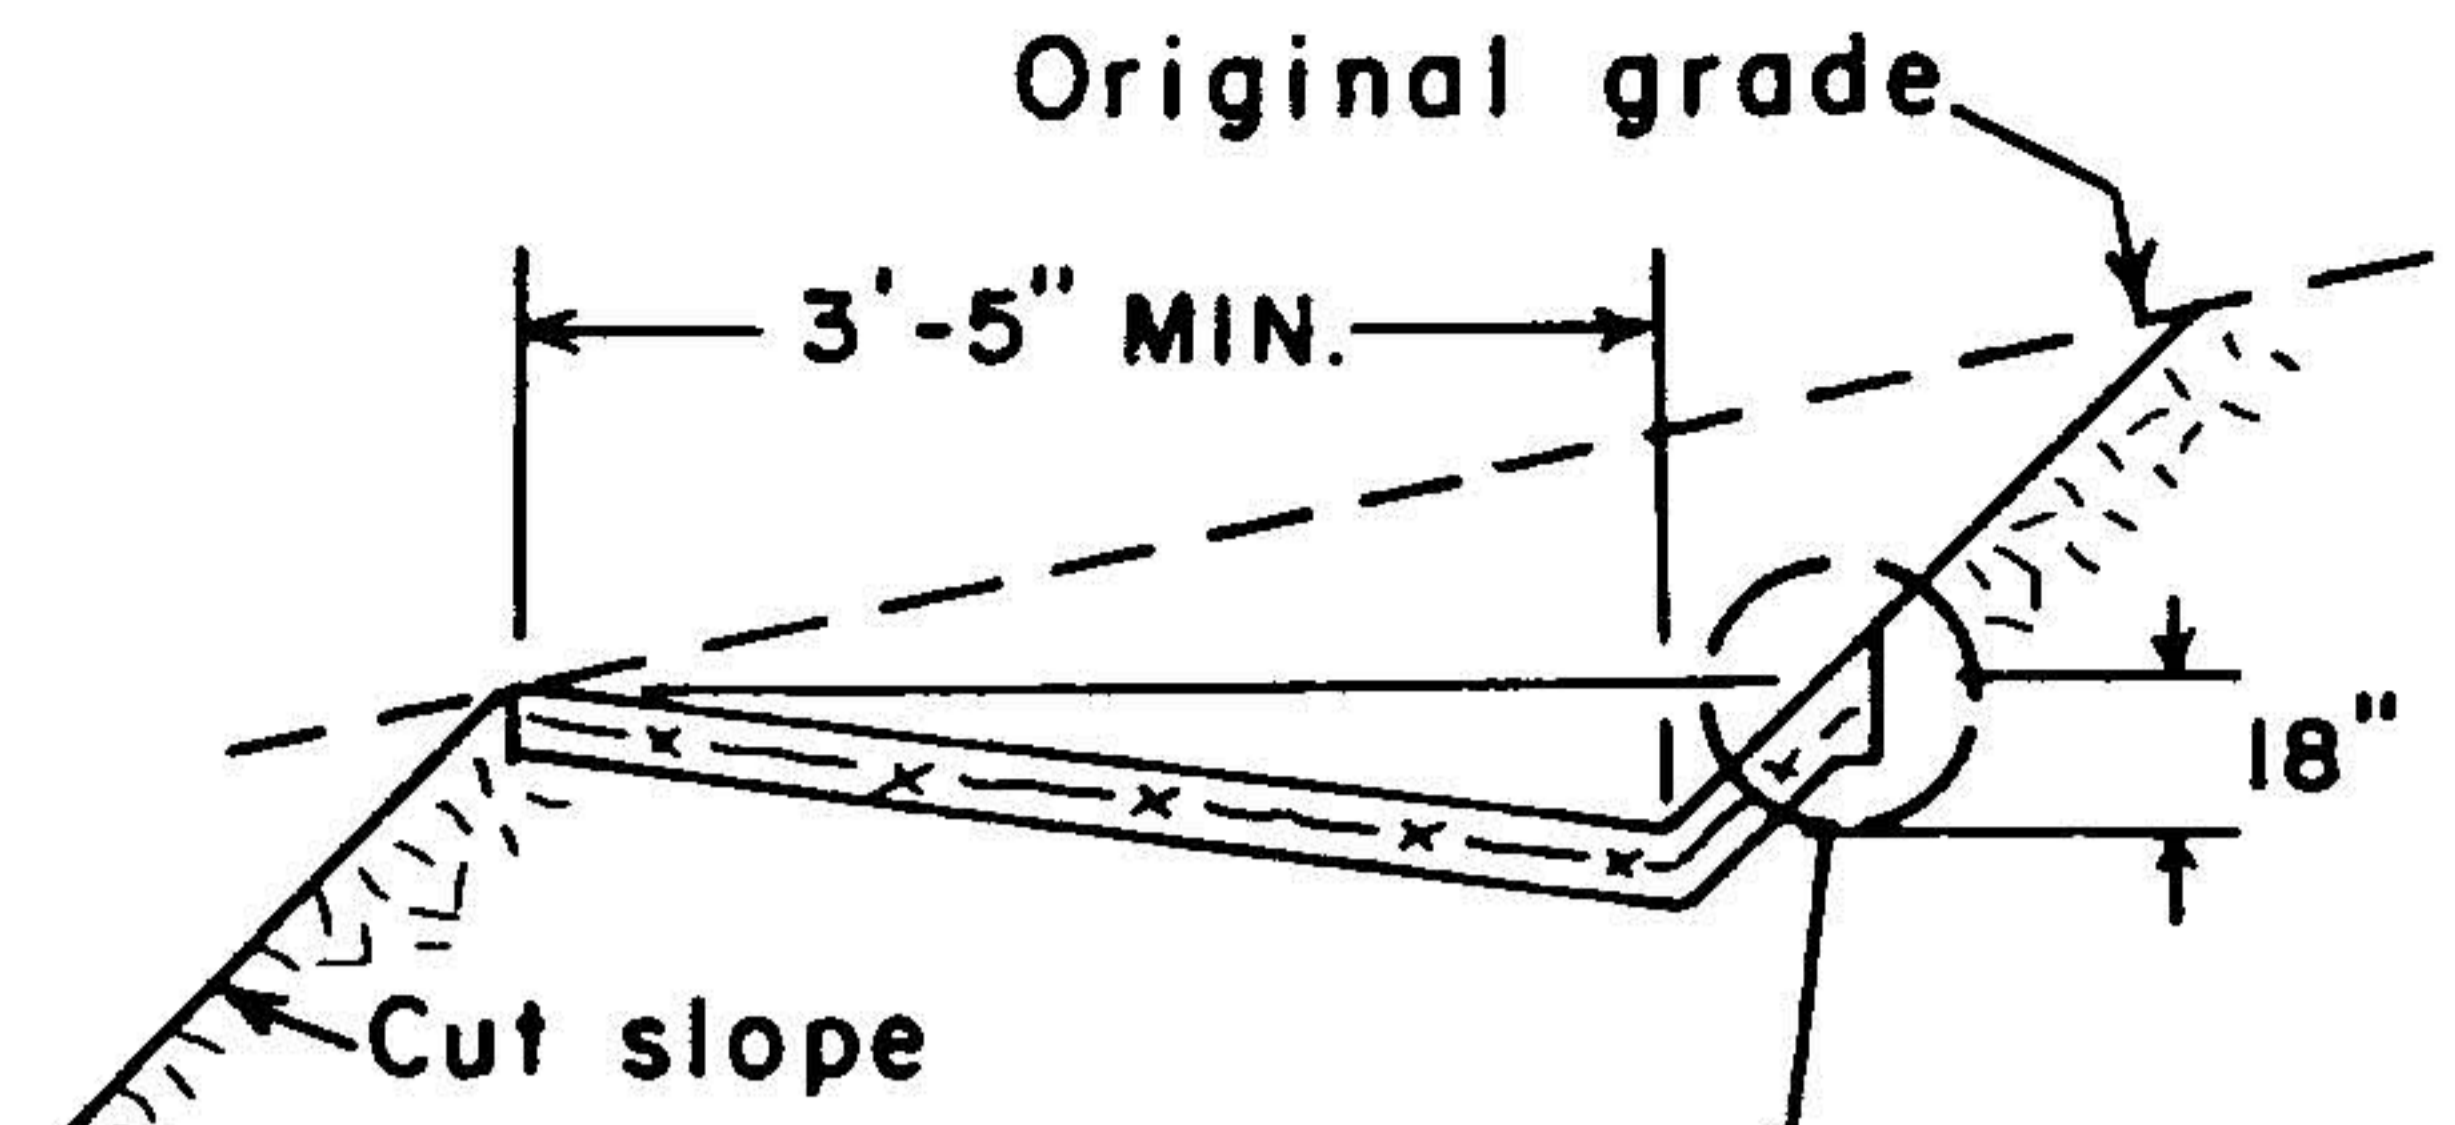
STRUCTURE "B"

DIVERTER TERRACE TOP OF CUT SLOPES

DETAIL (SEE ABOVE)

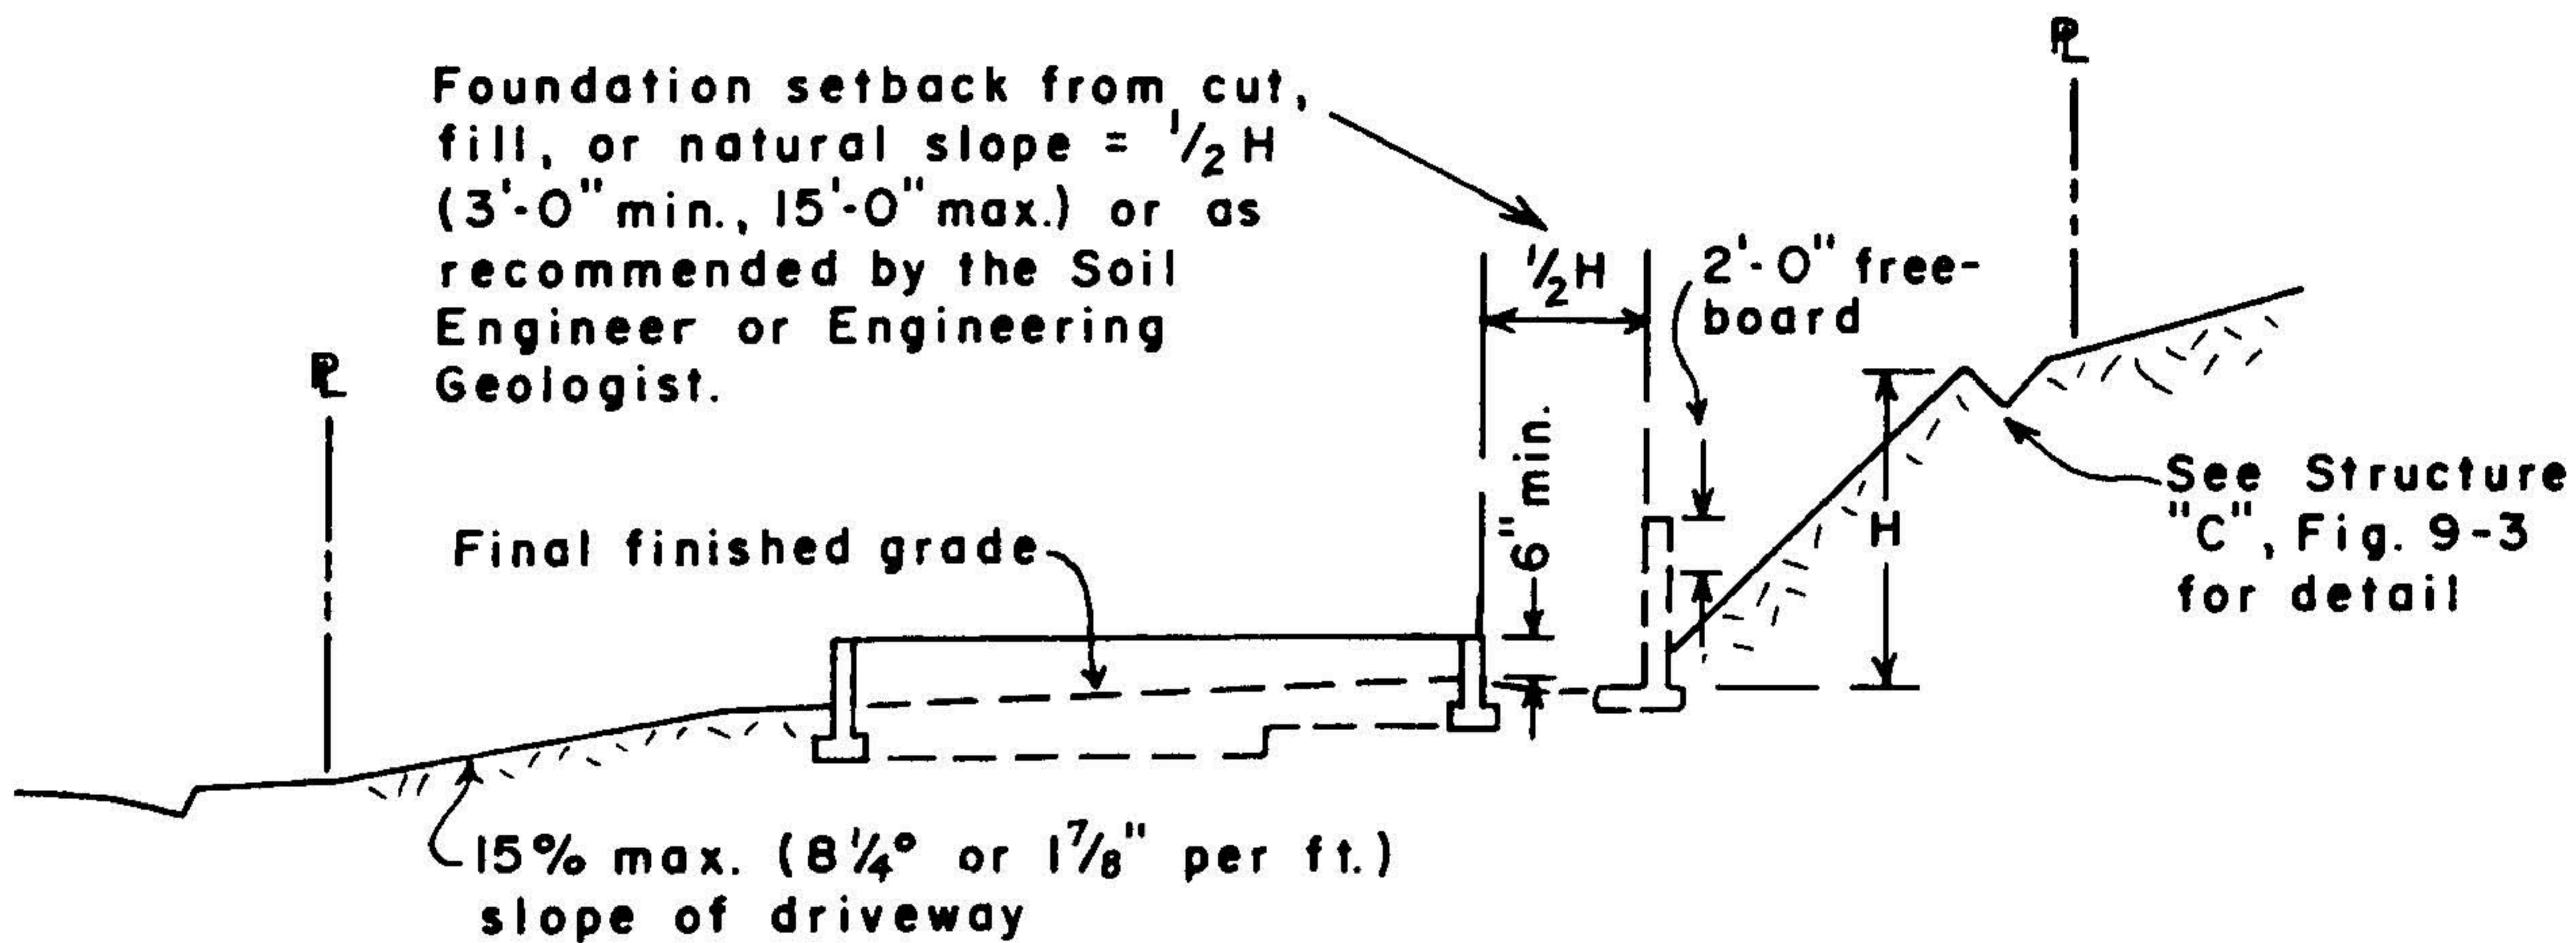
DRAINAGE AND PLOT PLAN

Foundation setback from cut, fill, or natural slope = $\frac{1}{2}H$ (3'-0" min., 15'-0" max.) or as recommended by the Soil Engineer or Engineering Geologist.

NOTE: Where "H" exceeds 20'-0", provide 4'-0" high with 2'-0" freeboard, designed retaining wall at toe of slope if foundation is within 15'-0" of the toe of slope. Beyond 15' setback, wall may not be required unless recommended by the Soil Engineer or Engineering Geologist.

SECTION A-A'

STEPPED FOUNDATIONS: Foundations for all buildings where the surface of the ground slopes more than one foot in ten feet shall be level or shall be stepped so that both top and bottom of such foundation are level. Minimum step 4'. (1979 UBC - Section 2907 (c))

Figure 9-4 Recommended minimum grading for a typical hillside lot.

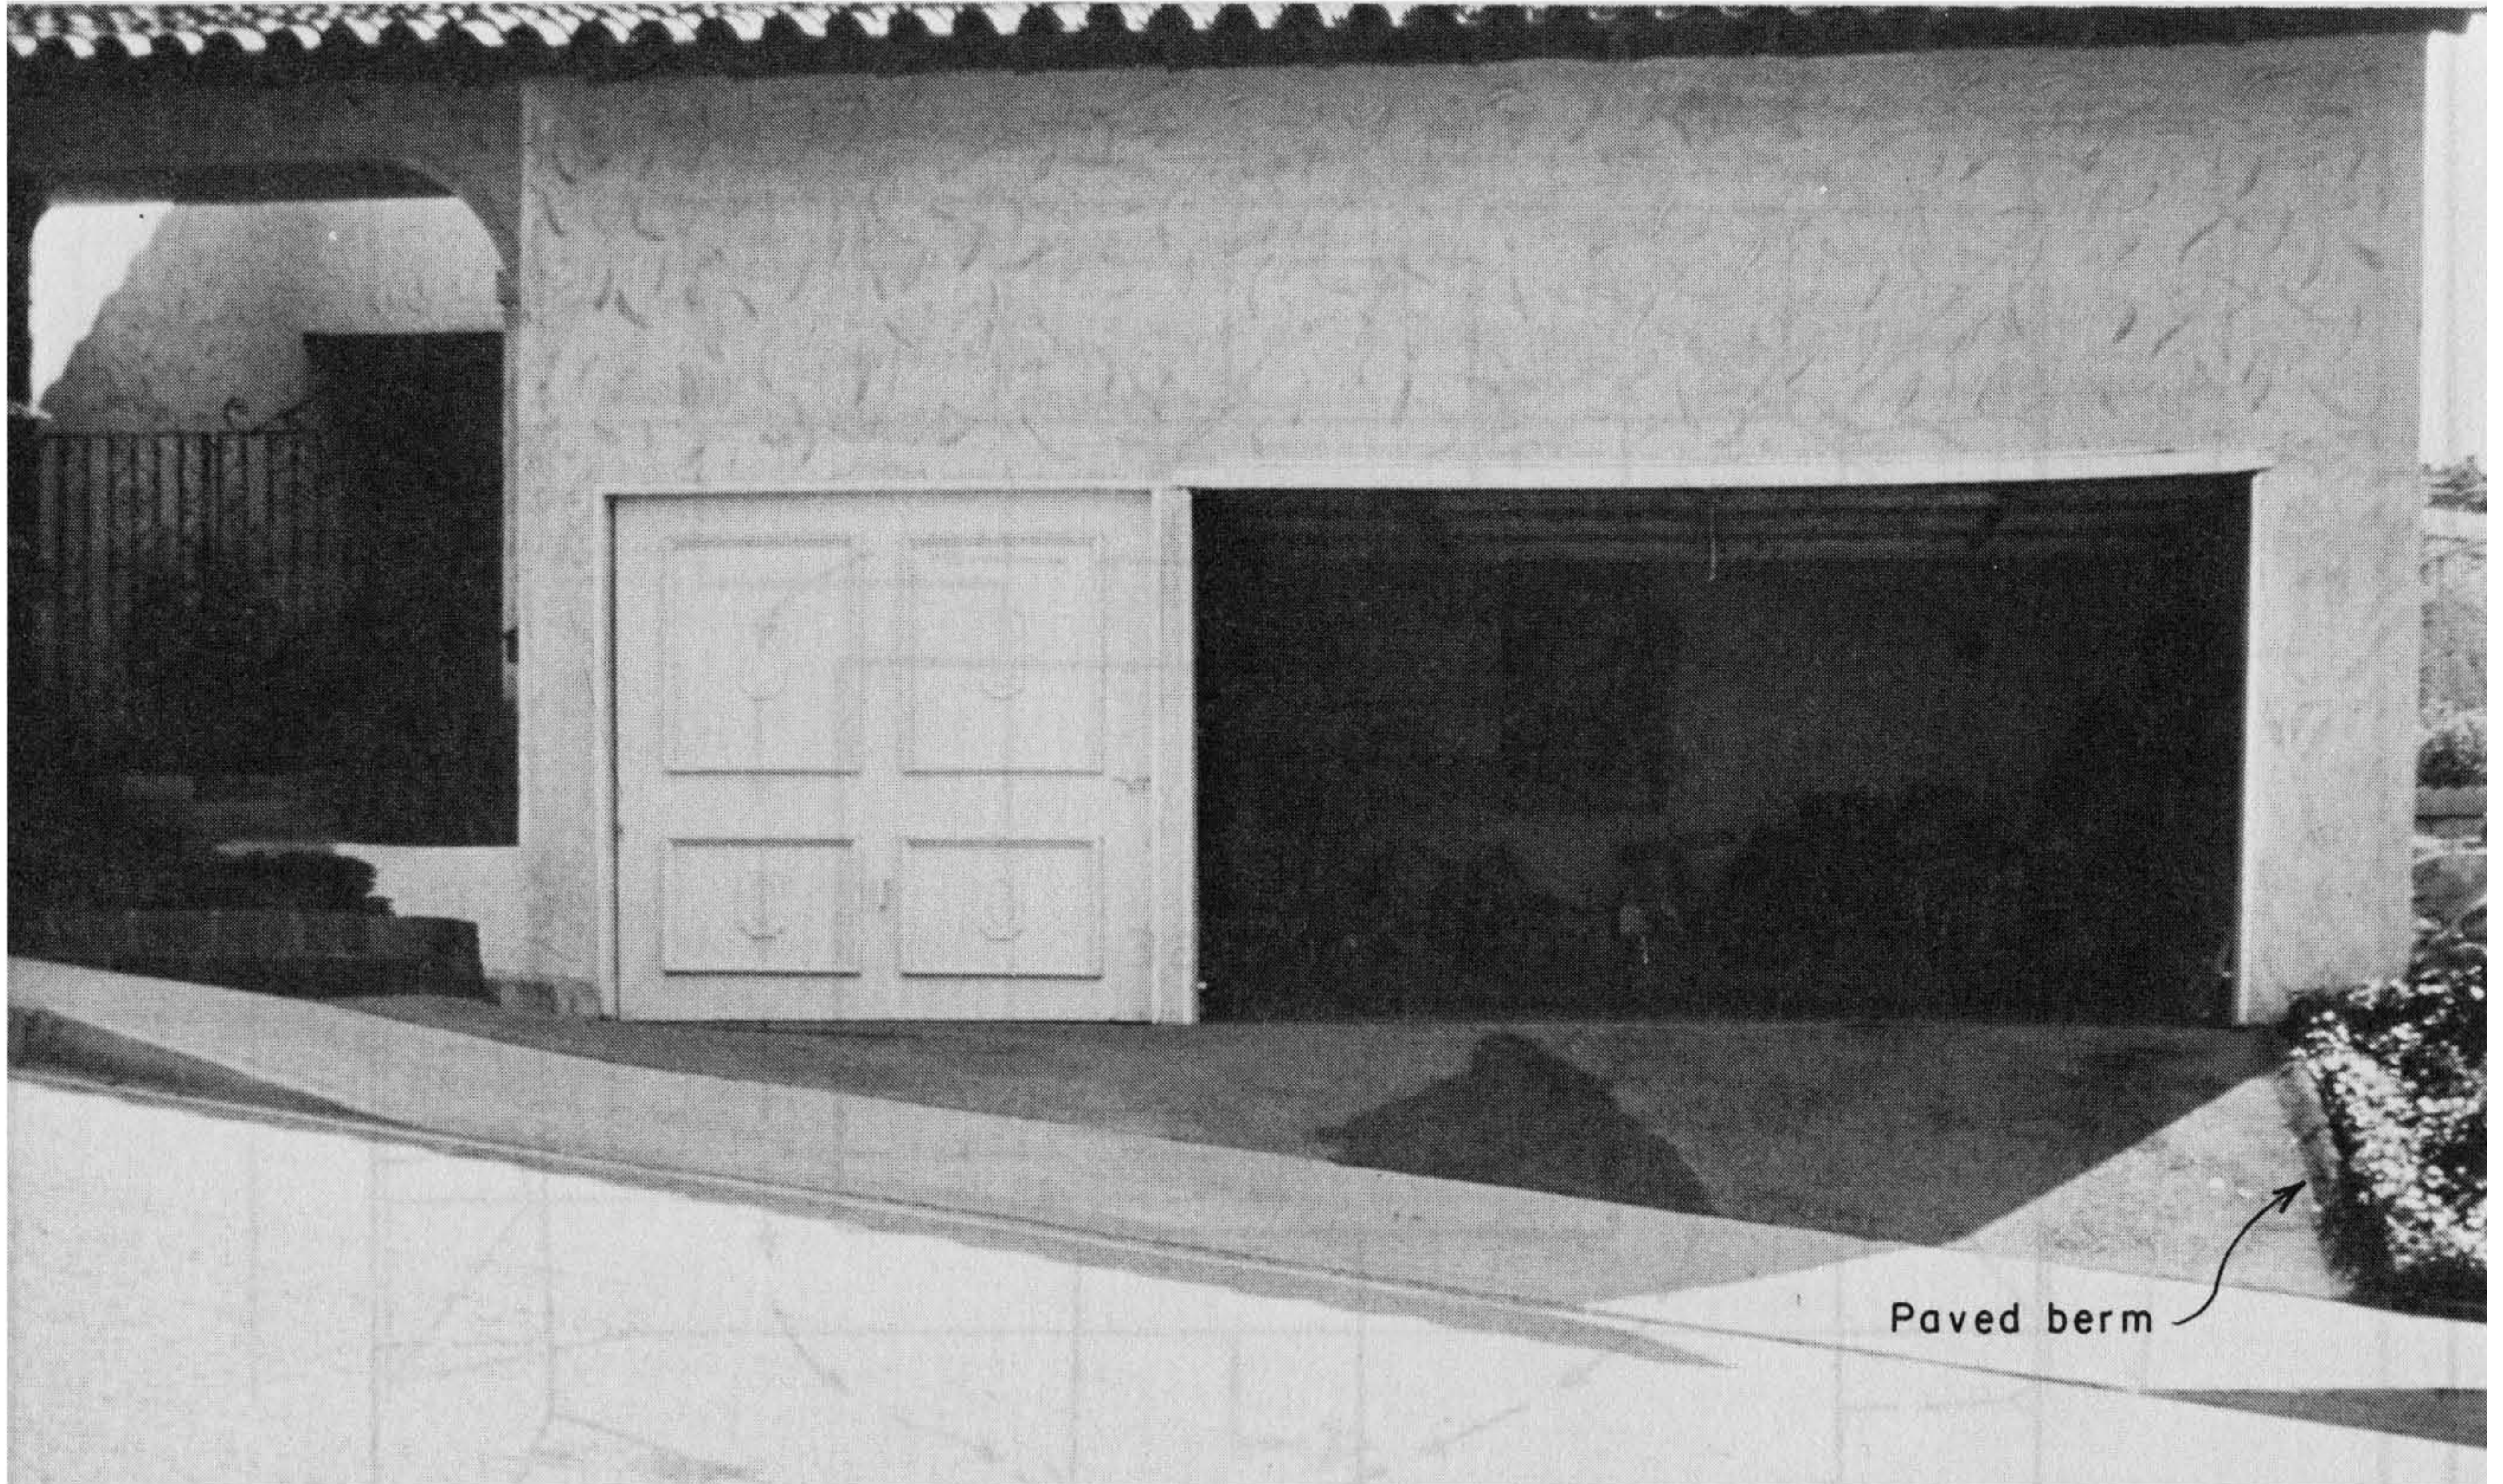
Figure 9-8 Lot drainage onto a steep street. Notice the asphalt berm on the right side of the driveway to assure that drainage stays in paved area. Photograph by and courtesy of Alex Bruce, senior building inspector, City of Los Angeles.

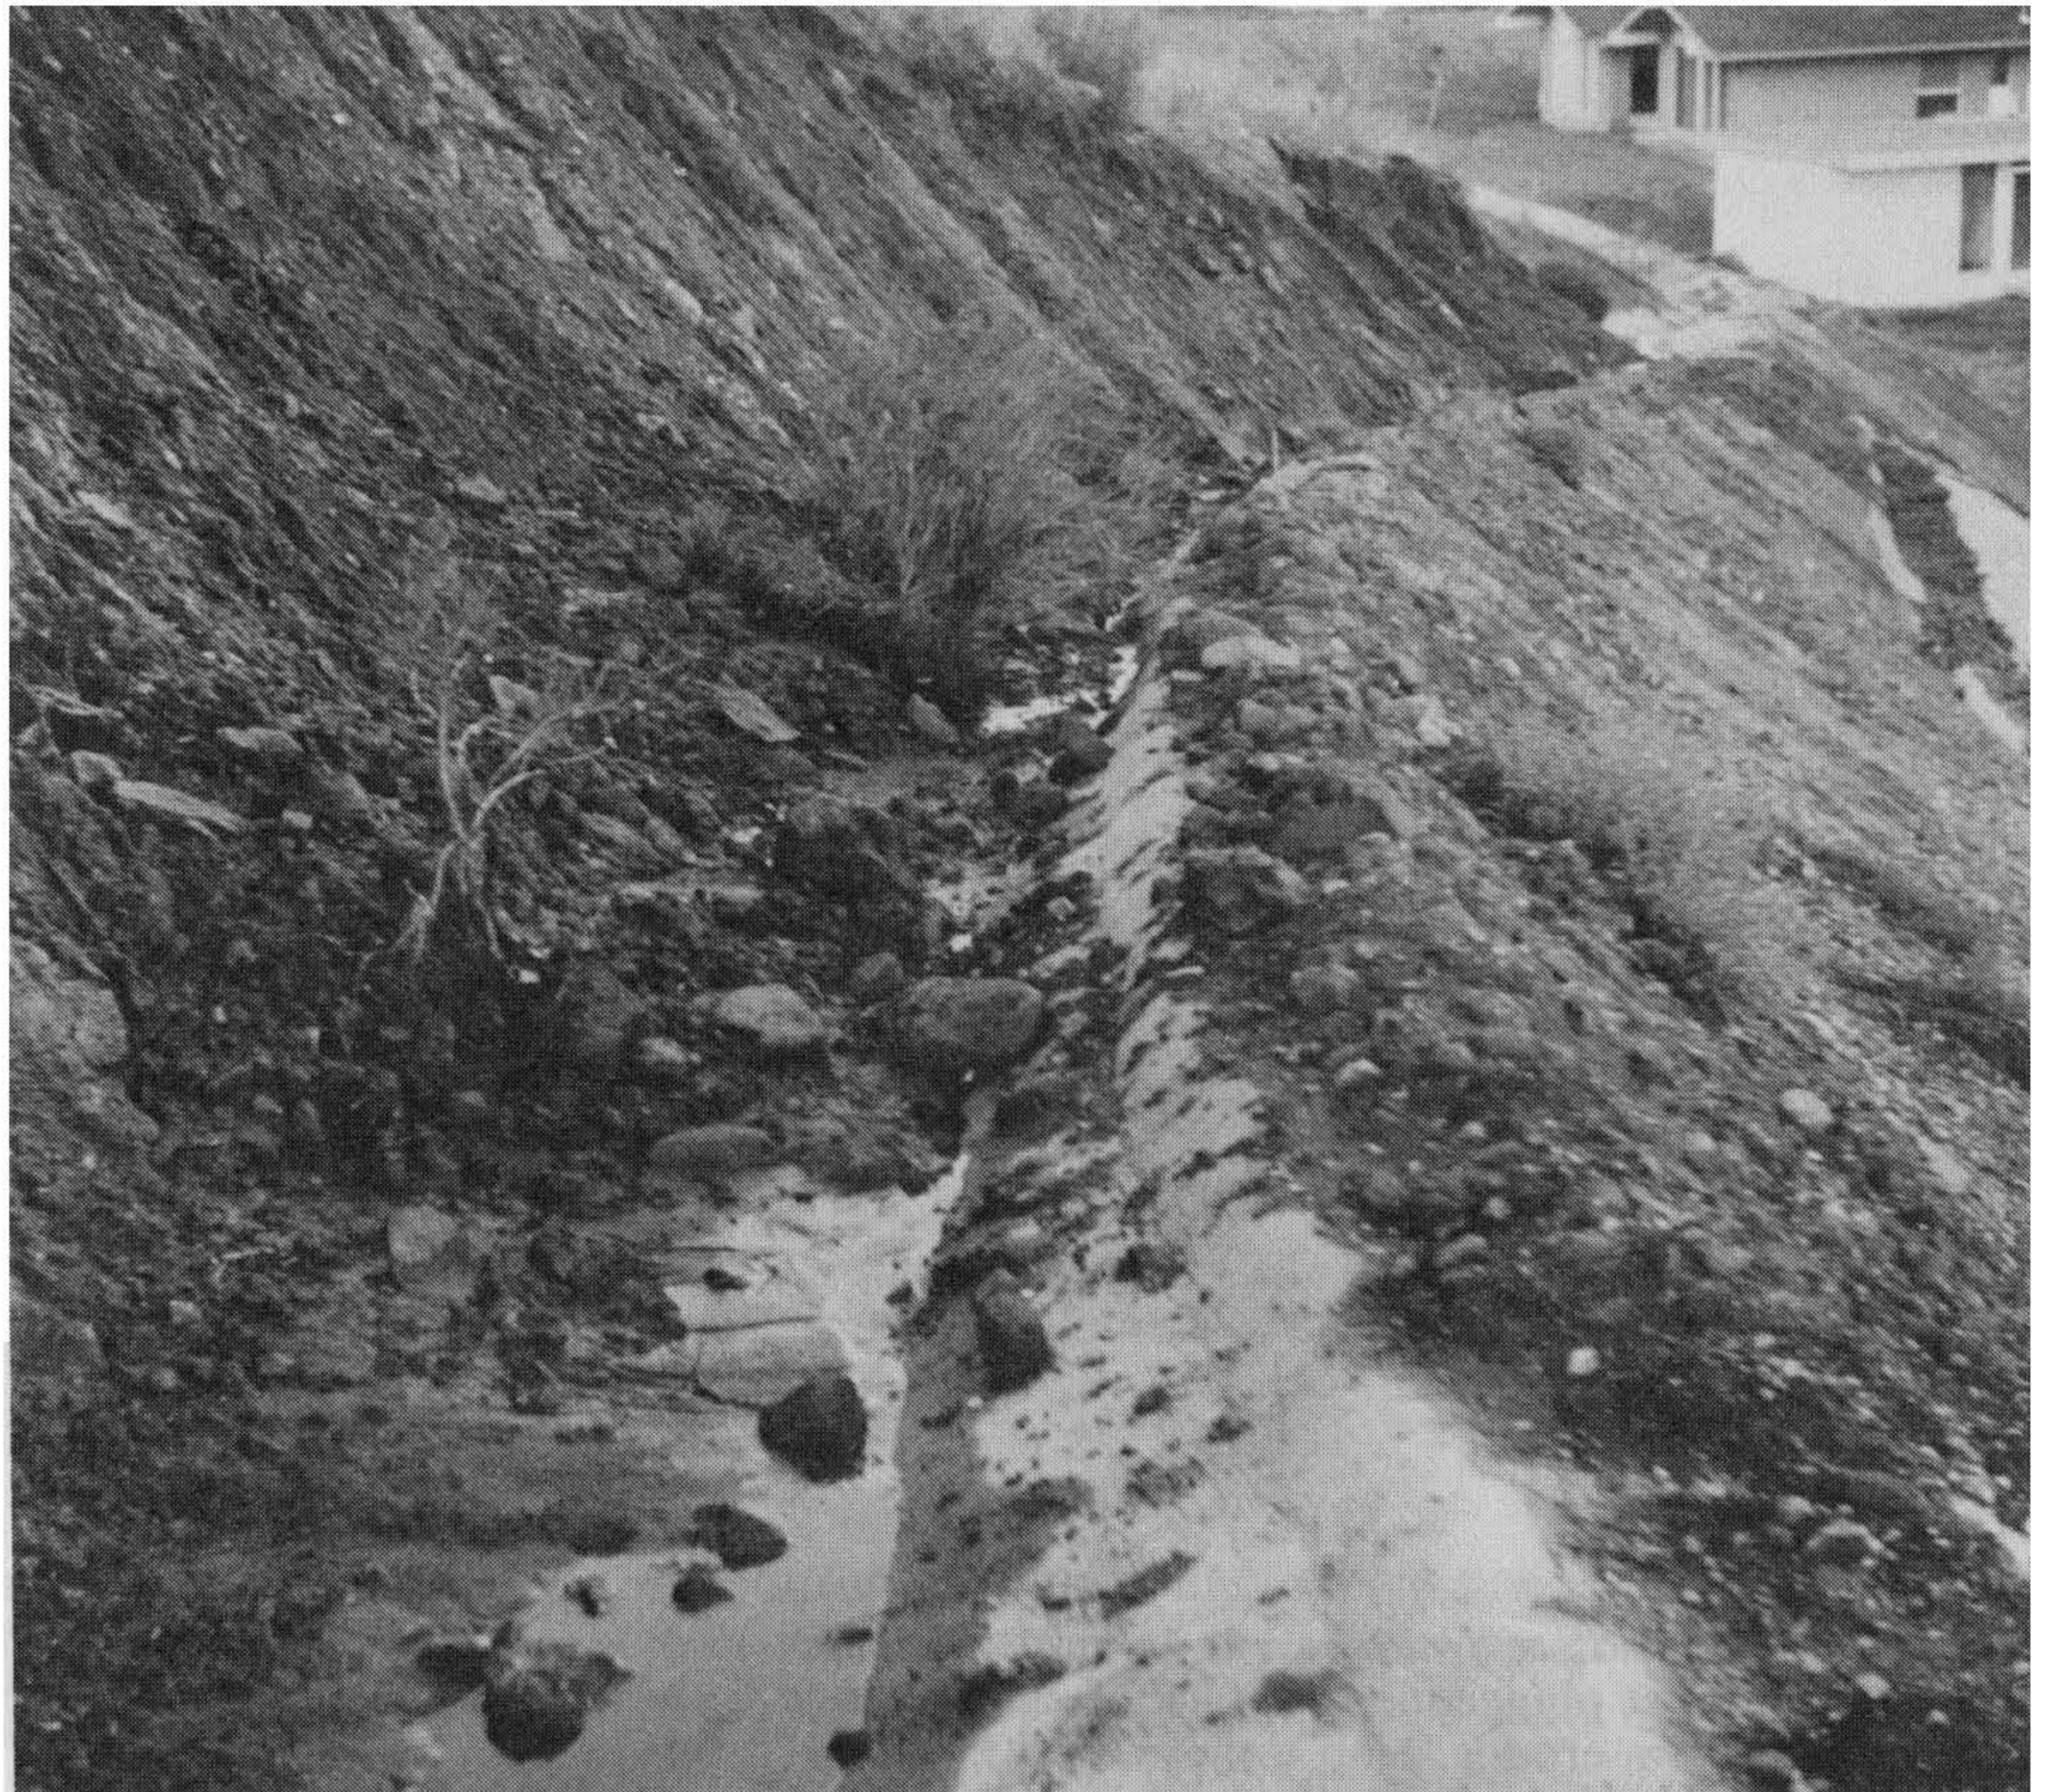
Figure 9-9 Colluvial soils and stream terrace gravel materials slumping and rilling into slope drains. These terrace slope drains have minimum gradients of 2%-4% which are insufficient for self-cleansing or removal of heavy slump materials. Photograph by C. Michael Scullin.

Terrace benches for constructing these drains should be at a maximum vertical interval of 30 feet to establish a realistic maximum exposed slope that can be planted and maintained without erosion for average conditions. The terrace drain gradient of 6% is necessary for the drain to be self-cleaning so as to reduce the need for owner maintenance since few hillside dwellers climb up or down slopes to clean these drains. (See Figures 9-9 and 9-10.)

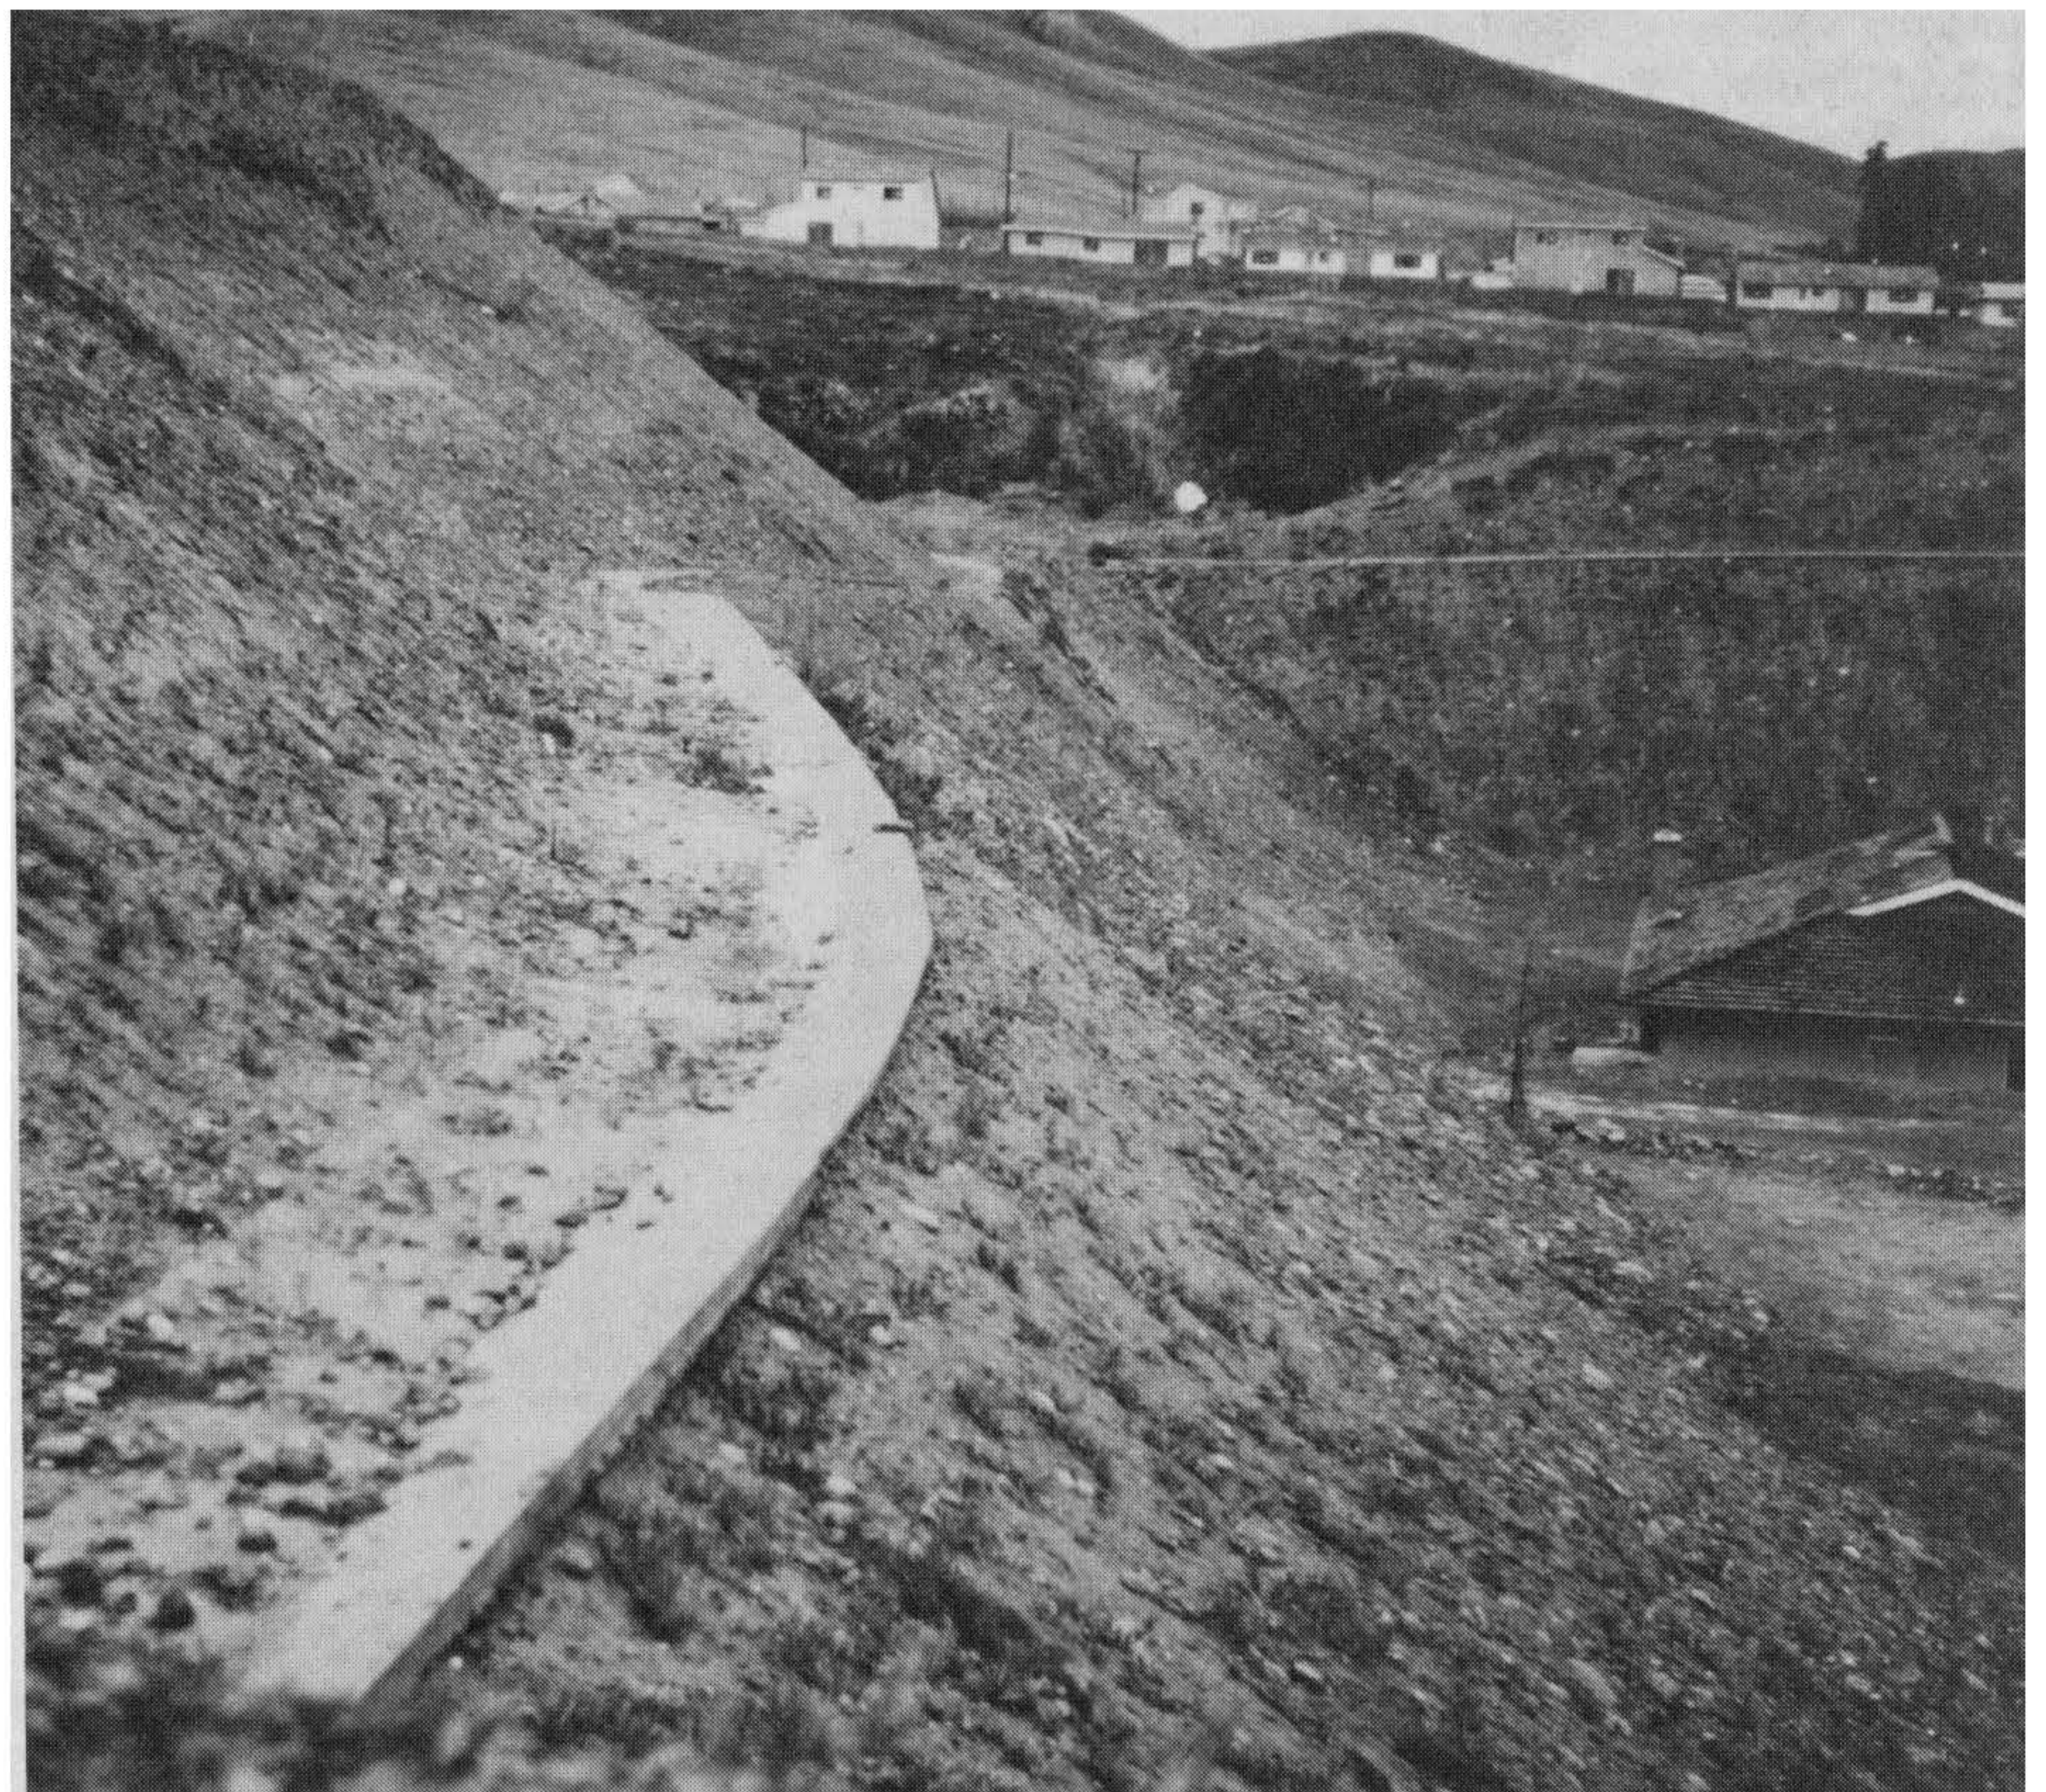
Figure 9-10 This terrace slope drain is too narrow and has a flat gradient of 2%. This type of terrace drain does not perform very well as it fills-in readily from siltation, and runoff overflows the drains to erode the slopes. Photograph by C. Michael Scullin.

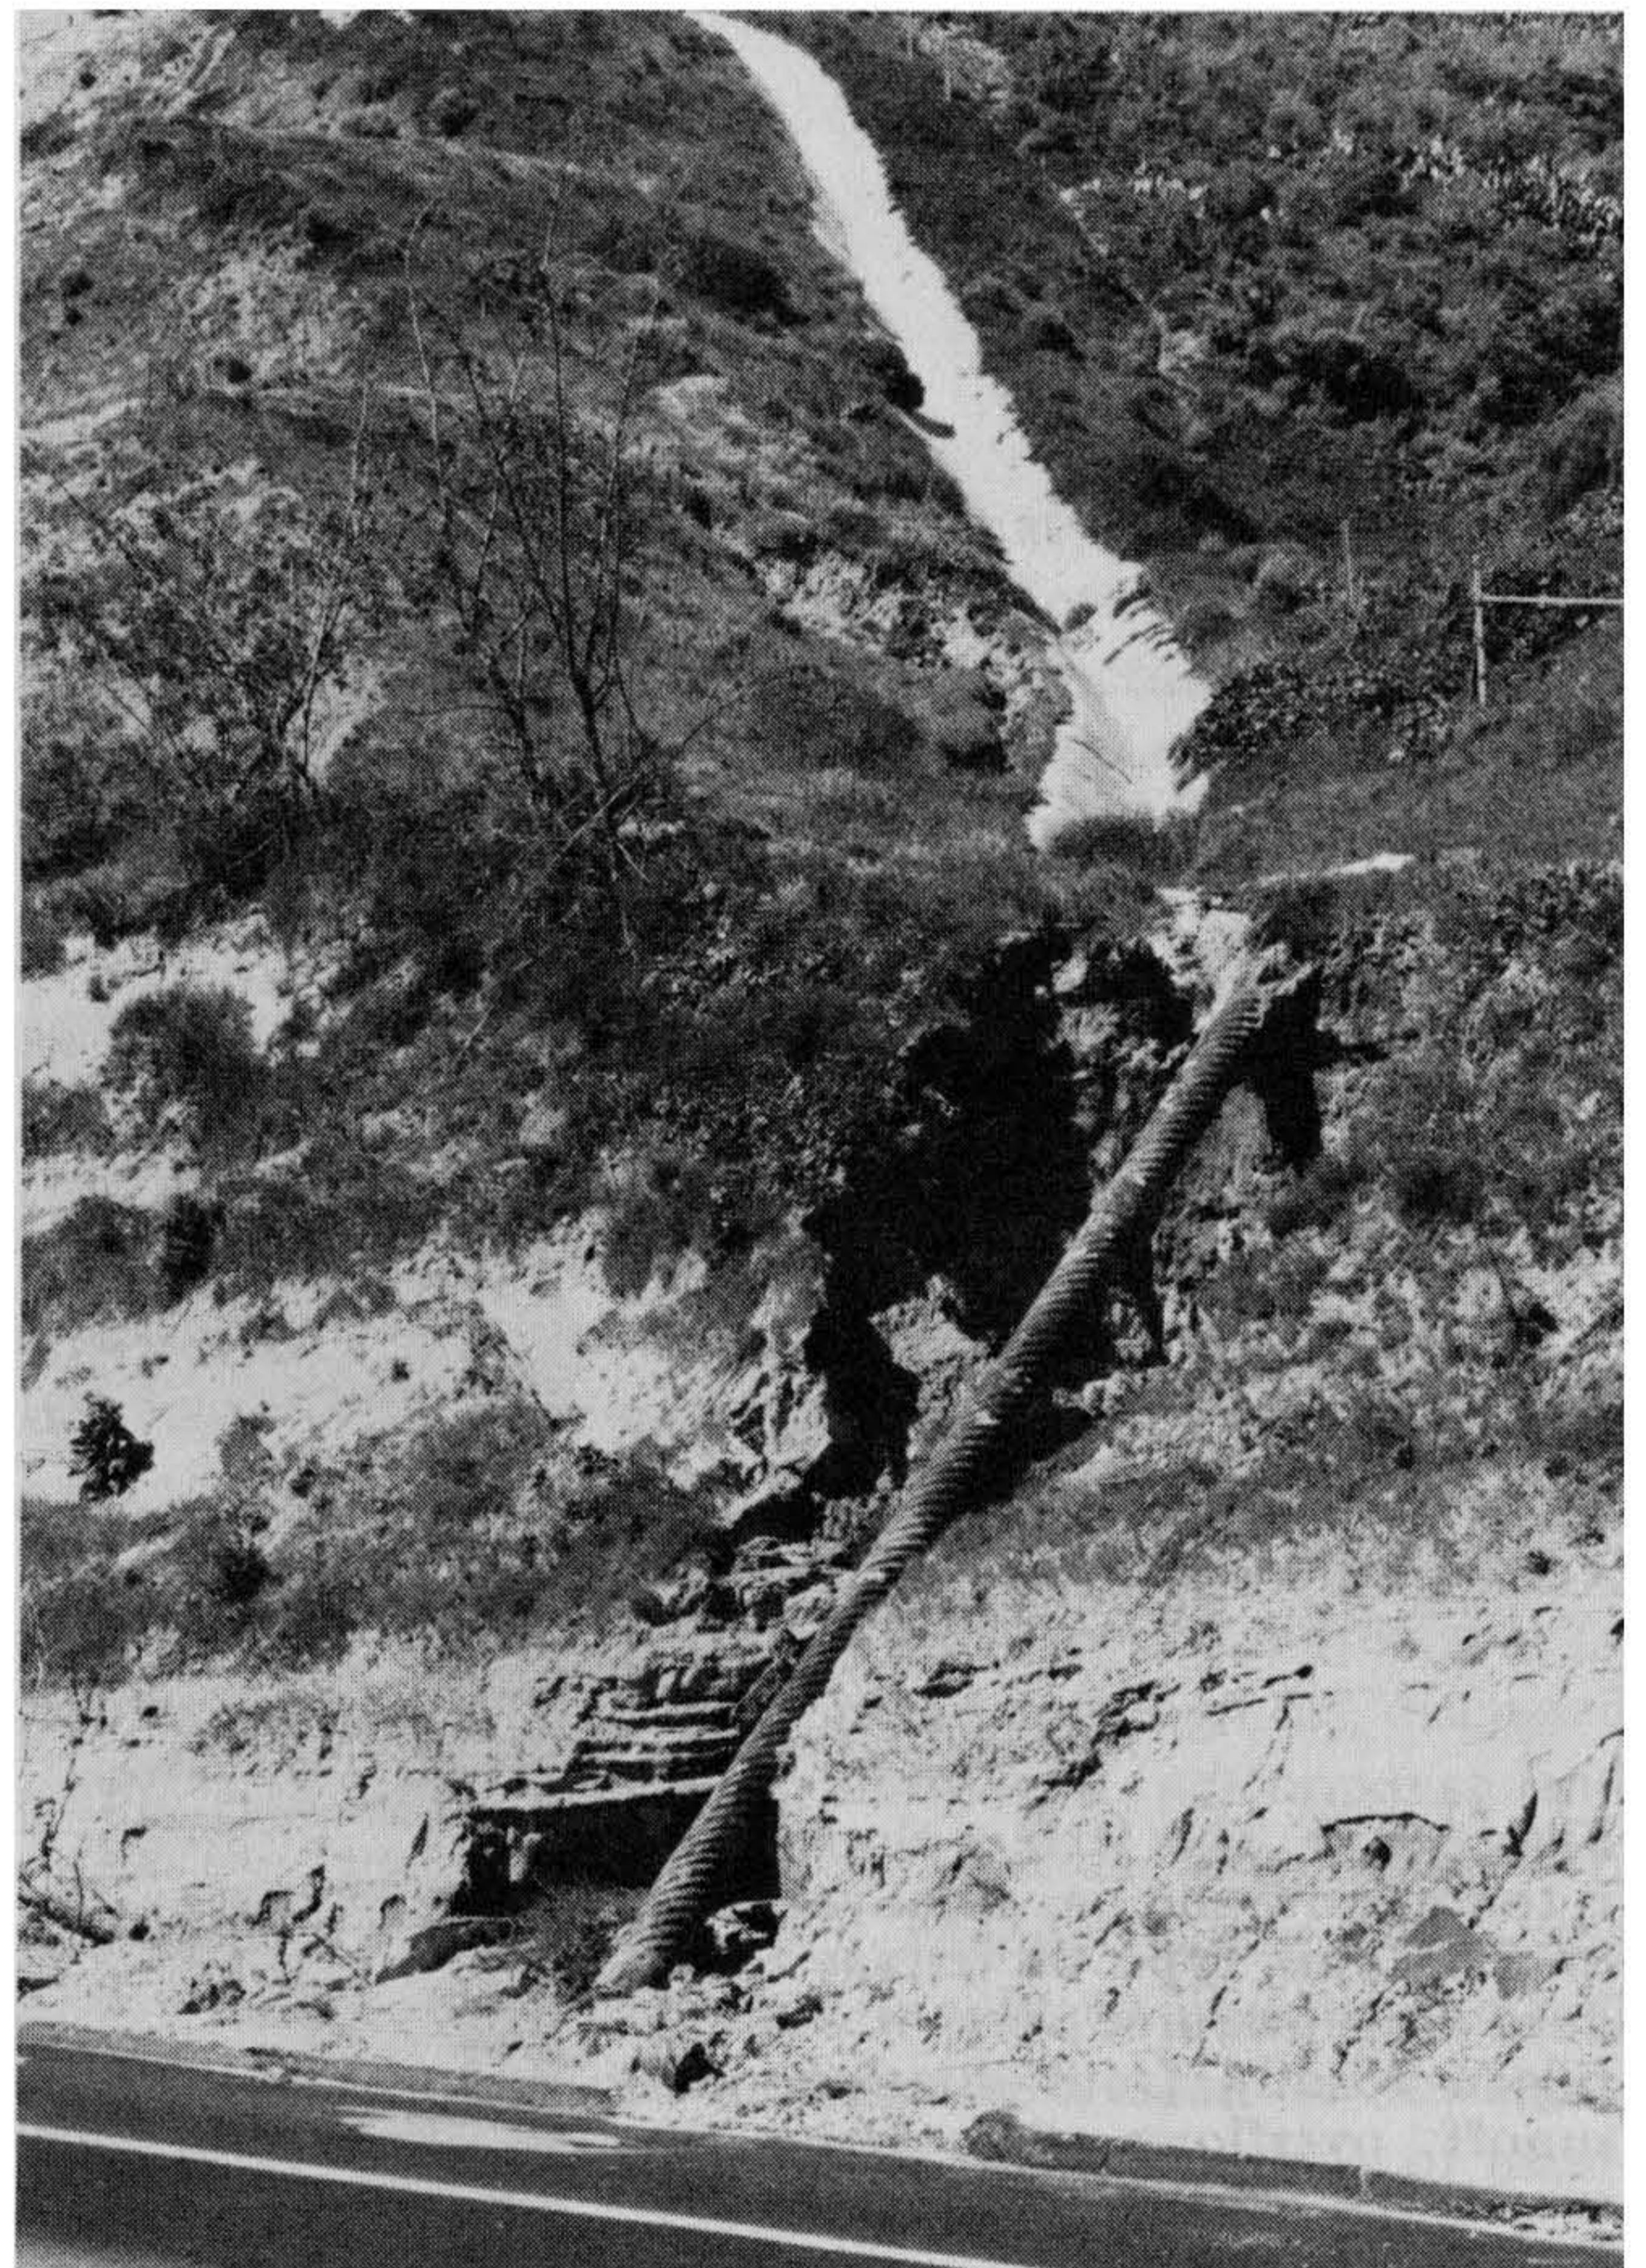
Figure 9-14 This brow-ditch drains along a top-of-slope drain into a paved down-drain and through the curb face into the street gutter. Photograph by C. Michael Scullin.
