DRAINAGE REQUIREMENTS AND MAINTENANCE OF HOMESITES

9-1 INTRODUCTION

EXCAVATION AND GRADING CODE ADMINISTRATION, INSPECTION, AND ENFORCEMENT

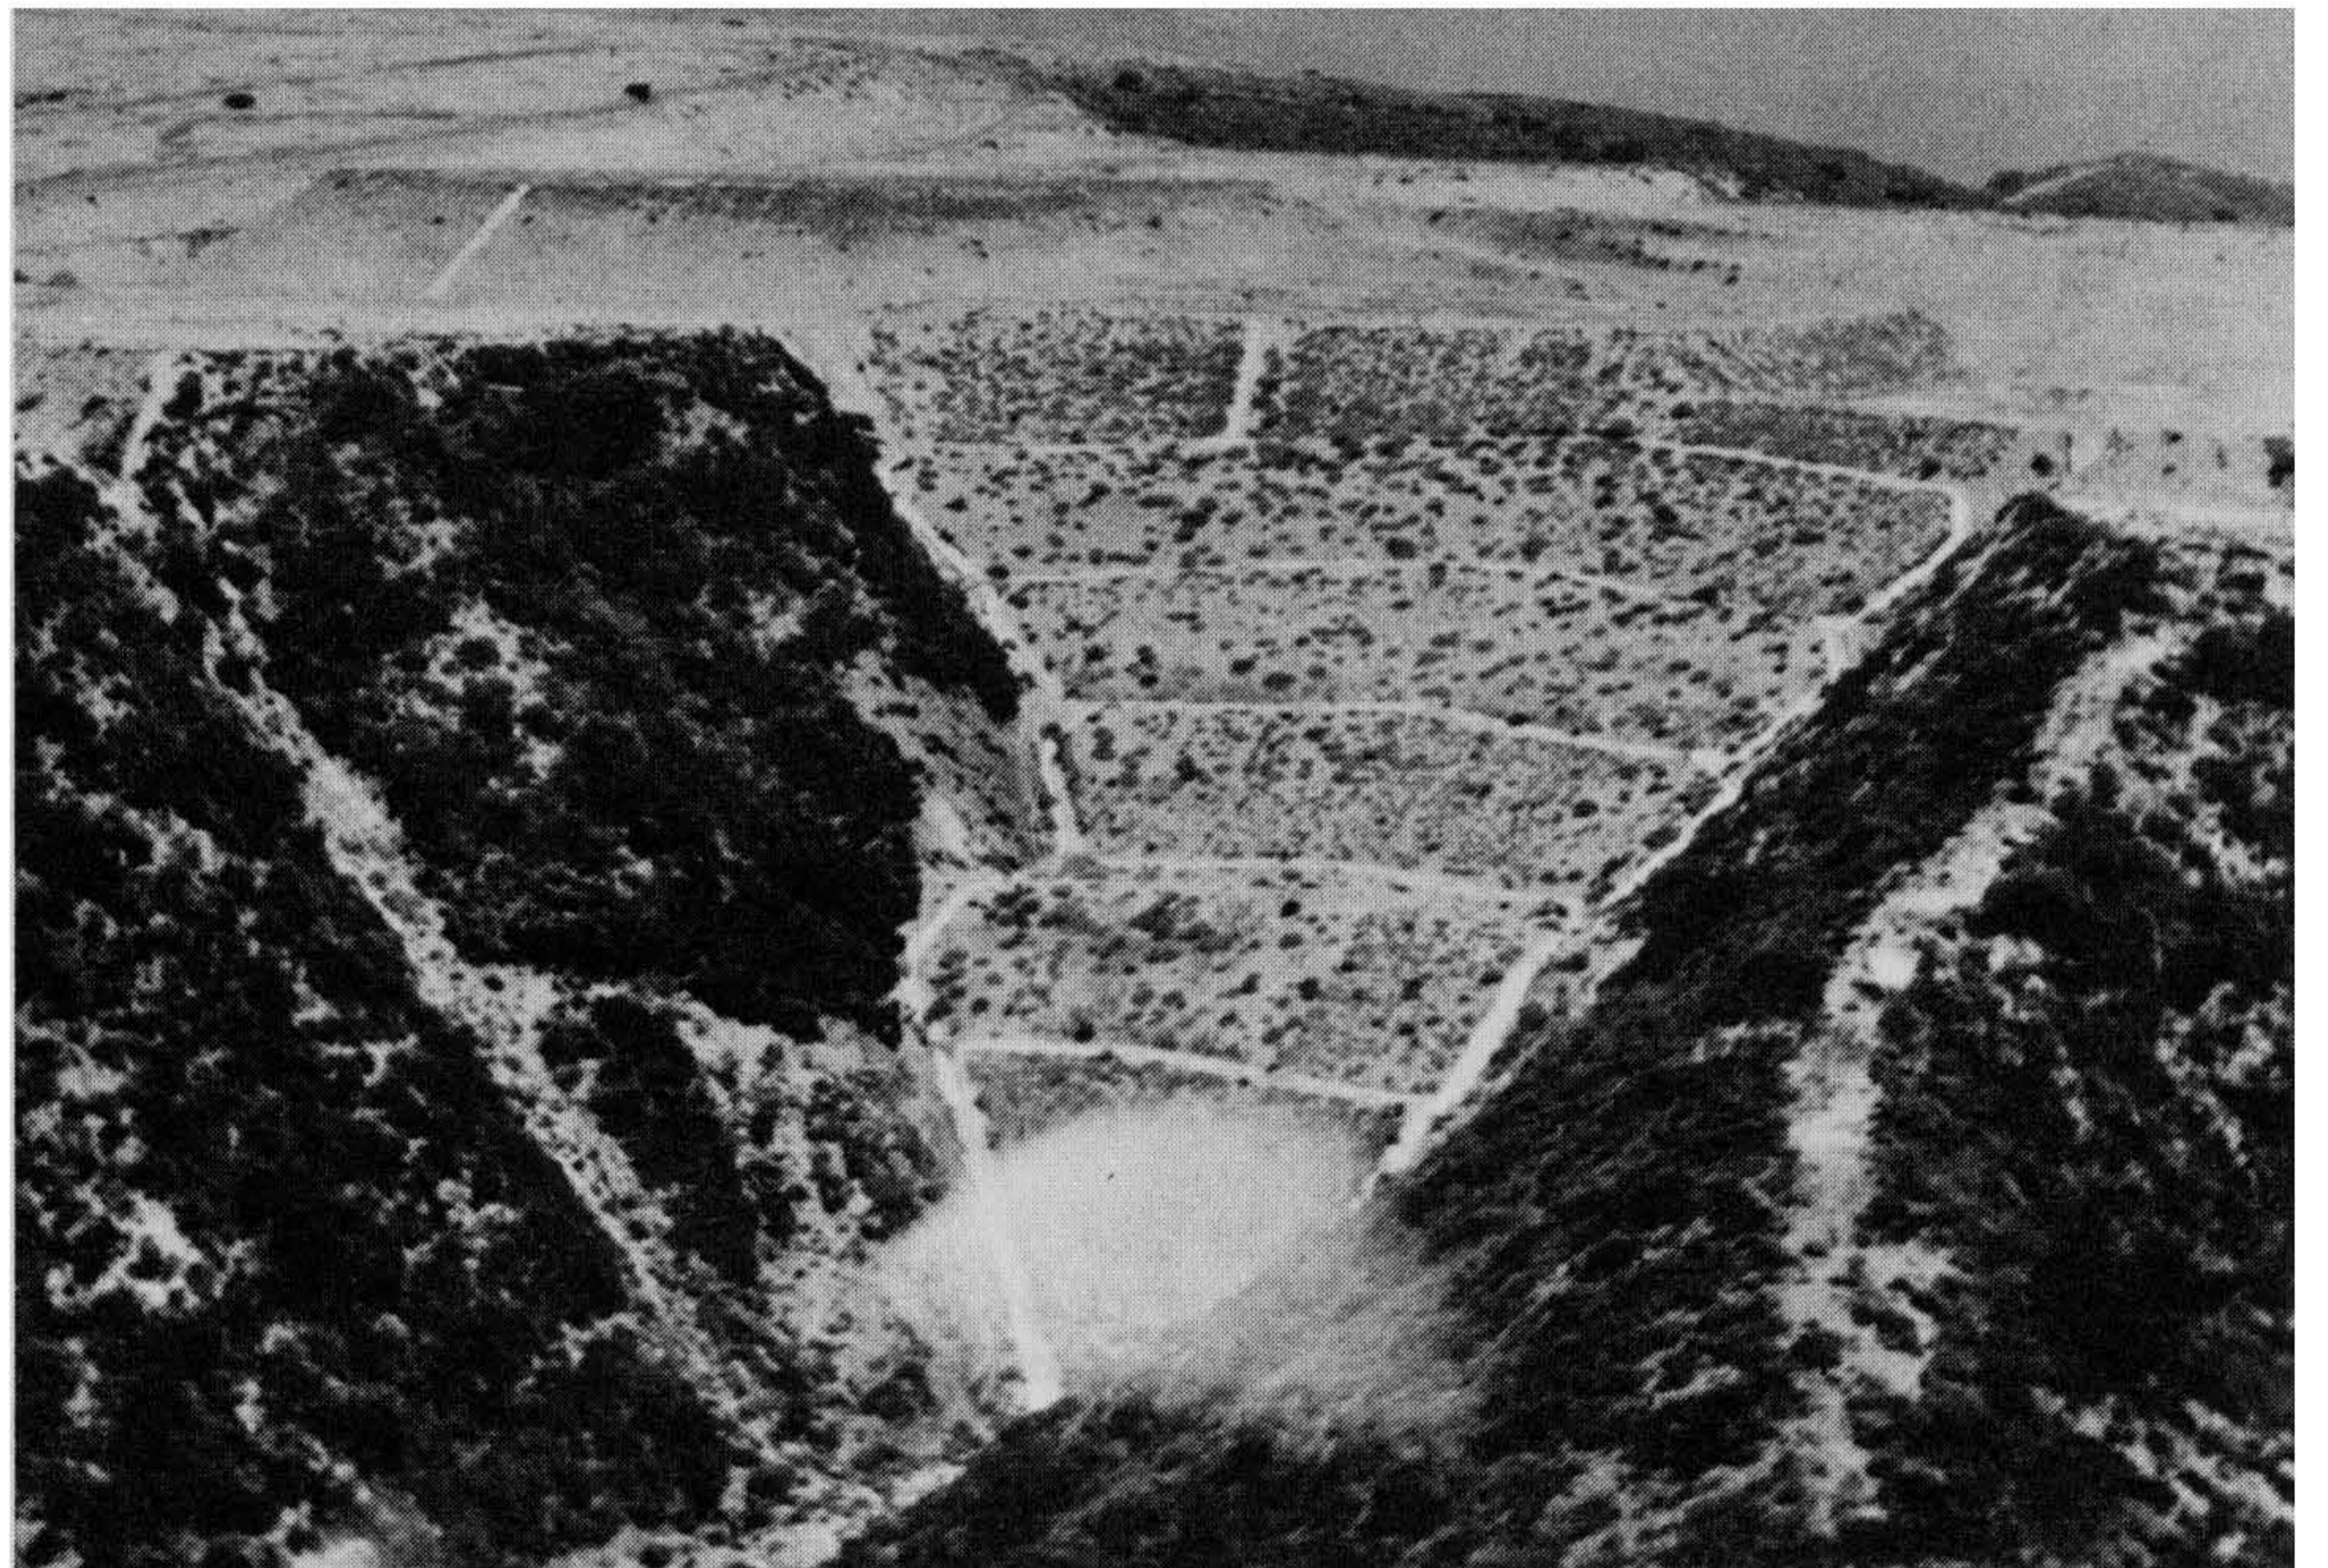
Figure 9-15 An engineered compacted fill in a V-shaped canyon with down-drains constructed along both daylight lines for good erosion control. Photograph by and courtesy of Robert W. Ross.

If a deep canyon fill is proposed in a steep V-shaped canyon, the terraces should be split in the middle and drained toward the toe or daylight line. (See Figures 9-15 and 9-16. The daylight lines should be in the location of the down drains since the grading in essence forms a smaller, concentrated ravine at each side of the fill slope along the daylight lines. This plan will require raising the freeboard of the down drain with diverter walls at each terrace inlet

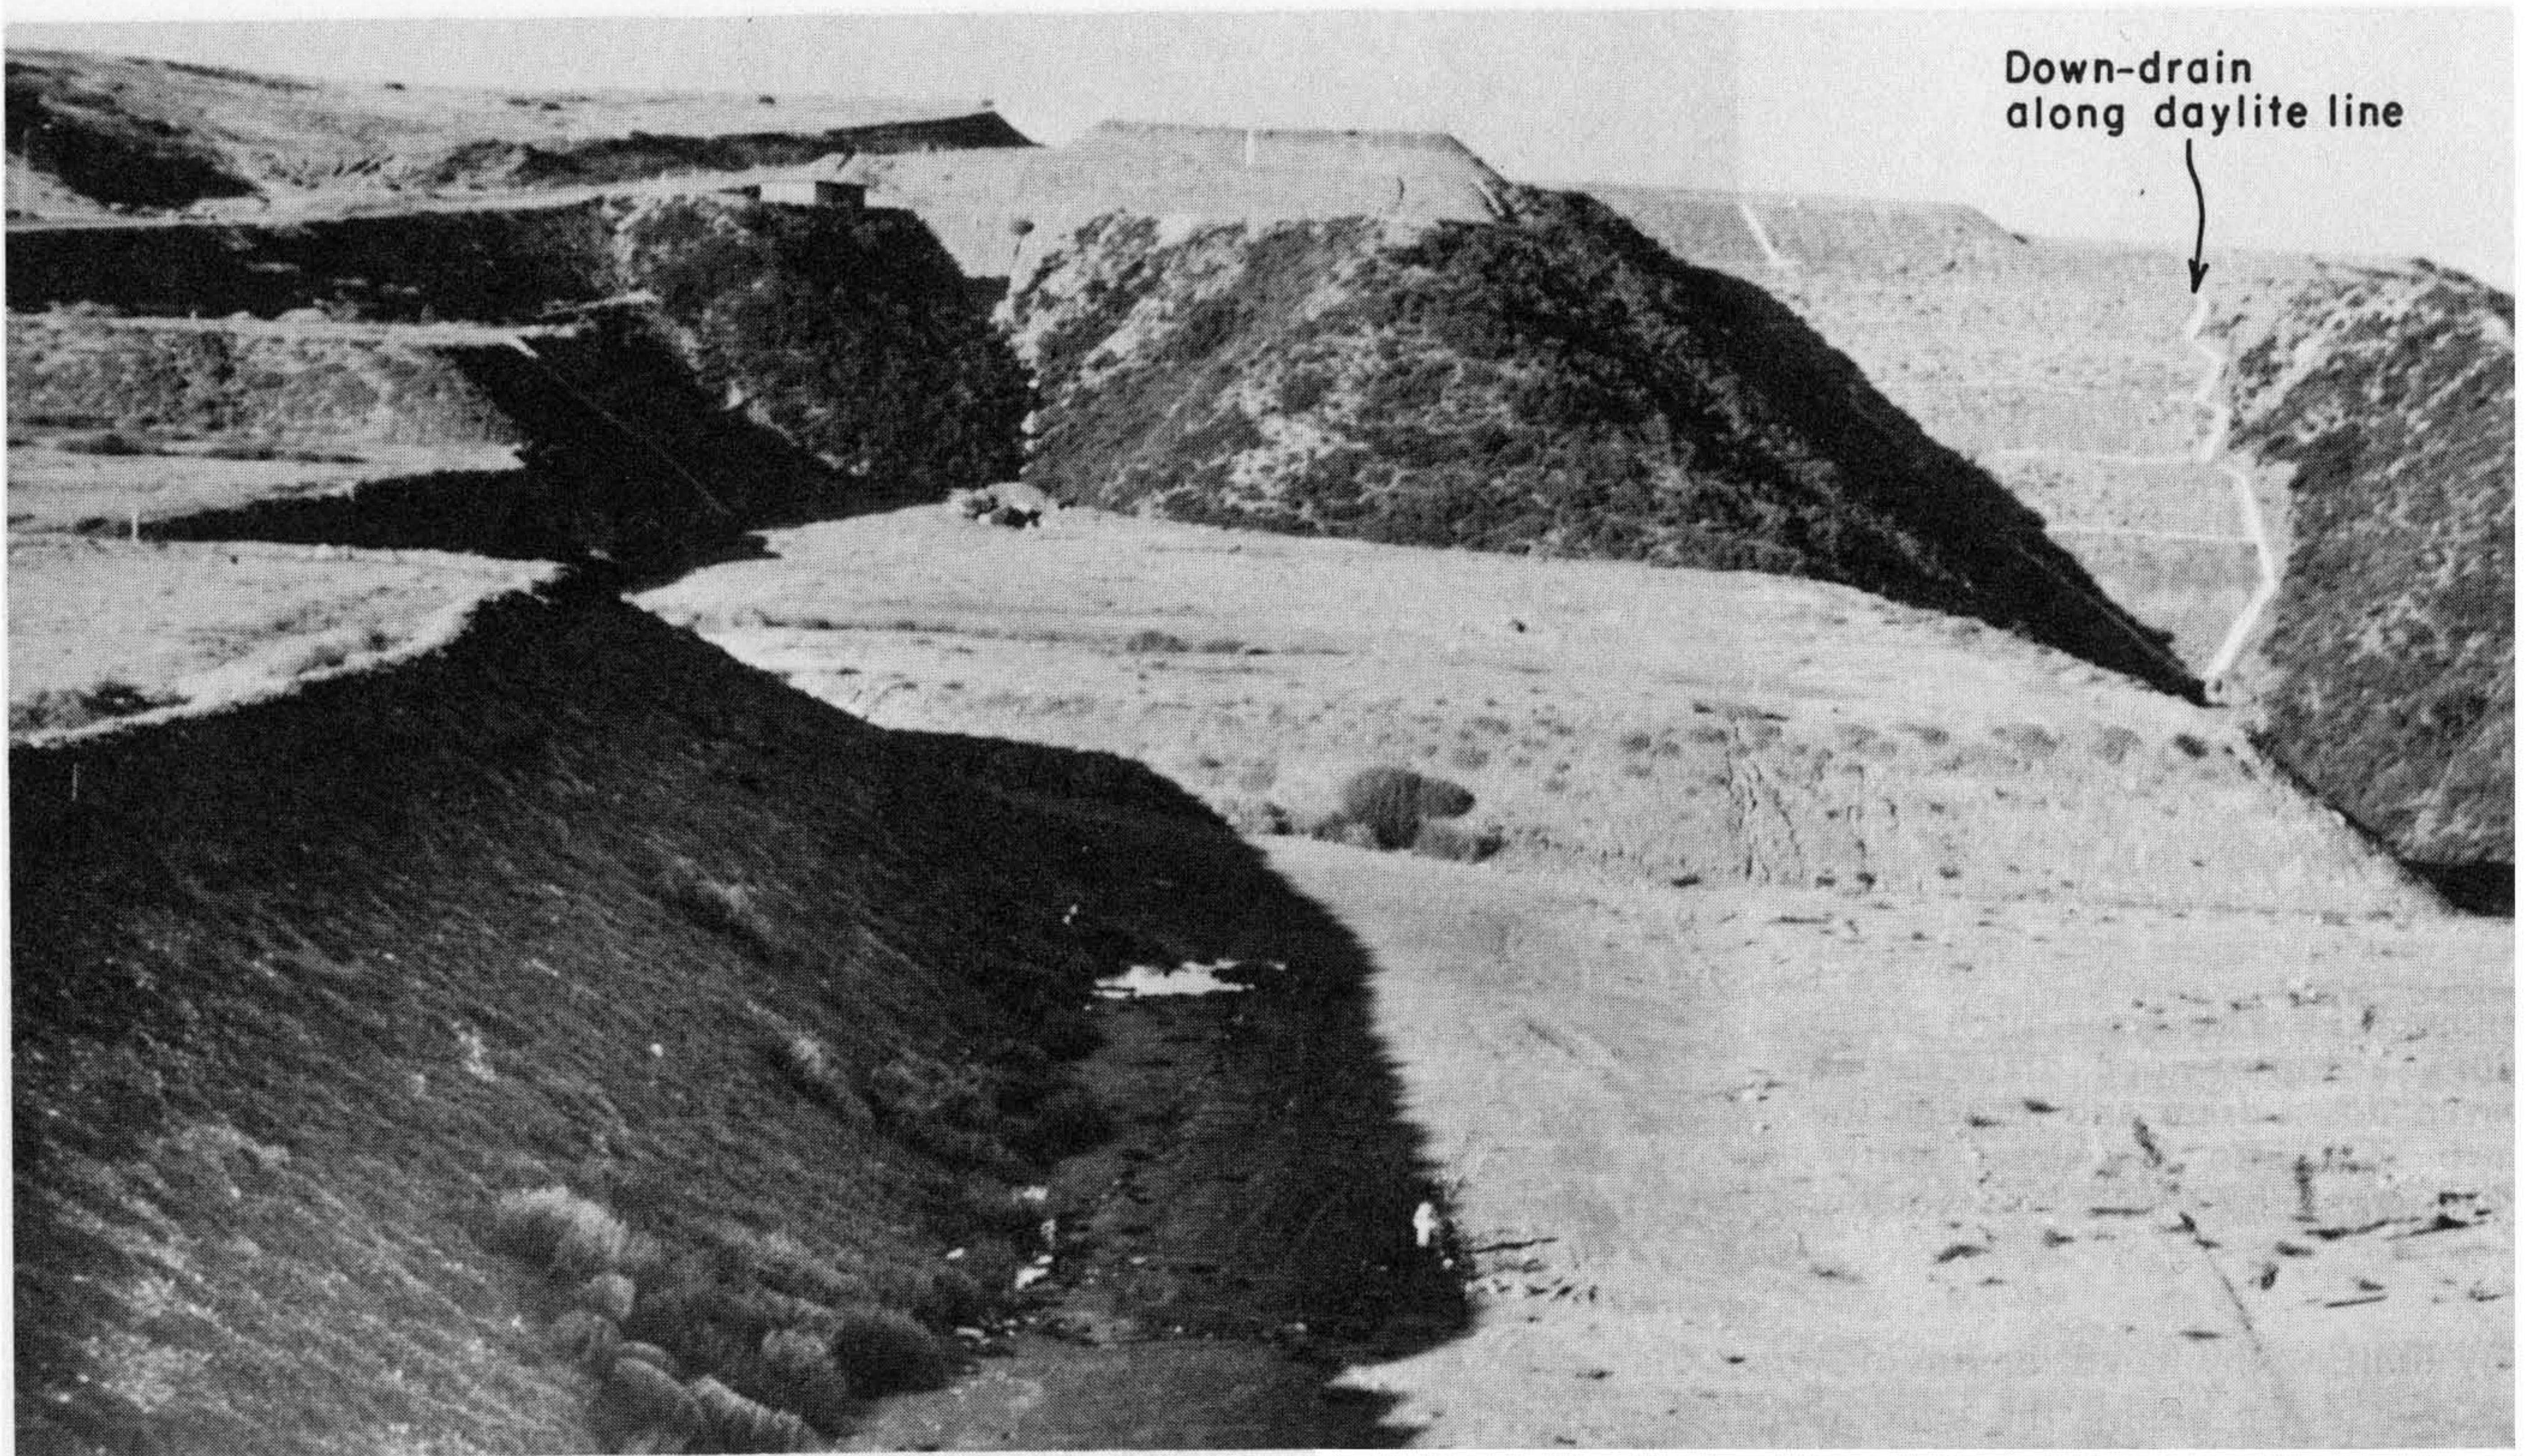
Figure 9-16 The deep V-shaped canyon fill in far right background has down-drains constructed along both daylight lines for better erosion control. Terrace drains are peaked in the center to drain both sides into down-drains. Photograph by and courtesy of Robert W. Ross.

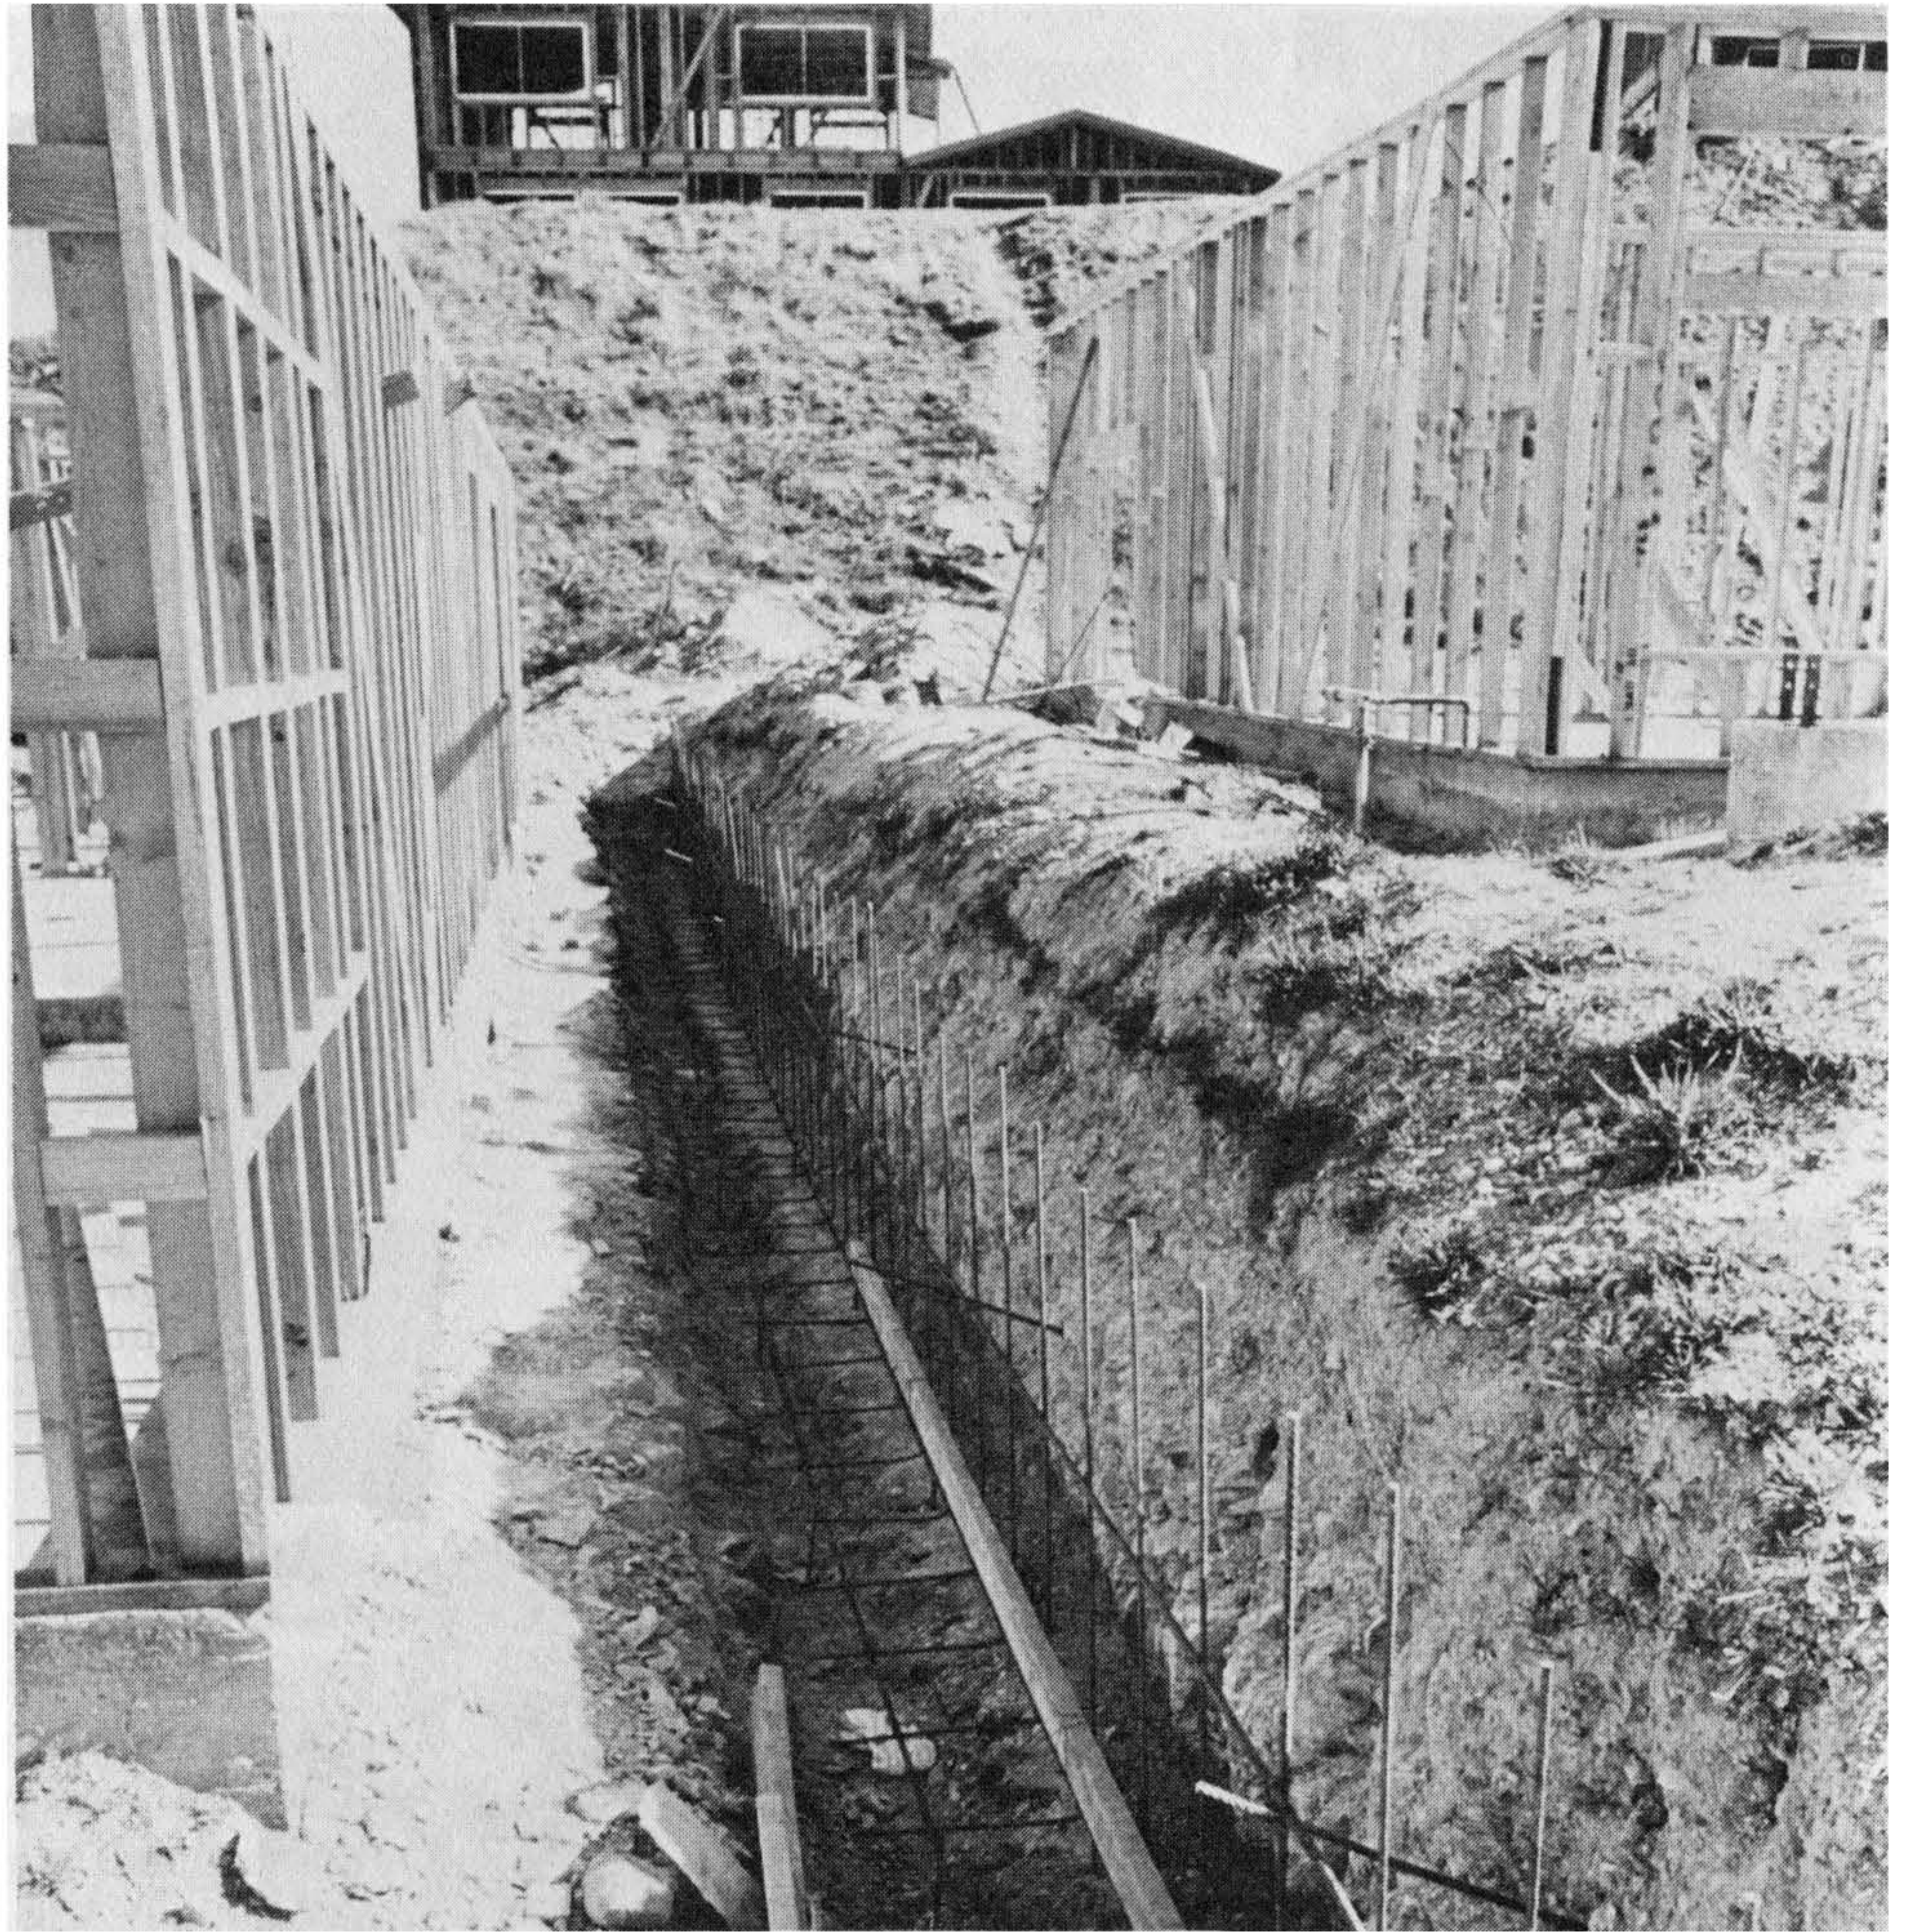
Figure 9-18 Retaining wall construction along a mutual property line. Notice the close proximity of the residence foundations to the property line and the narrow sideyard. Photograph by and courtesy of Alex Bruce, senior building inspector, City of Los Angeles.

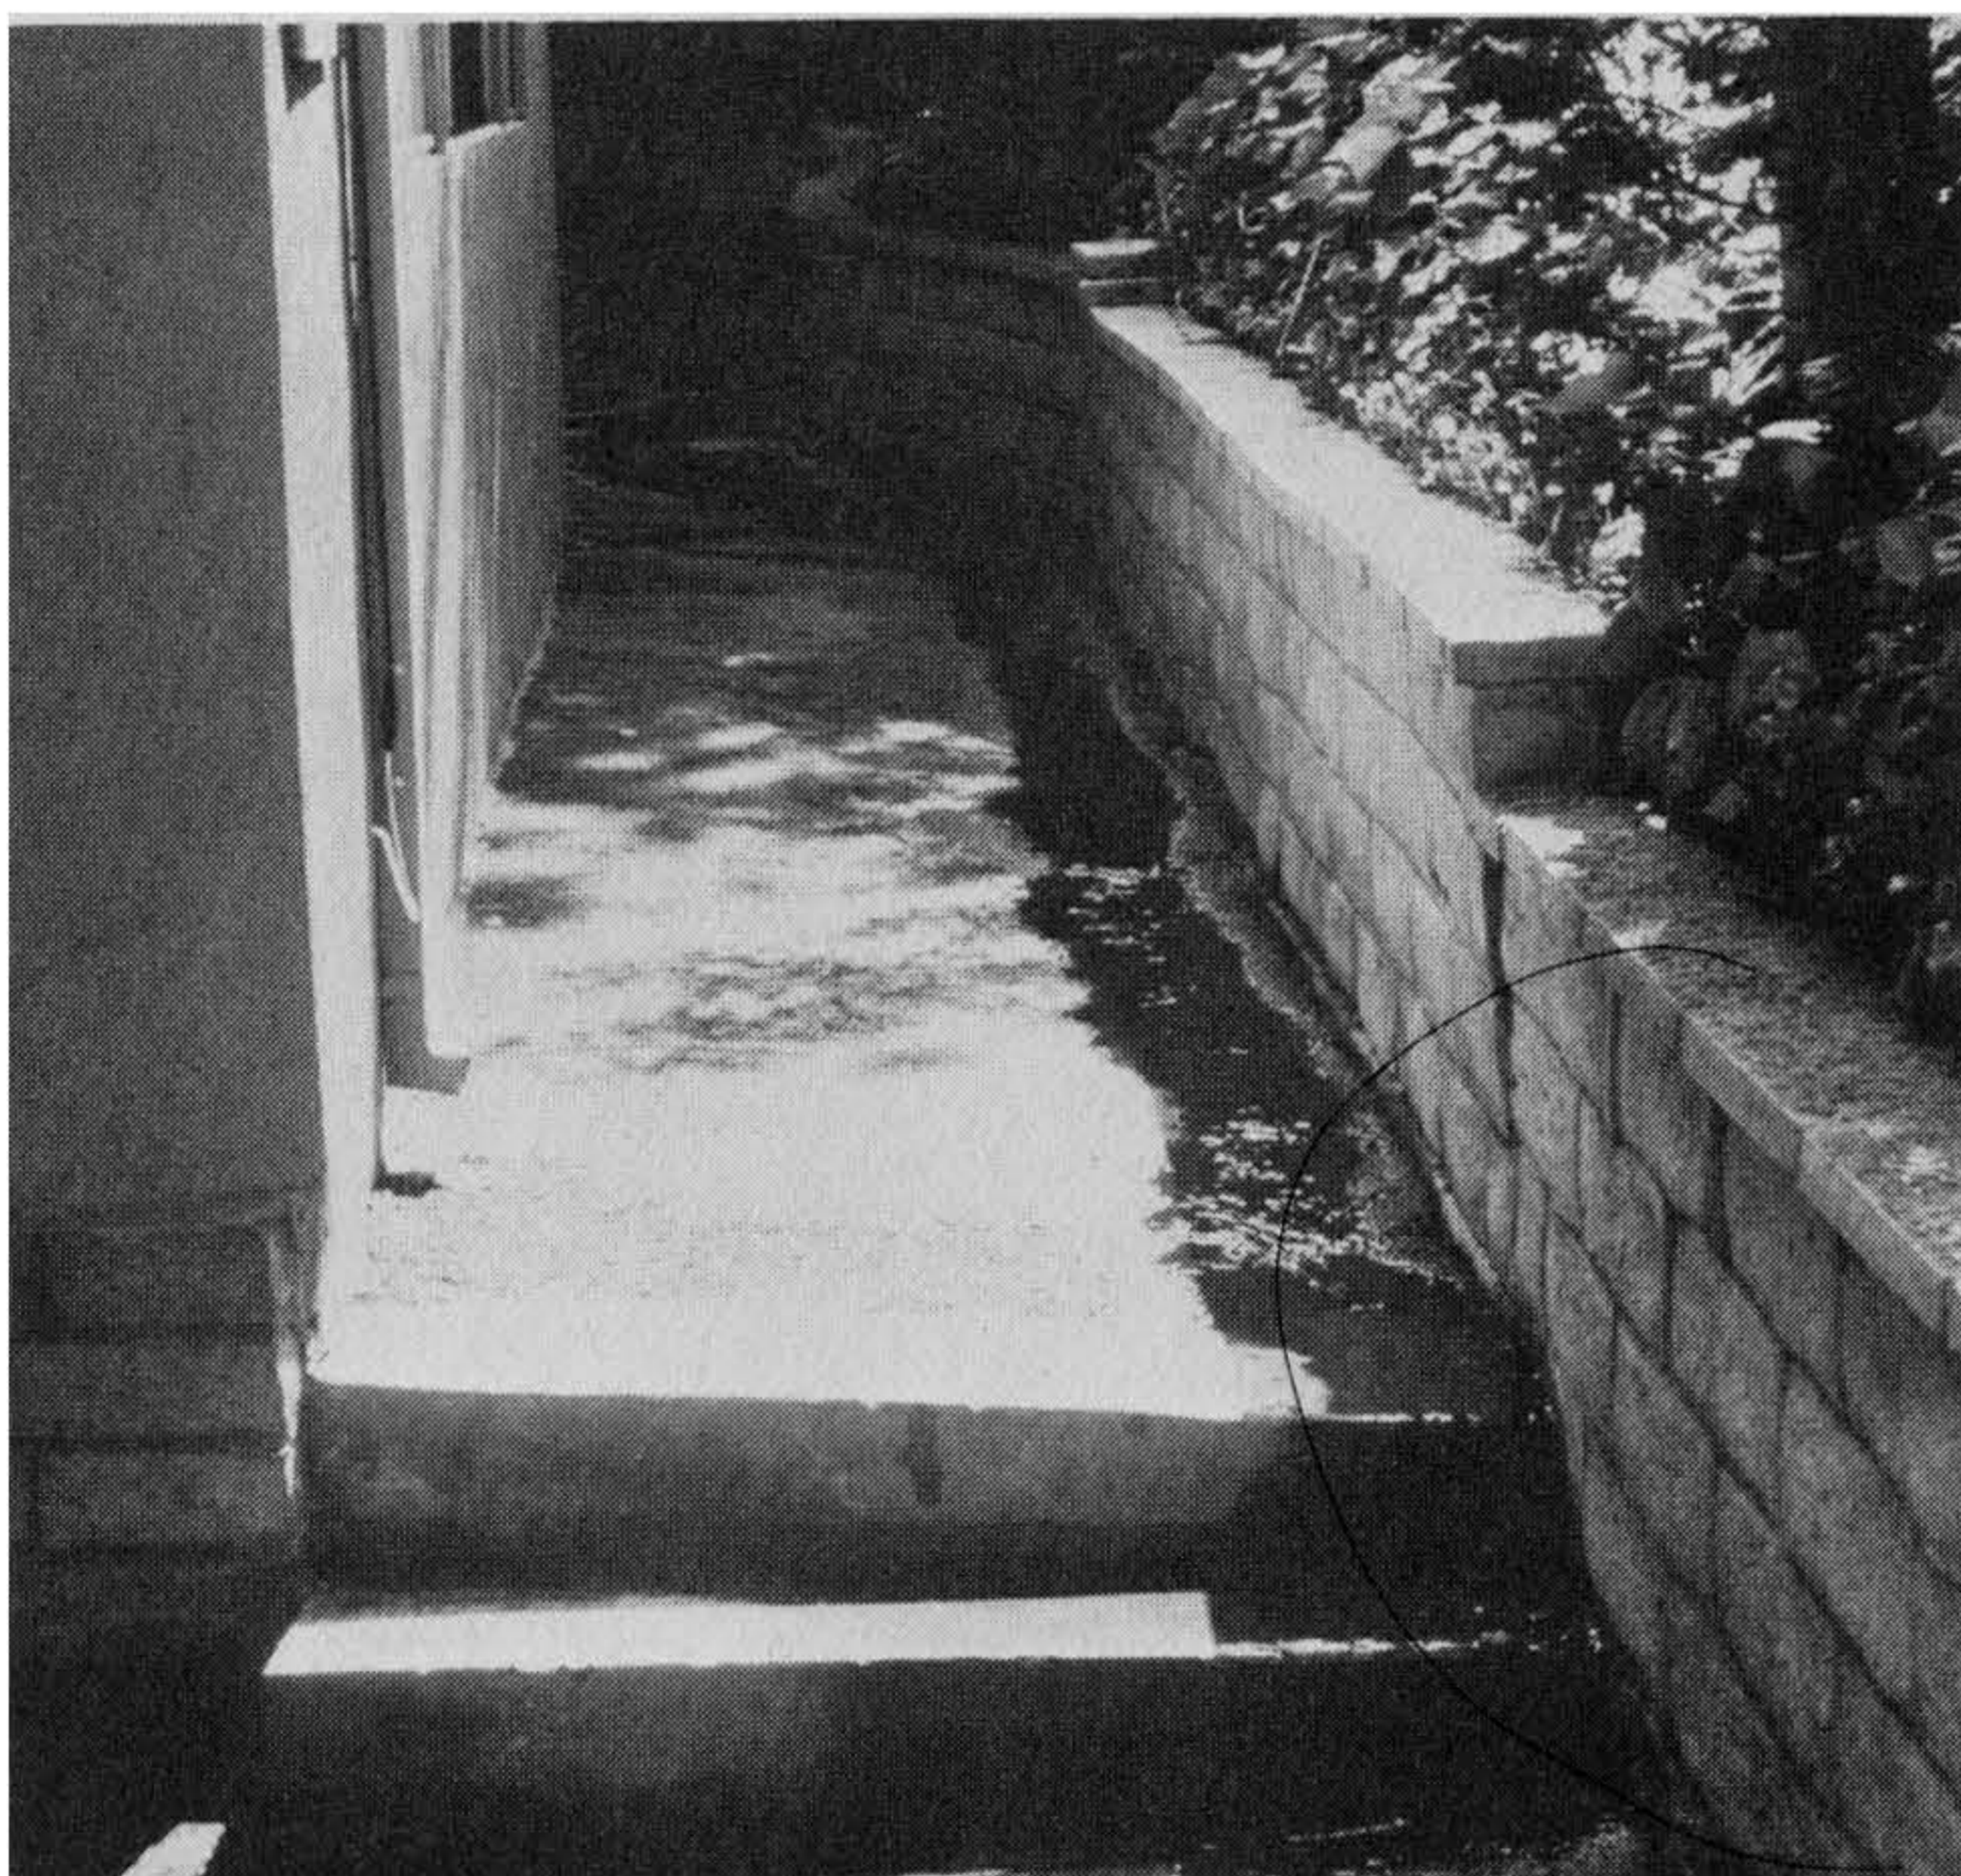
Figure 9-21 Here a depressed sidewalk drain carries drainage from the rear yard to the street. Photograph by C. Michael Scullin.

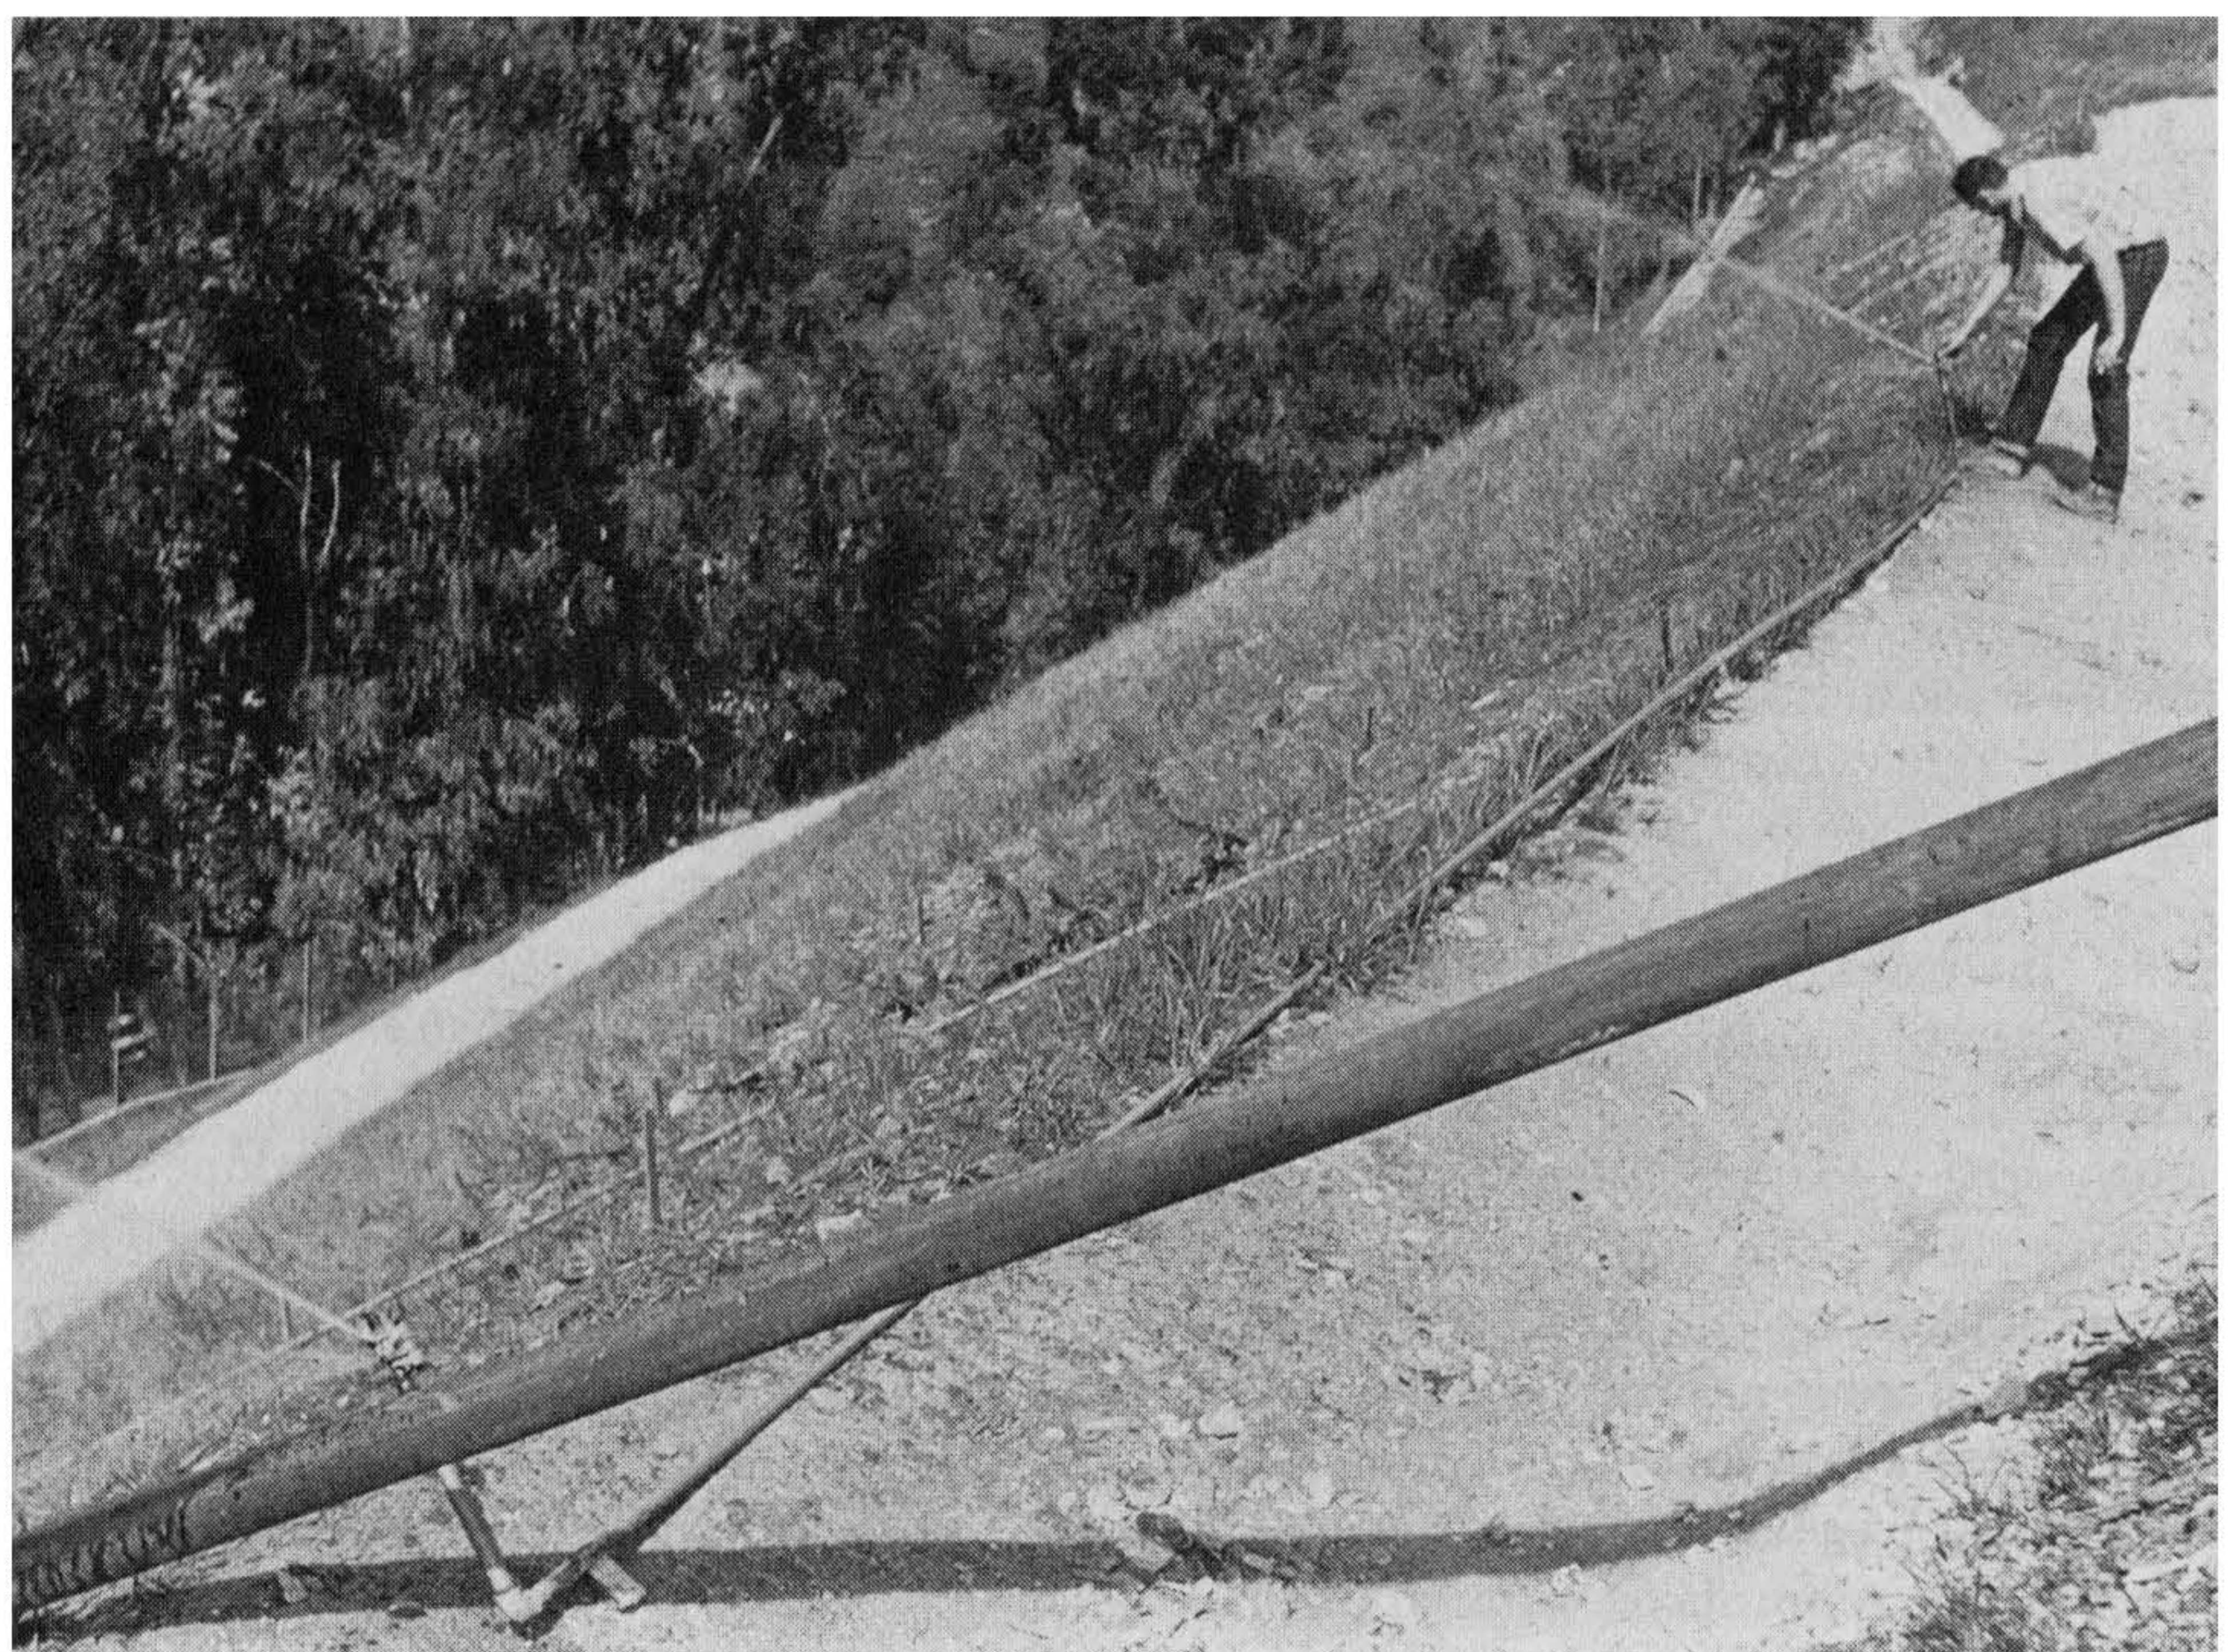
Figure 9-24 Checking sprinkler heads and "rainbird" performance. Close maintenance of watering devices is necessary to minimize oversaturation. Photograph by and courtesy of Alex Bruce, senior building inspector, City of Los Angeles.

tion during rainy periods. Such timing devices cause the sprinklers to function even during rainstorms! This type of abuse must be considered by governmental agencies that now require automatic sprinkling of cut and fill slopes. Manual operation of sprinklers should be considered as an alternative. (See Figure 9-24.) Further discussion of planting is provided in Section 9-5.

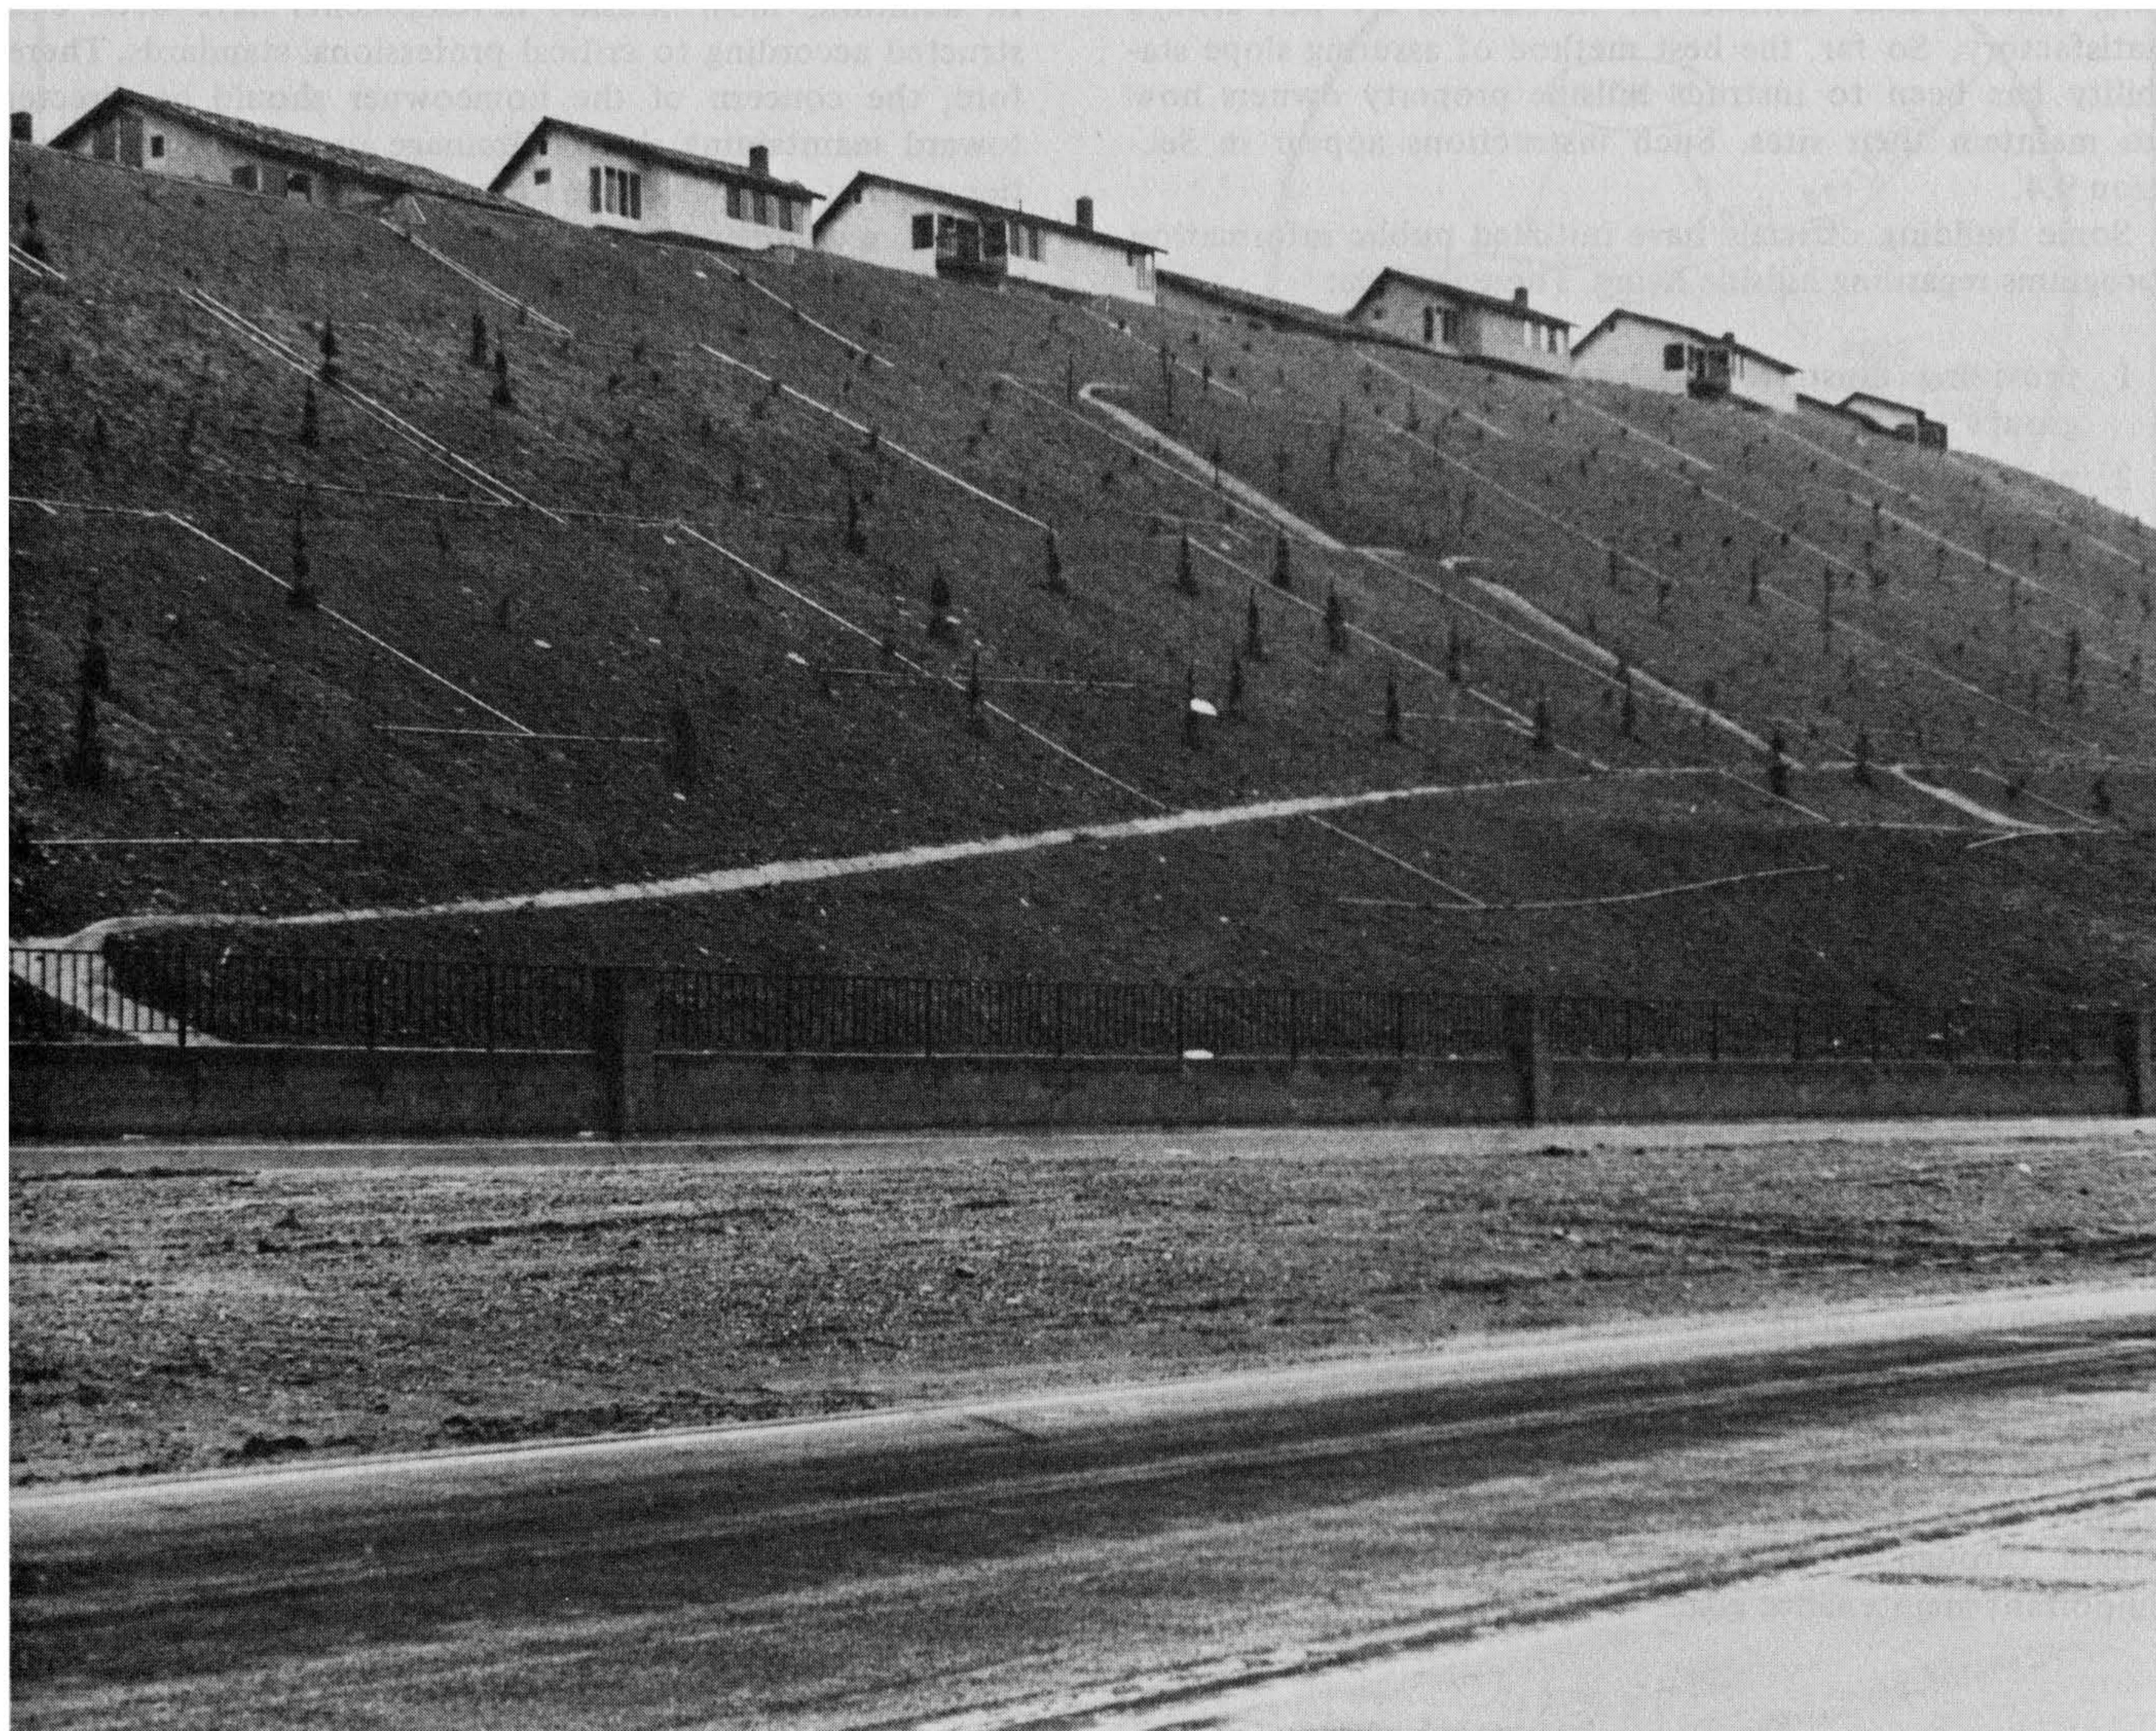
Figure 9-25 A well-compacted fill slope with all drainage devices functioning and minimum water applied. This slope has performed well through three heavy rain seasons. Photograph by C. Michael Scullin.
