DRAINAGE REQUIREMENTS AND MAINTENANCE OF HOMESITES

9-1 INTRODUCTION

EXCAVATION AND GRADING CODE ADMINISTRATION, INSPECTION, AND ENFORCEMENT

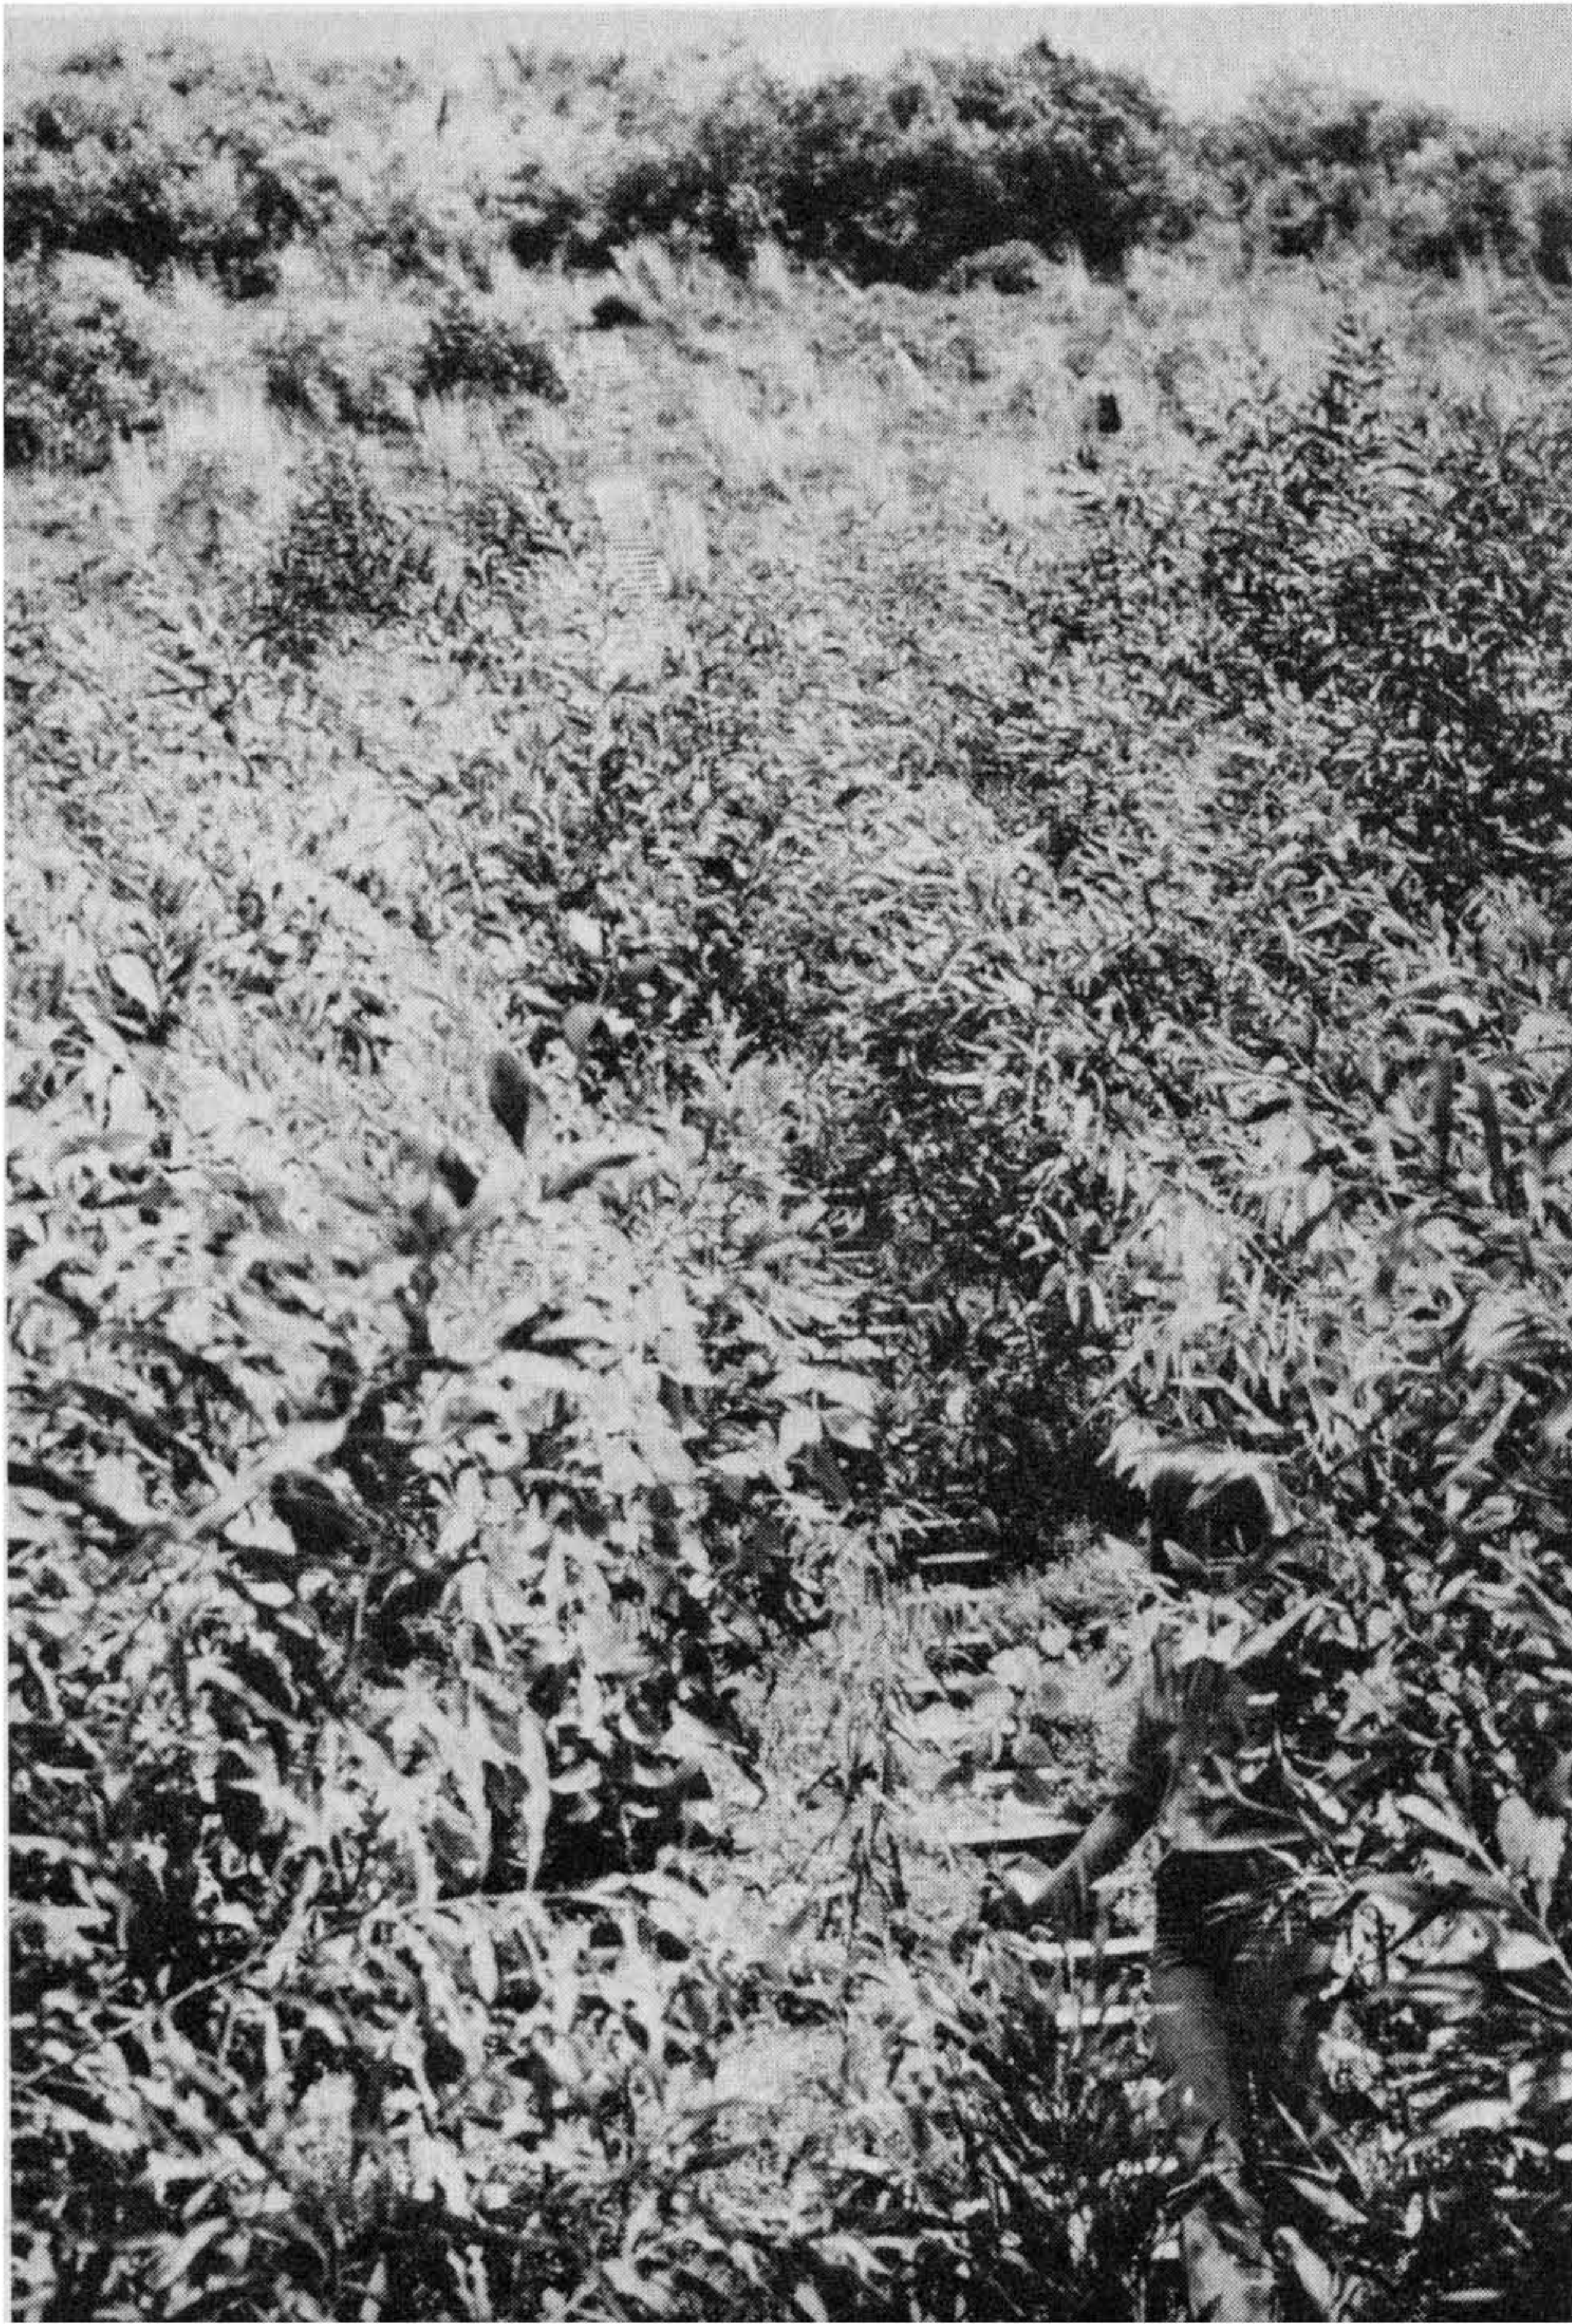
Figure 9-28 Mission Valley Crossroad Slopes fifteen months after using seedmix Mission Valley No. 69. Shrubs, trees, and ground covers provide the effect envisioned by the landscape architect. Photograph by and courtesy of Ronald Pecoff.

after hydroseeding installation. Figure 9-28 shows Mission Valley Crossroad Slopes 15 months after using seedmix Mission Valley No. 69 and shows the shrubs, trees, and ground covers used to provide the effect envisioned by the landscape architect. Figure 9-29 depicts the Mission Valley Crossroad Slopes seedmix, Mission Valley No. 69 four years after hydroseeding installation. No further maintenance was provided.

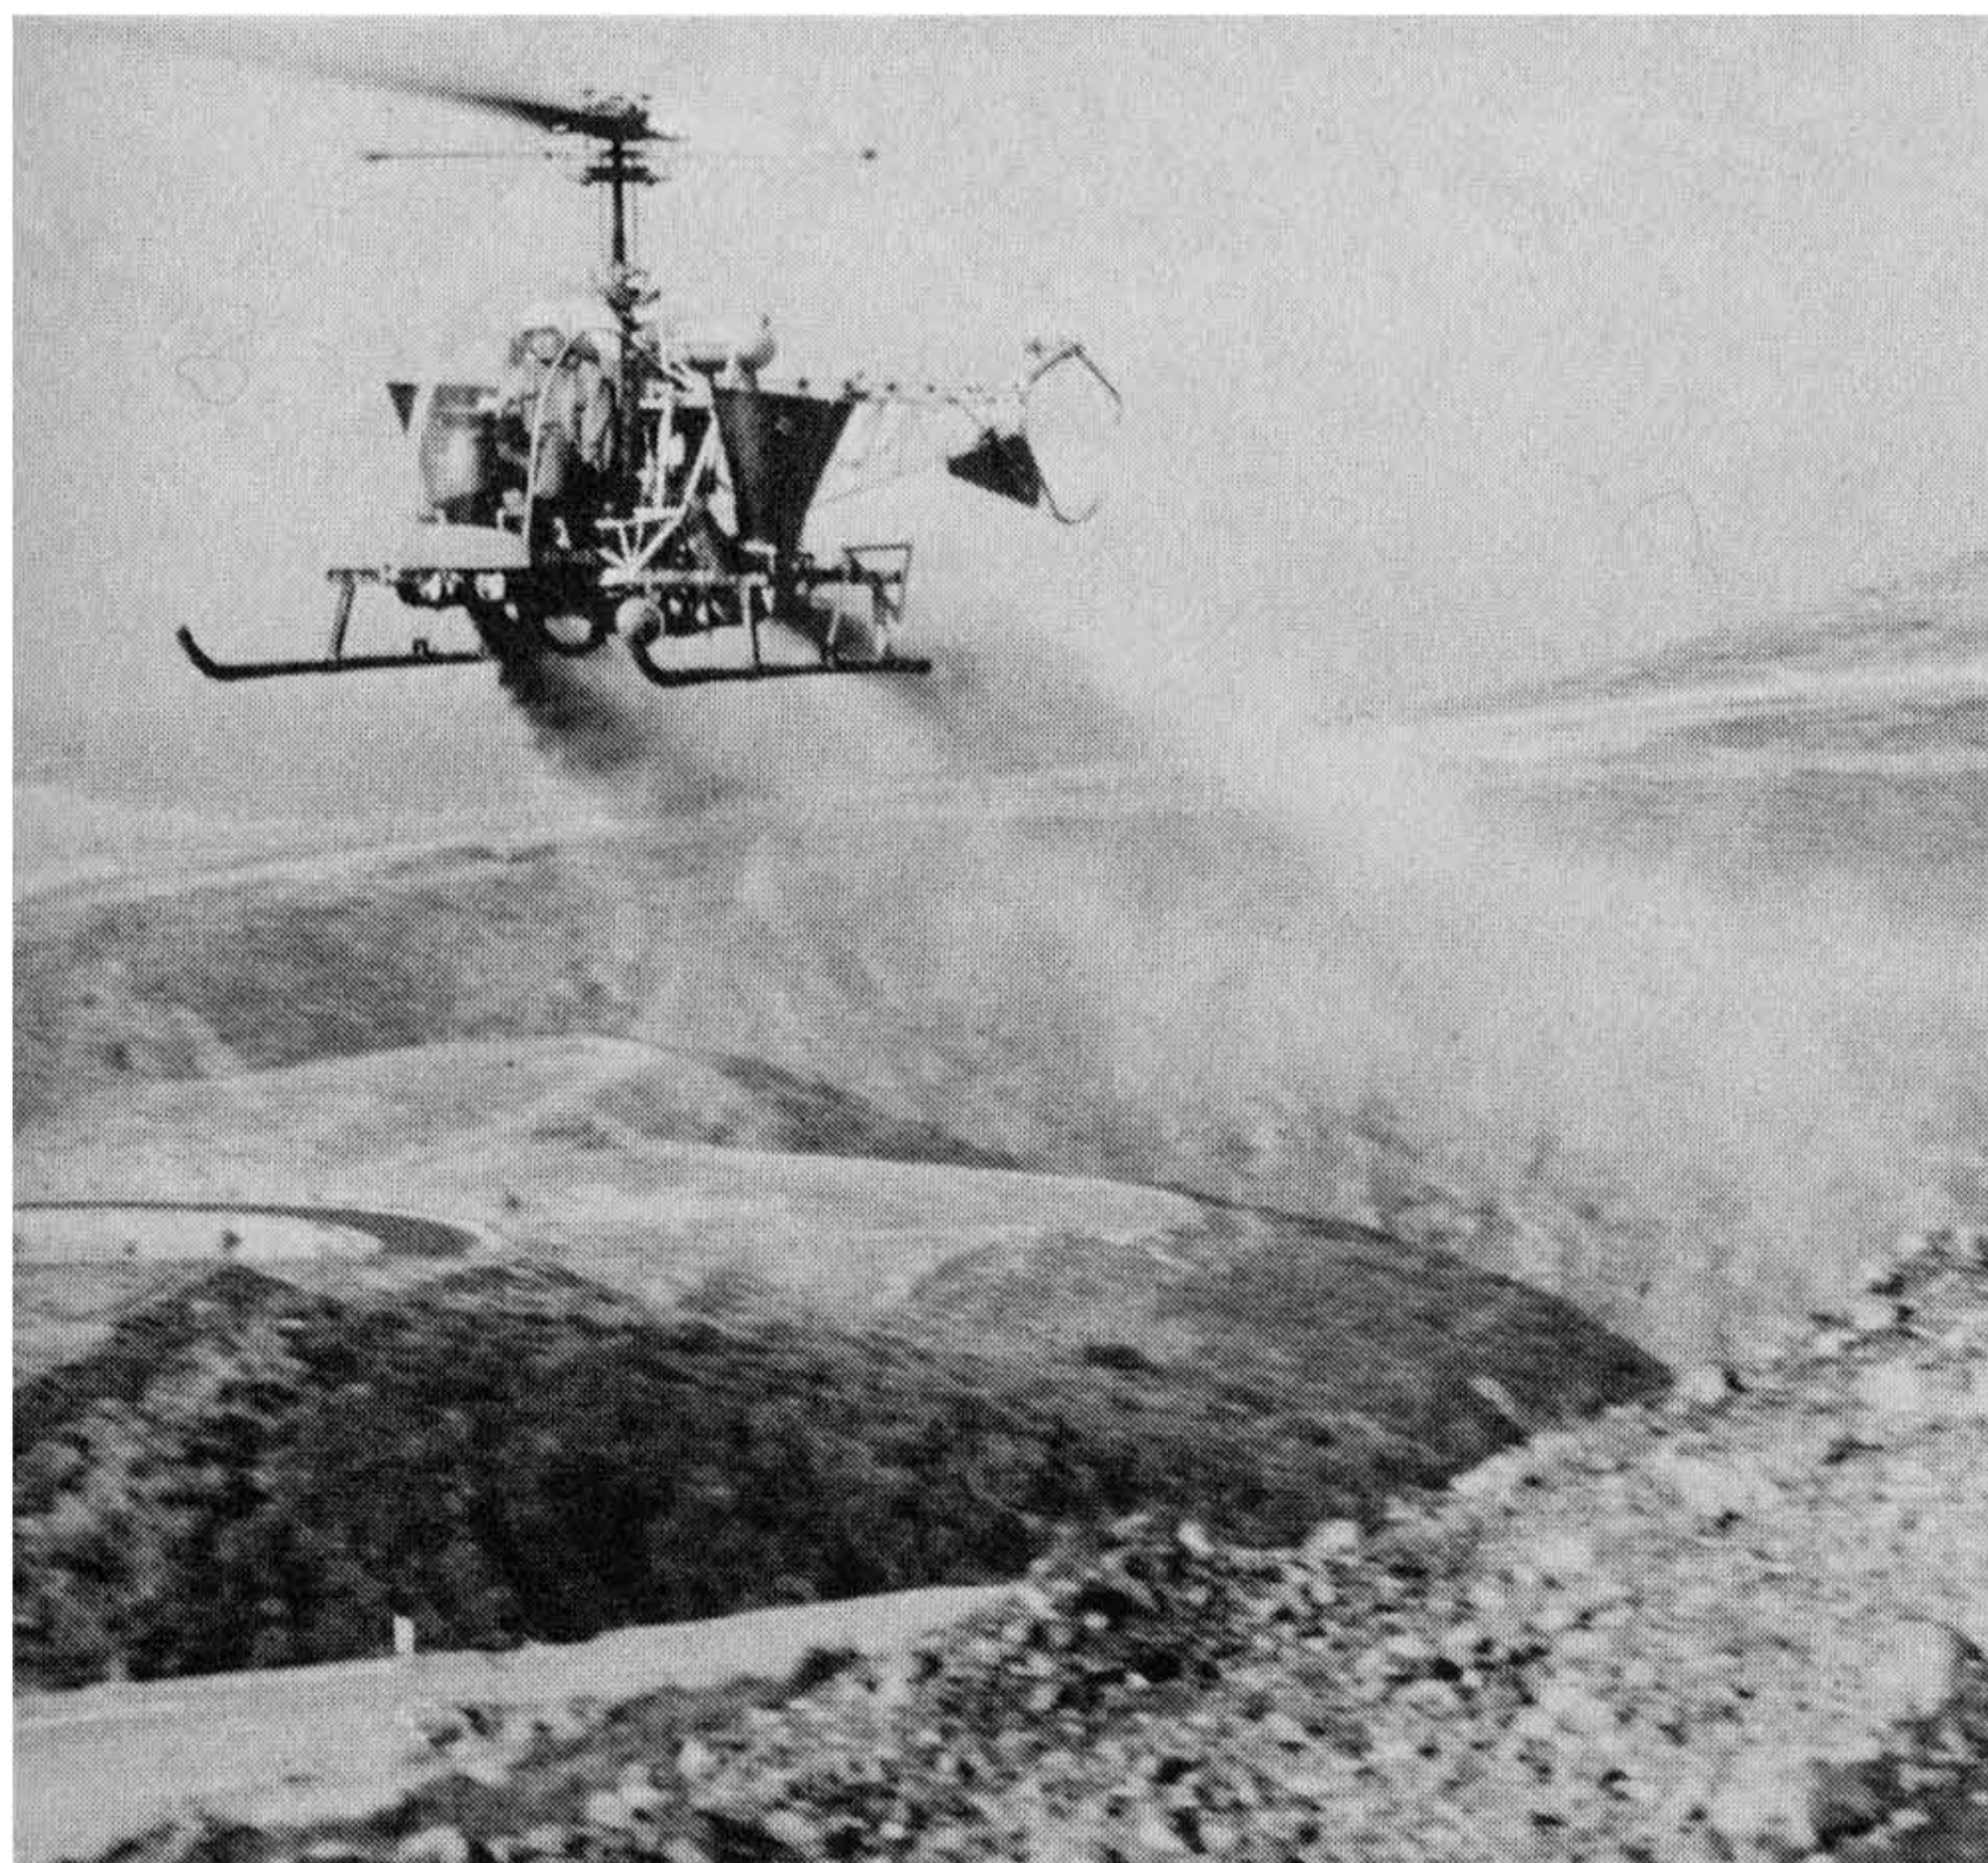
Figure 9-30 Aerial helicopter seeding of Vale IV, No. 117 seedmix for the La Costa Development Corporation. Photograph by and courtesy of Ronald Pecoff.

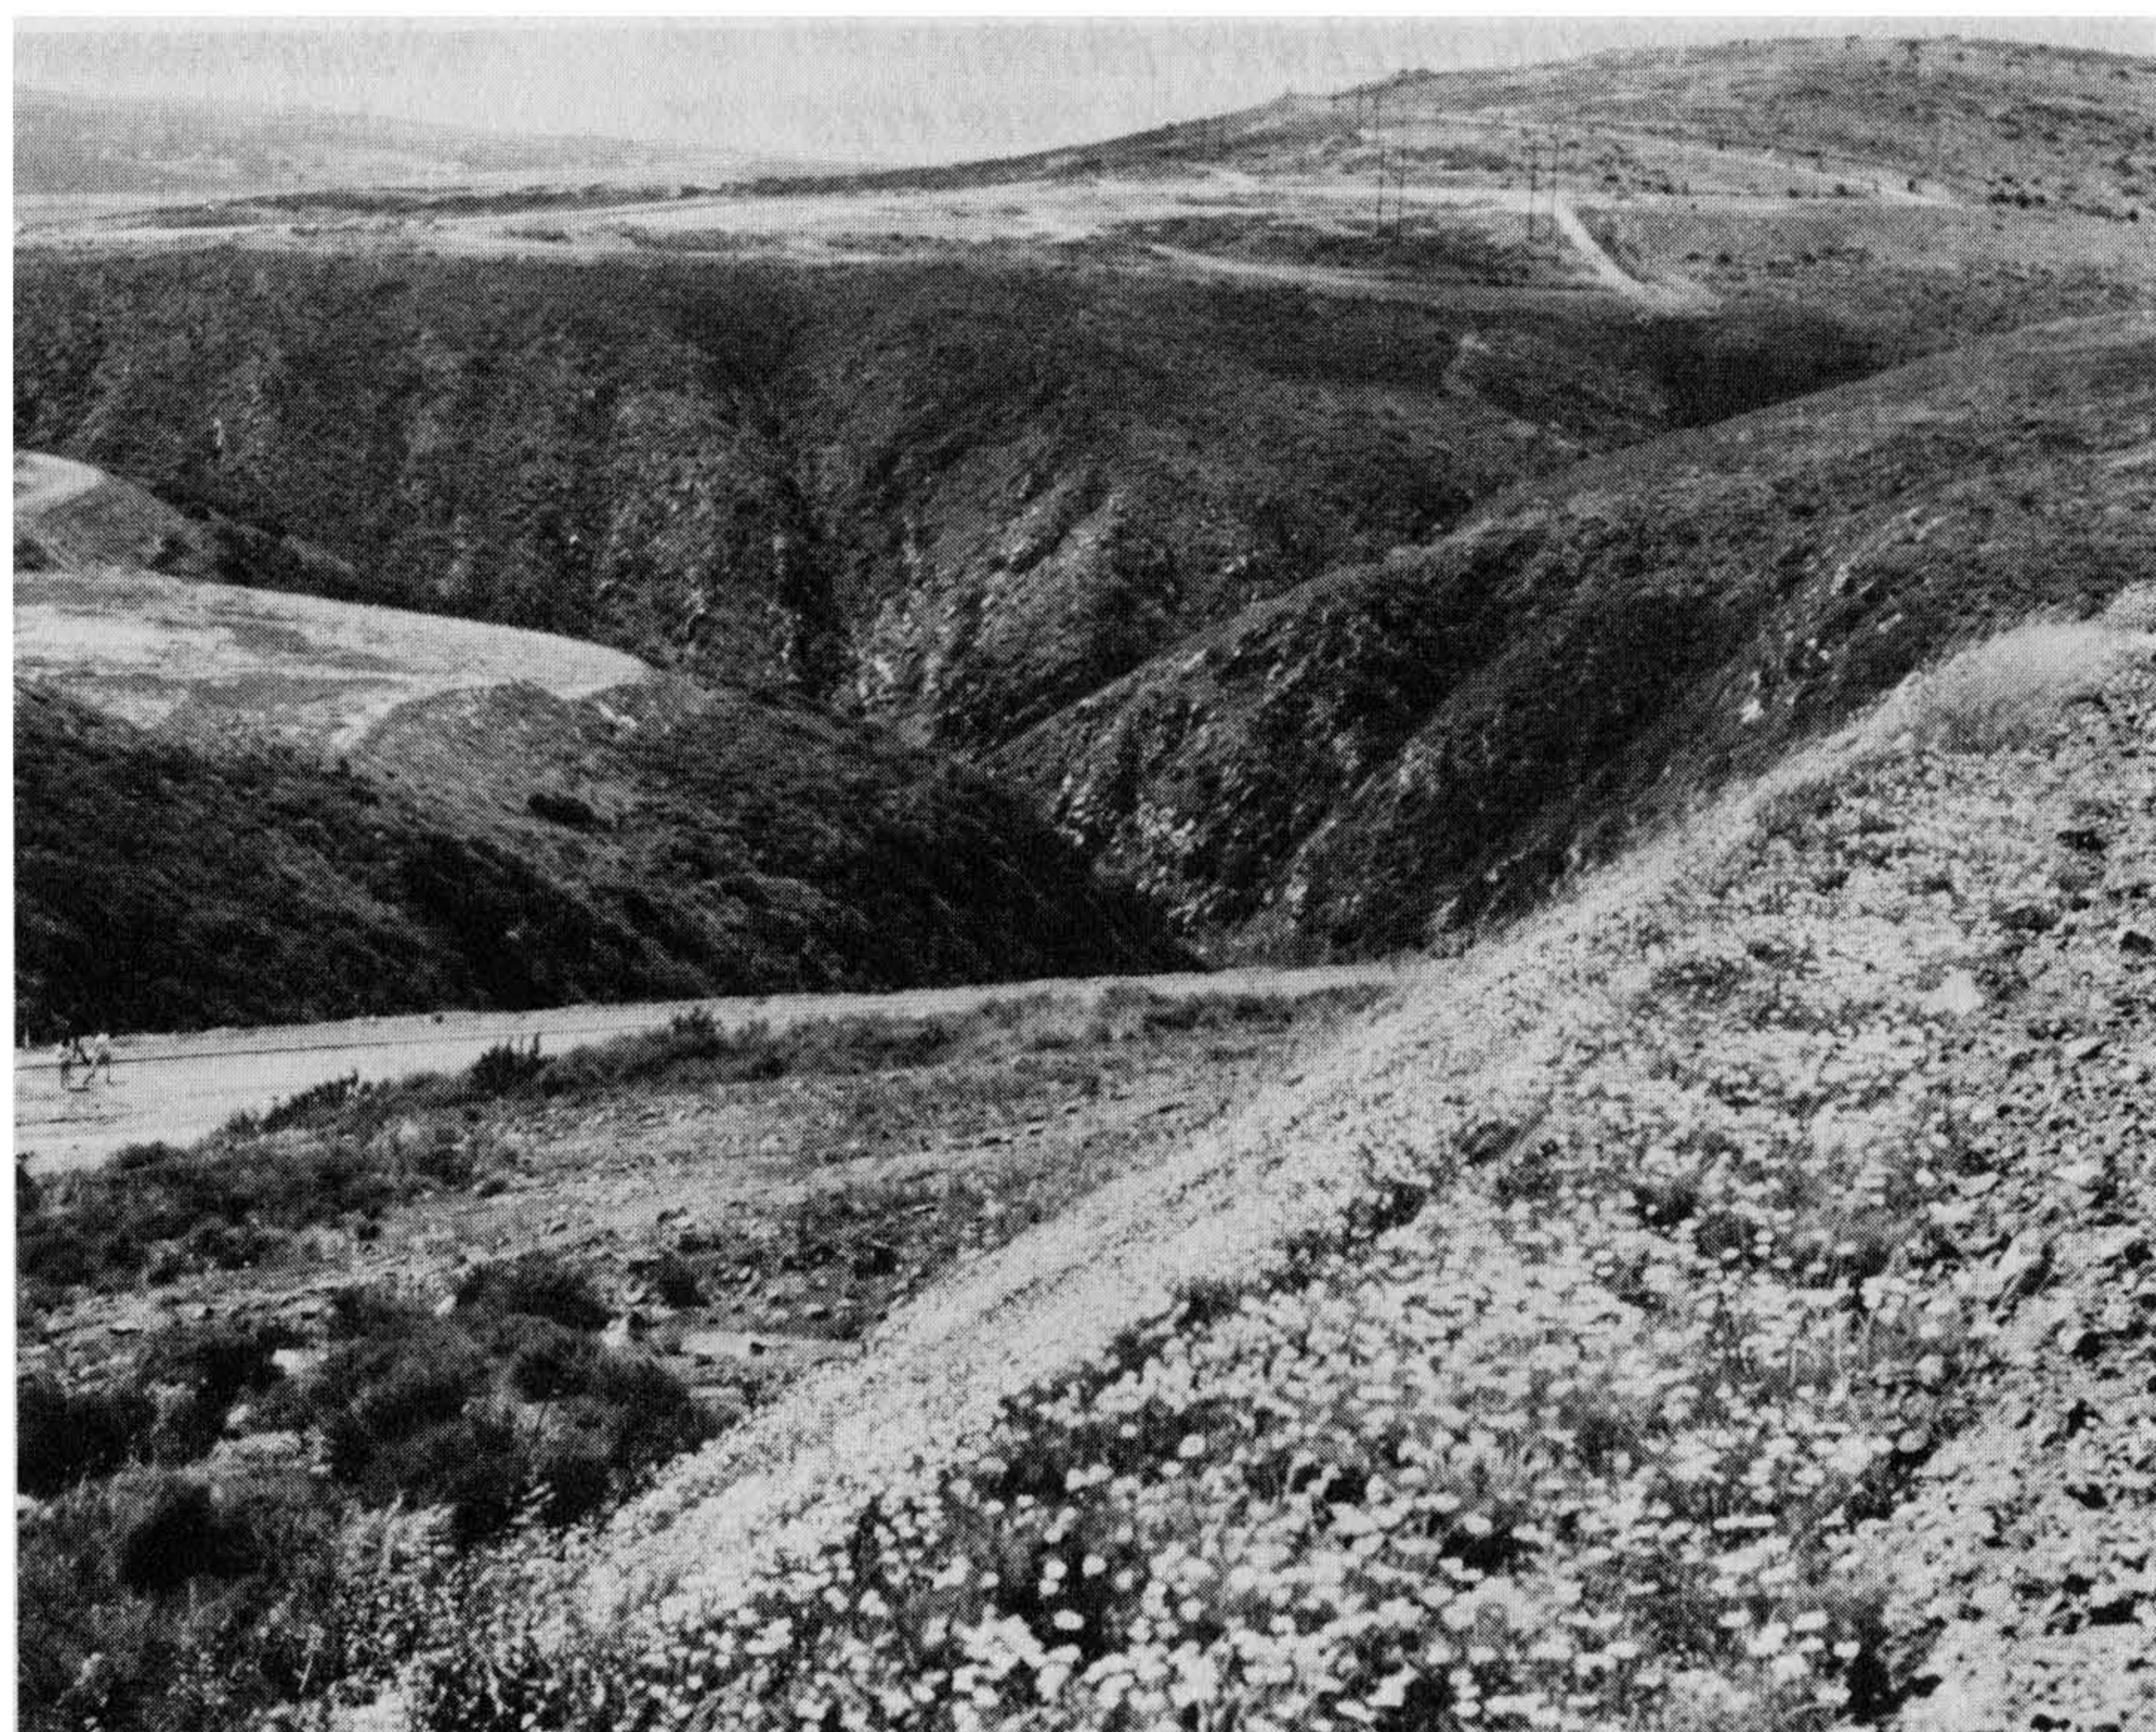
Figure 9-31 The results of seeding Vale IV, No. 117 one hundred and twenty days after helicopter installation. The mass flowering cover is primarily *Dimorphotheca aurantiaca* (South African trailing daisy) that has grown without supplemental irrigation but after three rainfalls. Photograph by and courtesy of Ronald Pecoff.

Figure 9-31 shows the results of seeding Vale IV, No. 117 120 days after the helicopter installation. The mass flowering cover is primarily *Dimorphotheca aurantiaca* that had grown after three rainfalls with no supplemental irrigation.

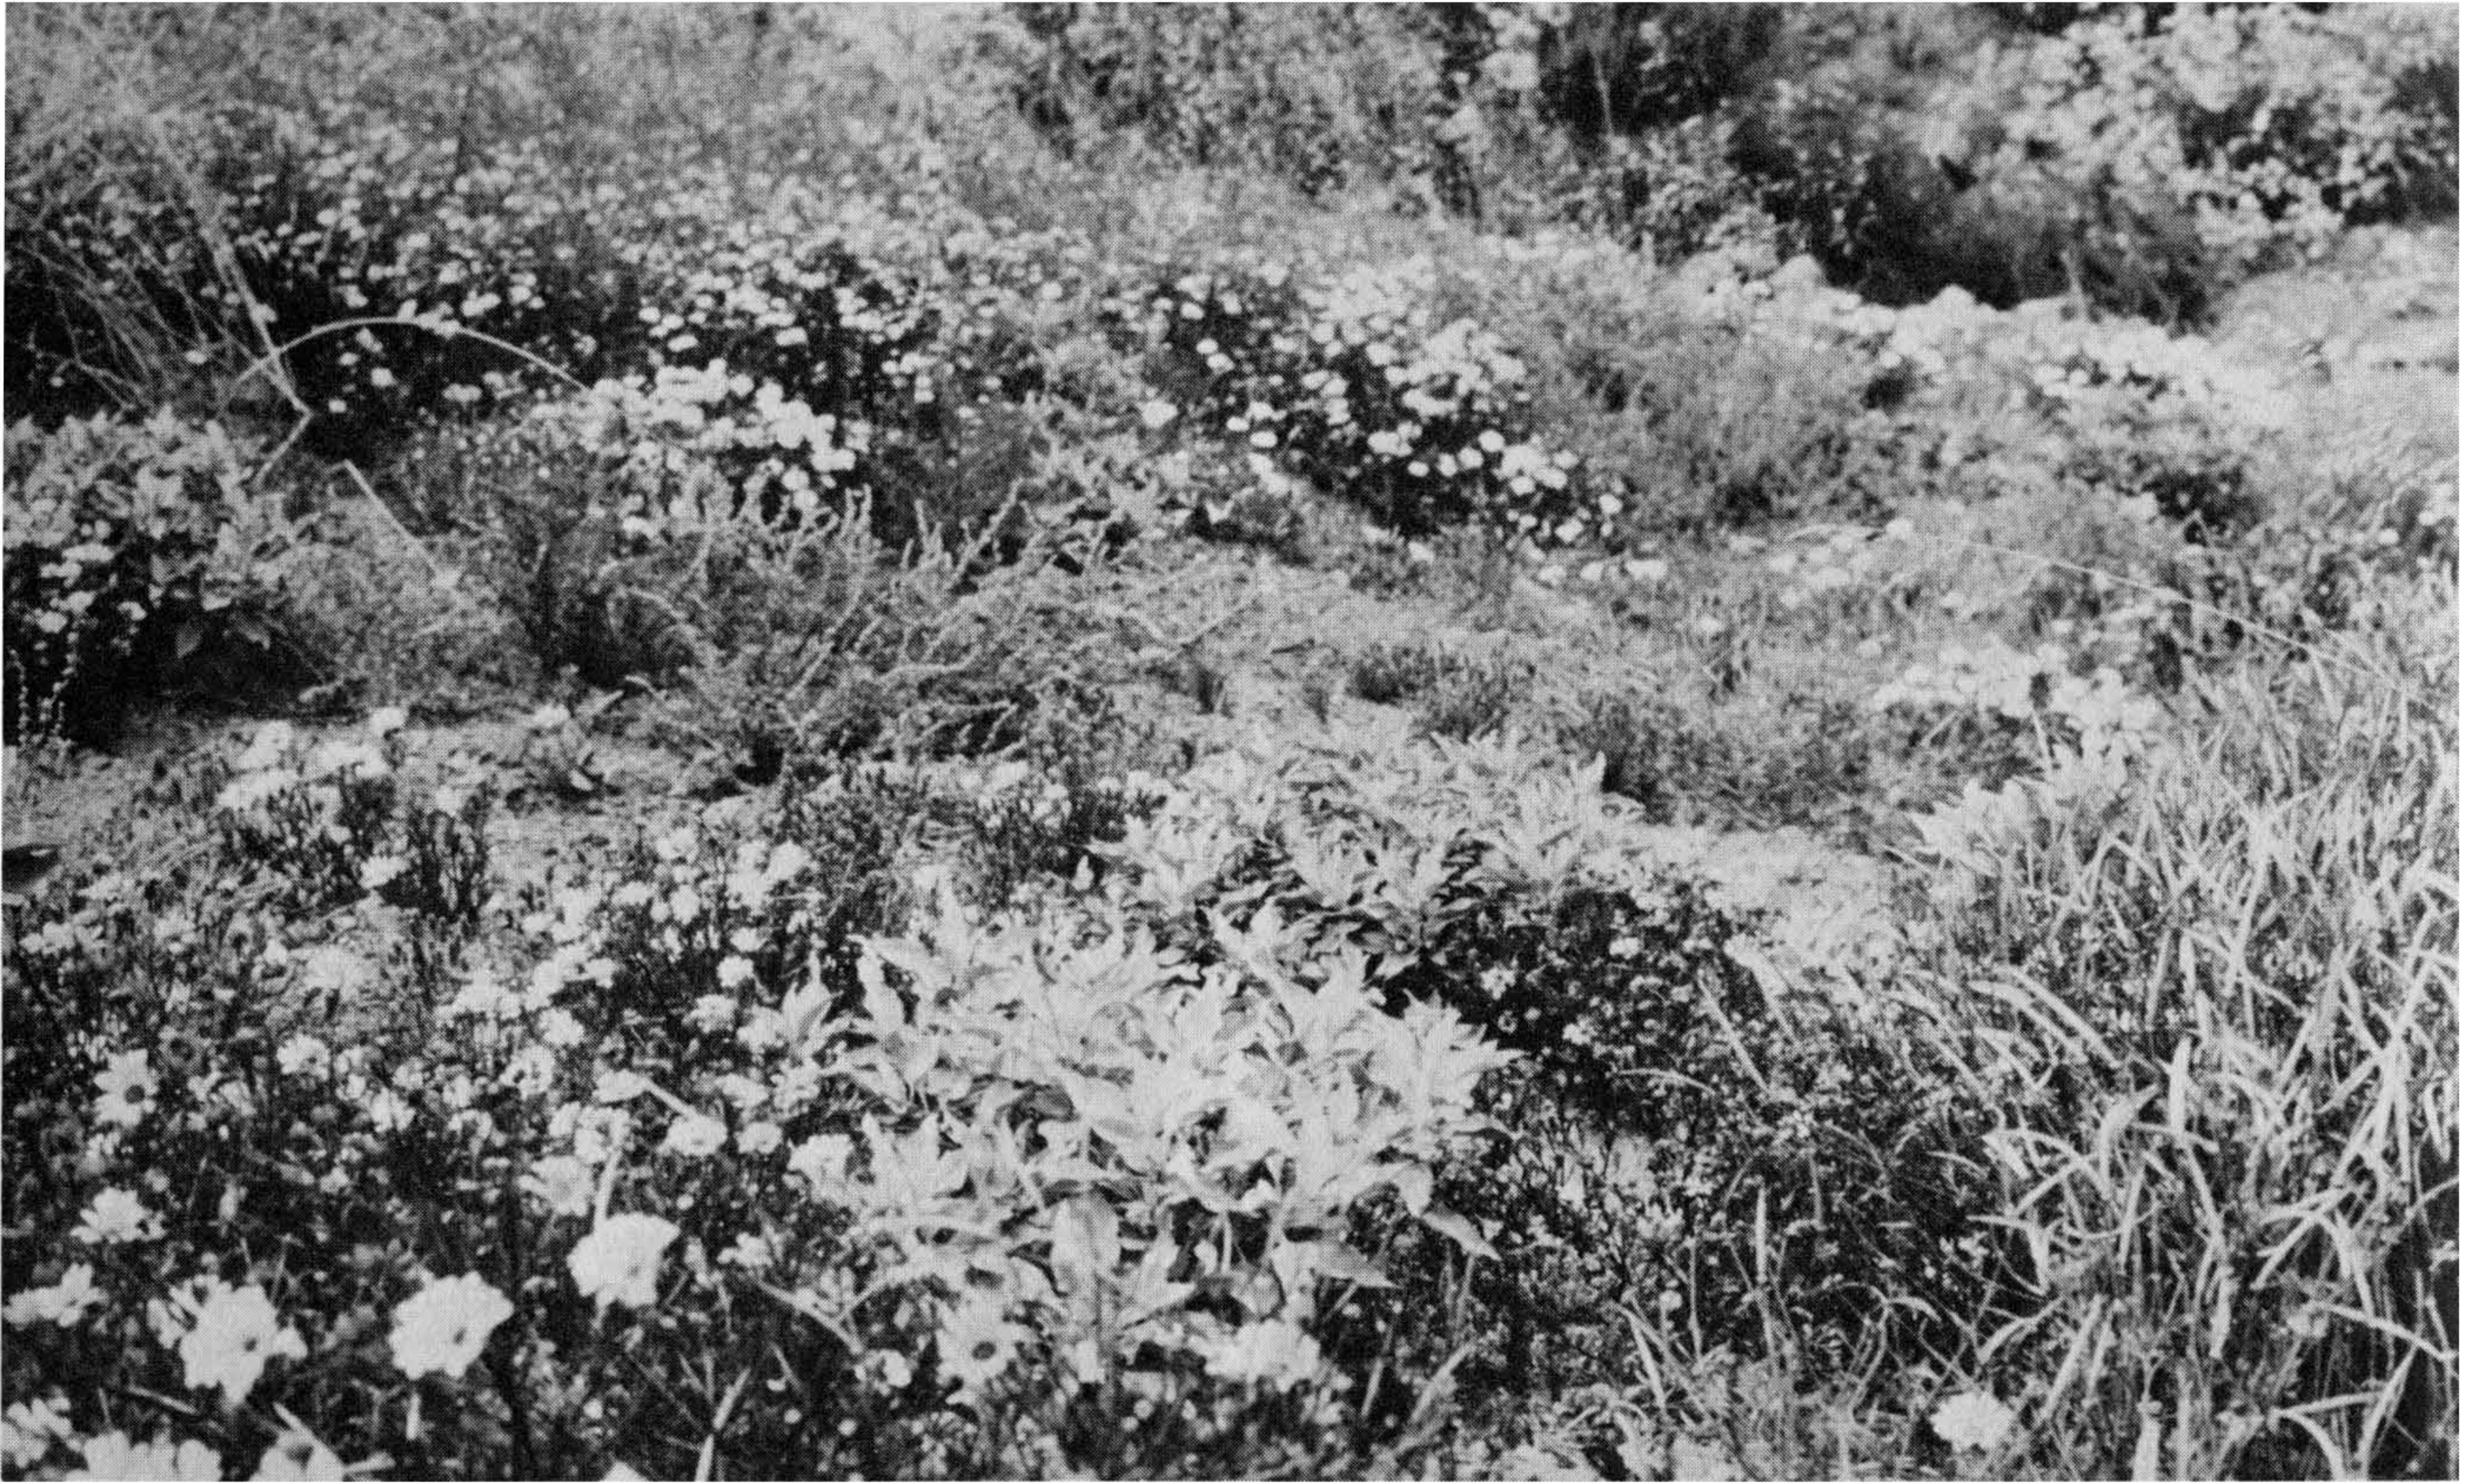
Figure 9-32 The results of seeding Vale IV, No. 117 seven months after the helicopter installation. Photograph by and courtesy of Ronald Pecoff.

Figure 9-32 shows the results of seeding Vale IV, No. 117 seven months after the initial helicopter installation. The species noted in the photograph are *Encelia farinosa*, *Atriplex glauca*, and *Eriogonum fasciculatum*. All are procumbent mounding spreading perennial ground covers with grey-green foliage. The flowering species are predominantly *Eschscholzia californica* and *Dimorphotheca aruantiaca*. The additional summer flowering period was the result of a two-inch summer rain. The *Acacia baileyana* and *Eucalyptus seanea* seedlings are not visible in the photograph; however, they were approximately three to four inches in height and evenly distributed over the slope.

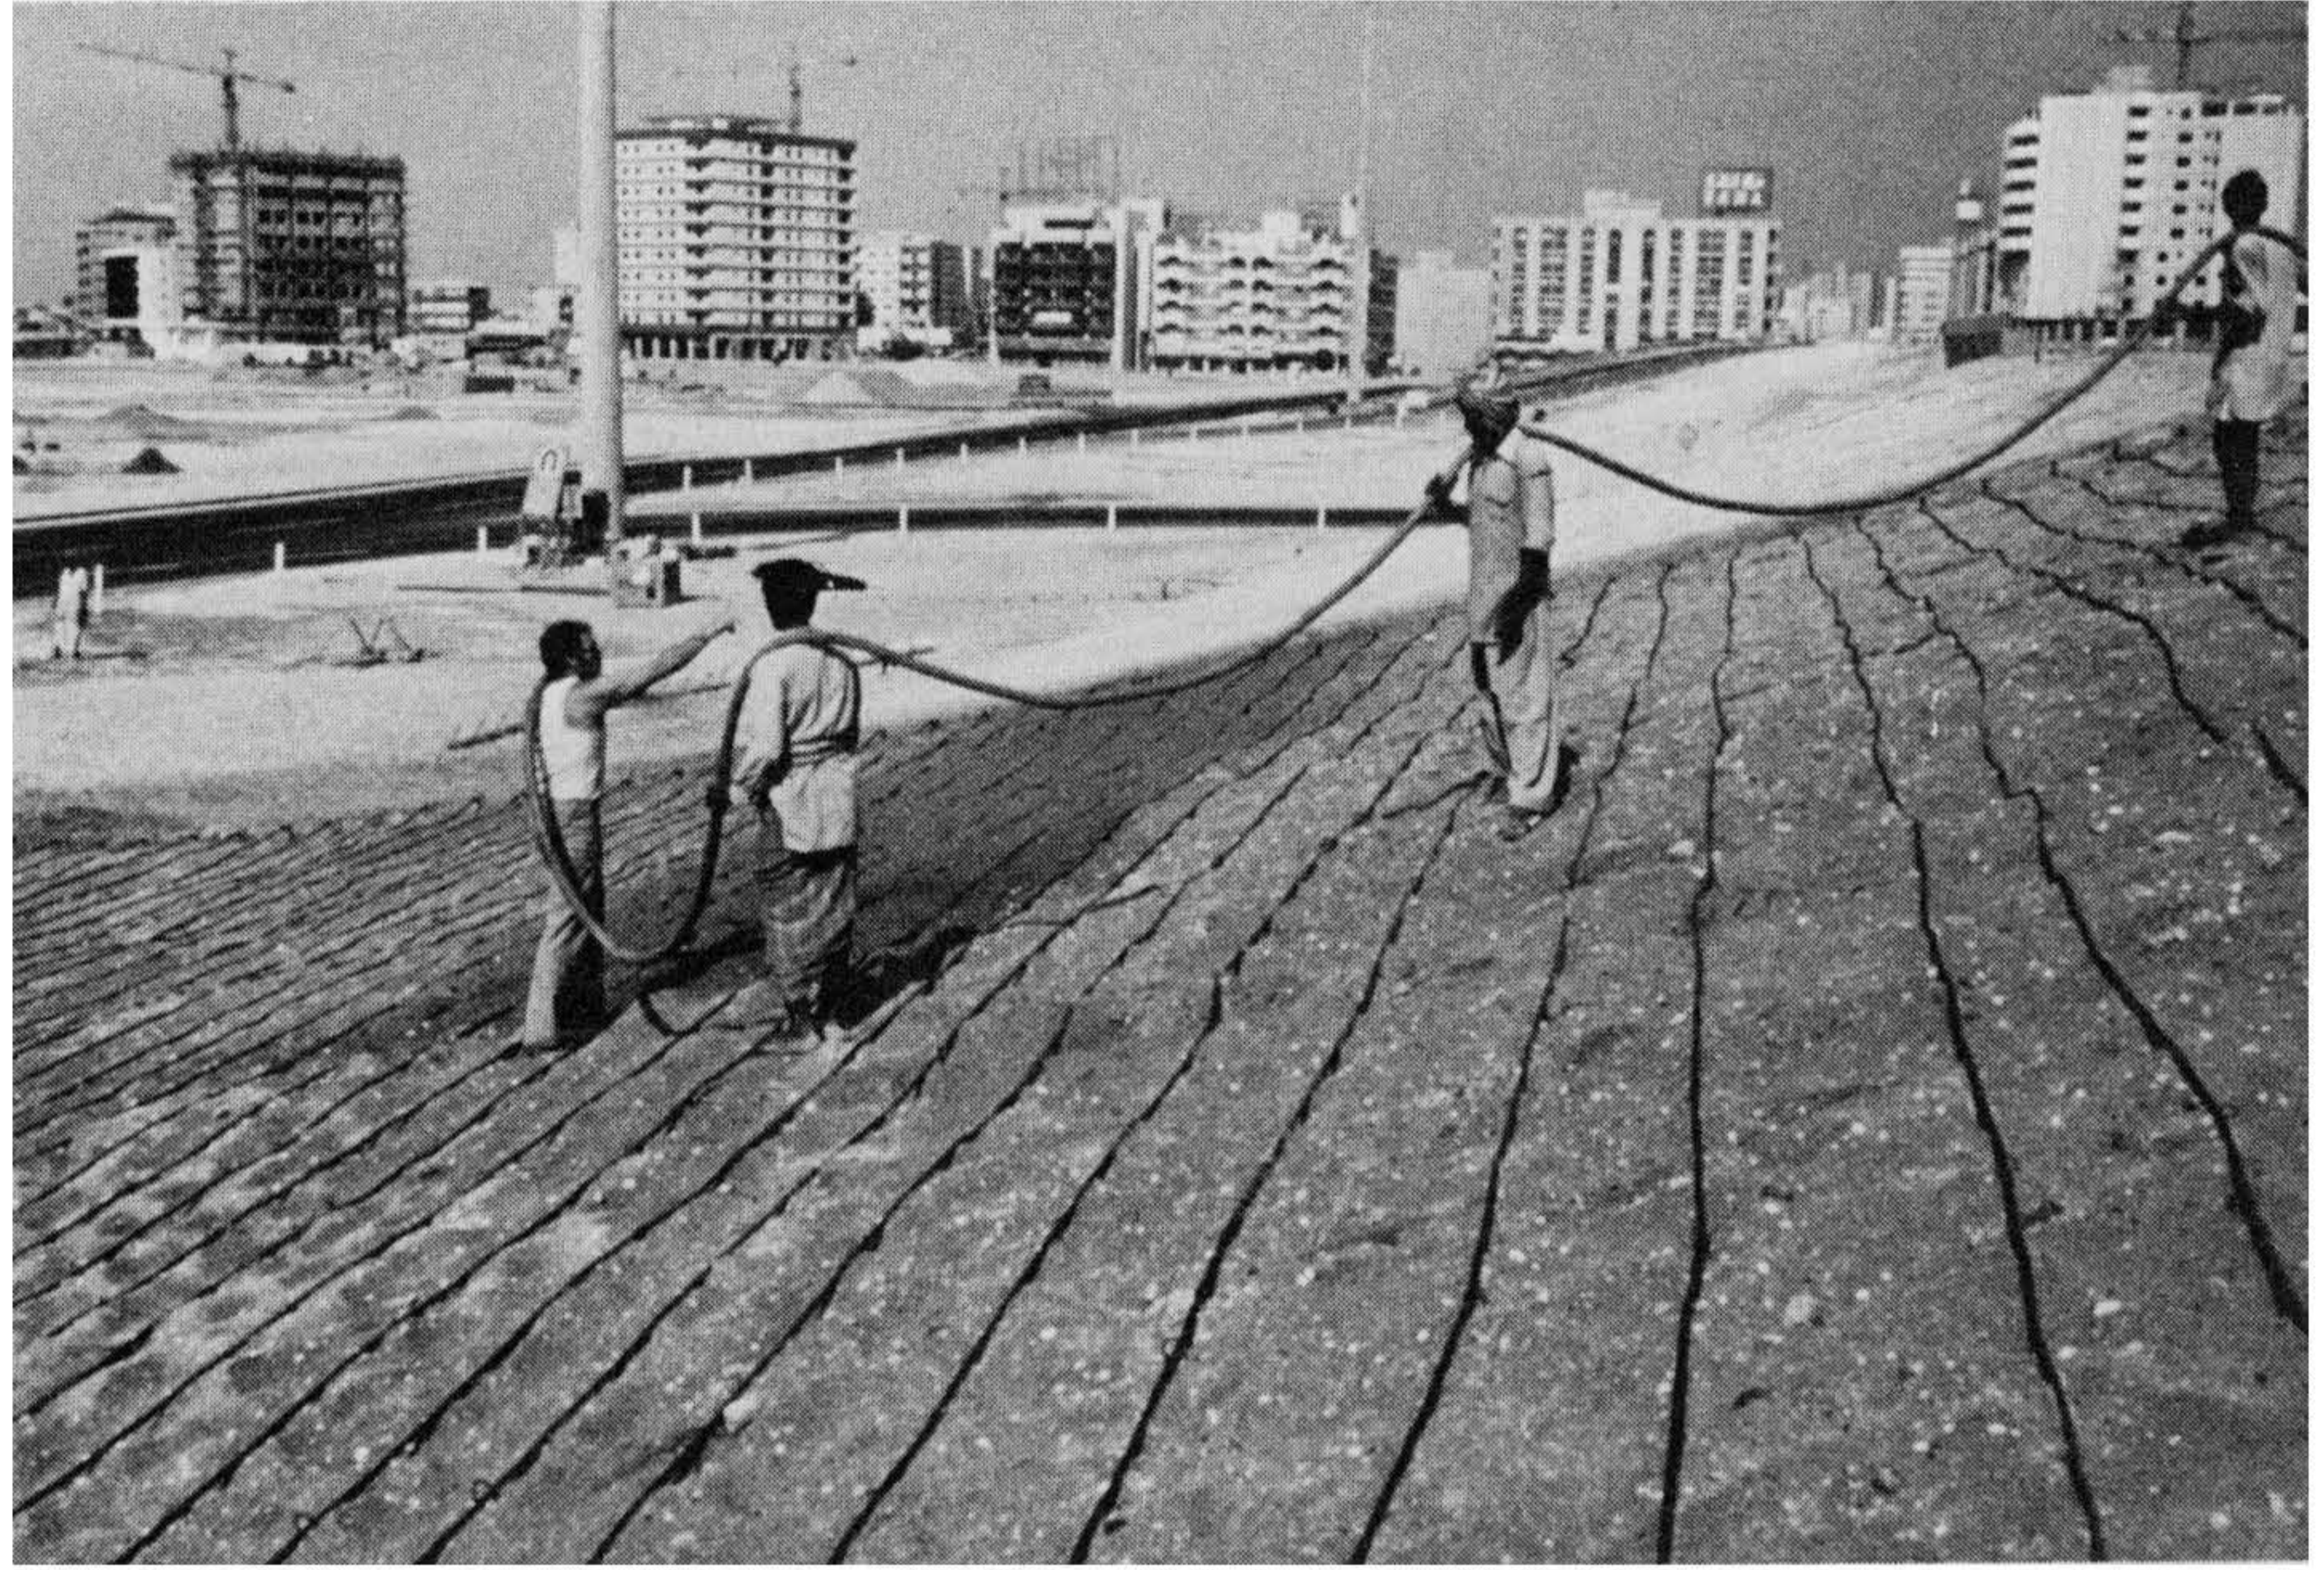
Figure 9-33 Hydroseeding installation at the El Khan Bridge Freeway Project, State of Sharjah, United Arab Emirates, November, 1978. This seedmixture was drilled into dredged sand via hydroseeding. Photograph by and courtesy of Ronald Pecoff.

Figure 9-33 shows the hydroseeding installation at the El Khan Bridge Freeway Project during November 1978. The seedmixture was drilled into the dredged sand via hydroseeding.

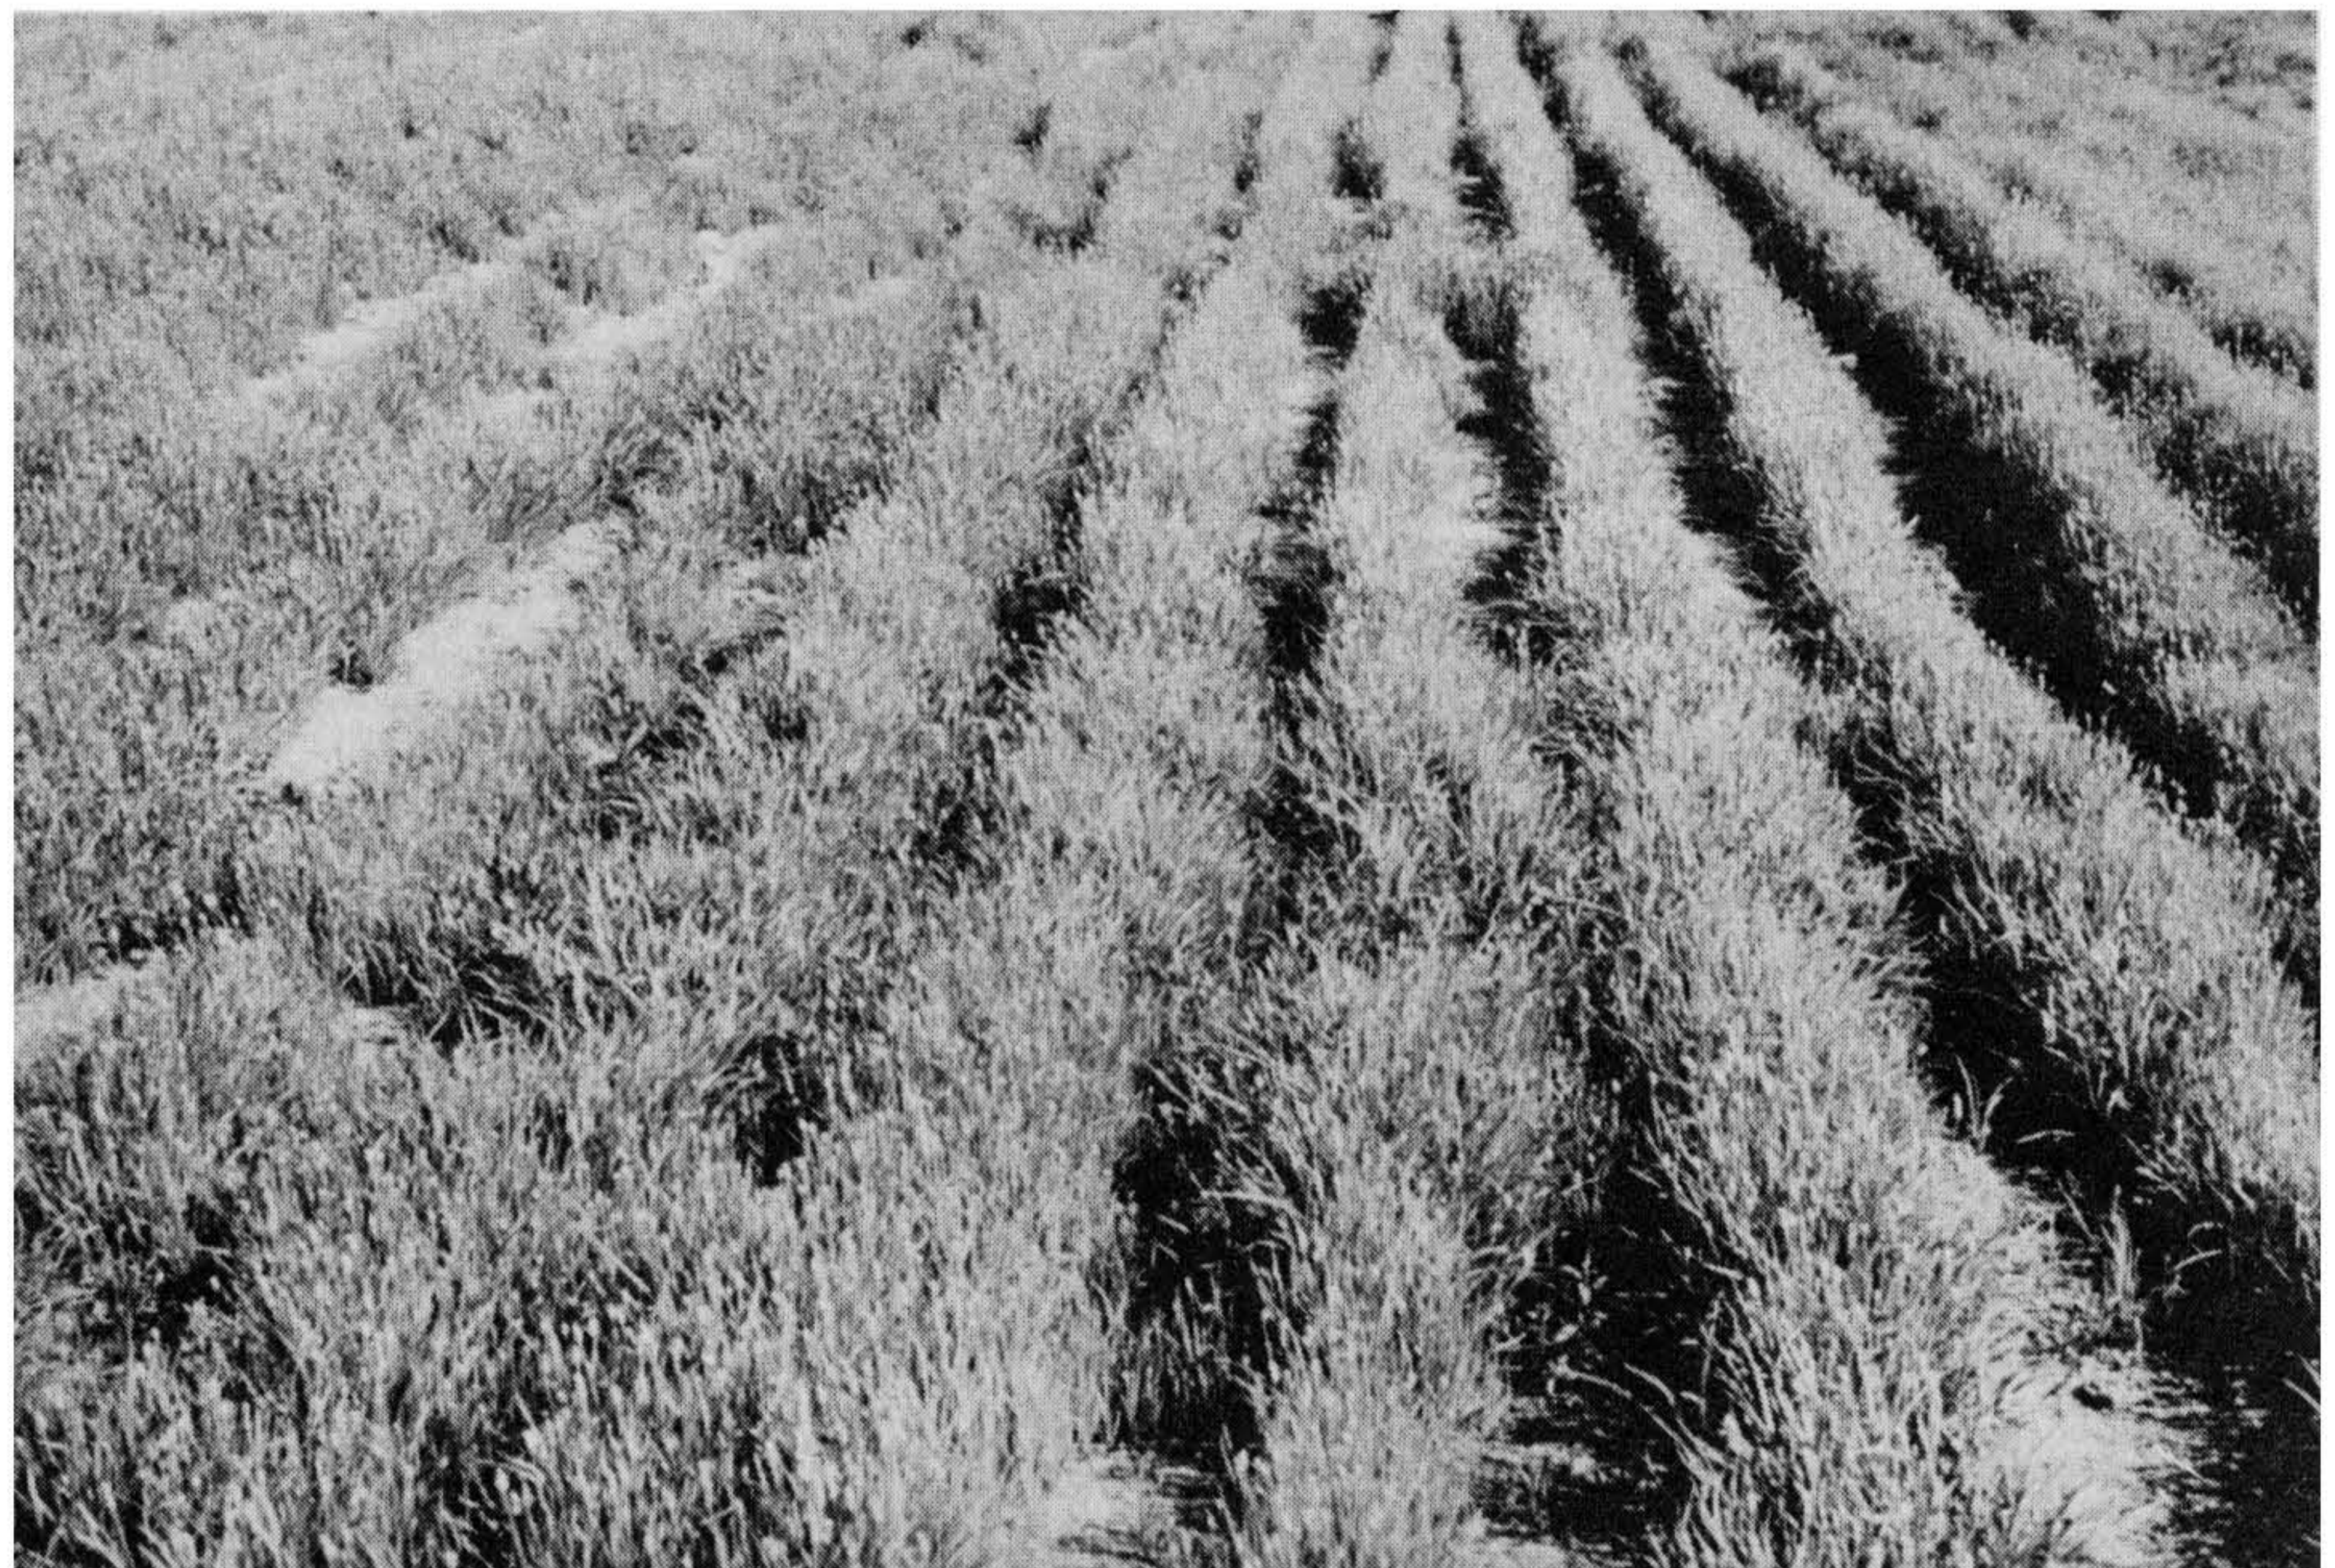
Figure 9-34 Three months' growth of UAE No. 198 seedmix at the El Khan Bridge Project. Predominate growth is occurring along the drip irrigation tubing. Photograph by and courtesy of Ronald Pecoff.

Figure 9-34 shows three month's growth of the UAE No. 198 seedmix at the El Khan Bridge Project. The predominant growth occurred along the drip irrigation tubing. The primary species depicted was a temporary erosion control annual, *Plantago indica*.
