DRAINAGE REQUIREMENTS AND MAINTENANCE OF HOMESITES

9-1 INTRODUCTION

EXCAVATION AND GRADING CODE ADMINISTRATION, INSPECTION, AND ENFORCEMENT

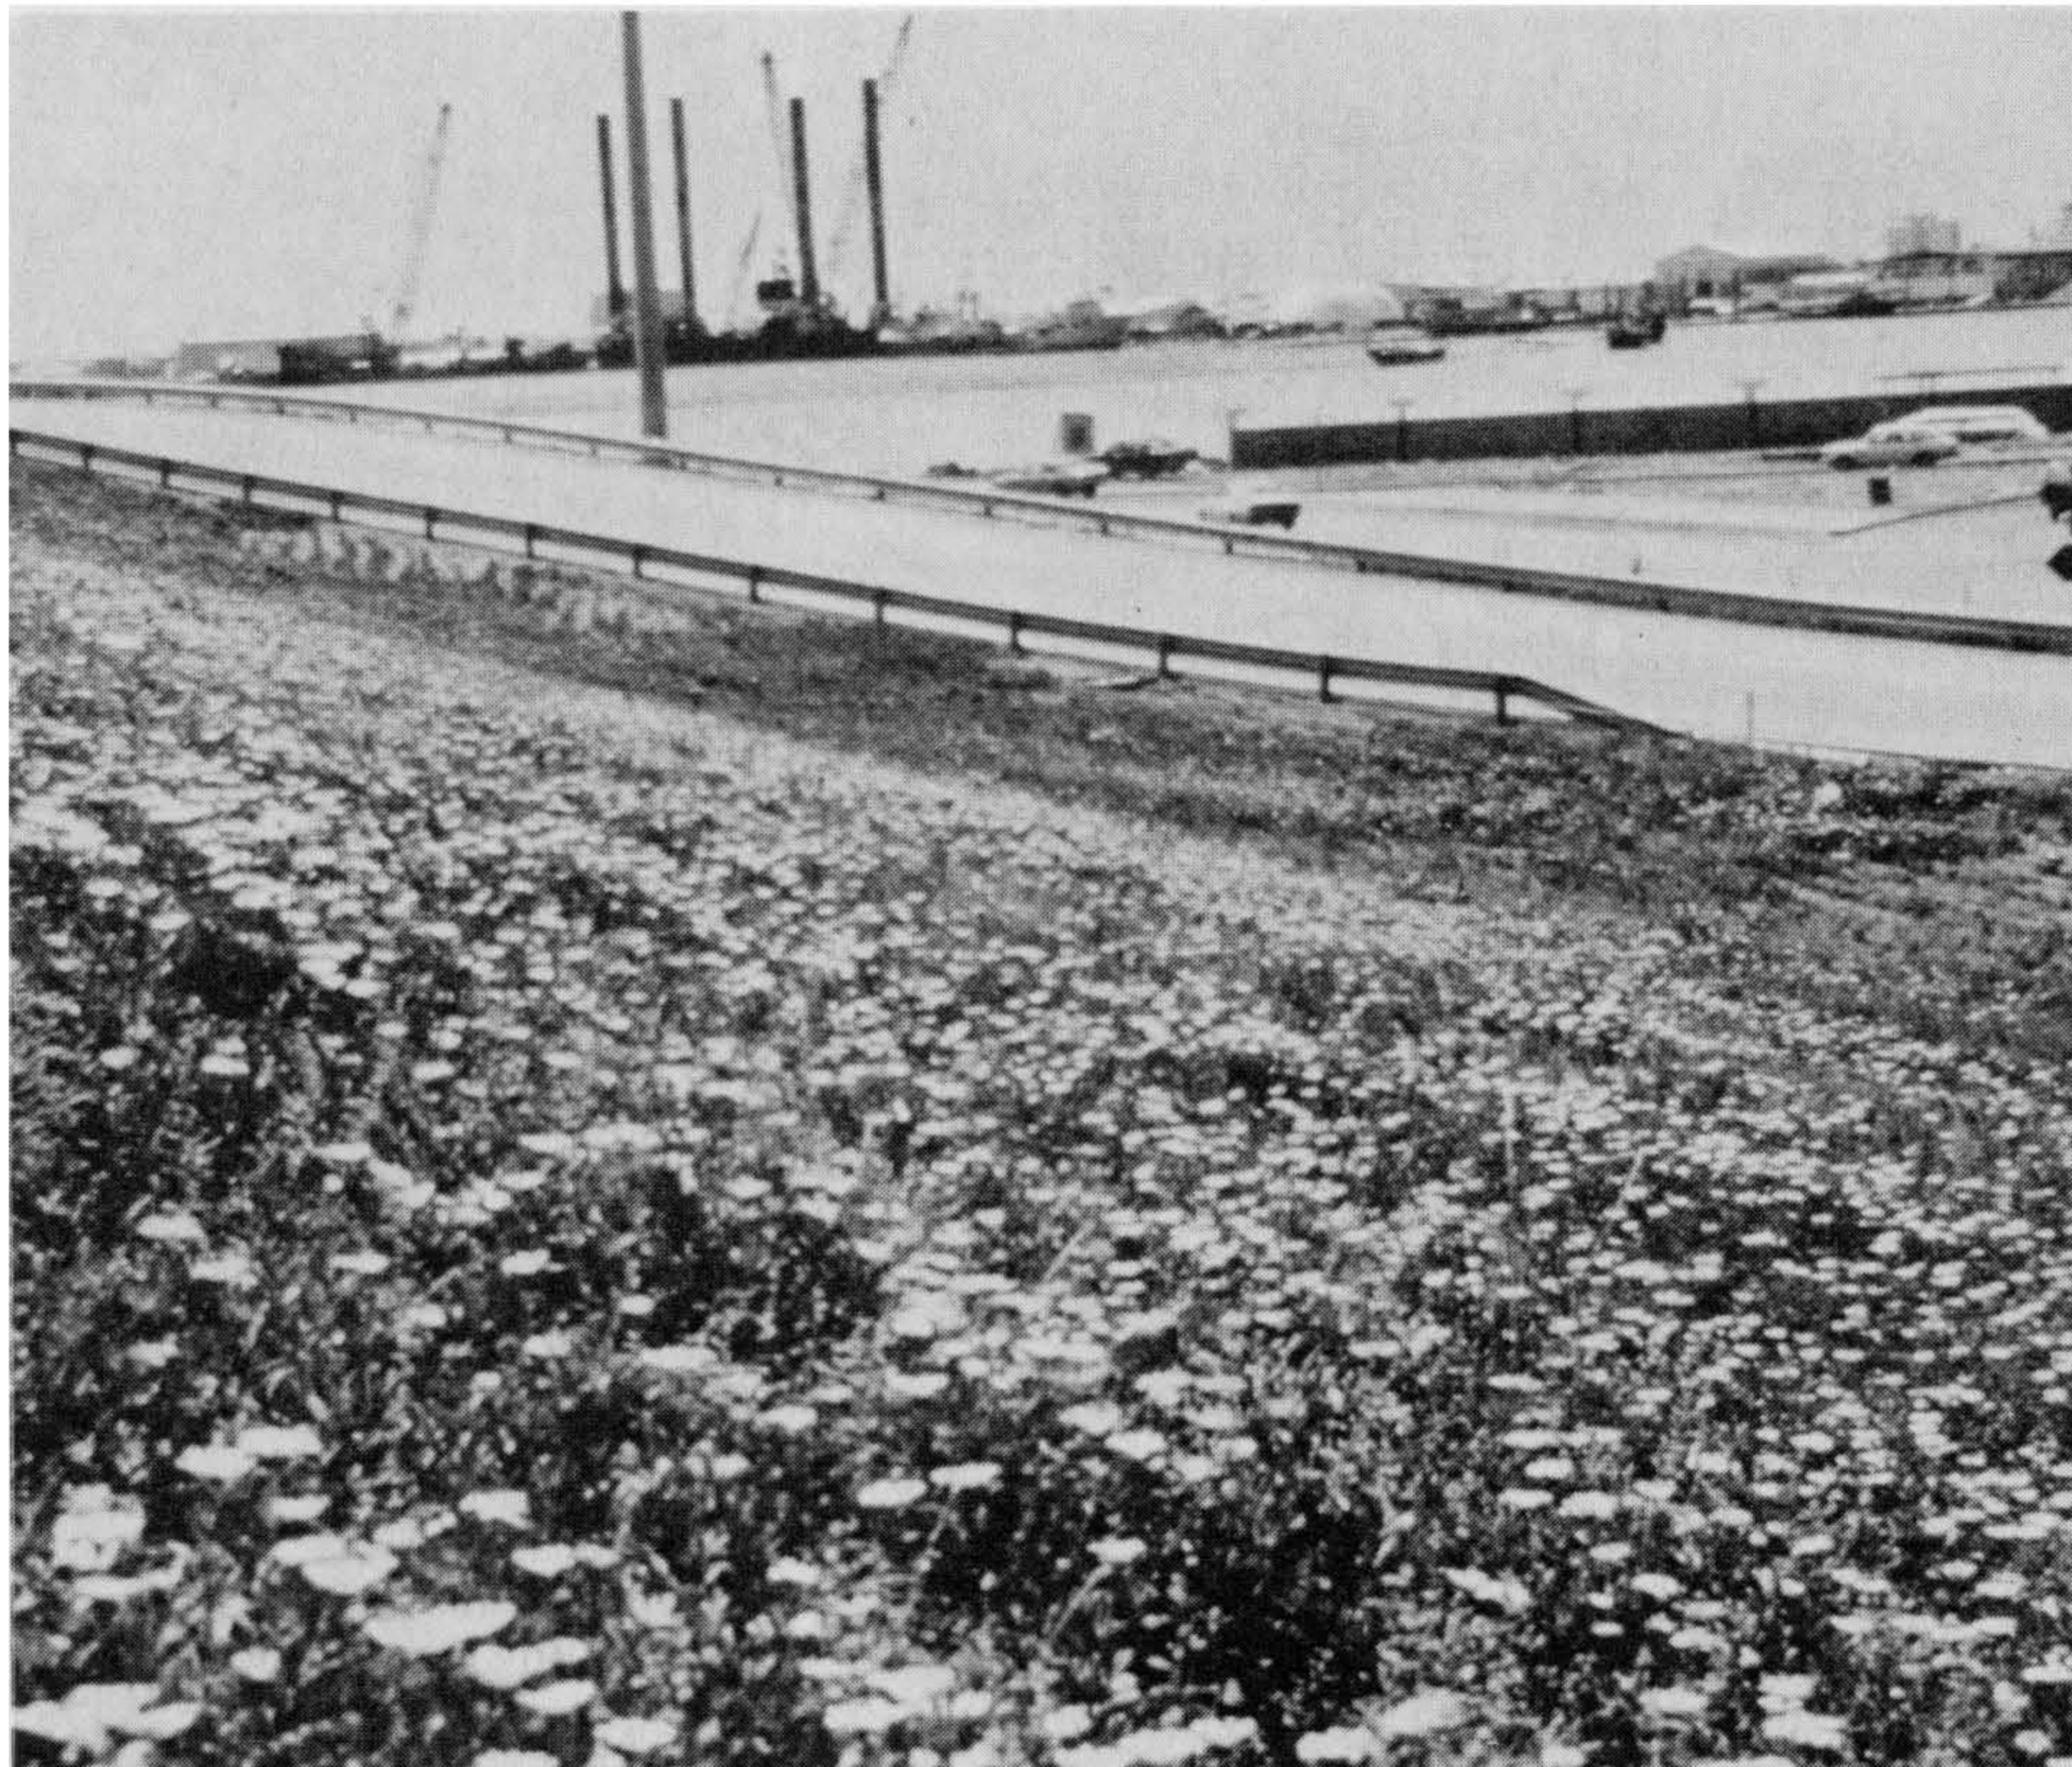
Figure 9-35 Six months' growth of seedmix UAE 198 at the El Khan Bridge Project. The seedmixture is in full flower, and the perennial ground covers are sufficiently established to begin growing horizontally, thus providing 100% erosion control coverage and maximum density. Photograph by and courtesy of Ronald Pecoff.

Figure 9-35 shows six month's growth of seedmix UAE No. 198 at the El Khan Bridge Project. The seedmixture was in full flower and the perennial ground covers were suf-

ficiently established to begin growing horizontally, thus providing 100% erosion control coverage and mass density.

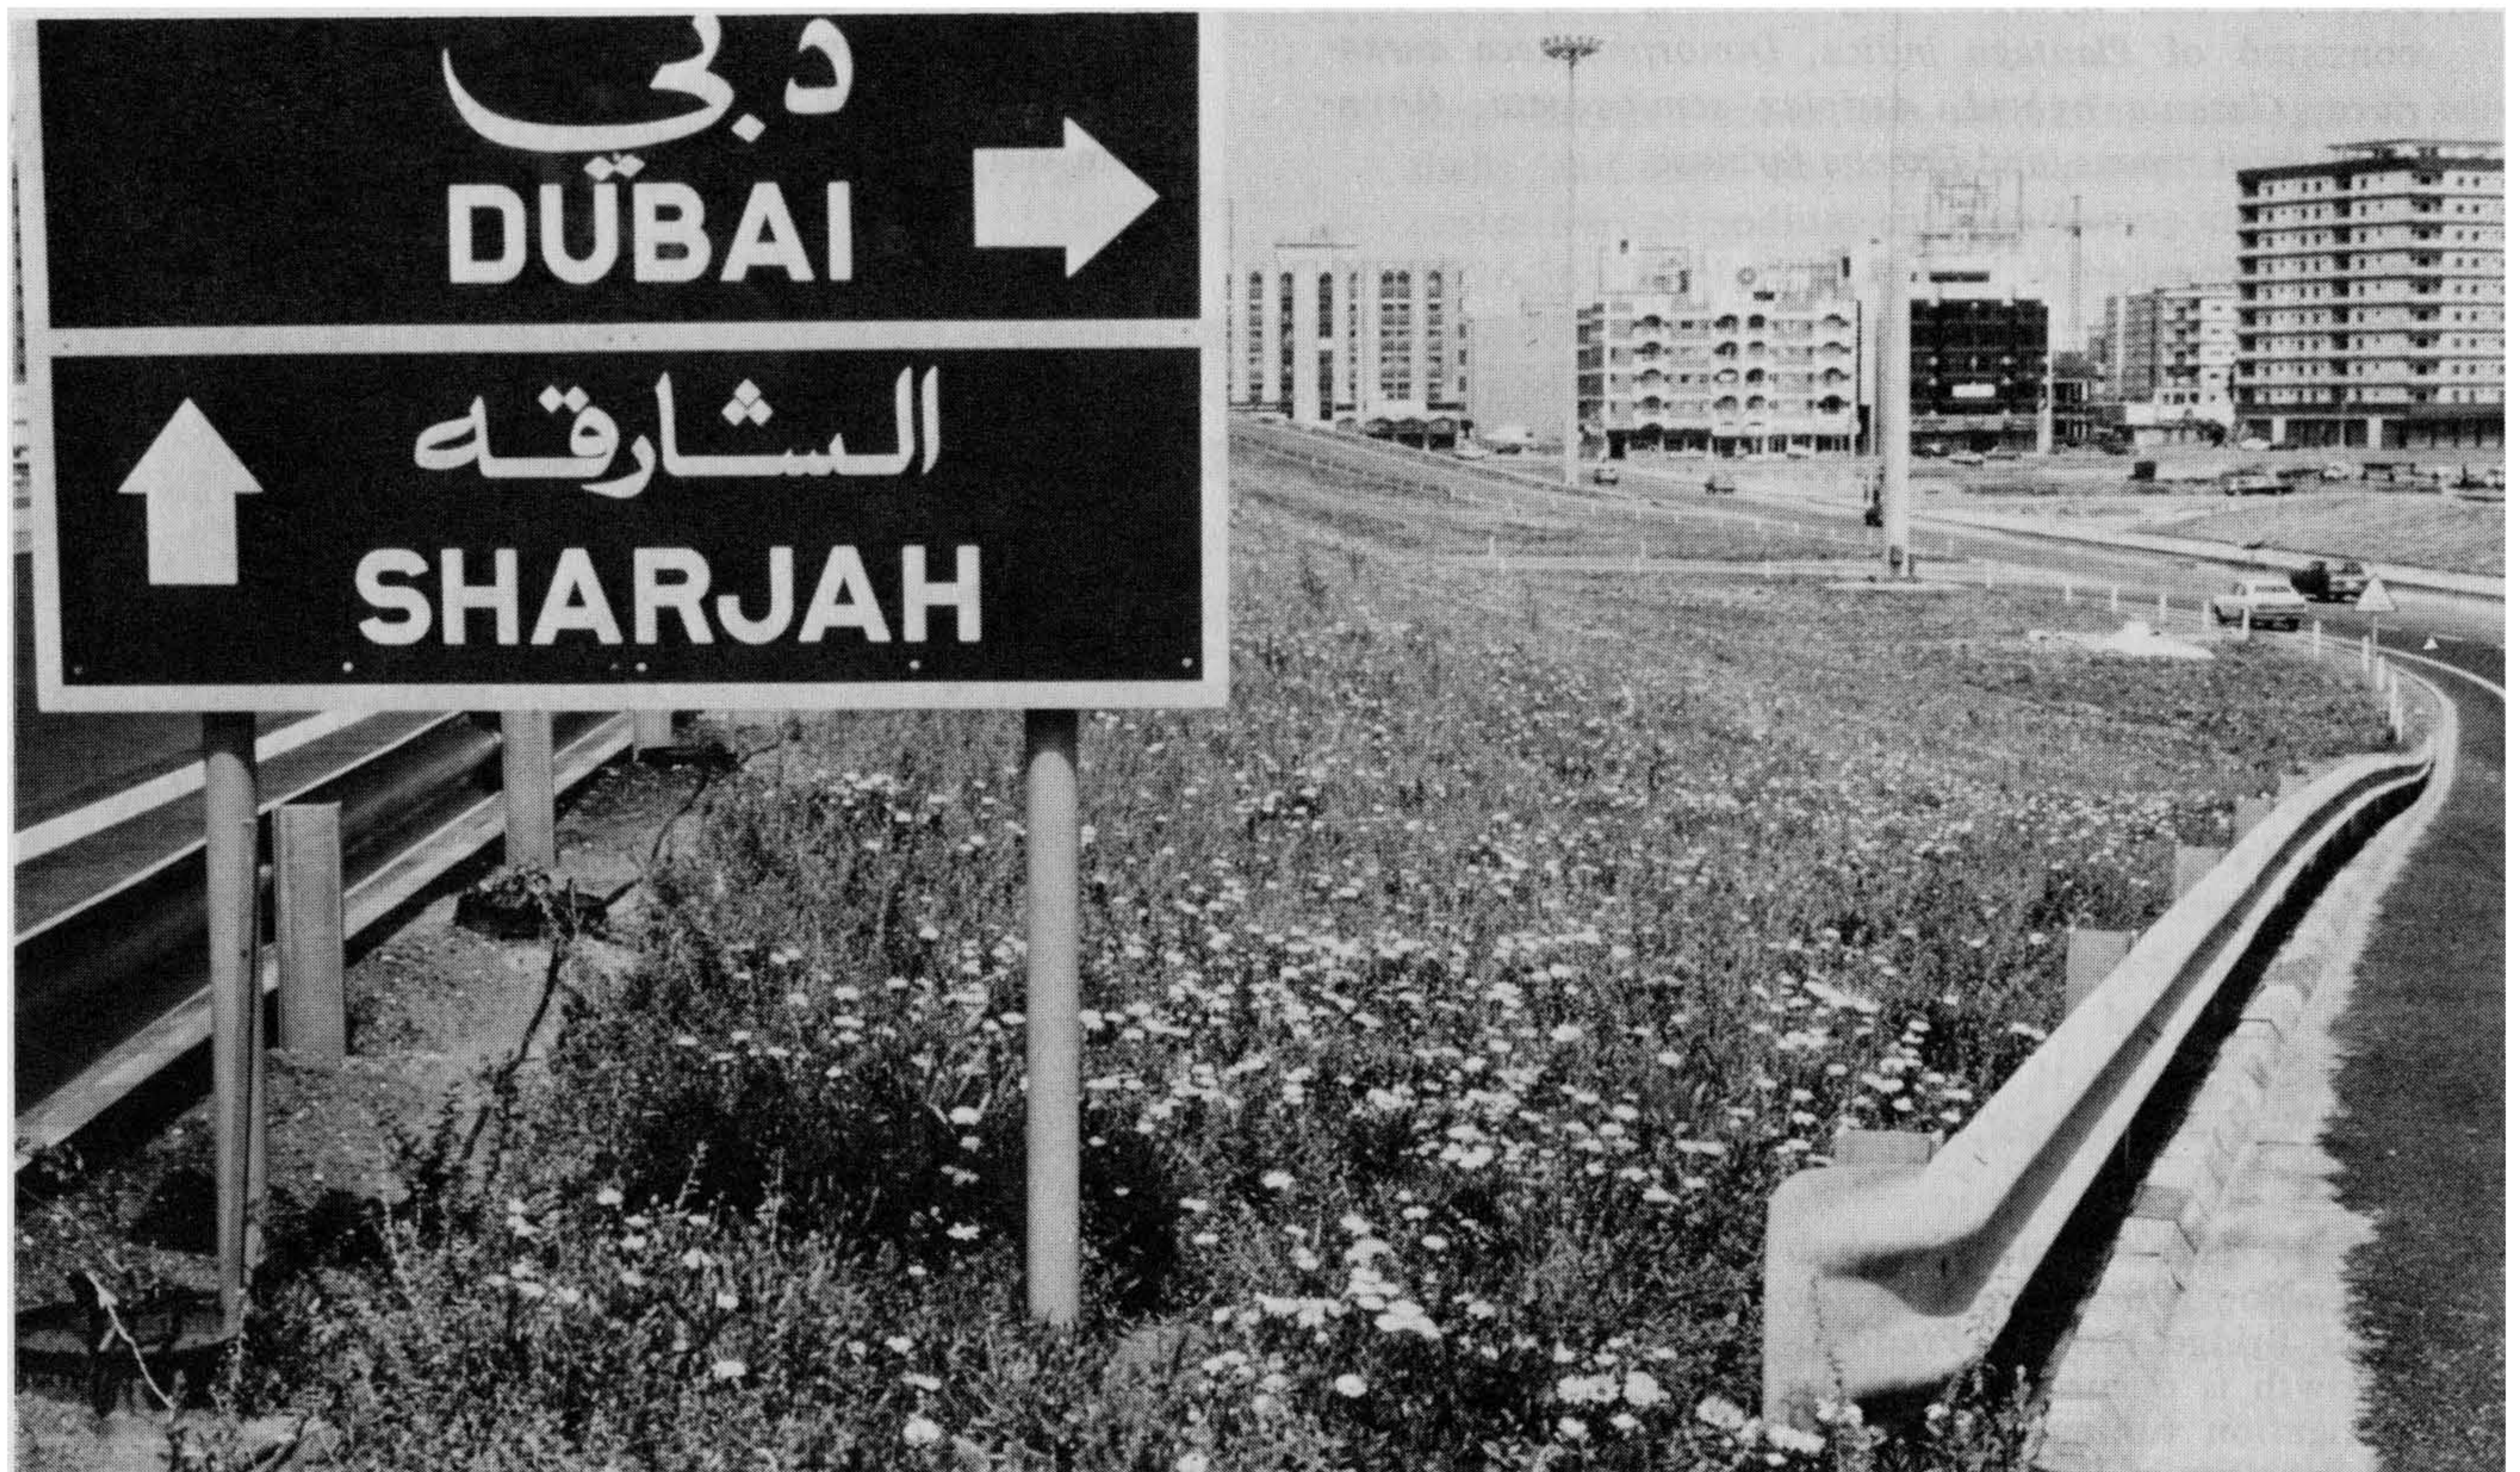
Figure 9-36 Seedmix UAE 198 eight months after installation. Now it provides an esthetically pleasing dense flowering cover which softens the hardscape of the bridge and freeway construction. Photograph by and courtesy of Ronald Pecoff.

Figure 9-36 shows seedmix UAE No. 198 eight months old, providing an aesthetically pleasing flowering dense cover that softens the hardscape of the bridge and freeway construction.

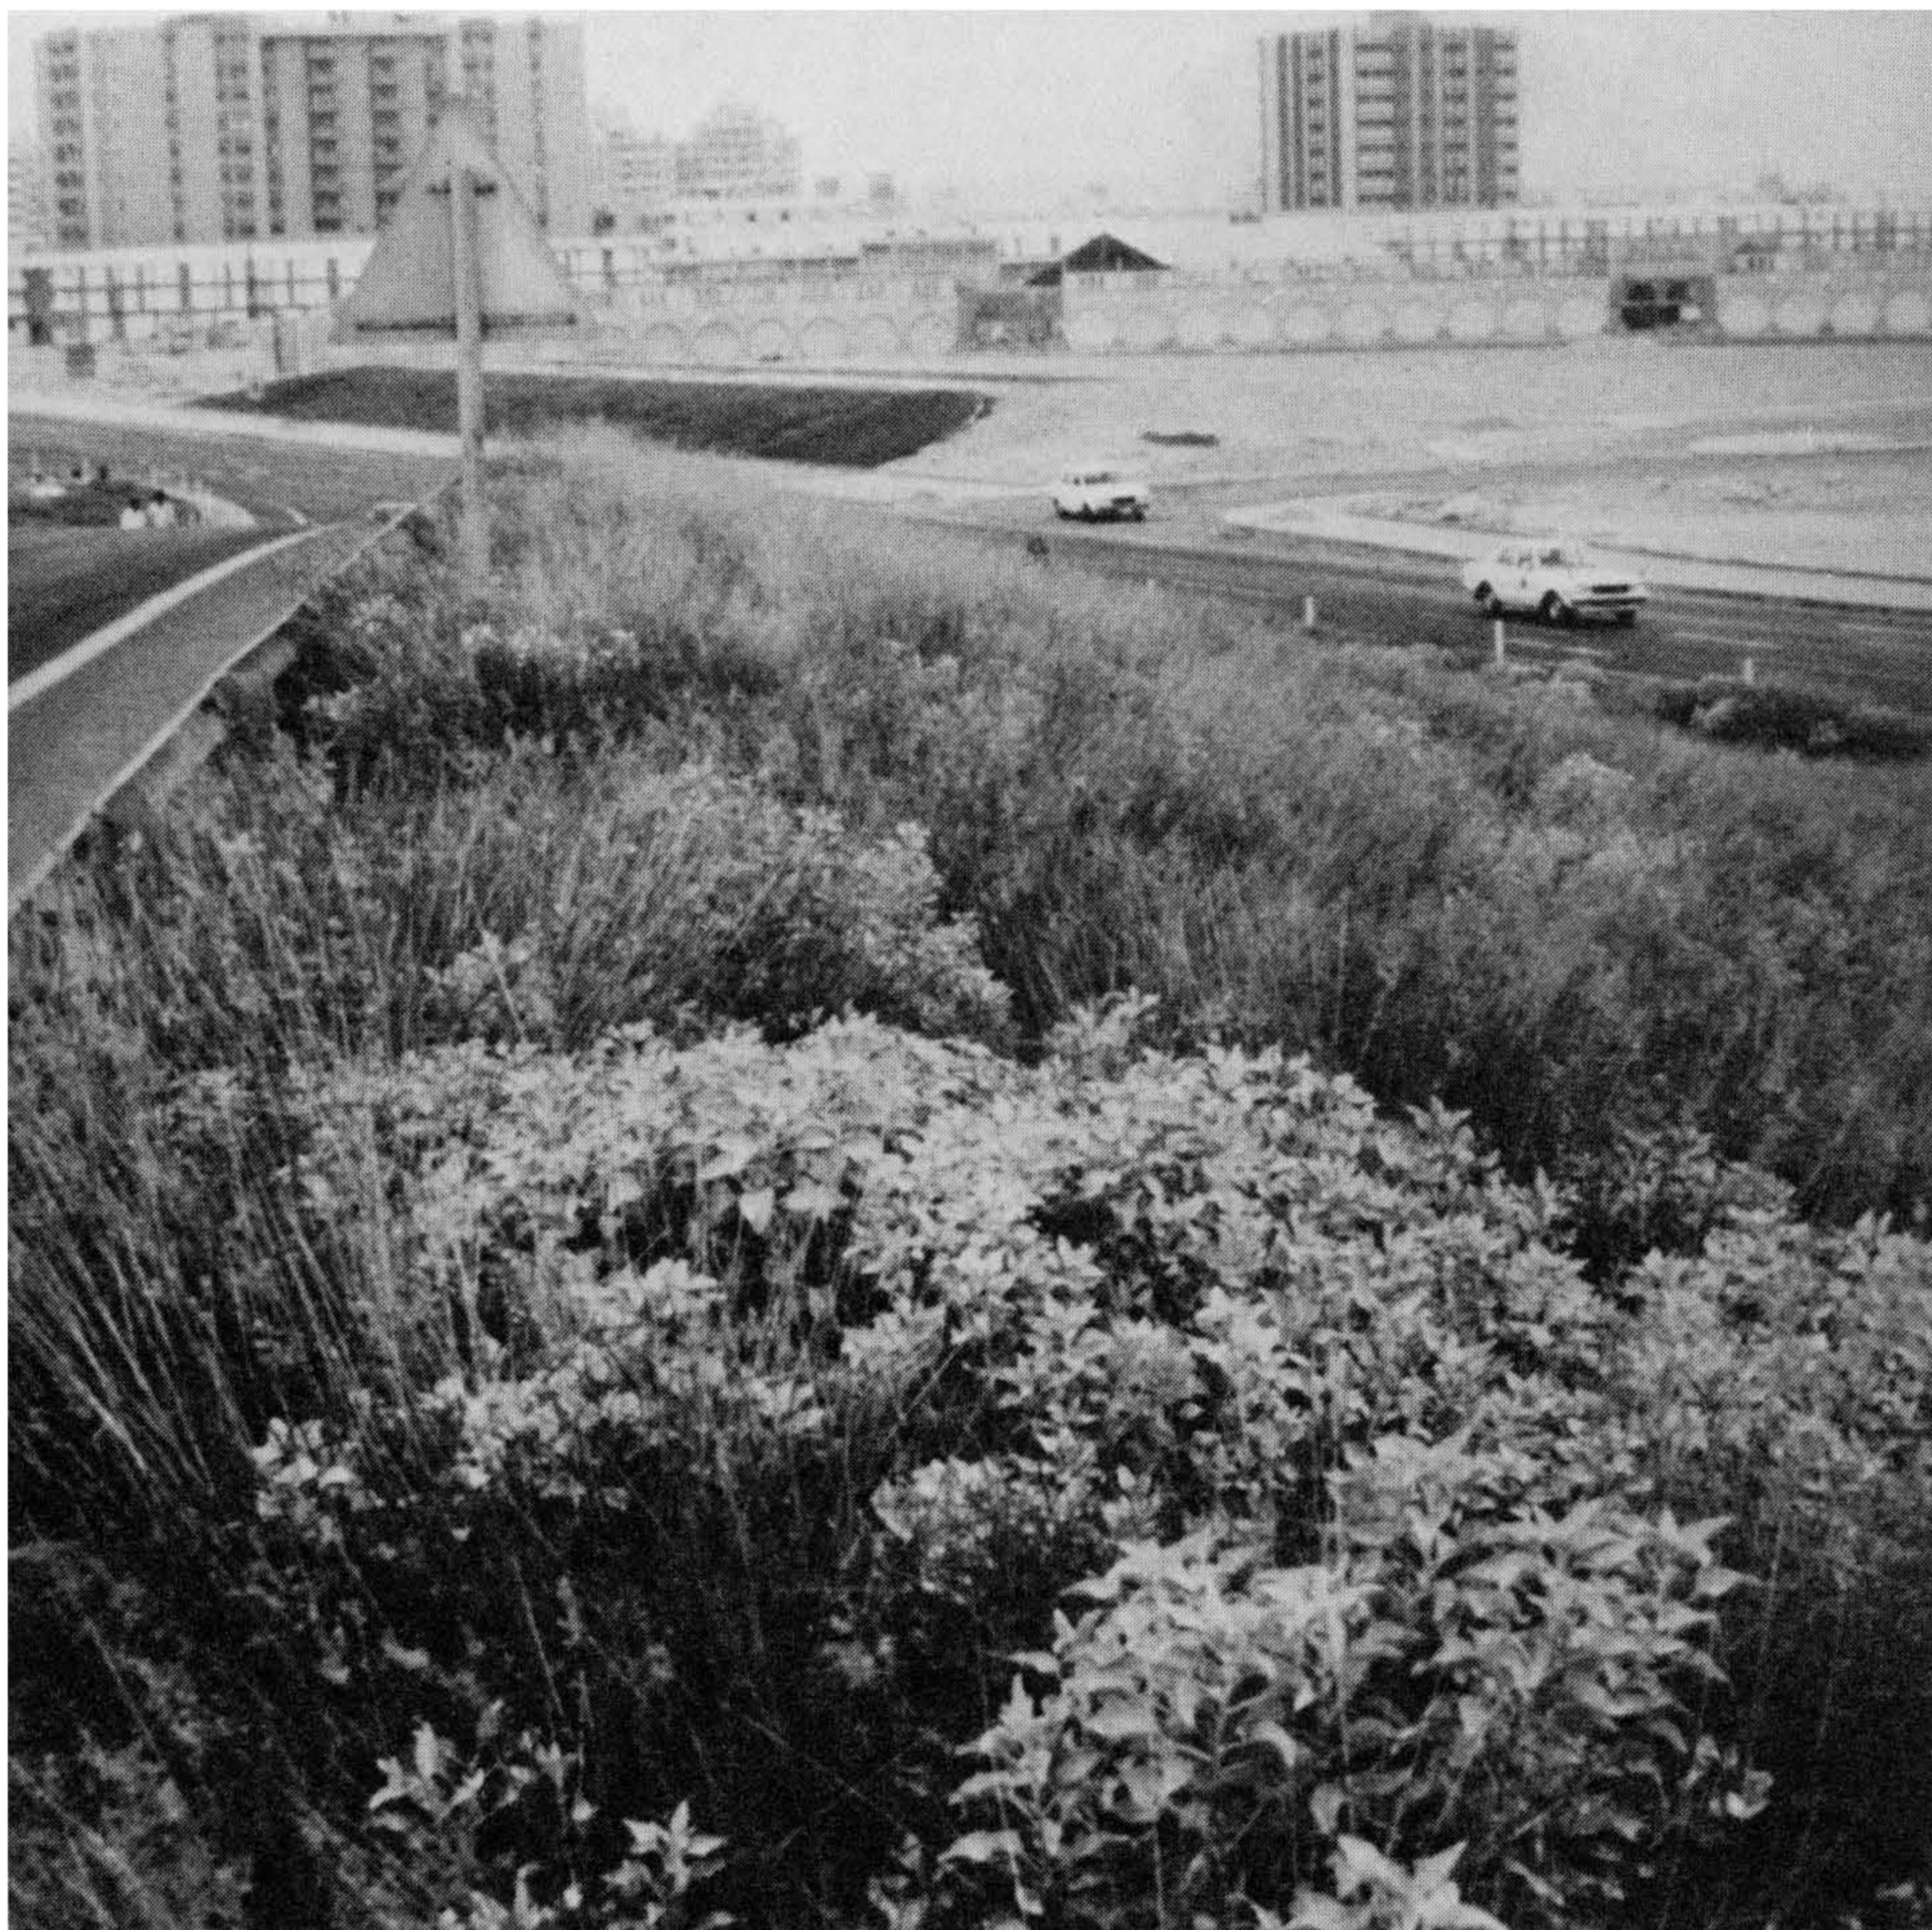
Figure 9-37 The results of seedmix UAE 198 at the Sharjah, UAE, El Khan Bridge Project after thirteen months' growth. The annual flowers have disappeared, and perennial shrubs and flowering grasses dominate the slopes. Photograph by and courtesy of Ronald Pecoff.

Figure 9-37 shows the results of seedmix UAE No. 198 at the Sharjah, UAE, El Khan Bridge Project after 13 months' growth. The annual flowers have disappeared, and the perennial shrubs and flowering grasses dominate the slopes.

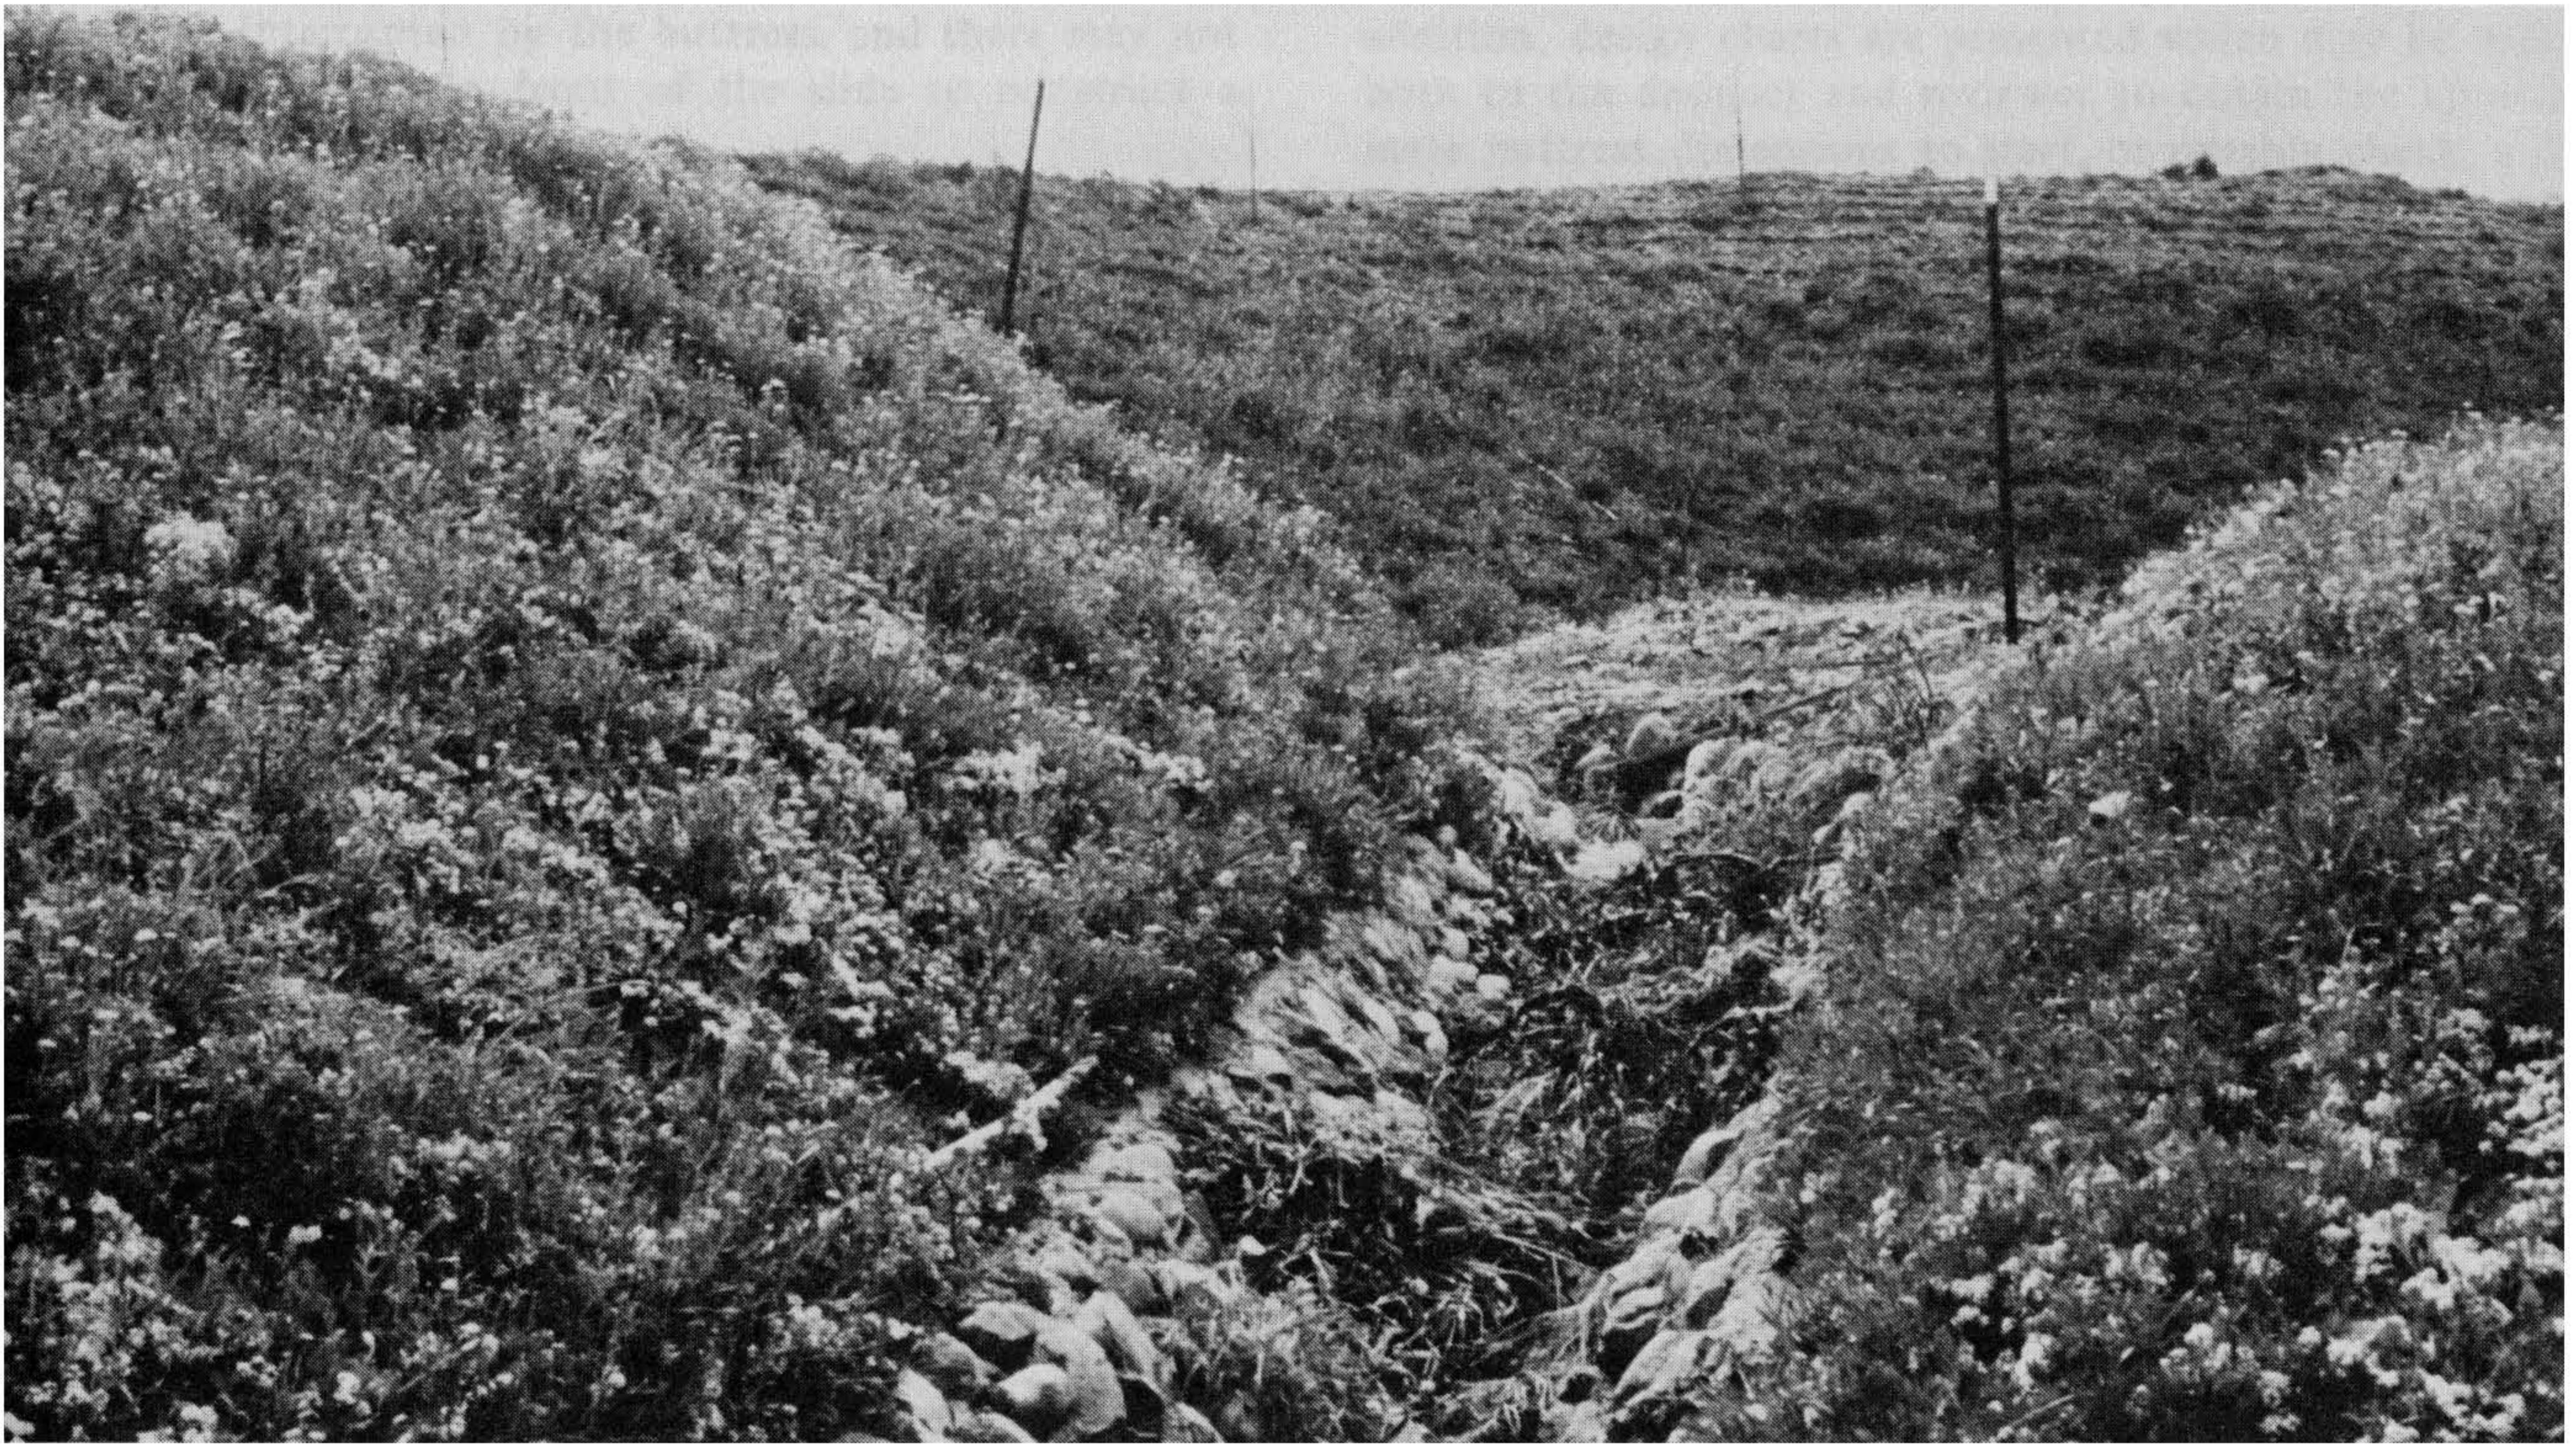
Figure 9-40 The results of twelve months' growth on contoured housing slopes utilizing Rolling Hills Berm No. 43 seedmix. The plant pallette hydroseeding mix has developed fully where the *O'Connors legume* has formed a

manicured dense cover and the gazanias, poppies, and nasturtiums have begun to mature and flower. Photograph by and courtesy of Ronald Pecoff.

Figure 9-40 shows the results after 12 months of growth on the contoured housing slopes utilizing the seedmix Rolling Hills Berm No. 43. Here the plant pallette has developed fully; the *O'Connors legume* has formed a manicured dense cover, and gazanias, poppies, and nasturtiums have matured and begun to flower.
