DAMS AND DISASTERS:

**a brief overview of dam building
triumphs and tragedies in California's
past**

J. David Rogers, Ph.D., PE., P.G., C.E.G., C.HG.

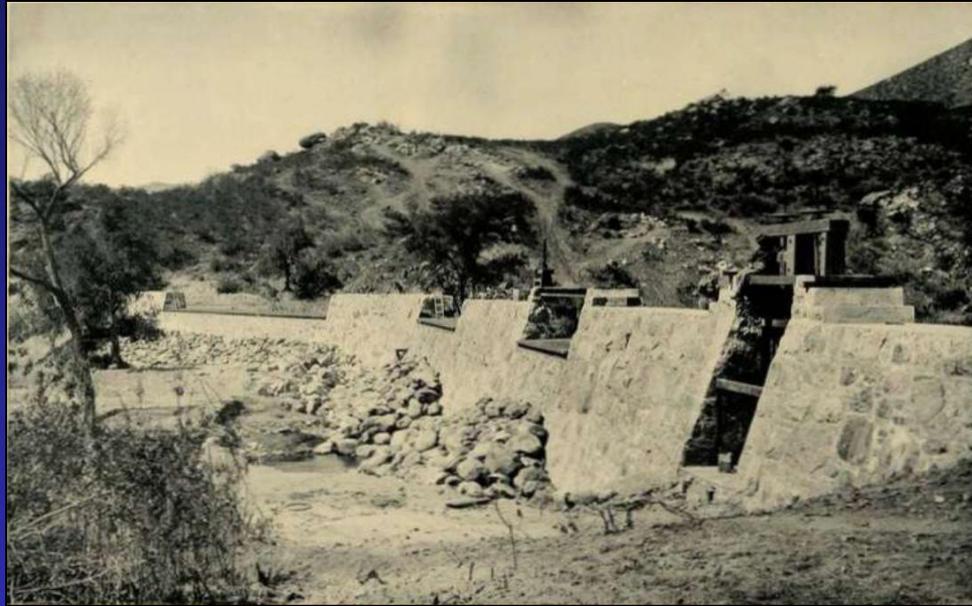
Oldest Dam and Irrigation canal in the United States (1815)

In 1814-15 a rubble masonry dam was constructed across the upper end of Mission Gorge in San Diego. It had a maximum height of about 13 feet, was 13 feet thick at its base, and was 244 ft wide. Water was released through gates and spillways into a six-mile long tile-lined flume, down Mission Valley, and terminating near the Franciscan Mission of San Diego de Alcalá, established in 1769.

The lower left image shows the dam being overtopped by the Flood of 1914 or 1916.

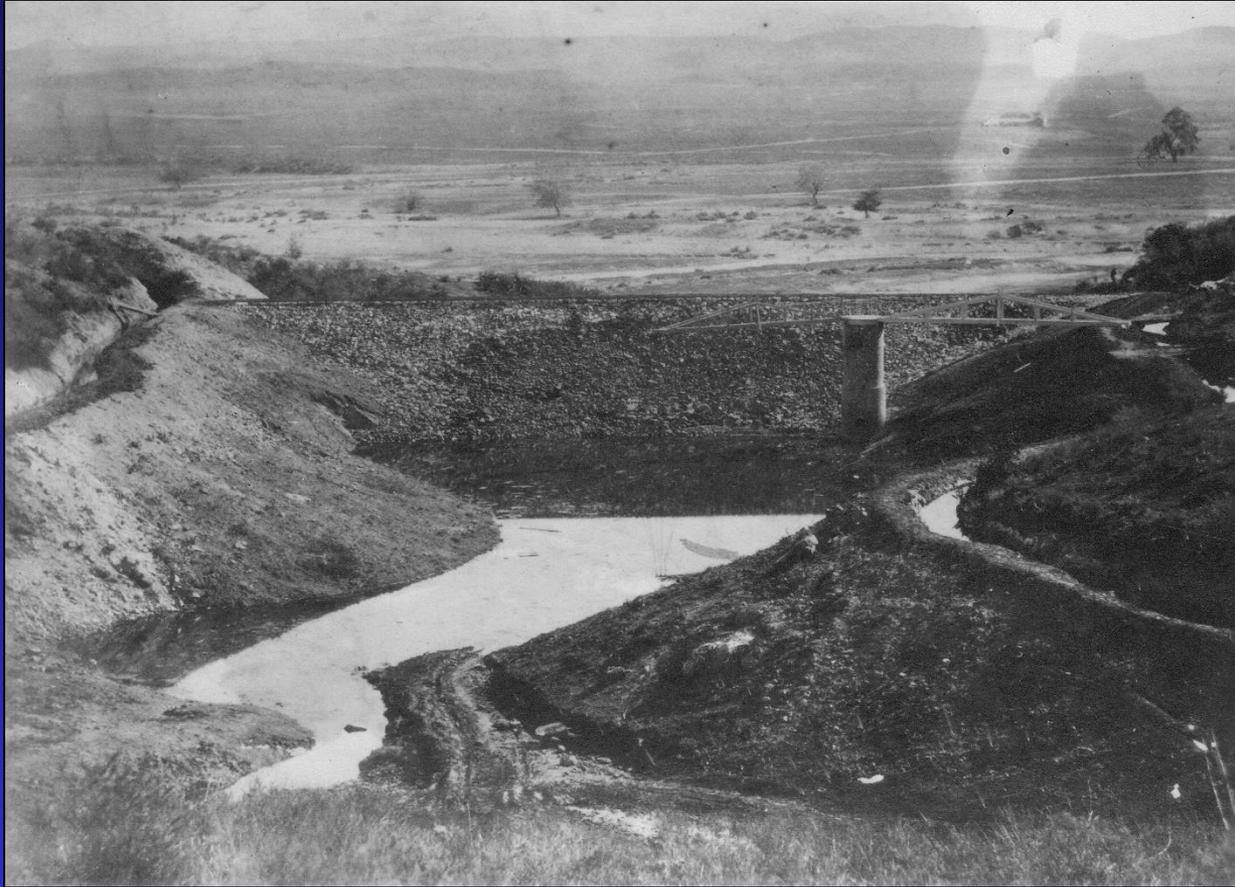
FIRST RESERVOIR IN LOS ANGELES

- **Buena Vista Reservoir** was constructed in 1868-69 using an earthfill embankment with riprap face, built to a crest elevation of 378 feet. It was built near what is now the southeastern tip of Elysian Park, in Los Angeles. It was built by privately owned Los Angeles Water Company as their first storage facility. This area is now part of Buena Vista Park, just off the Pasadena Freeway.

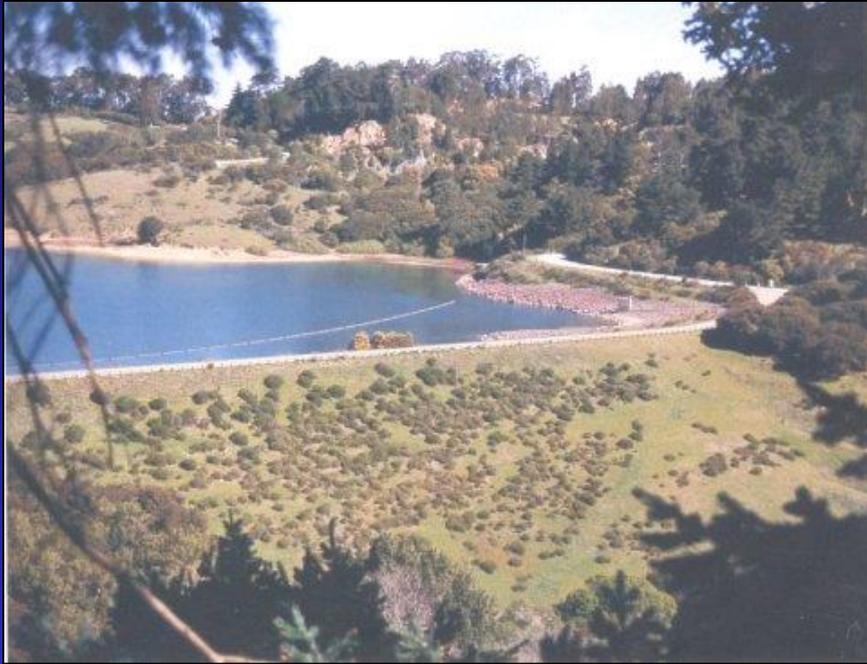
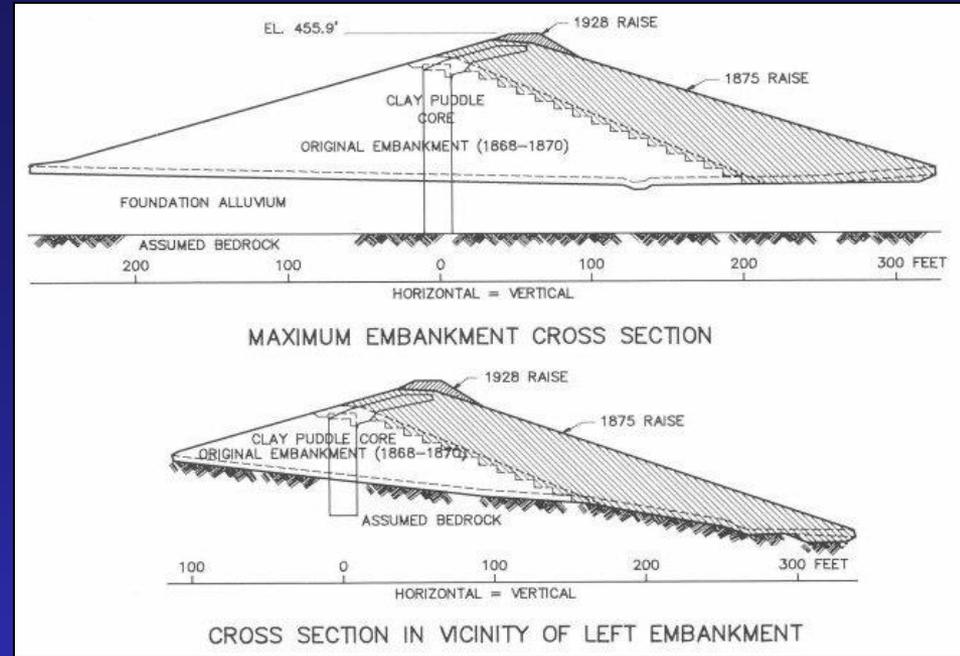
- **San Andreas Dam** was built to a height of 81 ft by the Spring Valley Water Company to provide water for San Francisco in 1868-70, and raised to a height of 97 ft in 1875 (the stippled area in the views at upper right).
- The M_w 7.9 1906 earthquake offset ran through the abutment between the main embankment and the left abutment embankment (shown above right).
- The site was likely subjected to a peak ground acceleration (PGA) exceeding 0.7g, without any overt damage being noted (this speaks to the resilience of earth embankments). The dam was raised another 6 ft in 1928, shown as the small shaded area near the crest, above right.

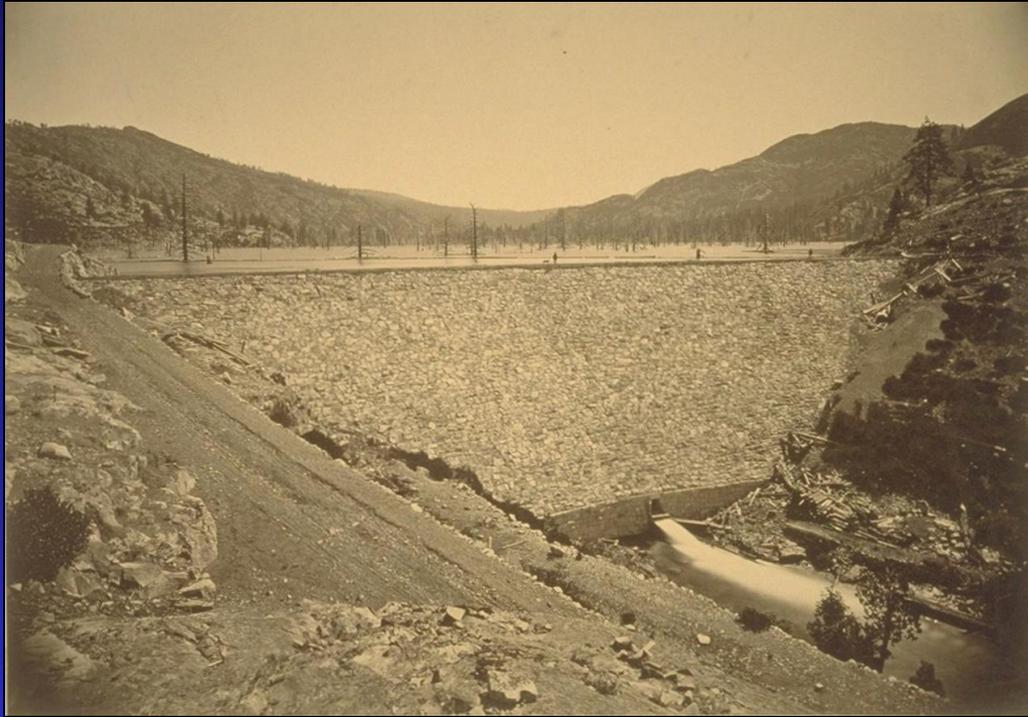
Fig. 3. Bowman, Section.

- **Bowman Dam** was California's second rockfill dam, built to supply water for hydraulic mining along the South Fork of the Yuba and upper Bear Rivers
- The upstream face was constructed with rock-filled timber cribs and sloped 0.58:1 (60 degrees) for the first 30 ft, then 1:1 (45 degrees) on both the up and downstream faces
- Originally 86 ft high, it was raised to 107 feet, making it the **highest dam in the world** between 1880-88
- In 1926 it was dismantled and replaced by a larger rockfill dam, 176 ft high, by the W. A. Bechtel Company.

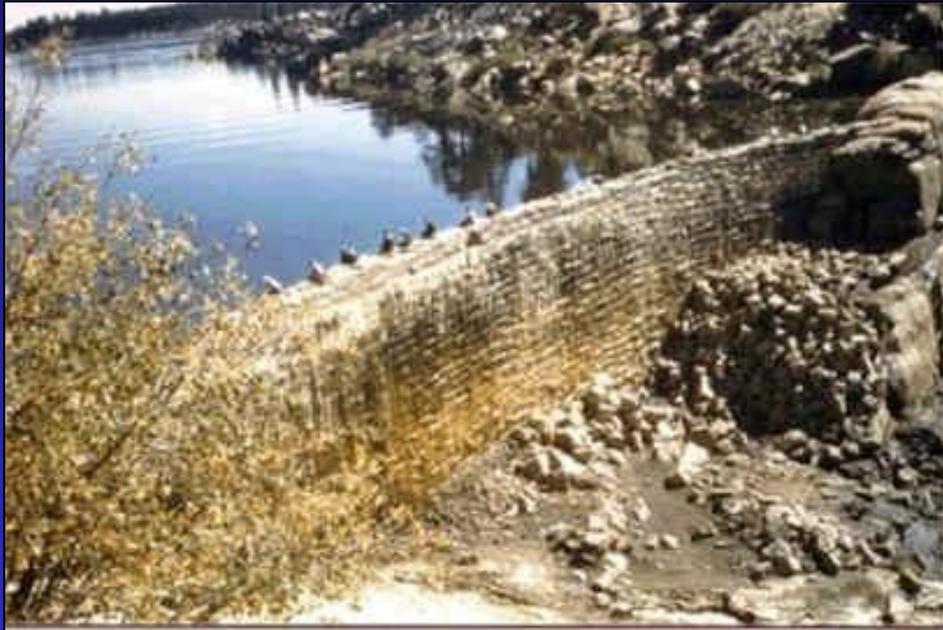
THE WORLD'S FIRST ARCH DAM; BEAR VALLEY DAM 1884

- A daring design by **Frank E. Brown, C.E.** (President of ASCE) and built of cyclopean masonry
- Formed the first **Big Bear Lake** in the San Bernardino Mountains

- The old arch dam was 64 feet high and 300 feet long, constructed on a radius of 335 feet. The spillway was 20 feet wide and extended 8.5 feet below the dam crest. The design was cited and criticized over the succeeding years.
- Despite the concerns, the dam survived repeated ice loadings and 2 ft deep overtoppings, in 1909-10 and 1910-11, which washed away the earthen stabilizing berms.

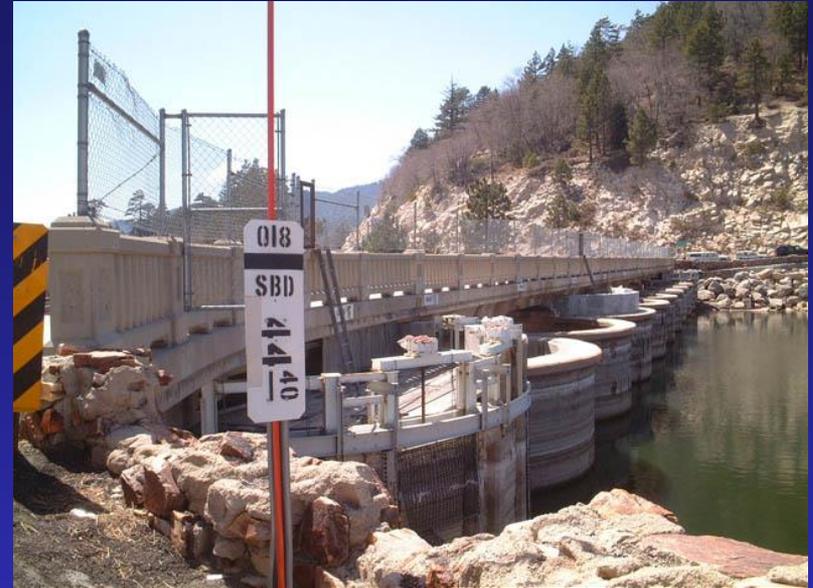
BIG BEAR VALLEY DAM

- A buttress dam designed by **John S. Eastwood** was built by the Bear Valley Mutual Water Company in 1911-12, which withstood significant overtopping in floods of January 1916
- The highway viaduct (upper right) was constructed across the dam in 1926 as part of the Rim of the World Highway
- When the lake is low, people can walk across the old arch dam, as seen in the postcard view at lower right

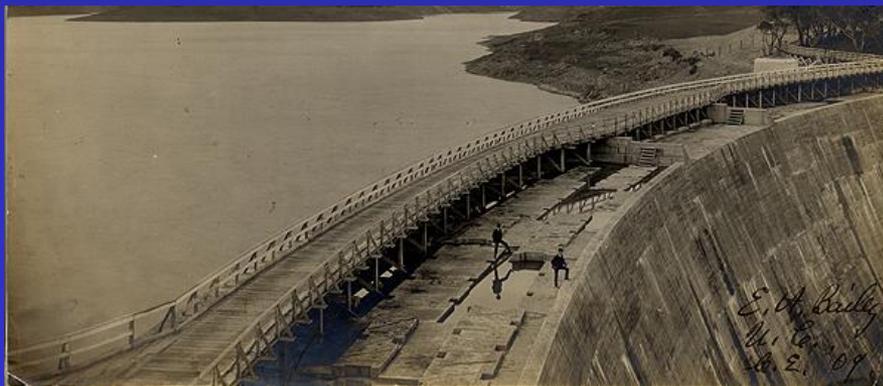
The system of interconnected blocks can be seen in the view, taken in 1909

- Intended to be 170 ft high, construction was halted at a height of 154 ft., with an arch radius of 632 ft.
- Situated 1000 ft east of the San Andreas fault, it survived the M_w 7.9 1906 earthquake without damage, because the foundation rock is so intensely fractured

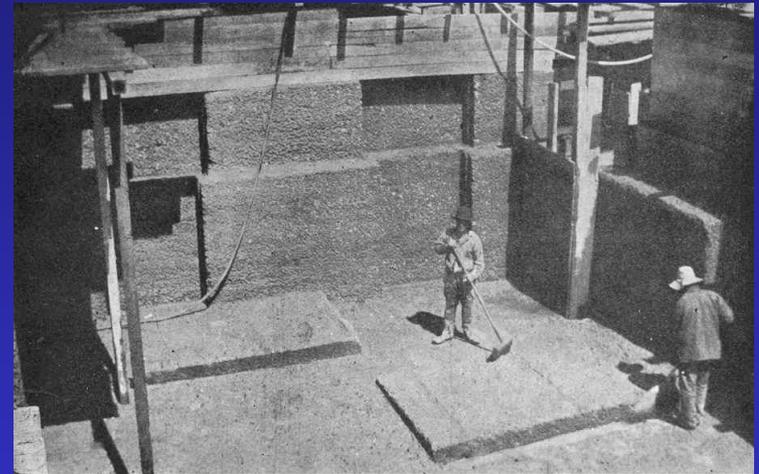
- **Crystal Springs Dam** was designed as a monolith of mass concrete, formed in an series of interconnecting blocks with grouted joints. All of the Portland cement was imported from England.
- The concrete mix was one barrel of Portland cement, two barrels of sand, $\frac{2}{3}$ barrel of water and 22 ft^3 of crushed stone; which equates to 470 lbs of cement per cubic yard, making very strong concrete

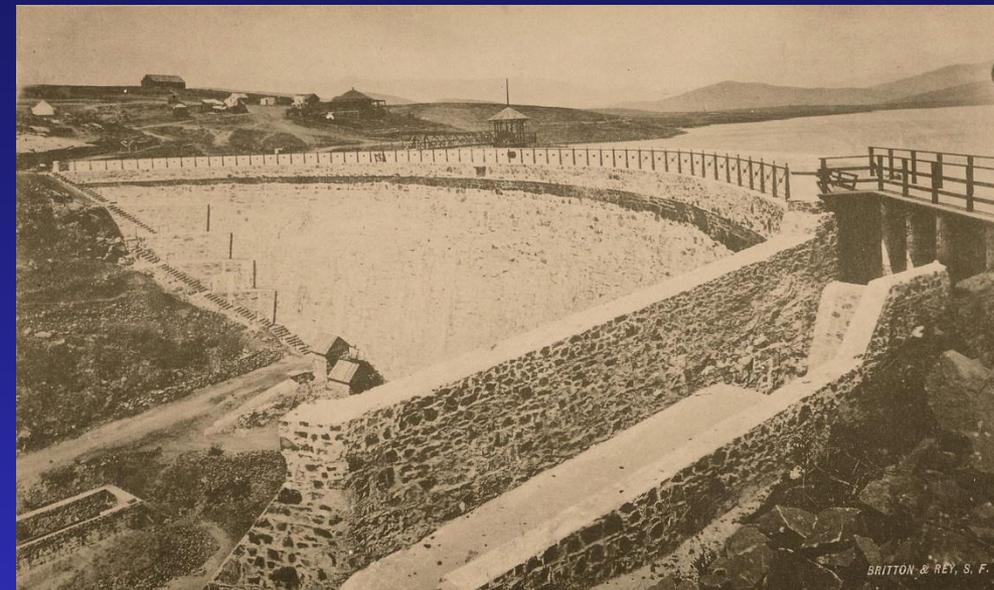
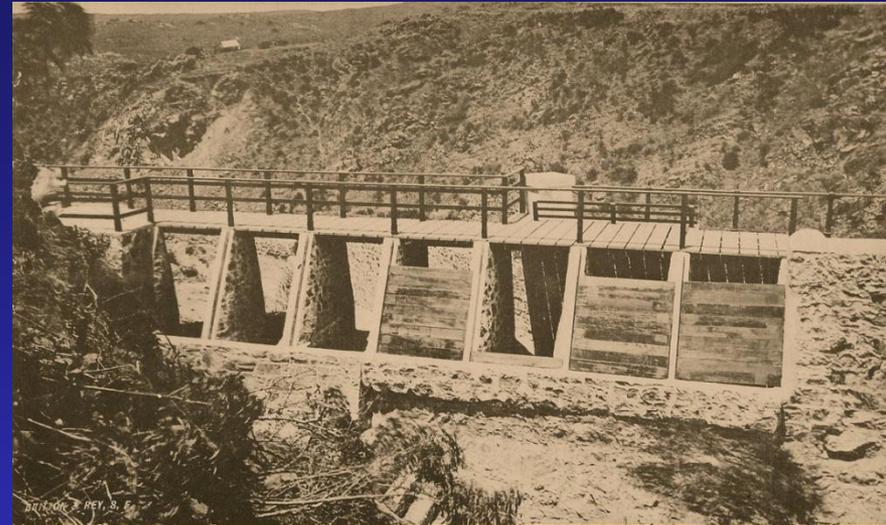
ESTIMATING THE ADEQUACY OF “WASTE WEIRS” IN THE EARLY DAYS

- At the October 1888 ASCE national meeting, former society President **James B. Francis** questioned the adequacy of the dam's spillway, given the tributary drainage area was 182 square miles. **James D. Schuyler** responded that the capacity was based on back-analyses of the 1884 flood in Sweetwater Creek. The design capacity of the “waste weir” (spillway chute) was 1800 cfs (upper right).

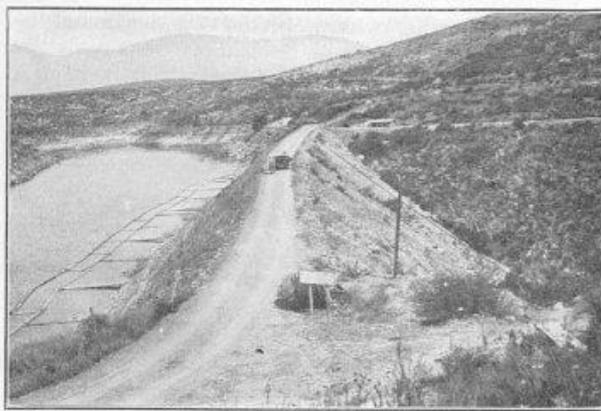
FIG. 5. LOWER OTAY DAM FOR SAN DIEGO WATER-SUPPLY ON OCT. 27, 1915

This view and Figs. 6 and 7 are reproduced from photographs taken by Allen Hazen, Oct. 27, 1915

- **Lower Otay Dam** was a 150 ft high loose rockfill embankment designed by developer E. S. Babcock. When completed in 1897, it was highest rockfill dam in world, until 1914.
- It was equipped with a 1/2" thick steel plate inside a 12" thick concrete diaphragm core wall. The rubble rock fill was placed 1.15:1 slopes (49 degrees).
- The daily leakage was between 225,000 and 400,000 gpd!

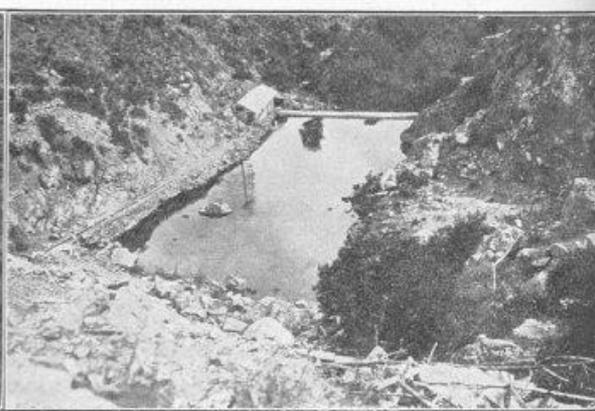
FIG. 6. VIEW OF DOWNSTREAM FACE OF LOWER OTAY DAM

Showing pool for impounding leakage and pumping house and pipe line delivering it back into reservoir

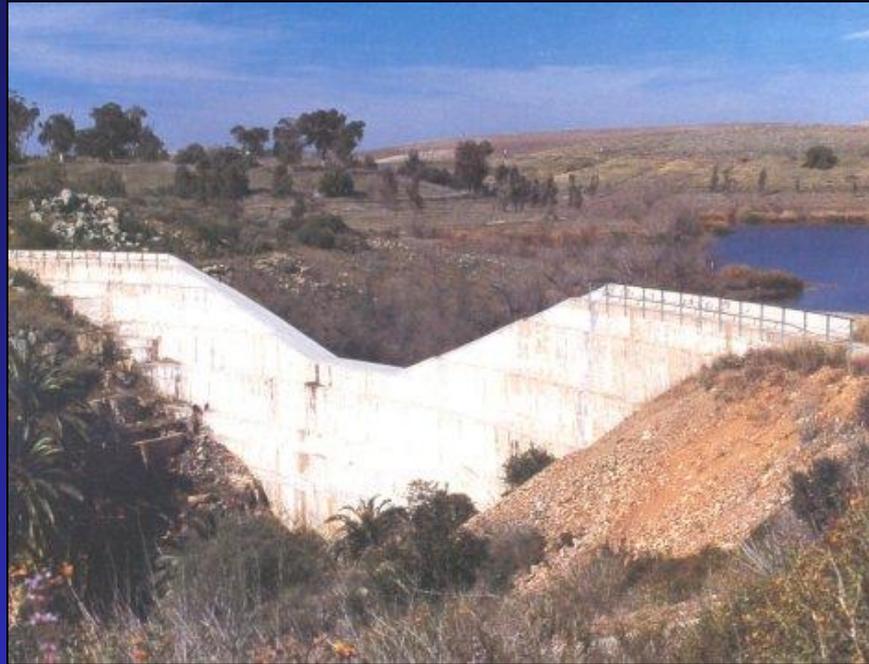
- **Upper Otay Dam** was the world's first reinforced concrete dam, 89 ft high, 350 ft long, on a radius of 359 ft. Designed by H.N. Savage and built 1898-1901 along Proctor Creek, upstream of Lower Otay Dam and Reservoir
- The dam was overtopped 3 ft deep in the Jan 1916 flood
- The trapezoidal slit 22 ft deep (shown above) was cut in 1985 to accommodate the revised design overflow of 10,500 cfs

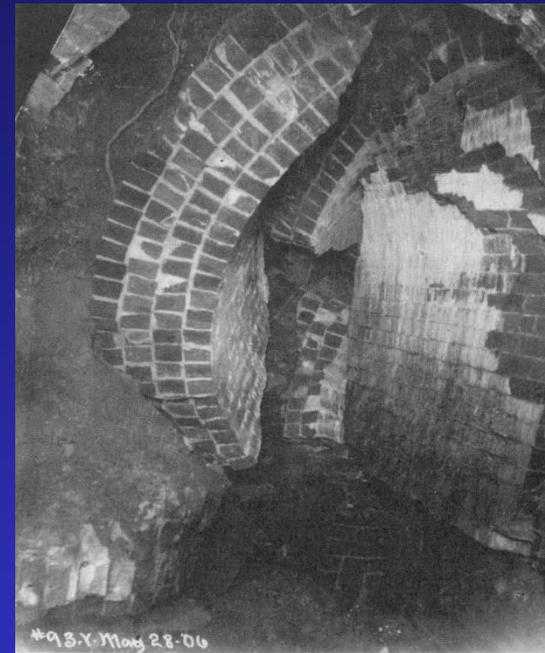
Collapsed section of the brick-lined wastewater (spillway) tunnel, where it crossed the fault

Map at left shows the line a surface fault rupture of 7 feet in the shudder ridge between the two embankments of San Andreas Dam during the April 1906 M_w 7.9 San Francisco earthquake (from Wood et al., 1908)

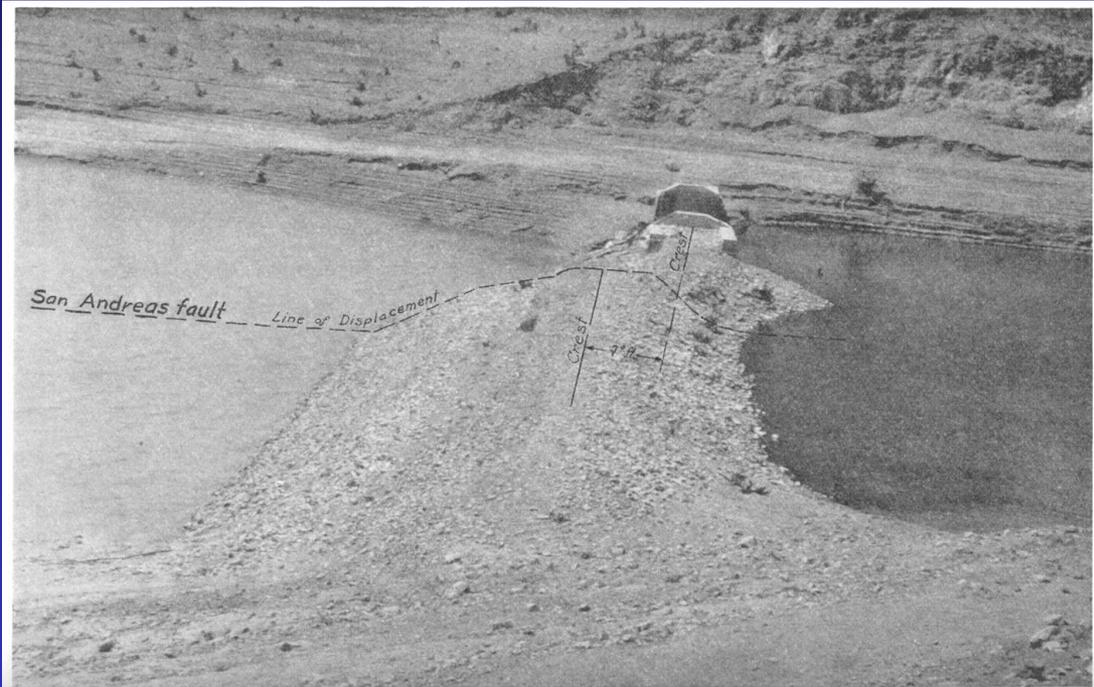
Fig. 2. View along the axis of the old dam in the San Andreas Valley (the same as fig. 1), showing the offset of about seven feet caused by the fault movement of April 18, 1906. Photo by G. F. Engle, April 17, 1931

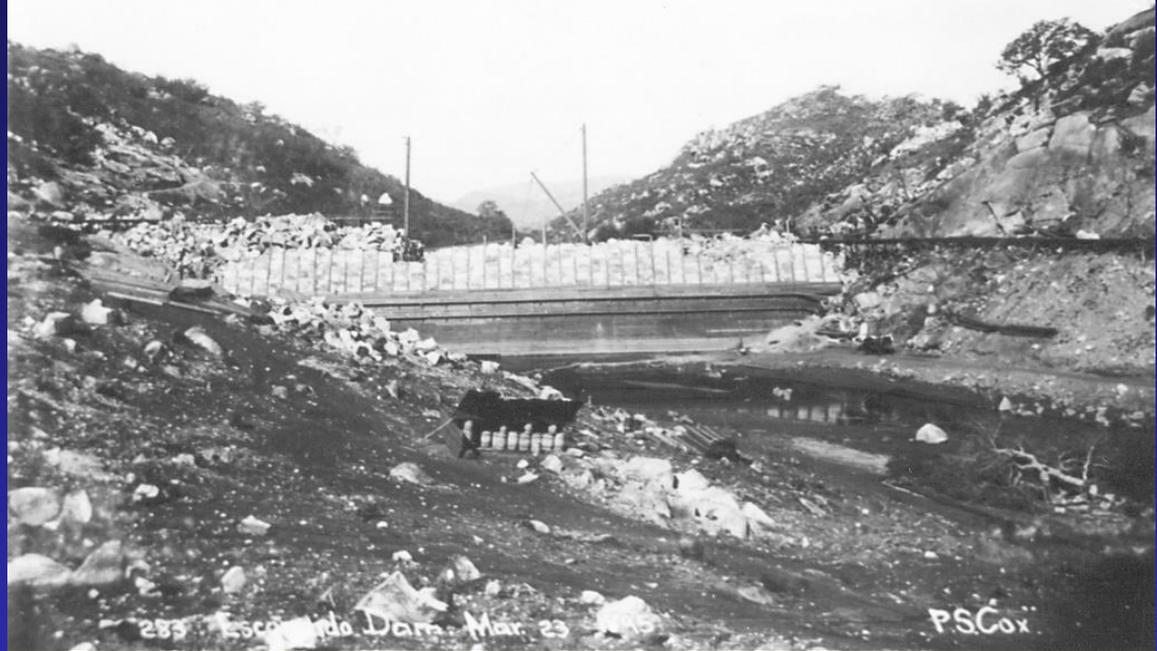
- **Escondido Dam** was one of the early rockfill dams in California, designed by **Frank E. Trask**. Its construction was supervised by **Harry Hawgood** in 1890-95, using 37,159 yds³ of rock.
- It was 76 ft high, with a 10 ft wide course of hand-laid stone on the upstream face, inclined at 63.5 degrees
- It survived 12" overflow during the record storms of January 1916, but afterwards, was found to have settled 12"
- It was dismantled and replaced by **Lake Wohlford Dam** in 1926

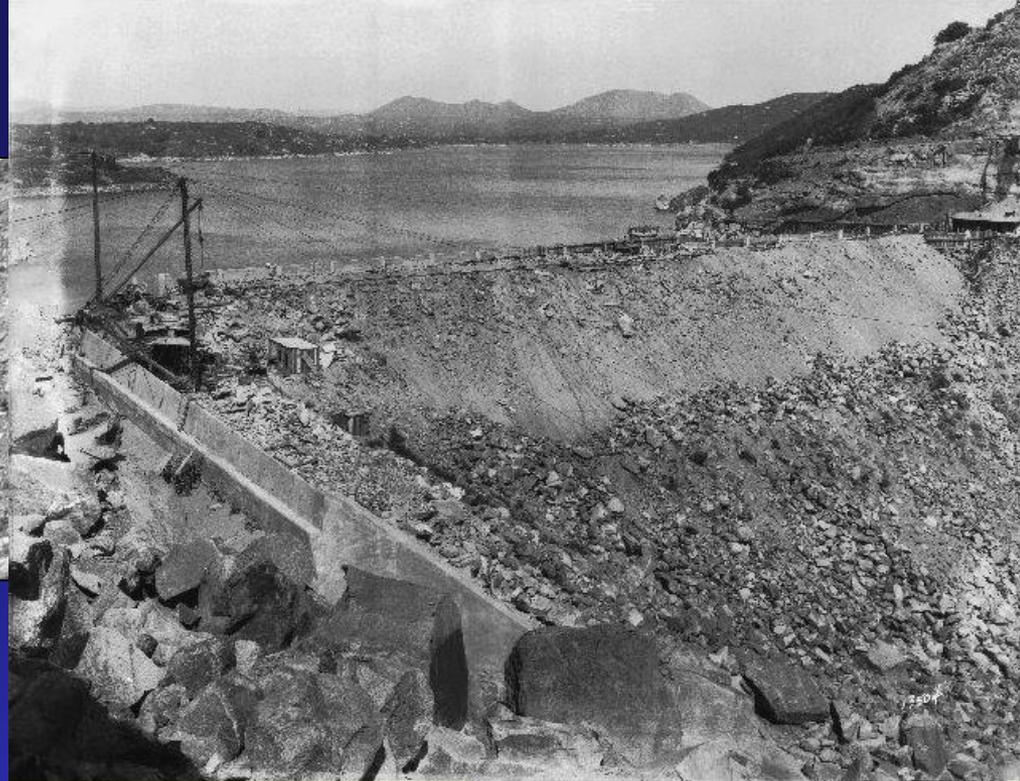
Right - Construction of the deep concrete cutoff wall commenced in 1893 and took six years to complete.

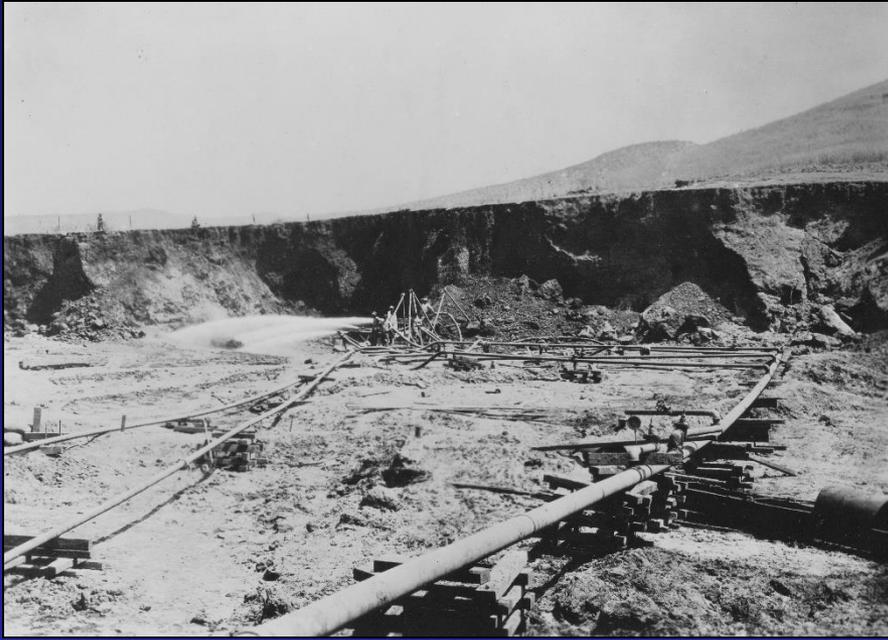
San Fernando Dam and Reservoir

- The original **San Fernando Reservoir** was constructed by the City of Los Angeles between 1911-17 using hydraulic “puddled fill technique,” shown at left.

This view shows the dam in 1920, as originally completed, with a reservoir capacity of 10,870 ac-ft.

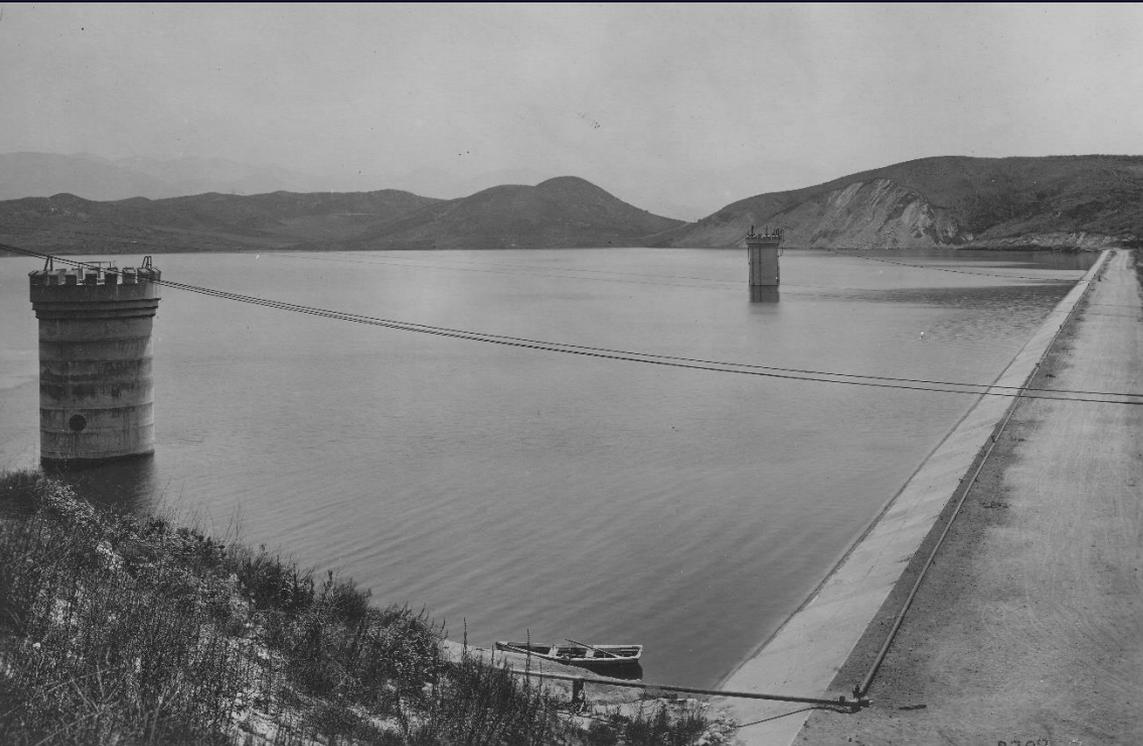
The embankment was raised 7 feet in four stages using rolled earthfill (over hydraulic fill). The last raise was completed in 1924-25, increasing its storage capacity to 14,670 ac-ft. It was renamed **Lower Van Norman Reservoir** in 1945.

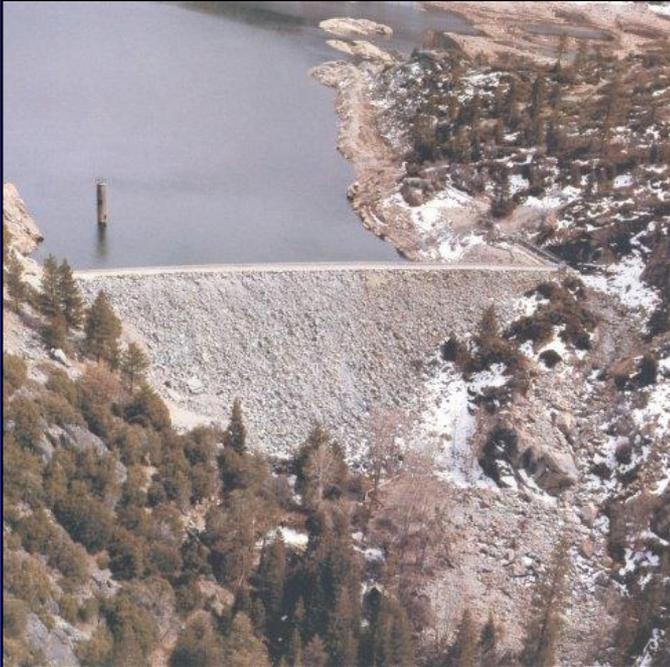
STRAWBERRY ROCKFILL DAM (1916)

- **Strawberry Dam** is a 143 ft high concrete-faced rockfill dam built by Pacific Gas & Electric between 1913-16 on South Fork Stanislaus River, with slight upstream curvature
- The rock fill was “drop compacted” by allowing ‘plum stones’ to fall 20 to 70 feet from cableways! Hand-stacked facing stones were 2 to 5 tons apiece
- 1.3:1 (37.6°) side slopes, it settled 2.1 feet (1.5%) in the first 20 yrs

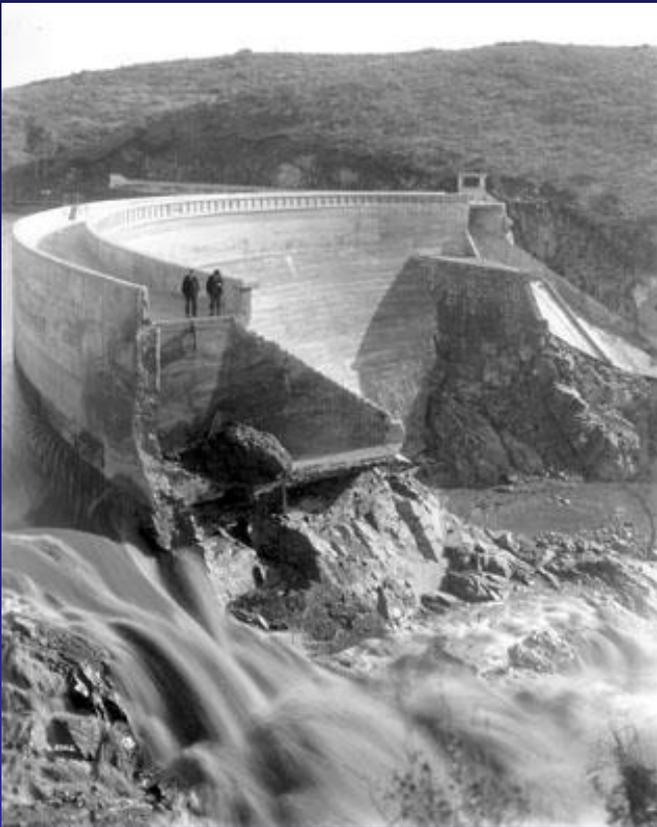
RIGHT ABUTMENT FAILURE OF SWEETWATER DAM (1916)

- In 1910-11 James D. Schuyler prepared a plan that raised **Sweetwater Dam** 15 feet, increasing the reservoir capacity by 70%.
- In January 1916, 8 to 20 inches of rain fell on the area, causing a peak discharge of 45,500 cfs for an hour, and an average flow of 20,000 cfs over 24 hours. The dam was overtopped to a depth of 3.66 feet, washing out the south abutment dike (shown here). 8 people were killed by the flooding.
- We would never build an arch dam in such fractured rock today.

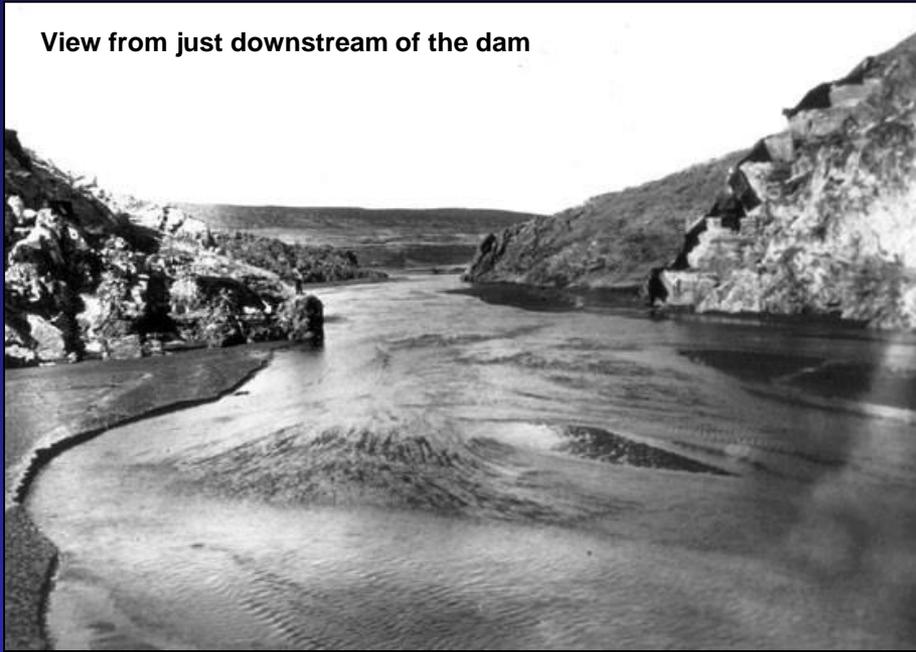
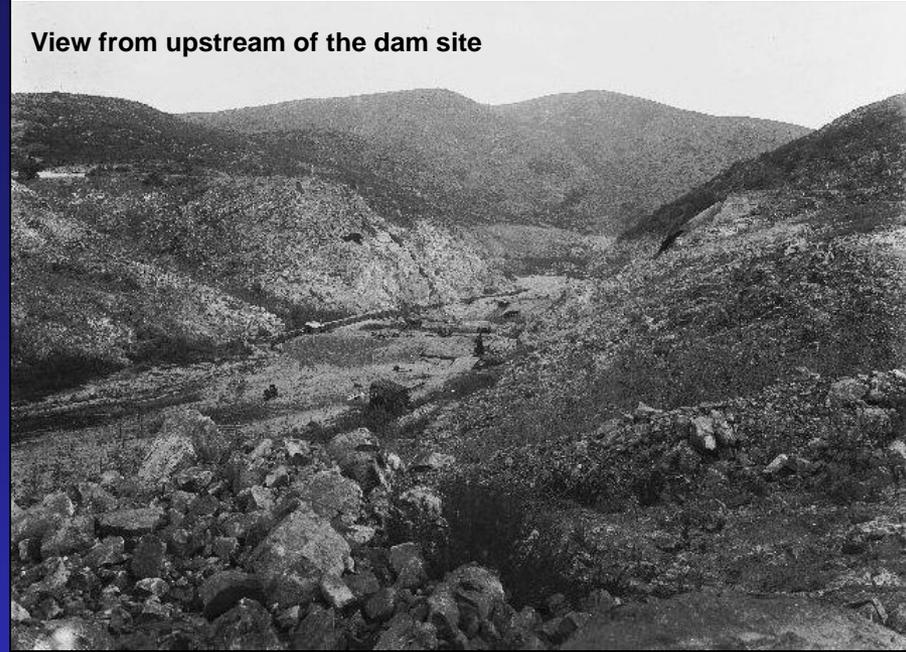
View from upstream of the dam site

- On January 27, 1916 the **Lower Otay Reservoir** rose 9.5 ft between 7AM and 5 PM, when the flow began to overtop the dam
- When the overflow reached 3,500 cfs it triggered severe erosion of the dam, causing it to fail within five minutes. All of the dam's rock fill was removed within 15 minutes, by 5:20 PM. 40,000 acre-feet of water was released, killing 30 people.

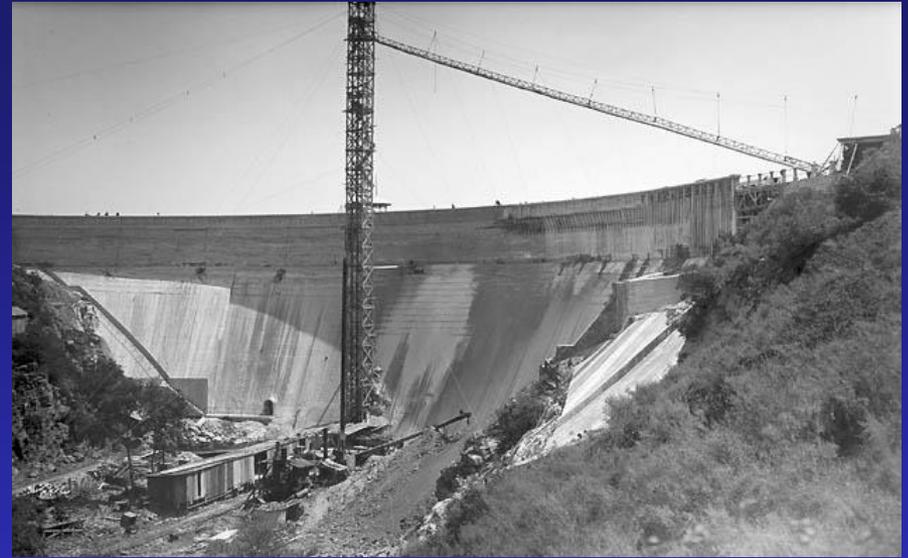
SWEETWATER DAM SPILLWAY CAPACITY ENLARGED FOR THIRD TIME IN 1919

- A massive retrofit of **Sweetwater Dam** was undertaken in 1918-19 to repair damage caused by the 1916 flood.
- The spillway capacity was increased to 45,000 cfs by enlarging the existing spillways and constructing a series of siphon spillway chutes on the right abutment (shown at left).

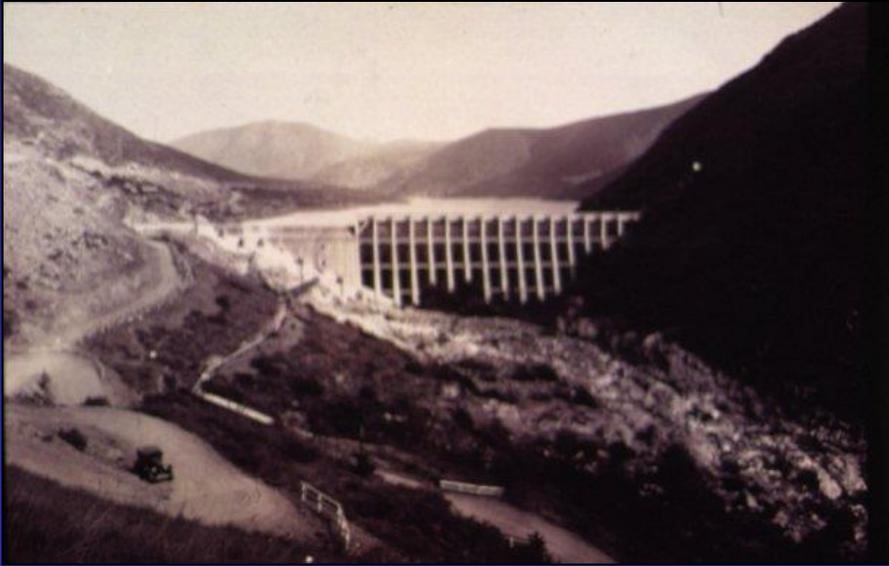
HIGHEST BUTTRESS DAM IN THE WORLD, BUT WITH CRACKS

- **Lake Hodges Dam** was designed by the legendary John S. Eastwood, it was an inclined multiple arch, which became vertical in the top 15 ft
- At 136 ft high, it was the highest buttress dam in the world in 1918
- The buttress supports developed cracks parallel to the minimum stress trajectories. A professional debate erupted as to the cause of these cracks; being induced tension, or caused by shrinkage of the concrete
- This cracking problem was not explained until after instrumentation and study of similar cracks in Rodriguez Dam in 1929, by Fred Noetzli, Hubert Woods, and Roy Carlson.

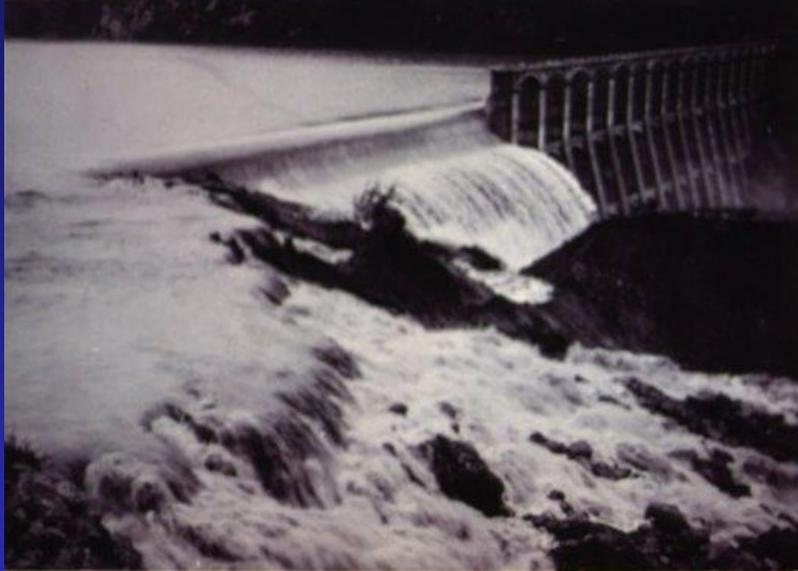
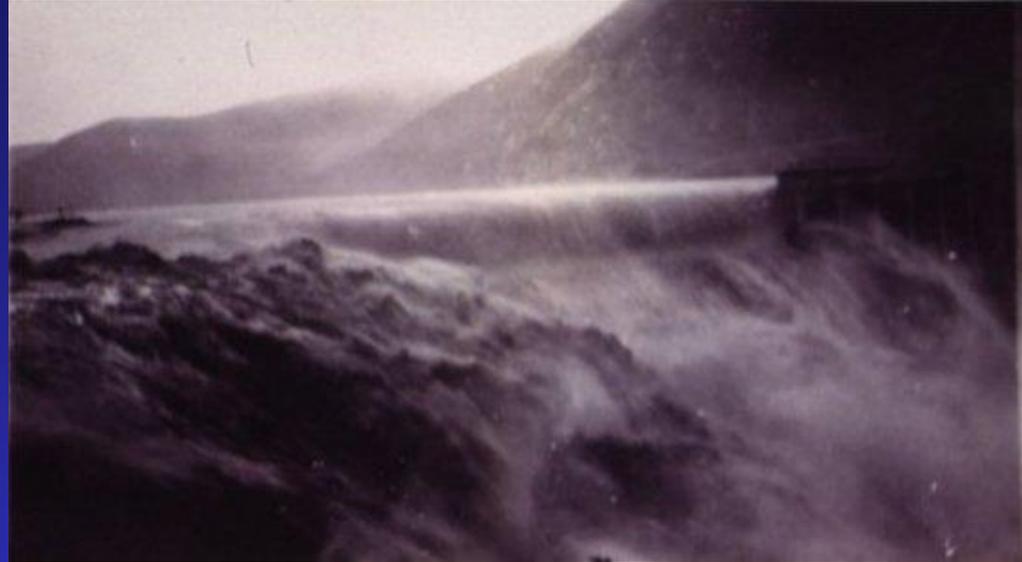
1927 FLOOD AT LAKE HODGES

- **Lake Hodges spillway** passing 45,000 cfs around 1:30 PM on February 16, 1927. Depth over spillway was 11 feet 8 inches. Reservoir drainage area was 303 mi².
- Concrete dam enthusiasts were quick to point out that buttress dams were better equipped to handle large bypass flow events without sustaining severe damage or failure...

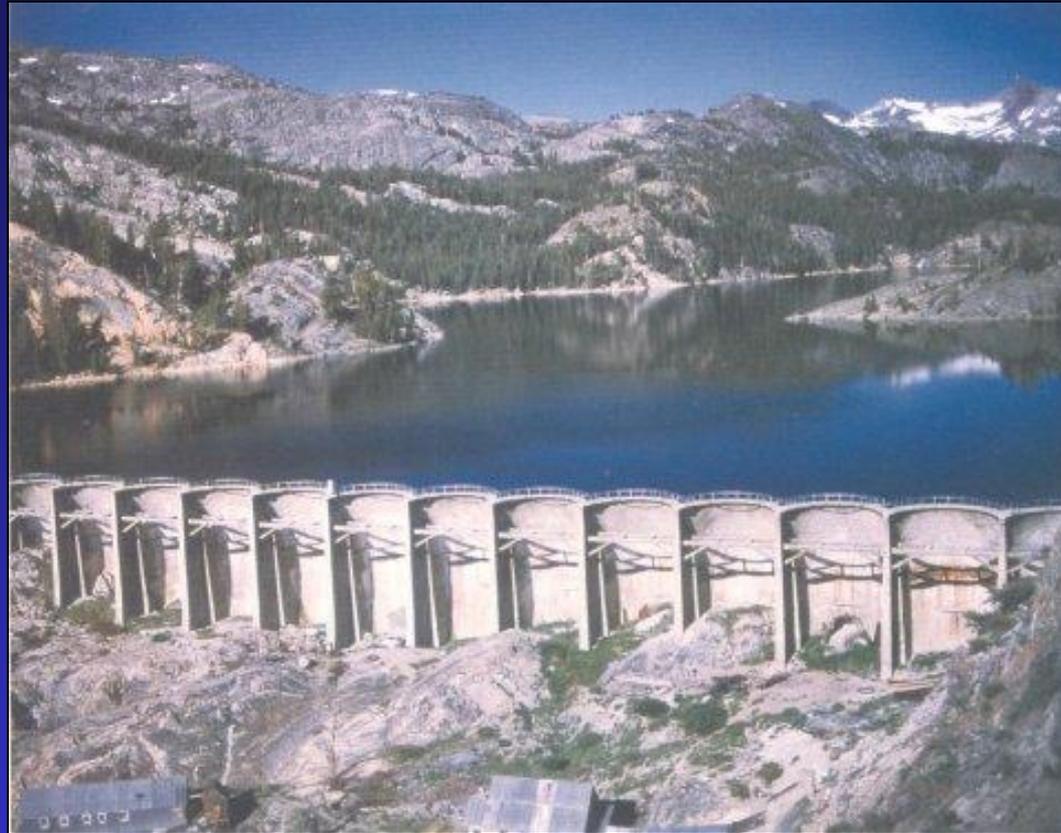
GEM LAKE DAM -1916

- **Gem Lake** and **Agnew Lake Dams** were built along Rush Creek on east side of the Sierra Nevada Mountains in 1915-16, at altitudes of 9000 and 8500 feet, respectively.
- Gem Lake Dam is 112 ft above the stream bed, with the highest cylinder arch being 84 ft high

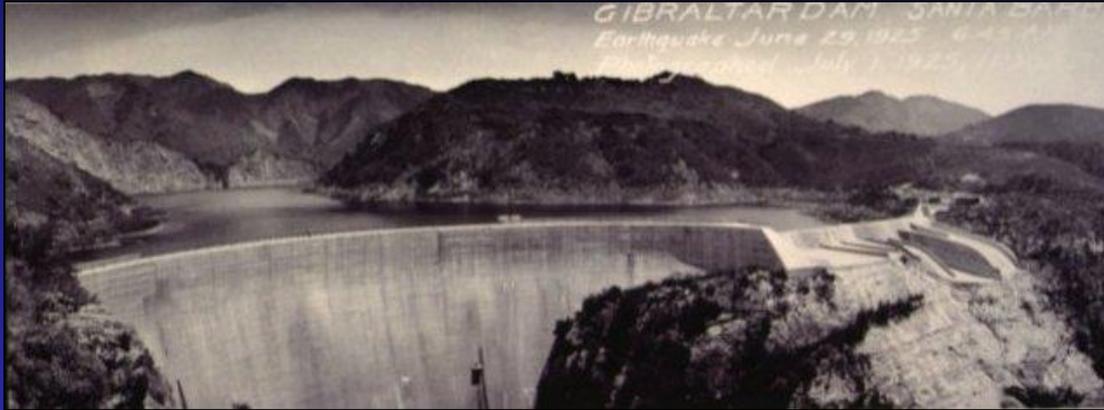
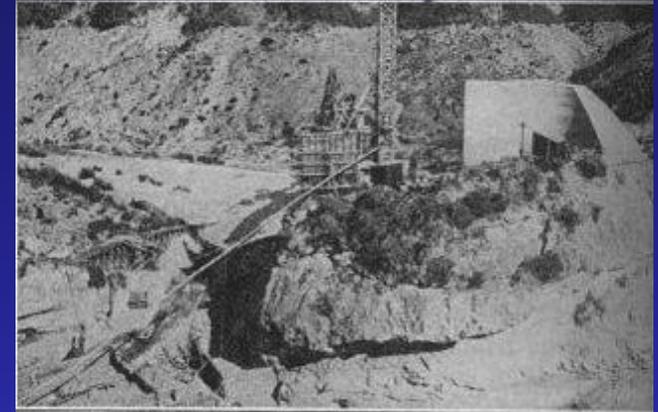
FIRST ARCH DAM WITH ARTIFICIAL THRUST BLOCK

- As originally constructed in 1918-20, **Gibraltar Dam** was a 185 ft high constant radius arch dam designed by **Quinton, Code and Hill** of Los Angeles to provide water from the Santa Ynez River for the City of Santa Barbara
- All construction materials and site access supplied through a 4-mile long 42" x 48" water supply tunnel
- A 3000 yd³ thrust block was built on the left abutment a year before the main dam to give it time to cure (above right)

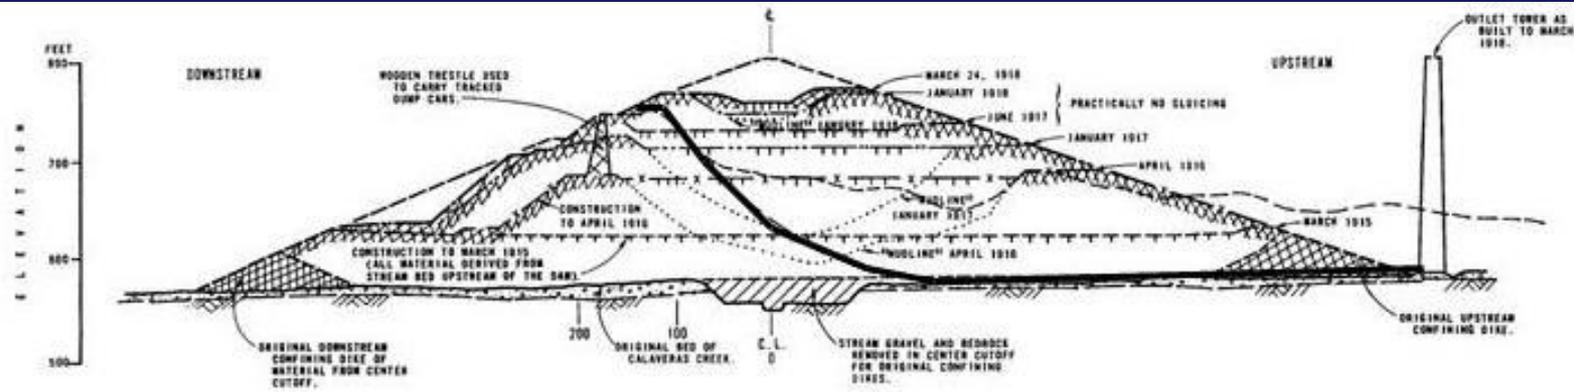
Section through the Calaveras Dam when the upstream shell failure occurred in March 1918

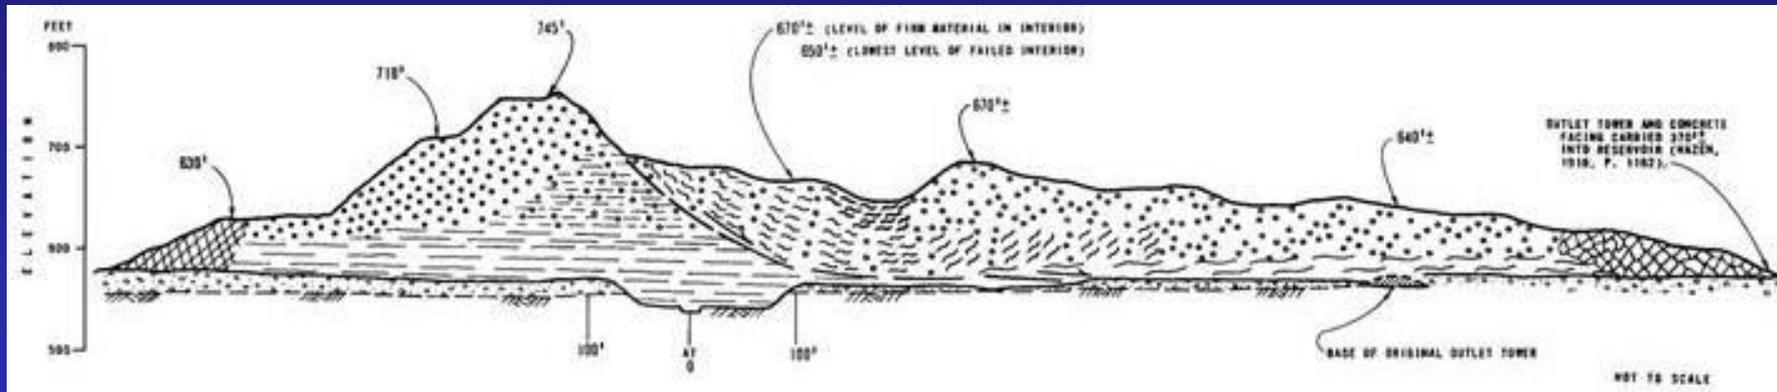
Section through the liquefaction flow slide of the dam's upstream shell in March 1918

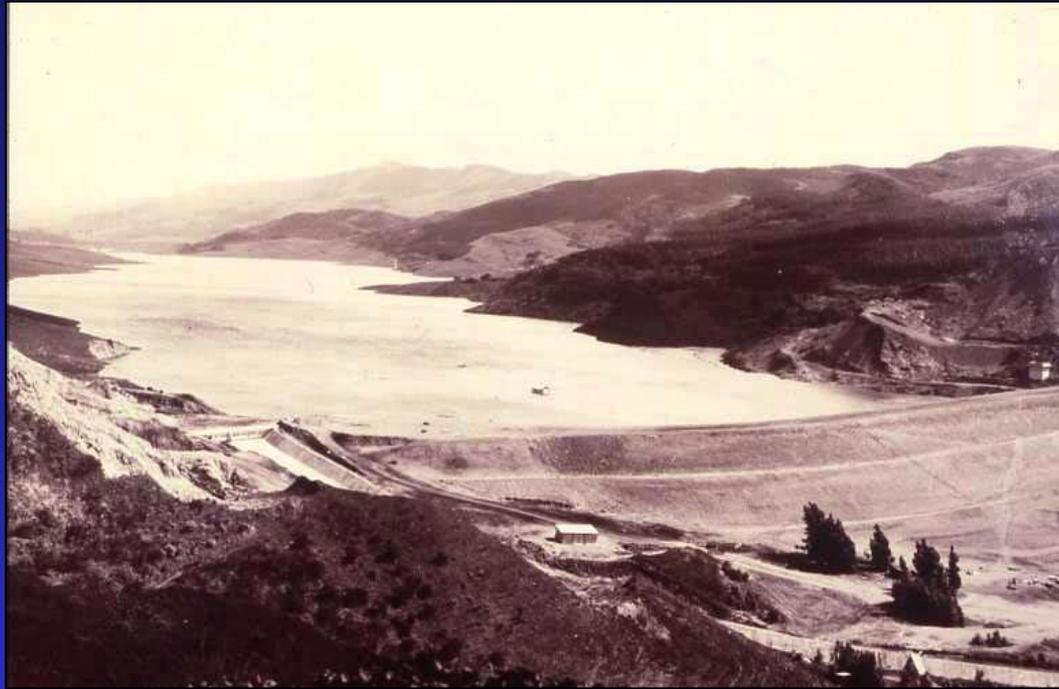
SAN PABLO DAM (1920)

- The **San Pablo Dam** was a hydraulic fill embankment 220 feet high, constructed by the East Bay Water Company in 1918-20
- Its volume of 2,200,000 cubic yards made it the **largest embankment dam in the continental United States** until completion of **Calaveras Dam** in 1925. It did not fill until 1937, with water from EBMUD's Mokelumne River aqueduct arrived.
- Buttress fill zones were placed up and downstream of the original dam in 1967 and 1979-80 to increase seismic stability. The alluvium just downstream of the dam's toe was stabilized using Cement Deep Soil Mixing in 2008-10 to increase resistance to liquefaction of the alluvium.
