DAMS AND DISASTERS:

**a brief overview of dam building
triumphs and tragedies in California's
past**

J. David Rogers, Ph.D., PE., P.G., C.E.G., C.HG.

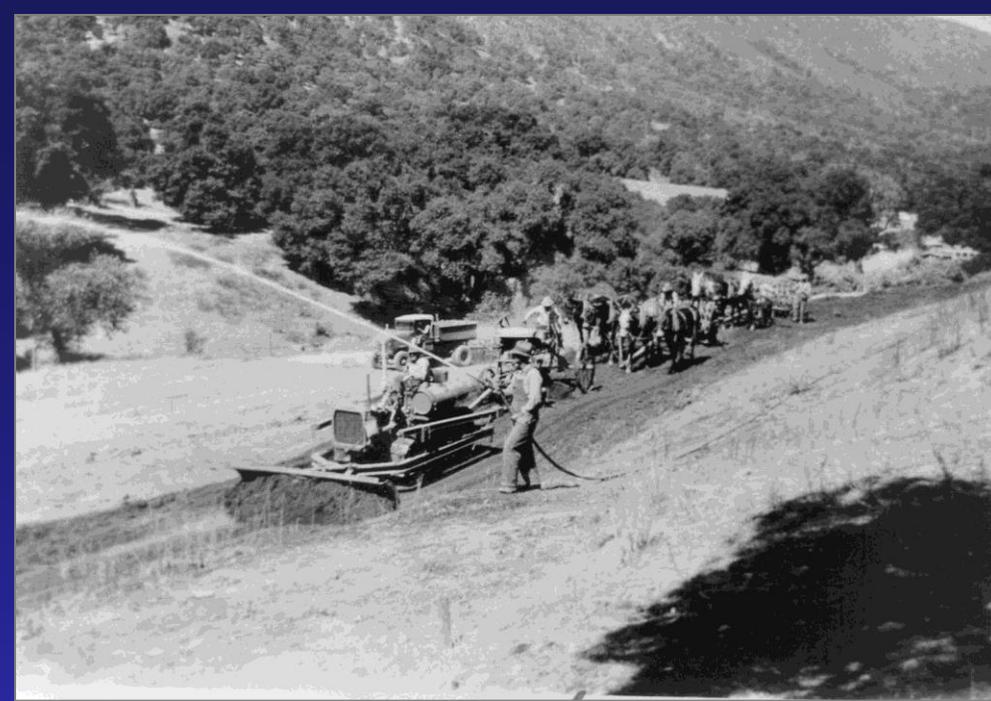
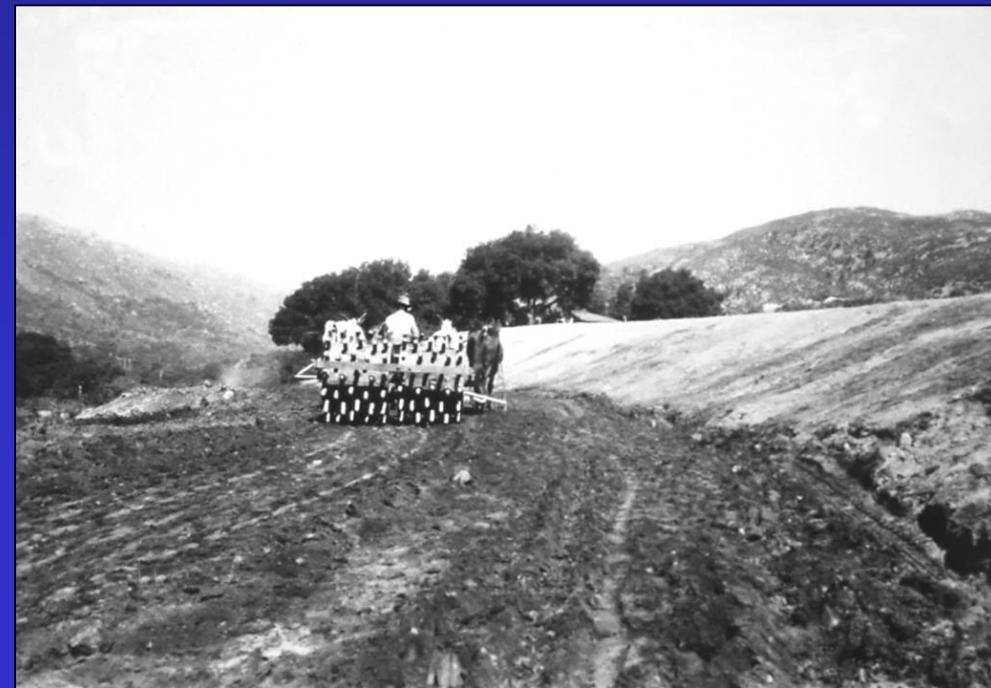
First dam compacted with sheepfoot rollers

- The first earth embankment dam compacted with sheepfoot rollers was the **Henshaw Dam** in 1920-23 for the Vista Irrigation District in San Diego County, shown at left.

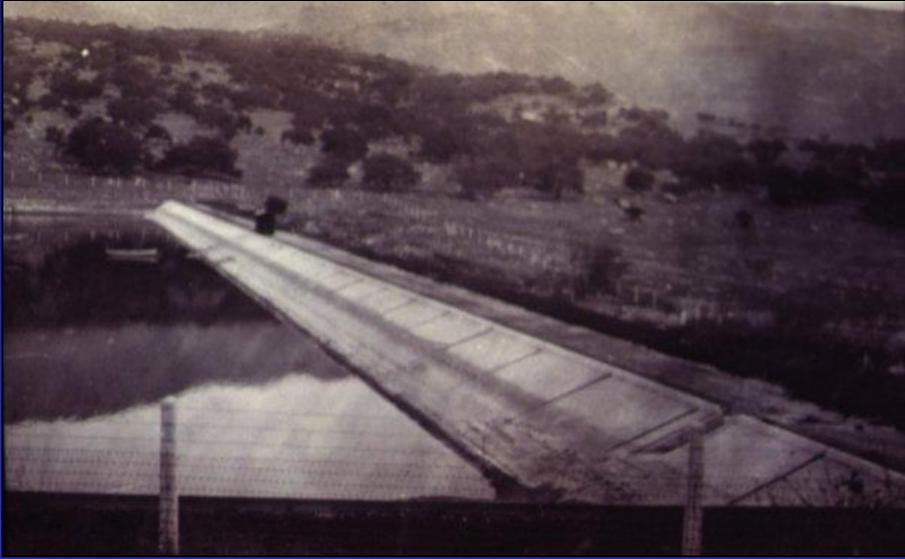
FIRST EARTHQUAKE-INDUCED FAILURE

- The **Sheffield Dam** was a concrete-faced embankment dam 25 feet high and 720 long built in 1917 to retain 30 mg of water for the City of Santa Barbara (shown at left)
- At 6:44 AM on June 28, 1925 a M_L 6.3 earthquake struck the Santa Barbara area, causing the uppermost portion of gravelly-sand foundation beneath the middle 300 ft of the dam to liquefy (shown at right), moving pieces of the dam up to 100 ft downstream
- The dam was taken out of service in May 2004

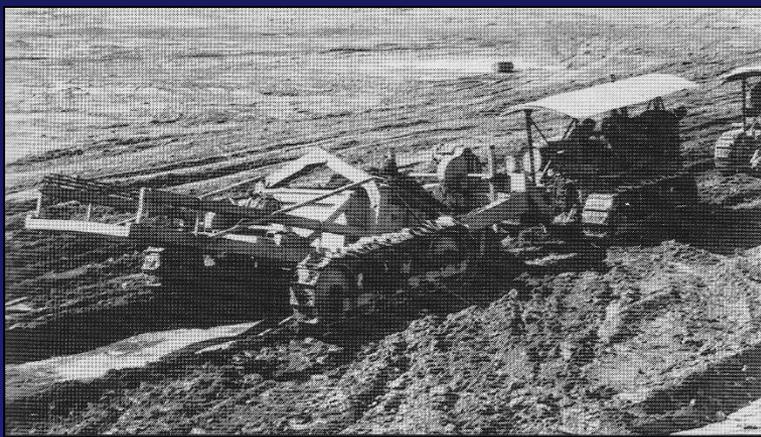
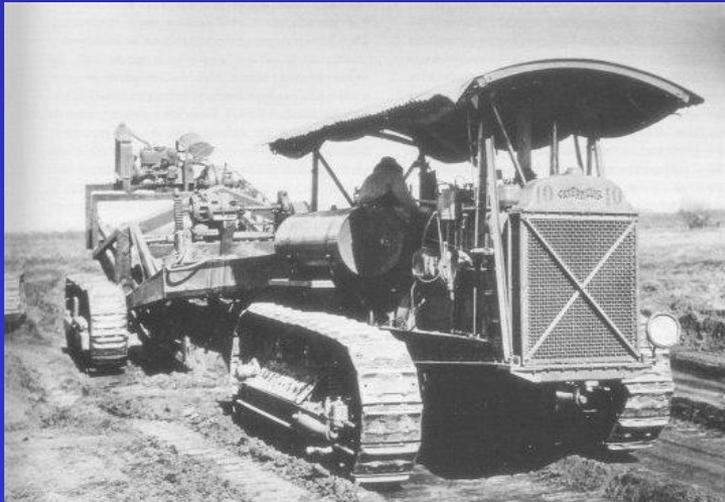
FIRST DAM BUILT WITH SCRAPPERS

- **Philbrook Dam** was an 85 ft high earth fill and wing embankment built by Kaiser Construction for PG&E as a power supply reservoir in 1926, off the West Branch of the Feather River
- Kaiser retained R.G. Letourneau Construction Co of Stockton to move the earth with his patented telescoping scrappers, shown at left. The fill volume in both embankments was 142,000 yds³
- It was the first rolled fill dam in the world constructed with mechanical scrappers

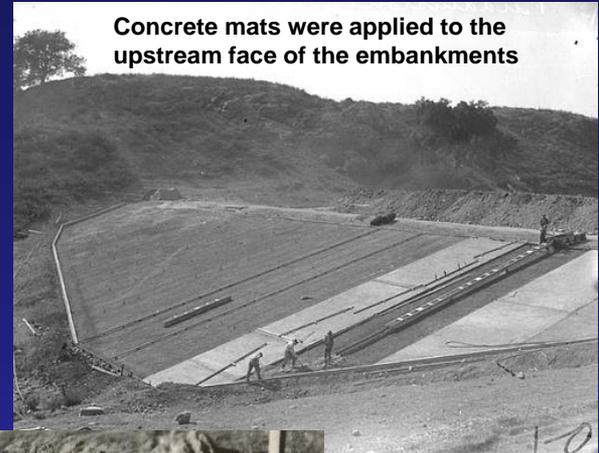
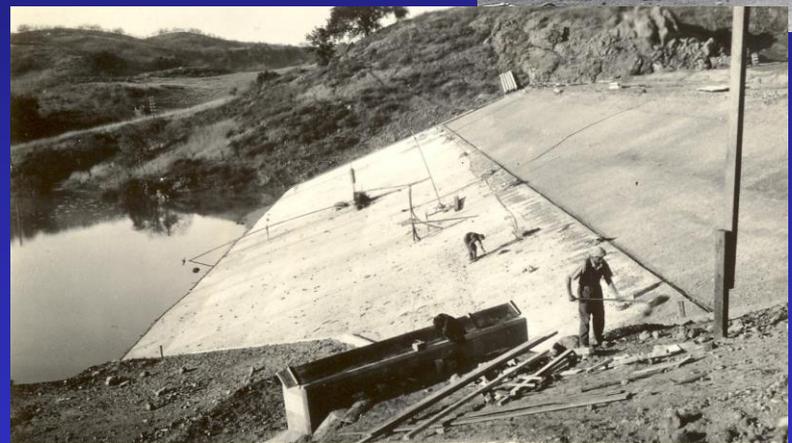
Puddingstone Cofferddam Failure

- **Puddingstone Dam and Reservoir** was built by Los Angeles City & County in 1925-28 along Walnut Creek, but also storing water diverted from San Dimas Creek. It was comprised of three rolled fill embankments up to 177 ft high, capable of storing 17,398 ac-ft. The soils were compacted with a sheepsfoot roller that employed ball-shaped heads, patented by contractor H.W. Rohl.

- Work began early in 1925 with excavation of a 5 x 7 ft outlet tunnel 700 ft long, about 35 ft above the streambed, while a 40 ft deep core wall was excavated into the creek channel and a temporary storage dam 53 ft high was to be constructed as a cofferdam. The cofferdam was only 45 ft high and storing about 500 ac-ft of water when storms dropped 8 inches of rain on the area in April 1926, producing an inflow of 500 cfs. This overwhelmed the outlet tunnel and the cofferdam began overtopping. 1 hr and 15 min later the cofferdam collapsed, resulting in a flood of 10,000 cfs lasting about 15 minutes, which eroded 18,000 yds³ of fill. Oddly, the reservoir has never spilled since that first year of construction.

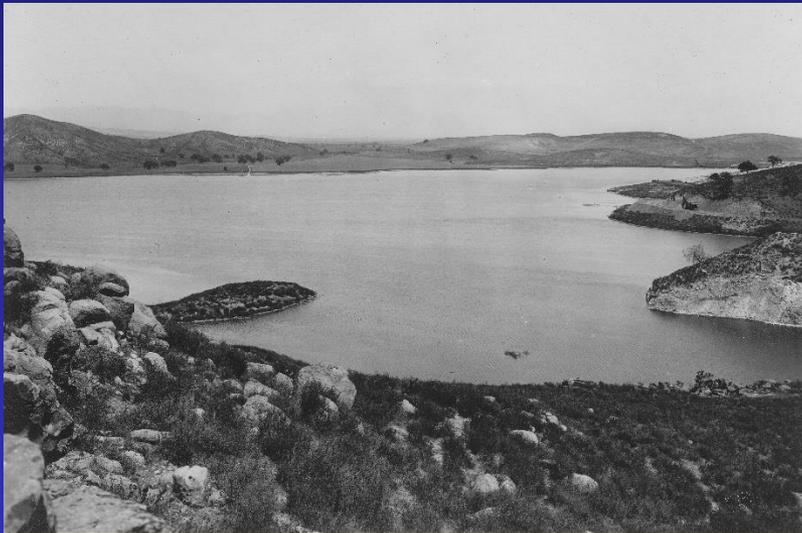
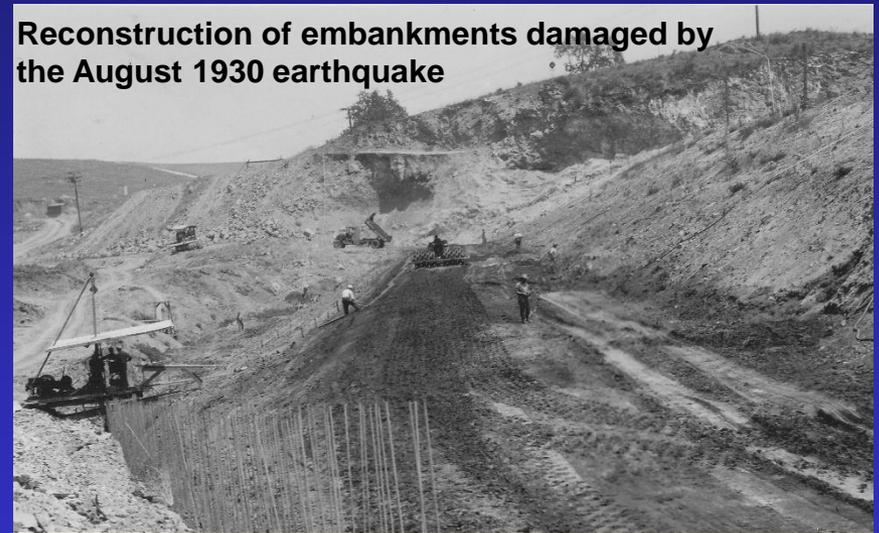
CHATSWORTH RESERVOIR – damaged by quake and eventual abandonment

Reconstruction of embankments damaged by the August 1930 earthquake

- **Chatsworth Dam** and reservoir was built by the City of Los Angeles for their Los Angeles Aqueduct in 1918, with a capacity of 10,000 acre-feet.
- It was built of hydraulic fill and tamped fill on the crest, and provided with a paved concrete face. It was constructed on a pervious foundation of unconsolidated late Quaternary age alluvium
- The **M 5.2 Santa Monica Bay earthquake** of **August 30, 1930** caused noticeable vertical cracking of the embankment crests, due to partial liquefaction and lurching, which increased leakage.
- The dam was eventually taken out of service in August 1969 because of increasing concerns about water quality due to algae plumes in the shallow bays and urban storm water influx. After the 1971 earthquake, additional concerns for seismic safety led to its abandonment as a storage facility.

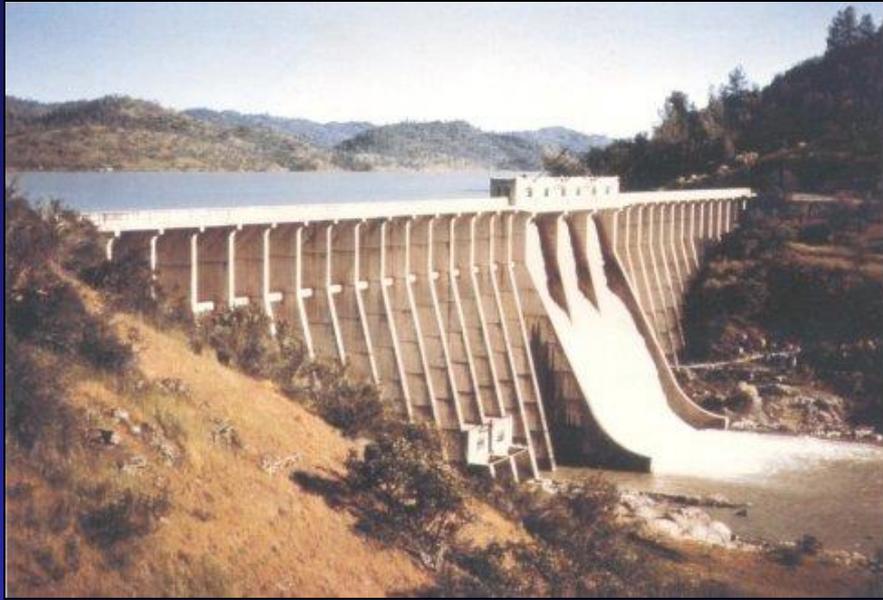
FIRST DAM BUILT OVER A FAULT

Stoney Gorge Dam was built for the Bureau of Reclamation by the Ambursen Dam Co. in 1926-28.

- A flat slab buttress structure was selected with 18 ft wide noncontinuous slabs because it was thought the best system to accommodate minor foundation movements along the fault exposed in the dam's foundation during construction (shown in red, below left).

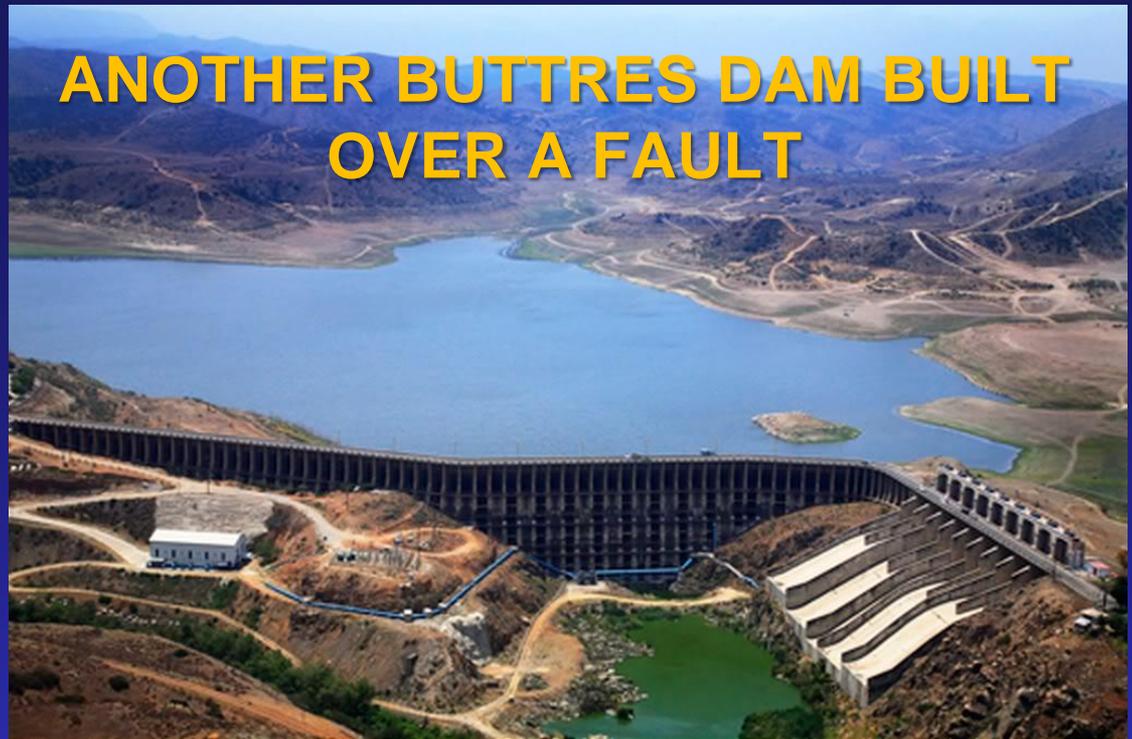
- **Rodriguez Dam** is a 240 ft high buttress dam constructed along the Tijuana River, just south of the border, in 1930. The height above stream bed was 187 ft. The faulted zone was bridged with an enormous arch (lower right), so the dam's buttresses would not bear on the fault (shown in red).

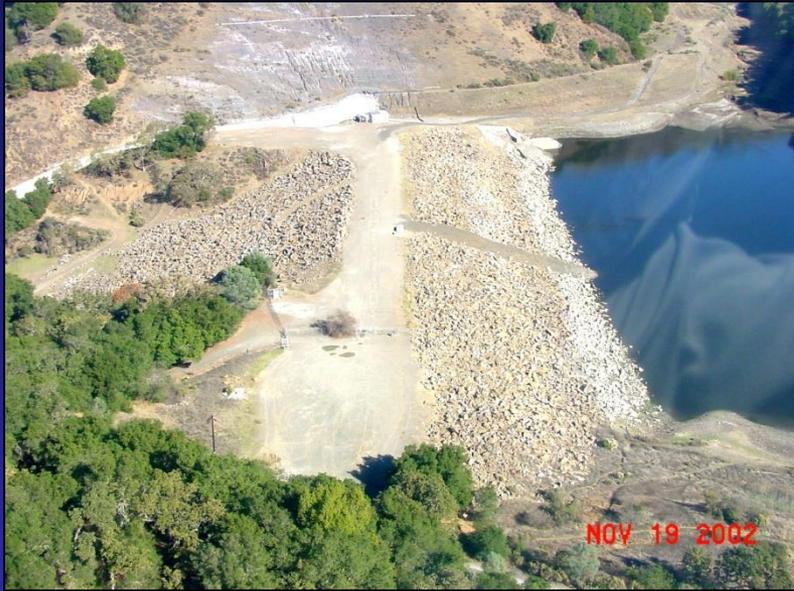
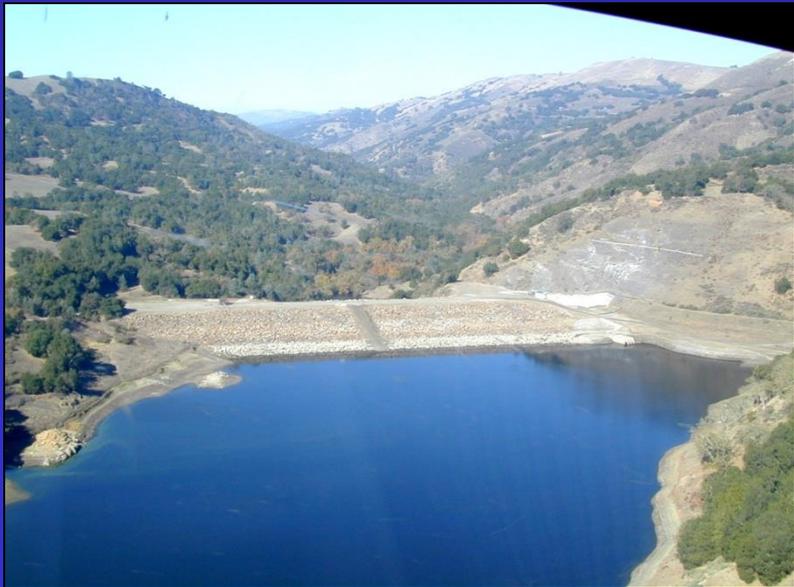
COYOTE DAM and CALAVERAS FAULT

- **Coyote Dam** was built along Coyote Creek east of Morgan Hill by the Santa Clara Valley Water District between 1934-36, storing 10,000 acre-feet of water
- It was knowingly built across the active 1000-ft wide trace of the Calaveras fault, and has performed well to date.

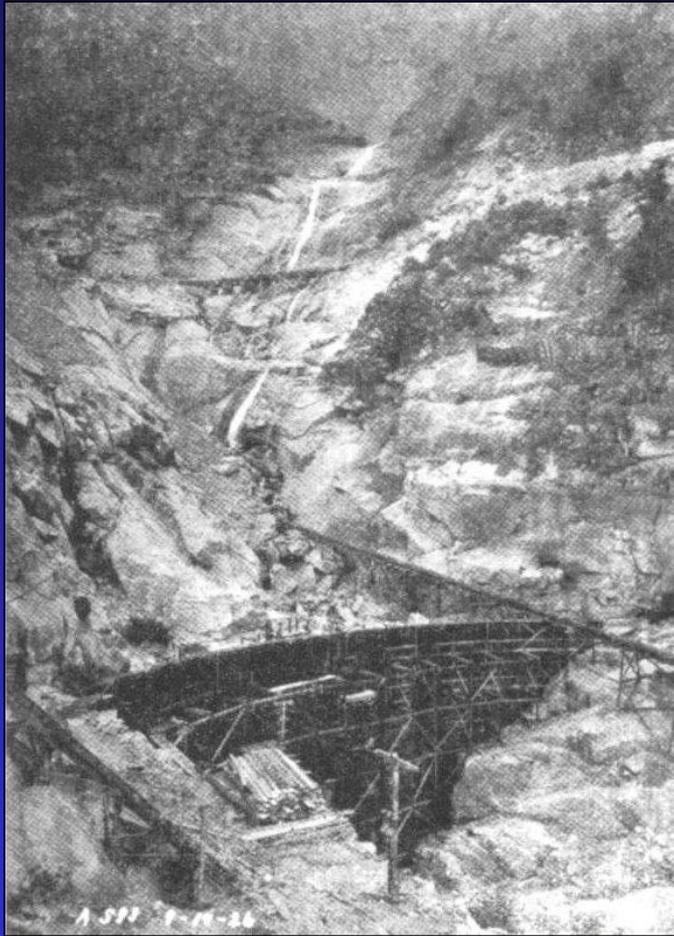
STEVENSON CREEK TEST DAM

- In the early 1920s the engineering profession came to recognize that a rational method of designing arch dams was lacking.
- In the spring of 1926 **The Engineering Foundation** decided to build and instrument a test structure in California, along a tributary of the San Joaquin River, east of Fresno

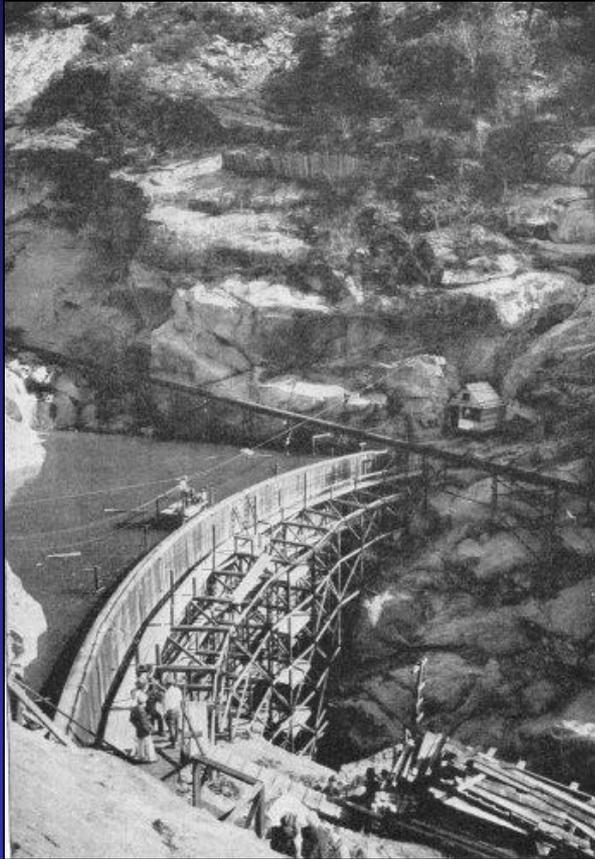
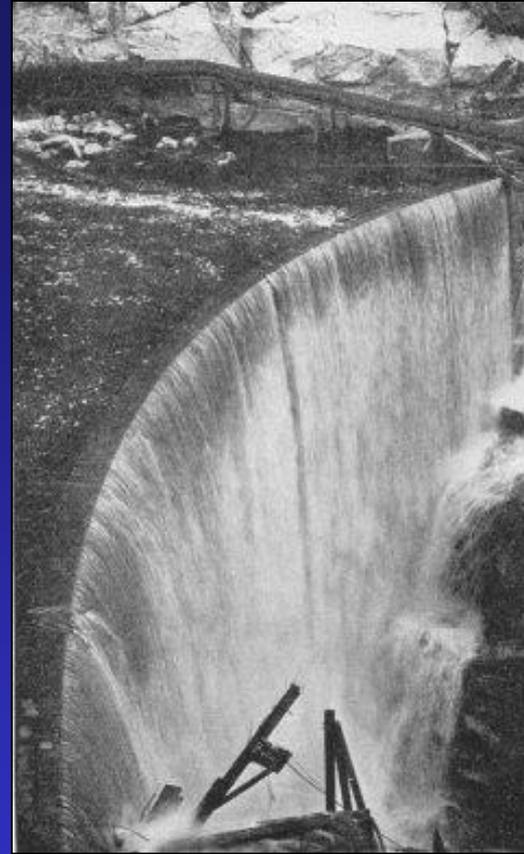
TWO KINDS OF TESTS

- The **Stevenson Creek Test Dam** developed maximum arch stresses of 207 psi at the crown and 879 psi at the abutments. 429 psi compression was measured at the downstream toe and 380 psi tension at the upstream heel (base).
- The dam survived overtopping in November 1926 (see right)

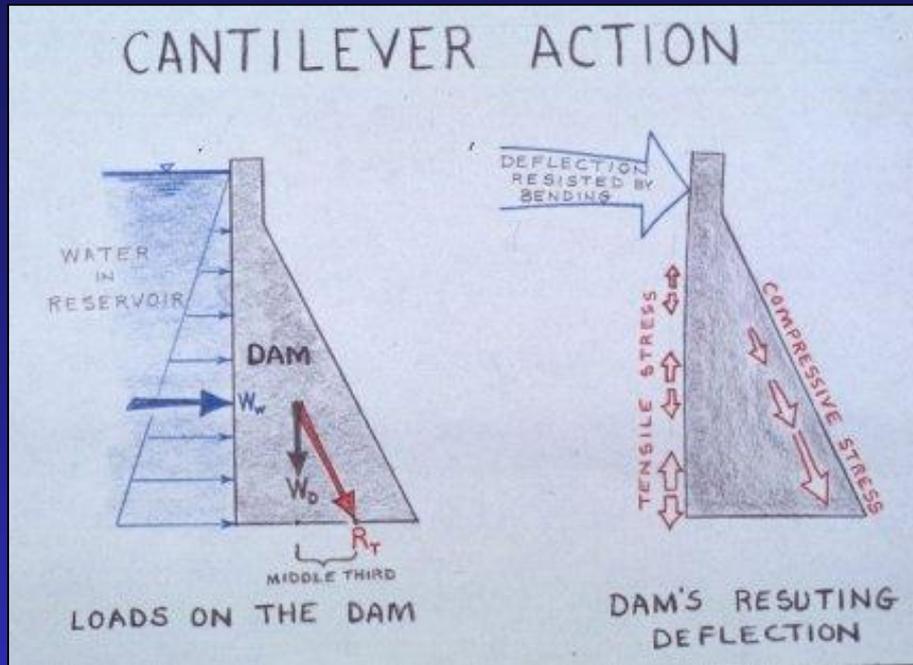
- **St. Francis Dam** was a gravity structure, deriving its stability from its dead weight.
- The ratio between the dead load acting vertically and the hydrostatic force acting horizontally determines the overturning factor of safety

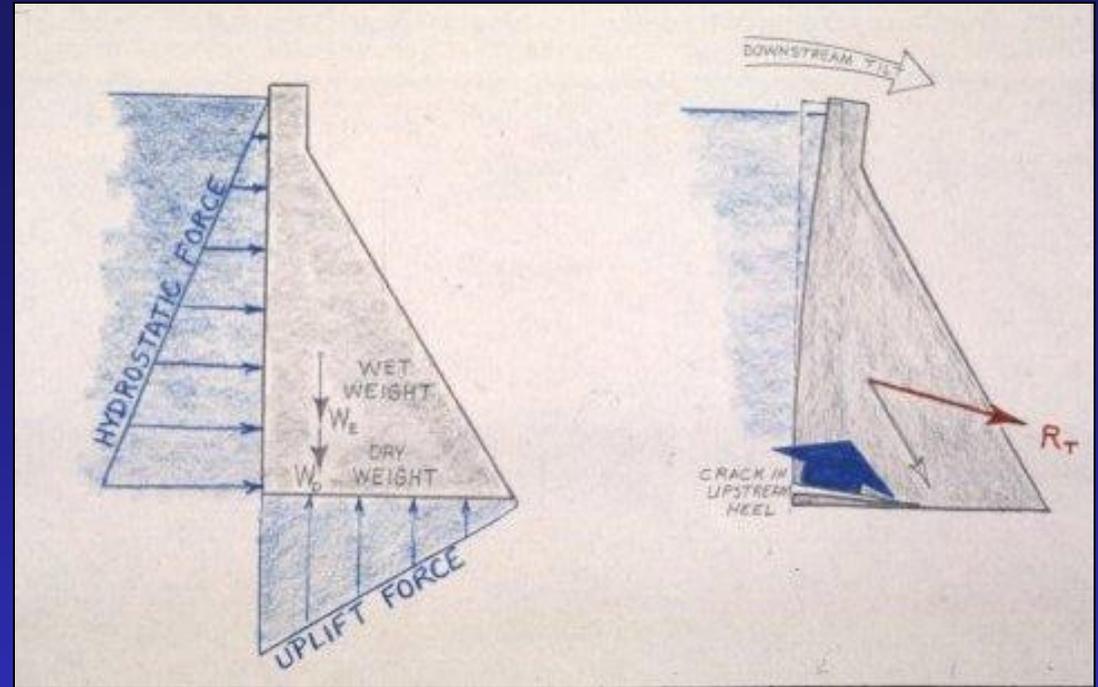
- Modern analyses reveal that when the reservoir rose within 5 feet of spillway crest, the dam became unstable
- A crack could then develop in the upstream heel
- A **heel crack**, such as that found after the failure, shown at lower right, would shift the resultant thrust far downstream, making it unstable in overturning

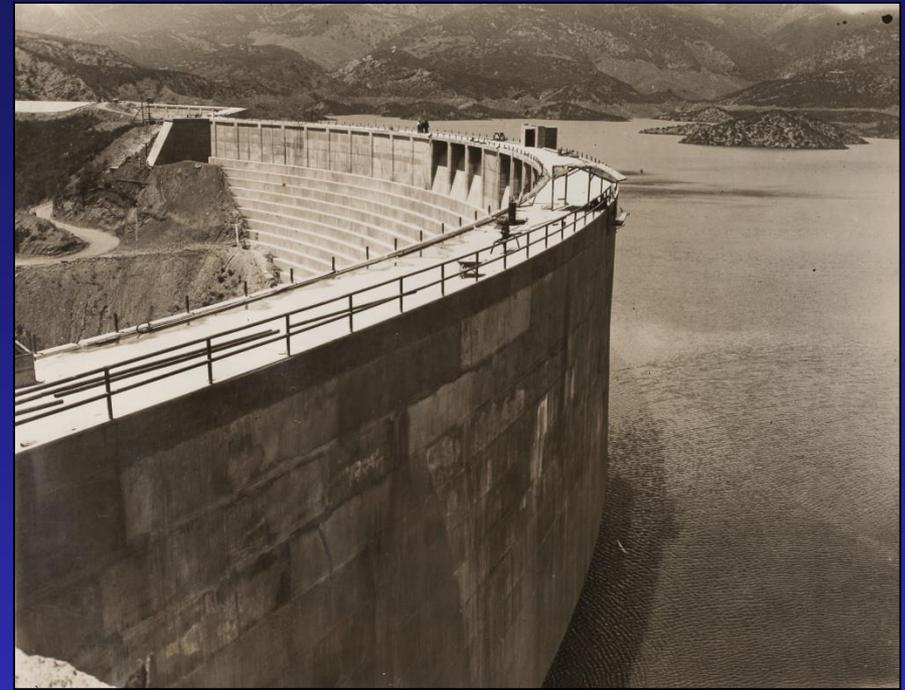
- **St Francis Dam** was arched upstream on a 500-ft radius, but was not designed for arch action.
- The arch loads on St. Francis become significant when the reservoir rose to within 11 feet of spillway crest, exceeding 10,000 psf

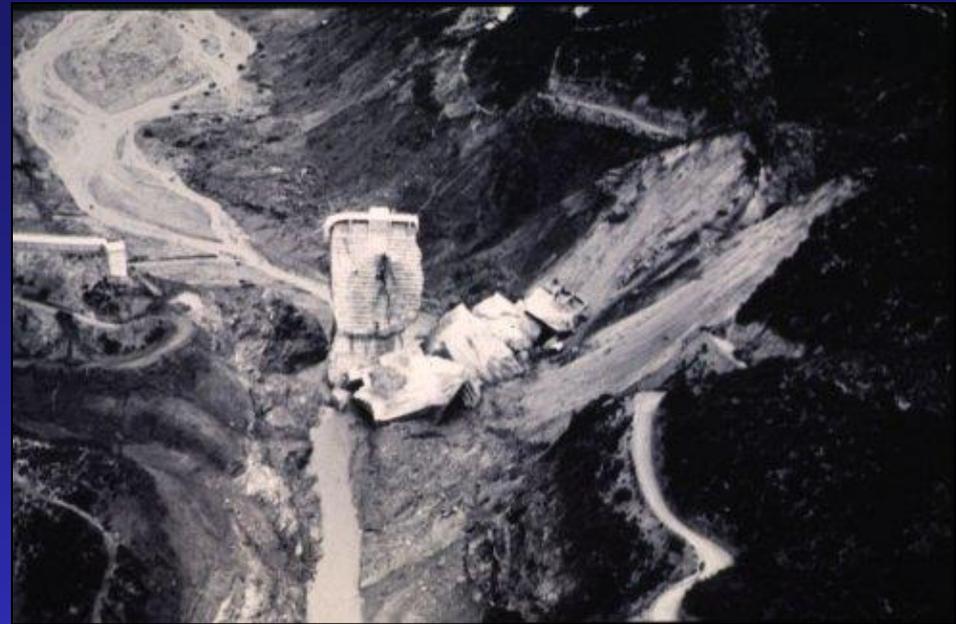
LEFT ABUTMENT LANDSLIDE

- Around midnight March 12/13, 1928 a massive landslide occurred along the dam's left abutment
- The landslide involved 1.52 million tons of schist moving against the dam's 271 thousand tons of concrete, so the schist won

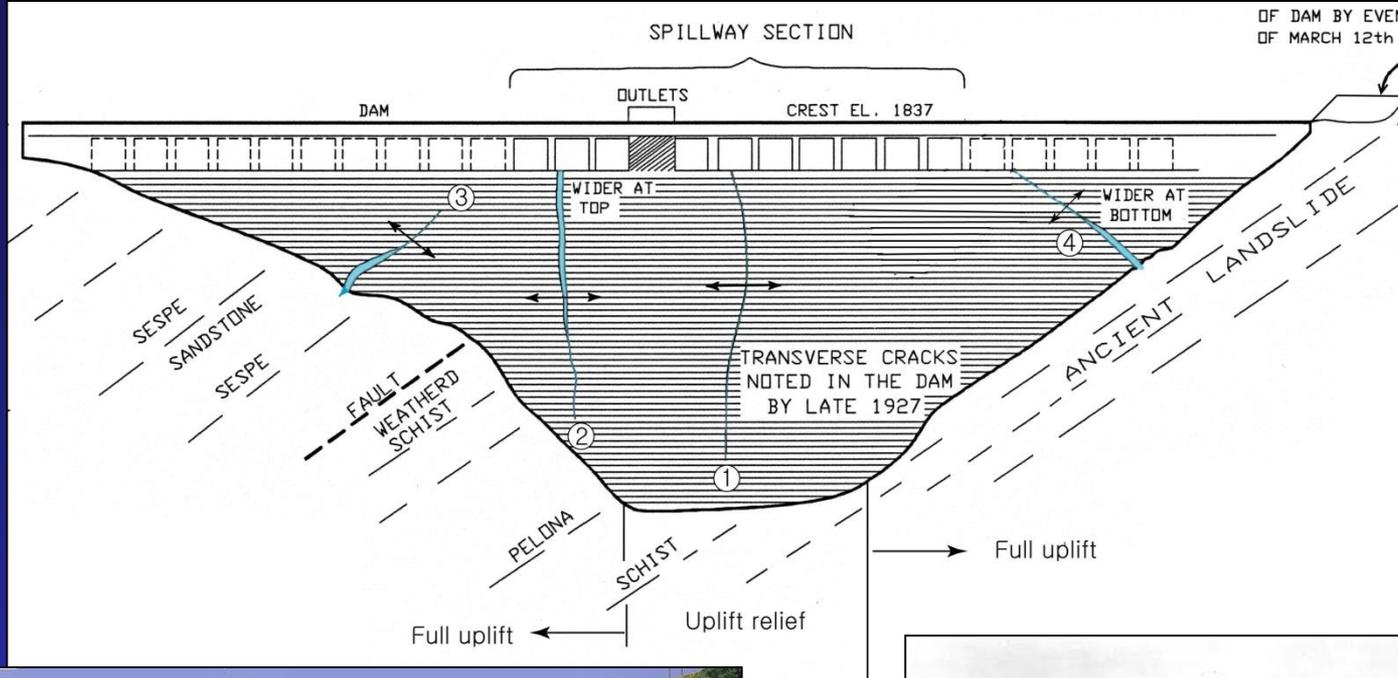
Four prominent shrinkage cracks developed in the main dam, allowing leakage of water, which increased as the lake level rose.

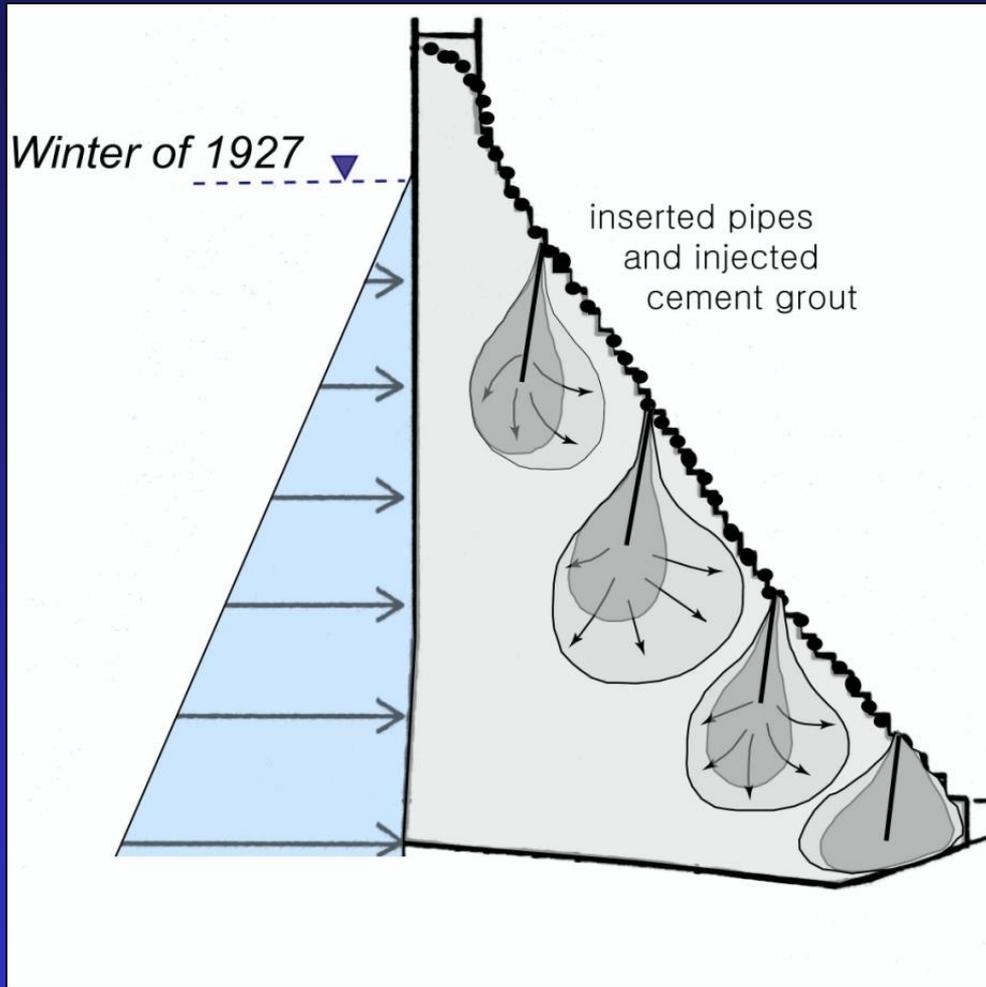
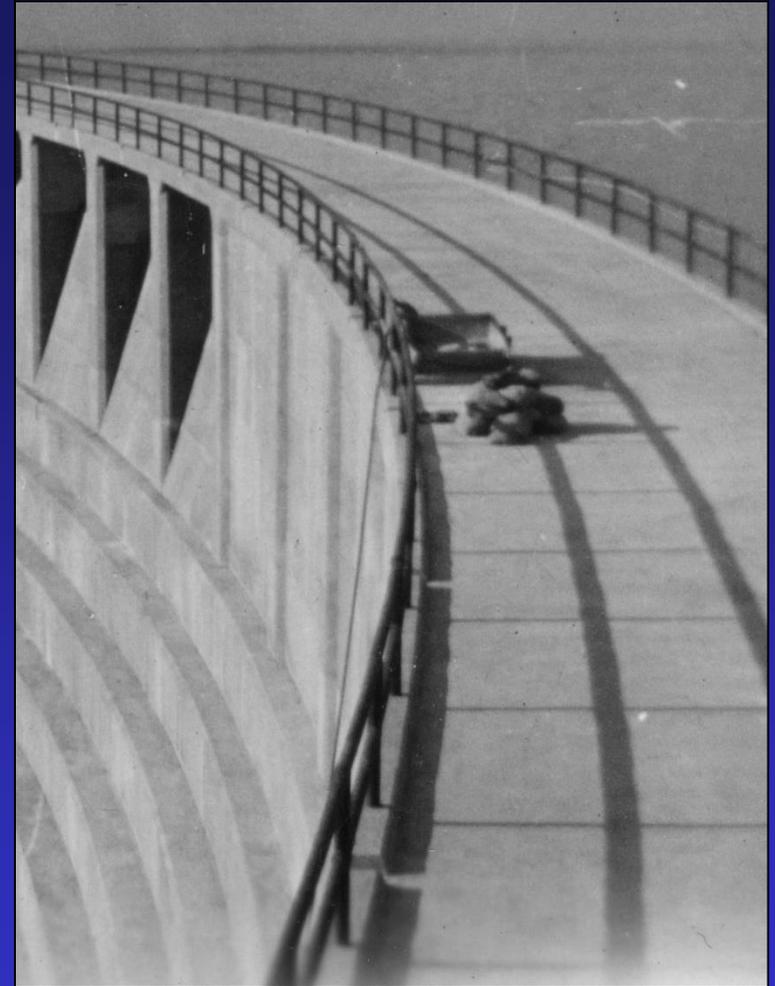
In January-February 1928 William Mulholland ordered the four transverse shrinkage cracks to be caulked with oakum, to prevent loss of cement grout injected into the openings.

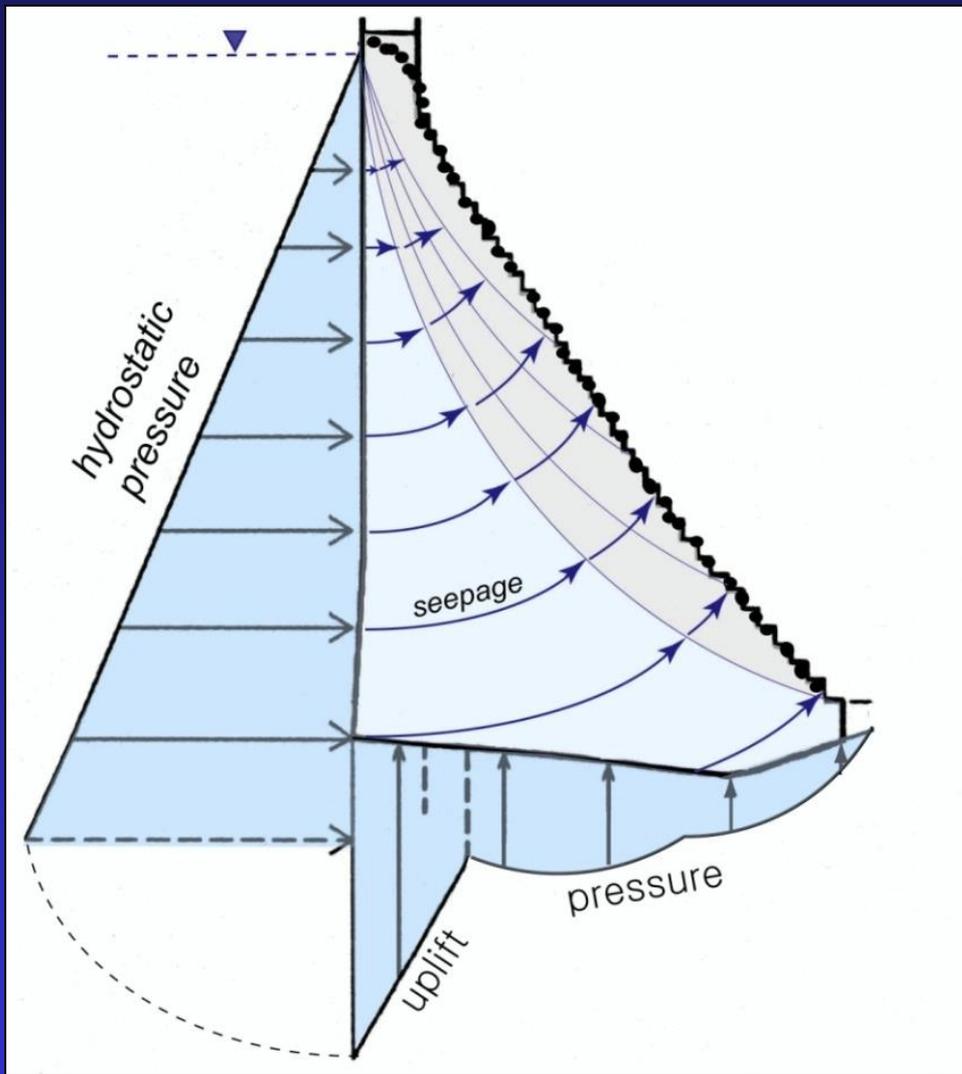
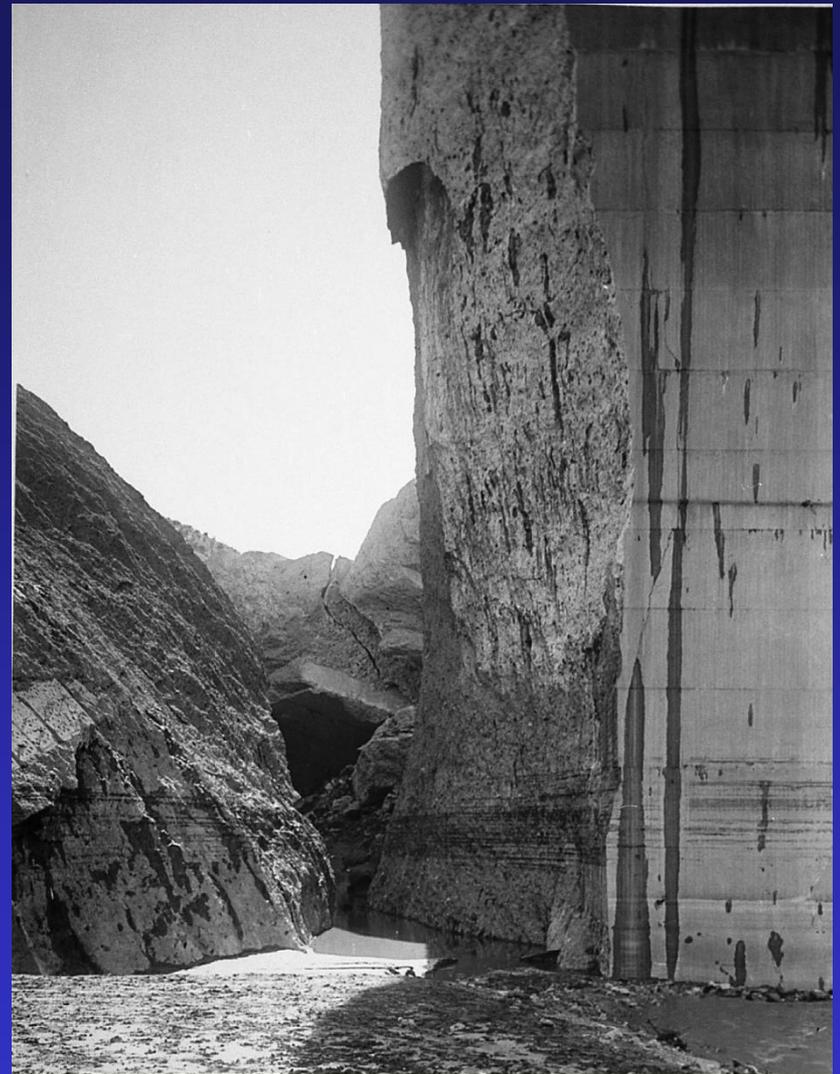
If the transverse shrinkage cracks were sealed at the dam's downstream face, full hydrostatic pressure would develop between adjacent blocks of the dam. This factor, more than any other, likely led to the structure's untimely and catastrophic failure.

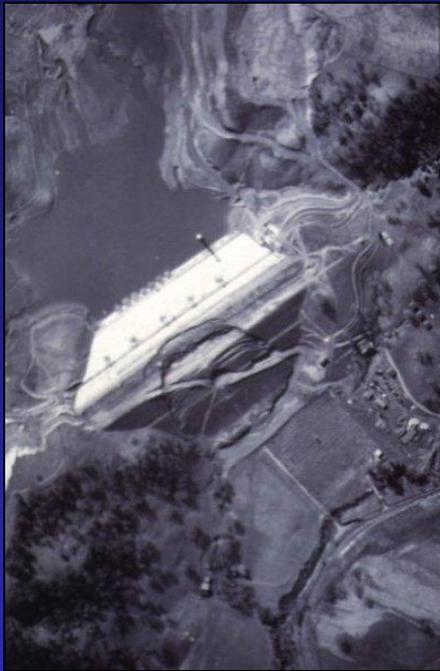
Cross section through the Lafayette Dam at the time of failure

Aerial photo of the slump

- The 160 ft high **Lafayette Dam** was an earthfill structure placed at a record rate of 9000 yds³ per day in 1928 by George Pollack Construction Co. for EBMUD. This rapid loading led to high pore pressures developing in the clayey foundation
- Between Sept. 17-21, 1928 the embankment suffered “excessive settlement” of 26 feet! It was never called a “landslide”!
- The dam was eventually completed in 1932, but with only 37% of the original storage capacity

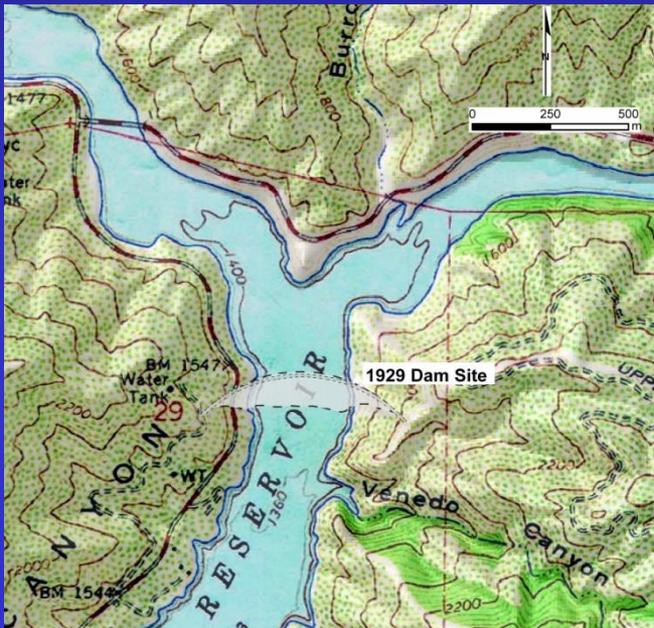
SAN GABRIEL DAM at THE FORKS SITE

- A \$26 million bond was approved by voters in LA Co in 1924 for construction of flood control structures
- The kingpin feature of this program was the **San Gabriel Dam**, a concrete gravity arch dam 512 feet high and 2,500 ft long, with volume of 3.8 million yds³
- When designed in 1927-28 it was the highest and largest concrete dam ever conceived

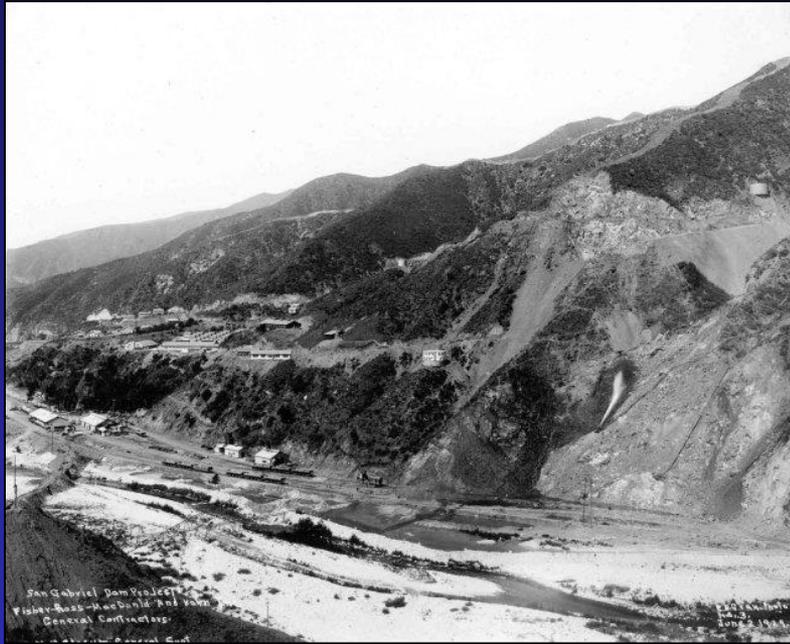
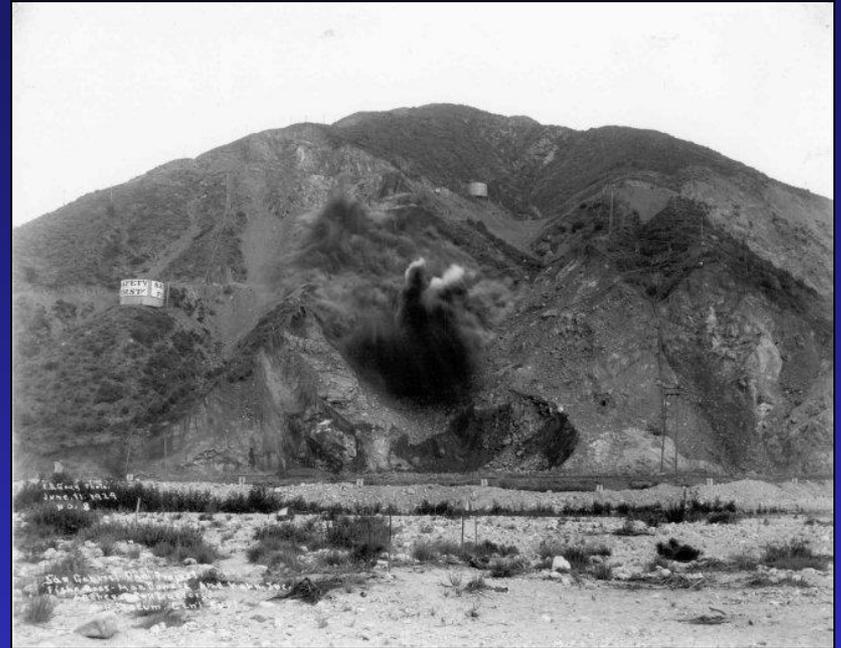
700,000 yds³ of abutment excavation

- Construction began in Sept. 1928, 6 months after the St Francis Dam failure. A rail line and contractors village for 500 men was built by the dam site (left view)
- By February 1929, abutment stripping began, removing 100,000 yds³ per month (right view)

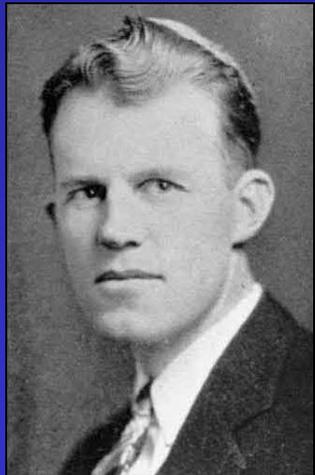
As Pacoima Dam began construction, the County hired **Roy Carlson** as their concrete and soil testing engineer. He developed the world's first strain meter that could be embedded in concrete (shown at right). Carlson also developed an adiabatic calorimeter and electrical-resistance thermometers to ascertain why concrete temperature increased during curing and how best to avoid cracking caused by these stresses.

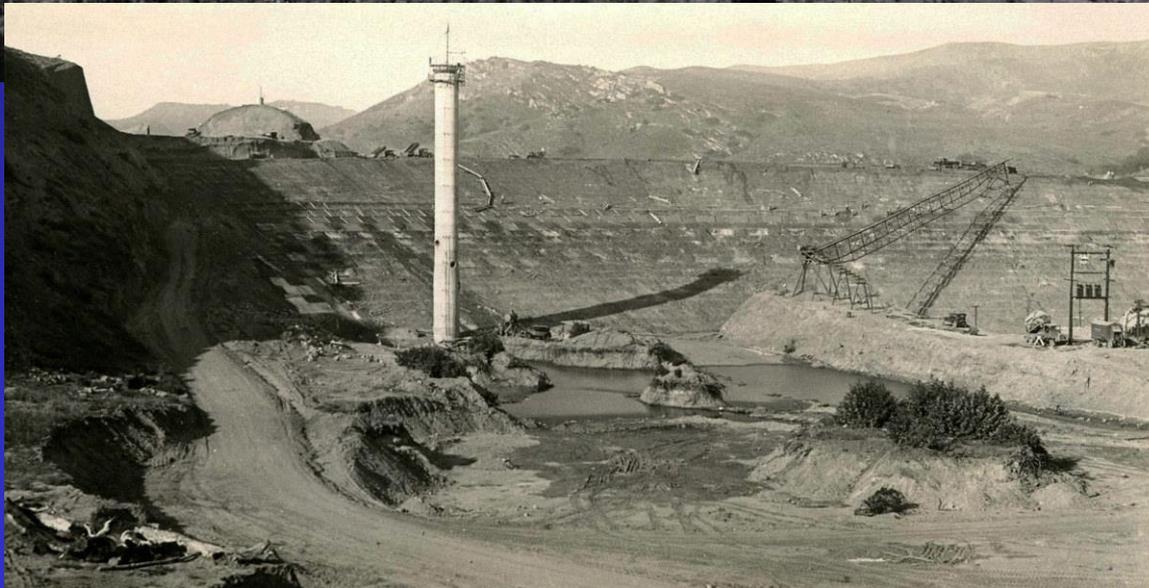
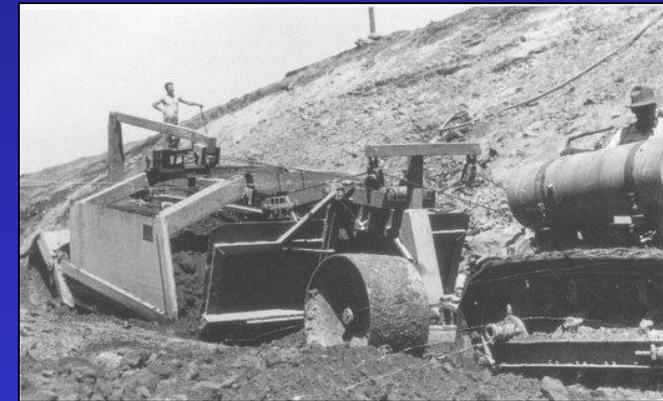
Letourneau Model A Carryall Scrapper at Santiago Dam in 1931

- In July 1931 earthmoving pioneer **R. G. "Bob" Letourneau** brought his 9 yd³ capacity Model A Carryall scrapers to Orange County to grade the 136 ft high **Santiago [Creek] Dam (Lake Irvine)** for the Orange County Flood Control District
- Letourneau placed 400,000 yds³ of compacted fill in the first month, setting a record for rolled fill construction
- The job was completed in the spring of 1932 with a final volume of 790,000 yds³

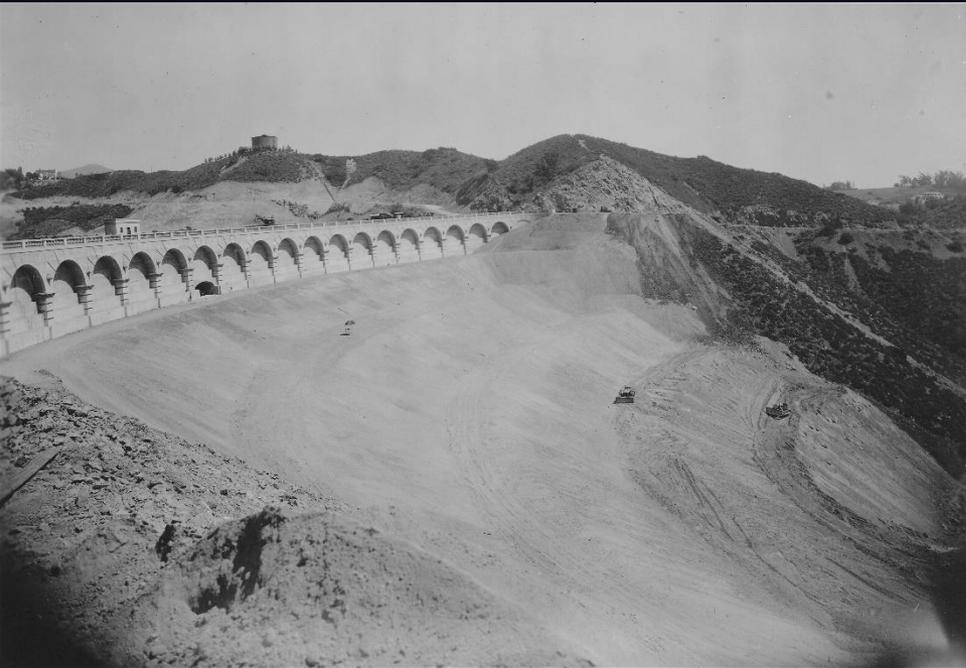
MOST PEER-REVIEWED DAM IN AMERICA

In 1933-34 the City of Los Angeles placed 330,000 yds³ of fill against the downstream face of Mulholland Dam, making it one of the most conservative dams in the state

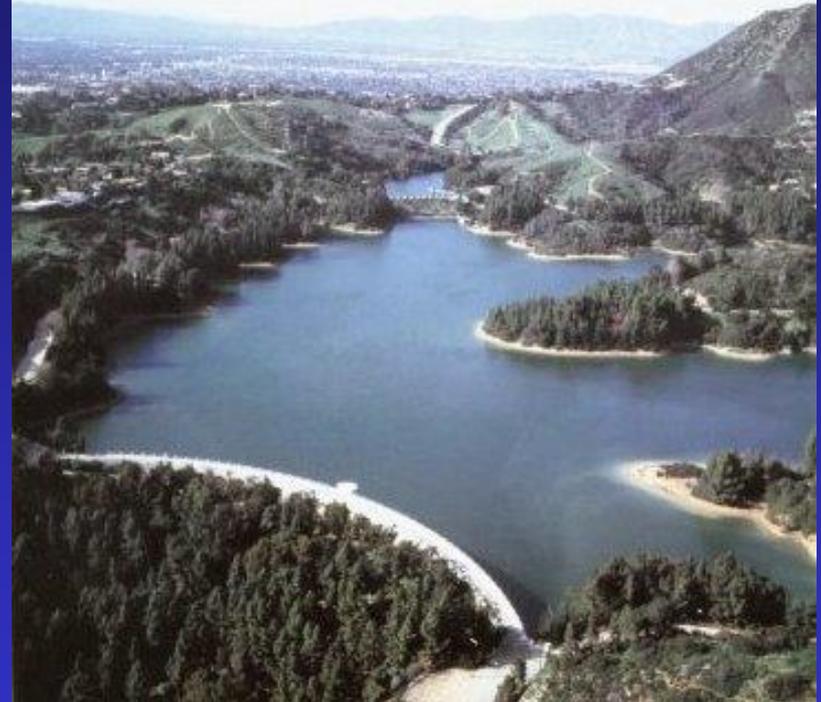
A camouflaged Mulholland Dam still retains Hollywood Reservoir

LADWP undertook a vigorous program of re-vegetation on the new buttress fill (lower left), which succeeded in screening the dam from most everyone's consciousness
