DAMS AND DISASTERS:

**a brief overview of dam building
triumphs and tragedies in California's
past**

J. David Rogers, Ph.D., PE., P.G., C.E.G., C.HG.

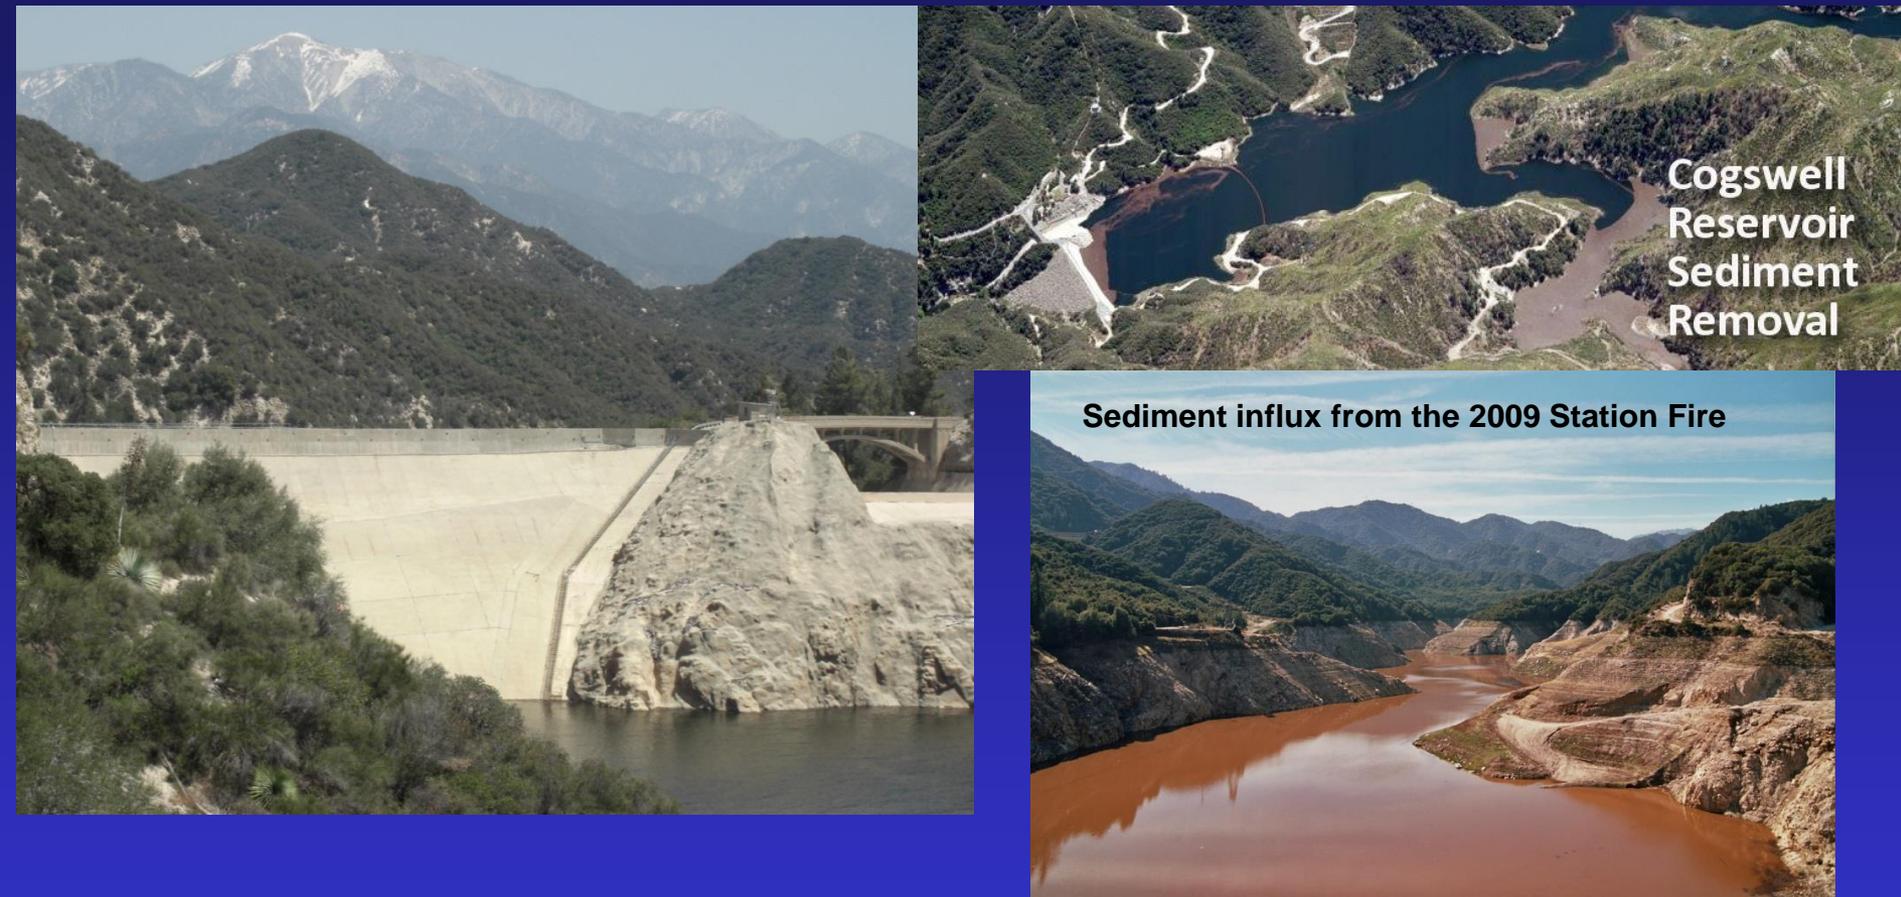
COGSWELL DAM TODAY

Cogswell Reservoir Sediment Removal

Sediment influx from the 2009 Station Fire

- **Cogswell Dam** underwent seismic upgrades and debris removals in the 1990s. The 2009 Station Fire burned 90% of its watershed, necessitating the removal of an additional 3.33 million yards of sediment

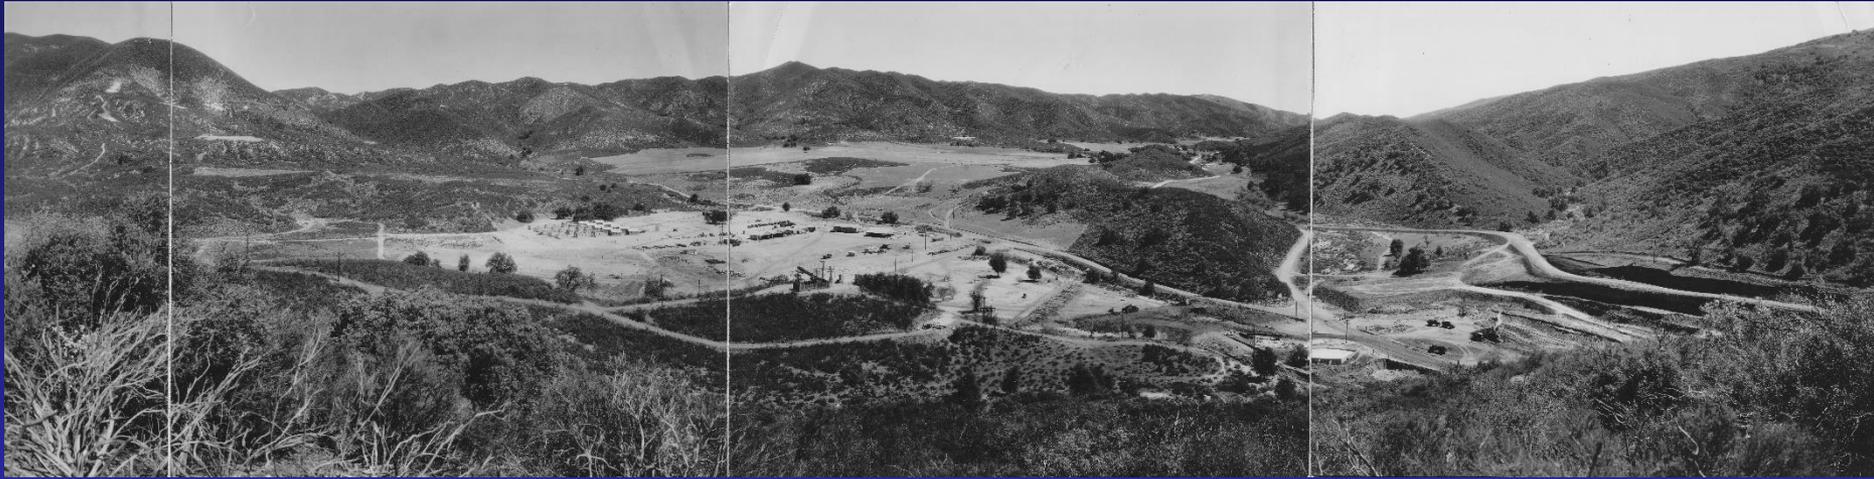
BOUQUET CANYON RESERVOIR

Panorama of the project site on September 1, 1932, showing the construction workers camp near center, which now lies beneath the reservoir. The main embankment was constructed at far right.

- **Bouquet Canyon Dam** was the replacement structure for the St Francis Reservoir was comprised of two embankments built in Bouquet Canyon in 1933-34
- The City's resident field engineer was the same man who had served in this capacity on the ill-fated St Francis Dam, **Ralph R. Proctor**

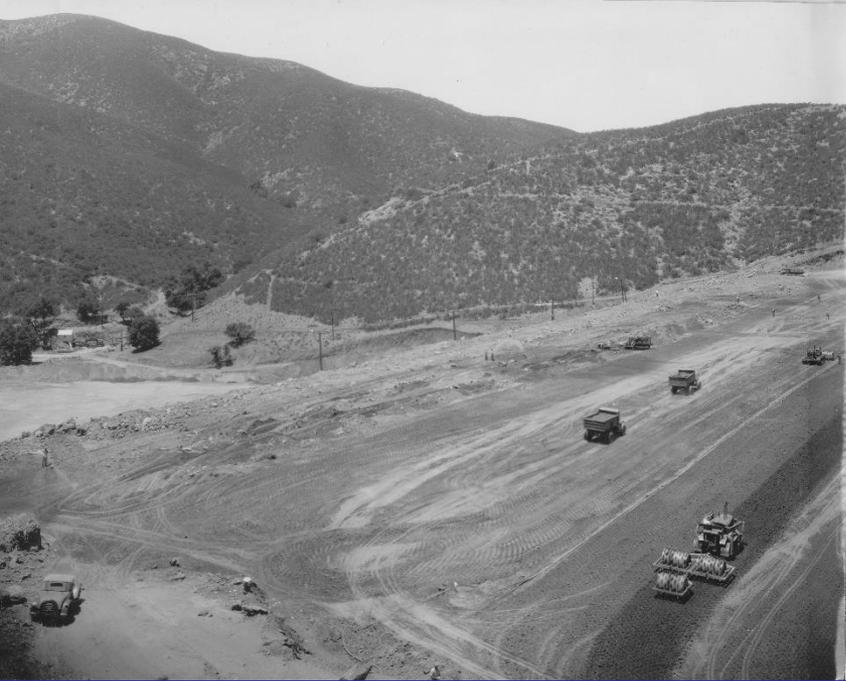
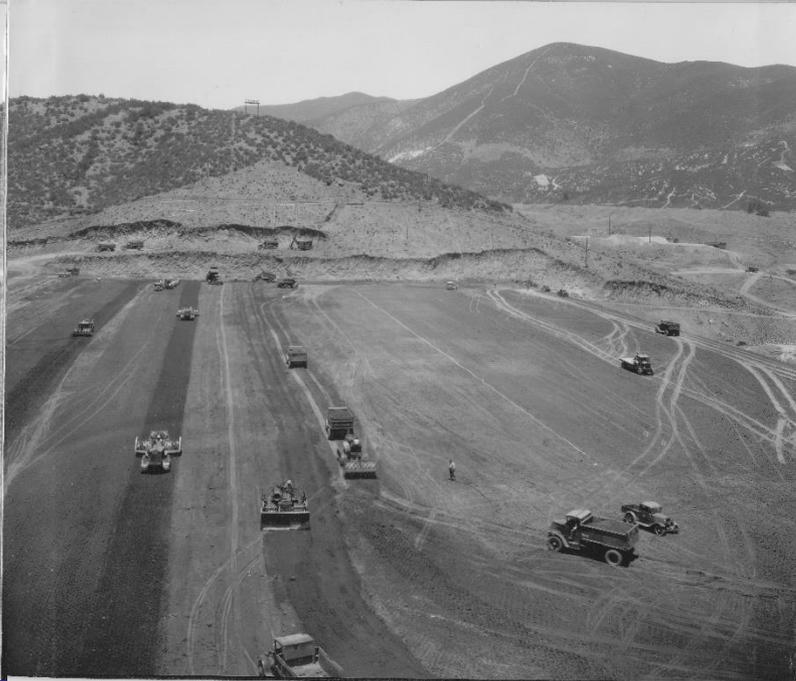
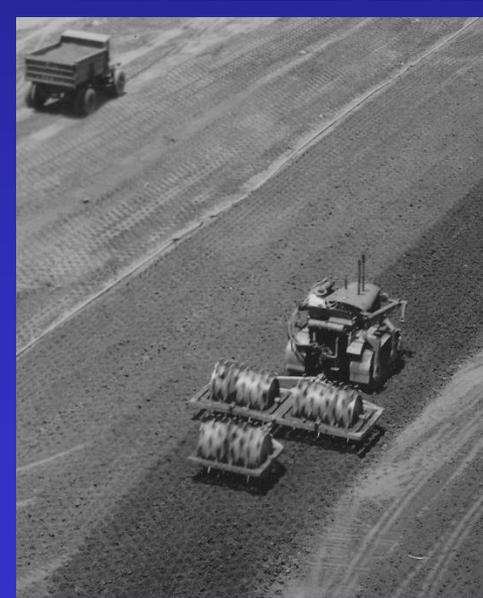
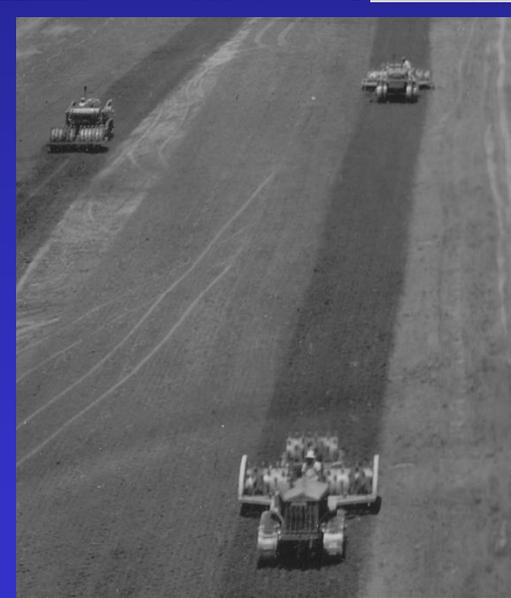
- The two **Bouquet Canyon** zoned fill embankments were constructed by the Los Angeles Department of Water & Power between 1932-34
- These were the first embankments constructed using the standard Proctor Compaction Test (ASTM D-698)

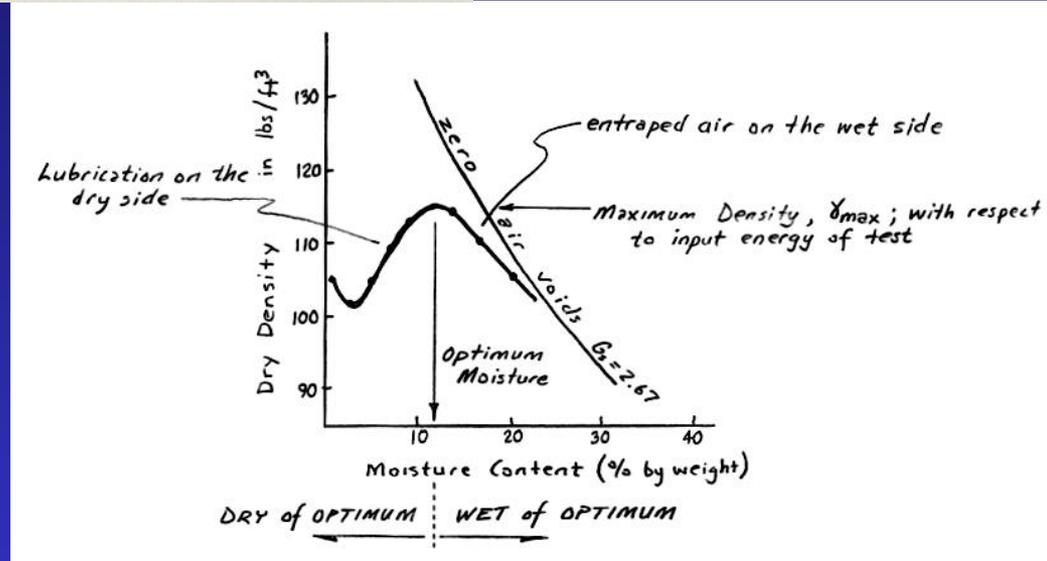
Fig. 2—Graph showing the effect of moisture content on the compacted weight, dry weight and voids of a soil when compacted by a particular method.

- **Ralph Proctor** devised an alternative method to California Test 216 introduced by the State Division of Highways in 1929, which measures the *maximum wet density* ('compacted weight,' shown above left), and controls the compactive effort based on the total weight, not the volume, of the test sample (Caltrans still uses this alternative test procedure).
- The primary advantage of Proctor's procedure is that the test results could be computed onsite, as evaporation of the compacted sample is not necessary. This allowed immediate adjustment of the soil water content, which was the *critical variable* the contractor needed to know.

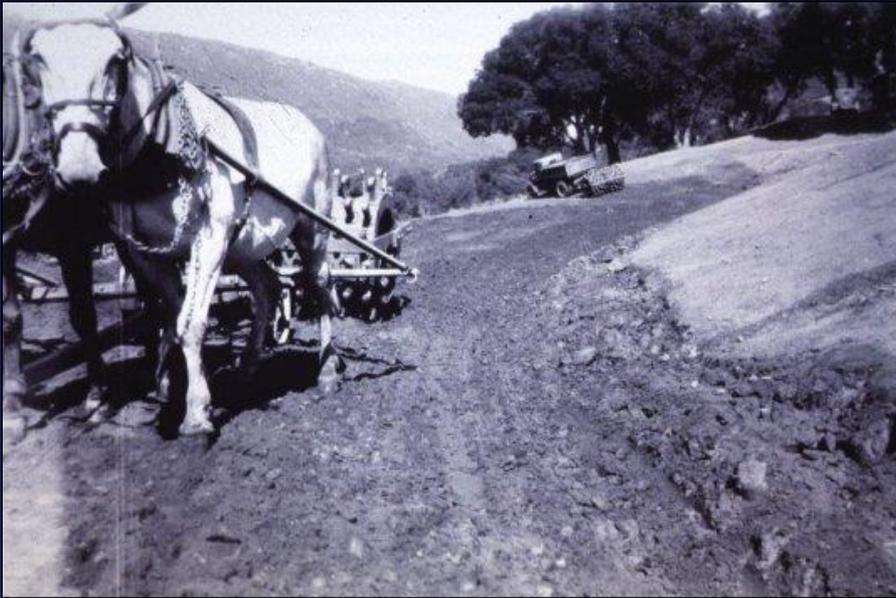
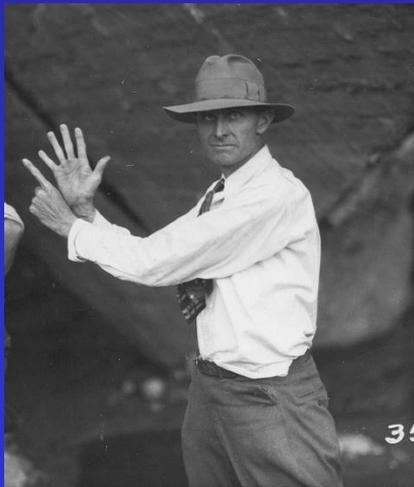
BIRTH OF THE COMPACTION TEST

- **Ralph Proctor** was charged with developing a test scheme for the earth fills at Bouquet Canyon which would engender confidence in the City's ability to build safe dams in the wake of the St Francis disaster
- What he came up with has been known as the "Proctor Compaction Test," which remains in use world-wide

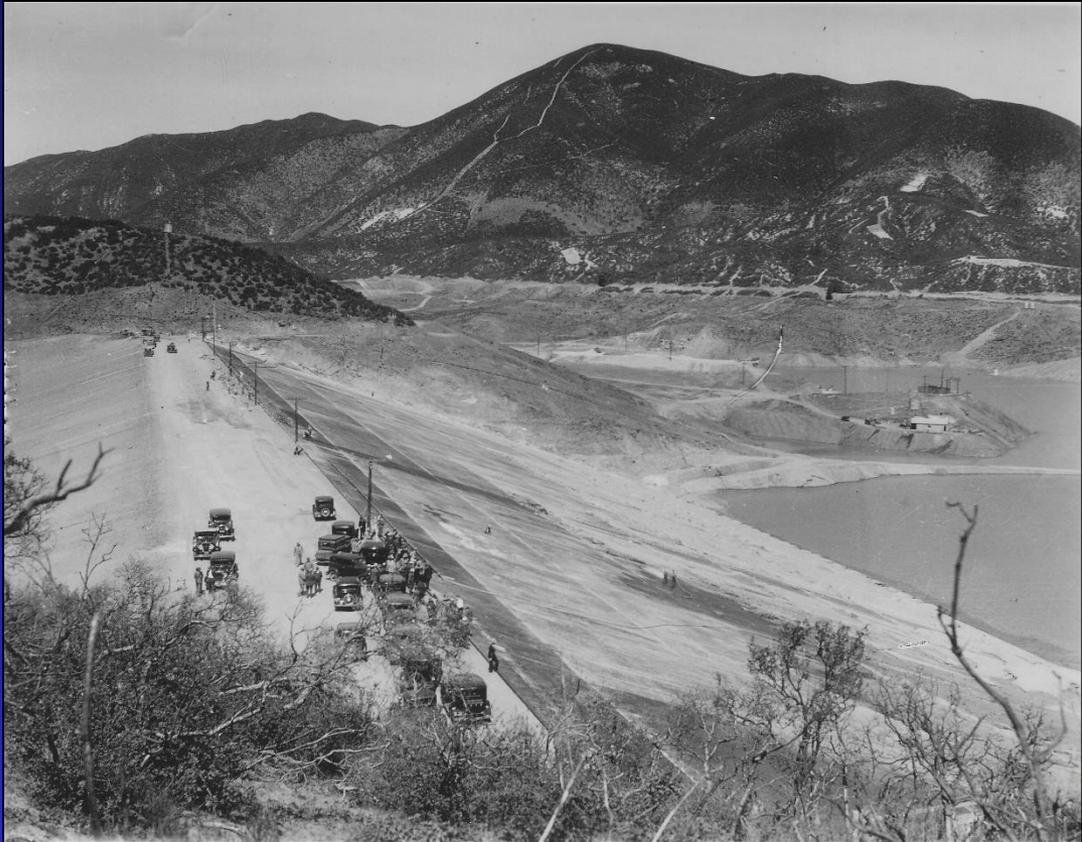
- Upper - The main embankment of **Bouquet Canyon Dam** was completed in March 1934, with concrete paving of the upstream face.
- Middle - Original design for main embankment
- As-built section thru main embankment – but in opposite direction
- Below right – Long-term monitoring of embankment

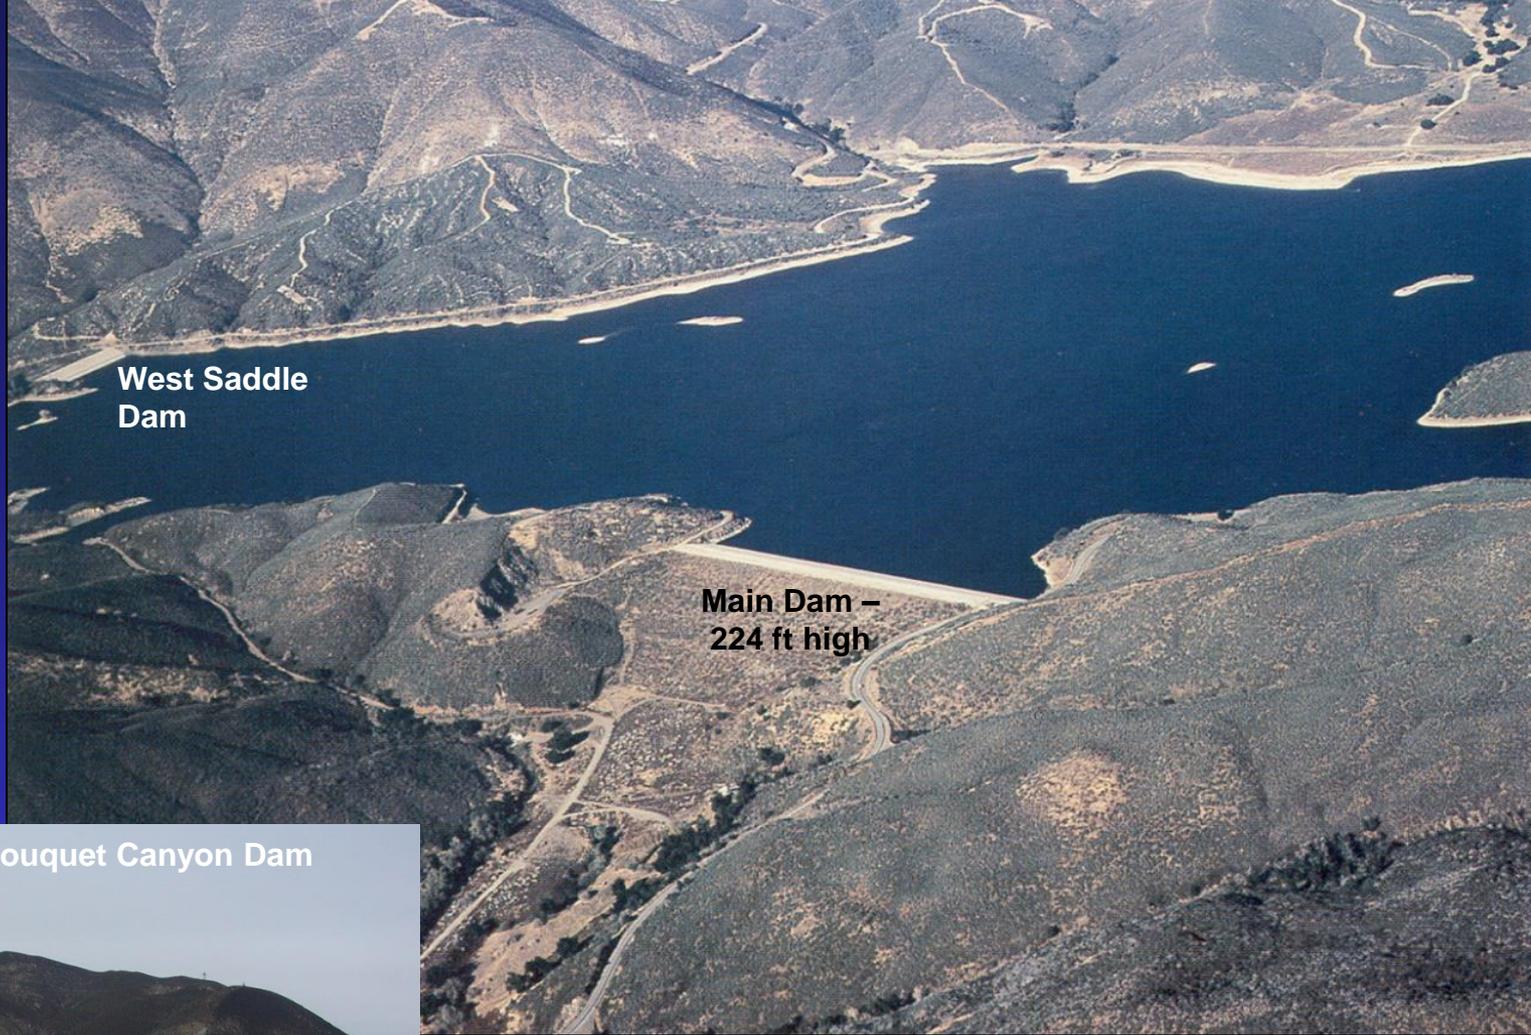
Form used to show 20 years record of rainfall, reservoir stages, seepage, lateral displacement and settlement of crest of dam, and dissolved solids in seepage water, together with earthquake, repair, grouting and related data.

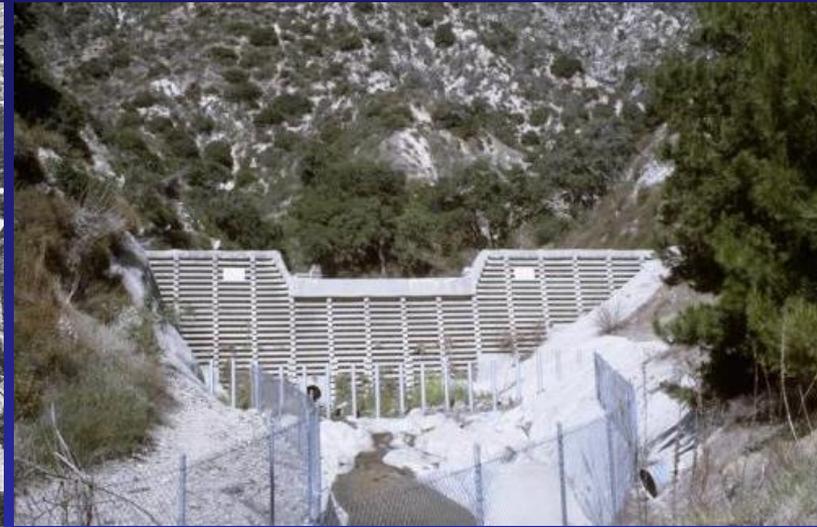
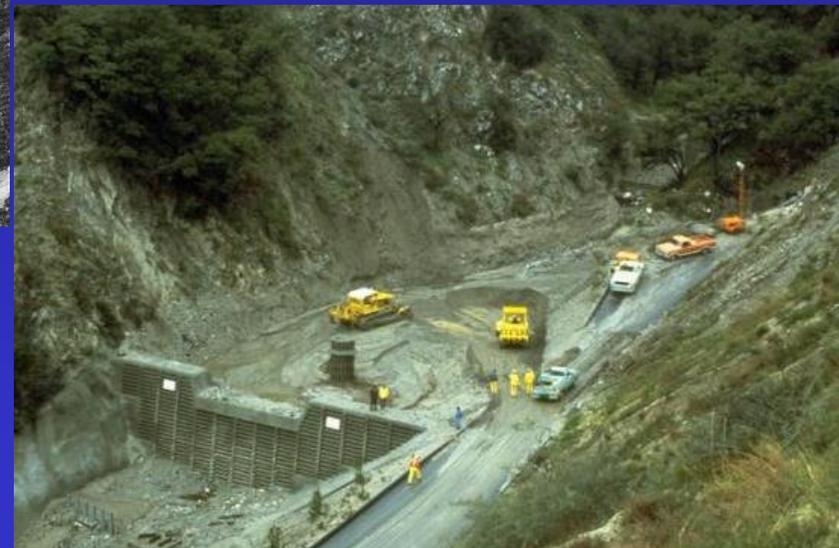
Gould Debris Basin
above La Cresenta

Crews mucking out a small debris basin in Los Angeles County. Note perforated riser intake tower.

Between 1925-60 the Los Angeles County Flood Control District constructed 93 dams for debris storage and hundreds of smaller check dams, intended solely for bed stabilization. The debris basins are periodically mucked out to preserve storage capacity (see lower right).

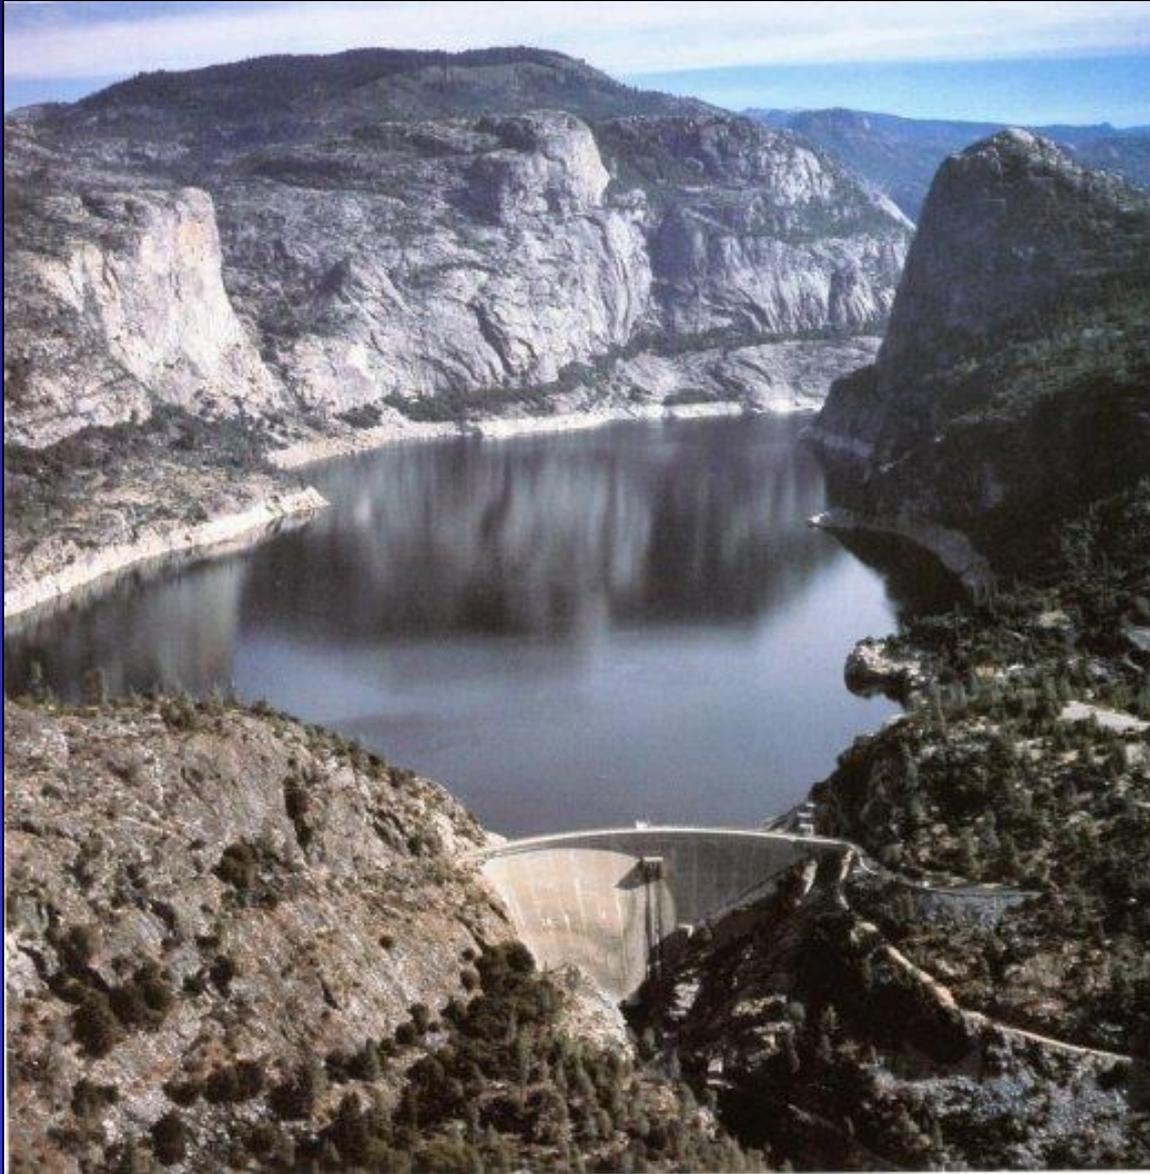
O'Shaughnessy Dam in Yosemite Park

- **O'Shaughnessy Dam** was constructed in two stages: between 1919-23 to a height of 344 ft, and again, in 1935-38 to the final height of 430 ft
- Unprecedented obstacles, including: higher strength concrete, artificial cooling of the mix and method of attachment had to be overcome. 2 to 4 ft wide joint between the two were used, which was grouted after concrete cured.

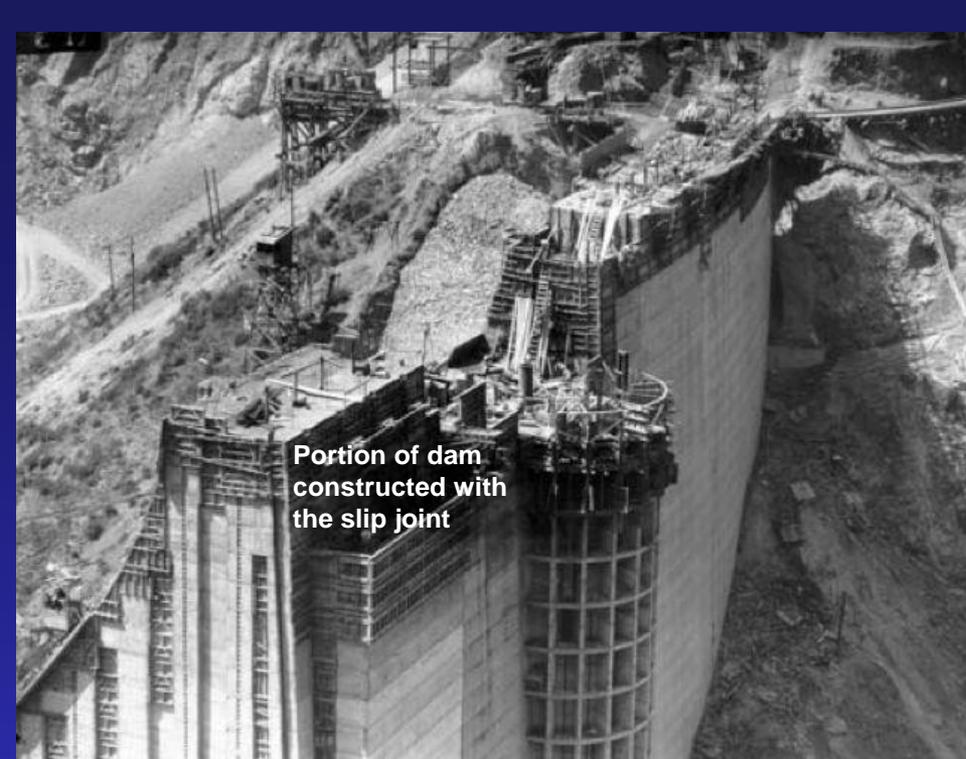
Morris Dam was built with a baffle slip joint (shown at middle and far right) designed to accommodate up to 6.5 ft of dip-slip fault offset

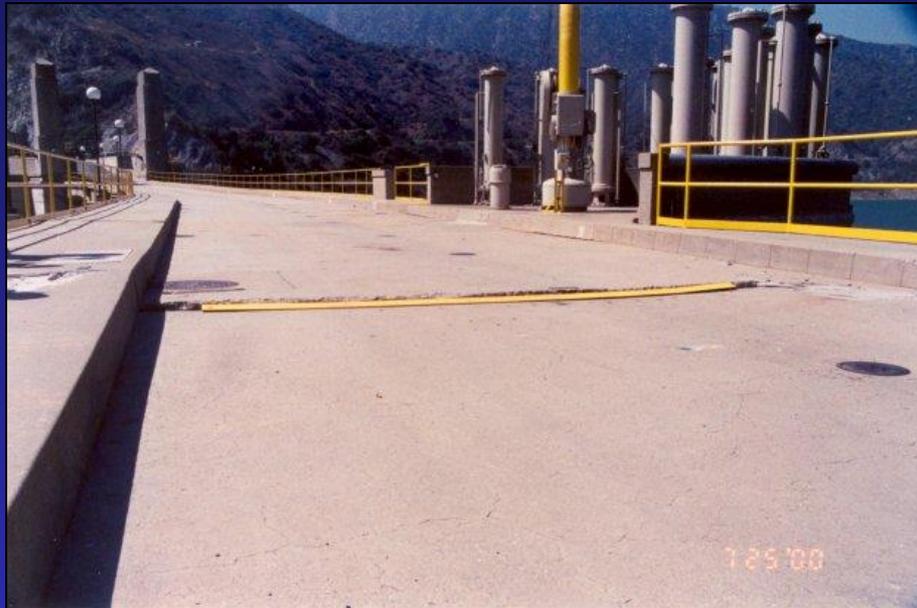
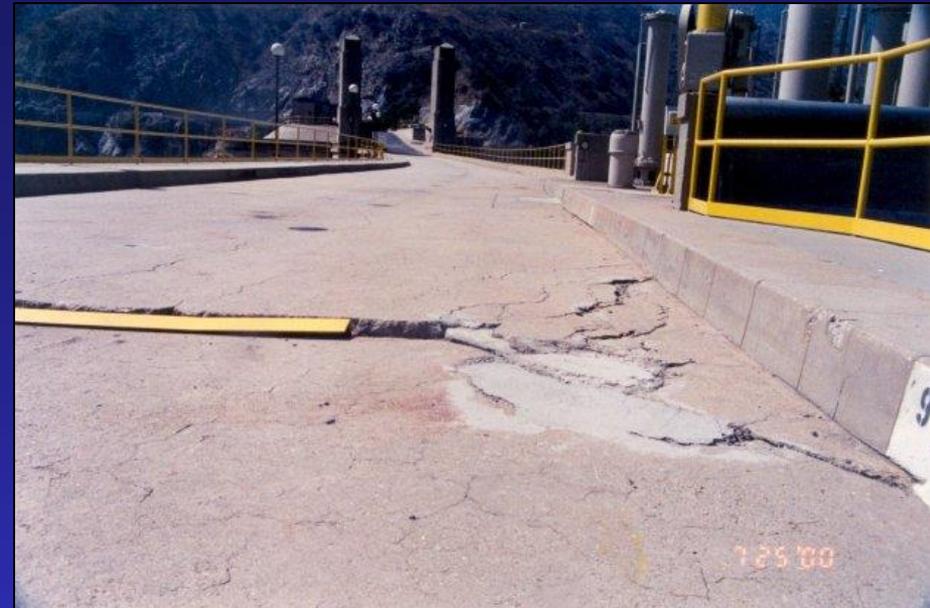
FAULT JOINT IN MORRIS DAM

- A Board of Consultants decided to construct the dam with a baffle joint capable of accommodating up to 6.55 ft of fault offset
- During excavation of the foundation a late Quaternary age fault was discovered near the right abutment. It was explored and examined
- It was decided to build a **slip joint** in the dam

- Since 1934 about 2.5 inches of vertical offset has been accommodated by the fault joint in **Morris Dam**, with the right abutment side down.
- No significant leakage has been observed along the joint

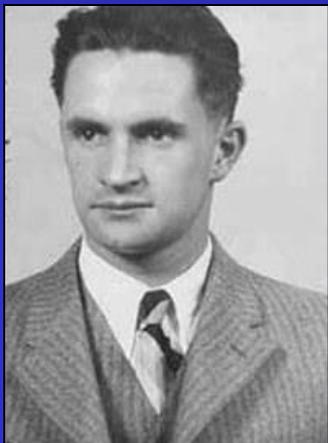
Fig. 13. Deflection curves of Morris Dam.

- In the wake of the **M_s 6.25 March 1933 Long Beach Earthquake**, the U.S. Coast Geodetic Survey allotted funds for the determination of dynamic properties of important structures
- They hired a young engineer named **John Blume** (at left), who built a dynamic exciter and used it on Morris Dam to determine the fundamental periods of vibration and deflection characteristics.

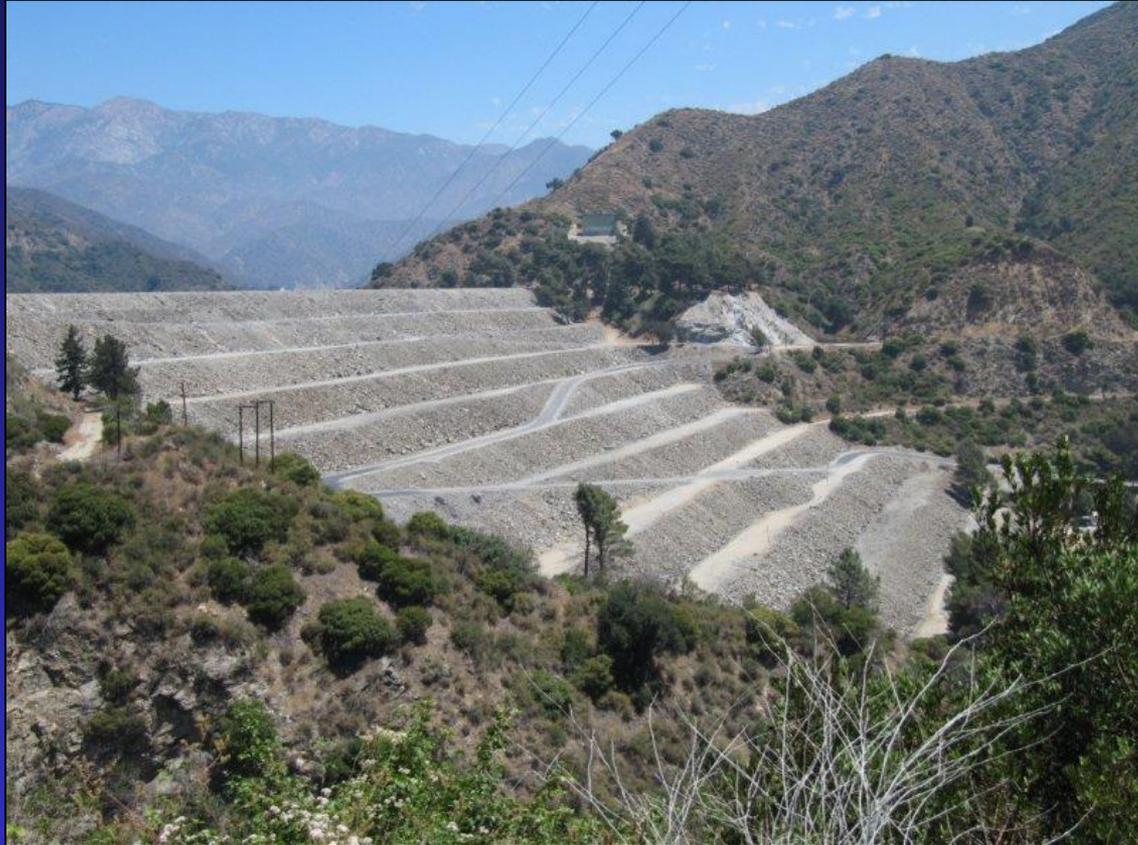
SAN GABRIEL DAM (1937)

- **San Gabriel Dam No. 1** was completed in July 1937 as the **highest rockfill dam in the world**
- It is 355 feet high, with 3:1 side slopes, necessitating a 2000 ft wide base with a volume of 10,572,000 yds³
- After 1969 storm season, a record 11 million yards of sediment was removed from the reservoir floor

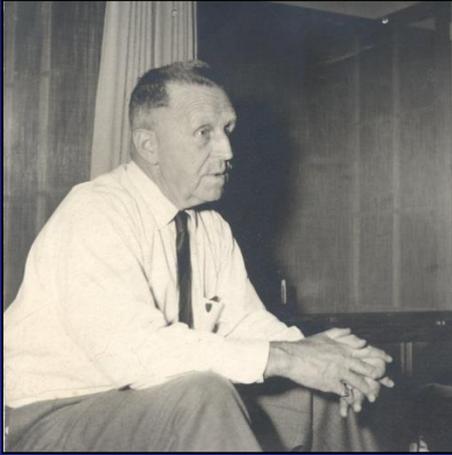
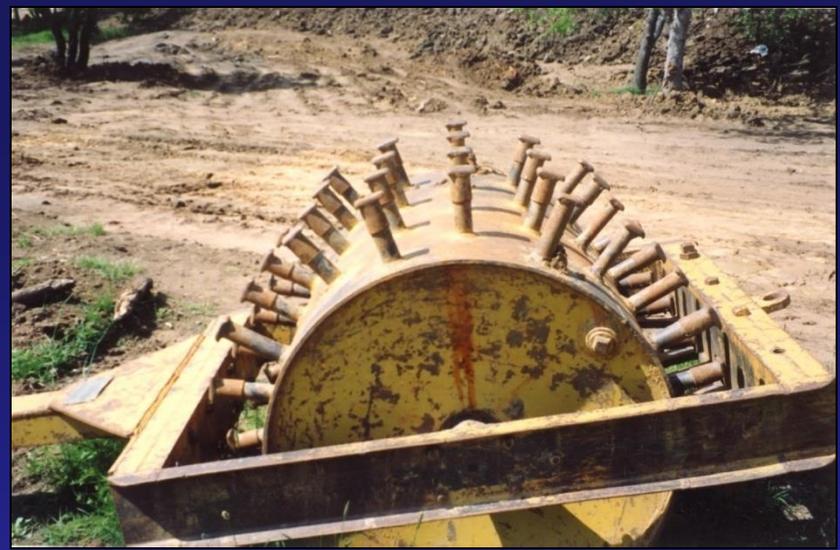
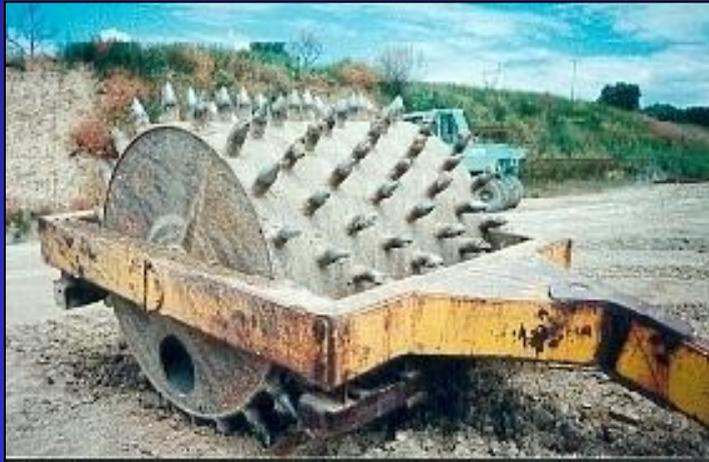
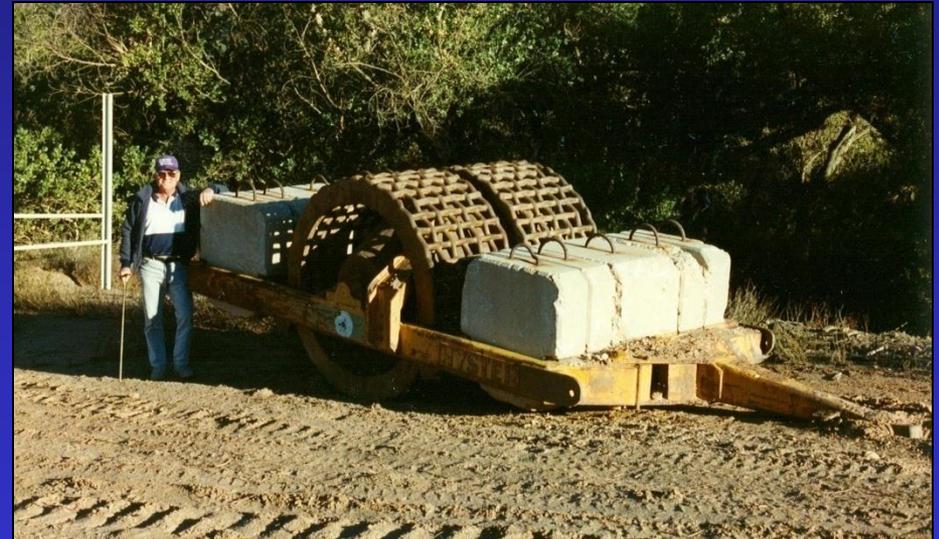
COMPACTING ROCK FILL

Paul Baumann (1892-1983) supervised the design and construction of the San Gabriel Dam in 1935-38. The record high rockfill dam contained 10,572,000 yds³ of disaggregated metamorphic rock, which presented compaction challenges.

- Image at upper left show the Allis Chalmers sheepsfoot roller that employed *replaceable* “hammerhead tips,” designed by Paul Baumann (above left). Lower left image shows the **spiked roller** using hardened steel tips, introduced in 1954. Image at lower right shows the **grid roller** developed by Gardner Byrne Construction Co of Los Angeles in 1947, acquired by Hyster in 1949. All three types were used by the Los Angeles County Flood Control District. during construction of rock and earth fill dams from 1935 onward.

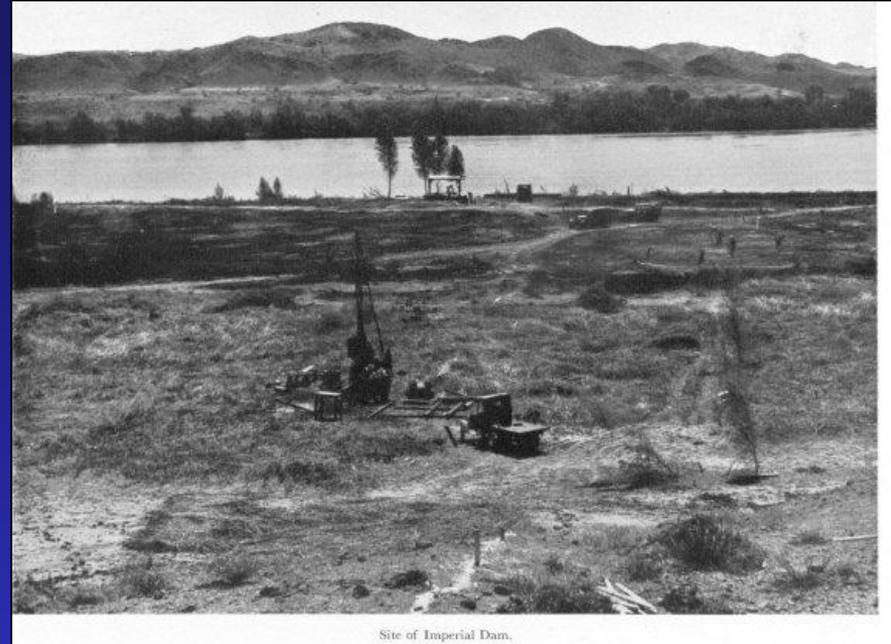
IMPERIAL DAM and DESILTING WORKS

- **Imperial Dam** is a buttress dam 50 ft high and 3,430 ft long, completed in 1938. Located 17 miles upstream of Yuma
- Water for the Gila and All American Canals is diverted here
- Deep unconsolidated soils infill the channel, large settlements predicted
- 4 layers of subdrain filters were constructed beneath the dam and spillway apron to reduce uplift and piping

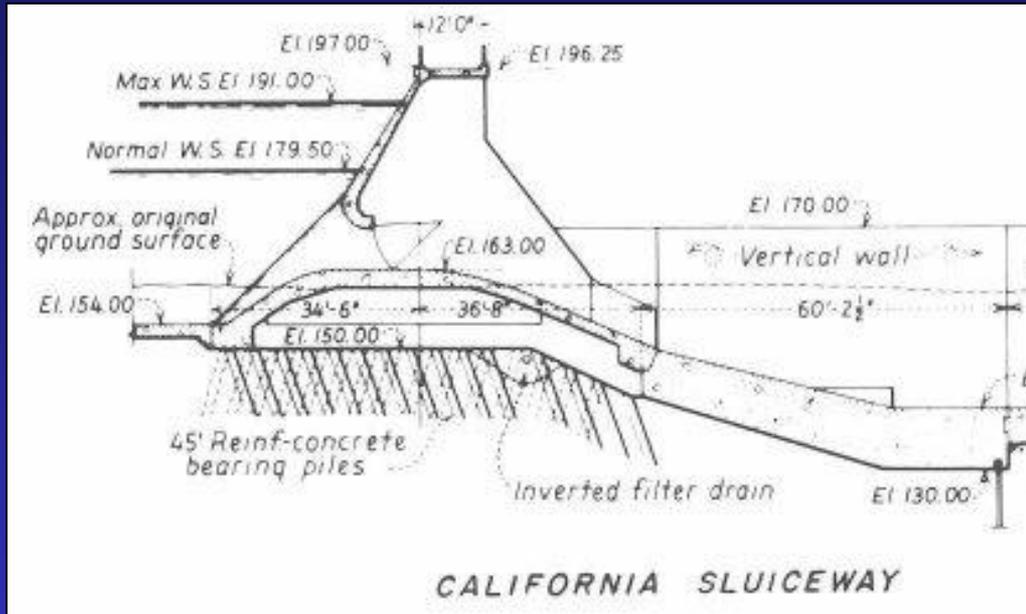
- **Imperial Dam** was built on battered concrete piles to check settlement of the main buttress dam structure because of soft alluvial soils underling the site were prone to future consolidation-induced settlement.
- The dam is designed as a floating structure, with rubber seals between buttress bays.

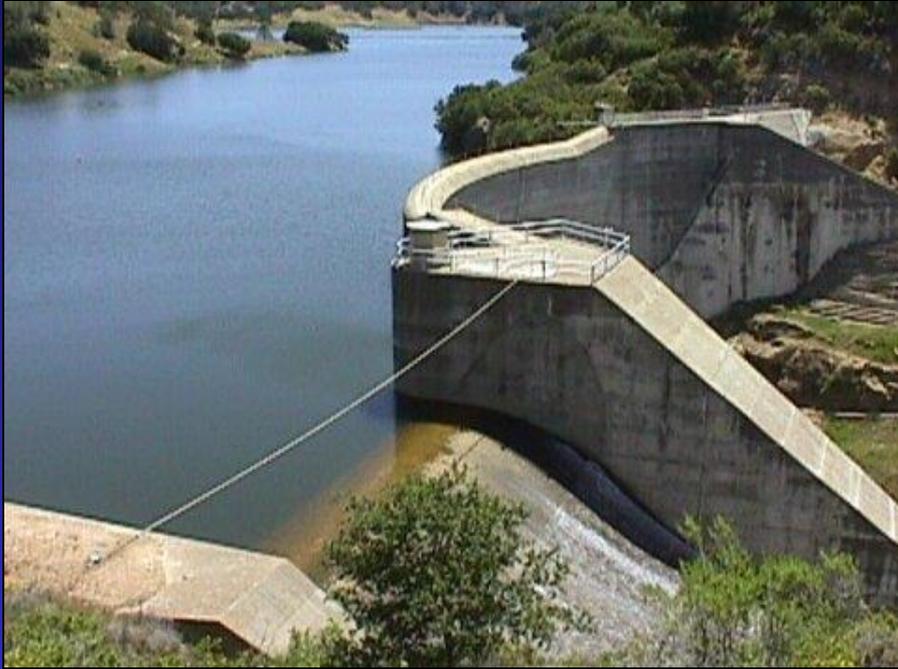
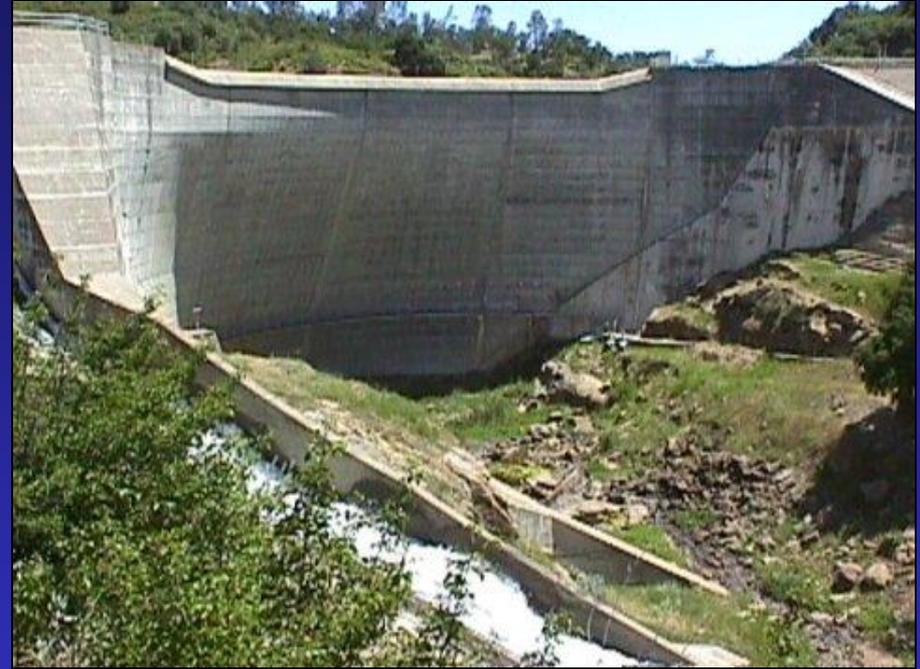
FIRST ARCH DAM WITH TWIN THRUST BLOCKS

- The **Camp San Luis Obispo Dam** was designed by Leeds, Barnard, Hill and Jewett in 1941 for the US Army. It was 185 feet high with a design reservoir capacity of 45,000 ac-ft
- It was renamed **Salinas Dam** and **Lake Santa Margarita** after the Second World War.
- It is now operated by City of San Luis Obispo

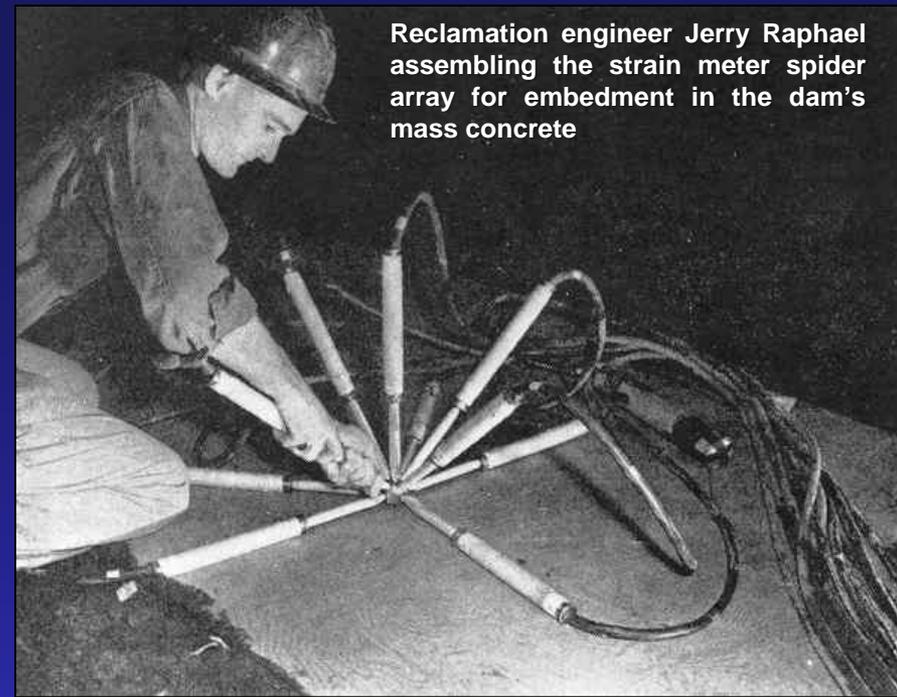
- Decision was made to fully instrument the dam while pouring the concrete
- The embedment of **Carlson strain, stress and temperature meters** allowed engineers to study the three-dimensional behavior of the dam through construction and into its service history
- These data allowed design assumptions to be validated, as well as monitor safety.
- These data showed Shasta Dam exhibited extremely conservative behavior, making it a good candidate for future heightening

- Analyses of the collected data led to reconsideration of methods of stress analysis for concrete gravity dams
- **Jerry Raphael** was recognized with ASCE's Moissieff Award in 1954 for his paper describing "**Stresses in Shasta Dam**"
- These data became background material for formulation of the **finite element method** of analyzing dams, by **Raphael** and **Ray W. Clough** at U.C. Berkeley in the early 1960s

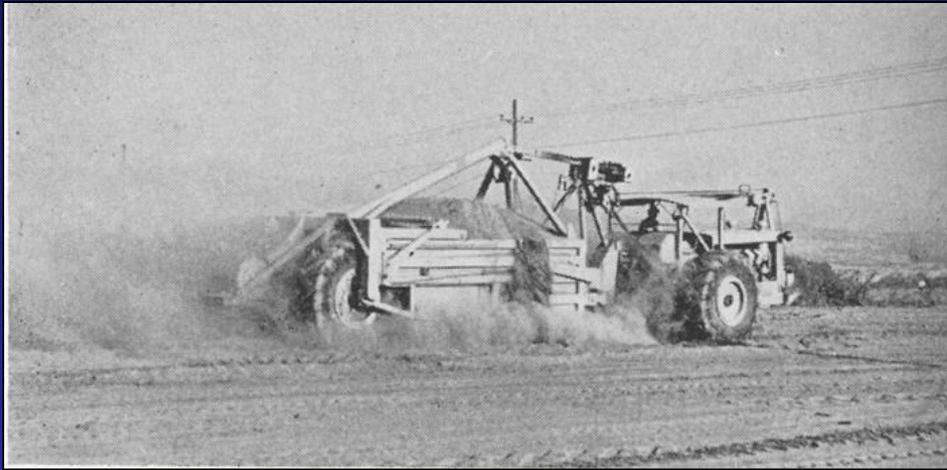
FIRST 'DRY FILL' EMBANKMENT

- The **Hansen Flood Control Basin** was constructed shortly before World War II (1938-41) as a dry compacted fill, to speed the job up and because it was intended to be a normally dry retention basin
- The Corps also built the Sepulveda, Lopez, Santa Fe, Prado, Whittier Narrows, and San Antonio flood retention basins in the Los Angeles area between 1938-57.

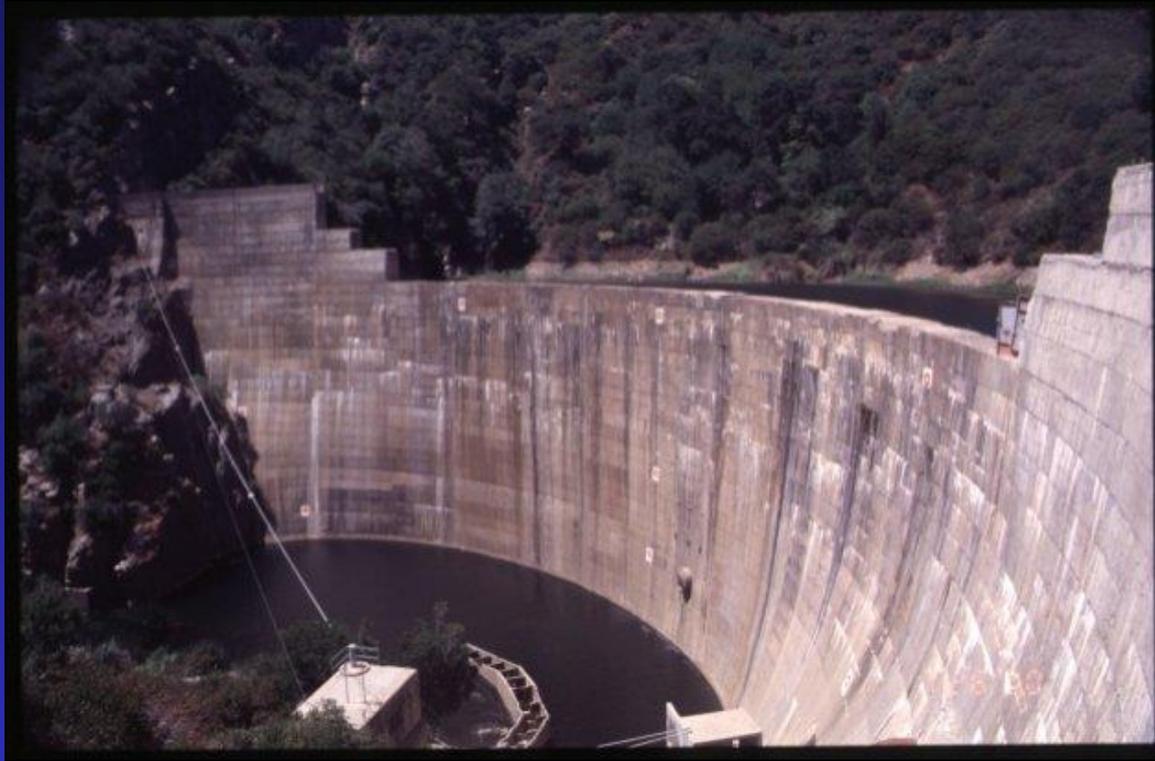
MATILIJA DAM (1947)

- **Matilija Dam** was 190-ft high constant angle arch dam designed by the Donald R. Warren Co. of Los Angeles in 1946. The designers recognized the need for using low alkali Portland Type II Cement and imported coarse aggregate from over 100 miles away (Irwindale) to better resist abrasion than onsite materials.
- Extreme case of cracking distress caused by alkali aggregate reaction because of glassy andesites and chalcedonic chert which somehow found their way into fine aggregate fraction of upper 40 feet. After studies in 1965, 1975 and 1977 the central crest was lowered in three steps, by as much as 40 feet.

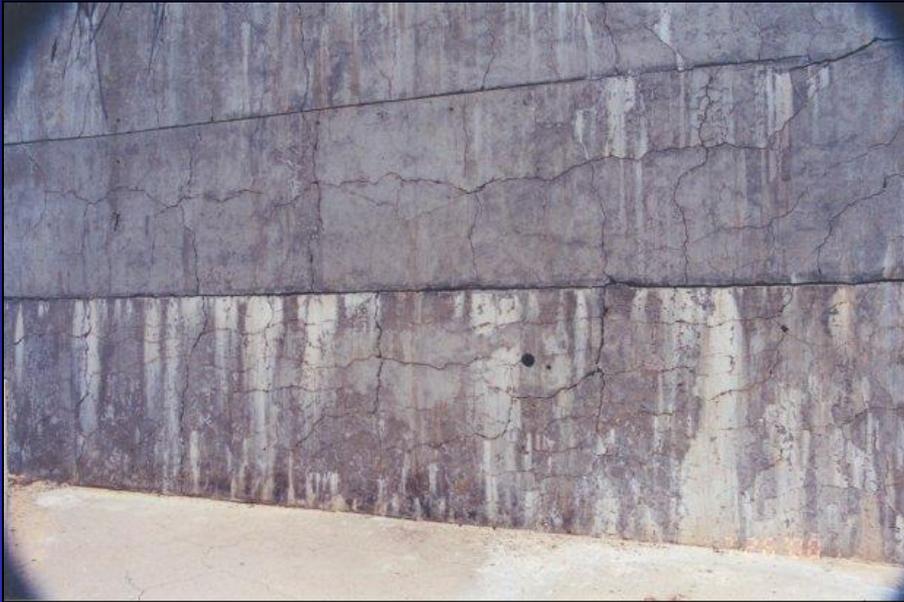
ALKALI AGGREGATE REACTION

- **Alkali aggregate reaction** was discovered in the early 1940s, as a handful of concrete structures began to experience expansion cracking.
- 40 years would pass before the precise mechanism was discovered; that being a chemical reaction between opaline quartz and the cement paste
