DAMS AND DISASTERS:

**a brief overview of dam building
triumphs and tragedies in California's
past**

J. David Rogers, Ph.D., PE., P.G., C.E.G., C.HG.

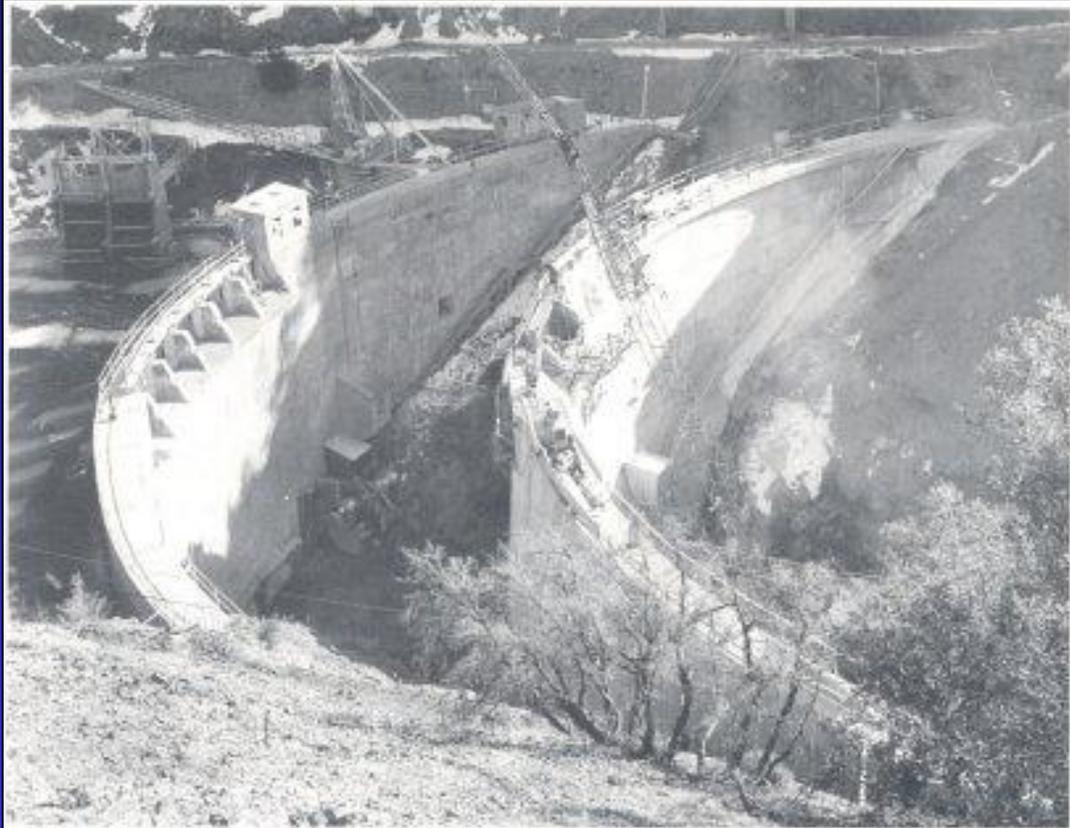
Figure 7-8 Drum Afterbay Dam replacement

- **Drum Afterbay Dam** was constructed by PG&E on the Bear River in 1924. It exhibited alkali aggregate reaction thru interaction of pyrite in the schist aggregate with the cement paste. The dam was replaced in 1966, as shown here.

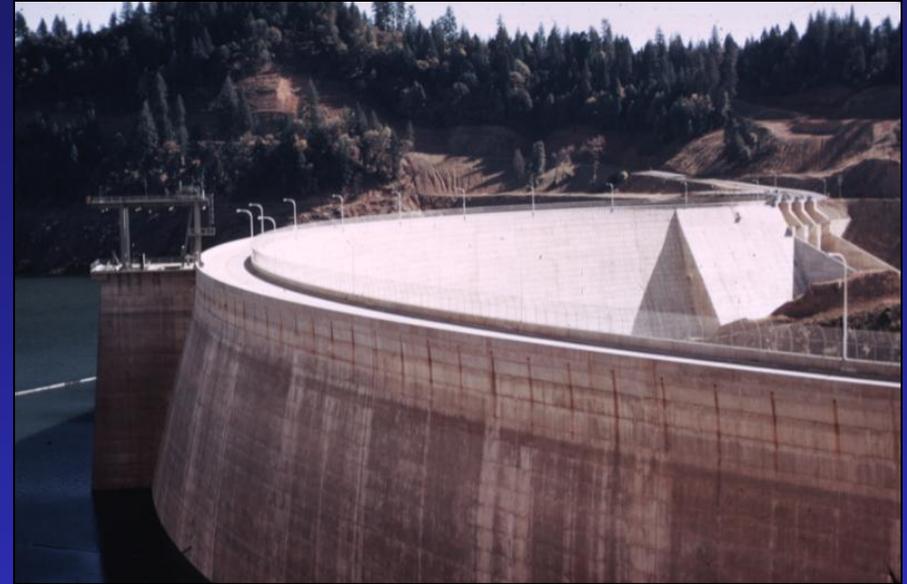
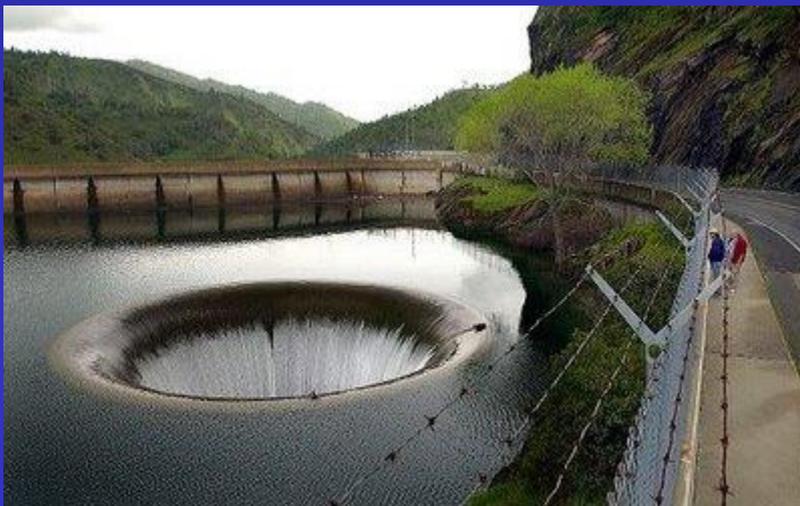
FIRST DOUBLY- CURVED THIN ARCH DAM IN AMERICA

- **Monticello Dam** is a medium thickness doubly-curved thin arch dam designed by the Bureau of Reclamation.
- It was 304 ft high, 100 thick at base and 12 ft thick at crest. Completed in 1957.
- Lower left: It also has the largest glory hole spillway in America, 72 ft in diameter narrowing to 28 ft, with a discharge capacity of 48,800 cfs

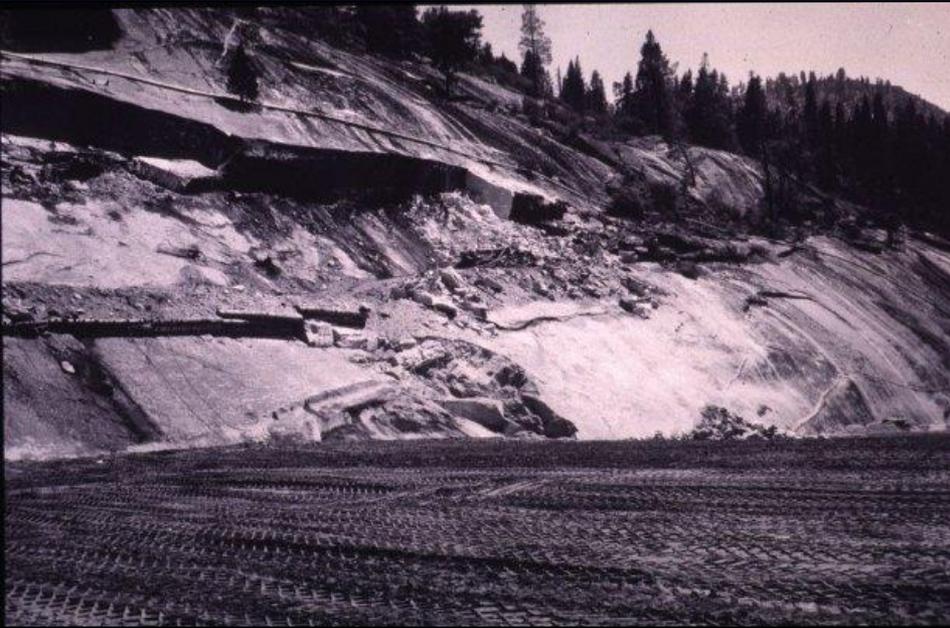
BATTLING EXFOLIATION

- During construction of **Mammoth Pool Dam** on the upper San Joaquin River in the late 1950's, thick slabs of the Mt Givens Granodiorite kept popping outward, as the outer rock was removed.
- Famed foundation engineer **Karl Terzaghi** was brought in as a consultant. He recommended placing the fill against the granite abutments, then grouting the exfoliation joints when the dam was finished.

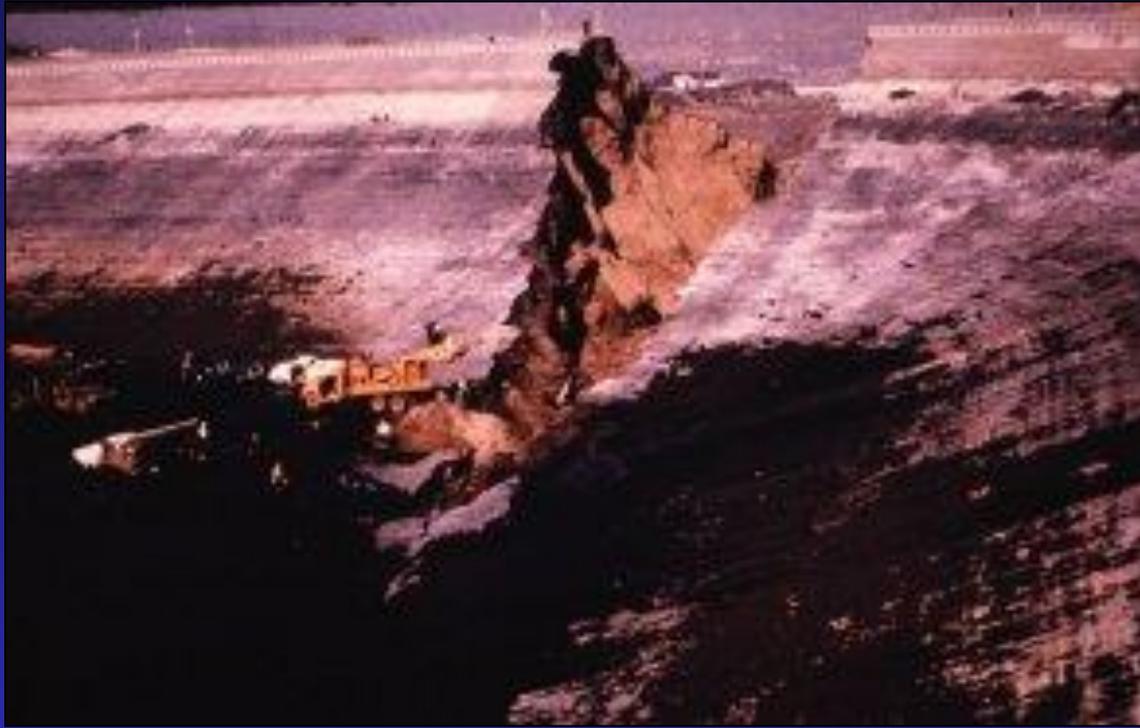
- The outflow continued for 77 minutes, till 4:55 PM
- Afterwards, the eroded chasm was 90 feet deep and 70 feet wide, curiously dry in appearance afterwards (right)
- The water had leaked through the abutment rock of the underlying Pico Formation, having first been noted at an elevation of 400 feet on the downslope face, 82 feet below crest

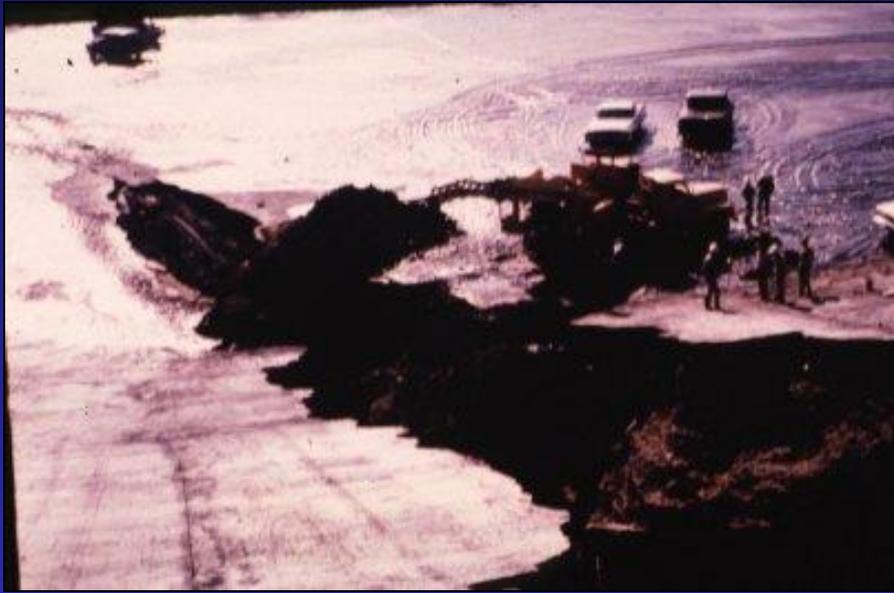
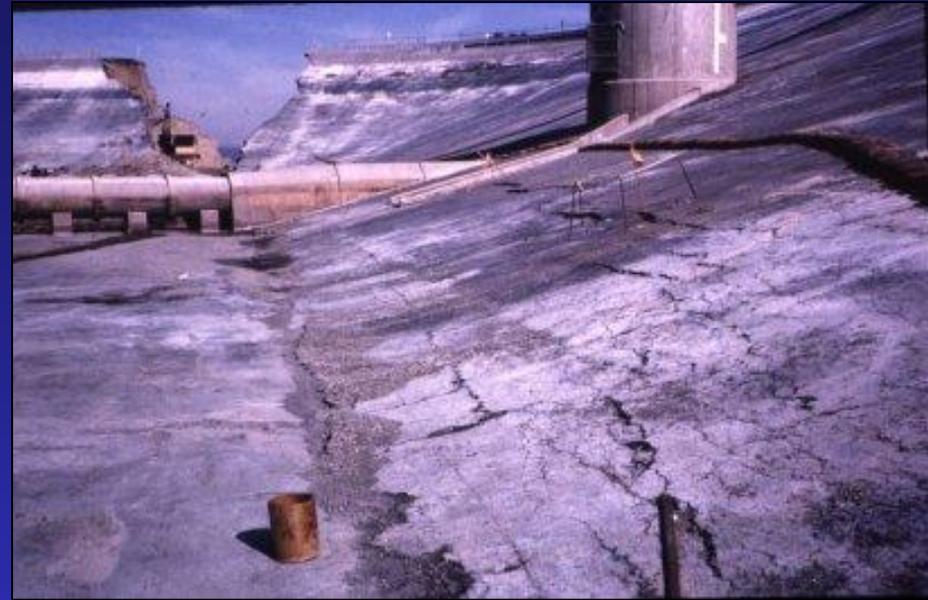
Instrumentation cannot save a flawed design

- The eroded chasm extended into the reservoir floor along a linear north-south trend (left)
- Subsequent examination revealed an active fault scarp extending through the reservoir floor, shown in right view
- Up to **12 inches of vertical offset** was noted along four strands of this fault exposed in the reservoir floor, diminishing towards the southerly side of the reservoir. The fault dipped 70 degrees west

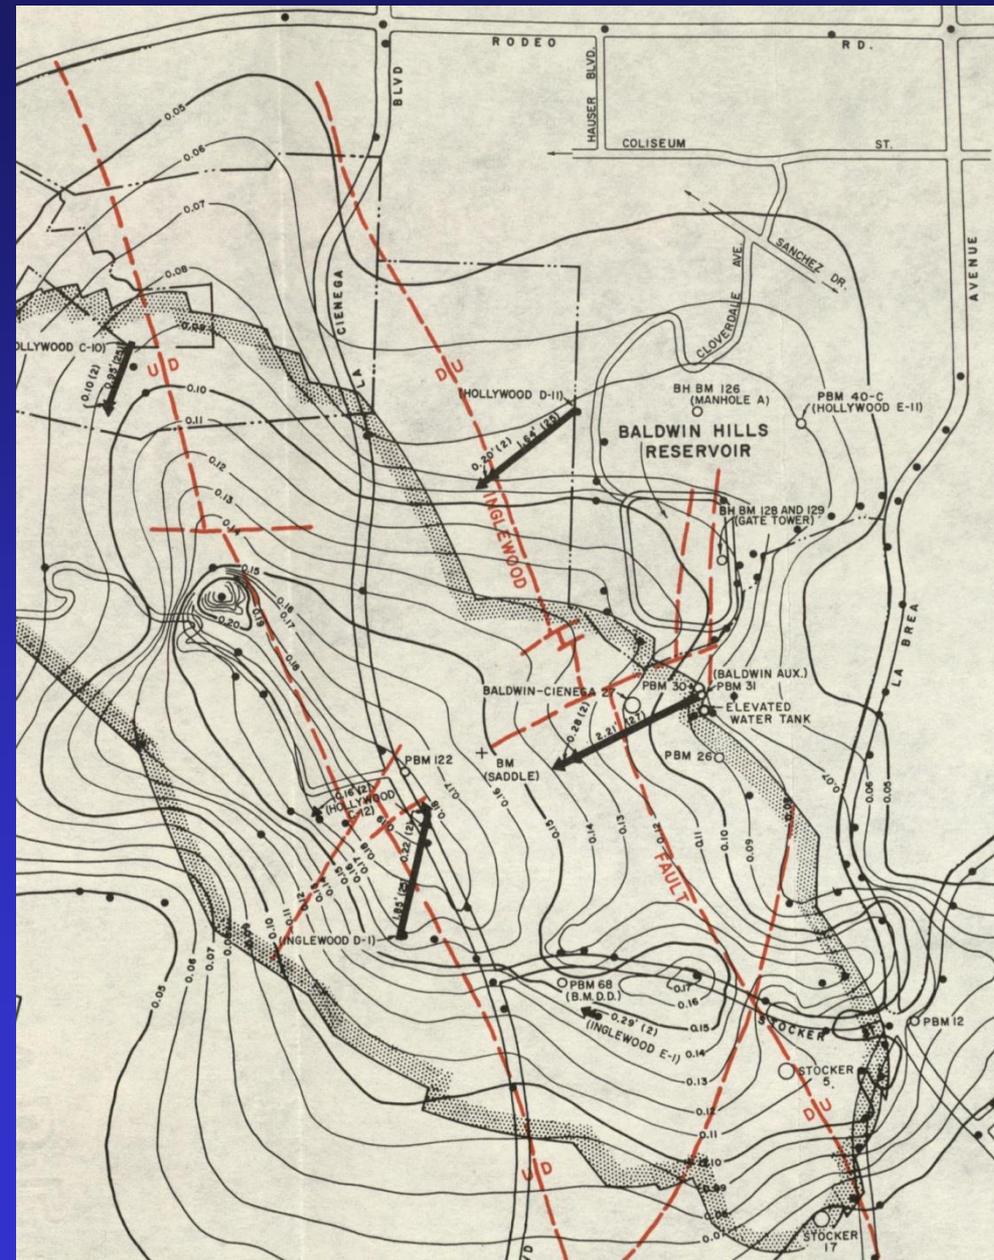
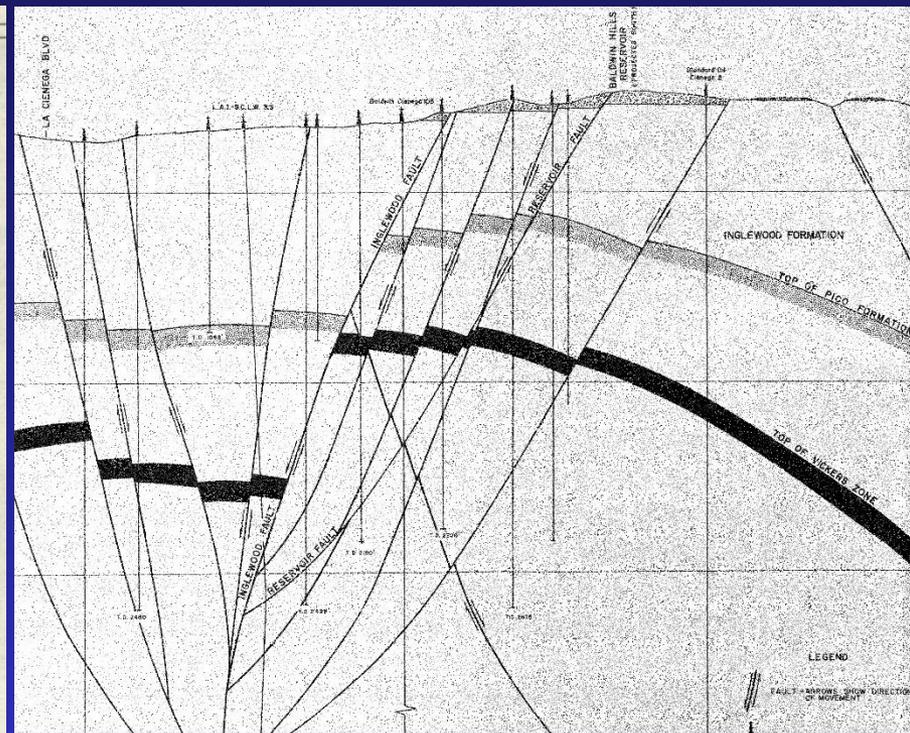
Map and section views showing faults and annual rates of subsidence measured in the Inglewood Oil Field. Note **movement vectors** in vicinity of the Baldwin Hills Reservoir (2.21 ft in WSW direction). A little over **1.5 feet of subsidence** was measured along the Reservoir fault during the 9 year life of the reservoir! This subsidence was likely engendered by petroleum withdrawal over the previous 20+ years.

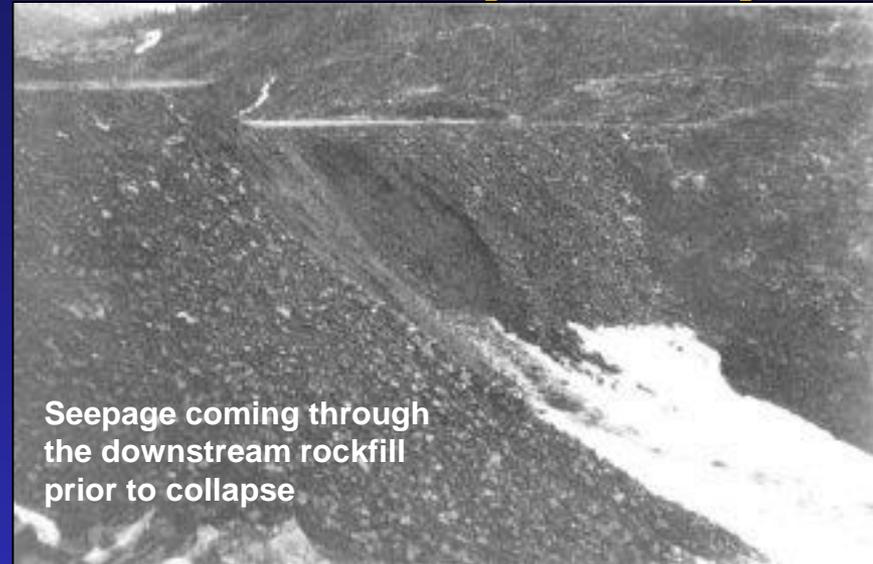
FAILURE OF HELLHOLE DAM DURING CONSTRUCTION (1964)

- **Hellhole Dam**, a zoned rockfill, was under construction on the Rubicon River west of Lake Tahoe at the time of the December 1964 storms
- The downstream shell had been filled to a height of 220 feet, about half the planned height of the dam (see section view at left)
- There was 70 feet of freeboard between the reservoir and the shell when the storms began

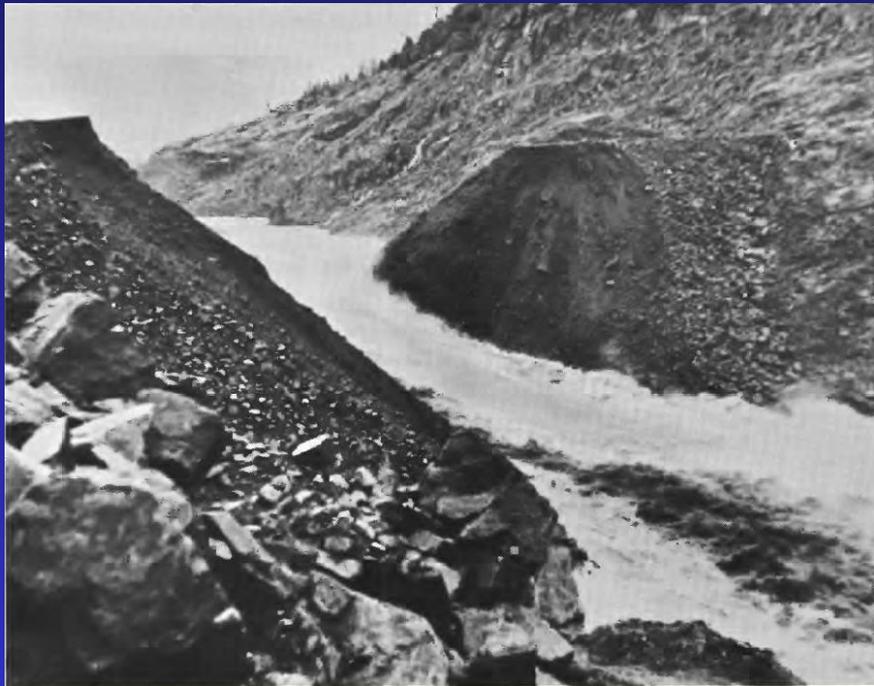
SPECTACULAR FLOOD

- The flood breached the rock shell around 9:30 AM on December 23, 1964 (left), releasing 24,800 ac-ft.
- The peak flow down the Rubicon River reached 240,000 cfs (right), clearing out the channel

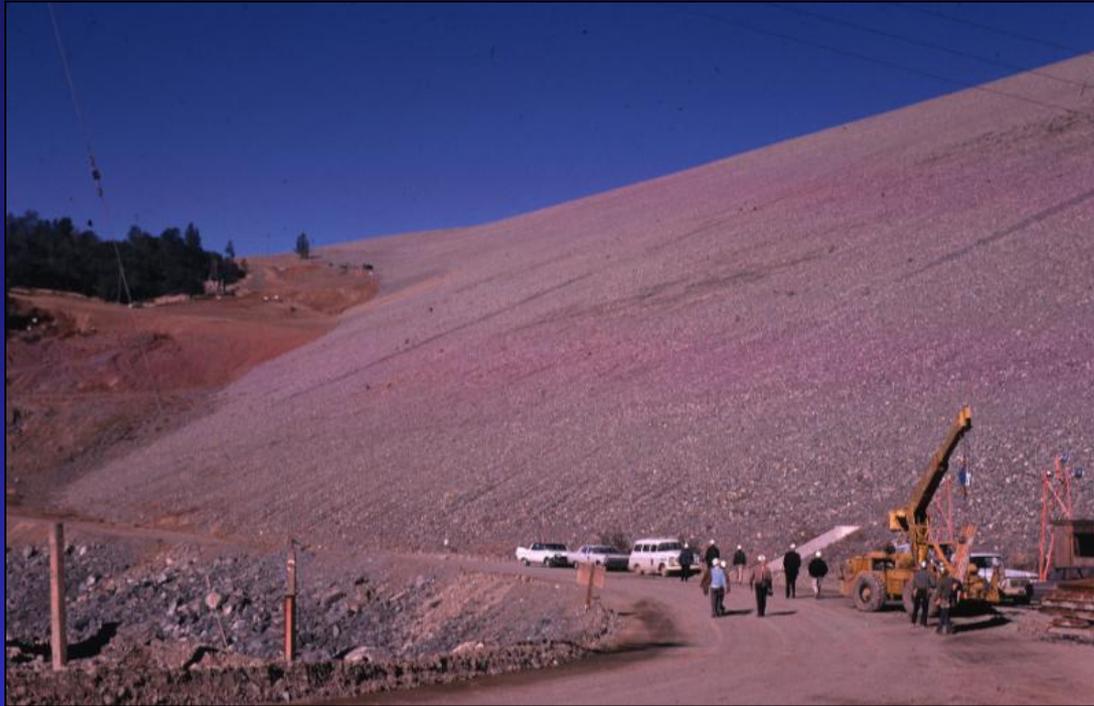
HIGHEST DAM IN THE WORLD (1967)

- At 770 feet high and 5,600 feet long, **Oroville Dam** was the highest dam in the world when it was completed on the Feather River in 1967. It was designed by the California Department of Water Resources and included 80 million yds³ of soil and rock.
- The original design concept had been a massive concrete multiple arch dam, which would have been the world's largest of that type.

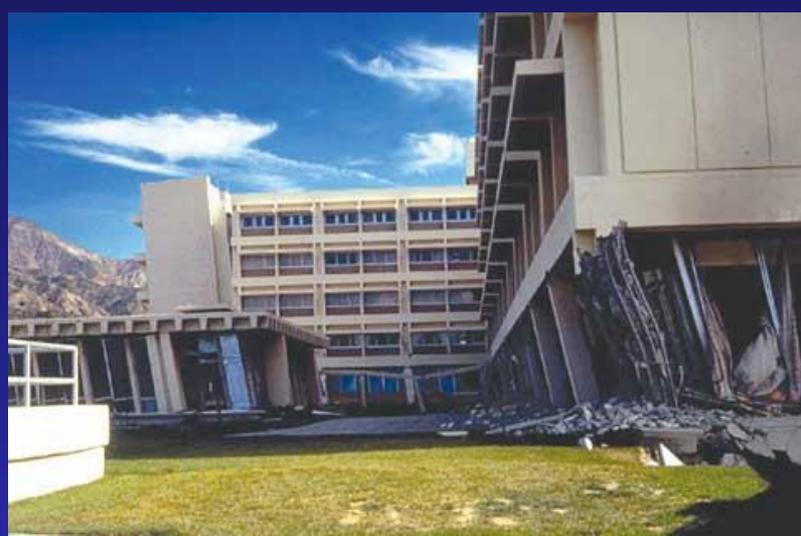
1971 San Fernando Earthquake

The shaking felled two hospitals, several freeway viaducts, and the Lower Van Norman Reservoir. It occurred along the San Fernando Thrust, shown at upper right.

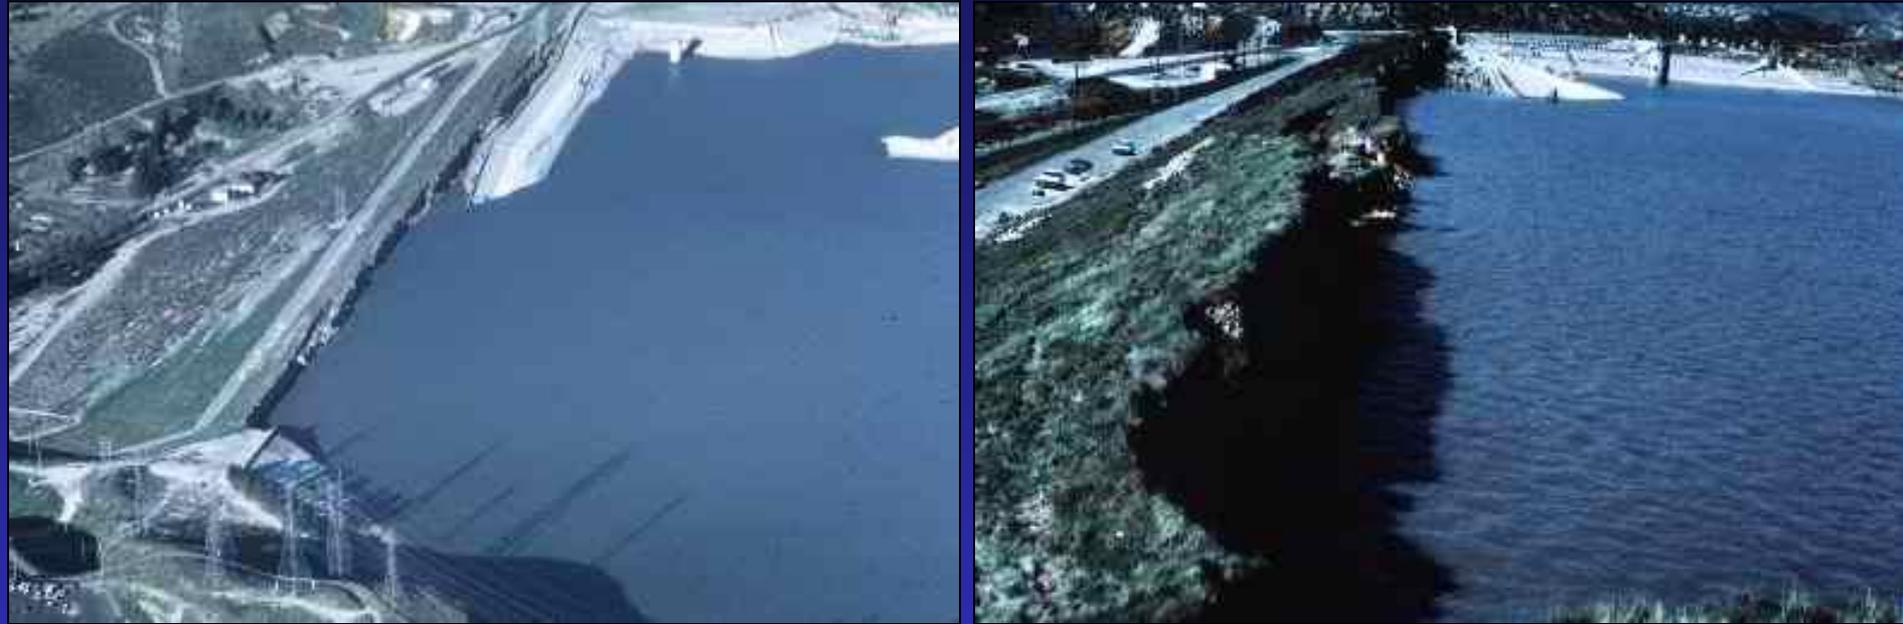
LOWER VAN NORMAN RESERVOIR FAILURE

- **Lower San Fernando Dam** was built by the City of Los Angeles as part of the Los Angeles Aqueduct in 1916-18, using puddled hydraulic fill. A rolled fill addition seven feet high was placed in 1924-25.
- The embankment failed during the Feb 9, 1971 M_w 6.7 San Fernando Earthquake, but no water was released

- Careful forensic evaluations by the geotechnical engineering group at U.C. Berkeley unraveled the dam's failure by **liquefaction of a zone of low density sandy hydraulic fill (shown in blue)** in the above sections
- The State subsequently slated 59 other dams for detailed assessment of vulnerability to seismic loading, beginning in 1973.

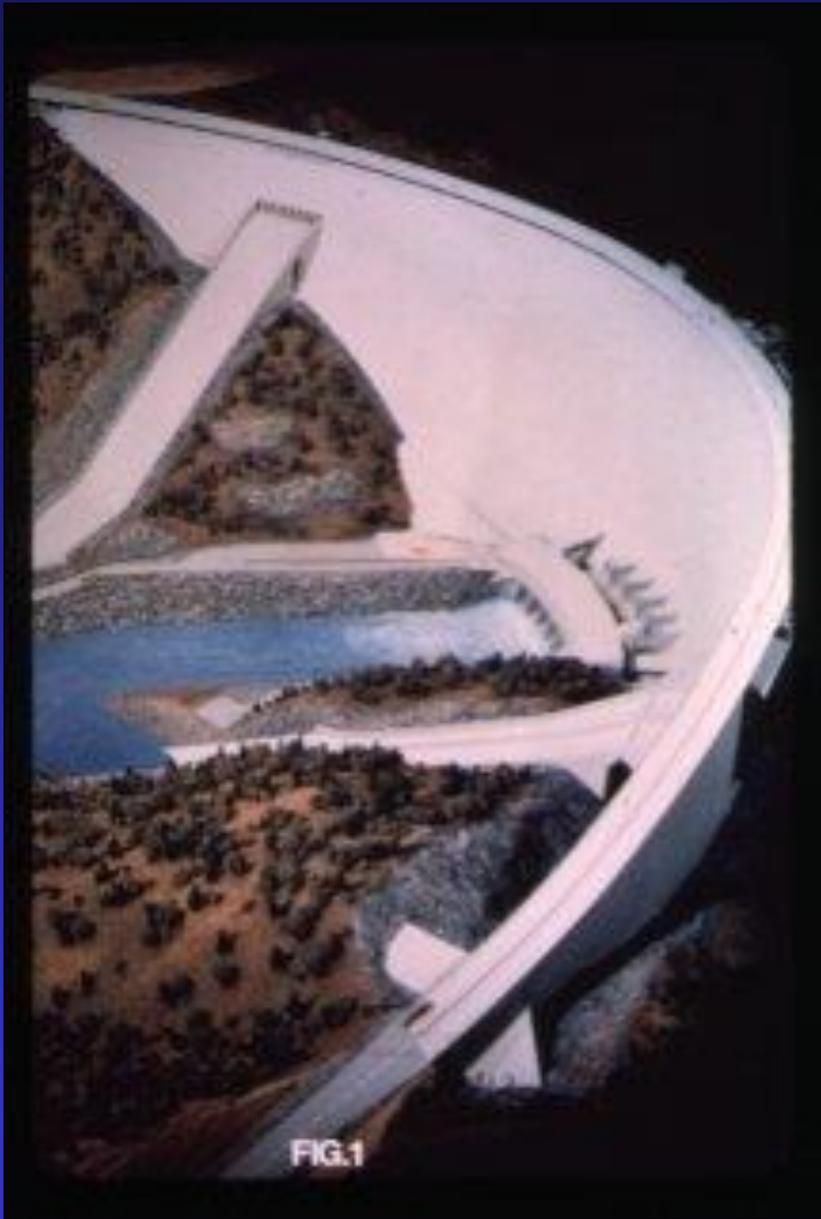
Most controversial dam project in California

- The **Auburn Dam** was designed by the Bureau of Reclamation in the mid-1960s to be the largest three-centered thin arch dam in the world.
- It was designed assuming that the Sierra Foothills were without any active seismicity

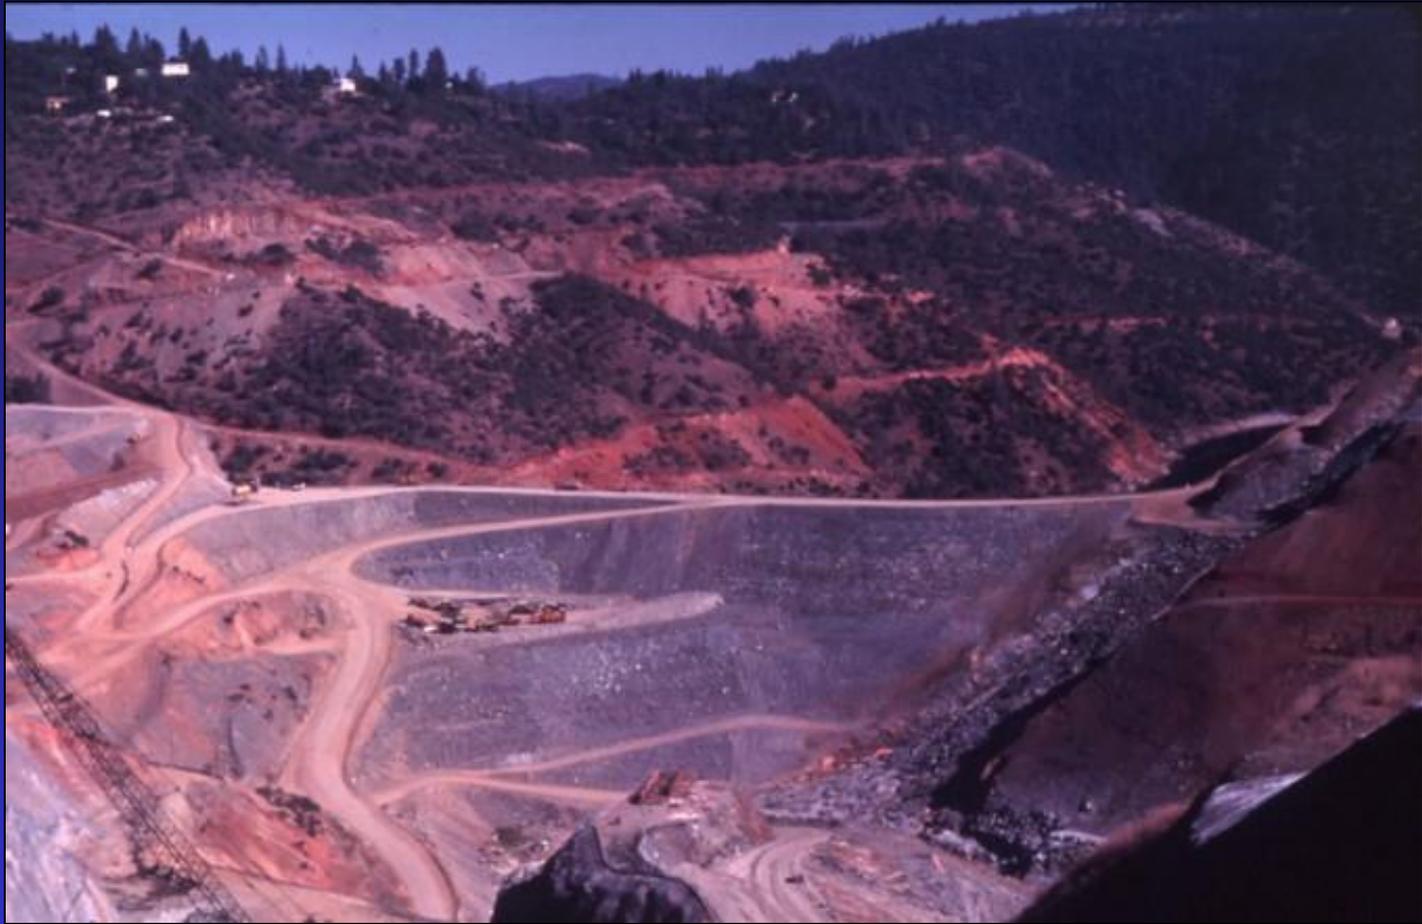
AUBURN COFFERDAM FAILURE

- A 207 feet high earthfill embankment cofferdam was constructed upstream of the Auburn Dam site in 1973-74
- A 33 ft diameter diversion tunnel was completed in 1971 with a maximum capacity of 74,000 cfs (photo R. Christopherson, American River College)

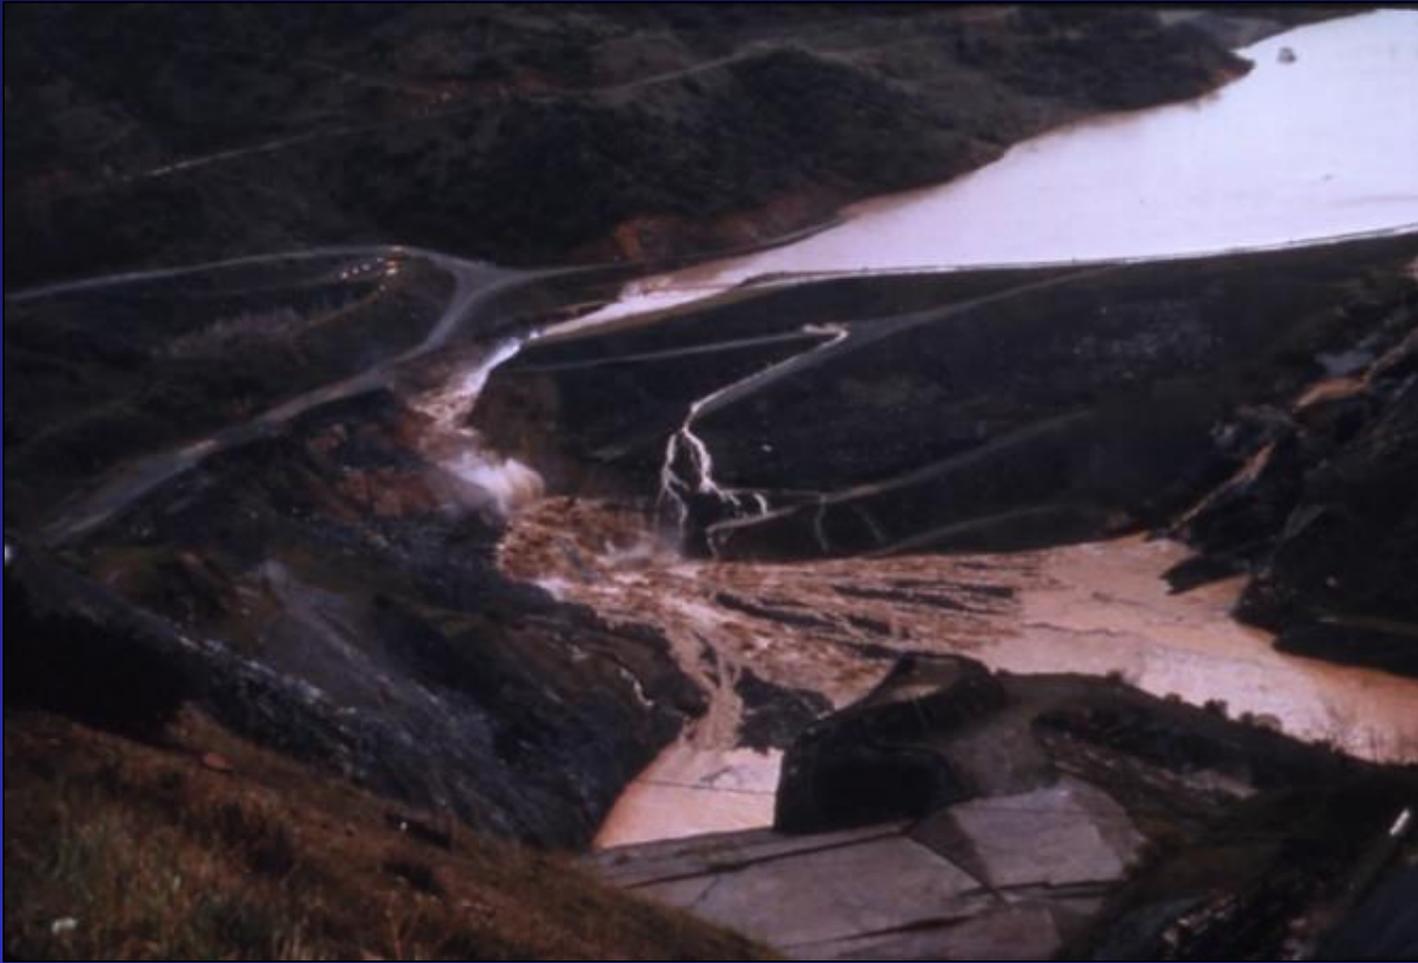
- In the early morning hours of February 18, 1986 the lake impounded by the cofferdam began rising 10 feet per hour, and began overtopping the right abutment area around 9 AM, when this picture was taken (photo by Robert Christopherson).

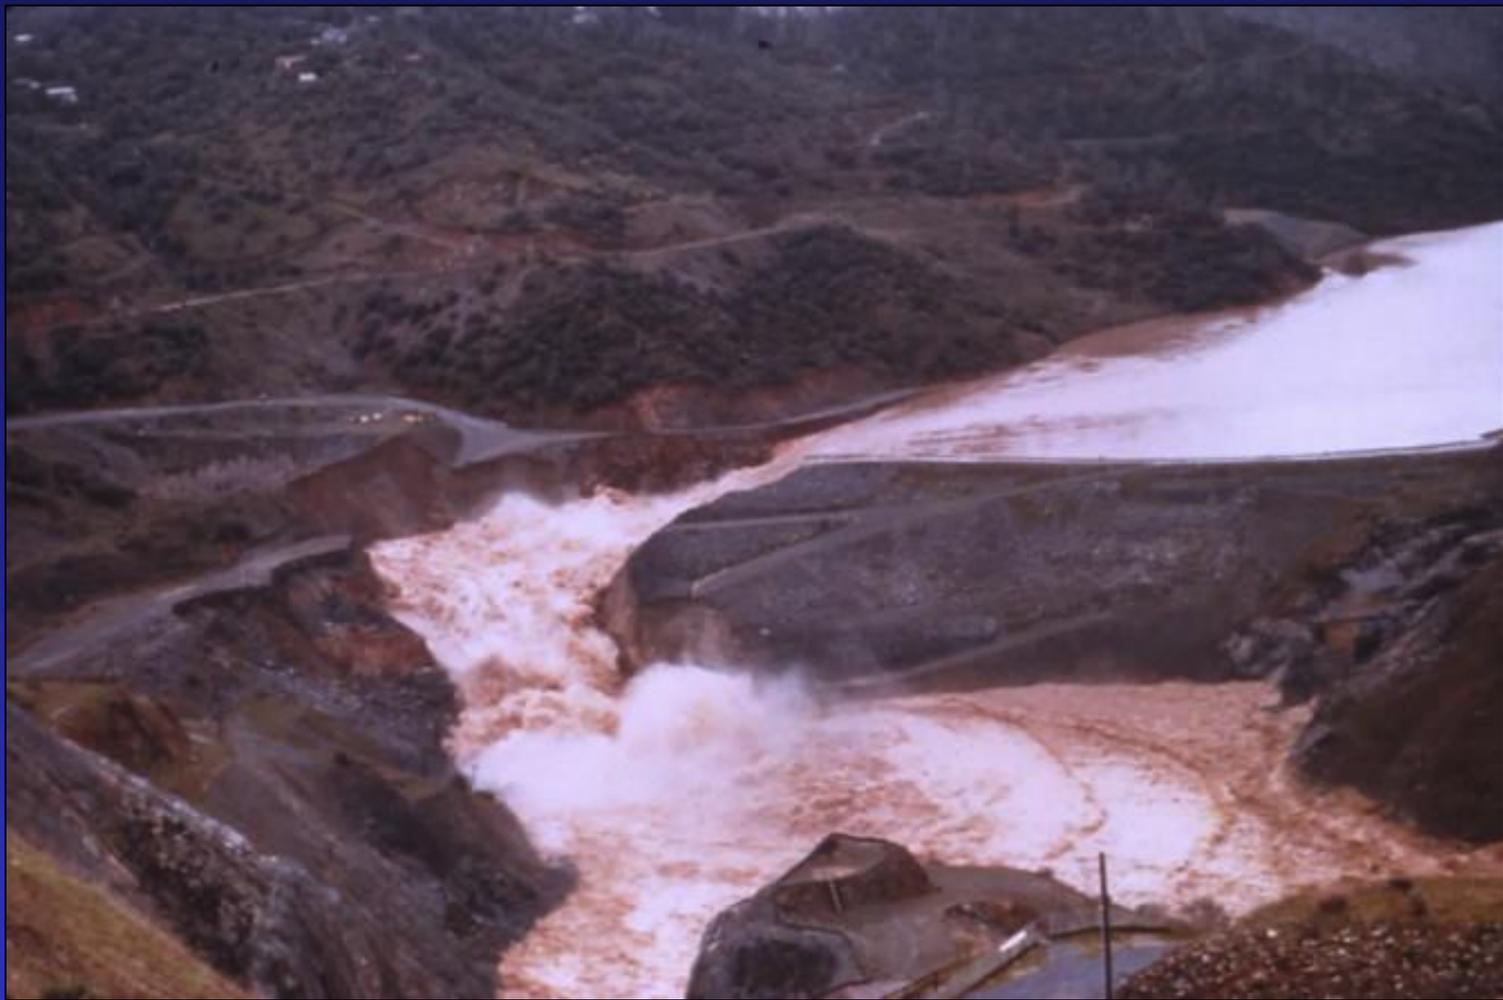
- **View of the cofferdam breach around noon on Feb 18th, when the outflow exceeded 100,000 cfs, forcing Folsom Reservoir (downstream) to begin releasing 130,000 cfs; 15,000 cfs beyond the downstream levee capacity (Photo by Robert Christopherson)**

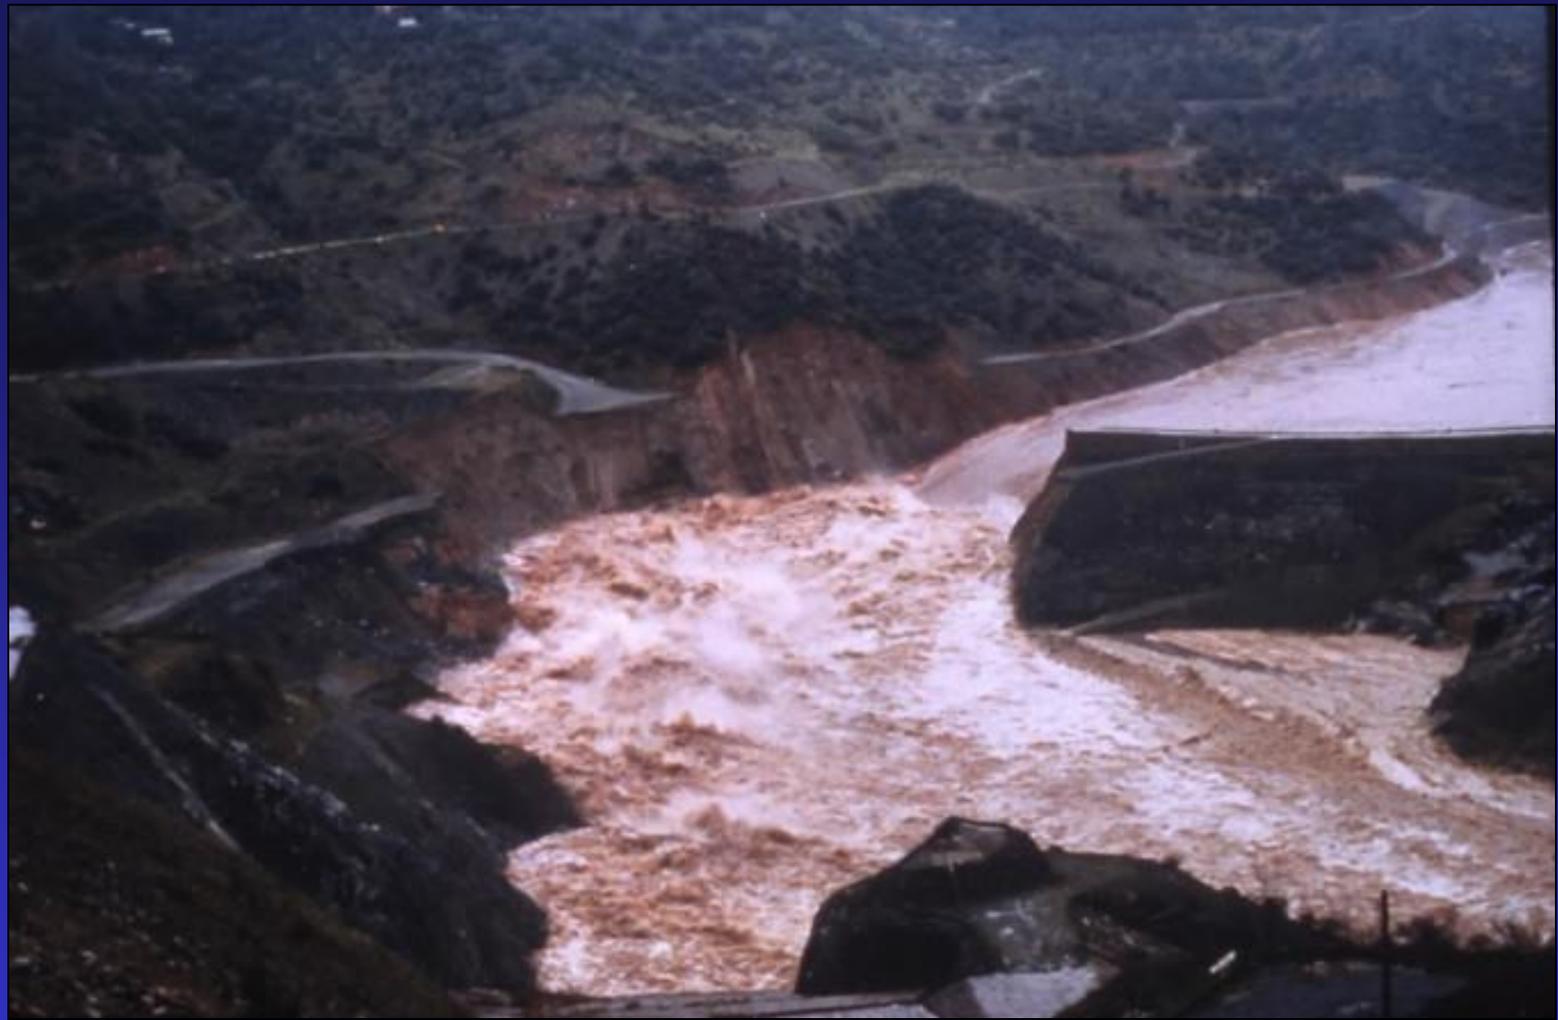
- **By early afternoon the flood peaked around 250,000 cfs, with a flow depth of 50 feet (shown here). By 4 PM the surge leveled out and the diversion tunnel was able to accommodate the incoming channel flow (Photo by Robert Christopherson)**

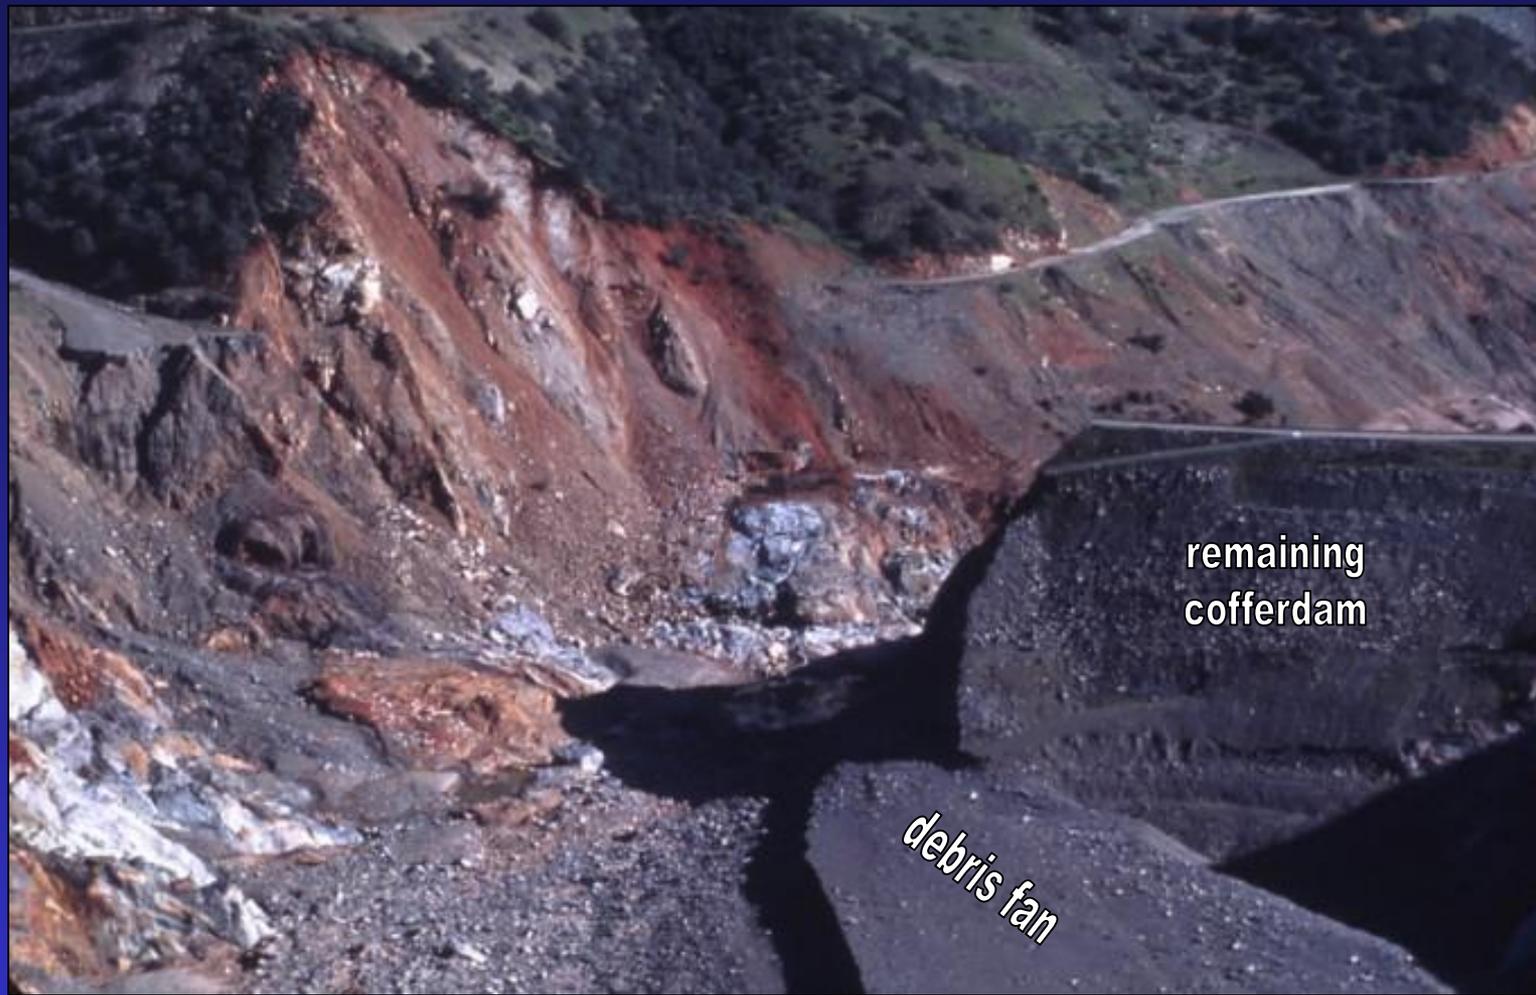
- Remains of the **Auburn cofferdam** after the Feb 18, 1986 failure. Two million cubic yards of material were eroded, excavating 25 feet beneath the original foundation, into metamorphic rock. The outbreak channel was filled with sediment to depths of between 20 and 100 feet.

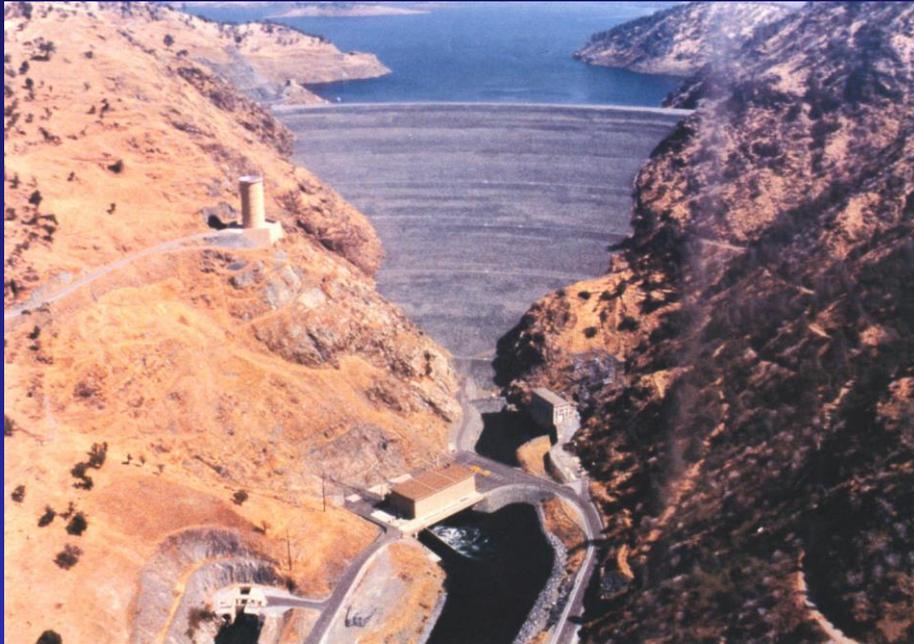
END OF THE BIG DAMS ERA

- In 1974-75 the State of California fought the U.S. Corps of Engineers over the building of **New Melones Dam** on the Stanislaus River. The feds won, but the fight signaled the end of the dam building era in California
- New Melones, a towering 607 ft high rockfill, was completed in November 1978, shortly after New Exchequer and New Don Pedro Dams.

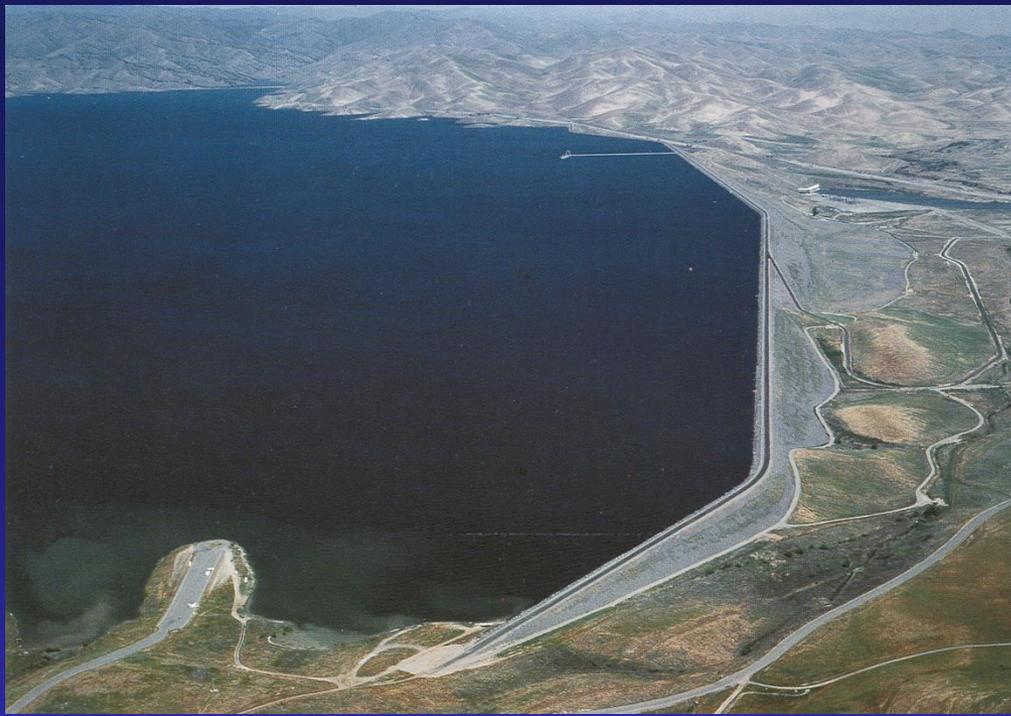
- In September 1981 a 1,700 ft long slide occurred in the upstream face of **San Luis Dam**, involving 1.4 million yds³ of earth in the repairs.
- Overconsolidated clayey colluvium left in-place beneath the dam lost strength over a period of 14 years, because of cycling of the reservoir pool.

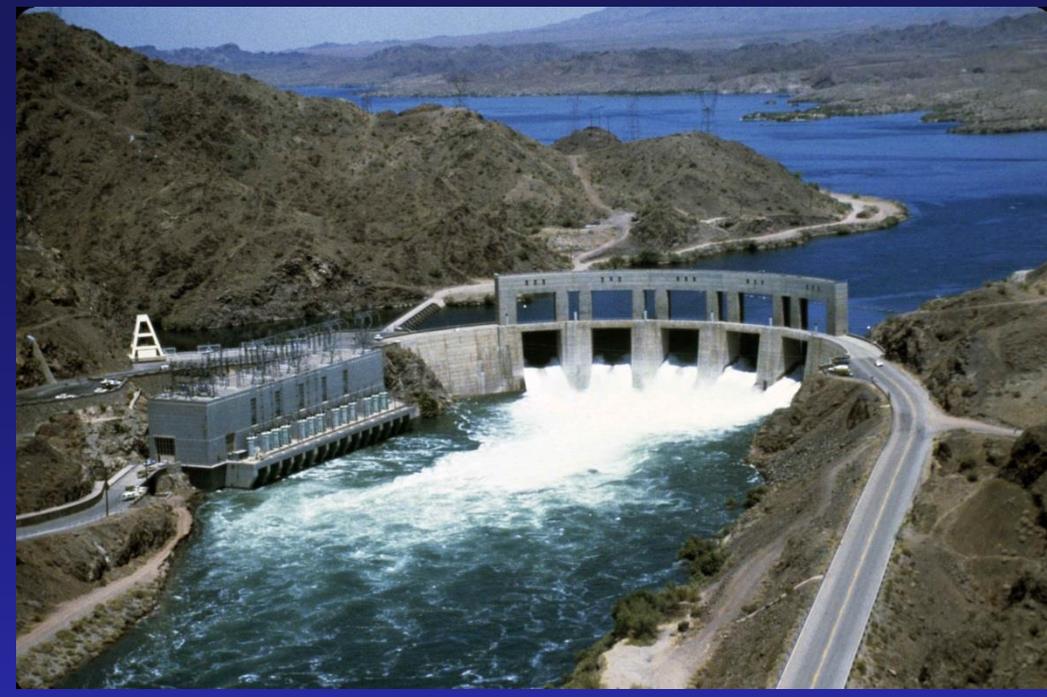
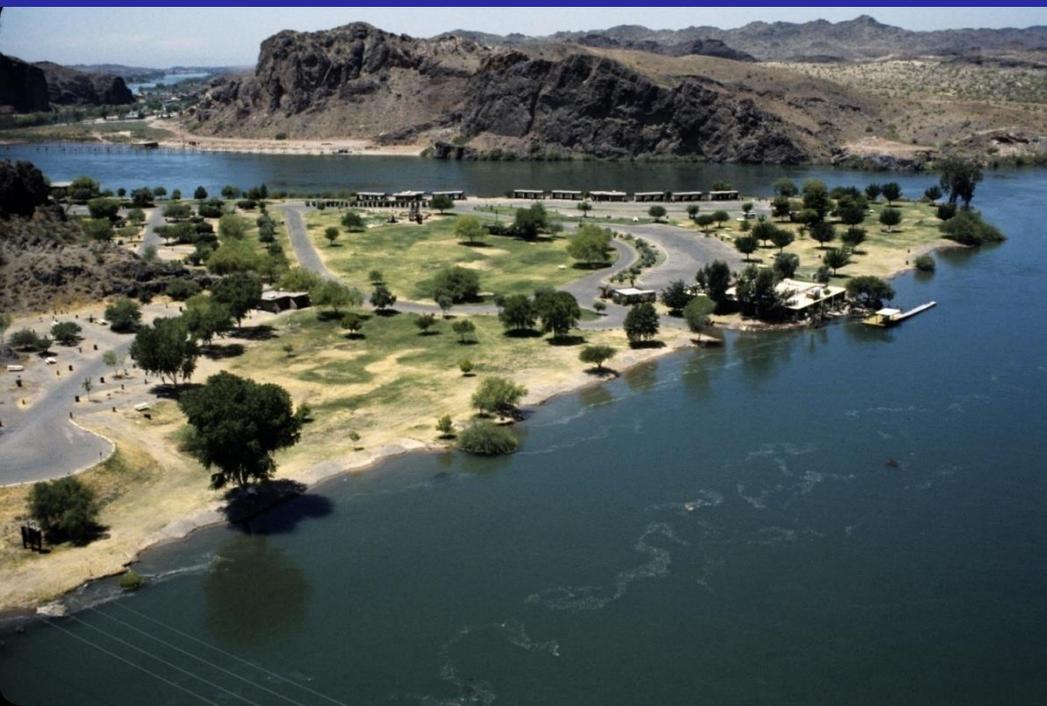
- These views show some of the high flows being passed through Parker Dam (above) and flooding the Buckskin Point-Colorado River State Park area, just below the dam
- The flooding was unnecessarily severe because of flawed runoff models then employed by the Bureau of Reclamation
