DAMS AND DISASTERS:

**a brief overview of dam building
triumphs and tragedies in California's
past**

J. David Rogers, Ph.D., PE., P.G., C.E.G., C.HG.

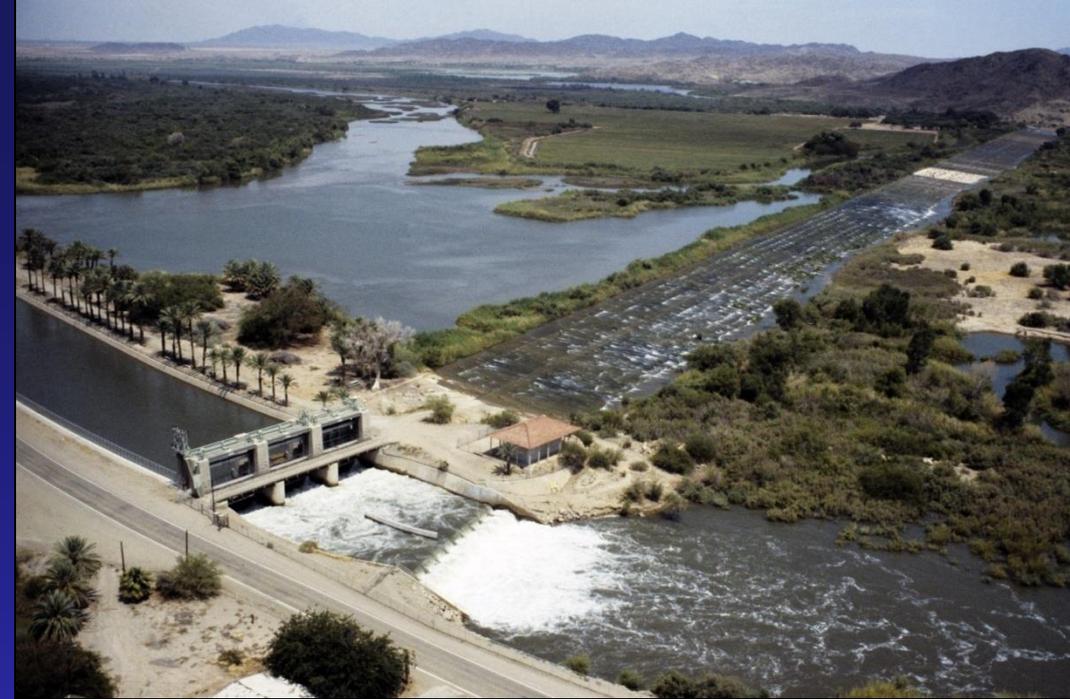
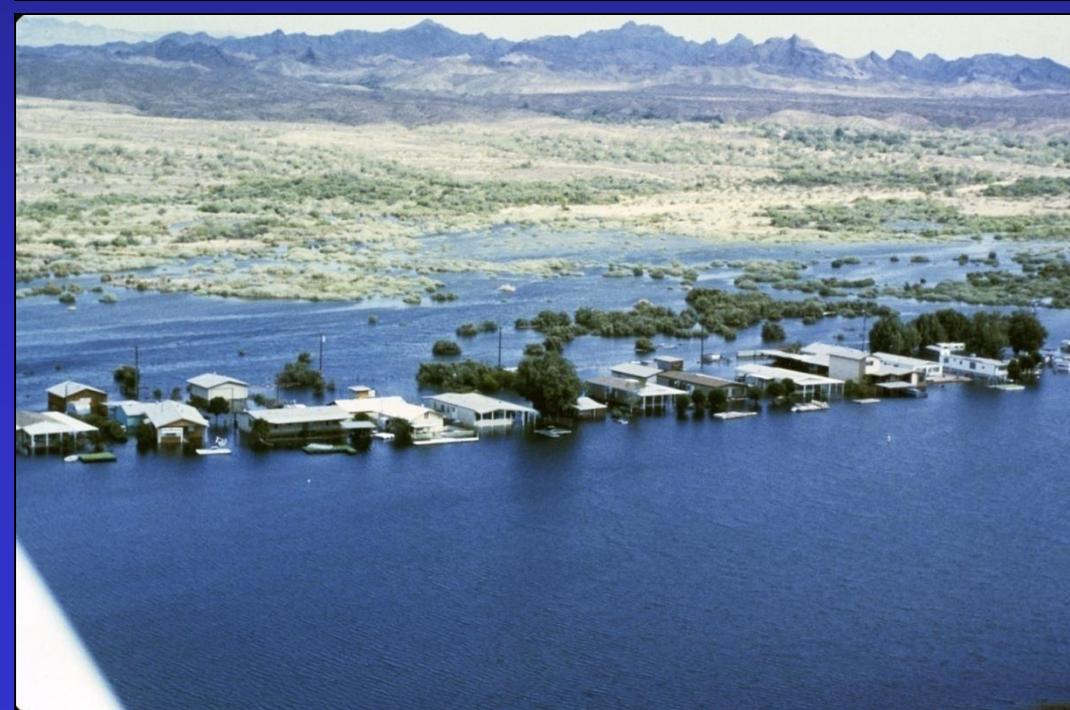
Record flows of 1983 on the lower Colorado River

- Aerial oblique view of the high water of summer 1983 overflowing the weir of Imperial Dam for the first time since the dam's completion in 1942
- Lower image shows inundation of vacation homes along the river in the Palo Verde Valley, near Blythe.

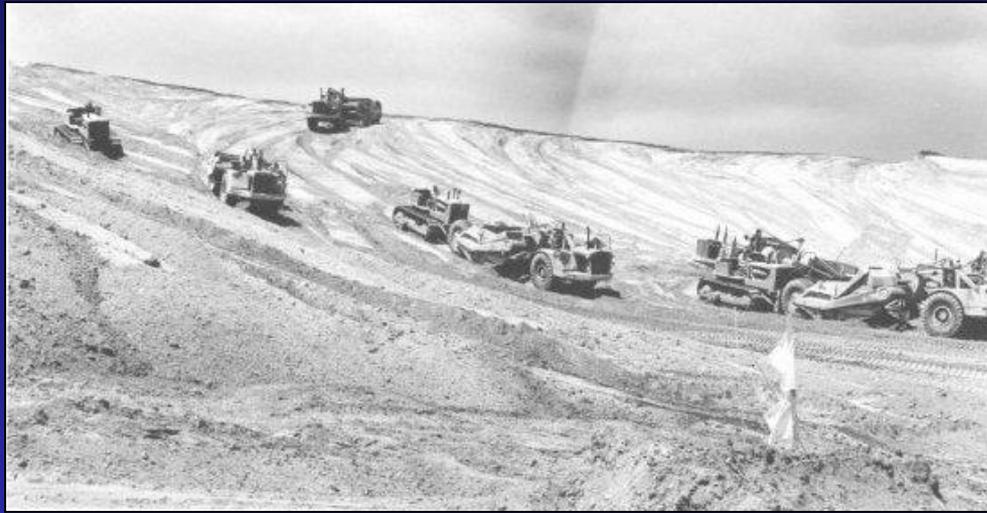
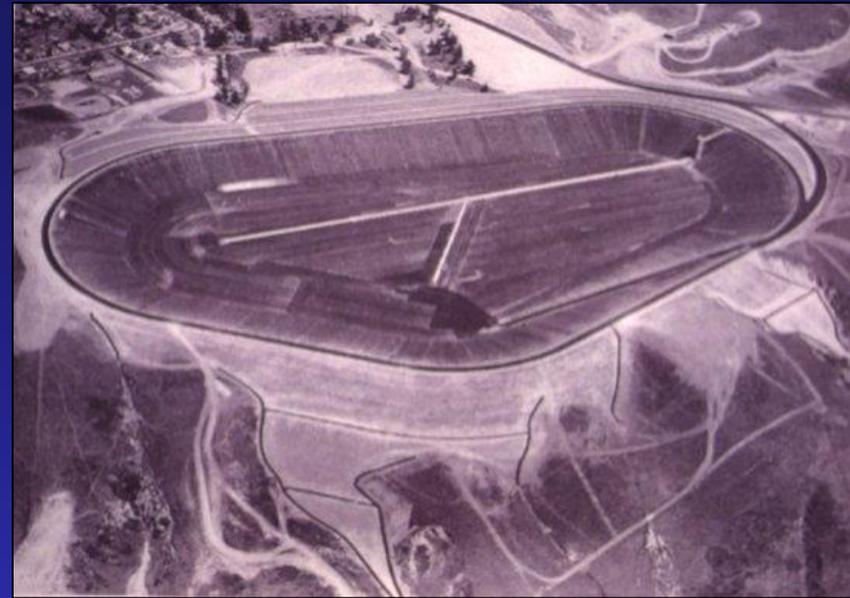
GARVEY RESERVOIR 1954-1988

- **Garvey Reservoir** was designed and built by the Metropolitan Water District in 1952-54 as an offstream storage reservoir. The embankments were up to 160 ft high and involved 3 million yds³ of grading on marine sandstones of the Repetto Formation of lower Pliocene age, in the Repetto Hills in Monterey Park, just east of downtown Los Angeles.
- The reservoir was shaken during the **Whittier Narrows earthquakes** on Oct. 1st (M_L 5.9) and 4th, 1987 (M_L 5.6). Piping leaks extended up into the lined reservoir floor, through openwork gravels, resulting in sand boils forming in the yards of homes constructed below the southern side of the facility. This was the first time hydraulic piping had proliferated beneath a continuous Hypalon reservoir liner.
- After several investigations, the State DSOD has refused to permit refilling and the reservoir is presently empty.

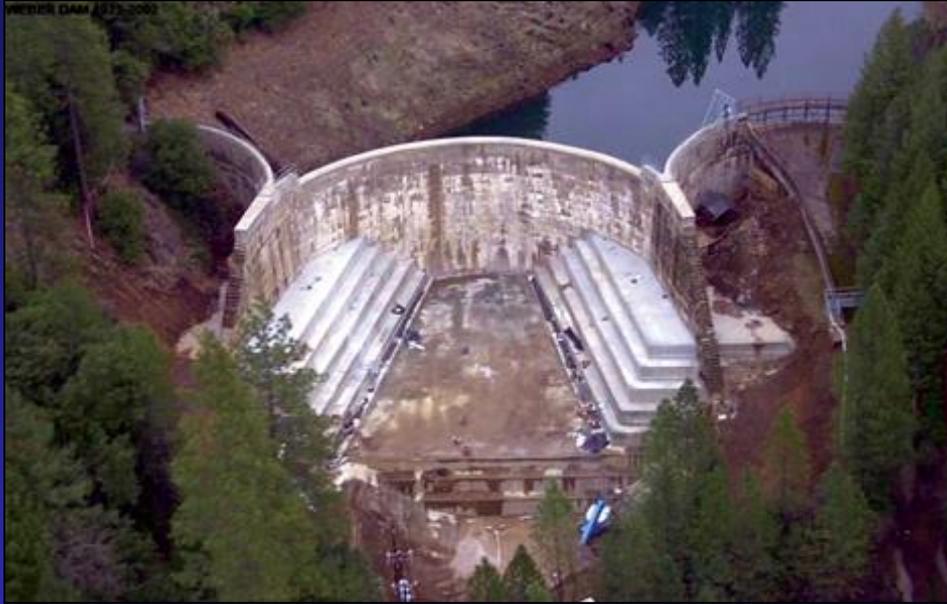
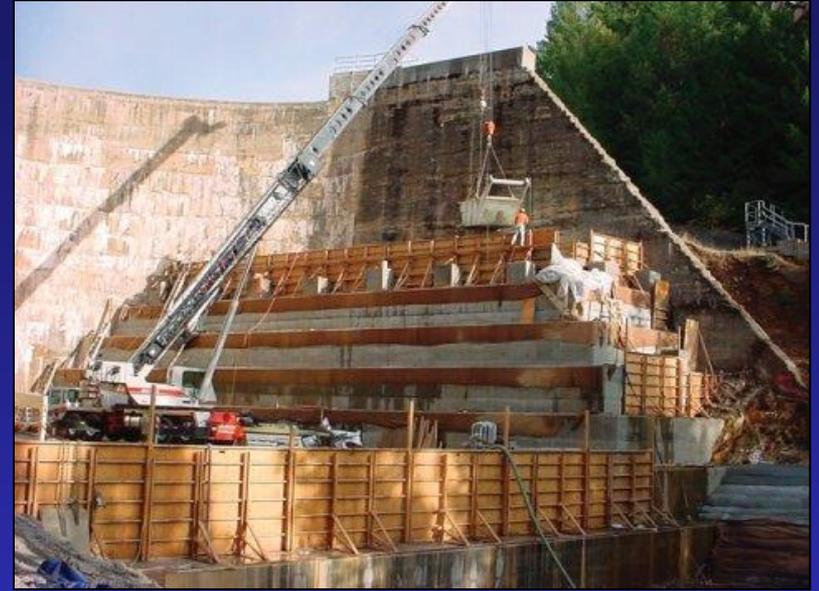
RETROFIT of EXISTING DAMS

- **Webber Creek Dam** is typical of many older structures across California. A multiple arch structure built in 1923-24, it was retrofitted in 2000-02 to increase seismic stability using **rolcrete technology**: a dry mix of concrete placed like compacted earth, which becomes stronger as it cures.

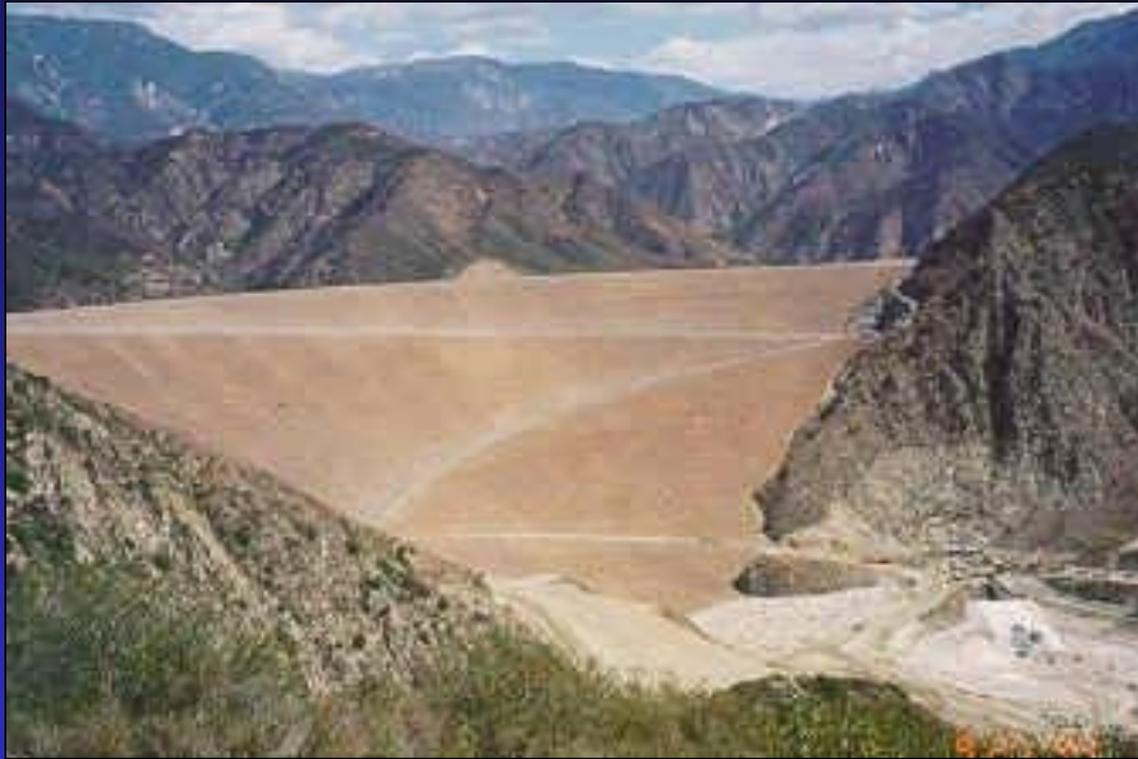
THE LAST BIG DAM ?

- **Seven Oaks Dam**, 550 ft tall and 37.6 million yds³, was completed in November 1999. It was designed by the Corps of Engineers and funded in 1986, following 20 years of environmental studies and legal battles.
- It is located along the upper Santa Ana River adjacent to the north trace of the San Andreas fault, near Mentone, CA
