# Overview of LANDSLIDE MITIGATION TECHNIQUES

**J. David Rogers, Ph.D., P.E., P.G.**

**Slope Stability & Landslides Course**

University of Wisconsin-Madison

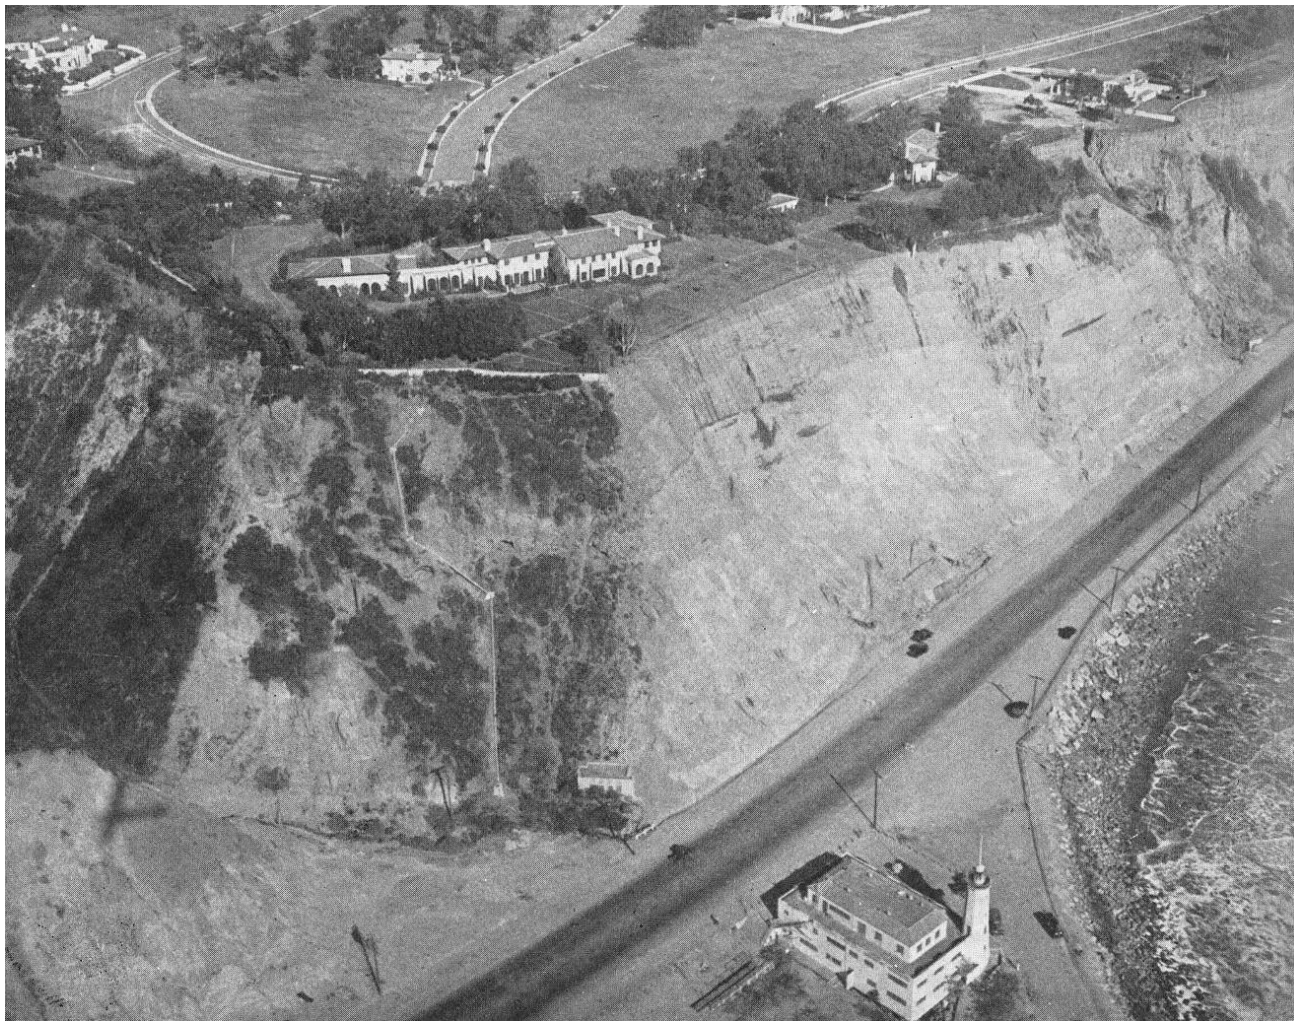
# 1932 Quelinda Estate Landslide

- The Quelinda Estate slide shut down Pacific Coast Highway in 1932.
- Los Angeles engineer Robert A. Hill attacked the clay seam at the base of the cliffs using hot air to desiccate the clay

- An ingenious system of tunnels were excavated and hot air was circulated through these to hasten desiccation of the low strength clay layer.

**The Quelimda Slide repair soldiered on successfully for about 15 years. At that juncture, the problem seemed solved because the site hadn't experienced any additional sliding, so the decision was made to shut down the furnace and the blowers.**

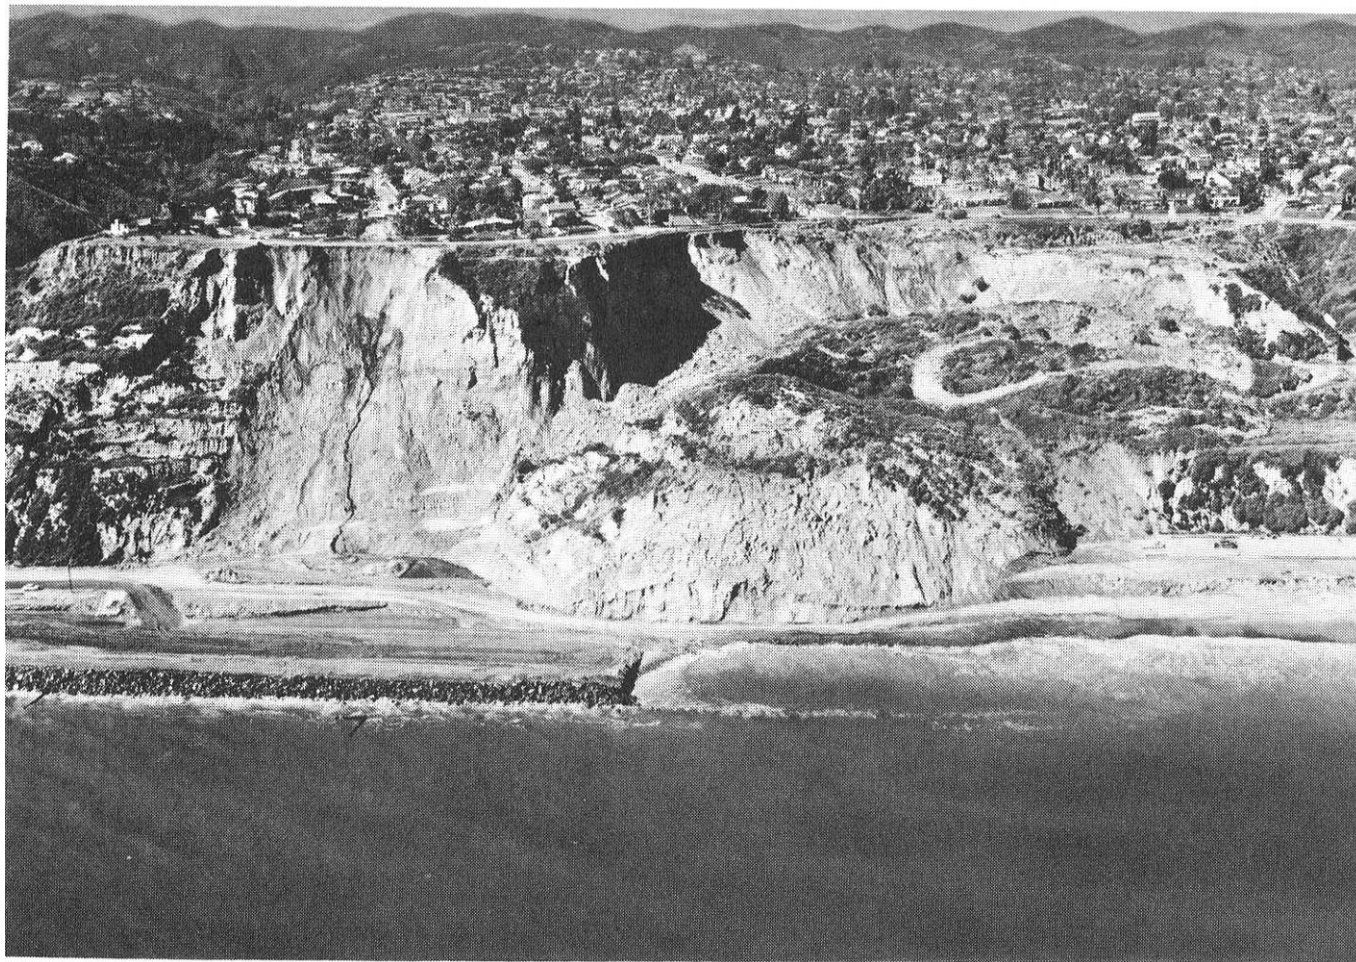
- The 1958 **Via de Las Olas Landslide** in Pacific Palisades closed Pacific Coast Highway and drew the City of Los Angeles into costly litigation.
- The City hired Mueser-Rutledge of New York City to make a comprehensive two-year study, which included mapping slides along 15 miles of coastline.

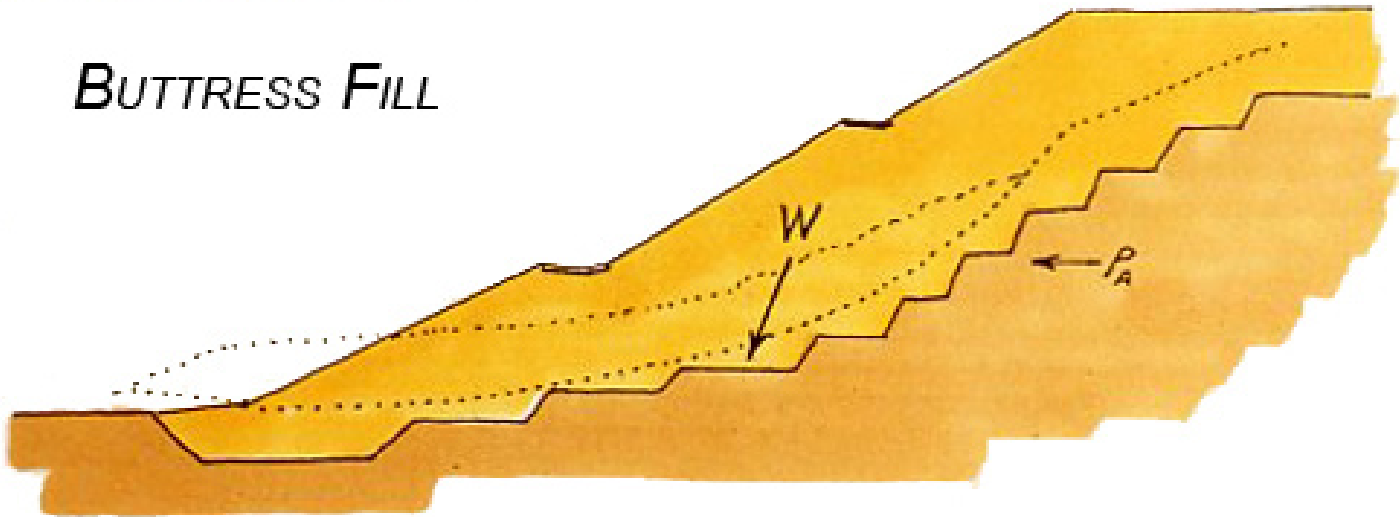
DEAD WEIGHT OF FILL,  $W$ , RESISTS LATERAL PRESSURE  
OF THE ADJACENT SLOPE,  $P_A$

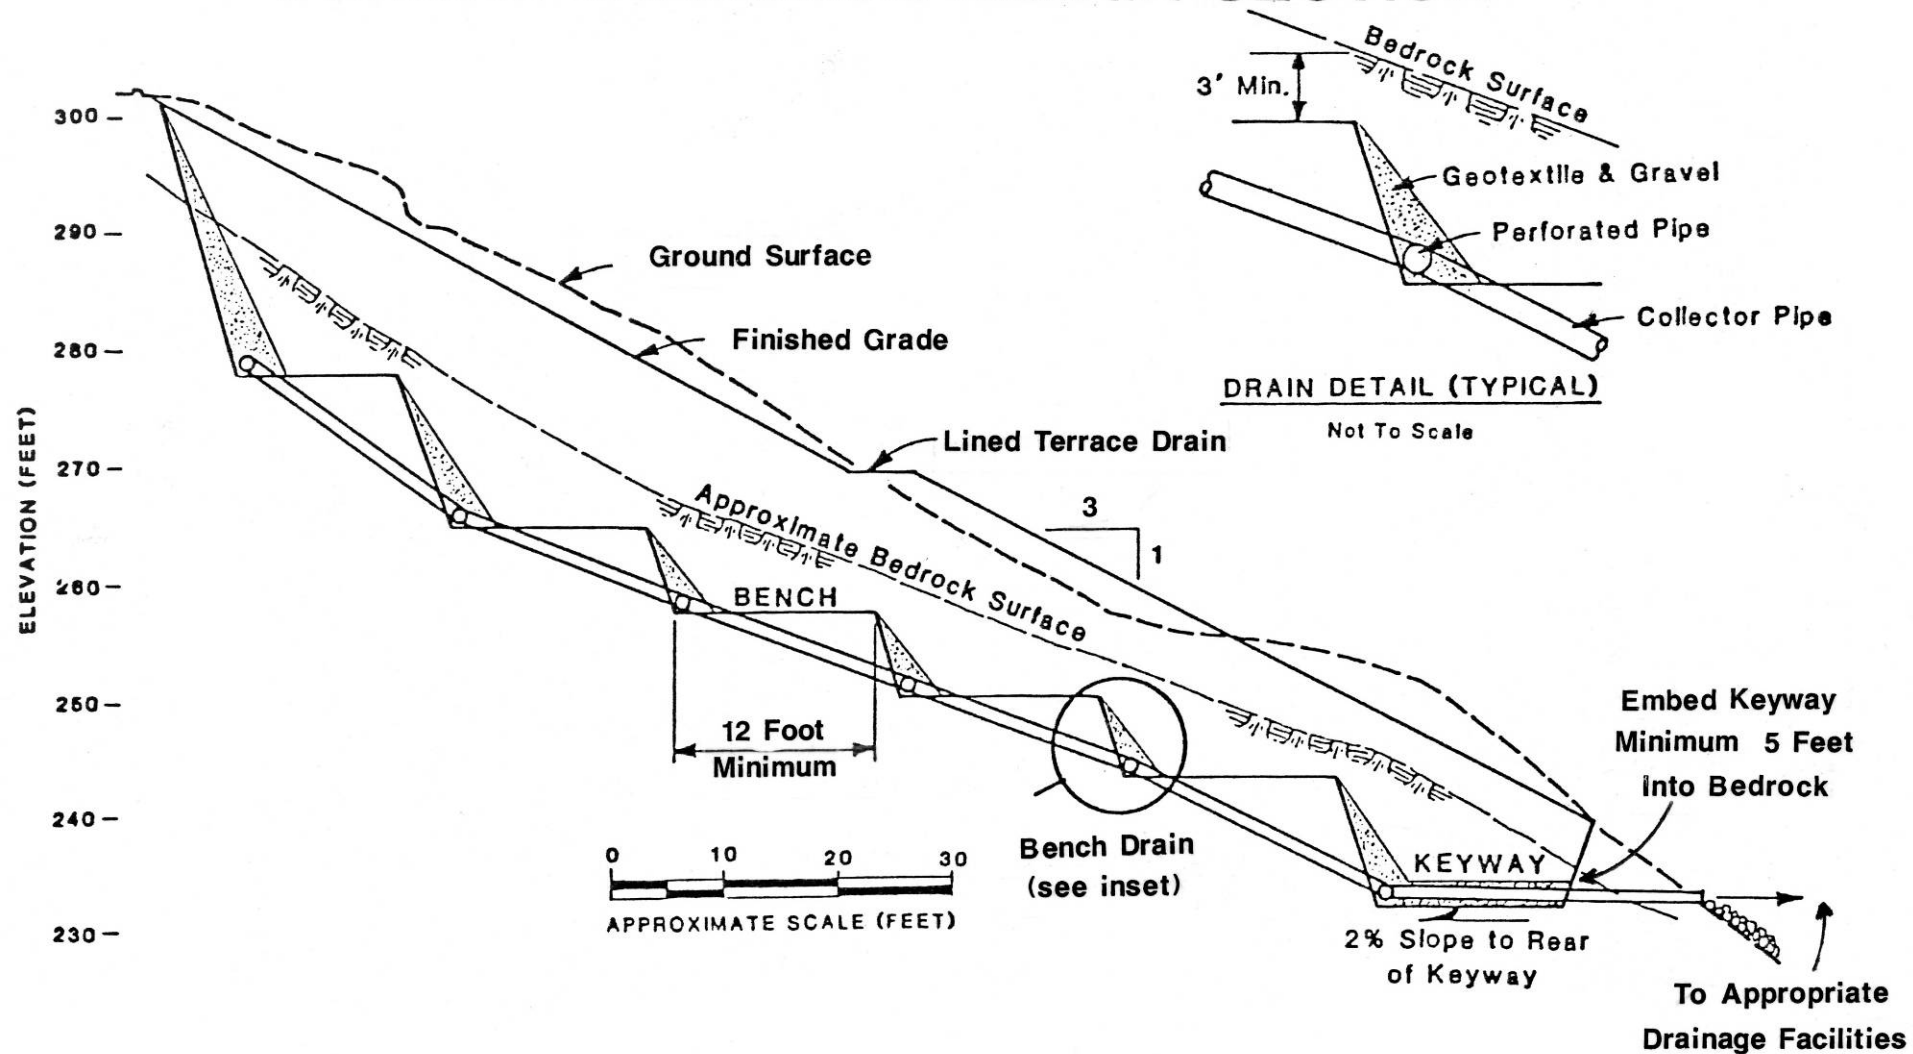
# TYPICAL LANDSLIDE REPAIR SECTION

- **Standard scheme for recompacted buttress fill repair of landslides using mass grading, adopted by City of Los Angeles in 1967.**

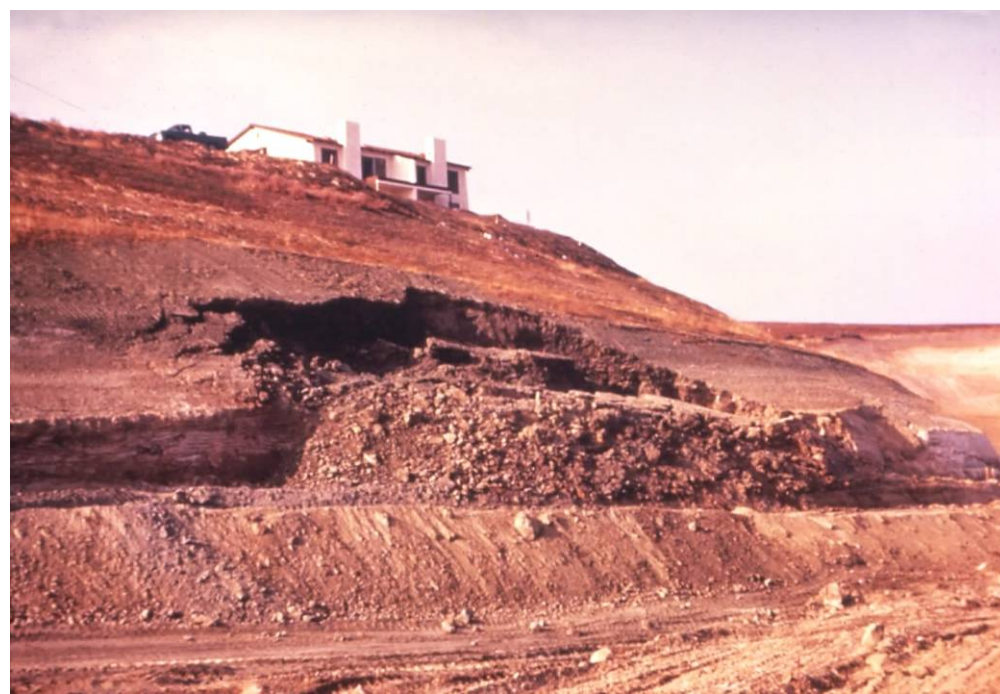
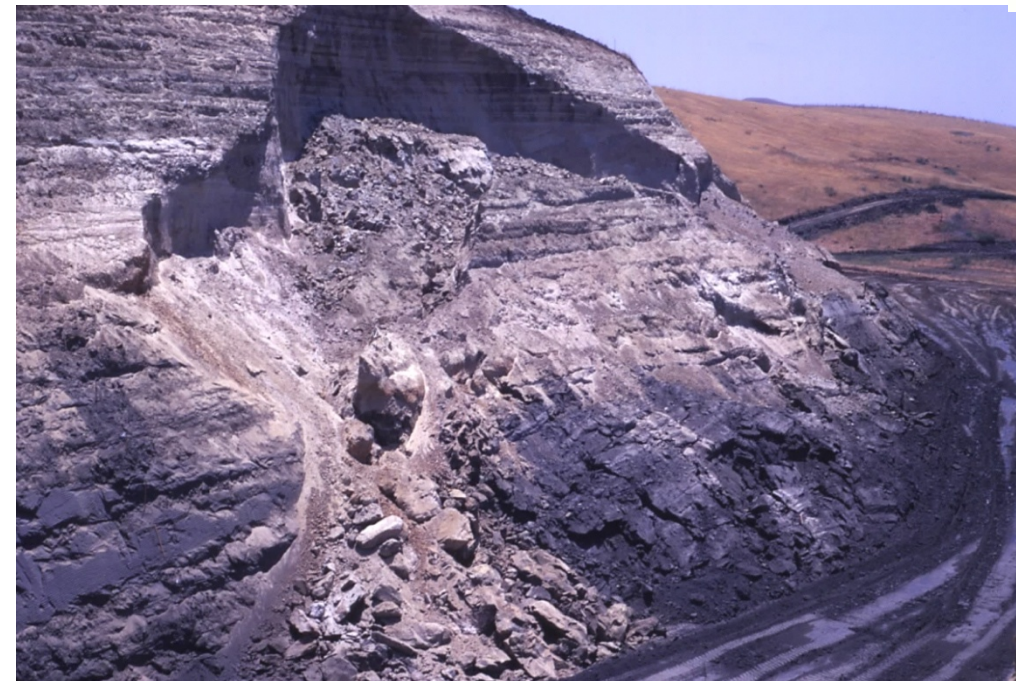
# Backslope Failures

**Backslope failures are common on slide repairs. These materials should be over-excavated as the fill buttress is brought upward, disaggregating the failed material and compacting it in the fill.**

**Do not leave the failed mass in-place; it will become a gigantic tension crack.**

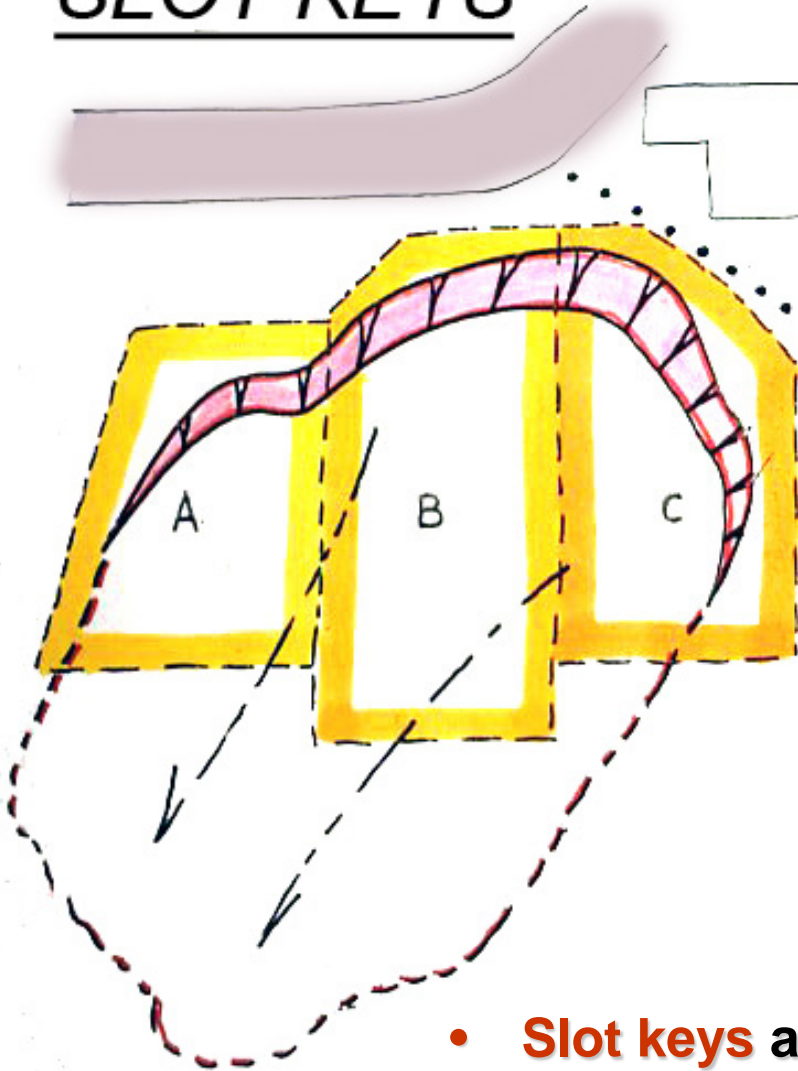
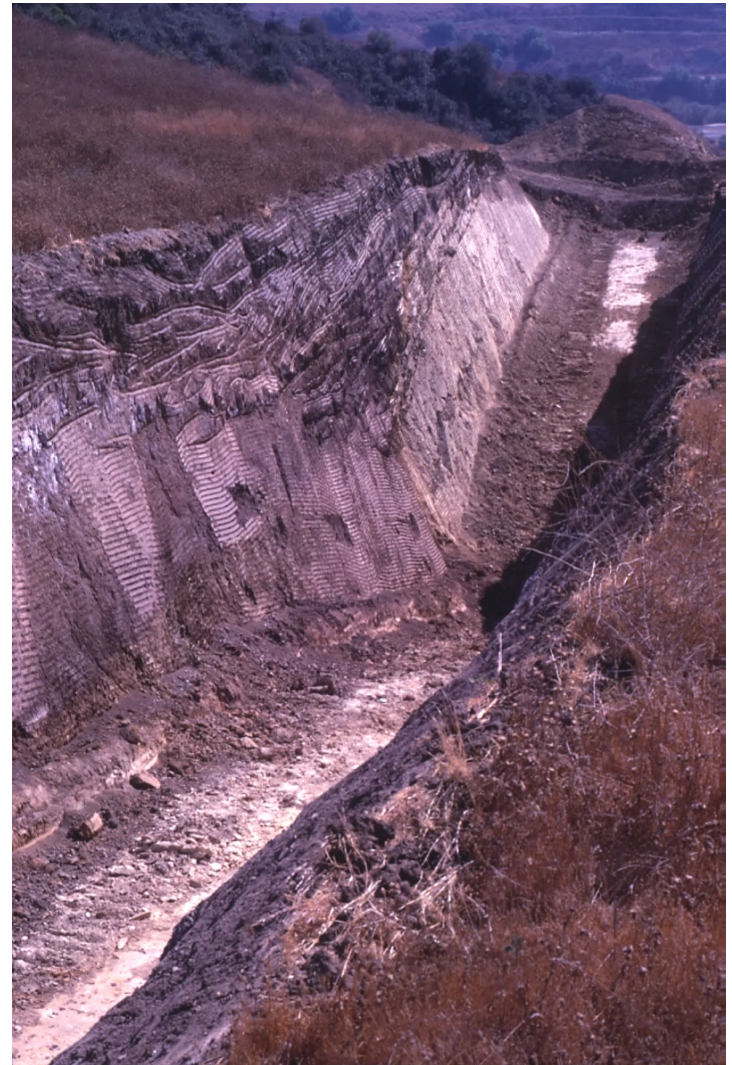
# SLOT KEYS

- **Slot keys** and **pin piles** are two options that can always be used to effect earthwork repairs in tight access situations, but the unit costs will be double or triple what they otherwise might be.

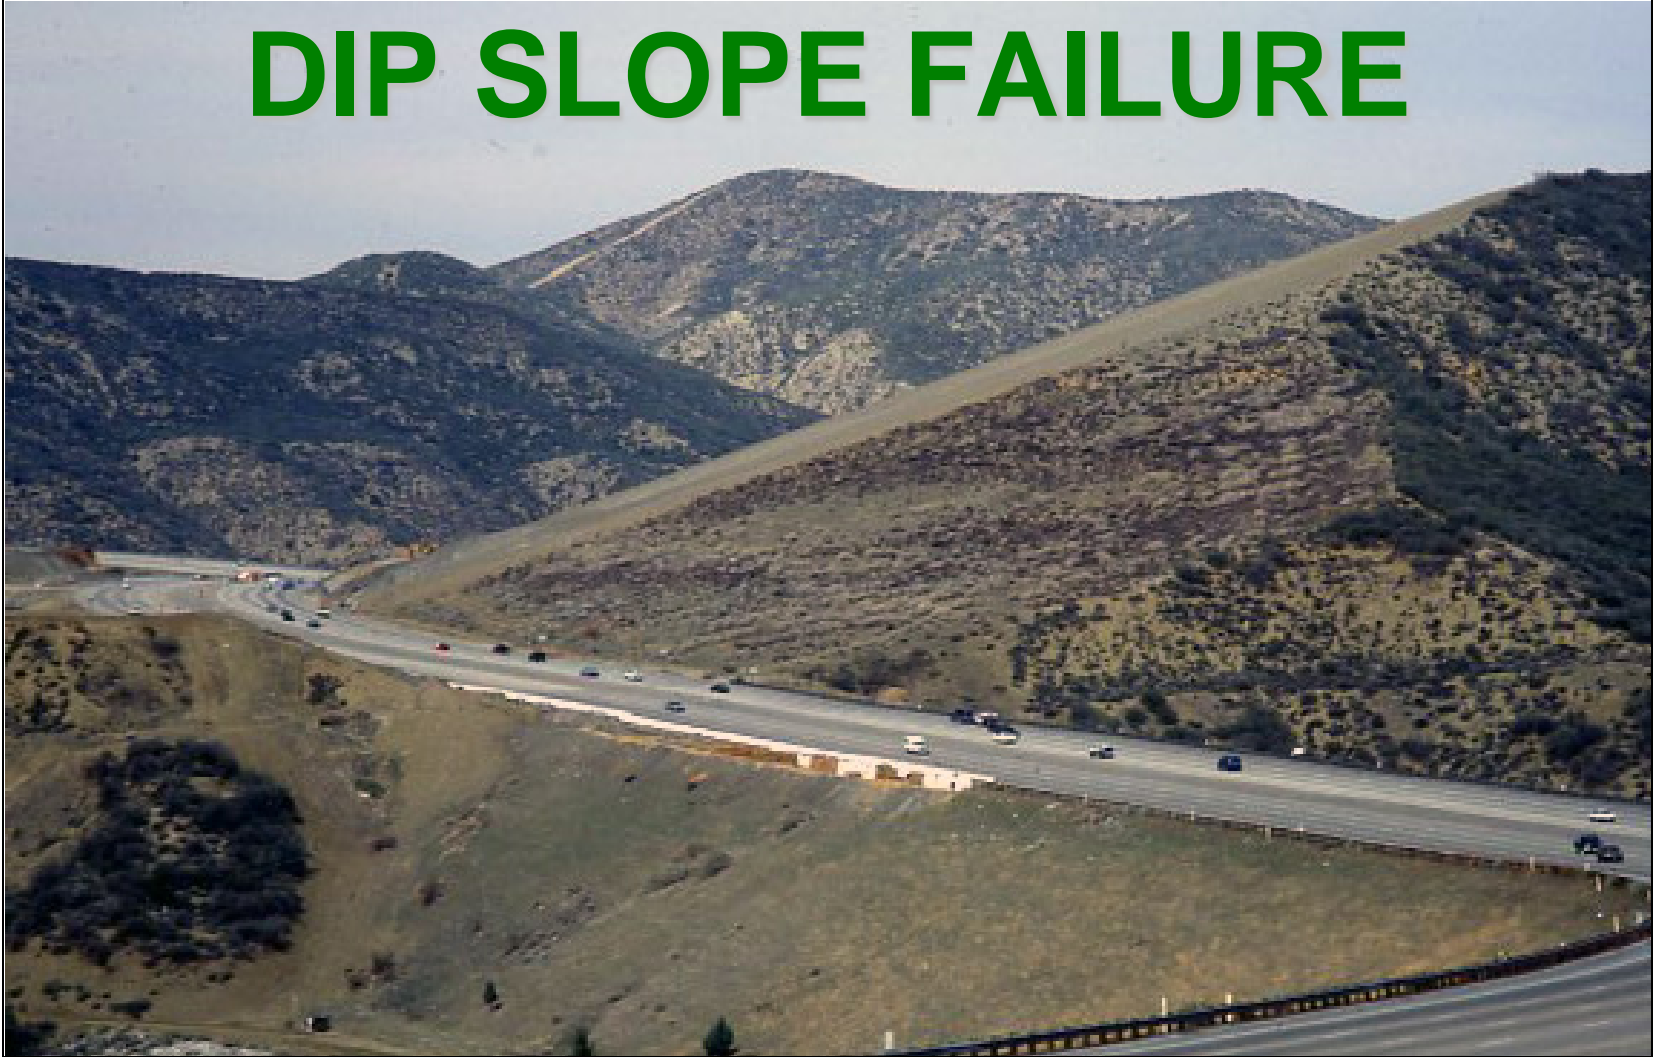
# DIP SLOPE FAILURE

- **Mitigation of a major dip slope failure along Interstate 5 on the Ridge Route (Grapevine Pass) through the Tehachapi Mountains in California. What had originally been a 1:1 cut, had to be laid back to its apparent dip of 30 degrees.**

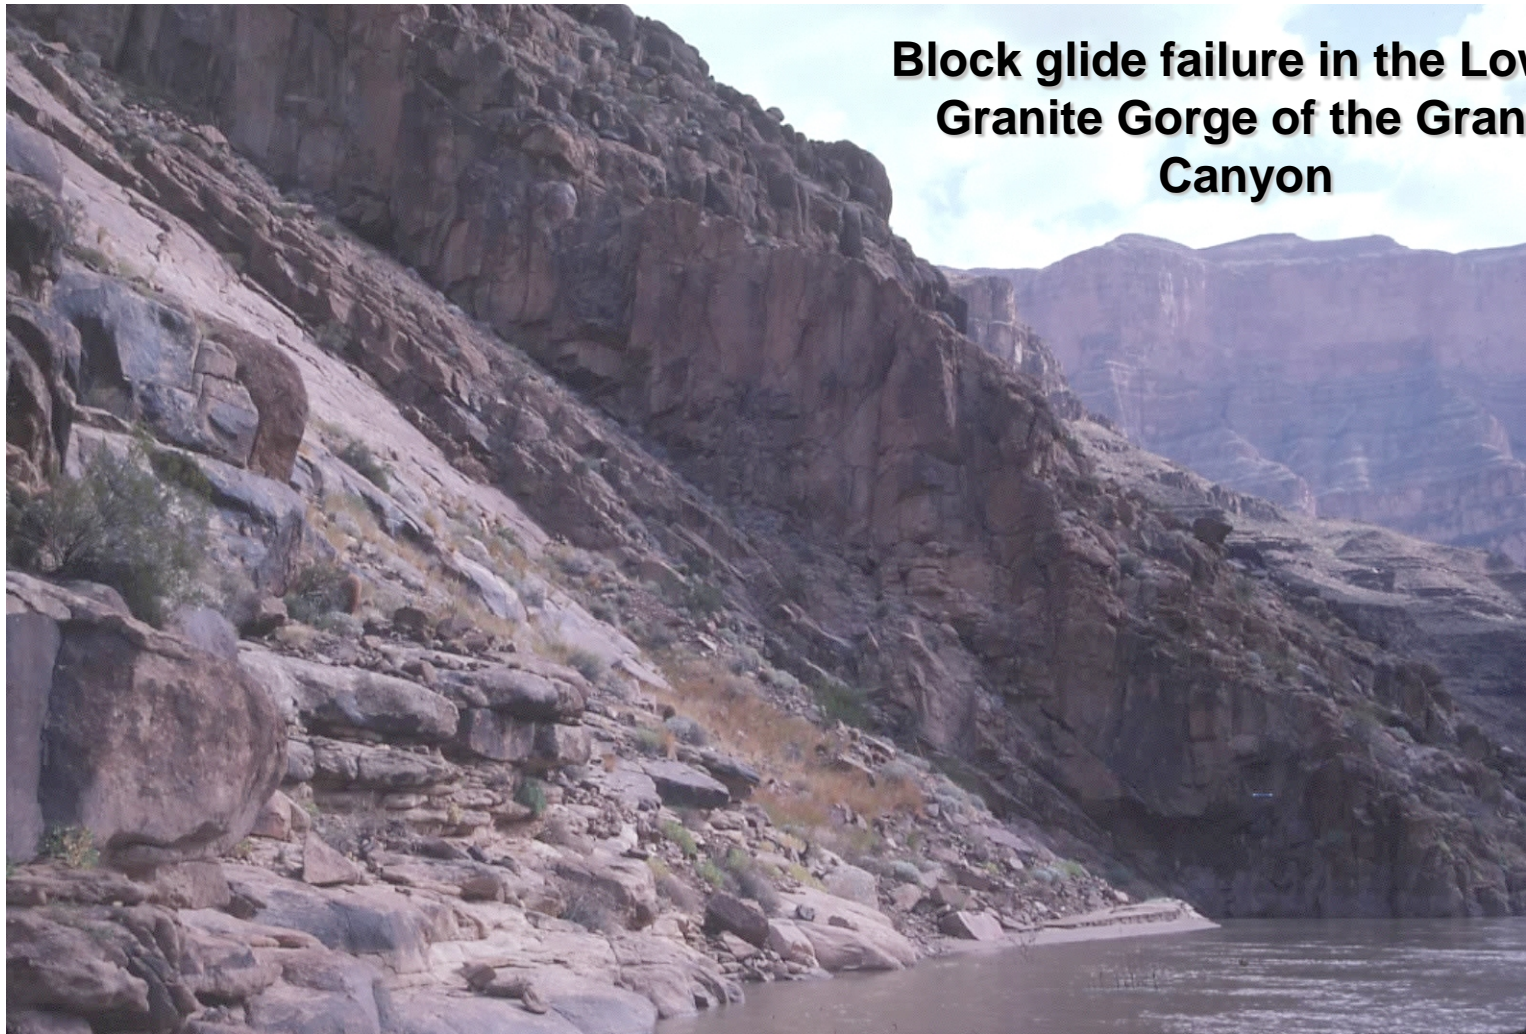
## Block glide failure in the Lower Granite Gorge of the Grand Canyon

- Dip slope conditions are also created by **inclined discontinuities**, such as systematic or secondary valley-side joints; especially in strongly foliated rocks, such as schist.

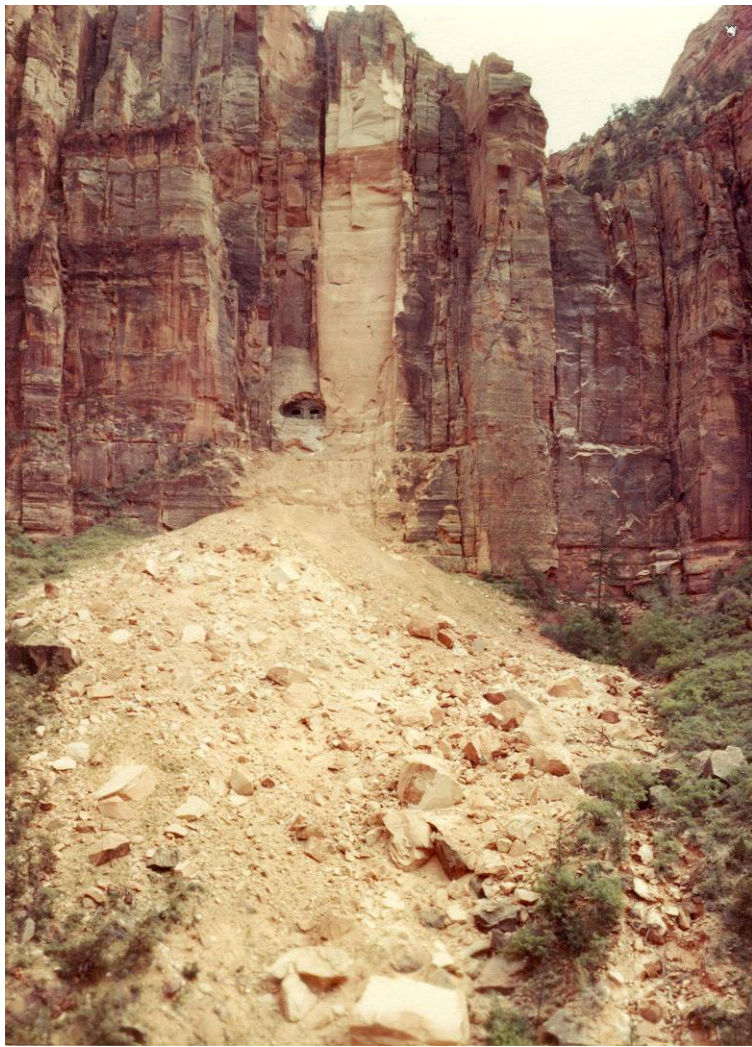
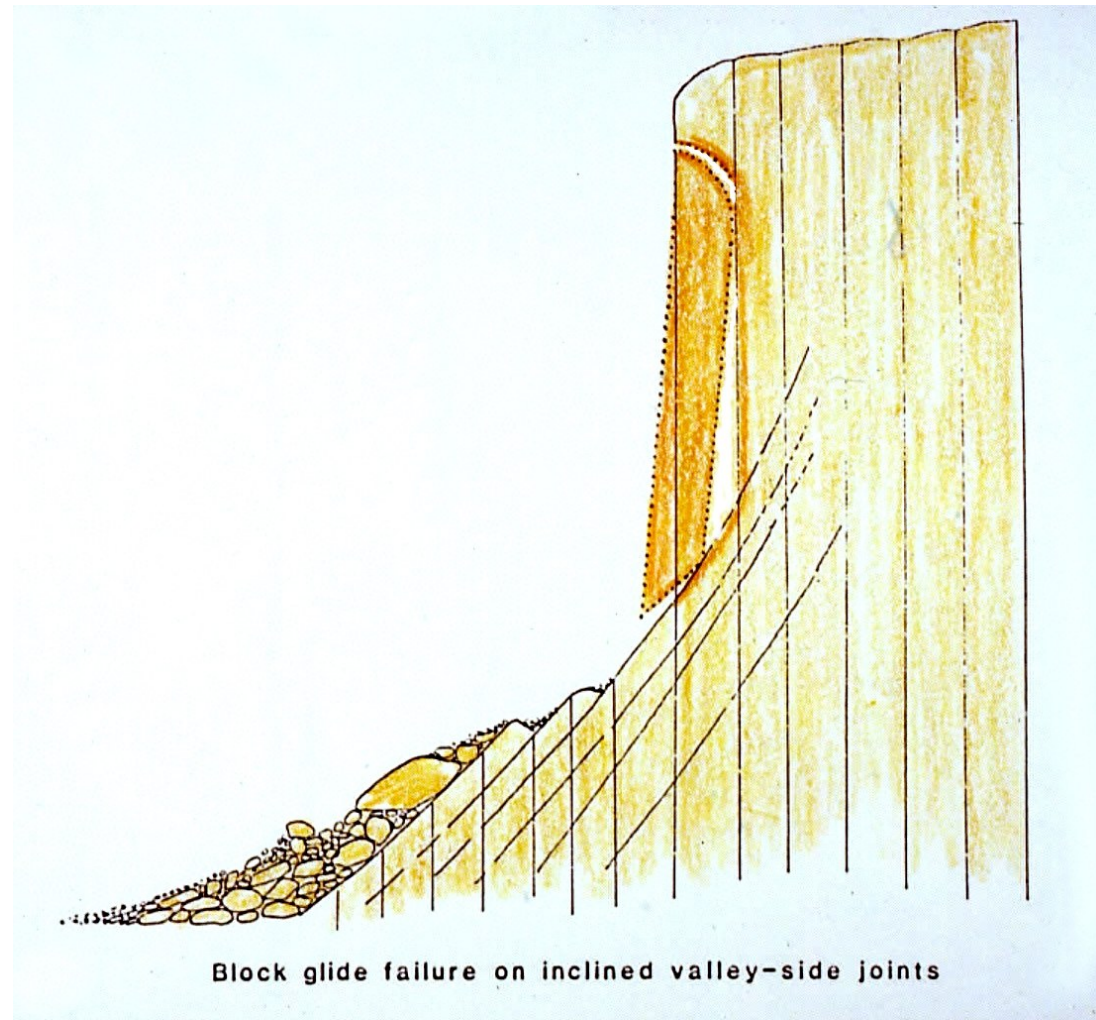
- Inclined **valley-side joints** span most rock falls along steeply inclined escarpments, as sketched here.

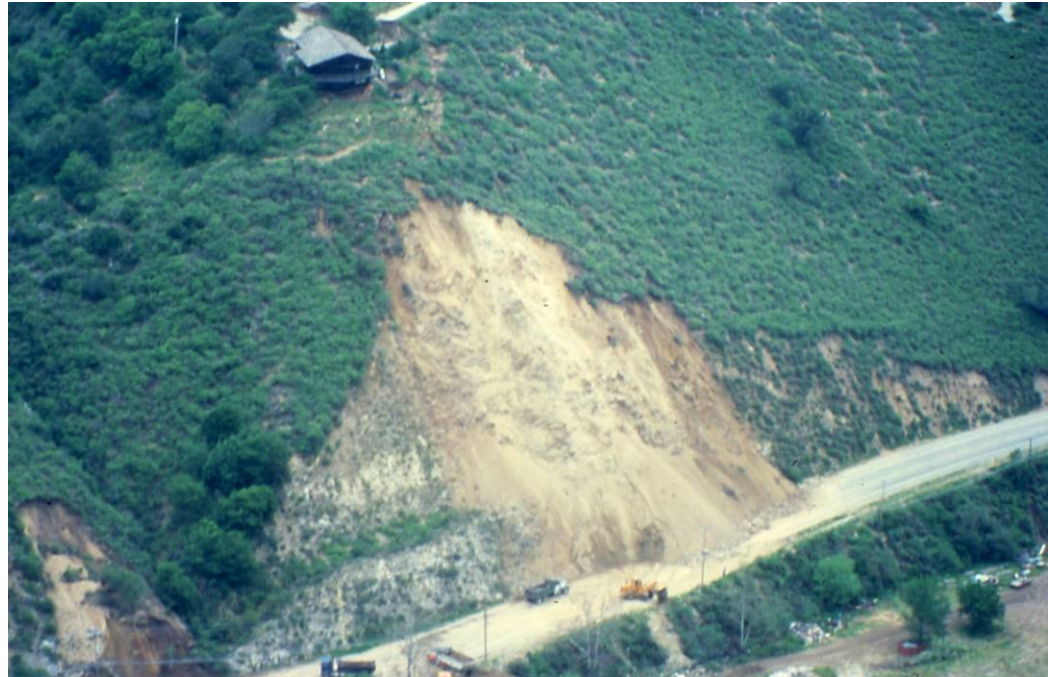
# Planes of foliation

- Carmel Valley Landslide of March 1983, in massive biotite gneiss
- 45 degree cut slope made in 1940
- Foliation dipping back into slope
- Massive **toppling failure** along inclined joints

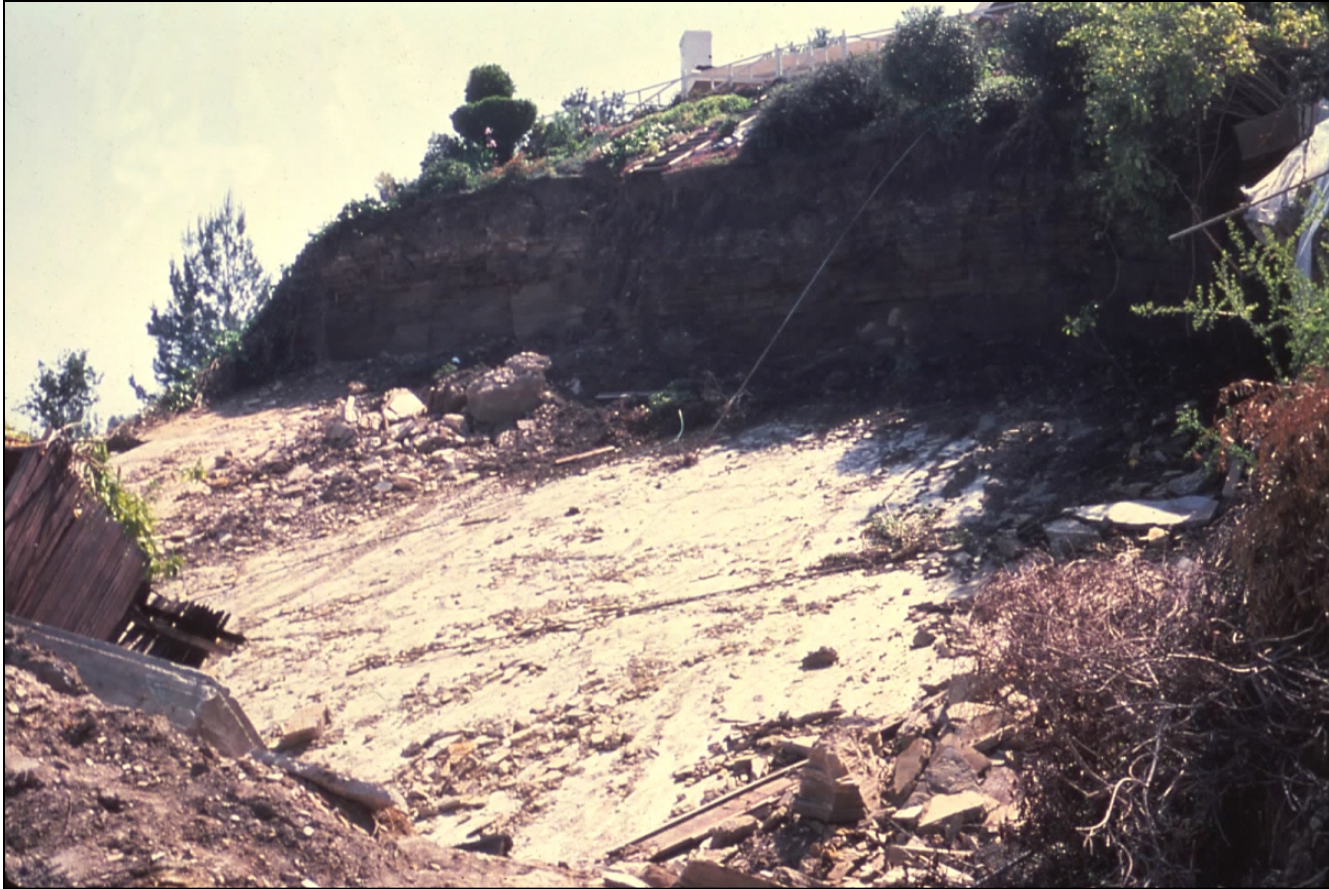
# DIP SLOPE FAILURE

- **Dip slope failure caused by surcharging slope with unkeyed fill and excavating toe of slope for development. Failure occurred along inclined bedding plane.**

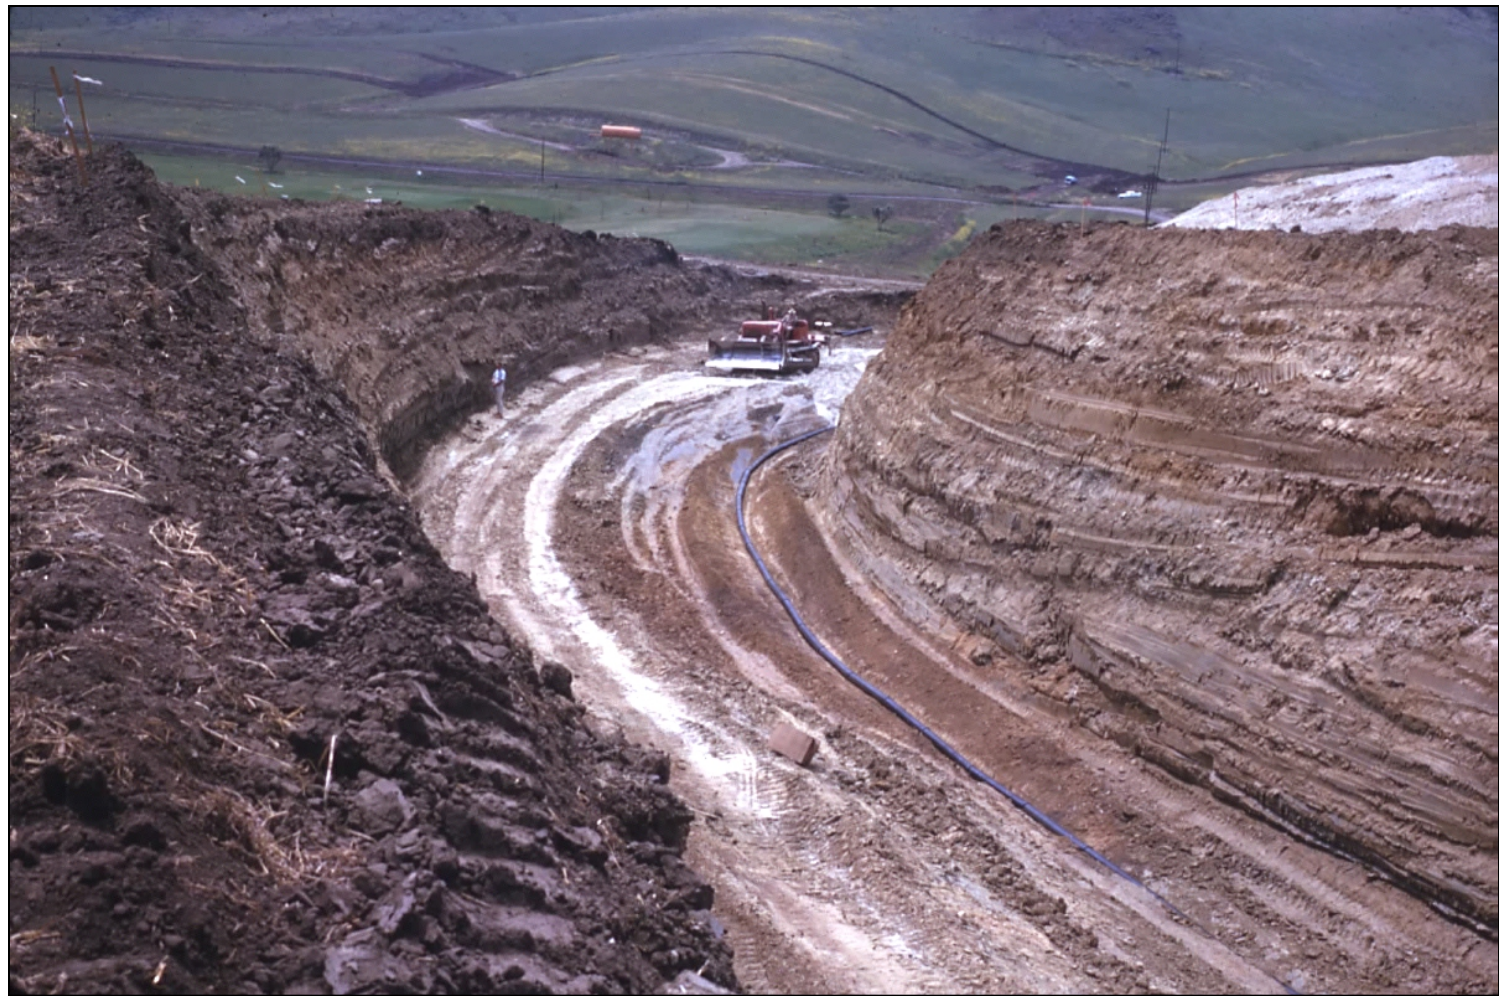
- Proper keying and benching of engineered fill requires **overexcavation** and **on-site engineering geologic observation**.

- The toe-of-fill keyway is the most important part of an embankment. It bears the overall thrust of the slope and usually contains the lowest subdrainage

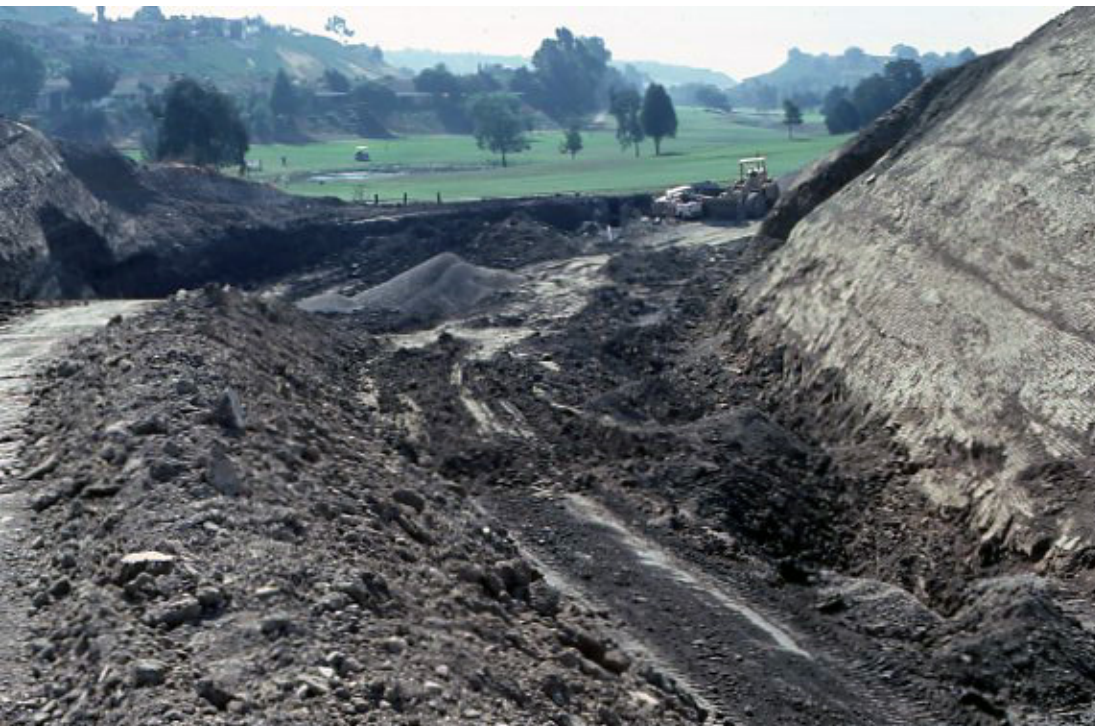
- **Shear keys and toe-of-fill keys need to extend beneath zones of past movement, such as the bedrock creep zone or zones of past and/or ancient landslippage**

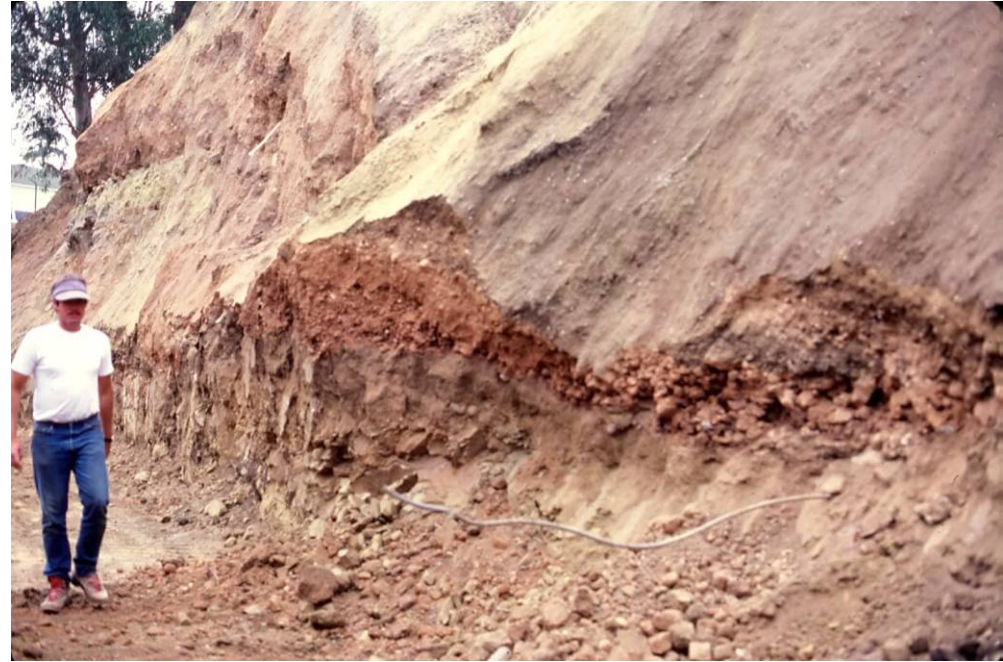
# Engineering geologic inspection needed

- Many buttress slide repairs have failed because the keyways were not extended to sufficient depth to intercept older slip surfaces. Keyways need to be observed by competent engineering geologists.

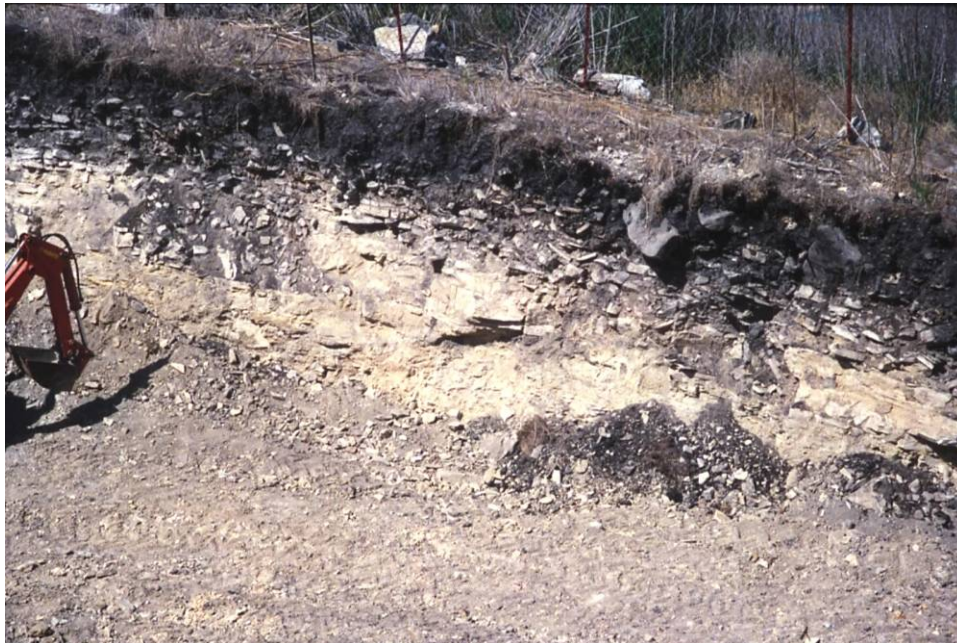
- A bedrock creep zone always exists on sloping ground; you just have to look for it. **Water** percolates through this zone. So it is of critical import.

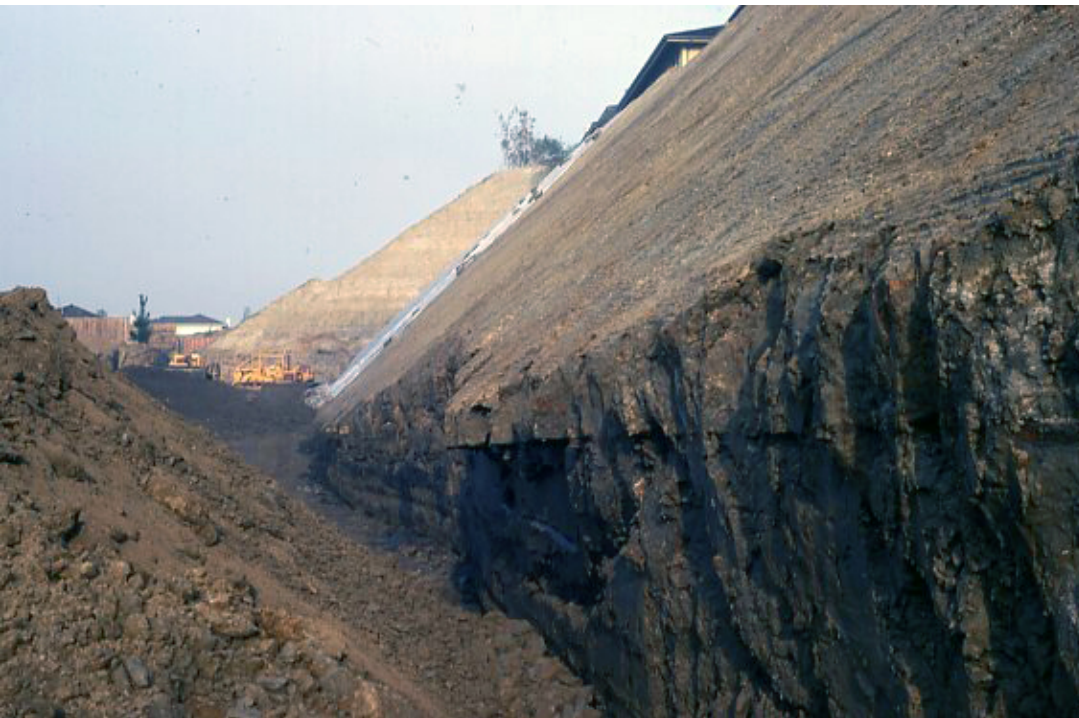
- Some slip surfaces are easy to see; many older, deeper surfaces are not easily recognized.
- The engineering geologist should also search diligently for *old slip surfaces*, which are often buried beneath active surfaces.

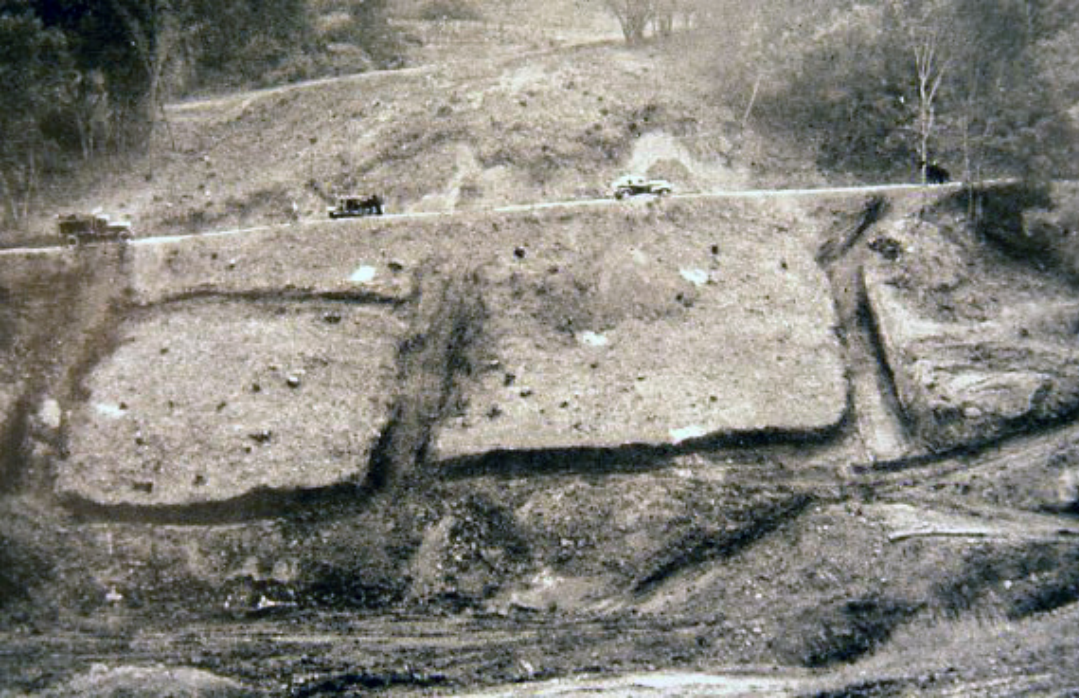
# Subdrains within embankments

- In 1938 the Cal Div Hwys began using drained embankments where slope stability problems were being experienced.

This shows subdrain trenches for embankment along the new Los Gatos-Santa Cruz Hwy

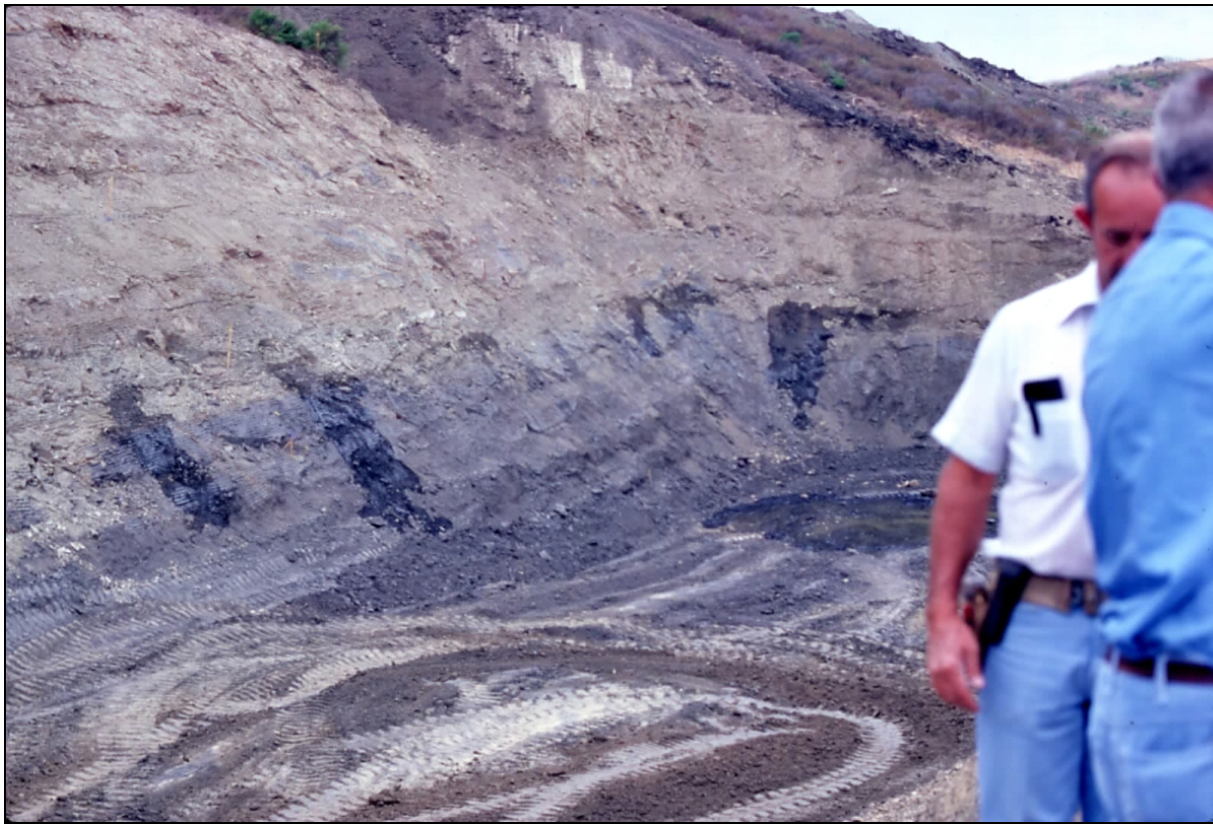
- Temporary backcuts should be inspected carefully, looking for physical evidence of **active seeps**, such as those shown above, along the contact between the weathered band and unweathered zones. **Evidence of past seepage, such as carbonate (caliche) is also valuable.**
