# Overview of LANDSLIDE MITIGATION TECHNIQUES

**J. David Rogers, Ph.D., P.E., P.G.**

**Slope Stability & Landslides Course**

University of Wisconsin-Madison

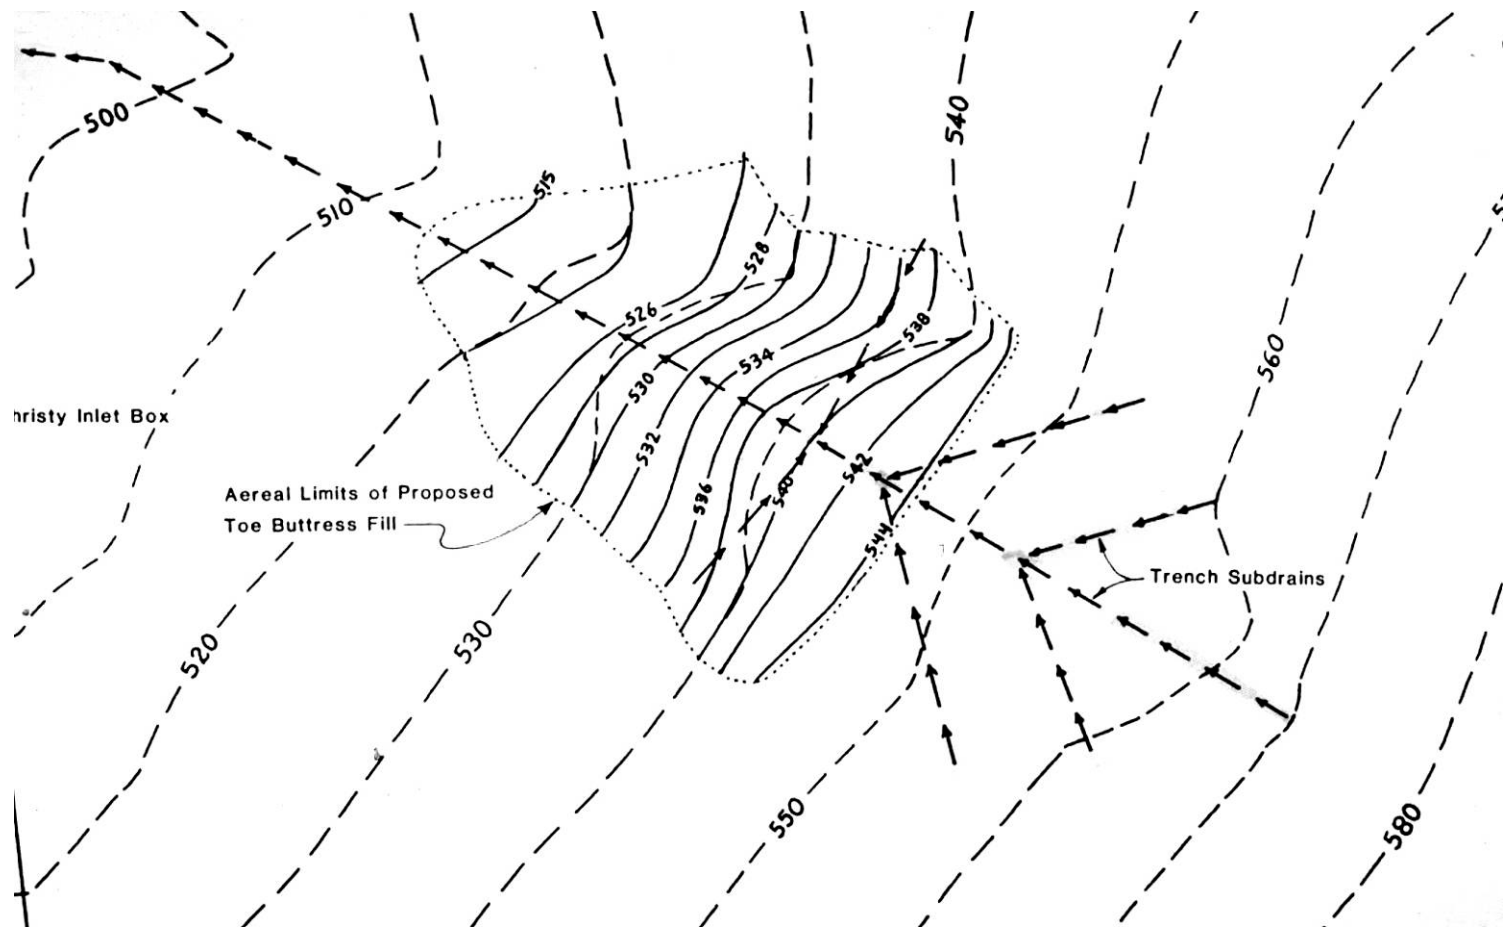
- Typical work plan for a **“birdfoot drain” slope repair**, employing a herringbone-shaped array of rock-filled trenches, sloped downhill to promote gravity flow (without collector pipes).

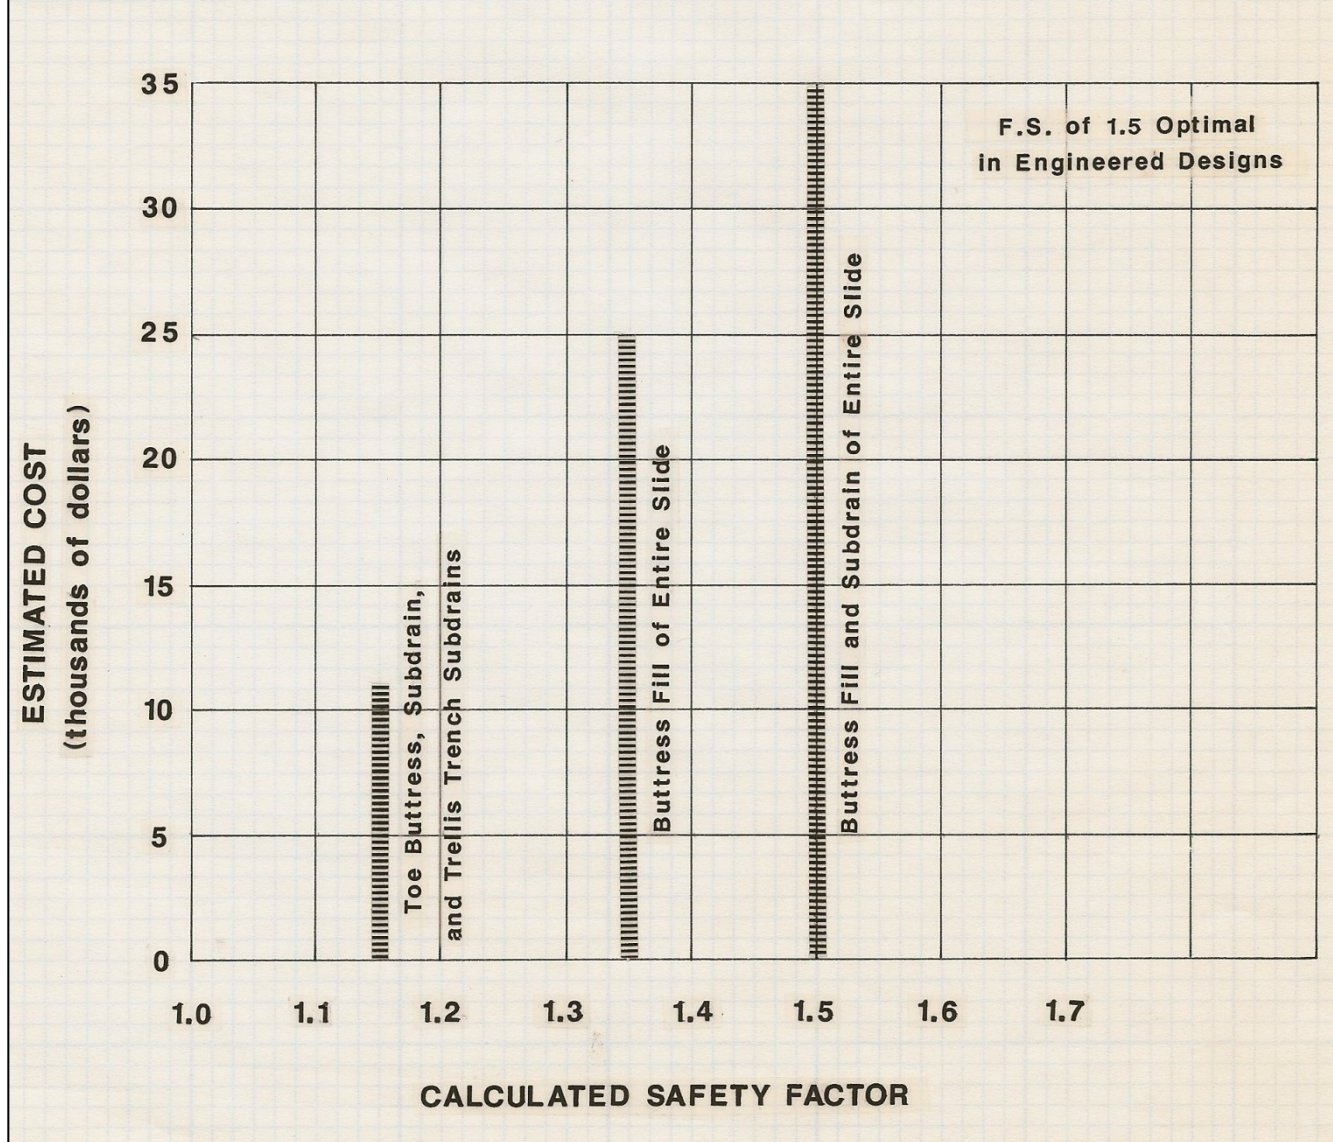
- **Cost-benefit analysis** of various schemes to repair a recently-active landslide, employing birdfoot drains or conventional buttress fill with subdrains. Note diminished factor of safety, which should be assessed using a **risk-consequence matrix**.

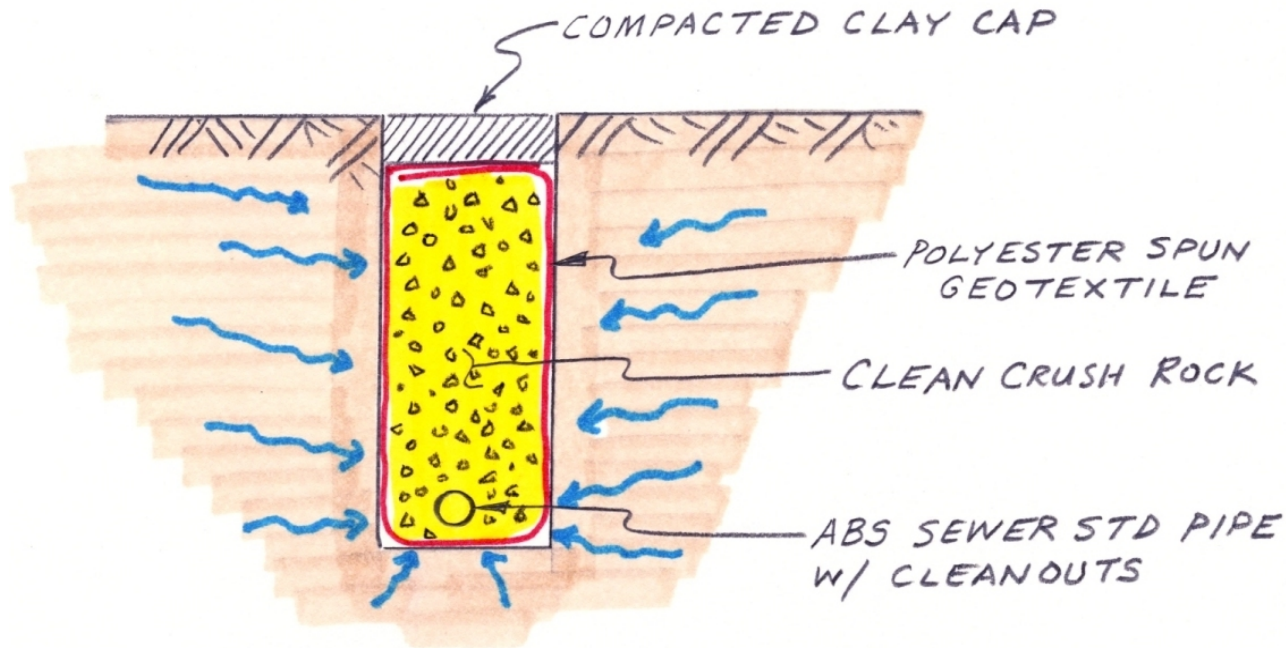
# GEOTEXTILE FILTER ENCASING A TRENCH SUBDRAIN

- Subdrains should be placed along the axes of former water courses, where they will be most effective – collecting water that percolates along “seepage conduits” developed over eons of time in native ground.

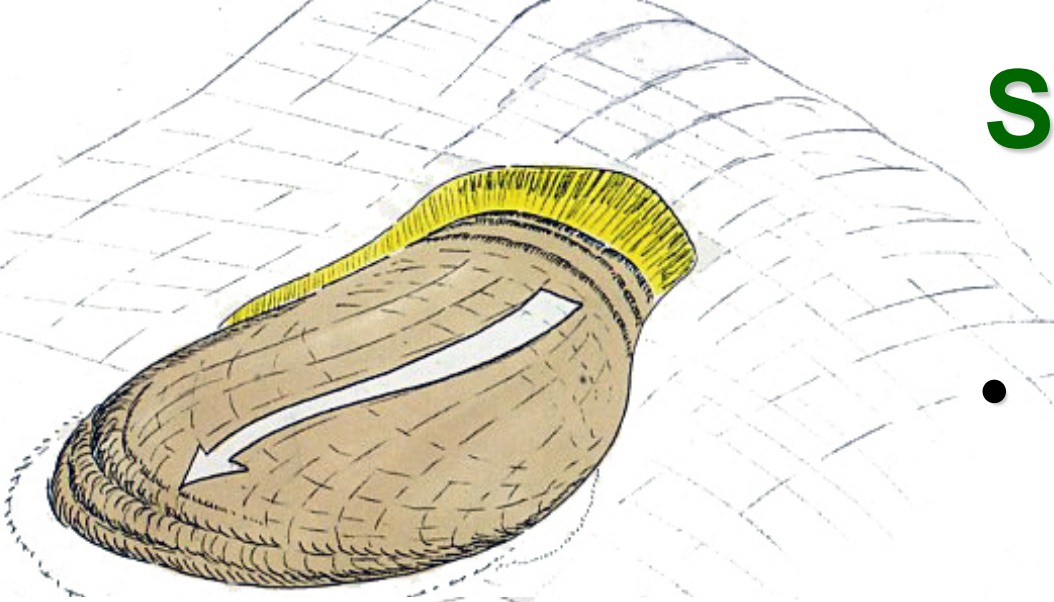
# States of Stress in a landslide

- The upper third of a landslide usually exhibits **active earth pressures**
- The neutral axis exhibits **at-rest pressures**
- The lower two-thirds of the slide can generate **passive earth pressures**

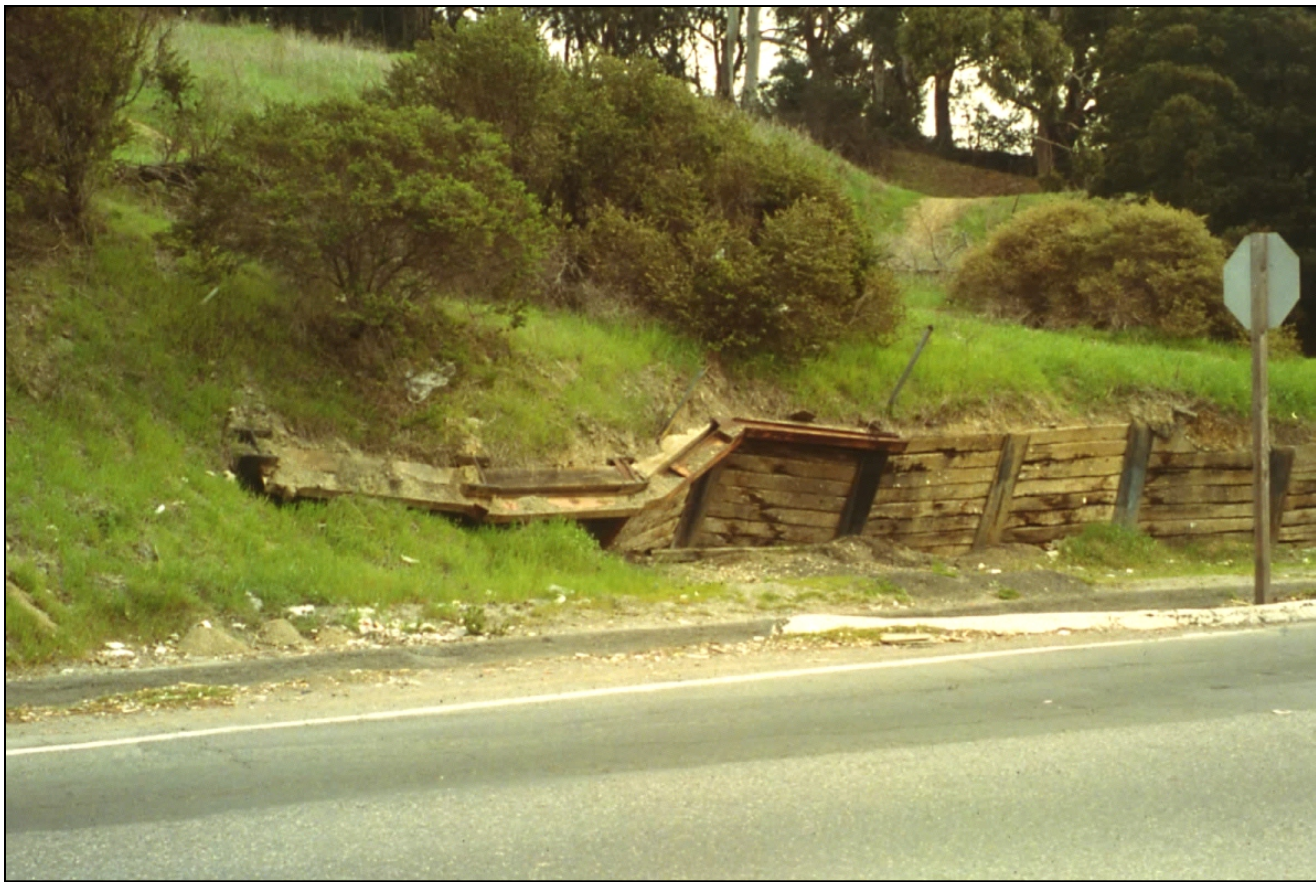
- **Bending failure of a 36-inch wide flange H-beam retaining wall constructed at the base of a creeping slope in Richmond, CA.**
- **The wall was not designed to resist the passive loads to which it was subjected**

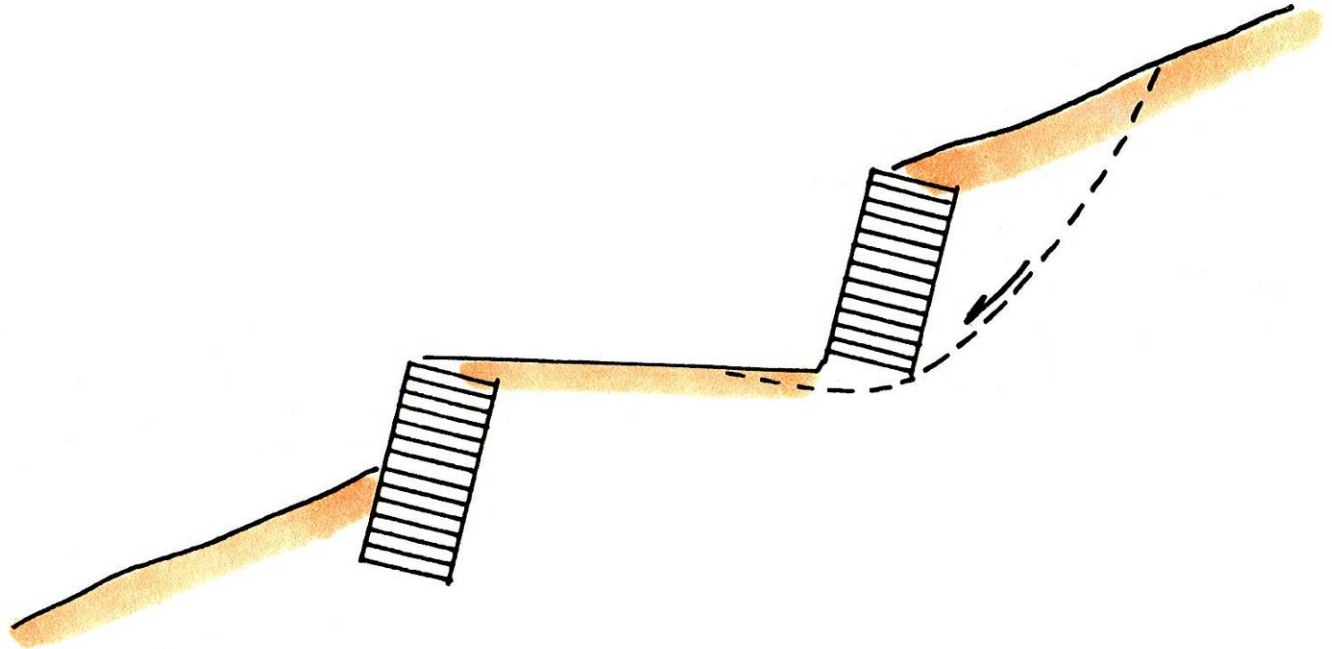
## Inadequate Toe Embedment

- Another common failure mode for crib walls constructed on hillsides is **inadequate toe embedment**, on either uphill or downhill walls, as sketched above.

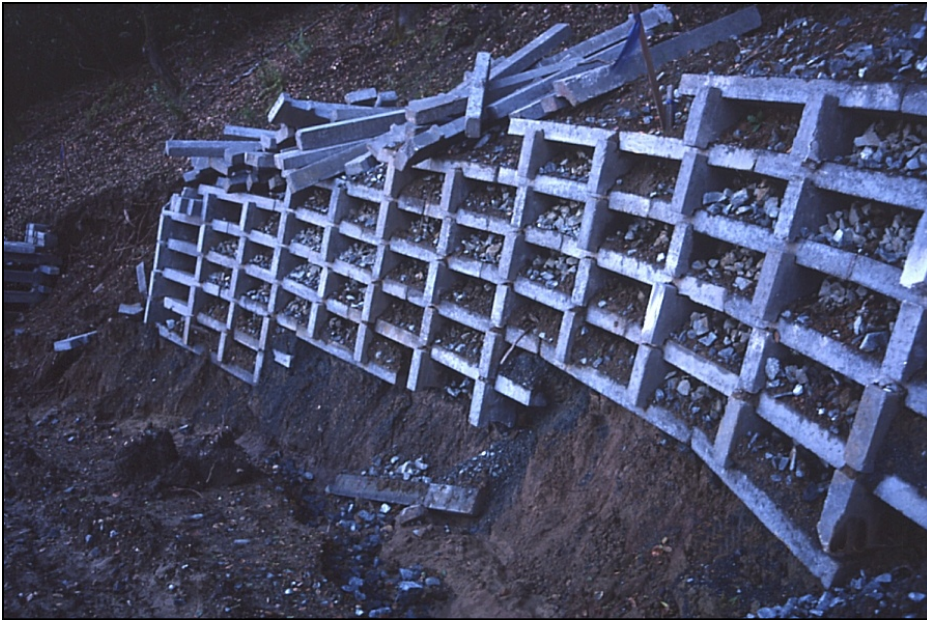
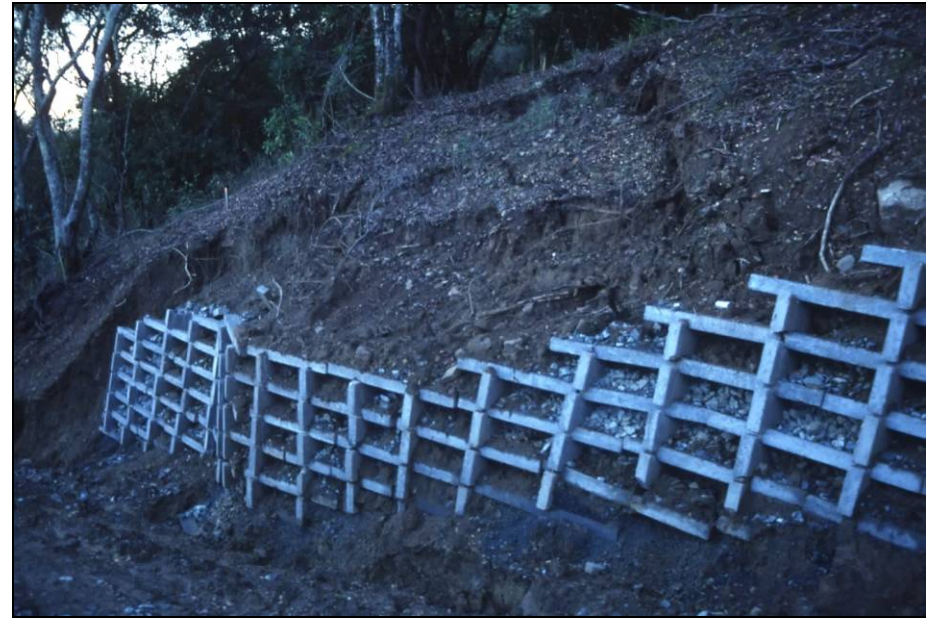
These failures occurred due to **inadequate toe embedment**. The contractor constructed the walls, but did not pave the road at the base of the walls because the job was shut down for the winter.

The thick pavement section (18 inches) was intended to buttress the toe of the walls, which were supporting road cuts.

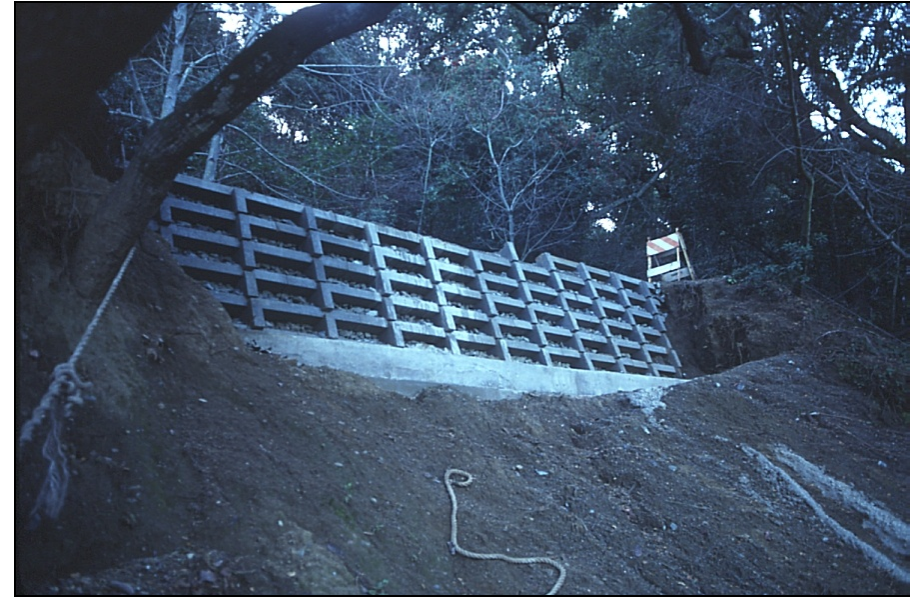
In cases where landslides create over-steepened descending slopes below paved rights-of-way, it may be advantageous to install drilled piers from truck-mounted drilling rigs on the remaining pavement, because it will require a minimum tonnage of import materials (steel reinforcing, concrete, and rockfill).

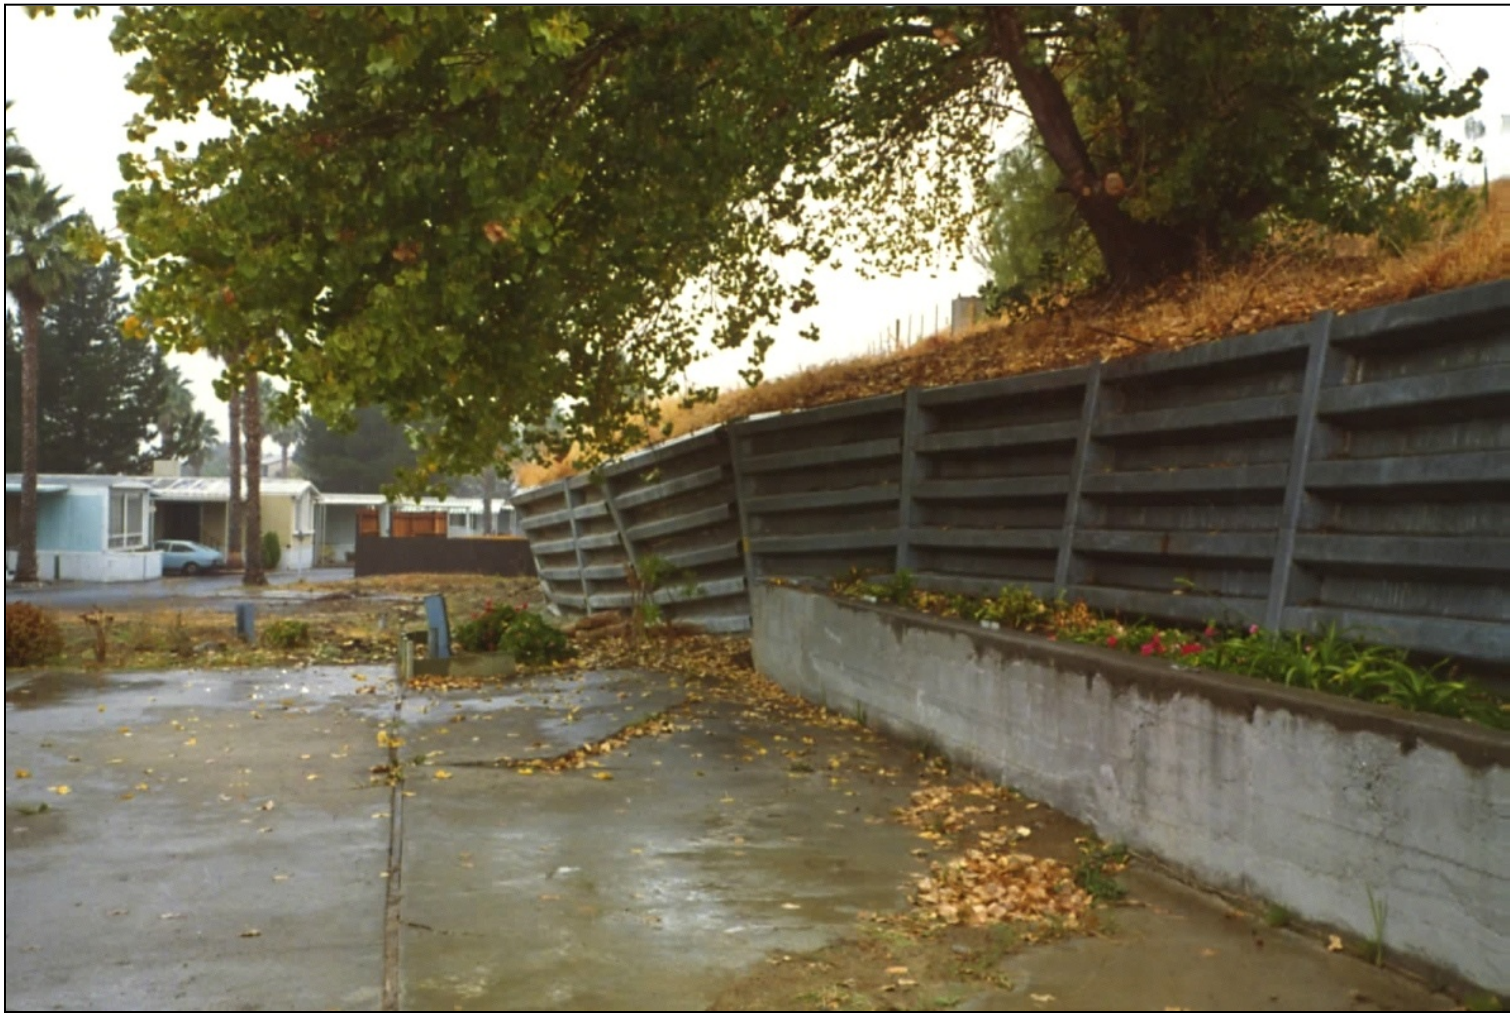
- **Steel bin walls** are designed using the same basis as crib walls and are generally conservative. This steel bin wall failed because it was designed for active soil pressures, not the landslide feature that lay above the wall.

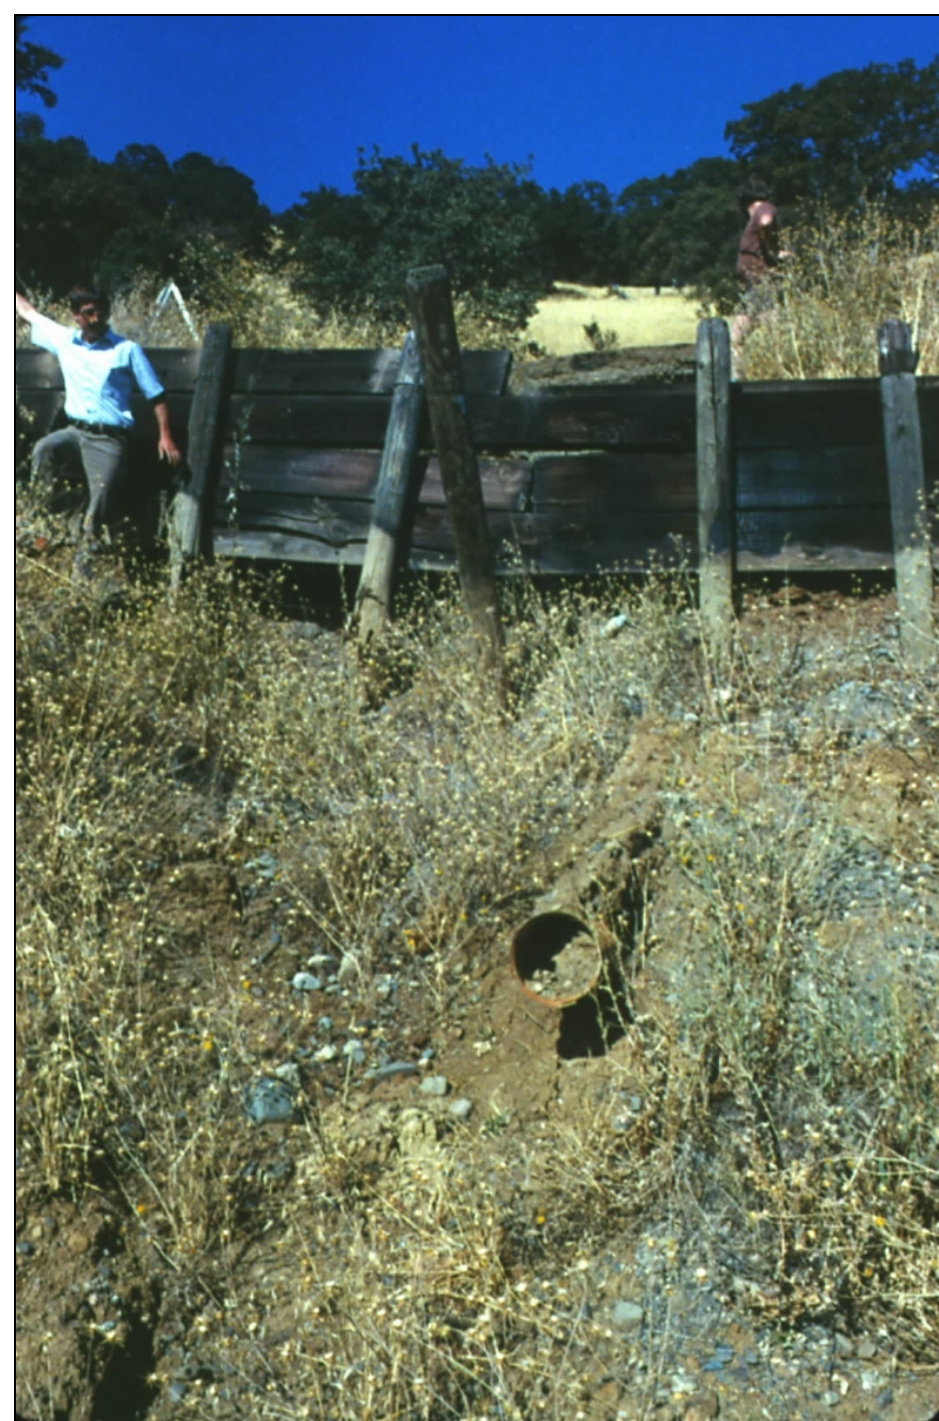
- **Toe kick-out failure** of cantilever walls often occurs when the cantilever elements are excessively thin, as shown here.
- Common examples of thin elements are railroad rails, telephone poles (shown here), and recycled I-beams
- This wall was tied back

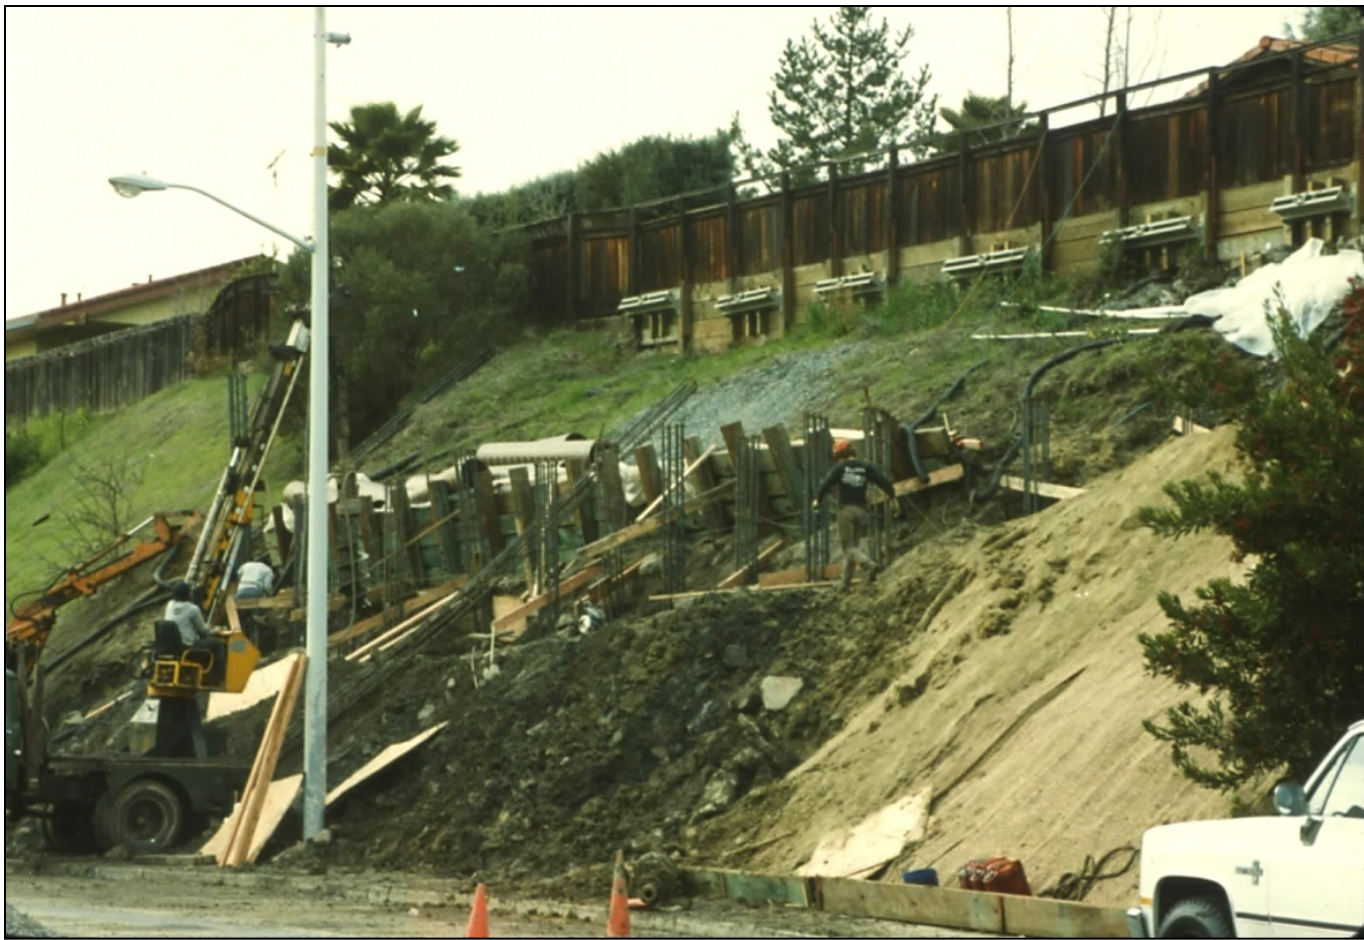
- **Titled tied-back cantilever wall being replaced. It is very difficult to design a cantilever wall on slopes steeper than 2:1 because of the paucity of passive reaction area and slope creep loads.**

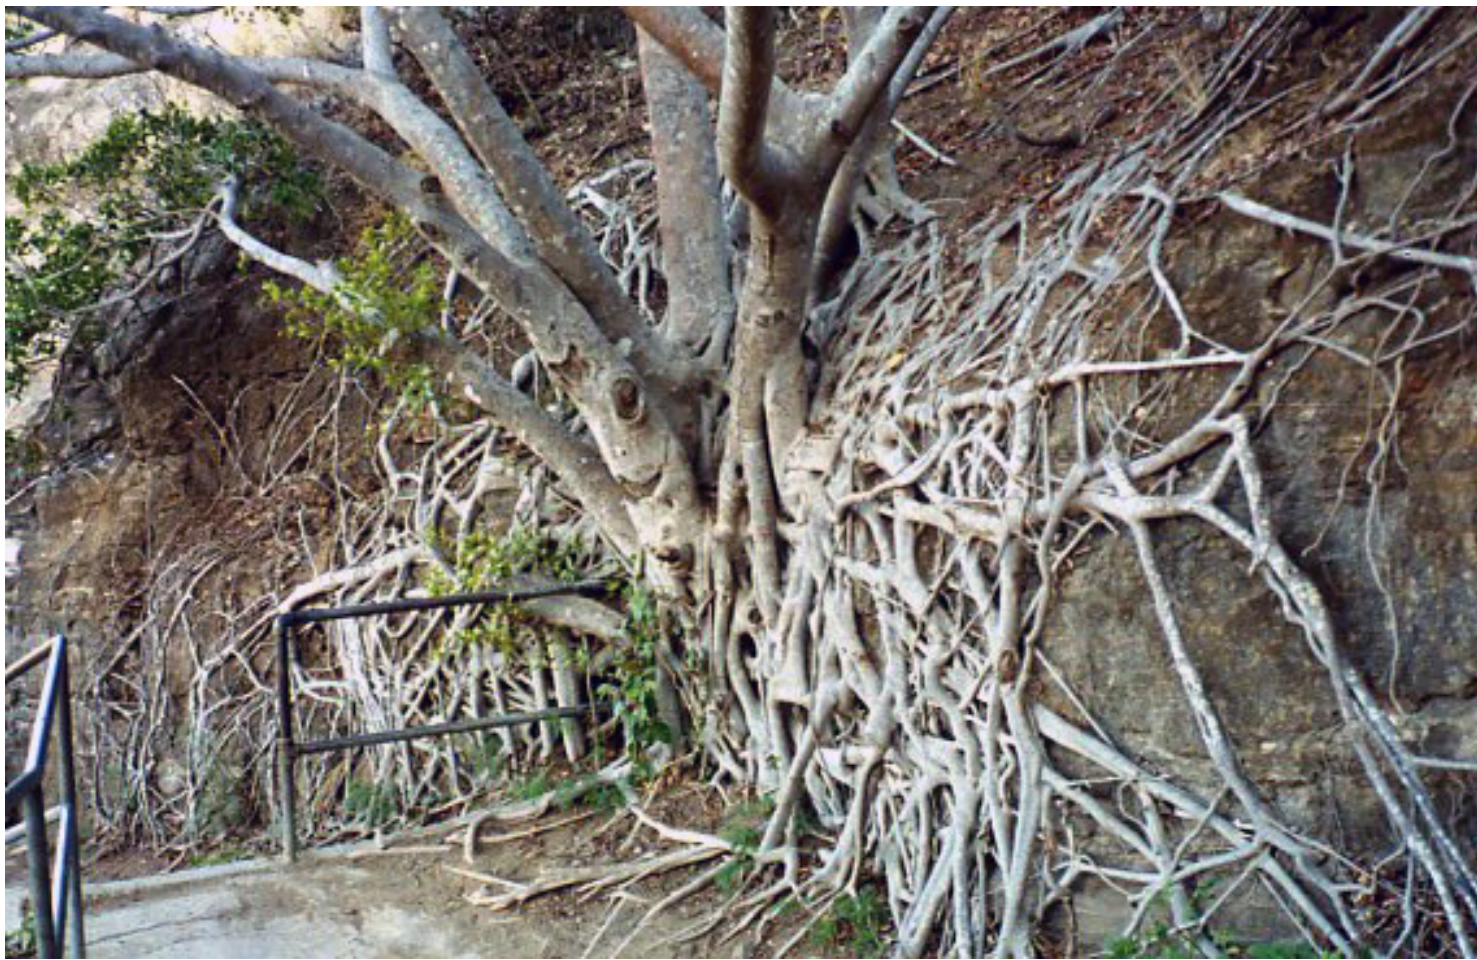
- **Nature's concept of soil reinforcement shown to good effect in the root network of a banyan tree, stabilizing a near-vertical cut along a trail leading up to Diamond Head, Oahu, Hawaii.**

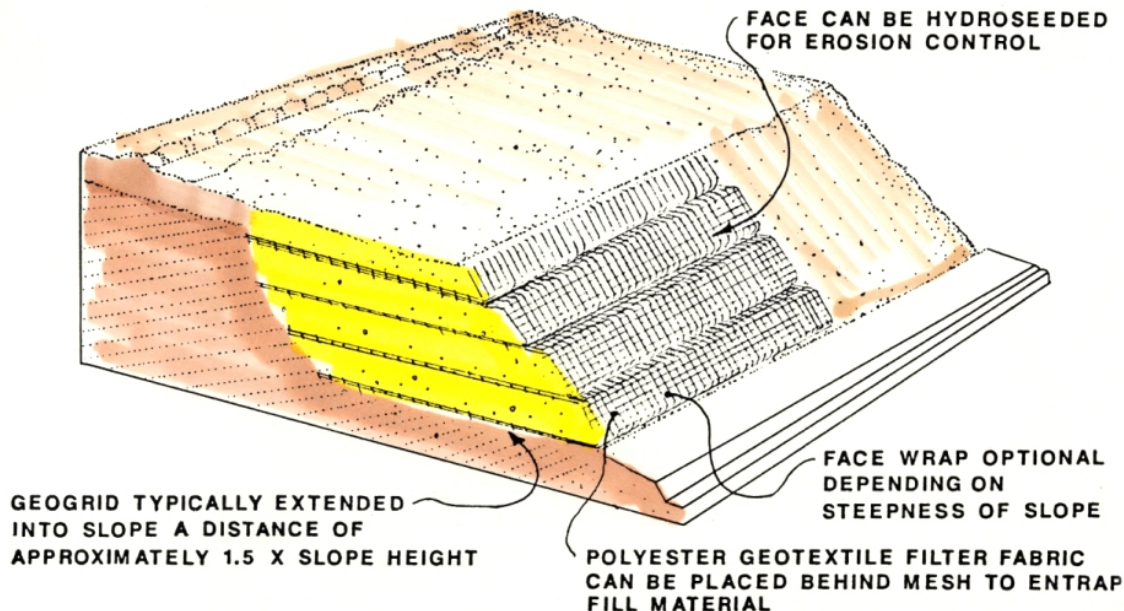
- **Geotextiles and reinforcing grids can be combined with low strength soils to engender additional shear strength; greatly enhancing repair options when space is tight.**

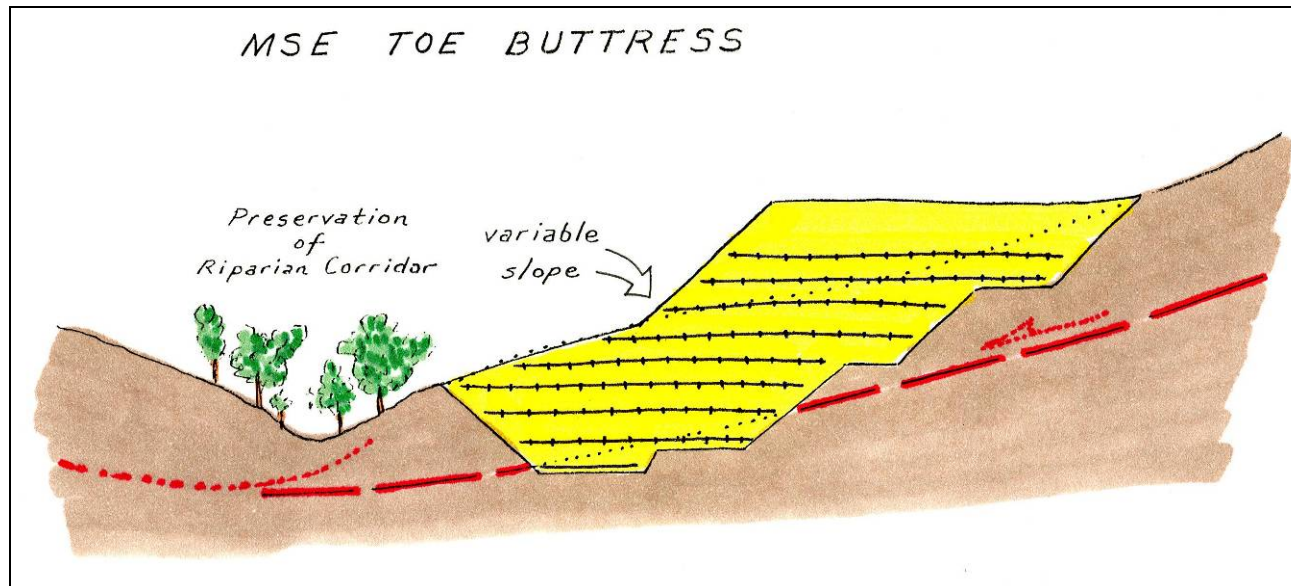
**MSE shear key at toe of ancient landslide complex**

**Tensile soil reinforcement can also be applied to landslide repairs, allowing selective reinforcement of limited zones, as sketch below left**

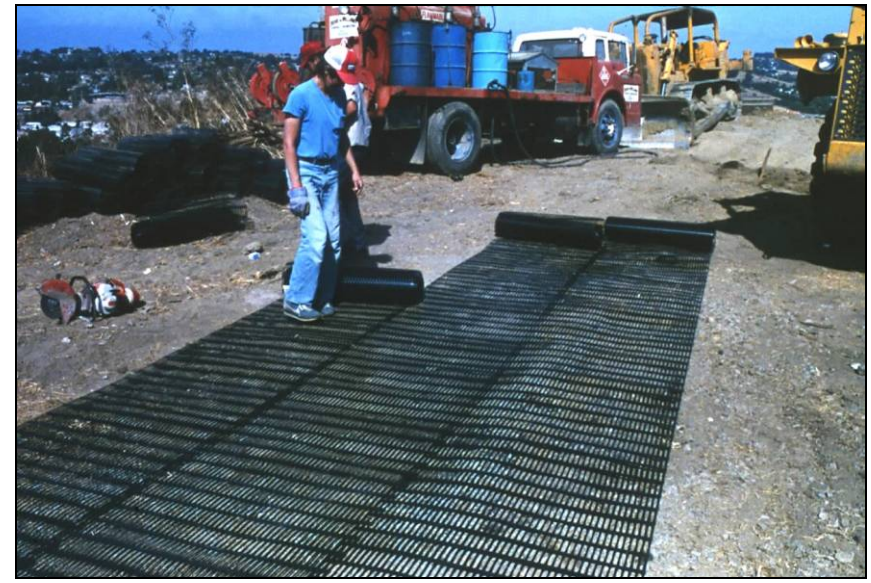
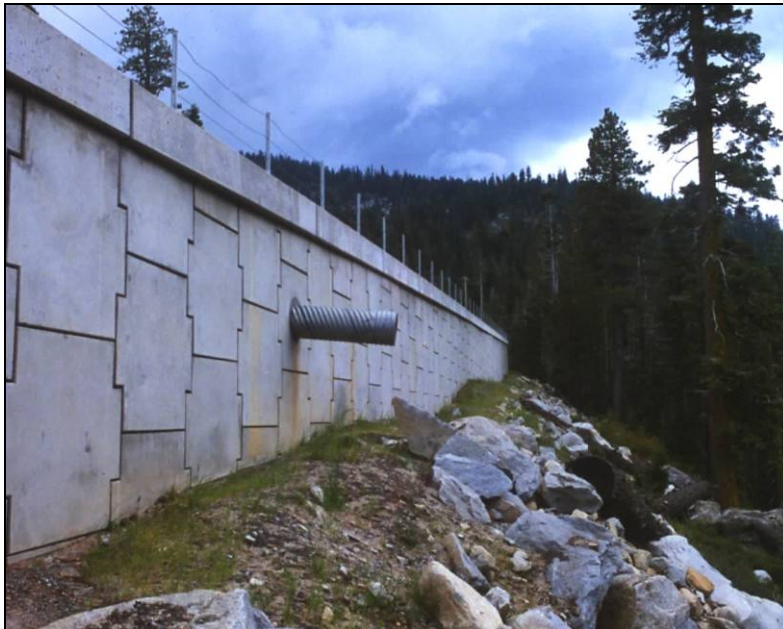
**First Reinforced Earth wall in USA -1969**

**Reinforced Earth wall on US 50**

**Mechanically Stabilized Embankments (MSEs) utilize tensile reinforcement in many different forms: from galvanized metal strips or ribbons, to HDPE geotextile mats, like those shown above right. This reinforcement increases the shear strength and bearing capacity of the backfill.**

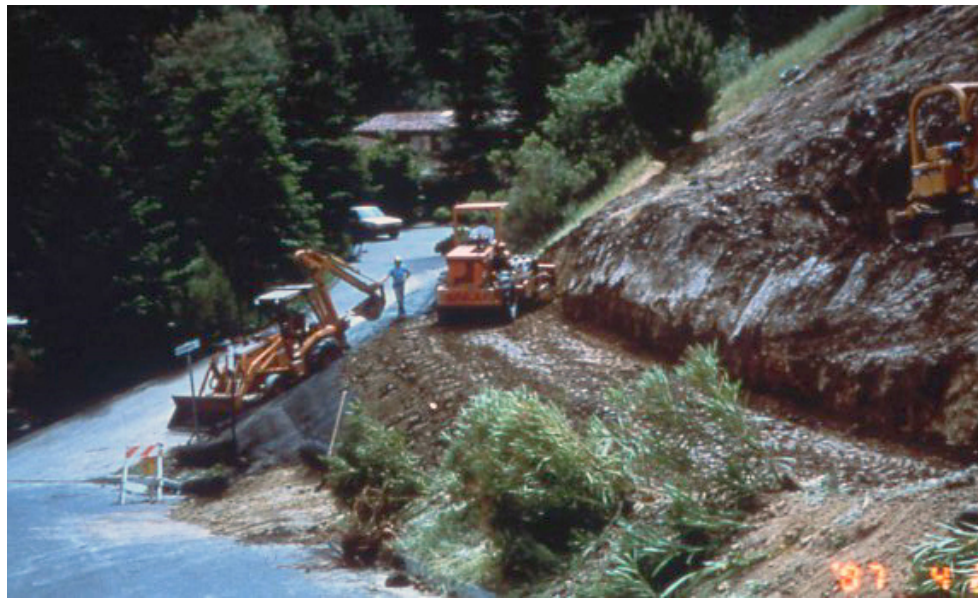
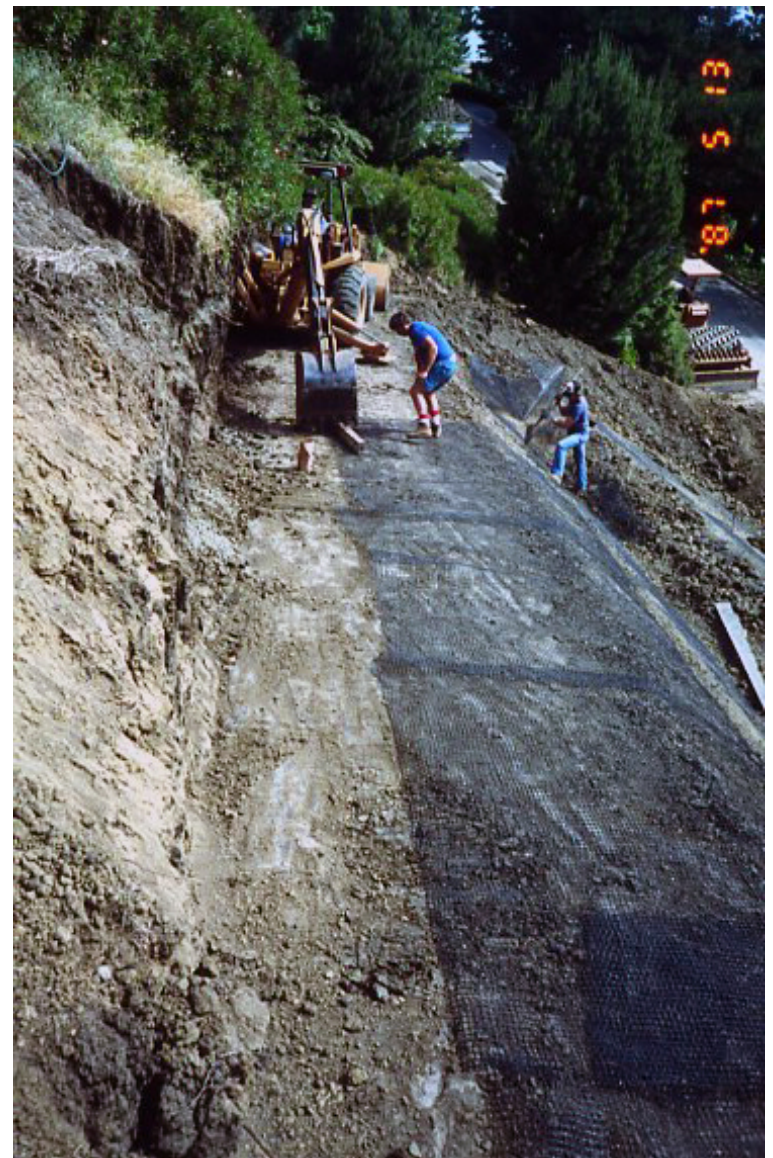
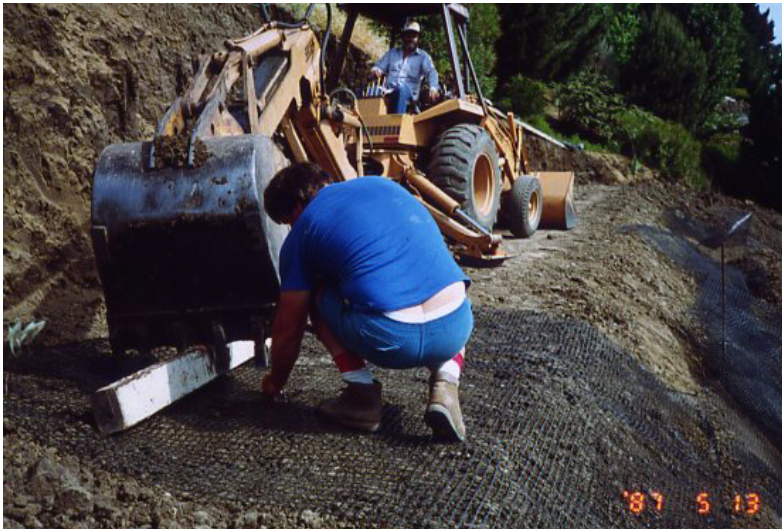
- **Tight face wrapping with geogrids can produce a neat face with near-zero erosion**

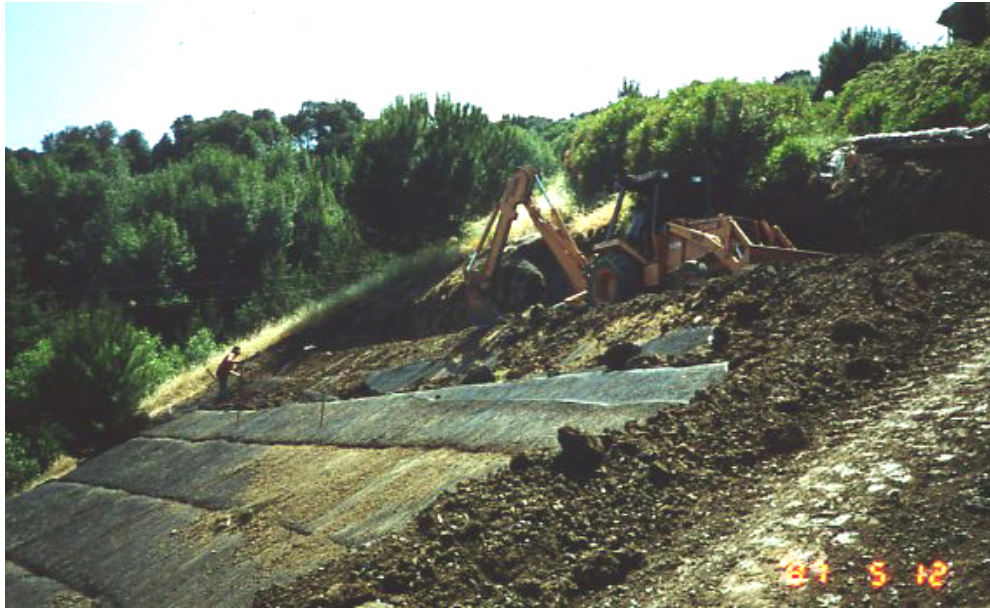
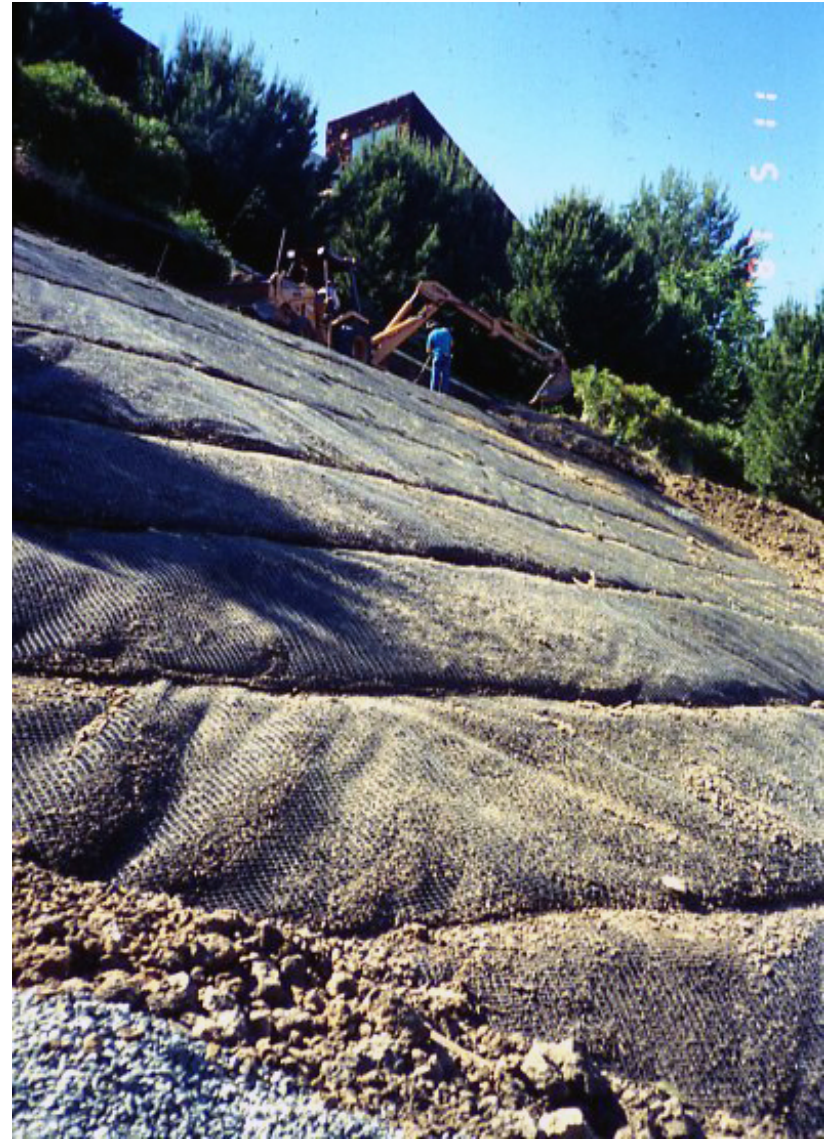
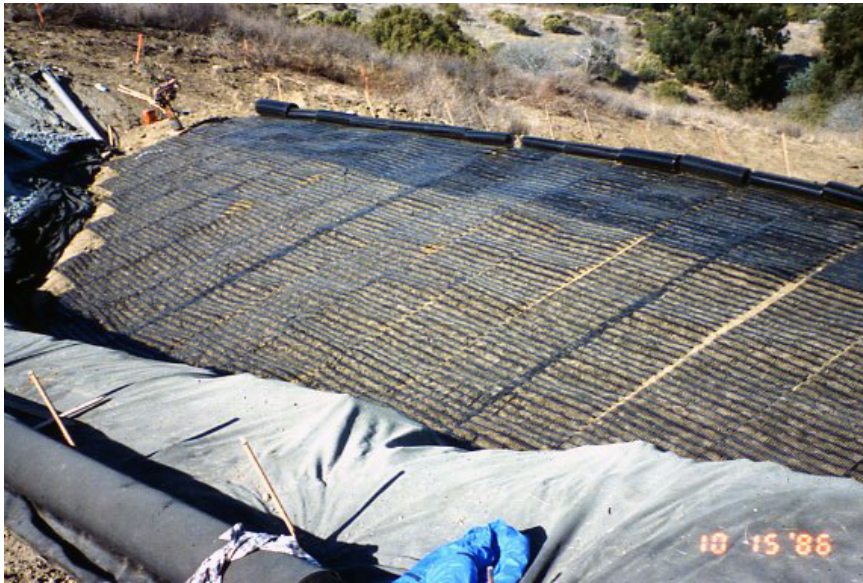
- **As each lift of grid is set, the last layer is brought up and wrapped, to create the finished face**

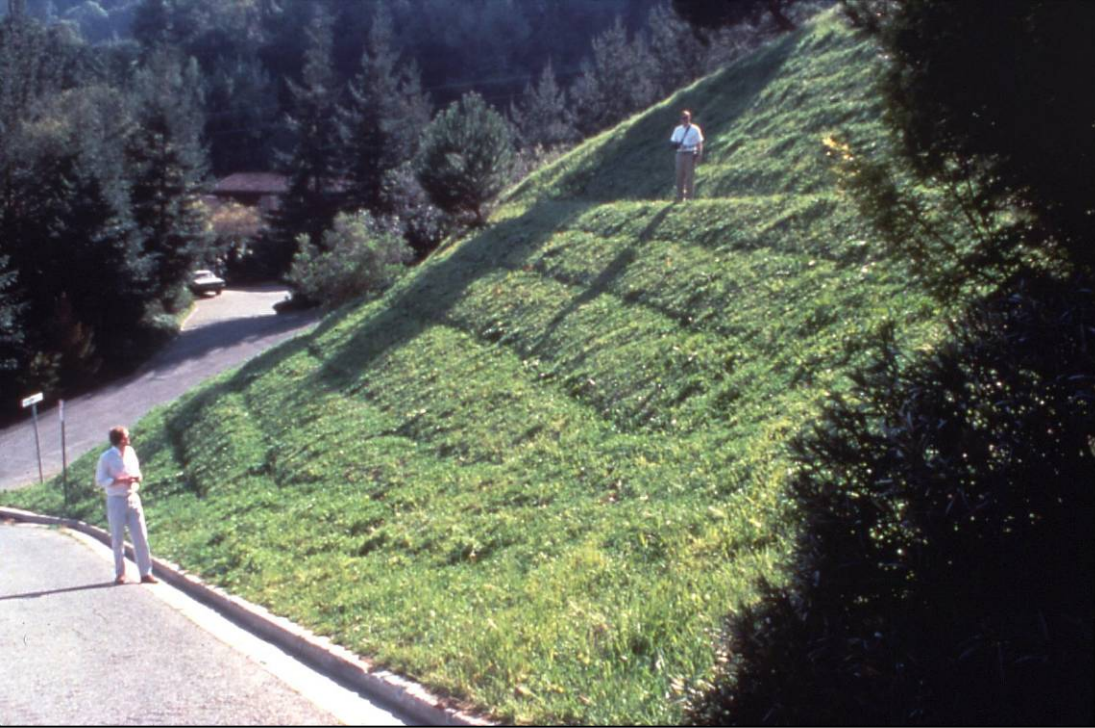
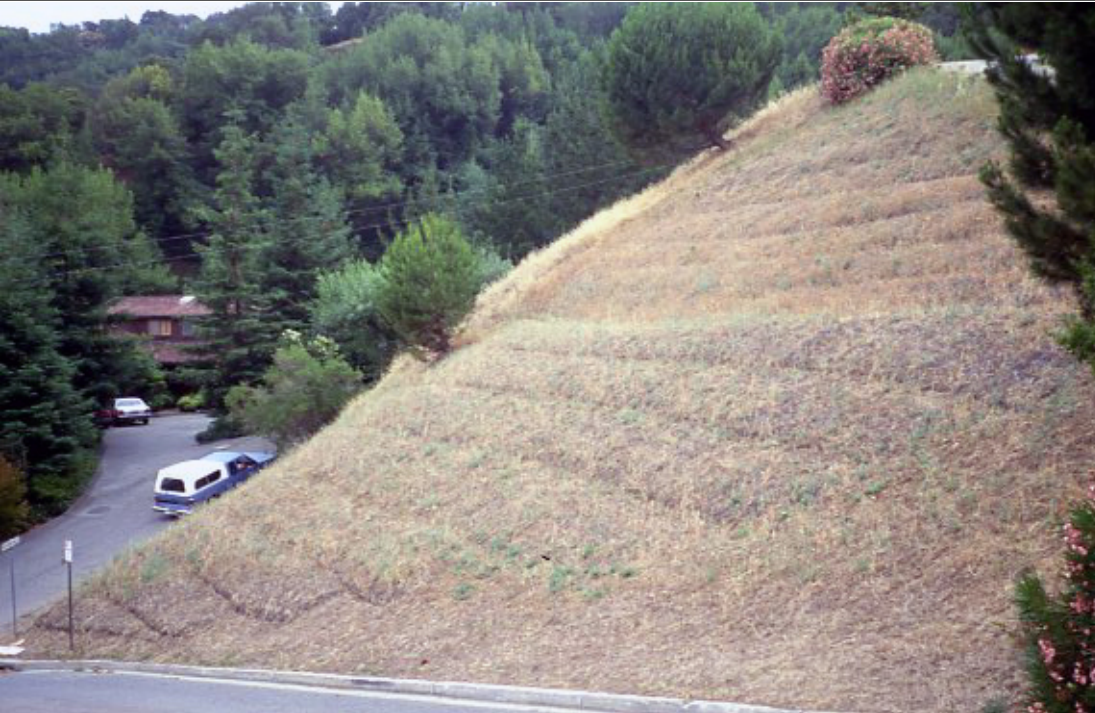
# Neat 45 degree face

- These images show the finished form of the MSE using face wrapping of the geogrid to eliminate erosion.
- Photos contrast vegetation cover during wet and dry seasons
