# Overview of LANDSLIDE MITIGATION TECHNIQUES

**J. David Rogers, Ph.D., P.E., P.G.**

**Slope Stability & Landslides Course**

University of Wisconsin-Madison

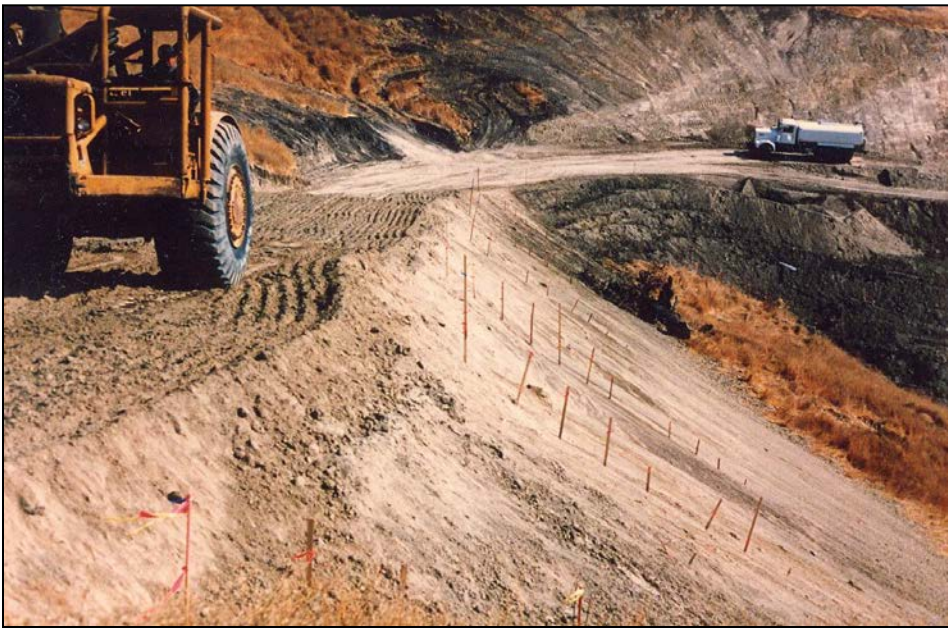
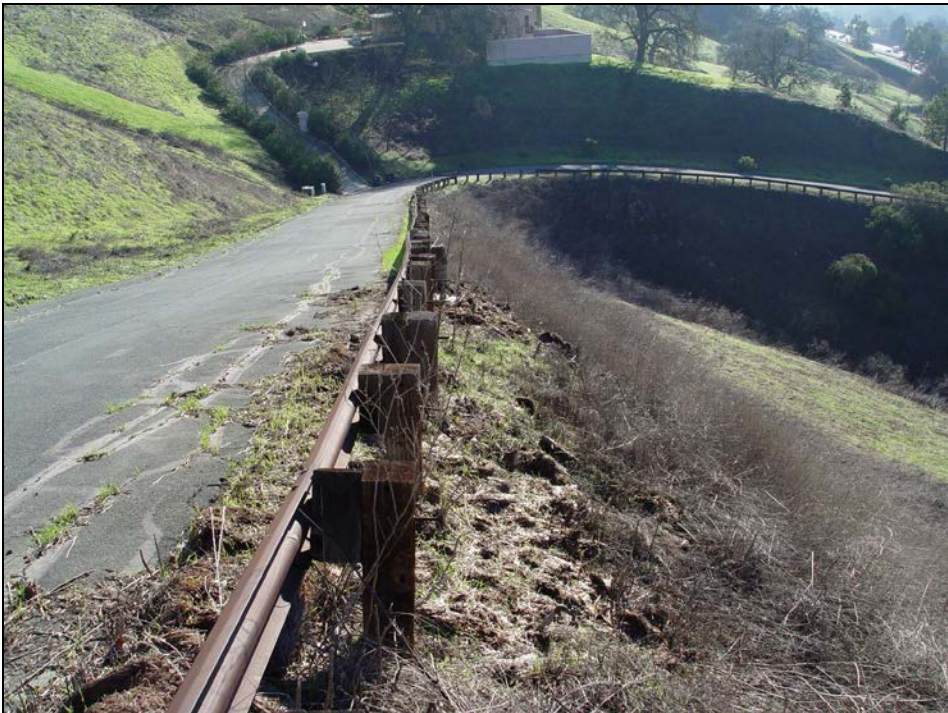
## 45 degree slope using false layers

- Upper left: Construction of 45 degree side-hill embankment for a road in steep terrain. False and full depth geotextile mats were incorporated into the fill, spaced every 12 inches
- Lower Left: Same slope after hydroseeding with a mix of fescue and wild mustard, two months later
- Upper right: Same project, as seen 20 years later, in 2007. It had weathered a brush fire, as well as numerous storms and record rainfall events.

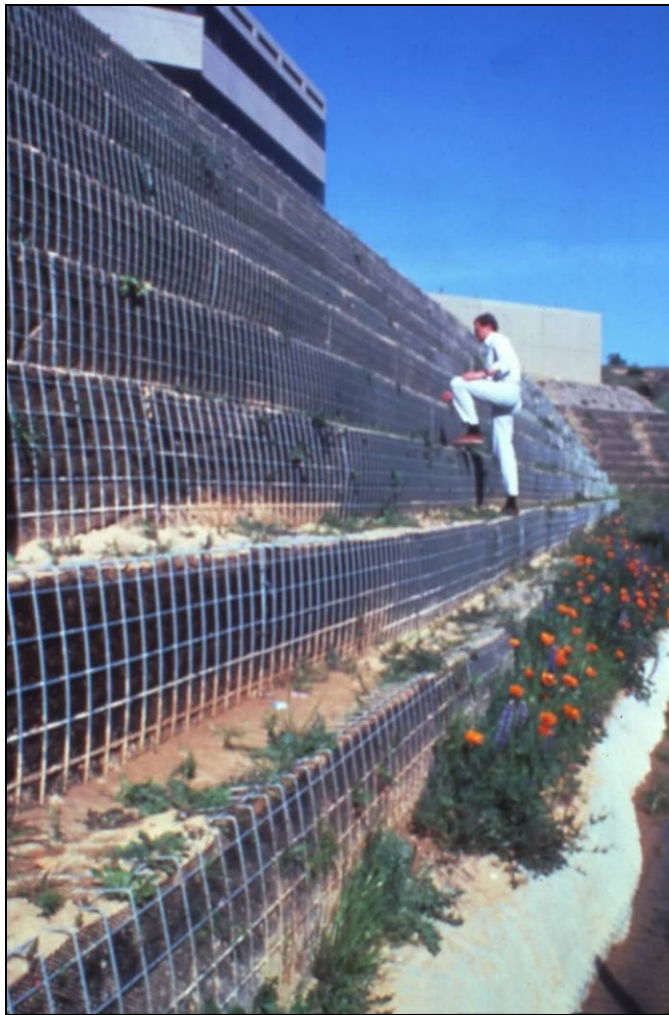
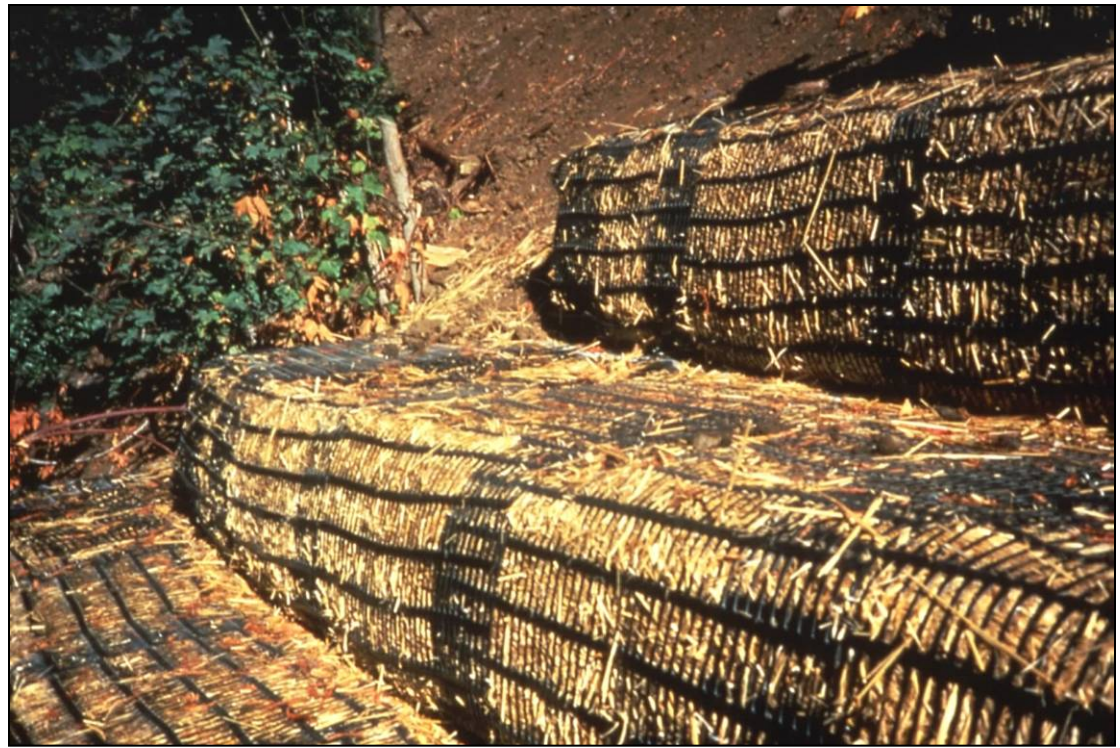
**WWM faces are useful for controlling the inclination of the finish slope.**

**Any number of **facing elements** may be used with MSEs.**

**These photos illustrate the use of hay bales wrapped with HDPE grids and galvanized welded wire mesh (WWM)**

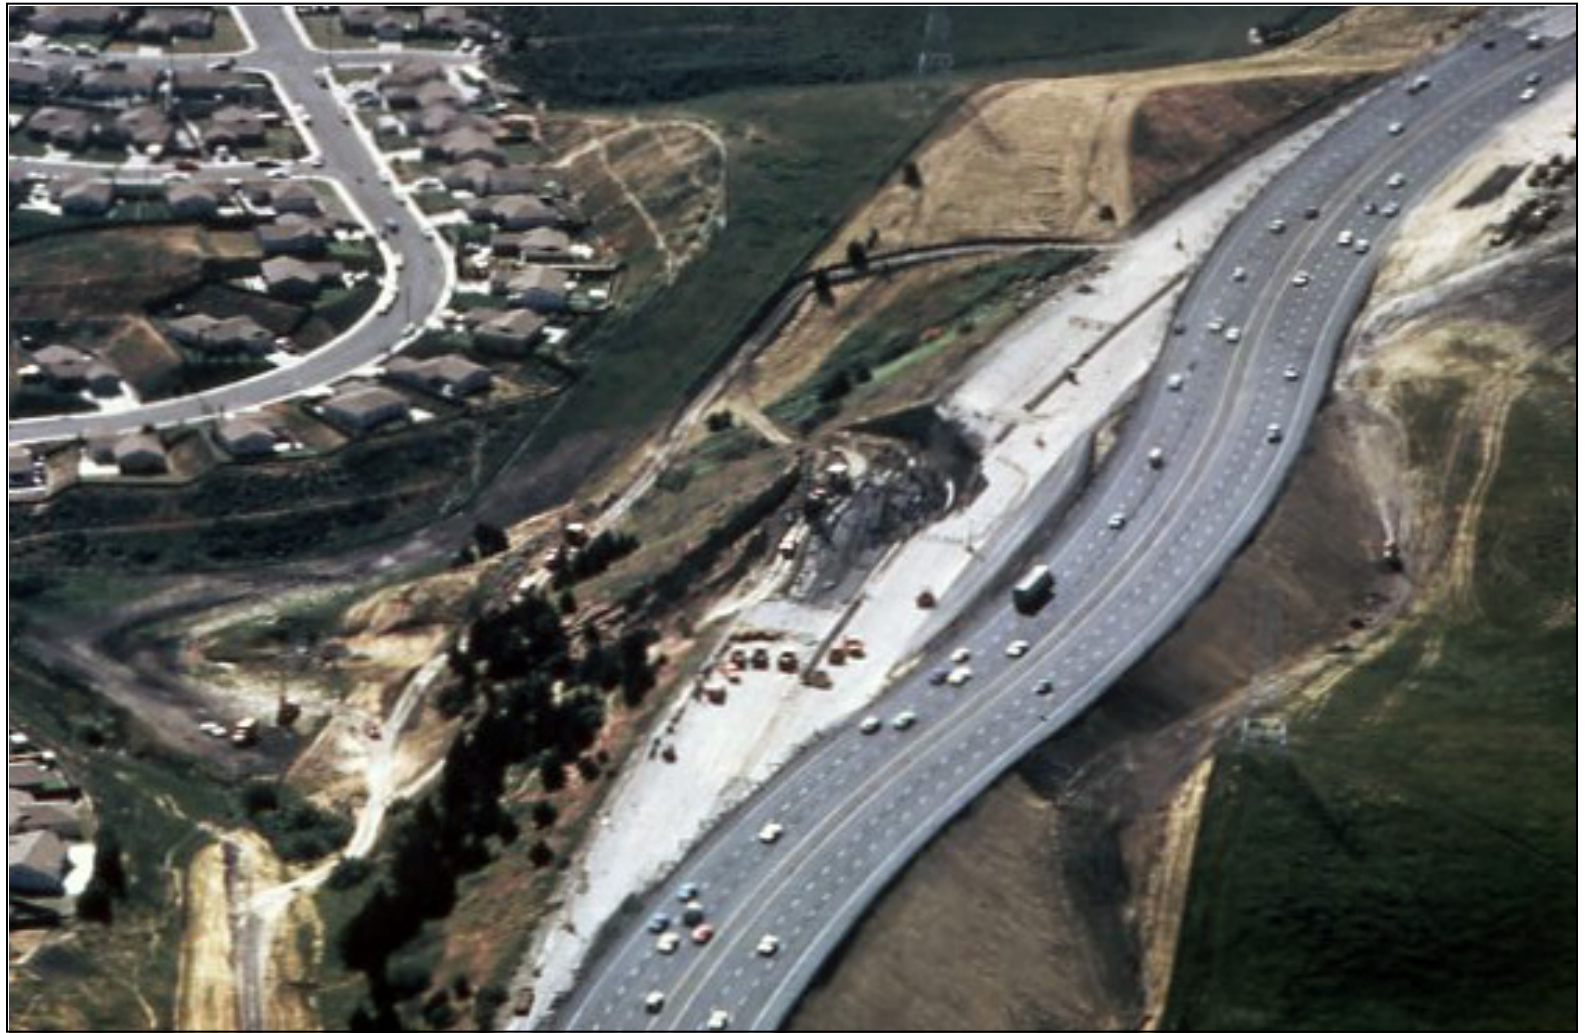
- A “**shoofly**” is a temporary re-routing of a rail line or highway while repairs are being effected. This shows the 6-lane shoofly for the “Pinole Hole” landslide along Interstate 80 in the San Francisco Bay Area 1969.

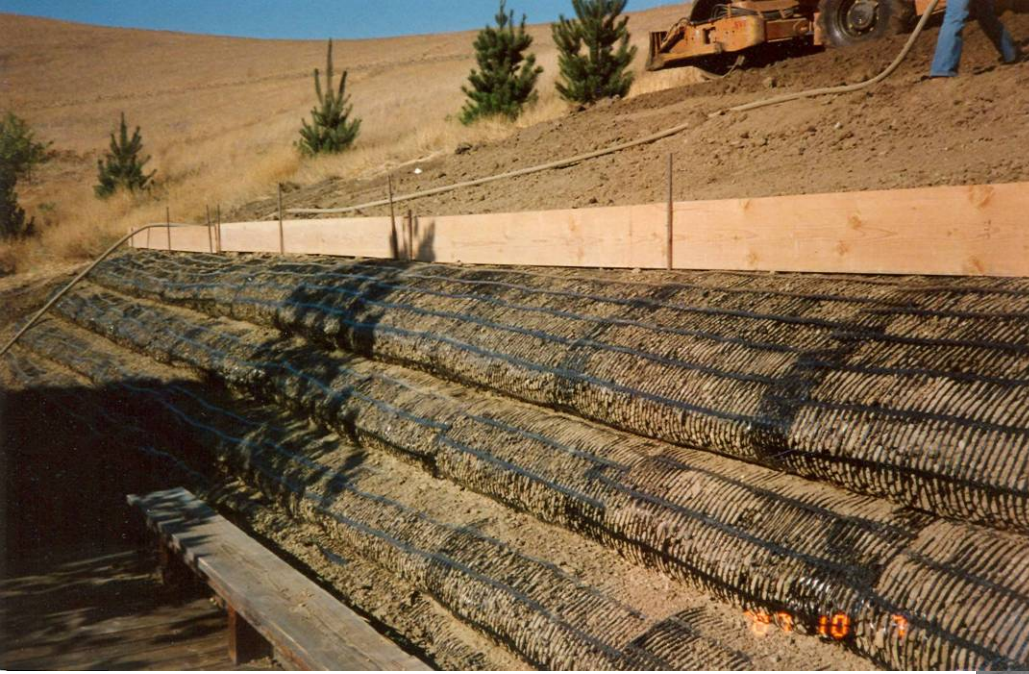
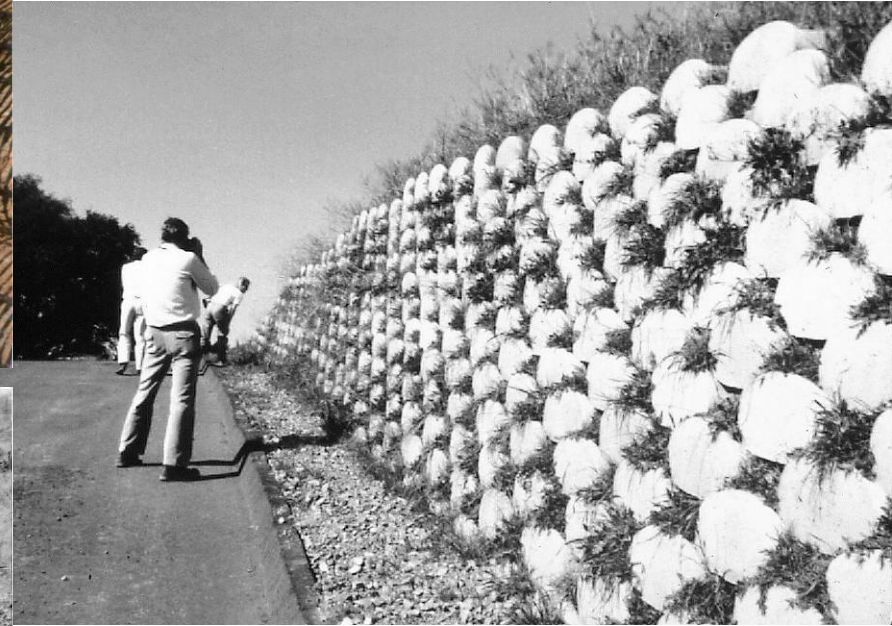
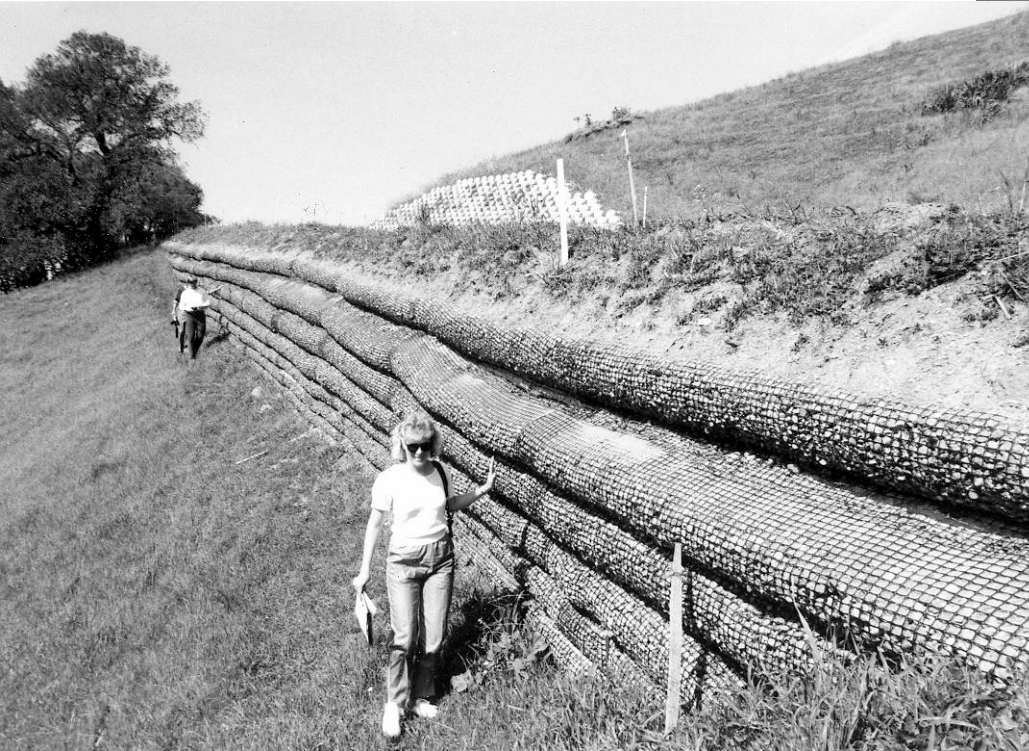
# Facing elements

**More examples of facing elements, including face wrapping of geotextiles, which can be employed with Mechanically Stabilized Embankments**

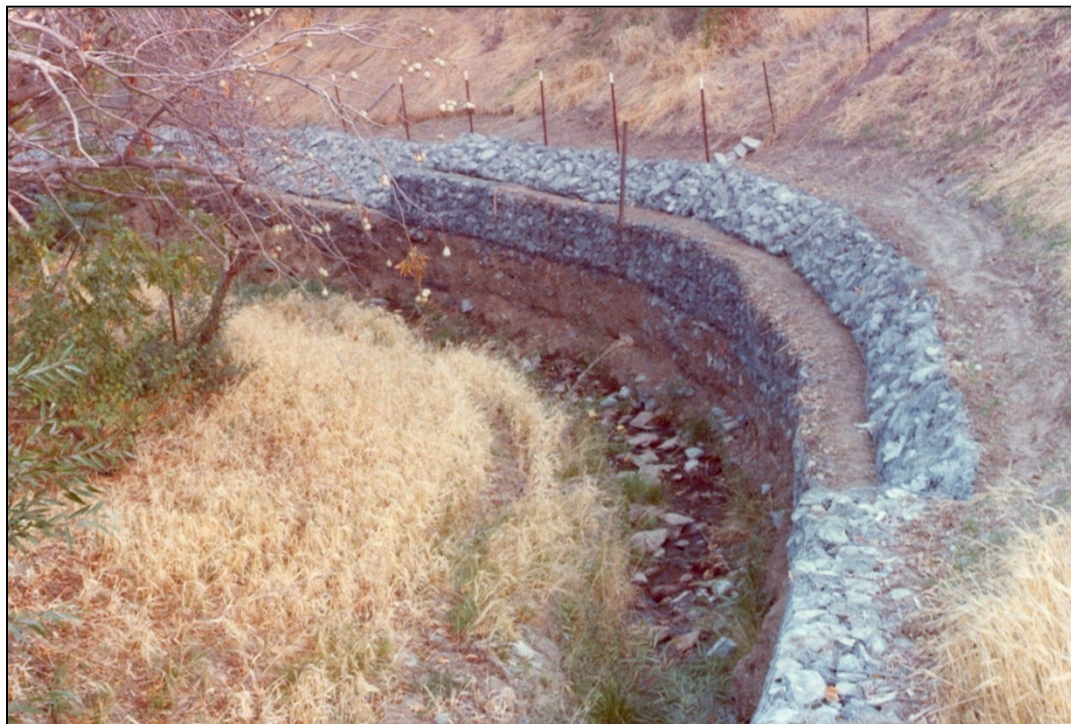
**Gabions work well in *unimproved channels* because they provide surface roughness more in harmony with natural channels. Gabions can also absorb significant deflections when undercut by the stream.**

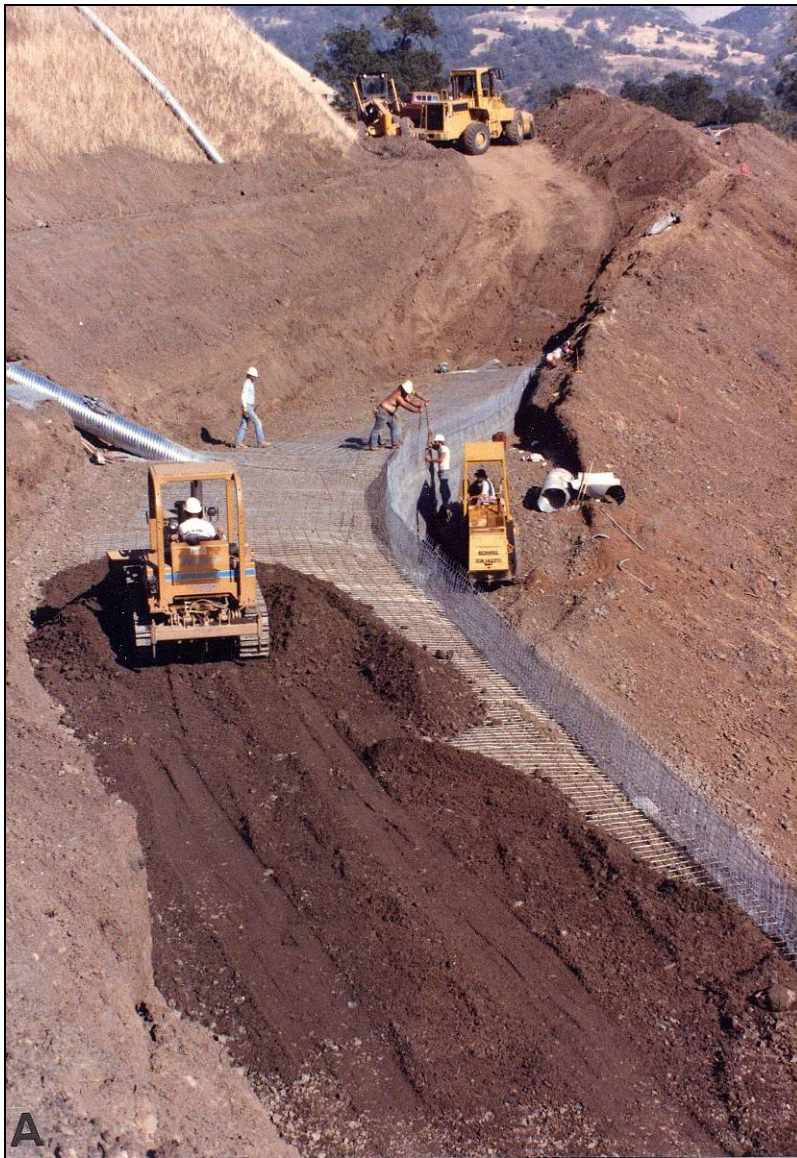
**Welded wire mesh walls** are constructed using the same design methodology for MSE structures, but employ the welded wire mesh as the reinforcing grid

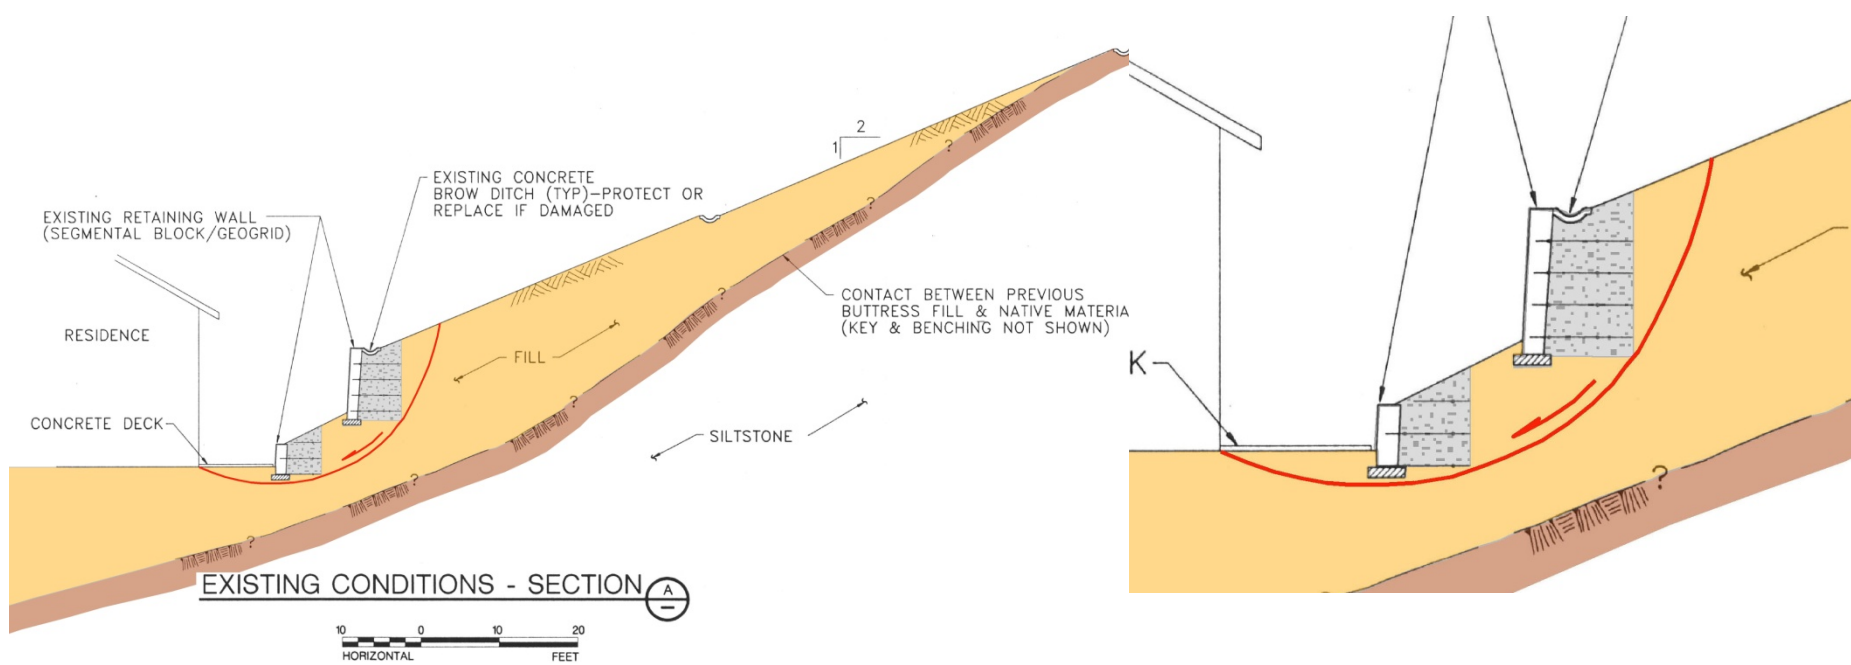
## Global stability problems common with stacked MSE Walls

Repairs are often expensive, if adjacent to high value structures or highways where closure is not a viable option.

In this case shown here cylindrical piers were used to stabilize the support system.

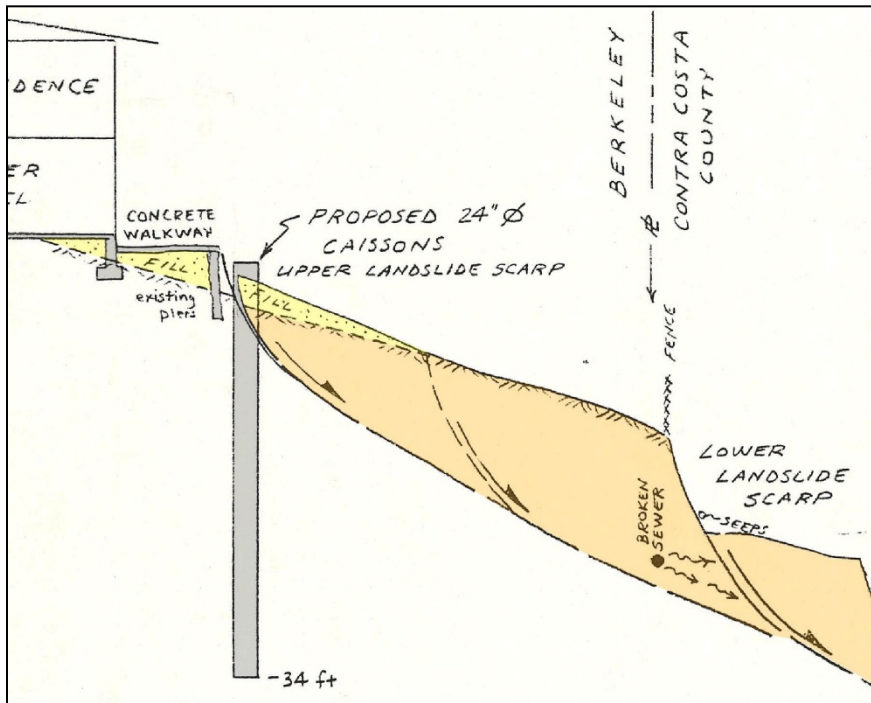
# Reduced Passive Loads

- Upper: The resisting passive earth pressures on the downslope side of the piers is significantly reduced by the presence of the landslide, which **cannot** be depended upon, because it could reactivate and translate further downslope.
- Lower: **Always define the design loads** with a loading diagram, as shown here.

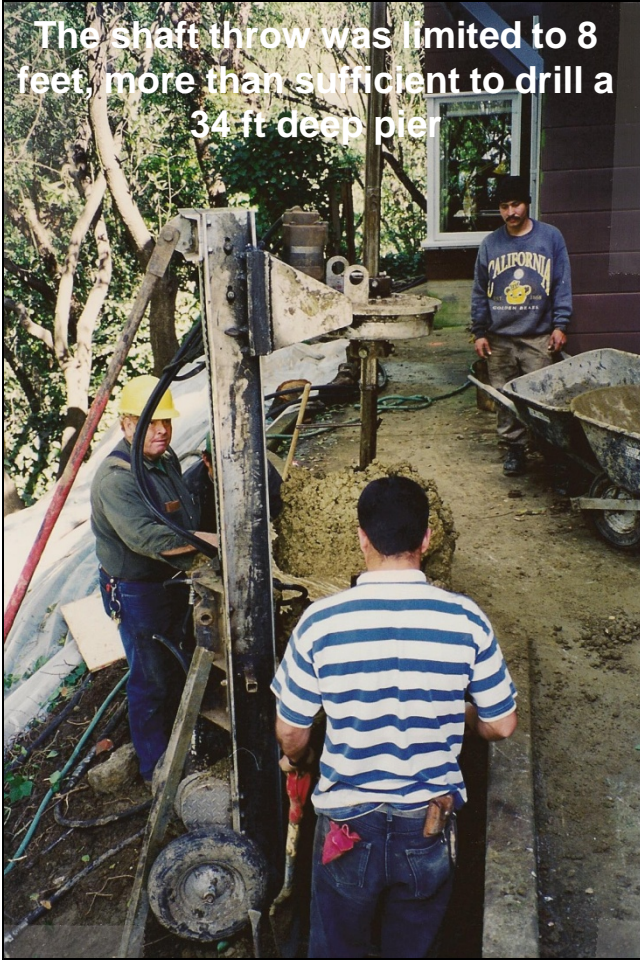
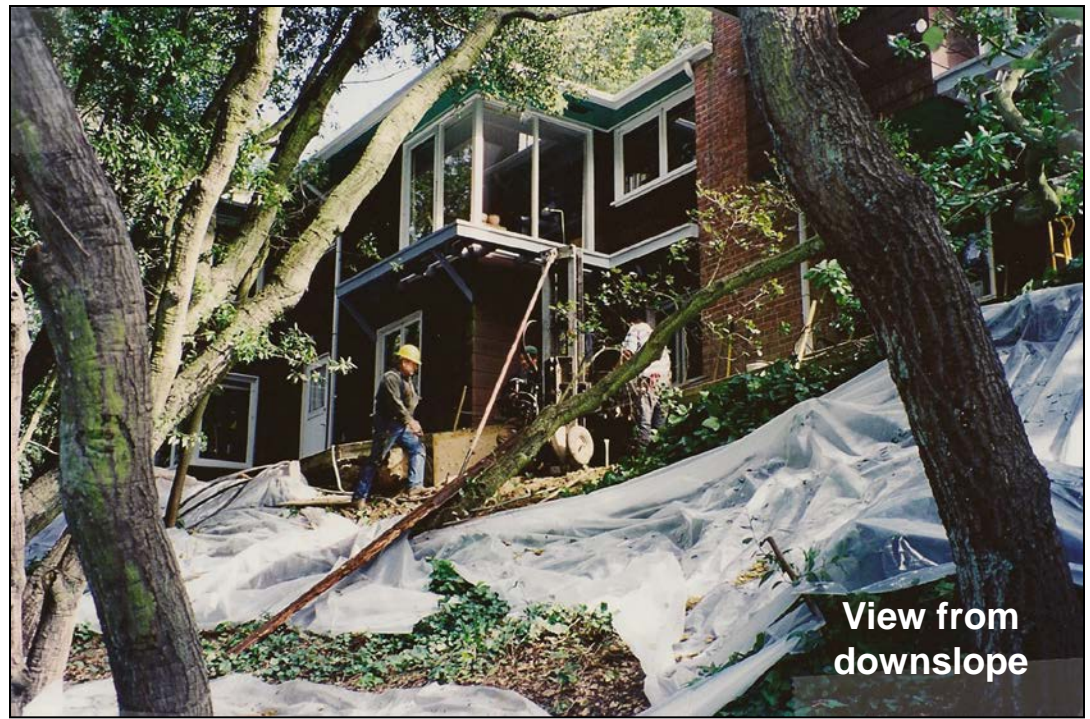
View from downslope

The shaft throw was limited to 8 feet, more than sufficient to drill a 34 ft deep pier

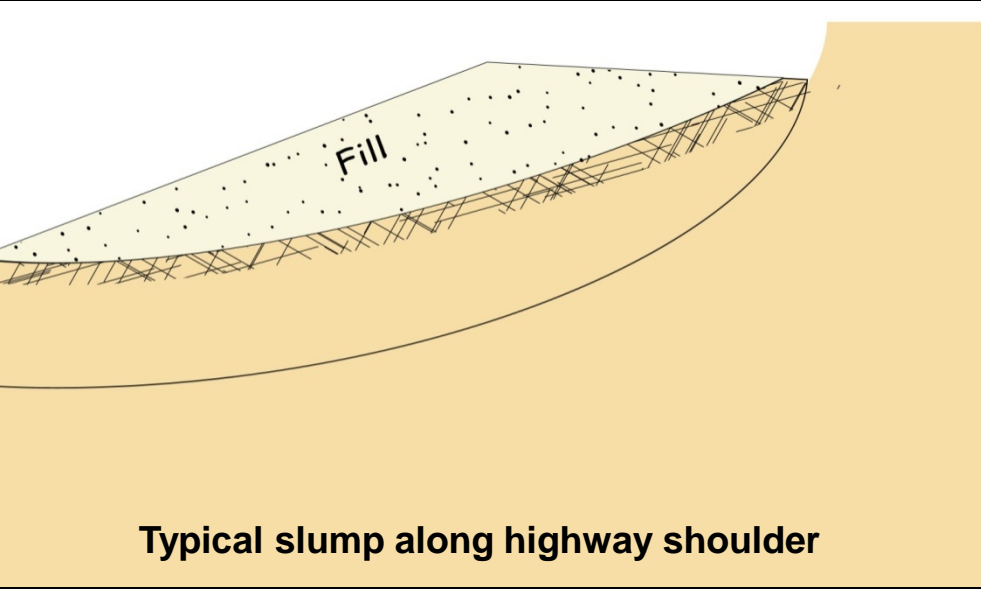
**Typical sequence employed to construct straight-shaft cylindrical piers for a slide repair, working off a small platform or highway shoulder adjacent to the crest of the slide.**

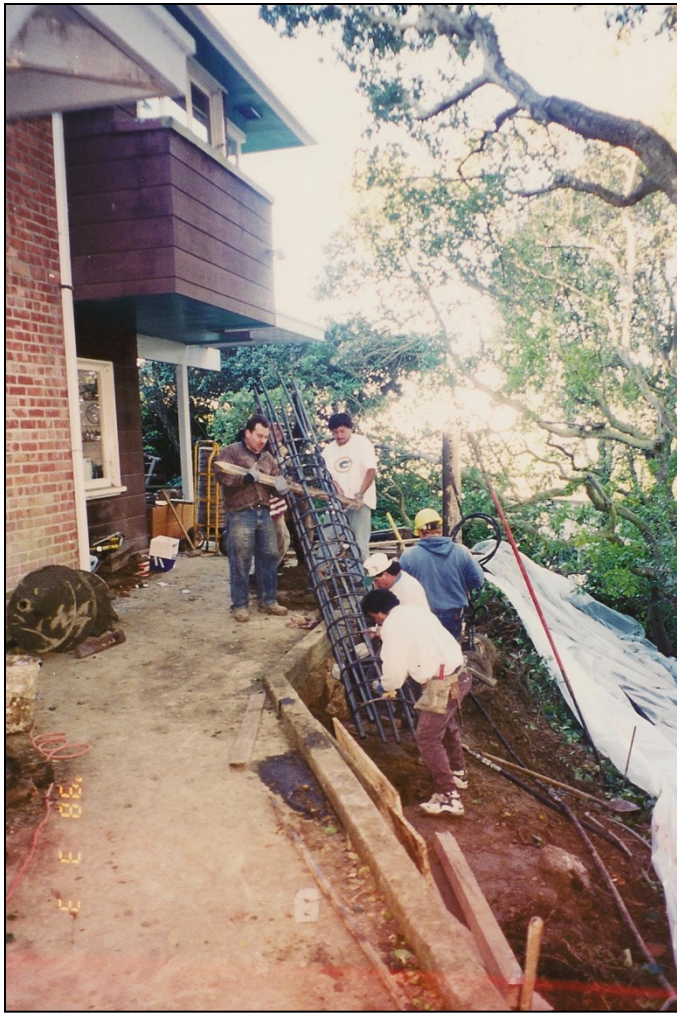
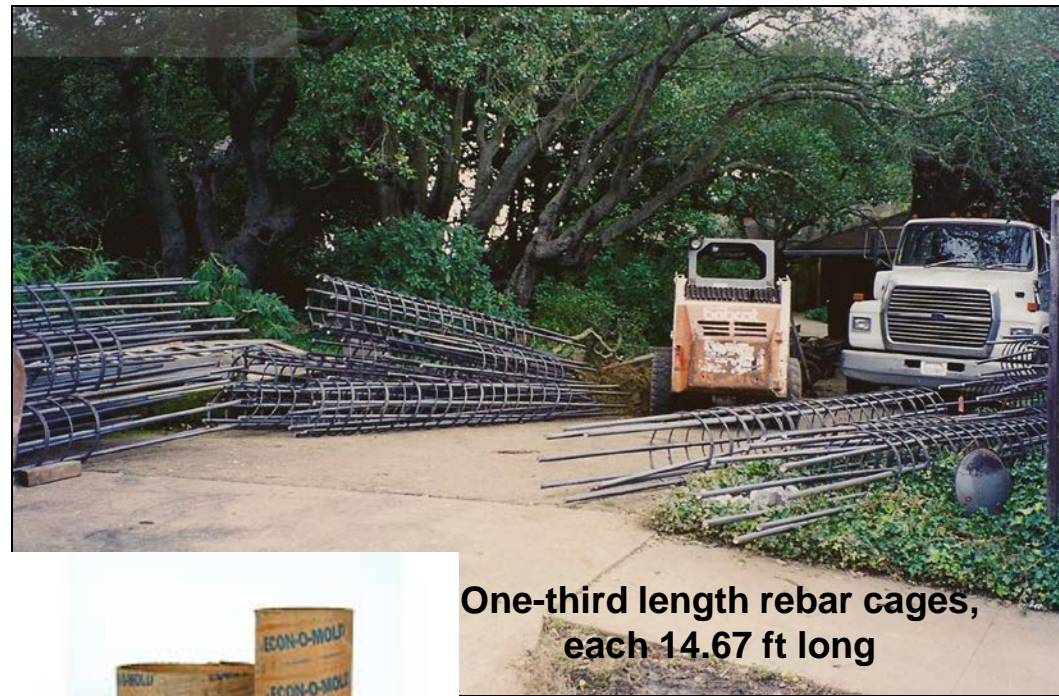
One-third length rebar cages, each 14.67 ft long

**Sontube forms** were used to extend the piers above grade

The **reinforcing cages** were split into thirds, 11.33 ft long, with 20 inch laps at either end, making the sections 14'-8" long. These were carefully lowered into the shaft immediately after cessation of drilling, and checked using boards, until the next section could be lapped and tied off.

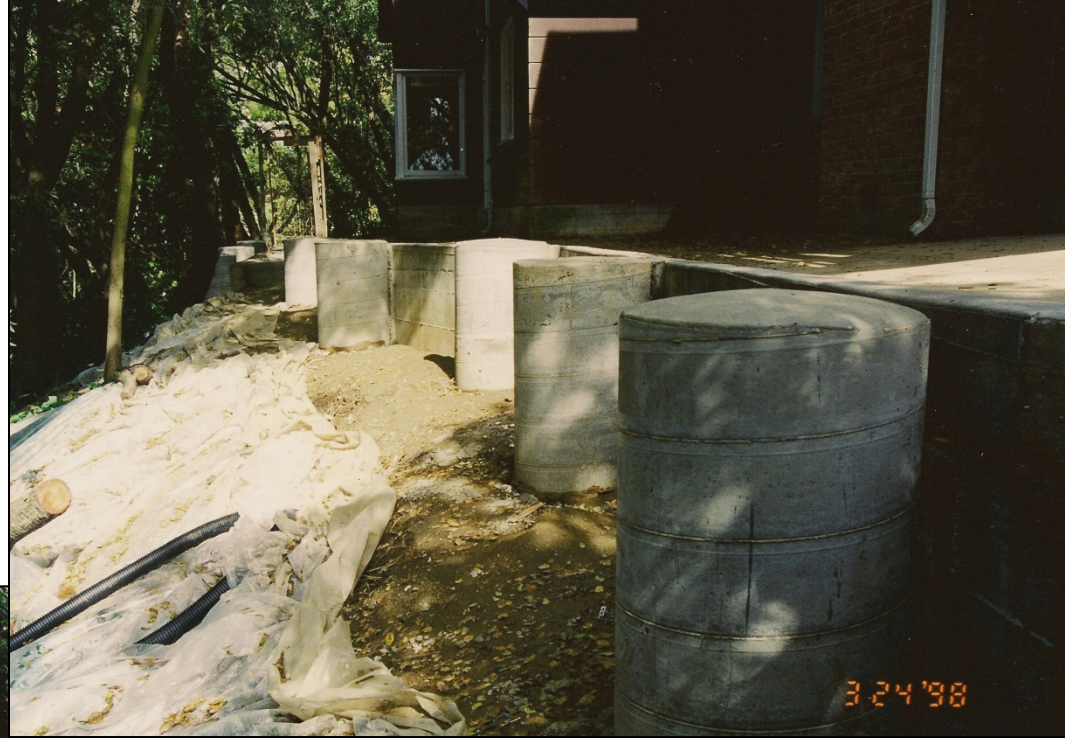
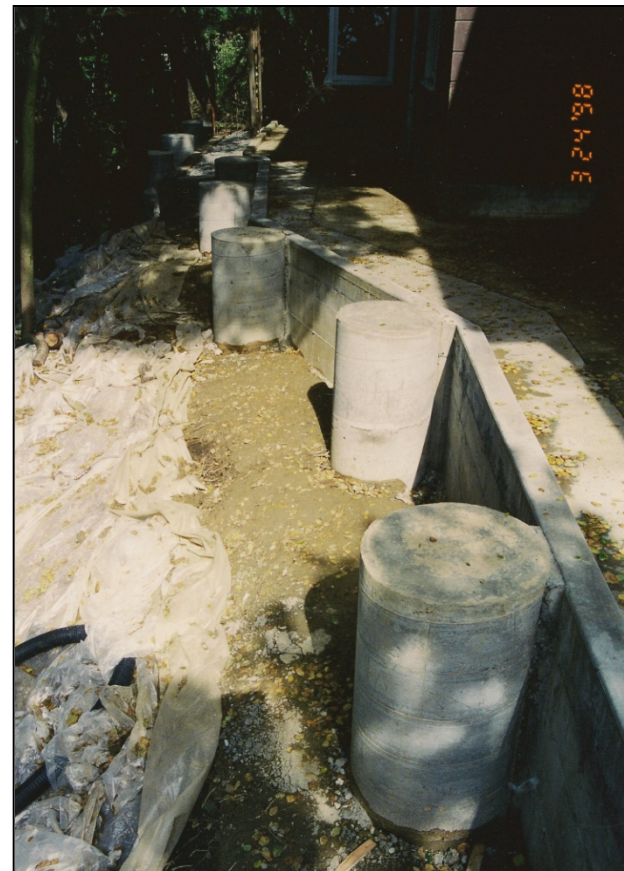
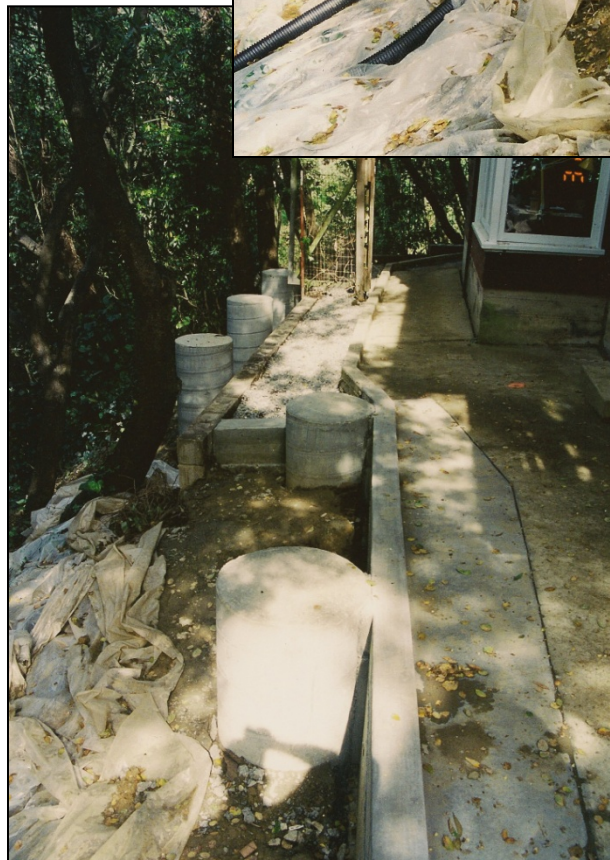
# Completed tie-beam pier wall

- The tie-beam wall was backfilled with free-draining gravel with a subdrain collector
- The pier wall is capable of supporting all the structural loads if the entire landslide *disappears* downslope

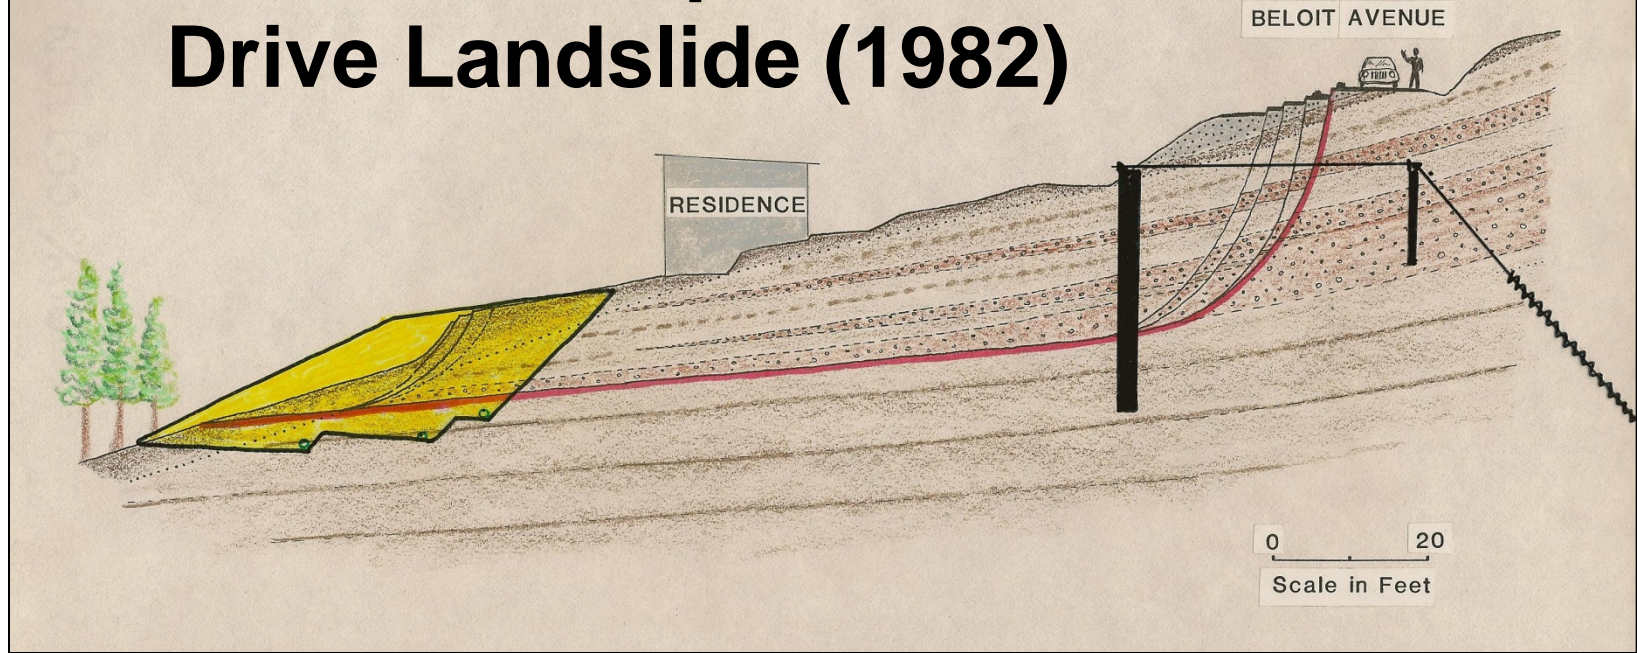
# Combination Repair of Beloit Drive Landslide (1982)

- The most cost-effective repairs are combination techniques, dictated by construction access and the haul distances of any imported materials

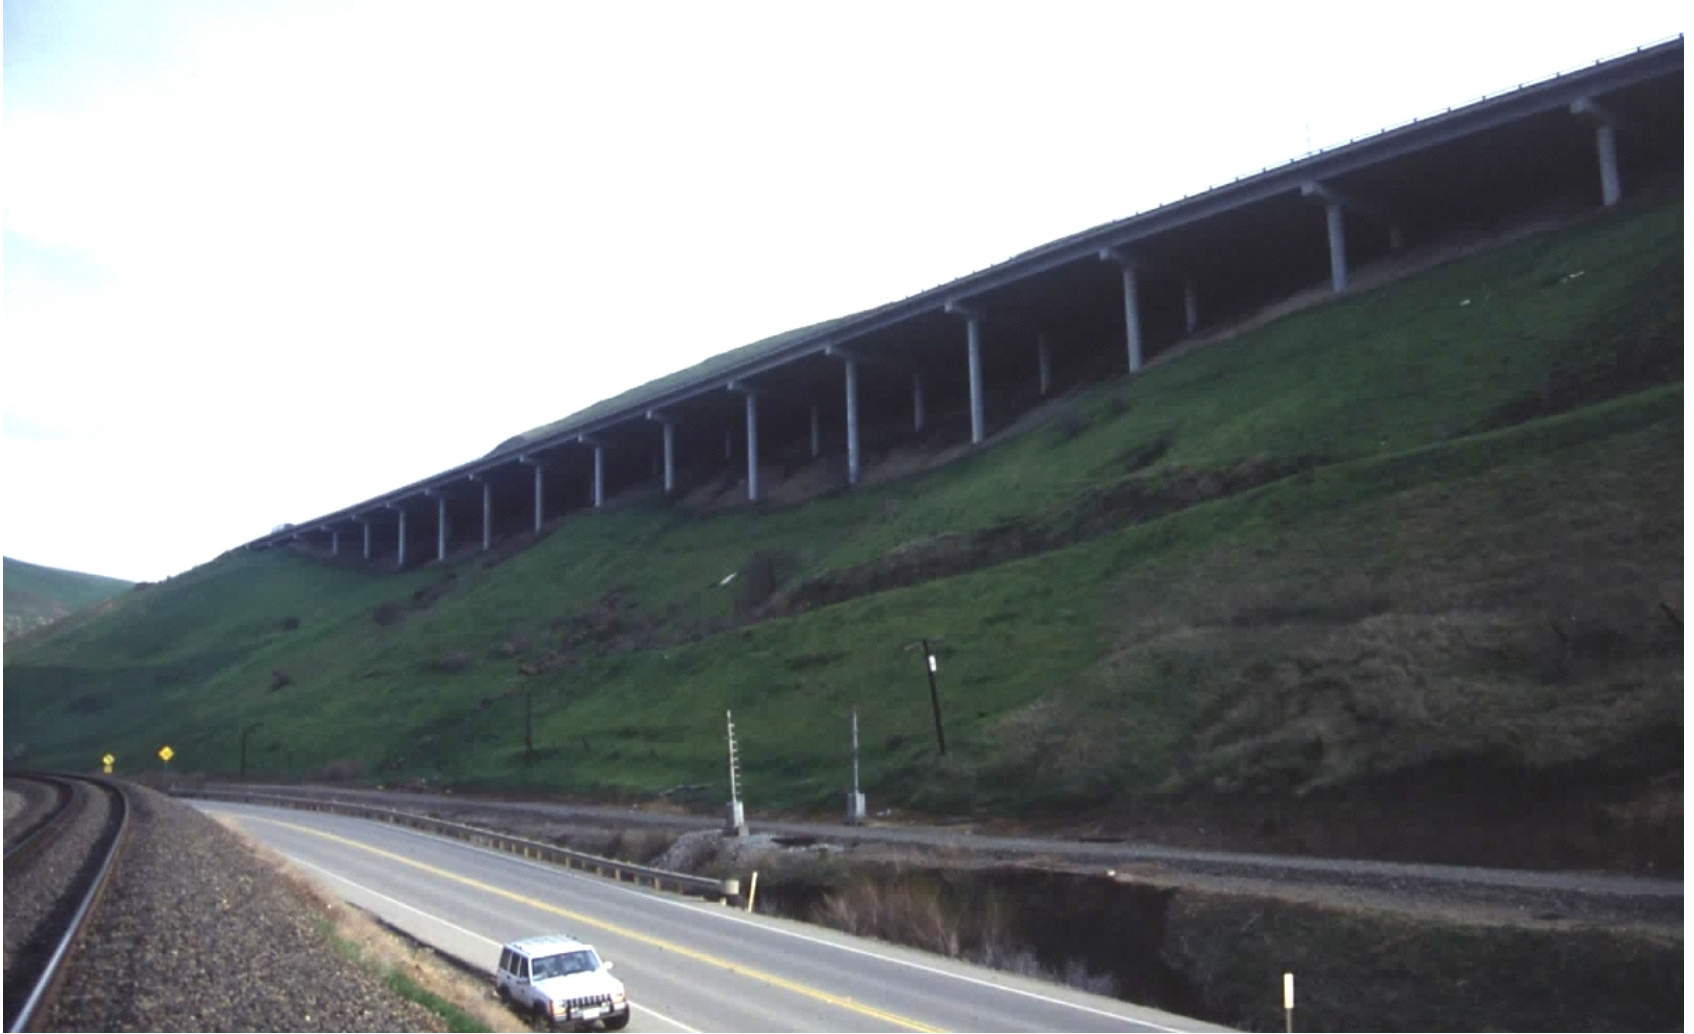
- Various support systems and elements can be **combined** to craft **creative solutions** for slope instability problems, as illustrated here.

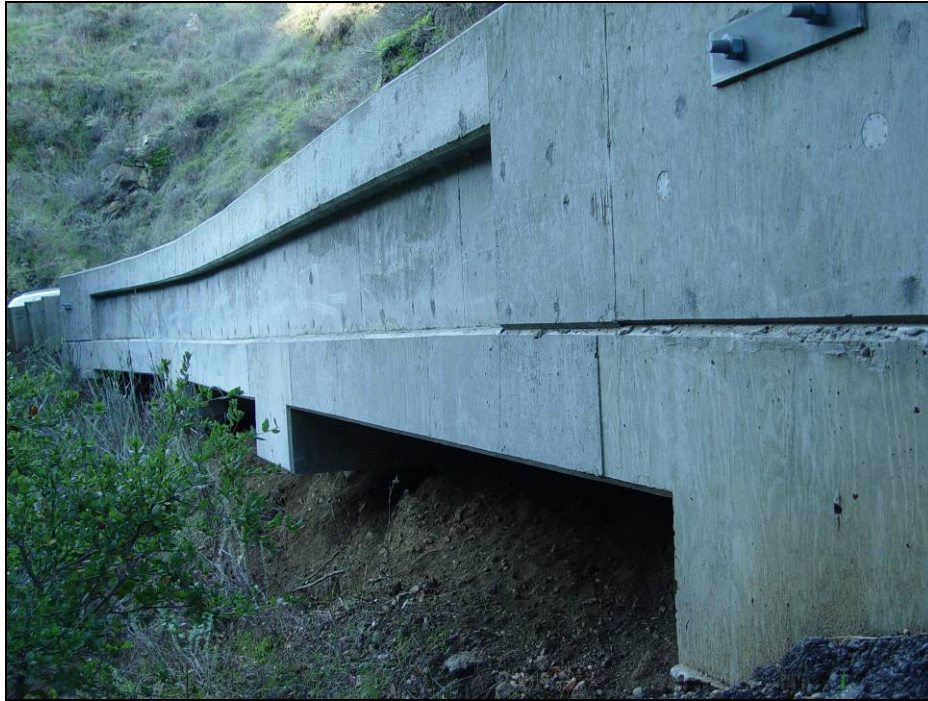
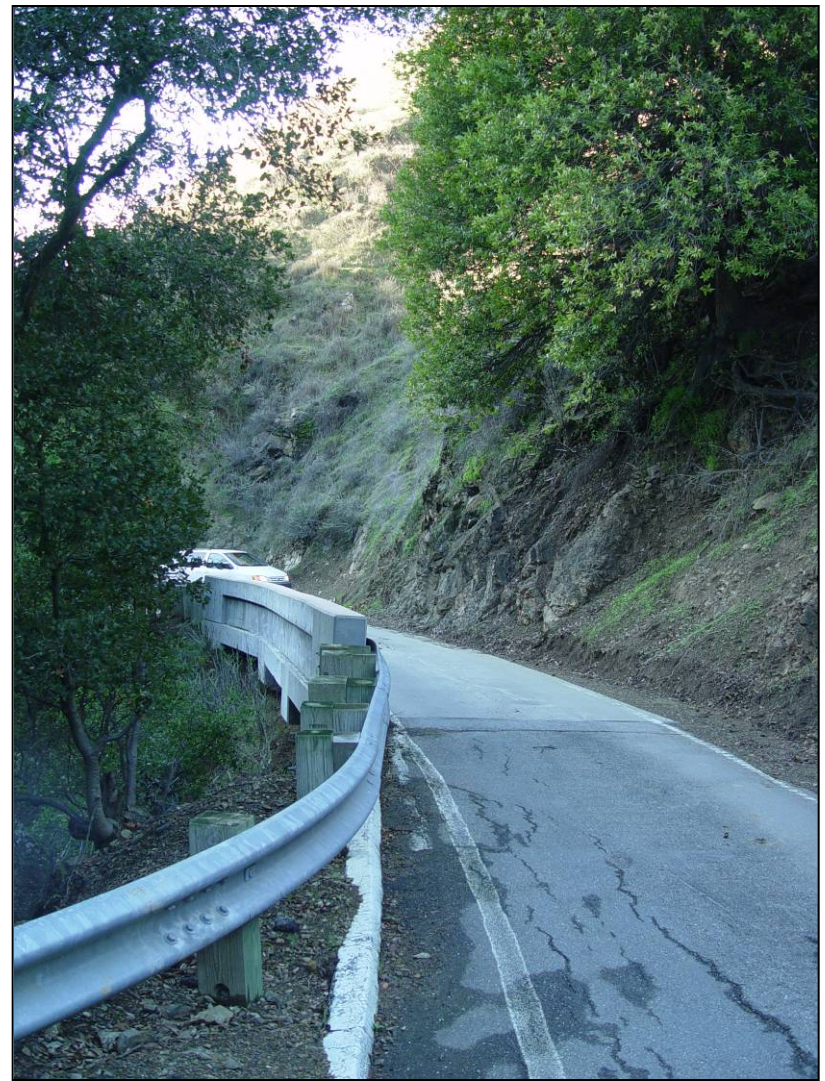
# BRIDGING OVER SLIDES

A **structural bridge** can be a cost-effective solution for maintaining a vehicular right-of-way over an active landslide or raveling rock fall site; if the structural deck can be poured-in-place as a *slab-on-grade*, founded on deep caissons. The troubled slope is then free to slide downslope, without impacting the road.

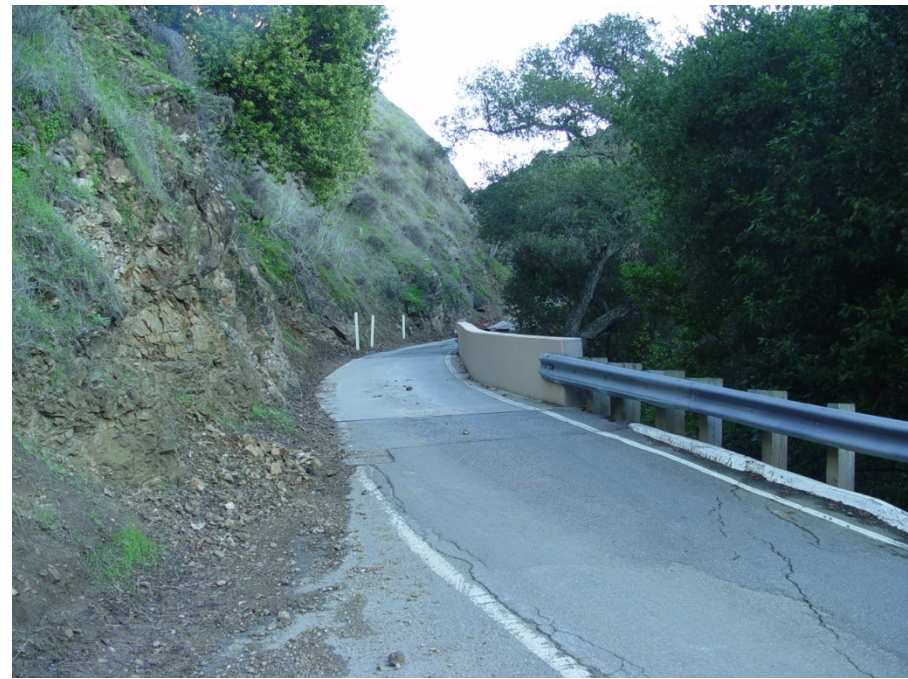
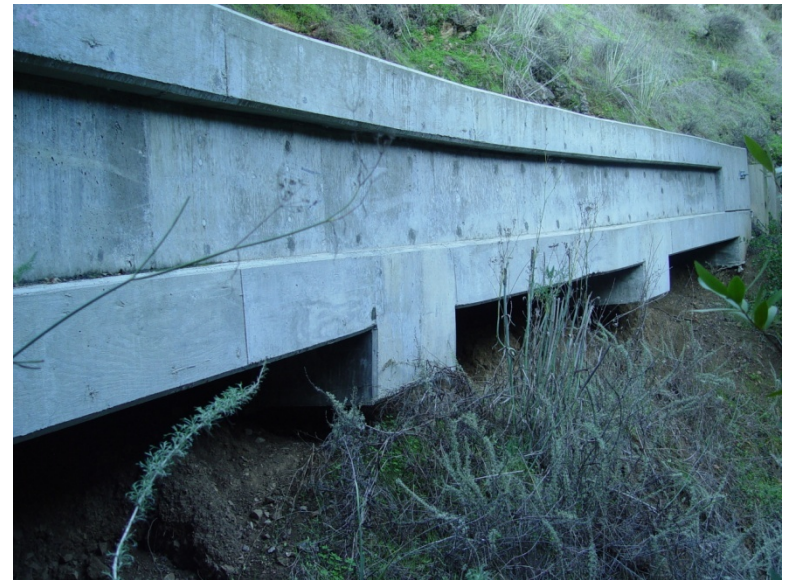
**A solid deck bridge can be poured-in-place on the bare ground, with a minimal amount of falsework supporting the overhanging areas.**

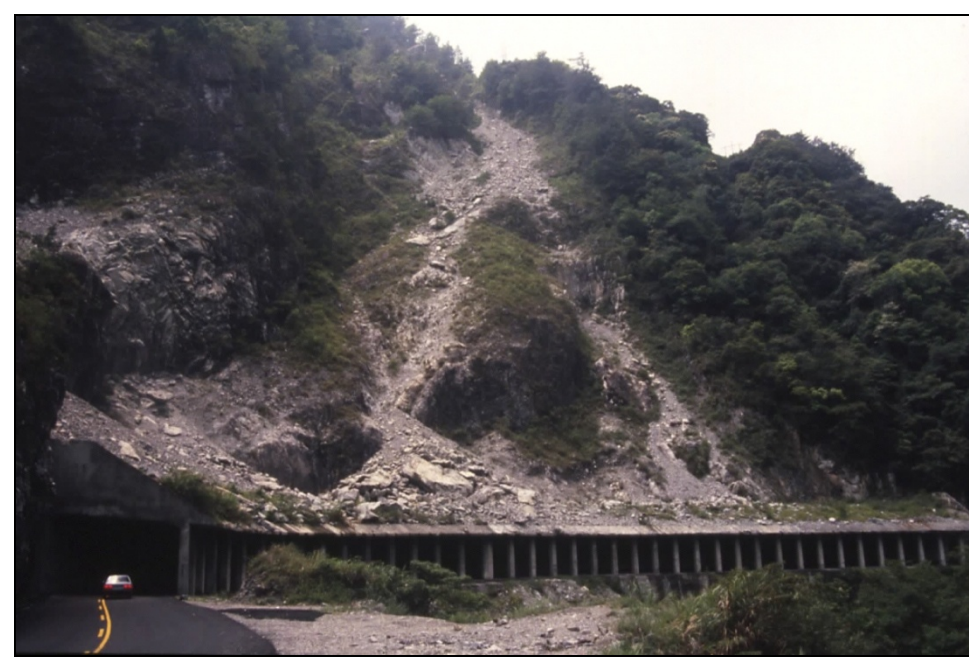
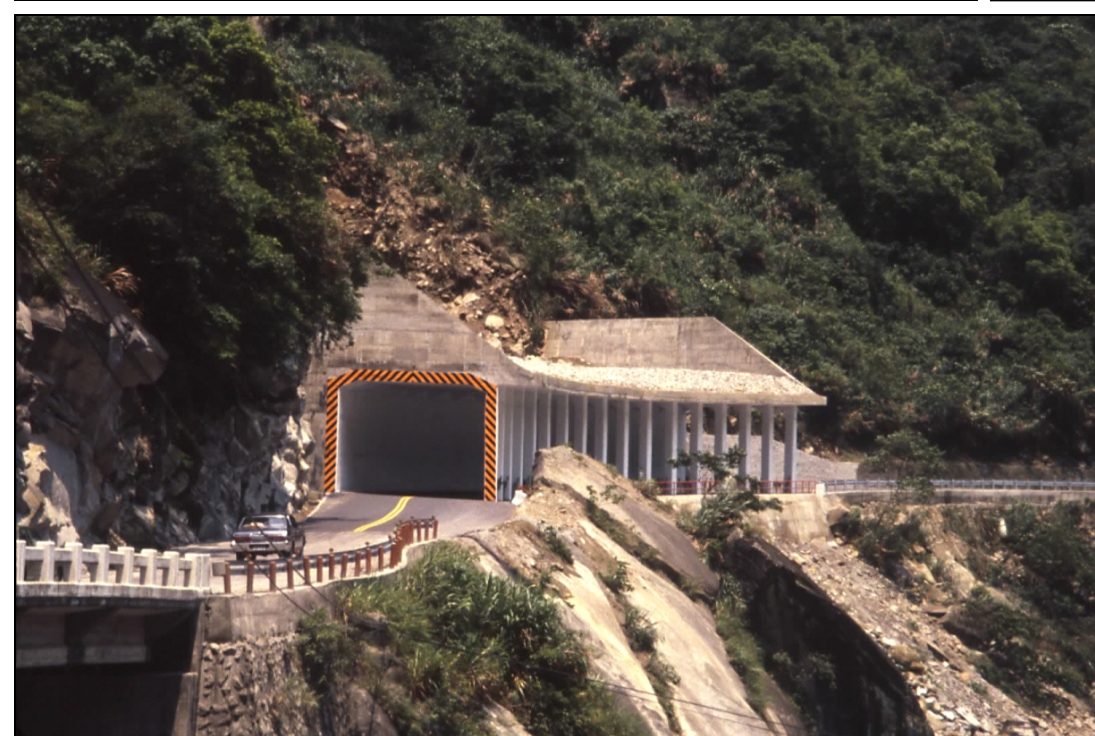
**Reinforced concrete shelters** have been employed along highways and railroads around the world to safely convey debris flows over these corridors. Such structures still require maintenance. These examples are from Taiwan and British Columbia.
