# Overview of LANDSLIDE MITIGATION TECHNIQUES

**J. David Rogers, Ph.D., P.E., P.G.**

**Slope Stability & Landslides Course**

University of Wisconsin-Madison

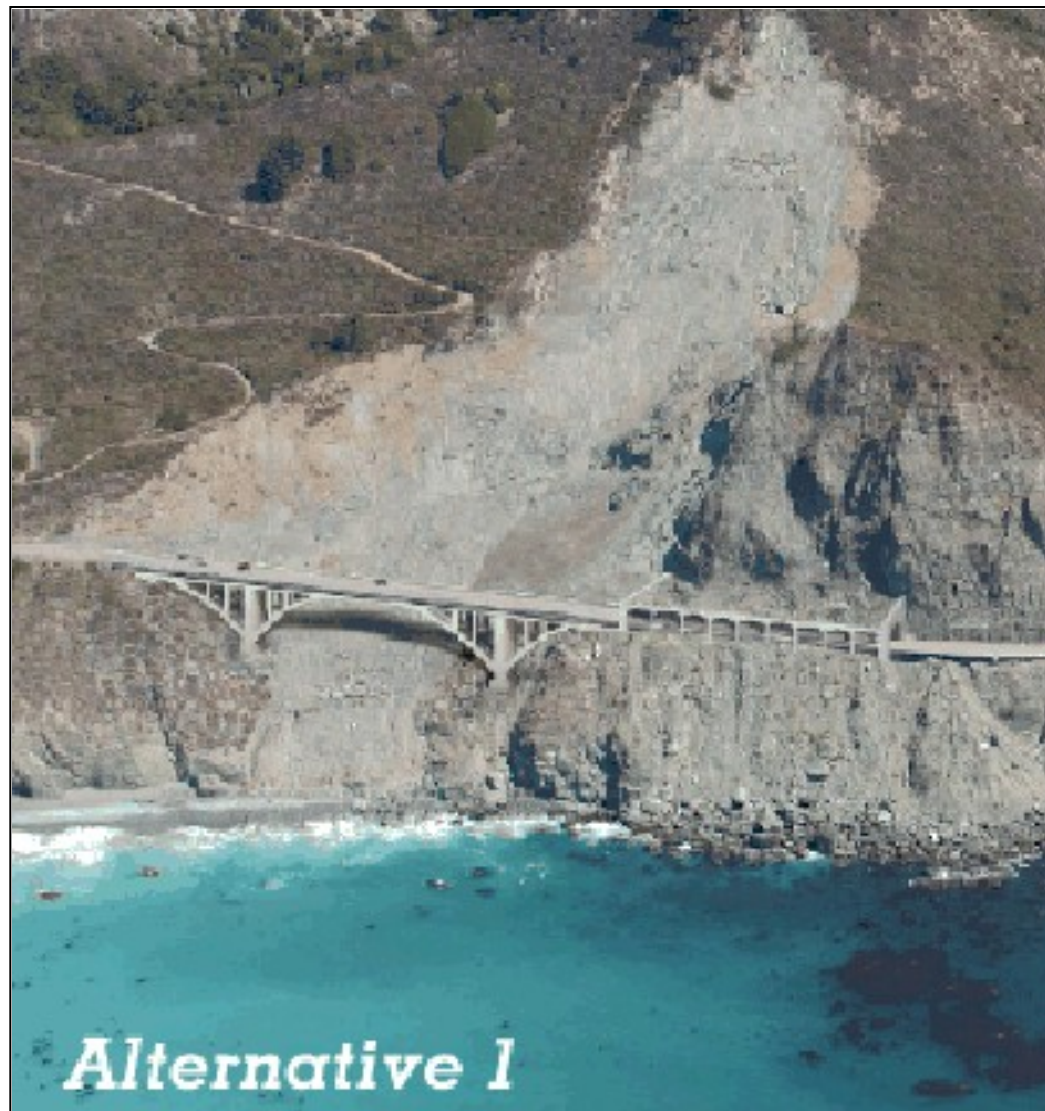
**Proposed structural repair employing a debris shed along California Route 1 in Big Sur, similar to what is used for mitigation of debris and rock slides.**

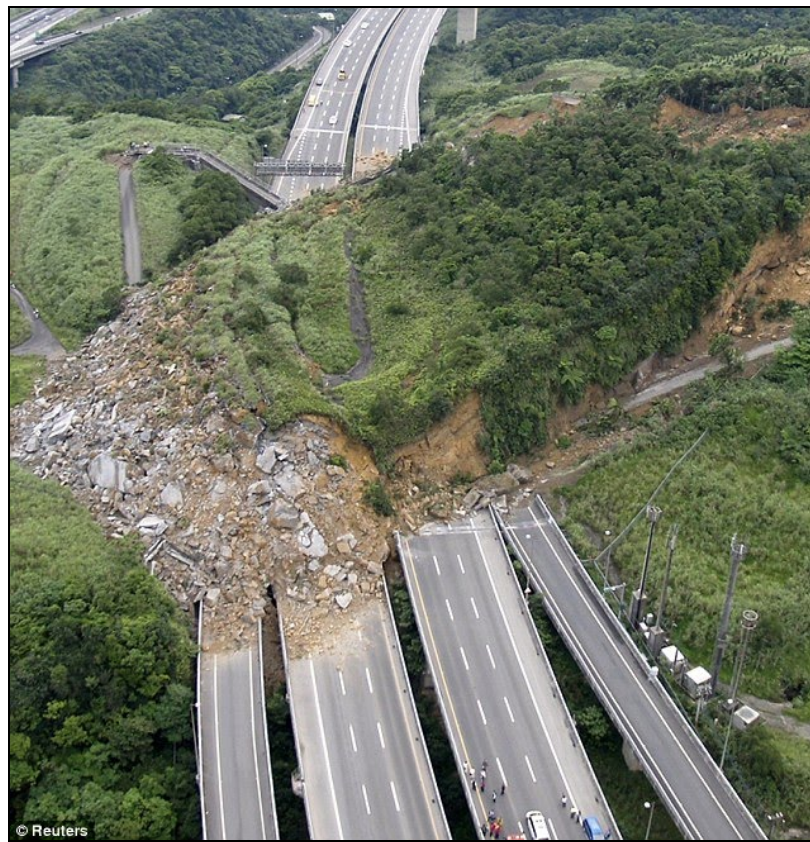
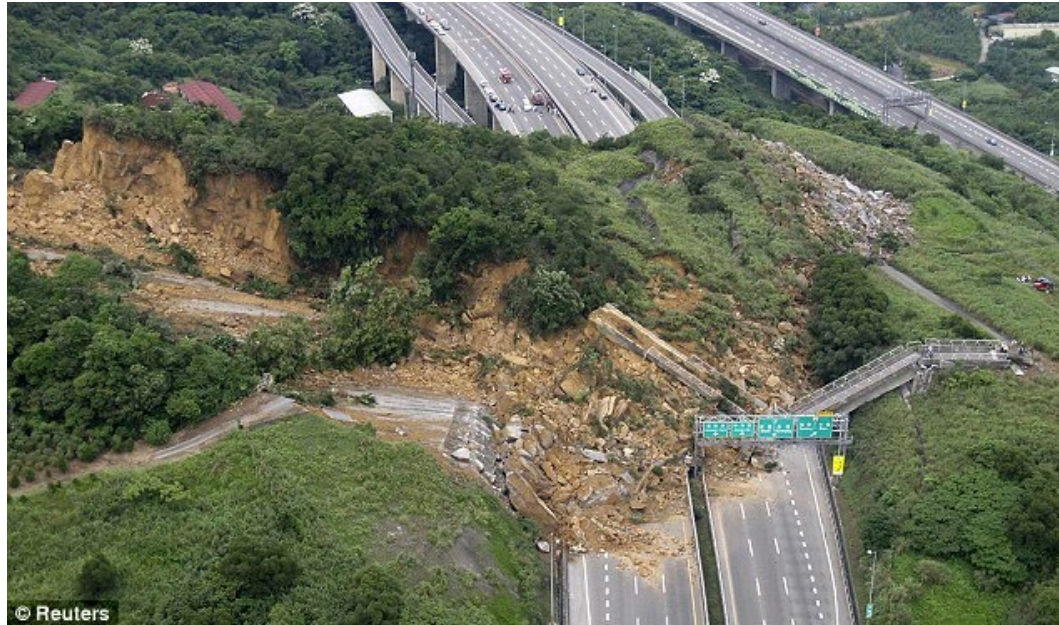
# Large Landslides

- In many cases the least expensive and quickest way to mitigate a major disruption of an Interstate highway is to either: 1) excavate the slide debris and leave a 100 to 200 ft wide buffer along the highway, or, 2) construct an inclined section, employing minimal excavation of the debris (which can destabilize the scarp).
