Geologic Influence on 2008 Midwest Levee Failures

J. David Rogers, Department of Geological Sciences & Engineering, Missouri University of Science & Technology, Rolla, Mo 65409, rogersda@mst.edu

Levee Investigation Overview

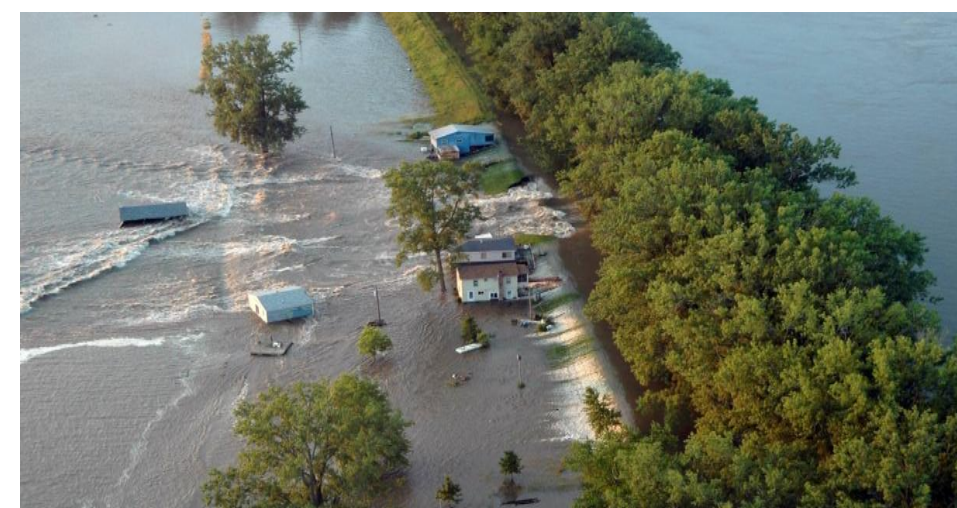
The Pillsbury Road Levee failure in the Cap au Gris District east of Winfield being overtopped on June 18, 2008. The crown of the levee was below design grade here because of the encroachment of the homes, which prevented the district from maintaining the design crest elevation.

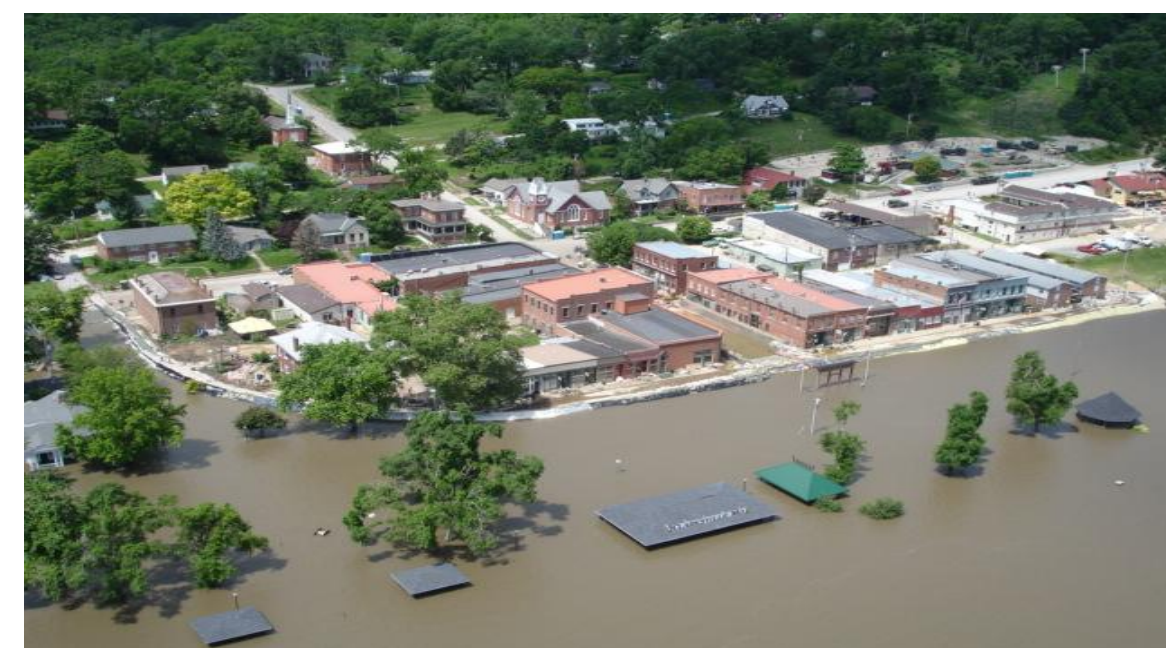
Hesco Bastions employed as "Port-a-dams" with sand bags as interactive flood management.

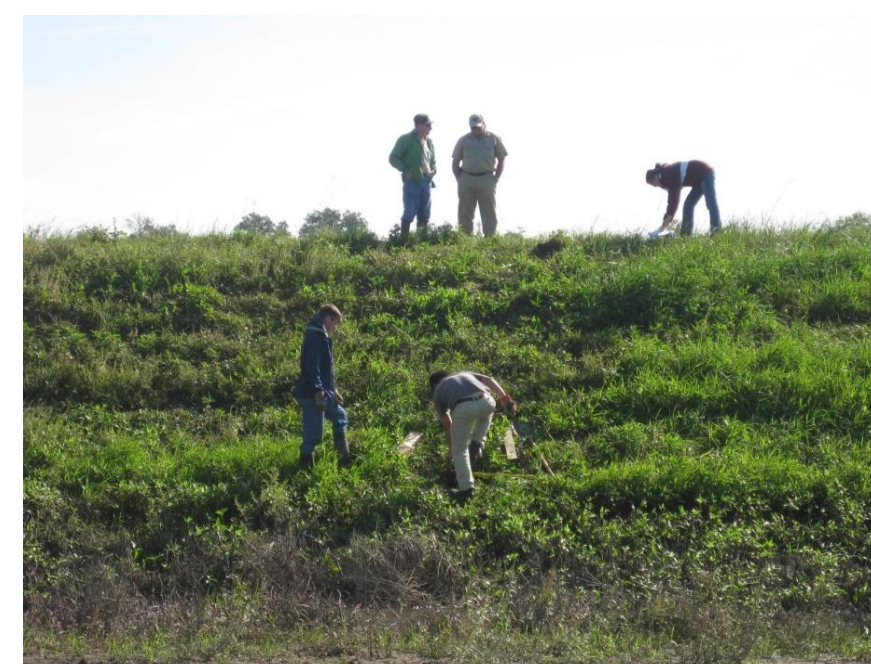
Erosion tests of samples recovered from the Brevator Levees revealed they have a slightly higher clay content than levees closer to the Mississippi River, which did not survive overtopping.

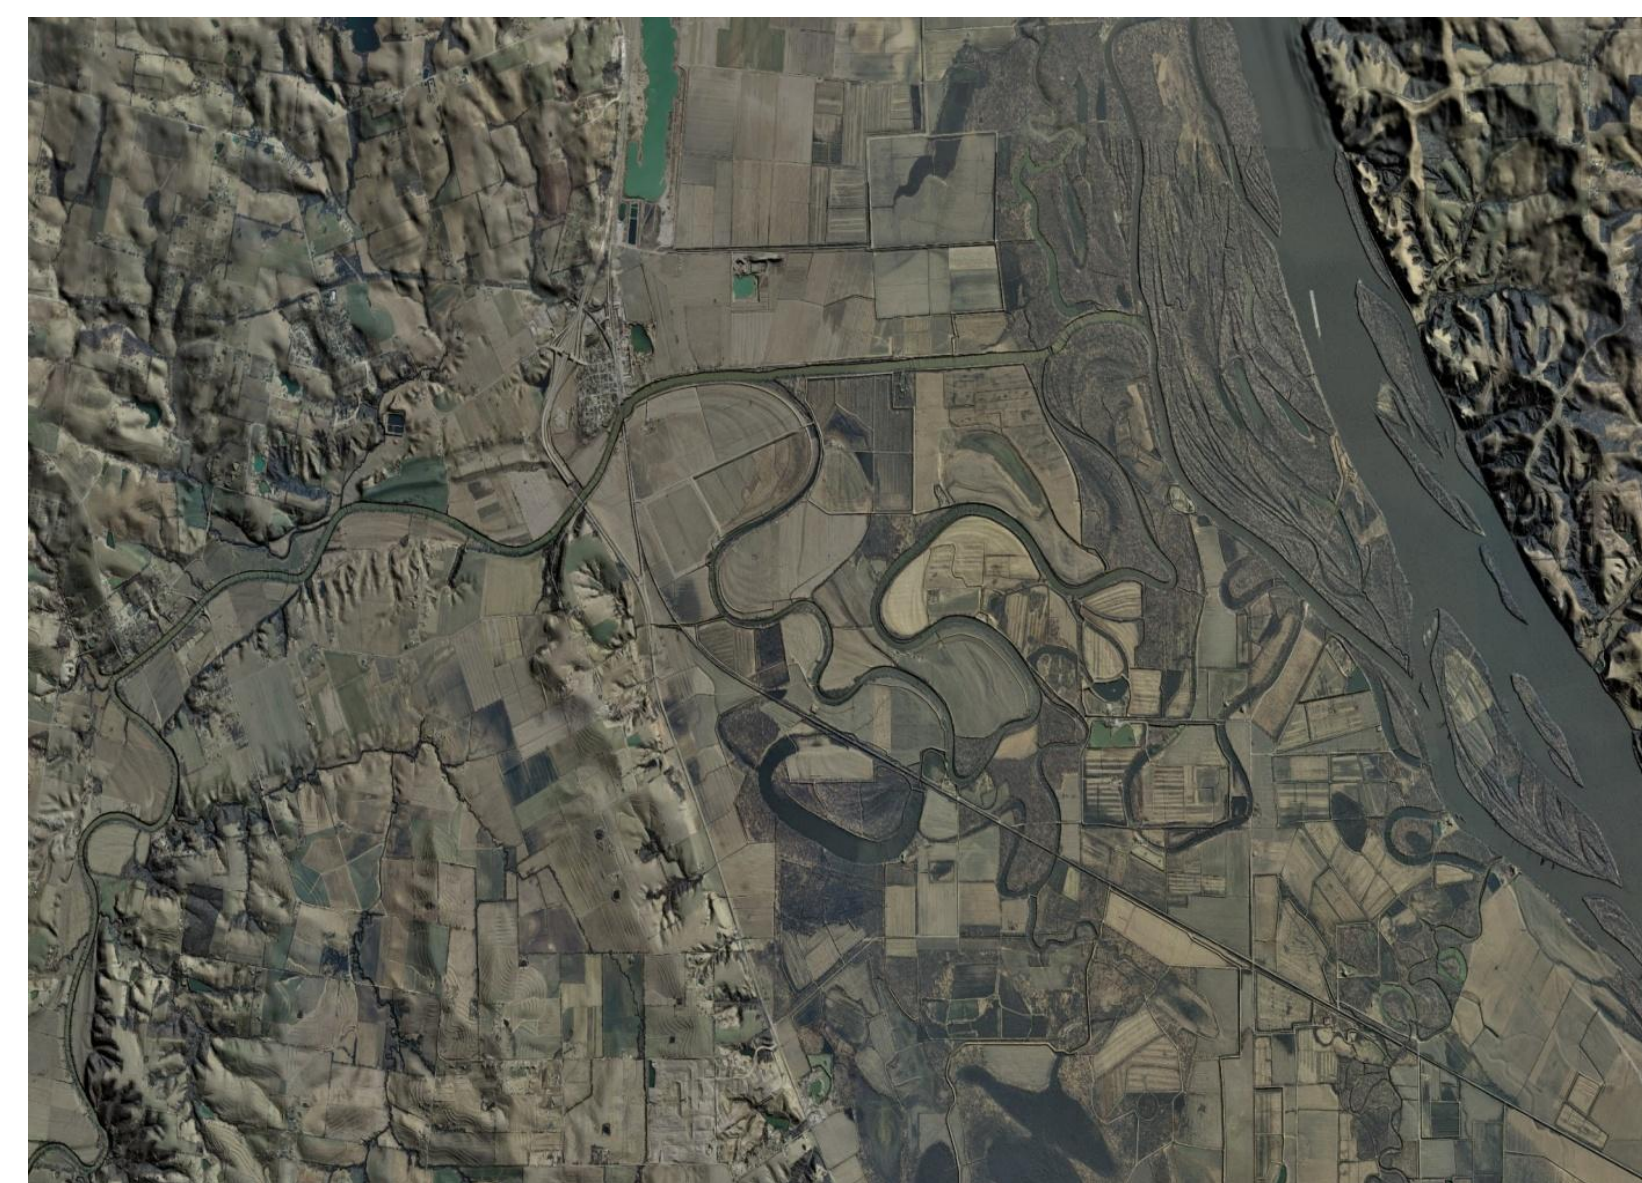
Aerial imagery wrapped on the LiDAR and DEM surface, showing development of the Mississippi River flood plain at mouth of the Cuivre River, in the Brevator Levee District. These levees survived 3 weeks of overtopping.

The Brevator Levee System was continuously overtopped by 0.5 to 1 meter of water for several weeks and experienced no detrimental erosion or breaching. This levee system was designed for a 14-year return period flood event and protects an area of over 740 hectares. The utilization of high cohesion clays and presence of grass turf greatly influenced the robustness and resiliency of this levee system.

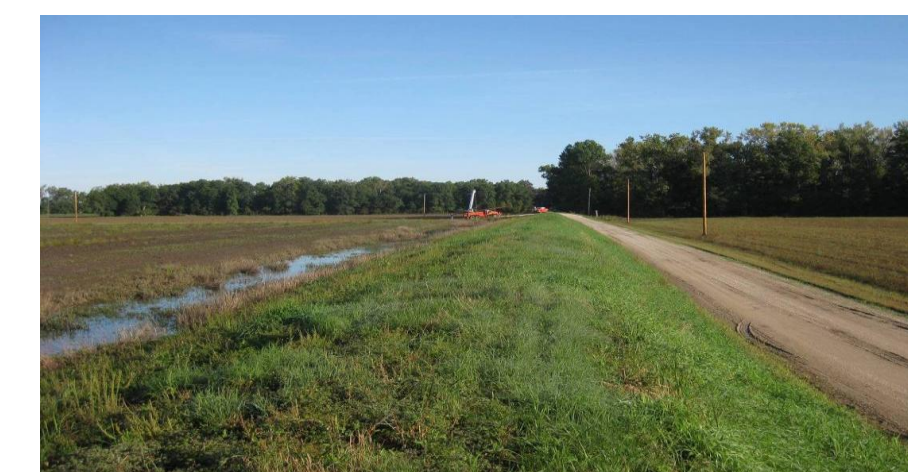
Resilient, overtopping resistant clay levee

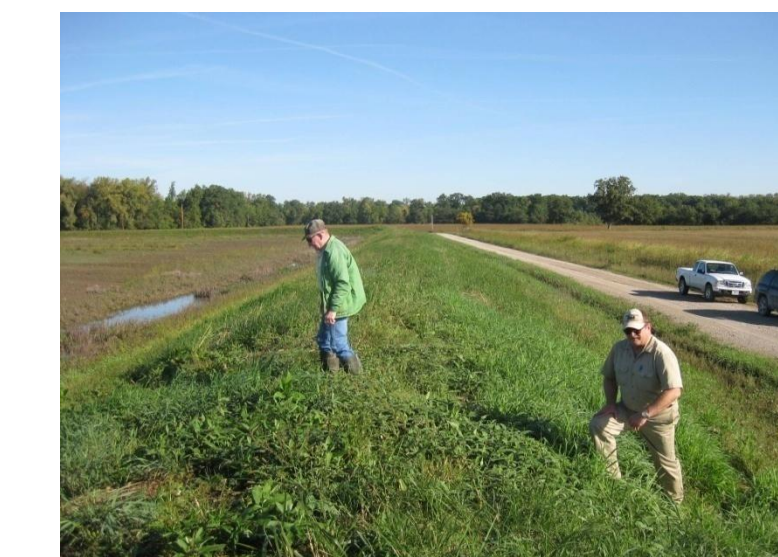
The Brevator District levees near Winfield survived 14 days of near-continuous overtopping, without failing

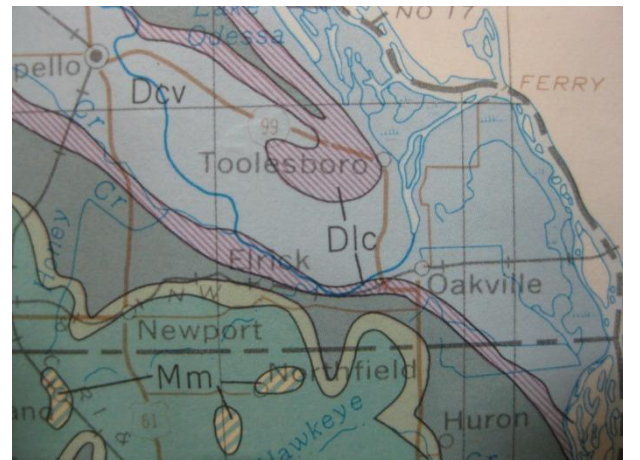
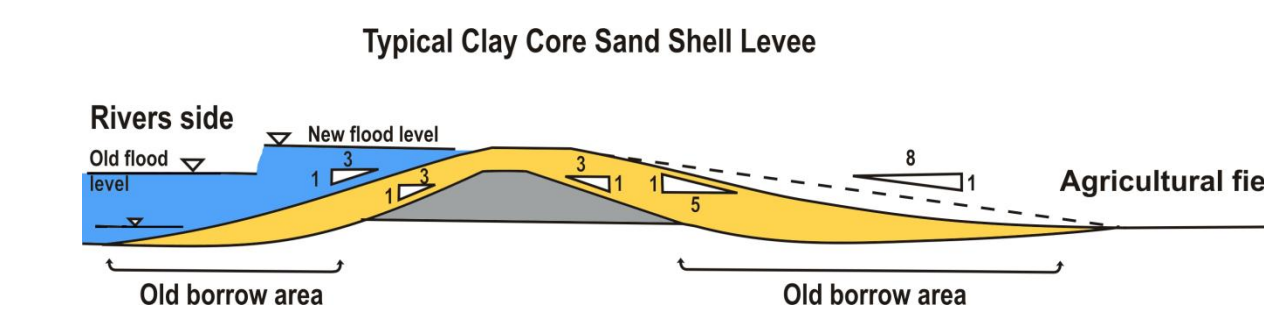
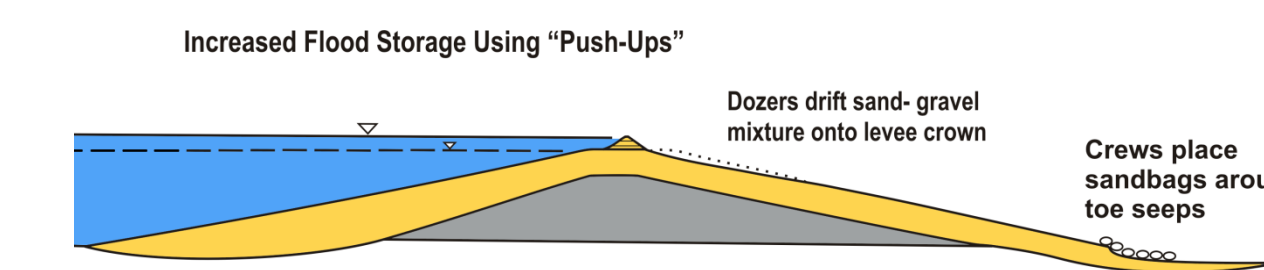
The levee foundation was a thin veneer of alluvial sands and gravels over lying on dark olive-gray shale of the Sheffield Formation, within the Devonian age Yellow Springs Group (Dys), close to its basal contact, with the gray shales of the Lime Creek Formation (Dlc), also of Devonian age. This created an unusual foundation condition in the upper Mississippi Valley, because of the enormous permeability contrast between the channel fill and the shallow bedrock.

The Two Rivers Levee system was designed for a 100-year flood event and protects over 7,100 hectares. It was reported that the flood stage (prior to catastrophic breaching) was 2 to 3 meters above the 500-year flood stage. The sand levee breach zone was over 1,450 meters long. The sand levees constructed along the Iowa River were completely washed away within the breach area. Significant scour holes were observed along the entire breach extents.

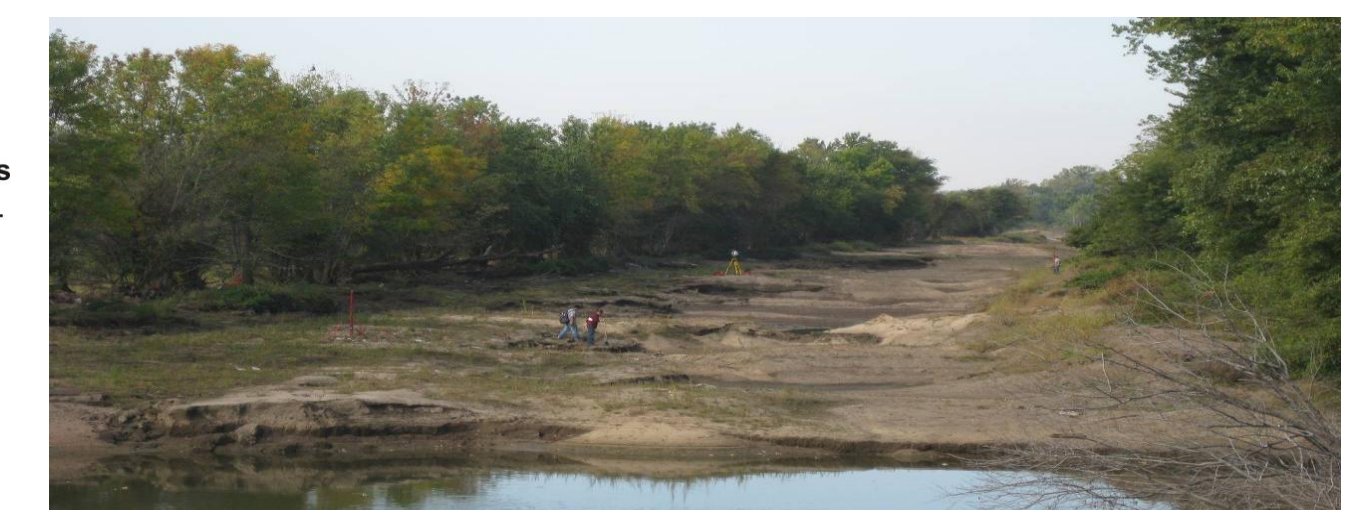
Catastrophic breaching of sand levees.

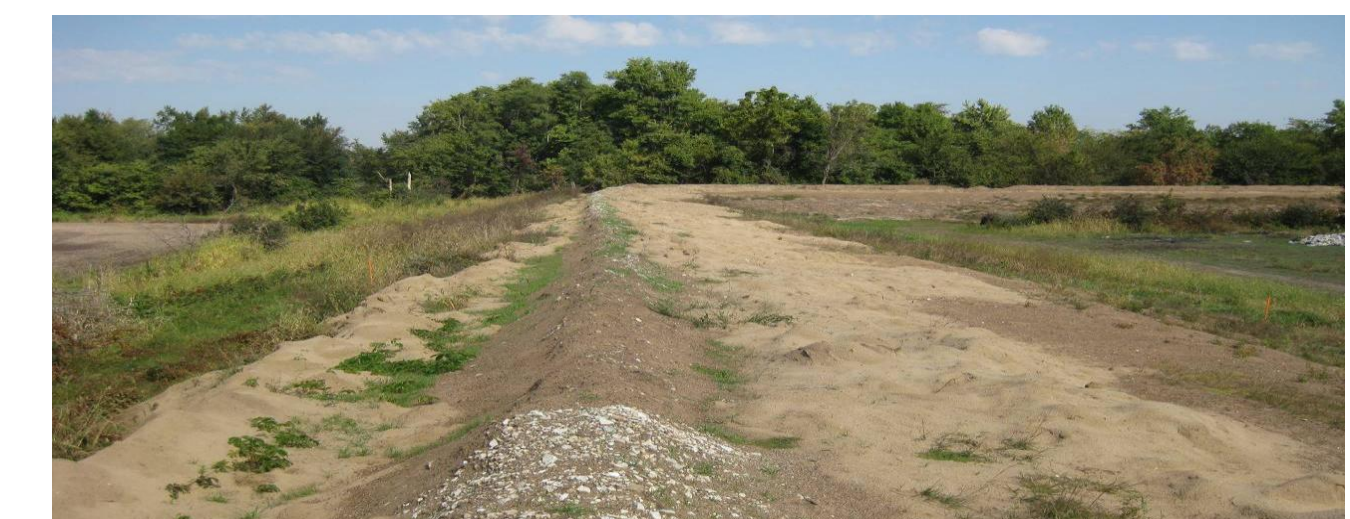
Remnant push-up features after interactive flood-fighting efforts.

Interactive flood fighting measures at the Two Rivers site included a 'push-up' technique where levee materials on the protected side are 'pushed up' to the crest of the levee in order to increase the crest elevation. Unfortunately, the interactive flood fighting measures were insufficient to prevent the catastrophic failure and resulting flooding of this area.

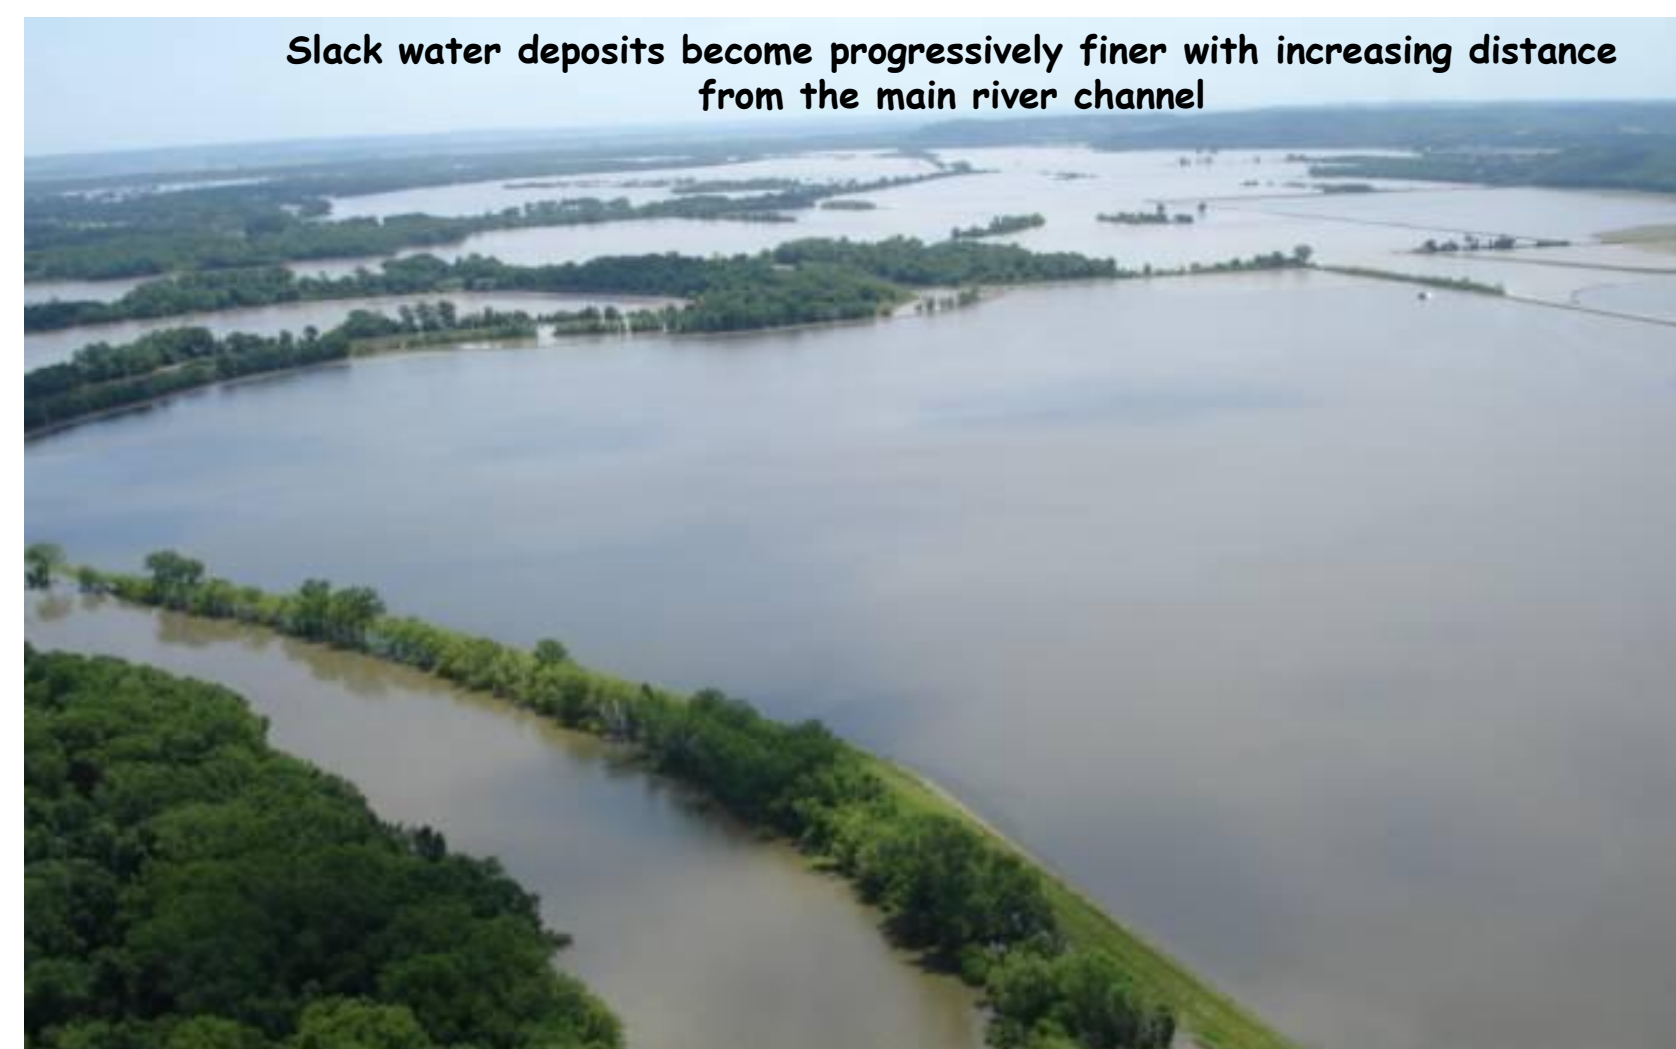
Aerial oblique view of the inundated upper Mississippi River flood plain in late June 2008. Note turbidity of the main channel at lower left, as compared to the stagnant flood water.

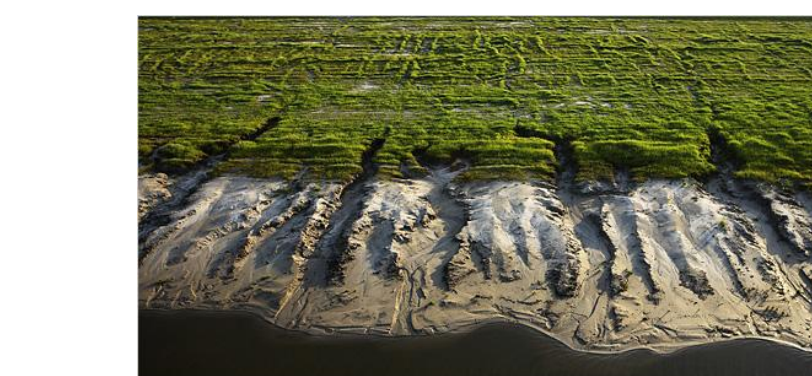
Two kinds of overtopping-induced damage

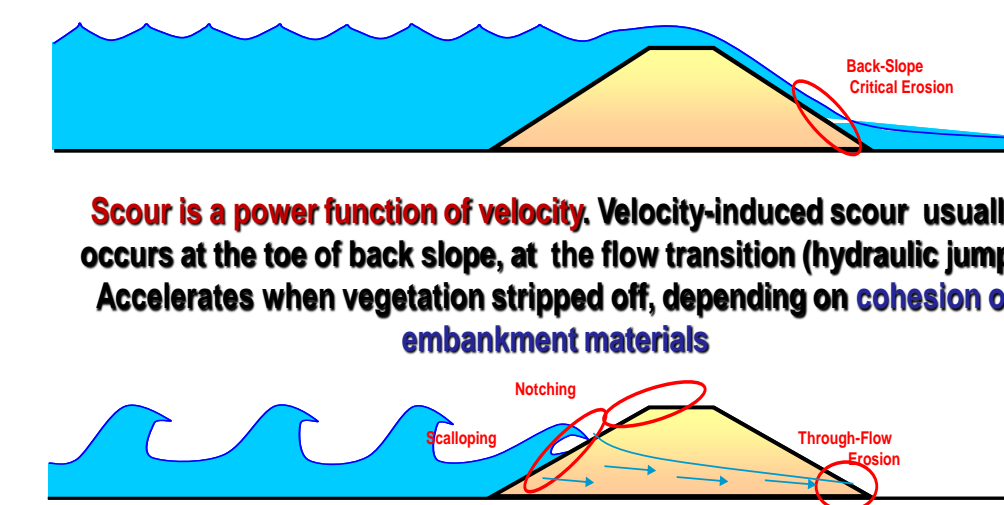
Scalloping and notching on the fetch side of the levee, due to wave pounding; and piping fomented by emergent seepage at the toe of the back slope
Note: damage at back slope toe looks similar for both modes

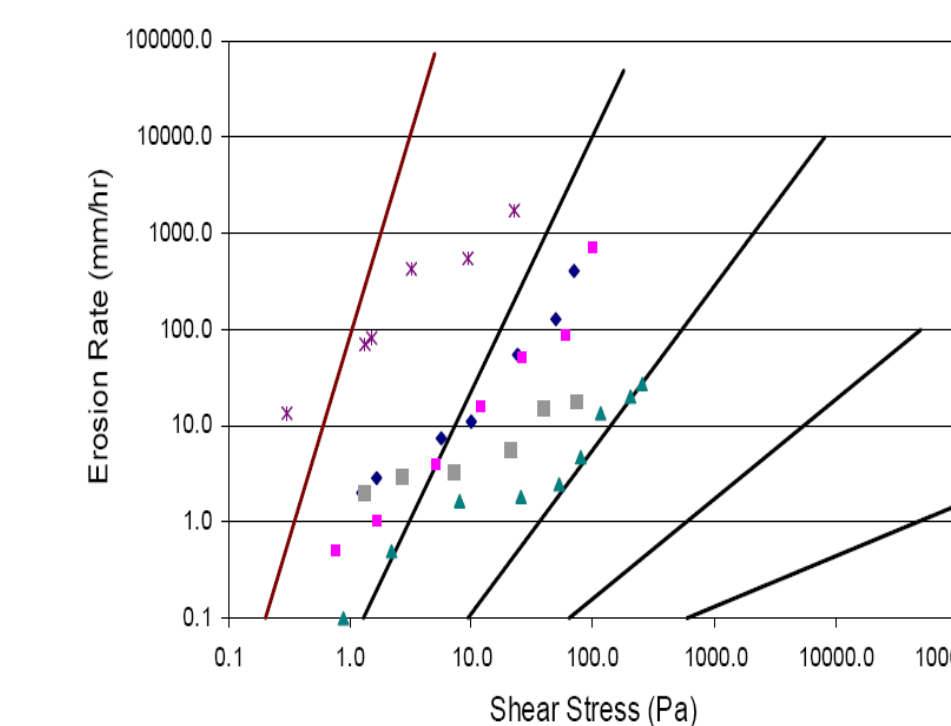
Erosion Rate vs. Shear Stress

Soil erodability data for Midwestern Levees sampled just after the 2008 floods. Small percentages of clay have a profound impact on levee resilience. Data from Michelle Bernhardt at Texas A&M, on our NSF investigative team.

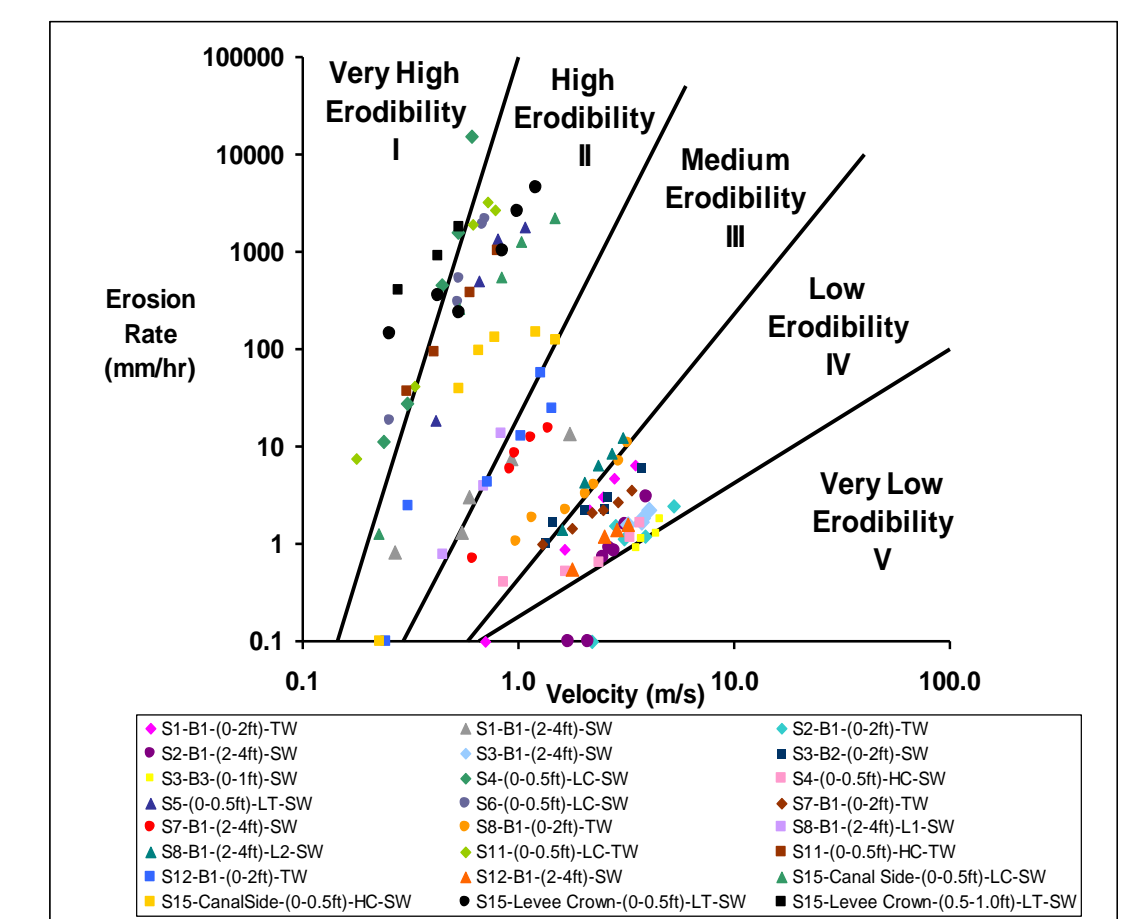
Soil erodability potential gleaned from laboratory tests by Prof. Jean-Louis Briaud at Texas A&M University. This plot shows data from the Mississippi Delta collected after Hurricane Katrina.
