CLAY CONTENT OF LEVEE EMBANKMENTS AND ITS ROLE IN SURVIVABILTY OF LEVEES DURING **OVERTOPPING EVENTS**

J. David Rogers, Ph.D., P.E., R.G. Natural Hazards Mitigation Institute Missouri University of Science & Technology

for the symposium on **Geologic Studies for Dams and Levees Association of Environmental & Engineering Geologists** Lake Tahoe, California September 25, 2009

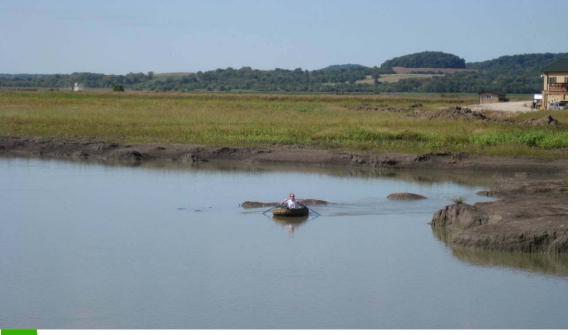
Cap au Gris breach which we surveyed and sampled. Very sandy silt.

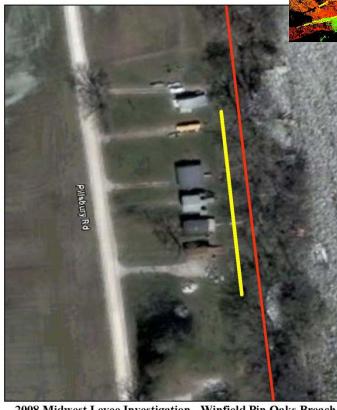
2008 Midwest Levee Investigation - Winfield Pin Oaks Breach Legend Winfield_Breach Winfield_Levees

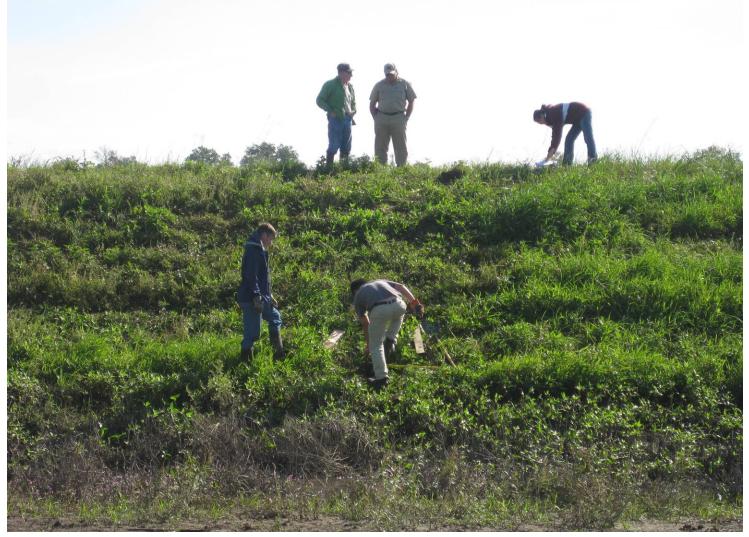
The Brevator District levees near Winfield survived 14 days of near-continuous
 overtopping, without failing

Erosion tests of samples recovered from the Brevator Levees revealed they have a much higher clay content than levees closer to the Mississippi River which did not survive overtopping.
