# RISK-BASED ASSESSMENT OF LEVEES- LESSONS LEARNED FROM THE 2011 MISSISSIPPI RIVER FLOODS

**J. David Rogers, Ph.D., P.E., P.G., C.E.G., C.HG.**

**ASCE Geo-Institute's Geoconfluence 2012  
Geotechnical and Geo-environmental Conference**

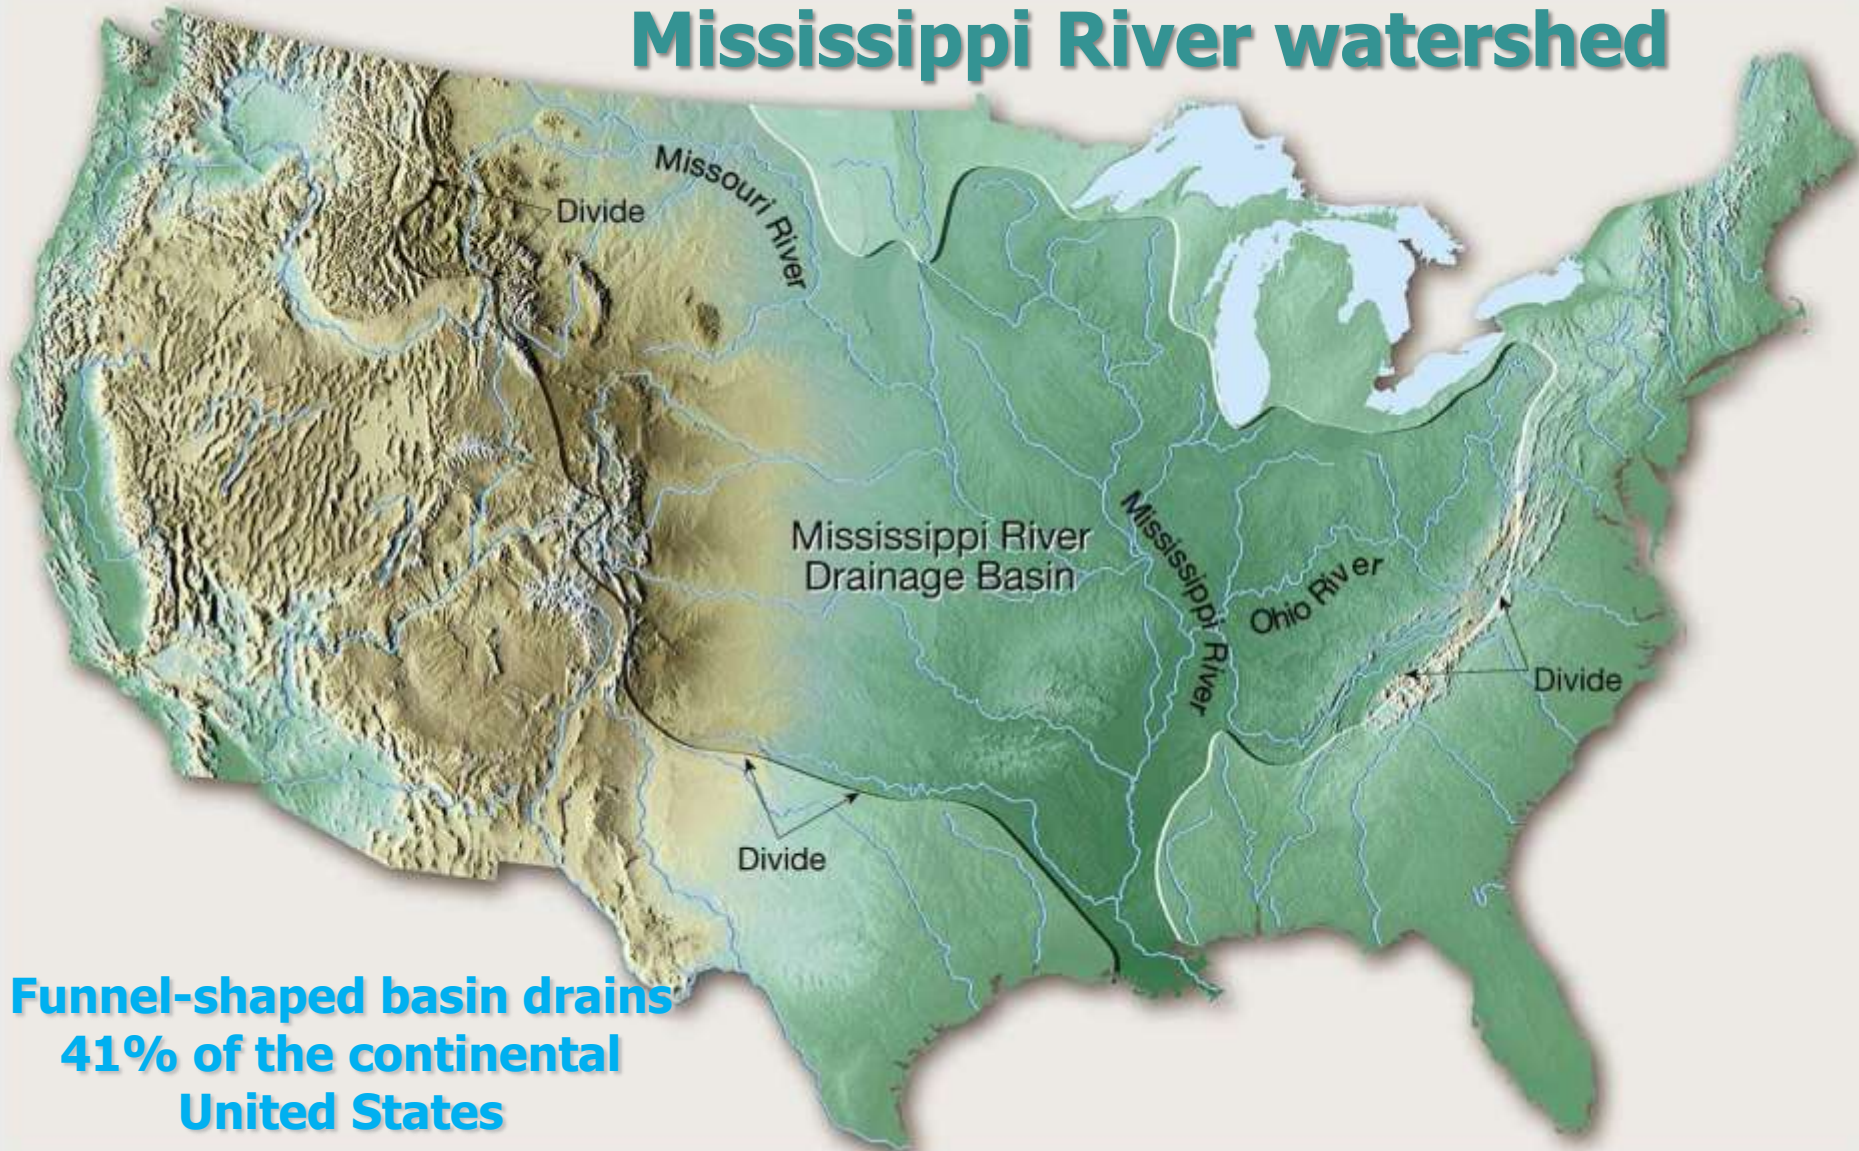
**Funnel-shaped basin drains  
41% of the continental  
United States**

**Average flow 640,000 cfs. Suspended sediment flux 180 million yds<sup>3</sup>/yr, one third of all US rivers. Long duration floods transport enormous volumes of sediment**

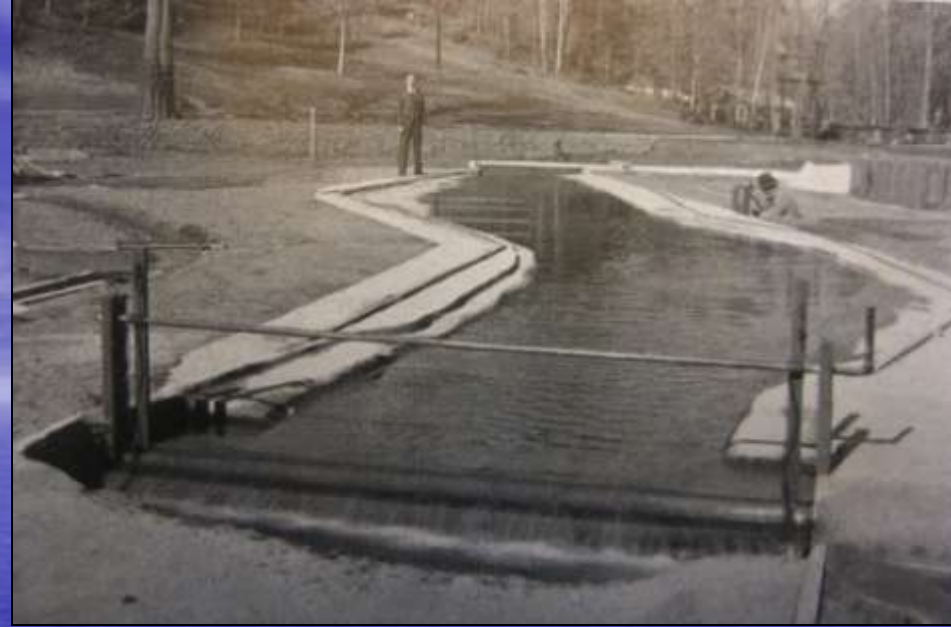
Vogel and Prof. Clarence Bardsley were the first engineers to ever construct **outdoor earthen bed hydraulic models**

The loess soils in Vicksburg were ideal for carving precise scale hydraulic models, with vertical exaggeration

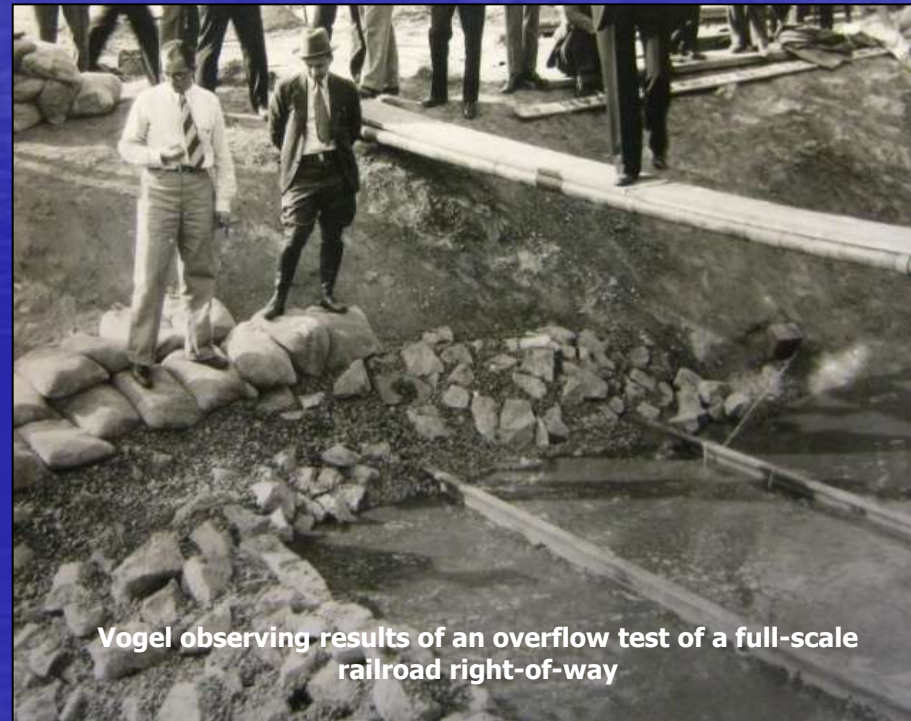
Vogel observing results of an overflow test of a full-scale railroad right-of-way

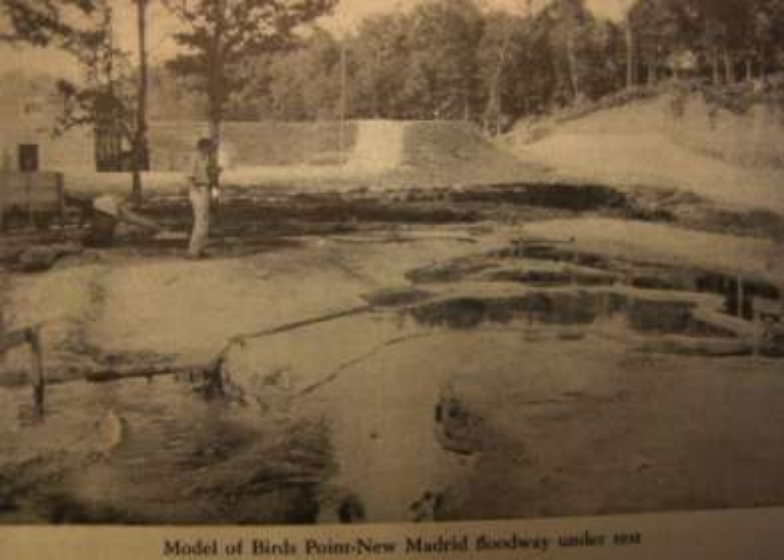
Model of Birds Point-New Madrid Floodway under test

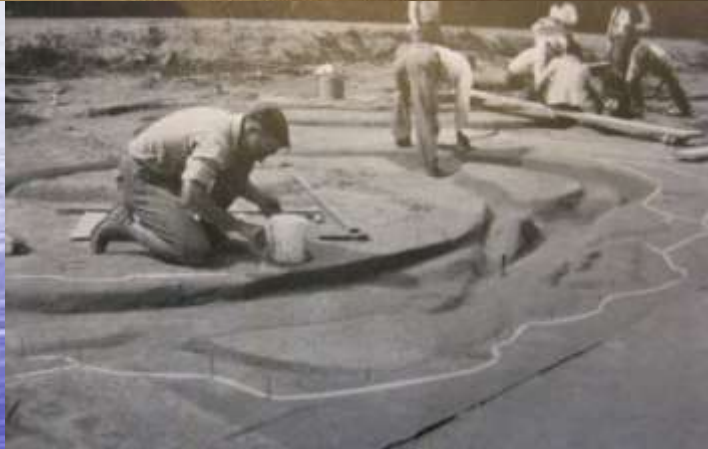
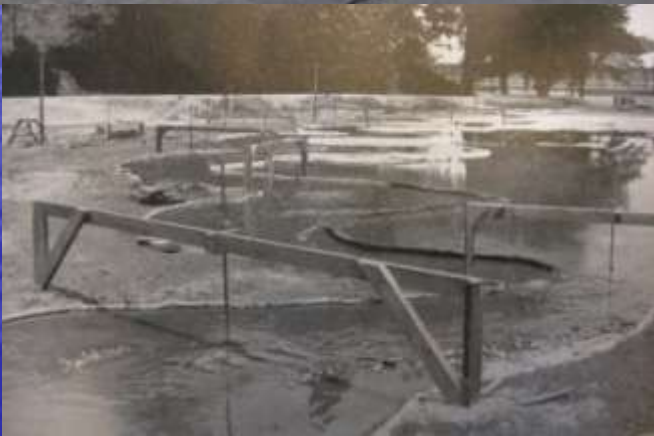
- The **Birds Point-New Madrid Floodway** was located in Missouri and starting just below the confluence of the Mississippi and Ohio Rivers at Cairo, IL, covering about 206 square miles.
- In 1932 WES performed a model study to determine the effects of operating the floodway on the lands lying within it and to predict the draw-down on the Mississippi River with the floodway in use.
- With more than 100 miles of river to simulate, Vogel built an 80-foot-long outdoor concrete model of the river channel, the overbank between levees, backwater areas, and the floodway.
- Vog took special care to correctly place drainage ditches, levee borrow pits, and other details that would affect water levels, and raised miniature levees with soil taken from actual on-site levee borings. These tests indicated that the new levees were of sufficient height to contain any projected flood

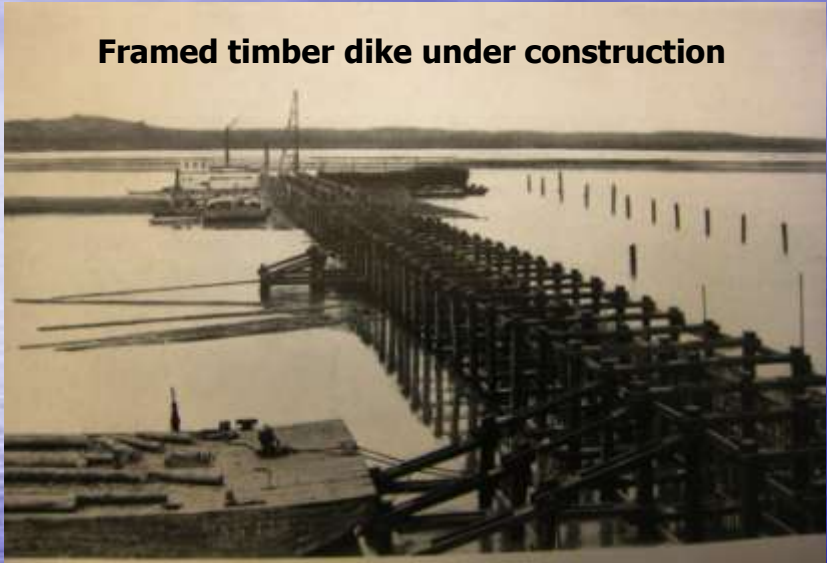
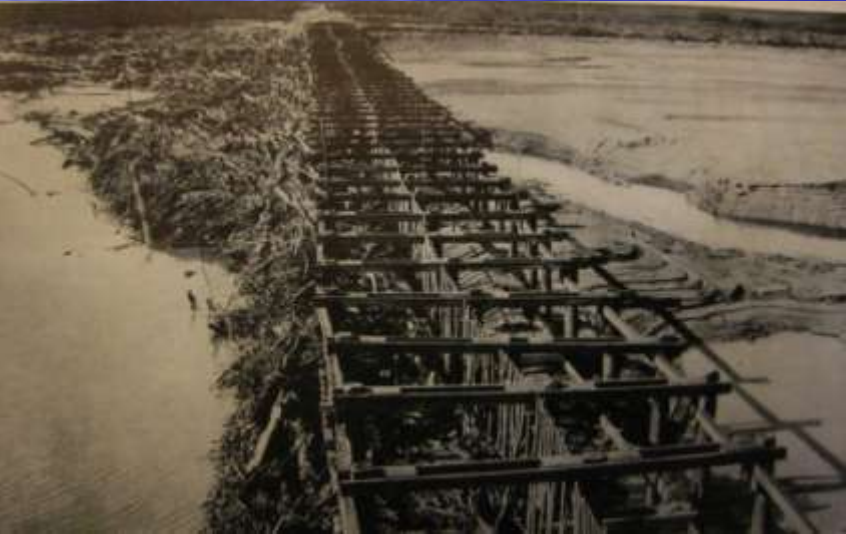
**Framed timber dike under construction**

Shallow navigation depths between Cairo and Memphis are being increased by narrowing and stabilizing the low-water channel by means of spur dikes

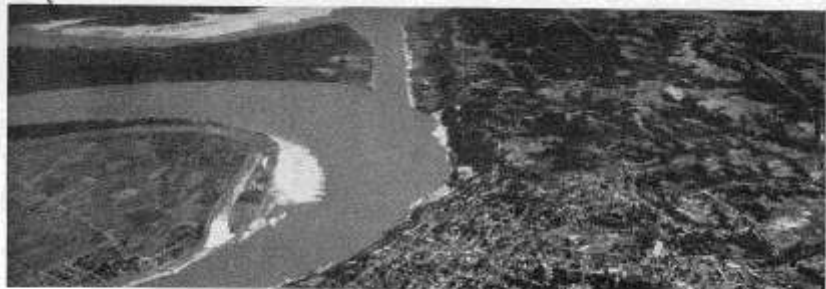
FIG. 1. INCREASING THE MISSISSIPPI'S CAPACITY: GILES CUTOFF IS BEING DREDGED AND VIDALIA POINT CUT BACK.

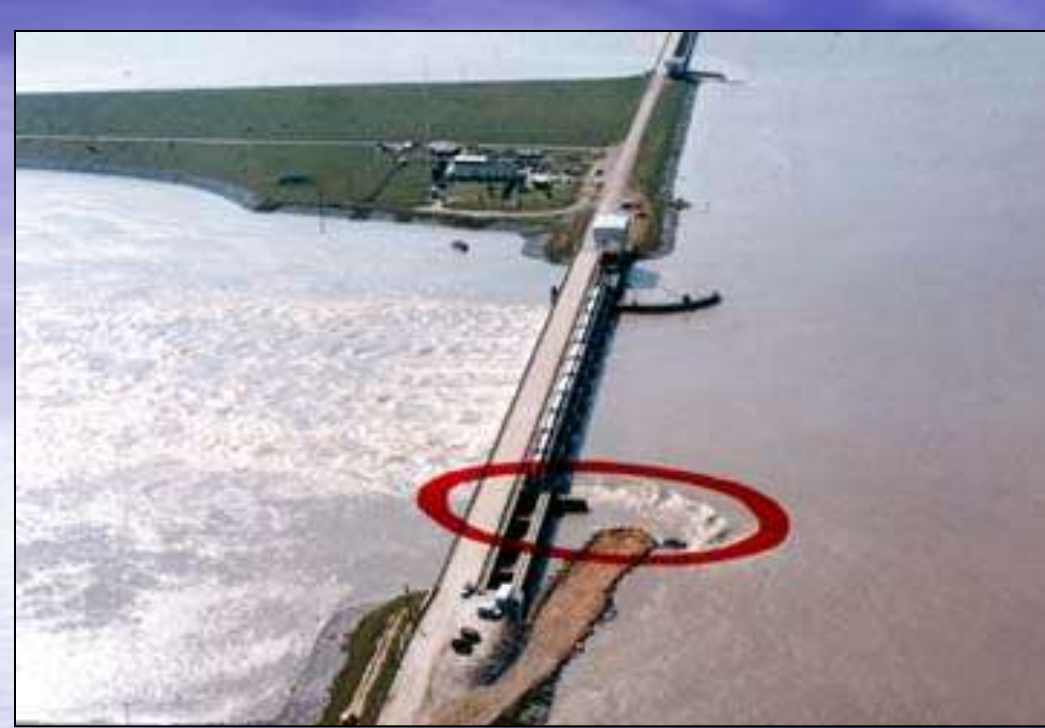
- During the '73 flood a large *back-eddy scour hole* developed on the up and downstream sides of the left abutment of the Low-Sill Diversion Structure
- Without the battered steel piles a new Mississippi River channel would have been carved down the Atchafalaya River to the Gulf !

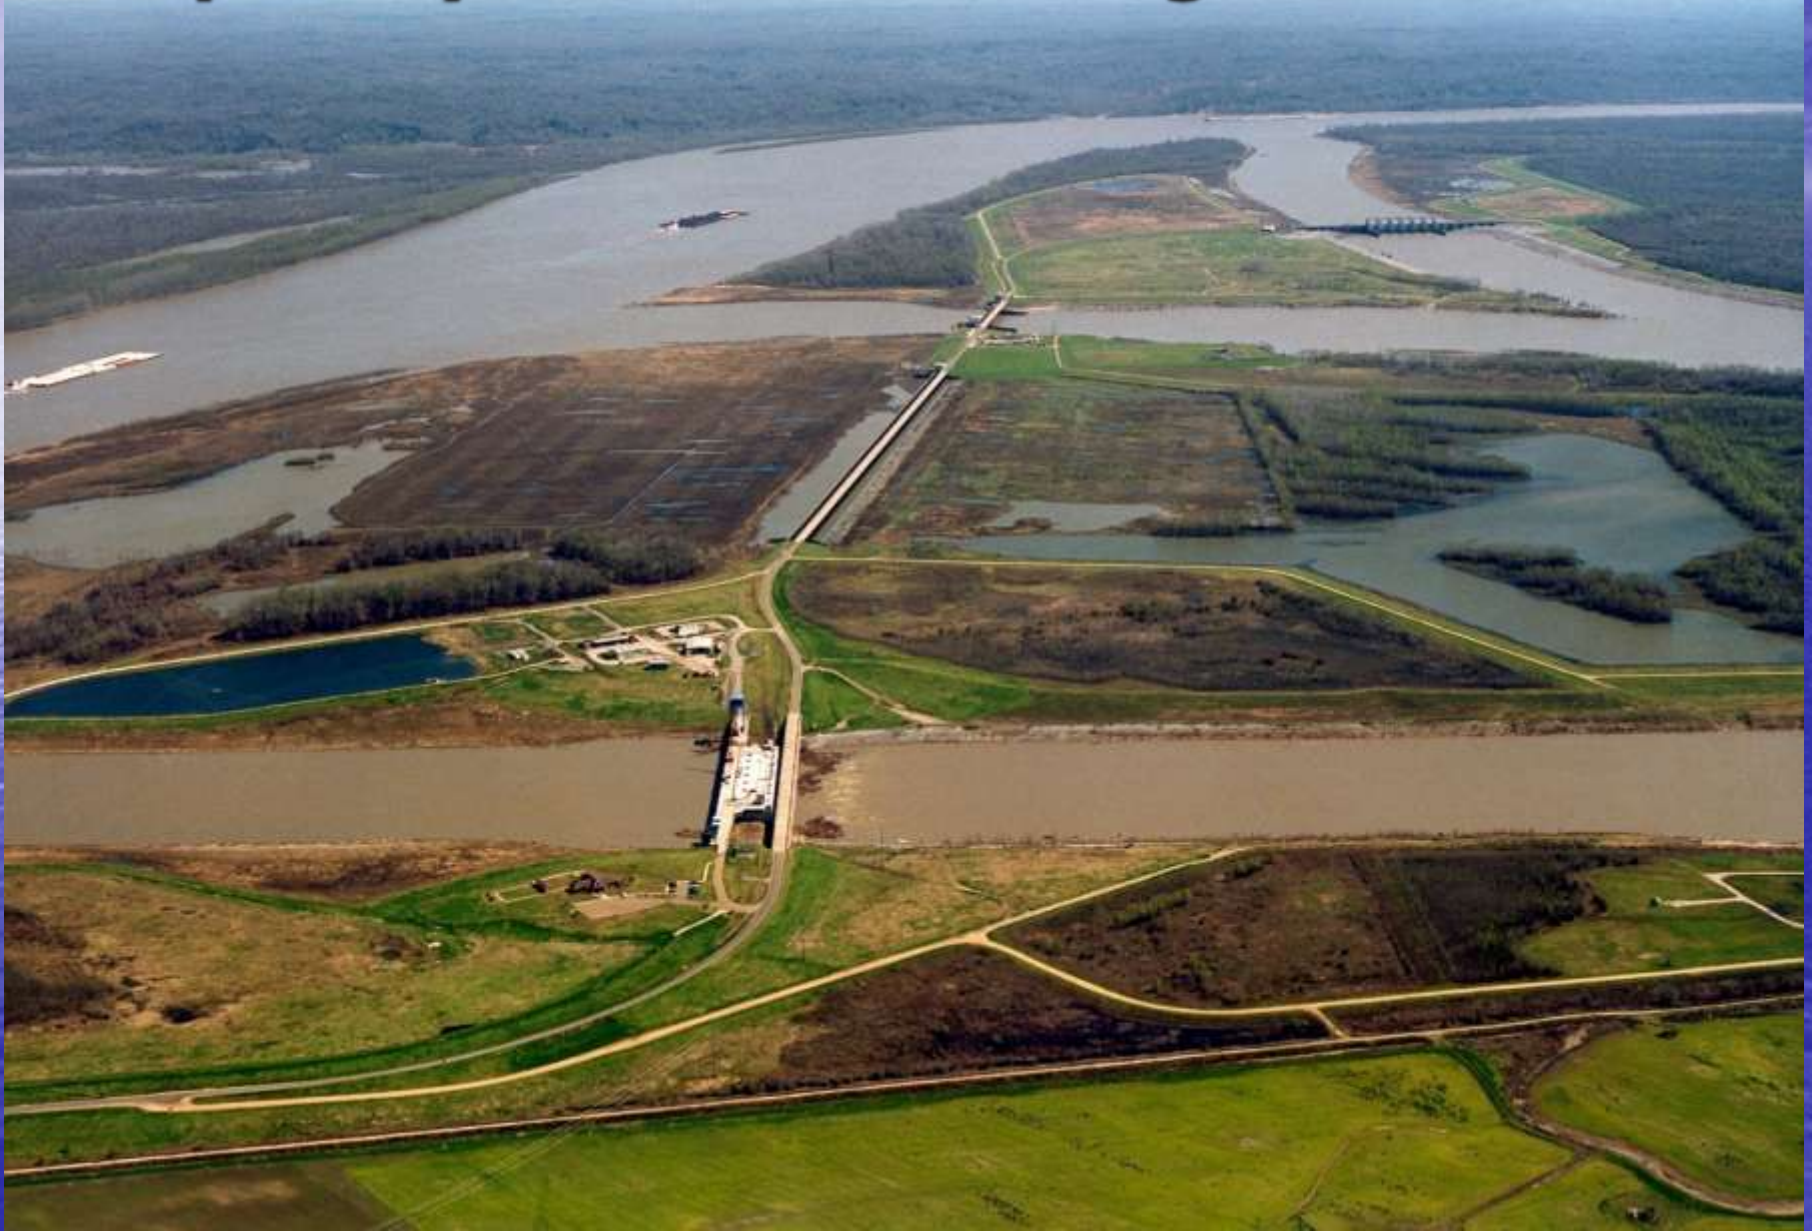
**Old River Control Structure Complex was completely rebuilt following the '73 flood**

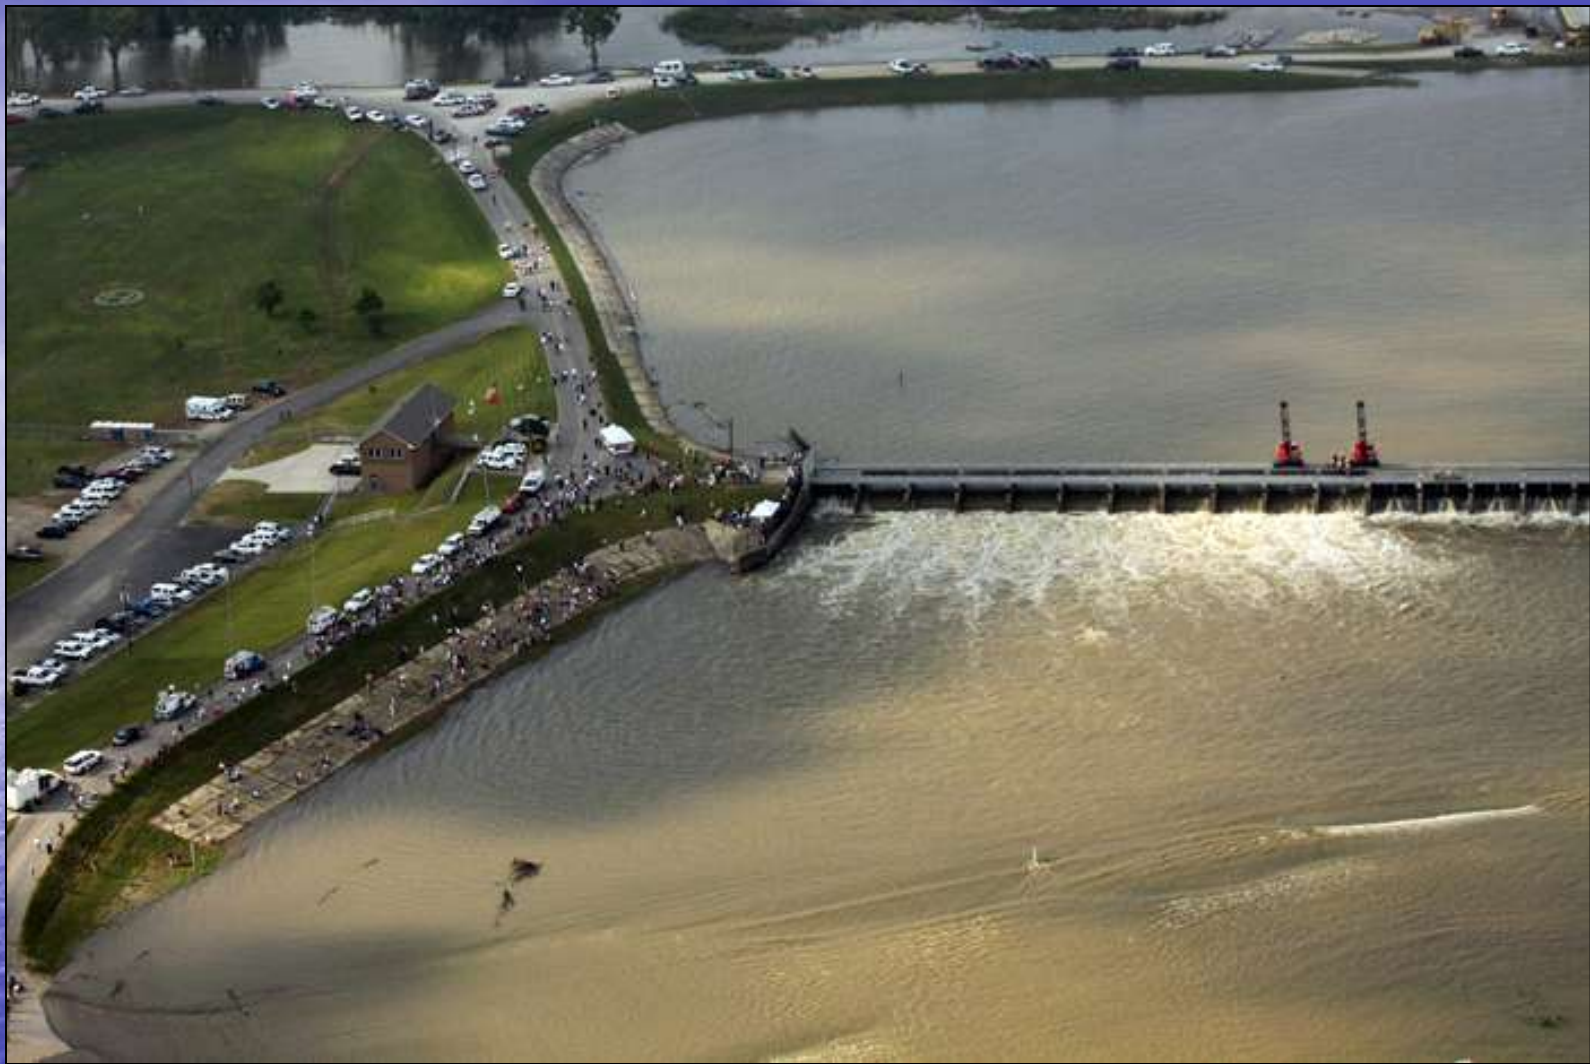
- About 1300 cfs was leaking through the needle logs prior to their being lifted at Bonnet Carre for the 10<sup>th</sup> time since 1932, on May 9th. The spillway is 7000 ft long.

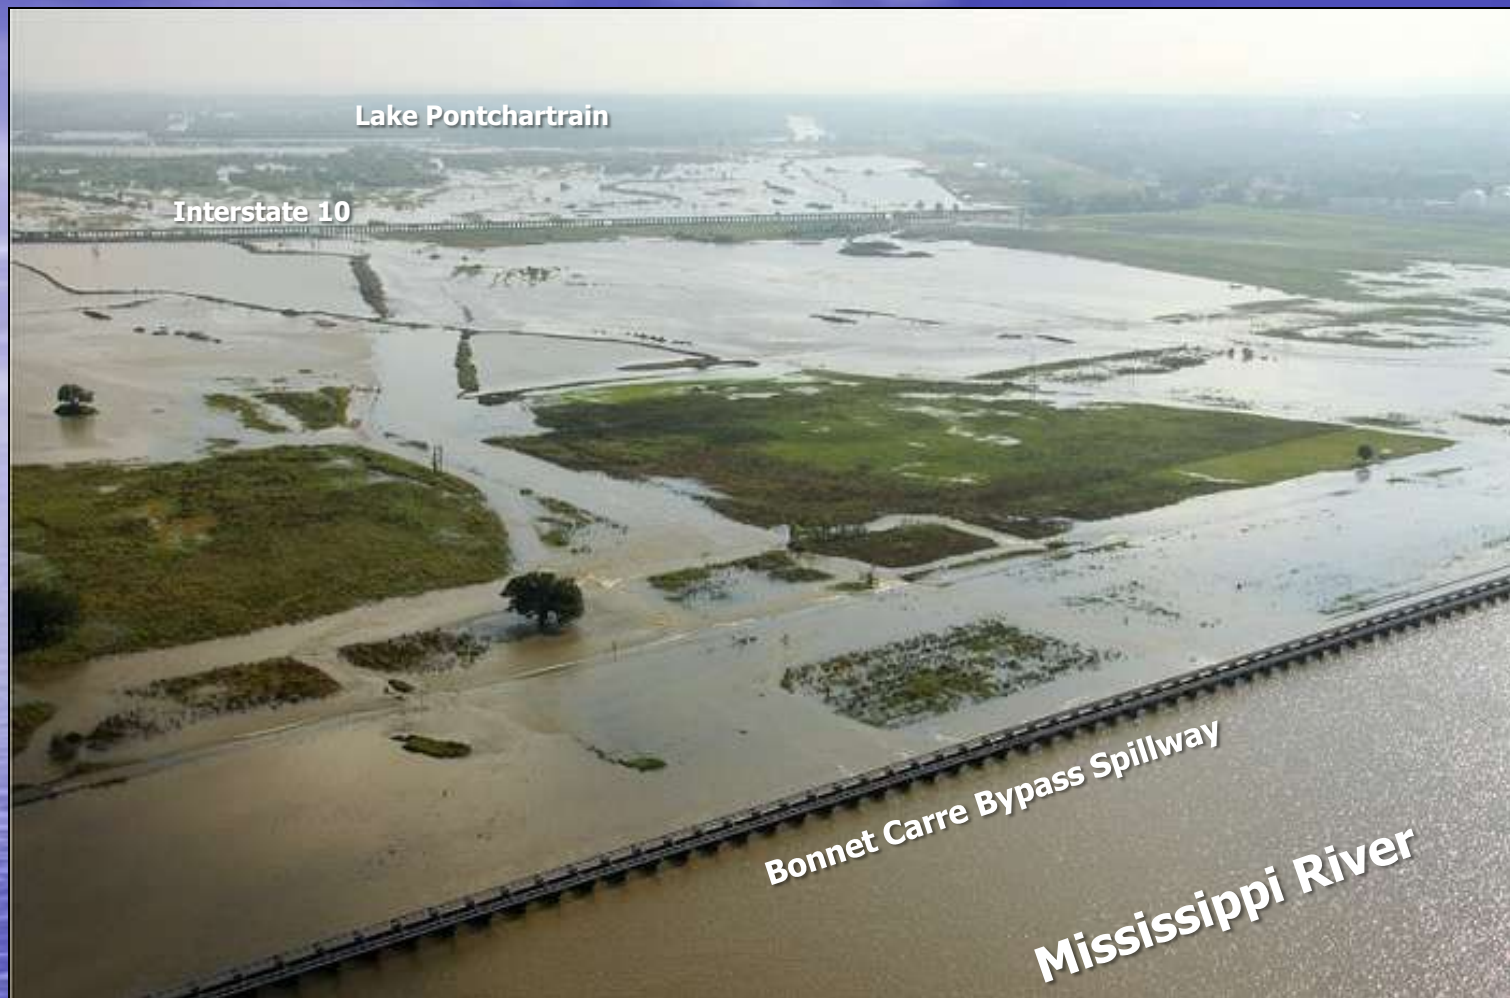
- The **Bonnet Carre Bypass Spillway** diverts flow 6 miles, into Lake Pontchartrain, which is at sea level. It was constructed a few miles downstream of a natural crevasse, which had breached 6 times in the previous 120 years.
- Four million cubic yards of sediment was mucked from the spillway channel after the 1997 overflows, increasing the spillway capacity.

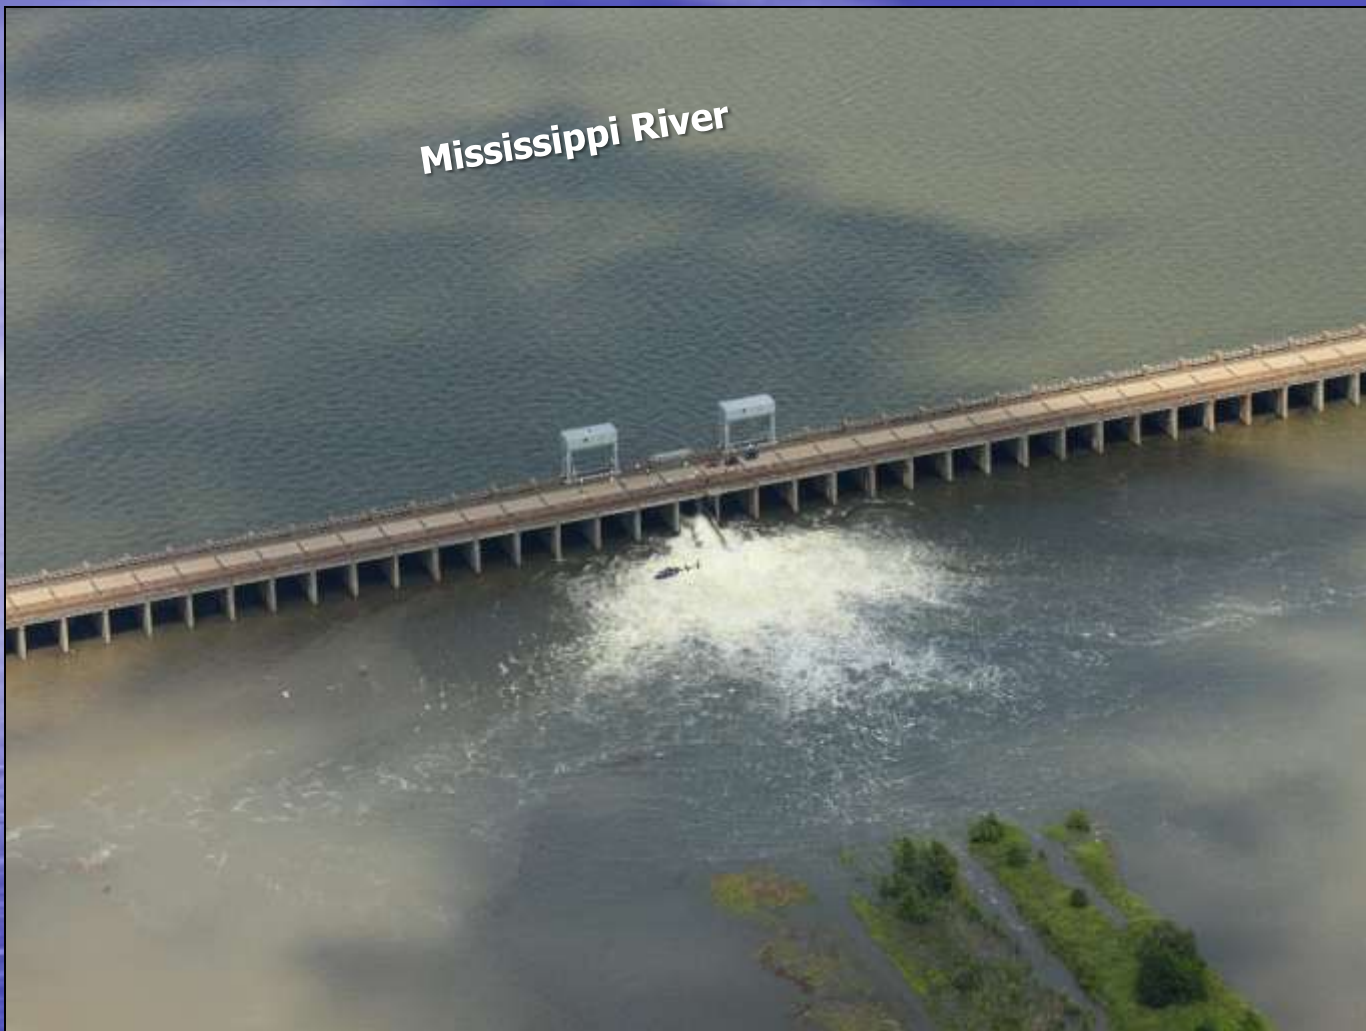
The **Morganza Spillway** was constructed in 1953-56, to retard the flow passing Baton Rouge to 1,500,000 cfs. It was only opened once previous to 2011, during the **1973 flood**. This shows the first bay being opened on May 11<sup>th</sup>, 2011 and the structure discharged a peak flow of 172,000 cfs on May 17<sup>th</sup>.

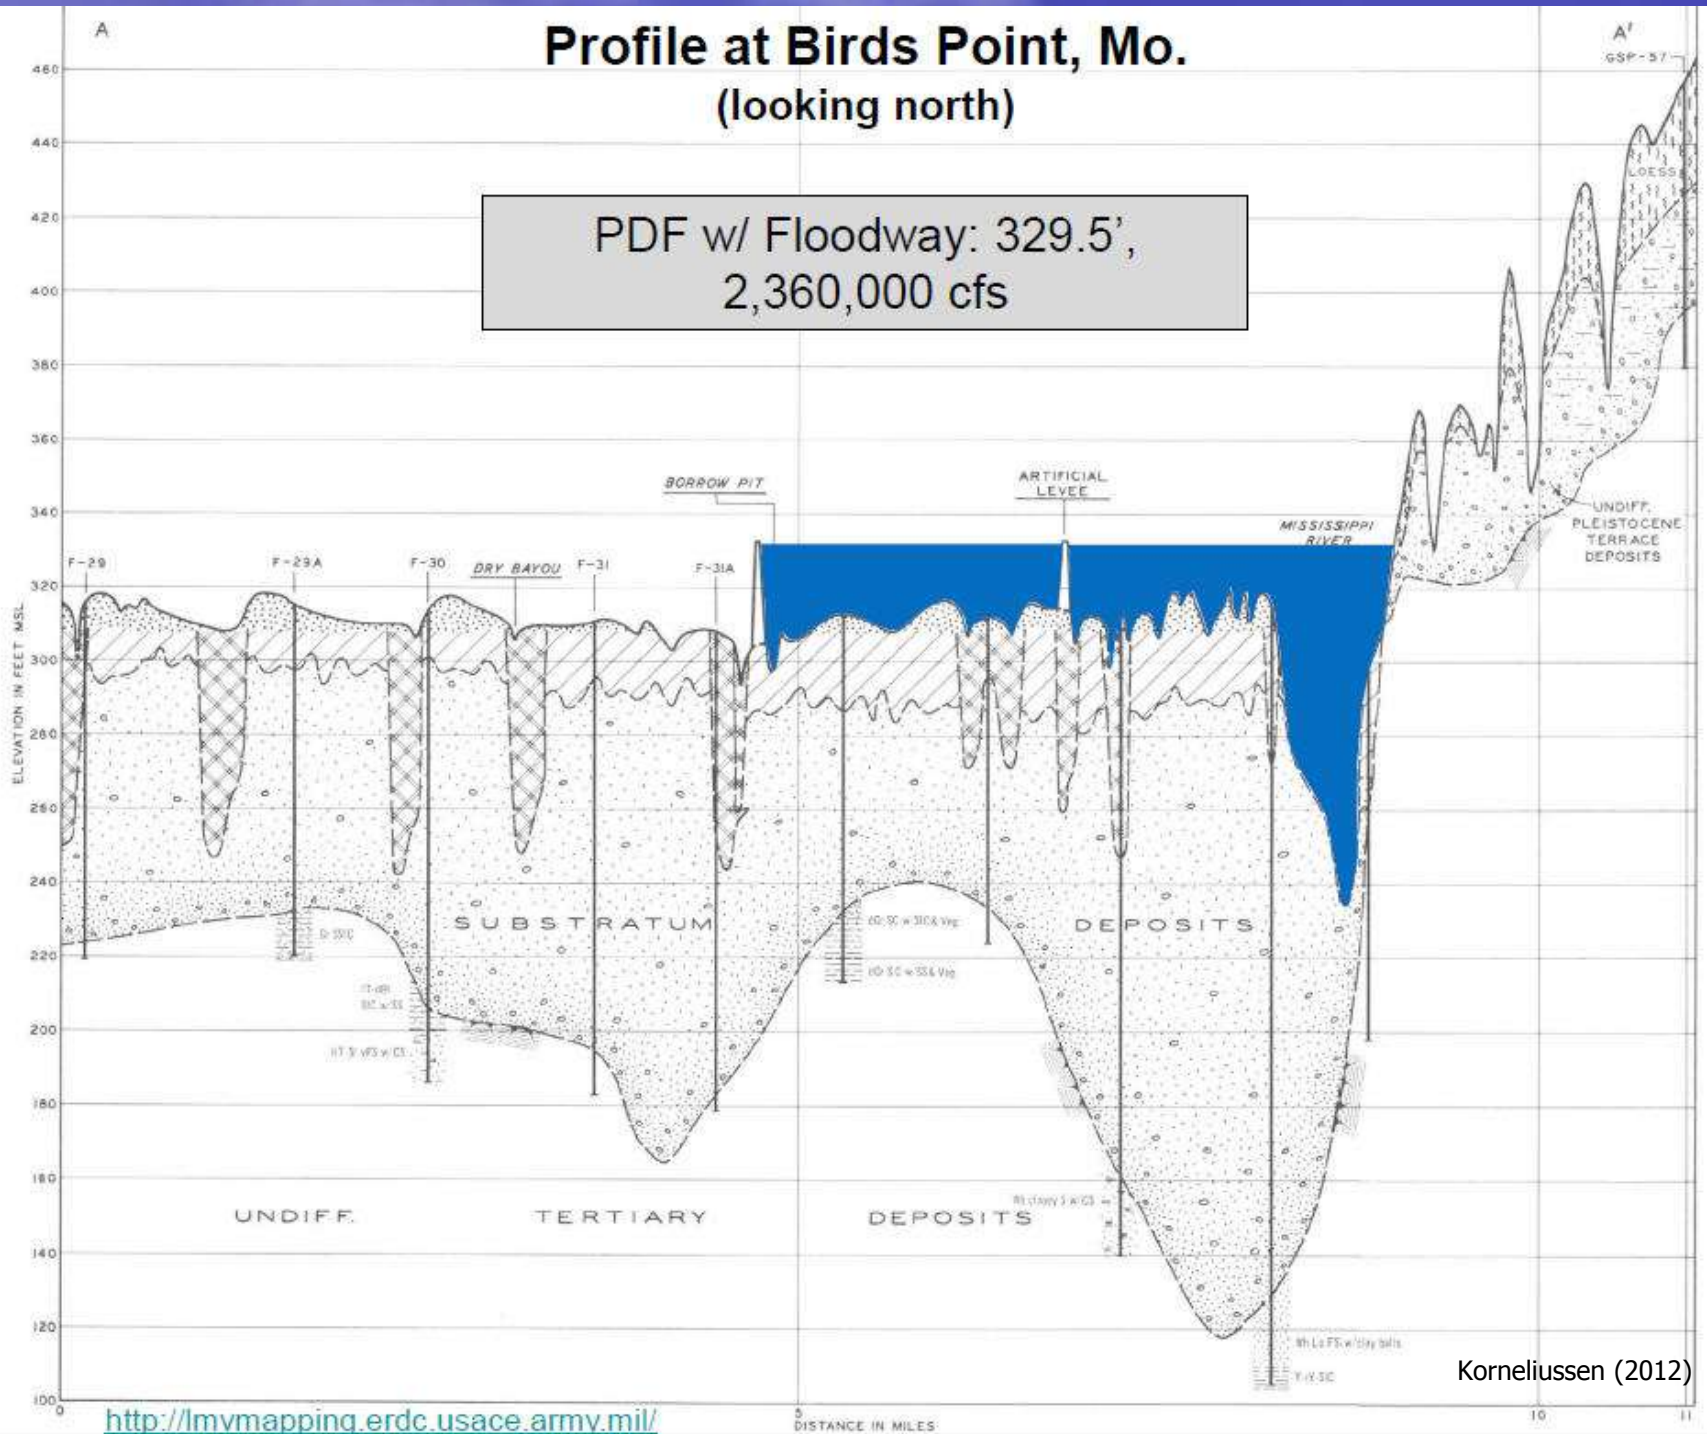
# Profile at Birds Point, Mo. (looking north)

PDF w/ Floodway: 329.5',  
2,360,000 cfs

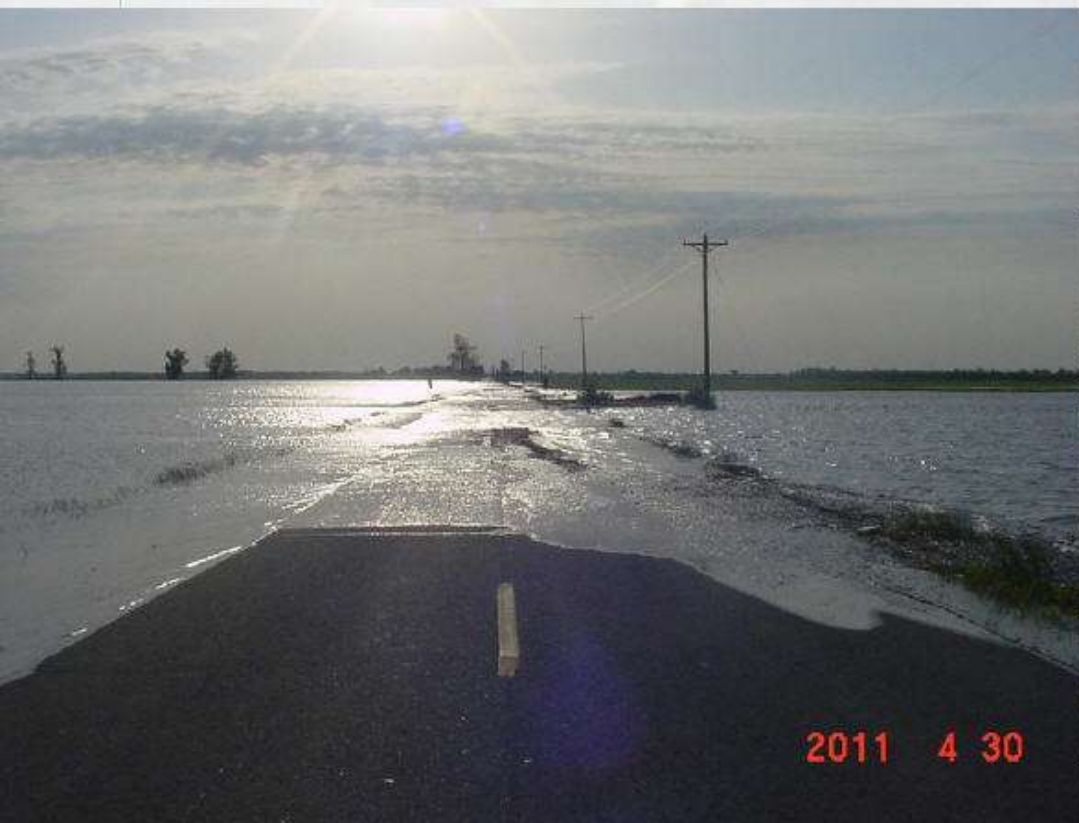
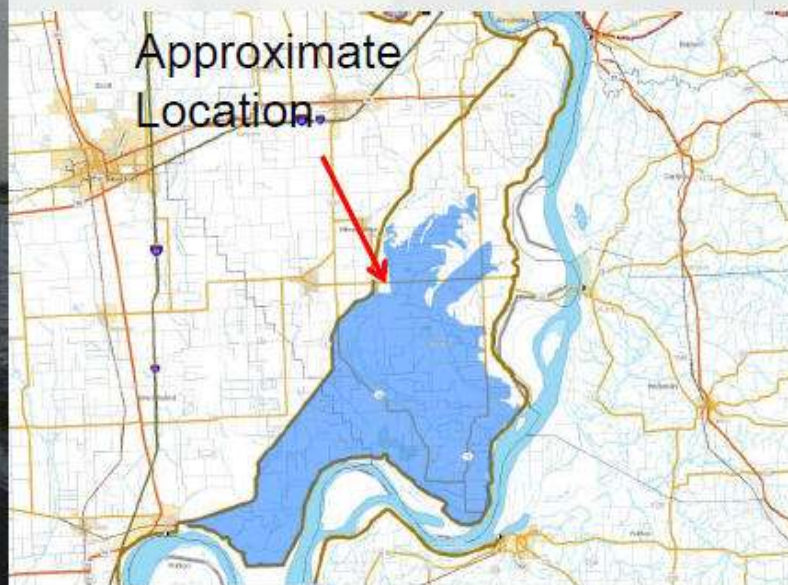
**Backwater over HWY 80 in Floodway between  
Setback Levee and HWY 77**

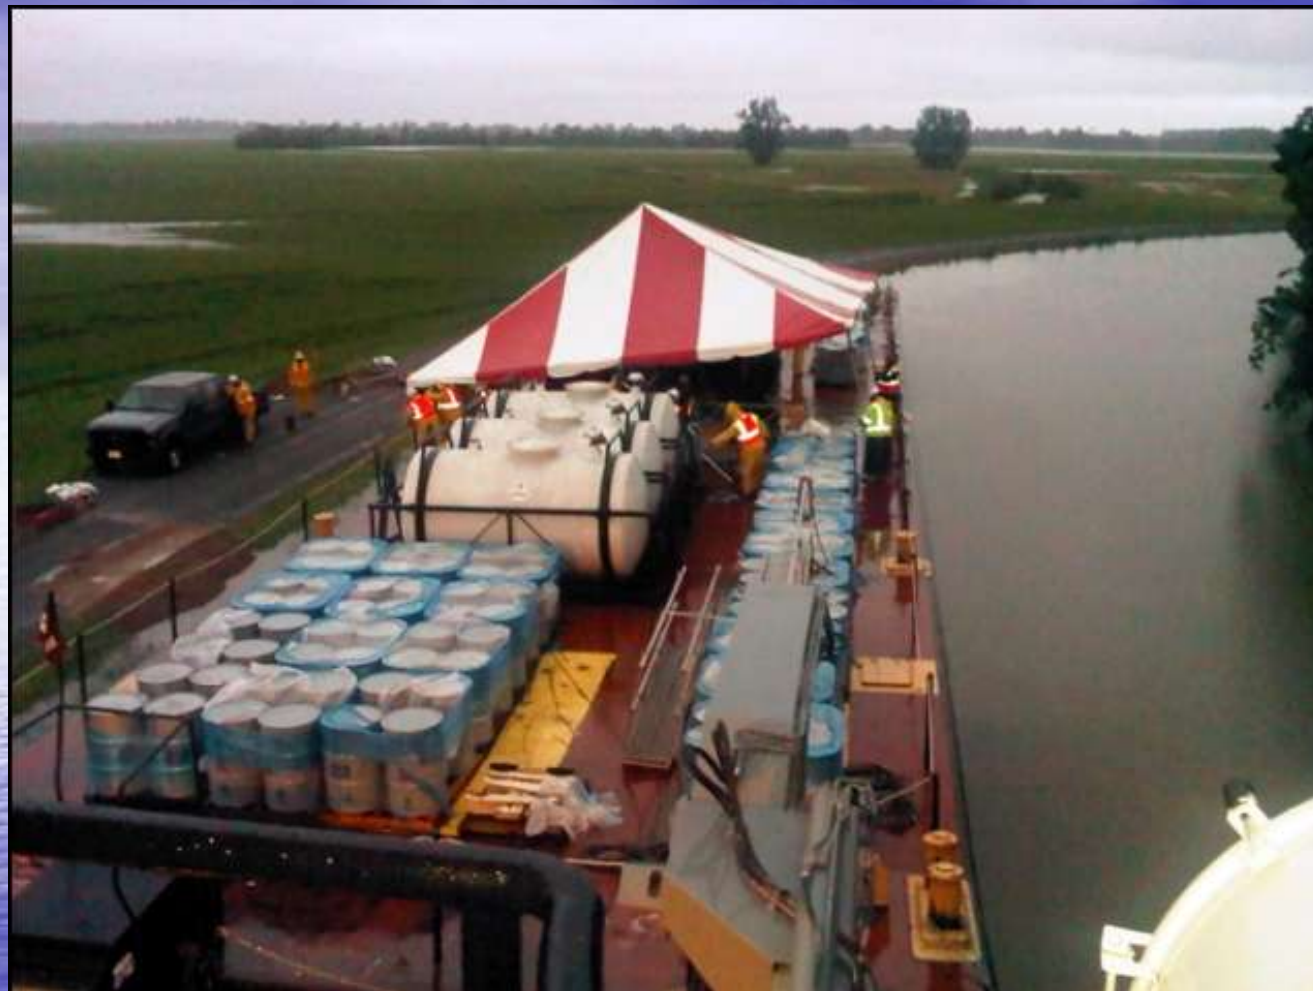
- Several thousand lineal feet of hollow PVC pipe was embedded in the *fuse plug levee* at Bird's Point. When the time came to blow the dike, the pipes were filled with blasting agent and detonated.

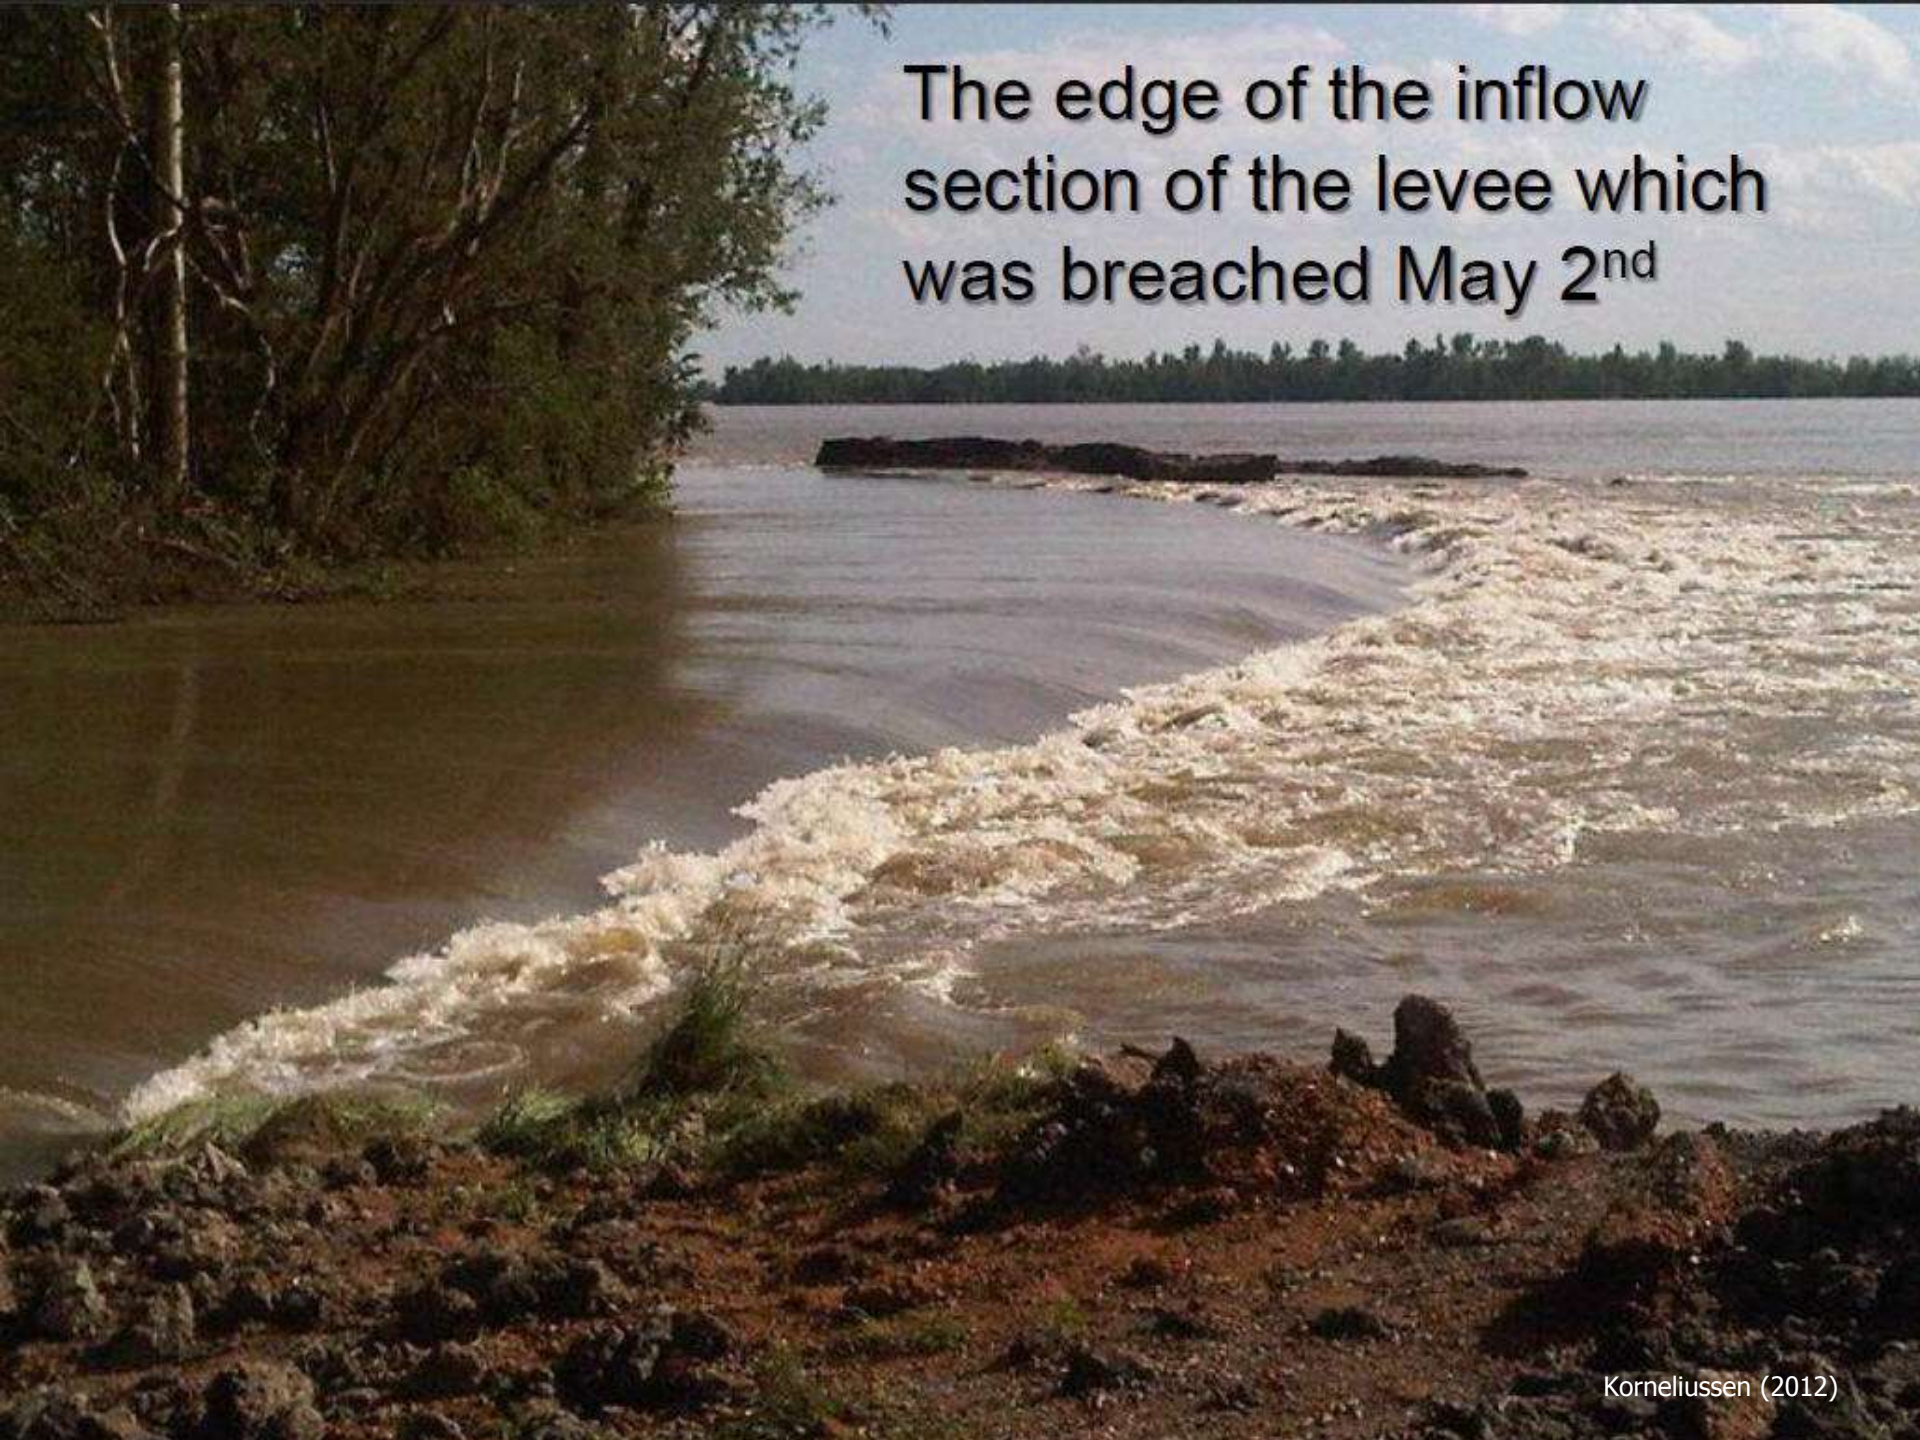
The edge of the inflow  
section of the levee which  
was breached May 2<sup>nd</sup>
