# RISK-BASED ASSESSMENT OF LEVEES- LESSONS LEARNED FROM THE 2011 MISSISSIPPI RIVER FLOODS

**J. David Rogers, Ph.D., P.E., P.G., C.E.G., C.HG.**

**ASCE Geo-Institute's Geoconfluence 2012  
Geotechnical and Geo-environmental Conference**

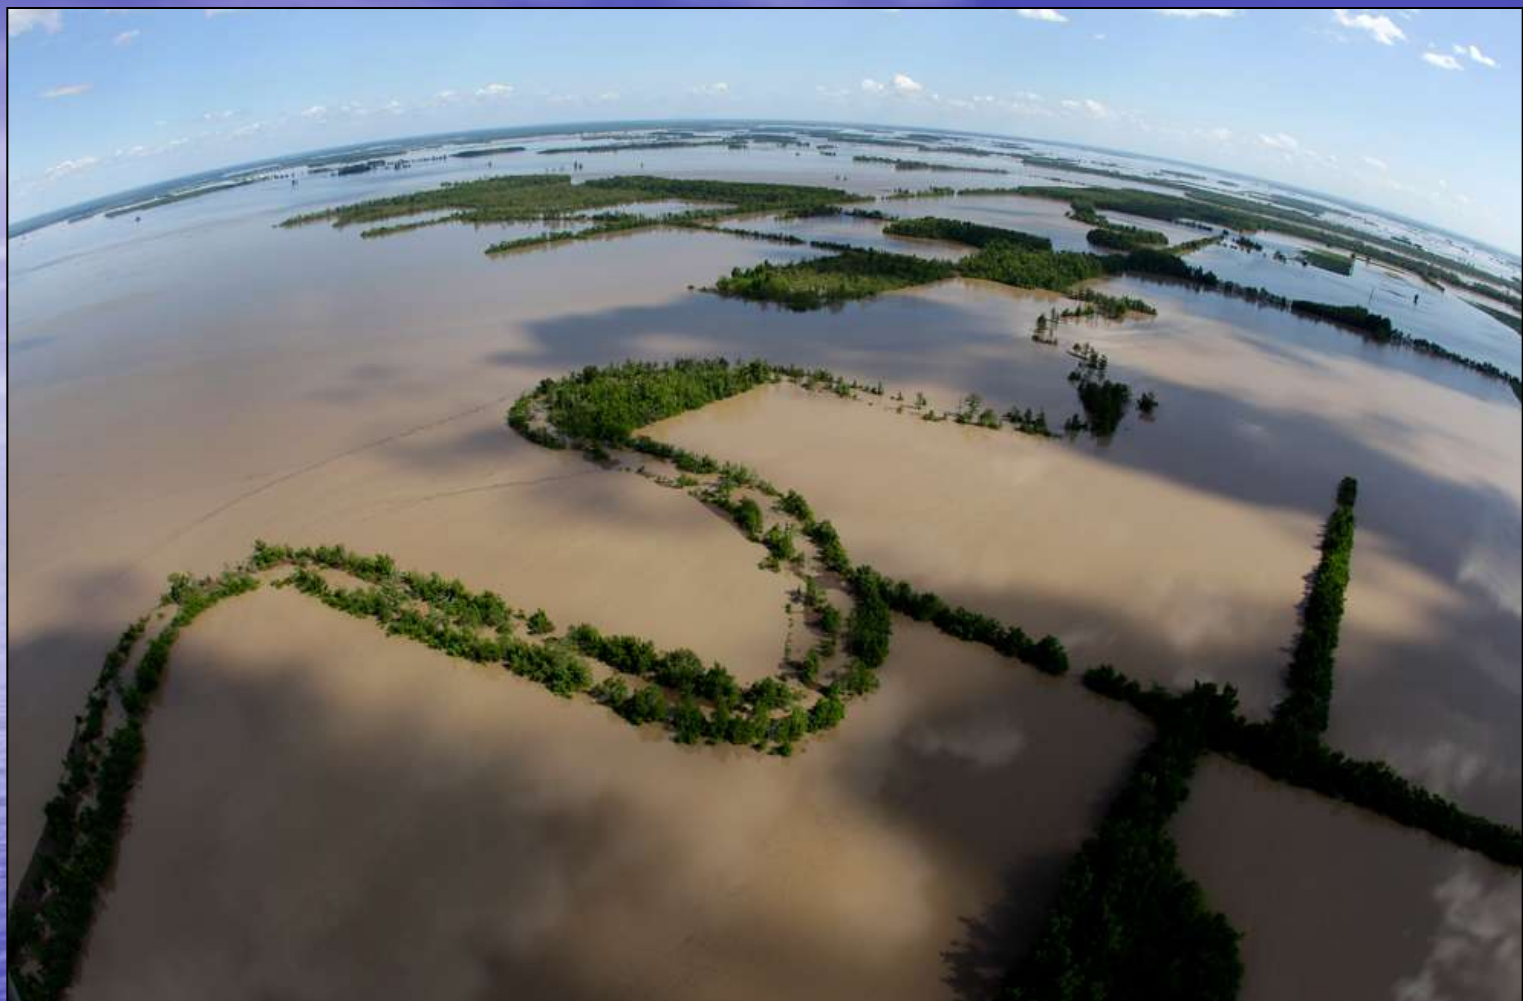
- Approximately 200,000 acres of essentially level flood plain within the **Bird's Point-New Madrid Floodway** was inundated within 36 hours of the detonation.
- The USGS deployed 40 hurricane *storm surge sensors* to monitor excavation of the crevasse scour hole and flow velocities, every 30 seconds.

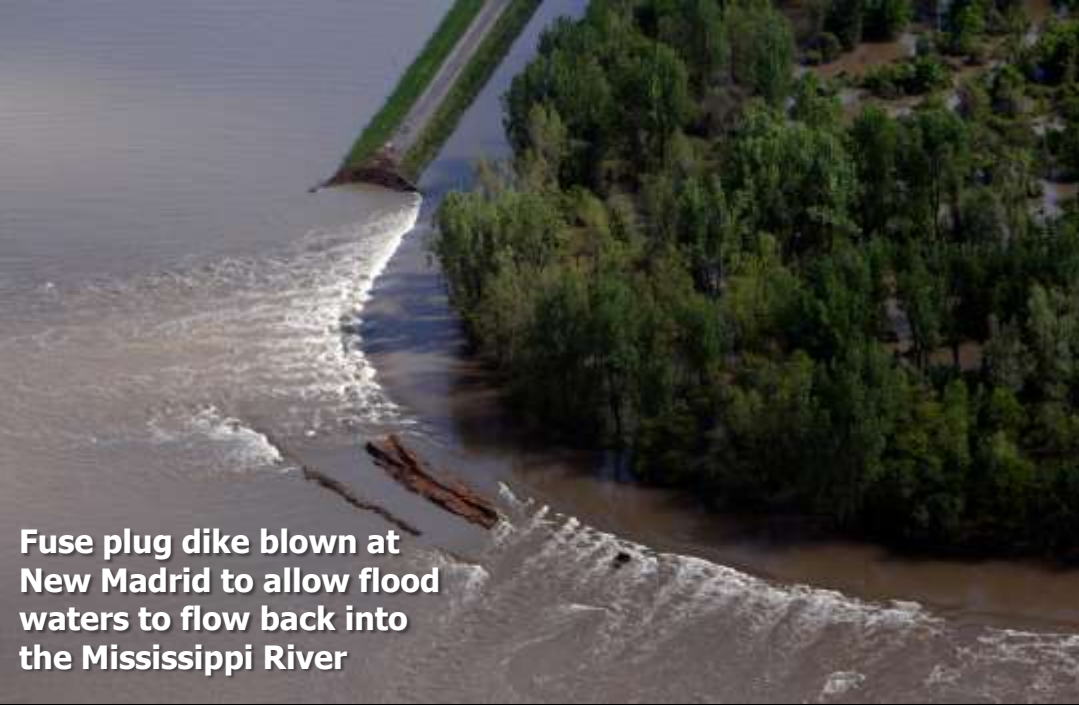
Fuse plug dike blown at New Madrid to allow flood waters to flow back into the Mississippi River

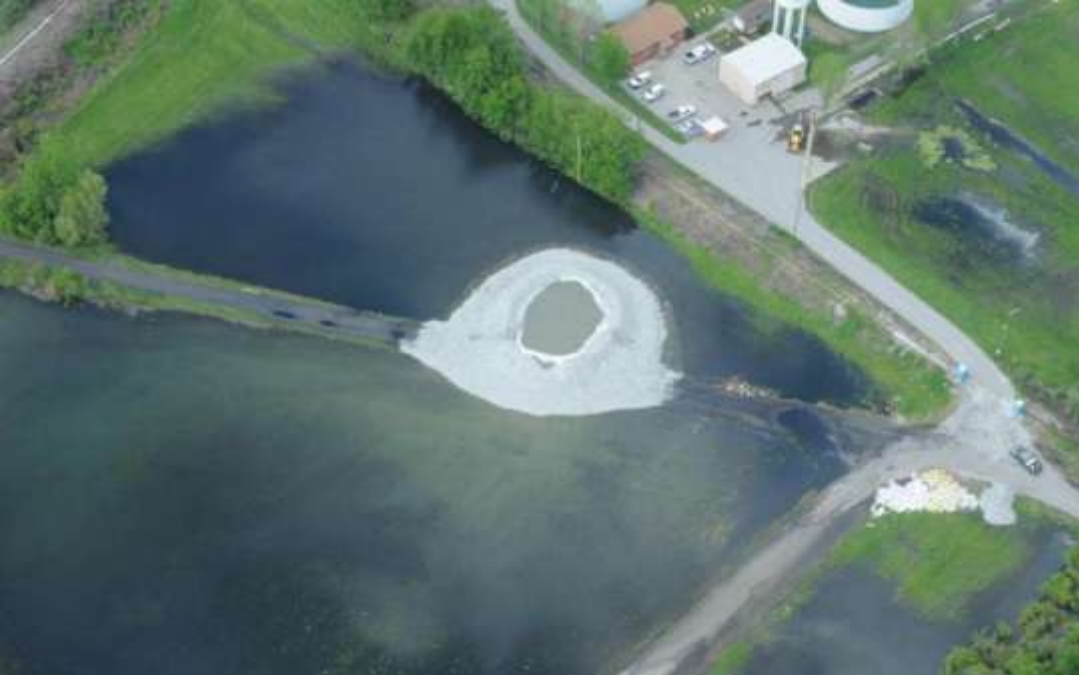
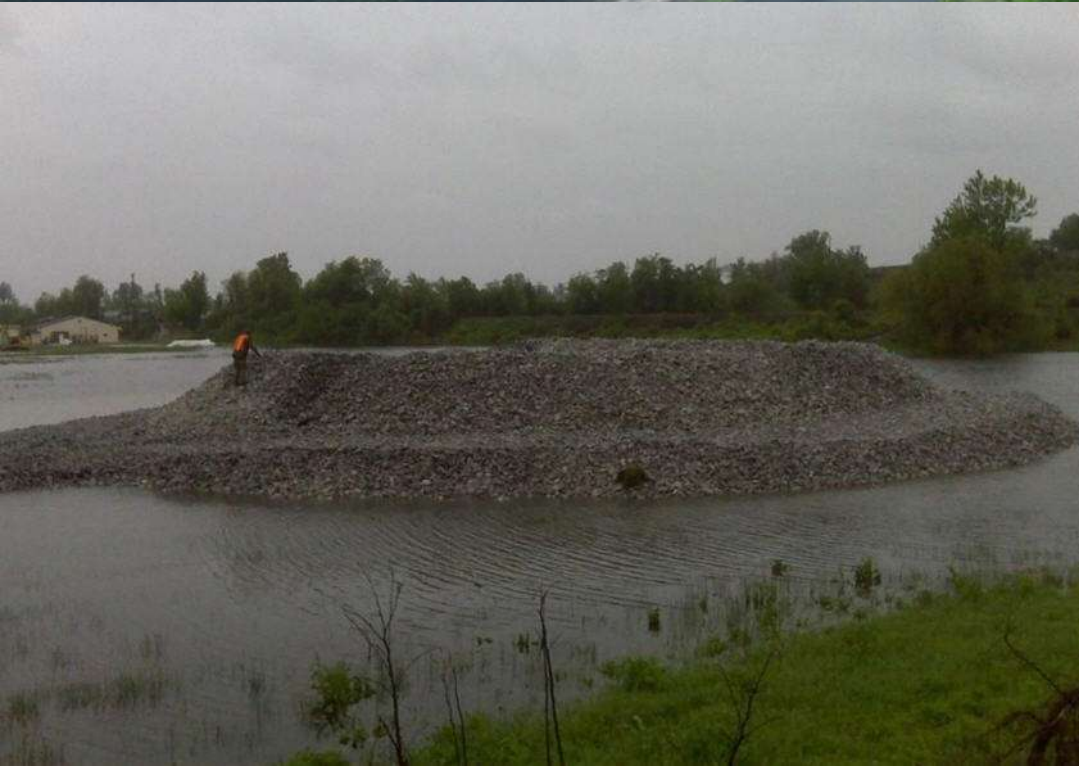
# ***Heroic flood fighting***

- **The MR&T system is designed to withstand a project flood provided the Corps six district can perform *"heroic flood fighting efforts,"* such as those shown here**

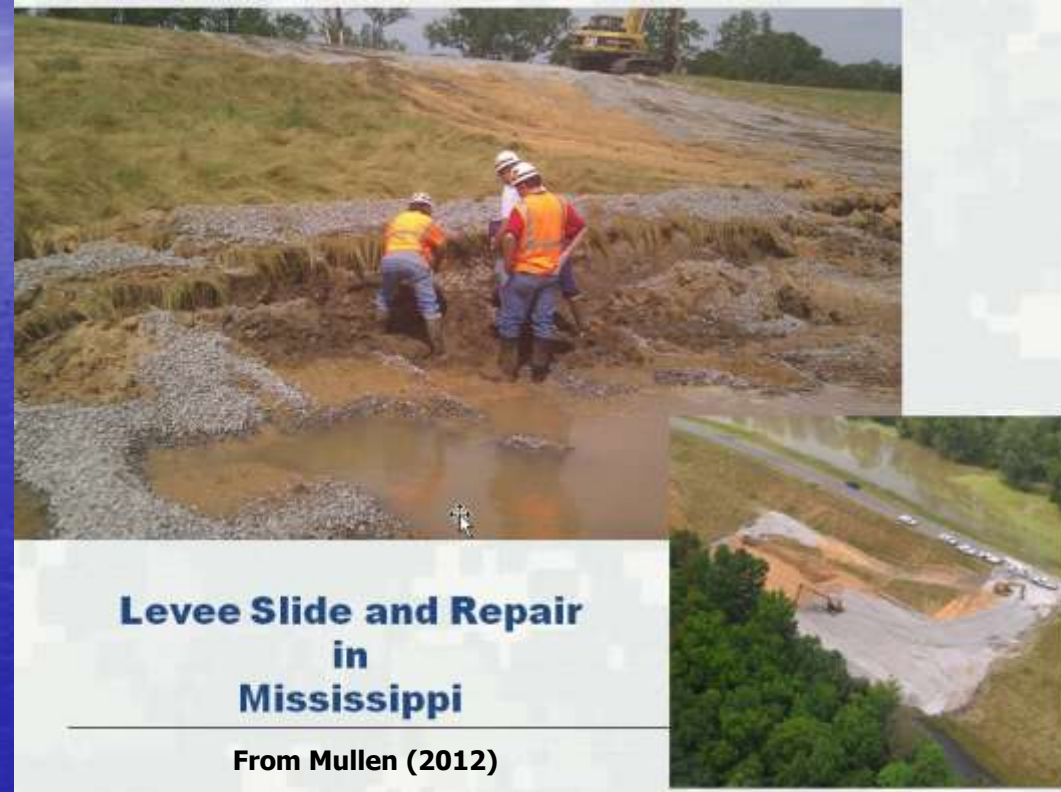
# The vexing problem - underseepage

- Map at left shows historic channels of the Mississippi River near New Madrid, MO. Most of the levees downstream of Cairo are built on **old channels**, which provide ready conduits for underseepage.

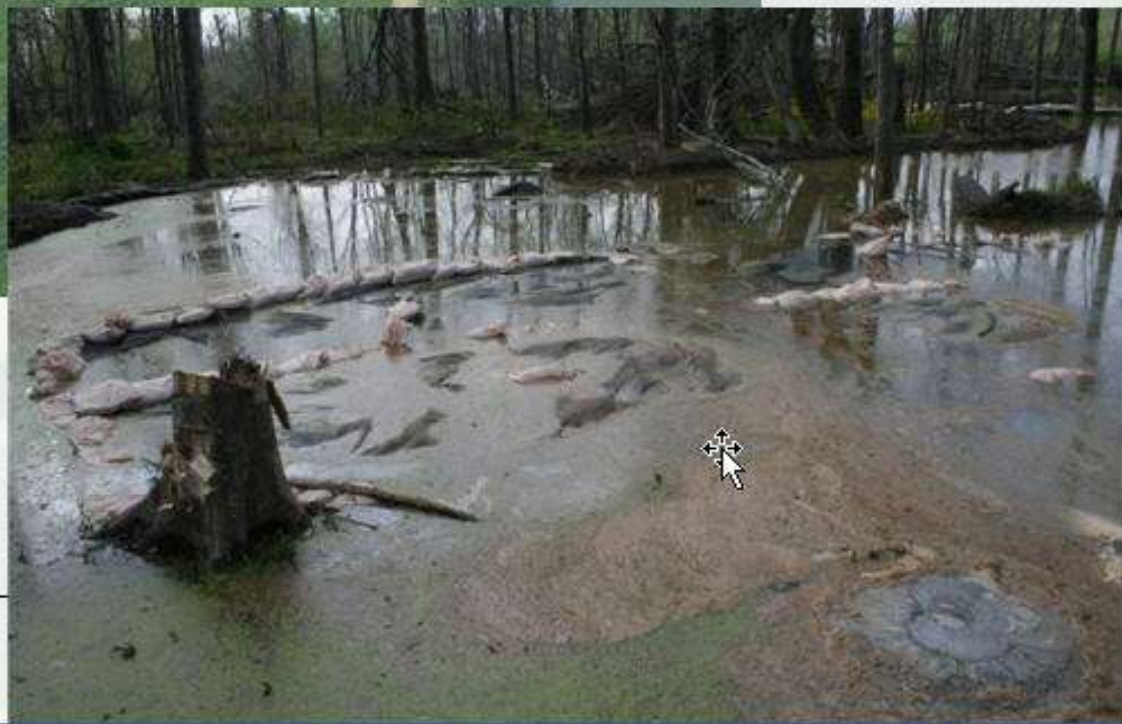
# Overbank flow along Sheep's Ridge Road and the Merriwether-Cherokee Revetment

Overbank Flow

MERRIWETHER - CHEROKEE REVETMENT

NORMAL FLOW

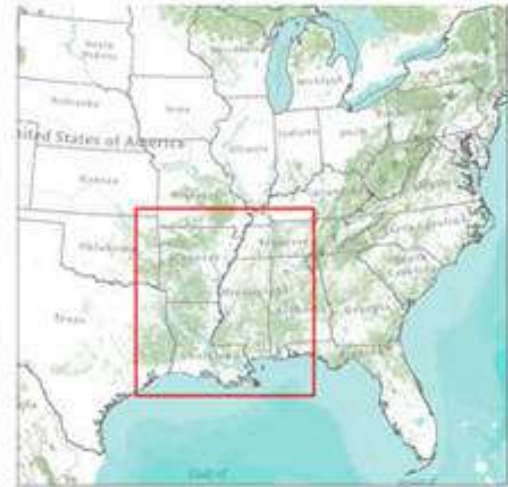
**INUNDATION MAP**

**Estimated Inundation Area**  
 1927 - 16,800,000 Acres  
 2011 - 6,350,000 Acres

**Lower MVD  
Estimated  
Inundation**

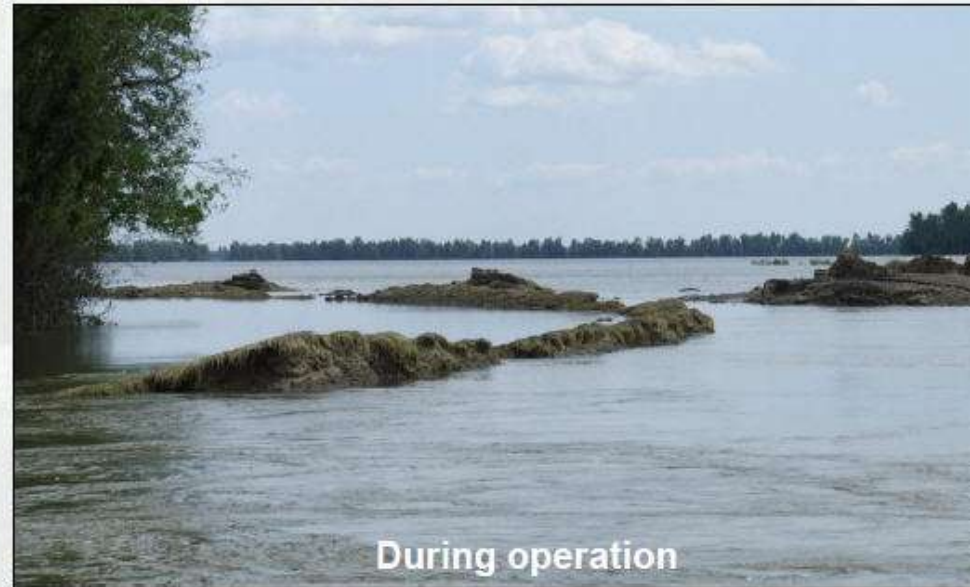
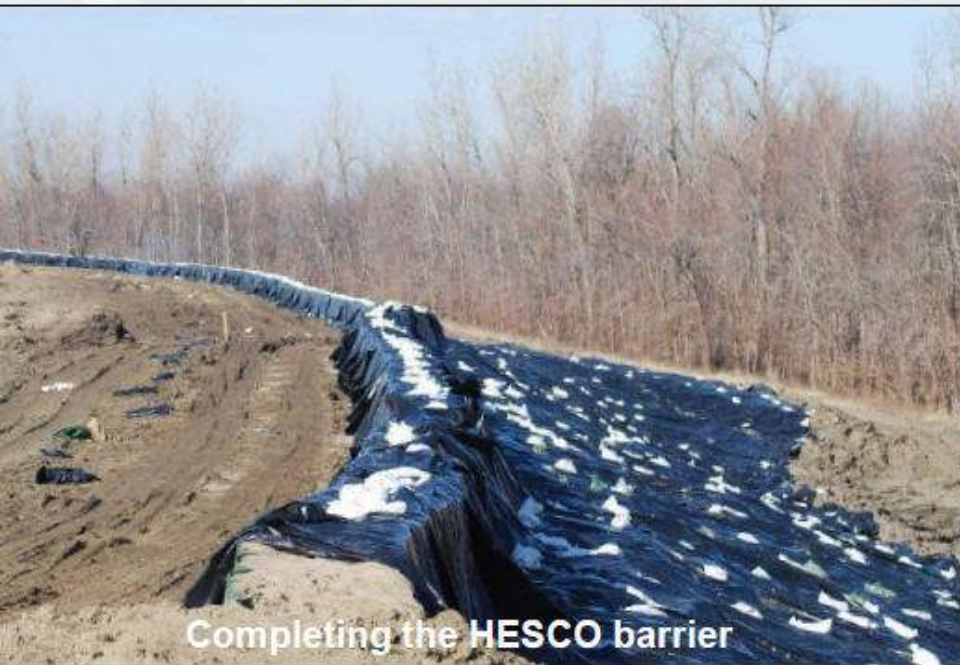
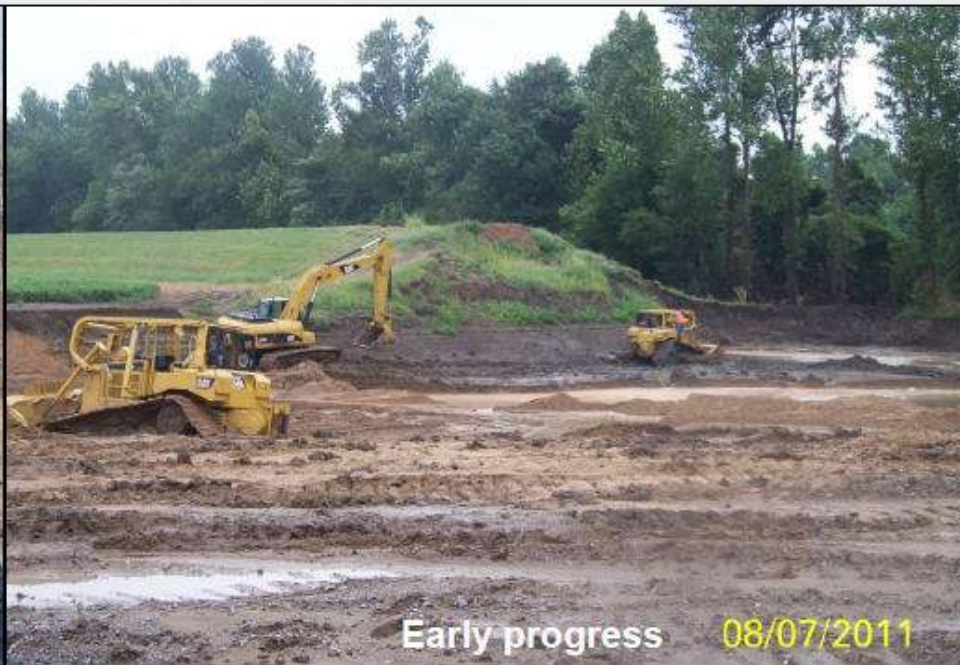
## Upper crevasse:

- ▶ Five 25-foot-deep scour holes filled to grade with sand and clay
- ▶ All 9,000 feet of crevasse is to a (Cairo) gage elevation of 51' or higher as of Oct. 28
- ▶ HESCO barriers to protect to 55 feet were installed as of Dec. 14
- ▶ Repairs to 55 feet will resume after the spring seasonal highwater recedes

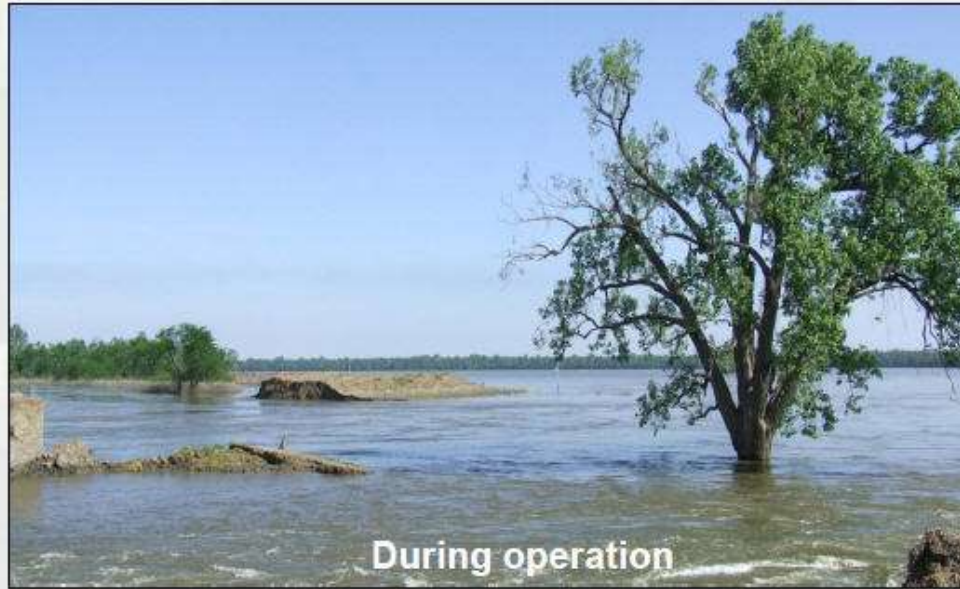
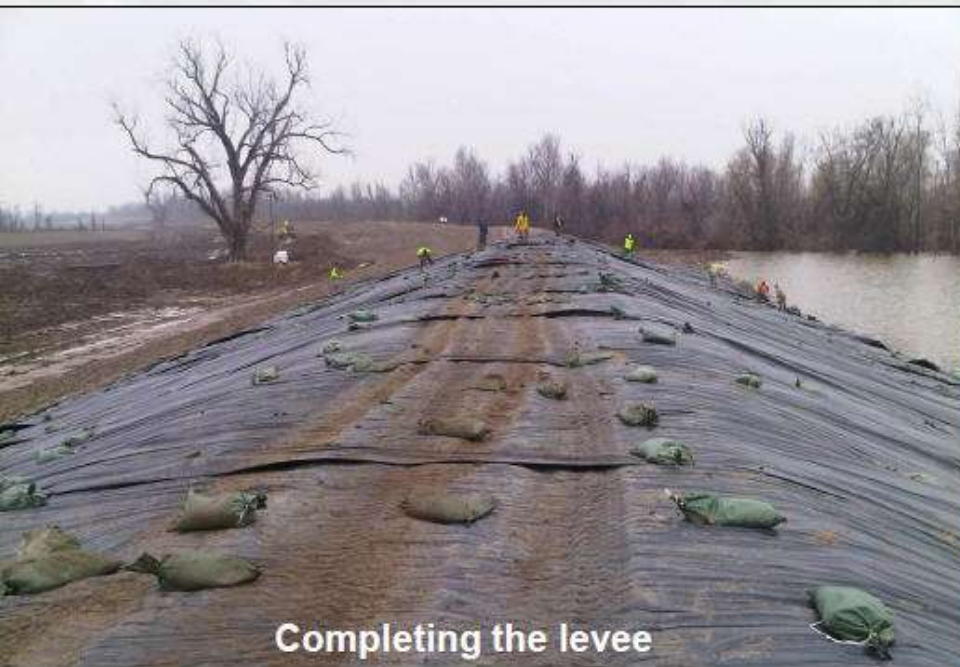
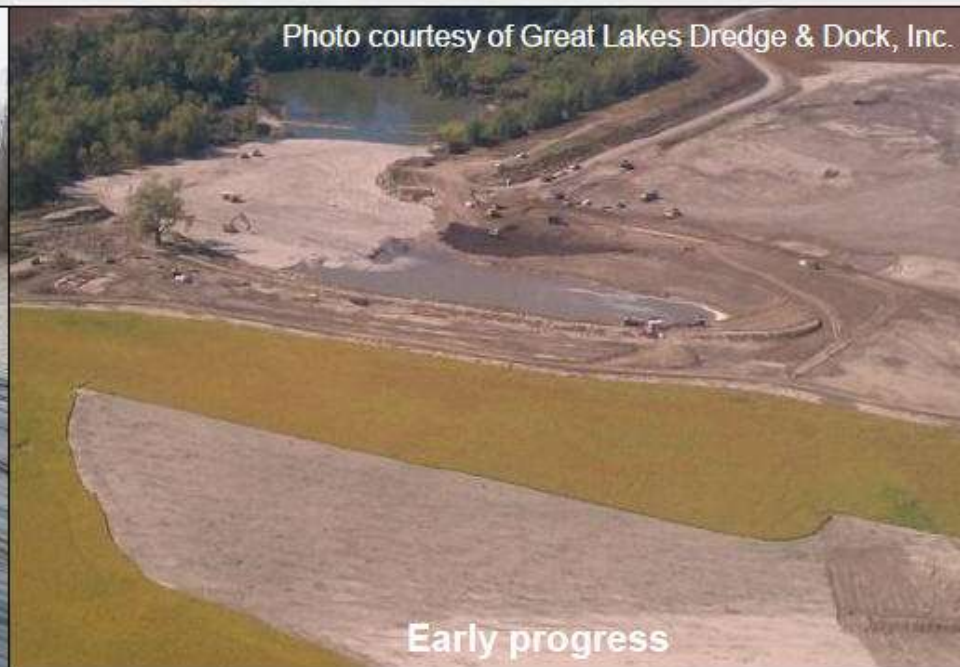
## Center crevasse:

- ▶ Scour hole filled with more than 300,000 cubic feet sand
- ▶ Clay cap to fill scour hole to grade
- ▶ 800 feet of levee reconstructed to a (Cairo) gage elevation of 55 feet as of Dec. 3
- ▶ 4,700 feet of levee that was explosively activated but did not degrade has been reshaped to Make Safe elevations

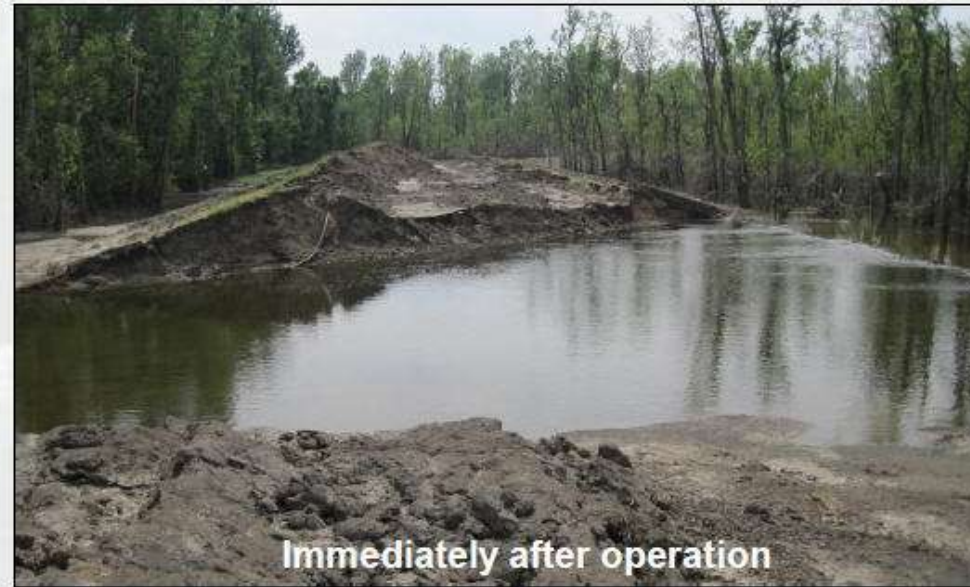
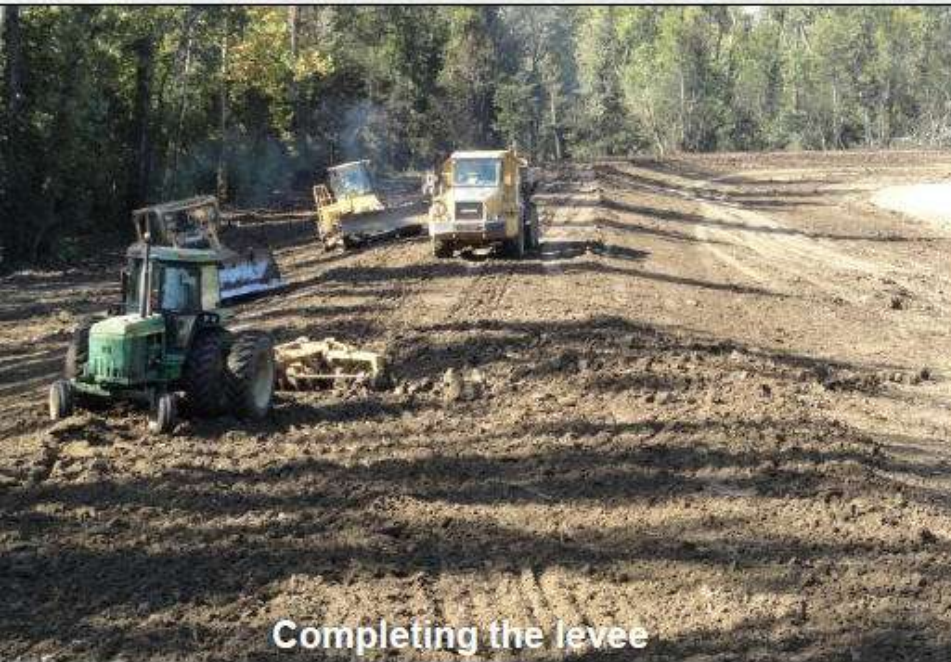
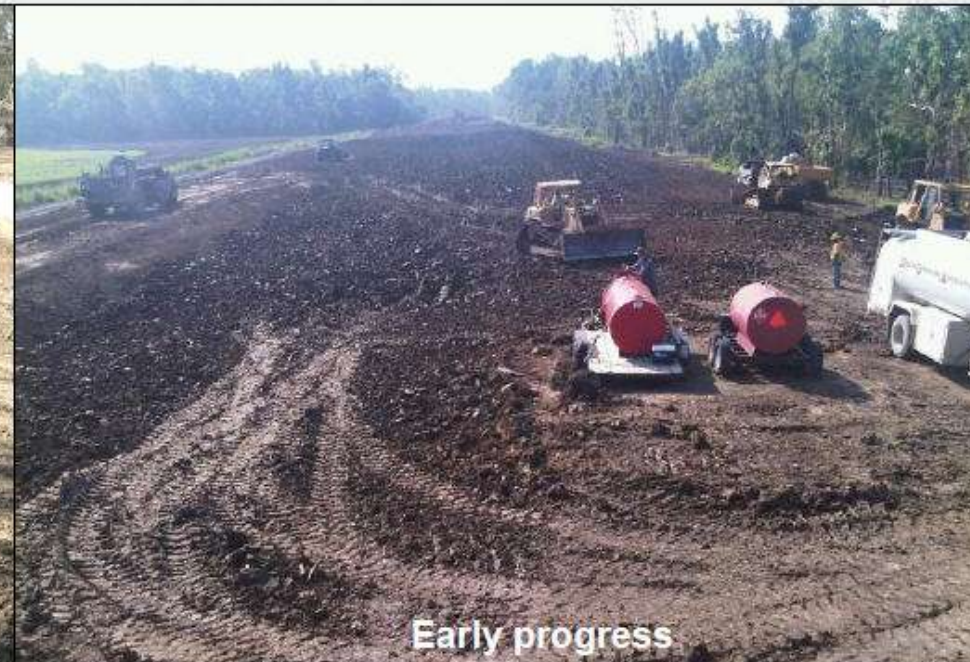
## Lower crevasse:

- ▶ Make Safe repairs complete Oct. 10 except for turfing
- ▶ 4,700 feet of levee repaired
- ▶ Work performed by a hired-labor crew from Vicksburg

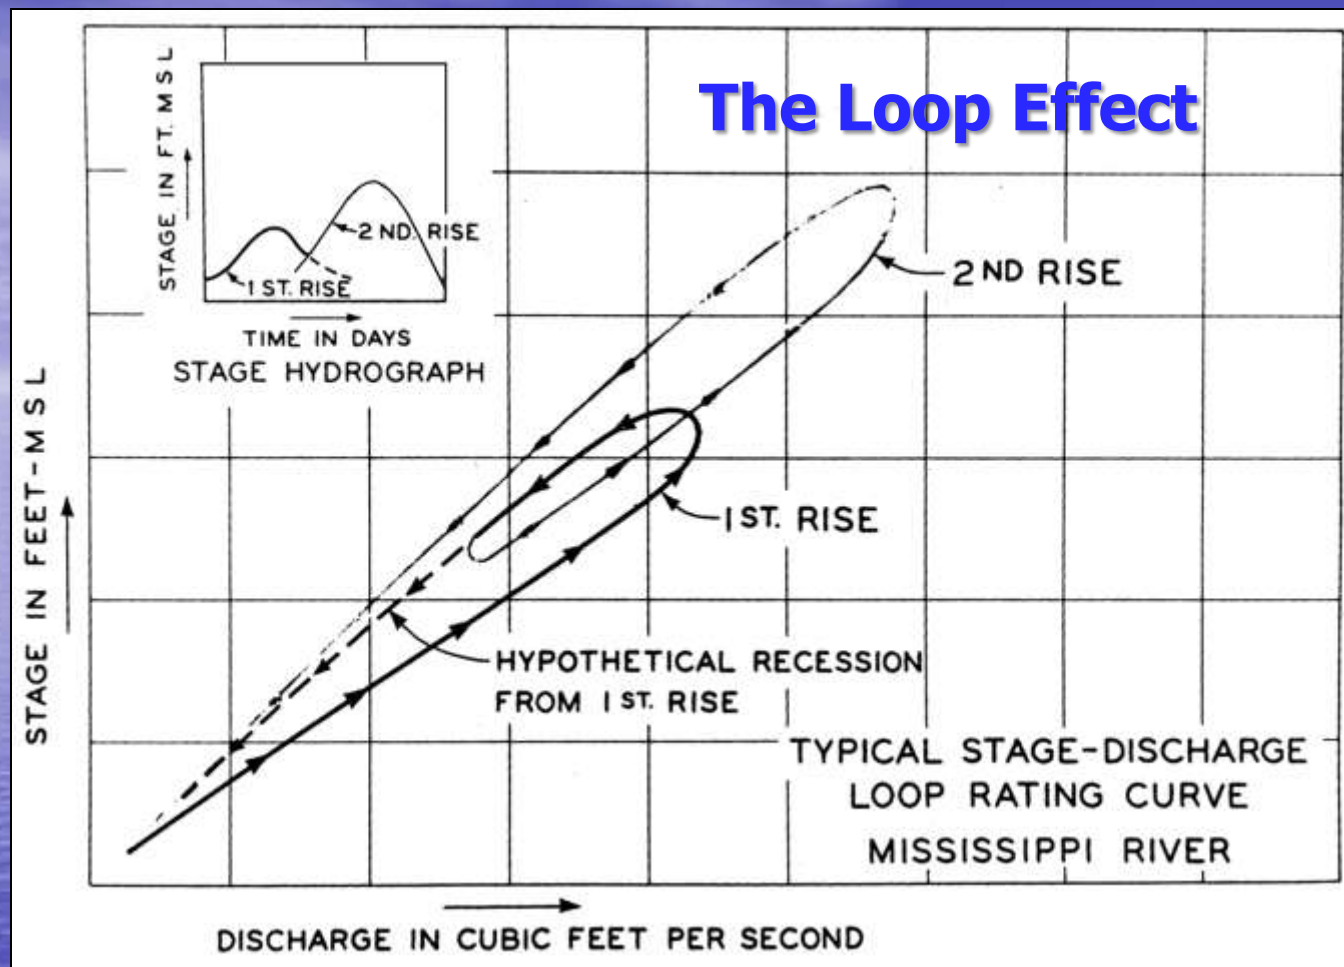
- Stage-Discharge 'Loop Rating Curve:'**  
 Typical increases in flow stage that accompanies successive peak flows, as observed in the 1973 Flood.

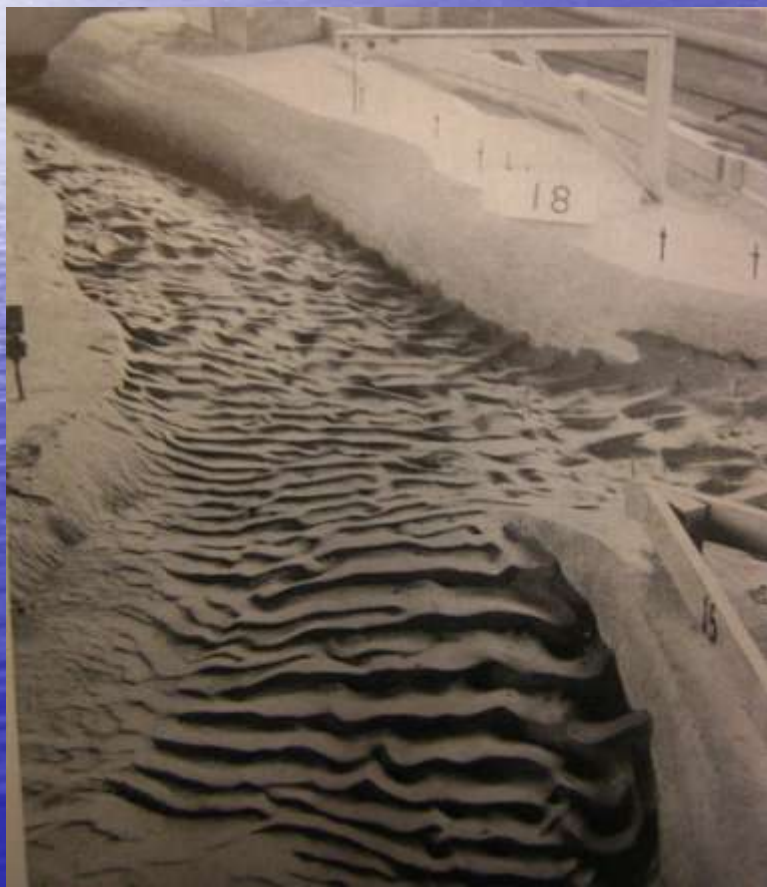
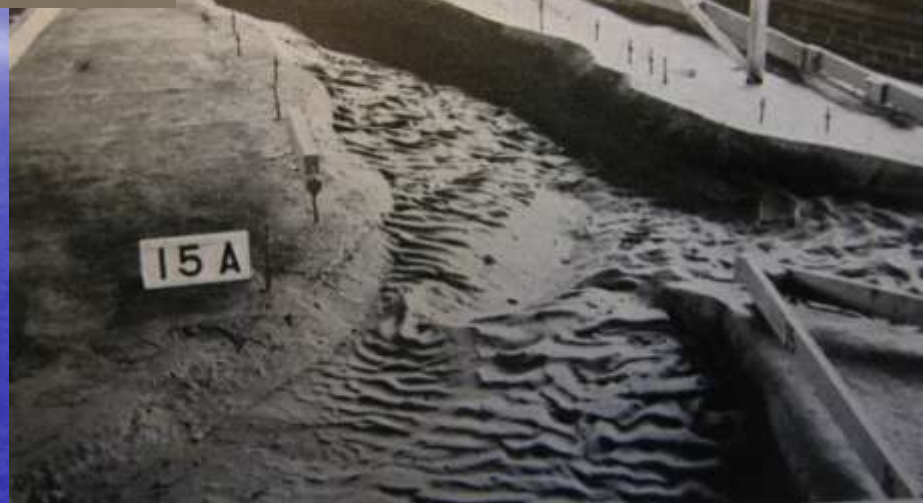
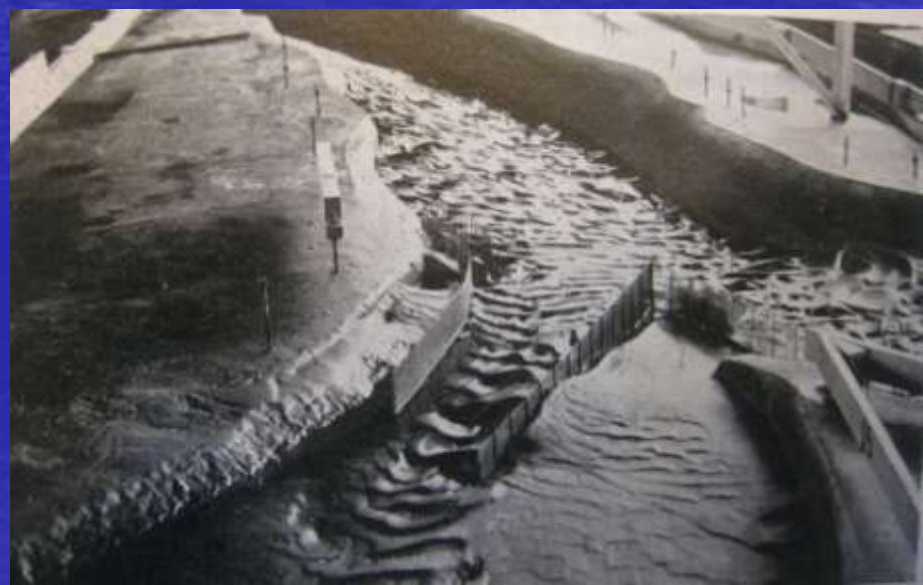
# Experiments with Movable Bed River Models

**Examining transient bed  
effects at constant  
flow values**

**Natural sand bed channel (lower left);  
dredged channel (upper right); and impact  
of structural dikes (lower right)**

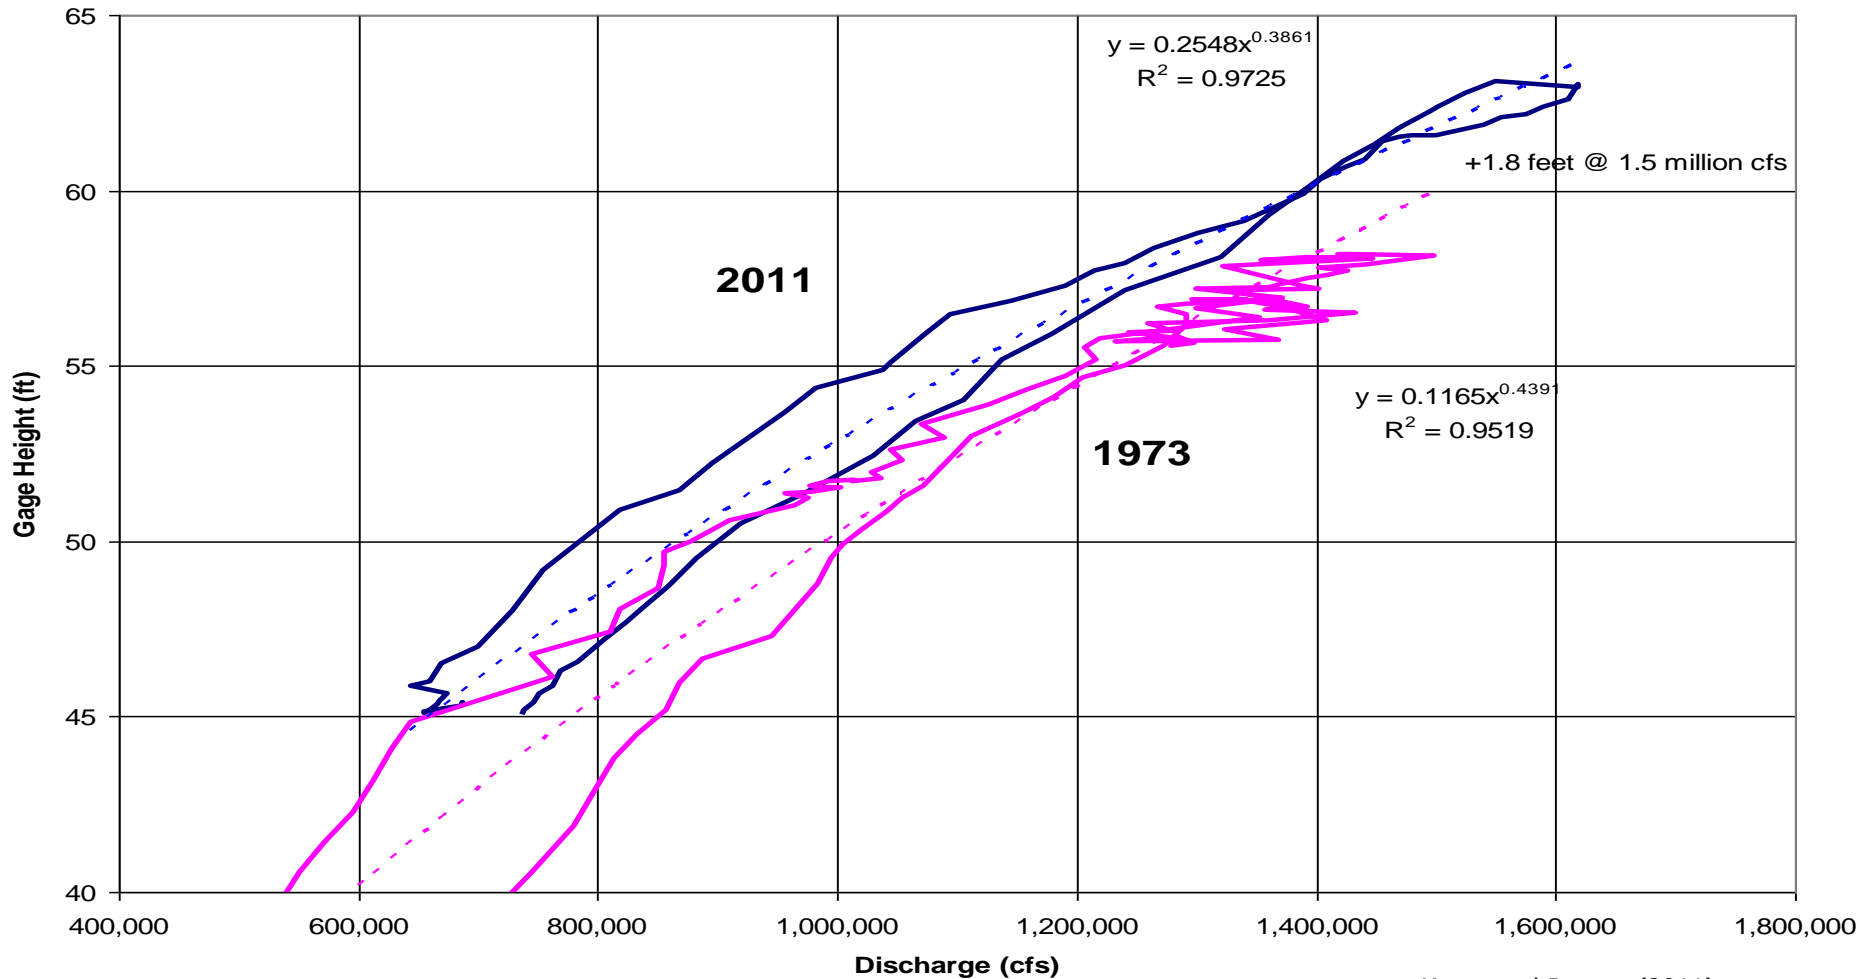
Comparison of Stage-Discharge Curves from 2011 and 1973 at Red River Landing

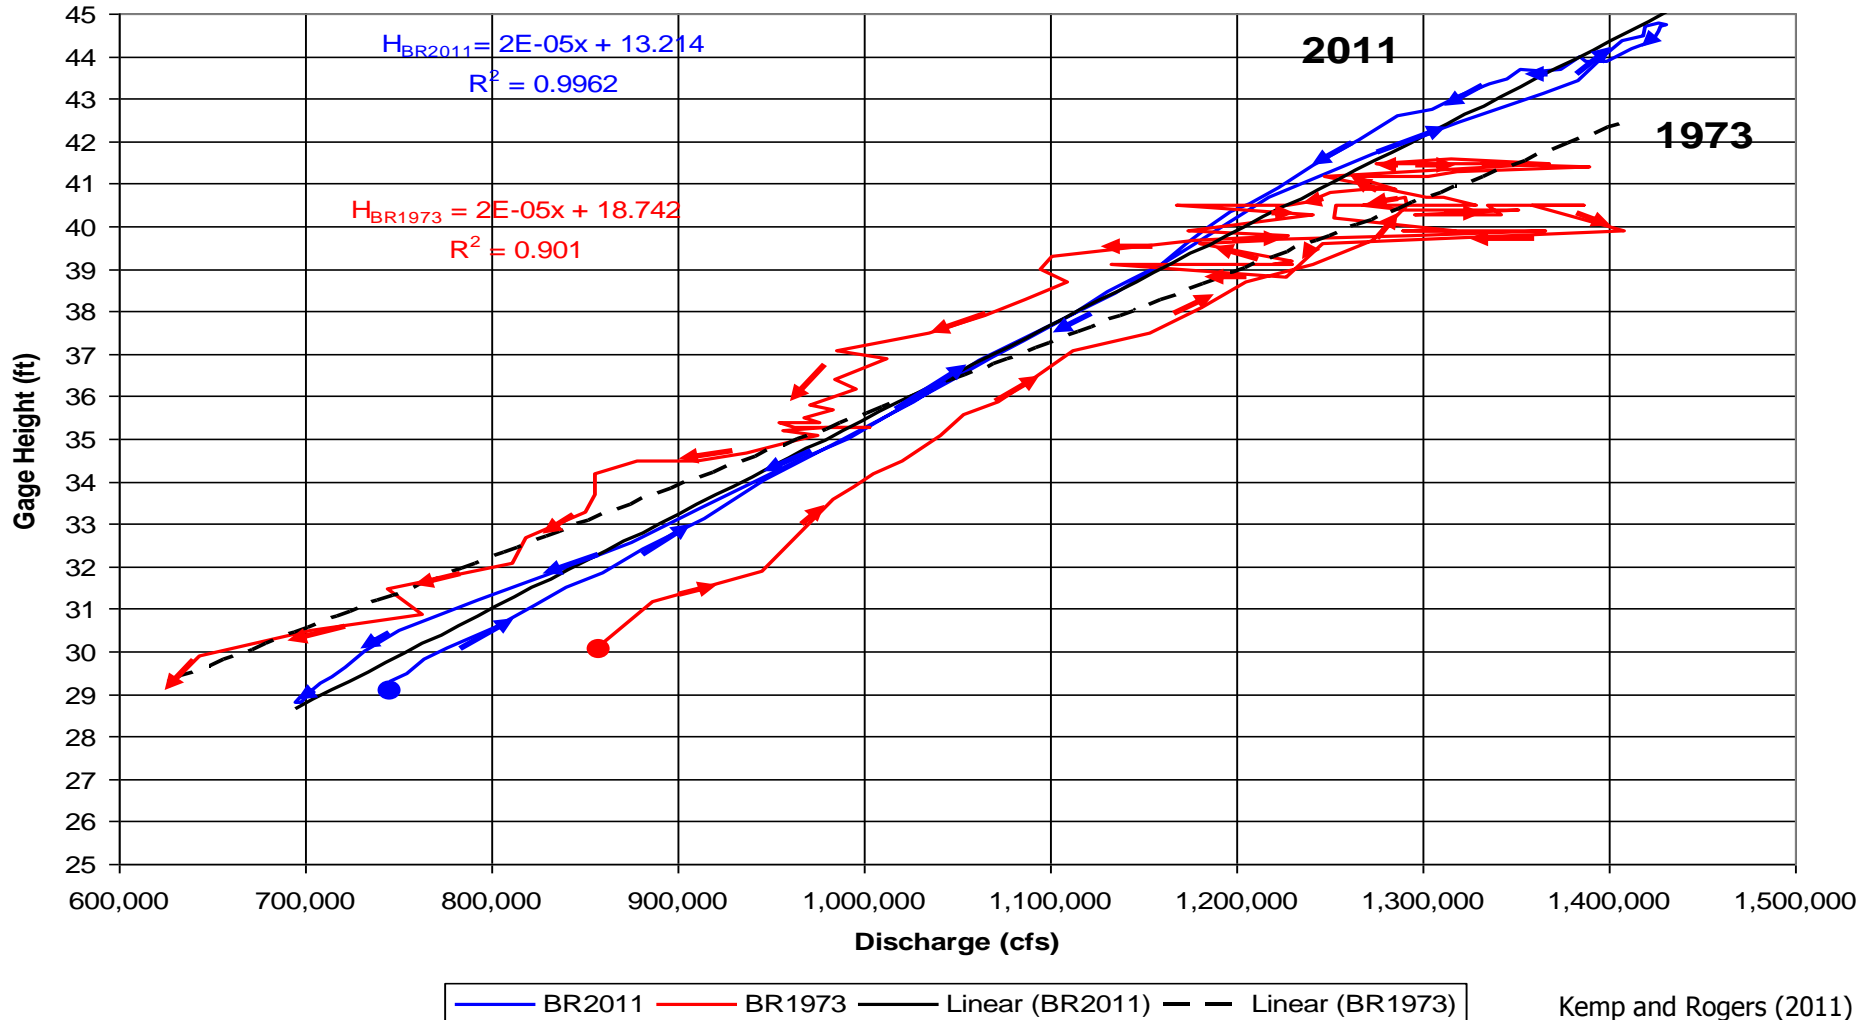
Comparison of Stage-Discharge Curves for the Mississippi River at Baton Rouge:  
1973 and 2011

+2 to 5 feet @1.4 million cfs

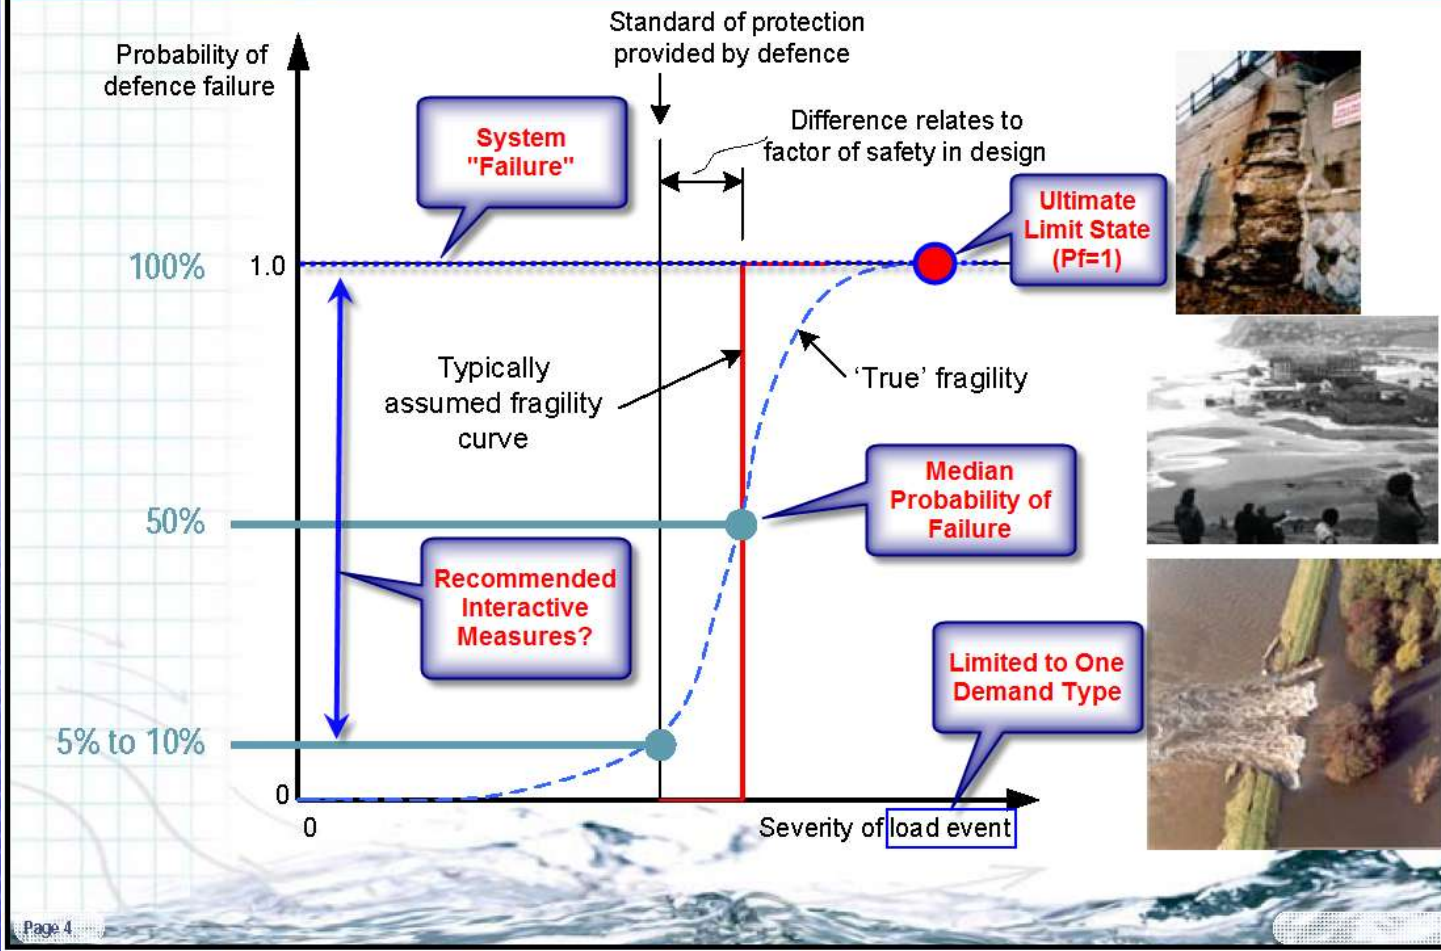
- Overview diagram of a fragility curve.** The y-axis represents the annualized probability of failure, while the x-axis represents loads of interest (such as river stage). Failure of the system occurs at a probability of failure equal to 1 (also known as the Ultimate Limit State). It can be very difficult to identify recommended interactive measures to manage increasing hazard levels. (modified from Simm, 2008; and Simm *et al*, 2010).

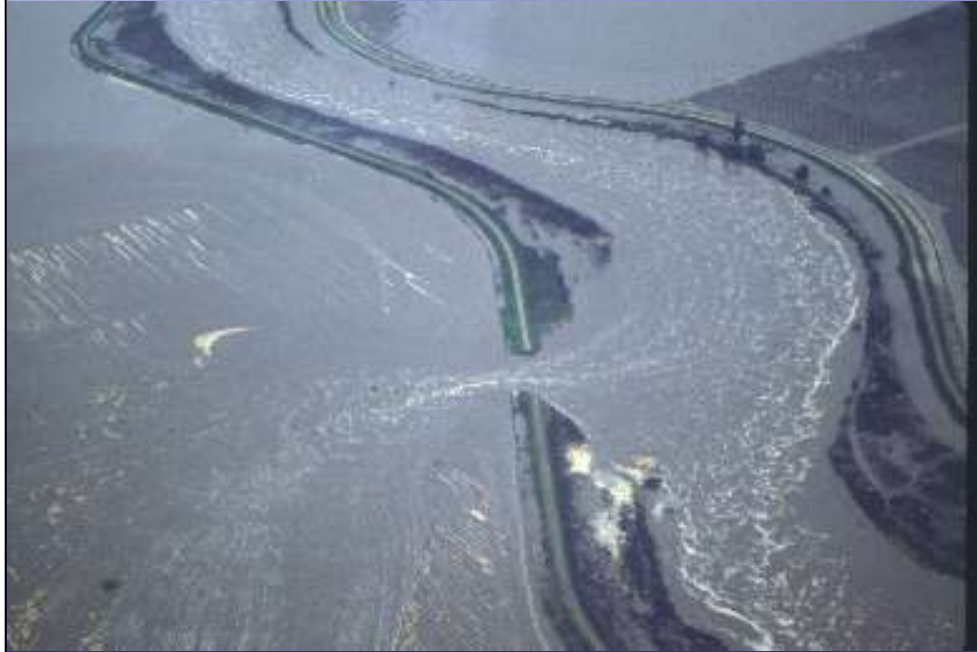
- A major shortcoming of levee is the differing foundation conditions upon which they are founded.

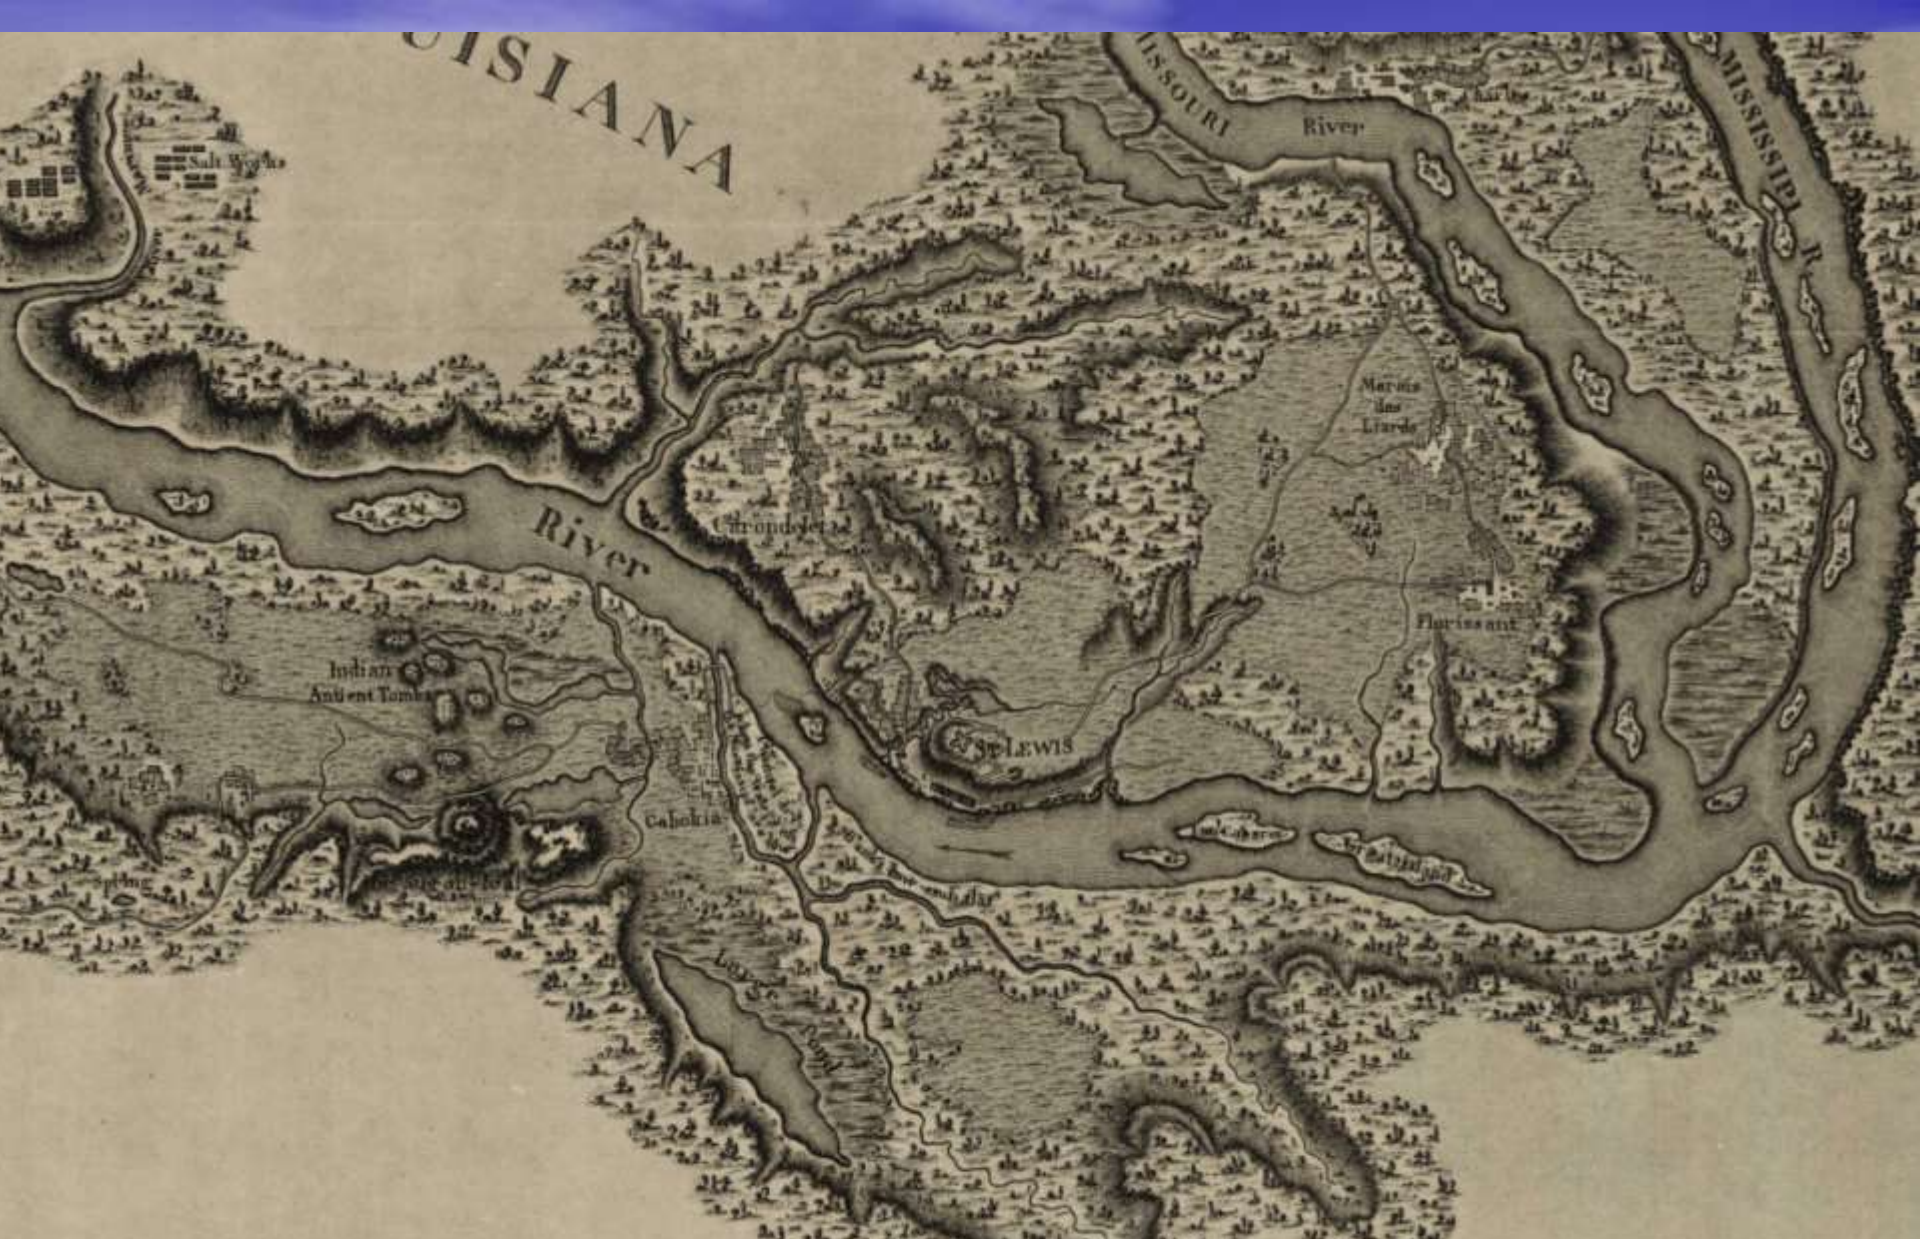
● 1796 Map of the St. Louis area by George Henri Victor Collot and P.F. Tardieu. Note all the lakes in the floodplain that no longer exist
